**Cell 1 Regional Coastal Monitoring Programme  
Walkover Inspection Surveys 2020**

**North Tyneside Council**

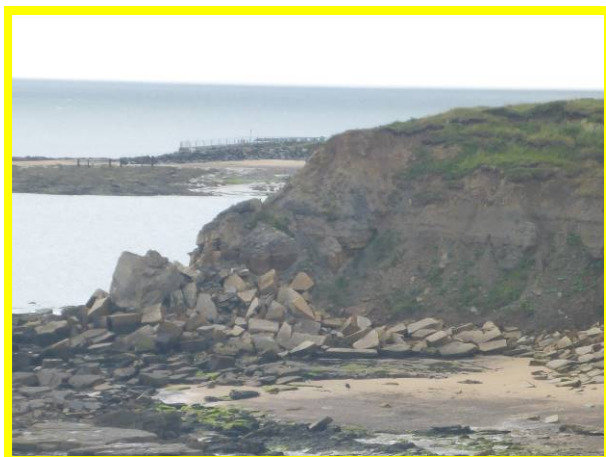
*Slippages in soft material along upper cliffs and rock fall at base (/4401C22)*

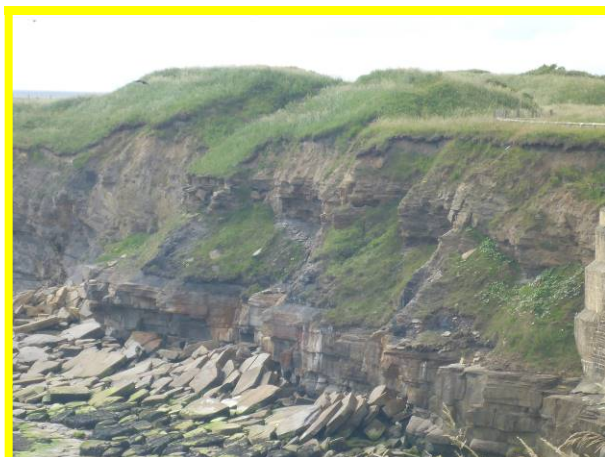
*Rock falls in hard material along lower cliffs (/4401C24)*

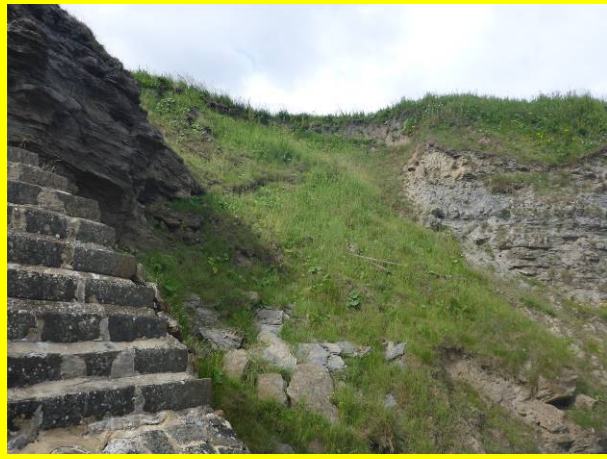
*Slippage from 2009 in soft material adjacent to Hartley Cove access steps (/4401C22)*

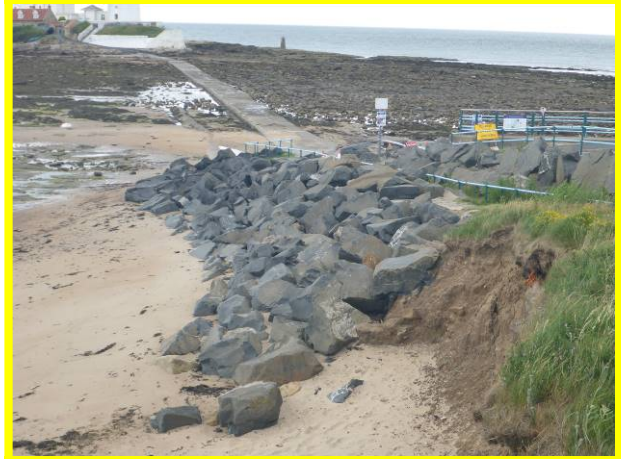
*Erosion adjacent to rock revetment by St Mary's Island causeway (/4401C24 & 25)*

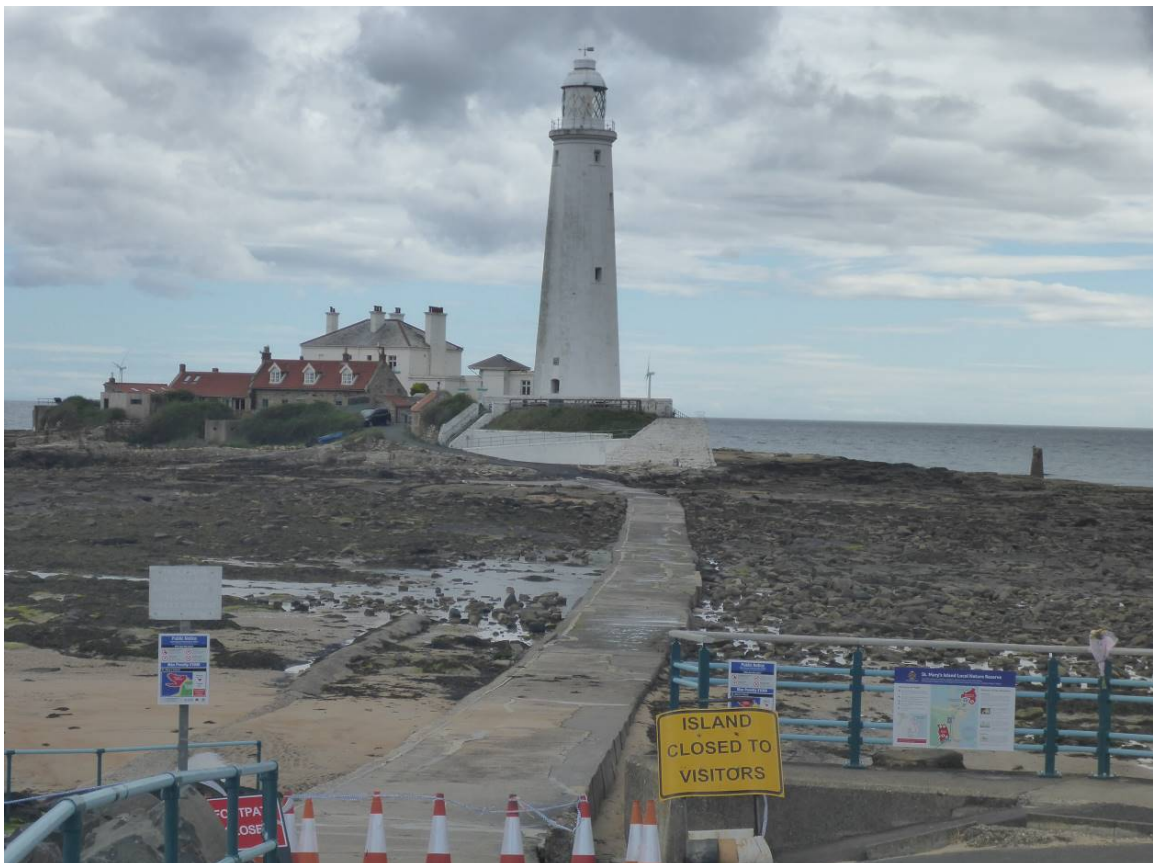
The Trinity Road seawall is generally well founded on the rock foreshore and in good condition with no signs of movement. There is clear evidence that previous repairs and ongoing maintenance have been undertaken and these mostly remain effective. There are some areas of wall where minor abrasion or spalling has occurred to the concrete face and some cold joints (cracks at construction joints) are apparent, but these do not deter from the overall effectiveness of the structure. The access ladders, promenade surfacing and shallow grass earth embankment behind the wall are in good condition. The handrailing was replaced prior to the 2018 inspections, using a style and colour consistent with the handrailing used elsewhere as part of the Whitley Bay Seafront Masterplan works.

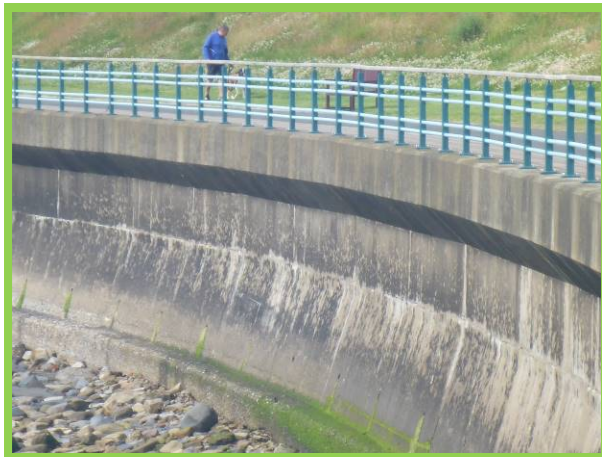
*Trinity Road seawall in good overall condition, but with some minor maintenance required (/4501C04)*

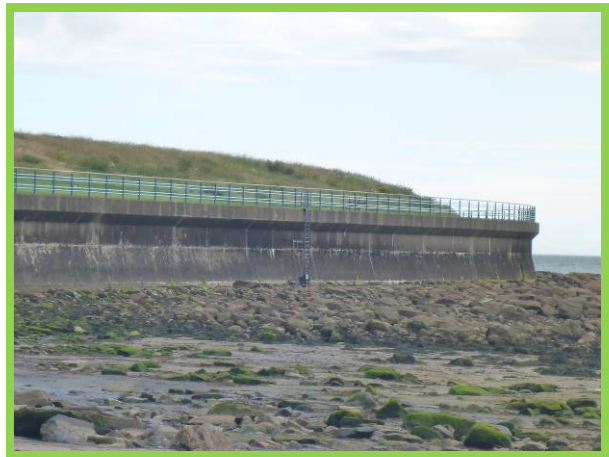
*Trinity Road seawall in good overall condition (/4501C04)*

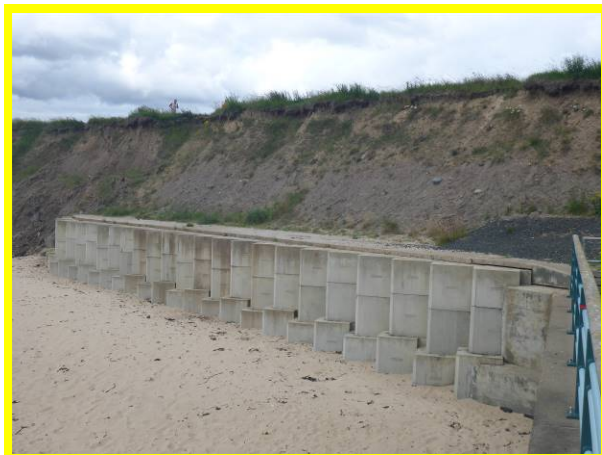
*New T-Block units (constructed in 2014) prevent outflanking at the southern end of Trinity Road seawall (/4501C05)*

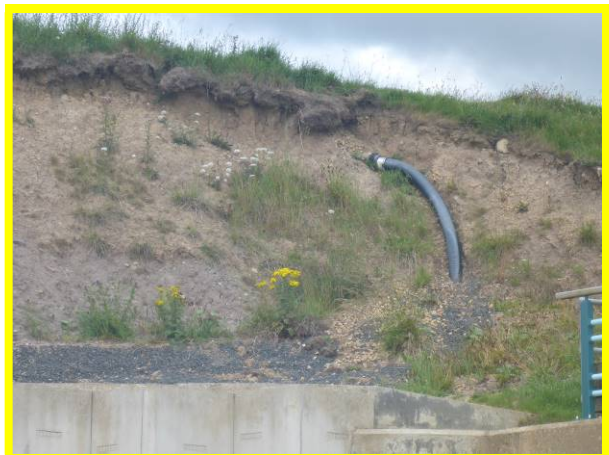
*Drainage added to cliffs above the T-Blocks (/4501C05)*

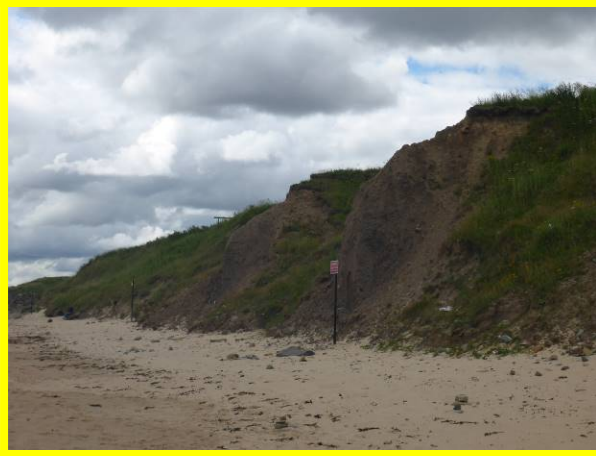
*Slumping undefended cliffs (/4501C05)*

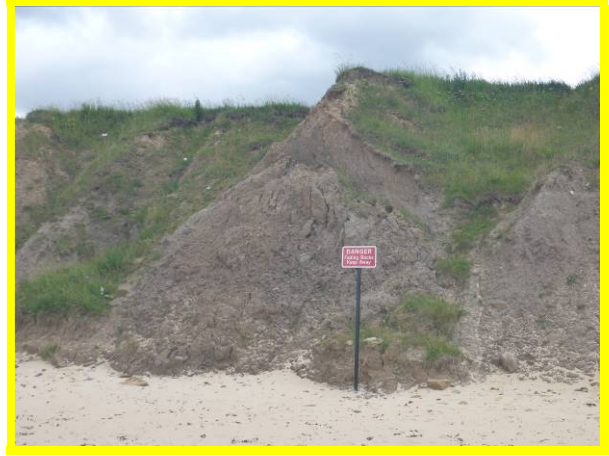
*Recently erected warning signs (/4501C05)*

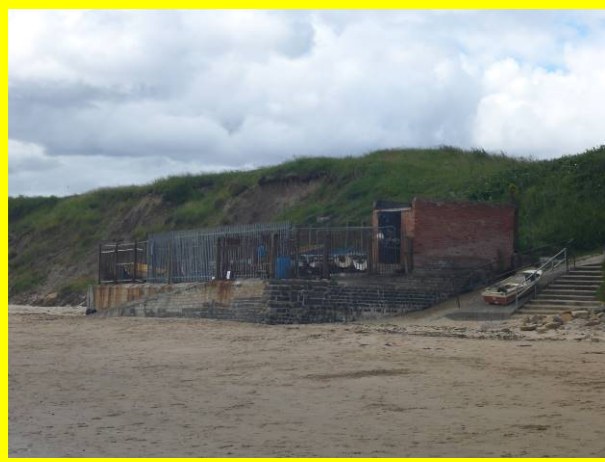
*Wall at boatyard (/4501C05)*

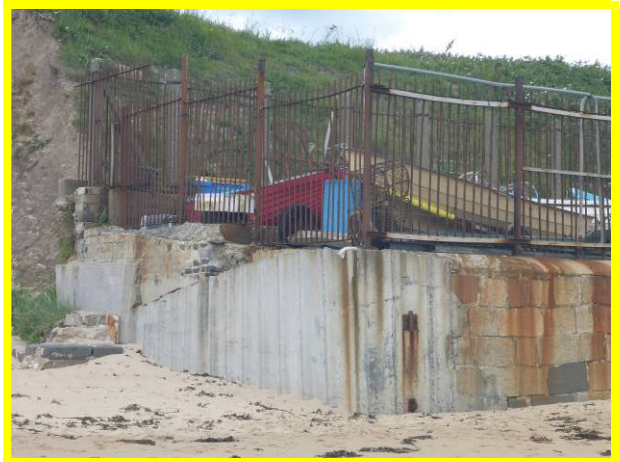
*Wall at boatyard (/4501C05)*

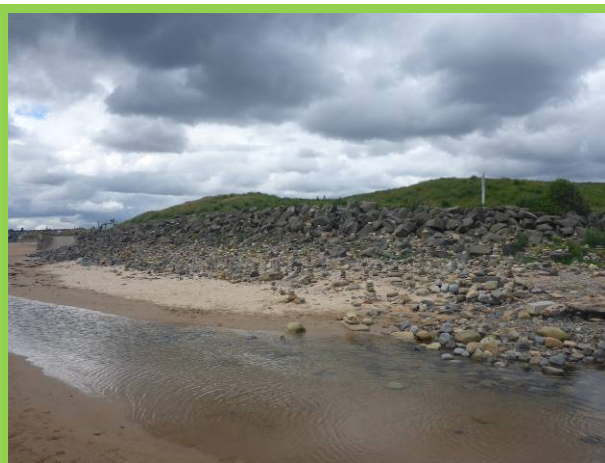
*Rock revetment near Briardene Burn (/4501C06)*

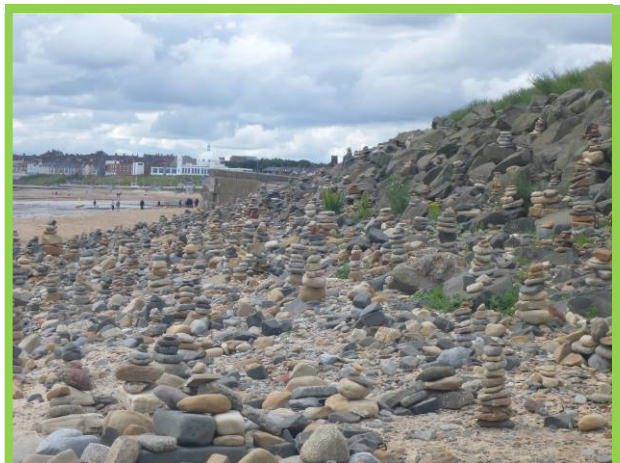
*High cobble berm near Briardene Burn (/4501C06)*

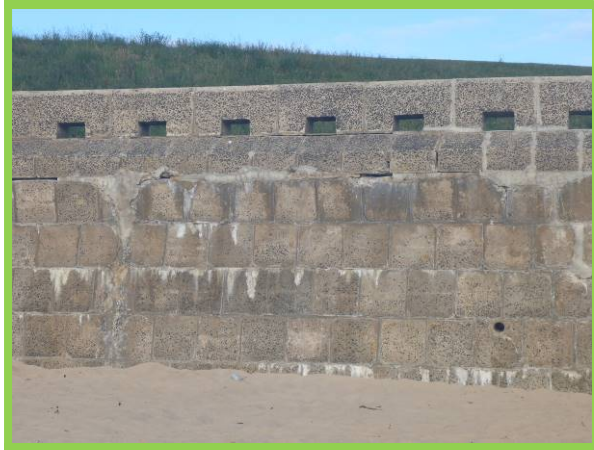
*Previous repairs and local open joints which would benefit from maintenance (/4501C07)*

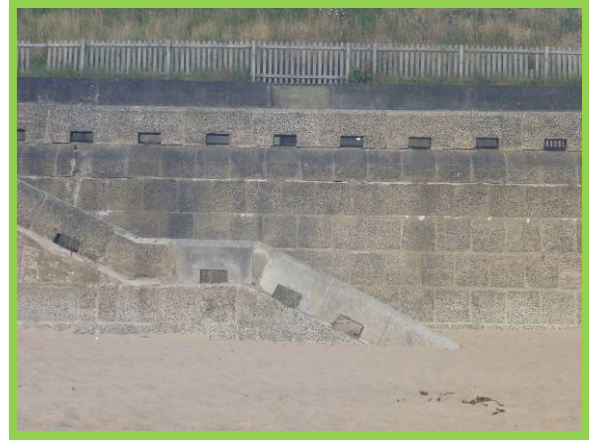
*Seawall and access ramp (/4501C07)*

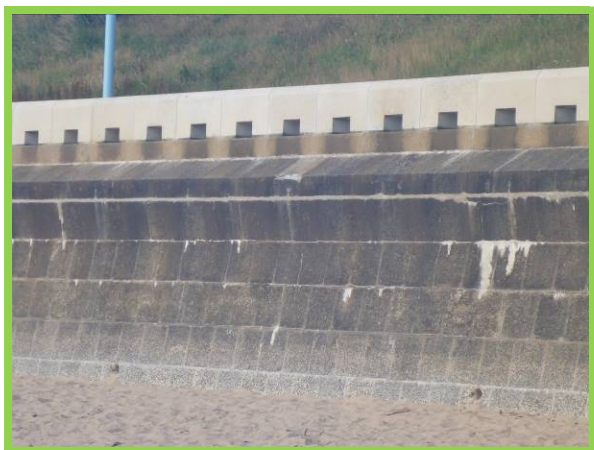
*New coping on blockwork seawall (/4501C07)*

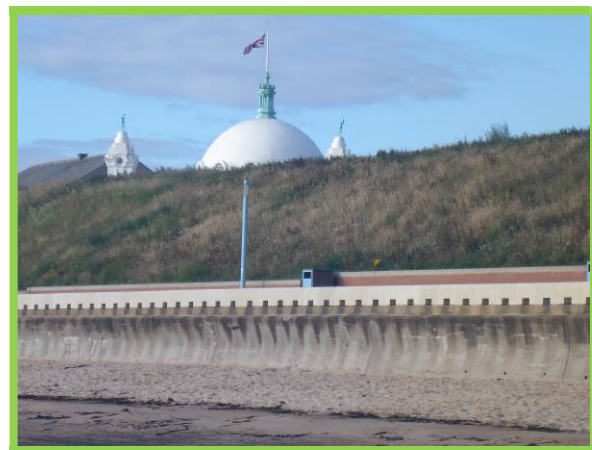
*New coping on concrete recurved seawall (/4501C08)*

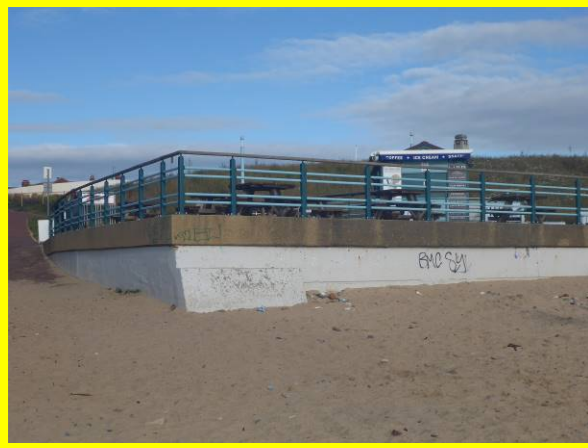
*Refurbished seawall north of beach access ramp (/4501C09)*

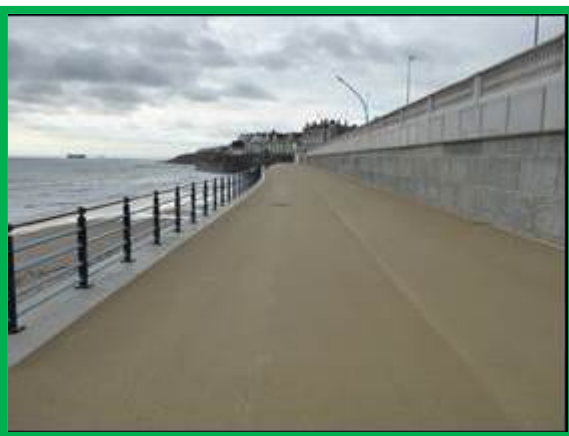
*Refurbished promenade (/4601C03)*

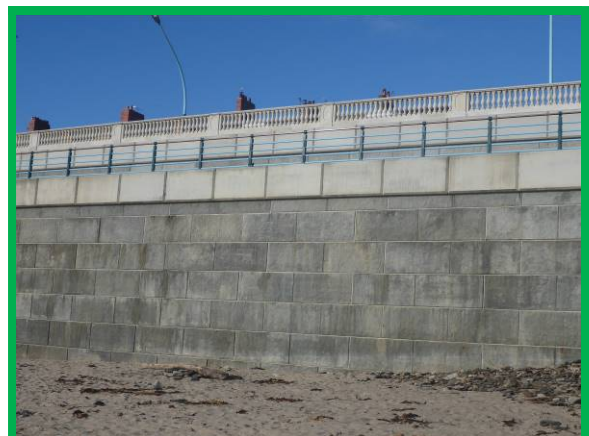
*Refurbished sea wall (/4601C03)*

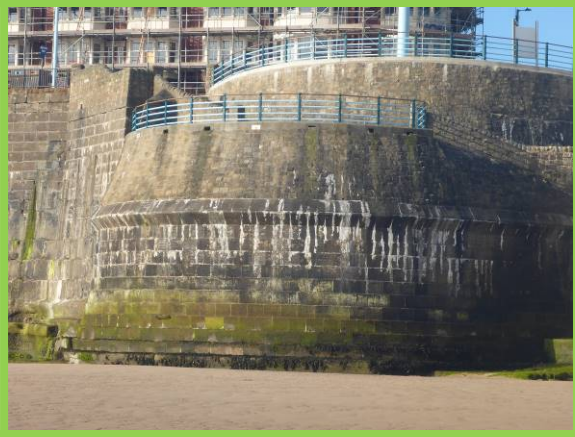
*Blockwork sea wall at first 'bullnose' (/4601C04)*

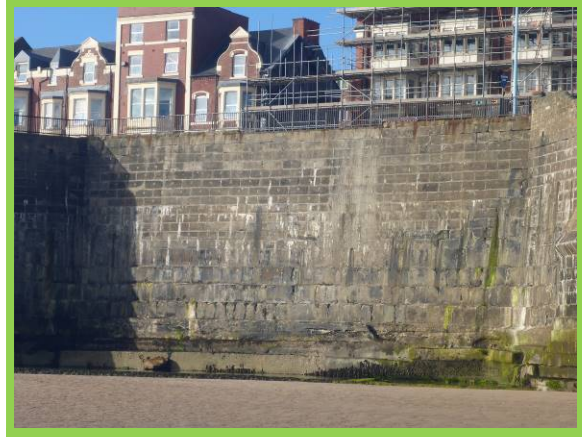
*High blockwork sea wall (/4601C04)*

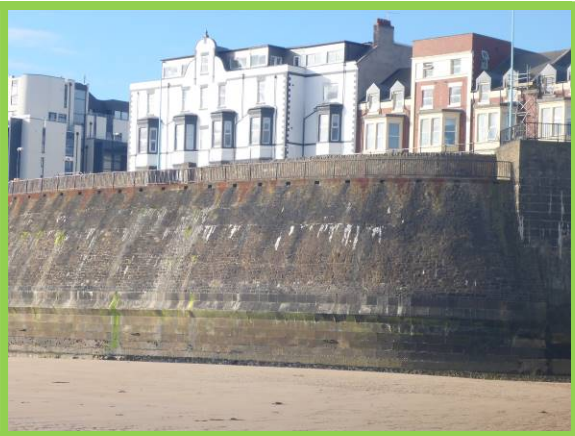
*High blockwork sea wall (/4601C05)*

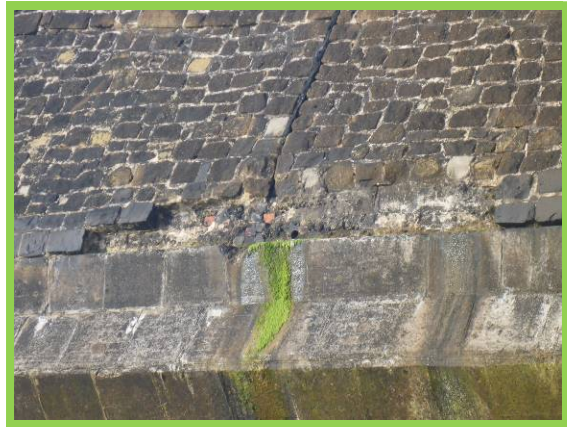
*Missing brickwork (/4601C05)*

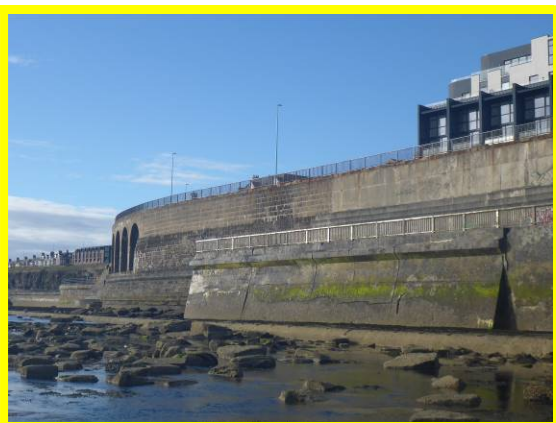
*Intermediate sea wall between Central and Southern Promenades (/4601C06)*

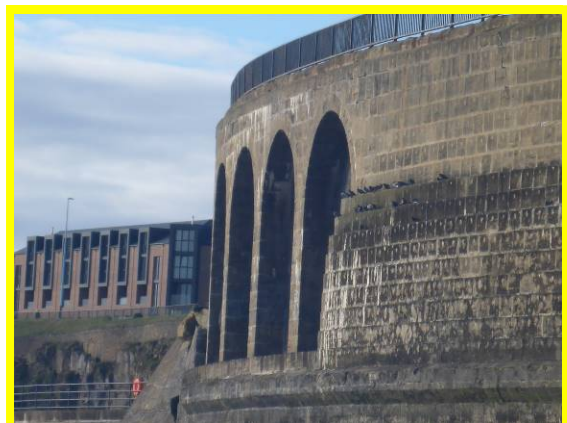
*High masonry blockwork wall with infilled arches (/4601C07)*

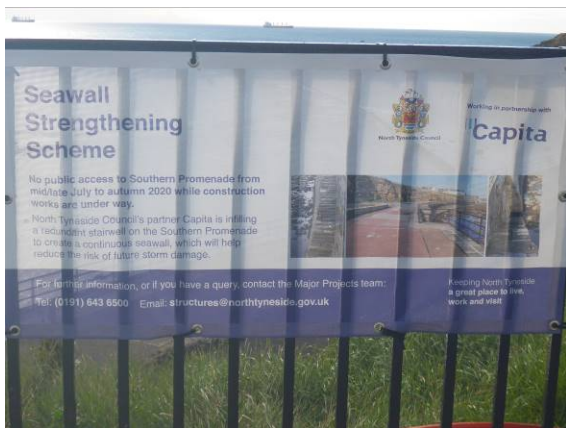
*Intermediate sea wall between Central and Southern Promenades (/4601C08)*

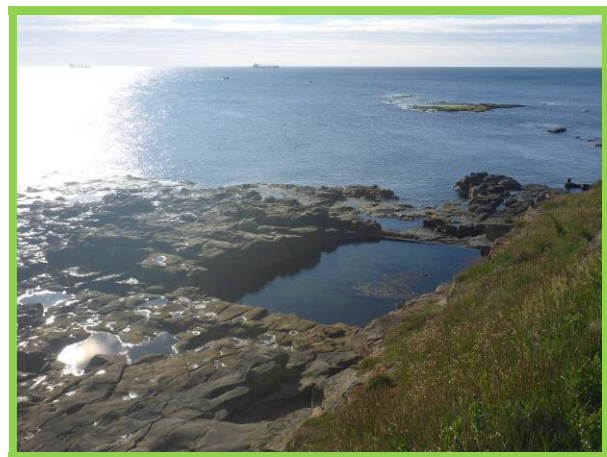
*Tidal pool (/4601C09)*

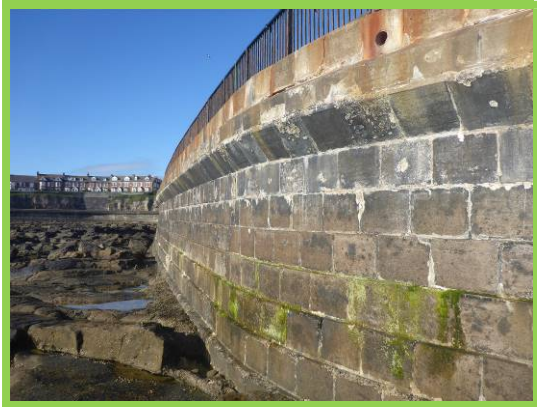
*Brown's Bay northern sea wall in generally fair condition (/4601C10)*

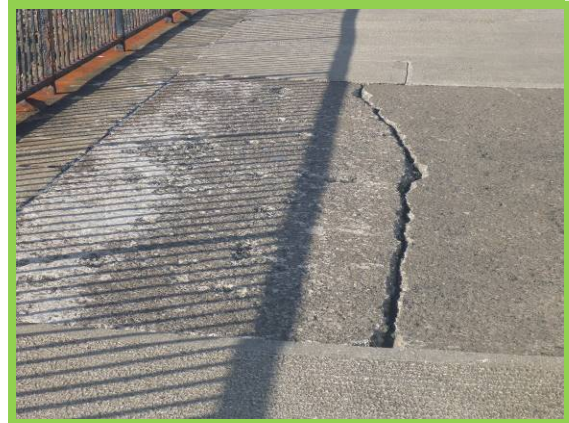
*Surface cracks in promenade deck at northern end (/4601C10)*

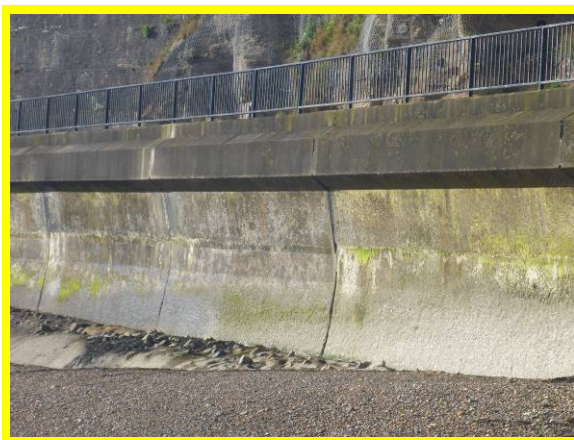
*Brown's Bay southern sea wall in generally fair condition (/4701C01)*

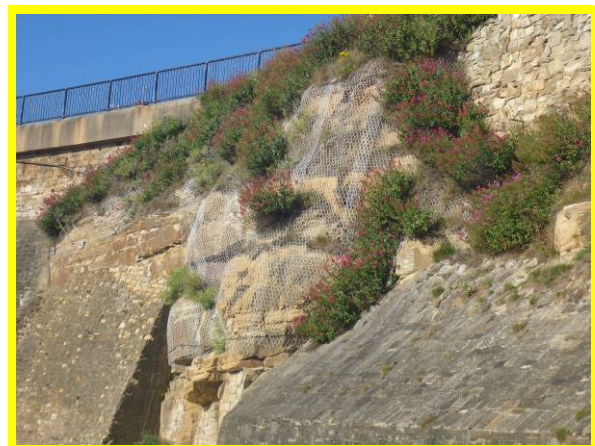
*Rock bolts and netting on slopes to rear of promenade (/4701C01)*

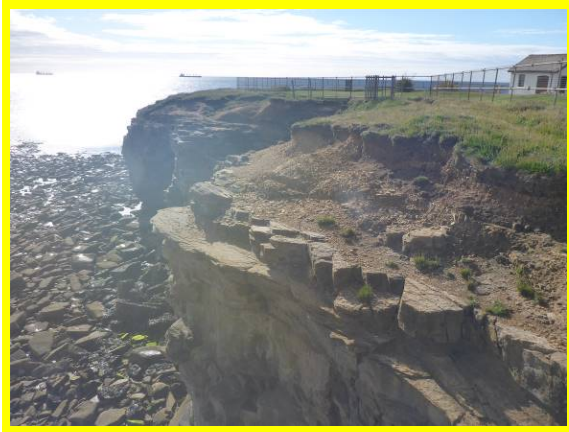
*High rock cliffs with thin capping of till on northern side of Brown's Point (/4701C02)*

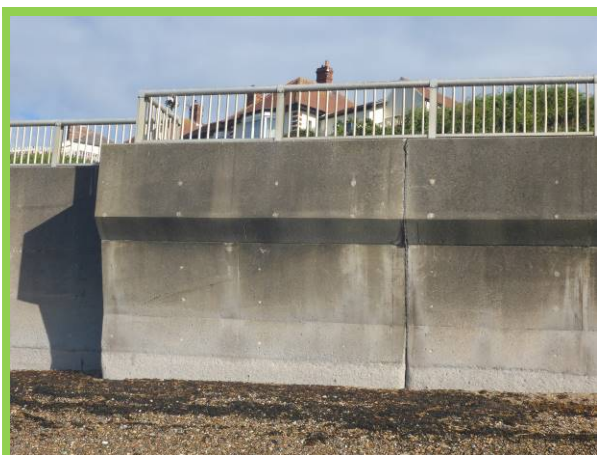
*First section of sea wall in generally good condition (/4701C04)*

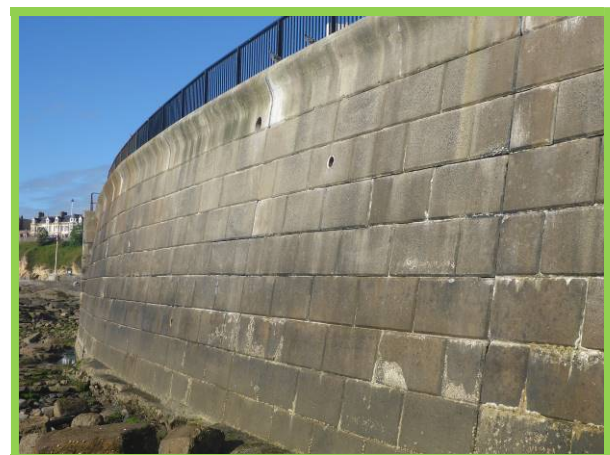
*Middle section of sea wall in generally good condition but with face abrasion (/4701C05)*

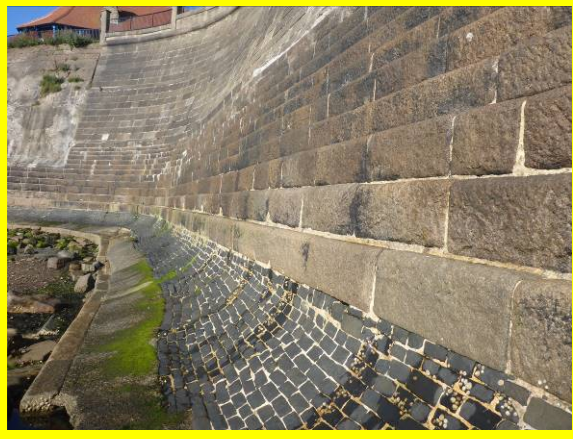
*Final section of sea wall in generally fair condition (/4701C06)*

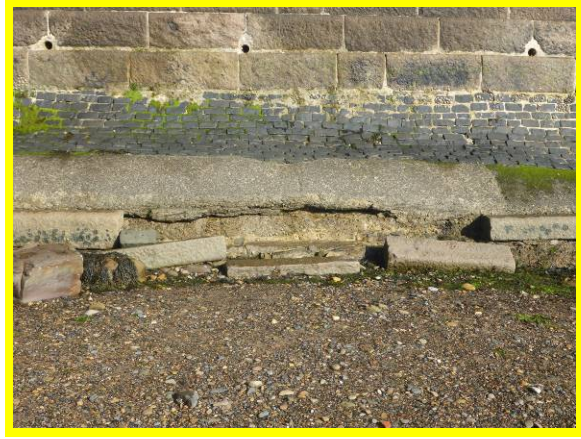
*Some defects at the toe apron (/4701C06)*

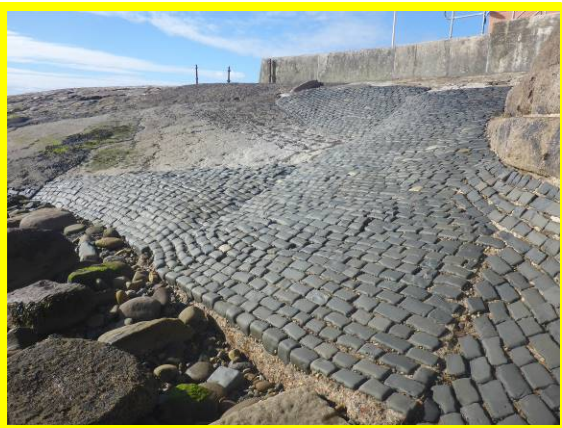
*Tie-in section between wall and pier (/4701C06)*

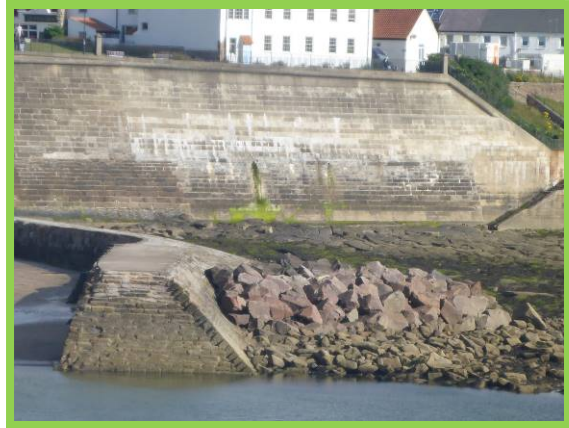
*Cullercoates North Pier – seaward end with rock armour emergency repair (/4701C07)*

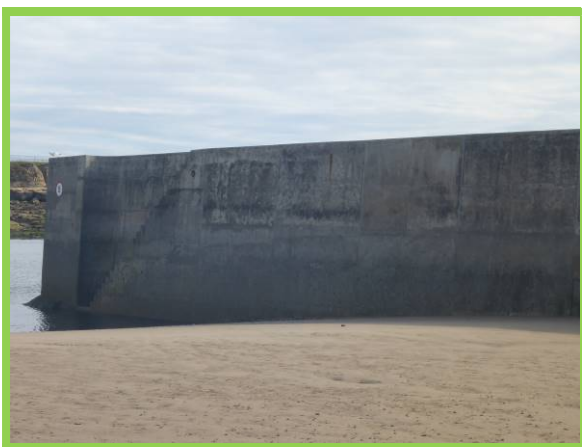
*Cullercoates South Pier – deck and vertical landward face (/4701C15)*

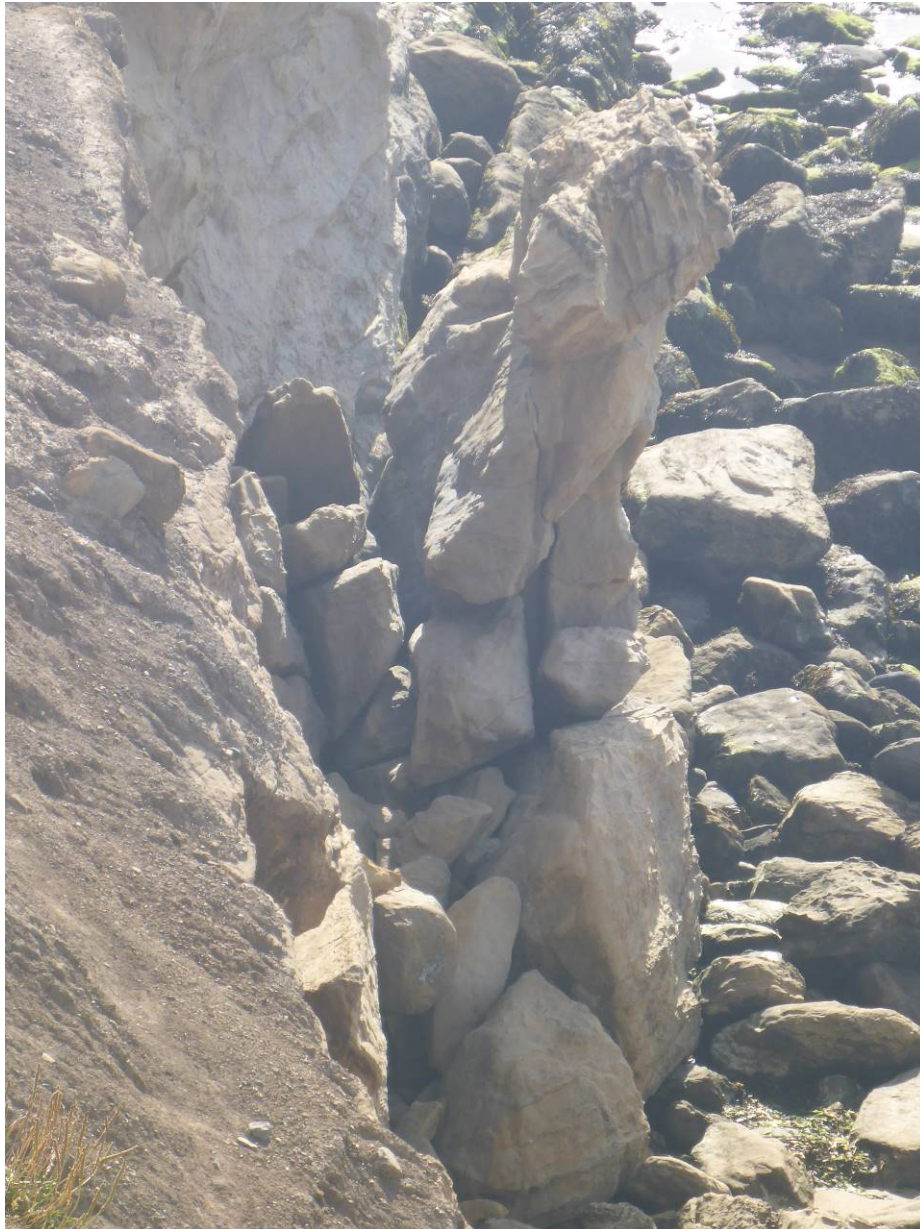
*Fragmenting rock stack near Tynemouth North Point  
that has the potential to topple (/4701C16)*

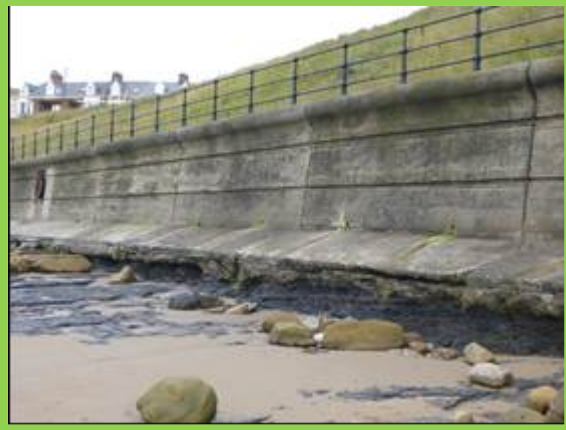
*Undercutting and exposure of coal at toe of wall from 2018 inspections (/4701C18)*

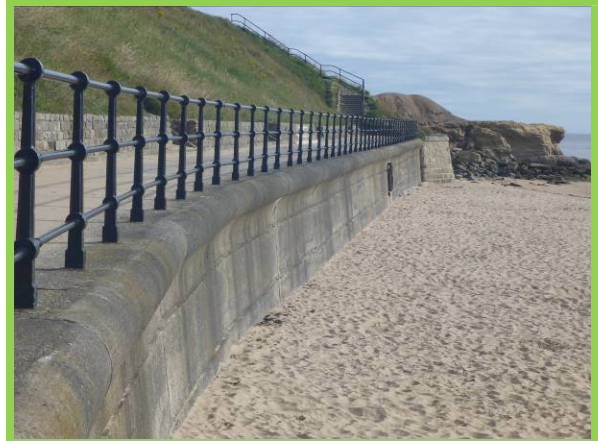
*Higher beach levels at wall's toe in 2020 inspections (/4701C18)*

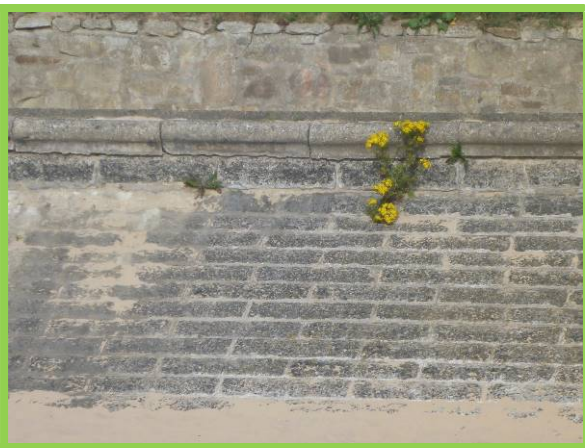
*Sloping blockwork revetment (/4701C19)*

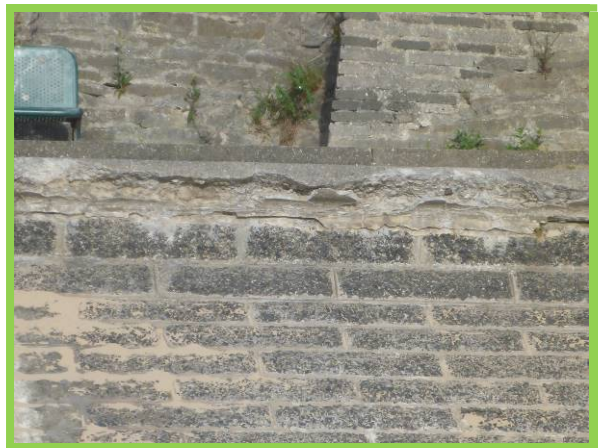
*Abrasion damage to the revetment crest (/4701C19)*

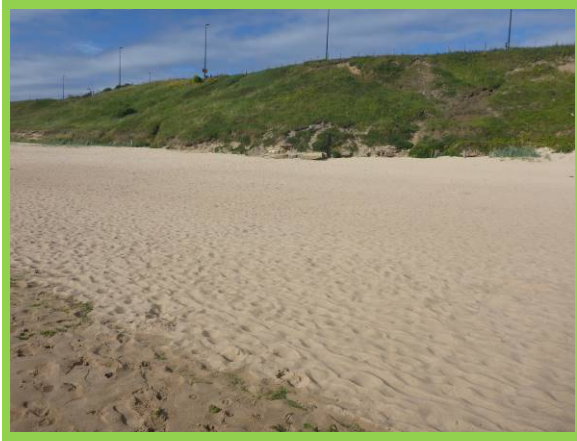
*Very healthy beach and dunes along Long Sands (/4701C21)*

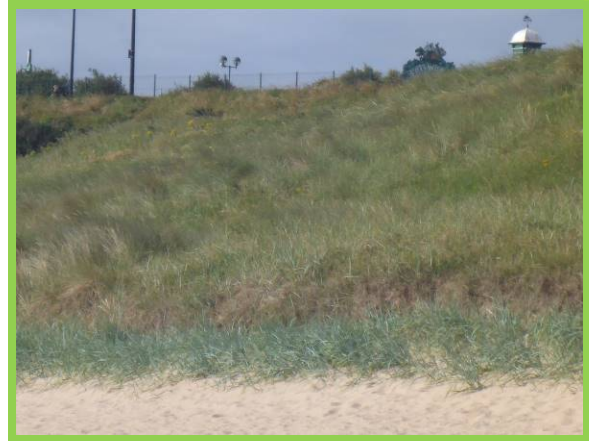
*Stable and well vegetated dunes along Long Sands (/4701C21)*

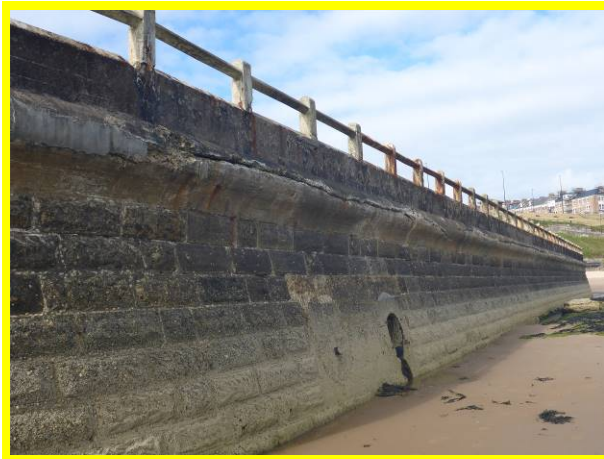
*Wall abrasion at the Outdoor Pool (/4701C24)*

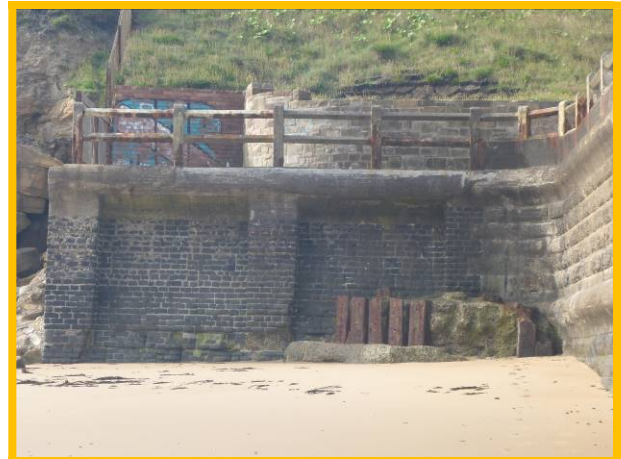
*Tie-in wall between Outdoor Pool and undefended rock cliffs (/4701C25)*

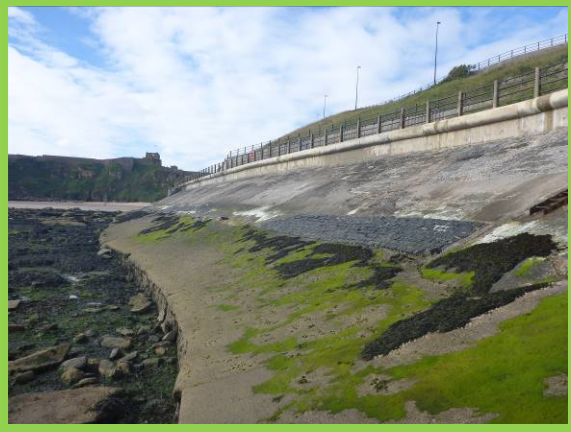
*Sea wall in fair condition with damage and abrasion of the apron (/4701C27)*

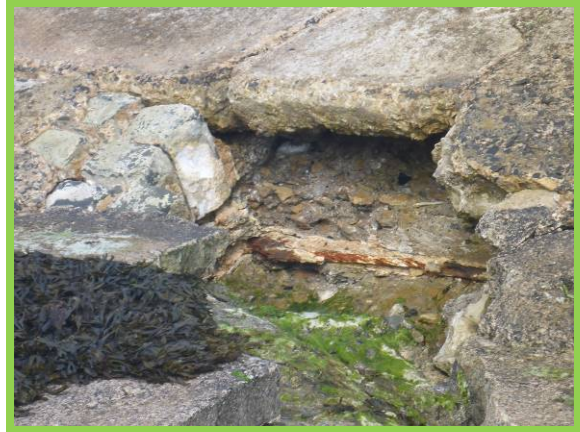
*Damaged apron (/4701C27)*

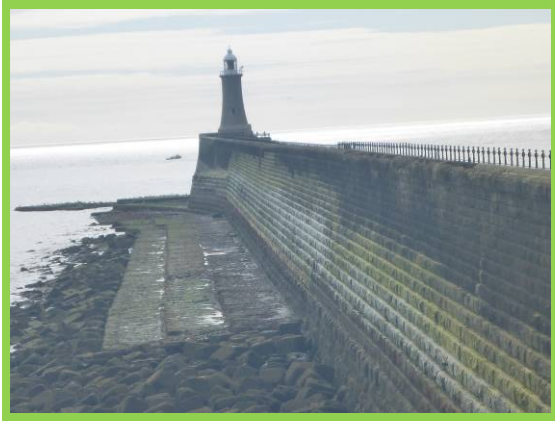
*North Pier appears in good overall condition and is well maintained (/4801C01)*

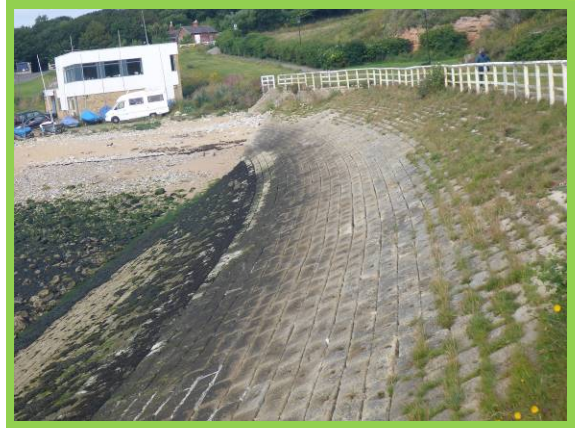
*Masonry revetment (/4801C02)*

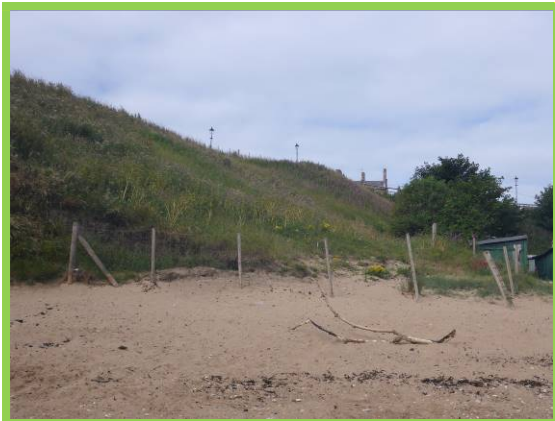
*Dune restoration at Prior's Haven (/4801C03)*

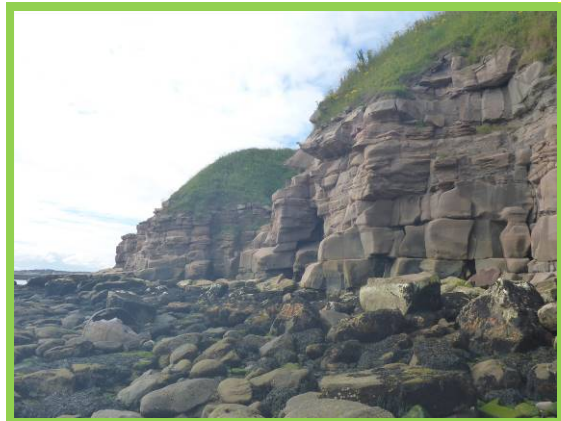
*Rock headland at Freestone Point (/4801C11)*

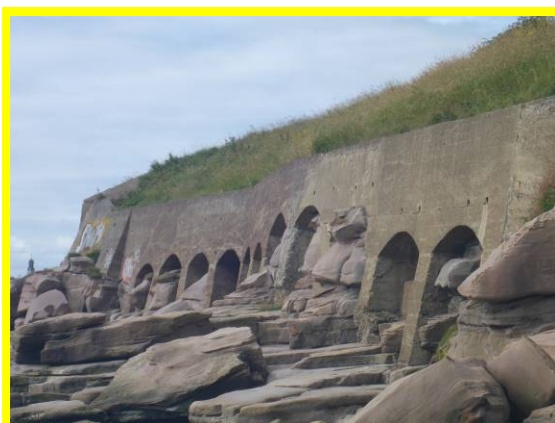
*Masonry and concrete arched seawall (/4801C04)*

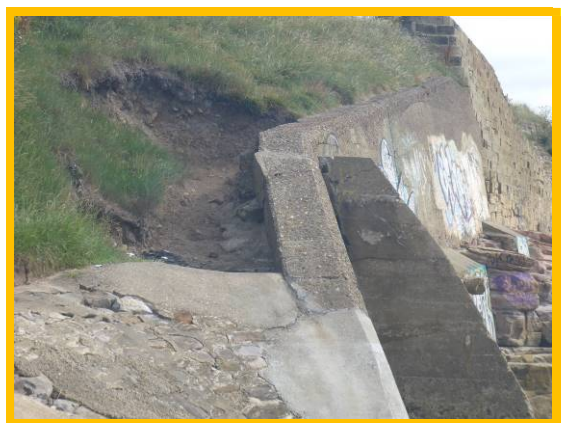
*Erosion above wall (/4801C06)*

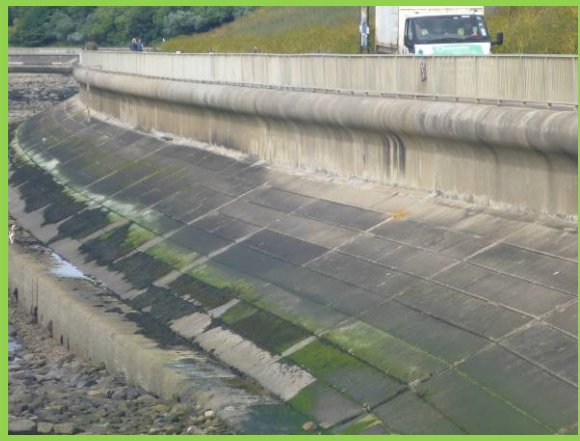
Concrete panel sloping revetment and short concrete toe wall (/4801C07)

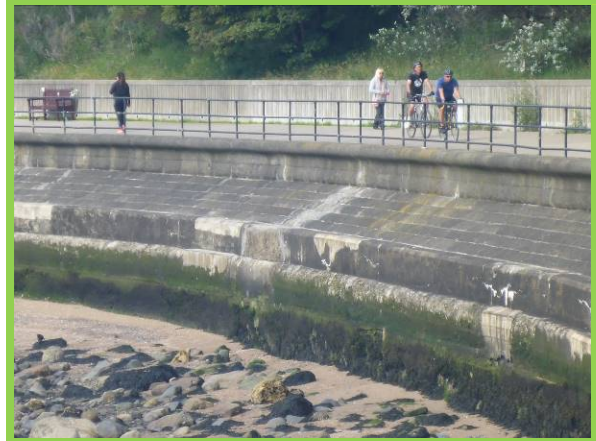
Concrete panel sloping revetment and high concrete toe wall (/4801C08)

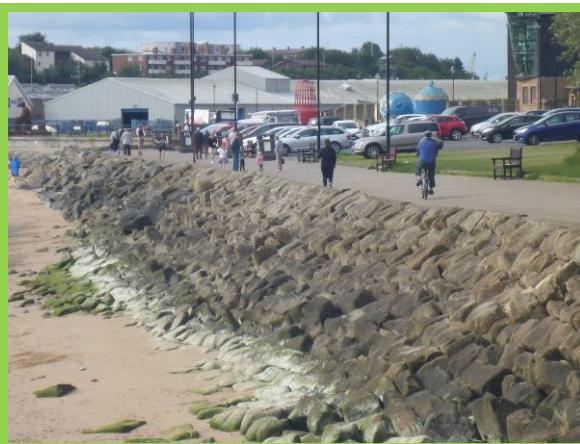
Masonry and concrete arched seawall (/4801C09)
