Northumberland and North Tyneside Coastal Monitoring Programme

Defence Inspection Overview 2008

September 2008
Inspection Report
9S0776

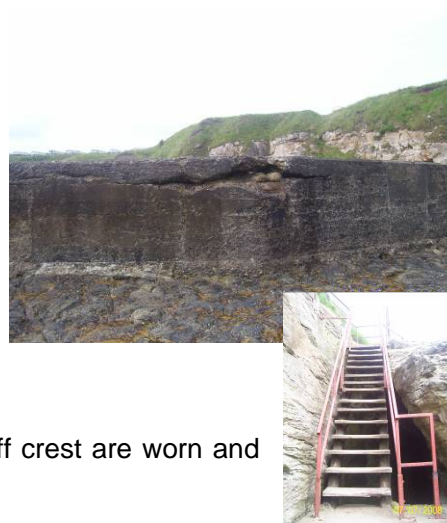
The wooden steps to providing access from the cliff crest are worn and potentially dangerous.

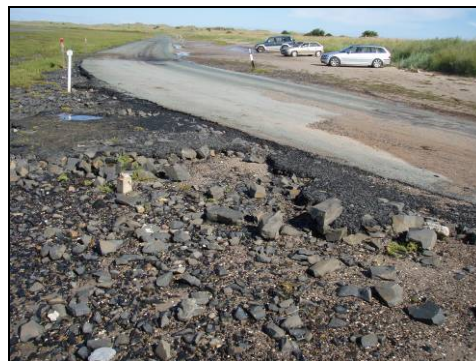
There are currently no issues of immediate or major concern on Holy Island. The minor issues noted included high exposure of the main road just before it rounds a bend and approaches the tourist car park. This is caused by a lack of fronting marsh to dissipate incoming energy before it impacts on the road edge. Some asphalt repairs have been made but the exposure continues.

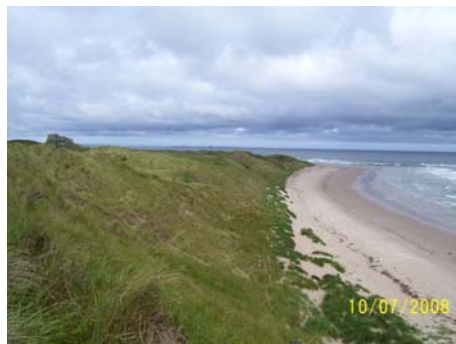
At Warren Mill there was no significant deterioration of structures. The blow out to the dunes noted in previous year's reports now has a substantial fore-dune growth closing the entrance to the blow out. There has been a general increase in volume of sand over Harness Rocks headland and this tends to extend down past Bamburgh. Much of the erosion to the toe of the dunes is now reversed with some areas of new fore-dune growth. This reflects a capacity for the frontage to respond to storms and the availability of sand over the foreshore to repair periods of damage.

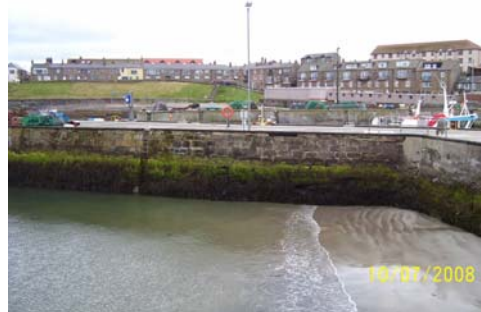
There are reports of some undermining towards the head of the main breakwater. This could not be confirmed due to water levels and this will be inspected separately. Otherwise the breakwater remains in reasonable condition. The only point noted within the harbour was that stones are missing beneath the timber coping to the inner breakwater. This would not appear to be significant risk at present but will need to be addressed to stop further deterioration.

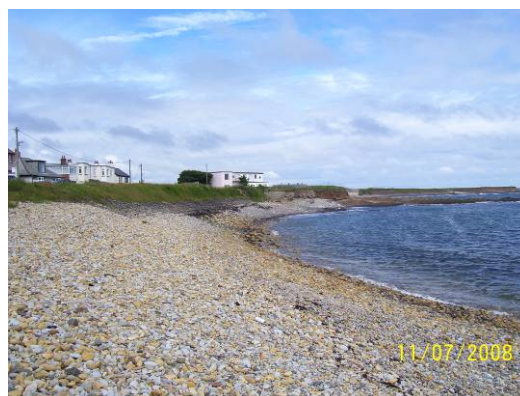
The rocky cliffs around Beadnell Haven and Red Brae are generally stable however there is evidence of erosion to the vegetated slope above the rocks.

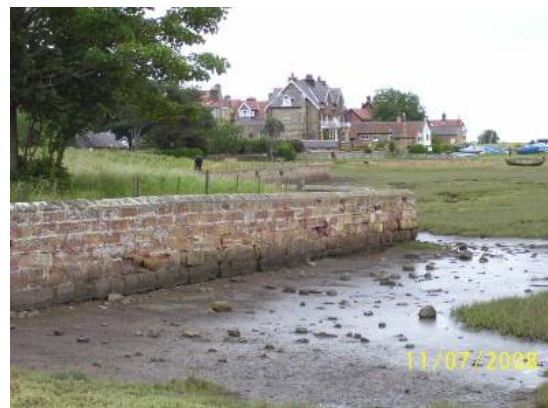
The wall to the back of the salting has suffered significant loss of pointing and potential movement. Some areas of previous repointing have subsequently cracked. Particularly at the corners, the wall may be in danger of collapse. Although only protecting fields, the wall also acts as pathway through to the road bridge. Work is required to improve the condition of this wall.

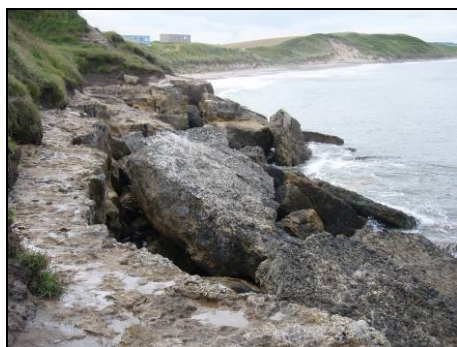
South of the mouth of the River AIn estuary the dunes at Buston Links are subject to ongoing erosion on the seaward face and concrete anti-tank blocks have been used in places at the dune toe in attempt to provide some stabilisation.

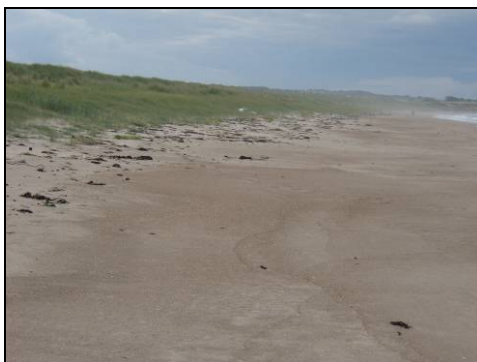
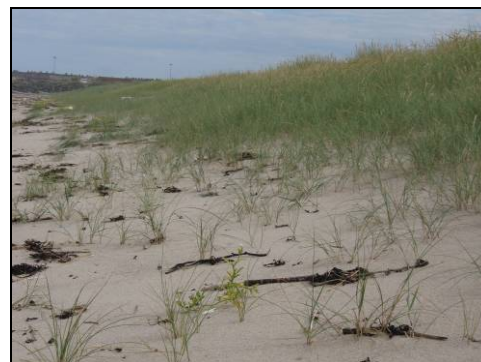
The most southerly zone exhibits very stable dunes fronted by relatively high beach levels (below left). Here, pioneer dune vegetation is growing (below right) and the backing dune system is very healthy and unaffected by erosion.

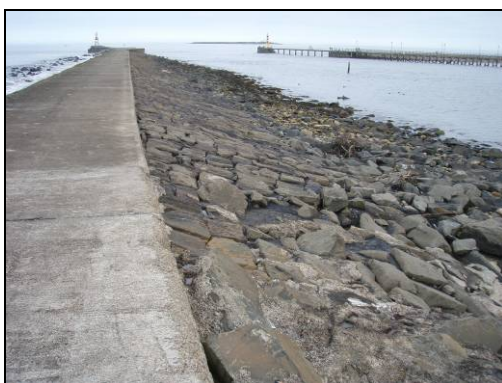
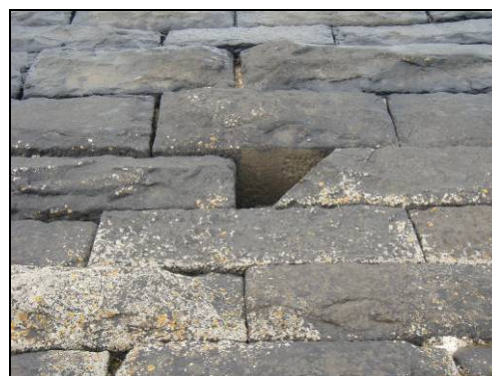
The North Pier at Warkworth Harbour is sub-divided into three defence units. The shore-connecting inner section is in reasonable condition and is well protected by rock armour on both sides. The mid section, however, is starting to exhibit some signs of displacement on the harbour-facing side (below left) and damage to blockwork on the seaward-facing side (below right) but overall remains in a fair condition.

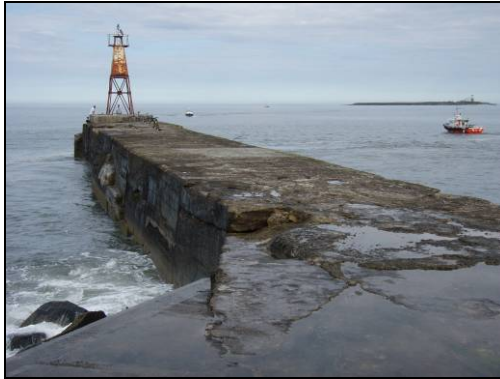
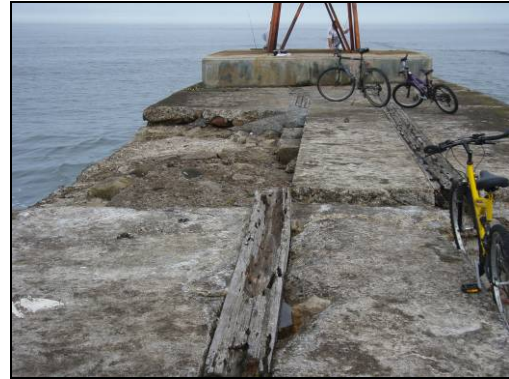
The outer pier end, however, as noted in previous reports is in a bad condition and remains disconnected from the main pier (below). The pier end is used by anglers and access to it remains a health and safety hazard. The pier end failed almost immediately after being constructed since it is not constructed on rock foundations. A study in 1980 (RT James) concluded that the northern tip of the breakwater served no significant coast protection function, so any remedial work would not attract Grand-in-Aid from central government's coastal defence budgets unless this view was revisited.

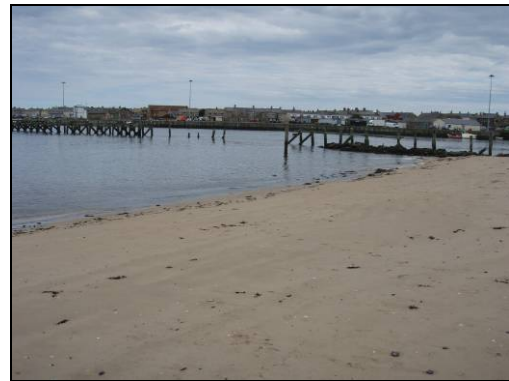
The north shore Wave Basin, in the lee of the North Pier, is exposed to waves propagating through the harbour mouth. There is considerably storm debris deposited on the beach and the North Jetty is almost totally dilapidated. Due to ongoing siltation problems in the harbour, land based plant is often used to excavate sand from south of the North Jetty and place it over the North Pier onto the beach at the southern end of Alnmouth Bay.

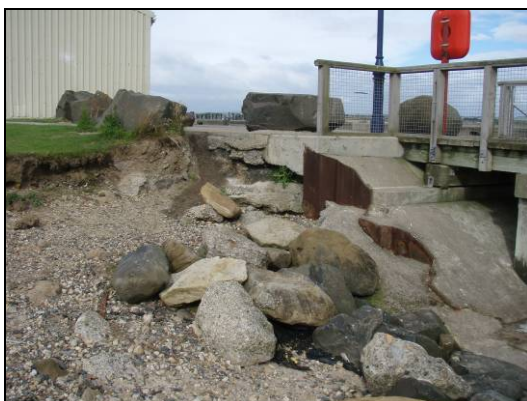
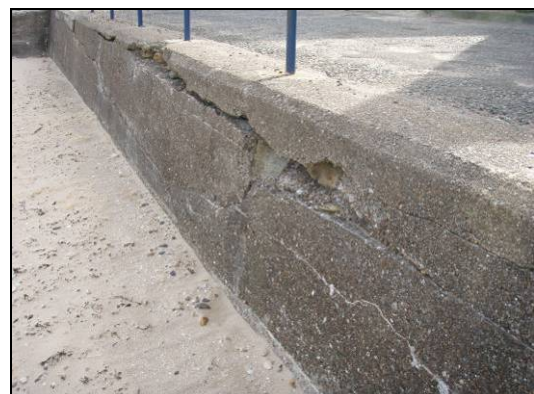
At the root of the recently refurbished South Jetty, there is a short section of rock revetment (below left) which has continued to be outflanked and overtopped resulting in further erosion of grassland behind. Elsewhere within the Little Shore Wave Basin the condition of the seawall and access ramp remains bad and this is in need of repair in several areas before wall failure occurs (example below right).

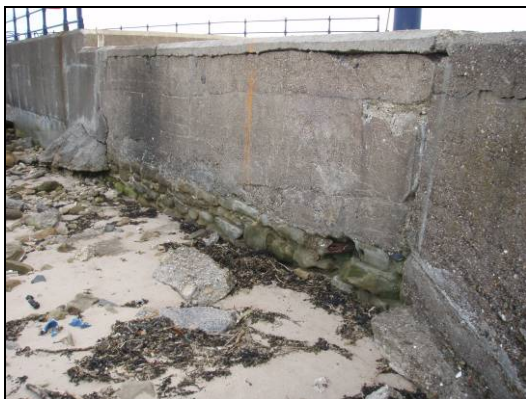
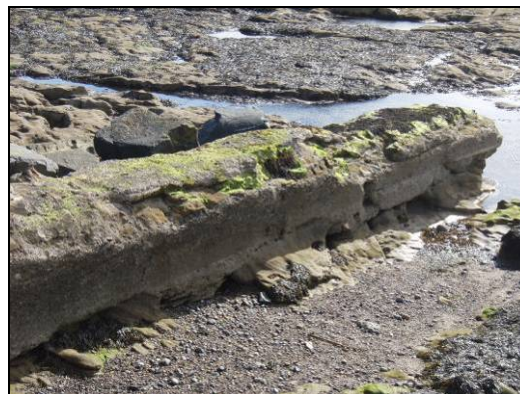
The inner face of the South Pier requires some attention (toe and cracks) at either end (below left), although the central section is in reasonable condition. The outer face is generally reasonable, except for longitudinal cracking along its southern most section. There is also major abrasion of the short concrete stub groyne (below right).

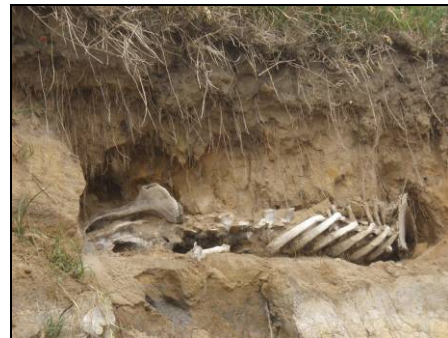
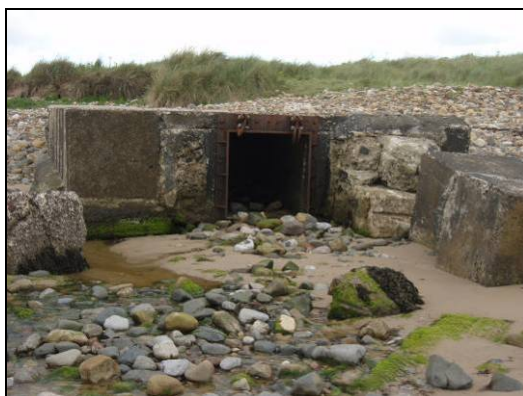
Along Togston Links to Hadston Carrs, the dunes are continuing to erode in localised sections on their seaward face through ongoing processes of slumping. This has exposed a dead animal carcass in the upper section of dune (right). The localised erosion to the immediate north and the immediate south of the piped outlet has also cut back to the access road and car park along this section in one location.

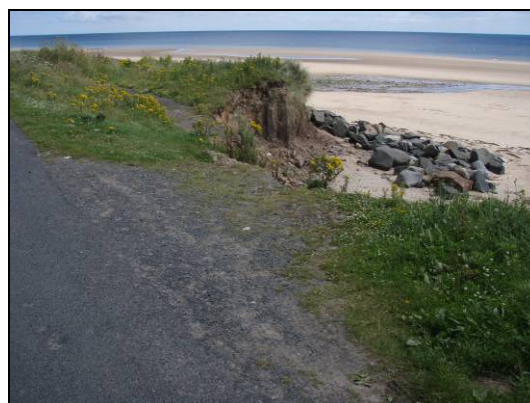
Here, the dune has now eroded through the ramp access path and will soon threaten the coastal road (right).

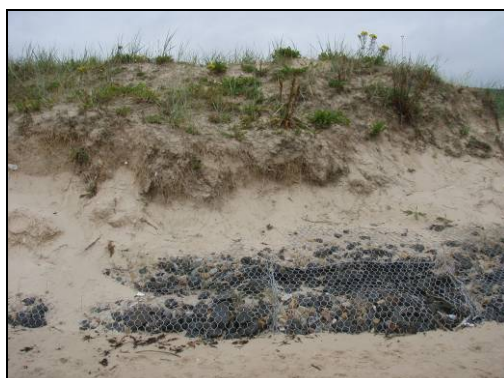
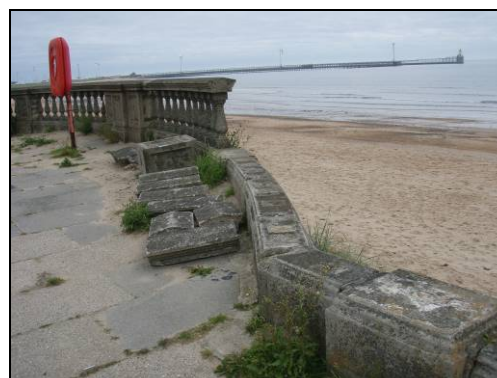
The rock-filled gabions further south have become exposed and many are broken, spilling rocks onto the foreshore (below, left). At Beach Gardens the wall is aged but in fair condition. There has been some cosmetic damage to the ornamental wall crest by the access steps which needs repair or removal (below, right)

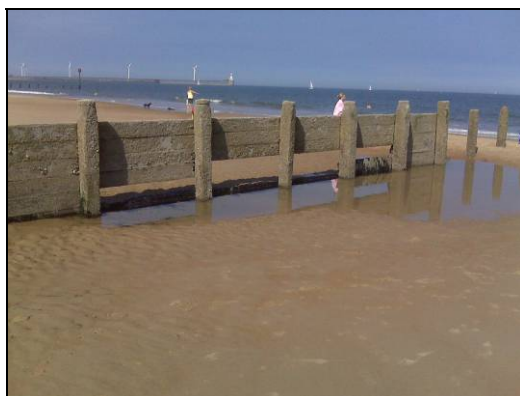
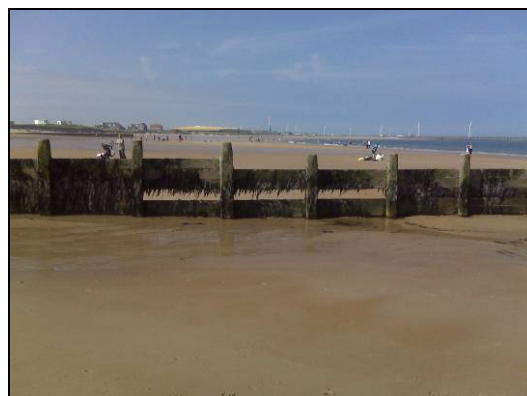
South of the promenade are three long timber groynes. These generally are in reasonable condition at their upper ends (although some gaps are evident between boards) and are proving effective at trapping beach sediment on their northern sides. However, the central groyne has a broken marker beacon and the southern groyne has no beacon. The groynes also have several timber boards missing from their seaward ends (examples below).

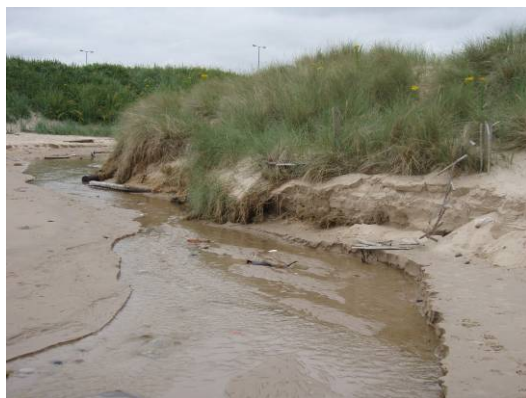
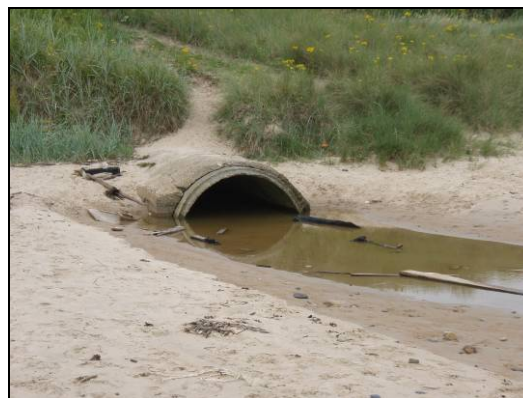
Between the groynes, the backing dunes are relatively stable and well vegetated. South of the southern groyne, however, the dunes start to become affected by the outfall channel of Meggies Burn. The channel runs north from the outfall before discharging across the foreshore, eroding the dune toe as it does so (below, left). There is considerable sand partially blocking the outfall pipe of Meggies Burn (below, right).

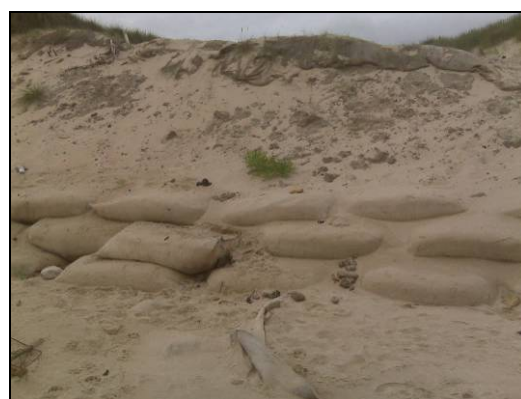
The central section of South Beach has been severely hit by storm activity, causing toe erosion and crest deflation in places. The areas which historically have been vulnerable, and where in April 2007 sand-filled geotextile bags were placed to reinforce the toe, were worst affected. This has resulted in re-exposure of the sand-filled bags at both locations where it was installed (left), and unravelling of the coir matting, which itself is causing more damage.

The area could usefully benefit from a further 'top-up' of sand recycled from the spending beach.

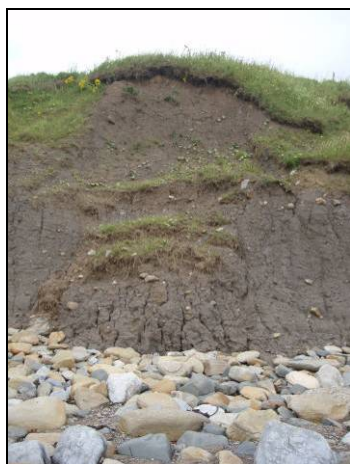
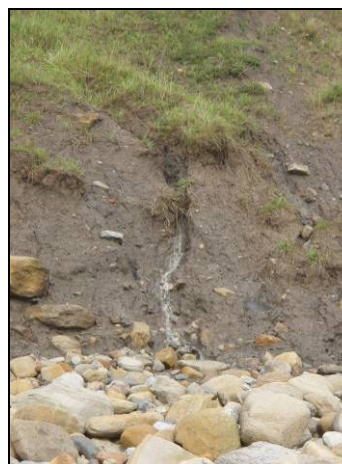
The undefended sea cliffs are actively slumping despite the presence of a boulder beach (below, left), but coastal protection intervention is not recommended due to the nature of the asset being affected (a Council-owned golf course). A small section of wall fronting the boatyard along the otherwise undefended length of cliff is in a poor condition and efforts have been made at patch-work repairs. Despite this, there are sections being both undermined and outflanked. The cliffs were actively expelling rainwater from their seaward face following the preceding night's intense storm (below, right).

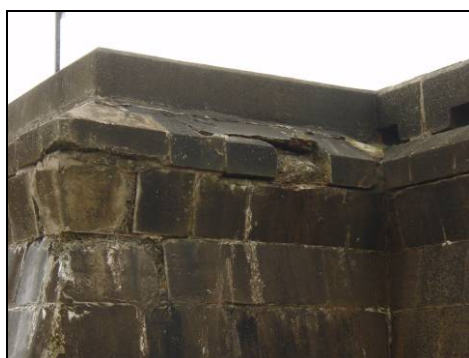
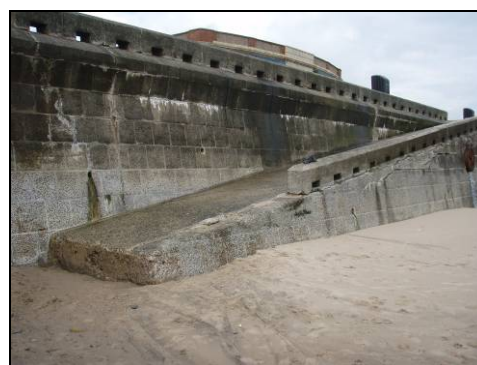
Further south, the revetment itself was in fair condition. This extends south around the mouth of the Briardene Burn to join the Whitley Bay seawall and promenade. The seawall structure is in a fair structural condition in most places, but there are specific areas of damage where routine repairs are needed. Cracks, gaps and areas of spalling should be addressed and the section of missing blockwork in the crest wall at its corner near access steps (below, left) should be filled. Also, the access ramp by the Rendezvous Café has a large longitudinal crack and missing section of crest wall (below right).

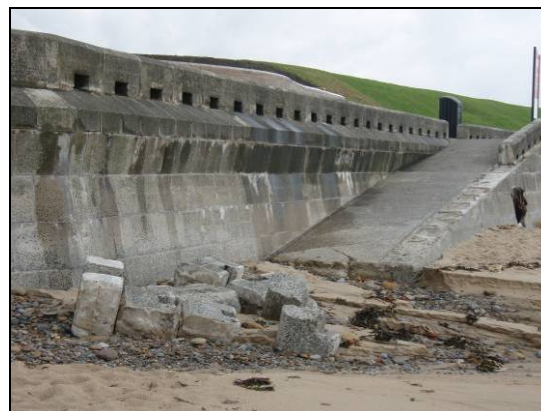
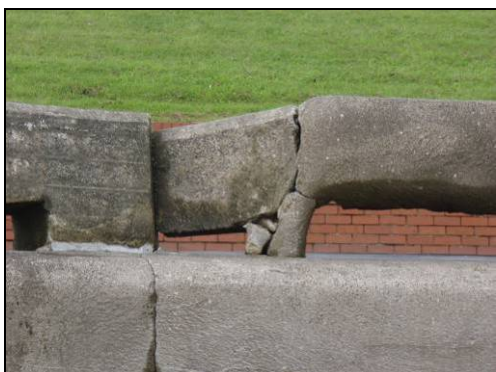
Between the Rendezvous Café and the Panama Swimming Club there are areas of larger diagonal cracking that need filling. Where previous repairs have been made they are holding effectively. Beach access steps north of the Swimming Club are damaged, as are the steps directly at the Club (missing crest wall on seaward face of steps in both cases). The greatest damage has occurred to the access ramp further south still, where the debris remained on the beach at the time of the inspection (right).

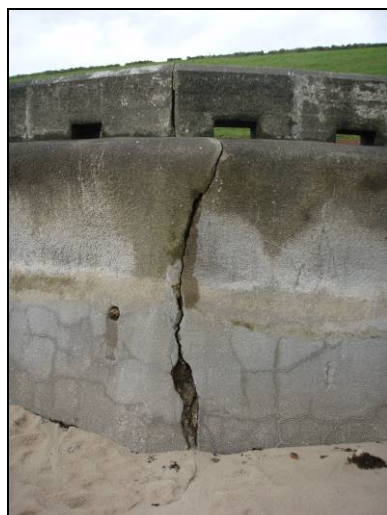
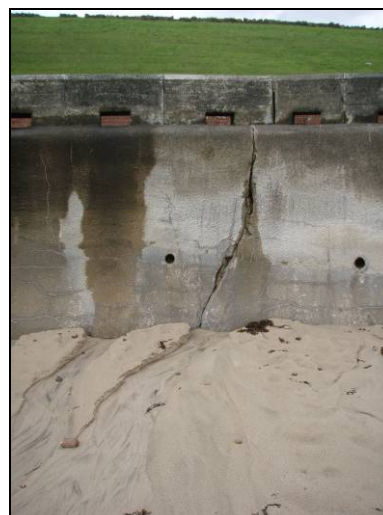
The adjacent seawall, which is backed by a grassed bank, is older and showing signs of deterioration. Some water return holes in the wall crest are blocked with debris and others are collapsed or in danger of imminent collapse (left). There is one very wide vertical crack (below, left) and another wide diagonal (below, right) in need of filling, as well as more moderate or minor longitudinal and vertical cracks.

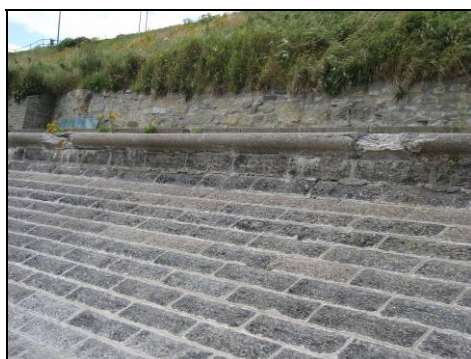
Along the concrete block revetment, there is damage to the crest wall and some cracks between the sloped revetment and the vertical wall (below left) which require repair. The dunes along Longsands are generally well vegetated and relatively stable. The main problem is associated with trampling erosion and efforts have been made to control this through fencing. Some fencing is now obsolete and in need of renewal. At the southern end of Longsands a wall extends around the now disused Outdoor Pool. The concrete coping section of this wall is rust-stained and spalling in places (below, right).
