# **NECAG Coast Protection Assets and Coastal Slope Condition Analysis**

## **South Tyneside Council Final Report**

**South Tyneside Council**

**April 2009**

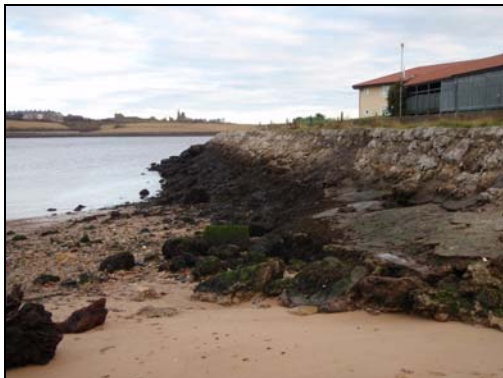
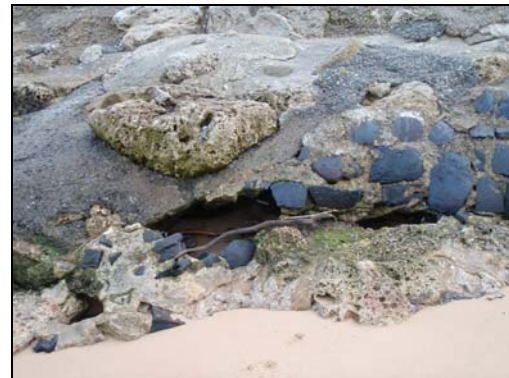
The grouted masonry revetment was in fair condition although voids were opening up at the toe due to erosion of mortar and missing masonry blocks (below). Local repairs to infill the voids should be carried out along with general replacement of missing masonry blocks and infilling of cracked mortar throughout the structure.

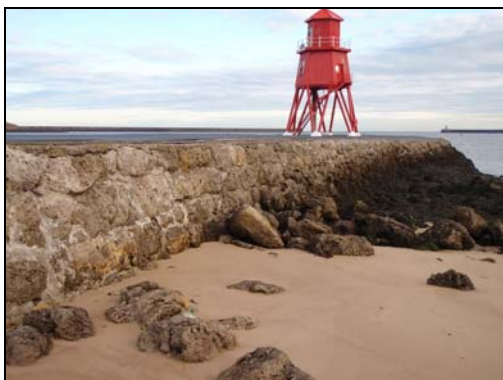
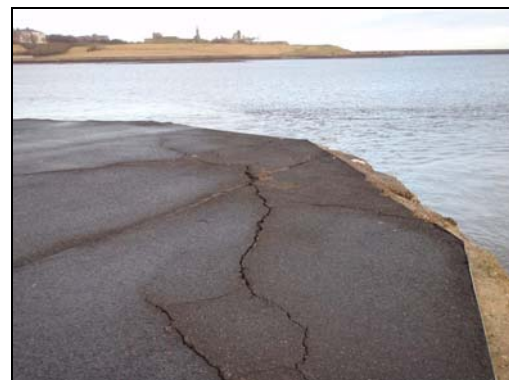
- South Groyne, Littlehaven  
The structure was in good to fair condition overall, but a specific problem was identified towards the roundhead of the structure, seaward of the Groyne Lighthouse. Extensive cracking was observed which is indicative of settlement occurring at the end of the structure and further survey is required to establish the scale of the problem.

The South Groyne acts to retain Herd Sand to the south. The grouted stone breakwater was in fair condition (below, left). There were minor voids due to missing masonry, a problem which was generally worse on the north face of the structure. A layer of rock armour was present at the toe of the groyne, along the northern face of the structure. Several rock armour units had been displaced, generally from the downstream end of the revetment. There was extensive cracking of the tarmac towards the roundhead of the structure, seaward of the Groyne Lighthouse (below, right). These cracks suggest settlement of the seaward end of the structure. A detailed survey of the structure should be undertaken to identify the scale of and establish a cause for the settlement. The cracks should be filled to prevent water ingress into the structure and further damage caused by mechanical weathering.

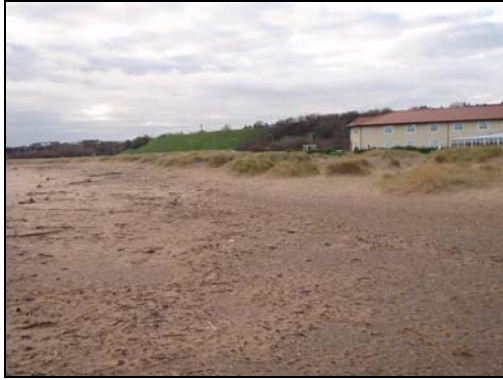
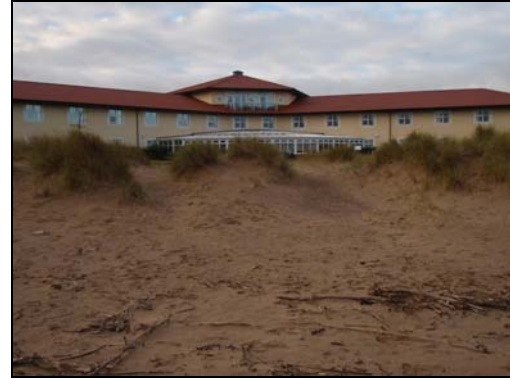
In the 1998 survey the frontage defending the hotel was described as a picket fence installed to create a dune. There was no fence present in the current inspection and it was unclear if the fence was buried under the sand or if it had been removed or destroyed. Low level sand dunes were present which were vegetated although erosion caused predominantly by members of the public walking through the dunes had reduced the vegetation coverage and the level of the dunes particularly around the central section (below).

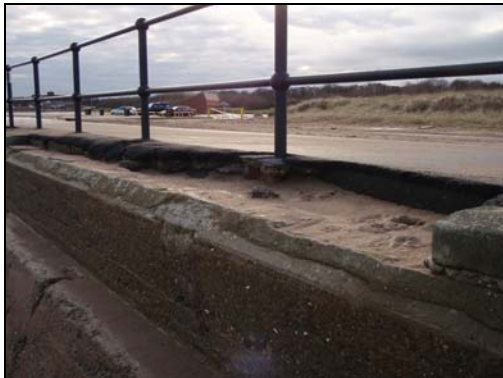
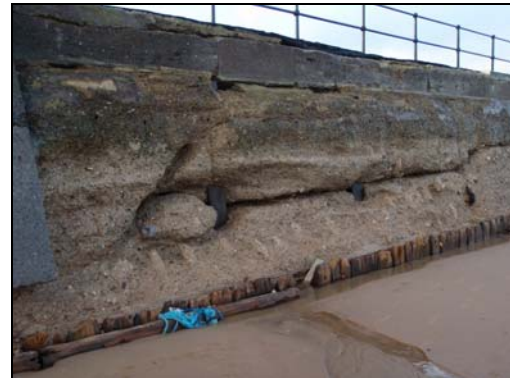
- Harbour Drive Seawall, Littlehaven  
The seawall is in poor condition, with missing coping stones exposing tarmac and leading to material loss. Extensive erosion has exposed wooden piles at the toe and within the structure. A more recent concrete encasement to the southern end of the asset is in good condition although a low beach level exposes the original concrete wall and timber piles at the toe of the wall.

The sea wall to the south of the Little Haven hotel was in poor condition in places. To the north of the wall, several sections of concrete coping were absent (below, left). Here, the tarmac promenade was exposed and beginning to erode, with further material loss. To the south the concrete of the wall has eroded significantly (below, right). Large cracks were opening into voids, with timber piles visible at the toe and within the structure. Remedial action is necessary to prevent increased erosion which could lead to undercutting of the promenade and potential failure of the wall.

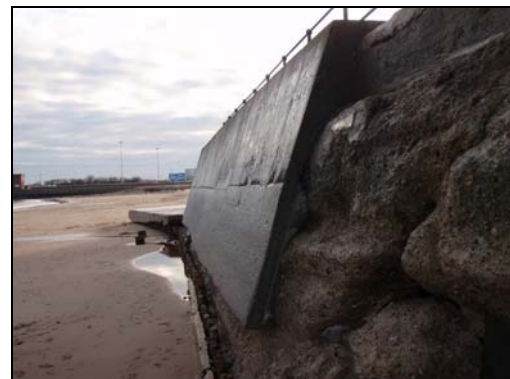
The southern extent of the wall has a concrete outer face (right). The concrete is in very good condition although a risk of undercutting remains as the original wall and timber piles are still exposed at the toe. This should be monitored as undercutting will reduce the effectiveness of the structure above. A potential solution to the damaged wall to the north would be to extend the concrete outer face.

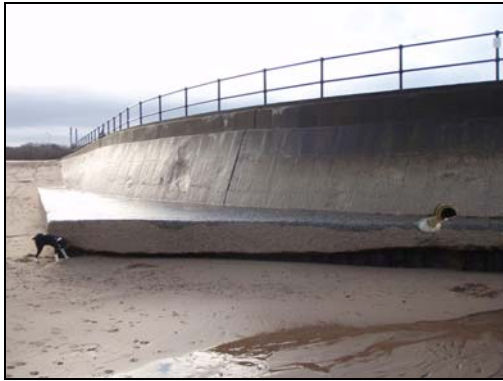
The seawall to the south is concrete with a concrete apron (left). The structure is in very good condition, with minor surface defects at the crest and some erosion at the apex of the curve. The low beach level has exposed the piles beneath the concrete apron which showed evidence of scour and significant corrosion. Deterioration of the piles could lead to undercutting of the apron and undermining of the wall, therefore the condition of the piles should be monitored.

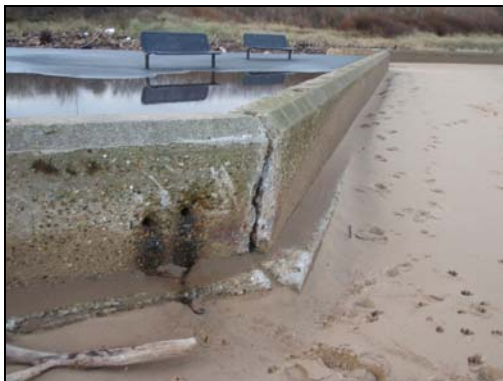
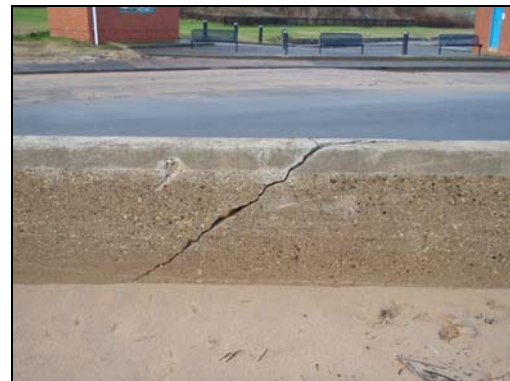
The defences to the north of South Pier consist of a low concrete wall which is in fair condition although many of the construction joints have widened and require infilling with sealant. There is a large crack passing through the full height of the wall which should be infilled. Minor spalling is evident around drainage outlets with water storage landward of the wall indicating potential drainage problems. These should be investigated to prevent mechanical weathering of the rear of the wall.

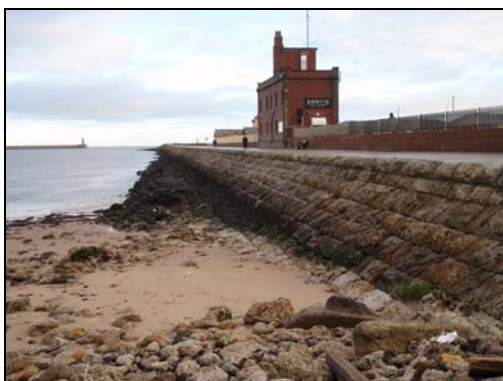
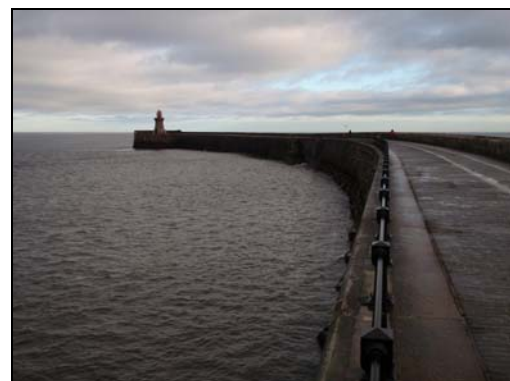
South Pier was in good condition. Minor repointing and replacement of missing/cracked masonry blocks should be carried out as part of routine maintenance work.

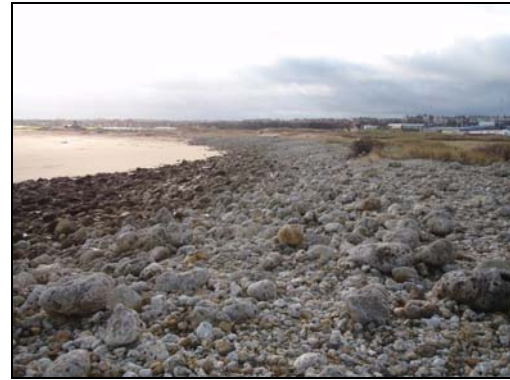
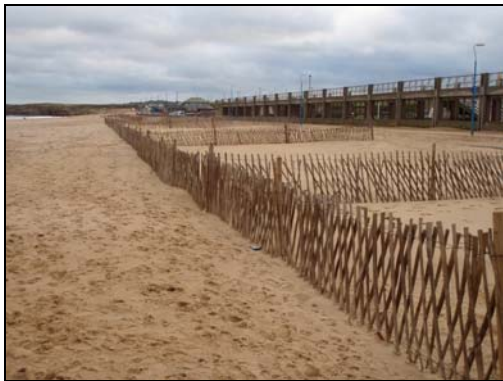
The stone embankment in front of the dunes to the south of South Pier (right), appears to have thinned out towards the southern end although the beach level was high at the time of survey and possibly buried some of the stones. The dunes had significant areas which were not vegetated although they generally appeared stable with no significant erosion of the seaward slopes.

The masonry and brickwork defences protecting the seafront amenities and car park were in very good condition. Chesnut fencing was present in order to manage beach levels in front of the structures (left).

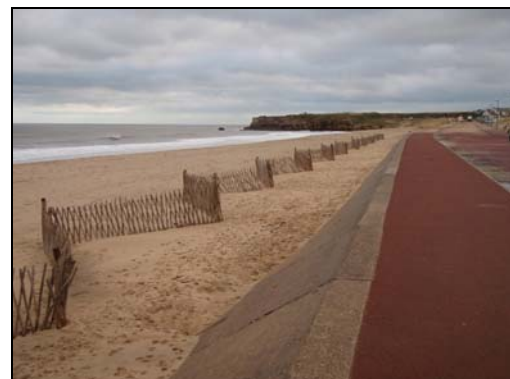
The defence at the southern end of Herd Sand consists of a concrete revetment (right), which was in good condition with minor spalling around construction joints. The revetment was fronted by chesnut fencing to encourage the accretion of wind-blown sand.

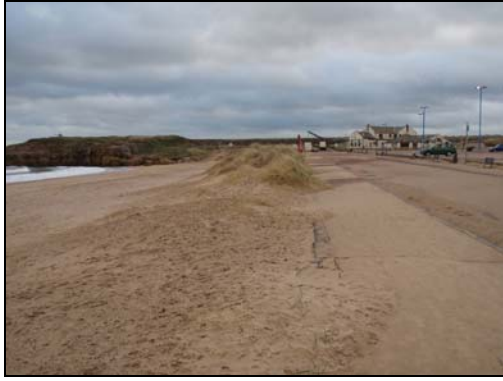
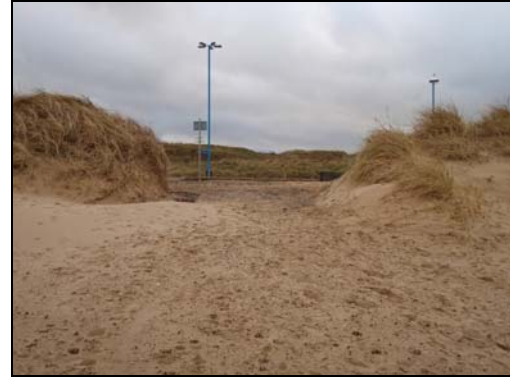
Seaward of the Mangos public house, dunes have formed over rock-filled gabion baskets (below). Local erosion of the dunes has taken place, the most significant of which was caused by members of the public walking through the dunes although also by surface water draining from the promenade. Members of the public should be discouraged from walking over the dunes and the drainage from the promenade may need attention to prevent excessive erosion of the dunes. The 2008 survey was carried out following heavy rainfall which is likely to have caused significant surface water run-off from the promenade as gulleys appeared to be blocked with sand. In eroded areas gabion baskets were visible and appear to be in good condition. The dunes should be monitored as the condition of the gabions beneath is unknown.

121AB901B0202C01	Herd Sand	Low	Nov 2008	Monitor sand dunes. Discourage members of the public walking over the dunes. Address drainage from promenade.
121AB901B0401C01	Marsden Bay	Medium	Nov 2008	Local repairs to concrete steps. Infill cracks and voids. Monitor undercutting of remaining steps and former lifeguard building.

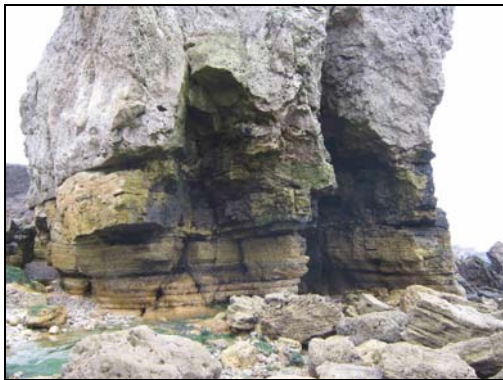
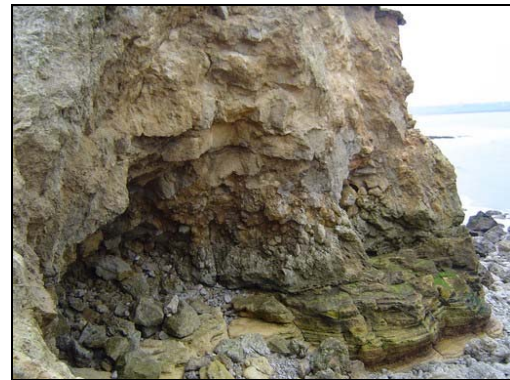
The rock headland of Target Rock was fractured with many loose and overhanging rocks. Differential erosion had led to the base of the headland eroding and causing undercutting of the material above and the formation of significant voids and caves within the outcrop (below). The undercutting was exacerbated by fissures eroded into the adjacent bedrock outcrop. A sink hole which had opened up to the rear of Target Rock was infilled with granite rock armour and covered with seeded topsoil as part of the 2008 construction works and this remedial work was in very good condition. The rock armour revetments tie into Target Rock and will act to prevent the outflanking of the rock which was beginning to occur. In general, the integrity of the outcrop worsened to the south.

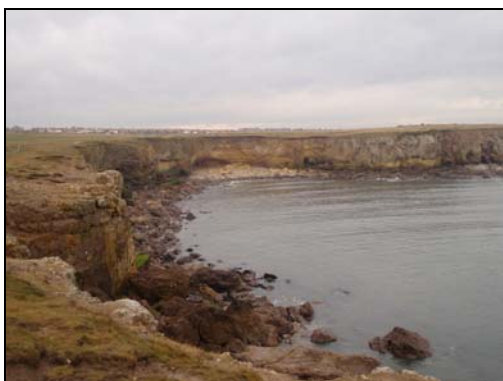
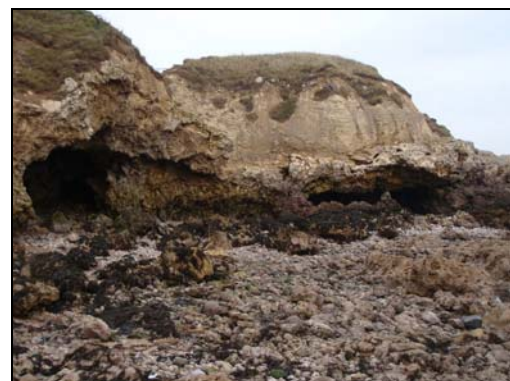
The northern extent of Frenchman's Bay is marked by the headland of Frenchman's Point. The cliff line is high, with an exposed rock foreshore with overlying sand in the shallow bays. The lower cliffs are extensively eroded with large voids and caves present (below, right). The steep upper cliffs appear stable and are largely devoid of vegetation.

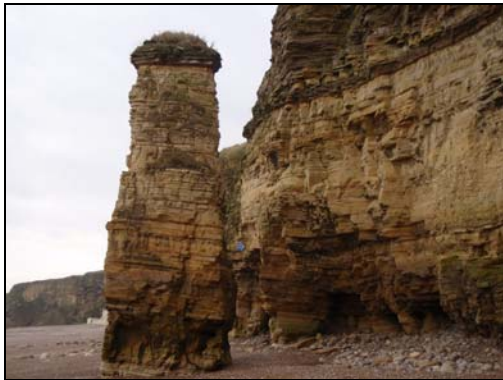
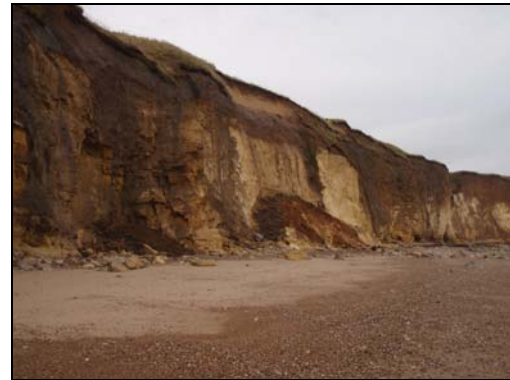
Marsden Bay is a 1.5km long bay with rock platforms to north and south, with a sand foreshore beneath steep Magnesian Limestone cliffs. There are several stacks (below, left) on the foreshore, including Marsden Rock, indicating differential erosion between harder and softer rock. There was evidence of a recent slope failure to the north of the bay (below, right).

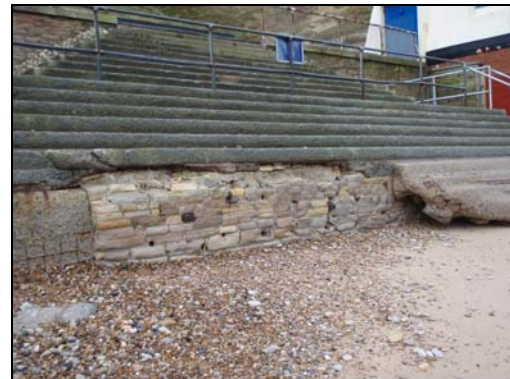
At the former lifeguard station, the defences consist of a masonry faced concrete wall buttressed by concrete steps providing access to the foreshore (right). The steps are missing or damaged towards the foot of the structure, exposing a masonry wall and reinforcement in the concrete. Access to the foreshore is via undamaged steps at the north, with access to the damaged section prevented by steel guardrail. The remaining steps were undercut and this must be monitored as damage could extend north and make the access unusable. The building contained cracks and voids in the concrete and masonry of the foundations which should be infilled to prevent extensive damage to the structure.

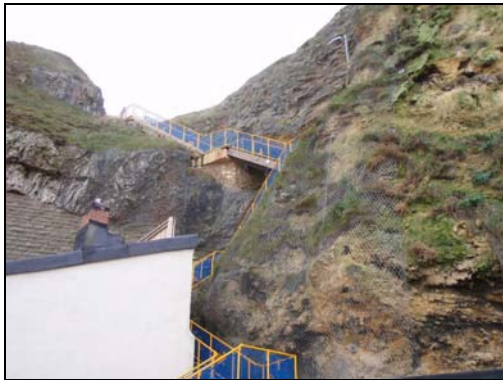
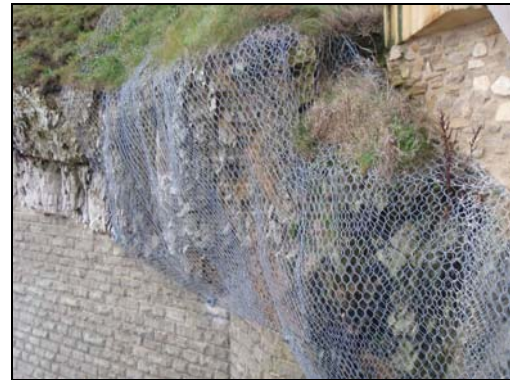
The Marsden Grotto Public House/Restaurant is situated at the foot of the cliff and is defended by a masonry wall which is in good condition (left). Access to the foreshore is via a set of wooden steps which zig-zag down from a car park on the cliff top. The previous steps were replaced in 2007 along with the addition of rock netting to prevent minor rockfalls from the concreted limestone cliff face (below). The steps and netting were in very good condition.

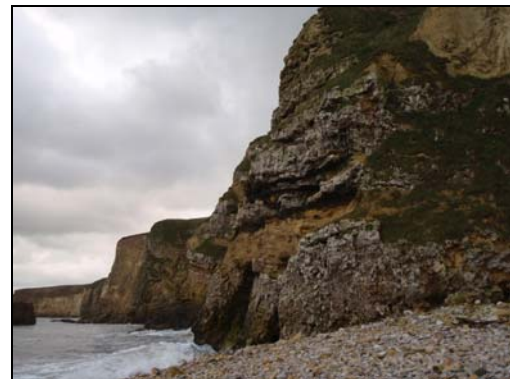
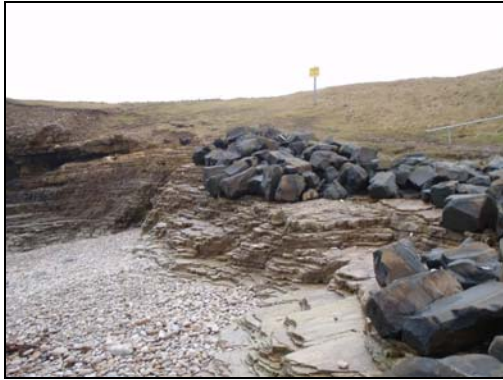
The Lizard Point Headland comprises generally hard rock cliffs with small bays and an open area of land above. The cliffs appeared stable with local areas of vegetation growth. There was evidence of historic slumping and sliding in places although the cliffs generally appeared inactive.

The Old Harbour Quarry to the south of Lizard Point comprises relatively low cliffs, quite deeply indented and caved in areas, with small pocket beaches. The cliff line acts as thin barrier in front of a now infilled and landscaped quarry area, extending back to the main coastal road. Locally caving of the cliff has reduced the width of solid rock barrier to as little as 2m, although more generally the barrier of natural rock is of the order of 20m. In places defence works have already been undertaken to resist local erosion (left).

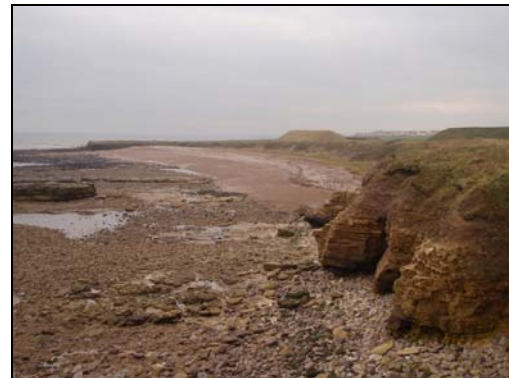
Souter Bay is a wider, longer length of beach frontage with a raised beach behind (right). The sediments are held by Souter Point. The cliff line to the rear of the beach is set at a less steep angle, with a good coverage of vegetation. Towards the north there was evidence of minor slope failure in the softer material towards the crest of the cliffs. There was no evidence of recent rock falls or significant material loss from the lower cliffs.
