Cell 1 Regional Coastal Monitoring Programme Walkover Inspection Surveys 2016

South Tyneside Council

September 2016

Walkover Inspection Surveys 2016

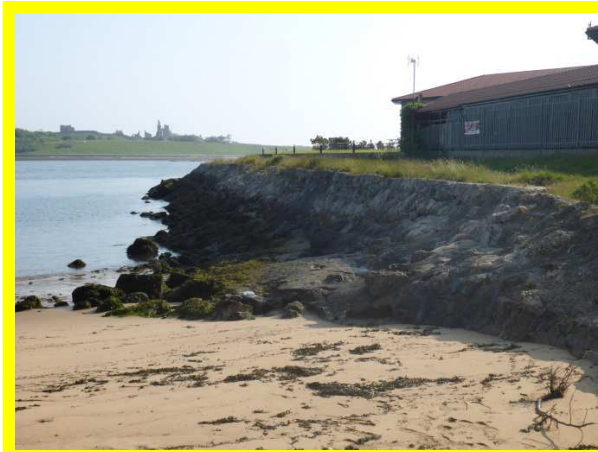
The grouted masonry revetment (/0101C01) starts at the boat slipway and extends along the eastern side of the wave basin to join the landward root of the South Groyne. Its management is the responsibility of the Port of Tyne. The revetment is in fair condition, although there is local undermining of the apron in one location and local voids appear in places in the crest.

Grouted masonry revetment in fair condition (/0101C01)

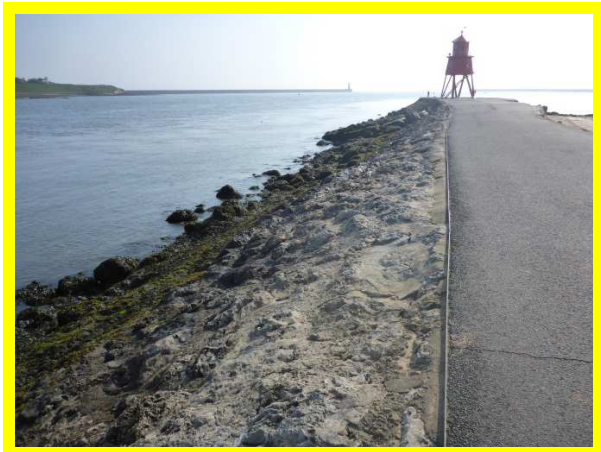
Along the northern (river-facing) side of the South Groyne (/0101C02) the resurfacing of the bitmac deck remains in generally good condition, but with one area near the head starting to show signs of localised cracking. The South Groyne itself is in generally fair condition, with only occasional missing stonework and the southern side is generally less exposed and therefore in slightly better condition than river-facing side.

River-facing side of South Groyne in fair overall condition (/0101C02)

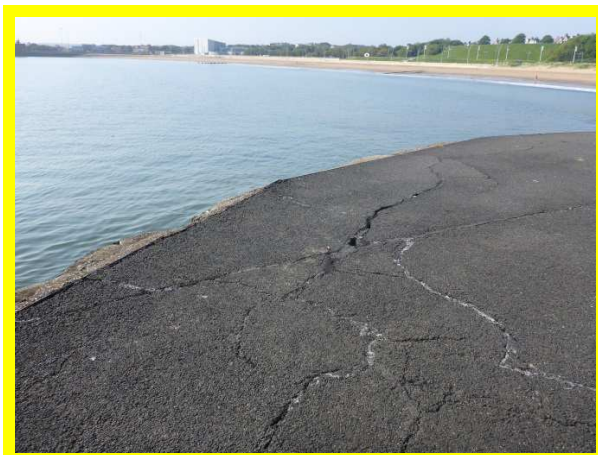
Localised cracking in bitmac deck at seaward end of South Groyne (/0101C02)

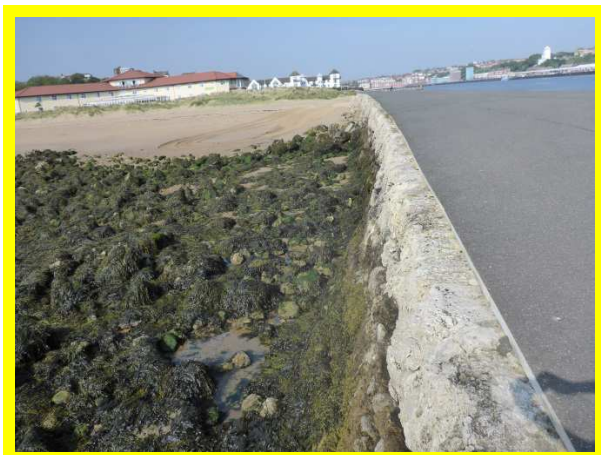
More sheltered southern side of South Groyne in fair overall condition (/0101C02)

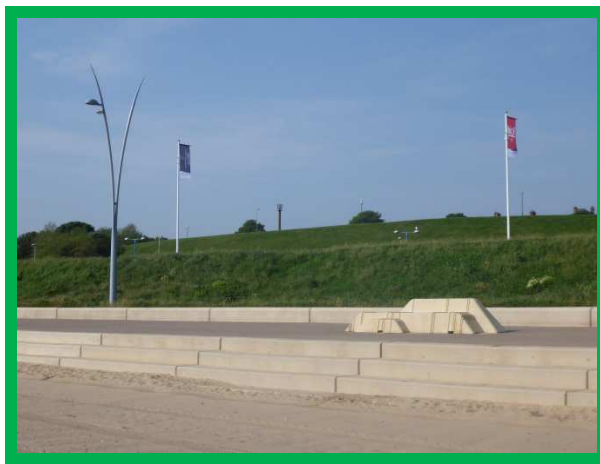
Northern section of Littlehaven promenade and seawall in very good condition (/0102C02)

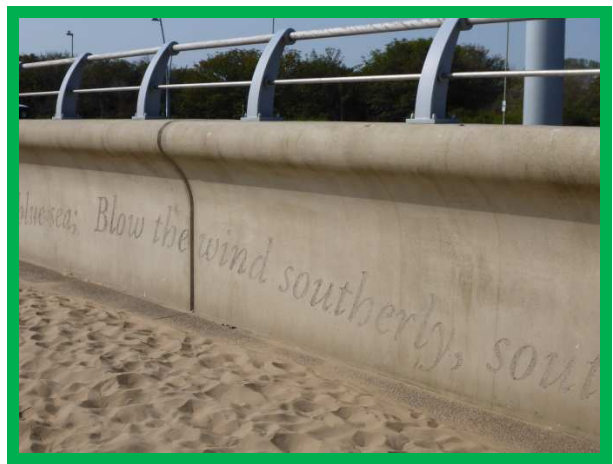
Central section of Littlehaven promenade and seawall in very good condition (/0102C02)

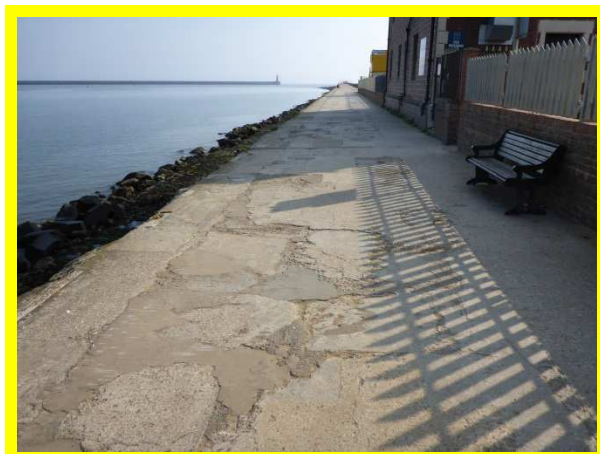
Deck abrasion and previous repairs on South Pier (/0103C01)

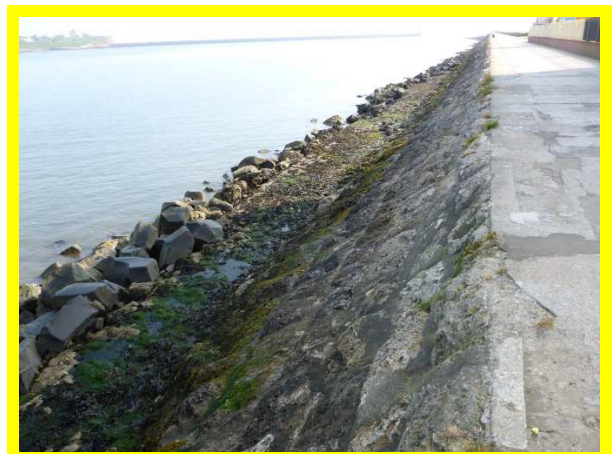
South Pier in overall fair condition along northern face (/0103C01)

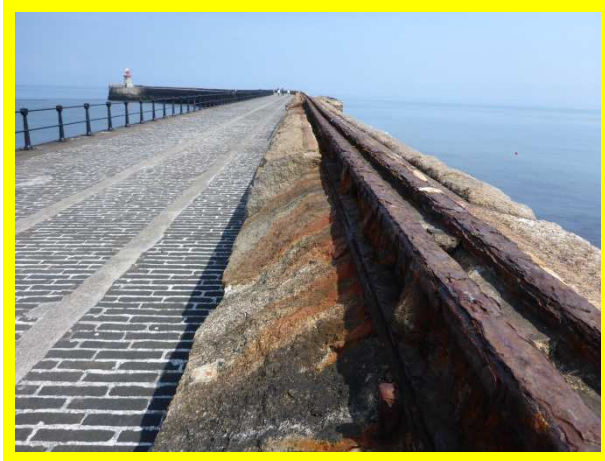
Deck abrasion/spalling and previous repairs on South Pier (/0103C01)

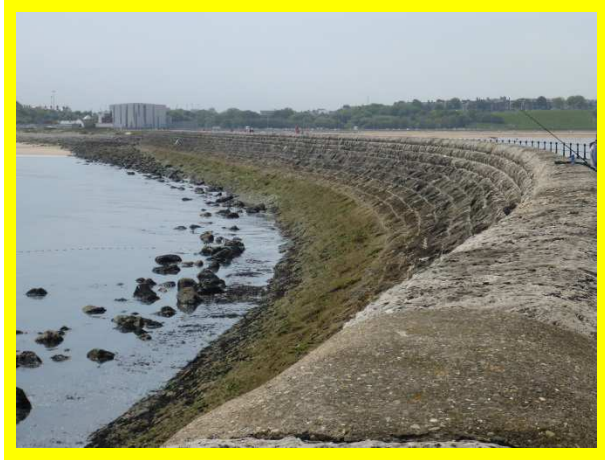
South Pier in overall fair condition along southern face (/0103C01)

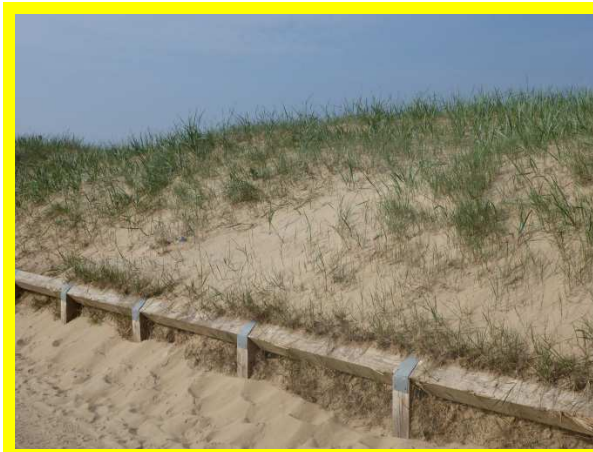
Plentiful sand but relatively sparse vegetation in dunes (/0201C01)

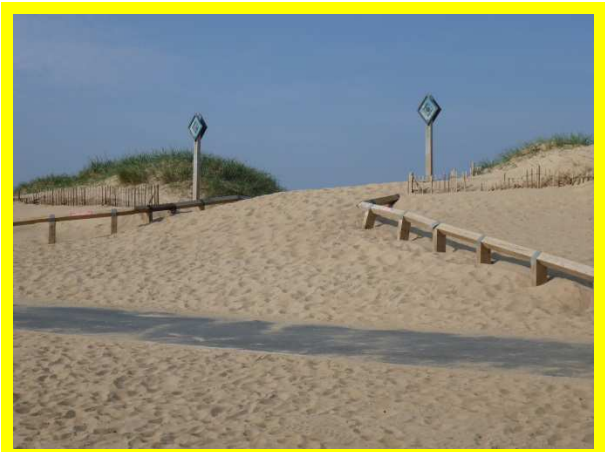
The northern section of Sandhaven between South Pier and the children's play area has a cobble berm in front of the dunes at its northern end which narrows and thins with progression south (/0201C01). Dune condition is fair with plentiful sand but relatively spare vegetation. The dunes continue south of the children's play with a wide fronting sand beach (/0201C02), continuing in fair condition. The 'donkey track' extends from the South Pier, initially mid-way through these dunes before switching to seaward of the dune toe to meet the Lifeguard Station further south before returning to the main promenade. The donkey track had been swept clear of sand immediately before the inspections and it was apparent that previous defects in the surface have been repaired and are holding well, retaining the structure in overall fair condition. In places there is too much sand accumulation, causing burial of the recently constructed boardwalks and fencing.

Sand accumulation swamping dunes and burying footboards and fencing (/0201C01)

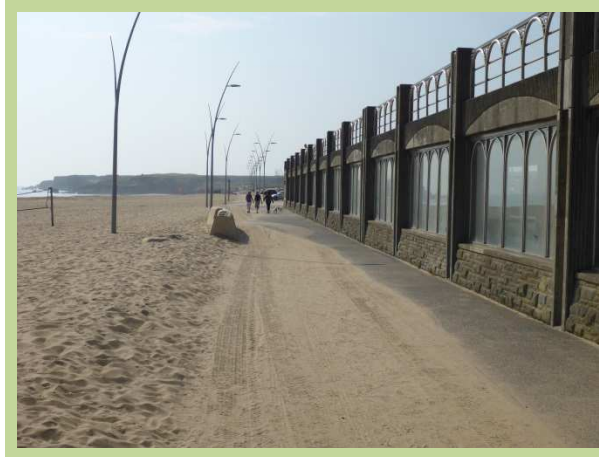
Healthy beach levels at amphitheatre (/0201C03)

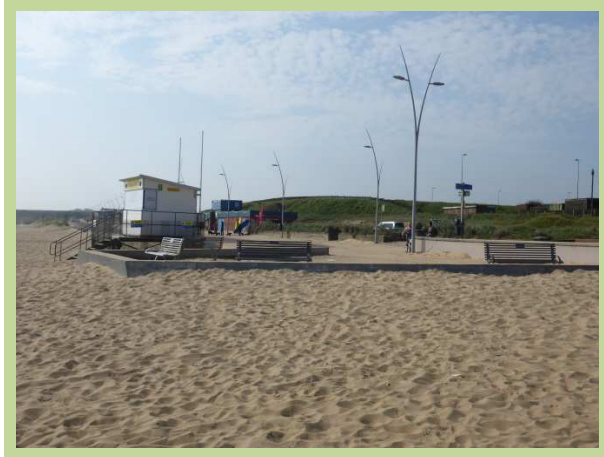
Good condition of reconstructed wall, with high surrounding beach levels (/0201C04)

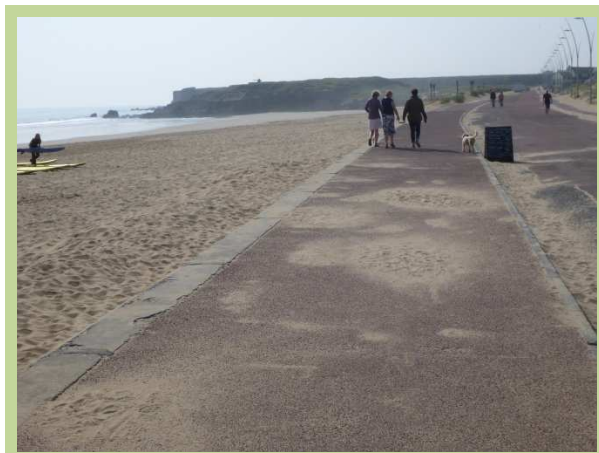
Healthy beach levels south of lifeguard station (/0201C05)

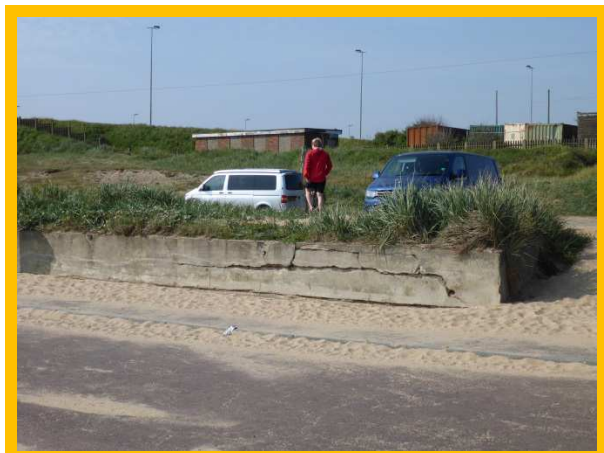
Cracking in wall to rear of promenade at southern end of Sandhaven (/0202C01)

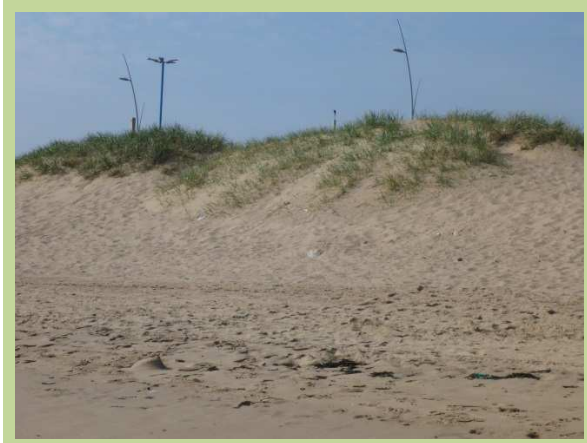
Stable but narrow dunes at south end of Herd Sands (/0202C01)

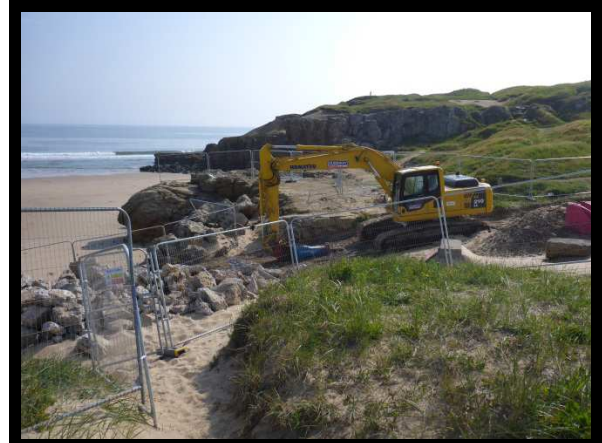
Old slipway demolished ready for construction of replacement at southern end of Herd Sands (/0202C01)

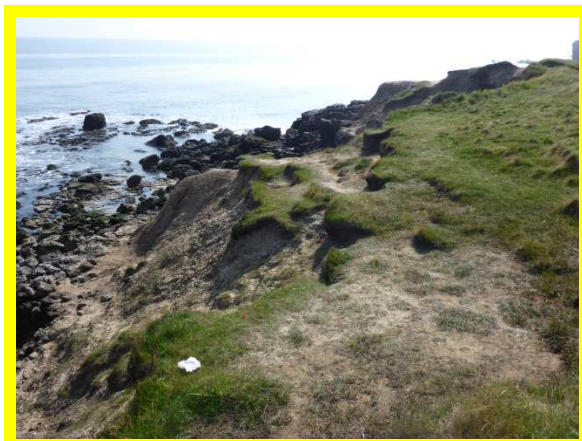
The Trow Point headland (/0302C01) remains as a competent mass controlling evolution of the bay to its south, despite localised rockfalls in the harder material and slumps in the overlying softer material. Some areas of softer material remain in an over-steep condition and therefore further local slumps should be expected. This area should be monitored at regular intervals. Vermin continues to be a problem in this area.

Localised slumps in soft material at Trow Point Trow Point (/0302C01)

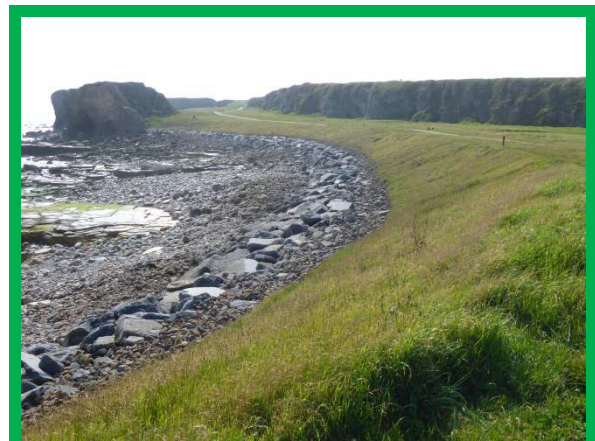
The rock revetment and re-graded slope at Graham's Sand (/0302C02) remain in a very good condition since completion of the scheme in 2008. There were signs that rabbits were still active in the area. Vermin control should be implemented to avoid them burrowing in the re-graded slope and destabilising it.

Rock revetment and re-graded slope at Graham's Sand (/0302C02)

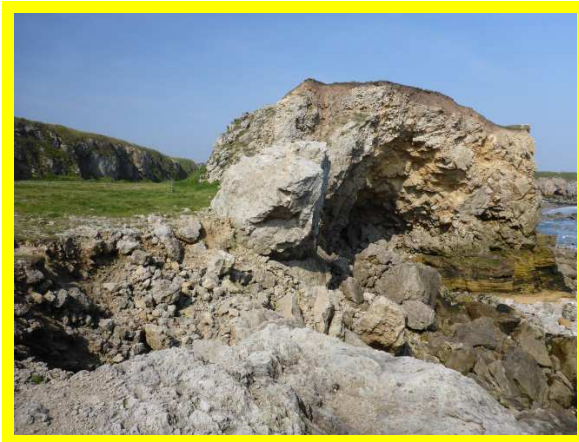
The headland at Target Rock (/0302C03) has always been the most vulnerable of the three headlands at Trow Quarry due to its partly fragmented state, with undercutting at lower levels and caves forming at the base. The material between the rock masses continues to erode, with rock debris and brickwork evident on the foreshore. As in previous inspections, there is sufficient residual rock headland not to cause a concern relating to the potential outflanking of the defences in Graham's Sand and Southern Bay.

Localised fragmentation of Target Rock (/0302C03)

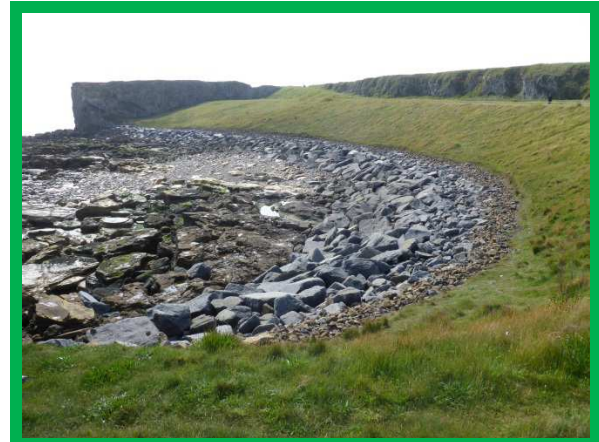
Rock revetment and re-graded slope at Southern Bay (/0302C04)

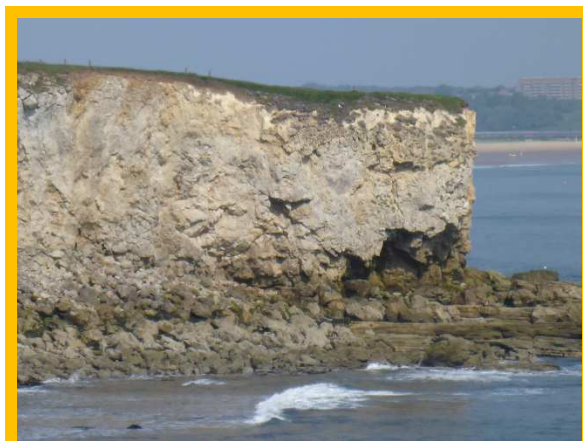
The rock headland at Frenchman's Point (/0401C04) was in a competent form but there are a number of arches formed on the southern side formed by undercutting at the toe. A major rock fall occurred within Frenchman's Bay in 2010 (/0401C04). This resulted in the cliff face moving closer to the coastal path and The National Trust realigning the path, fencing and installing new warning signs. The rock debris at the toe of the cliffs partly remains to the present day and will continue to provide a degree of protection to the cliff toe until the material is moved away by marine action and the process will start again.

Arches formed by undercutting at base of cliffs at Frenchman's Point (/0401C04)

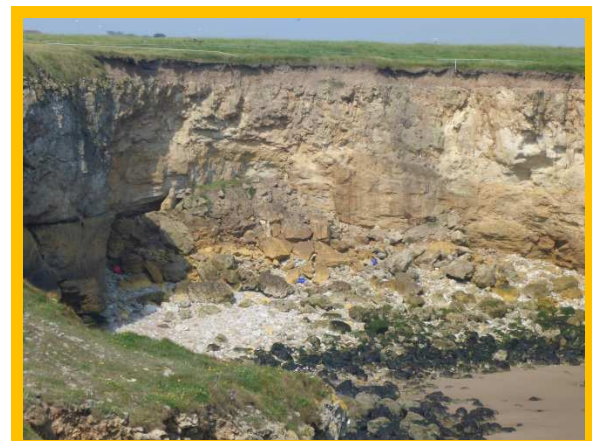
Residual debris from previous large rock fall in Frenchman's Bay (/0401C04)

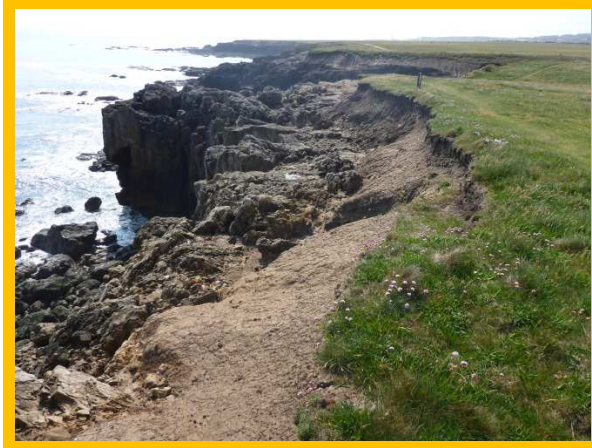
Debris flow in softer material (/0401C04)

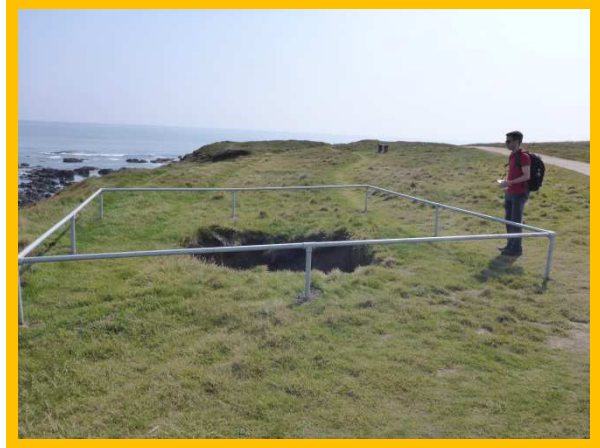
Sink hole south of Man Haven Bay (/0401C04)

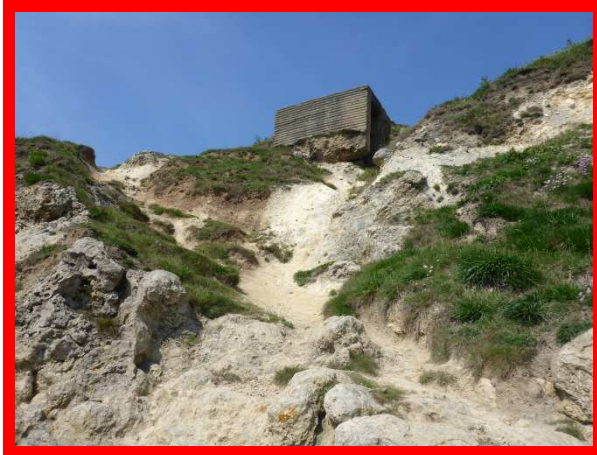
Concrete bunker at northern access ramp to Marsden bay (/0401C04)

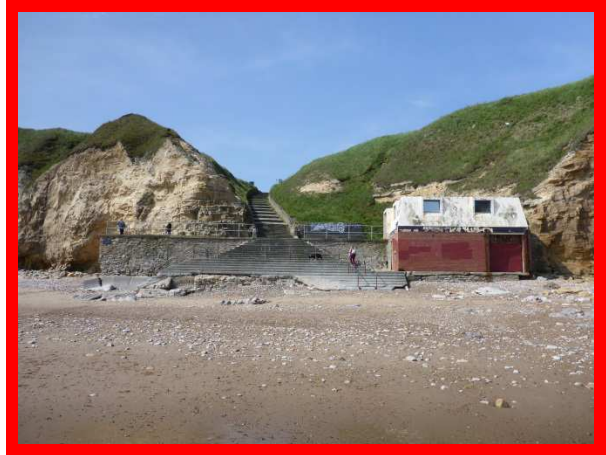
Disused lifeguard station and the Redwell Steps access (/0401C01)

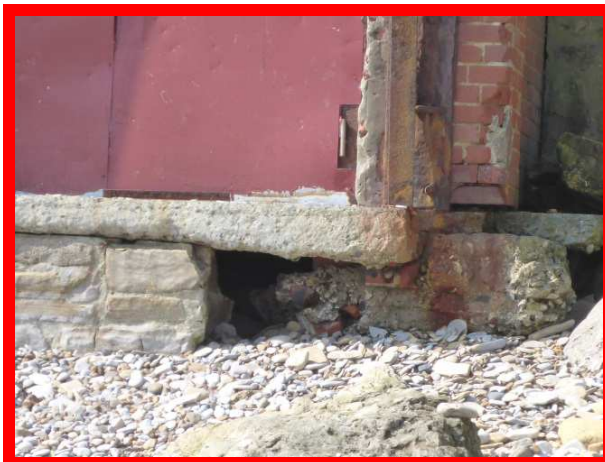
2. At the disused lifeguard station the stone-faced wall (/0401C01) is undermined leading to voiding beneath the building. There are also numerous notable gaps between the stonework and concrete coping.

Undermining and voids at disused lifeguard station (/0401C01)

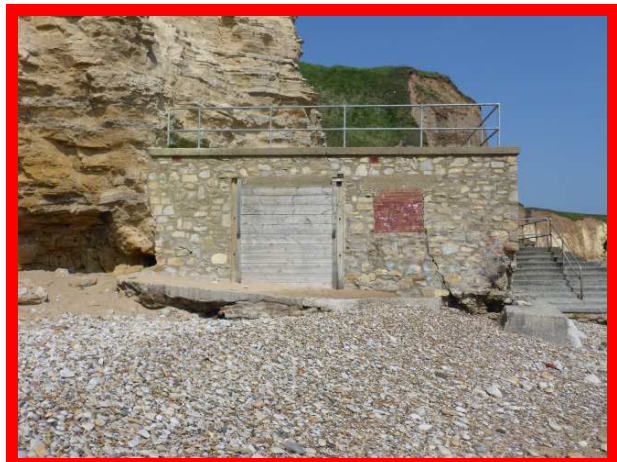
3. The buttress landing to the Redwell Steps (/0401C01) is badly damaged along its length. The National Trust has guided access down the steps along specified routes, using hand railing in order to ensure the public avoids the worst affected areas. They have also bolted a temporary metal step at the base of the concrete steps to ease access to the beach. In many places along the toe, the buttress is undermined and badly abraded. The buttress houses a storage building which has an entrance and bricked-up window at the southern end. This face of the structure is particularly badly undermined and the wall is cracking.

Undermining and cracking at storage building on south face of buttress to access steps (/0401C01)

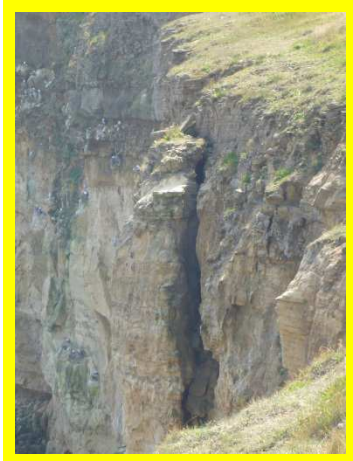
Between the Grotto and the former access road to Lizard Point Car Park (/0401C05) the cliffs generally (currently) appear more stable than those in the north of the bay and in places are fronted by small cobble berms. However, occasional rock falls and numerous caves and arches at the base of the cliffs are still evident. Elsewhere along this southern section of Marsden Bay there are several other areas where small and localised toppling or slumping has occurred in the softer material that overlays the harder rock structure, including several areas where further local slumping is imminent. Additionally there is evidence of vertical cracking in the cliff face at several locations, including those where the cliff is within closest proximity to the coast road. Further rockfalls are likely at these locations although the presence of nesting birds in many of these sections suggest that such failure is not necessarily imminent.

Vertical cracks in the cliff face (/0401C05)

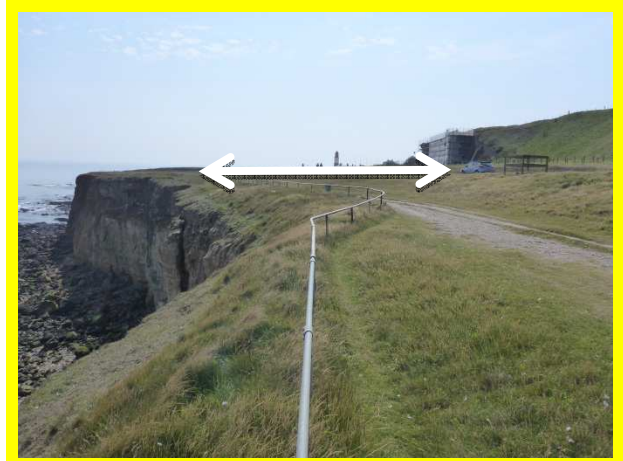
Proximity of cracked cliff to Coast Road (/0401C05)

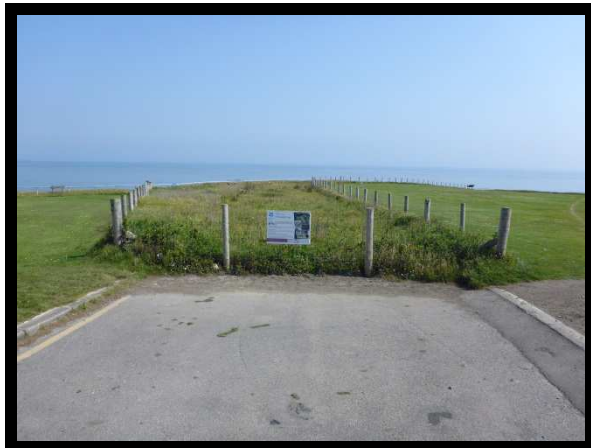
Natural re-wilding of the car park access road (/0402C01)

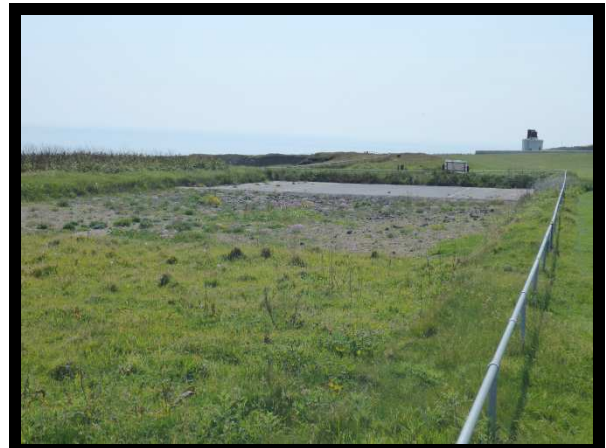
Natural re-wilding of the car park (/0402C01)

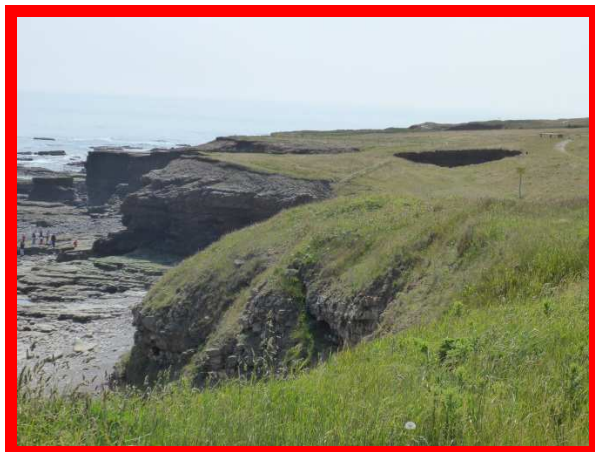
This sink hole has increased markedly in size since it first appeared around 2005 and The National Trust has fenced off this area and placed warning signs and diverted the public coastal footpath. In 2005 the sink hole measured 11m long by 6m wide at the cliff top, whilst in 2015 it measured 17m long by 13m wide. The cave formation at the base of the cliffs has also increased, with 'daylight' now clearly visible from the enlarged sink hole above at the rear of the cave. At some point, a large section of cliff at this headland is likely to collapse. However, the adjacent caves still have not breached through the limestone ridge. The existing concrete defences, previously used to 'plug' two nearby caves at this headland, are continuing to be undermined.

Enlarged sink hole at the former Old Harbour Quarry – general view (/0501C01)

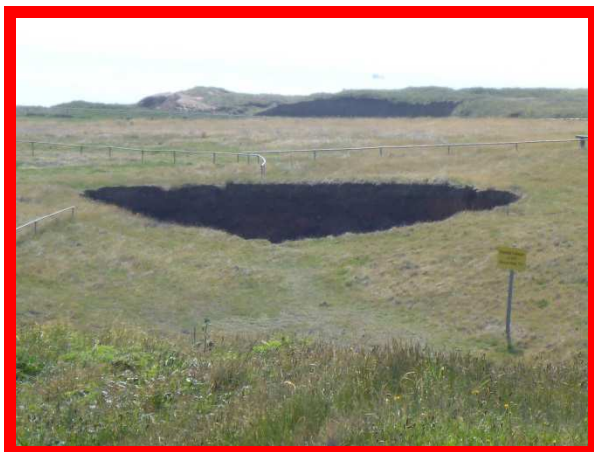
Enlarged sink hole at the former Old Harbour Quarry – detailed view (/0501C01)

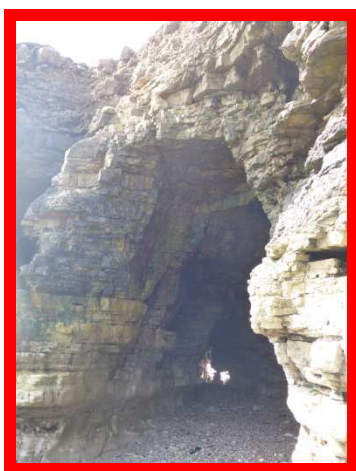
Enlarged cave at the former Old Harbour Quarry – general view (/0501C01)

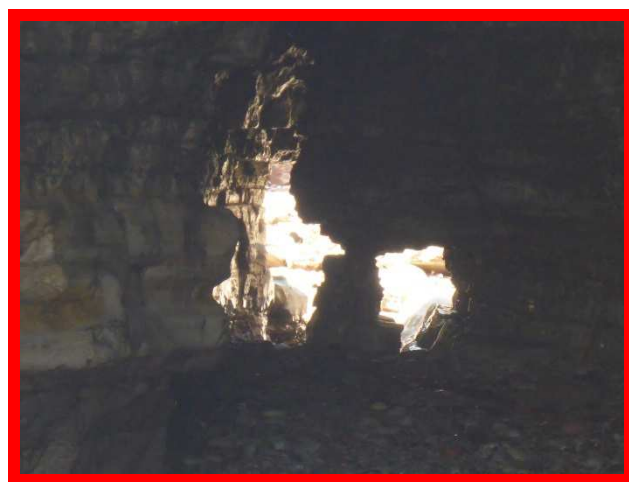
Enlarged cave hole at the former Old Harbour Quarry – detailed view (/0501C01)

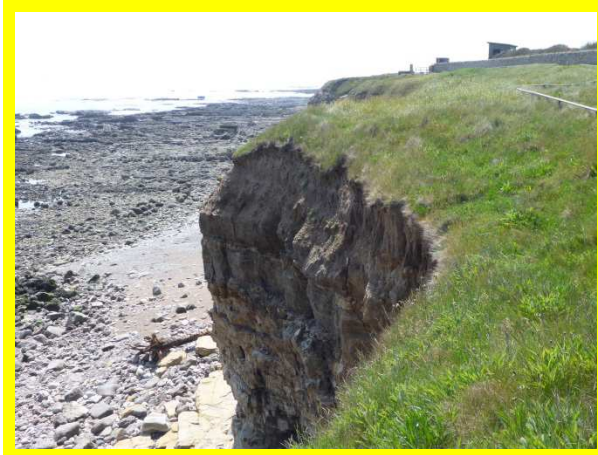
Along the Whitburn Nature Reserve (/0502C01), erosion has in a small number of locations caused the cliff top to come in close proximity to the public footpath. Low level fencing and warning signs have been erected by The National Trust in these areas. Elsewhere the cliffs remain stable.

Generally stable cliffs but some local slumps close to footpath at Whitburn nature Reserve (/0502C01)

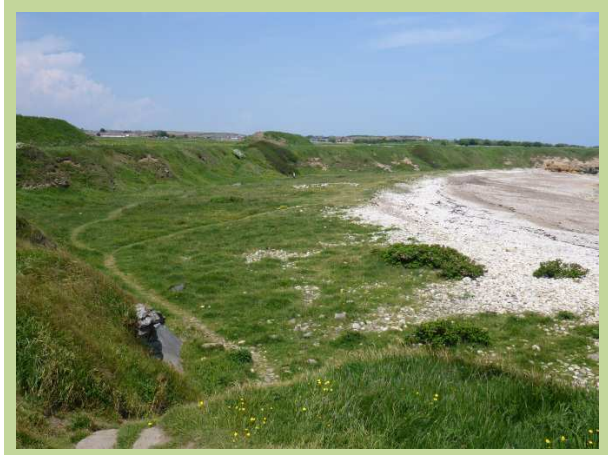
Backshore and slopes well protected by wide foreshore at northern section of Rifle Ranges (/0502C02)

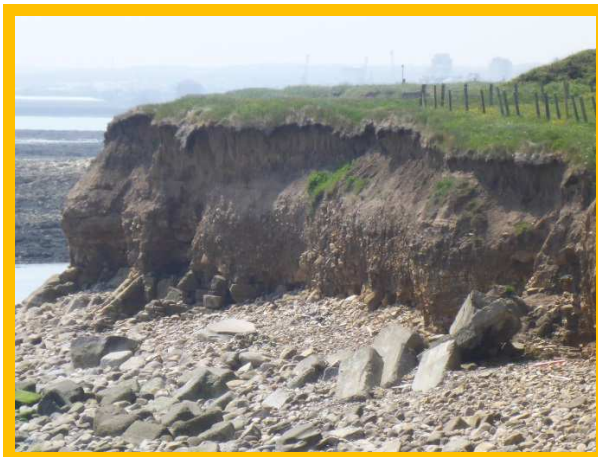
The southern section of the Rifle Ranges (/0601C02) is actively experiencing small and localised slumps along its length, a few of which are becoming close to the public coastal footpath, but still nothing of major concern. In one area, close to the mound and military building, concrete blocks appear to have been dumped at the toe of the cliffs to slow recession. In another area, a drainage pipe has lost its headwall due to localised slumping and this needs attention to ensure adequate drainage and remove the concrete debris.

Regular small and localised slumps at southern section of Rifle Ranges (/0601C02)

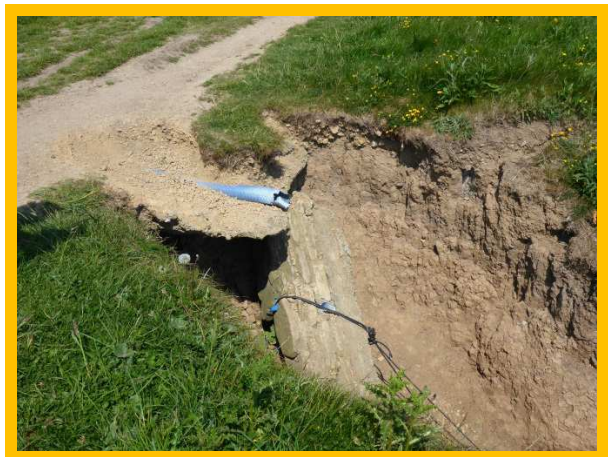
Failed headwall due to localised slumping (/0601C02)

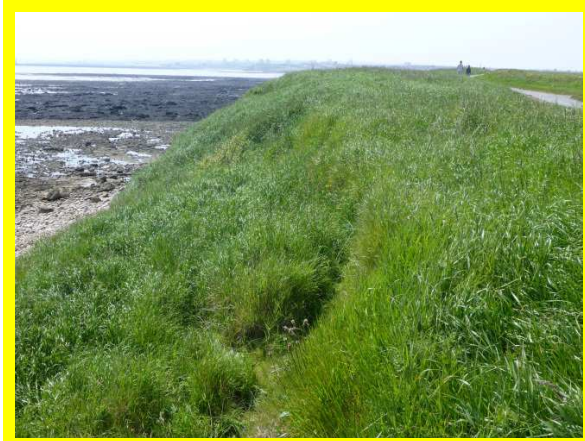
Generally stable cliffs with occasional small and localised slumps (/0601C01)

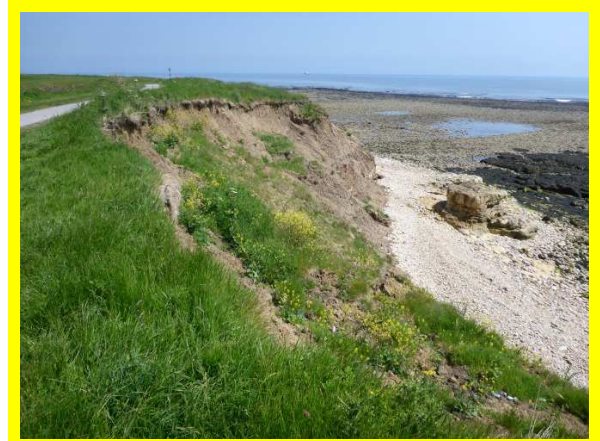
Generally stable cliffs with occasional small and localised slumps (/0601C01)
