**Cell 1 Regional Coastal Monitoring Programme  
Walkover Inspection Surveys 2020**

**South Tyneside Council**

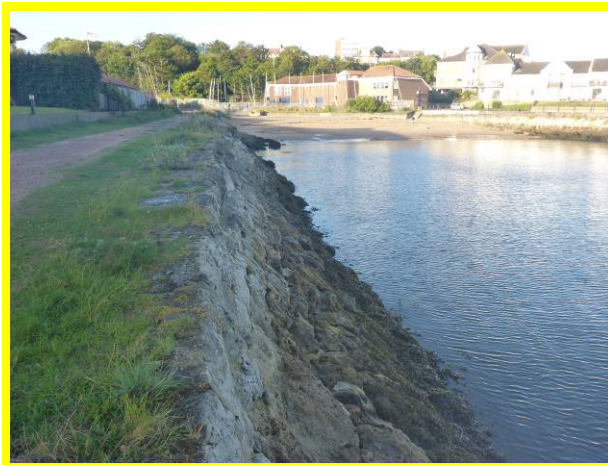
*Grouted masonry revetment in fair condition (/0101C01)*

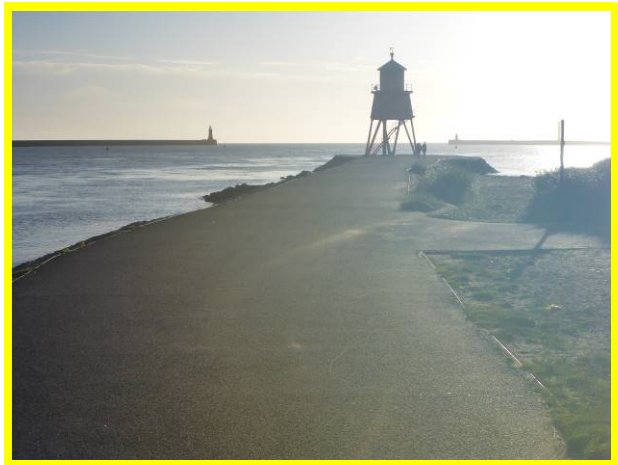
*South Groyne in fair overall condition (/0101C02)*

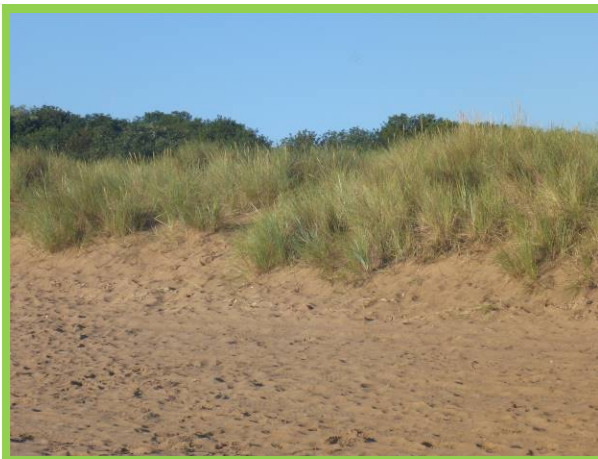
*Stable dunes (/0102C03)*

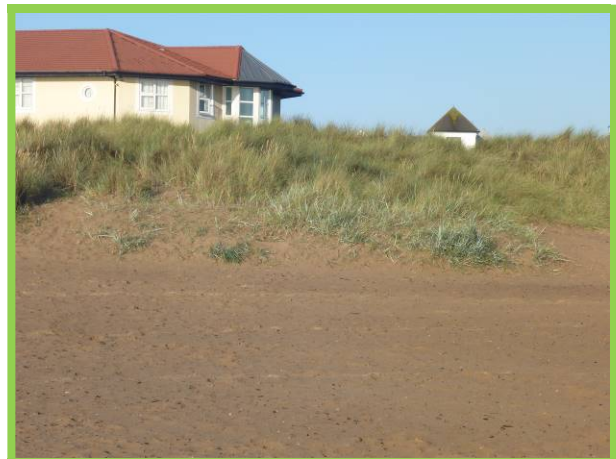
*Stable dunes (/0102C03)*

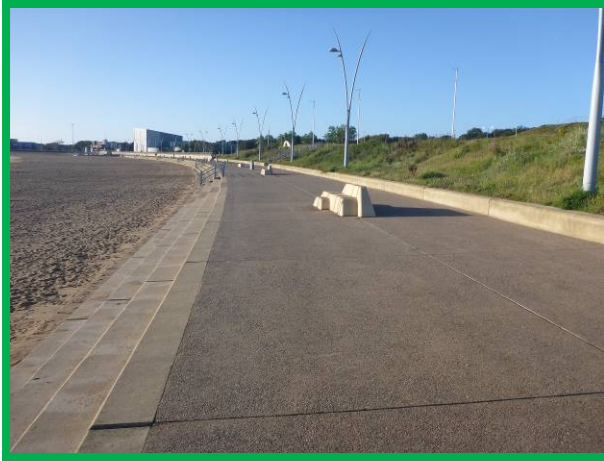
*Littlehaven promenade and seawall in very good condition (/0102C02)*

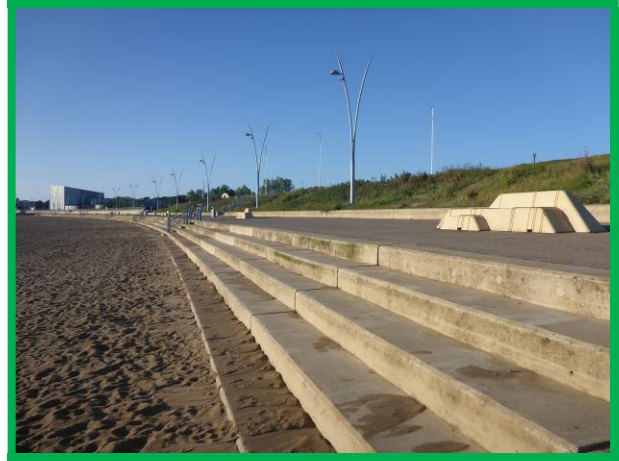
*Littlehaven promenade and seawall in very good condition (/0102C02)*

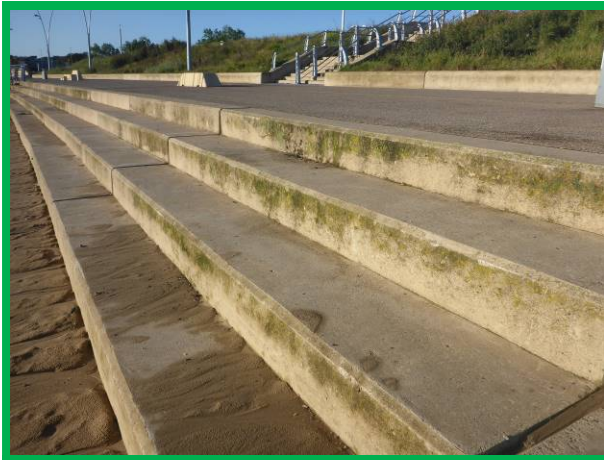
*Littlehaven promenade and seawall in very good condition (/0102C02)*

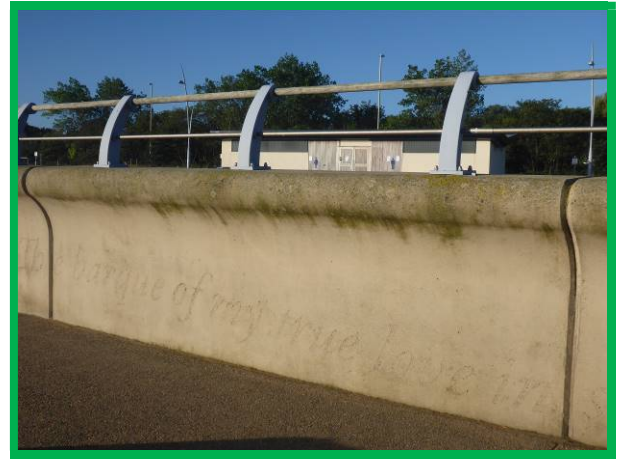
*Littlehaven promenade and seawall in very good condition (/0102C02)*

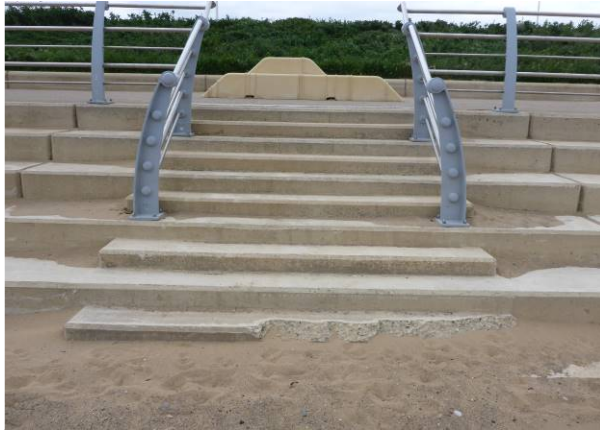
*Damaged beach access step at northern end of promenade in need of repair when seen in 2018 (/0102C02)*

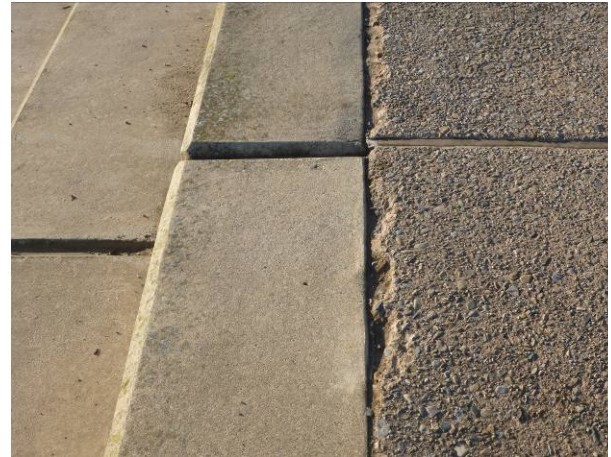
*Minor abrasion at interface between stepped apron and promenade (/0102C02)*

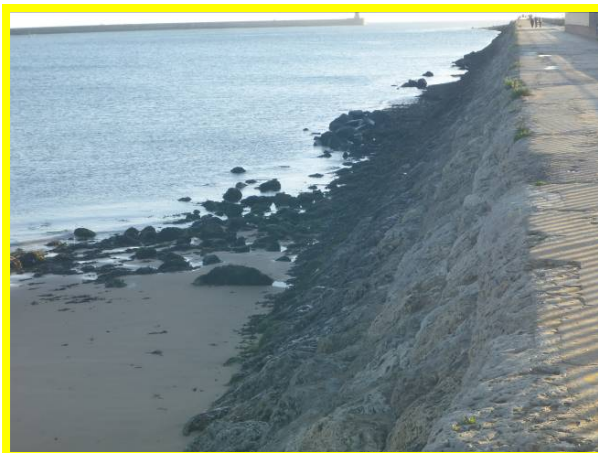
*South Pier in overall fair condition along northern face, landward end(/0103C01)*

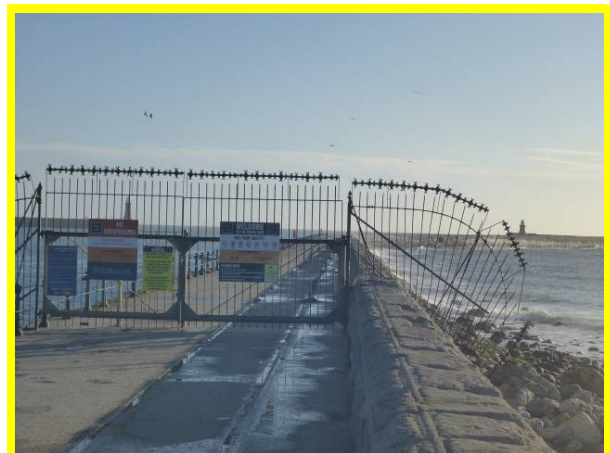
*Seaward sections of South Pier closed to public access due to Covid-19 pandemic (/0103C01)*

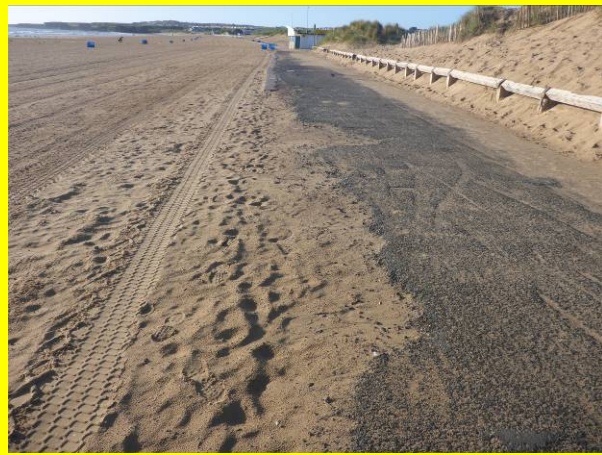
*Plentiful sand but relatively sparse vegetation in dunes (/0201C01)*

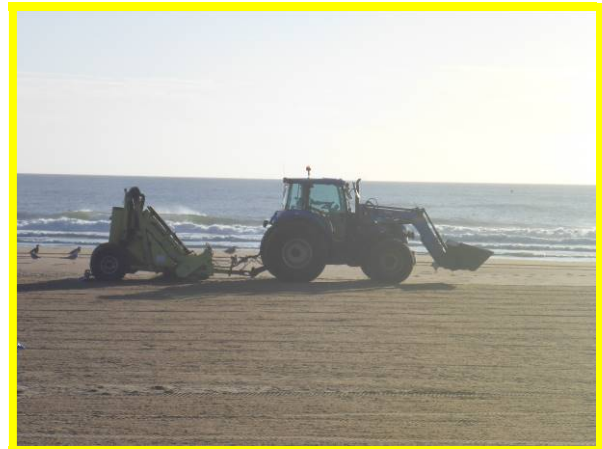
*Beach combing operations underway (/0201C01)*

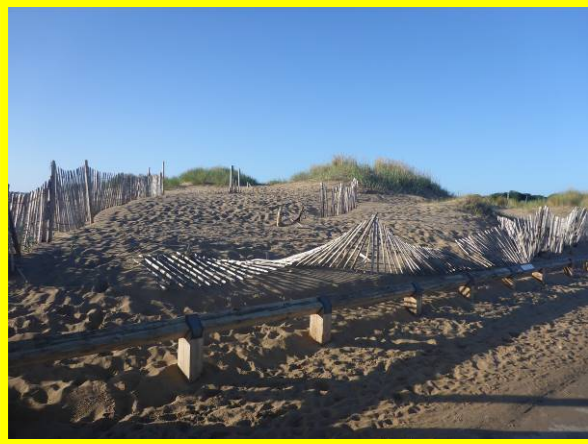
*Fencing blown over (/0201C01)*

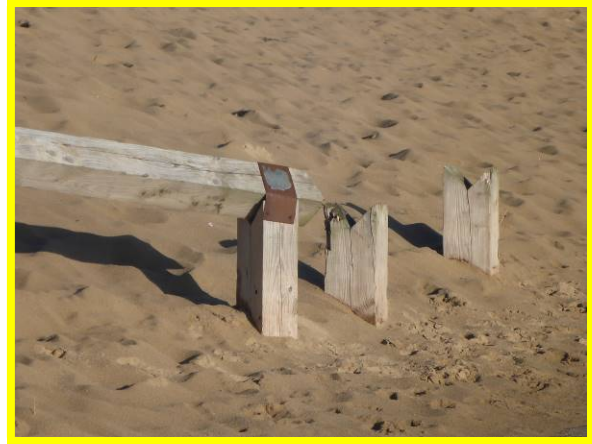
*Missing timber fence rail at access point (/0201C01)*

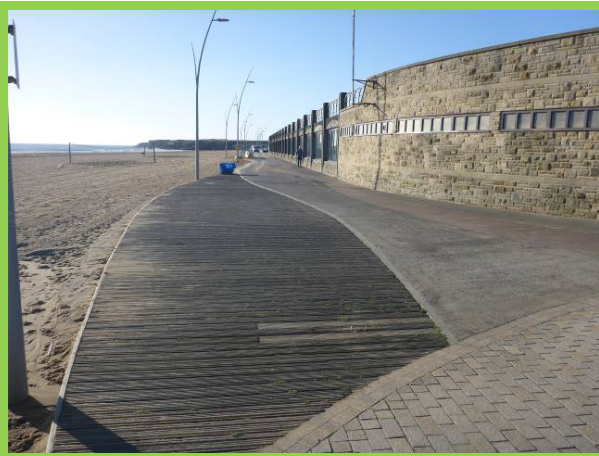
*Healthy beach levels at amphitheatre (/0201C03)*

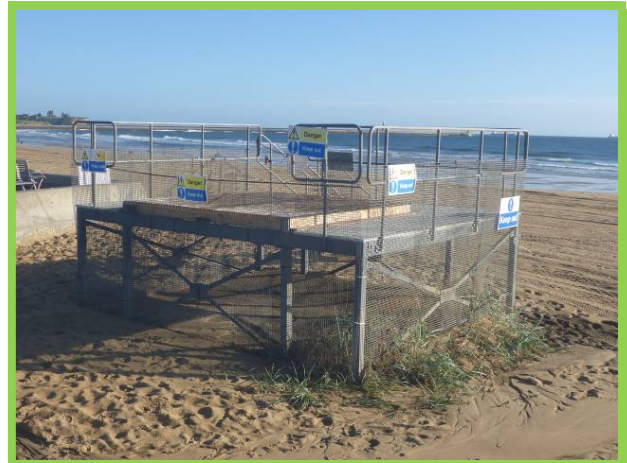
*Disused lifeguard station platform next to reconstructed wall promontory (/0201C04)*

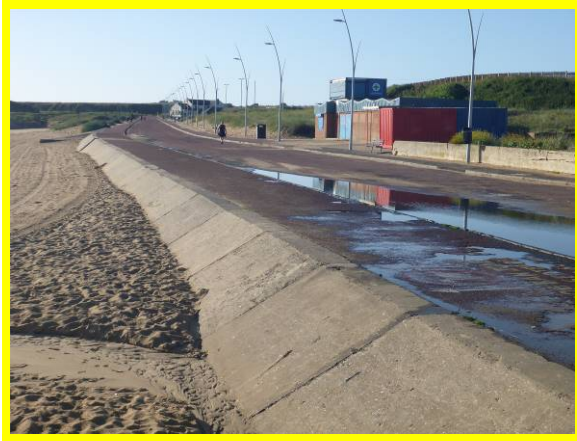
*Healthy beach levels in vicinity of lifeguard station and surf school (/0201C05)*

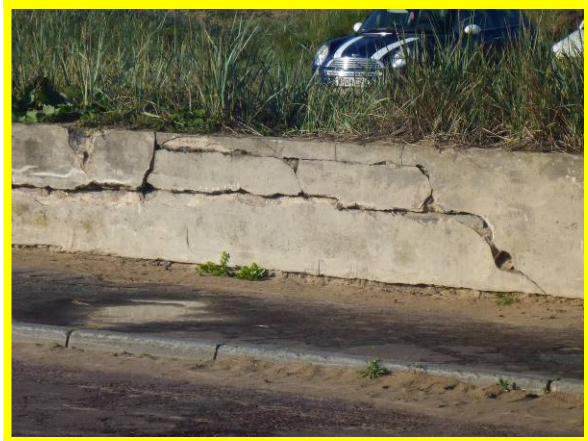
*Cracking to render on wall at rear of promenade (/0202C05)*

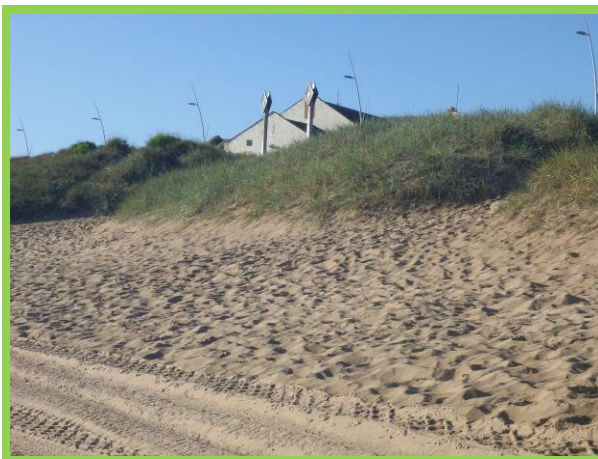
*Stable but narrow dunes at south end of Herd Sands (/0202C01)*

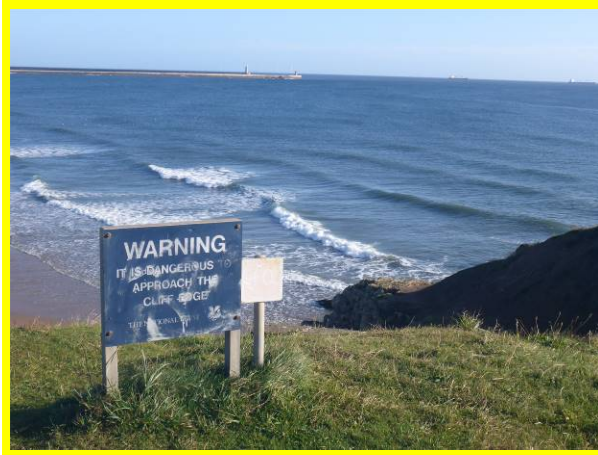
*Localised slumps in soft material at Trow Point (/0302C01)*

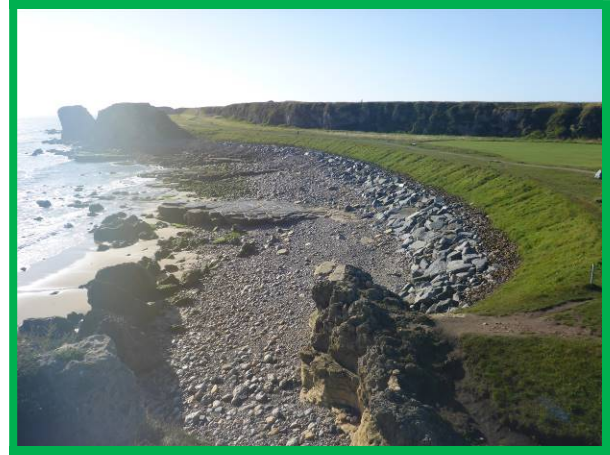
*Rock revetment and re-graded slope at Graham's Sand (/0302C02)*

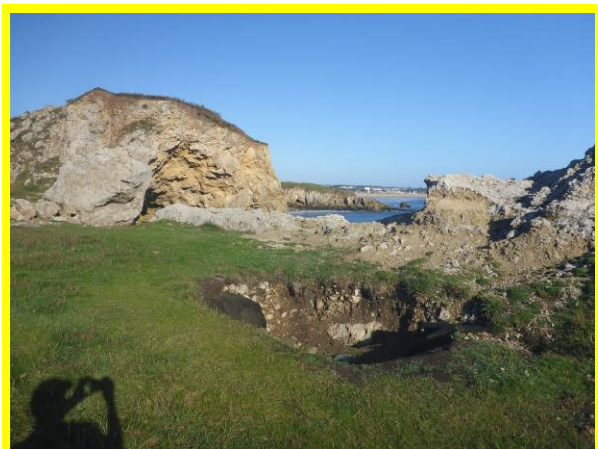
*Localised fragmentation of Target Rock and sink hole to rear (/0302C03)*

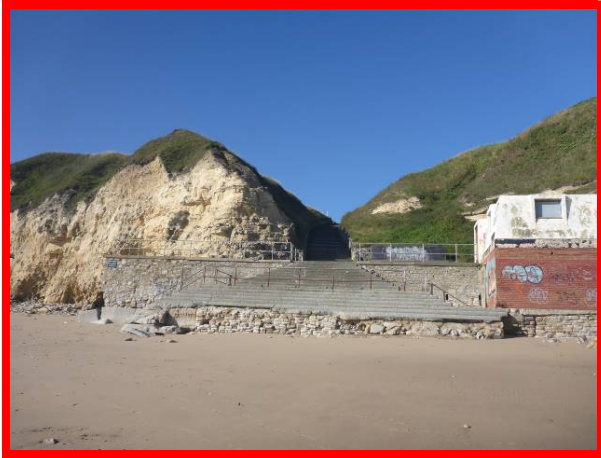
*Disused lifeguard station and the Redwell Steps access (/0401C01)*

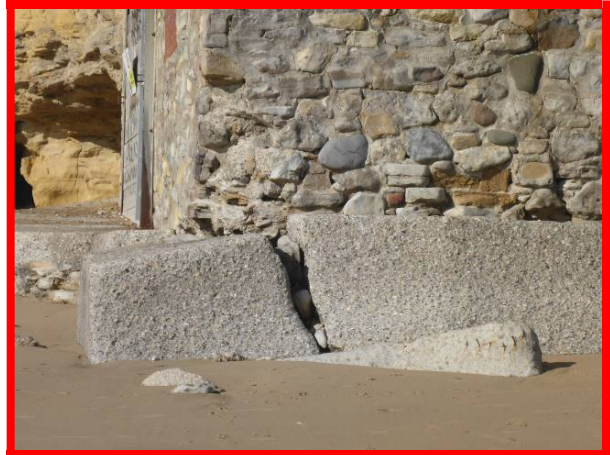
*Undermining and cracking at storage building on south face of buttress to access steps (/0401C01)*

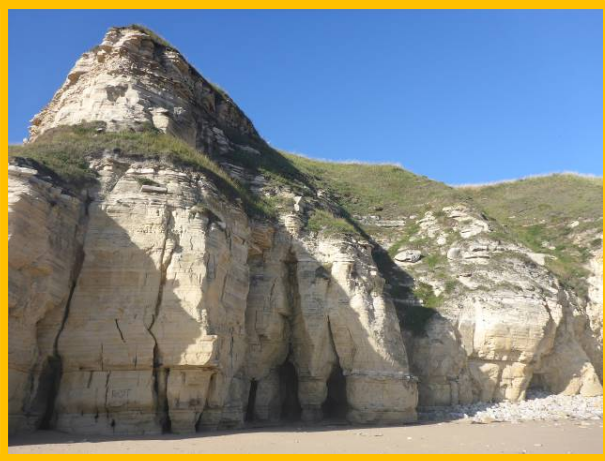
*Caves and arches along toe of cliffs in Marsden Bay (/0401C03)*

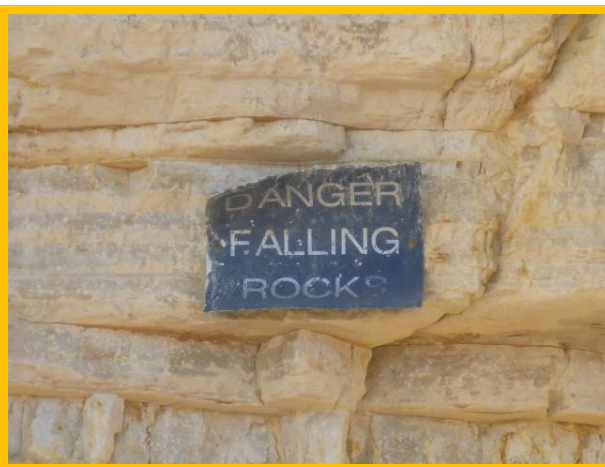
*One small warning sign – bent condition (/0401C03)*

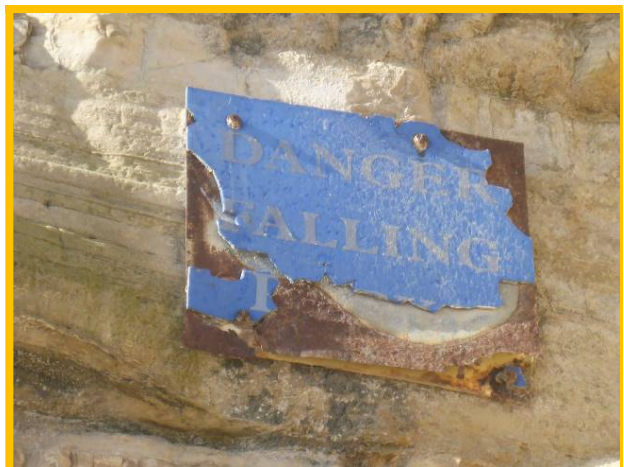
*One small warning sign – broken condition (/0401C03)*

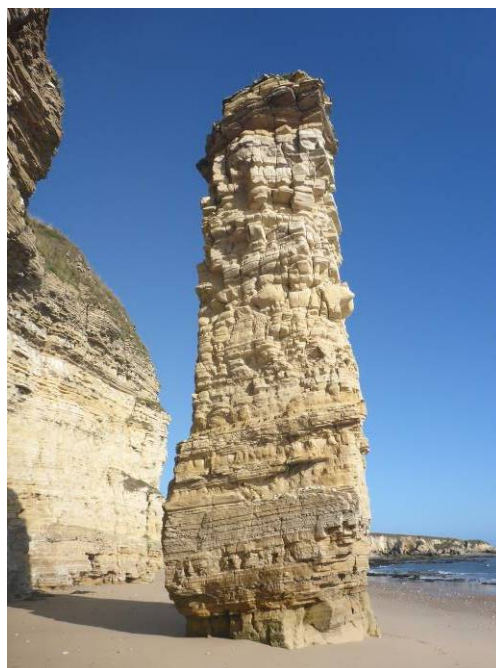
*Lot's Wife rock stack (/0401C03)*

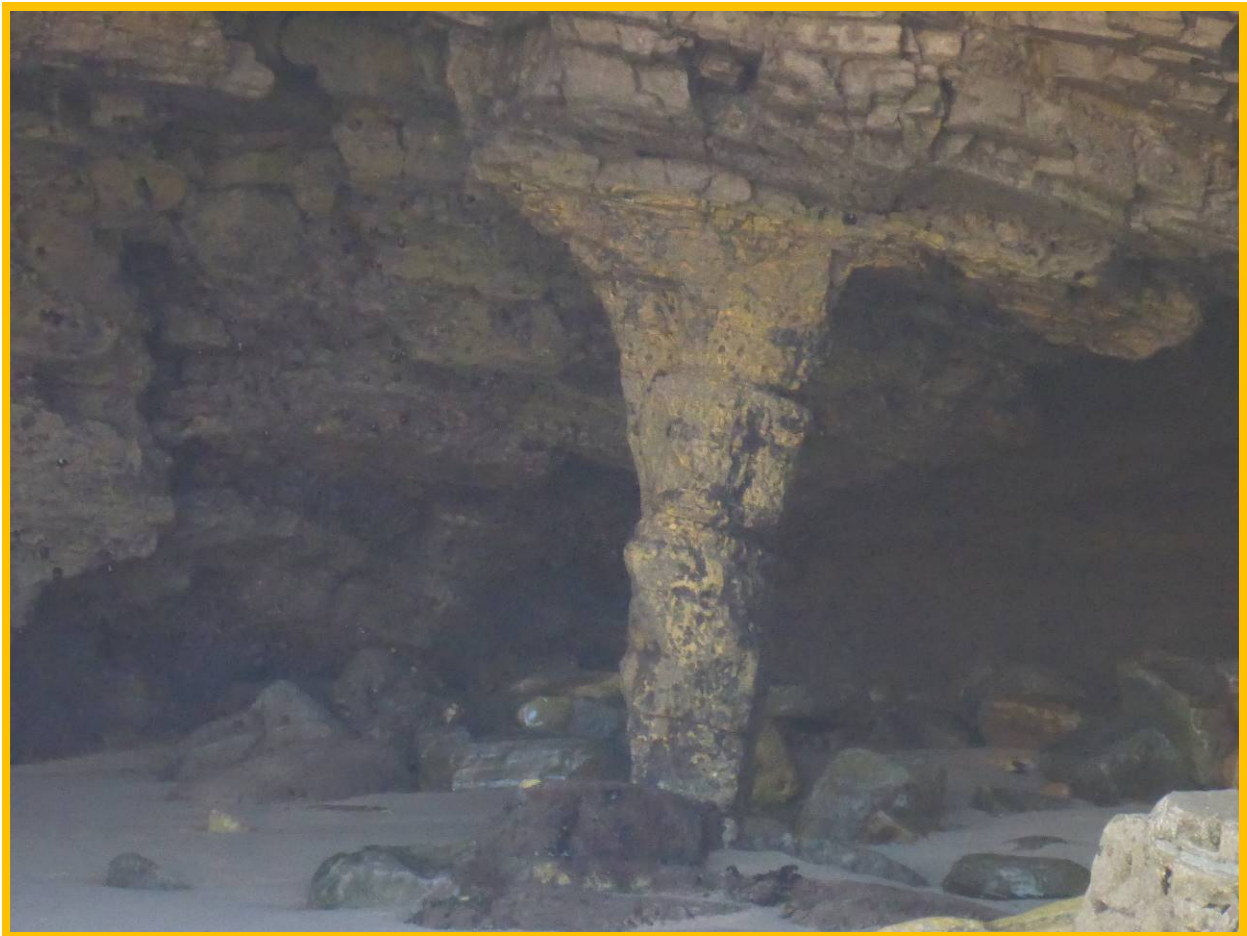
*Thin rock column within cave along toe of Marsden Rock (/0401C03)*

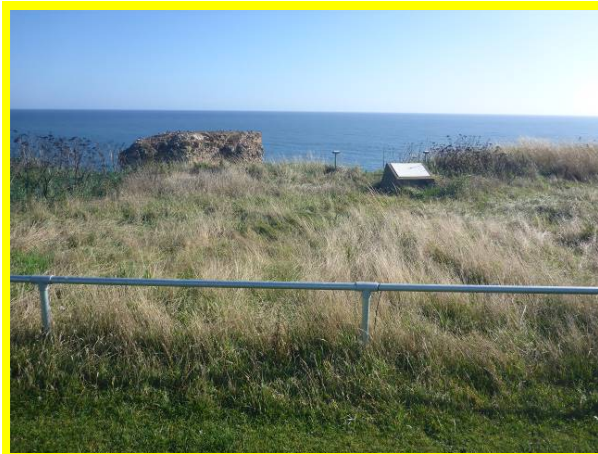
*Marsden Bay – relocated footpath and low-level fencing (/0401C05)*

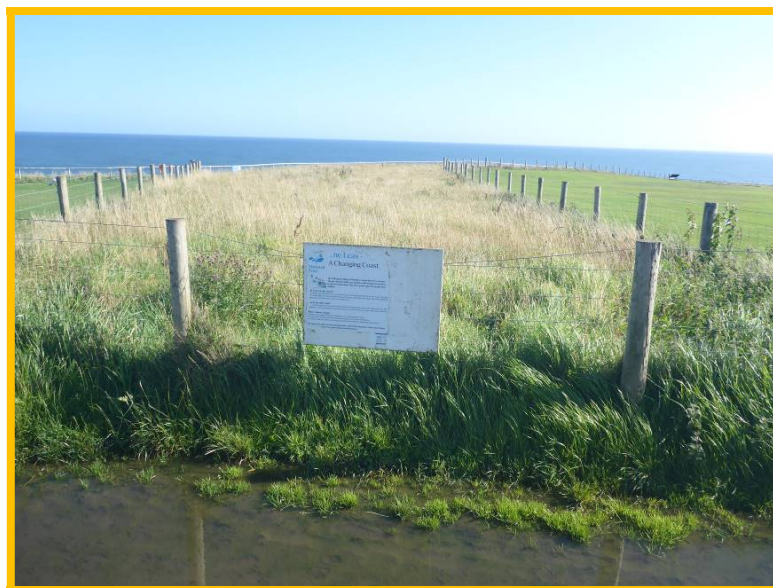
*Natural re-wilding of the car park access road (/0402C01)*

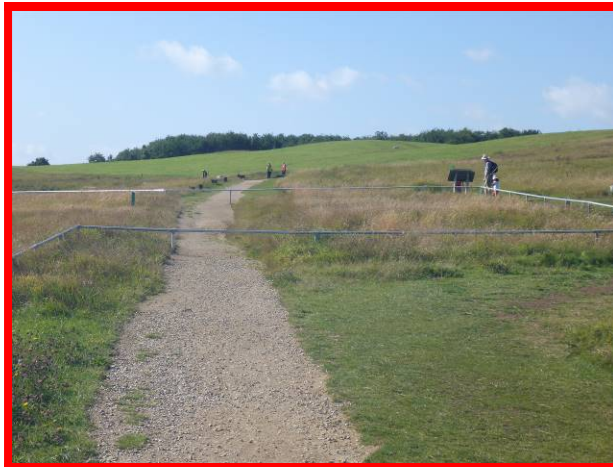
*Fencing to divert the public around a new sink hole at Whitburn Coastal Park (/0501C01)*

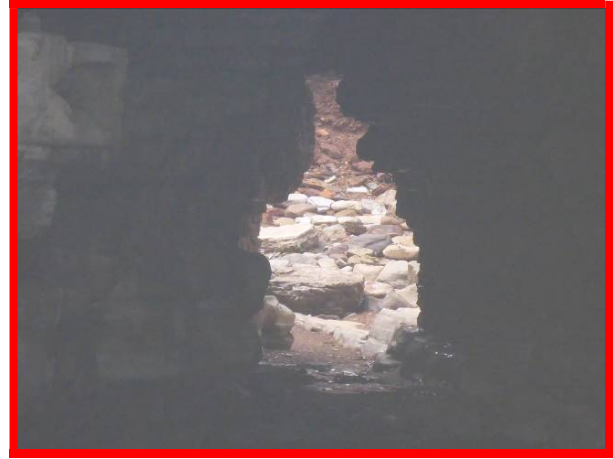
*Enlarged cave hole at the former Old Harbour Quarry –view in 2020 (/0501C01)*

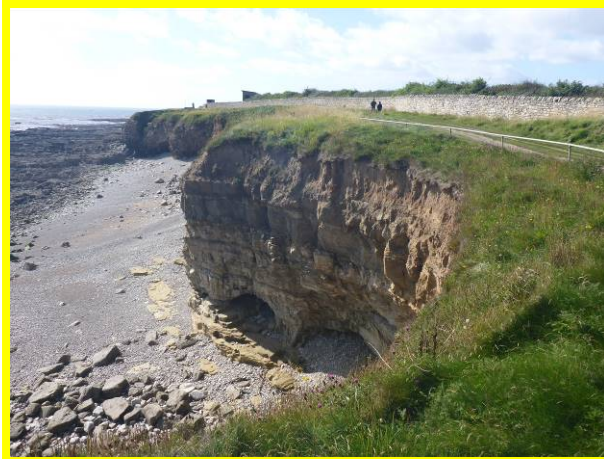
*Generally stable cliffs but some local slumps close to footpath at Whitburn Nature Reserve (/0502C01)*

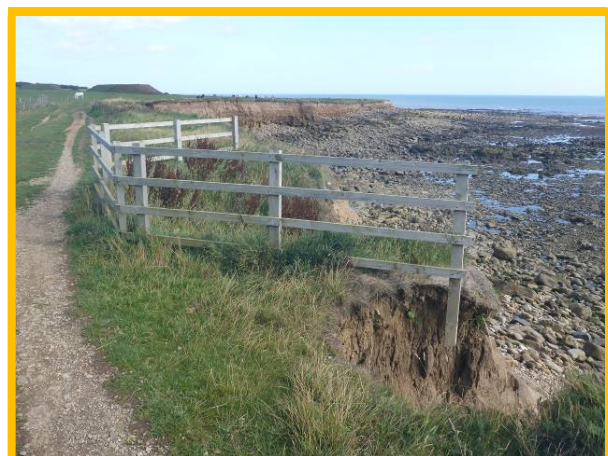
*Repaired outfall – note loss of cliff top around fence post (/0601C02)*

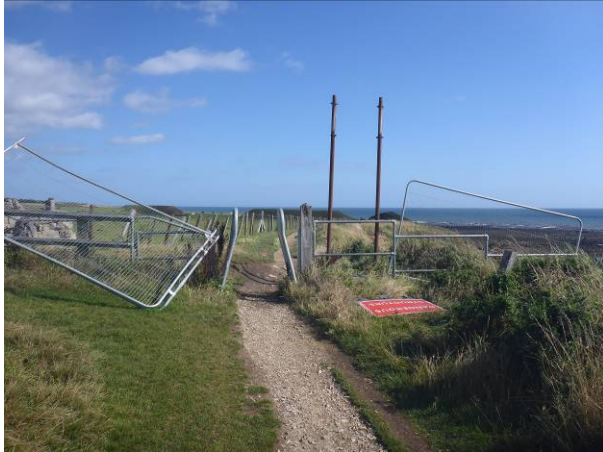
*Fencing and signage blown over by the wind*
