**Cell 1 Regional Coastal Monitoring Programme
Coastal Walkover Inspections 2010**

**Sunderland City Council
Final Report**

October 2010

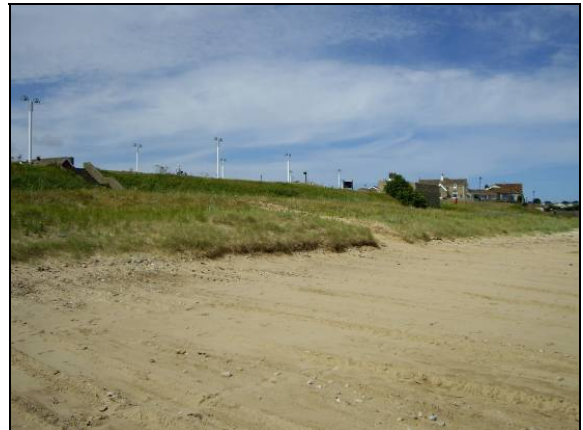
The frontage landward of the Whitburn Steel outcrop consists of an undefended natural grassed embankment fronted by vegetated sand dunes (right). The dunes appeared relatively stable with good vegetation cover and minimal erosion at the toe.

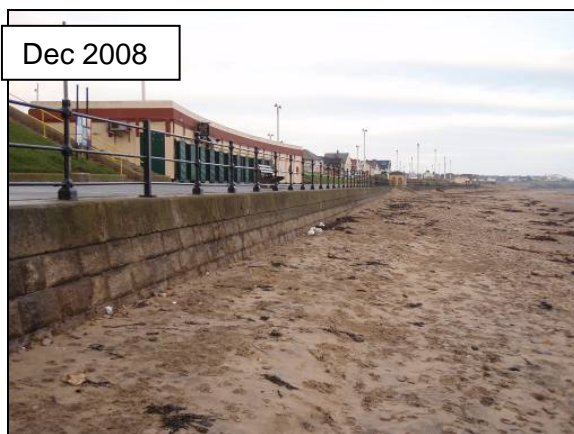
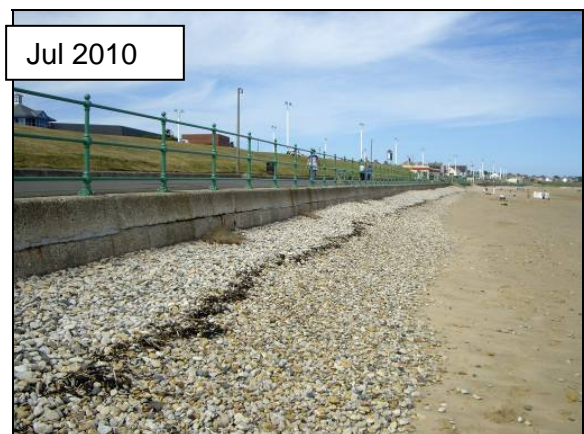
The promenade is fronted by concrete and masonry seawalls. The beach level in 2010 (below right) was higher than observed during the 2008 inspection (below left) and shingle was present up against the seawall. The walls are in fair condition with several longitudinal cracks and vertical cracks extending through the full visible height of the wall. Mortar is missing locally and the structures would benefit from local repointing.

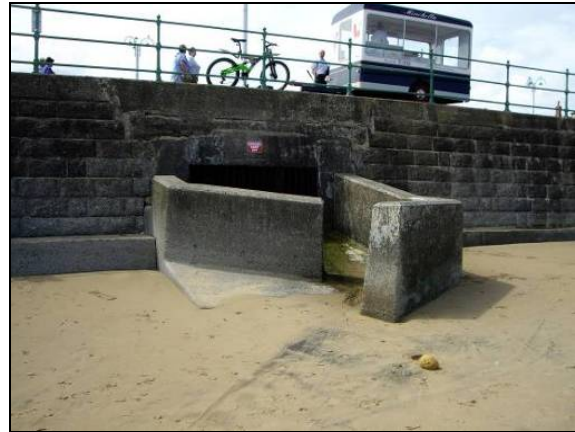
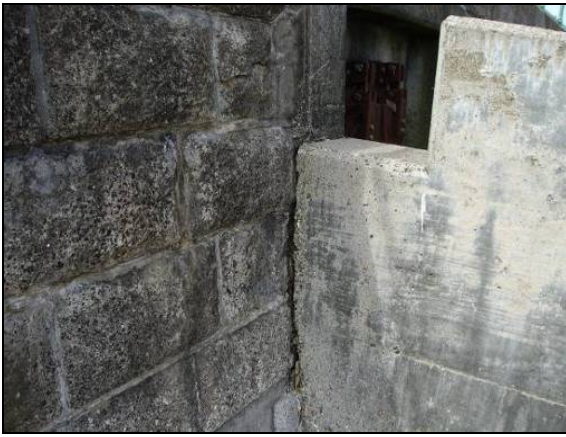
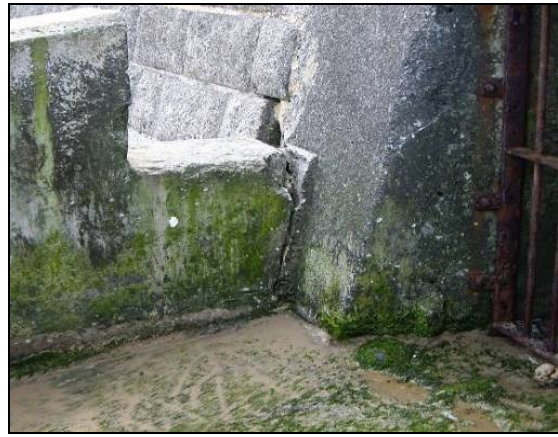
Two concrete outfall structures are located immediately seaward of the seawall (one shown right). Vertical cracks were present (below left) and construction joints had opened in the outfall structures (below right) suggesting that minor settlement may have occurred. Although this did not appear to adversely effect the seawall, the structures should be monitored as any excessive movement could damage the wall behind. It would be beneficial to infill the cracks to minimise the effect of freeze-thaw action.

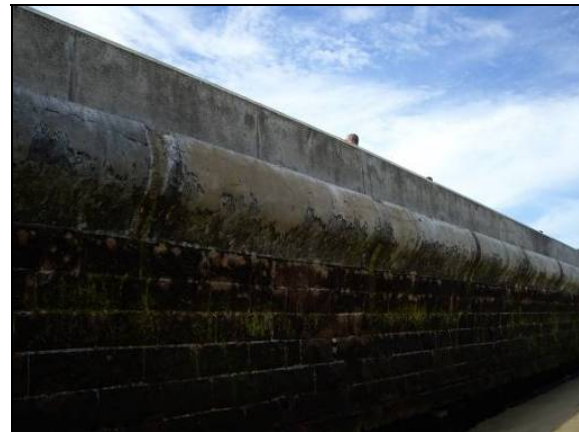
South of the access steps opposite Dykelands Road, the precast concrete coping takes on a curved profile with a precast concrete parapet wall replacing the steel guardrail. The concrete of the coping was extensively spalled along most of its length and patchwork repairs were evident locally (right).

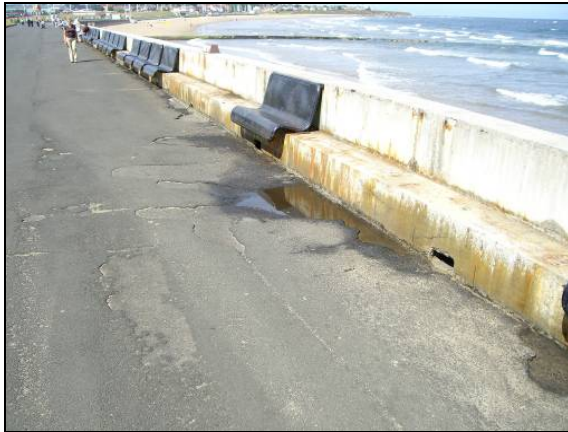
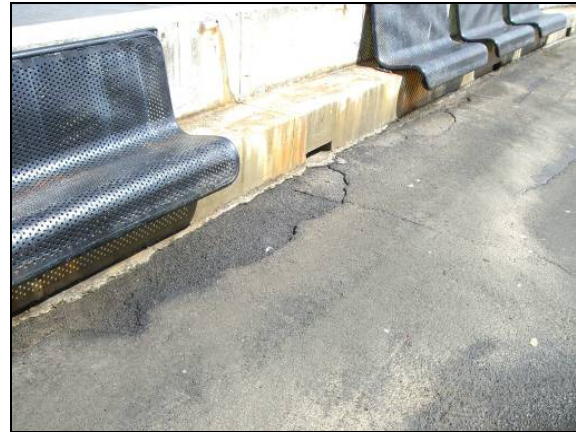
The parapet wall has a stepped profile on the landward side which is used to support benches. Rust staining was present throughout although this appeared to be from the benches rather than reinforcement from the concrete (below left). The base of the wall was spalled with most significant damage occurring around the drainage holes. The bitumen surface of the promenade was also worn locally along the base of the wall and extending landward locally, most likely as a result of overtopping (below right).

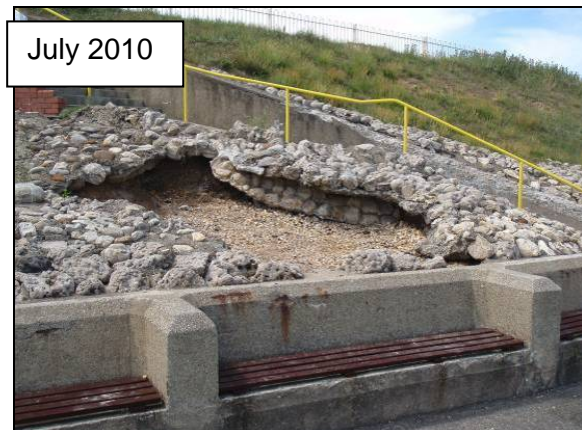
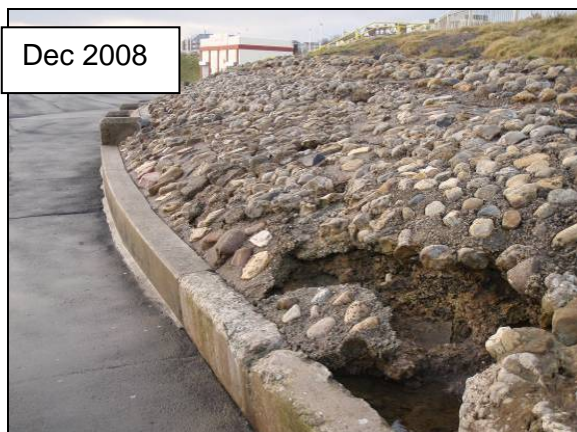
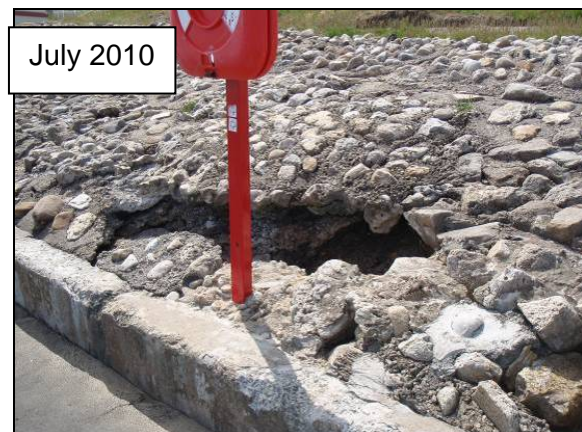
Local damage was observed to the grouted stone revetment landward of the promenade around Roker Cliff Park (right). Voids identified in the 2008 inspection (below left) appeared to have deepened in the interim with further loss of infill material. One of the voids has had a lifebelt stand installed into a concrete base although it appears that the remainder of the void was not filled during this operation (below right).

It would be prudent to infill the voids to minimise the risk of further expansion and the potential reduction in stability of the embankment above.

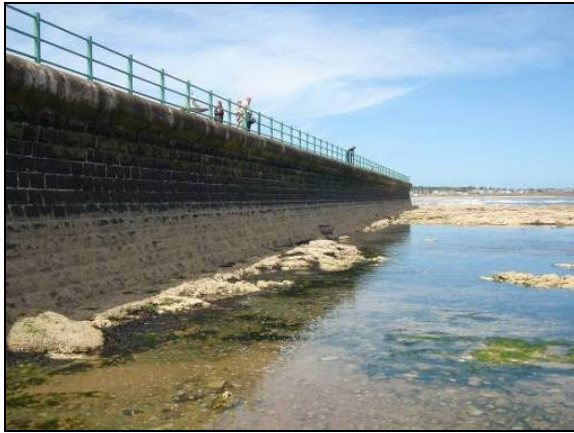
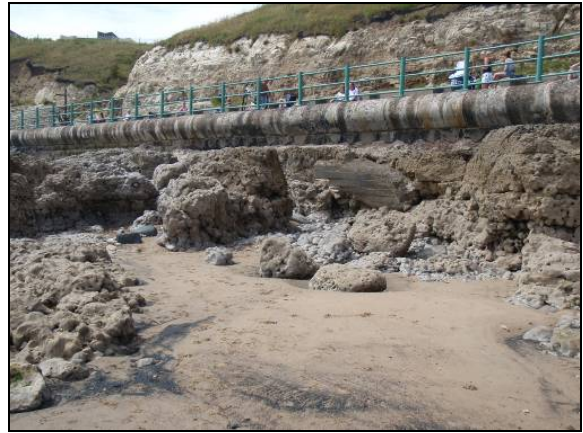
The masonry seawall backing Parson's Rocks is in good condition (below left). The masonry structure ties in with the elevated rock outcrop at its southern end. Here grouted rubble has been used to infill voids between the rock and the masonry and these repairs appeared to be performing well (below right).

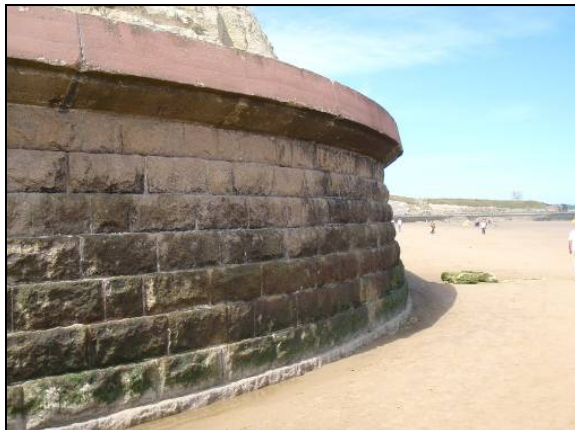
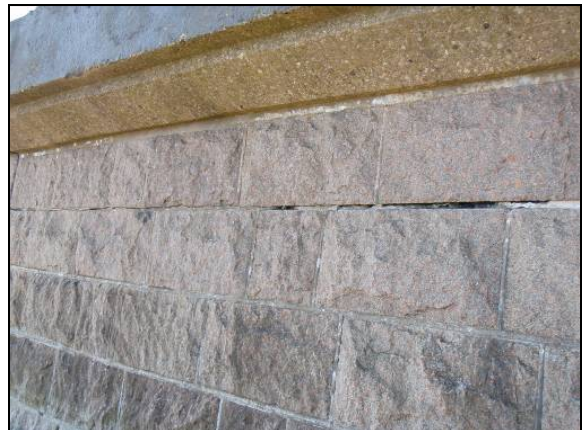
South of Parson's Rocks, the high masonry wall with concrete coping was in generally good condition (below left) with only minor loss of mortar and spalling noted (below right). The natural cliff above appeared to be relatively stable.

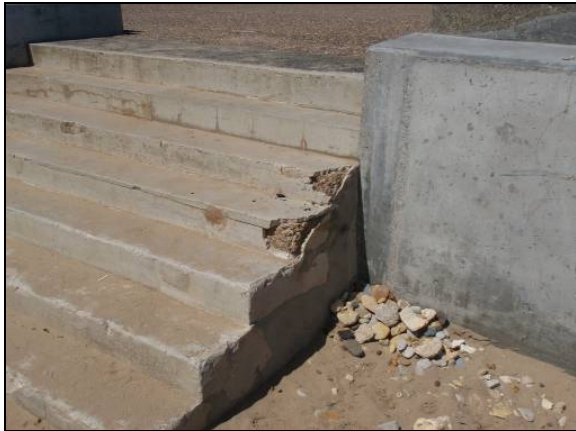
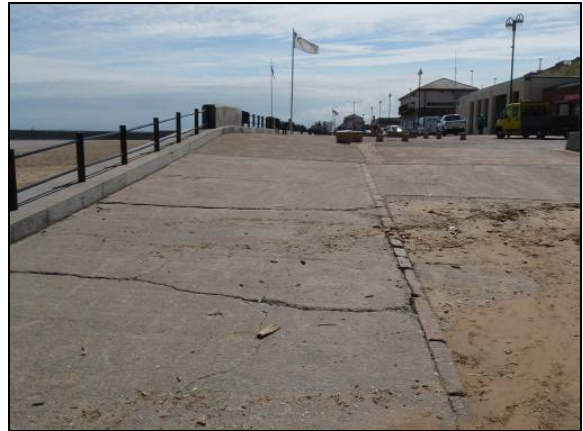
The low level concrete wall fronting Marine Walk was in good condition. Minor damage has occurred to the finish of a set of access steps, exposing the concrete infill (below left). Cracking was evident in the concrete access ramp at the northern end of Marine Walk (below right). Minor shrinkage cracking in the concrete cladding has not worsened from that reported in 2008.

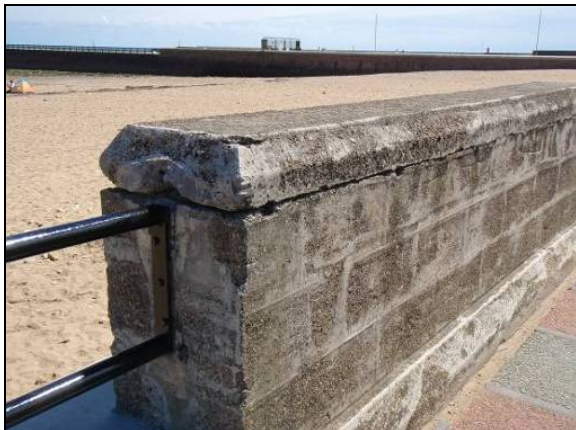
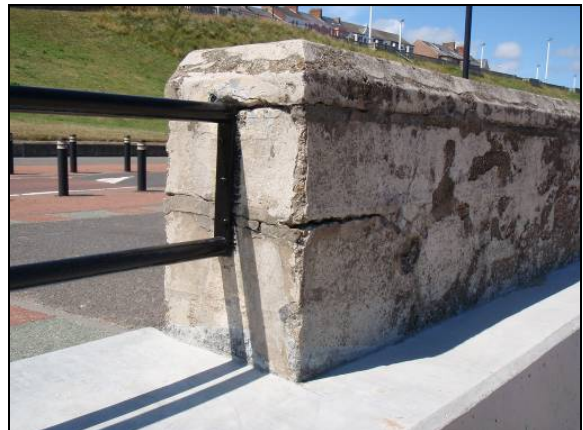
Open jointing and cracking was observed around the fixings of the steel guardrail sections into the masonry seawall (below, left and right). The coping stones appear to have lifted locally, opening the joint between the coping and the masonry wall. Minor pointing should be used to infill any gaps and worst affected coping stones removed and reset.

121AB90 1B0702C 05	Roker	Wall	Low	31/12/2012	Improve condition through maintenance	Minor repointing to masonry wall around connection with steel guardrail.
121AB90 1B0702C 04	Roker Pier	Pier	Medium	31/12/2012	Improve condition through maintenance	Minor repointing. Repairs to deck surface.

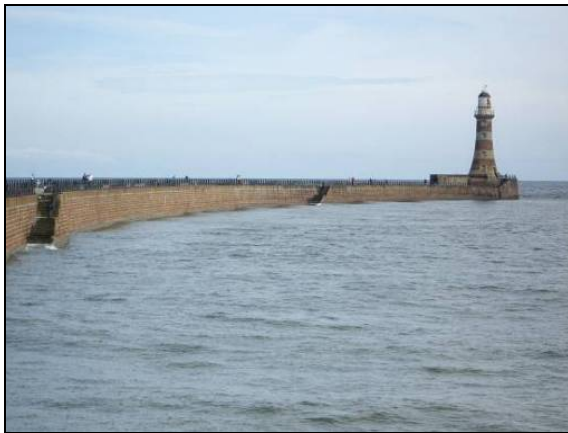
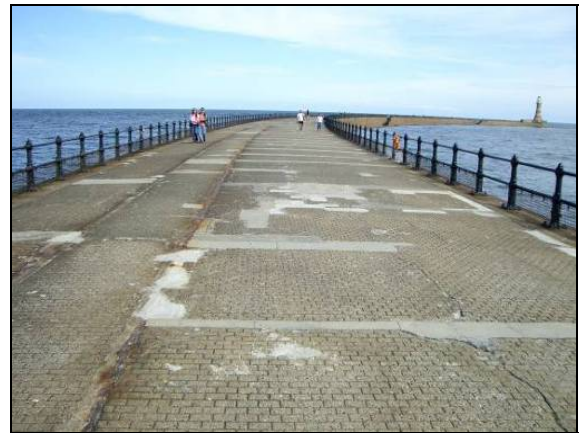
Roker Pier appeared to be in good condition above the waterline, with no significant changes from the 2008 inspection (below left). Previous local repairs to the concrete deck appear to be working well, however, several longitudinal cracks were identified which would benefit from infilling to minimise water ingress (below right).

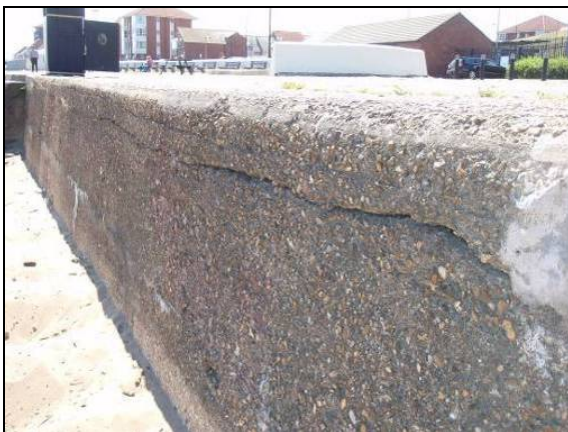
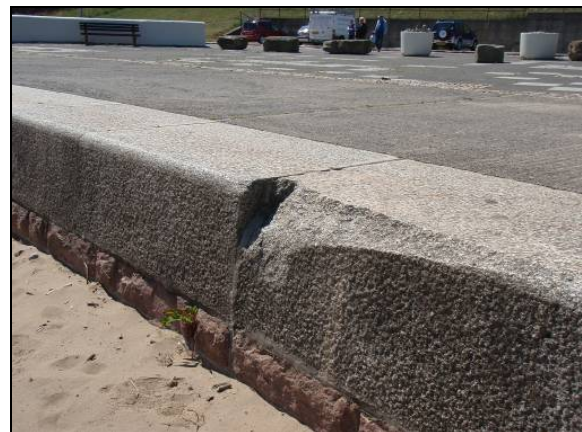
South of Roker Pier the masonry and concrete seawall is in good condition with evidence of previous patch repairs. A construction joint appears to be widening below the top slab of the structure (below left) and minor impact damage is evident in the concrete coping (below right). The level of the fronting beach was similar to that observed in 2008.

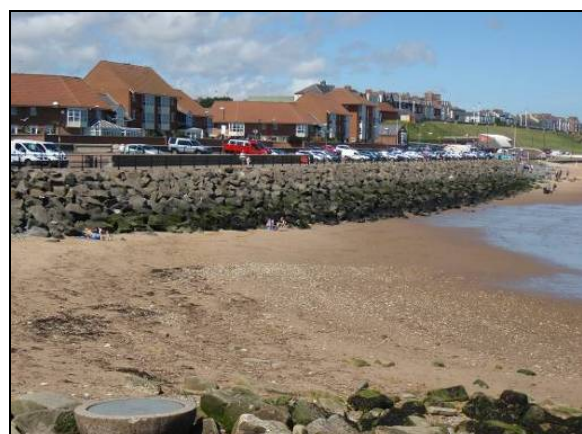
The rock armour revetment fronting the public car park (right) is in good condition with no significant movement of armour units which maintain suitable interlock and a good profile throughout. The concrete seawall and the walls of the car park behind appeared in good condition.

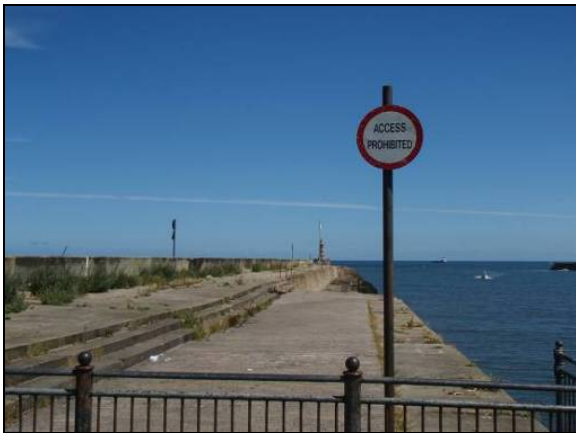
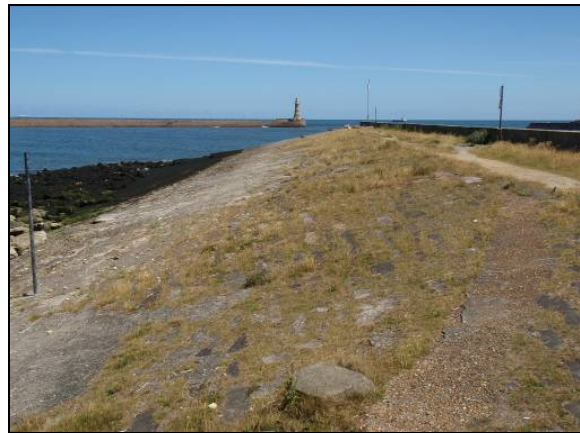
The structure remains fenced off to members of the public (below left) with signs describing the structure as unsafe and therefore assessment was not possible. From the landward end, the structure appeared in similar condition to that reported in 2008 with missing concrete and masonry from both the grouted revetment forming the northern face and the masonry wall forming the southern face (below right). No significant global movement or distress was visible from the landward end.

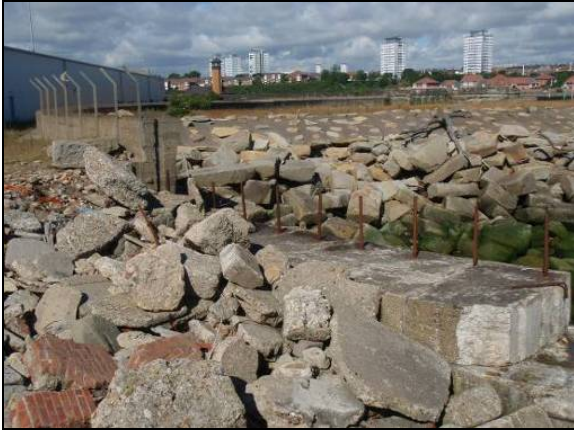
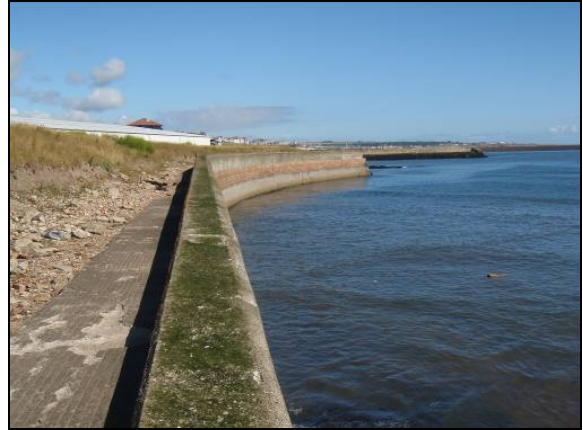
The northernmost structure consists of a grouted stone revetment with a rock armour toe (below left). The revetment ties into a masonry seawall with a precast concrete recurve crest. The wall was in good condition, with minor spalling and cracking of the concrete and spalling to the surface of the concrete walkway to the rear.

South of the revetment, the seawall is backfilled with random rubble (below right). Reinforcement bars stand vertically from the top of the concrete wall and it appears these were placed to allow the continuation of a concrete boundary wall which has not been carried out. The crest level is lower around the tie in with the risk of fill material washout. This did not appear to be a problem at present as the rubble was as observed in the 2008 inspections. However, this should continue to be monitored because extensive loss of material may lead to collapse or outflanking of the seawall to the south.

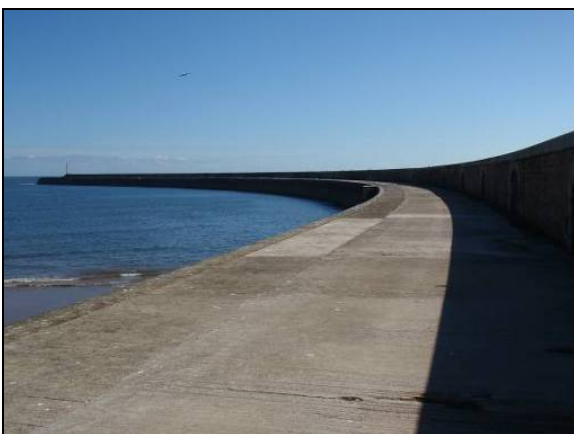
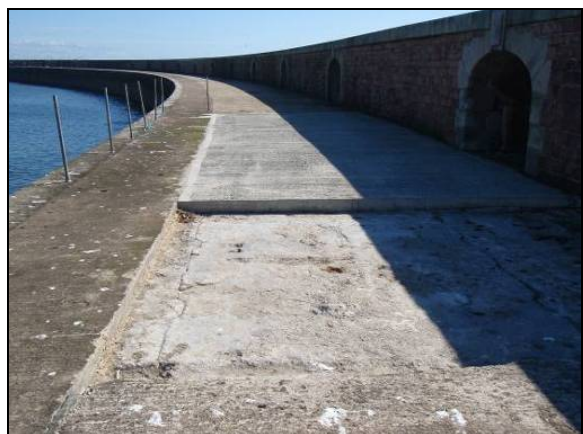
The New South Pier appeared to be generally in good condition (below left) with only minor defects of mortar loss between masonry blocks and minor cracking to concrete elements noted. There were no signs of global movement and distress which suggest that below the waterline the foundations of the structure are functioning satisfactorily.

Repairs have previously been carried out to the deck of the pier, with insitu concrete slabs. This work was not completed and a section of deck has been prepared for an insitu concrete pour but not yet filled with concrete (below right). This does not appear to have any adverse effect on the structure although it would be prudent to infill the section to prevent water ingress into the surrounding repairs.

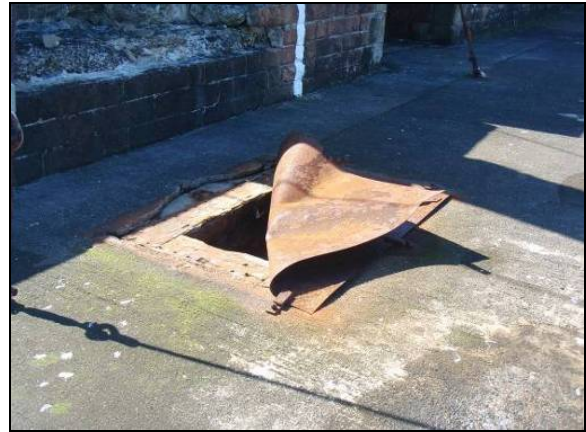
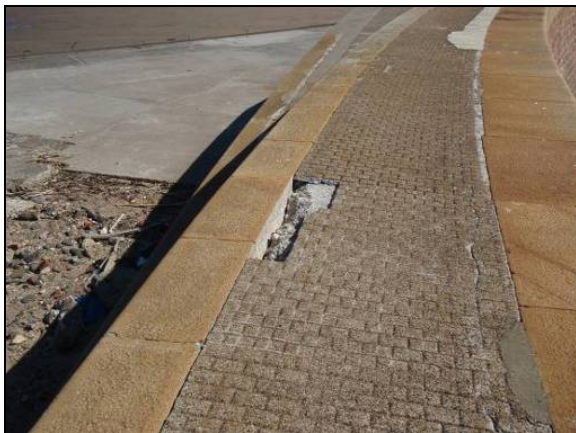
A former access passage runs through the centre of the structure. The openings to the passage are now covered with steel panels, however, the panel nearest the nose of the pier has been lifted by the force of the water (right). The void within the pier was observed to be full of water which oscillated with wave action. The structure appeared unaffected but this may be a potential source of problems as water passing through the body of the structure may start to wash out fine materials and hydraulic forces applied within the structure may reduce its integrity. The pier acts to shelter the harbour entrance to the north and should continue to be regularly monitored and maintained.

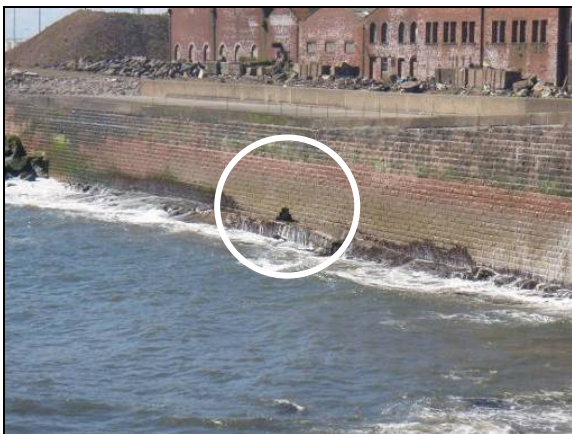
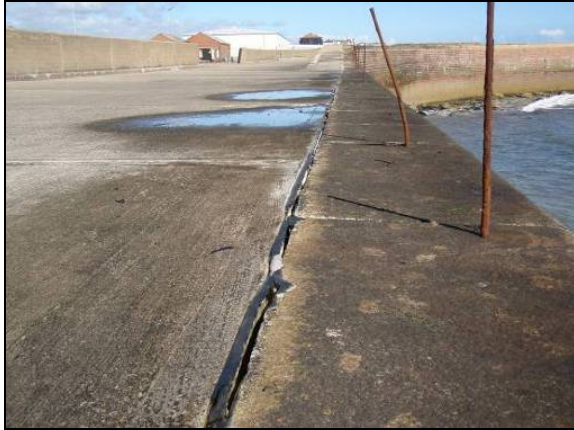
A void was visible at the base of the wall, with approximately eight masonry blocks missing from the seaward face (below, left and right). It was not possible to ascertain the depth of the void as the tide prevented access. Further investigation should be carried out and an appropriate local repair carried out urgently to prevent the void expanding.

The most significant deteriorations in condition identified are the void in the base of the seawall and the further deterioration of the seawall adjacent to the missing coping units within the Port of Sunderland.

The void identified at the base of the seawall within the Port of Sunderland should be repaired as a matter of urgency to avoid further damage to the asset. The missing precast concrete coping units in the seawall at the southern extent of the Port should be replaced with similar units or a robust repair implemented to prevent the unravelling of the structure over time.

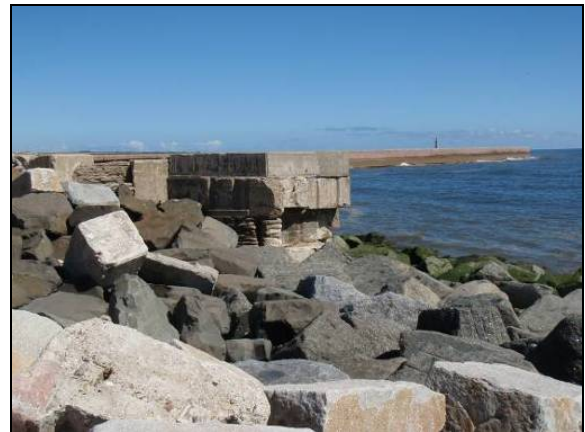
The southern extent of the wall appeared to be cantilevered slightly due to loss of material and/or displacement of rock armour units (right). Bagwork is present as a local repair although unsupported concrete blocks appeared to have moved slightly. The structure appeared stable, however, this area is likely to be a potential weakness from which the structure could start to unravel and future monitoring is important.

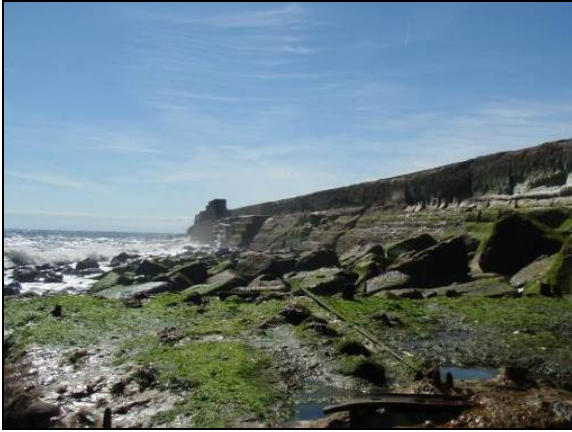
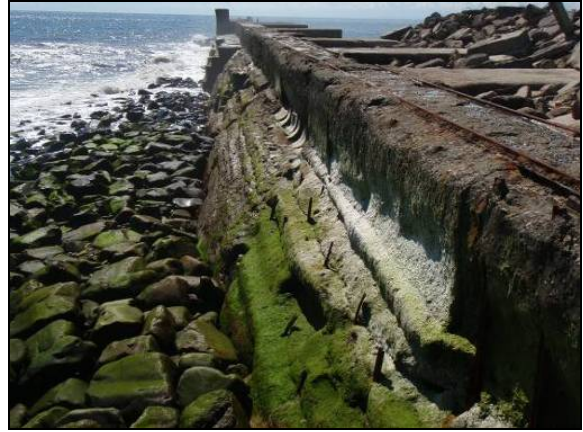
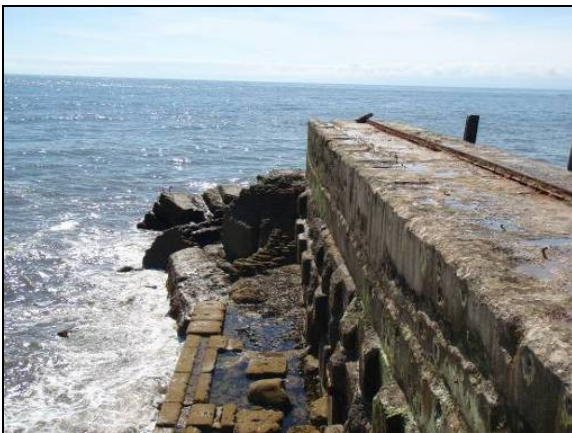
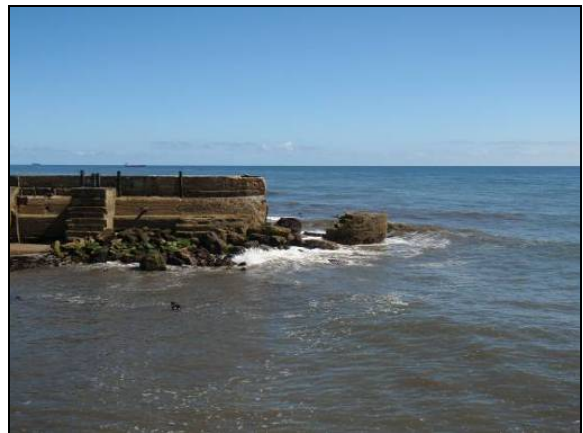
The South Outlet is formed between the North East Pier and the South West Breakwater. As reported in 2008, the structures remain in poor and fair condition respectively and appeared to have experienced further degradation although no significant failures.

Extensive erosion was evident to the seaward face of the North East Pier, with local loss of material and void formation (above top left & right). The deck was severely abraded and evidence of chloride attack was noted (above, bottom left). Exposed reinforcement was observed throughout. The roundhead of the pier has become detached (above, bottom right) with significant material loss, leaving the exposed nose of the pier vulnerable to wave attack and reducing the level of protection to the South Outlet. Significant movement/settlement of concrete blocks has occurred in proximity to the former roundhead.

The landward face of the structure was in slightly better condition. Concrete blocks form abutment walls which are generally intact although the concrete was extensively abraded with spalling and rust staining present throughout.

The South West Breakwater requires extensive remedial work and the North East Pier requires major refurbishment or possible replacement although the importance of maintaining the South Outlet is unlikely to be significant enough to justify the significant capital expenditure required. The size of the structures means that they will continue to provide some protection to the headland even if no remedial action or maintenance program is undertaken. Monitoring should continue, to ensure that the protection provided is sufficient for the needs of the Port and therefore a strategy should be developed for the South Outlet which incorporates the development plans of the Port.

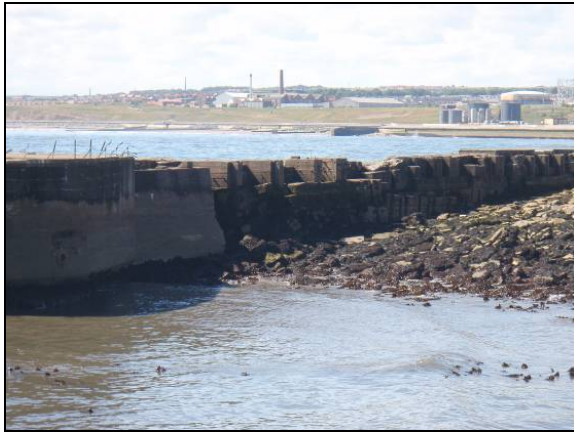
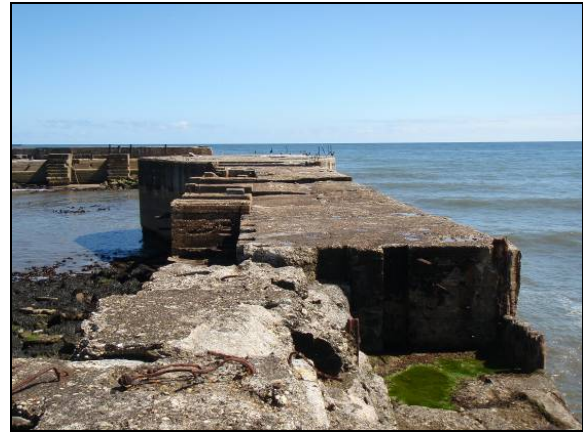
The South West Breakwater has experienced further degradation of the concrete deck of the roundhead. There was evidence of undercutting and displaced masonry blocks at the seaward end of the structure at the tie in between the masonry and the concrete roundhead, particularly on the northern side (below left) although global movement of the structure was not evident. The southern side was generally in good condition although the upper section was badly abraded with exposed reinforcement (below right).

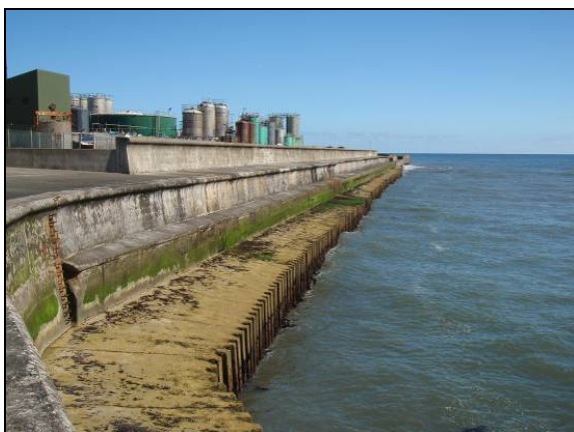
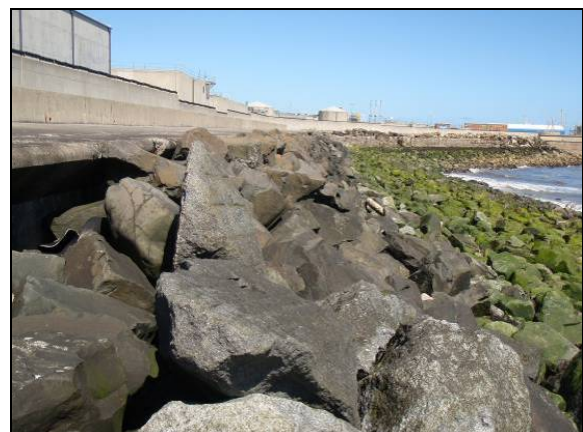
The structures appeared to be in good condition throughout. The condition of the steel sheet piles could not be ascertained due to the water level, although the visible sections appeared in fair condition with no signs of global movement or distress in the walls which may be associated with problems below the waterline. Minor cracking and surface deterioration reported in 2008 was still present and had not worsened significantly.

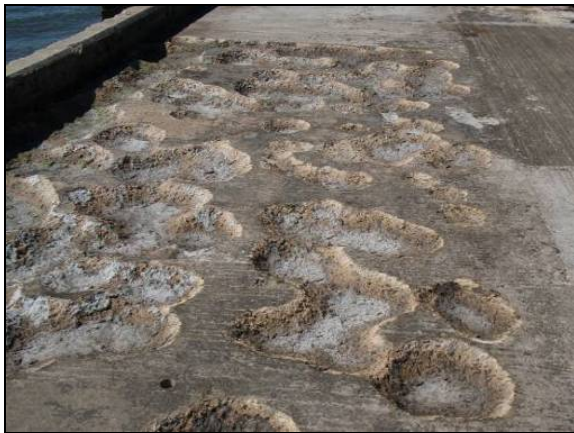
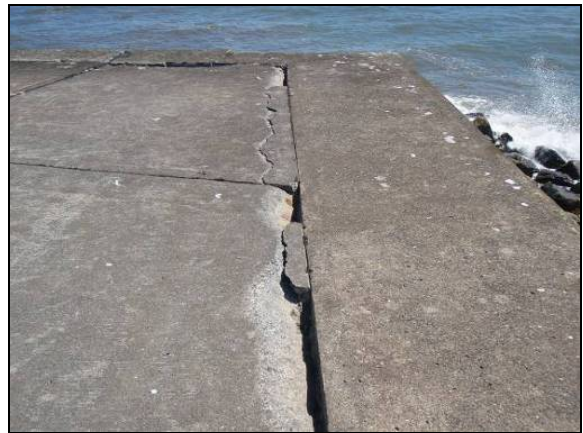
Surface deterioration locally associated with chloride attack has created a 'cratered' profile on the surface of an insitu concrete repair (below left). A widening of construction joints between the concrete apron and the concrete coping (below right) and local spalling was observed in several locations. Local patch repairs should be implemented to prevent ingress of water.

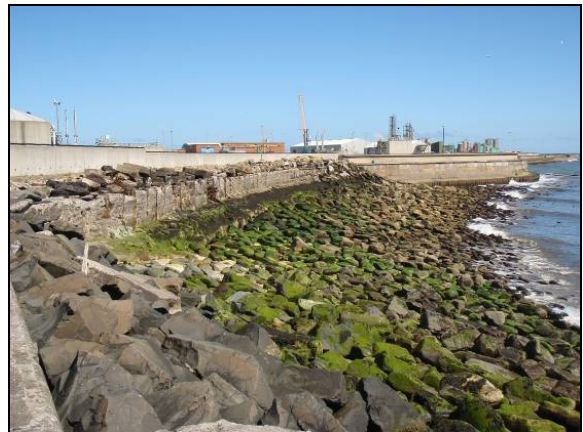
The insitu poured concrete wall with timber piles and rubble backfill, located to the north of the sewage works was generally in fair to poor condition as reported in 2008 (right). The standard of defence could be improved significantly by the addition of an upgraded rock armour revetment, similar to that fronting the sewage works.

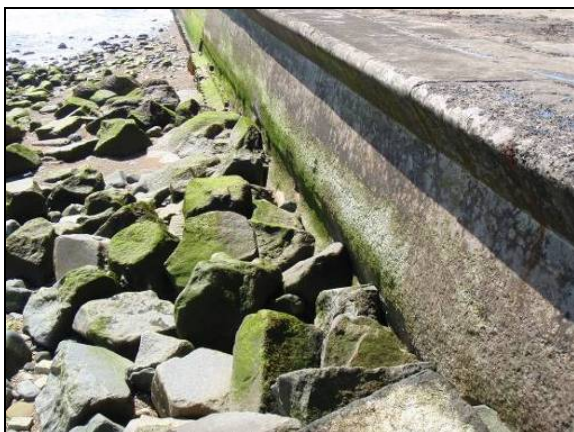
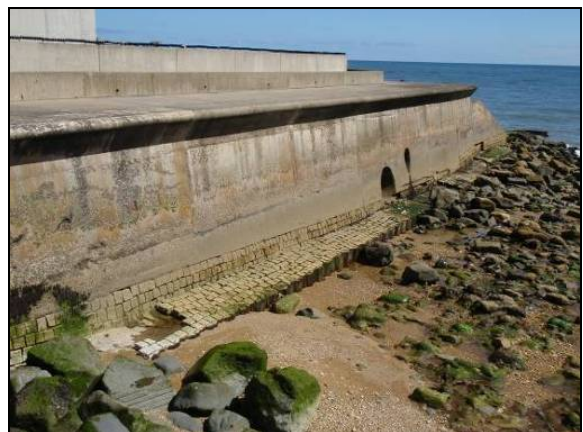
Erosion and scour was evident at the northern extent of the seawall fronting the sewage works, potentially exacerbated by scour effect around rock armour units. Loss of masonry blocks from the apron at the base of the wall has increased since the 2008 inspection (below, left & right).

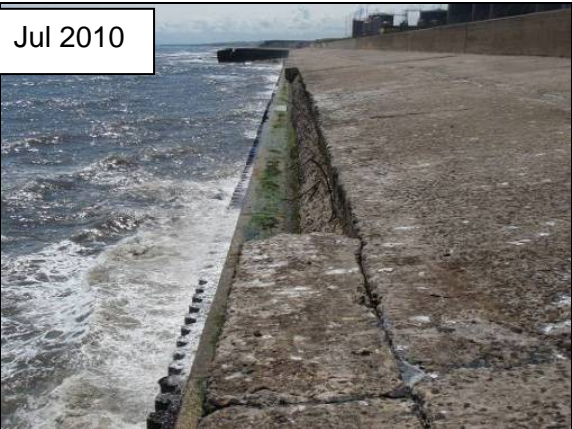
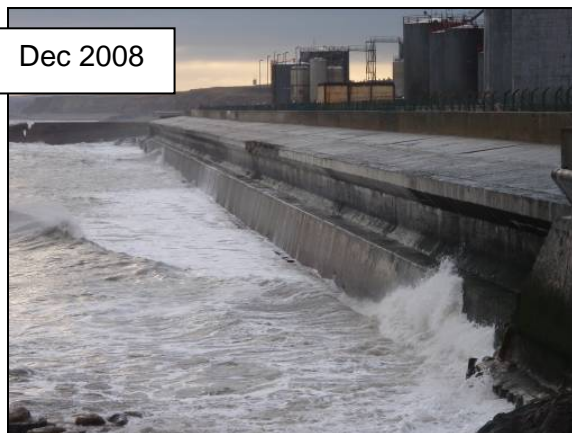
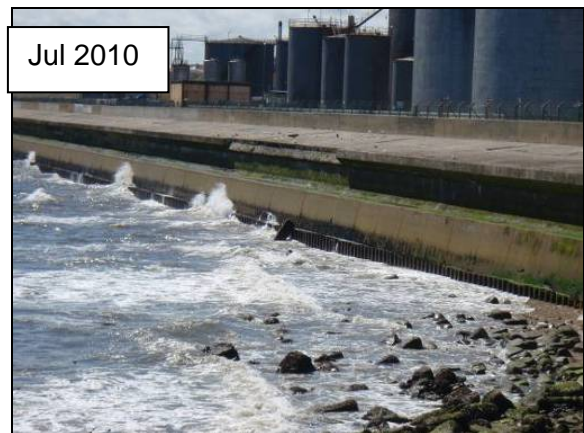
As reported in 2008, several sections of precast concrete coping are missing, exposing reinforcement and concrete backfill (right). The extent of the missing section appeared to be similar between 2008 and 2010 (below, left and right respectively) although the recent inspection noted that precast sections either side of the missing sections were cracking and appeared to be displaced.

It is understood insitu concrete repairs have previously been placed at each end of the missing section to prevent water ingress behind the adjacent coping units although this had been washed out. The adjacent pre-cast concrete units appear likely to fail in the near future unless action is taken.

Concrete exposed by the loss of the coping units appears in fair condition although monitoring should continue as the defect appears to be unravelling the structure as it expands. A more robust repair or replacement of the missing units is recommended.

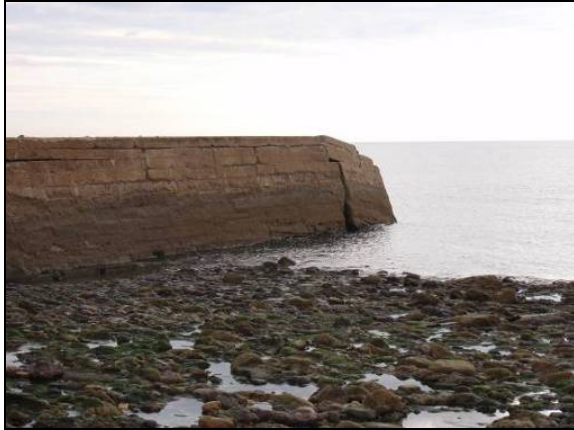
At the southern extent of the seawall fronting the sewage works, erosion of the concrete was more apparent. In this location reinforcement was beginning to be exposed and the exposed tops of sheet piles corroded significantly with rust staining of the concrete. This is due to the high wave energies in this area as waves predominantly run along the wall in a southerly direction. Rock armour units have been placed and sand/shingle is retained between the seawall and breakwater.

The breakwater marking the southern extent of the Port of Sunderland has failed at the seaward end (left). The breakwater appeared in a similar condition to that reported in 2008, with no further movement apparent, suggesting that the structure was reasonably stable.

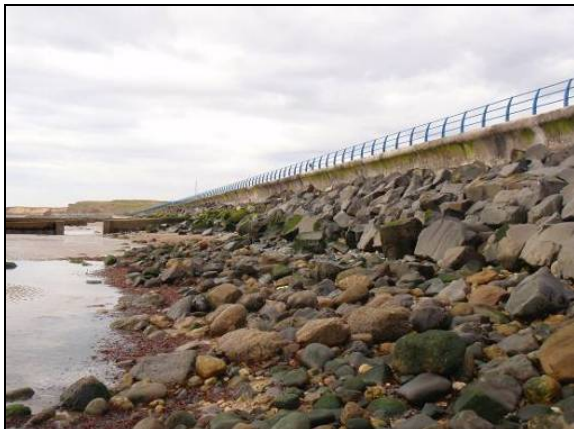
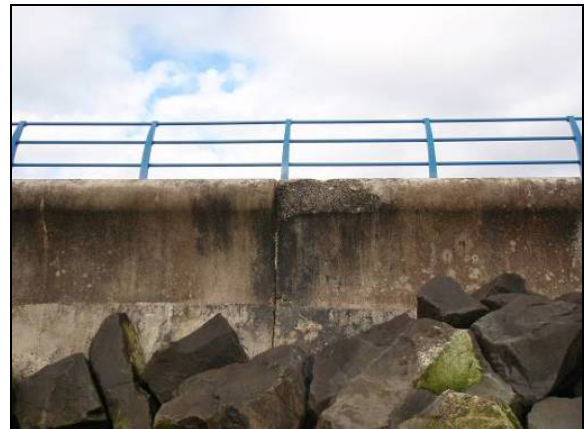
South of the port boundary the concrete Hendon Seawall is generally in good condition. Where present, rock armour is also in good condition with appropriate voids and good interlock between units (below left).

Sealant is missing from construction joints locally (below right). Minor spalling was evident around drainage holes with exposed reinforcement.

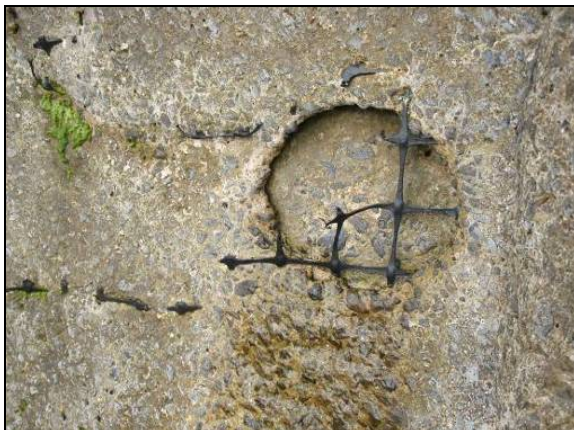
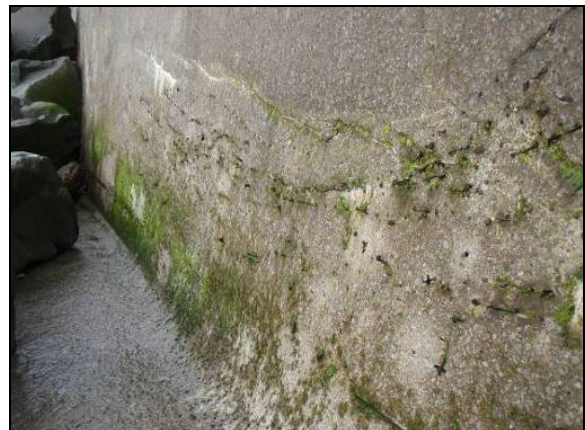
Erosion of the concrete was observed locally, with geogrid reinforcement becoming exposed (below left). This is most prevalent in close proximity to the rock armour units (below right) suggesting erosion exacerbated by scour. The defects did not appear to affect the structural integrity of the seawall.

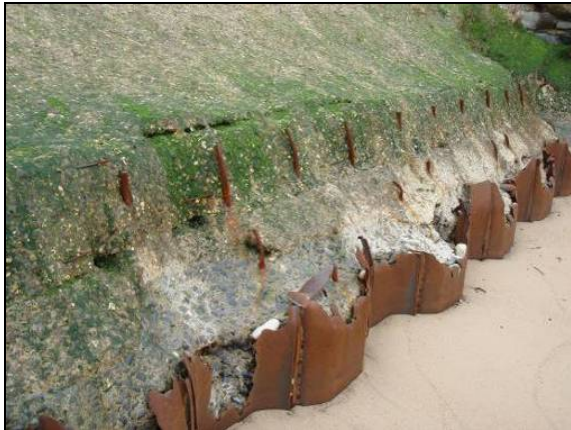
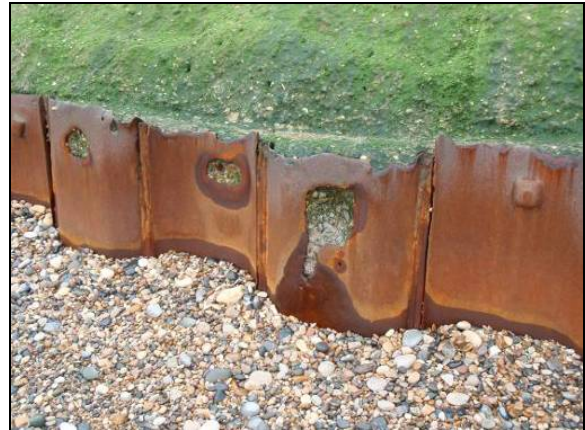
Steel sheet piles were visible at the toe of the wall along the majority of the length. The piles displayed surface corrosion throughout (below left) and loss of section locally (below right). Corrosion appeared worst around bolt holes. The access ramp opposite Sea Beach Road showed the most extensive corrosion of the sheet piles and also exposure of reinforcement bars within the concrete.

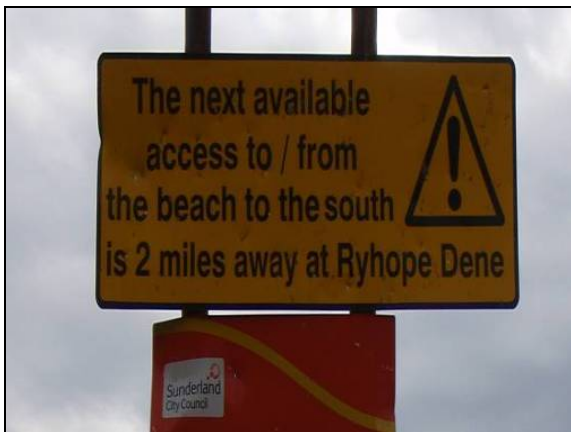
Signage is present at the end of the promenade at the southern extent of Hendon Beach, warning members of public about the restricted access to the foreshore (left). The only formal access points are Hendon Beach and Ryhope Dene. Additional hazards included on warning signs include large breaking waves, tides and unstable cliffs.

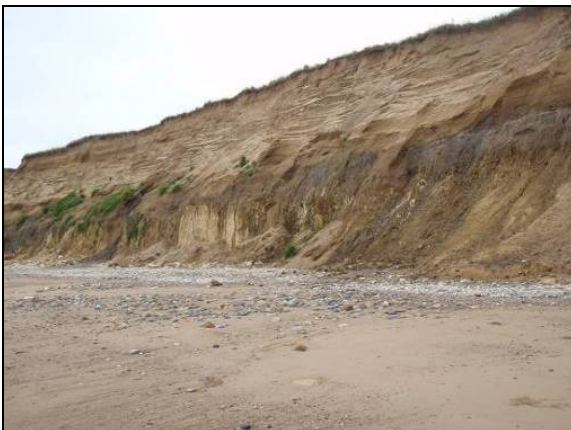
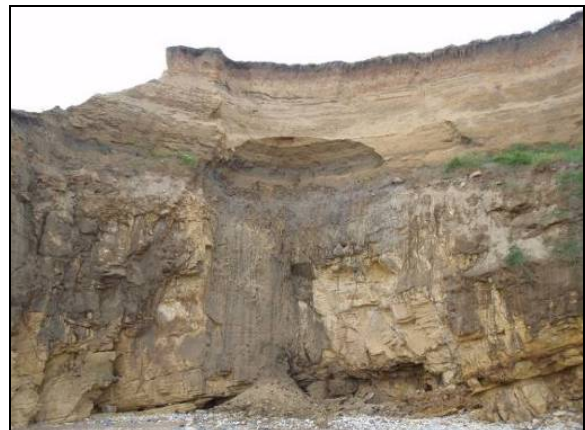
The frontage comprises of Magnesian Limestone cliffs overlain by softer glacial till (below left). Local failure of upper cliff slopes is common along this frontage and appears to generally occur due to erosion by wind blown spray and weathering as opposed to mechanical action at the base of the cliffs (below right). Evidence of tunnelling by sand martins was also observed in the soft material.

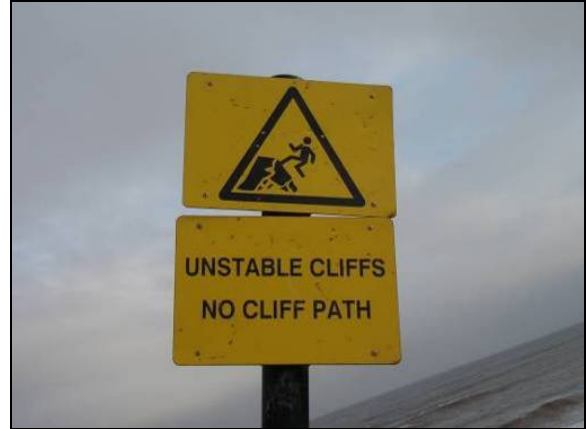
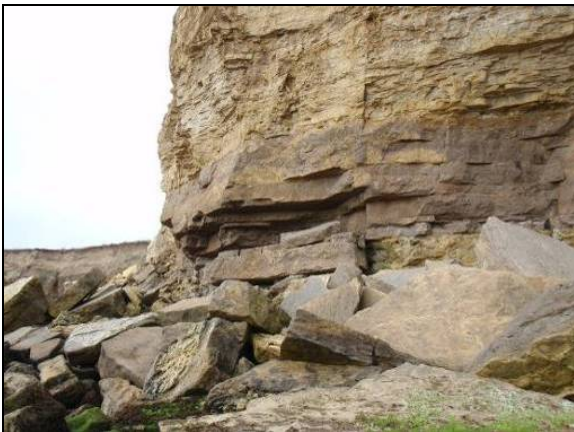
Several slope failures occurred in close proximity to the cliff top footpath, with Halliwell Banks particularly affected (below left). Signs are present to warn members of the public that the cliffs are unstable and that there is no footpath along the cliff top (below right). However, the track appeared to be well worn and on the day of inspection, several people were observed using the footpath. Recent slope failures could potentially be obscured by long grass and the proximity of the retreating cliff edge to the footpath is an ongoing public health and safety concern.

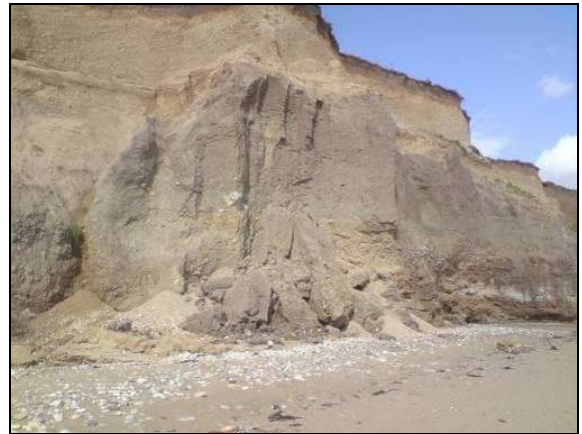
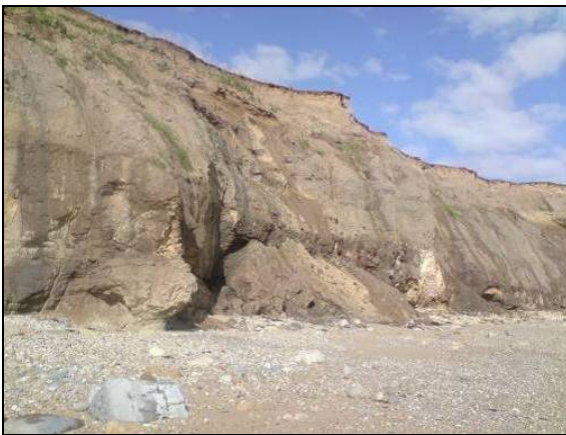
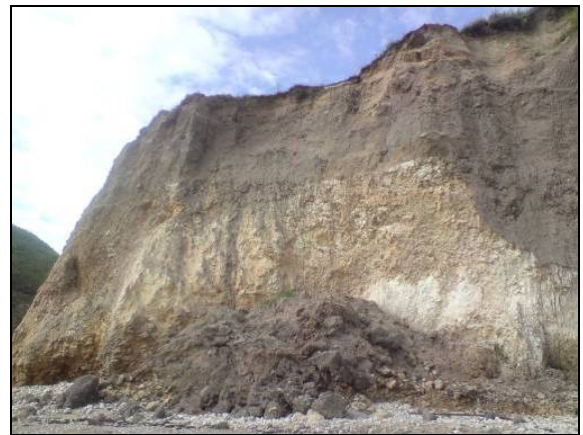
Between the headlands formed by Salterfen Rocks and Pincushion, the frontage is not protected by a rocky foreshore and the slope failures were more extensive (right & below, left & right). Several failures appear to be more recent as exposed faces appeared clean. Vertical cracks were visible, identifying areas which may fail in the near future.

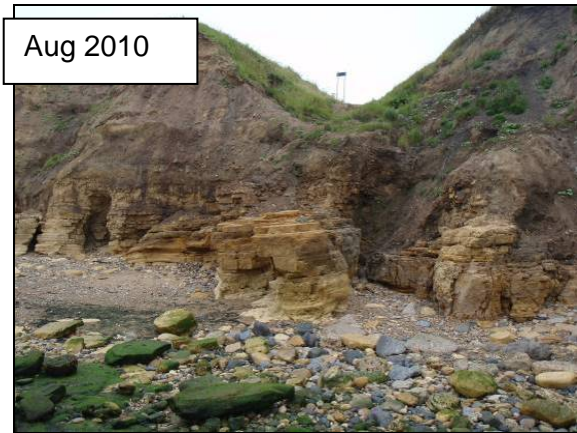
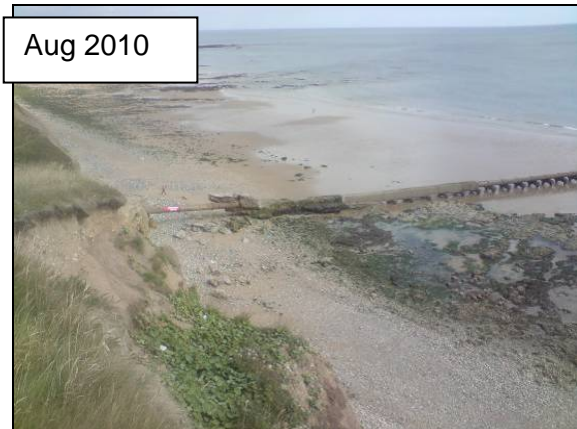
The most significant change appears to have been the removal of two failing structures along the undefended Ryhope frontage (below).

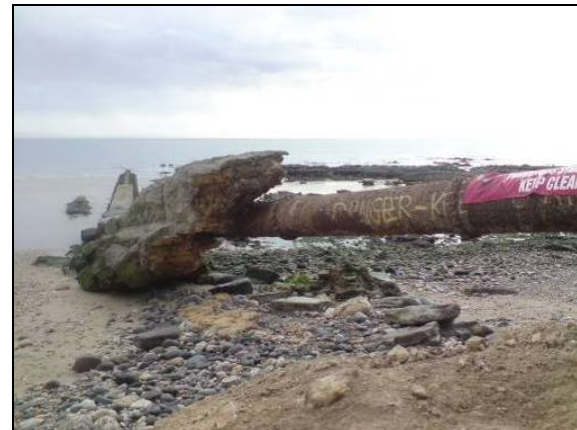
The outfall pipe at the southern outfall is still present and now spans between the cliff and the remains of the concrete structure. Northumbrian Water Limited have fixed a banner to the pipe ("DANGEROUS STRUCTURE KEEP CLEAR") (below , left and right).
