Cell 1 Regional Coastal Monitoring Programme Walkover Inspection Surveys 2016

Sunderland City Council

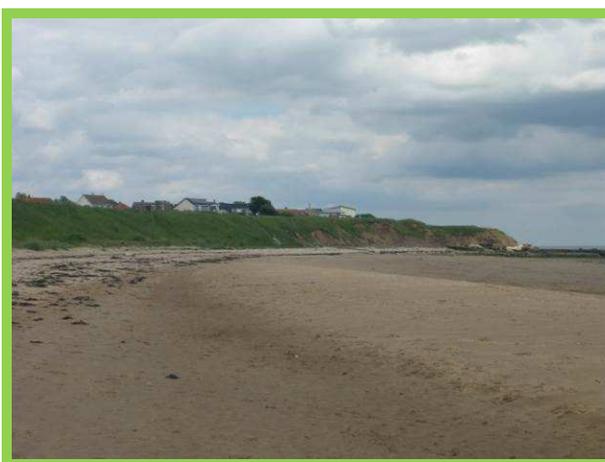
View towards north boundary, shingle berm at toe. (Asset Ref No. 121AB901B0602C01)

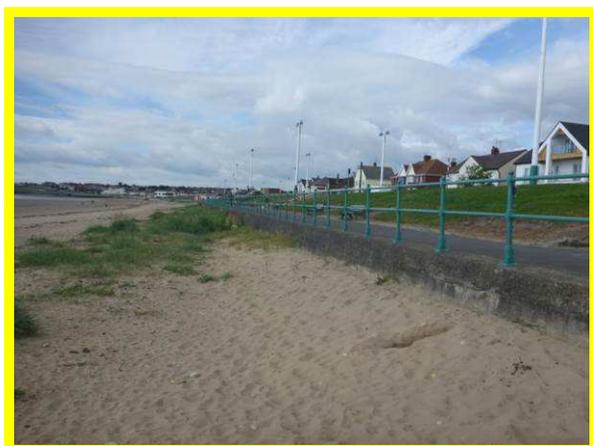
Sandy upper beach surface in front of concrete seawall. (Asset Ref No. 121AB901B0603C01)

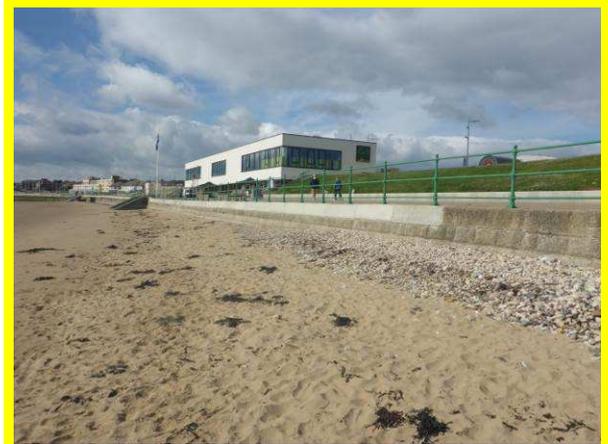
Coping blocks and handrails replaced following storm damage.
(Asset Ref No. 121AB901B0603C01)

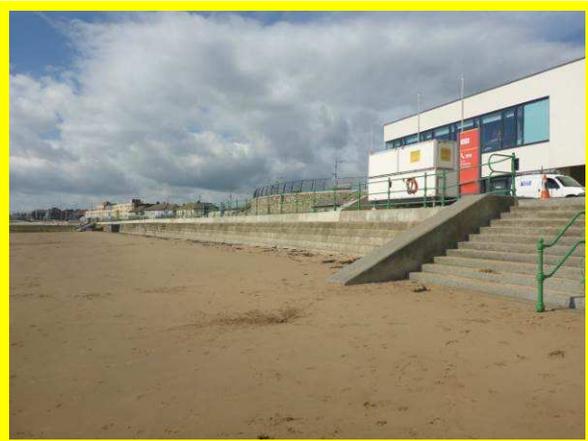
Repaired concrete coping above masonry seawall.
(Asset Ref No. 121AB901B0603C02)

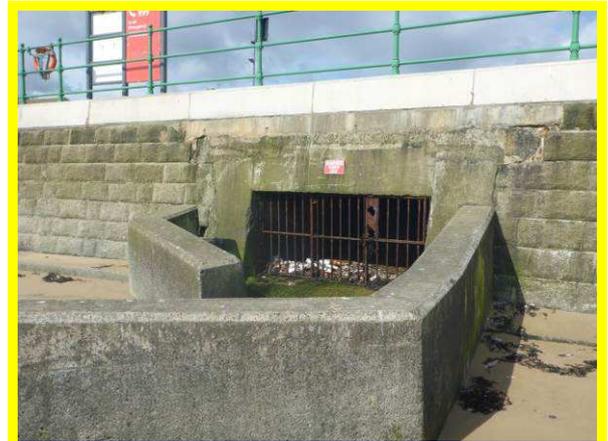
Repaired concrete coping above outfall structure.
(Asset Ref No. 121AB901B0603C02)

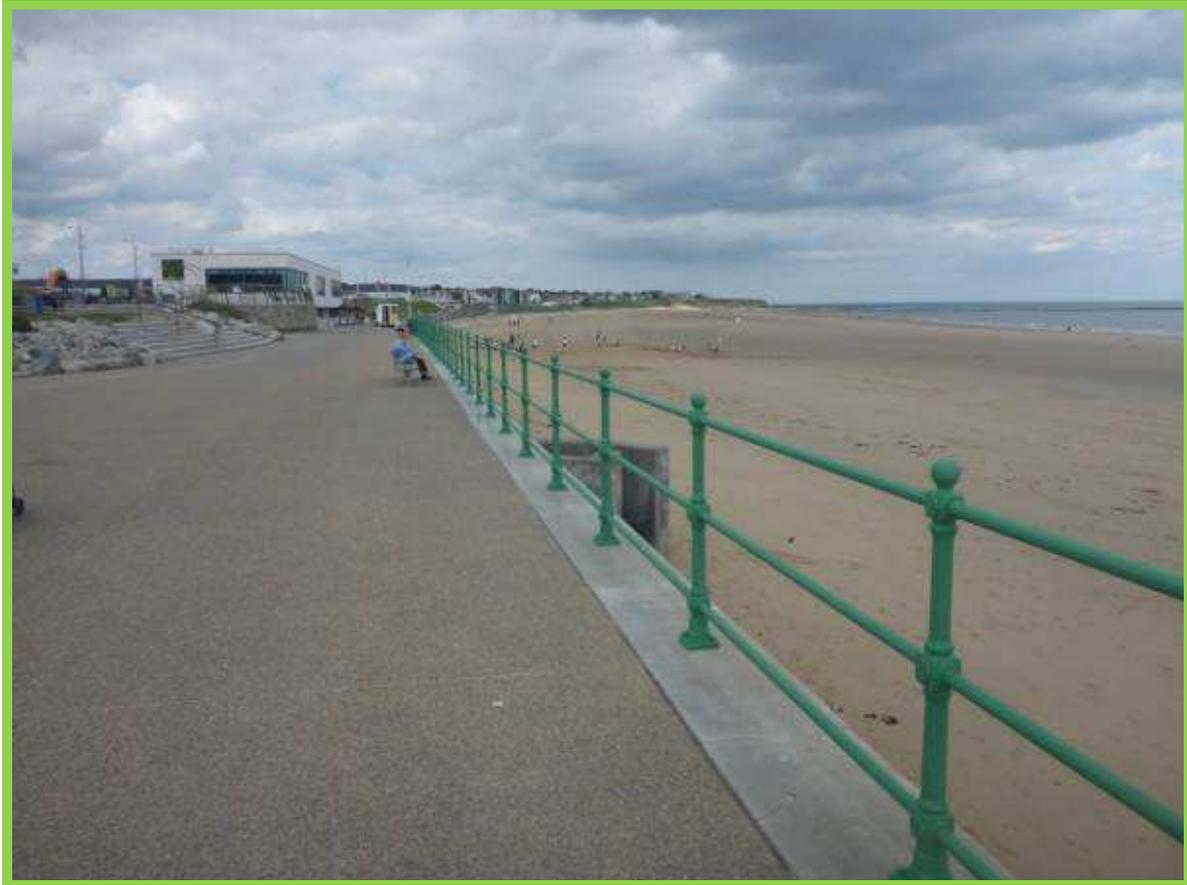
New exposed aggregate concrete surfacing on promenade behind seawall at southern end. (Asset Ref No. 121AB901B0603C02)

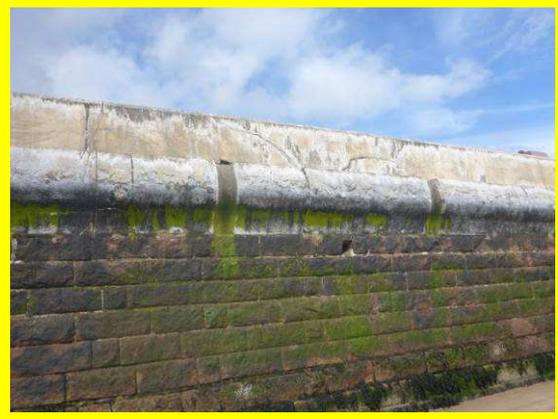
Cracking in seaward side of crest wall.
(Asset Ref. No. 121AB901B0603C03)

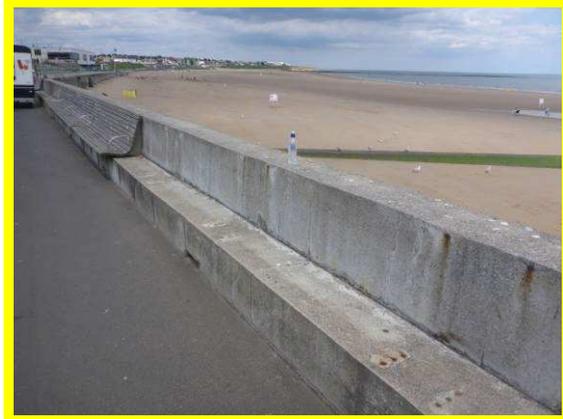
Rust staining at fixings from previous seats, cracking in crest wall. (Asset Ref. No. 121AB901B0603C03)

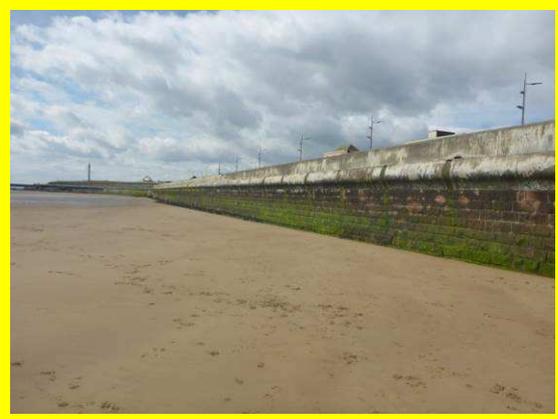
Higher beach level covering toe. Missing mortar / open joints between blocks (Rust staining at fixings from previous seats, cracking in crest wall).
(Asset Ref. No. 121AB901B0603C03)

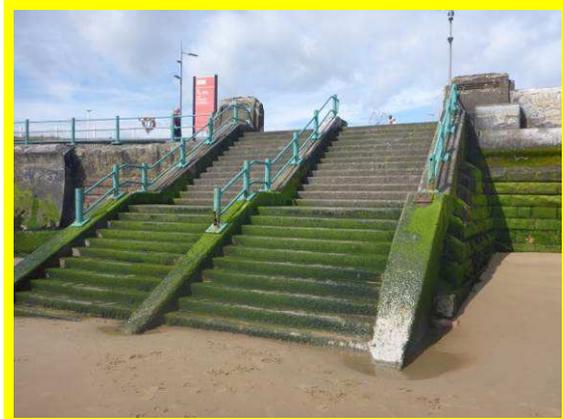
Steps at traffic roundabout: handrails heavily corroded, lower steps abraded exposing reinforcement and covered in algae.
(Asset Ref. No. 121AB901B0603C03 / B0604C01)

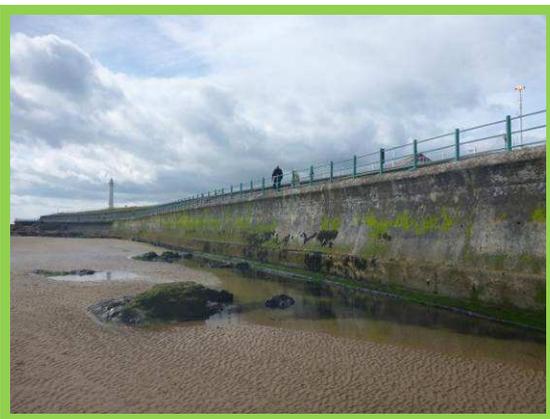
Beach levels similar to September 2014.
(Asset Ref. No. 121AB901B0604C01)

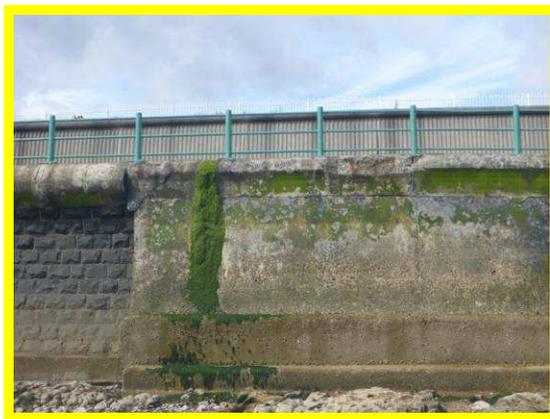
Damaged section of coping and chloride staining (Asset Ref. No. 121AB901B0604C01)

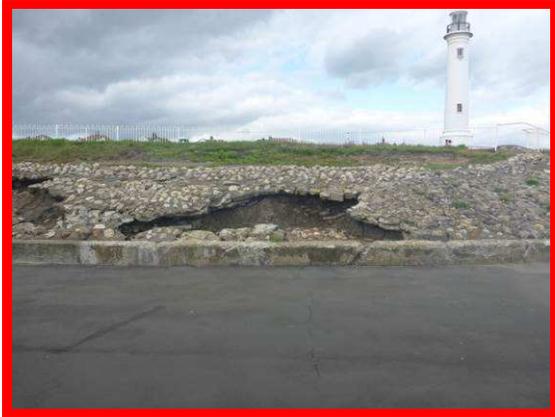
(Asset Ref. No. 121AB901B0604C02)

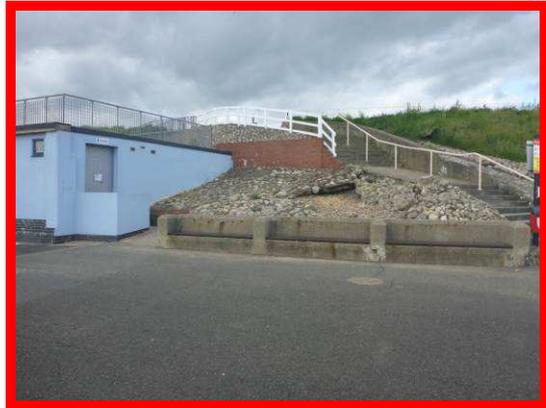
(Asset Ref. No. 121AB901B0604C02)

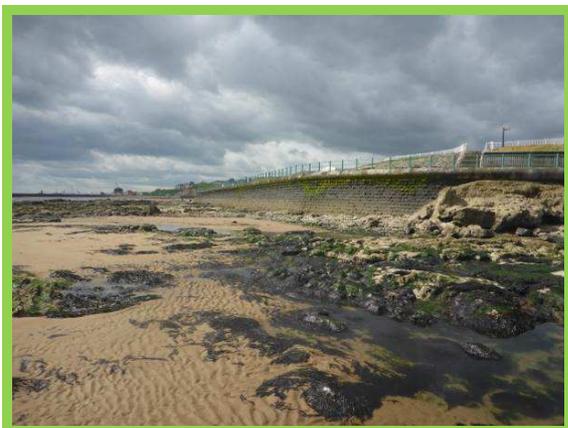
View northwards from Parsons Rocks, seawall generally in good condition.
(Asset Ref. No. 121AB901B0604C02)

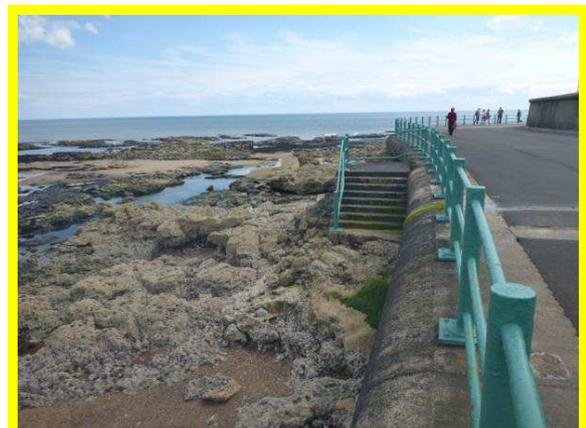
Eroded natural rock at access steps to Parsons Rocks (access to steps blocked by handrail).
(Asset Ref. No. 121AB901B0604C02)

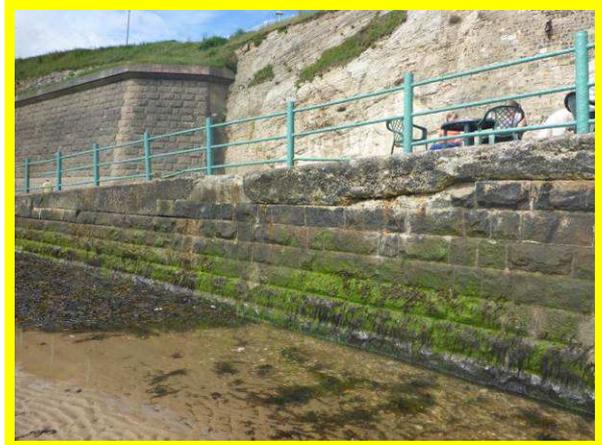
Damage to coping on ramp south of Parsons Rocks. (Asset Ref. No. 121AB901B0604C02)

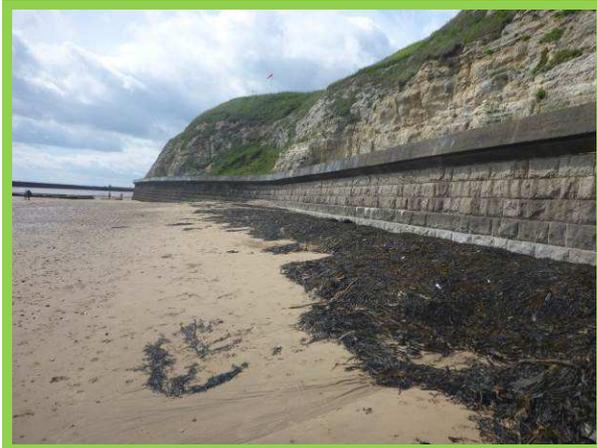
Masonry wall generally in good condition (Asset Ref. No. 121AB901B0605C01)

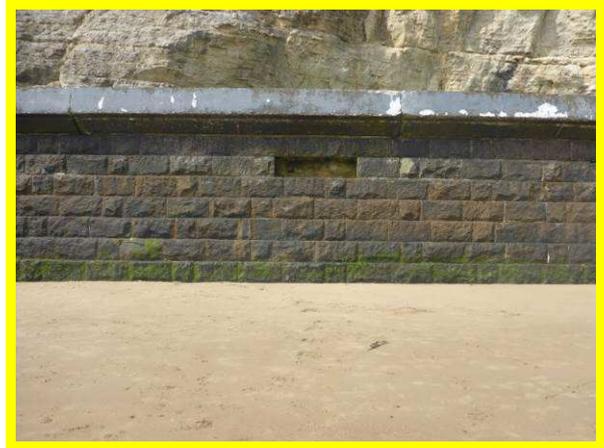
Missing block on most exposed seaward extent of wall. (Asset Ref. No. 121AB901B0605C01)

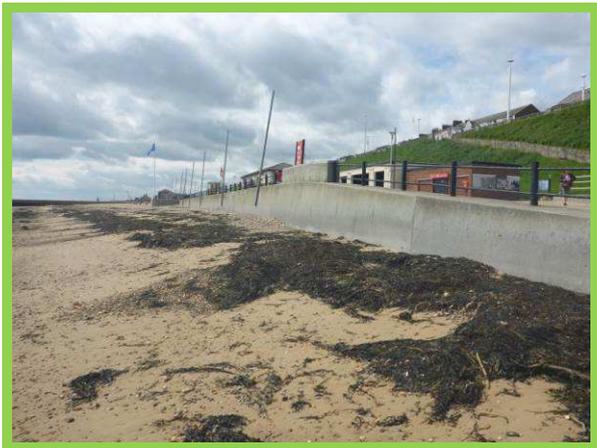
Low concrete encased wall at Marine Walk in fair to good condition. (Asset Ref. No. 121AB901B0605C02)

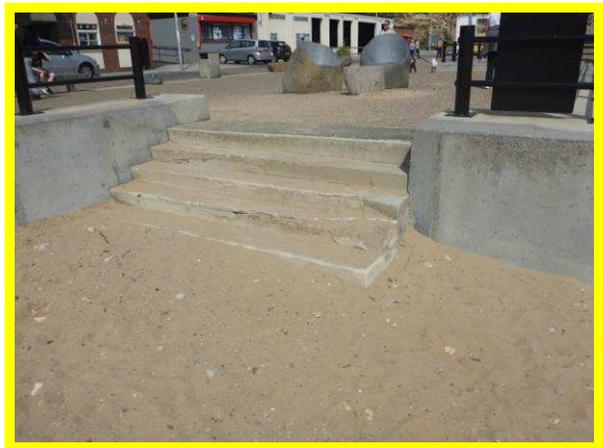
Damaged concrete access steps needing repair. (Asset Ref. No. 121AB901B0605C02)

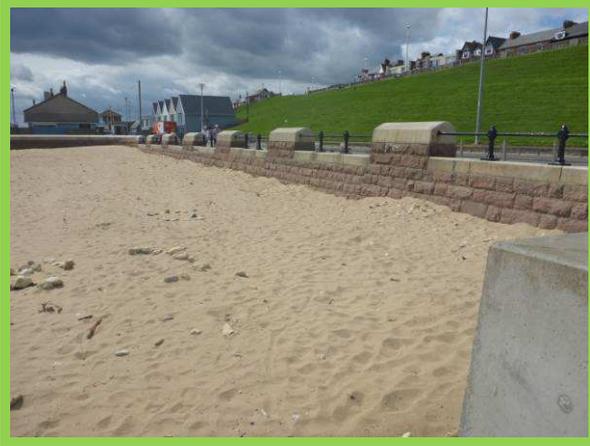
Southern section of masonry wall protected by wide beach in good overall condition. (Asset Ref. No. 121AB901B0605C02)

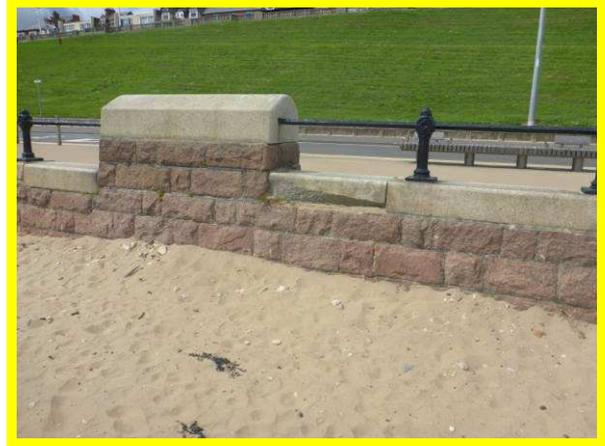
Localised recent damage to coping stone. (Asset Ref. No. 121AB901B0605C02)

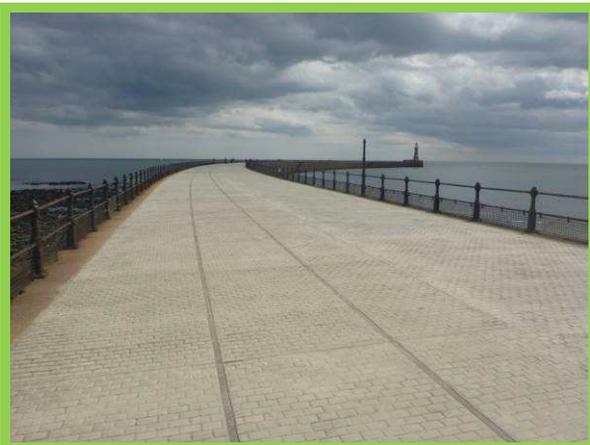
New concrete surfacing of pier (Asset Ref. No. 121AB901B0702C04)

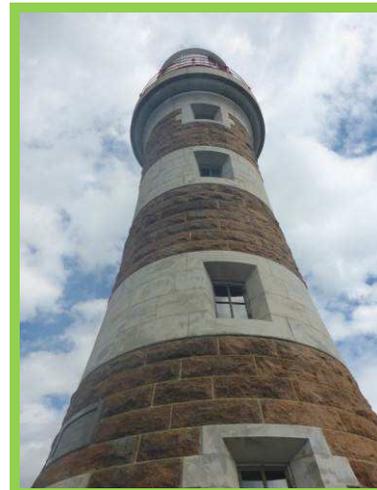
Recently refurbished lighthouse appears in good condition. (Asset Ref. No. 121AB901B0605C02)

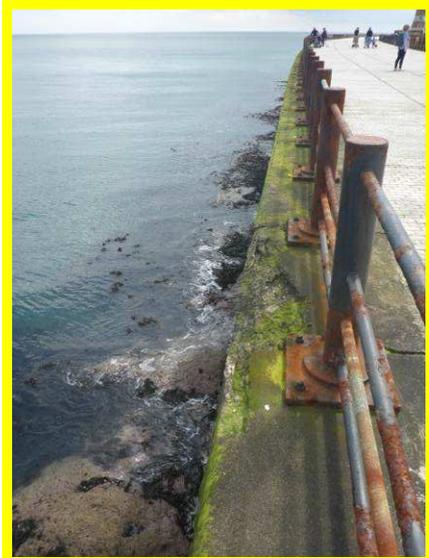
Typical localised damage to coping stone.

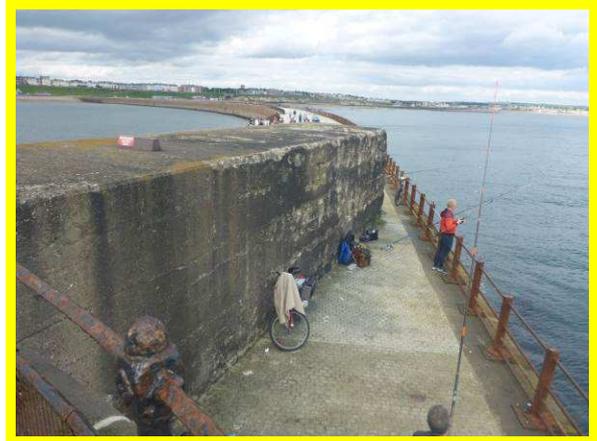
Concrete structure adjacent lighthouse heavily abraded on northern and top face.
(Asset Ref. No. 121AB901B0605C02)

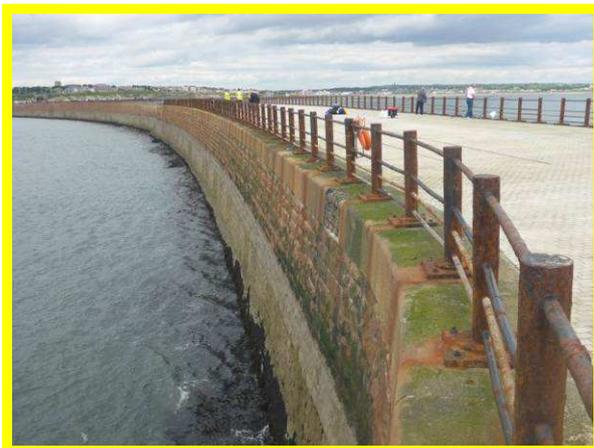
Rust staining on masonry from corroded handrail
(Asset Ref. No. 121AB901B0605C02)

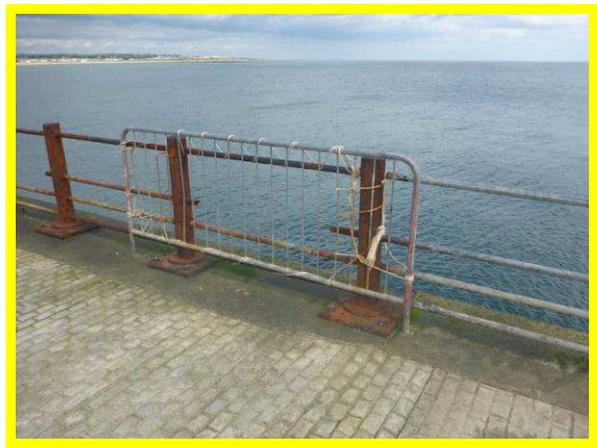
Handrail needing replacement
(Asset Ref. No. 121AB901B0605C02)

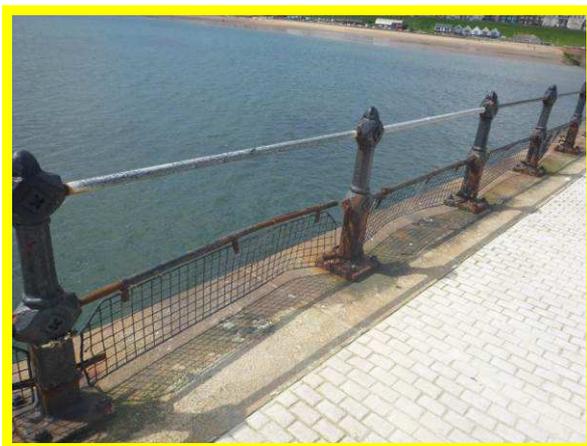
Failed handrail posing public safety risk.
(Asset Ref. No. 121AB901B0702C05)

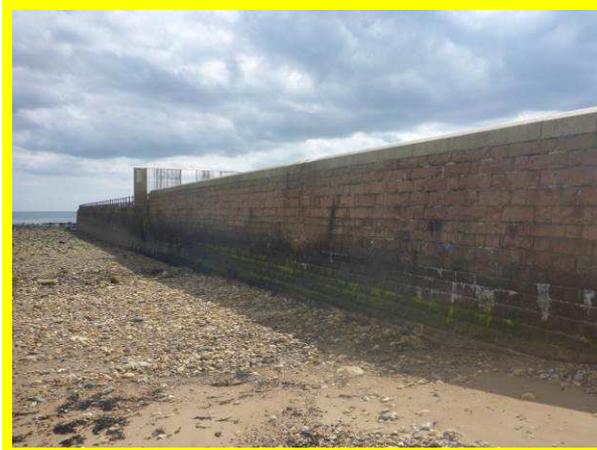
View on northern side of masonry wall at root of pier – localised abrasion and mortar loss observed.
(Asset Ref. No. 121AB901B0702C05)

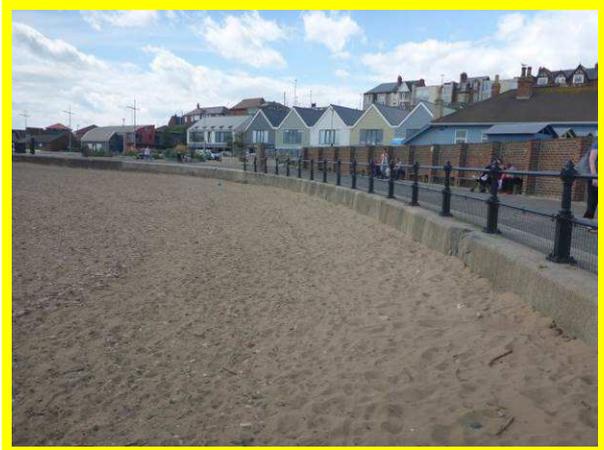
View on masonry splash wall at southern root of pier – several sections of damaged/broken off coping.
(Asset Ref. No. 121AB901B0702C05)

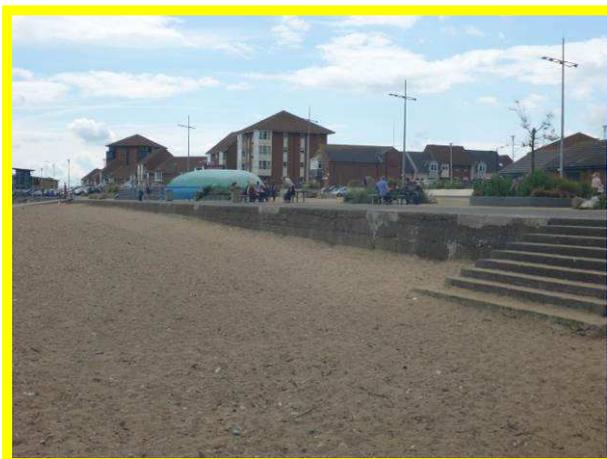
Multiple patch repairs and horizontal cracks in concrete wall. (Asset Ref. No. 121AB901B0702C01)

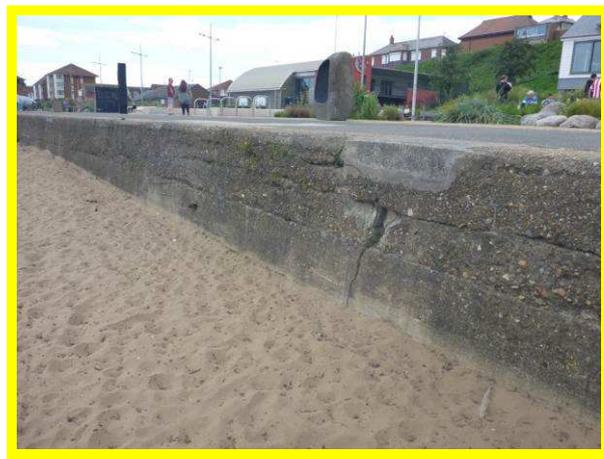
Example of spalling between horizontal cracking
(Asset Ref. No. 121AB901B0702C01)

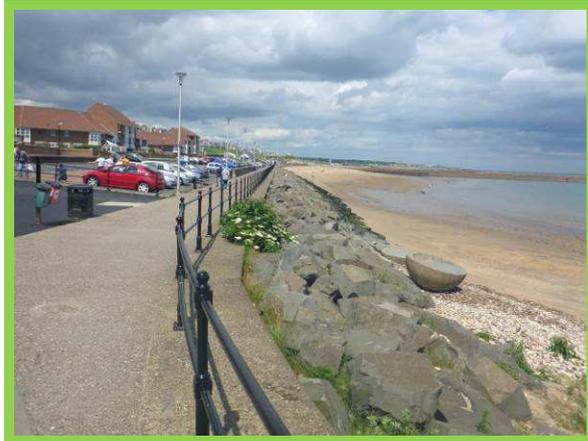
Rock armour and promenade crest in good condition. (Asset Ref. No. 121AB901B0702C02)

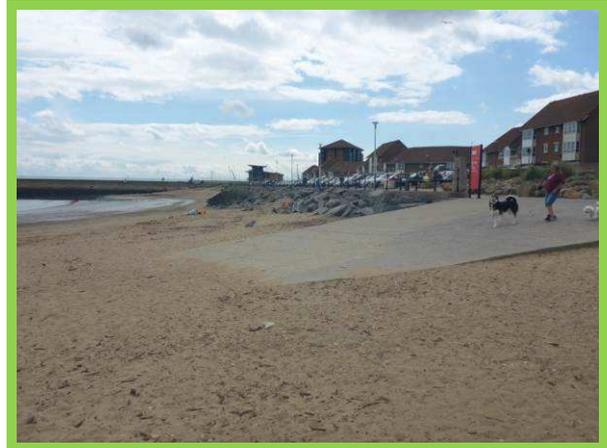
Slipway in good condition. (Asset Ref. No. 121AB901B0702C02)

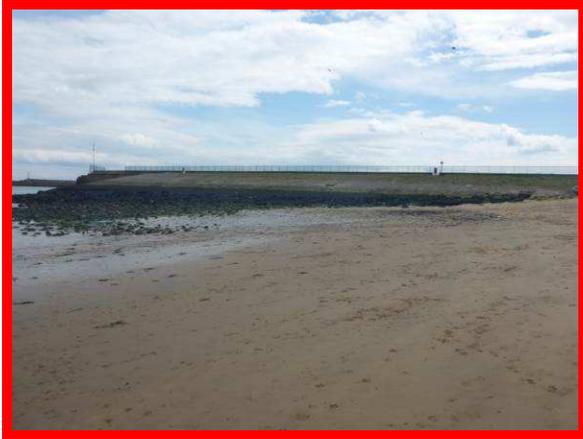
View on northern face of Old North Pier, minimum 3 No. voids observed in face. (Asset Ref. No. 121AB901B0702C03)

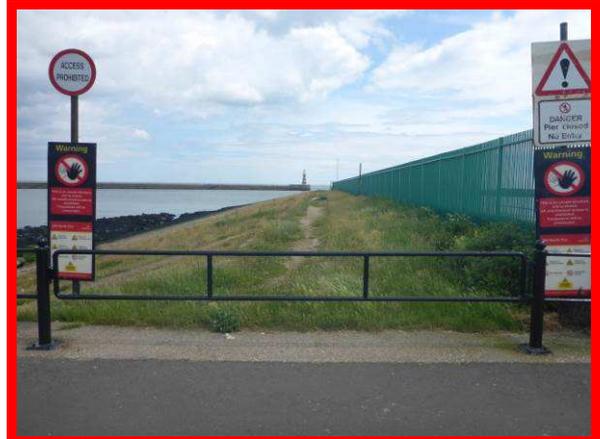
Old North Pier closed to Public. (Asset Ref. No. 121AB901B0702C03)

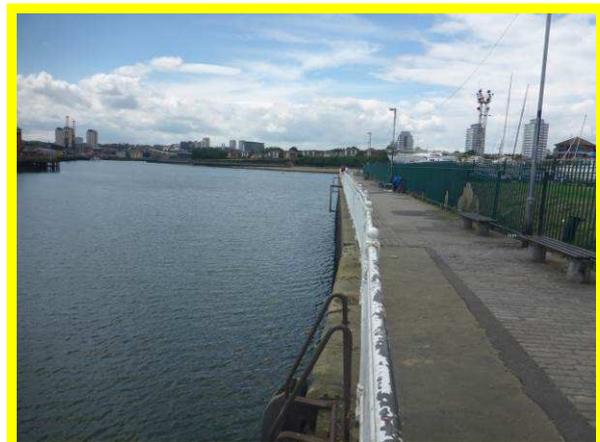
Concrete promenade at "Rat House Corner" in fair condition. (Asset Ref. No. 121AB901B0702C03)

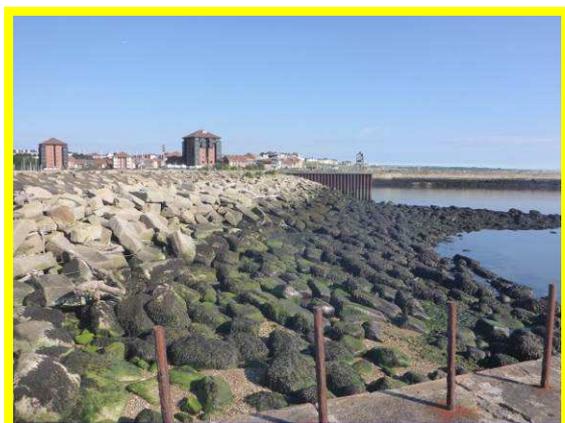
View of rock revetment from south showing loosely placed armour
(Asset Ref. No. 121AB901BO703C03)

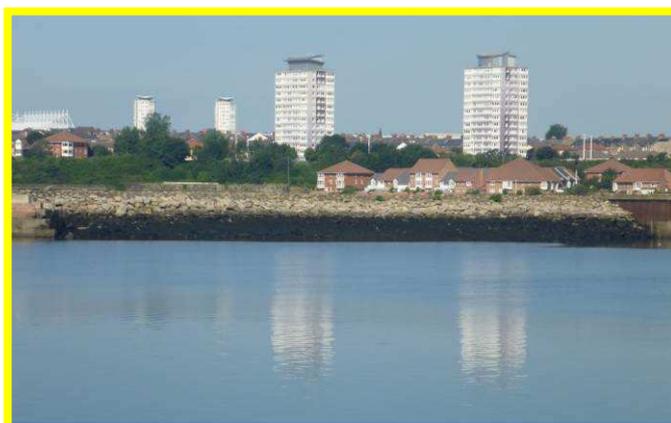
View of revetment from New South Pier
(Asset Ref. No. 121AB901BO703C03)

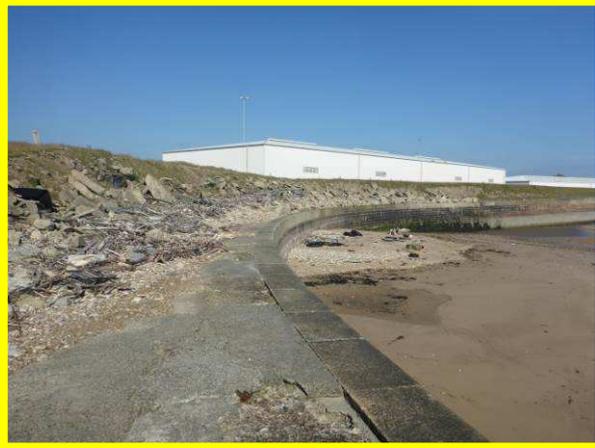
Crest and rear embankment damage due to wave overtopping.
(Asset Ref. No. 121AB901BO703C02)

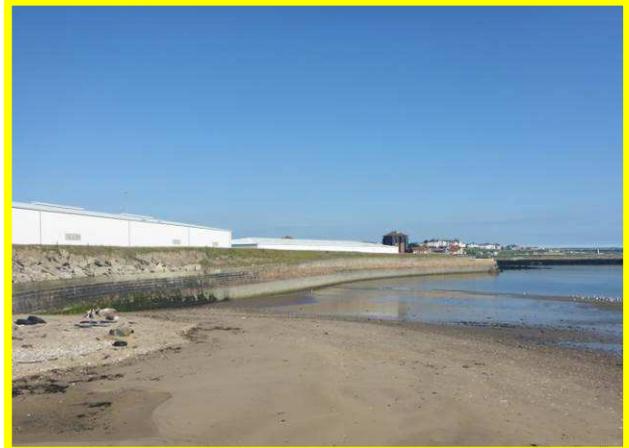
Masonry wall in fair condition except for missing blocks at North end.
(Asset Ref. No. 121AB901BO703C02)

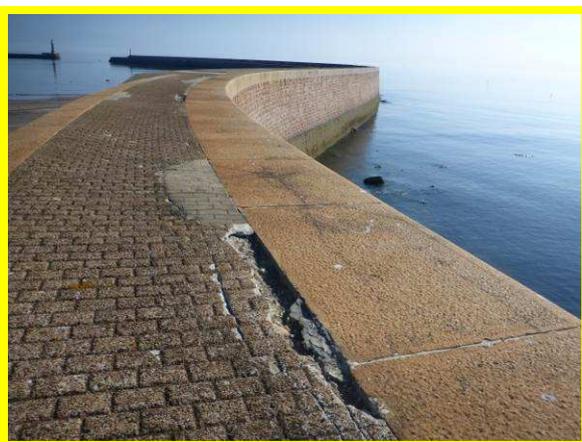
Voids in blockwork of upper deck appear to have been repaired although further damage has taken place. (Asset Ref. No. 121AB901B0703C01)

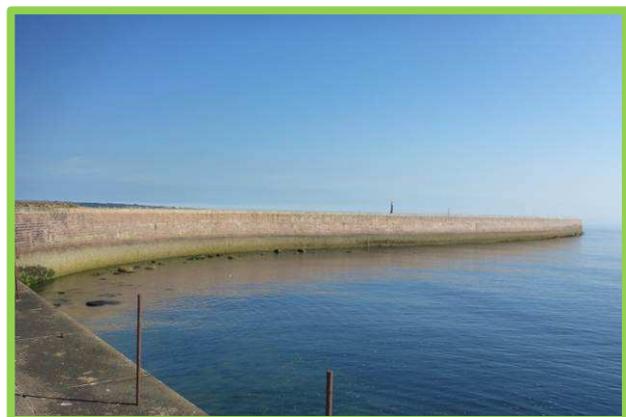
View of south face of wall from land. (Asset Ref. No. 121AB901B0703C01)

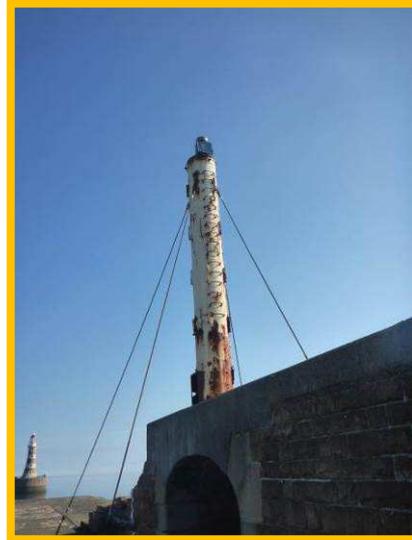
Navigation light support column and cables remain highly corroded and in poor condition. (Asset Ref. No. 121AB901B0703C01)

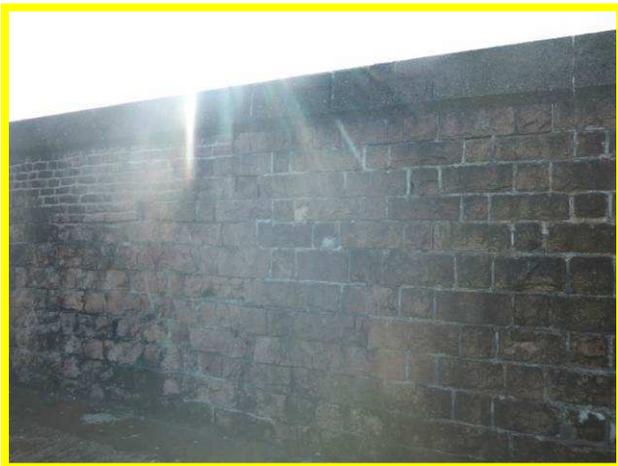
Abraded brickwork at wall between lower and upper deck. (Asset Ref. No. 121AB901B0703C01)

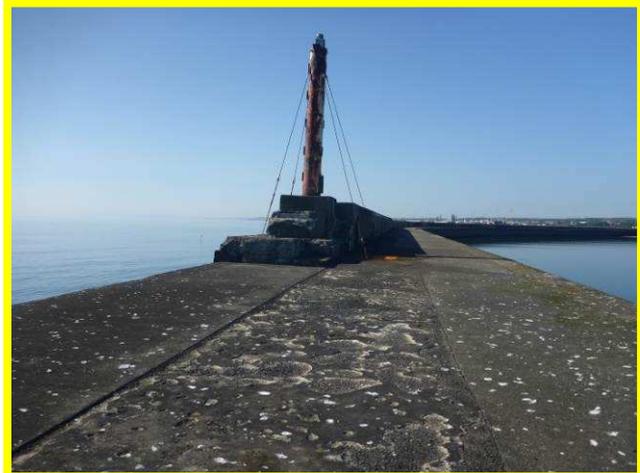
Missing blockwork from seaward end of upper deck, concrete slabs of lower deck spalled. (Asset Ref. No. 121AB901B0703C01)

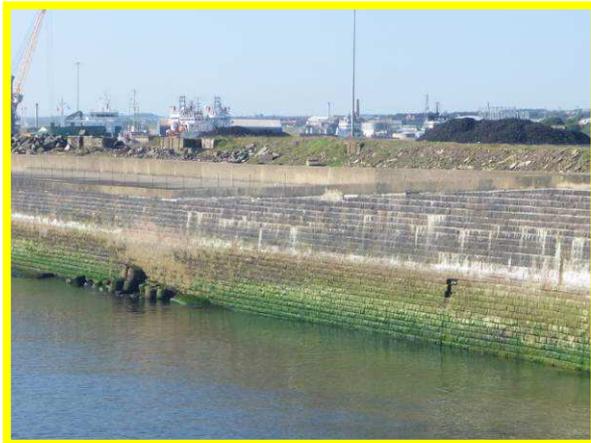
Old void covered with rock (left),
New missing blocks and open joint (right).
(Asset Ref. No. B901B0801C03)

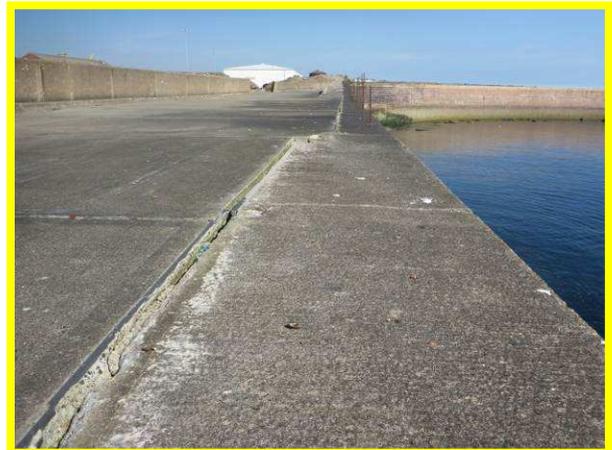
Deck slab lifted above coping block.
(Asset Ref. No. B901B0801C03)

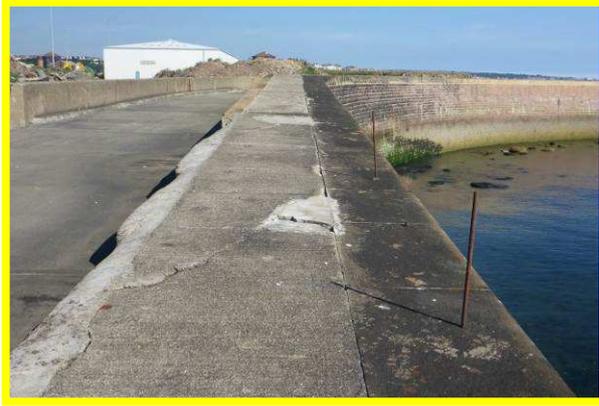
Cracking in concrete on deck above masonry wall. (Asset Ref. No. B901B0801C03)

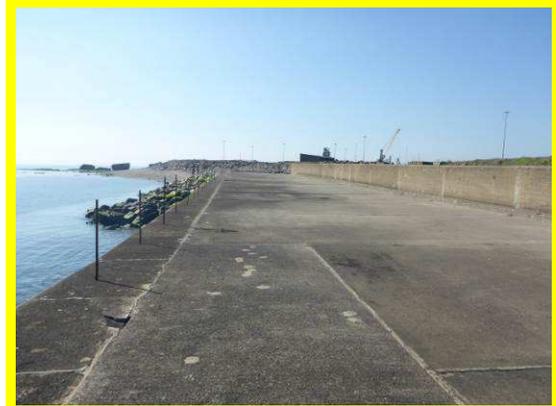
Pooling marks indicate crest slabs are sagging in middle. (Asset Ref. No. B901B0801C03)

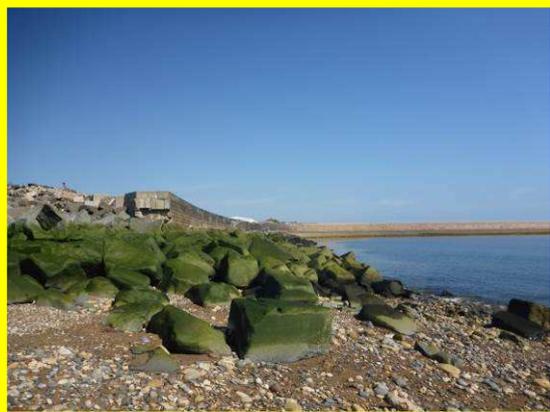
Southern end of wall remains damaged as in previous inspections, beach level lower than in 2013 and 2014 inspections revealing rock. (Asset Ref. No. B901B0801C03)

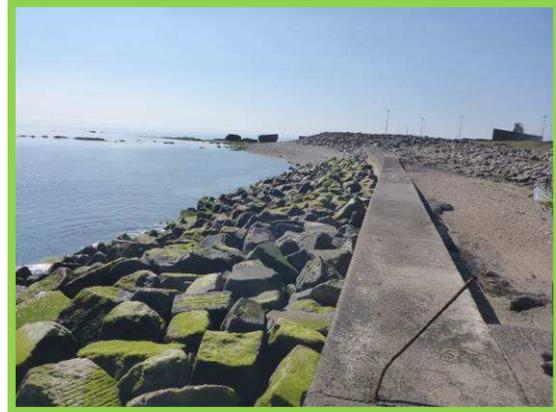
Rock armour at southern end of wall in good condition. (Asset Ref. No. B901B0801C03)

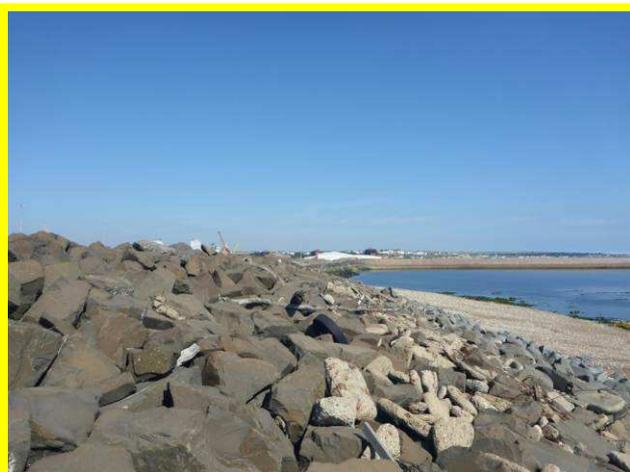
Rock/rubble revetment north of derelict groyne) in fair condition. (Asset Ref. No.121AB901B0801C02)

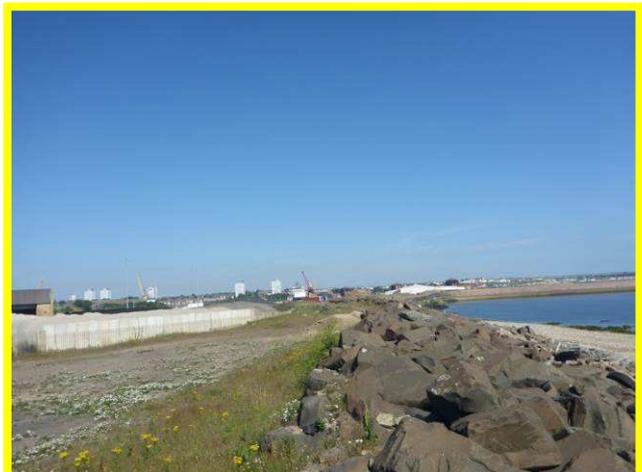
Uneven crest level of revetment. (Asset Ref. No.121AB901B0801C02)

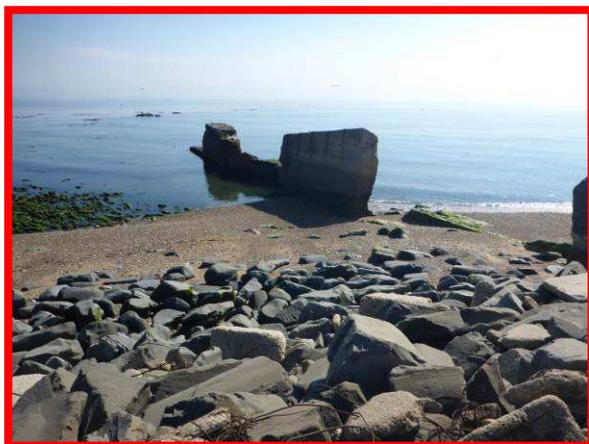
Derelict concrete groyne from north.
(Asset Ref. No. 121AB901B0801C01)

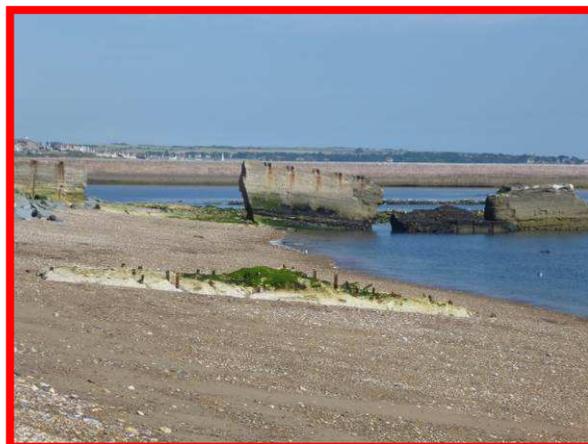
Derelict concrete groyne from south.
(Asset Ref. No. 121AB901B0801C01)

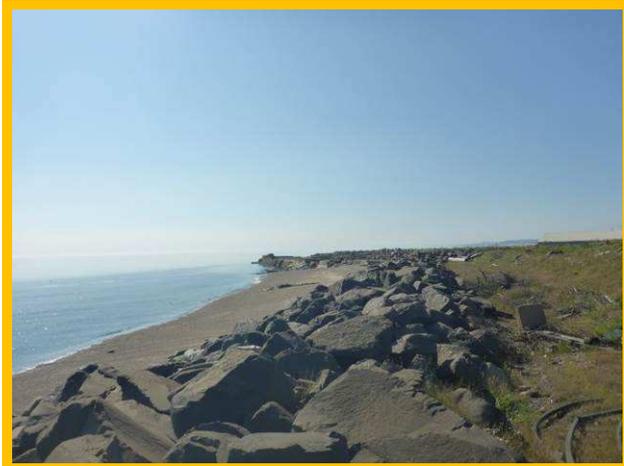
Derelict former defence structures with stacked bund of rock armour at crest.
(Asset Ref. 121AB901B0801C05)

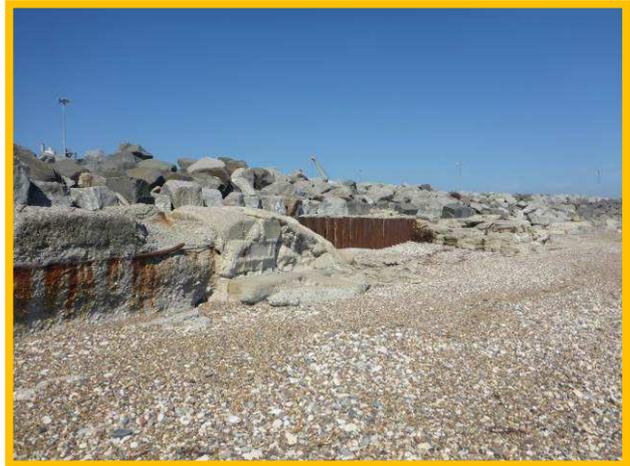
Derelict former defence structures.
(Asset Ref. No. 121AB901B0801C05)

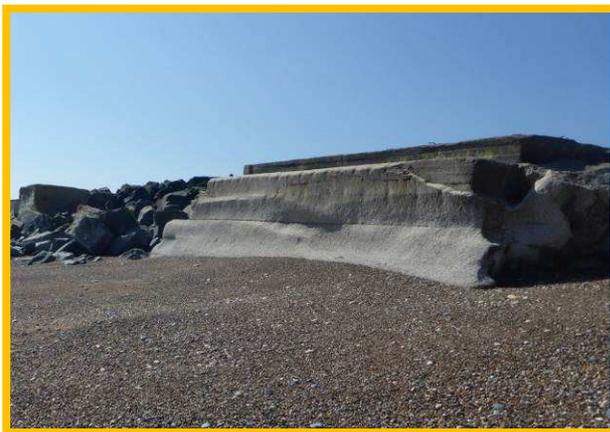
Abraded concrete structure with cracks in concrete and rust staining.
(Asset Ref. No. 121B901B0801C07)

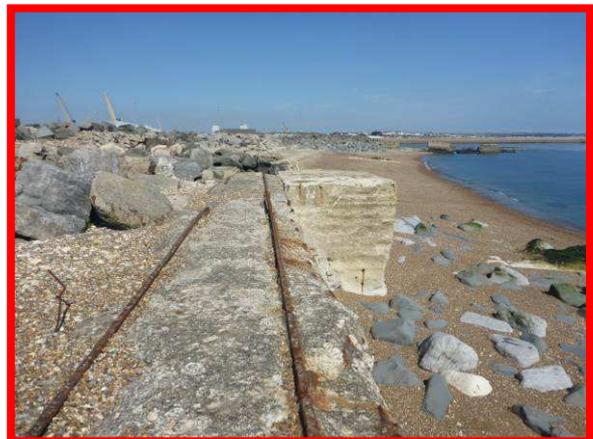
Reinforcement exposed.
(Asset Ref. No. 121B901B0801C07)

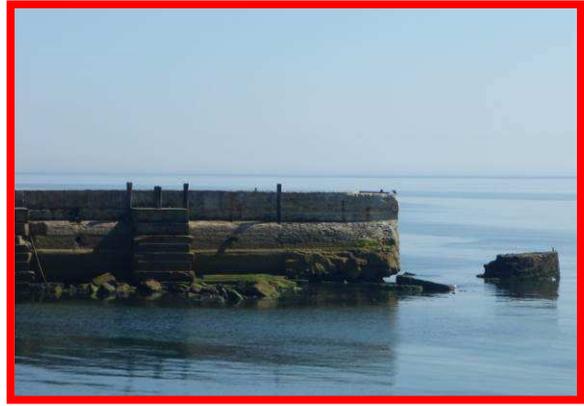
Failed roundhead of Pier. Existing nose of pier appears to be undercut further than 2014. (Asset Ref. No. 121B901B0801C04)

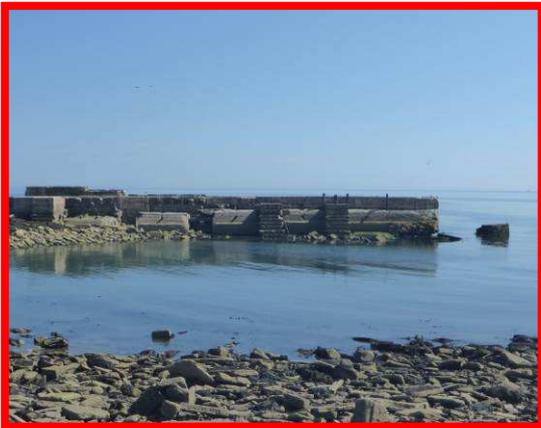
Outer end of North East Pier viewed from south. (Asset Ref. No. 121B901B0801C04)

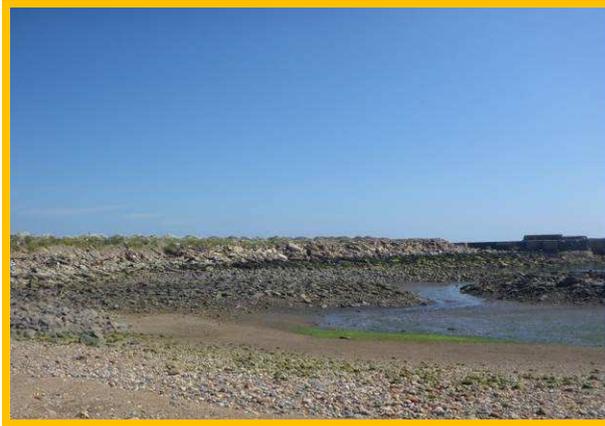
Tipped rubble at northern end of south outlet basin. (Asset Ref. No. 121AB901B0801C08)

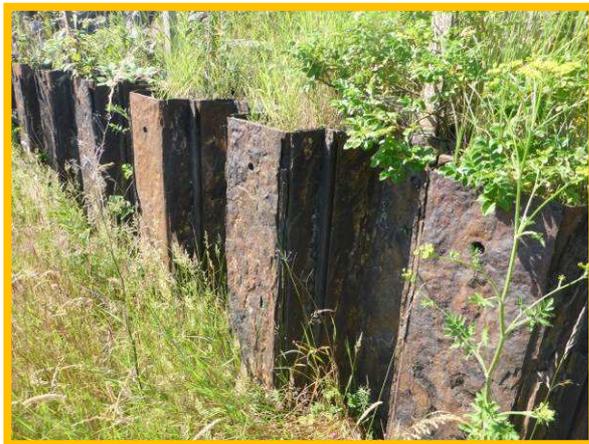
Heavily corroded sheet pile wall (Asset Ref. No. 121AB901B0802C07).

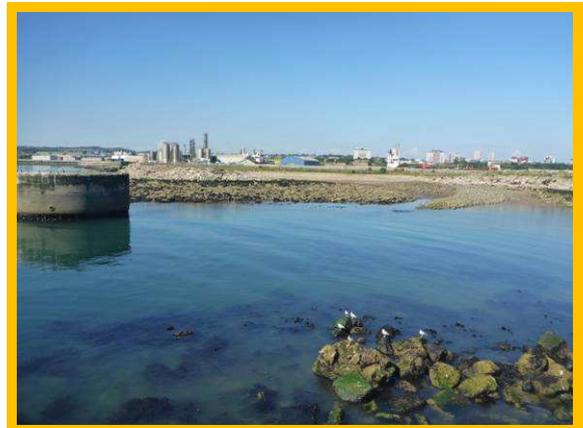
South side of basin taken from end of North East Pier. (Asset Ref. No.121B901B02C06)

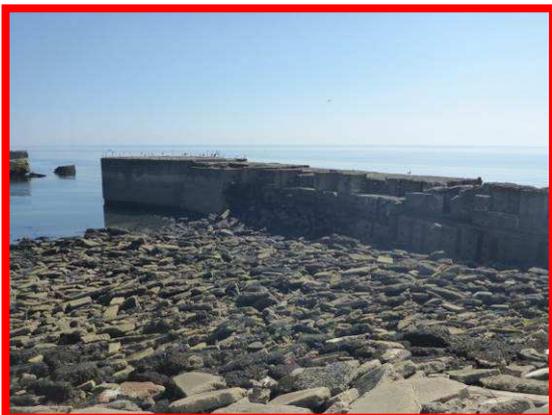
Image showing missing blockwork from landward side of SW Breakwater. (Asset Ref. No. 121AB901B0802C05)

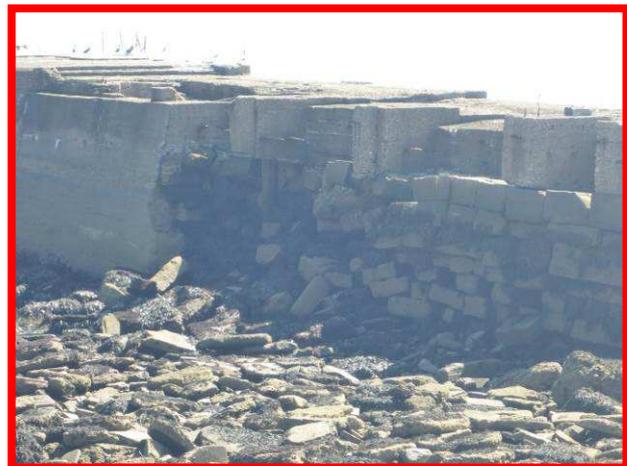
Displaced core blocks of SW Breakwater. (Asset Ref. No. 121AB901B0802C05)

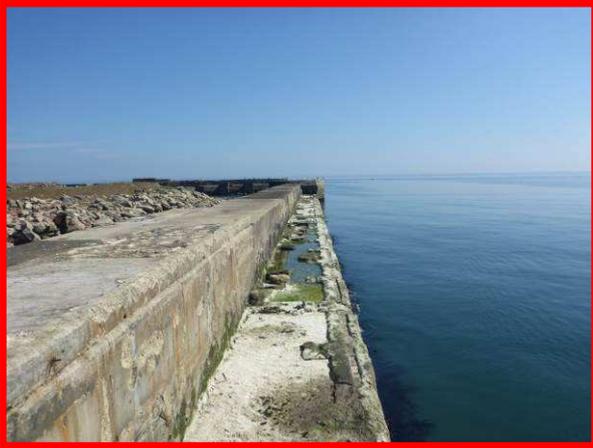
Missing section from seaward side of SW Breakwater.
(Asset Ref. No. 121AB901B0802C05)

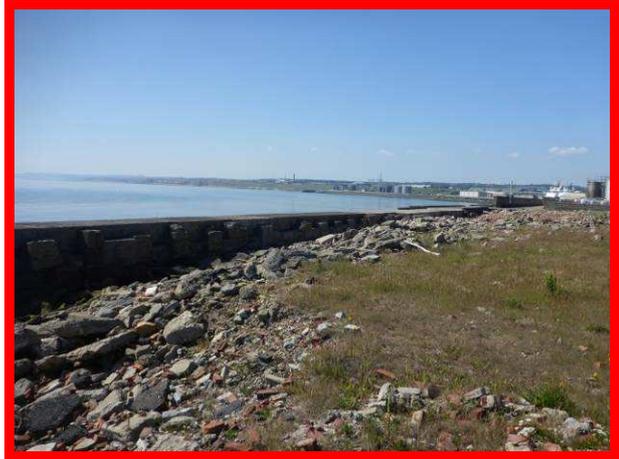
Demolition waste tipped on landward side, damaged blocks.
(Asset Ref. 121AB901B0802C05)

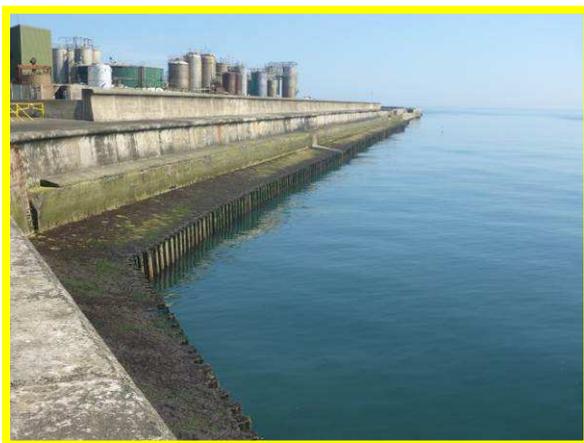
Spur barrier wall.
(Asset Ref. No. 121AB901B0802C04)

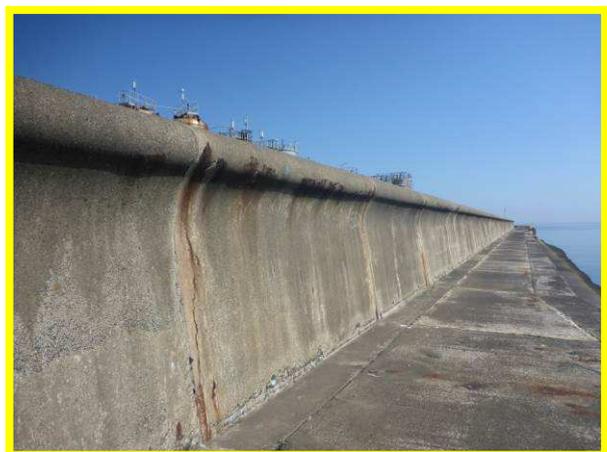
Cracking and spalling of upper sea wall.
(Asset Ref. No. 121AB901B0802C04)

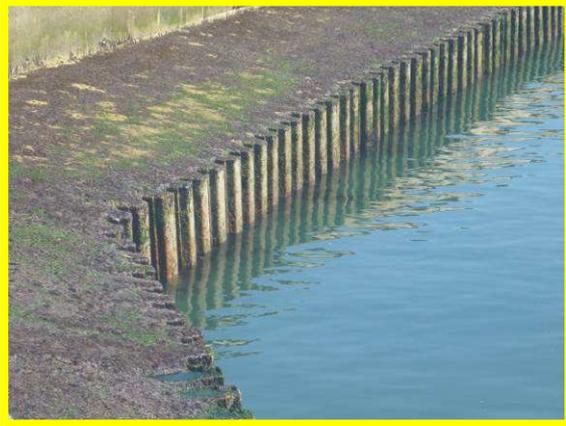
Corroded sheet pile wall at toe. (Asset Ref. No. 121AB901B0802C04)

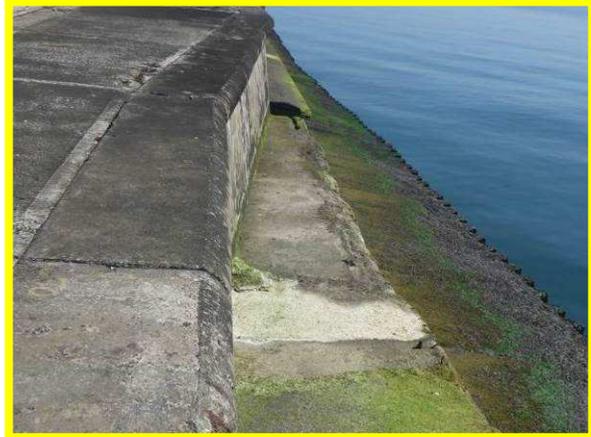
Missing section of lower deck slab. (Asset Ref. No. 121AB901B0802C04)

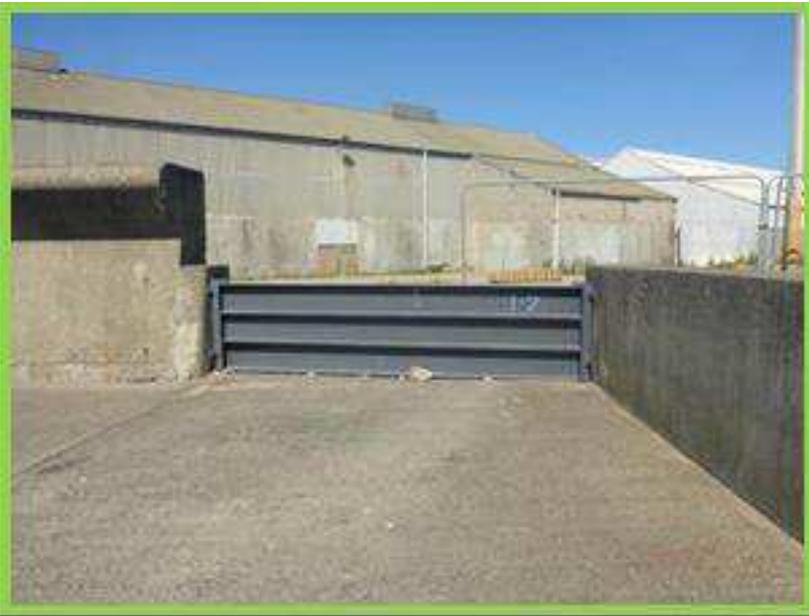
Flood boards remain (Asset Ref. No. 121AB901B0802C04)

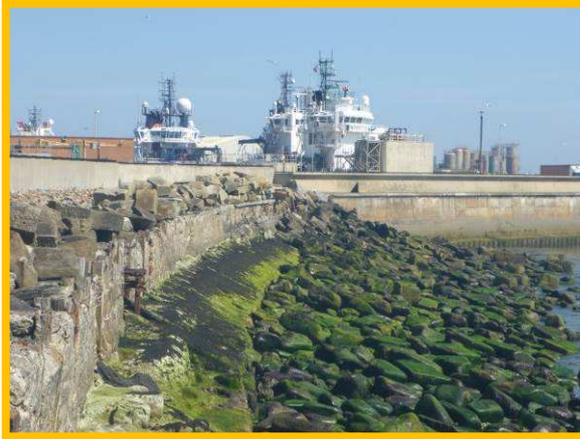
Sea wall in similar or worse condition to 2014.
(Asset Ref. No. 121B901B0802C03)

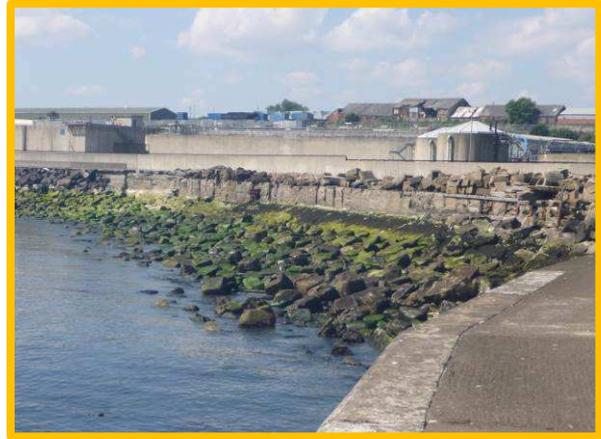
Rock armour in similar poor condition to 2014.
(Asset Ref. No. 121B901B0802C03)
