Cell 1 Regional Coastal Monitoring Programme Walkover Inspection Surveys 2016

Sunderland City Council

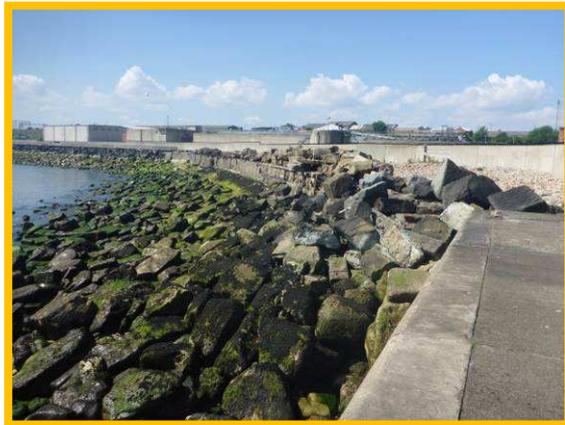
Collapsed section of wall infilled with
rock/rubble. (Asset Ref. No.
121B901B0802C03)

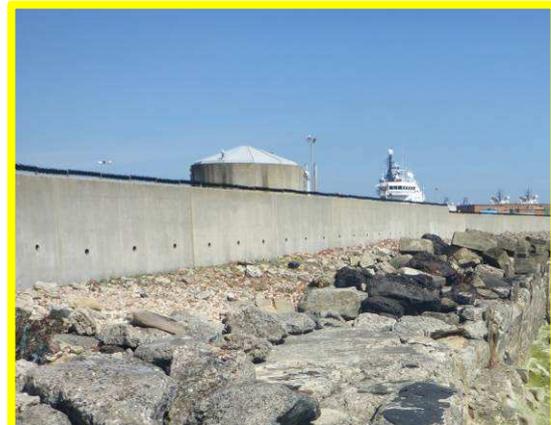
Concrete boundary wall with unprotected crest
apron. (Asset Ref. No. 121B901B0802C03)

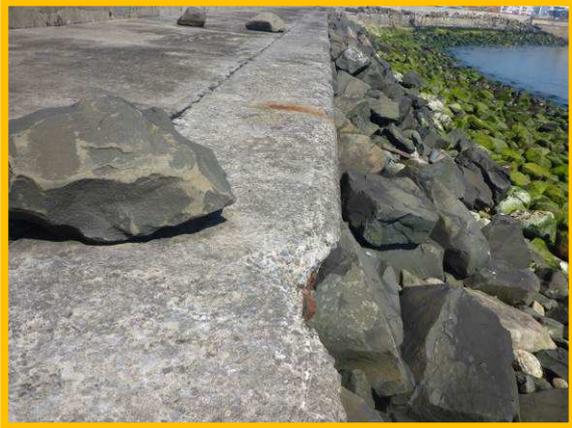
Displaced rocks and damage to coping exposing corroded reinforcement.
(Asset Ref. No. 121AB901B0802C02)

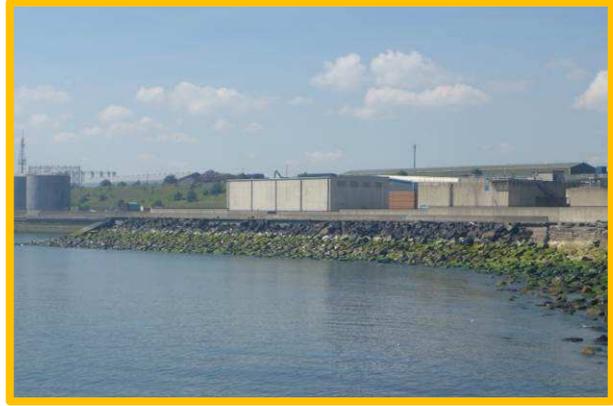
Image of asset taken from spur barrier wall.
(Asset Ref. No. 121AB901B0802C02)

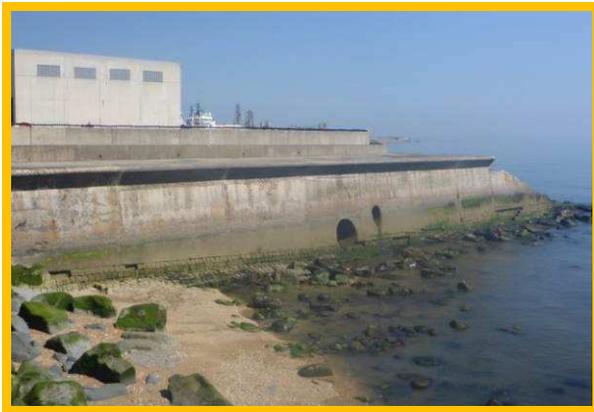
Missing facing masonry requires attention.
(Asset Ref. No. 121AB901B0802C01)

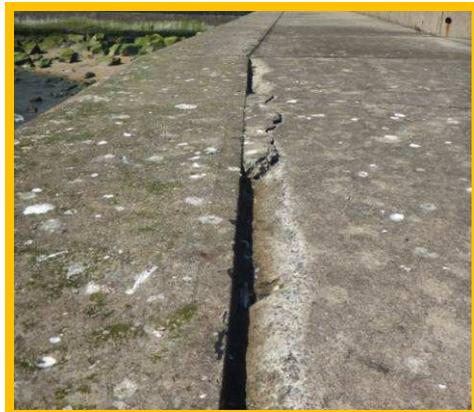
Cracking between coping and deck slab towards North. (Asset Ref. No. 121AB901B0802C01)

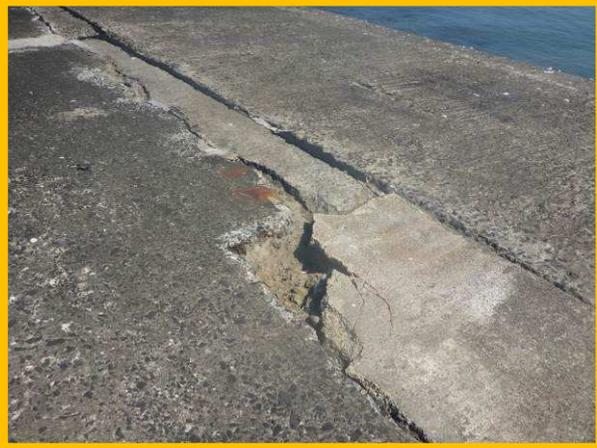
Cracking in concrete deck surface.
(Asset Ref. No. 121AB901B0802C01)

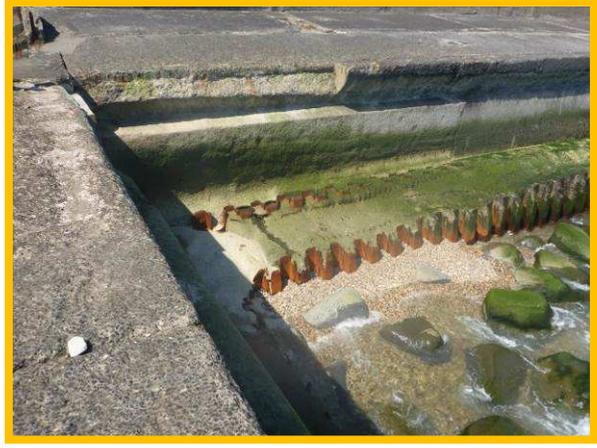
Missing coping beam and corroded / holed
sheet pile wall toe.
(Asset Ref. No. 121AB901B0802C01)

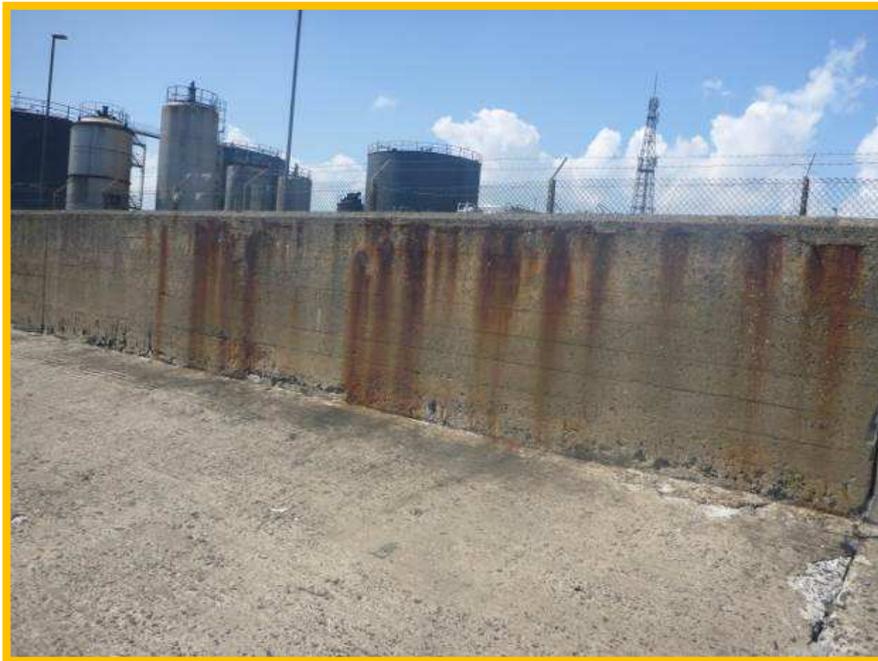
Crest wall spalled and corrosion stained (Asset Ref. No. 121AB901B0802C01)

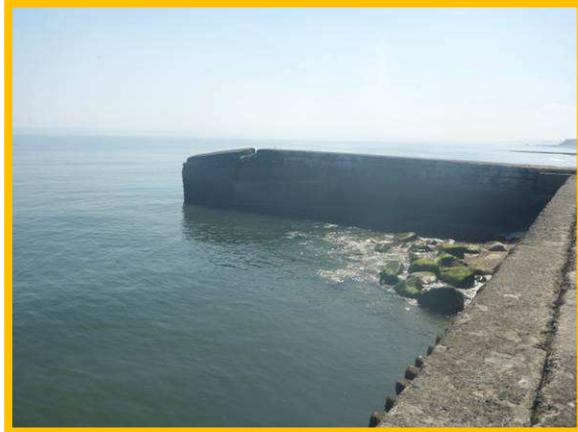
Breakwater with nose detached, from north side.
(Asset Ref. No. 121AB901B0803C02.)

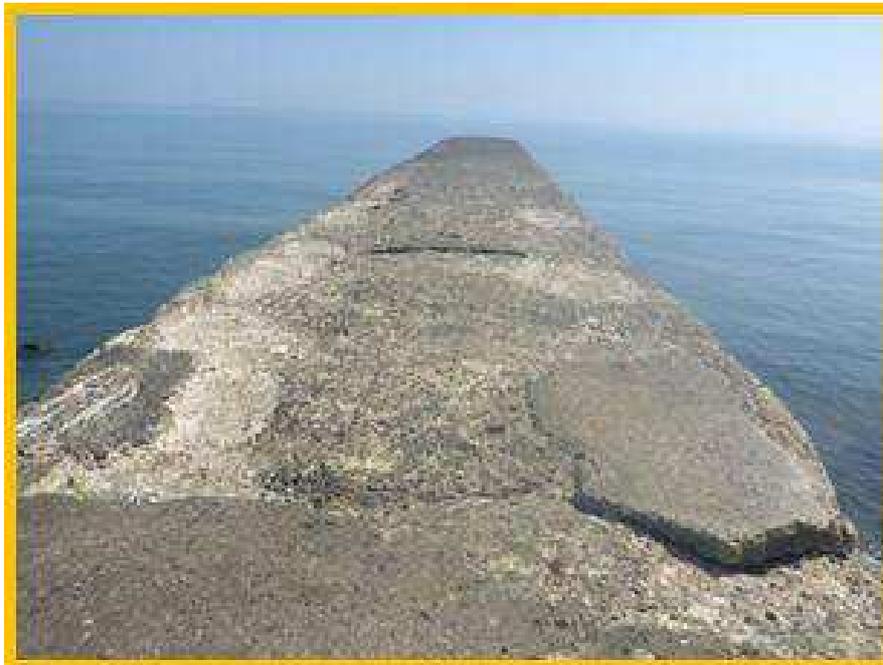
Spalled deck surface of breakwater. (Asset Ref. No. 121AB901B0803C02.)

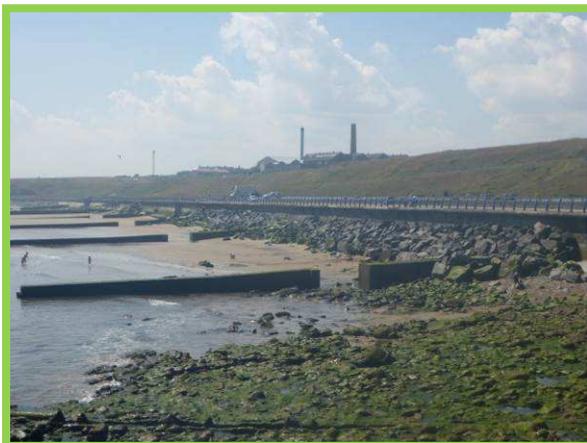
Rock armour in good condition.
(Asset Ref. No. 121AB901B0803C02)

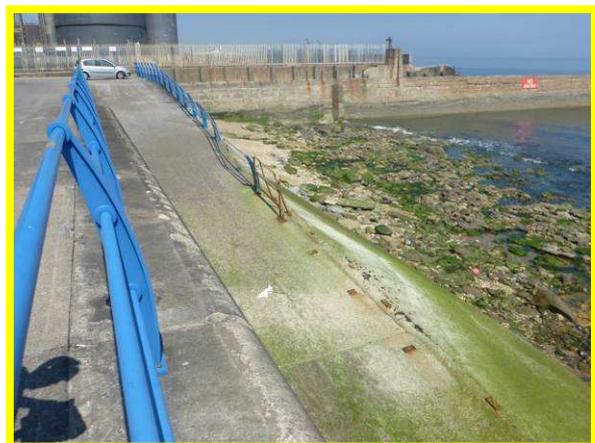
Failed railings towards northern end of beach.(Asset Ref. No. 121AB901B0803C02)

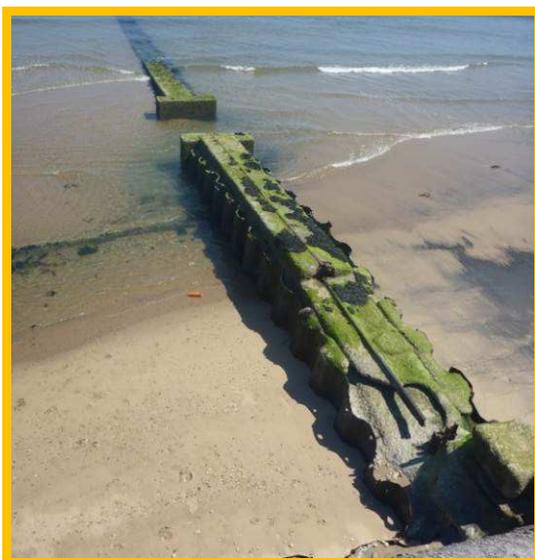
Inner end of groyne heavily abraded.
(Asset Ref. No. 121AB901B0803C02)

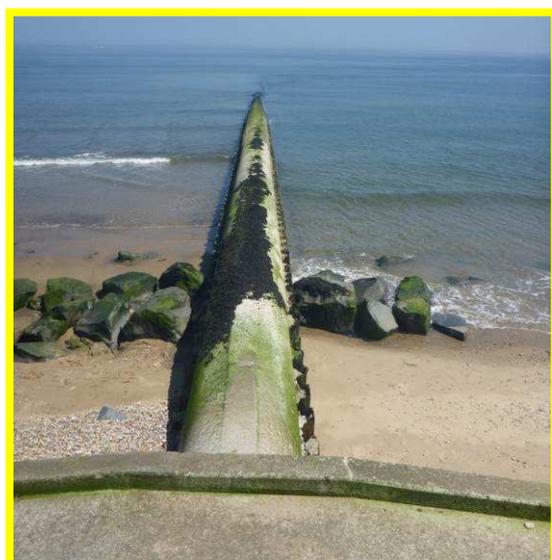
Concrete sewage outflow pipe in fair condition,
corroded piling.
(Asset Ref. No. 121AB901B0803C02)

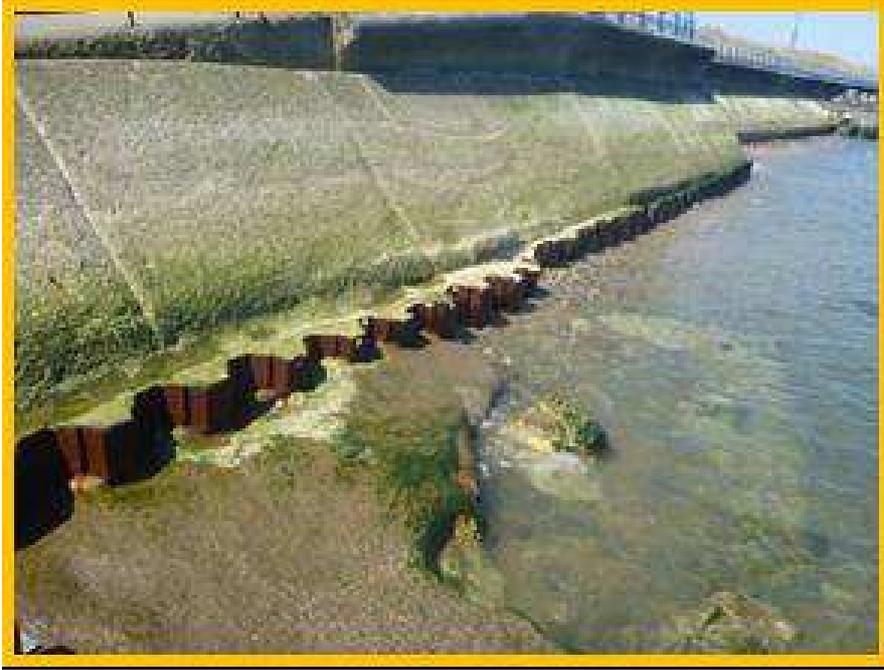
Highly abraded and corroded steel toe piling. (Asset Ref. No. 121AB901B0803C02)

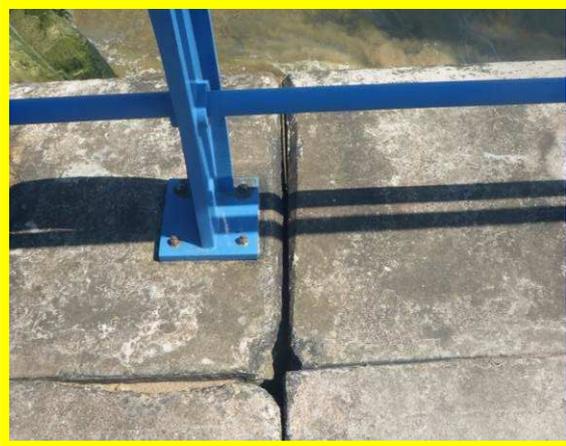
Missing sealant between slabs.
(Asset Ref. No. 121AB901B0803C02)

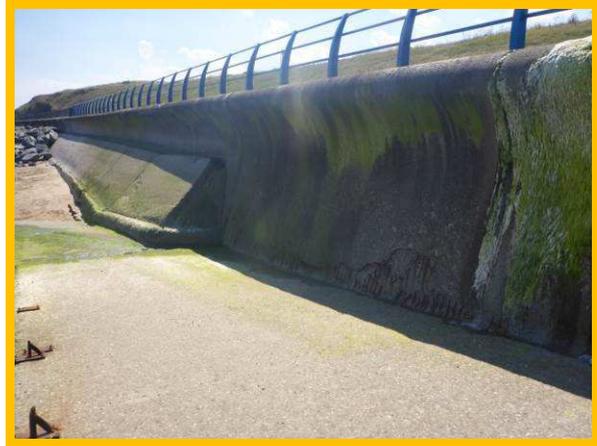
Seawall abraded exposing reinforcement.
(Asset Ref. No. 121AB901B0803C02)

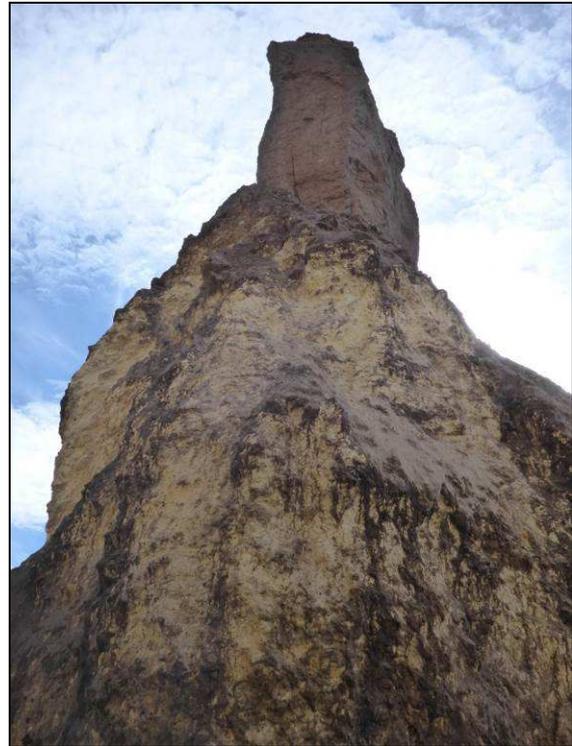
Sea stack at Pincushion (Asset Ref. No. 121AB901B0804C02)

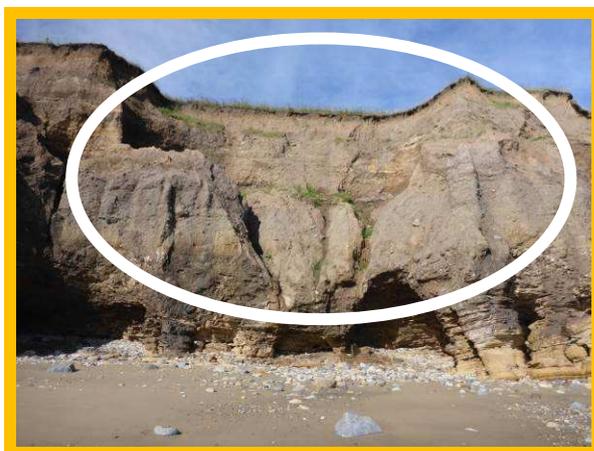
Slumped cliff section at Halliwell Banks (Asset Ref. No. 121AB901B0804C02)
