## **Cell 1 Regional Coastal Monitoring Programme Walkover Inspection Surveys 2018**

**Sunderland City Council**

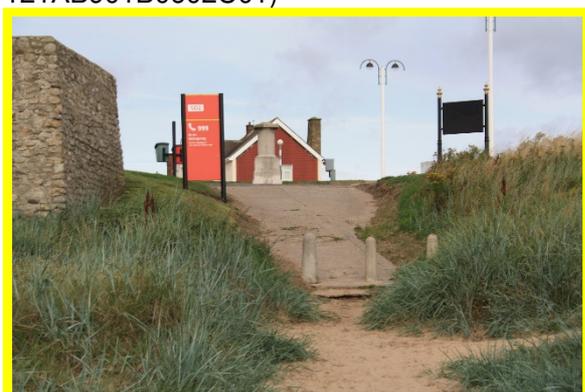
Undercut access ramp at Whitburn Steel (Asset Ref No. 121AB901B0602C01)

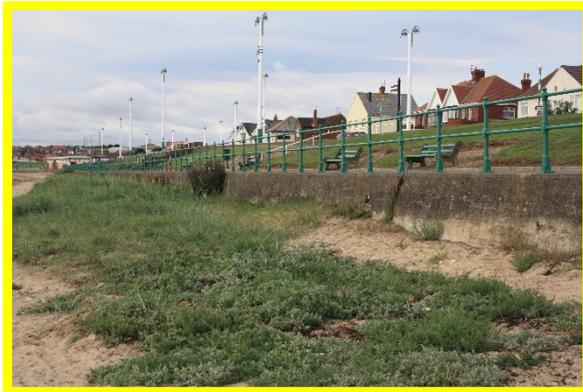
Sandy upper beach surface and dune accretion in front of concrete seawall. (Asset Ref No. 121AB901B0603C01)

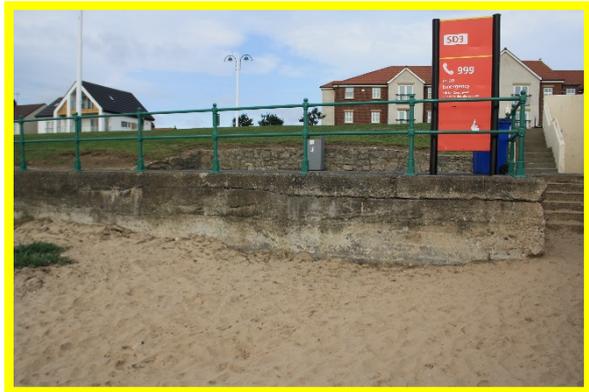
Spalled/damaged concrete cope and facing (Asset Ref No. 121AB901B0603C01)

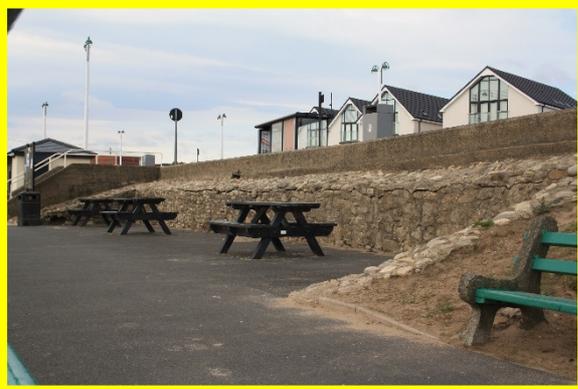
Cracked rear revetment at picnic area (Asset Ref No. 121AB901B0603C01)

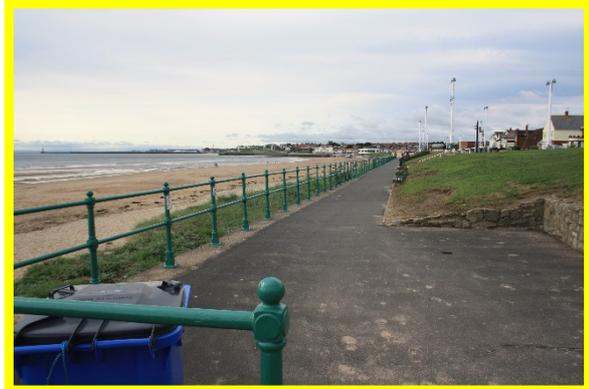
Asphalt surface appears in good condition, erosion to rear embankment (Asset Ref No. 121AB901B0603C01)

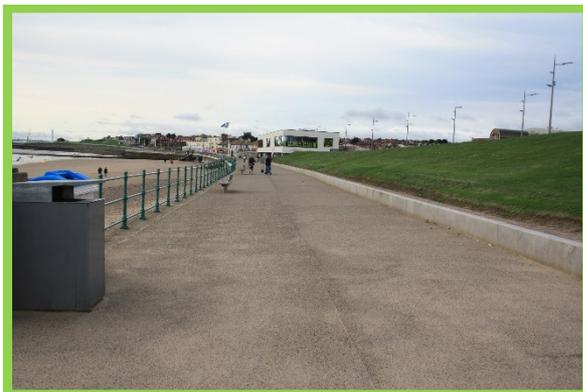
Exposed aggregate concrete surfacing on promenade behind seawall at southern end. (Asset Ref No. 121AB901B0603C01)

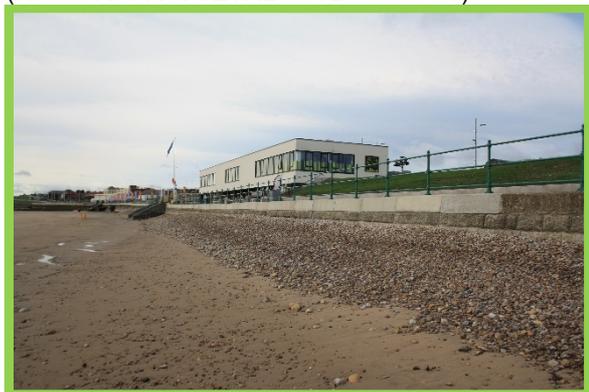
Repaired section of coping blocks. (Asset Ref No. 121AB901B0603C01)

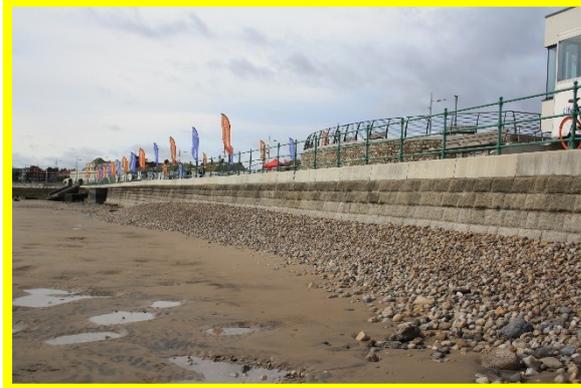
Repaired concrete coping above masonry seawall.  
(Asset Ref No. 121AB901B0603C02)

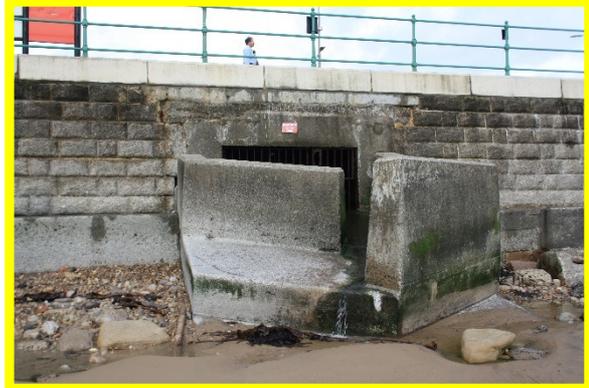
Repaired concrete coping above outfall structure.  
(Asset Ref No. 121AB901B0603C02)

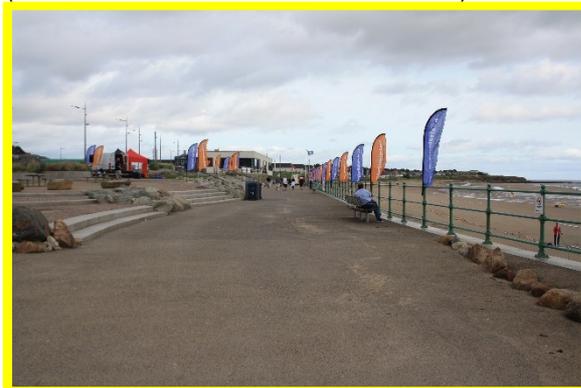
Exposed aggregate concrete surfacing at southern end.  
(Asset Ref No. 121AB901B0603C02)

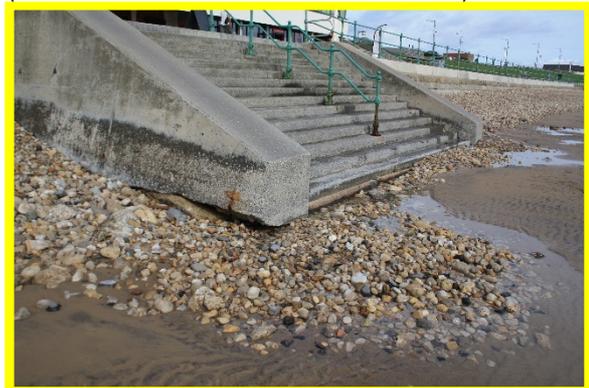
Low beach levels exposing undercut toe of access steps adjacent the Fat Buddha restaurant.  
(Asset Ref No. 121AB901B0603C02)

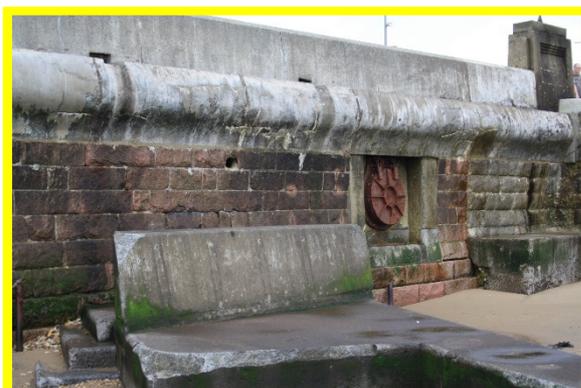
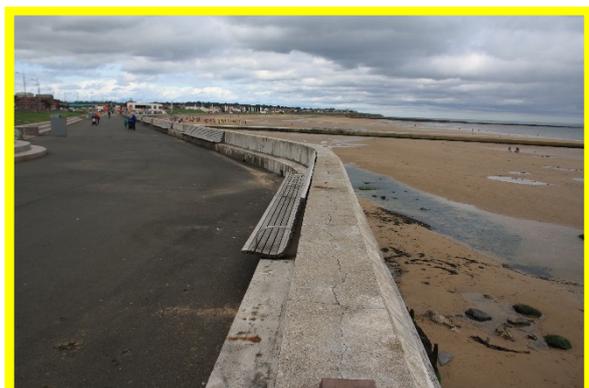
Cracking in seaward side of crest wall  
(Asset Ref. No. 121AB901B0603C03)

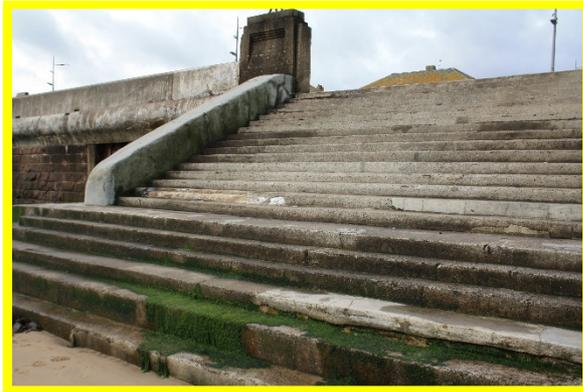
Abraded/spalled nosing of access steps at  
Dykeland Road roundabout.  
(Asset Ref. No. 121AB901B0603C03)

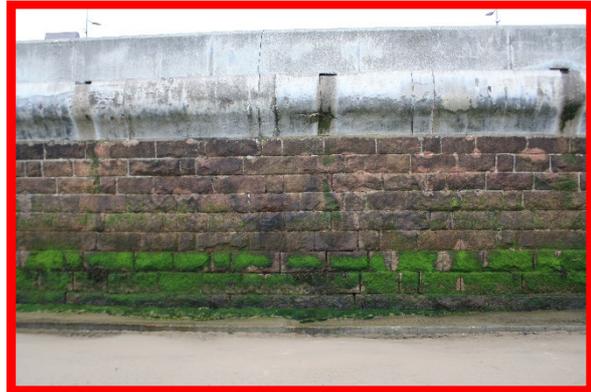
Low beach levels exposing open joints at toe of  
wall (Asset Ref. No. 121AB901B0603C03)

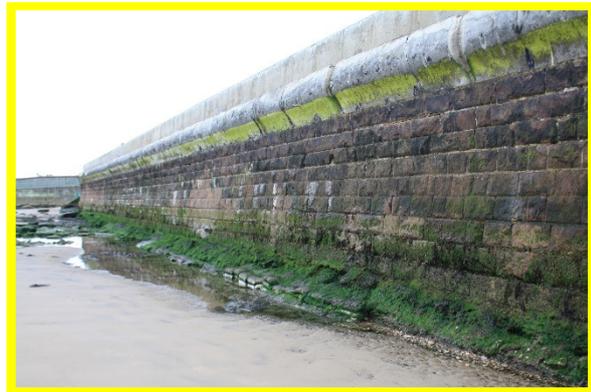
Previous bag-work repairs exposed, local  
voiding at toe  
(Asset Ref. No. 121AB901B0603C03)

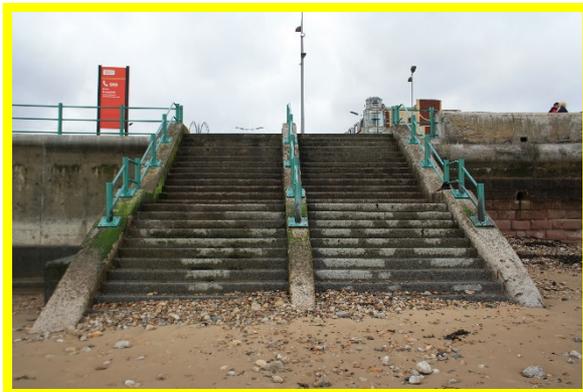
Recently replaced handrails at Seaburn  
Terrace roundabout steps, algae removed  
(Asset Ref. No. 121AB901B0603C03 /  
B0604C01)

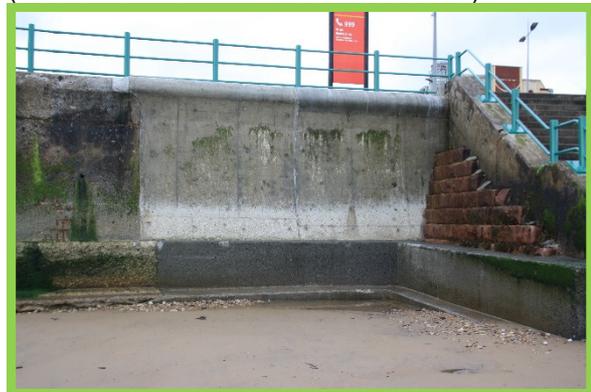
Recently constructed seawall infill section  
adjacent to steps at Seaburn Terrace  
(Asset Ref. No. 121AB901B0603C03)

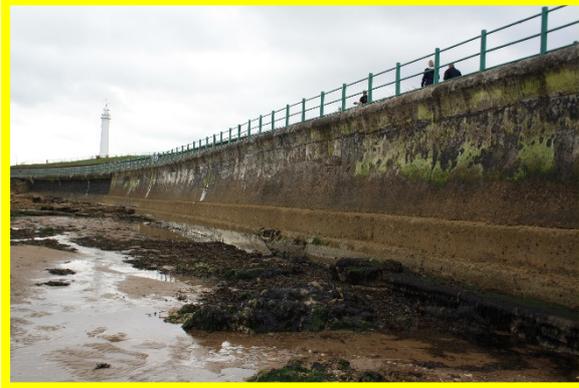
Beach levels similar to September 2014.  
(Asset Ref. No. 121AB901B0604C01)

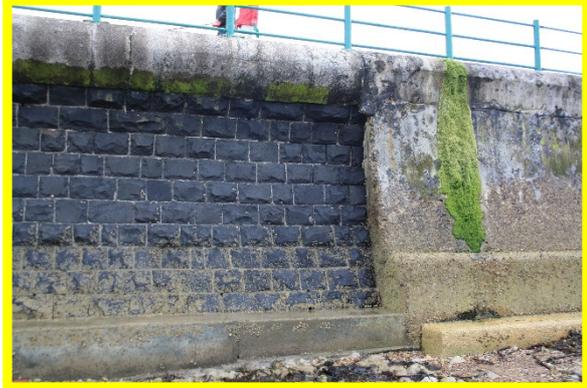
Damaged section of coping and chloride staining (Asset Ref. No. 121AB901B0604C01)

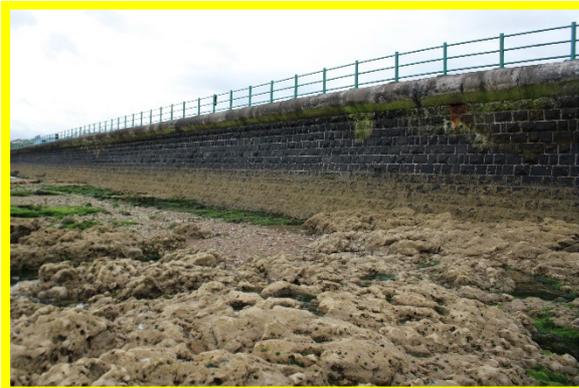
View southwards from Parsons Rocks, seawall in fair condition.  
(Asset Ref. No. 121AB901B0604C02)

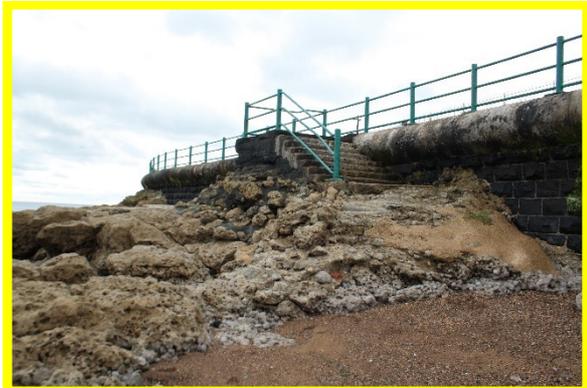
Eroded natural rock at access steps to Parsons Rocks (access to steps blocked by handrail).  
(Asset Ref. No. 121AB901B0604C02)

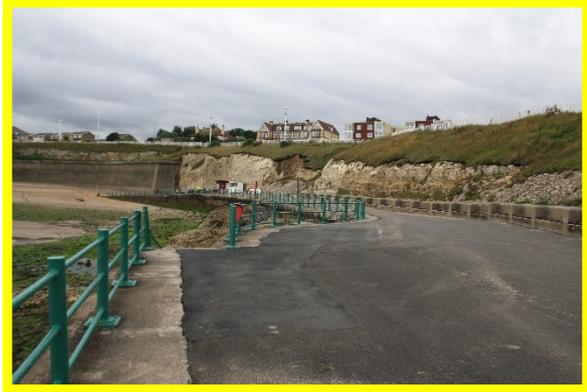
Asphalt surface replaced locally at promenade (Asset Ref. No. 121AB901B0604C02)

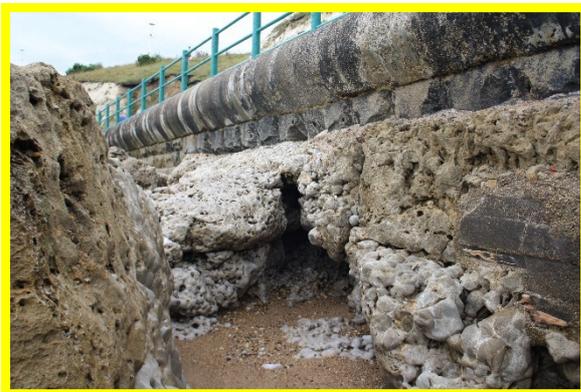
Eroded limestone outcrop void beneath promenade at south of Parsons Rocks. (Asset Ref. No. 121AB901B0604C02)

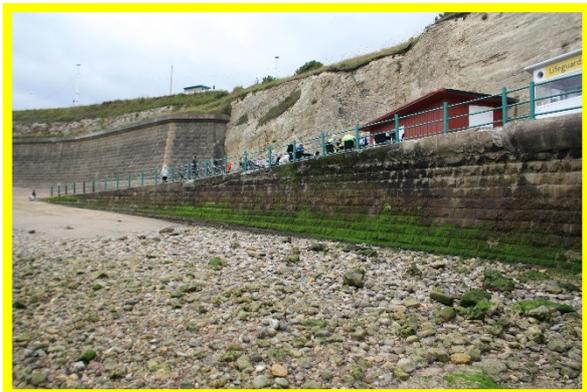
Damage to coping on ramp south of Parsons Rocks. (Asset Ref. No. 121AB901B0604C02)

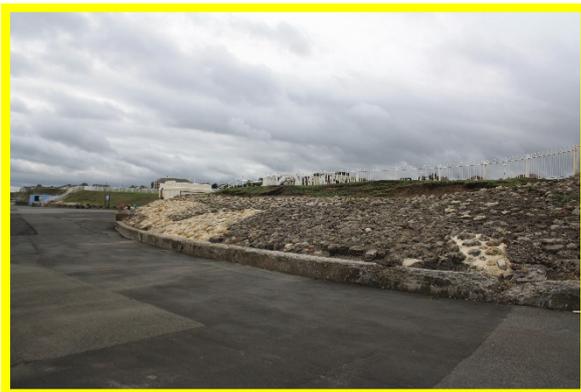
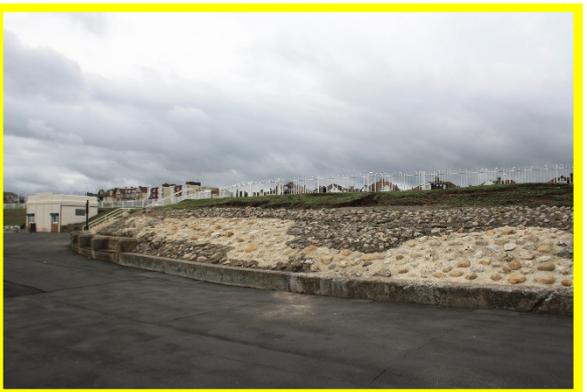
Recently infilled voids in grouted revetment (Asset Ref. No. 121AB901B0604C02)

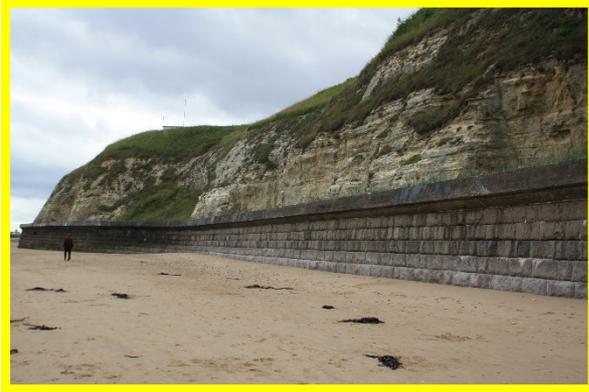
Masonry wall generally in good condition  
(Asset Ref. No. 121AB901B0605C01)

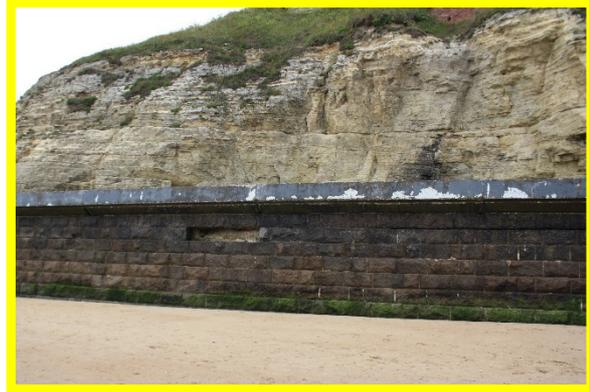
Hole at missing block has extended since 2016  
and longitudinal crack has formed.  
(Asset Ref. No. 121AB901B0605C01)

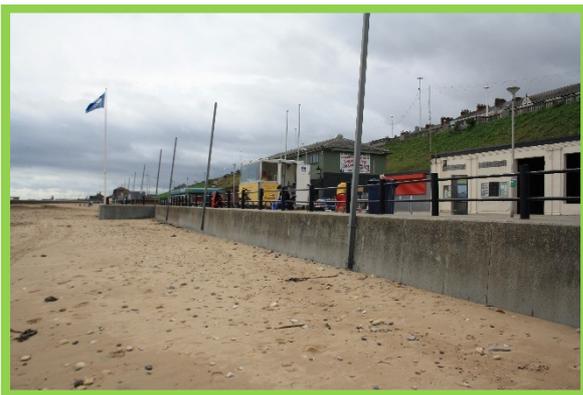
Low concrete encased wall at Marine Walk in  
fair to good condition.  
(Asset Ref. No. 121AB901B0605C02)

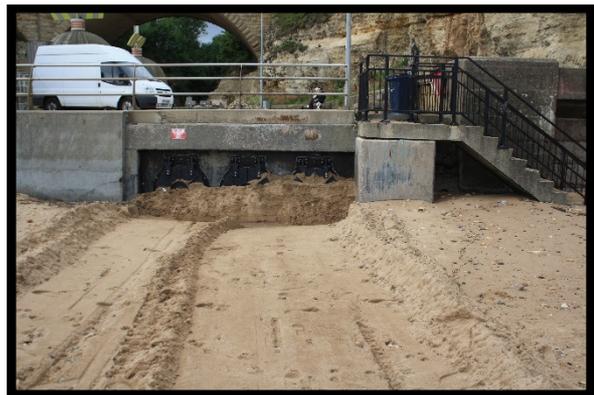
Sand noted to have been excavated/cleared  
from in front of outfall pipes.  
(Asset Ref. No. 121AB901B0605C02)

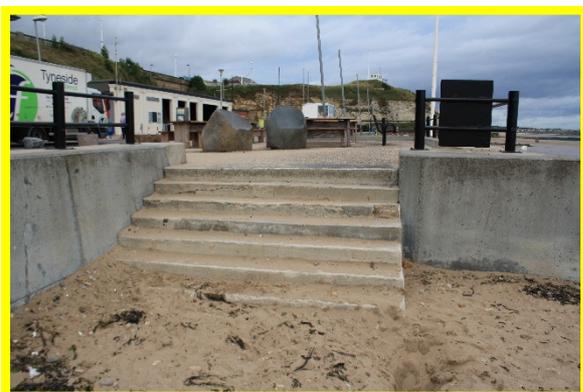
Damaged concrete access steps needing  
repair. (Asset Ref. No. 121AB901B0605C02)

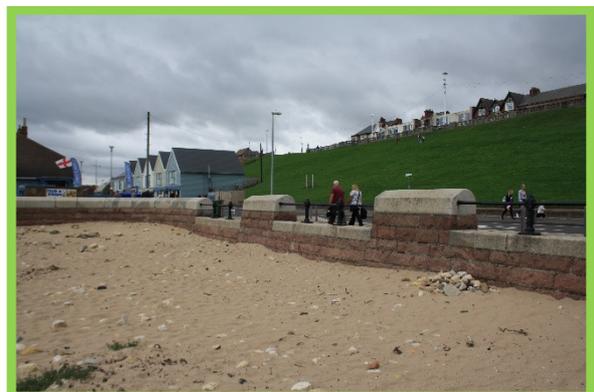
Southern section of masonry wall protected by  
wide beach in good overall condition.  
(Asset Ref. No. 121AB901B0605C02)

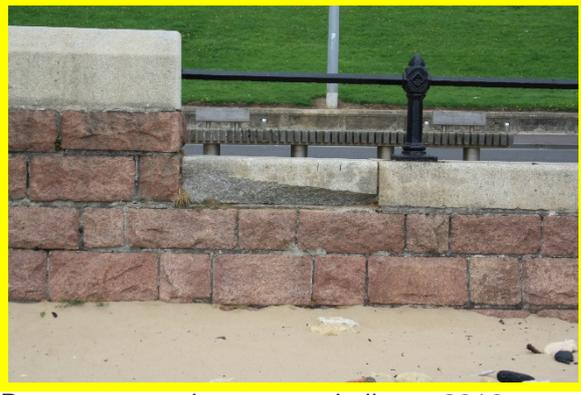
Damage to coping stone, similar to 2016.  
(Asset Ref. No. 121AB901B0605C02)

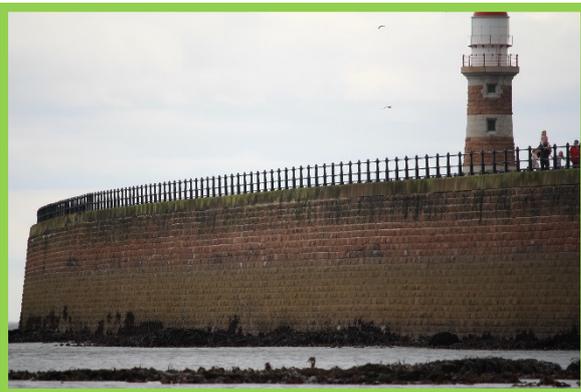
Northern (outer) face of pier  
(Asset Ref. No. 121AB901B0702C04)

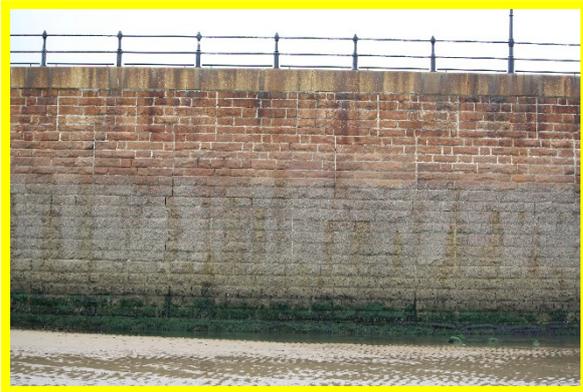
Roker Pier northern (inner) face, vertical cracks and open joints at toe  
(Asset Ref. No. 121AB901B0702C04)

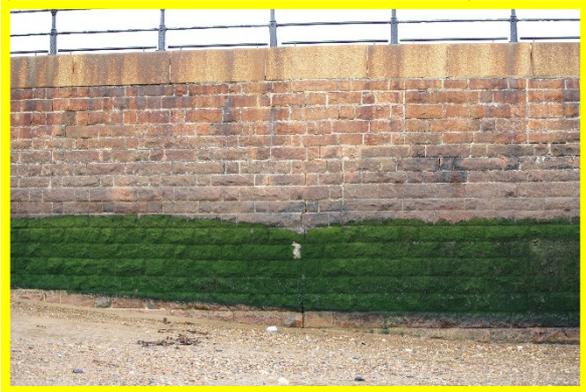
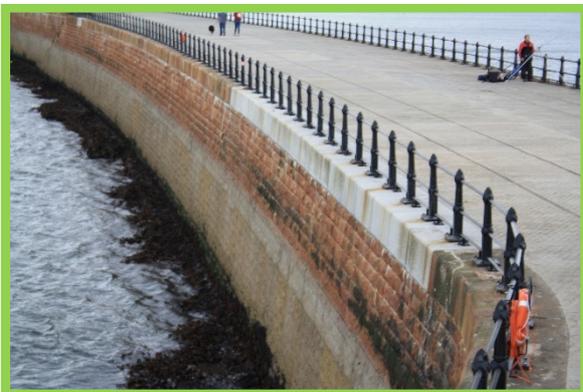
Recently replaced handrail and coping blocks.  
(Asset Ref. No. 121AB901B0702C04)

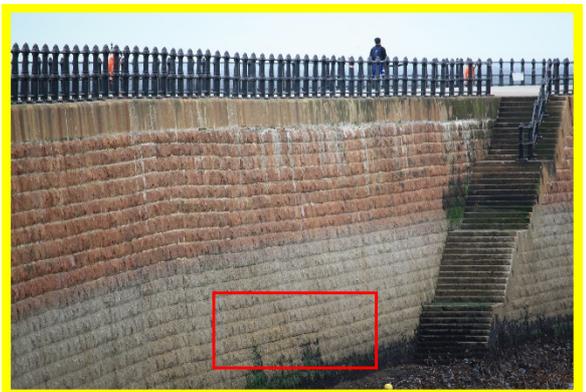
Potential settlement crack towards toe of  
northern face  
(Asset Ref. No. 121AB901B0702C04)

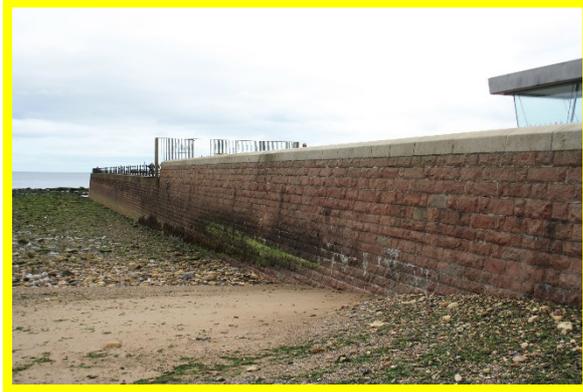
View on northern side of masonry wall at root of pier – localised abrasion and mortar loss. (Asset Ref. No. 121AB901B0702C05)

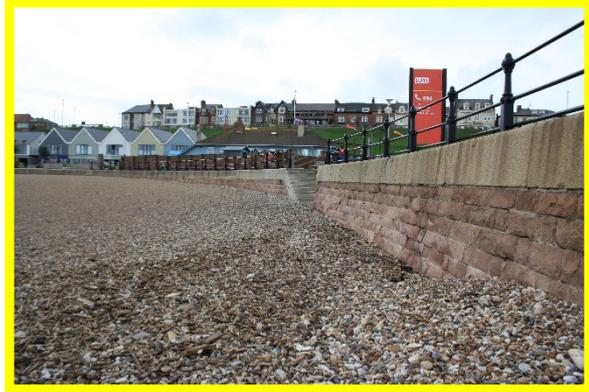
Masonry splash wall at southern root of pier – sections of damaged coping and weathered masonry. (Asset Ref. No. 121AB901B0702C05)

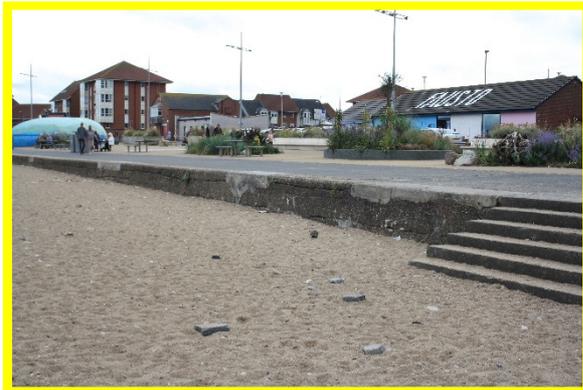
Patch repairs and horizontal cracks in concrete wall. (Asset Ref. No. 121AB901B0702C01)

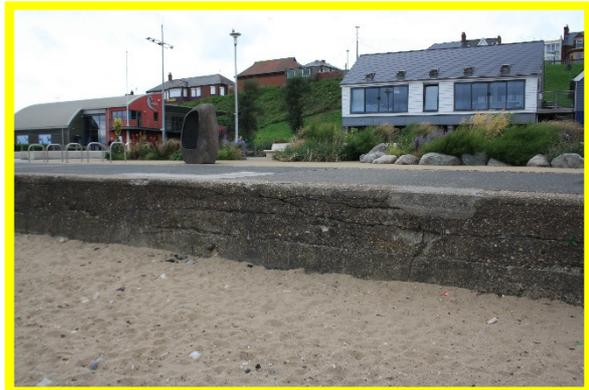
Example of spalling between horizontal cracking (Asset Ref. No. 121AB901B0702C01)

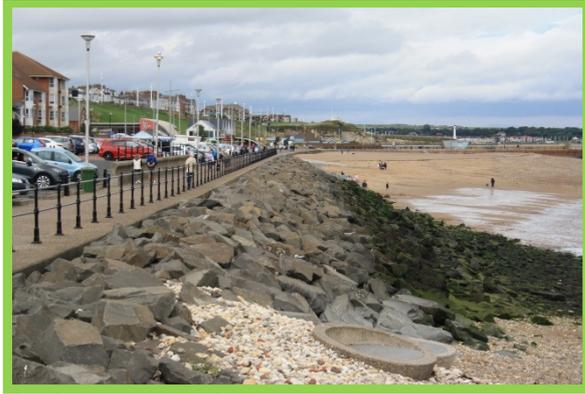
Rock armour and promenade crest in good condition. (Asset Ref. No. 121AB901B0702C02)

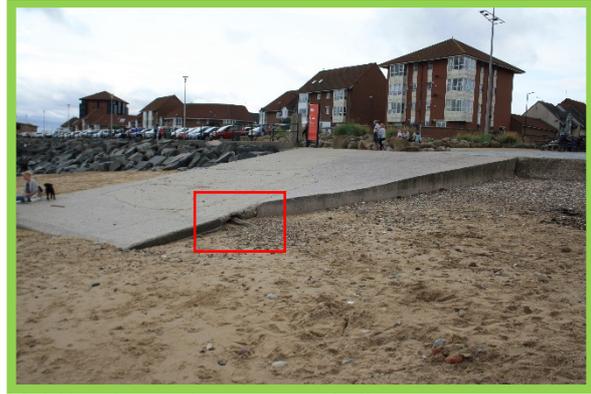
Void/undercutting at toe of slipway. (Asset Ref. No. 121AB901B0702C02)

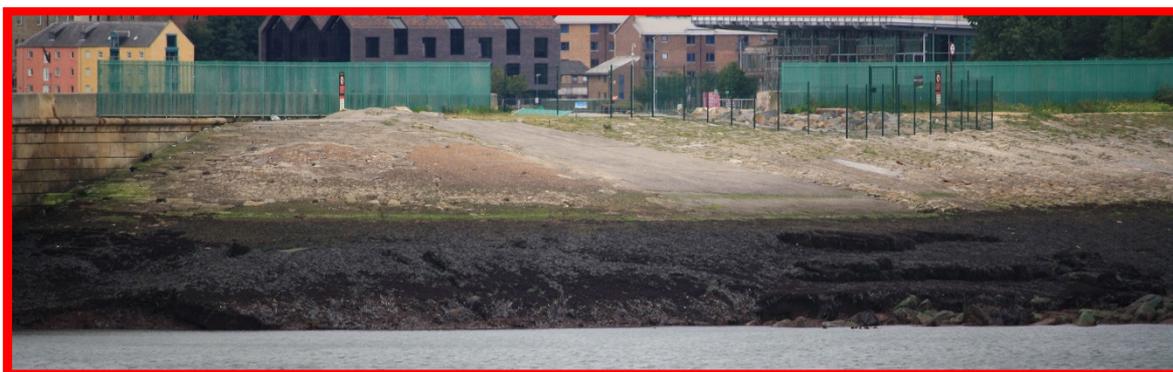
Northern face of Old North Pier, voids at toe (Asset Ref. No. 121AB901B0702C03)

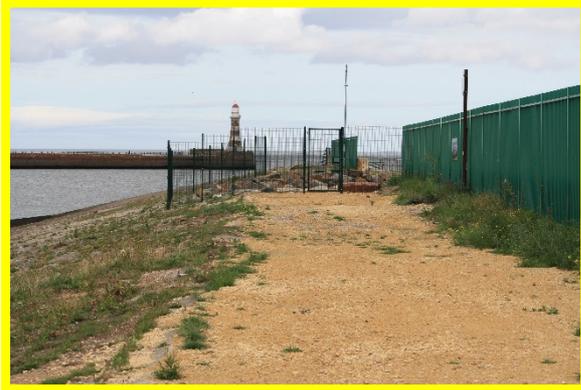
Recently constructed haulage path on crest of Old North Pier for delivery of rock repairs (Asset Ref. No. 121AB901B0702C03)

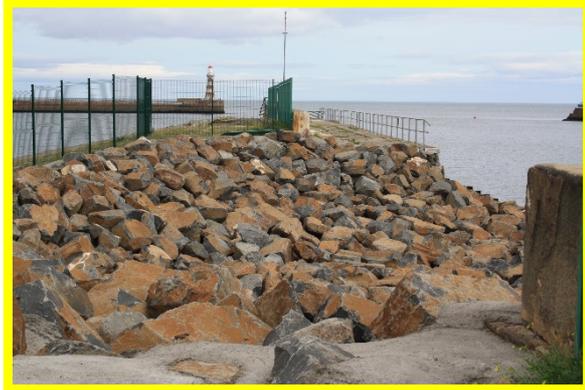
Recent breached infilled with rock armour and grout. (Asset Ref. No. 121AB901B0702C03)

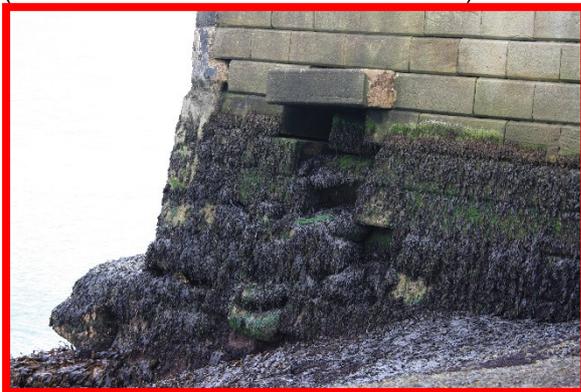
Missing blocks at seaward end (Asset Ref. No. 121AB901B0702C03)

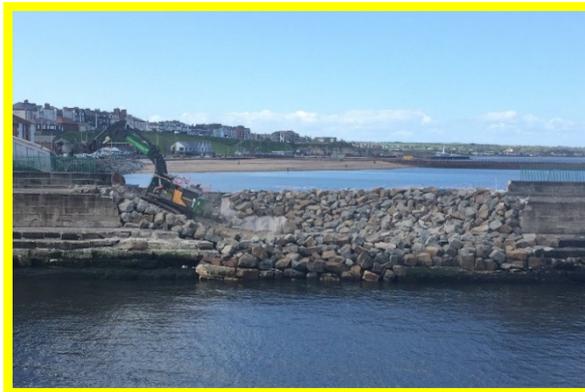
Old North Pier undergoing repair works at breach, taken 10 May 2018. (Asset Ref. No. 121AB901B0702C03)

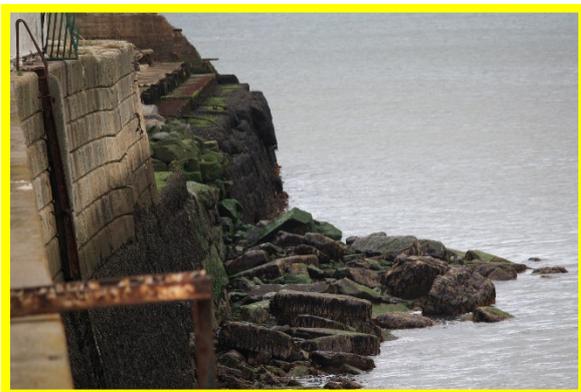
Collapsing masonry on southern face (Asset Ref. No. 121AB901B0702C03)

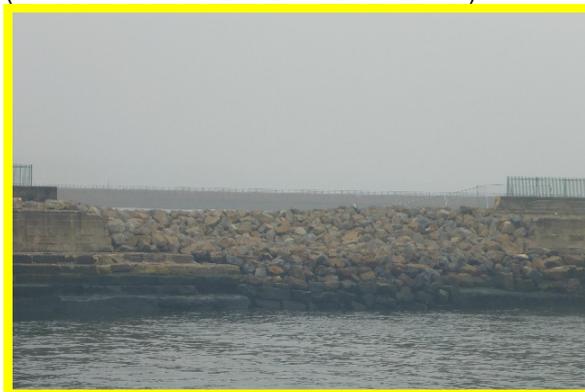
Old North Pier southern face (Asset Ref. No. 121AB901B0702C03)

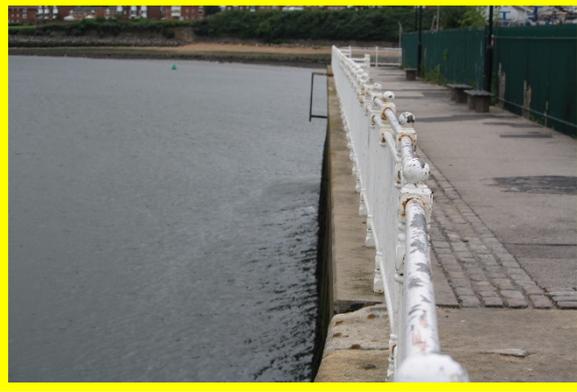
Damage to concrete coping at “Rat House Corner”. (Asset Ref. No. 121AB901B0702C03)

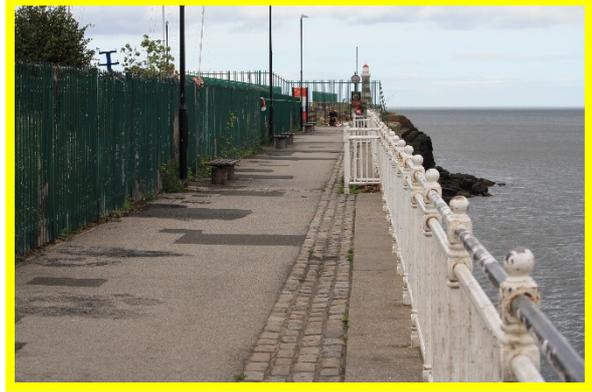
Promenade at “Rat House Corner” in fair condition (Asset Ref. 121AB901B0702C03)

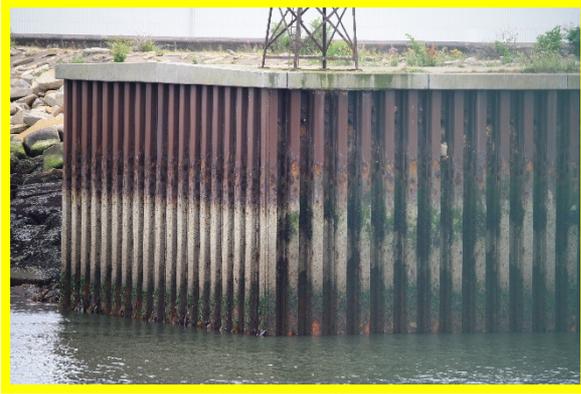
Staining at toe of sheet pile river navigational wall at north end potentially indicating microbial induced corrosion (MIC) reducing structural capacity  
(Asset Ref. No. 121AB901BO703C03)

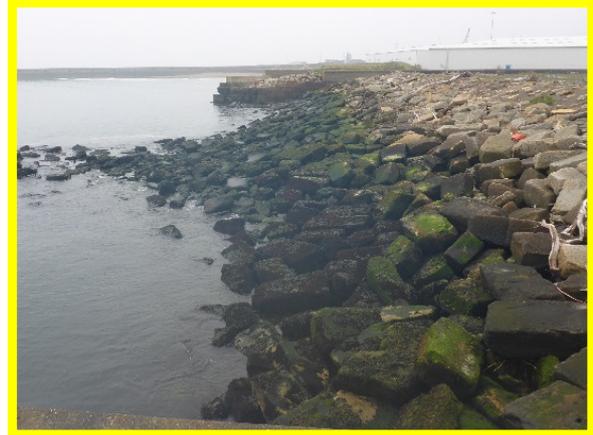
View of rock revetment from north showing loosely placed armour  
(Asset Ref. No. 121AB901BO703C03)

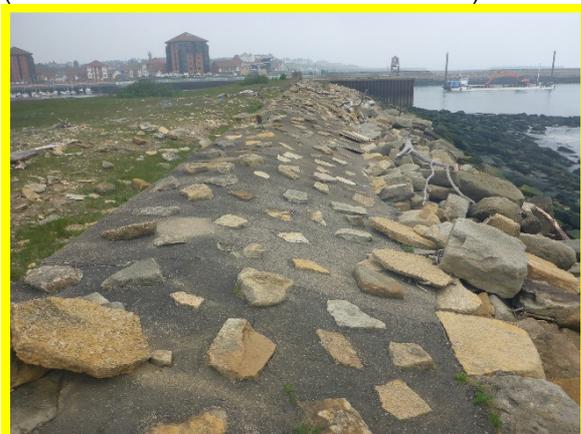
View of revetment crest from south.  
(Asset Ref. No. 121AB901BO703C03)

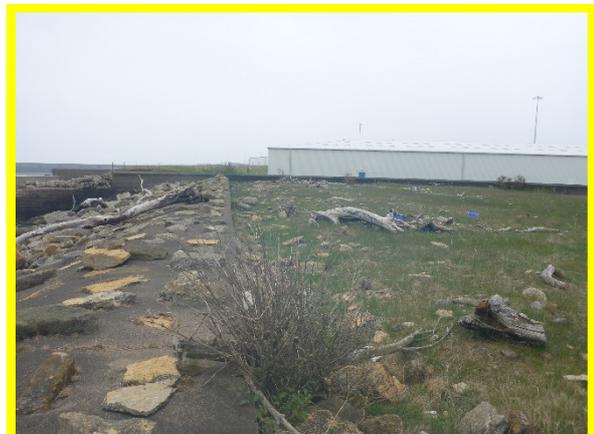
Low spot on landward side of concrete crest  
(Asset Ref. No. 121AB901BO703C03)

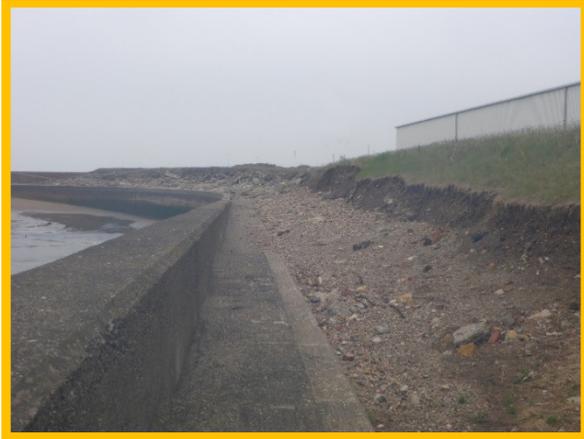
Extensive crest and rear embankment damage due to wave overtopping.  
(Asset Ref. No. 121AB901BO703C02)

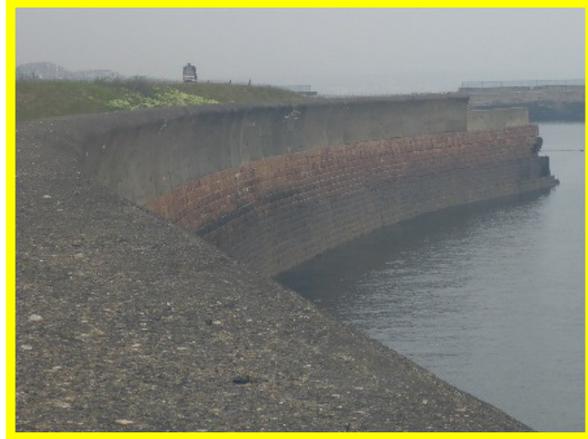
Masonry wall in fair condition except for missing blocks at North end.  
(Asset Ref. No. 121AB901BO703C02)

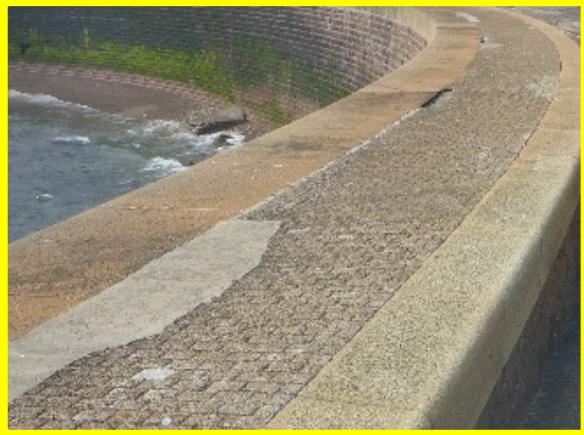
Voids in blockwork of upper deck appear to have been repaired although further damage has taken place. (Asset Ref. No. 121AB901B0703C01)

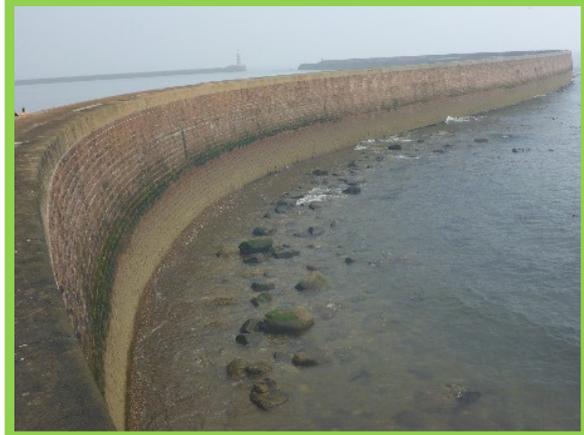
View of south face of wall from land. (Asset Ref. No. 121AB901B0703C01)

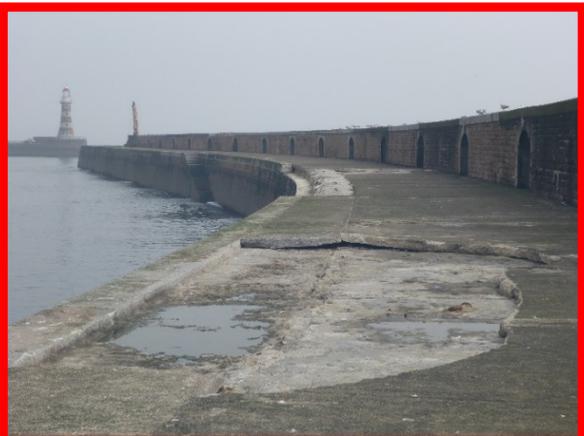
Damage to lower deck level and cope blocks. (Asset Ref. No. 121AB901B0703C01)

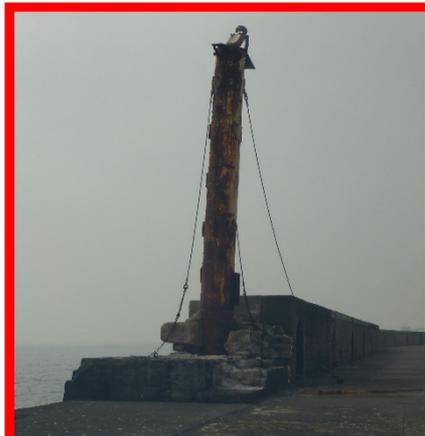
Corroded navigation light column unsupported and leaning precariously. (Asset Ref. No. 121AB901B0703C01)

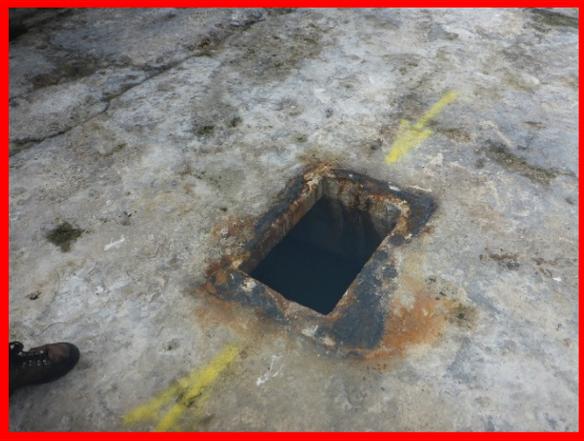
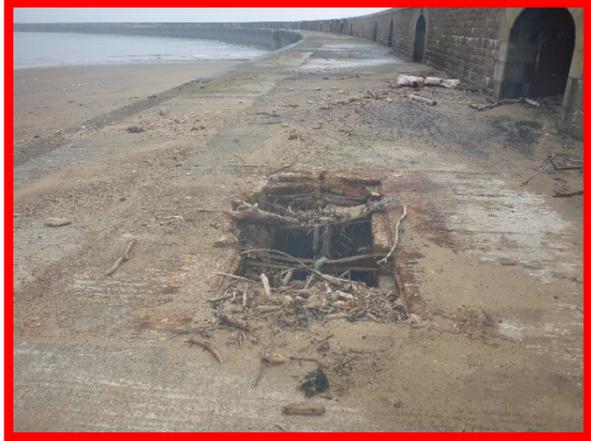
Open chambers on deck of pier posing fall/entrapment risk. (Asset Ref. No. 121AB901B0703C01)

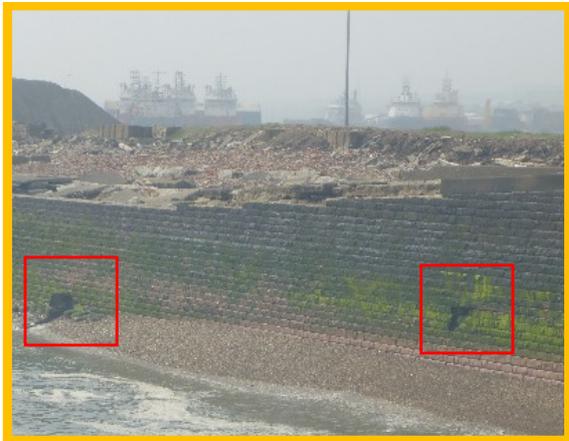
Previous void covered with rock (left),  
Further missing blocks and open joint (right).  
(Asset Ref. No. B901B0801C03)

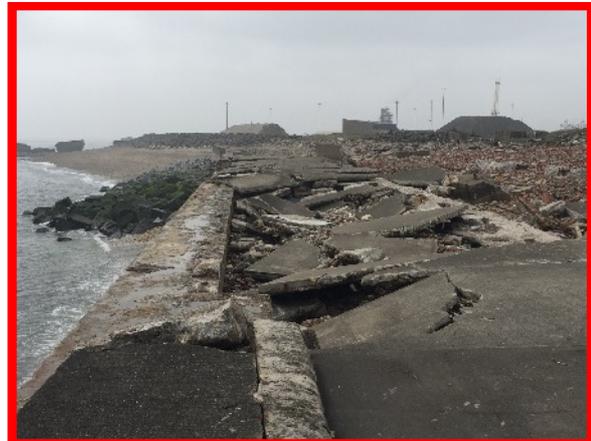
Deck slab and rear wall broken up.  
(Asset Ref. No. B901B0801C03)

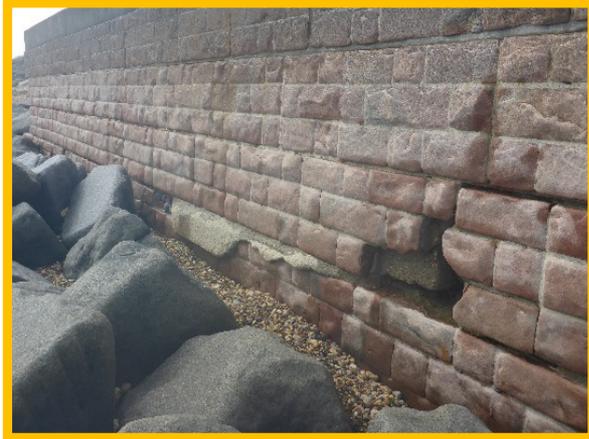
Missing blocks and open joints at toe of masonry wall. (Asset Ref. No. B901B0801C03)

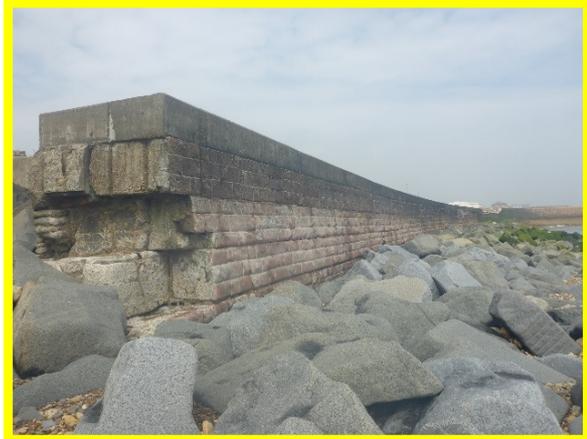
Rock armour in fair condition although gaps present. (Asset Ref. No. B901B0801C03)

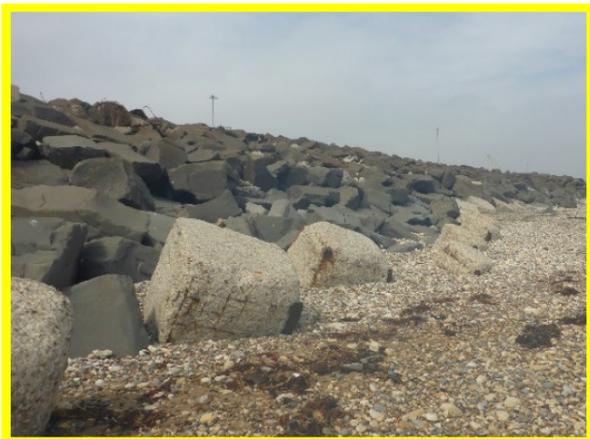
Rock/rubble revetment north of derelict groyne. (Asset Ref. No.121AB901B0801C02)

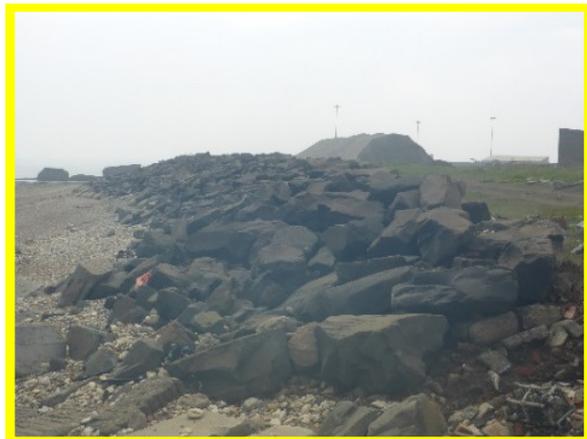
Uneven crest level of revetment. (Asset Ref. No.121AB901B0801C02)

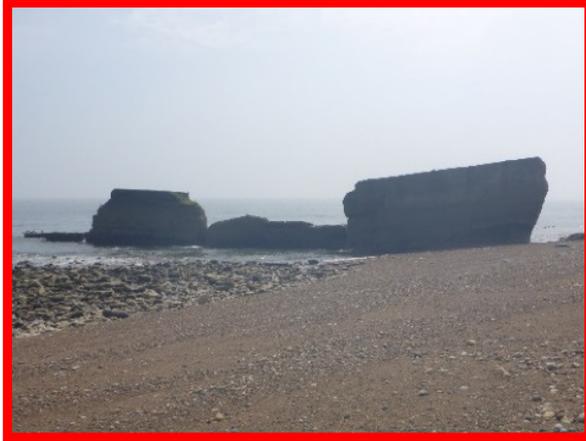
Derelict concrete groyne from north.  
(Asset Ref. No. 121AB901B0801C01)

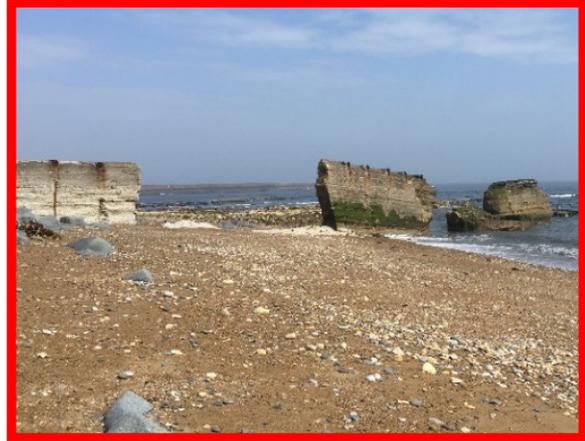
Derelict concrete groyne from south.  
(Asset Ref. No. 121AB901B0801C01)

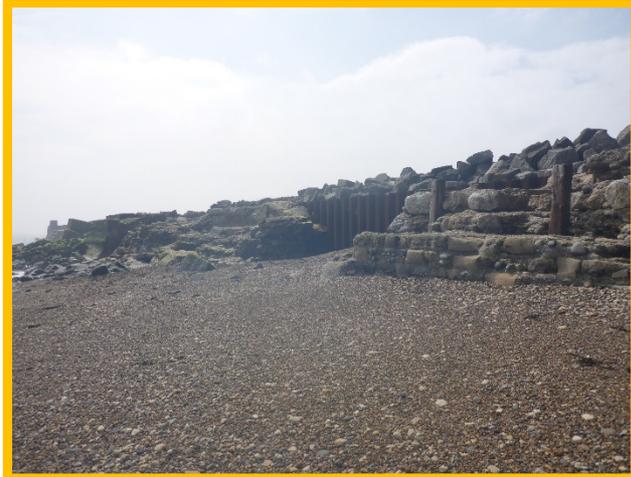
Derelict former defence structures with stacked bund of rock armour at crest.  
(Asset Ref. 121AB901B0801C05)

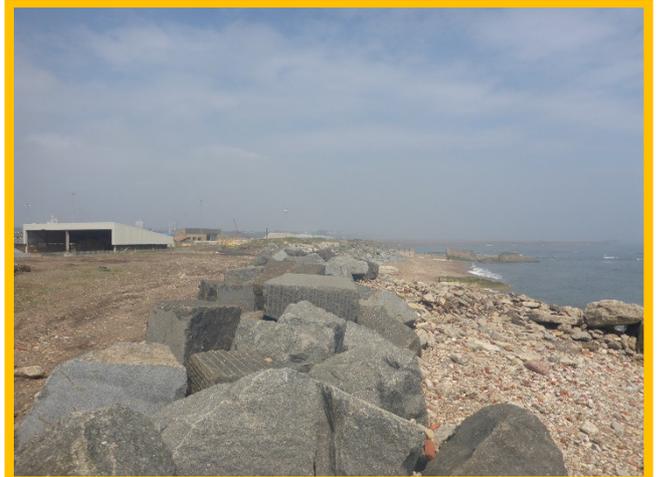
Rock armour at crest of derelict former defence structures.  
(Asset Ref. No. 121AB901B0801C05)

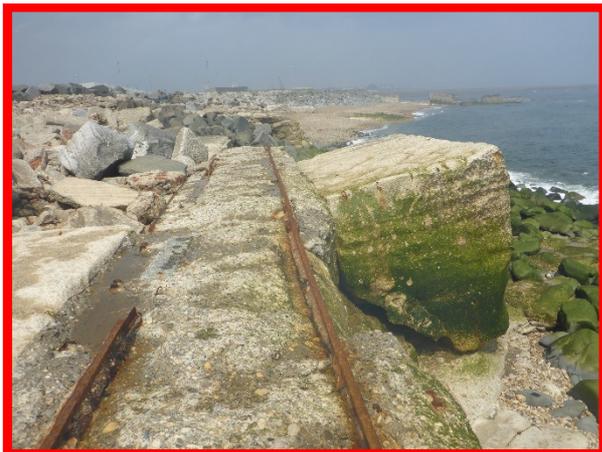
Buttress detached from main structure  
(Asset Ref. No. 121B901B0801C07)

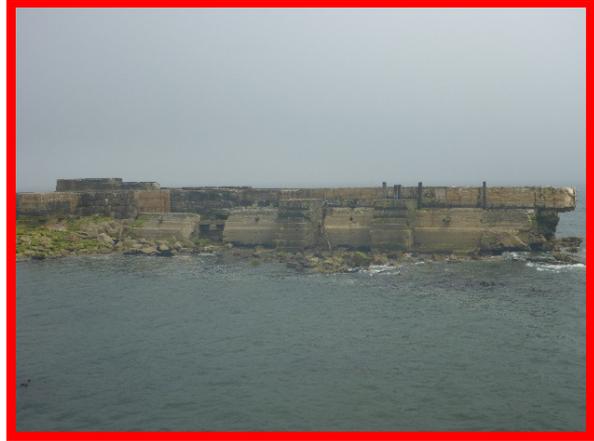
North East Pier viewed from south.  
(Asset Ref. No. 121B901B0801C04)

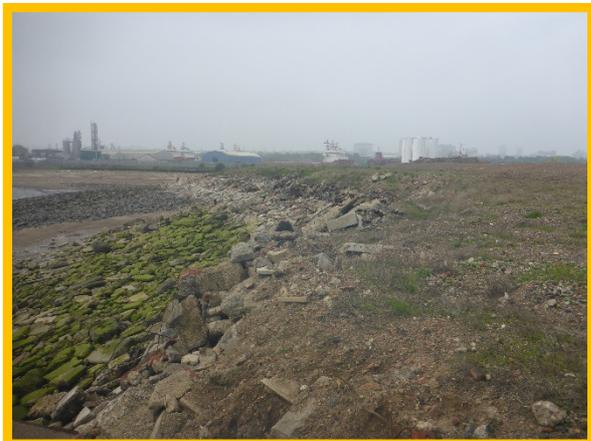
Tipped rubble at northern end of South Outlet basin. (Asset Ref. No. 121AB901B0801C08)

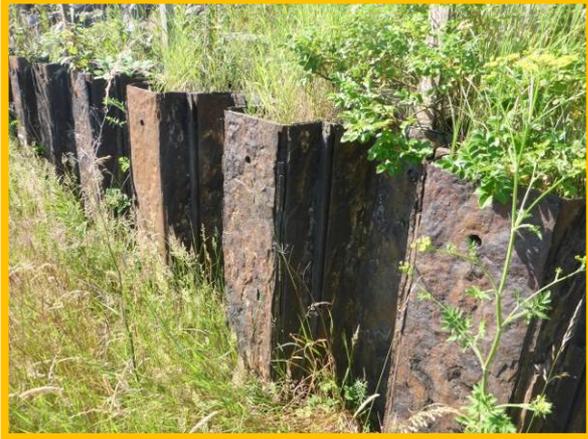
Heavily corroded sheet pile wall, taken 2016 (Asset Ref. No. 121AB901B0802C07).

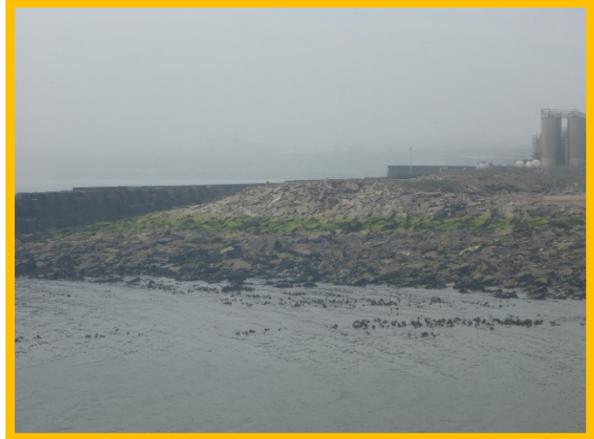
South side of basin taken from northern end of south outlet. (Asset Ref. No.121B901B02C06)

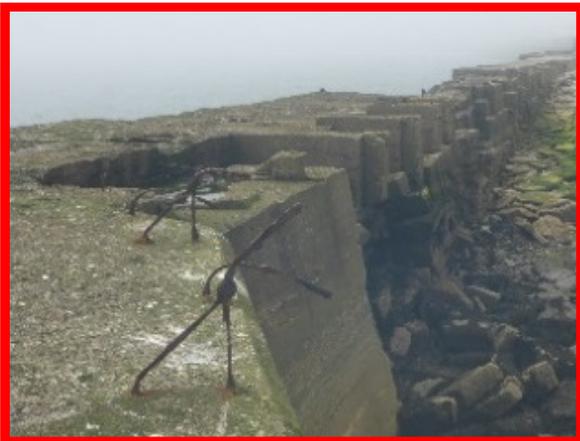
Collapse on landward side of SW Breakwater similar to 2016. (Asset Ref. 121AB901B0802C05)

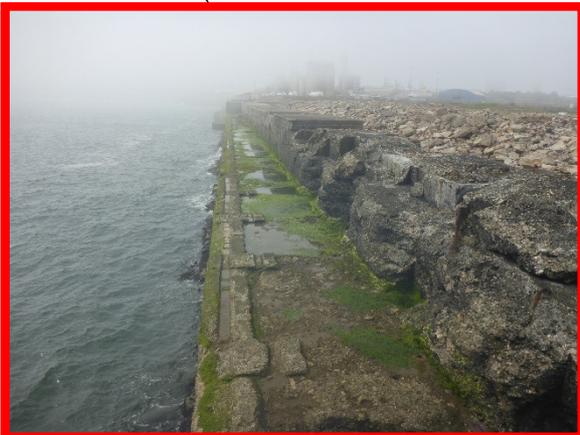
Missing section at seaward side of SW Breakwater. (Asset Ref. 121AB901B0802C05)

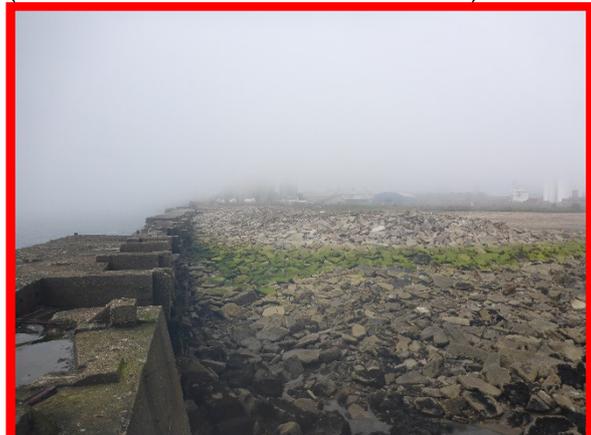
Demolition waste tipped on landward side, damaged blocks. (Asset Ref. 121AB901B0802C05)

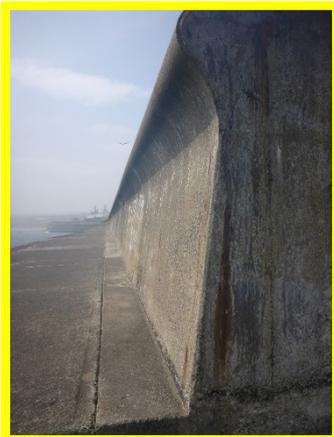
North end of Spur Barrier upper wall.  
(Asset Ref. No. 121AB901B0802C04)

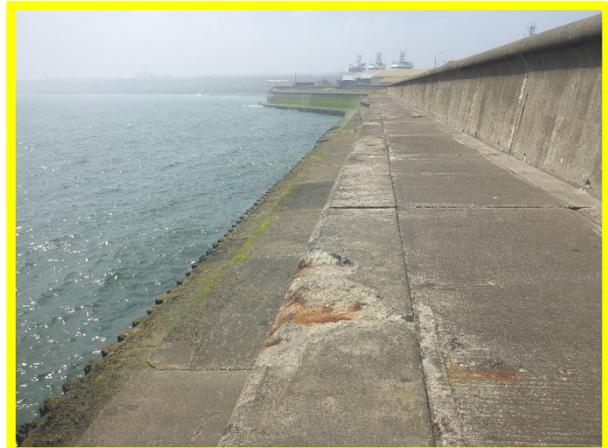
Cracking and spalling of upper sea wall.  
(Asset Ref. No. 121AB901B0802C04)
