## **Cell 1 Regional Coastal Monitoring Programme Walkover Inspection Surveys 2018**

**Sunderland City Council**

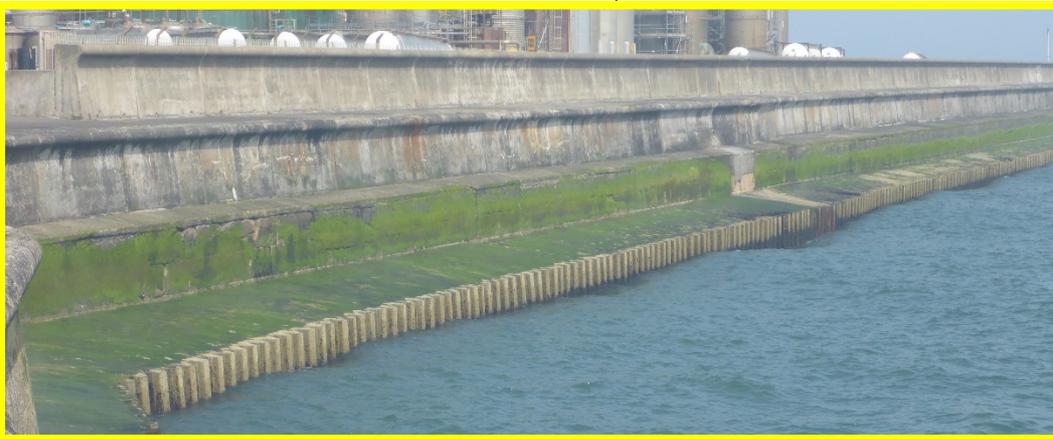
Spalling and localised damage to Spur Barrier wall.  
(Asset Ref. No. 121AB901B0802C04)

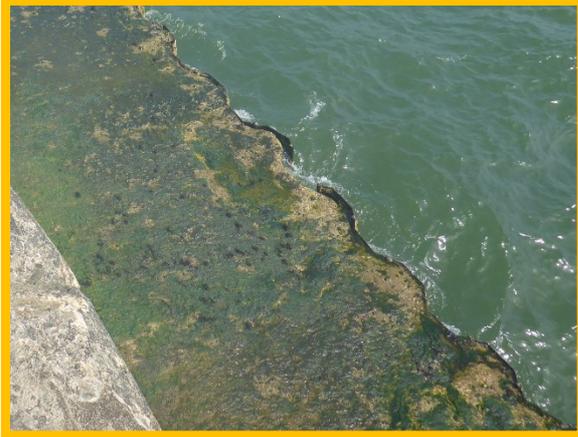
Corroded/abraded sheet pile wall at toe. (Asset Ref. No. 121AB901B0802C04)

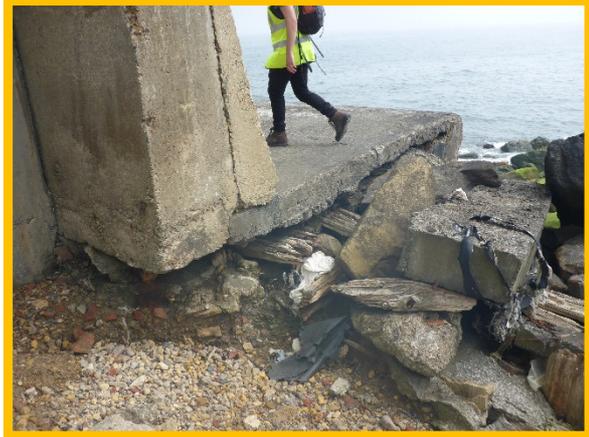
Undermining of upper seawall at south end. (Asset Ref. No. 121AB901B0802C04)

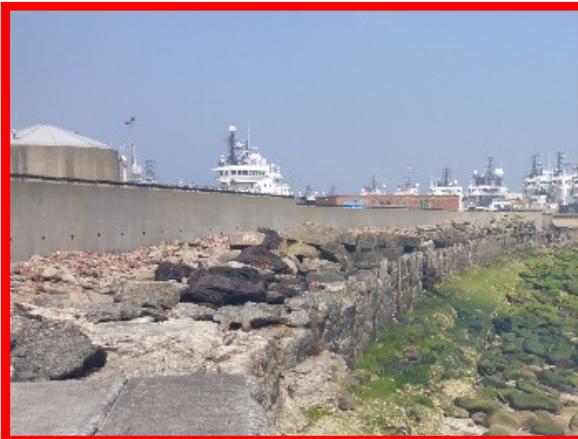
Sea wall in similar condition to 2016. (Asset Ref. No. 121B901B0802C03)

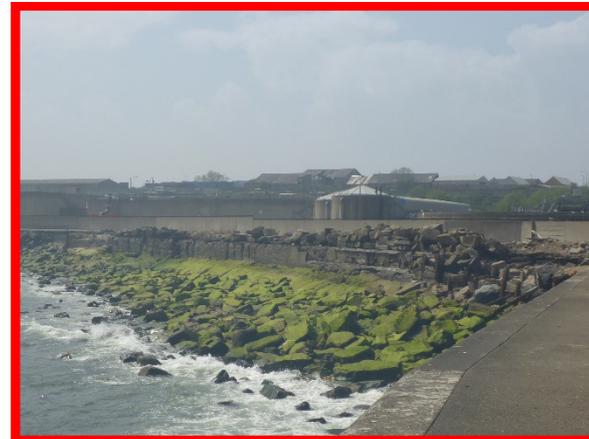
Rock armour in similar poor condition to 2016. (Asset Ref. No. 121B901B0802C03)

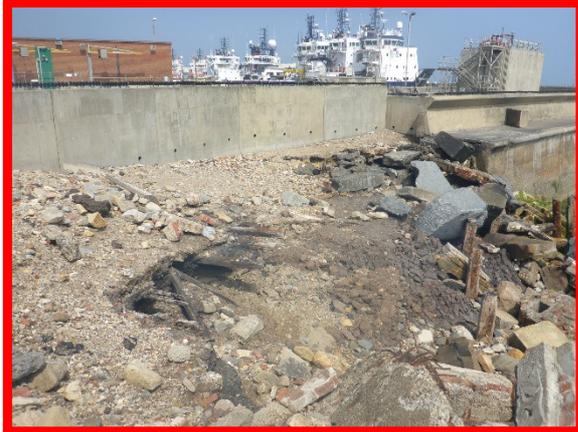
North end where rock/rubble crest has collapsed since 2016.  
(Asset Ref. No. 121B901B0802C03)

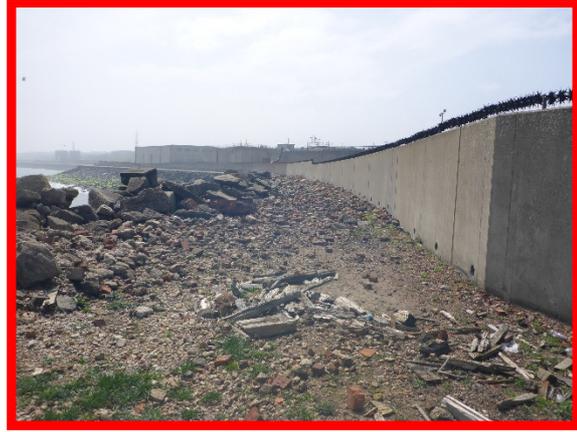
Concrete boundary wall with unprotected crest apron. (Asset Ref. No. 121B901B0802C03)

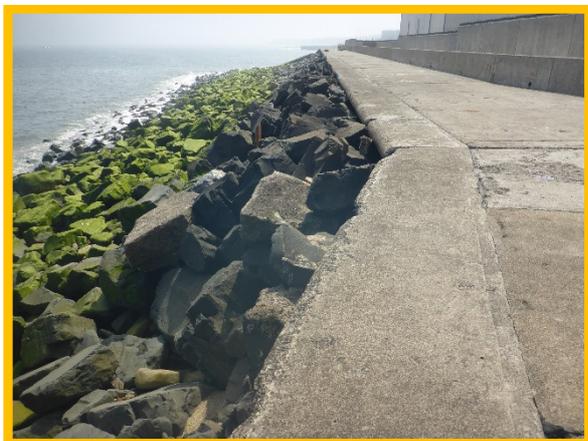
Damaged cope blocks  
(Asset Ref. 121AB901B0802C02)

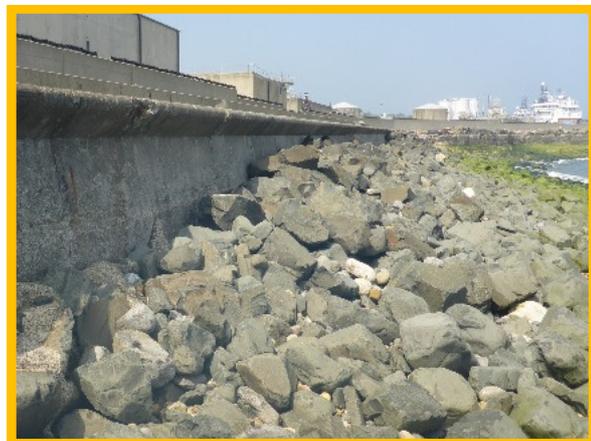
Unprofiled rock armour of varying (small) sizes, damaged cope.  
(Asset Ref. No. 121AB901B0802C02)

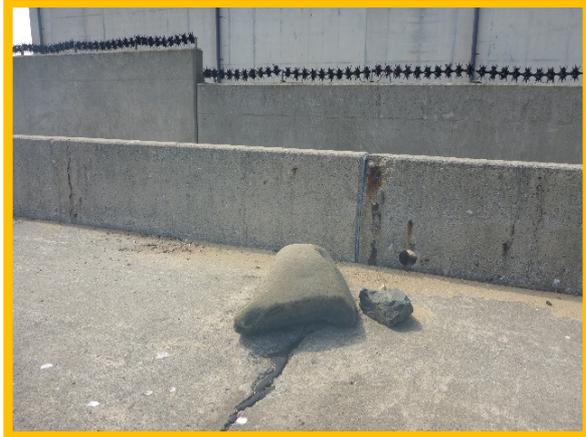
Displaced rock damaging deck slab and rear splash wall exposing reinforcement.  
(Asset Ref. No. 121AB901B0802C02)

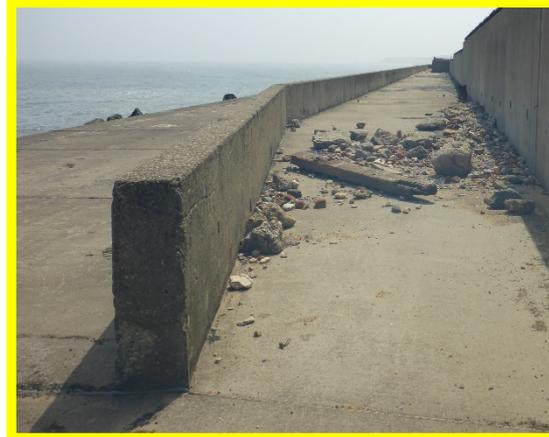
Overtopping debris between splash wall and rear boundary wall  
(Asset Ref. No. 121AB901B0802C02)

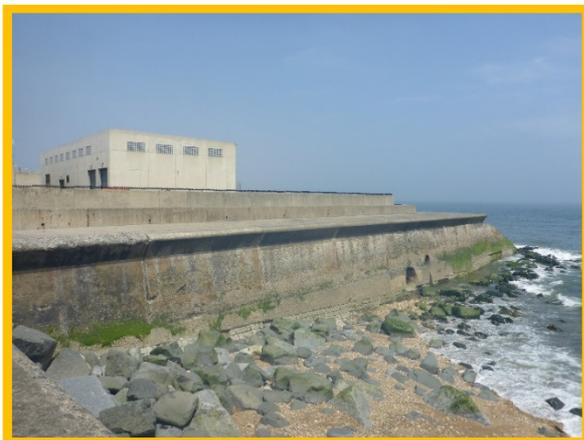
Missing facing masonry requires attention.  
(Asset Ref. No. 121AB901B0802C01)

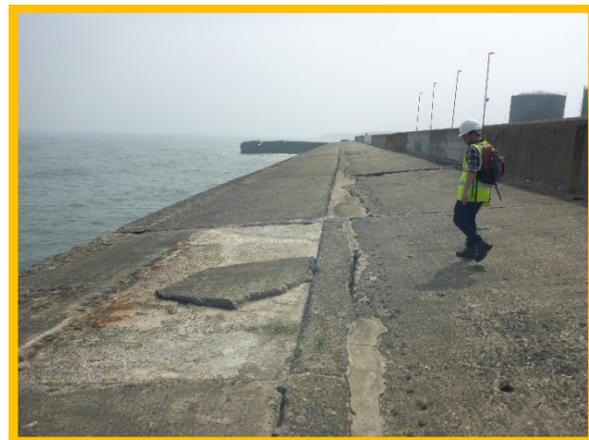
Extensive cracking and spalling of deck slab.  
(Asset Ref. No. 121AB901B0802C01)

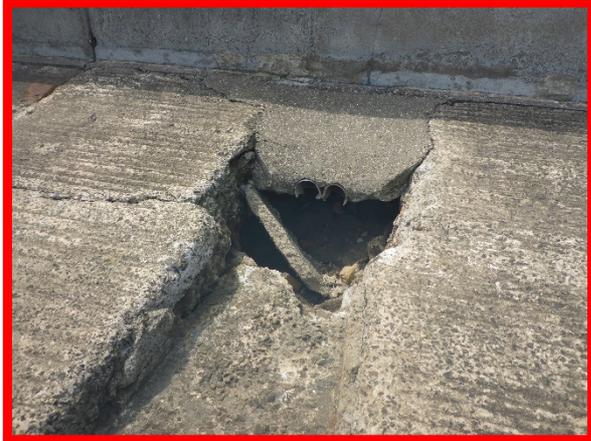
Example of damaged deck slab at outfall drain leading to washout of infill material. (Asset Ref. No. 121AB901B0802C01)

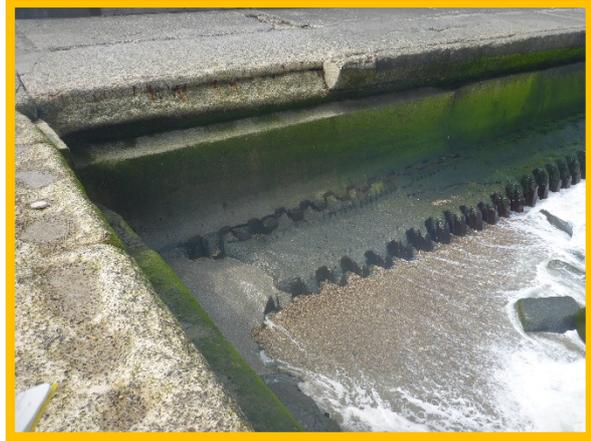
Missing cope beam and corroded / holed sheet pile wall toe. (Asset Ref. 121AB901B0802C01)

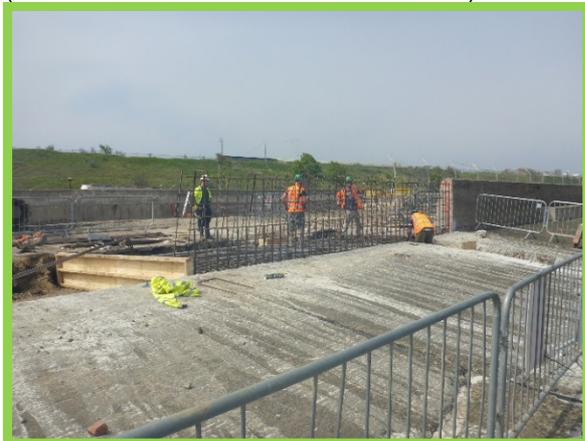
Works ongoing to replace sections of rear wall. (Asset Ref. No. 121AB901B0802C01)

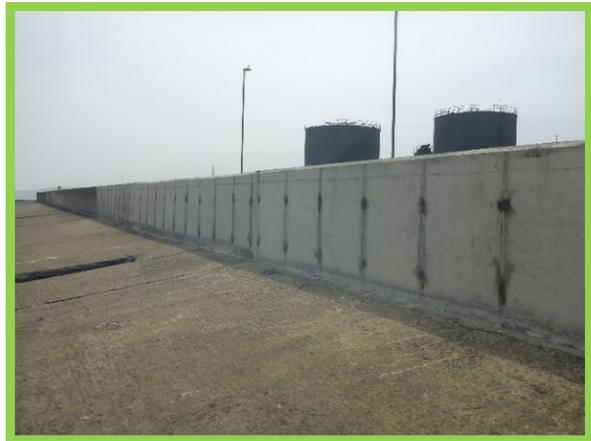
Sections of recently replaced rear wall. (Asset Ref. No. 121AB901B0802C01)

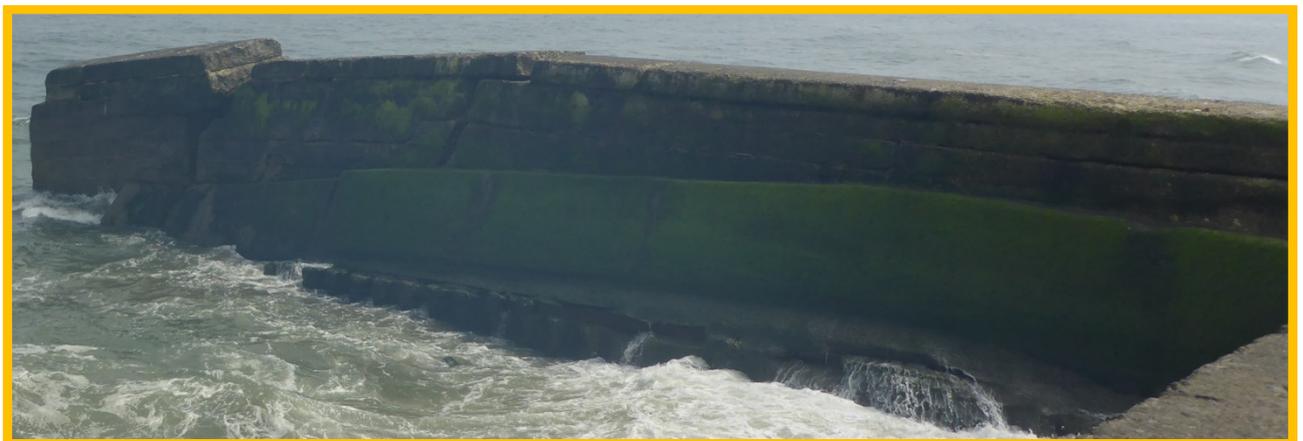
Breakwater with nose detached, from north side. (Asset Ref. No. 121AB901B0803C02.)

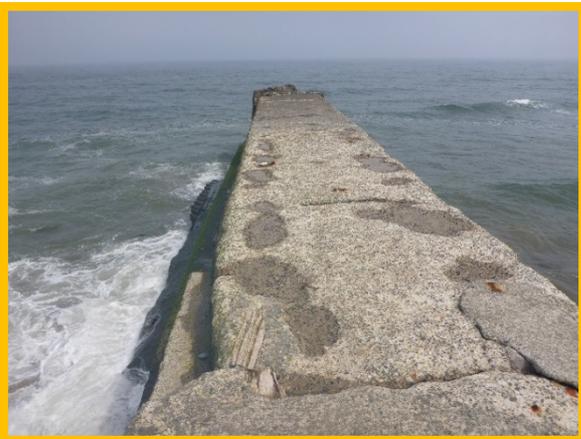
Spalled deck surface of breakwater.  
(Asset Ref. No. 121AB901B0803C02)

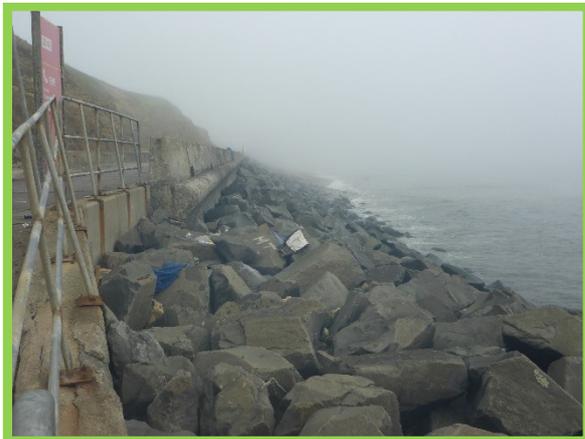
Rock armour generally in good condition.  
(Asset Ref. No. 121AB901B0803C02)

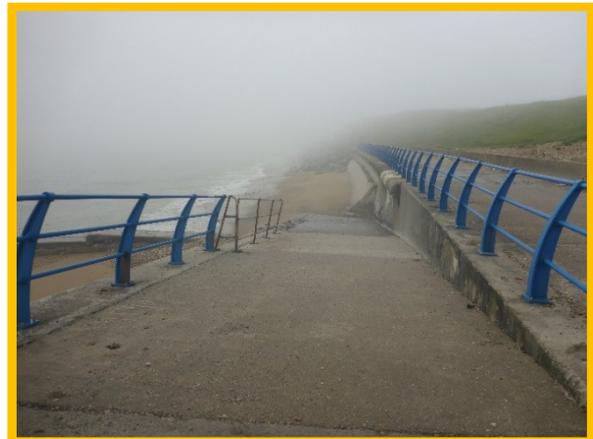
Failed railings at northern end.  
(Asset Ref. No. 121AB901B0803C02)

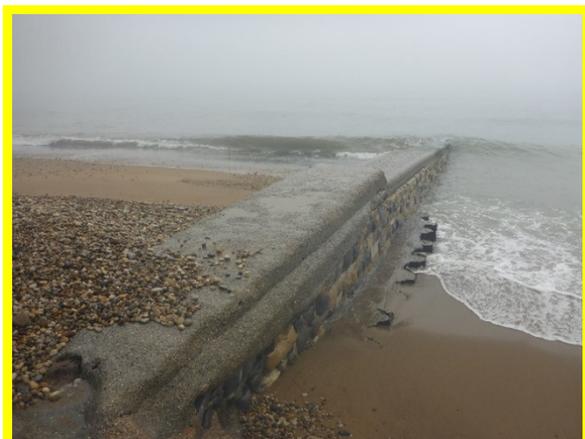
Shingle accumulated at landward end of groyne, approx. 1m height.  
(Asset Ref. No. 121AB901B0803C02)

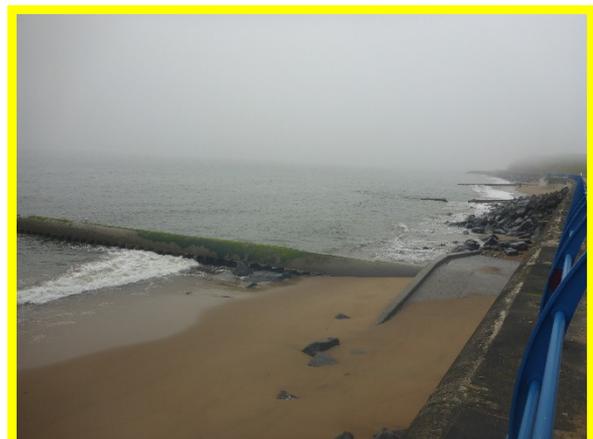
Concrete sewage outflow pipe in fair condition, heavily corroded / abraded at pile head.  
(Asset Ref. No. 121AB901B0803C02)

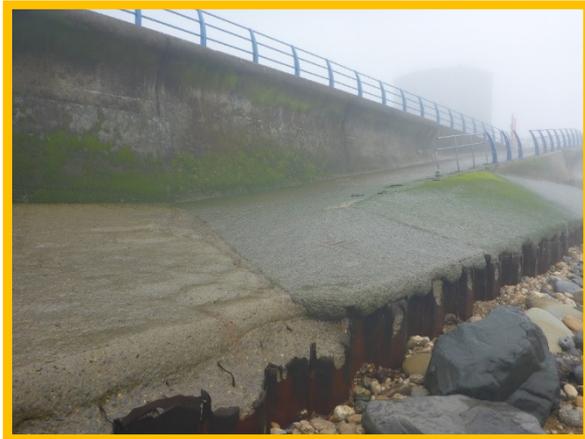
Heavily abraded and corroded steel toe piling.  
(Asset Ref. No. 121AB901B0803C02)

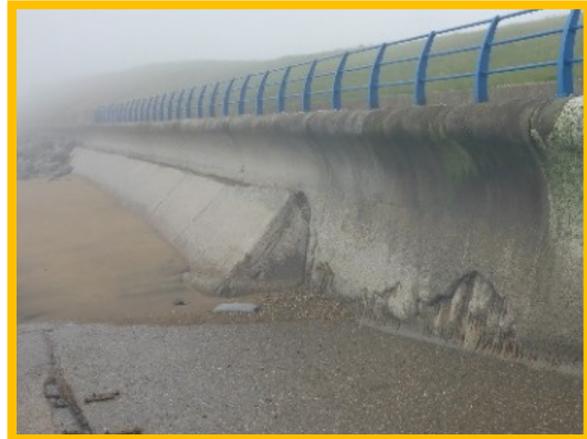
Seawall abraded exposing reinforcement.  
(Asset Ref. No. 121AB901B0803C02)

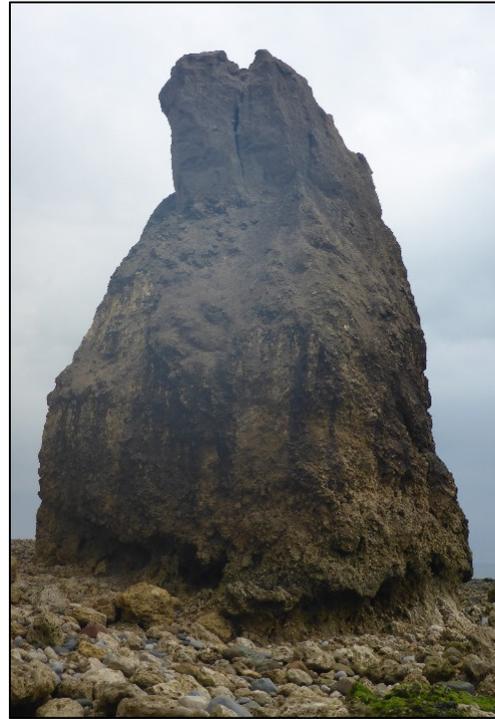
Sea stack at Pincushion  
(Asset Ref. No. 121AB901B0804C02)

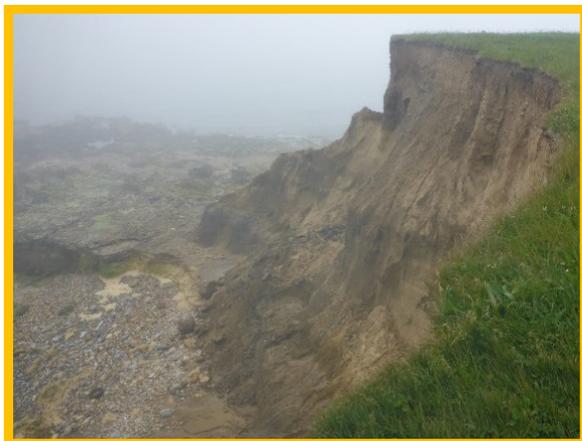
Recent slumping at Salterfen Rocks  
(Asset Ref. No. 121AB901B0804C03)

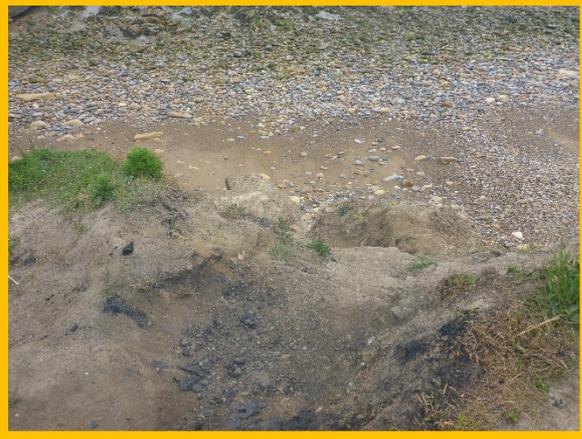
Erosion to steps at Ryhope Nook  
(Asset Ref. No. 121AB901B0804C03)

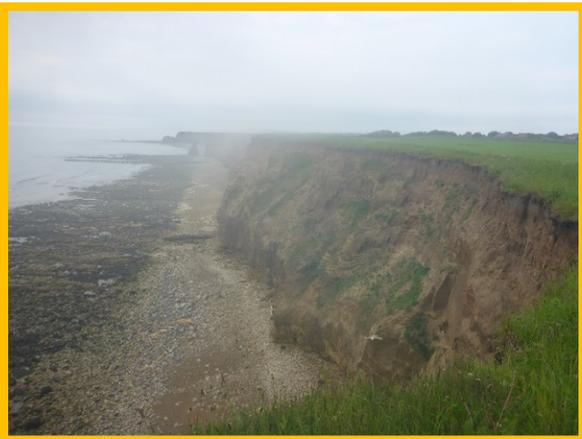
Looking south towards sea stack at Ryhope Dene (Asset Ref. No. 121AB901B0804C02)

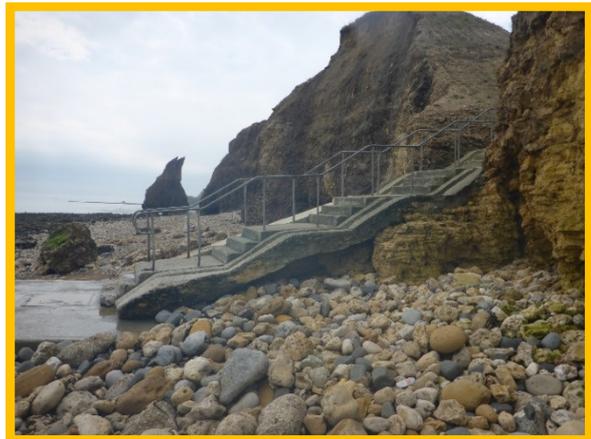
Access steps at Ryhope Village Dene in fair condition, although locally undercut.  
(Asset Ref. No. 121AB901B0804C02)

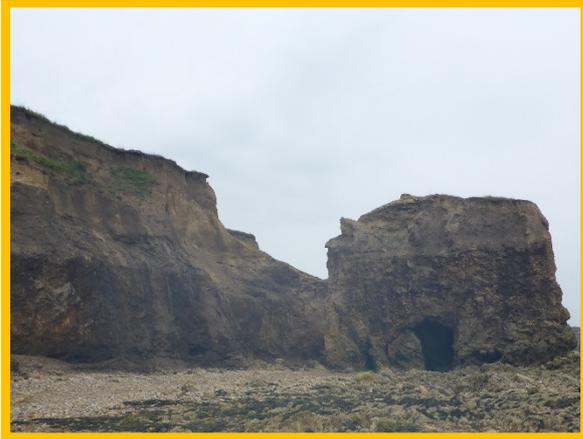
Slumping and seepage near sea stack at Pincushion (Asset Ref. 121AB901B0804C02)
