Cell 1 Regional Coastal Monitoring Programme Walkover Inspection Surveys 2020

Sunderland City Council

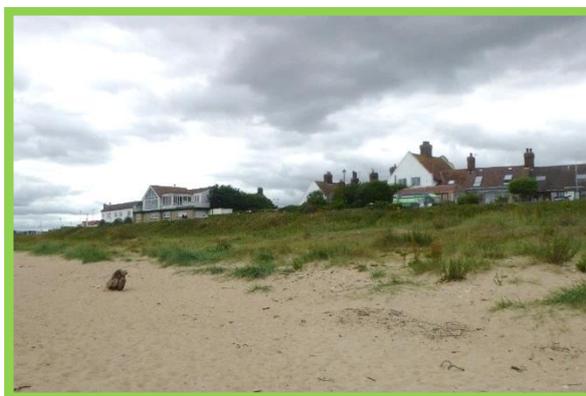
Well vegetated slope, embryonic dune growth at toe. (Asset Ref No. 121AB901B0602C01)

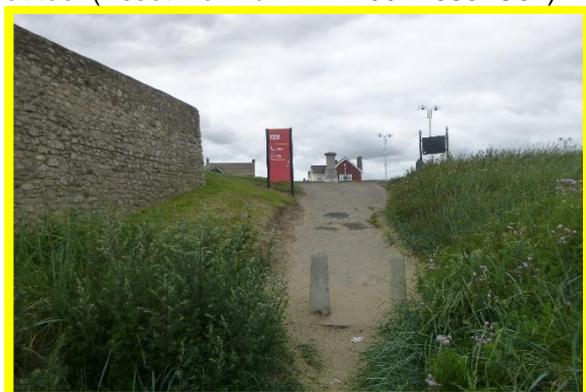
Access ramp at Whitburn Steel, toe undercut during previous inspections. (Asset Ref No. 121AB901B0602C01)

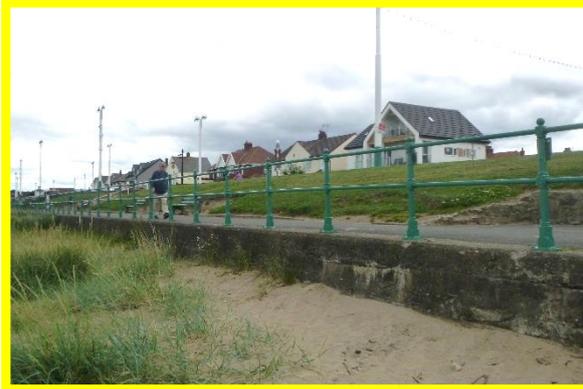
Sandy upper beach surface and dune accretion in front of concrete seawall.
(Asset Ref No. 121AB901B0603C01)

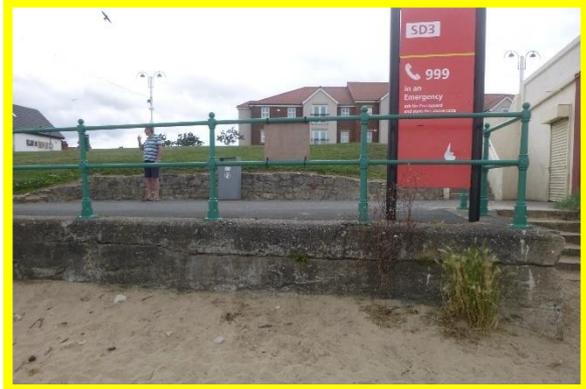
Spalled/damaged concrete cope and facing
(Asset Ref No. 121AB901B0603C01)

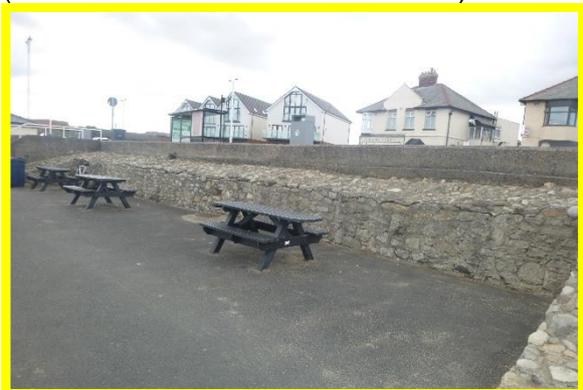
Cracked rear revetment at picnic area
(Asset Ref No. 121AB901B0603C01)

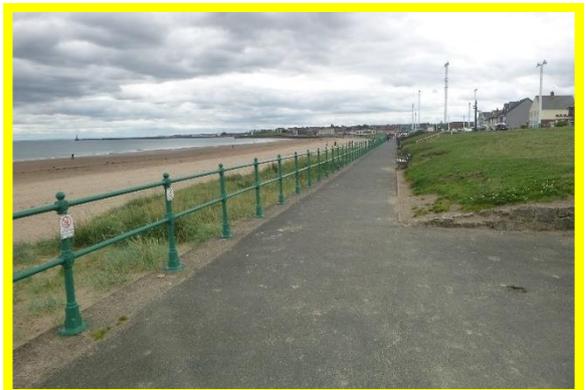
Asphalt surface appears in good condition,
erosion to rear embankment
(Asset Ref No. 121AB901B0603C01)

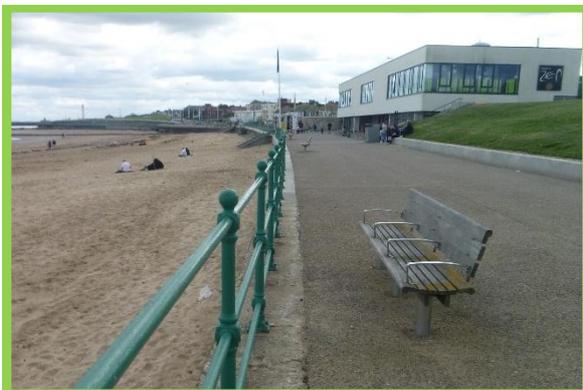
Exposed aggregate concrete surfacing on
promenade behind seawall at southern end.
(Asset Ref No. 121AB901B0603C01)

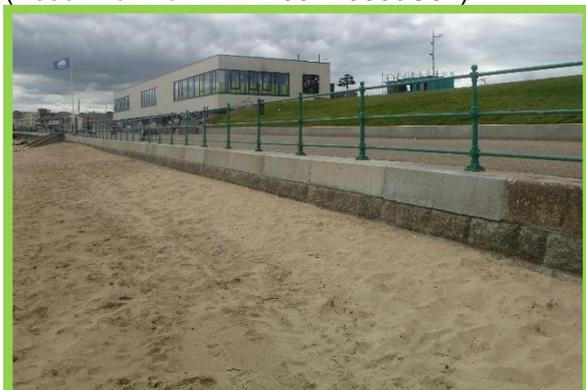
Repaired section of coping blocks.
(Asset Ref No. 121AB901B0603C01)

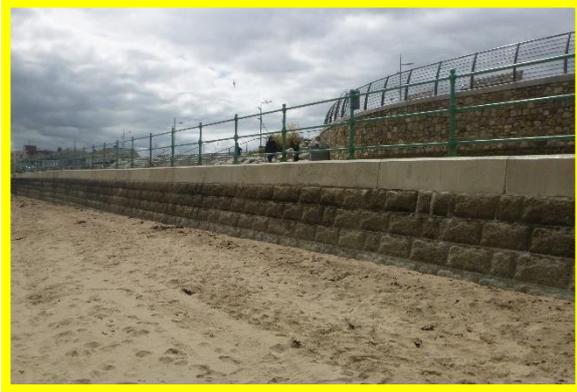
Repaired concrete coping above masonry seawall.
(Asset Ref No. 121AB901B0603C02)

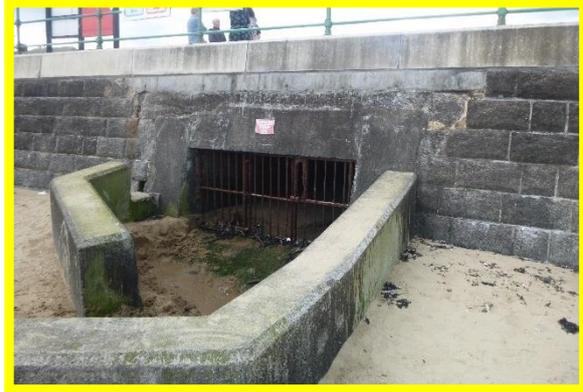
Repaired concrete coping above outfall structure.
(Asset Ref No. 121AB901B0603C02)

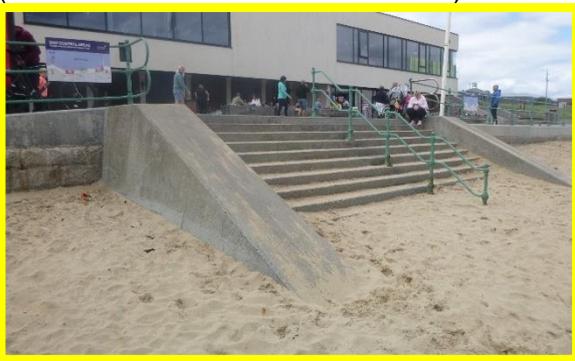
Beach level at steps adjacent Fat Buddha restaurant approx. 1m higher than 2018, previously undercut.
(Asset Ref No. 121AB901B0603C02)

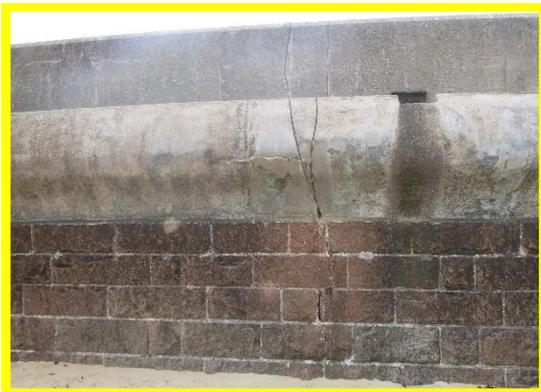
Cracking in seaward side of crest wall
(Asset Ref. No. 121AB901B0603C03)

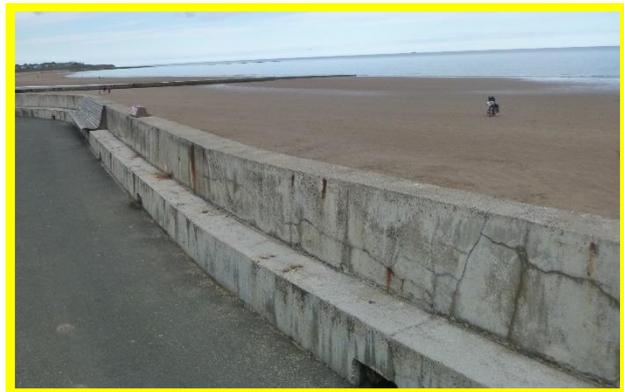
Rust staining at fixings from previous seats, cracking in crest wall.
(Asset Ref. No. 121AB901B0603C03)

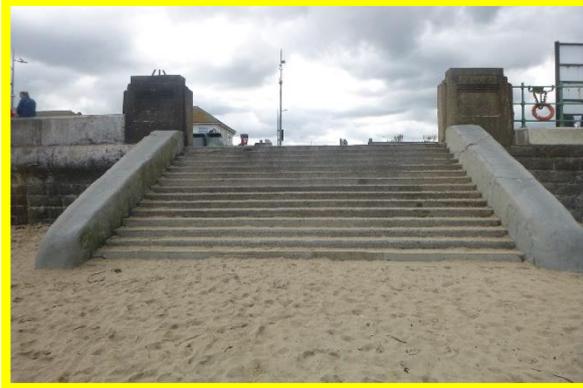
Access steps at Dykeland Road roundabout, beach covering heavily abraded lower steps (Asset Ref. No. 121AB901B0603C03)

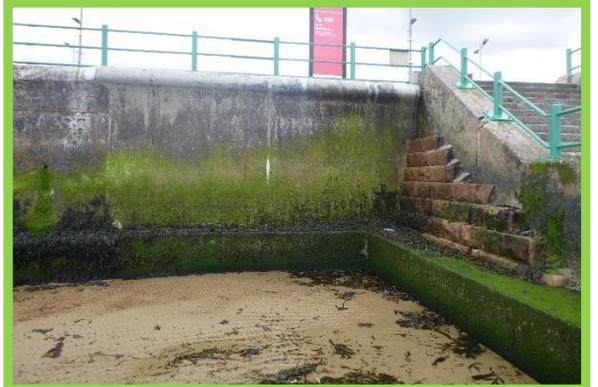
Recently constructed seawall infill section adjacent to steps at Seaburn Terrace (Asset Ref. No. 121AB901B0603C03)

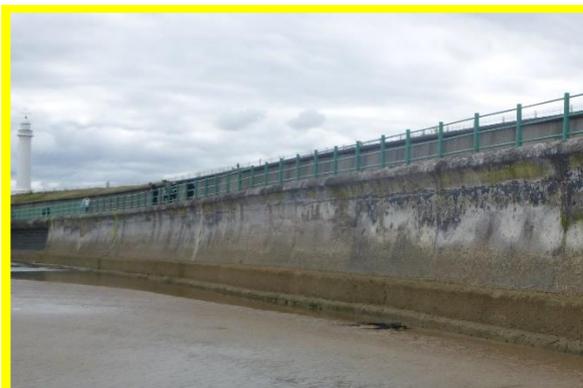
Beach levels higher than 2018, spalling damage at crest. (Asset Ref. No. 121AB901B0604C01)

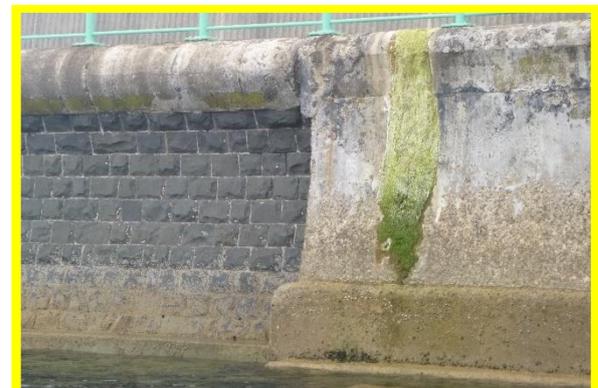
Damaged section of coping and chloride staining (Asset Ref. No. 121AB901B0604C01)

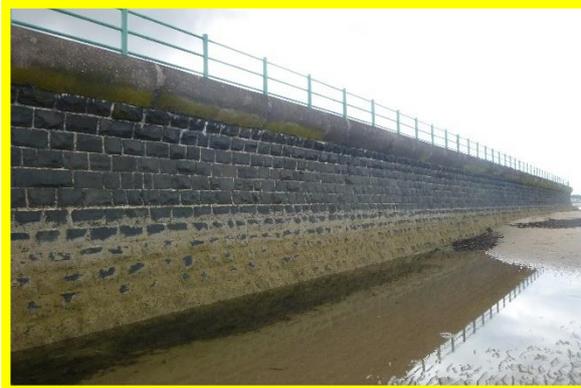
View northwards from Parsons Rocks, seawall in fair condition.
(Asset Ref. No. 121AB901B0604C02)

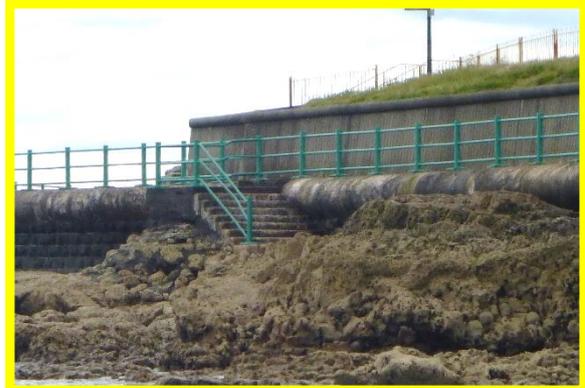
Eroded natural rock at access steps to Parsons Rocks (access to steps blocked by handrail).
(Asset Ref. No. 121AB901B0604C02)

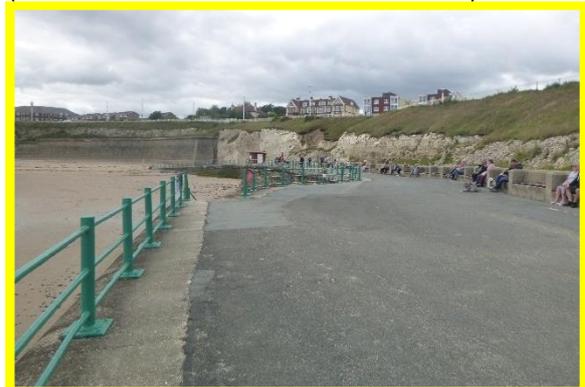
Asphalt surface replaced locally at promenade
(Asset Ref. No. 121AB901B0604C02)

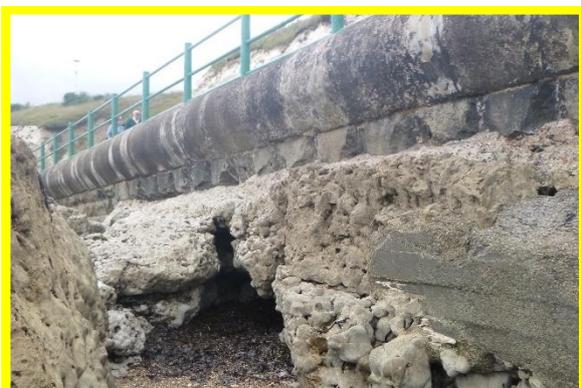
Eroded limestone outcrop void beneath promenade at south of Parsons Rocks.
(Asset Ref. No. 121AB901B0604C02)

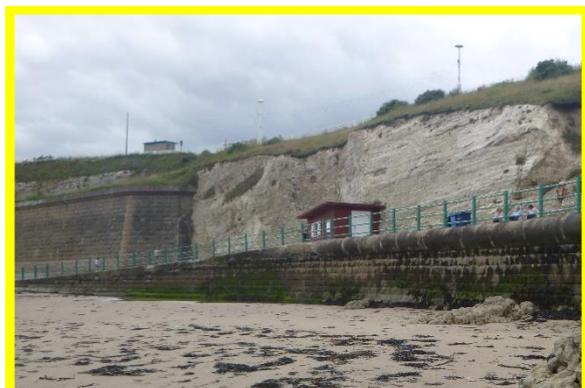
Damage to coping on ramp south of Parsons Rocks. (Asset Ref. No. 121AB901B0604C02)

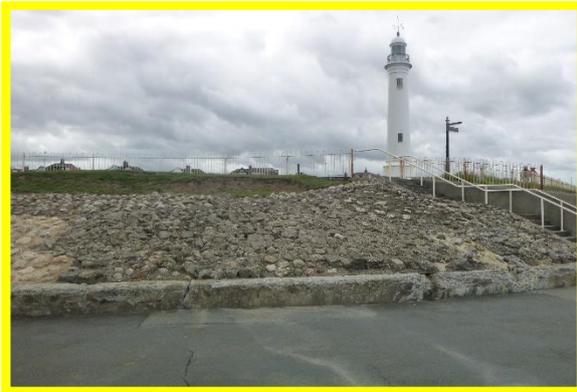
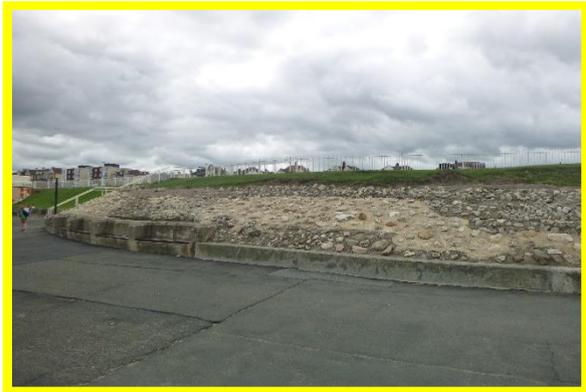
Recently infilled voids in grouted revetment (Asset Ref. No. 121AB901B0604C02)

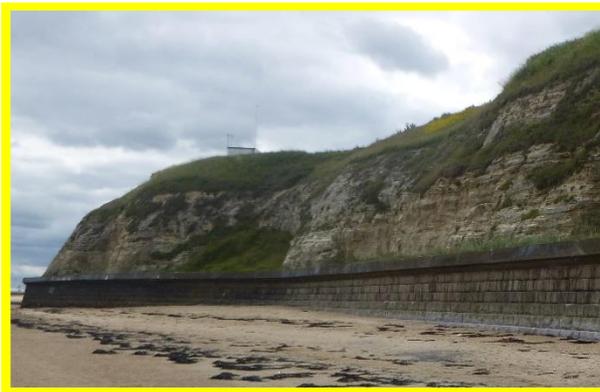
Masonry wall generally in good condition (Asset Ref. No. 121AB901B0605C01)

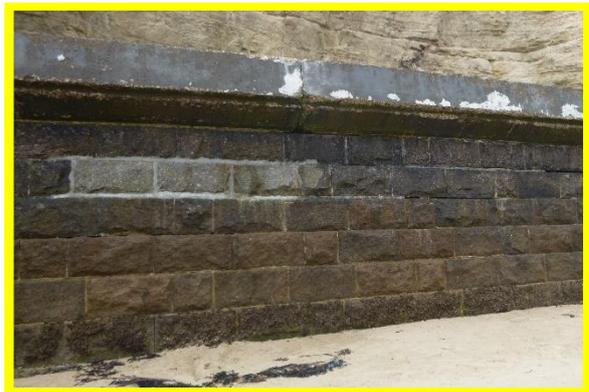
Area of missing blocks repaired since 2018, part of longitudinal crack remains. (Asset Ref. No. 121AB901B0605C01)

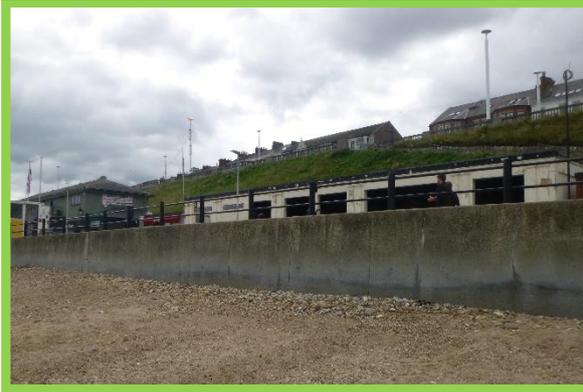
Low concrete encased wall at Marine Walk in fair to good condition.
(Asset Ref. No. 121AB901B0605C02)

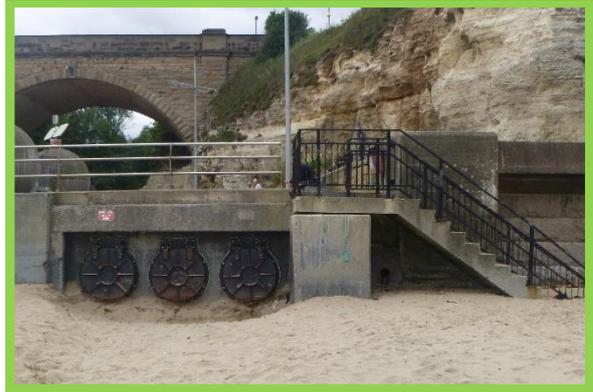
Outfall pipes at north end of Marine Walk.
(Asset Ref. No. 121AB901B0605C02)

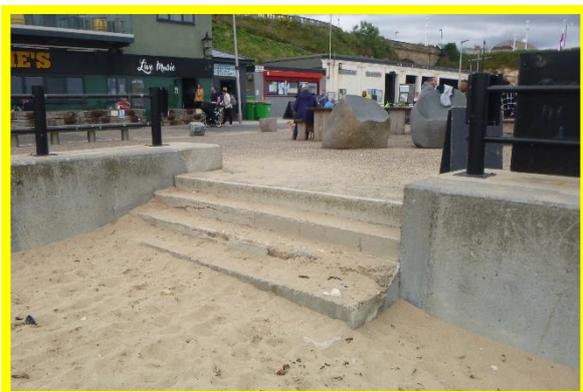
Damaged concrete access steps needing repair. (Asset Ref. No. 121AB901B0605C02)

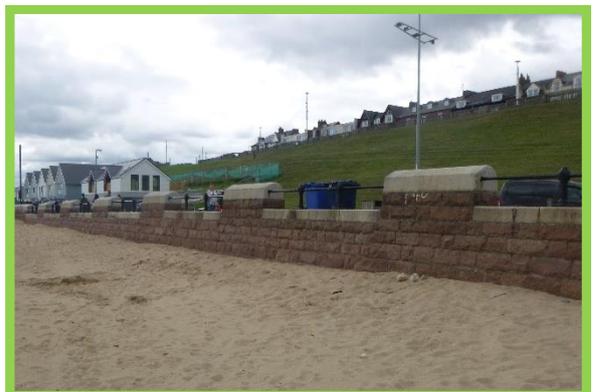
Southern section of masonry wall protected by wide beach in good overall condition.
(Asset Ref. No. 121AB901B0605C02)

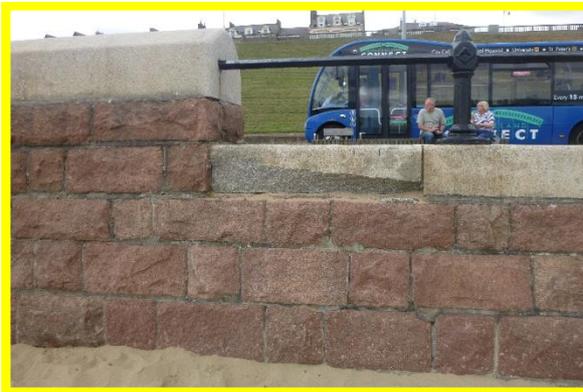
Damage to coping stone, similar to 2016.
(Asset Ref. No. 121AB901B0605C02)

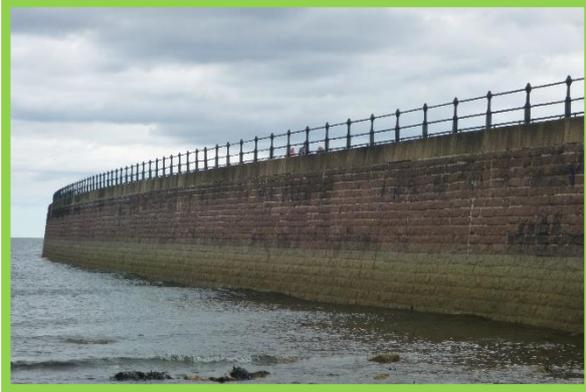
Northern (outer) face of pier
(Asset Ref. No. 121AB901B0702C04)

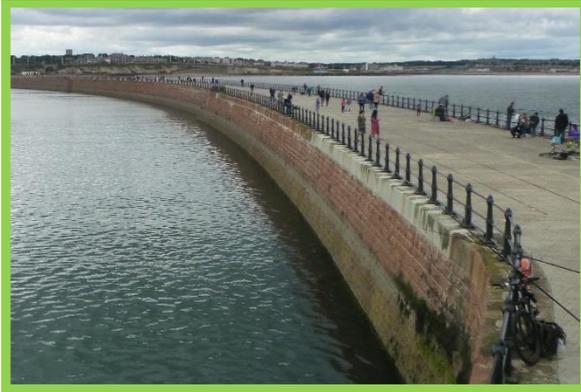
Recently replaced handrail and coping blocks.
(Asset Ref. No. 121AB901B0702C04)

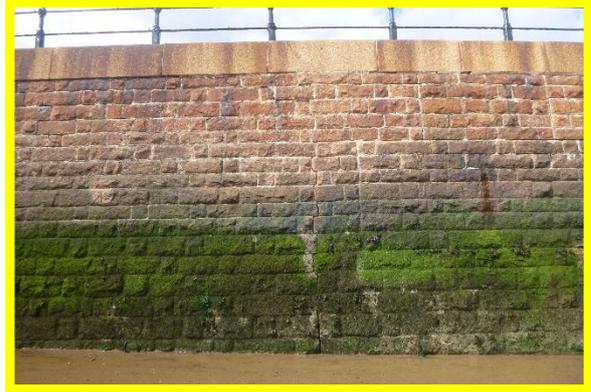
Roker Pier northern (inner) face, vertical cracks and open joints at toe
(Asset Ref. No. 121AB901B0702C04)

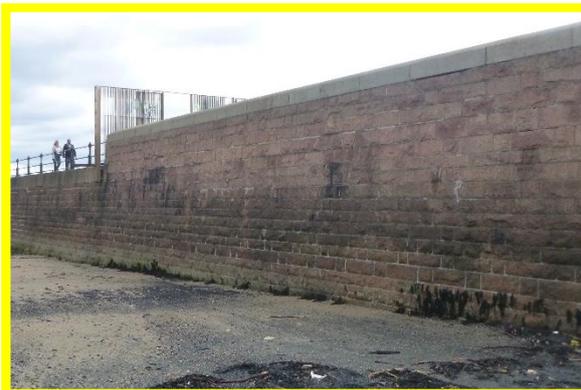
View on northern side of masonry wall at root of pier – localised abrasion and mortar loss.
(Asset Ref. No. 121AB901B0702C05)

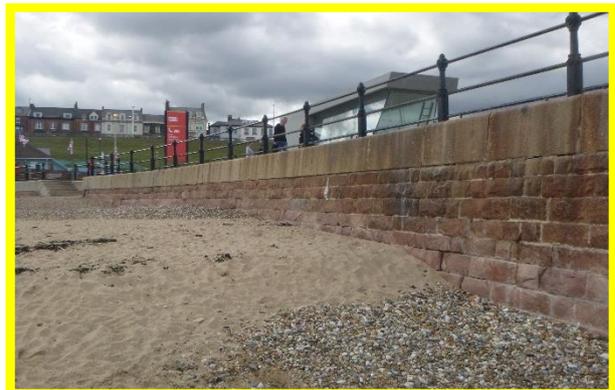
Masonry splash wall at southern root of pier – sections of damaged coping and weathered masonry.
(Asset Ref. No. 121AB901B0702C05)

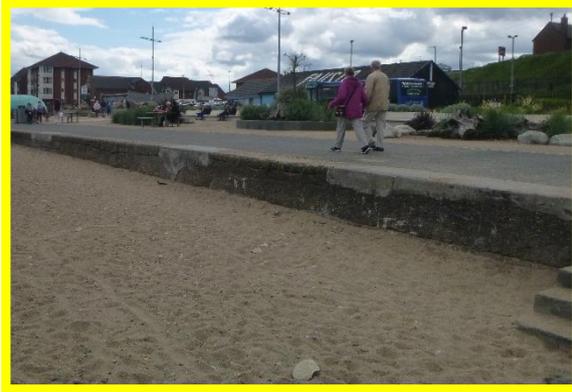
Patch repairs and horizontal cracks in concrete wall. (Asset Ref. No. 121AB901B0702C01)

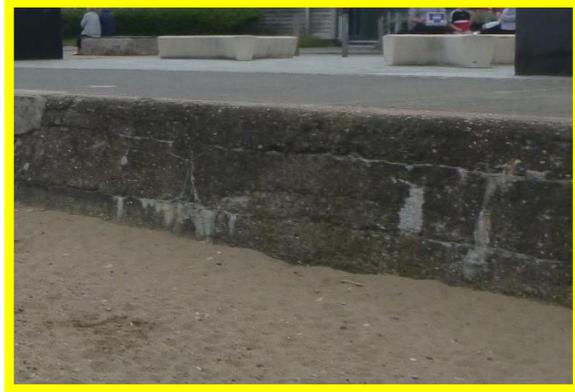
Example of spalling between horizontal cracking (Asset Ref. No. 121AB901B0702C01)

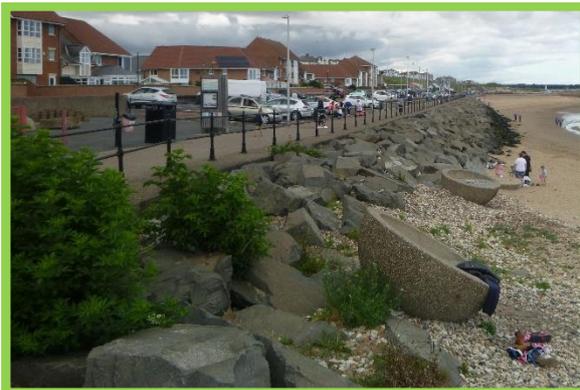
Rock armour and promenade crest, vegetation growth. (Asset Ref. No. 121AB901B0702C02)

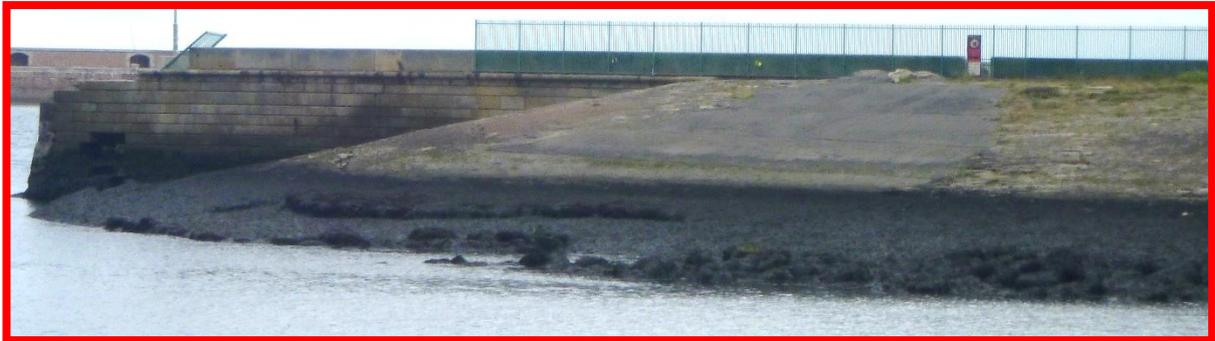
Northern face of Old North Pier, voids at toe (Asset Ref. No. 121AB901B0702C03)

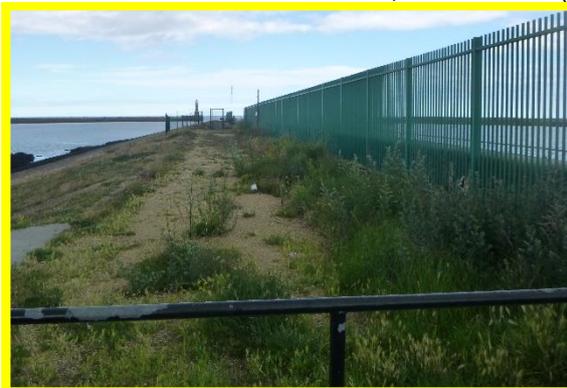
Vegetation growth on haulage path built for delivery of rock repairs.
(Asset Ref. No. 121AB901B0702C03)

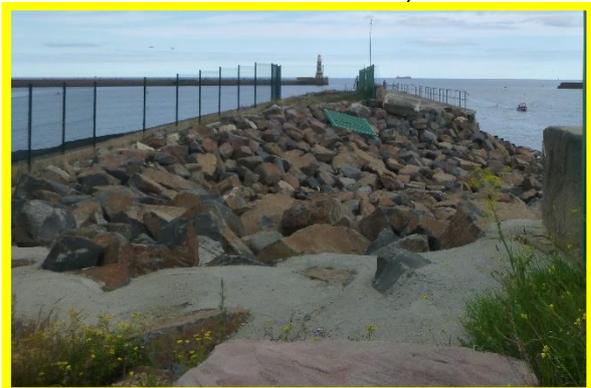
Former breach infilled with rock armour and grout. (Asset Ref. No. 121AB901B0702C03)

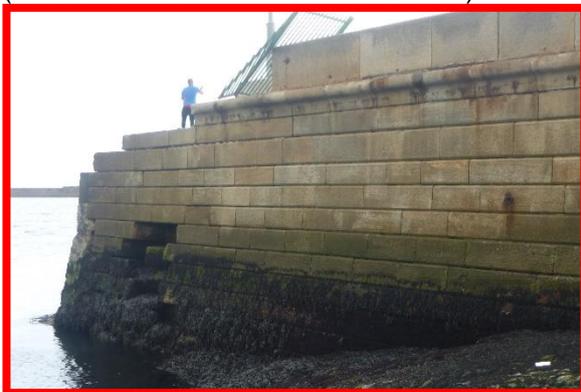
Further missing blocks at seaward end since 2018. (Asset Ref. No. 121AB901B0702C03)

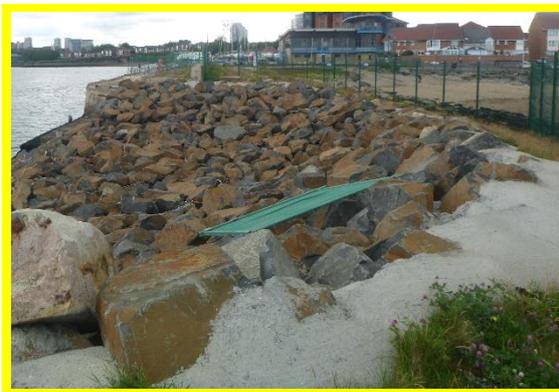
Fencing detached locally enabling access by public to unsafe structure.
(Asset Ref. No. 121AB901B0702C03)

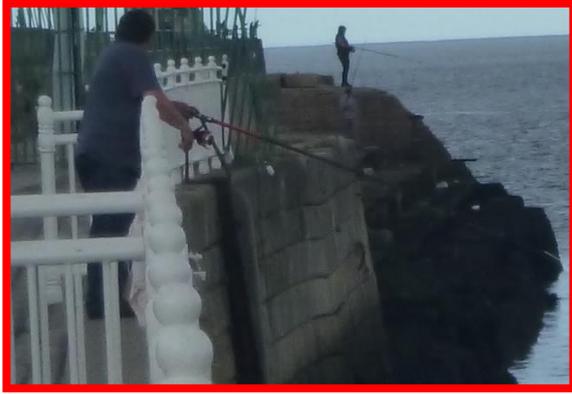
Collapsing masonry on southern face
(Asset Ref. No. 121AB901B0702C03)

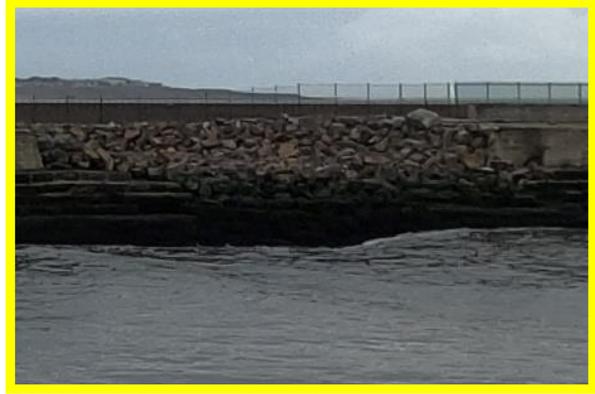
Old North Pier southern face
(Asset Ref. No. 121AB901B0702C03)

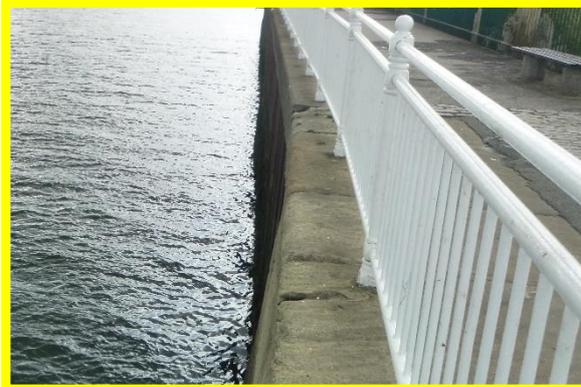
Damage to concrete coping at “Rat House Corner”. (Asset Ref. No. 121AB901B0702C03)

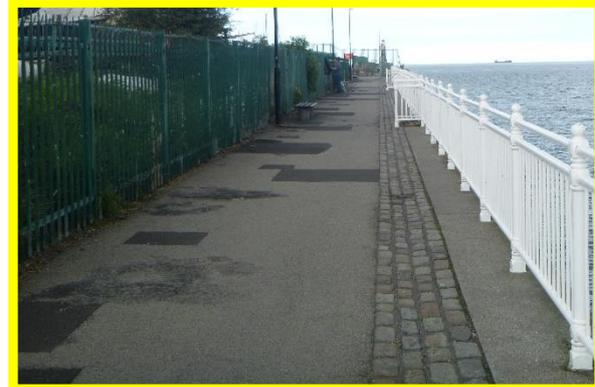
Promenade at “Rat House Corner” in fair condition (Asset Ref. 121AB901B0702C03)

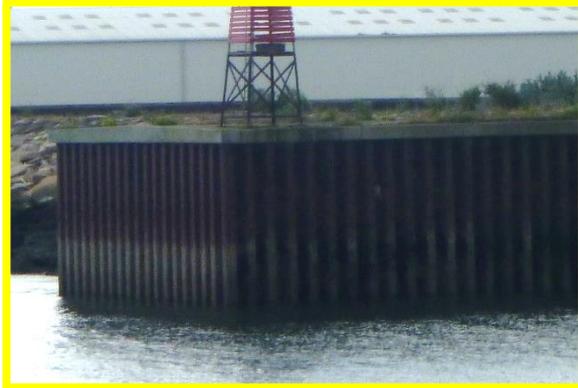
View on sheet pile river navigation wall, noted previously with staining indicating microbial induced corrosion (MIC) reducing structural capacity (Asset Ref. No. 121AB901BO703C03)

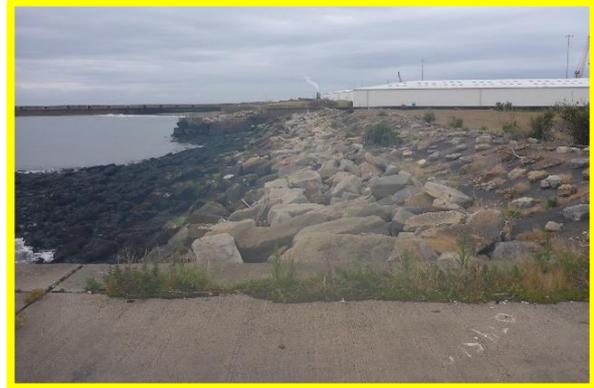
View of rock revetment from north showing loosely placed armour (Asset Ref. No. 121AB901BO703C03)

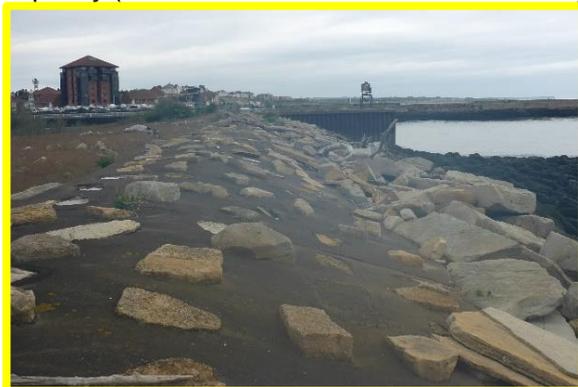
View of revetment crest from south. (Asset Ref. No. 121AB901BO703C03)

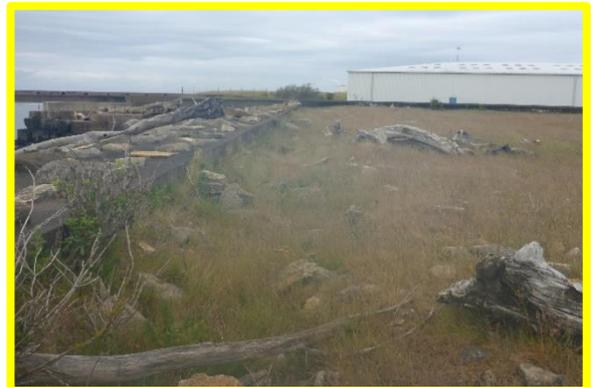
Low spot on landward side of concrete crest and overtopping/rock debris (Asset Ref. No. 121AB901BO703C03)

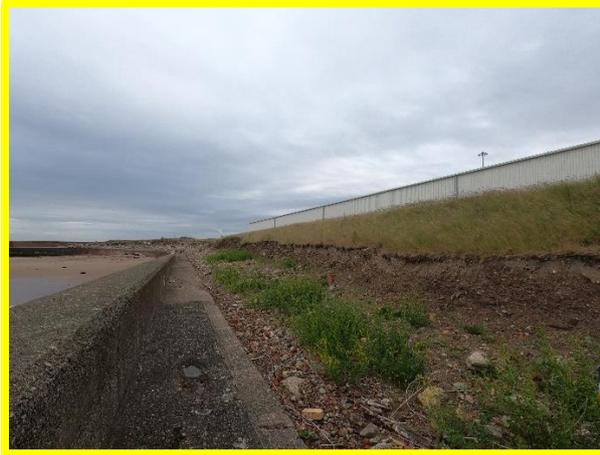
Extensive crest and rear embankment damage due to wave overtopping.
(Asset Ref. No. 121AB901BO703C02)

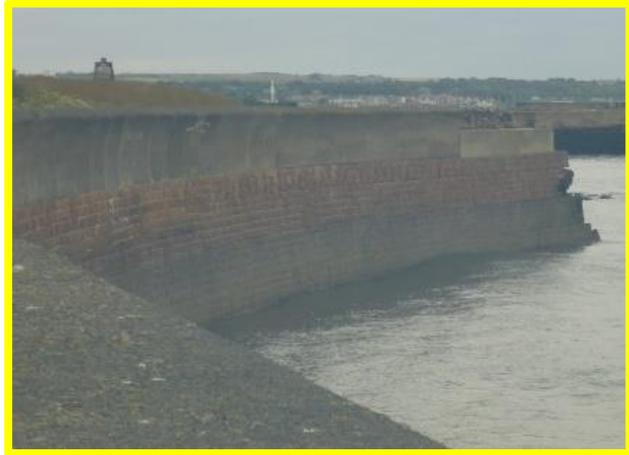
Masonry wall in fair condition except for missing blocks at North end.
(Asset Ref. No. 121AB901BO703C02)

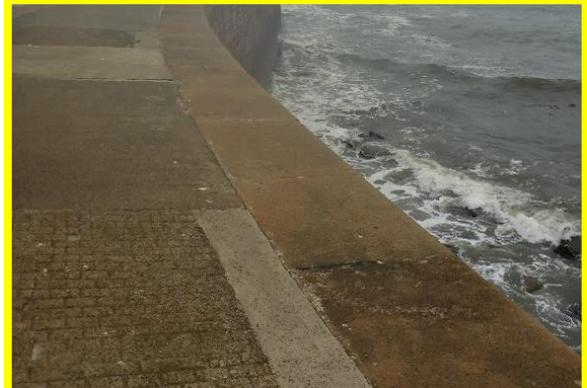
Local repairs to upper deck from root of pier. (Asset Ref. No. 121AB901B0703C01)

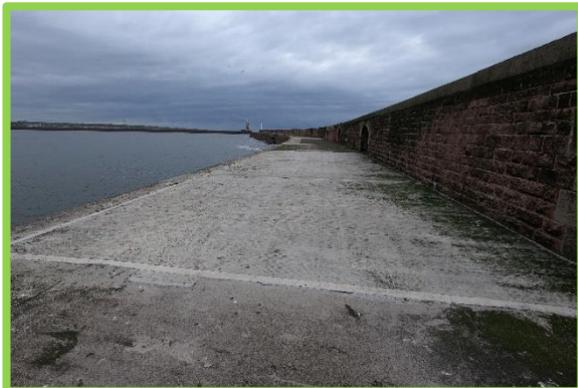
Recently repaired lower deck and cope blocks. (Asset Ref. No. 121AB901B0703C01)

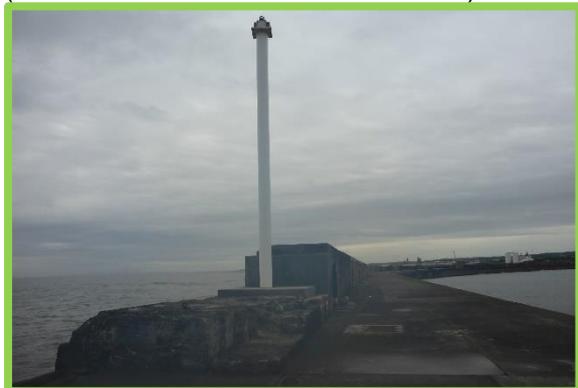
Recently installed navigation light column. (Asset Ref. No. 121AB901B0703C01)

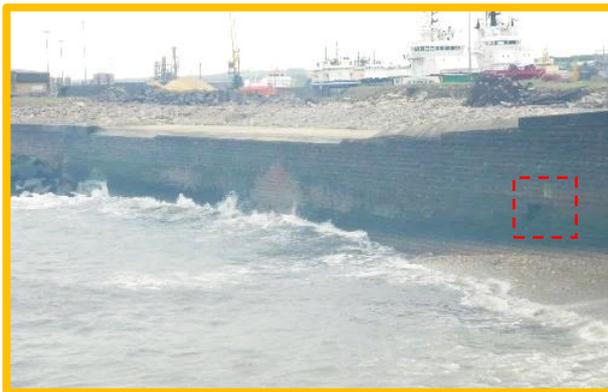
Localised missing blocks and open joint, similar to 2018. (Asset Ref. No. B901B0801C03)

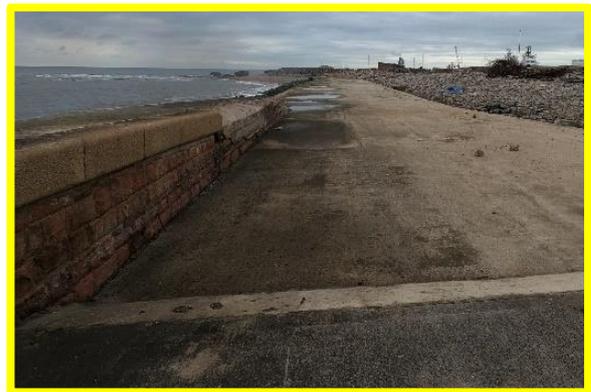
Deck slab repaired with concrete infill. (Asset Ref. No. B901B0801C03)

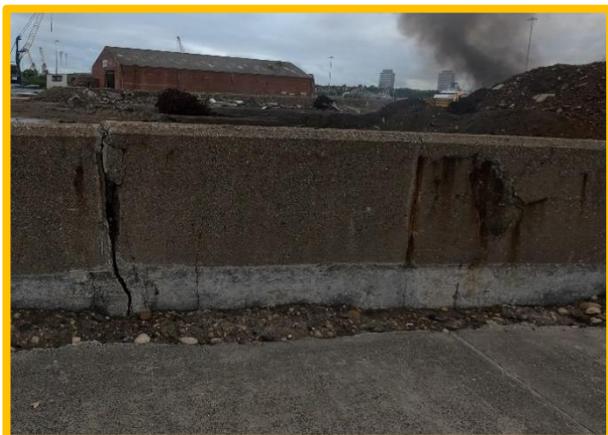
Open joints and corrosion spalling to rear splash wall. (Asset Ref. No. B901B0801C03)

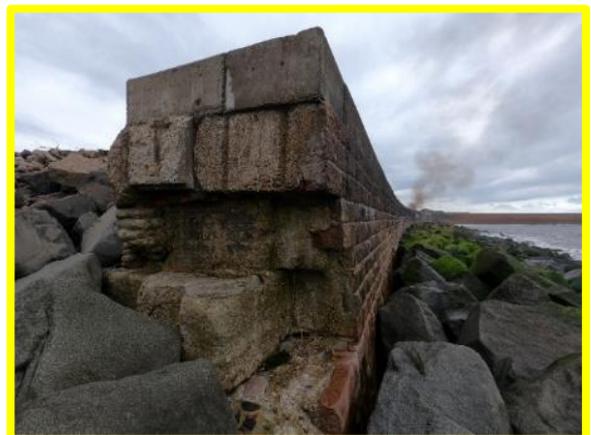
Missing blocks and open joints at toe of masonry wall. (Asset Ref. No. B901B0801C03)

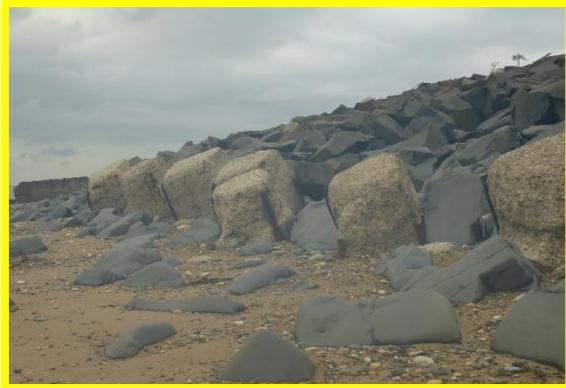
Rock/rubble revetment north of derelict groyne.
(Asset Ref. No.121AB901B0801C02)

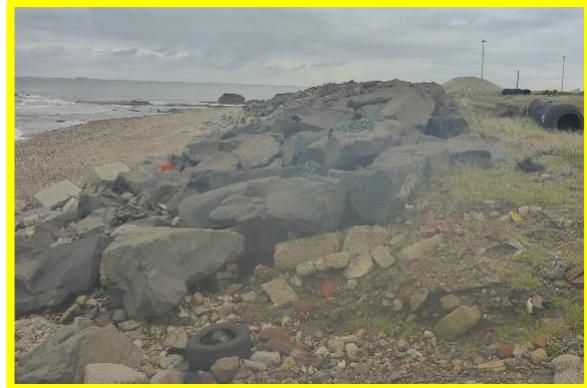
Uneven crest level of revetment.
(Asset Ref. No.121AB901B0801C02)

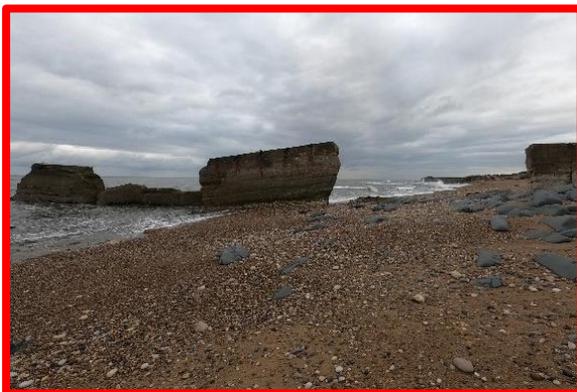
Derelict concrete groyne from north.
(Asset Ref. No. 121AB901B0801C01)

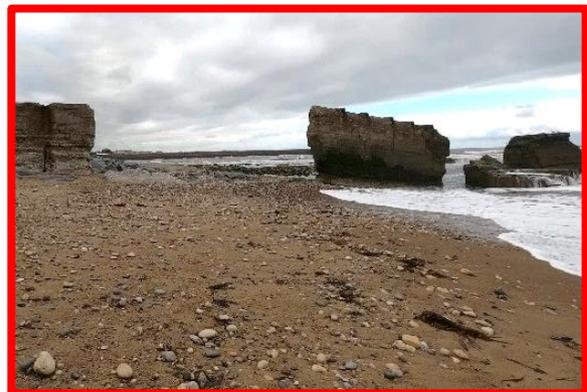
Derelict concrete groyne from south.
(Asset Ref. No. 121AB901B0801C01)

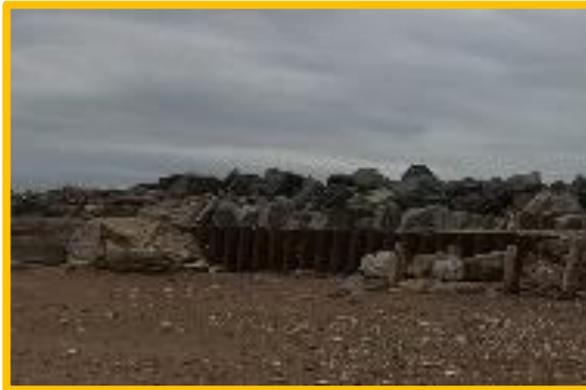
Derelict former defence structures with stacked bund of rock armour at crest.
(Asset Ref. 121AB901B0801C05)

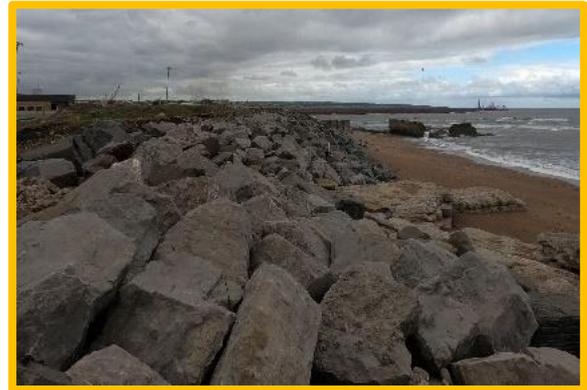
Rock armour at crest of derelict former defence structures. (Asset Ref. No. 121AB901B0801C05)

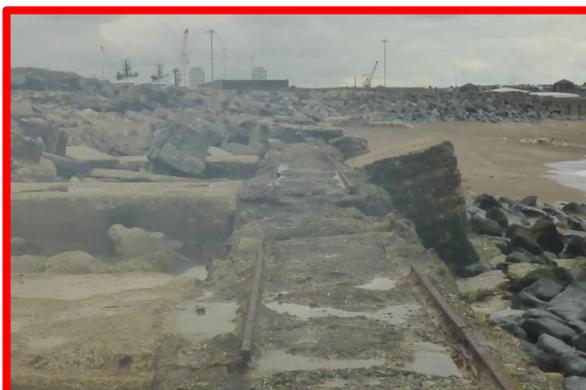
Buttress detached from main structure
(Asset Ref. No. 121B901B0801C07)

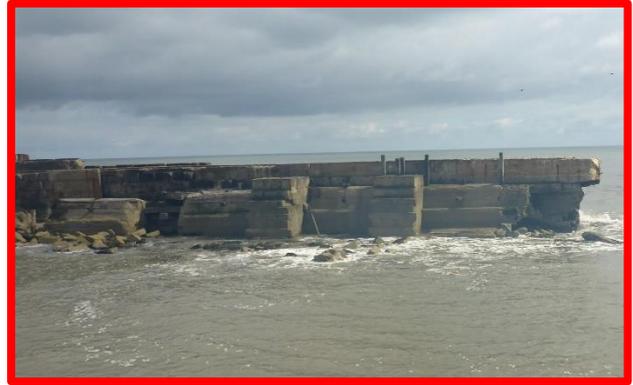
North East Pier viewed from south.
(Asset Ref. No. 121B901B0801C04)

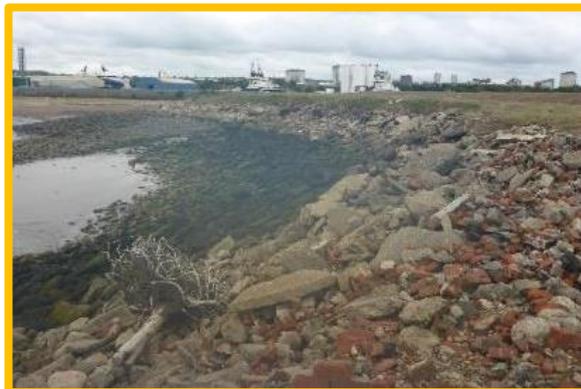
Tipped rubble at northern end of South Outlet basin. (Asset Ref. No. 121AB901B0801C08)

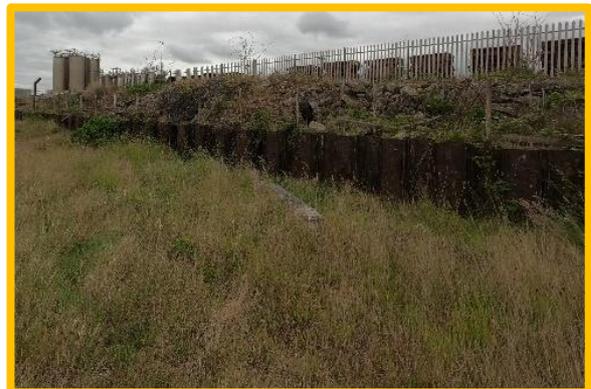
Heavily corroded sheet pile wall
(Asset Ref. No. 121AB901B0802C07).

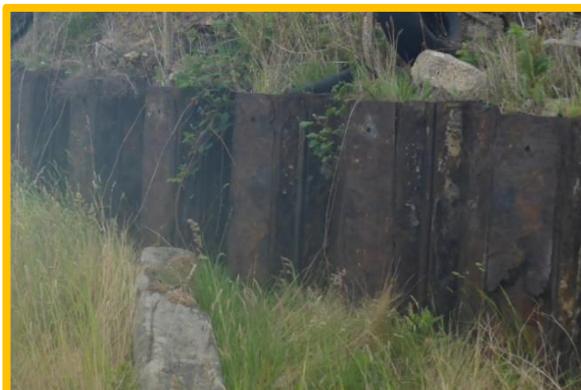
Heavily corroded sheet pile wall
(Asset Ref. No. 121AB901B0802C07).

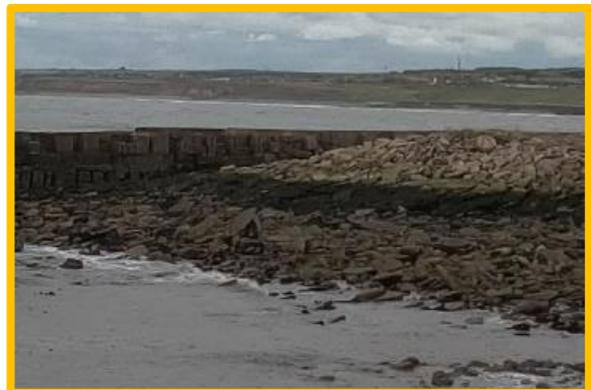
South side of basin taken from northern end of south outlet. (Asset Ref. No.121B901B02C06)

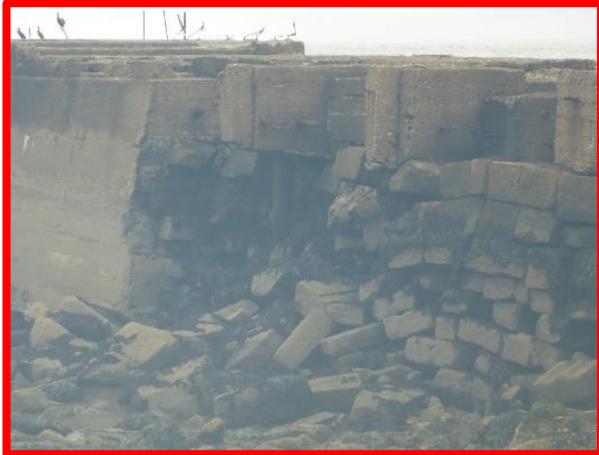
Collapse on landward side of SW Breakwater similar 2018. (Asset Ref. 121AB901B0802C05)

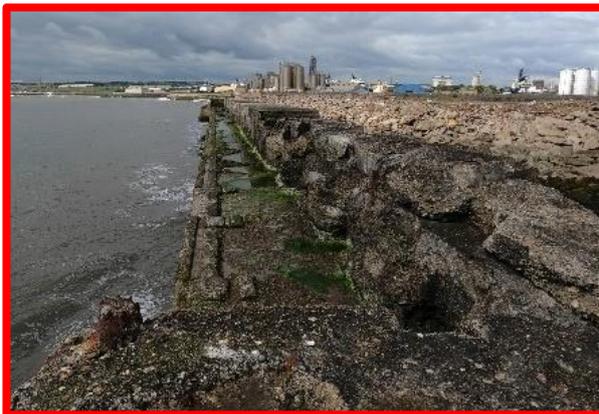
Missing section at seaward side of SW Breakwater. (Asset Ref. 121AB901B0802C05)

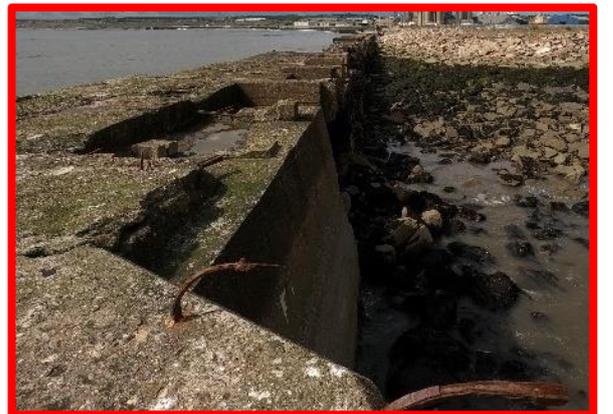
Demolition waste tipped on landward side, damaged blocks. (Asset Ref. 121AB901B0802C05)

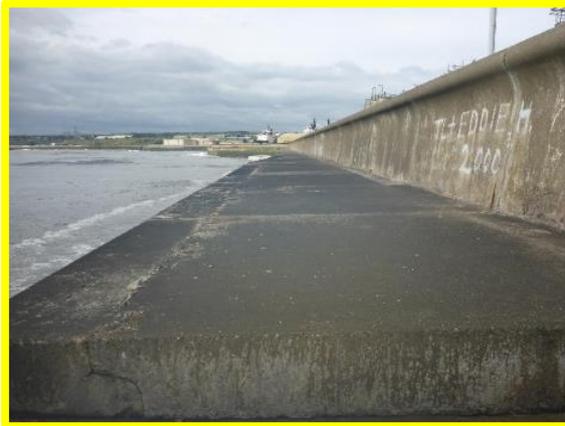
North end of Spur Barrier upper wall.
(Asset Ref. No. 121AB901B0802C04)

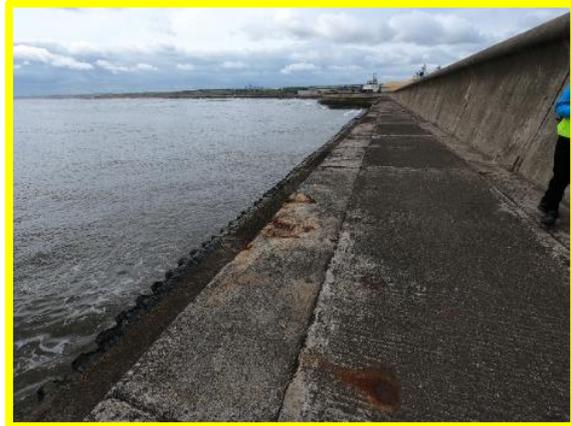
Cracking and spalling of upper sea wall.
(Asset Ref. No. 121AB901B0802C04)

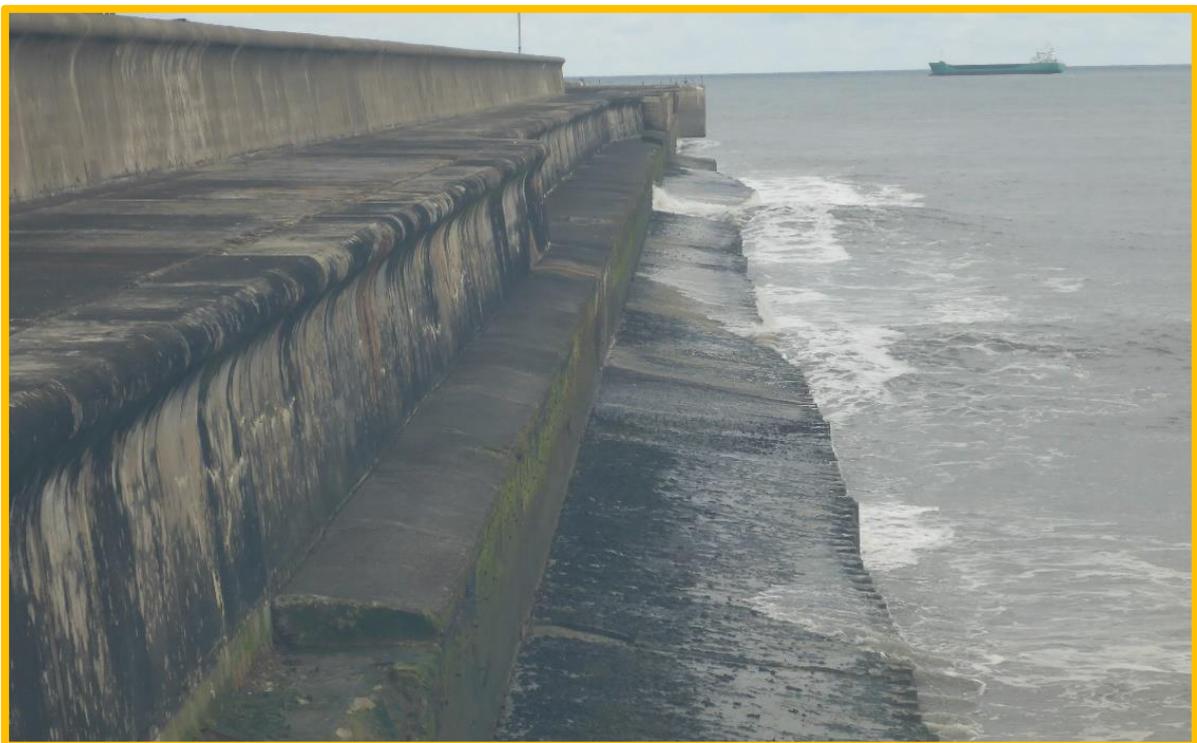
Spalling and localised damage to Spur Barrier wall.
(Asset Ref. No. 121AB901B0802C04)

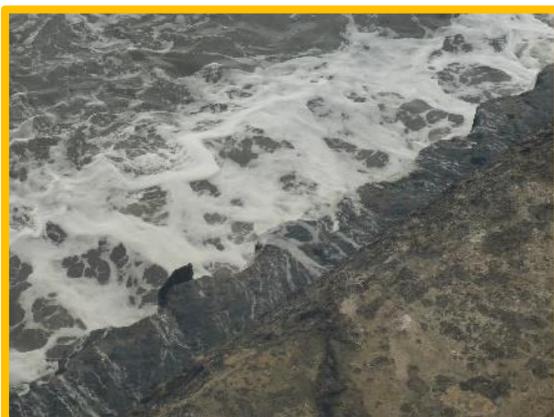
Corroded/abraded sheet pile wall at toe.
(Asset Ref. No. 121AB901B0802C04)

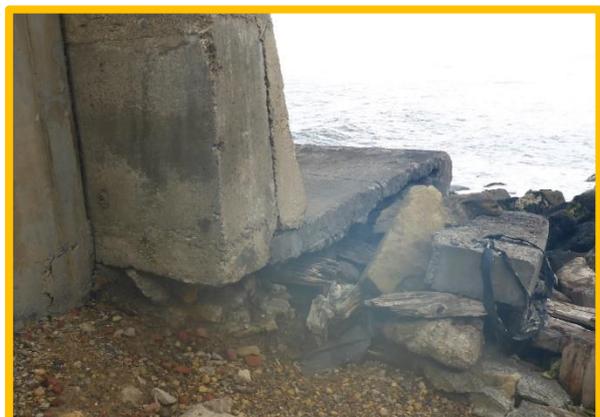
Undermining of upper seawall at south end.
(Asset Ref. No. 121AB901B0802C04)

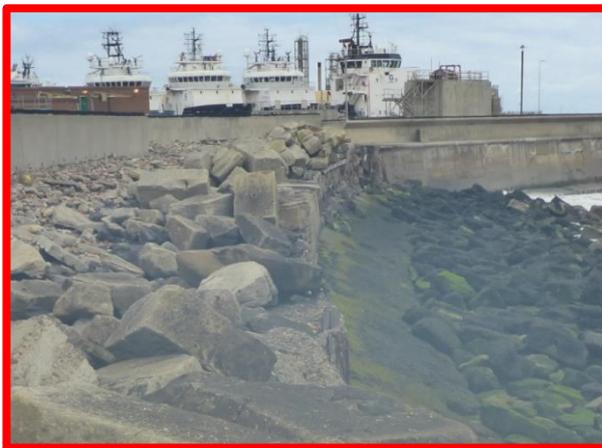
Sea wall in similar condition to 2018.
(Asset Ref. No. 121B901B0802C03)

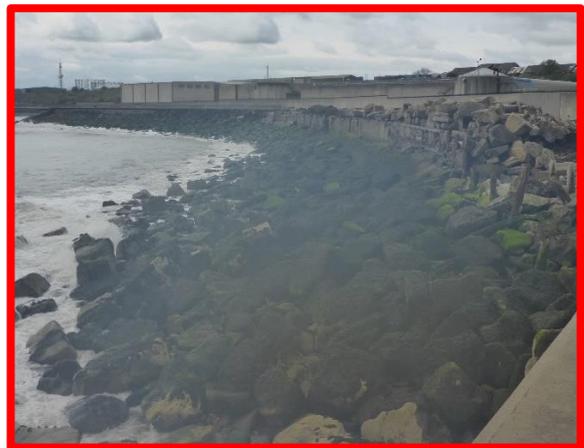
Rock armour in poor condition similar to previous inspections.
(Asset Ref. No. 121B901B0802C03)

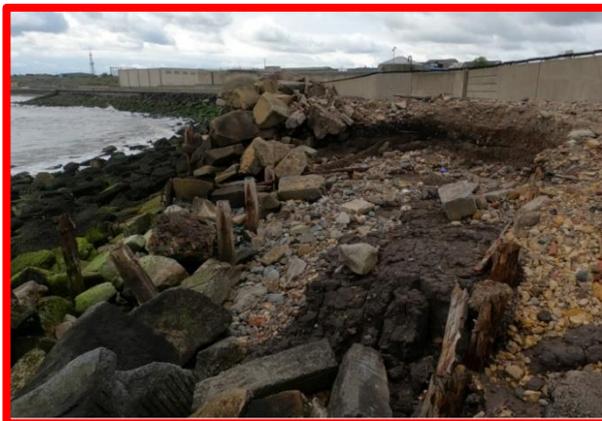
Scour hole at north end following collapse of defences observed in 2018 survey.
(Asset Ref. No. 121B901B0802C03)

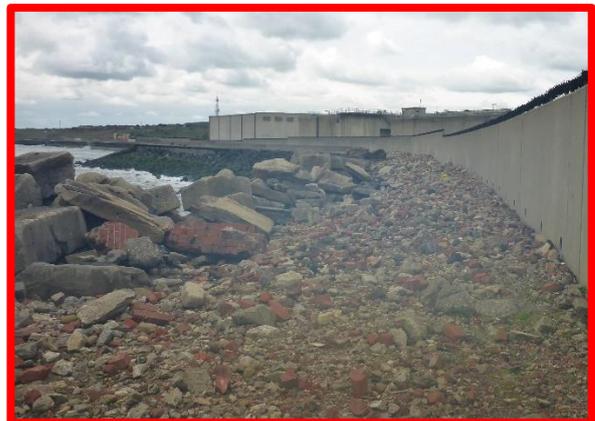
Unprotected crest apron and rear concrete boundary wall.
(Asset Ref. No. 121B901B0802C03)

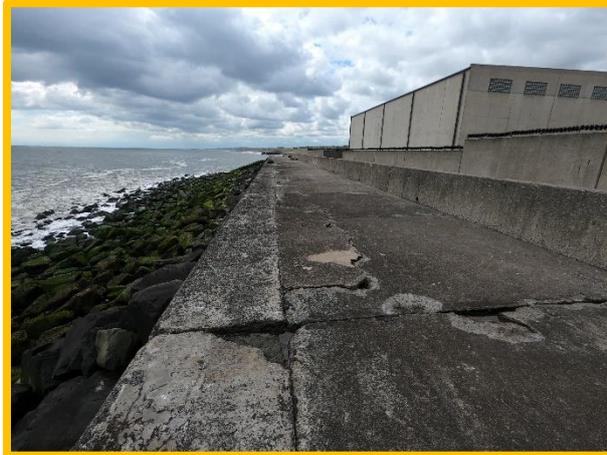
Damaged cope blocks and deck slab
(Asset Ref. 121AB901B0802C02)
