Cell 1 Regional Coastal Monitoring Programme Walkover Inspection Surveys 2020

Sunderland City Council

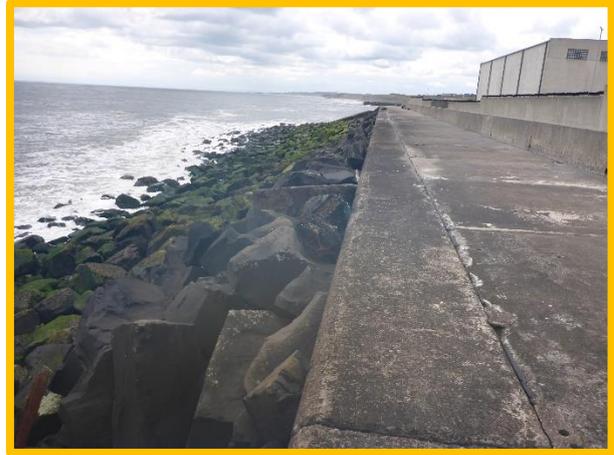
Relatively steep, uneven rock armour profile.
(Asset Ref. No. 121AB901B0802C02)

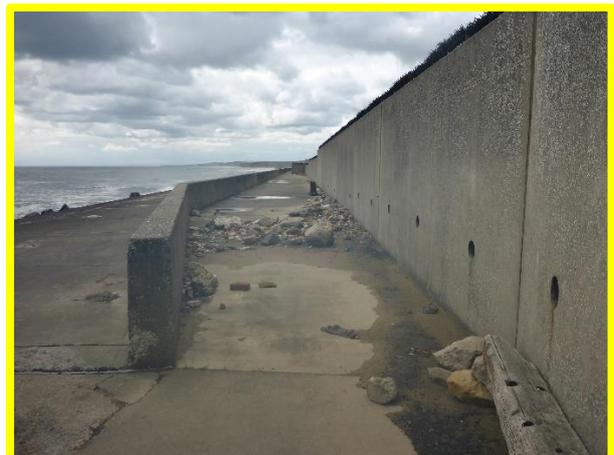
Overtopping debris between splash wall and rear boundary wall.
(Asset Ref. No. 121AB901B0802C02)

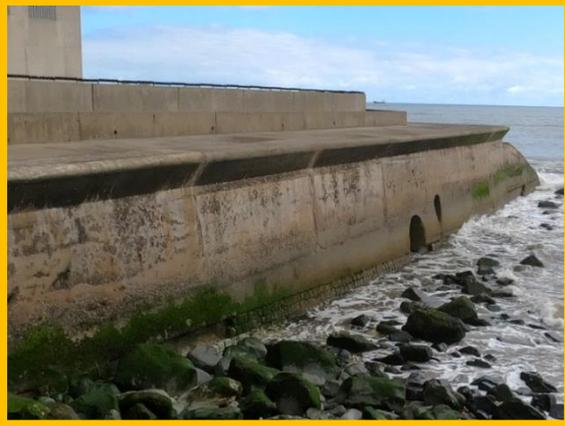
Missing facing masonry requires attention.
(Asset Ref. No. 121AB901B0802C01)

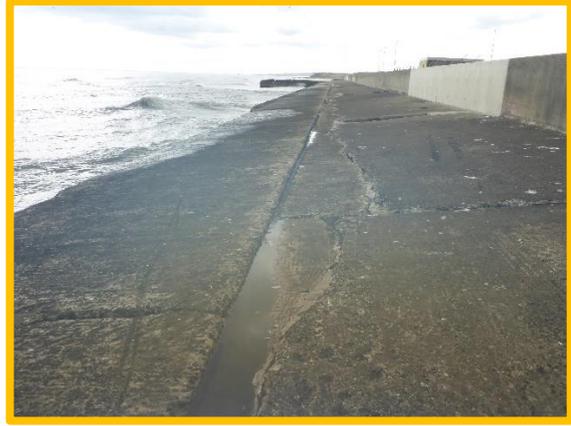
Various cracks and open joints to deck slab with past concrete repairs.
(Asset Ref. No. 121AB901B0802C01)

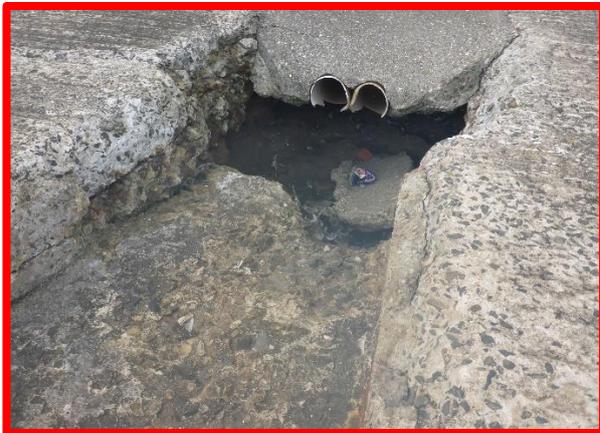
Example of damaged deck slab at outfall drain leading to washout of infill material.
(Asset Ref. No. 121AB901B0802C01)

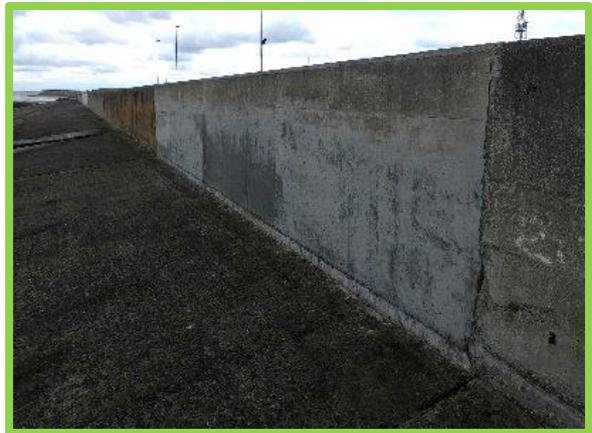
Section of recently replaced rear wall.
(Asset Ref. No. 121AB901B0802C01)

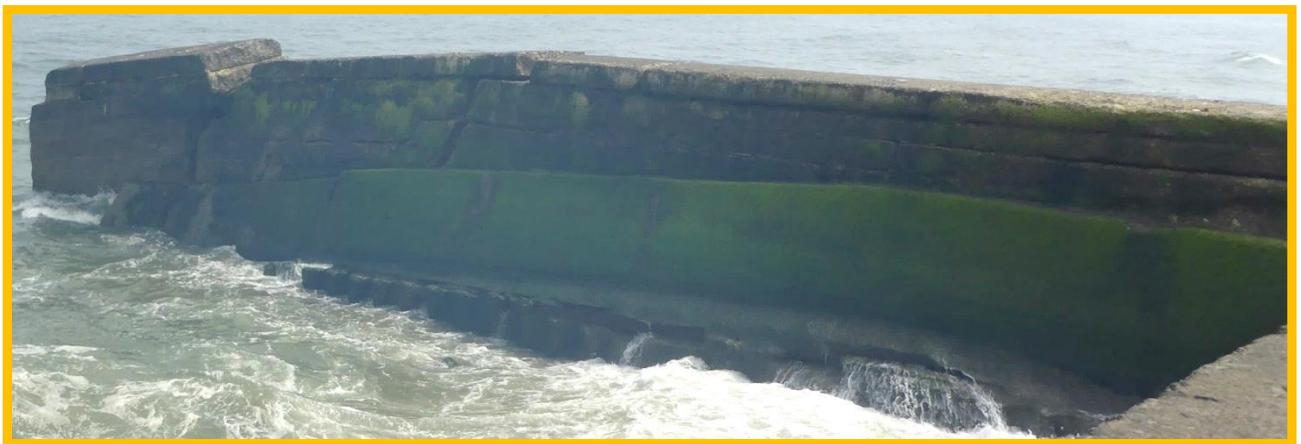
Breakwater with nose detached, from north side. (Asset Ref. No. 121AB901B0803C02.)

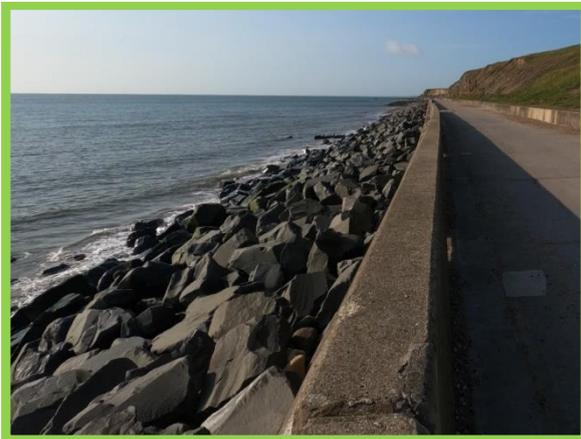
Rock armour generally in good condition.
(Asset Ref. No. 121AB901B0803C02)

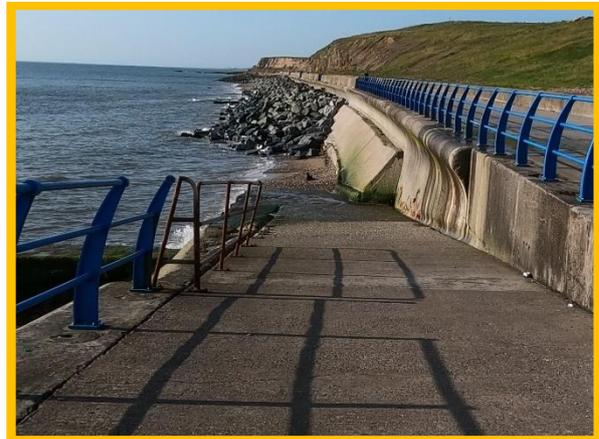
Failed railings along beach ramp.
(Asset Ref. No. 121AB901B0803C02)

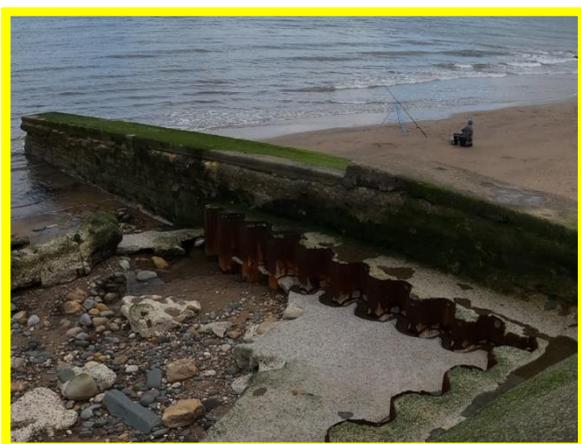
Concrete groyne, beach levels lower than 2018.
(Asset Ref. No. 121AB901B0803C02)

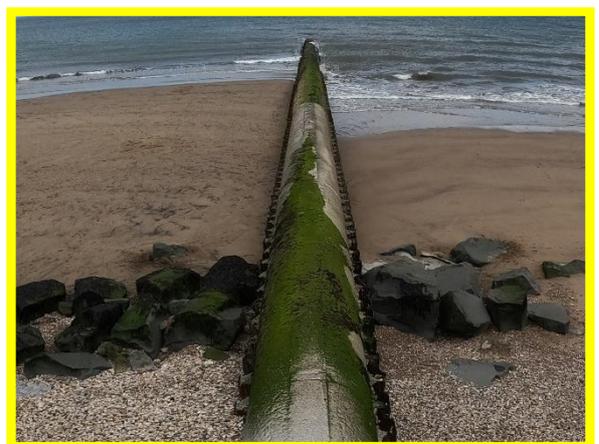
Concrete sewage outflow pipe in fair condition,
heavily corroded / abraded at pile head.
(Asset Ref. No. 121AB901B0803C02)

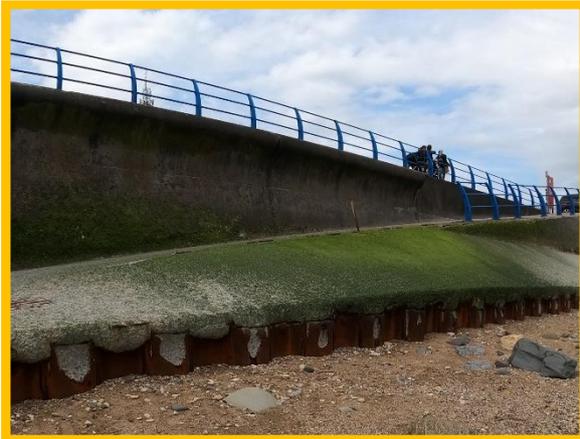
Heavily abraded and corroded steel toe piling.
(Asset Ref. No. 121AB901B0803C02)

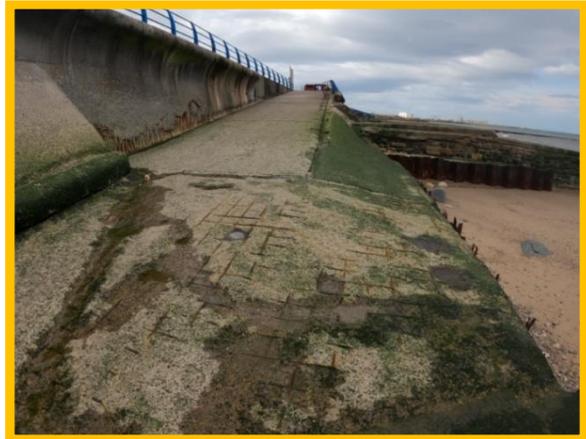
Exposed reinforcement to seawall and ramp.
(Asset Ref. No. 121AB901B0803C02)

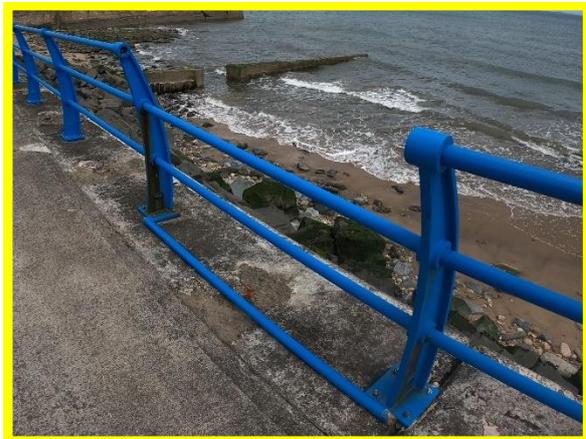
Localised section of damaged railing
(Asset Ref. No. 121AB901B0803C02).

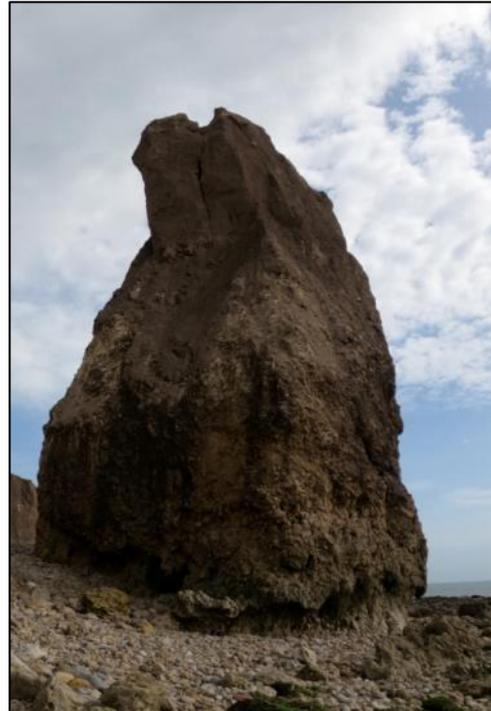
Sea stack at Pincushion
(Asset Ref. No. 121AB901B0804C02)

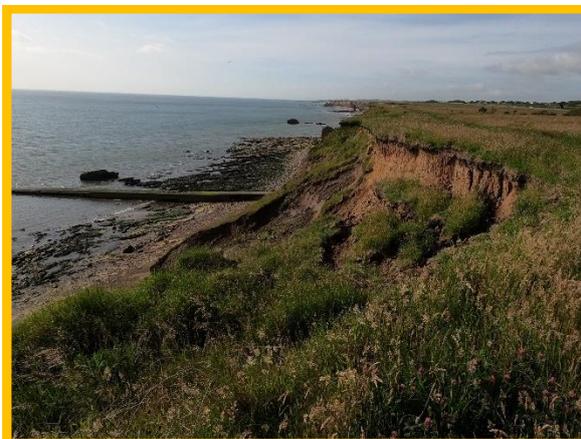
Recent slumping at Salterfen Rocks
(Asset Ref. No. 121AB901B0804C03)

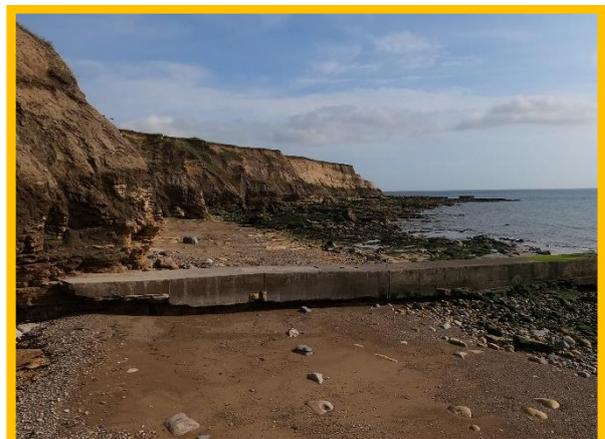
Undercutting to Ryhope Nook outfall.
(Asset Ref. No. 121AB901B0804C03)

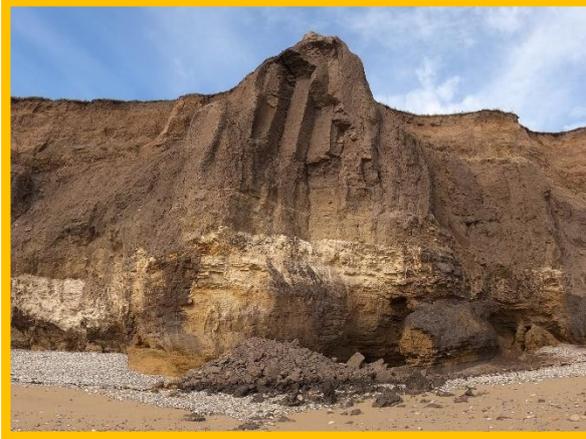
Recent Slumping along Halliwell Banks (Asset Ref. No. 121AB901B0804C02)

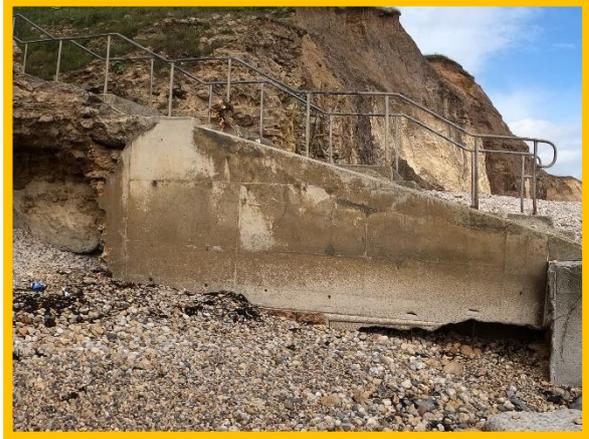
Access steps at Ryhope Village Dene in fair condition, although locally undercut. (Asset Ref. No. 121AB901B0804C02)

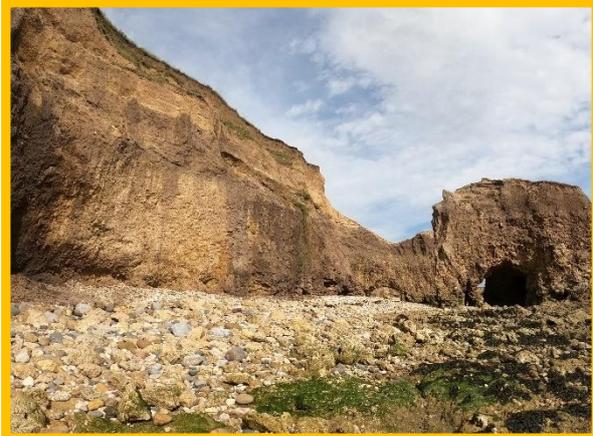
Slumping and seepage near sea stack at Pincushion (Asset Ref. No. 121AB901B0804C02)
