Cell 1 Regional Coastal Monitoring Programme Walkover Inspection Surveys 2022

Sunderland City Council

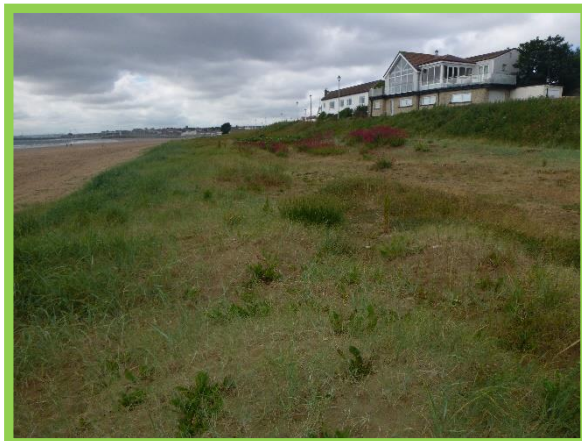
Well vegetated slope, embryonic dune growth at toe. (Asset Ref No. 121AB901B0602C01)

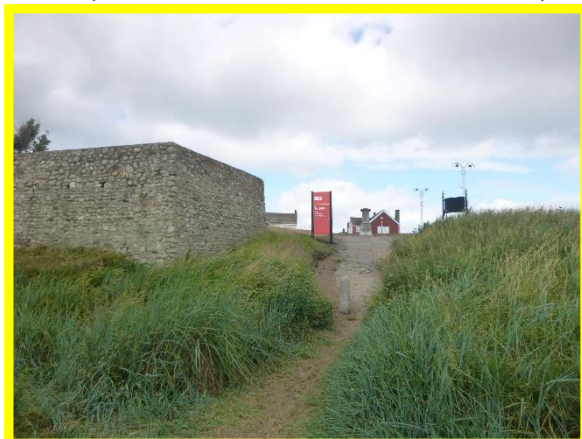
Access ramp at Whitburn Steel, toe undercut during previous inspections. (Asset Ref No. 121AB901B0602C01)

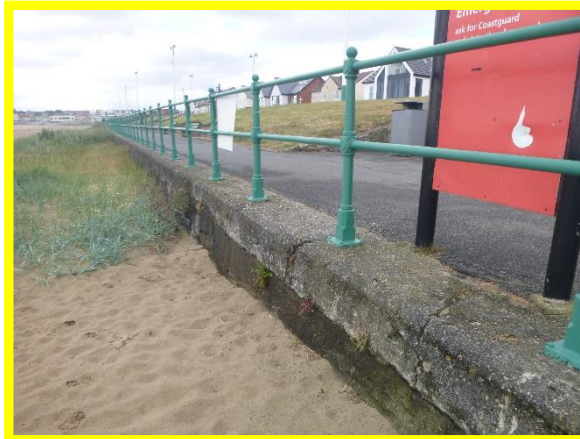
Sandy upper beach surface and dune accretion in front of concrete seawall.
(Asset Ref No. 121AB901B0603C01)

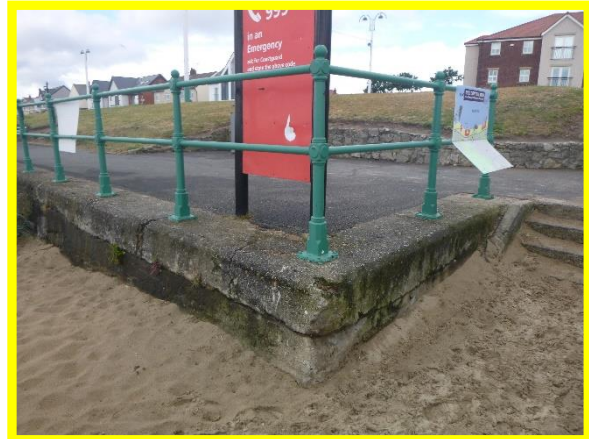
Spalled/damaged concrete cope and facing
(Asset Ref No. 121AB901B0603C01)

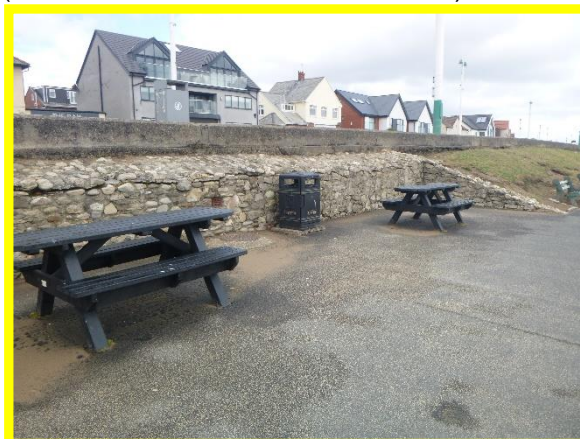
Lateral crack along rear of revetment at picnic area
(Asset Ref No. 121AB901B0603C01)

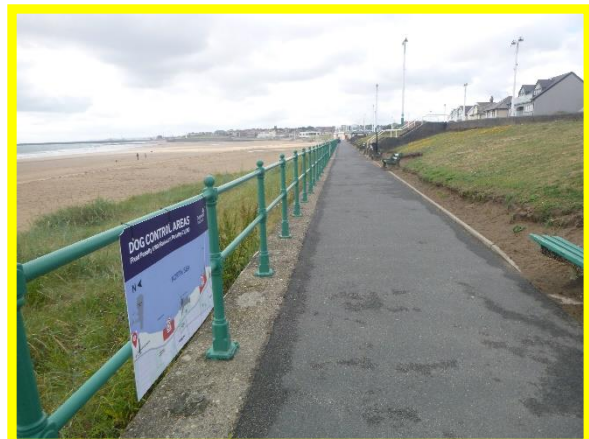
Asphalt surface appears in good condition,
erosion to rear embankment
(Asset Ref No. 121AB901B0603C01)

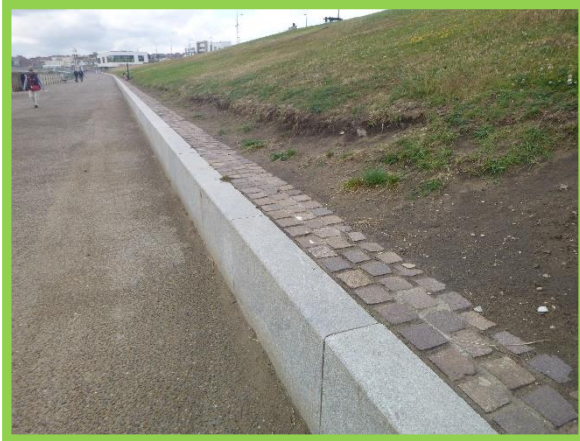
Erosion along the crest of the low retaining wall at the rear of the promenade.
(Asset Ref No. 121AB901B0603C01)

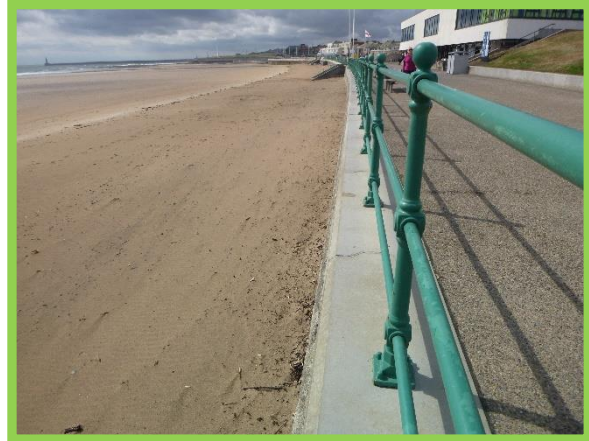
Repaired section of coping blocks in good condition.
(Asset Ref No. 121AB901B0603C01)

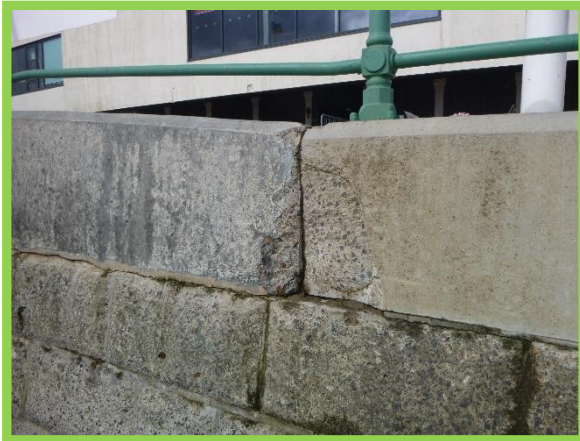
Localised damage on repaired section of coping.
(Asset Ref No. 121AB901B0603C01)

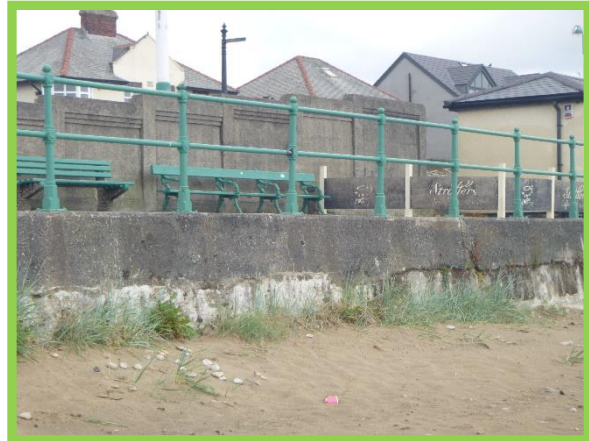
Original coping in fair condition.
(Asset Ref No. 121AB901B0603C01)

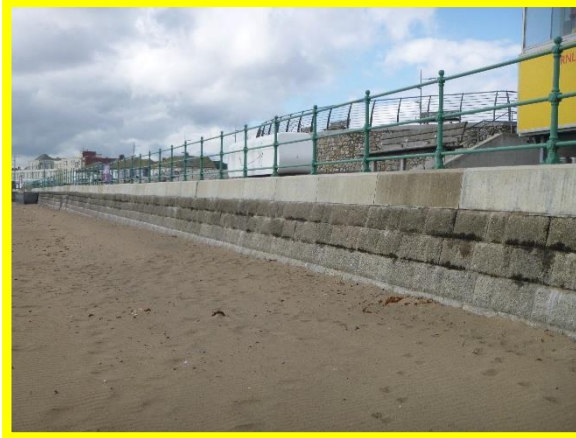
Repaired concrete coping above masonry seawall generally in good condition.
(Asset Ref No. 121AB901B0603C02)

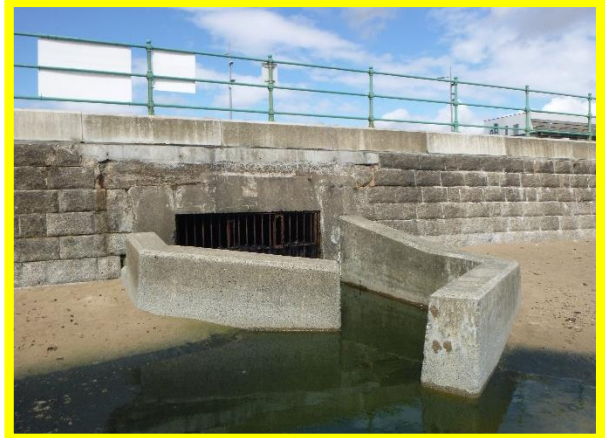
Repaired concrete coping above outfall structure in fair condition.
(Asset Ref No. 121AB901B0603C02)

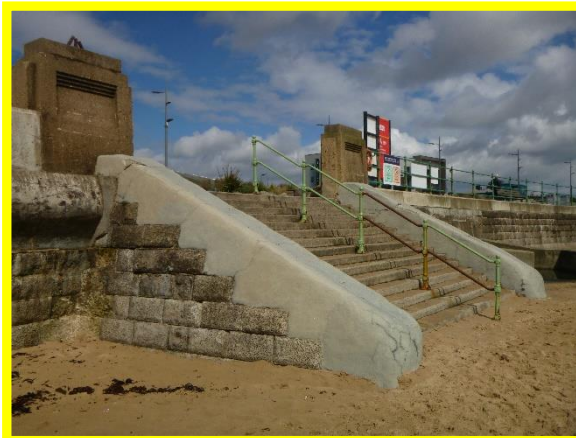
Repairs to step abutments in fair condition. Handrail is corroded in places
(Asset Ref No. 121AB901B0603C02)

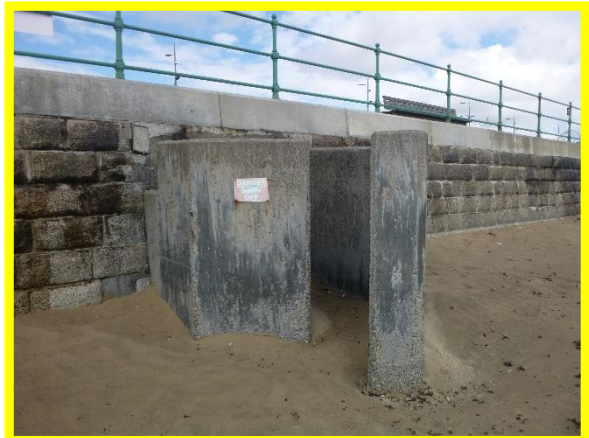
Beach level the same as in 2020
(Asset Ref No. 121AB901B0603C02)

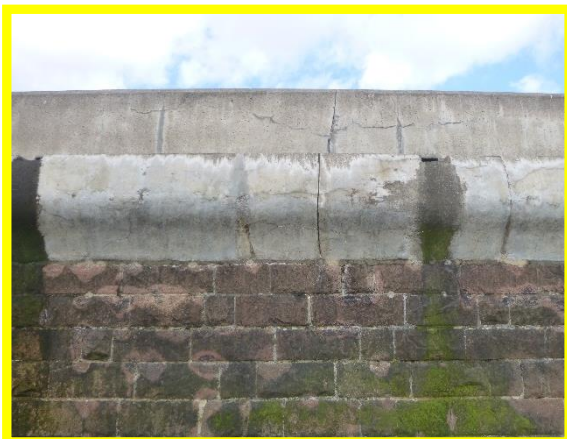
Cracking in seaward side of crest wall
(Asset Ref. No. 121AB901B0603C03)

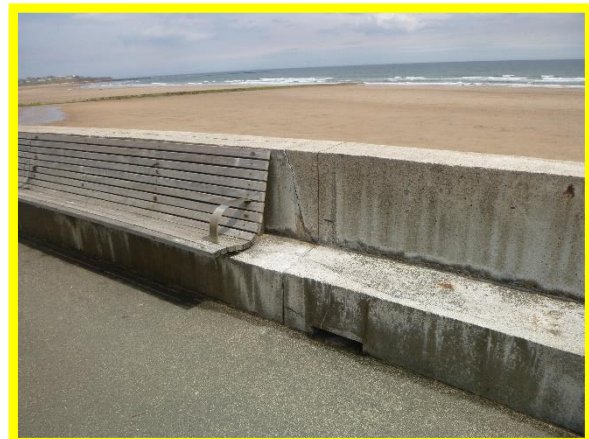
Rust staining and cracking in crest wall.
(Asset Ref. No. 121AB901B0603C03)

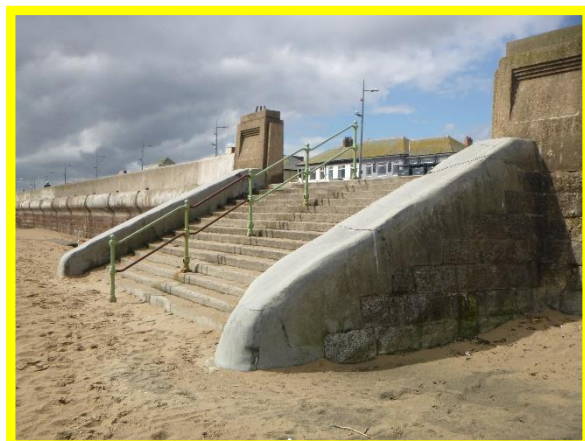
Access steps at Dykeland Road, beach covering heavily abraded lower steps (Asset Ref. No. 121AB901B0603C03)

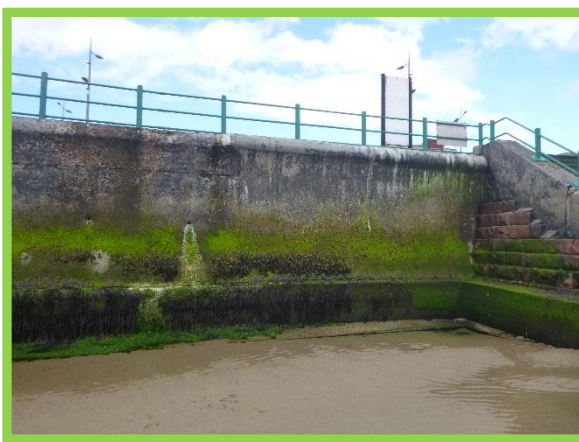
Recently constructed seawall infill section adjacent to steps at Seaburn Terrace (Asset Ref. No. 121AB901B0603C03)

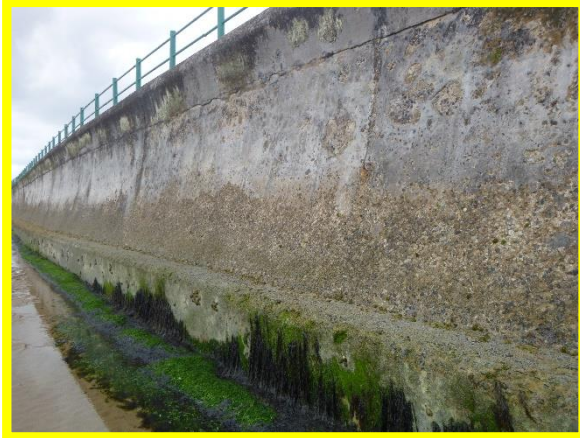
Beach levels marginally lower than 2020, spalling damage at crest and abrasion across wall face.
(Asset Ref. No. 121AB901B0604C01)

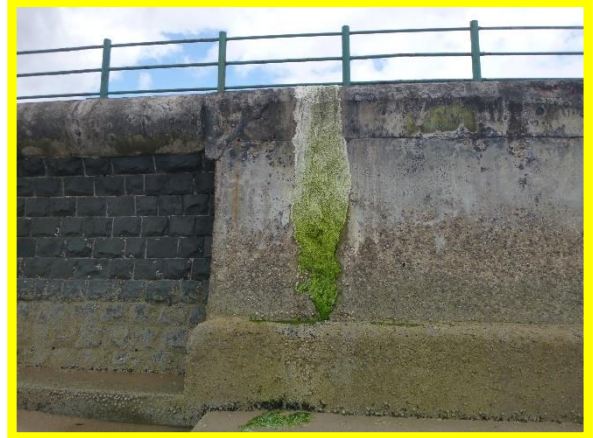
Damaged section of coping and chloride staining (Asset Ref. No. 121AB901B0604C01)

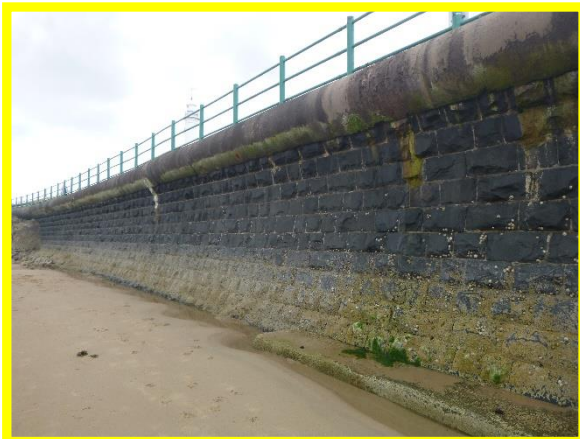
View northwards from Parsons Rocks, seawall in fair condition.
(Asset Ref. No. 121AB901B0604C02)

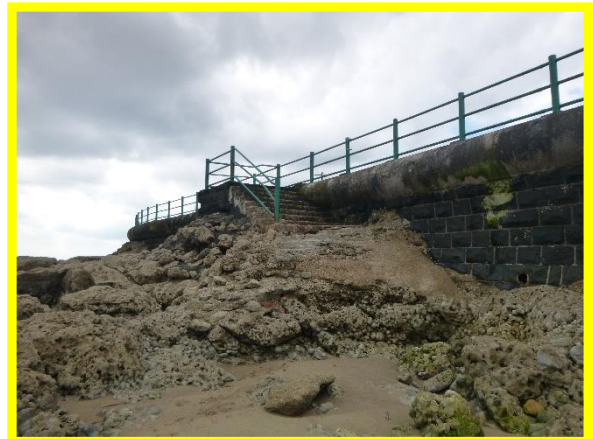
Eroded natural rock at access steps to Parsons Rocks (access to steps blocked by handrail).
(Asset Ref. No. 121AB901B0604C02)

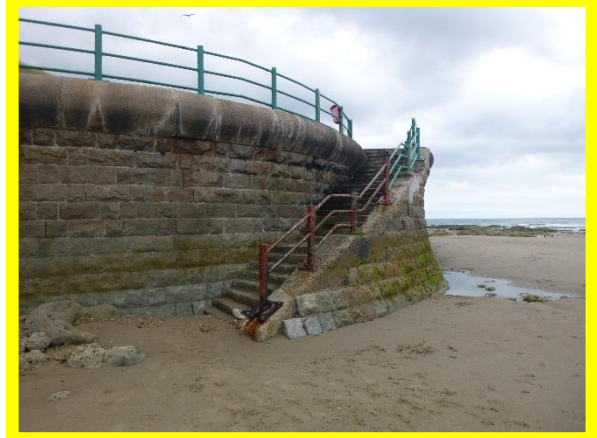
Access steps at southern end of defence in fair condition. (Asset Ref. No. 121AB901B0604C02)

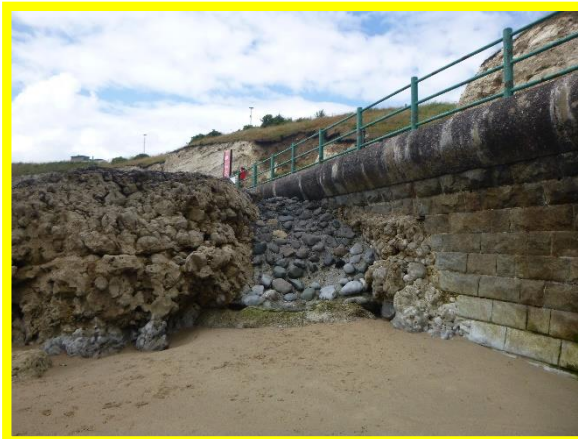
Eroded limestone outcrop void beneath promenade at south of Parsons Rocks. (Asset Ref. No. 121AB901B0604C02)

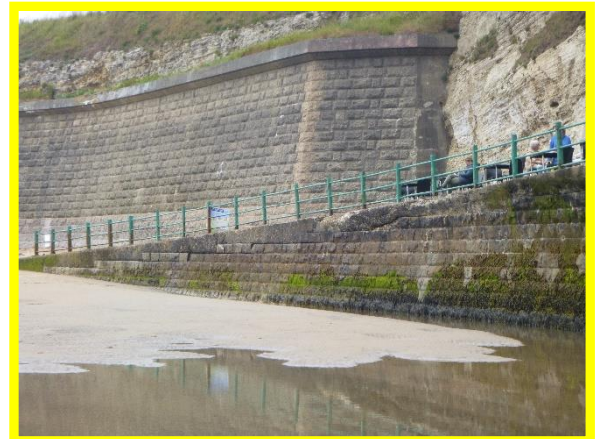
Damage to coping on ramp south of Parsons Rocks. (Asset Ref. No. 121AB901B0604C02)

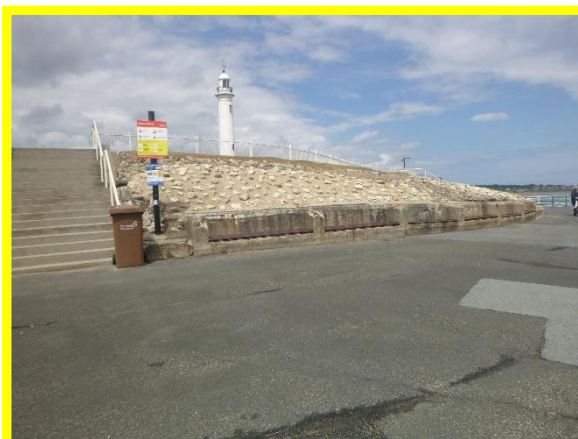
Recently infilled voids in grouted revetment (Asset Ref. No. 121AB901B0604C02)

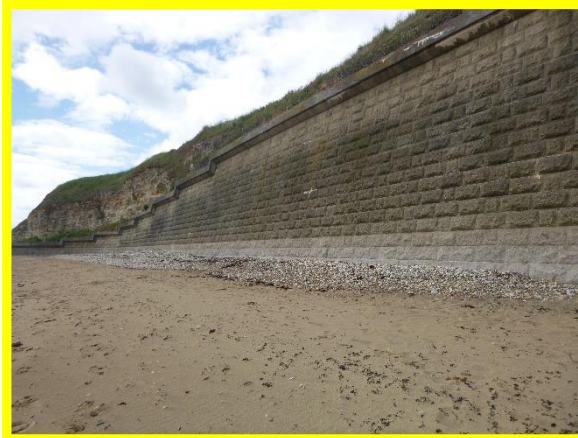
Masonry wall generally in good condition
(Asset Ref. No. 121AB901B0605C01)

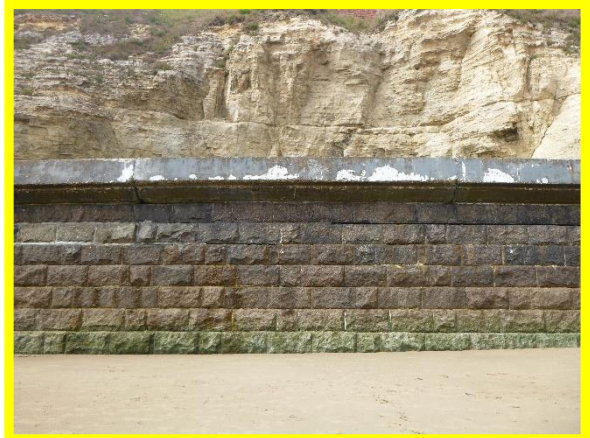
Area of missing blocks repaired since 2018,
part of longitudinal crack remains.
(Asset Ref. No. 121AB901B0605C01)

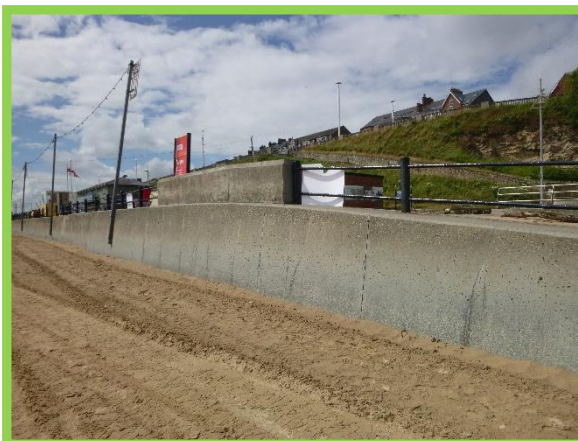
Low concrete encased wall at Marine Walk in
fair to good condition.
(Asset Ref. No. 121AB901B0605C02)

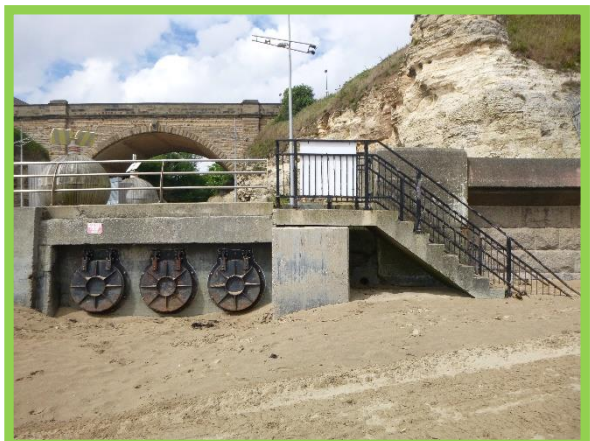
Outfall pipes at north end of Marine Walk.
(Asset Ref. No. 121AB901B0605C02)

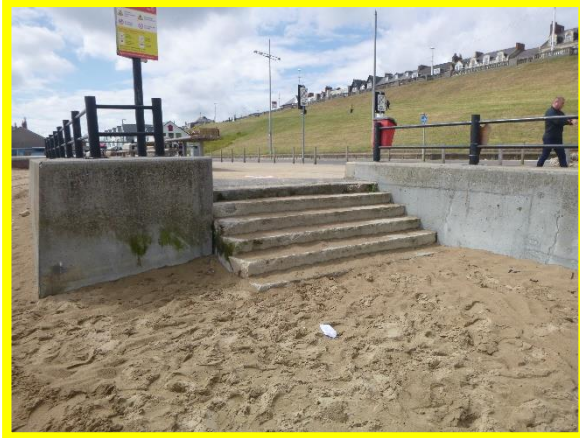
Northern access steps in fair to poor condition requiring minor repairs. (Asset Ref. No. 121AB901B0605C02)

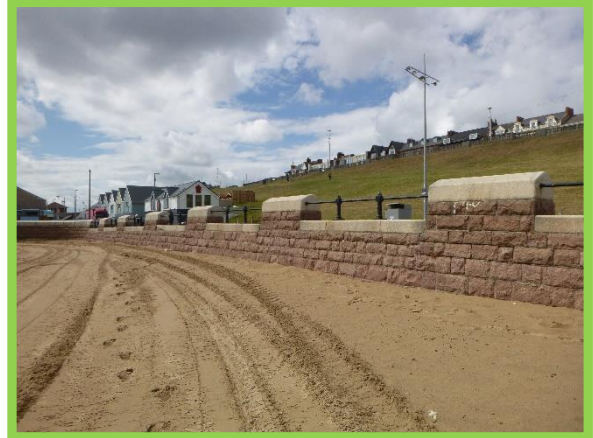
Southern section of masonry wall protected by wide beach in good overall condition. (Asset Ref. No. 121AB901B0605C02)

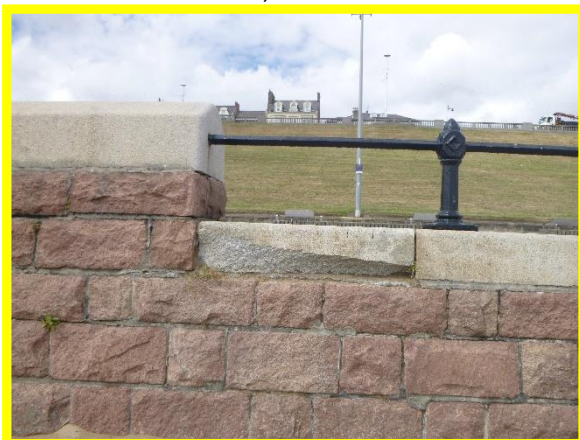
Damage to coping stone, similar to 2020. (Asset Ref. No. 121AB901B0605C02)

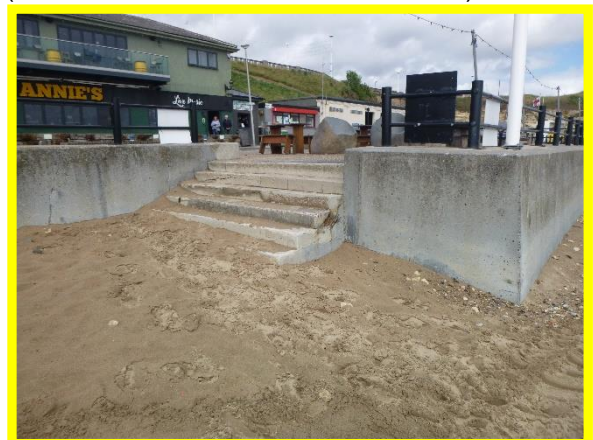
Southern access steps in fair condition with historic repair holding. (Asset Ref. No. 121AB901B0605C02)

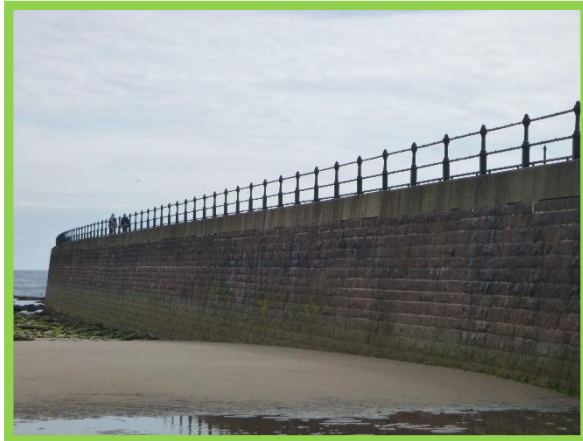
Northern (outer) face of pier
(Asset Ref. No. 121AB901B0702C04)

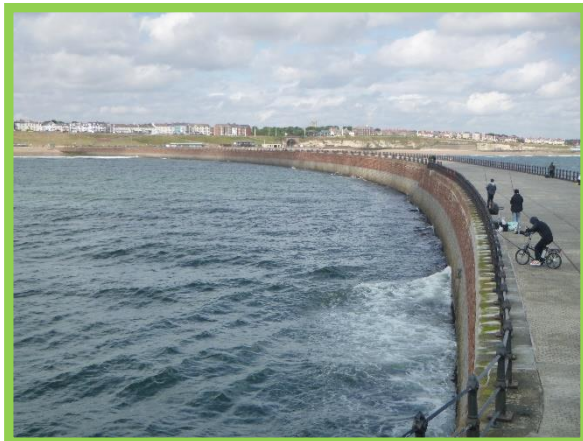
Recently replaced handrail and coping blocks.
(Asset Ref. No. 121AB901B0702C04)

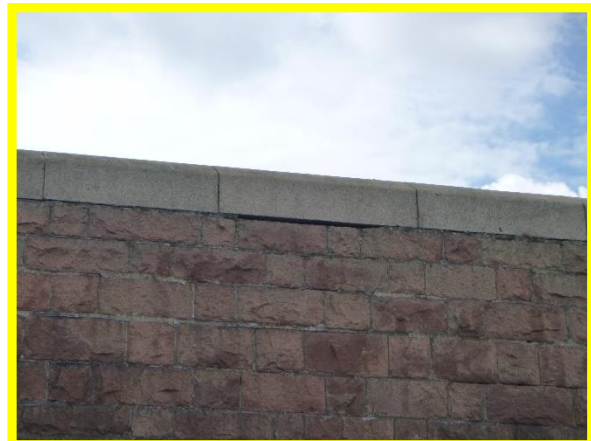
Roker Pier northern (outer) face, vertical cracks and open joints along coping
(Asset Ref. No. 121AB901B0702C05)

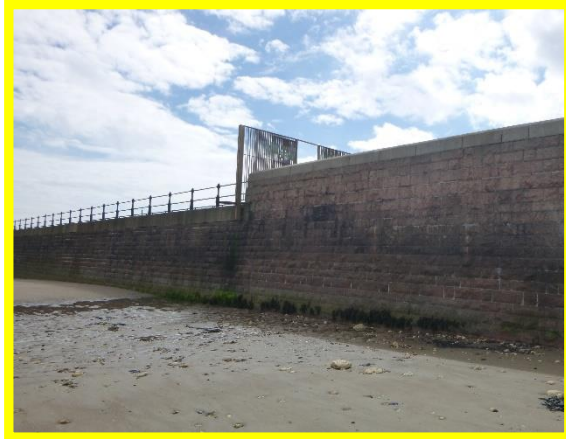
View on northern side of masonry wall at root of pier – localised abrasion and mortar loss. (Asset Ref. No. 121AB901B0702C05)

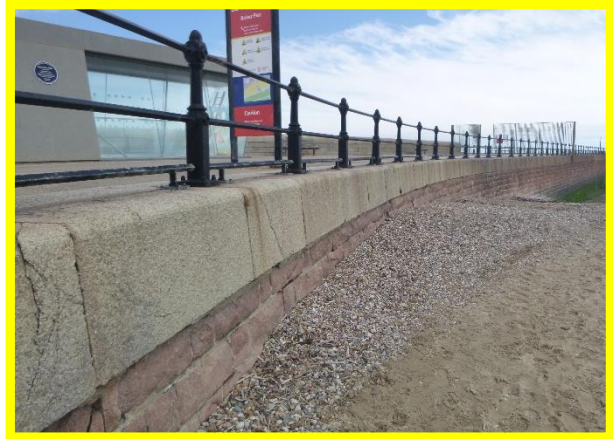
Masonry splash wall at southern root of pier – sections of damaged coping and weathered masonry. (Asset Ref. No. 121AB901B0702C05)

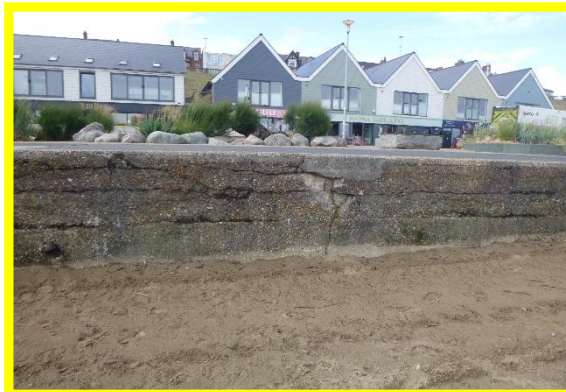
Patch repairs and horizontal cracks in concrete wall. (Asset Ref. No. 121AB901B0702C01)

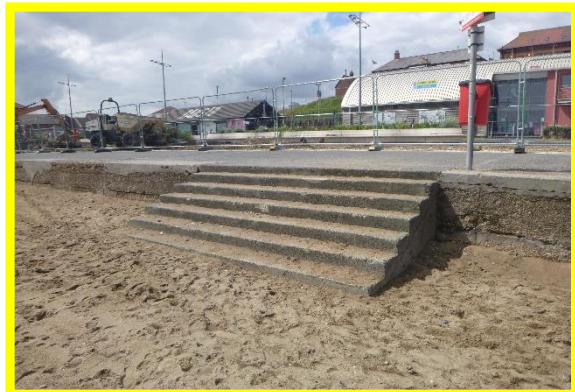
Example of spalling between horizontal cracking (Asset Ref. No. 121AB901B0702C01)

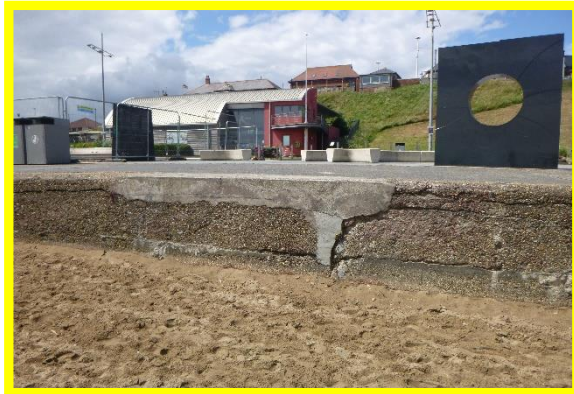
Patch repairs and horizontal cracks in concrete wall. (Asset Ref. No. 121AB901B0702C01)

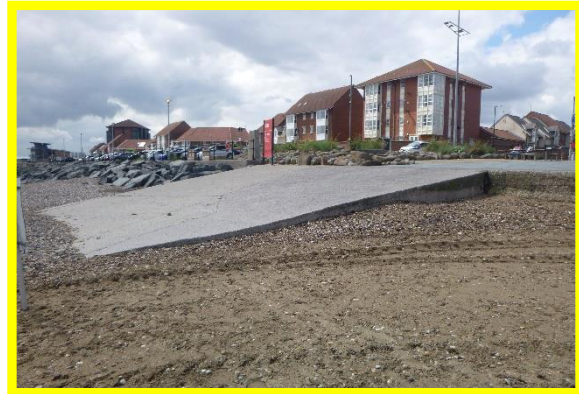
Slipway at southern end of wall in fair condition. (Asset Ref. No. 121AB901B0702C01)

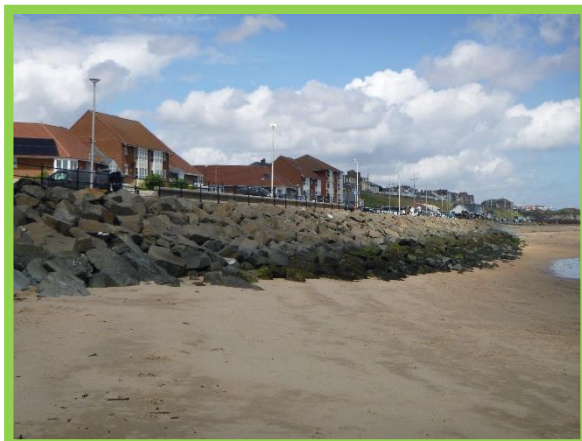
Even profile and crest level on rock armour revetment . (Asset Ref. No. 121AB901B0702C02)

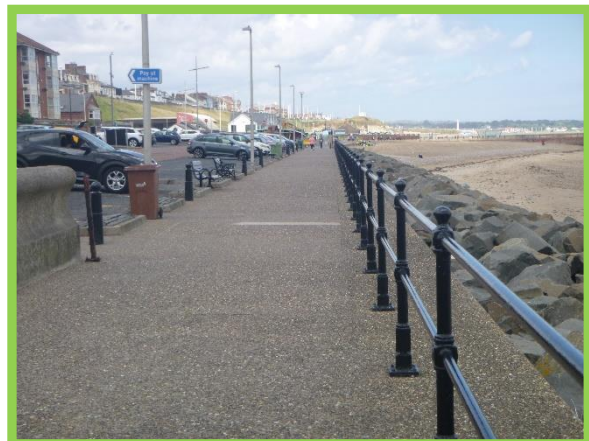
Rock armour and promenade in good condition. (Asset Ref. No. 121AB901B0702C02)

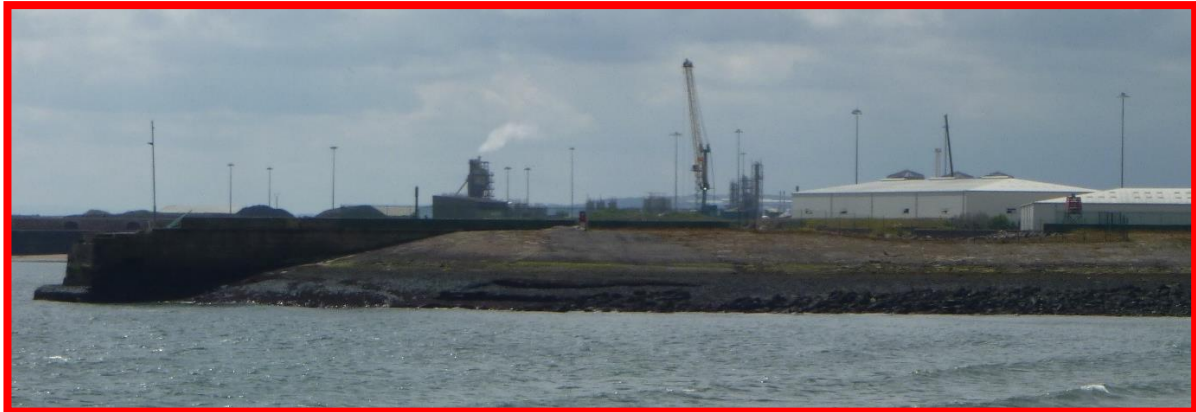
Northern face of Old North Pier, voids at toe (Asset Ref. No. 121AB901B0702C03)

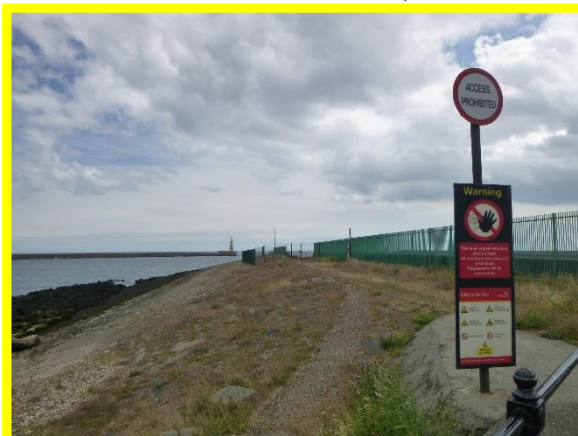
Vegetation growth on haulage path built for delivery of rock repairs.
(Asset Ref. No. 121AB901B0702C03)

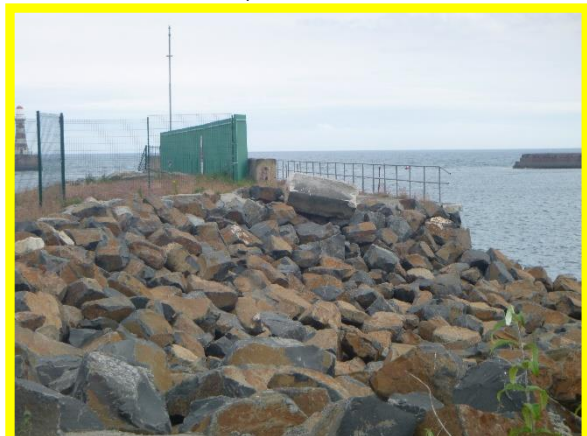
Former breach infilled with rock armour and grout. (Asset Ref. No. 121AB901B0702C03)

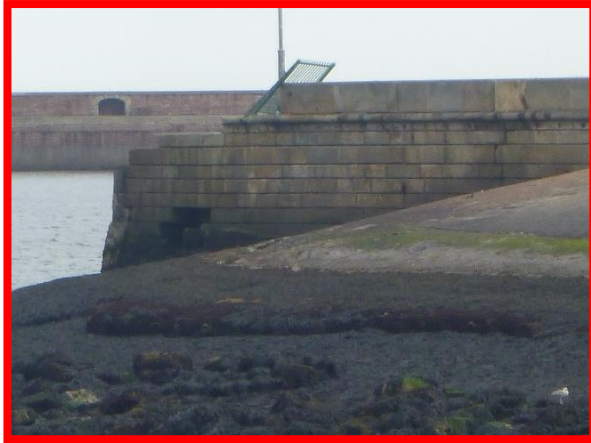
Missing blocks at seaward end of Old North Pier. (Asset Ref. No. 121AB901B0702C03)

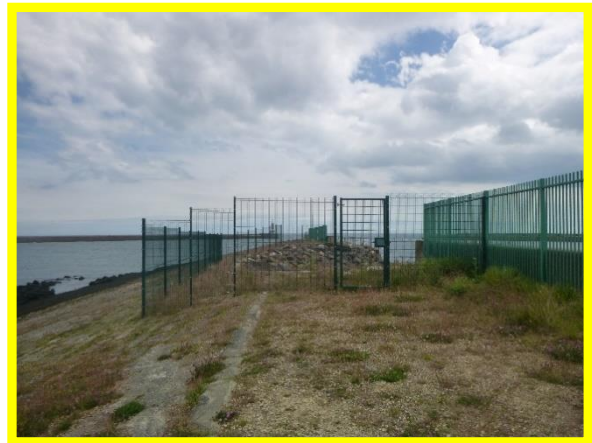
Fencing detached locally enabling access by public to unsafe structure. (Asset Ref. No. 121AB901B0702C03)

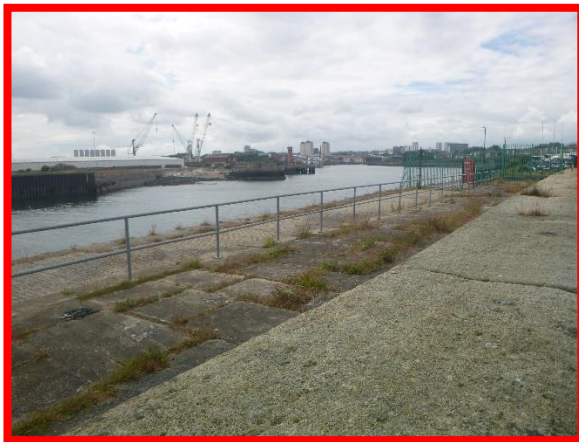
Cracked deck slab and splash wall with vegetation growth throughout. (Asset Ref. No. 121AB901B0702C03)

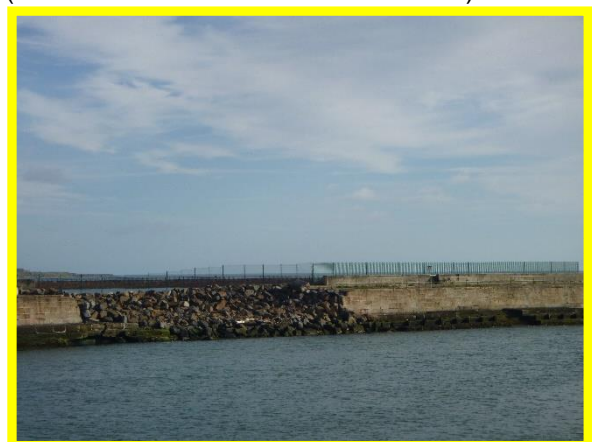
Old North Pier southern face showing extent of the breach. (Asset Ref. No. 121AB901B0702C03)

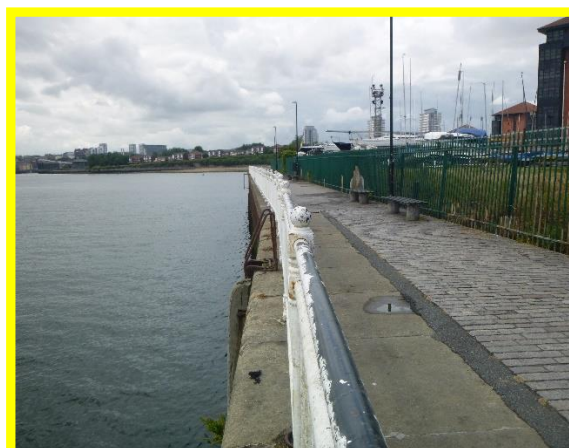
Damage to concrete coping at "Rat House Corner". (Asset Ref. No. 121AB901B0702C03)

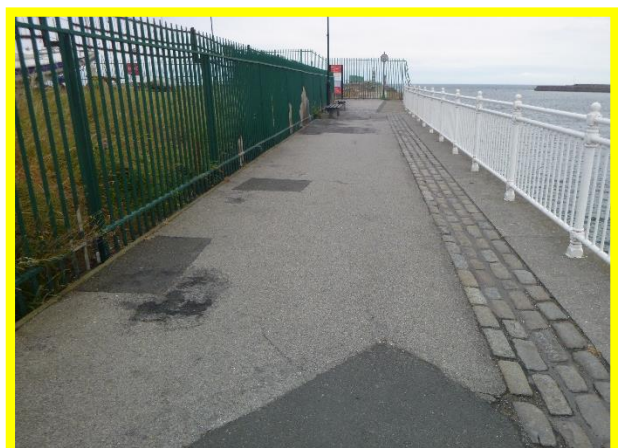
Promenade at "Rat House Corner" in fair condition (Asset Ref. 121AB901B0702C03)

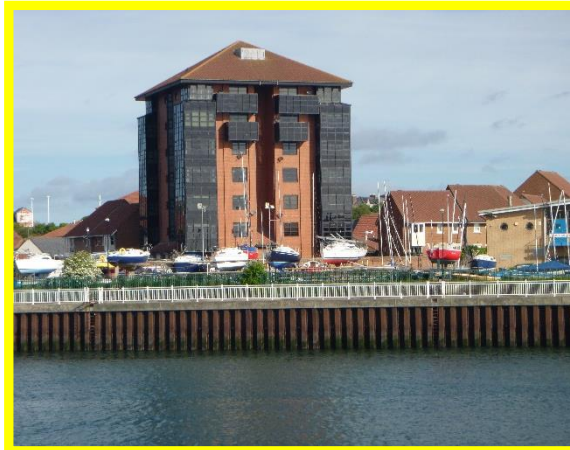
Sheet piling along southern face of wall
(Asset Ref. No. 121AB901B0702C03)

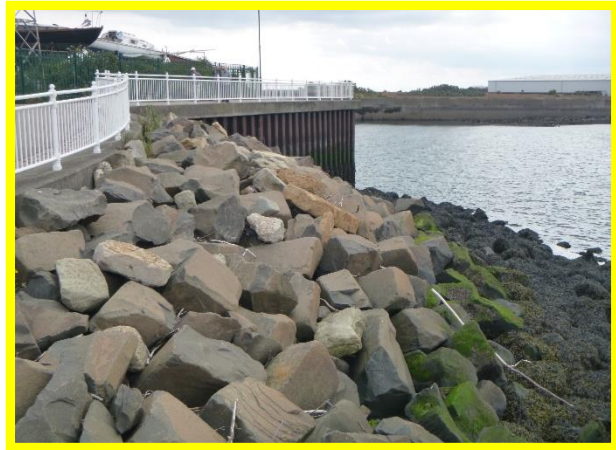
Sheet piling at "Rat House Corner" in fair
condition (Asset Ref. 121AB901B0702C03)

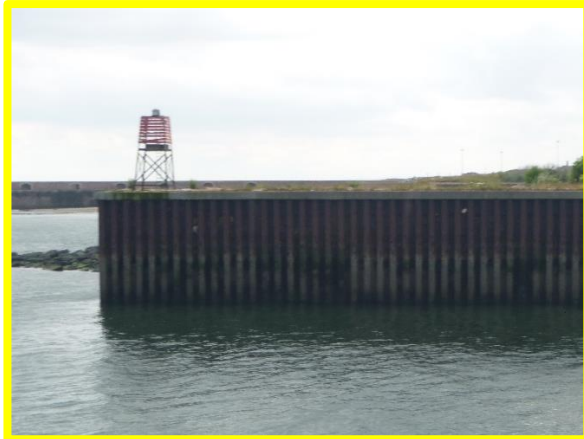
View on sheet pile river navigation wall, noted previously with staining indicating microbial induced corrosion (MIC) reducing structural capacity (Asset Ref. No. 121AB901BO703C03)

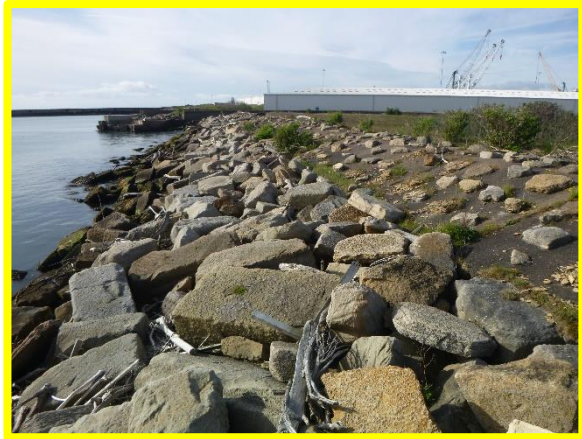
View of rock revetment from north showing loosely placed armour (Asset Ref. No. 121AB901BO703C03)

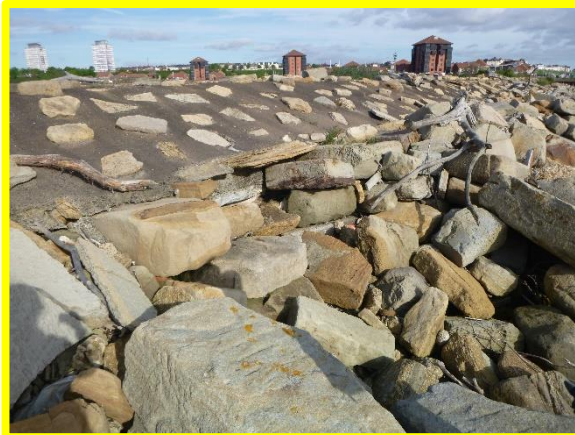
View of slumping at southern end of revetment (Asset Ref. No. 121AB901BO703C03)

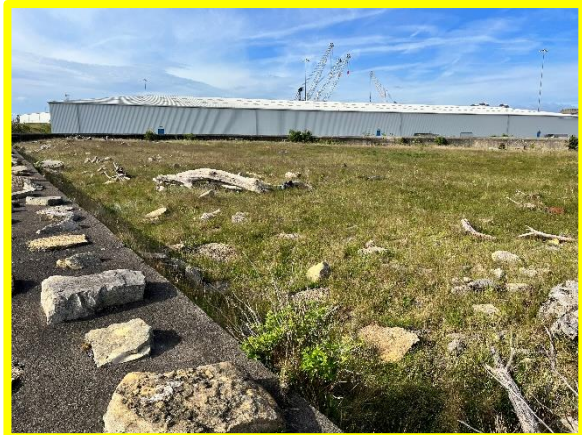
Low spot on landward side of concrete crest and overtopping/rock debris (Asset Ref. No. 121AB901BO703C03)

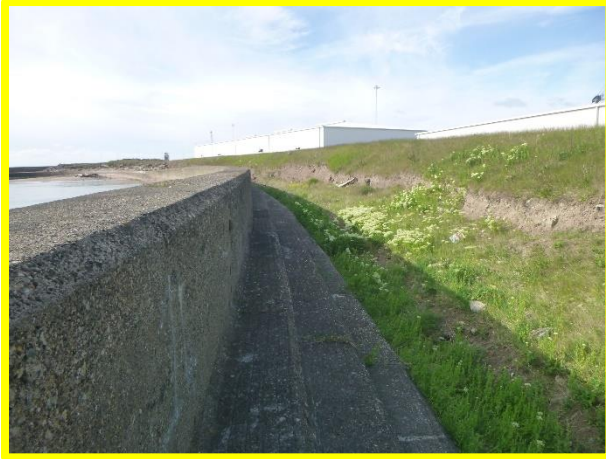
Extensive crest and rear embankment damage due to wave overtopping.
(Asset Ref. No. 121AB901BO703C02)

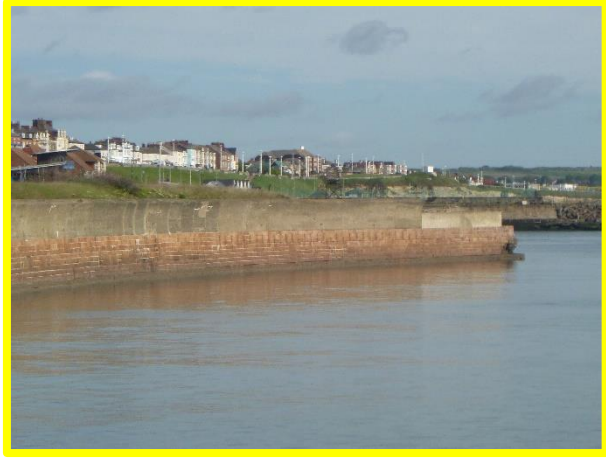
Masonry wall in fair condition except for missing blocks at North end.
(Asset Ref. No. 121AB901BO703C02)

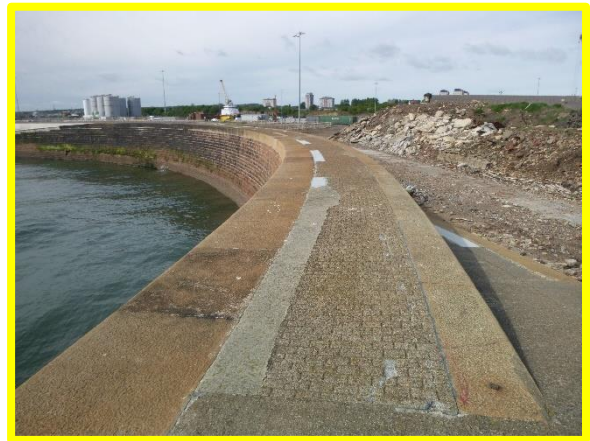
Local repairs to upper deck from root of pier. (Asset Ref. No. 121AB901B0703C01)

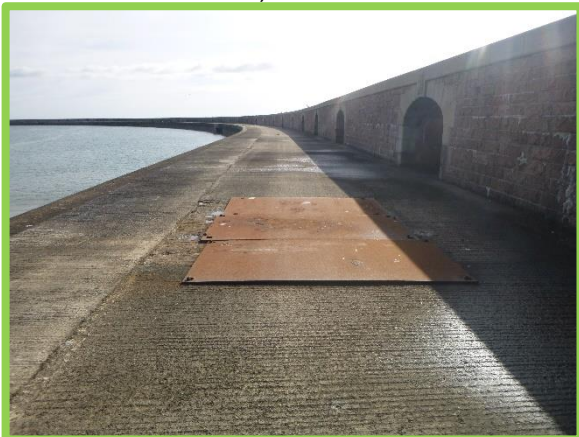
Steel sheet covering void reported in 2018. (Asset Ref. No. 121AB901B0703C01)

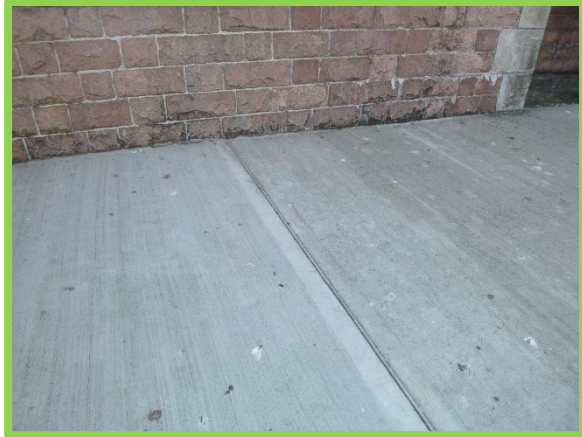
Repaired slabs in good condition.
(Asset Ref. No. 121AB901B0703C01)

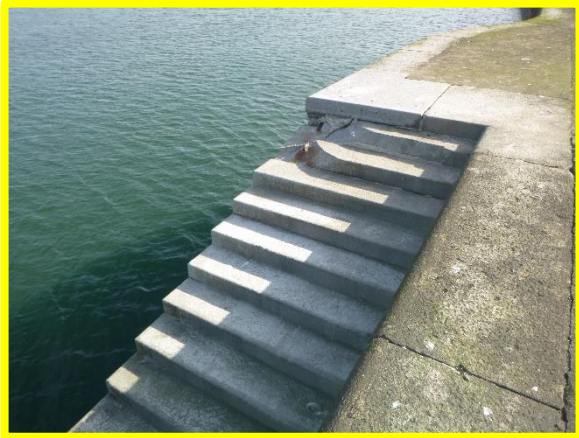
Damage to access steps.
(Asset Ref. No. 121AB901B0703C01)

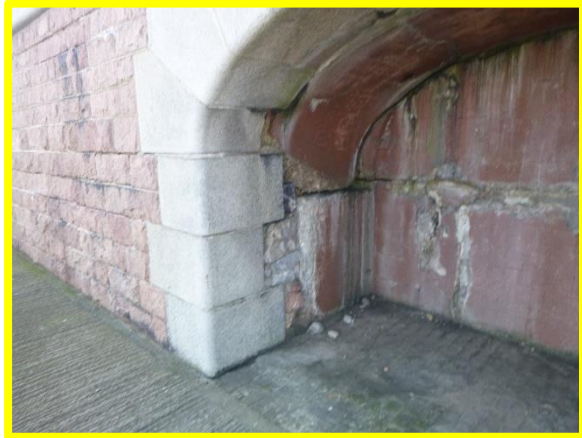
Damage in upper wall recess.
(Asset Ref. No. 121AB901B0703C01)

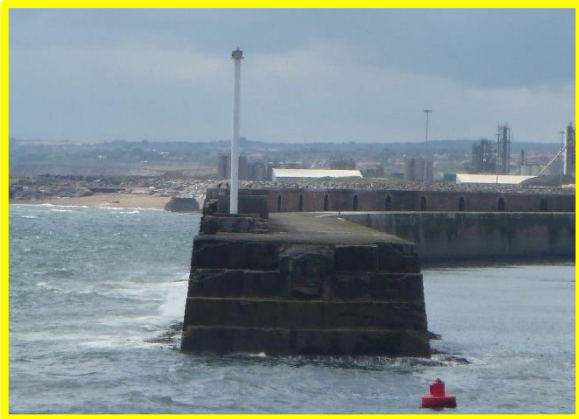
Northern tip of New South Pier.
(Asset Ref. No. 121AB901B0703C01)

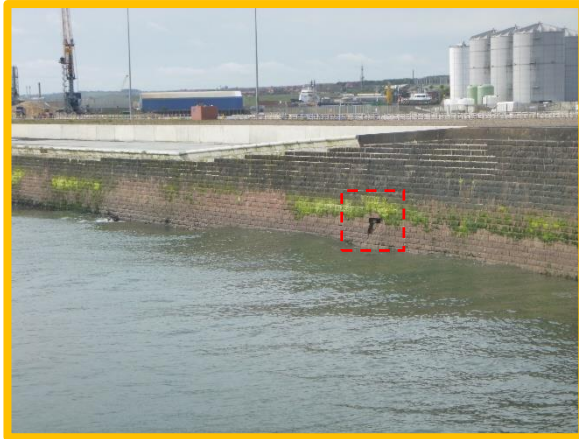
Localised missing blocks worsened (since 2020) and open joint, similar(to 2020). (Asset Ref. No. B901B0801C03)

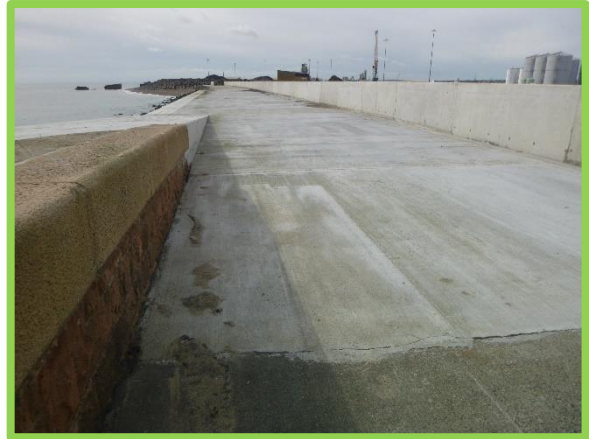
Deck slab repaired and new precast splash wall constructed. (Asset Ref. No. B901B0801C03)

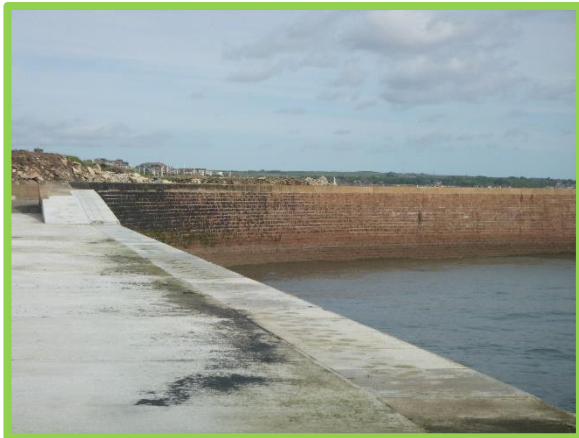
New precast coping stones. (Asset Ref. No. B901B0801C03)

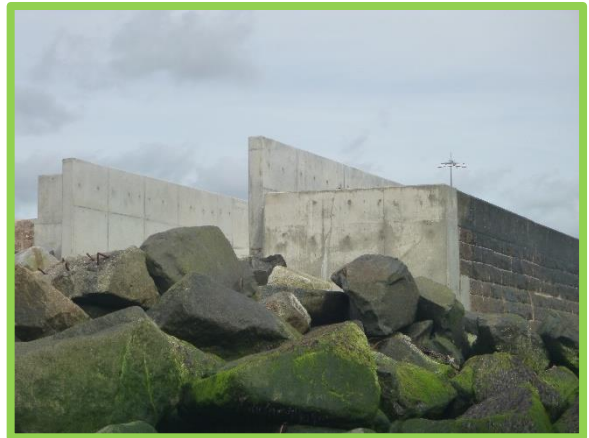
Southern end of wall repaired. (Asset Ref. No. B901B0801C03)

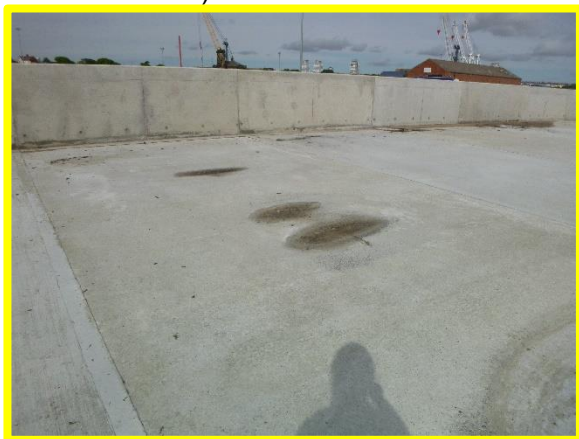
Depressions in deck slab. (Asset Ref. No. B901B0801C03)

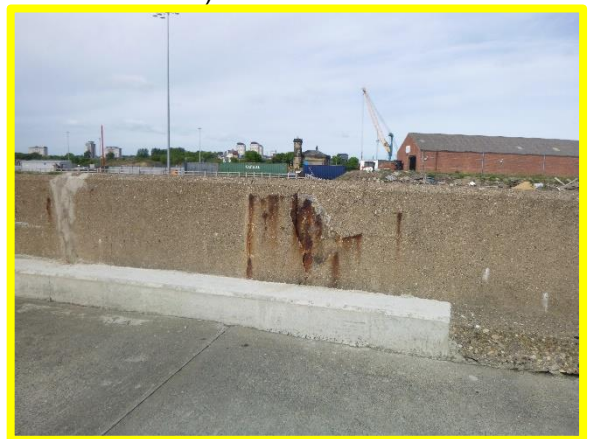
Remaining section of original splash wall in poor condition. (Asset Ref. No. B901B0801C03)

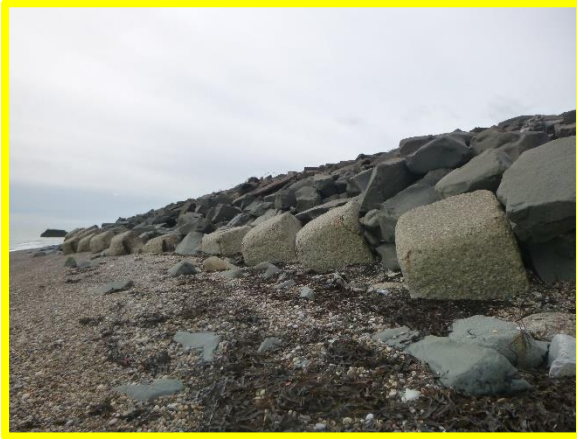
Rock/rubble revetment north of derelict groyne.
(Asset Ref. No.121AB901B0801C02)

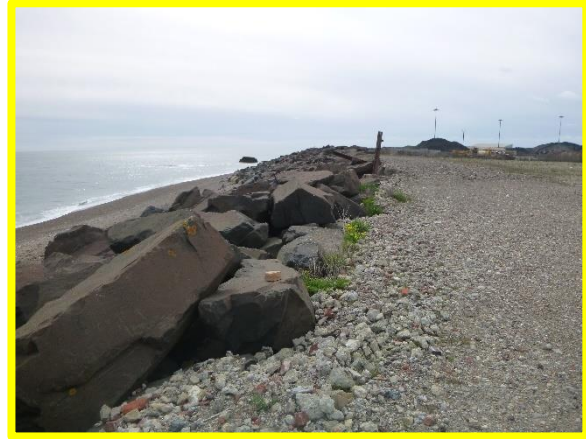
Uneven crest level of revetment. Embankment to rear has been reprofiled and is in good condition
(Asset Ref. No.121AB901B0801C02)

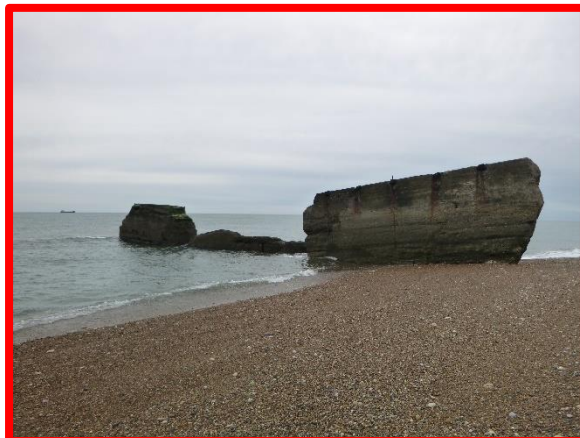
Derelict concrete groyne from north.
(Asset Ref. No. 121AB901B0801C01)

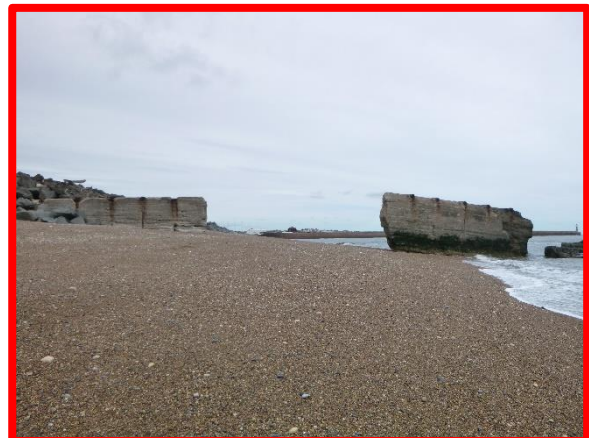
Derelict concrete groyne from south.
(Asset Ref. No. 121AB901B0801C01)

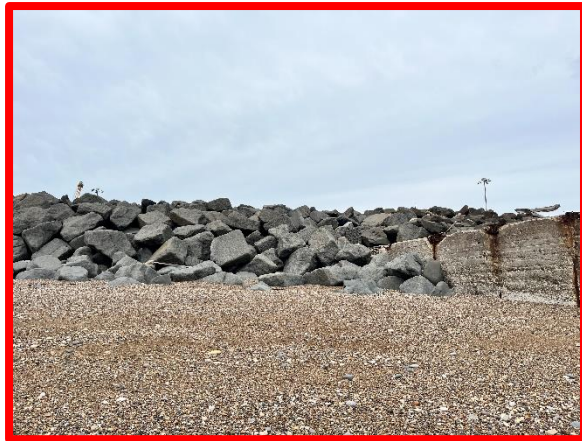
Derelict concrete groyne from north.
(Asset Ref. No. 121AB901B0801C06)

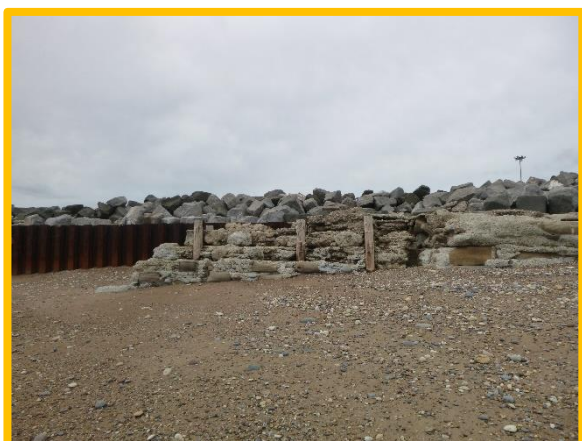
Derelict former defence structures with stacked bund of rock armour at crest.
(Asset Ref. 121AB901B0801C05)

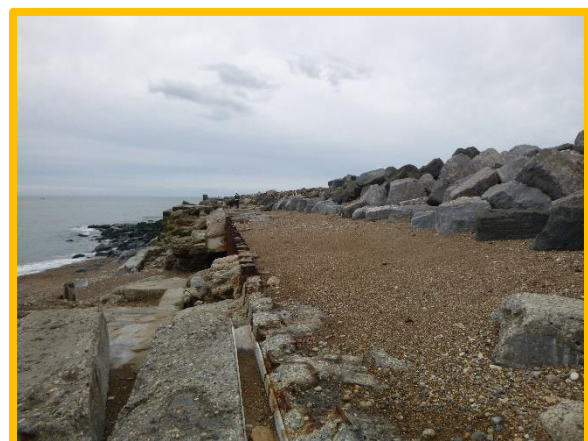
Derelict concrete wall and heavily corroded sheet piles with rock armour crest. (Asset Ref. No. 121AB901B0801C05)
