Cell 1 Regional Coastal Monitoring Programme Walkover Inspection Surveys 2022

Sunderland City Council

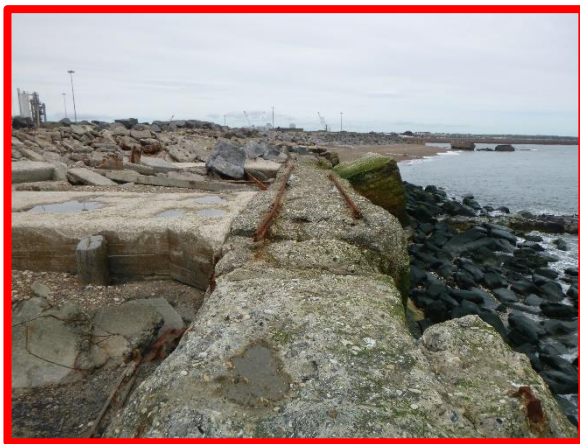
Buttress detached from main structure and heavily abraded deck
(Asset Ref. No. 121B901B0801C07)

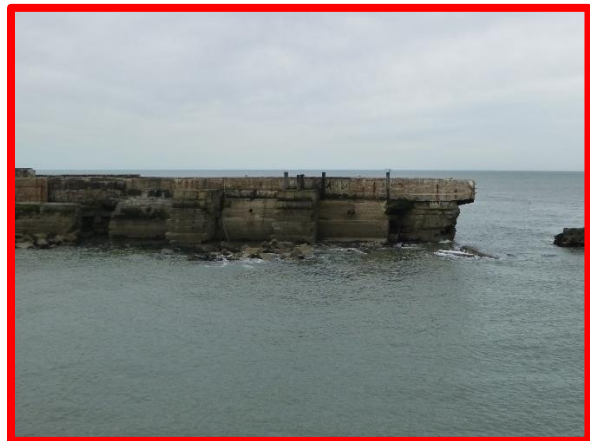
North East Pier viewed from south.
(Asset Ref. No. 121B901B0801C04)

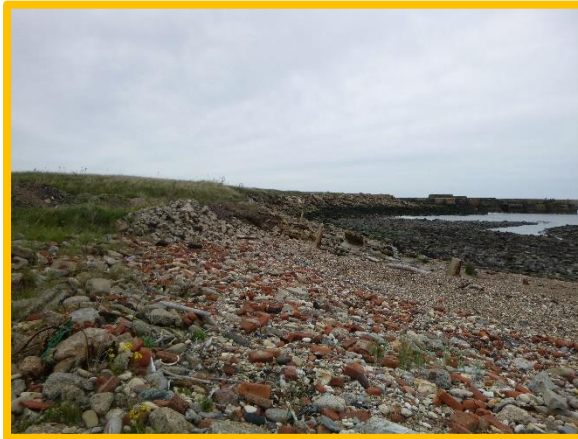
Tipped rubble at northern end of South Outlet basin. (Asset Ref. No. 121AB901B0801C08)

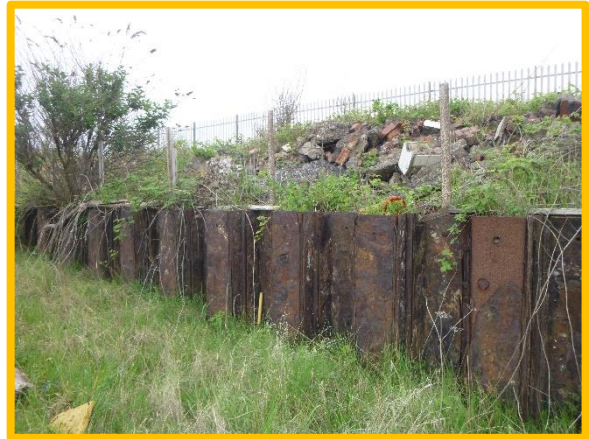
Heavily corroded sheet pile wall (Asset Ref. No. 121AB901B0802C07).

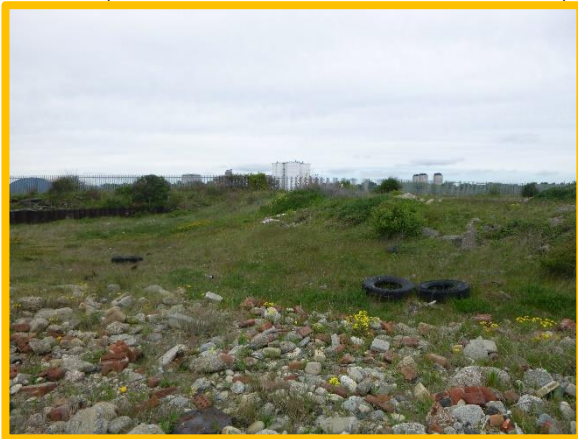
Informal transition between infill (C08) and sheet pile wall (C07). (Asset Ref. No. 121AB901B0802C07).

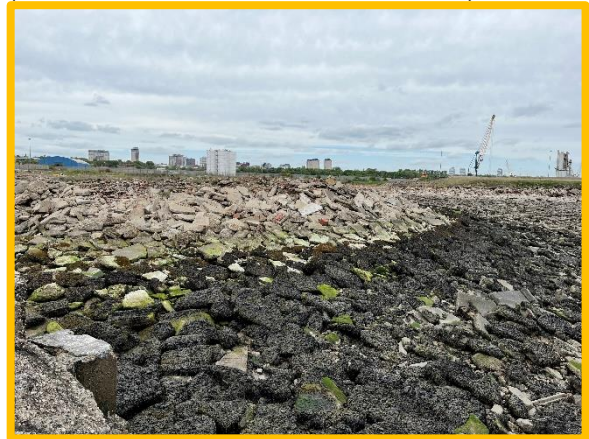
South side of basin taken from South West Breakwater. (Asset Ref. No. 121B901B02C06)

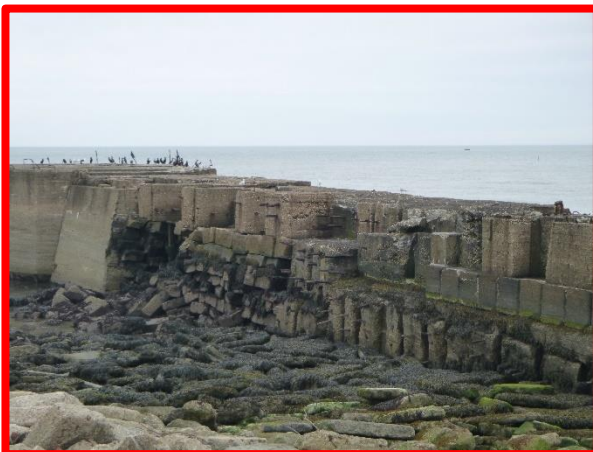
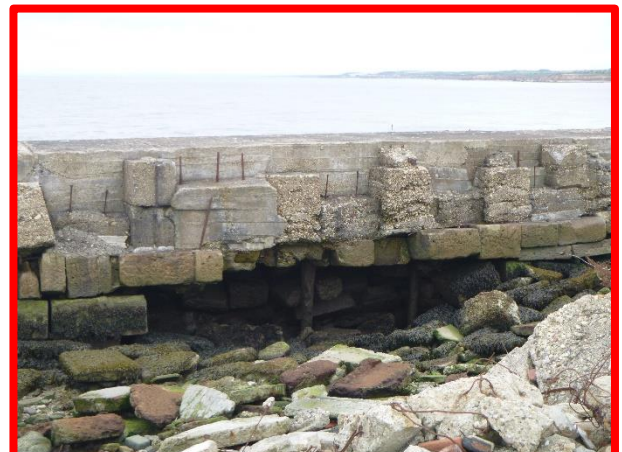
Significant displacement of blocks on landward side of SW Breakwater.. (Asset Ref. 121AB901B0802C05)

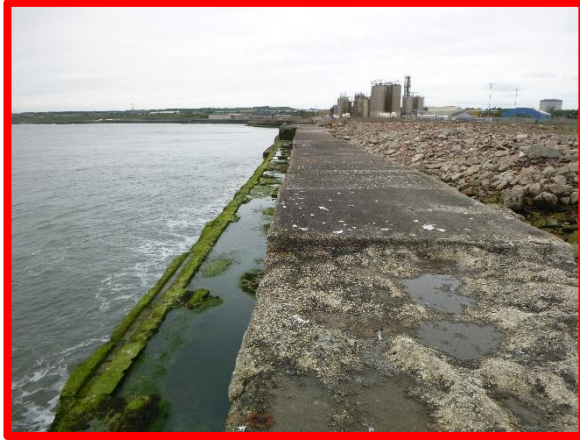
Extensive damage to concrete apron on seaward face of structure. (Asset Ref. 121AB901B0802C05)

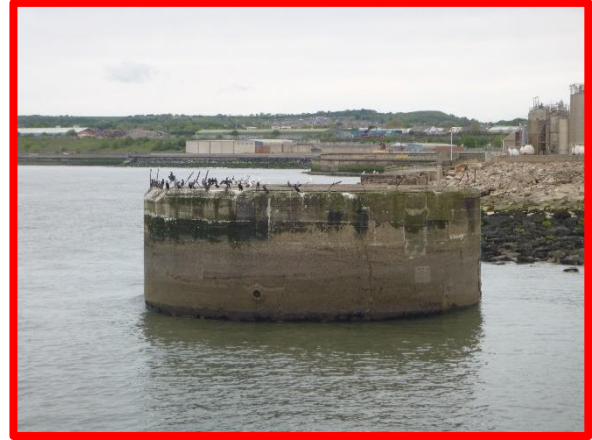
The roundhead is undercut, and the deck is heavily abraded. (Asset Ref. 121AB901B0802C05)

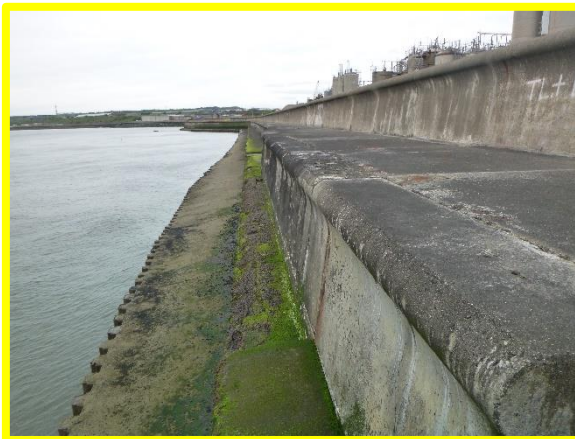
North end of Spur Barrier upper wall. (Asset Ref. No. 121AB901B0802C04)

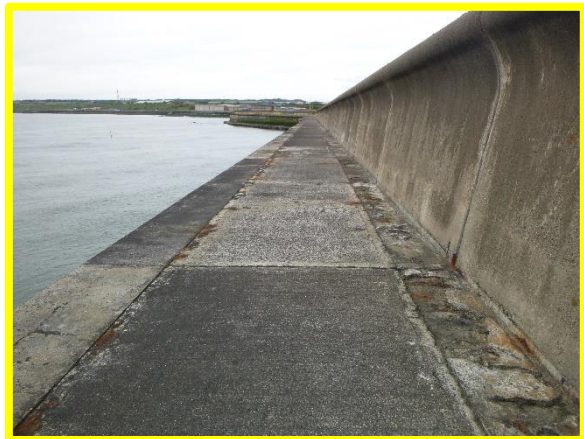
Cracking and spalling of upper sea wall. (Asset Ref. No. 121AB901B0802C04)

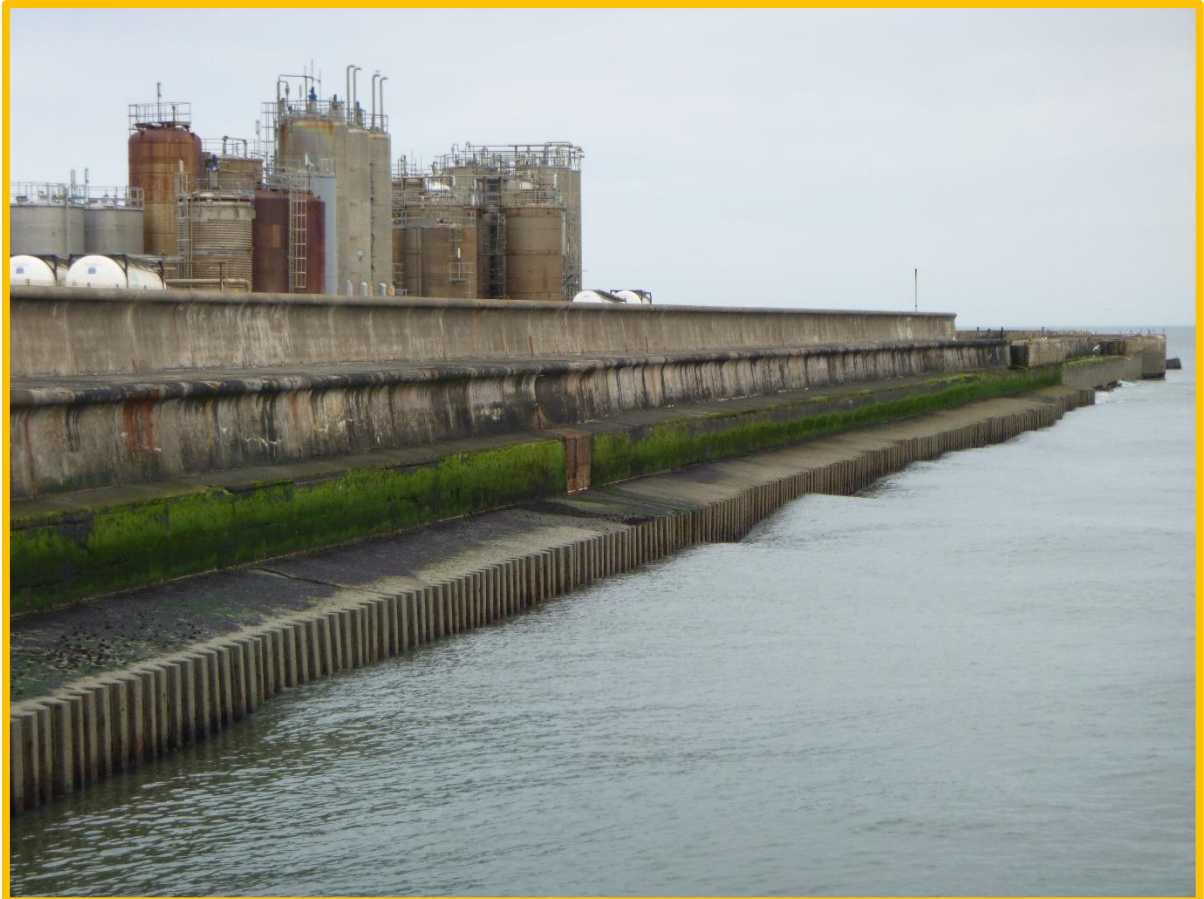
Spur Barrier wall in fair overall condition with evidence of localised damage throughout structure. (Asset Ref. No. 121AB901B0802C04)

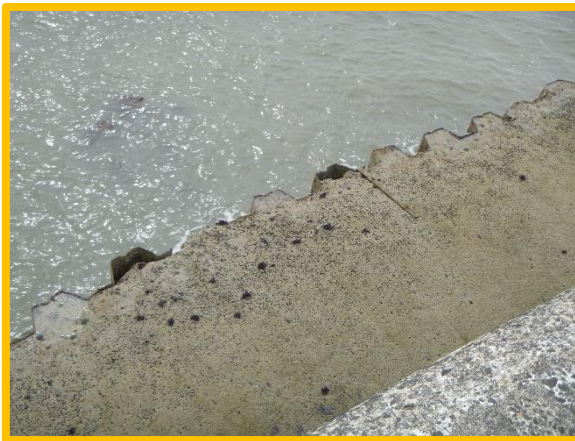
Corroded/abraded sheet pile wall at toe. (Asset Ref. No. 121AB901B0802C04)

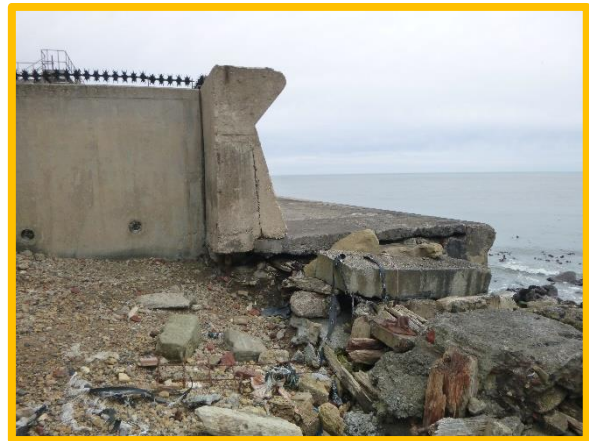
Undermining of upper seawall at south end. (Asset Ref. No. 121AB901B0802C04)

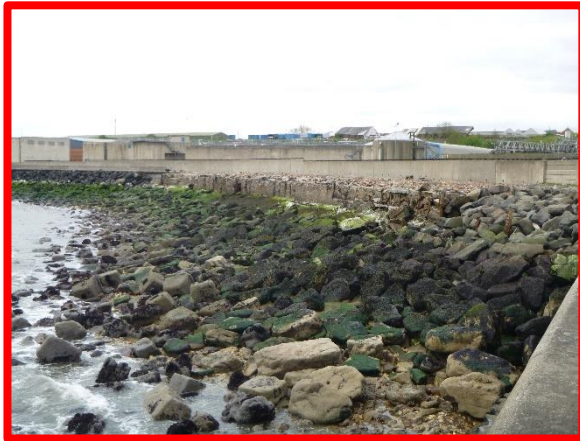
Sea wall in similar condition to 2020.
(Asset Ref. No. 121B901B0802C03)

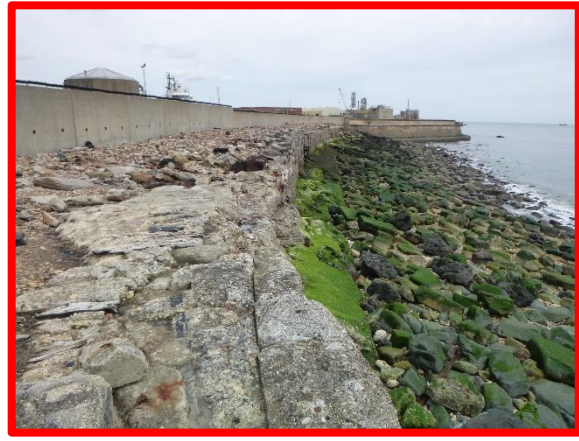
Rock armour in poor condition similar to previous inspections.
(Asset Ref. No. 121B901B0802C03)

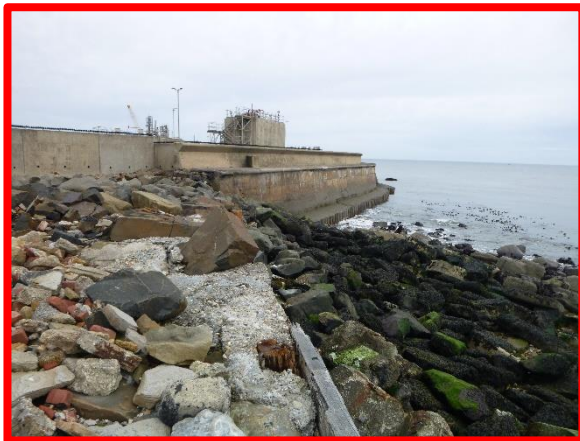
Scour hole at north end has been infilled with rock armour..
(Asset Ref. No. 121B901B0802C03)

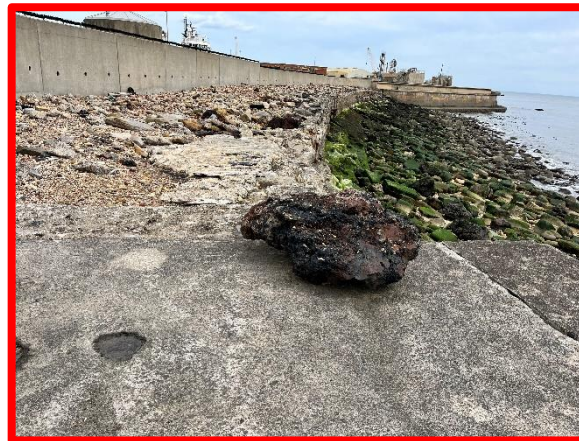
Unprotected crest apron and rear concrete boundary wall.
(Asset Ref. No. 121B901B0802C03)

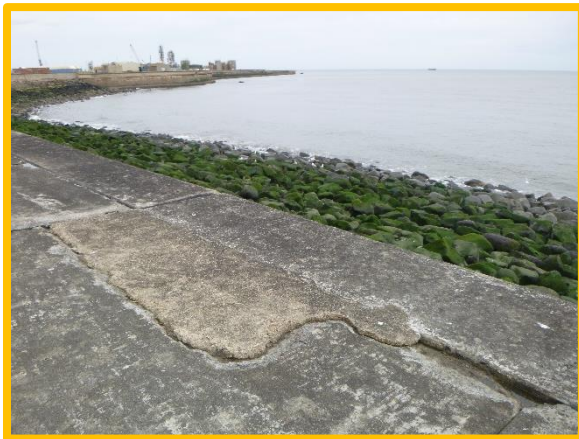
Damaged cope blocks and deck slab
(Asset Ref. 121AB901B0802C02)

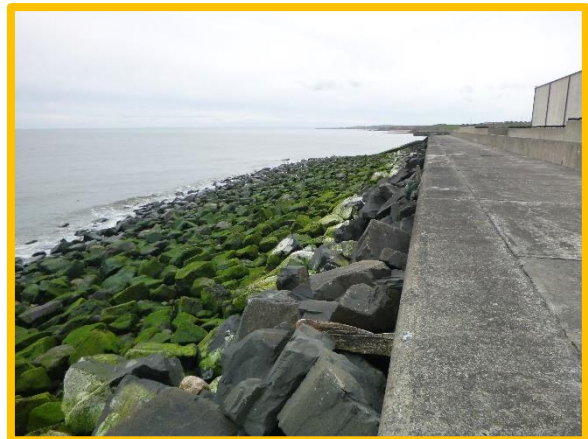
Steep, uneven rock armour profile.
(Asset Ref. No. 121AB901B0802C02)

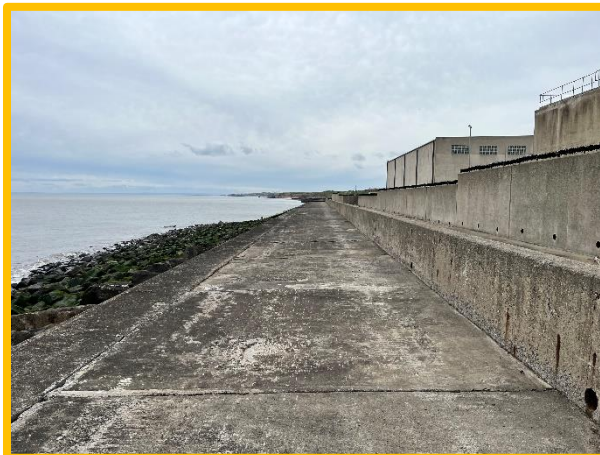
Abrasion and cracking of deck slab. (Asset Ref. No. 121AB901B0802C02)

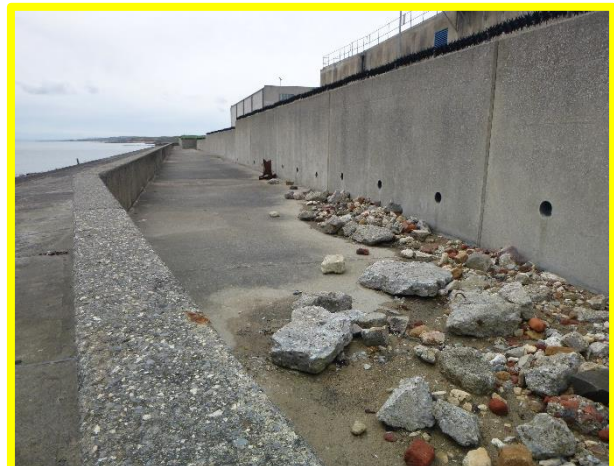
Overtopping debris between splash wall and rear boundary wall.
(Asset Ref. No. 121AB901B0802C02)

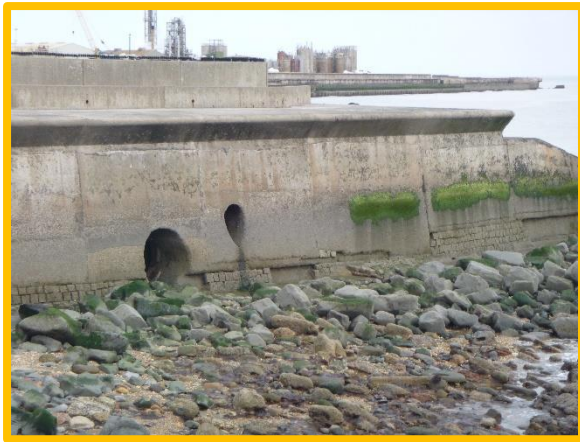
Missing facing masonry requires attention.
(Asset Ref. No. 121AB901B0802C01)

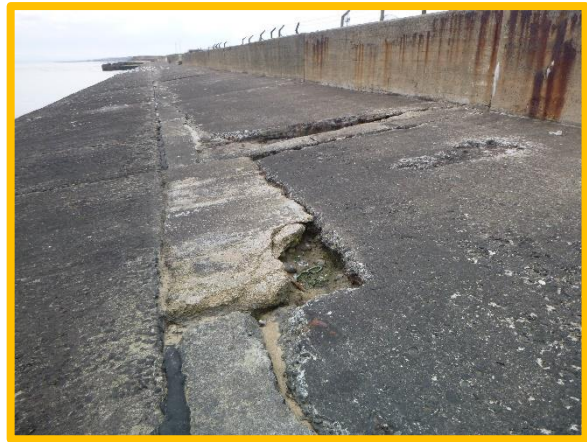
Various cracks and open joints to deck slab with past concrete repairs.
(Asset Ref. No. 121AB901B0802C01)

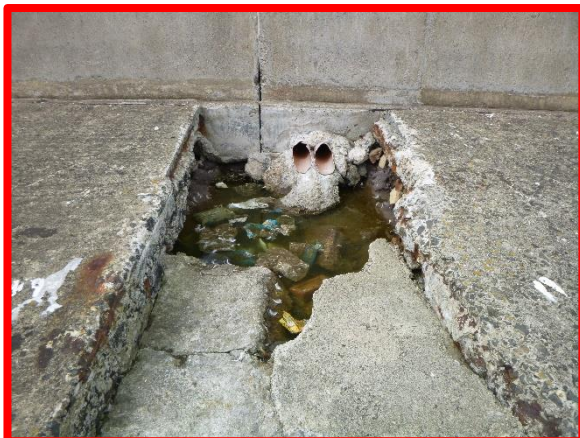
Example of damaged deck slab at outfall drain leading to washout of infill material.
(Asset Ref. No. 121AB901B0802C01)

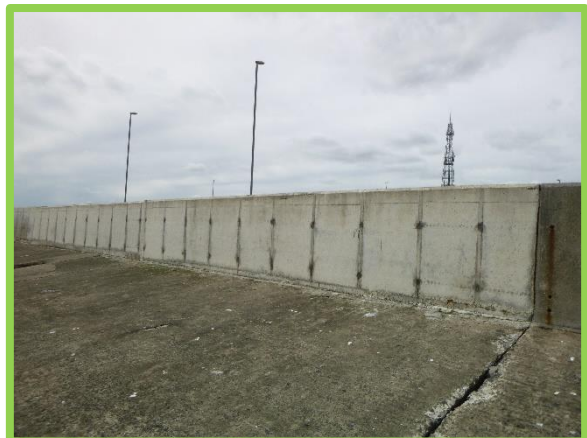
Section of recently replaced rear wall.
(Asset Ref. No. 121AB901B0802C01)

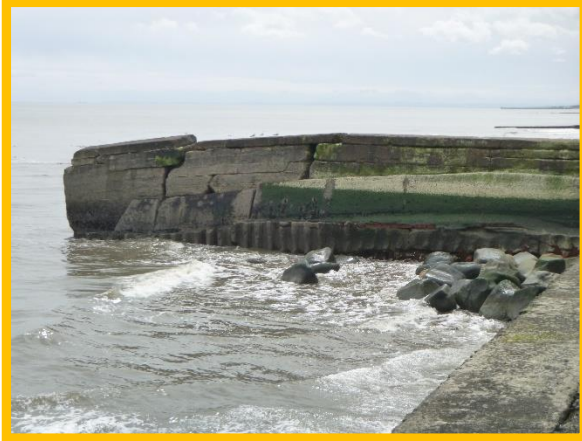
Breakwater with nose detached, from north side. (Asset Ref. No. 121AB901B0803C02.)

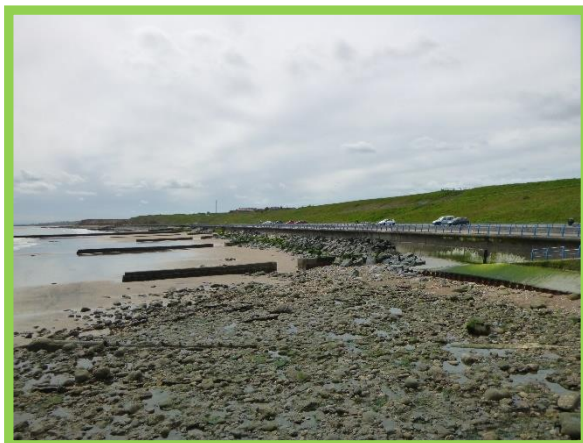
Hendon Seawall, groynes and rock armour
(Asset Ref. No. 121AB901B0803C02)

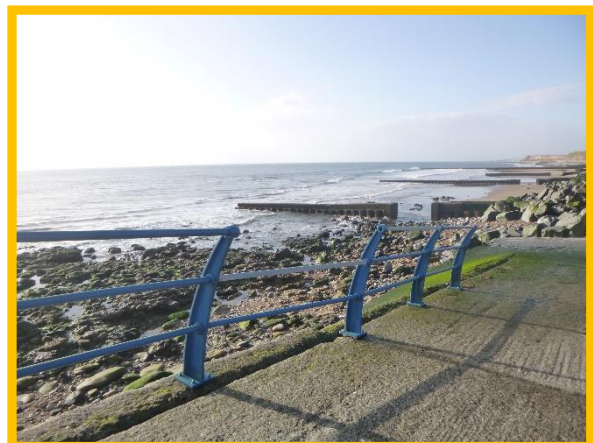
Failed railings along the northernmost ramp.
(Asset Ref. No. 121AB901B0803C02)

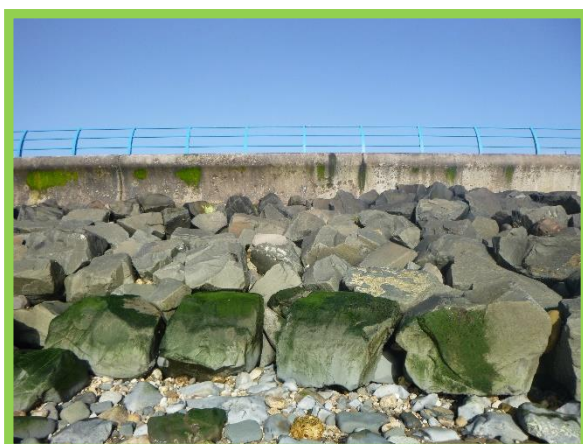
Rock armour generally in fair condition.
(Asset Ref. No. 121AB901B0803C02)

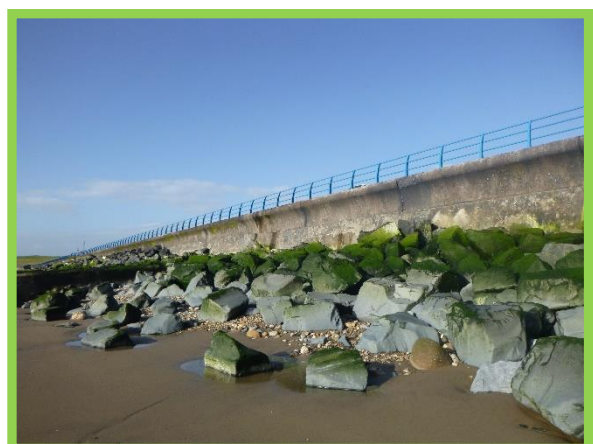
Movement of rock armour
(Asset Ref. No. 121AB901B0803C02)

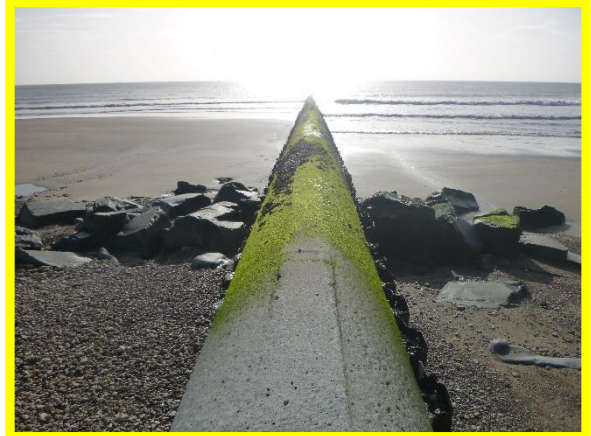
Concrete sewage outfall pipe in fair condition, heavily corroded / abraded at pile head. (Asset Ref. No. 121AB901B0803C02)

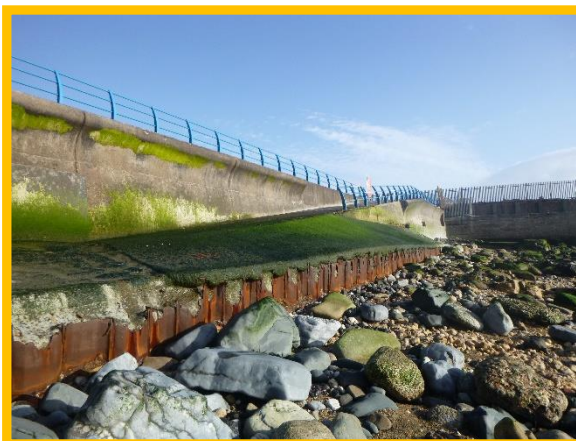
Heavily abraded and corroded steel toe piling (northernmost slipway). (Asset Ref. No. 121AB901B0803C02)

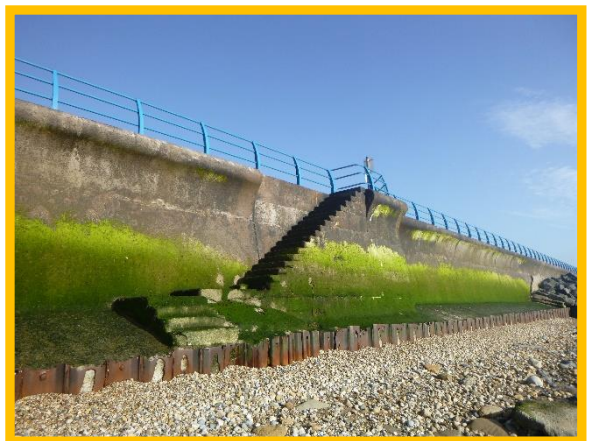
Exposed reinforcement to seawall and redundant steps. (Asset Ref. No. 121AB901B0803C02)

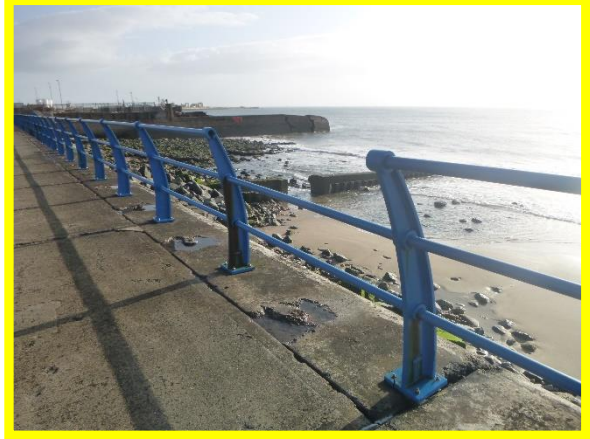
Localised section of damaged railing
(Asset Ref. No. 121AB901B0803C02).

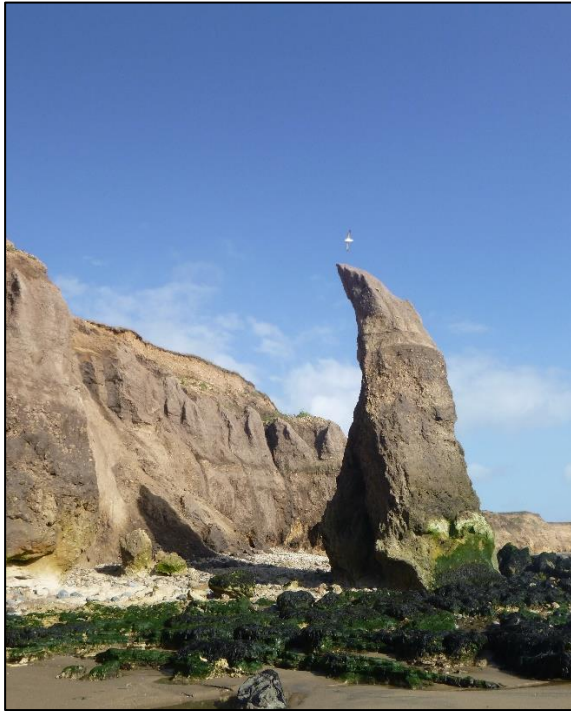
Sea stack near Ryhope Village Dene
(Asset Ref. No. 121AB901B0804C02)

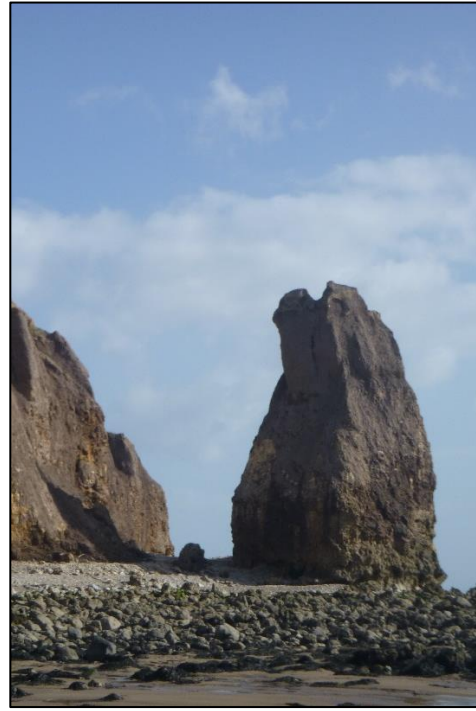
Sea stack at Pincushion
(Asset Ref. No. 121AB901B0804C02)

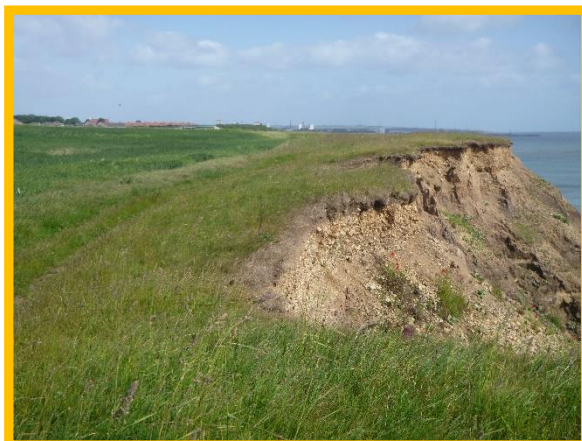
Recent slumping at Salterfen Rocks
(Asset Ref. No. 121AB901B0804C03)

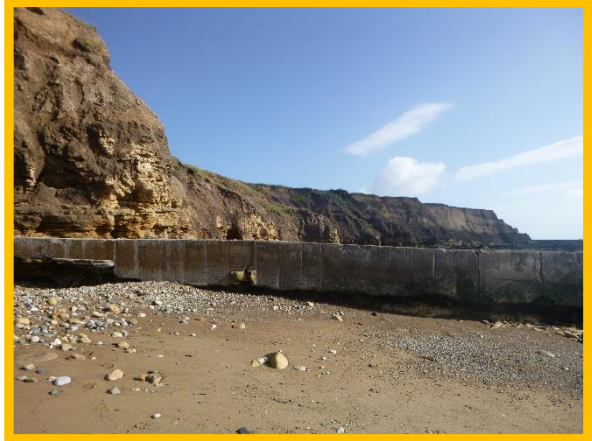
Undercutting to Ryhope Nook outfall.
(Asset Ref. No. 121AB901B0804C03)

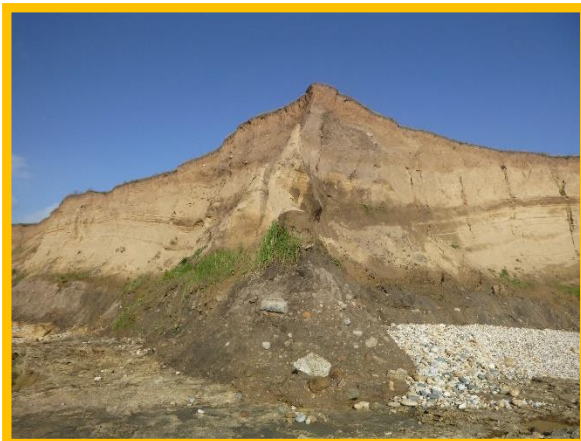
Recent Slumping along Halliwell Banks
(Asset Ref. No. 121AB901B0804C02)

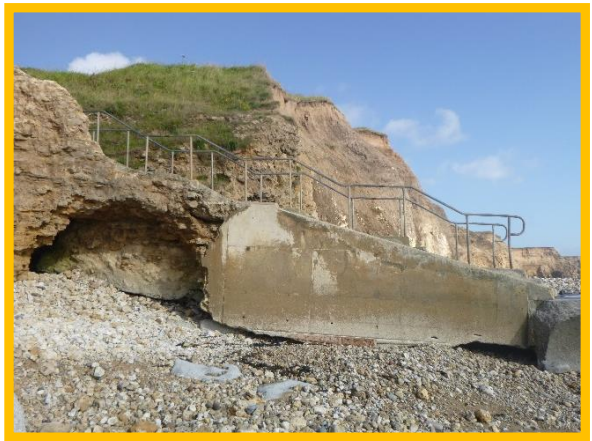
Access steps at Ryhope Village Dene in fair condition, although locally undercut.
(Asset Ref. No. 121AB901B0804C02)

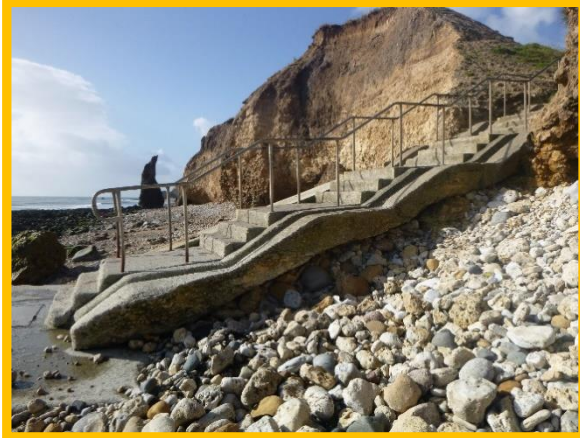
Access steps at Ryhope Village Dene in fair condition
(Asset Ref. No. 121AB901B0804C02)

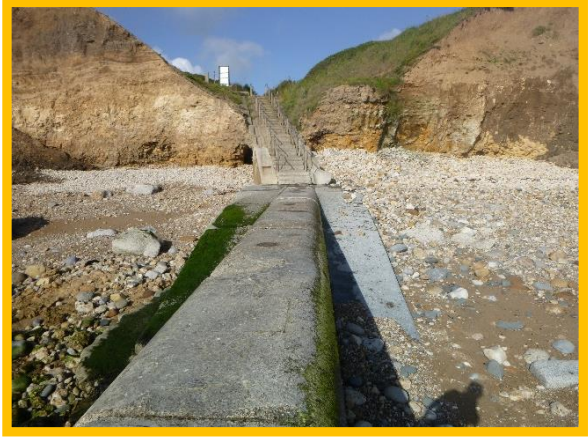
Access steps at Ryhope Village Dene in fair condition, although locally undercut.
(Asset Ref. No. 121AB901B0804C02)

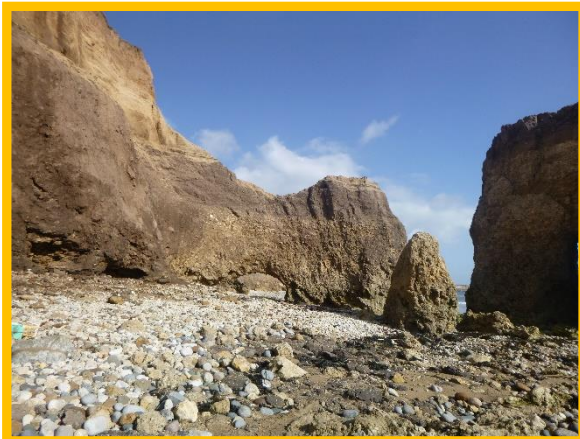
Slumping and seepage near sea stack at Pincushion (Asset Ref. 121AB901B0804C02)
