**NECAG Coast Protection Assets
and Coastal Slope Condition Analysis**

**Durham County Council
Final Report**

April 2009

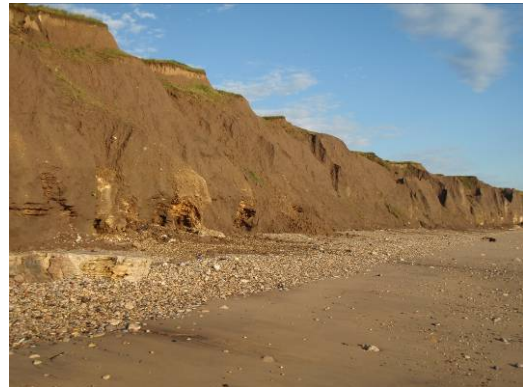
The northern section of Durham County Council's frontage, extending immediately south from Ryhope Dene, is undefended sea cliff (right). The cliffs comprise a magnesian limestone base with overlying glacial till. There is ongoing active slumping in the till, but this is relatively small-scale. Due to heavy rainfall on the previous day, the cliffs were experiencing a lot of water seepage through their face in the softer overlying material at the time of the inspection.

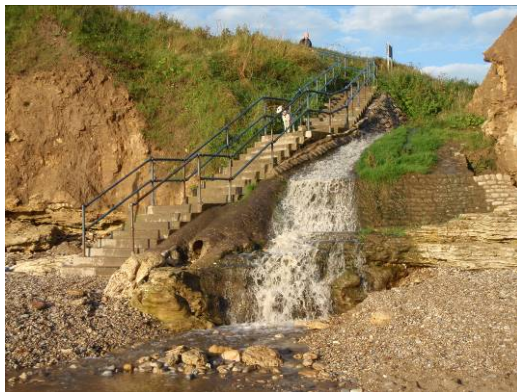
The heavy rainfall of the previous day also had the effect of causing spate in the watercourse flowing down the side of the access steps to the beach from the car park (left).

This caused a minor and temporary increase in the width of channel that is formed across the foreshore enabling drainage of the watercourse out to sea.

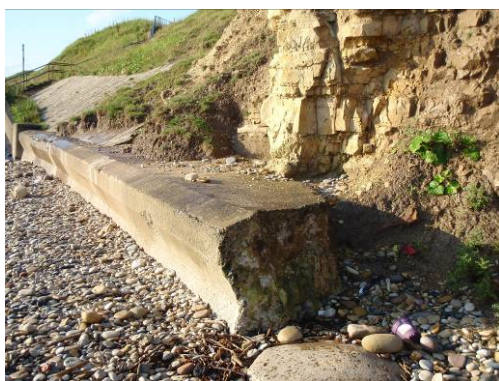
Immediately south of the car park access steps is a short undefended length of cliff which is experiencing ongoing slumping in the softer till material. Further south still is a short (about 10m) section of wall which is in poor condition and is being a little outflanked at its northern end (below left) and its crest is moderately abraded. This wall immediately grades into a larger seawall and promenade, with occasional access steps or ramps from the promenade to the beach. The grassed slope above the northern-most access ramp is covered by a blockwork revetment which is in fair condition (below right).

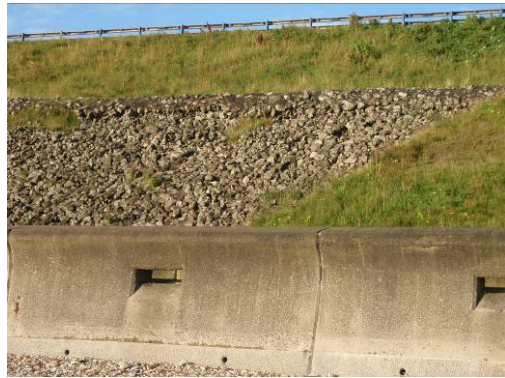
The cliffs and slopes behind the main length of seawall were mostly stable at the time of inspection, but one area had small rock placed to stabilise the slope (right).

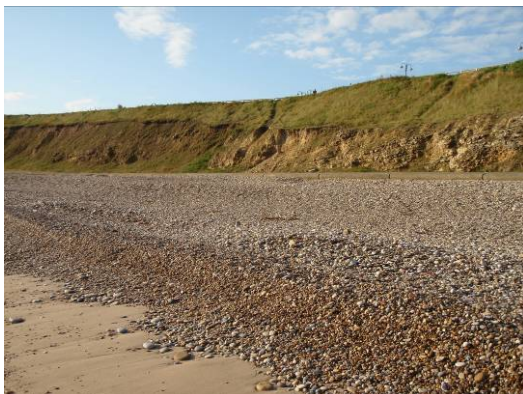
The beach condition could generally be described as 'good'. At the southern end of the frontage, beach levels almost reached the seawall crest (left).

Whilst this provides a good degree of protection to the sea wall, such extensive accretion in itself presents a problem to the Council since waves run up the 'ramp' formed by the coarser beach material, overtop the sea wall and effect the face of the backing sea cliffs.

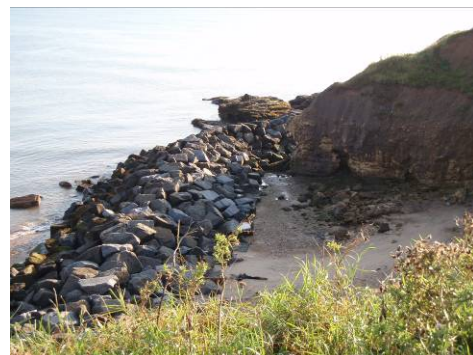
At the northern section of the headland, this is in the form of a berm located seaward of the actual toe of the cliff (right). The structure is fairly substantial in armour size and in good condition.

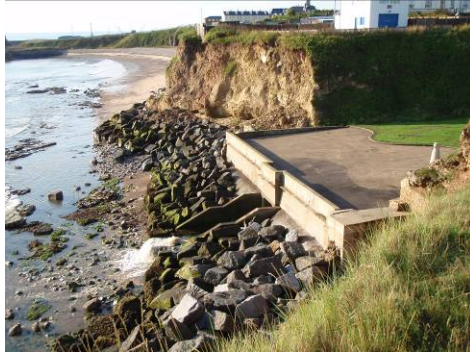
On the southern side of the headland, there is a concreted platform under which an outfall discharges to sea (left). The revetment extends around this outfall and head wall.

Whilst the concrete is in a badly abraded condition, the structure is now well stabilised by the rock armour forming the revetment.

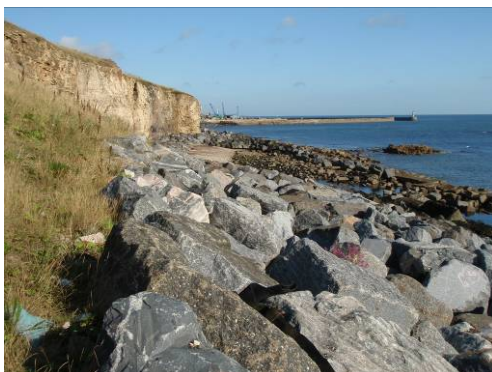
From the root of the structure protecting South Dock southwards to around Seaham Fleet Rock, a wide rock revetment has been placed (left) since the last recorded entry in NFCDD.

In the northern section, this armouring is stabilising the wall to South Dock, but further south it is protecting cliffs that previously were undefended and rapidly eroding.

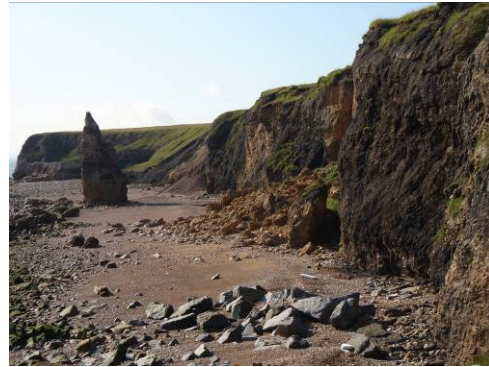
Just to the north of a rock stack on the foreshore, a recent rock fall was observed (right).

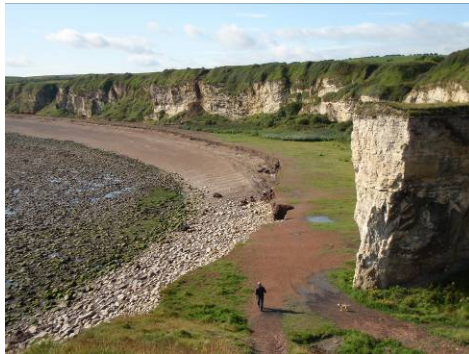
Along Blast Beach there remains a good degree of protection to the backing sea cliffs provided by the colliery waste beach in most places (left), although towards the south the width decreases notably. In local areas the soft cliff material has experienced slumping and the harder rock some vertical cracking, possibly indicative of settlement due to subsidence.
