**Cell 1 Regional Coastal Monitoring Programme  
Walk-over Visual Inspections of Assets**

**Durham County Council  
Final Report**

**September 2012**

## **Walk-over Visual Inspections of Assets**

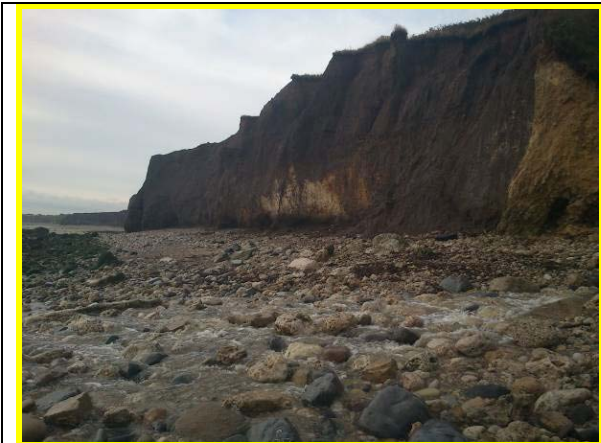
Looking south from Ryhope Dene. Frequent slumps and mudslides in upper till. (Asset ref. No. 121AB901B0804C01)

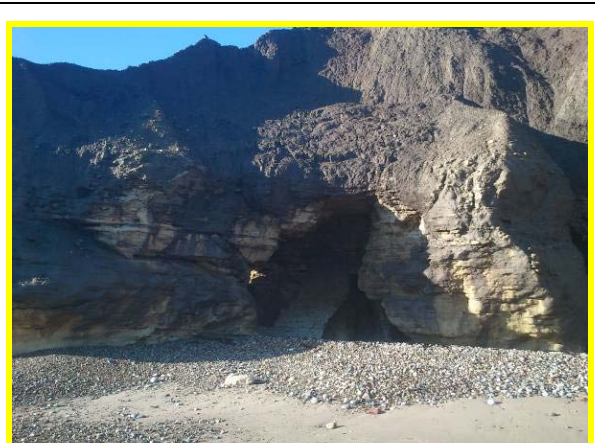
Caves in lower cliff with mudslides in till above. (Asset ref. No. 121AB901B0804C01)

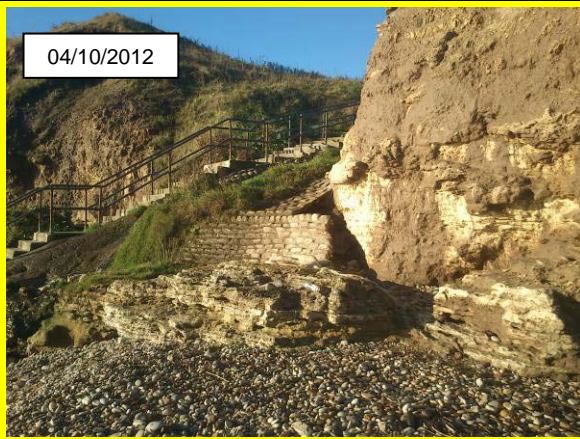
Outflanking at north of steps unchanged from 2010. (Asset ref. No. 121AB901B0804C01)

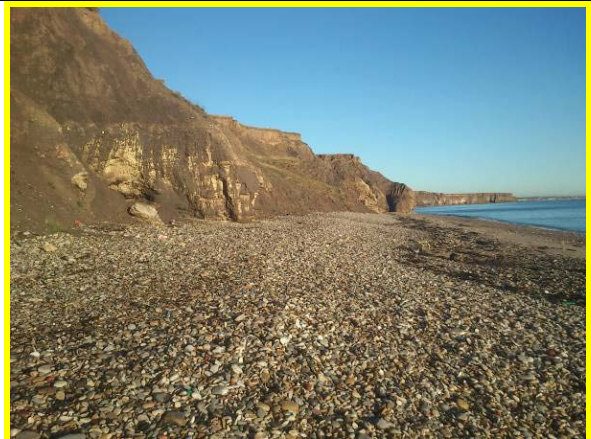
Looking north from near access steps. Mudslides covering sections of the limestone base. (Asset ref. No. 121AB901B0804C01)

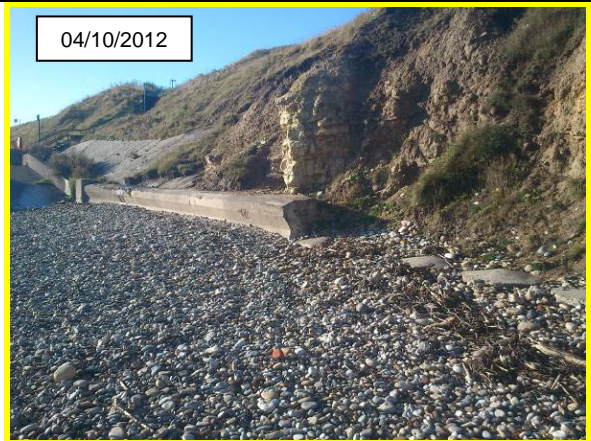
Minor outflanking at interface with wall. (Asset ref. No. 121AB901B0804C01)

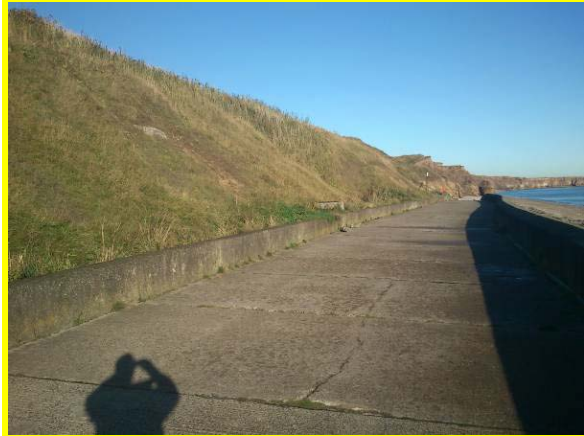
Cracks to promenade with vegetation growth.  
Well vegetated cliff to rear.  
(Asset ref. No. 121AC901C0102C01)

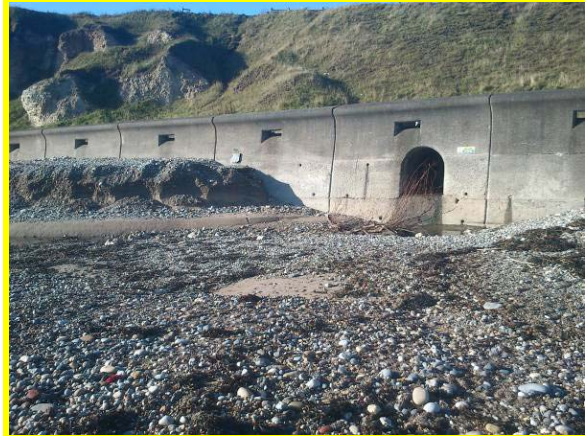
Scour channel at outfall from Seaham Dene  
(Asset ref. No. 121AC901C0102C01)

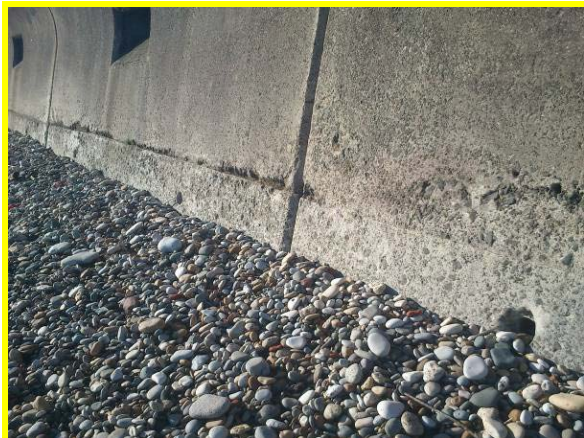
Minor abrasion damage to lower wall  
(Asset ref. No. 121AC901C0102C01)

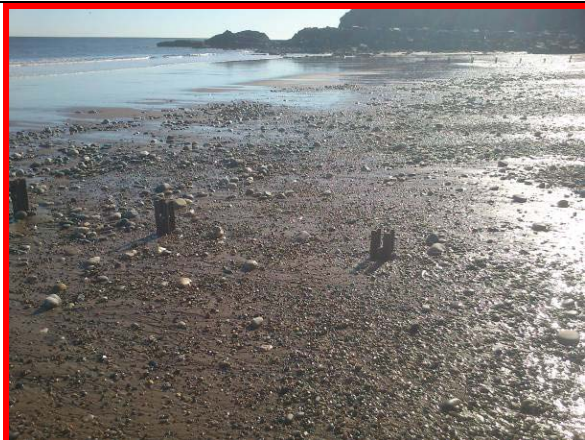
Groyne piles on beach at south end.  
Recommended to confirm redundant and  
remove to reduce H&S risks.  
(Asset ref. No. 121AC901C0102C01)

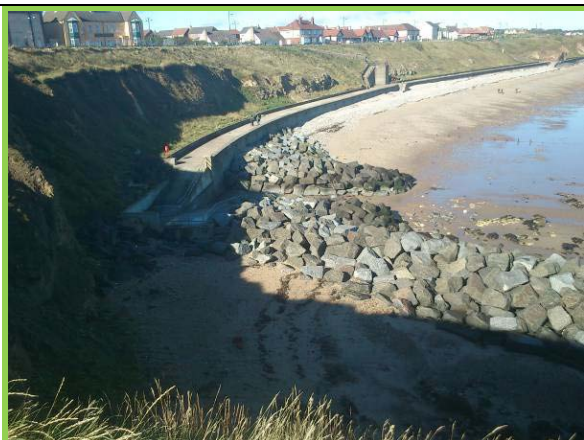
Rock armour protecting headland south of  
seawall in good condition  
(Asset Ref. No.121AC901C0103C01)

121AC901C0103C01	CPSE-220/6803/01	680301	Cliff / Scarp	NZ42914990, NZ42984992	93.5	04/10/2012	As Prev:Rock armour berm/revetment extends around Featherbed Rocks south. Armour in good condition. Some continued erosion of sea cliffs to south where berm is seaward of cliff toe. Some outflanking between concrete platform/cliffs to south of	2	2	>20	Monitor.	no repairs
121AC901C0103C02	CPSE-220/6806/01	680601 Concrete wall to base of eroding cliff. Rock protection scheme under study.	Wall	NZ43024978, NZ43004984	72.6	04/10/2012	Rock armour revetment in good condition, but erosion of cliff edge continues due to weathering.	2	2	>20	Monitor.	no repairs
121AC901C0103C03	CPSE-220/6804/01	680401 Concrete wall to base of eroding cliff. Very poor condition. Collapsed slab behind. Rock protection scheme under study.: Emergency rock armour repairs to breac	Wall	NZ42994986, NZ42984992	78.6	04/10/2012	Rock armour revetment constructed in front of cliff toe. Some ongoing erosion of cliff behind through weathering.	2	3	11 - 20	Monitor cliff behind armour	no repairs

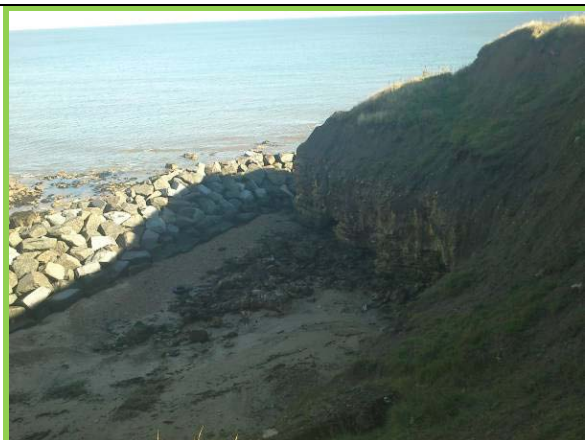
Continued slumping of upper cliff behind rock  
armour berm.  
(Asset Ref. No. 121AC901C0103C01)

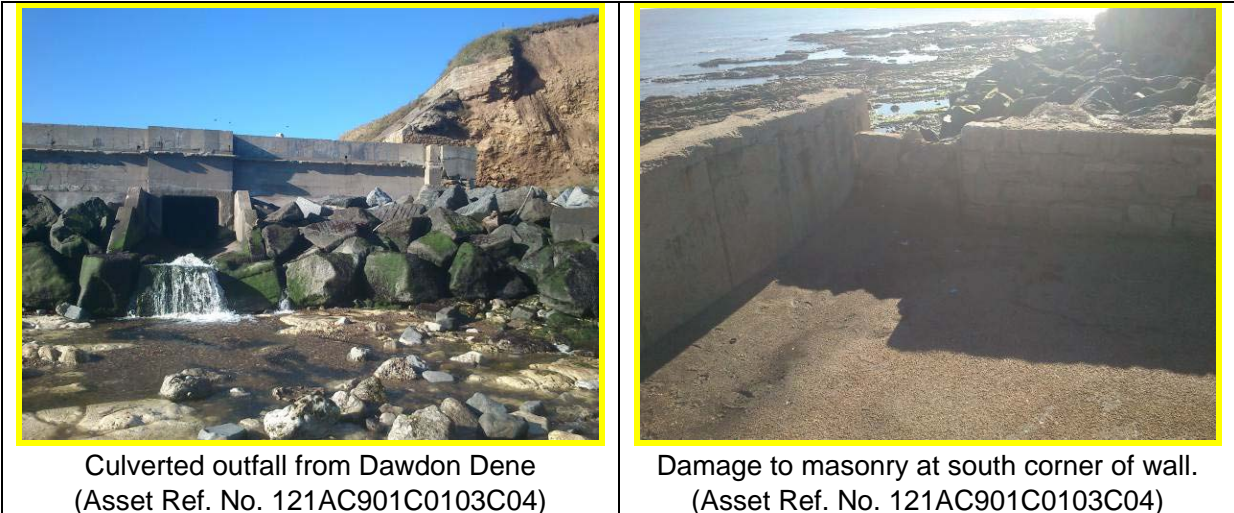
South of the headland, the rock armour protects a short length of concrete wall with a large outfall from the culverted Dawdon Dene, (below left), which is NFCDD asset 121AC901C0103C04. At the north and south of the wall there is some masonry placed to fill the previous slight outflanking at the tie-in to the limestone cliffs. This has been damaged at the south corner, see below right and needs a small repair. The crest wall has vertical cracks which should be repaired.

121AC901C0103C04	CPSE-220/6805/03	680503 Gunnited rock toe to wall. Rock protection scheme under study.	Apron	NZ43004984, NZ42994986	22.6	04/10/2012	Rock armour protecting short length of wall with large outfall. Wall in fair condition, armour good. Damage to wall at S corner where ties into eroding rock outcrop.	3	3	11 - 20	Monitor for outflanking. Repair cracks in crest wall.	routine
121AC901C0103C05	CPSE-220/6808/01	680801 Slipping cliff. To path and police station.	Cliff / Scarp	NZ43114957, NZ43204952	103.9	04/10/2012	As previous survey. High levels of pebble beach berm protecting cliff toe. Healthy beach levels and no signs of slipping in the cliff.	2	2	>20		no repairs
121AC901C0103C06	CPSE-220/6807	undefended	Cliff / Scarp. Limestone	NZ43114957, NZ43024978	223.3	04/10/2012	Fair. Partly undefended, but is a 'transition zone' from rock armour to north to undefended frontage. Cliffs in south well vegetated, but with signs of continued slumping. Erosion and slumping continue in north, with sheds / fence close to edge.	3	4	>20	Public safety needs monitoring - access to cliff top controlled by fencing.	routine

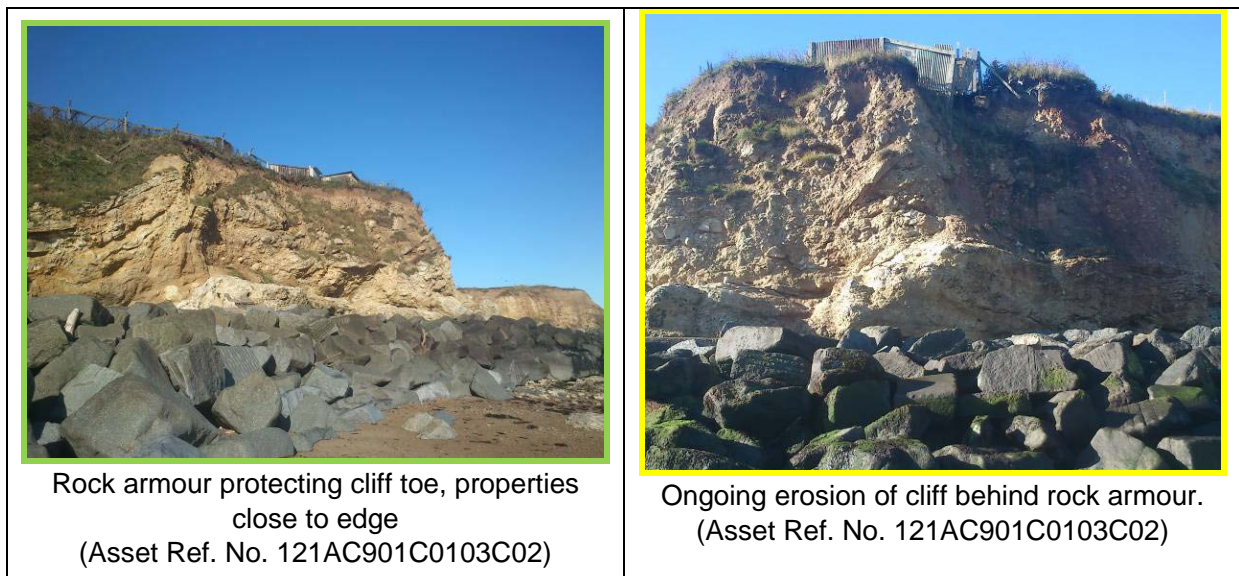
The rock revetment extends around the small headland to south of the outfall. Although the rock armour is in good condition the limestone cliff is continuing to erode through weathering, see below right, and this is putting the cliff top properties and boundary fence at imminent risk from erosion see below.

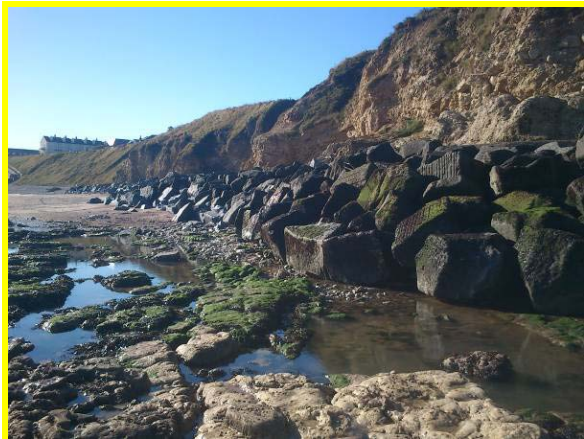
Rock armour protecting cliff toe tapers out  
(Asset Ref. No. 121AC901C0103C06)

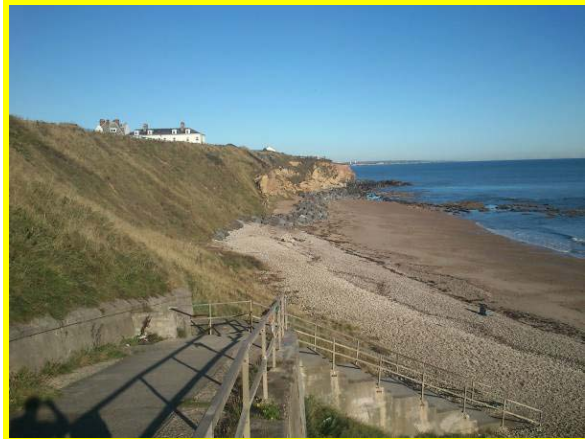
Signs of previous slumping in cliff to north of  
beach access ramp.  
(Asset Ref. No. 121AC901C0103C06)

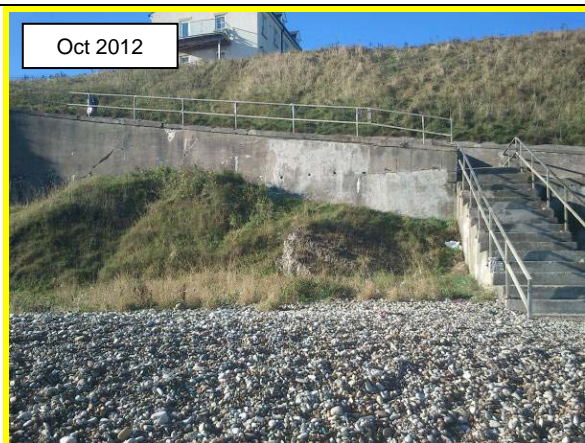
The beach access ramp and steps are supported by a vertical concrete wall, below left that has a large diagonal crack through the full height. The crack is also present on the photo from in 2010 so the situation does not seem to have significantly worsened. There was also minor cracking to retaining wall at toe of slope to rear of ramp.

Beach access ramp and steps.  
(Asset Ref. No. 121AC901C0103C07)

121AC901C0103C07	CPSE-220/6808/01	680801 Slipping cliff. To path and police station.	Cliff / Scarp	NZ43134950, NZ43094957	84.1	04/10/2012	Diagonal cracking to seaward face of wall retaining access ramp/steps. Beach levels high. Minor cracking to retaining wall at toe of slope to rear of ramp.	3	4	11 - 20	Repairs to cracks.	routine
121AC901C0104C01	CPSE-220/6812/02	681202 Recurved splash wall set back from main wall. Protection against overtopping into South dock.	Splash Wall	NZ43414885, NZ43424897	190.7	04/10/2012	Only viewed from distance due to access restrictions to port. Rock armour revetment appears to still be in very good condition.	1	1	>20	2-yearly inspections.	routine

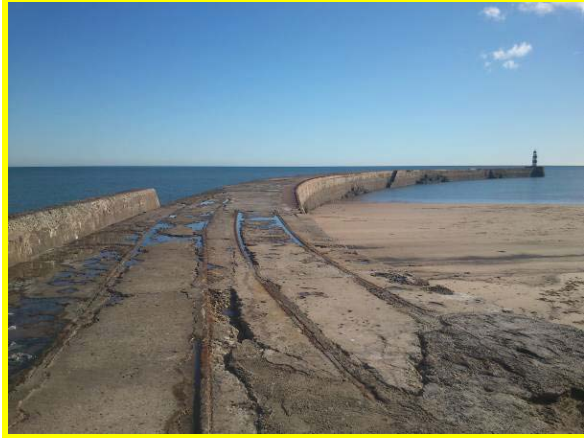
The North Pier was viewed through the locked access gate, see photo below left. The concrete deck shows significant damage and weathering, see photo below left, although the massive structure still clearly provides an effective coast protection function and is therefore assumed to be in fair overall condition.

View of North Pier  
(Asset Ref. No. 121AC901C0104C03)

It is recommended that more detailed inspections, including vessel based and underwater inspection are undertaken by the Dock Company once the regeneration project is complete and if not already in progress a maintenance programme should be put in place.

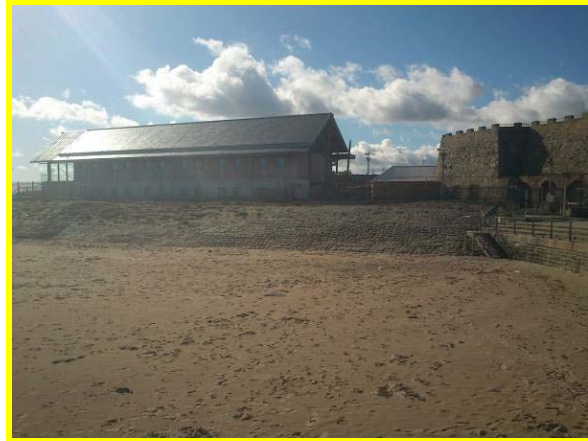
The dressed masonry wall at the back of the beach in the outer harbour appeared to be in fair condition when viewed from a distance, below right.

Dressed masonry revetment slope with new marina building to rear.  
(Asset Ref. No. 121AC901C0104C05)

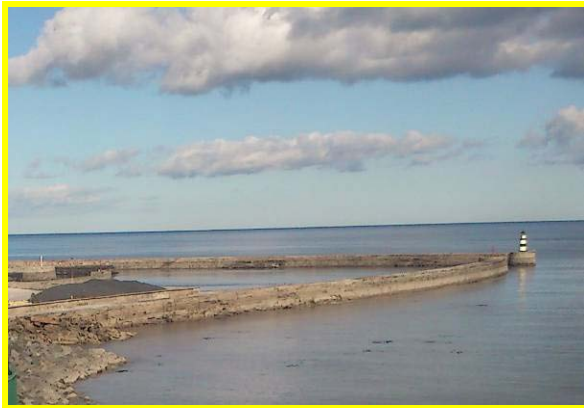
The South Pier was only inspected from a distance as it is within the port operational area, see photos below. The main pier appeared to be in fair overall condition, although there are visible areas of damage seaward of the rock armour. At the root of the pier rock armour has been placed at the tie in to the coast, below right as part of a previous phase of regeneration. The armour continues to the south protecting the port access road and appeared to be in very good condition.

View of South Pier  
(Asset Ref. No. 121AC901C0104C17)

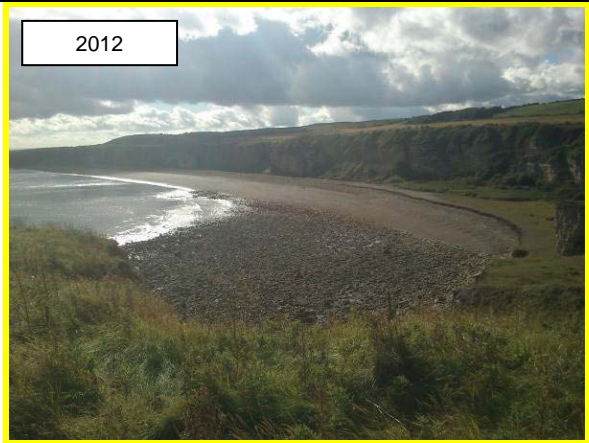
Eroding colliery Spoil at Blast beach  
(Asset Ref. No. 121AC901C0107C01)

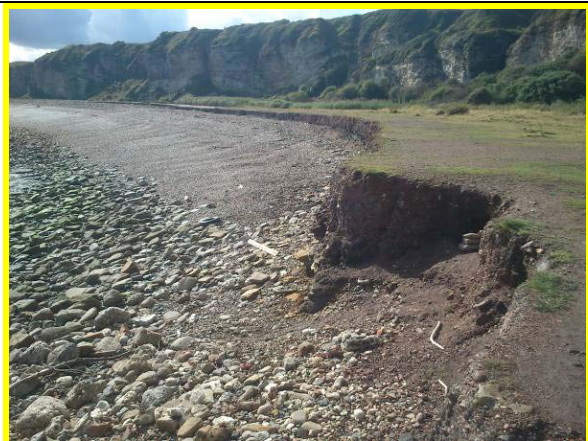
Eroding spoil at north end of Blast beach  
(Asset Ref. No. 121AC901C0107C01)

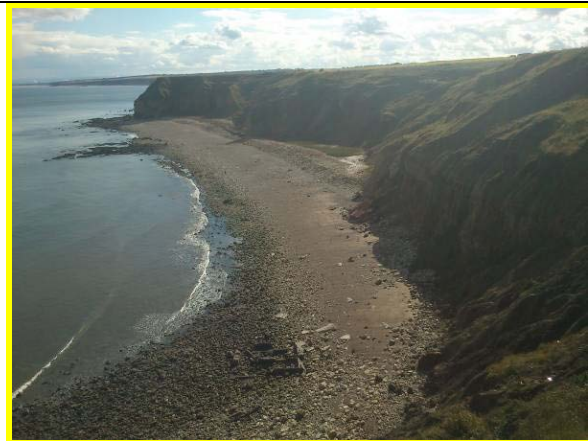
View of beach at Easington Colliery, between  
Loom and Fox Holes showing colliery waste in  
centre of bay and localised slumps and a cliff  
fall in the centre of the picture  
(Asset Ref. No. 121AC901C0201C01)

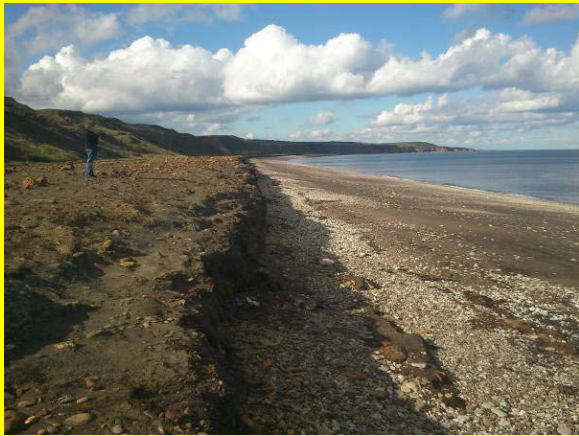
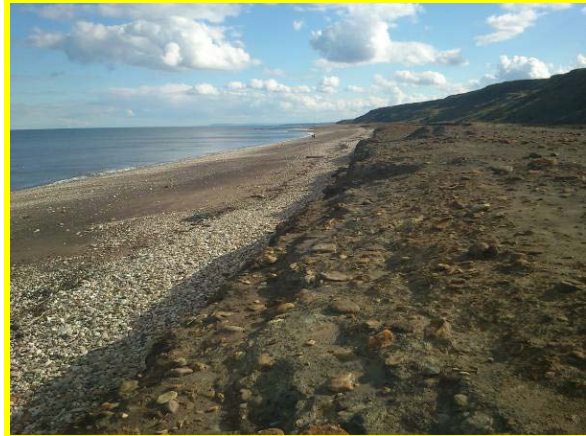
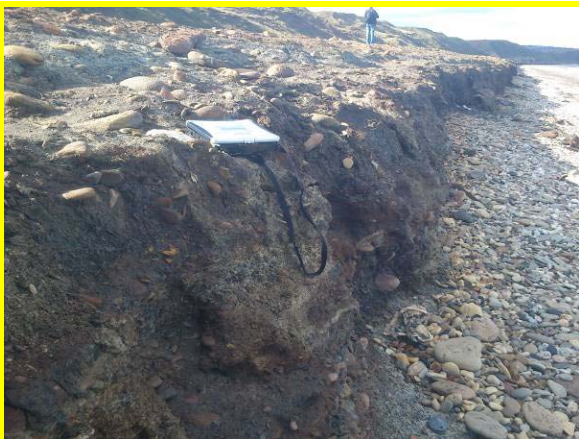
At the time of the inspection the eroding face of the colliery spoil had formed a low cliff on the beach between 0.5m and 1m in height, see below. Seaward of the beach cliff there was a large cobbles wedge at the back of the inter-tidal beach. It was noted that the upper beach

Eroding edge of colliery spoil at Horden Beach  
(Asset Ref. No. 121AC901C0201C02)

is used by a number of recreational vehicles. This should be discouraged as the cliff at the edge of the eroding waste forms a significant hazard that can change on a daily basis.

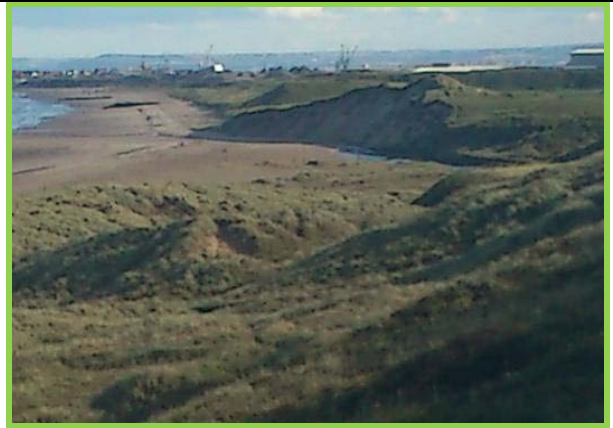
Sand dunes at Crimdon Beck, showing erosion  
of dune face to south (Asset Ref. No.  
121AC901C0301C01)
