Cell 1 Regional Coastal Monitoring Programme Walkover Inspection Surveys 2022

Durham County Council

June 2022

Walkover Inspection Surveys 2022

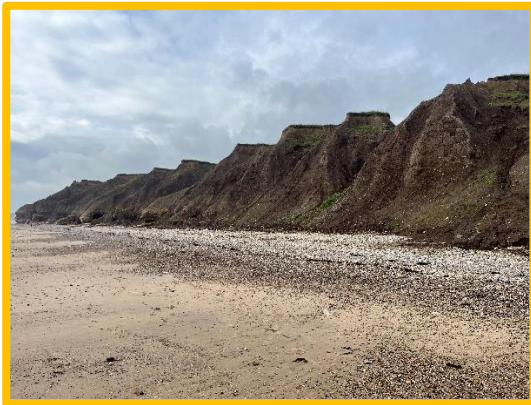
Glacial Till slumping along the majority of the frontage (/0804C01)

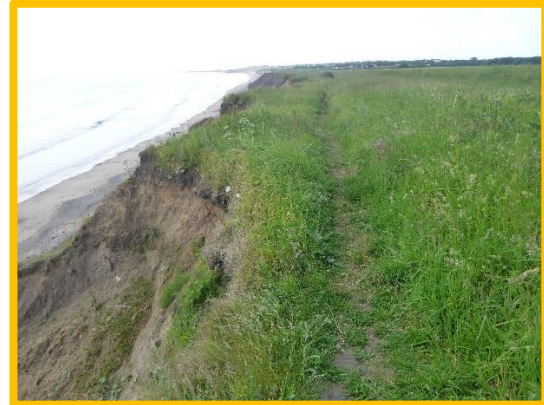
Along the asset length, the England Coast Path runs in close proximity to the cliff top, within 0.5m in places. It is likely the footpath will need to be rolled back in the near future as the cliff continues to retreat.

England Coast Path in close proximity to retreating cliff top (/804C01)

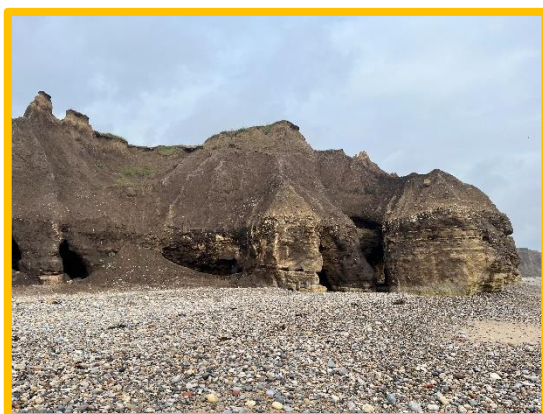
Undefended sea cliffs with till sitting on limestone (/0804C01)

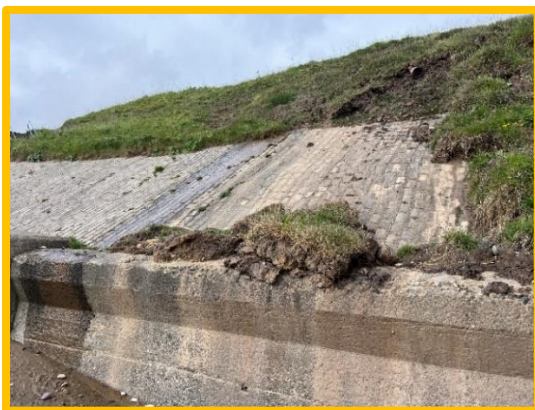
Bulging blockwork revetment and small slippage of till above. (/0102C01)

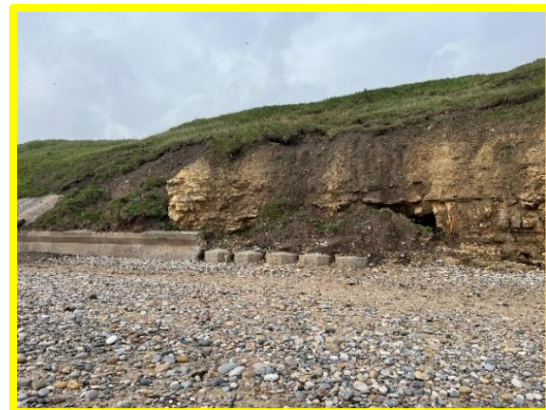
Minor outflanking to low level wall. Low beach levels exposing concrete blocks. (/0102C01)

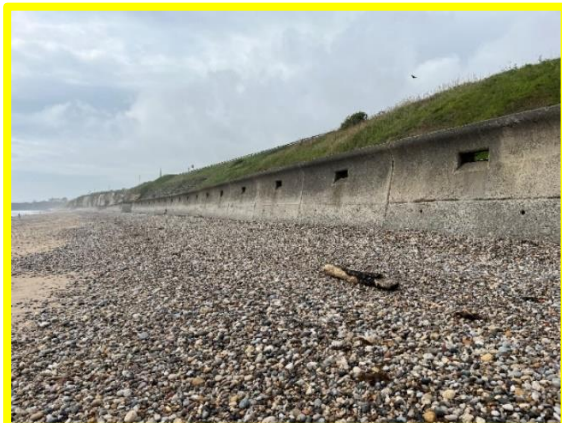
Northern section of Seaham sea wall with minimal abrasion (/0102C01)

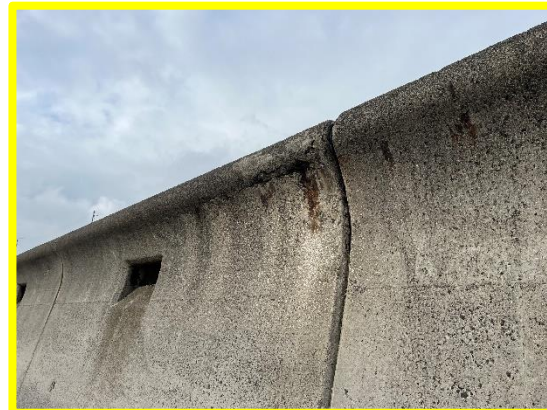
Horizontal cracking to bullnose (/0102C01)

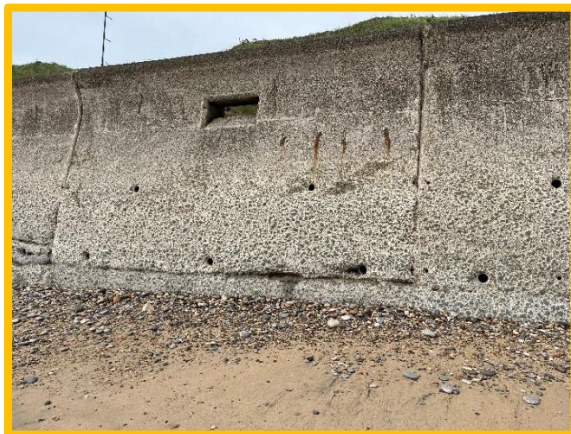
Spalling of bullnose on sea wall to the south (/0102C01)

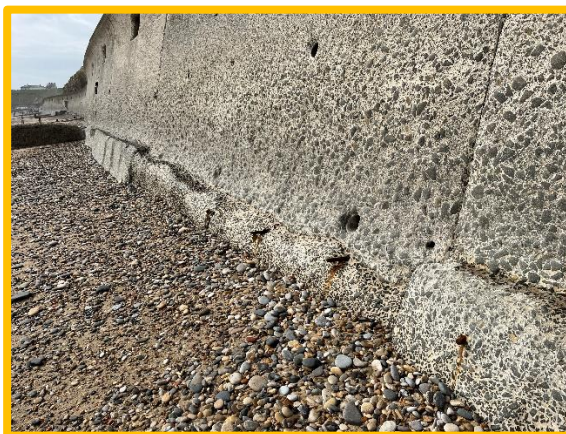
The abrasion damage to the main sea wall increases to the south, roughly corresponding with the location of the failed beach groynes. The abrasion in some locations has exposed the reinforcement in the face of the wall and also in the concrete toe beam. In local areas, spalling/corrosion damage was noted to the bullnose of the seawall, again worsening with progression south. All plastic and cast iron flap valves along the wall have failed and are absent.

Heavily abraded wall exposing reinforcement (/0102C01)

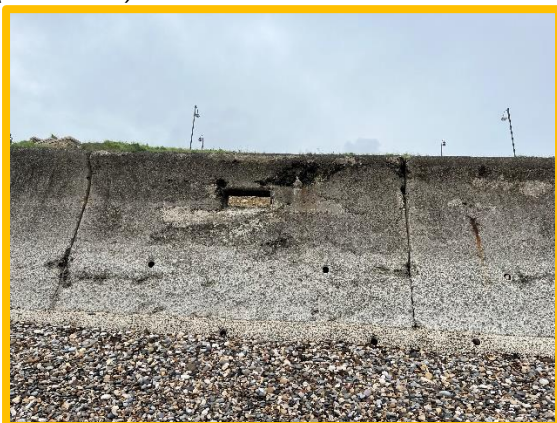
Heavily damaged section of sea wall to the south (/0102C01)

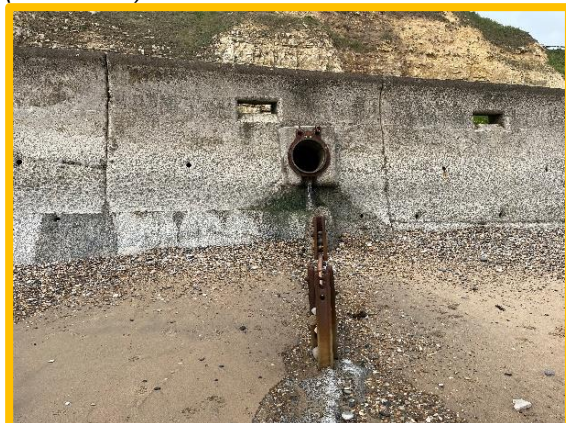
Missing cast iron flap valve (/0102C01)

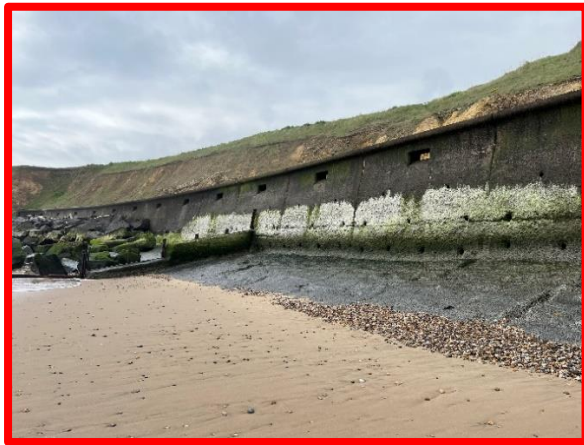
High beach levels concealing failed section of concrete apron identified in 2020 (/0102C01)

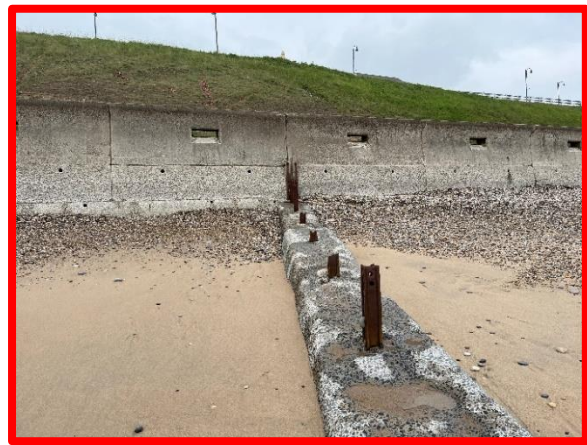
Remnants of derelict groynes (/0102C01)

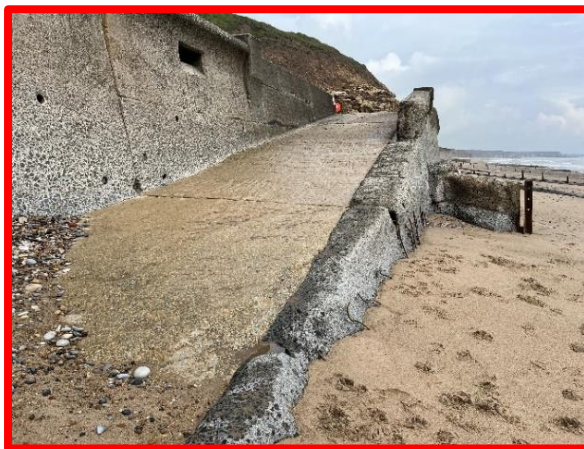
At the southern end of the sea wall, the access ramp is heavily abraded and its deck is cracked/broken locally exposing underlying fill which may be vulnerable to washout. It was reported in 2018 and 2020 that reinforcement is exposed due to abrasion damage posing a health and safety hazard. It is recommended that remedial works should be undertaken to trim protruding bars.

Hole in deck of ramp and exposed reinforcement (/0102C01)

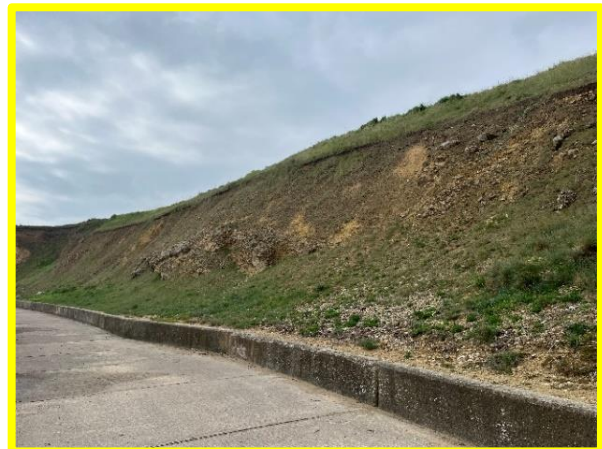
The cliffs behind the promenade are steeper and past episodes of slippage have left a headscarp visible. No 'fresh' slippages have been noted since the 2020 inspection, indicating a period of stability.

Headscarp in backing cliffs formed by previous slippages (/0102C01)

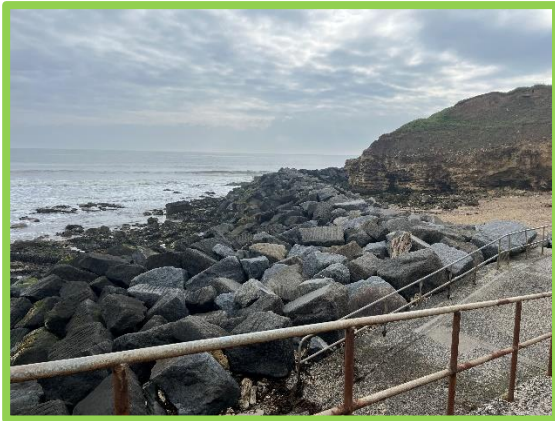
Rock berm around Featherbed Rocks headland (/0103C01)

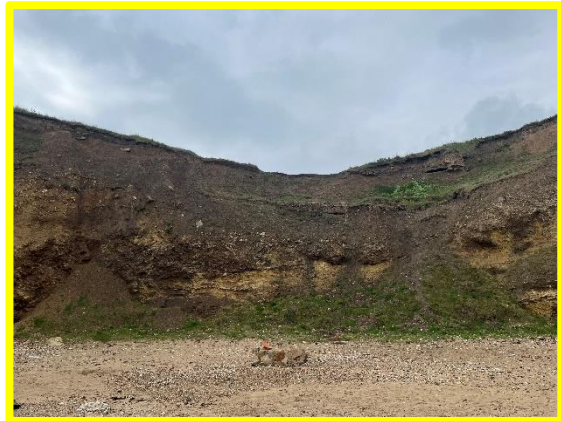
As previously reported, some cliffs to the rear of the rock armour still show evidence of slow erosion and slumping of the upper till layers. This is particularly apparent at the northern face of Featherbed Rocks headland where evidence of small failures were again apparent in 2022.

Small scale failures to North face of Featherbed Rocks headlands (/0103C01)

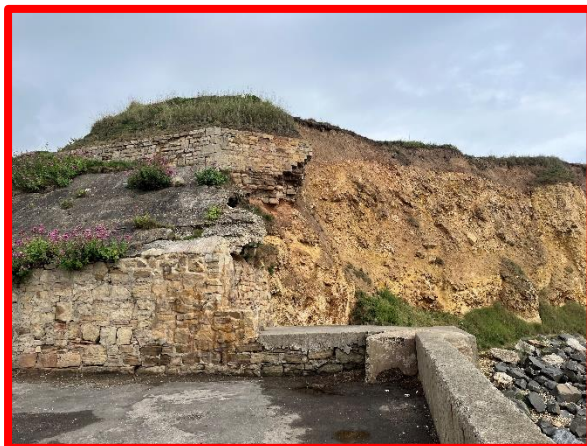
At the tie-in between the outfall's concrete platform and the cliffs to the north, a section of masonry wall above a sloping poured concrete revetment has failed, leaving a section of the wall partially suspended. Although no change was again identified in 2022, this remains an area of concern as a secondary failure appears imminent.

Masonry wall and concrete revetment at tie-in to cliffs breaking-up (/0103C04)

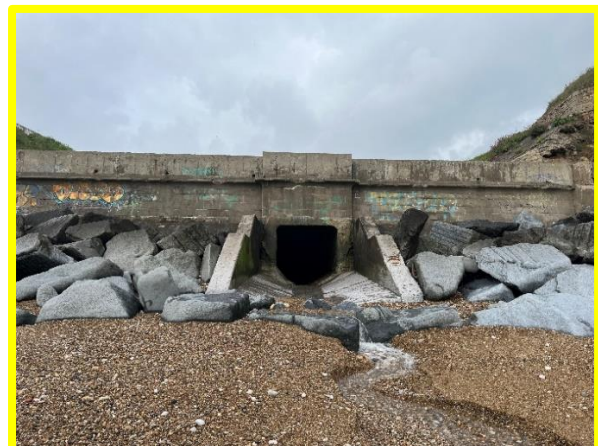
Rock berm around Dawdon Dene culvert and further south (/0103C04)

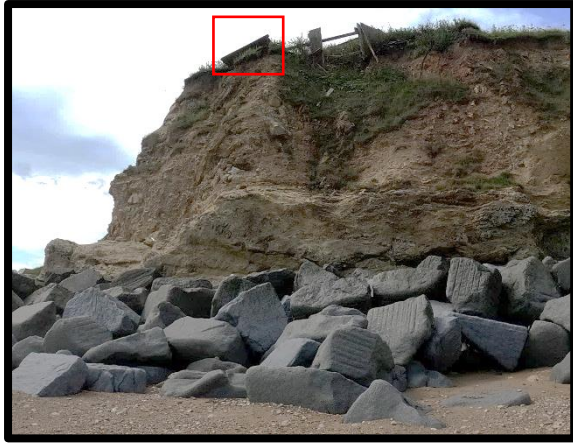
Erosion affecting fence line of properties to south Dawdon Dene Outfall -2018 (/0103C02)

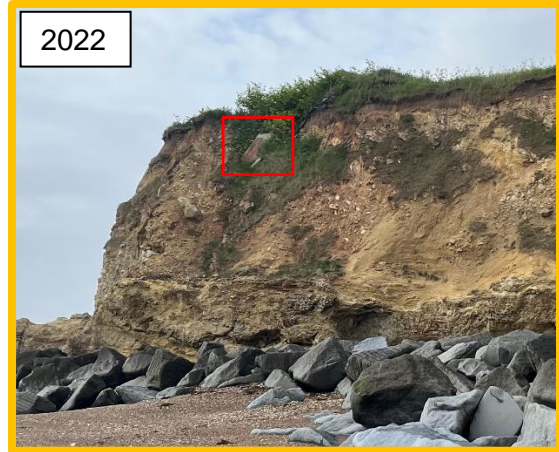
Immediately south of the outfall's concrete platform, cliff recession continues to affect the fence line in the vicinity of the Coastguard Station. In 2022, it was noted a sheet of corrugated steel, previously observed forming part of the fence line, had been displaced and was located on the cliff face itself suggesting further erosion had occurred in this location.

Erosion affecting fence line of properties to south Dawdon Dene Outfall - 2020 (/0103C02)

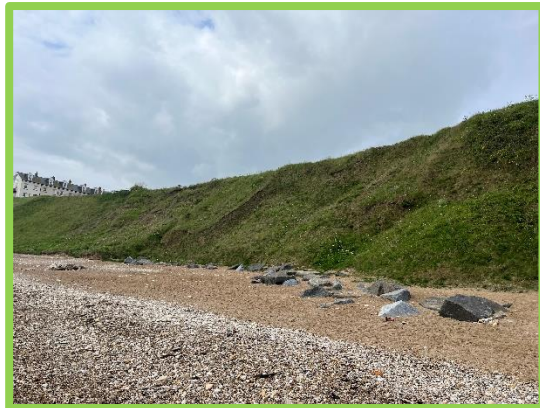
Local slumps in cliffs (/0103C06)

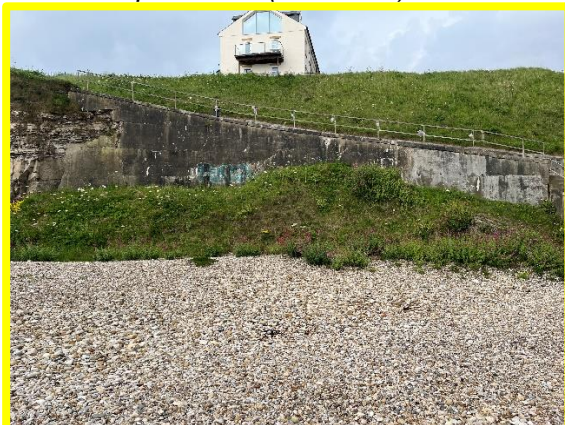
Cracking in retaining wall to access steps and ramp (/0103C07)

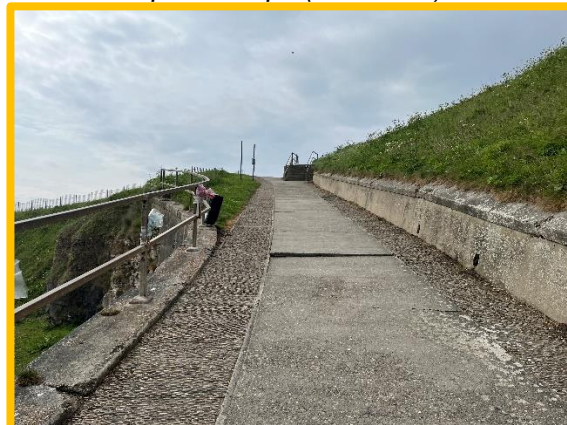
Movement of deck slabs in access ramp (/0103C07)

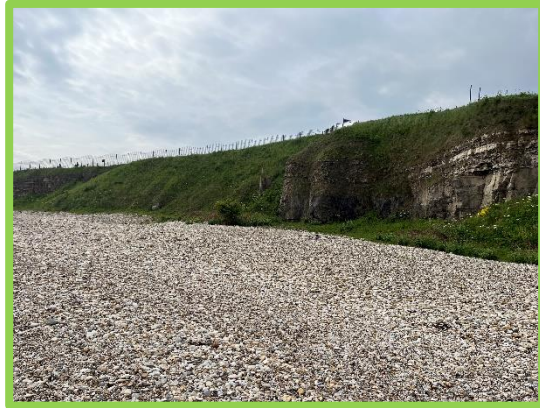
*Stable cliff fronted by healthy cobble beach
(/0103105)*

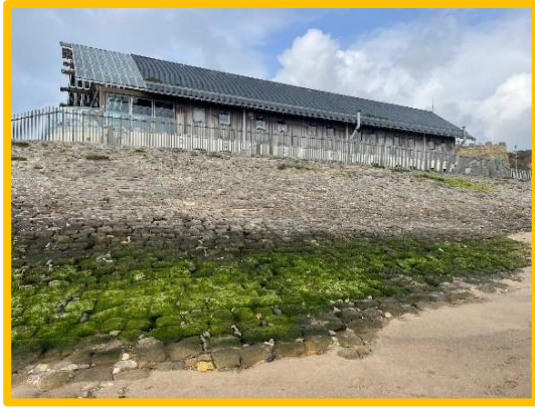
Open joints and vegetation growth on masonry revetment. High sediment levels (/0104C05)

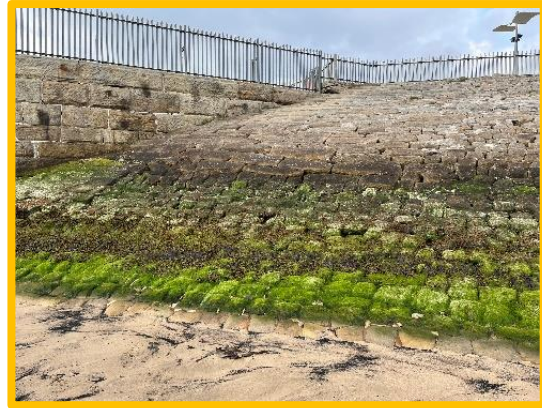
Uneven profile (/0104C05)

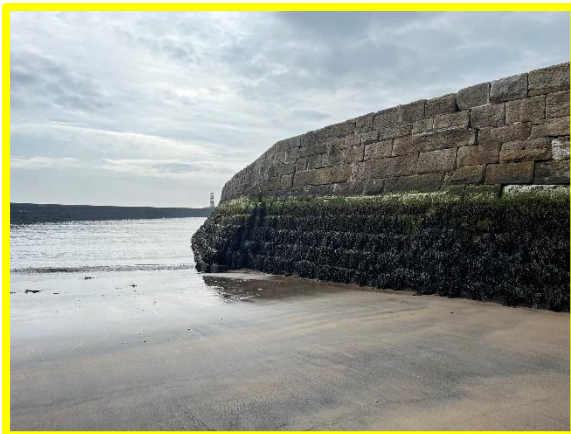
Inner Pier north face largely obscured by marine growth (/0104C06)

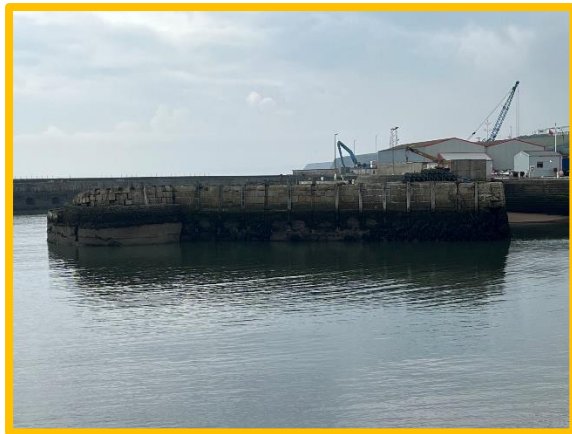
Loss of blocks and open joints (/0104C09)

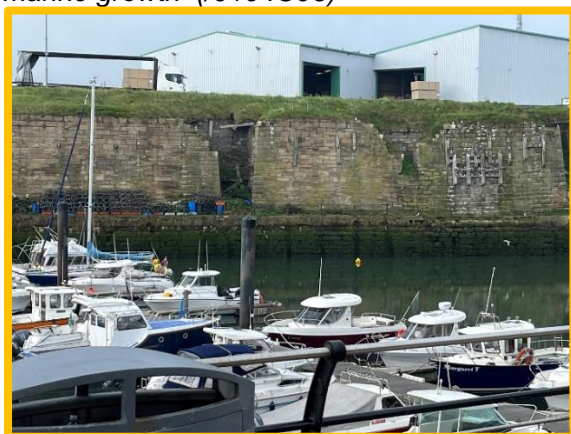
Gaps between blocks at Seaham North Dock (/0104C12)

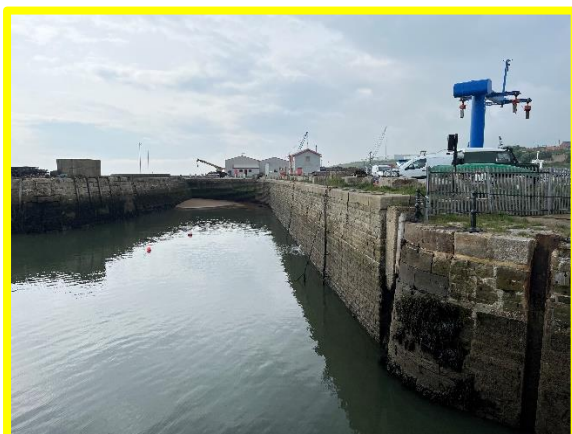
Inner face appeared in good to fair condition (/0104C10)

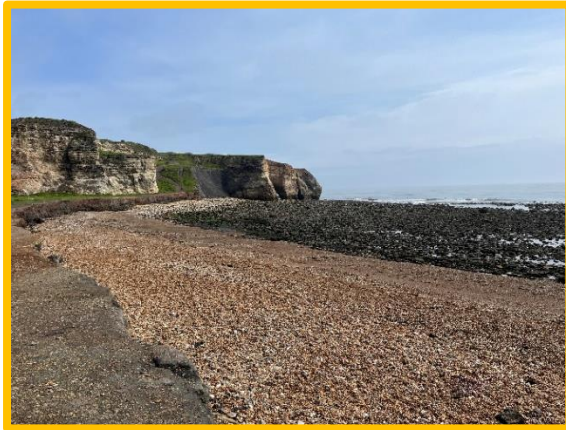
Informal access point onto Blast Beach (/0103C07)

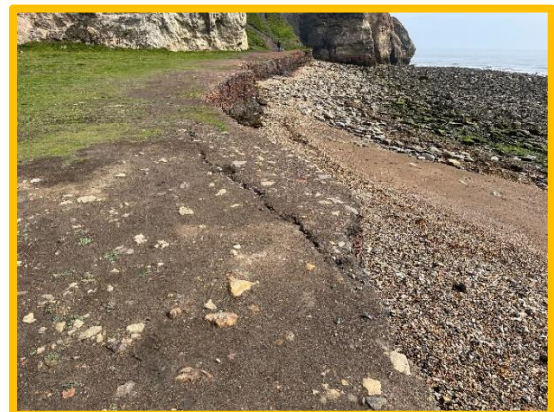
Tension cracks in actively eroding colliery spoil (/0103C07)

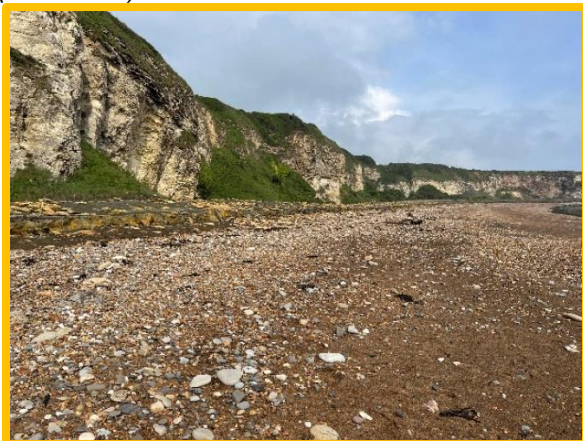
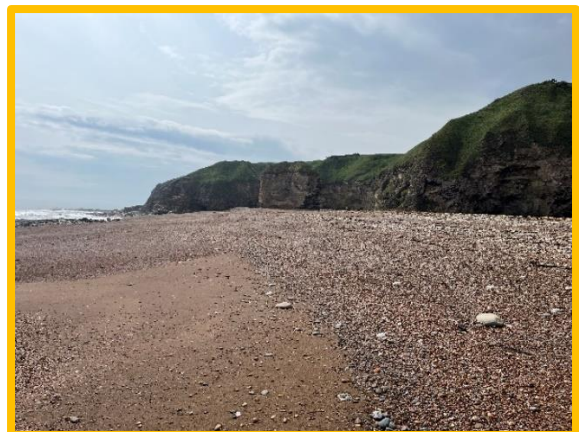
Colliery spoil cliffing reducing in height from North to South (/0103C07)

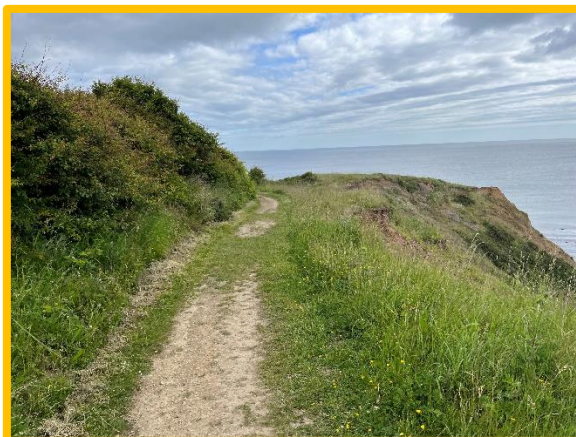
Eroding cliff top creating pinch point in coastal path. (/0201C01)

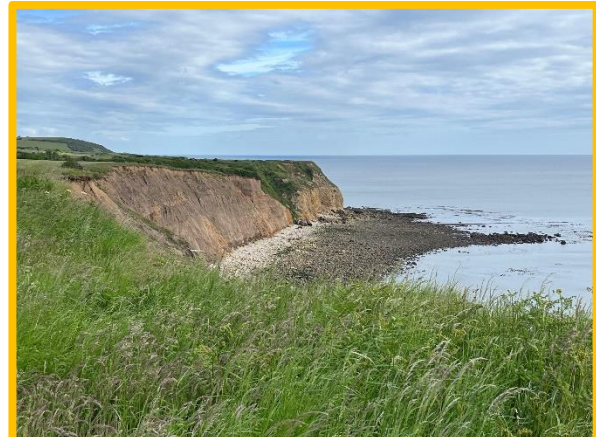
Actively eroding section of cliff (/C0201C01)

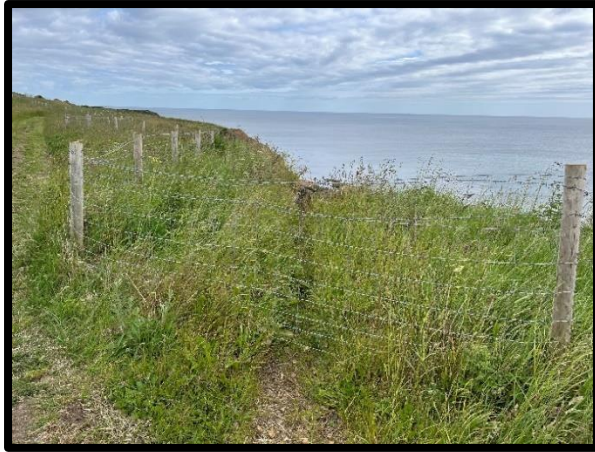
Previous cliff failure through coastal footpath fenced off (/0201C01)

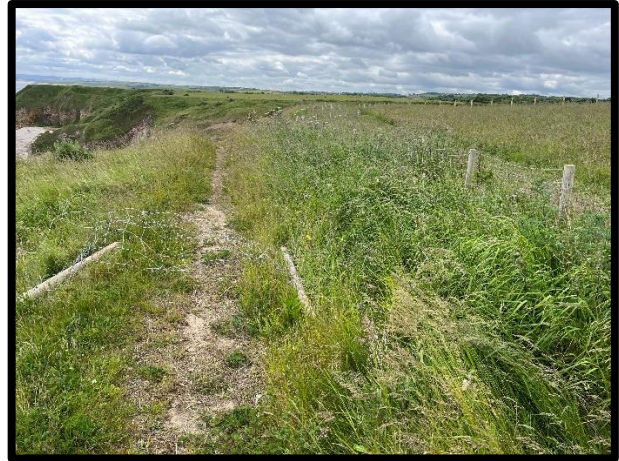
Previous cliff failure through coastal footpath. Fence to prevent access has failed (/0201C01)

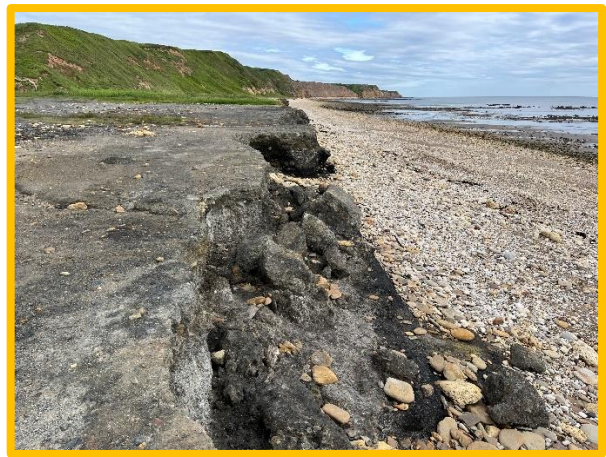
Significant ongoing erosion to the colliery spoil to the North of the bay. Note – tension cracks and debris piles (/0201C02)

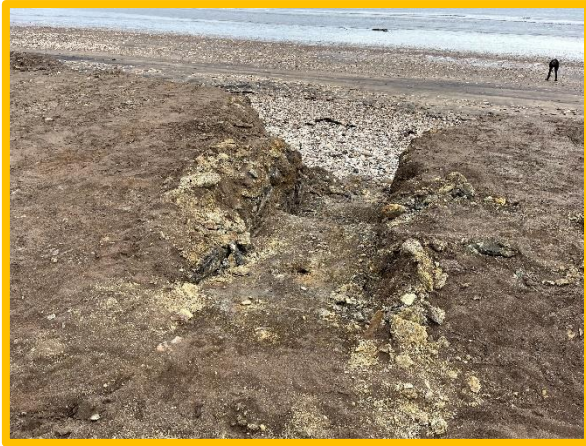
Informal access steps benched through the colliery spoil (/0201C02)

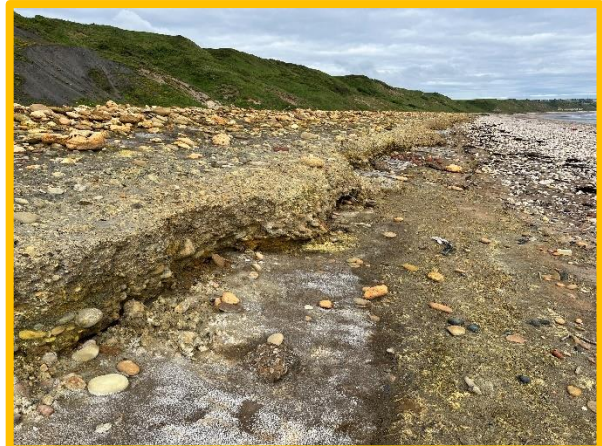
Minor erosion to colliery spoil to the south of the bay (/0201C02)

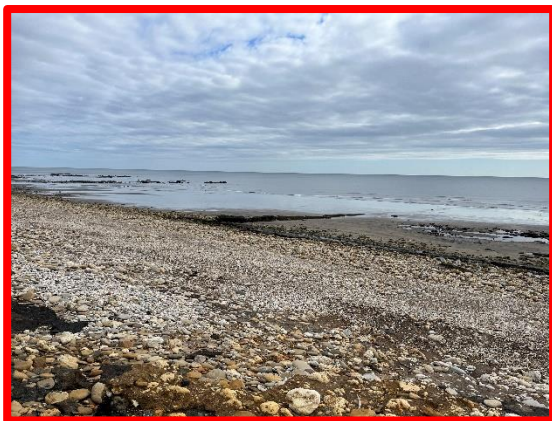
Failed concrete collar outfall (/0202C02)

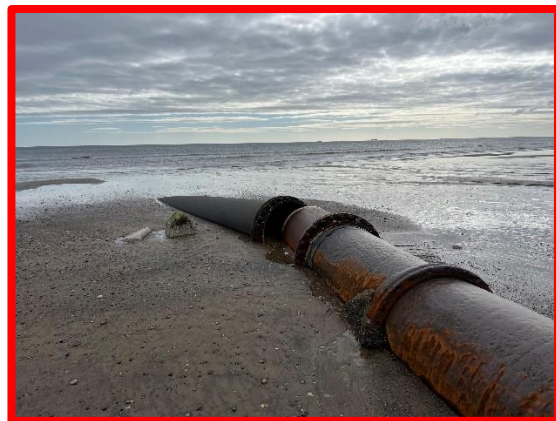
Failed large cast iron outfall (/0202C02)

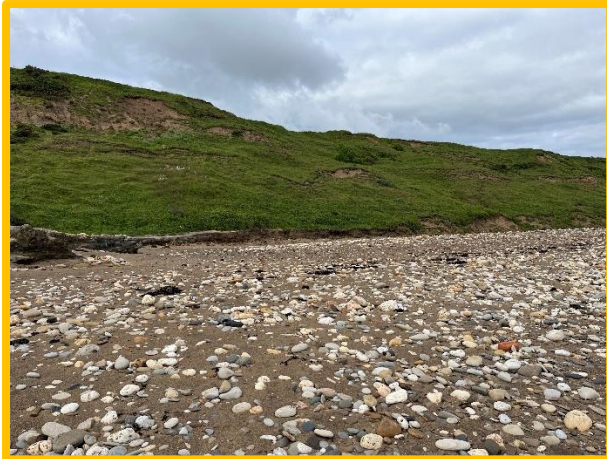
Former mouth of Castle Eden Dene eroding channel through foreshore and undercutting cliff toe. (/0202C02)

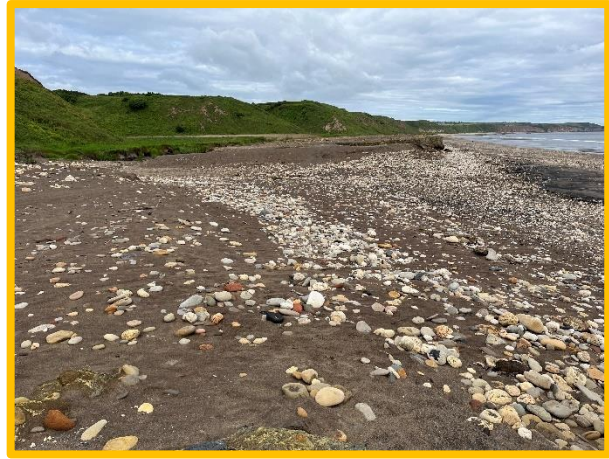
Mouth of Castle Eden Dene eroding significant channel through (/0202C02)

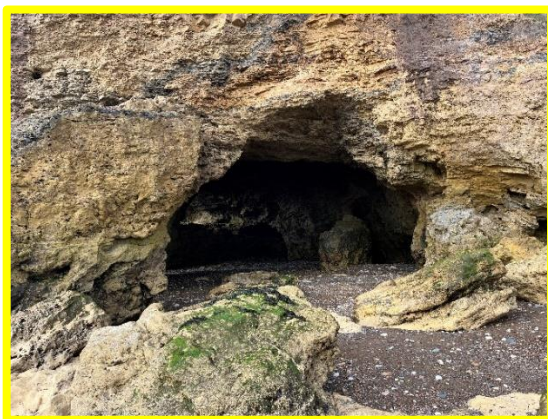
Vast cave formation at Blackhall rocks (/0301C01)

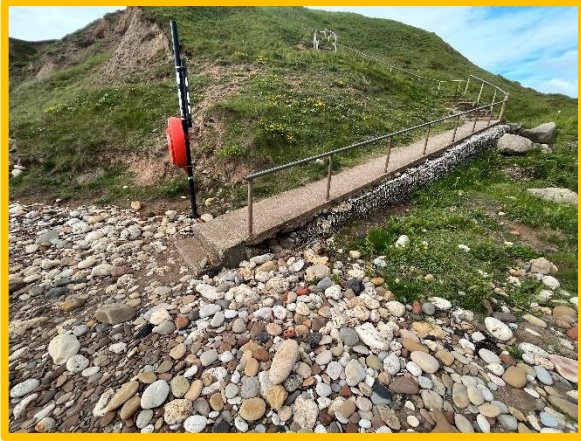
Gabion baskets retaining access ramp in poor condition (/0301C01)

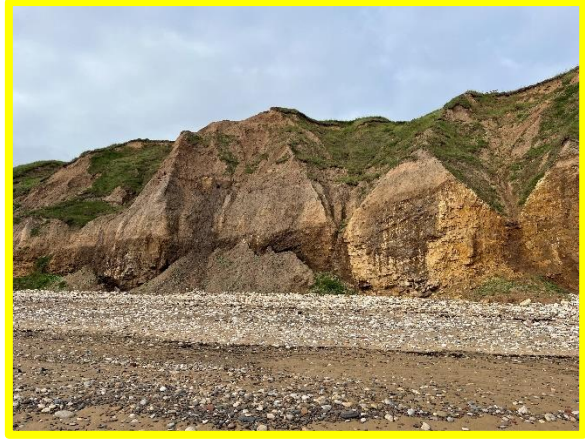
Large-scale slump of softer material (/0301C01)

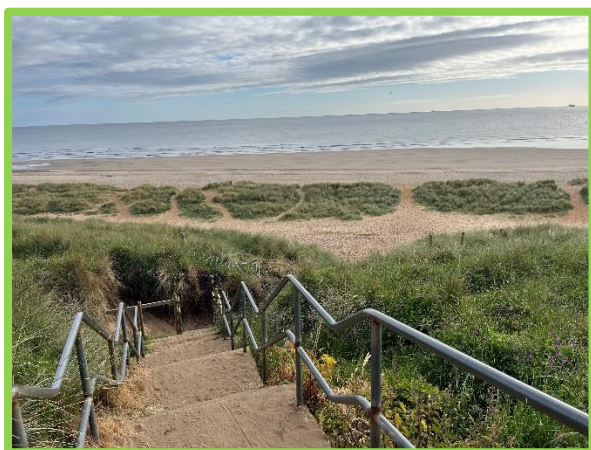
Stable dunes at Crimdon, access paths trodden through dunes (/0301C02)
