NECAG Coast Protection Assets and Coastal Slope Condition Analysis

The assessment of coastal protection assets and slopes along the Hartlepool Borough Council frontage was carried out by a team of asset inspectors and structural engineers during September and October 2008. All assets were graded based on their condition, residual life and urgency of repair work. Observations were photographed and all data were stored in the National Flood and Coastal Defence Database (NFCDD).

Hartlepool Borough Council's frontage extends from Crimdon Beck in the north to the North Gare Breakwater in the south. It comprises natural dunes, towns defended by sea walls and revetments, and key maritime structures such as port or harbour breakwaters.

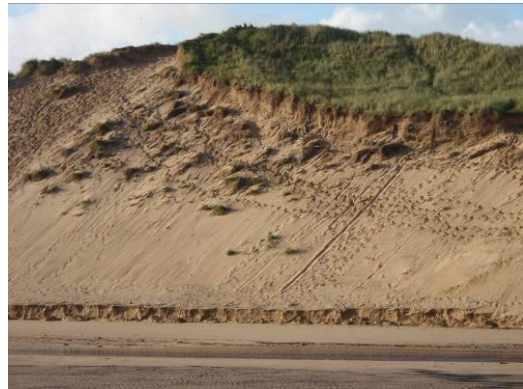
The dunes immediately at the mouth of Crimdon Beck (south side) are high, steep and bare of vegetation. Cliffling is occurring at the toe of these dunes, caused by the proximity of the channel of the Beck.

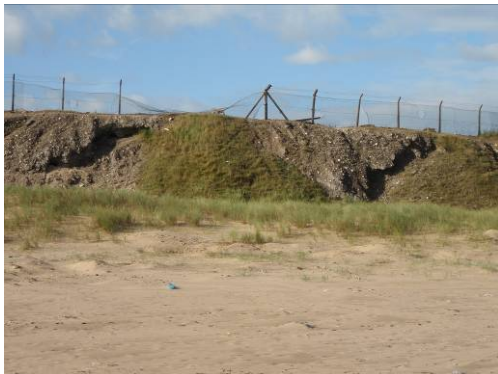
Further south still, the beach is crossed by industrial pipelines and other structures. The first outfall structure has a concrete deck and steel sheet pile sides. The piles are severely corroded but the concrete is in good condition. Healthy dunes with new vegetation growth back the beach between here and the second major outfall structure. This is similar in condition to the first outfall, although it also suffers minor damage to the concrete capping beam on its southern side. Just to the south, there is an obsolete timber pipeline-support structure which has been partially excavated.

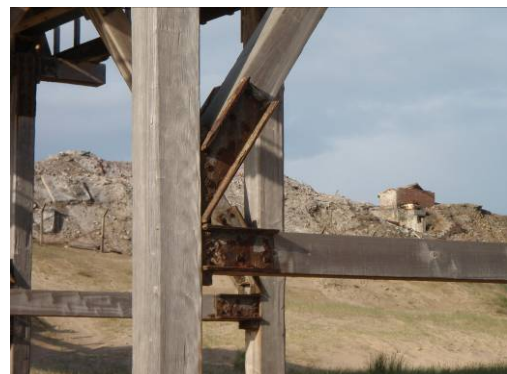
The third and fourth main outfall structures, close to the pier, are largely buried by high beach levels but the exposed sections were in good structural condition.

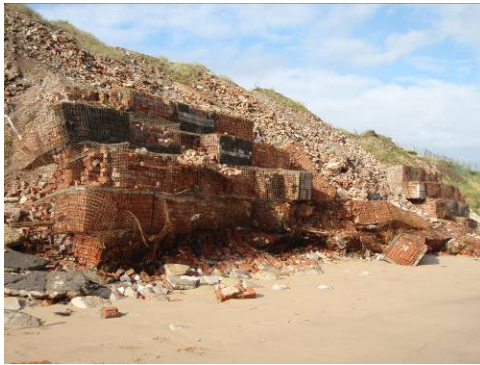
The first outfall south of the pier is in a ruinous condition. There appears to have been excavation of the upper beach to locate the head of this structure, with the hole being left open. Here the backing dunes are in a relatively stable condition, although they occupy only a narrow width before the industrial wasteland is reached. The slag bank backing the dunes is in a poor

condition due to slumping (again, not marine-induced). Towards the southern end of this frontage rubble has been tipped down the slag bank.

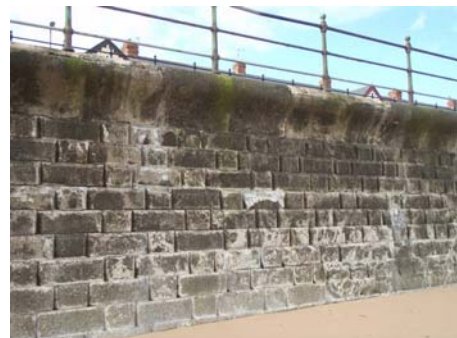
No major gaps or voids were observed in the mortar between blocks, although spalling of the capping beam was quite extensive. Previous repairs are evident, and these seem to be holding well. Very occasional minor vertical cracks were observed and some of the blocks suffer from minor abrasion.

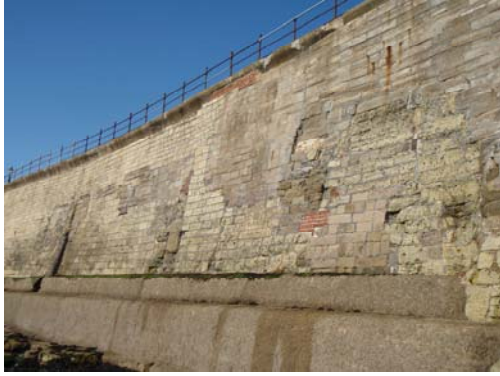
Further south, the wall is faced with larger concrete blockwork. There is continued spalling of the capping beam with progression south-east along the headland and at the southern-most end the wall is in places locally very badly abraded. Here, hand railing was heavily rusted, although some had been repainted or replaced. Structurally, there are few cracks or voids and no evidence of undermining. Previous repairs seem to be holding well. At the very southern end, around the vicinity of the pipeline, the wall is cosmetically poor in appearance with very heavy abrasion of the blockwork and concrete apron. Locally, reinforcement bars are exposed in the concrete apron. Several areas have been subject to extensive concrete and blockwork repairs, but numerous areas remain abraded. Overall, the fair condition of the wall is retained through a very good programme of inspection and maintenance by the Council.

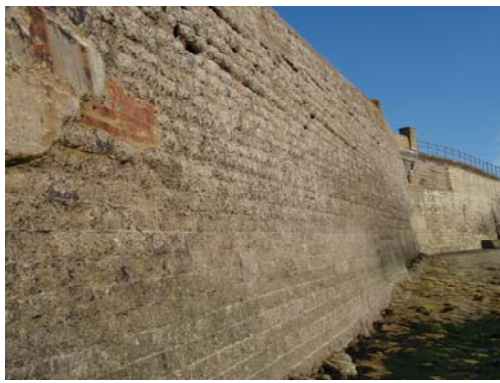
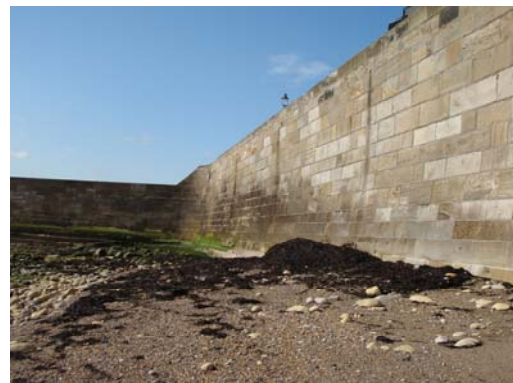
The adjacent length (below, left) is heavily abraded, but shows no voids. The final section (below, right), abutting the landward end of The Heugh Breakwater is in a good condition with only local and minor abrasion.

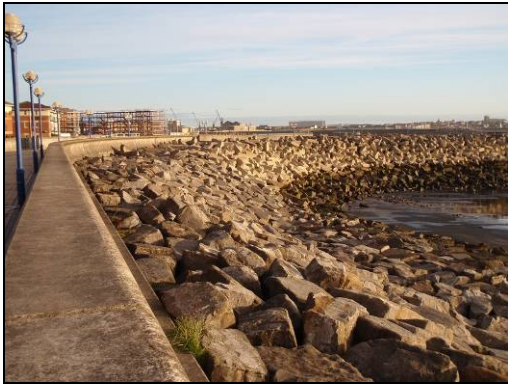
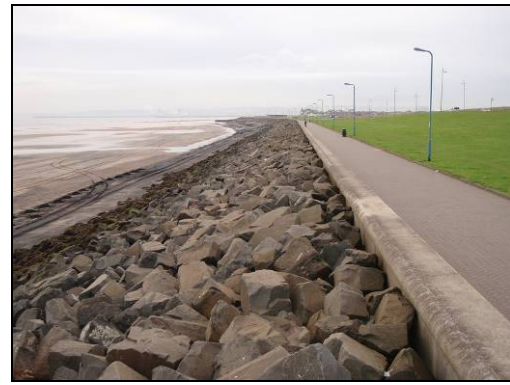
To the south of the South Pier the concrete accropodes are replaced by dolerite rock armour units forming a revetment in front of a concrete recurved splash wall. This forms part of a coastal protection scheme, completed in 2003 which extends along approximately 2.5 km of the coastline, to the north of Seaton Carew.

The asset was in very good condition with no significant visible defects in the concrete of the splash wall or the seawall below. The density of the rock armour revetment appeared consistent with crest and bank profiles intact. There was minor displacement of some of the armour stones towards the toe of the revetment.

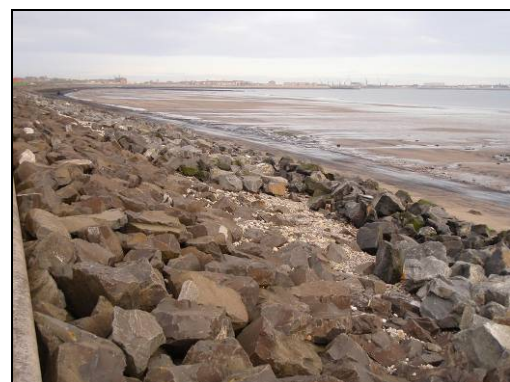
To the north of the concrete outfall, seaward of Newburn Bridge, there appears to be some thinning of the armour layer with an area of beach material visible.

Shingle had accreted in the spaces between some armour units so the performance of the revetment in dissipating wave energy may be slightly reduced.

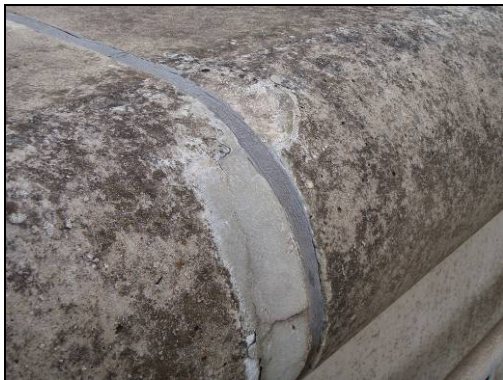
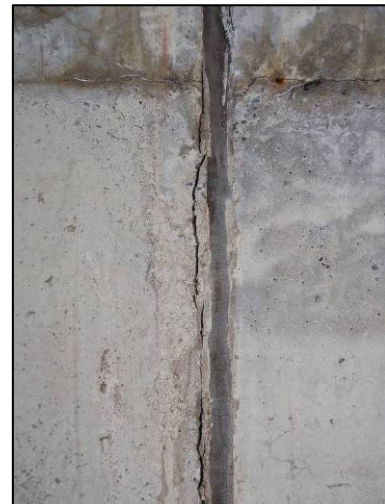
Inland of the Little Scar outcrop, a concrete ramp provides access to the foreshore through a reduced rock revetment. The seawall and ramp structure is in good condition. Some minor cracks were visible around construction joints with evidence of previous repairs. The concrete surface is stained beneath the drainage outlets and minor deterioration of the surface is beginning to occur. The reduced rock armour revetment is in good condition.

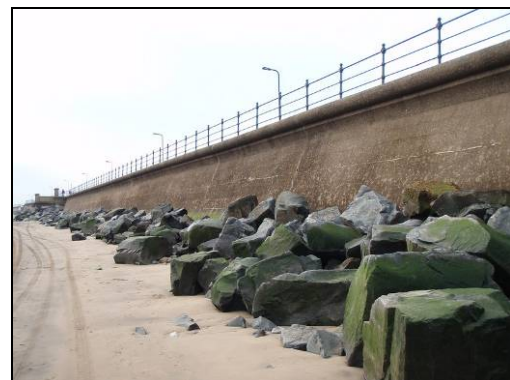
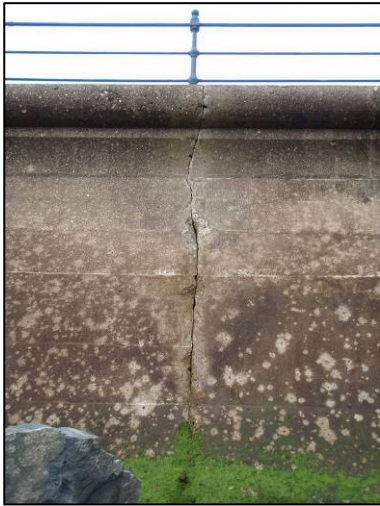
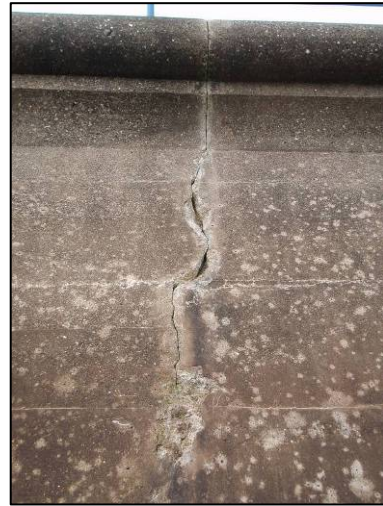
South of the access ramp the rock armour revetment is reduced to toe protection in front of a concrete seawall. The seawall has construction joints at approximately 20m centres, many of which have expanded and caused cracking of the surrounding concrete. The vertical cracks typically extend from the crest of the wall to the visible base. Localised spalling was occurring around some of the cracks, notably near the crest of the wall and close to drainage outlets.

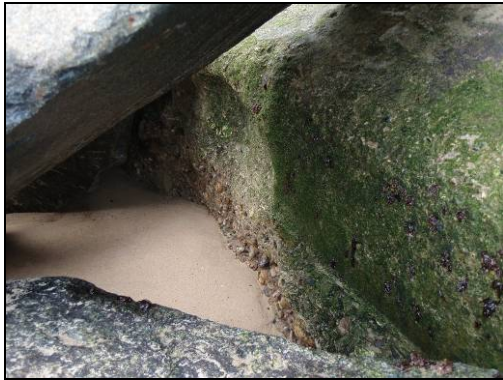
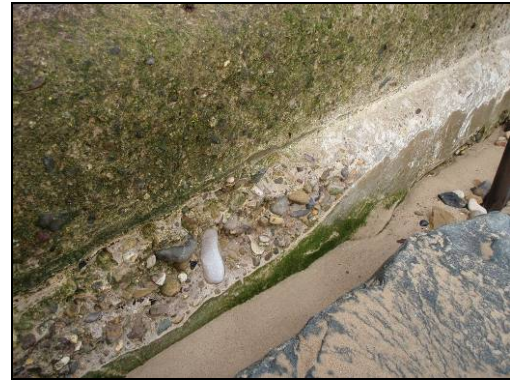
Spalling and scour damage to the seawall was evident behind the rock armour. Vegetation was present on sections of the seawall sheltered by the rock armour. The rock armour units were well placed with no significant displacement evident.

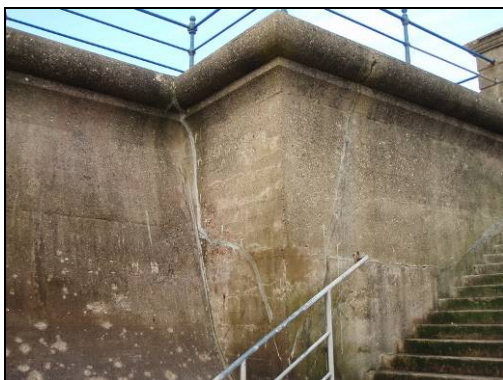
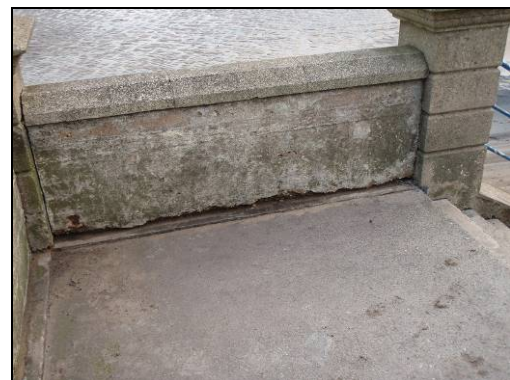
The seawall above the access steps appeared to have settled, causing large vertical cracks which have previously been in-filled. The concrete wall fronting the access steps was eroded significantly at its base.

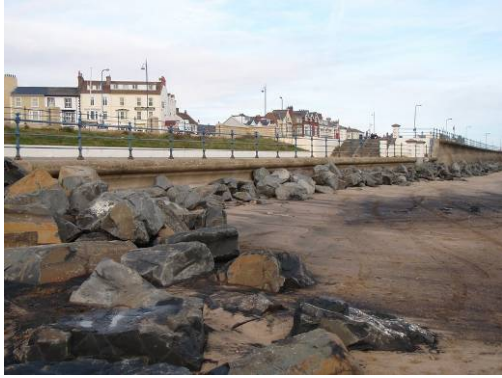
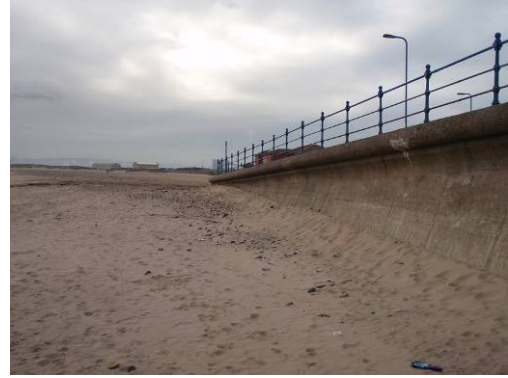
To the south, the crest level of the seawall is reduced. The rock armour thins, eventually leaving the concrete seawall exposed down to beach level. The beach level increased moving southwards. The widening of construction joints and the associated cracking was also present along the lower seawall.

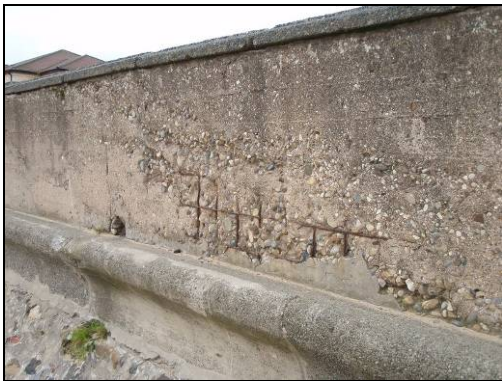
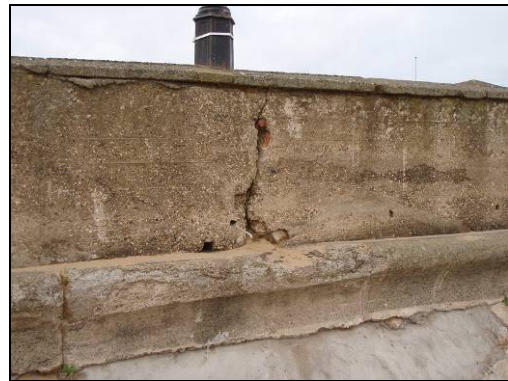
The upper concrete wall was spalled in some locations with exposed reinforcement. Minor cracking was present in some joints towards the crest of the wall with several more significant cracks extending through the full height of the wall.

The grouted stone revetment was in fair condition. Cracks were developing in the revetment face, with missing grout and occasional missing blocks. There was no evidence of undercutting although the beach level was sufficiently high to cover the toe of the revetment. To the south, the masonry becomes regular and coursed and here the structure was in better condition.

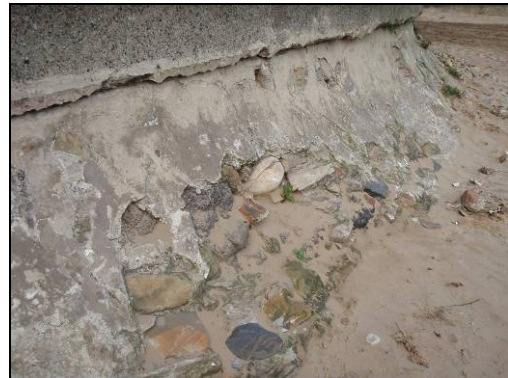
The defence ends at another access point to the foreshore. The access is flanked by masonry walls which were in fair condition with missing mortar and concrete render in places. To the south of the access, a grouted stone revetment with a concrete surface layer was in good condition, although missing concrete render to the northern end of the revetment (at the tie in with the masonry wall) was beginning to expose the infill material.

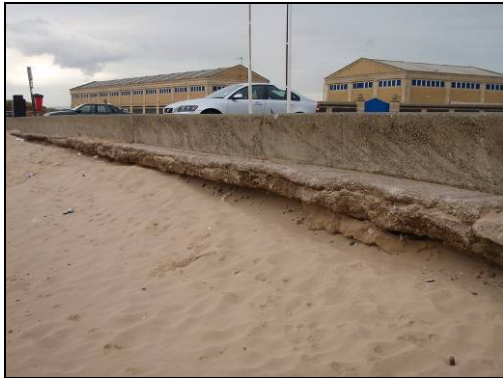
The car park to the south of Seaton Carew is fronted by a concrete wall. Localised lowering of the beach level had exposed a concrete apron which was being undercut. Access to the beach is to the north of the wall. Here a section of the wall has been displaced although this will not affect the performance of the asset significantly. Rock armour units provide some protection to the access, although this appears predominantly to prevent vehicular access to the foreshore.

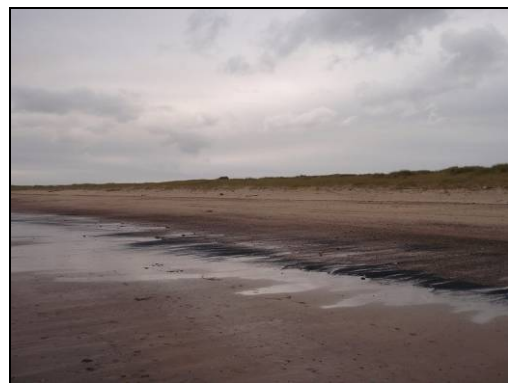
The dunes had a good coverage of established vegetation, with localized areas of non-vegetated dune. The most significant erosion of the dunes appears to be that caused by members of the public creating makeshift footpaths.

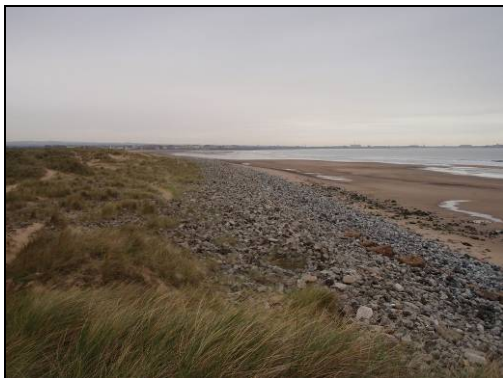
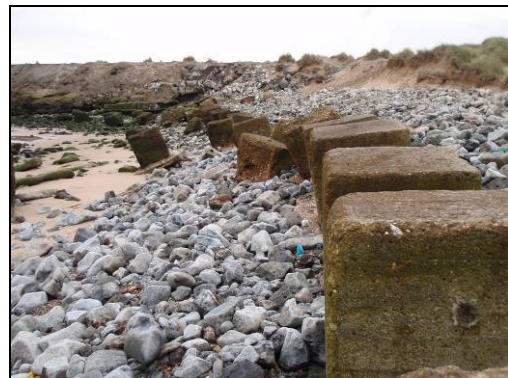
Towards the southern extent of undefended frontage there is a stone/rubble embankment which ties in with the North Gare Breakwater. There are several large concrete blocks and smaller pre-cast concrete blocks acting to limit the erosion of the dunes landward of the structure and outflanking. There is slight displacement of some of the concrete blocks, although the embankment is generally in good condition.

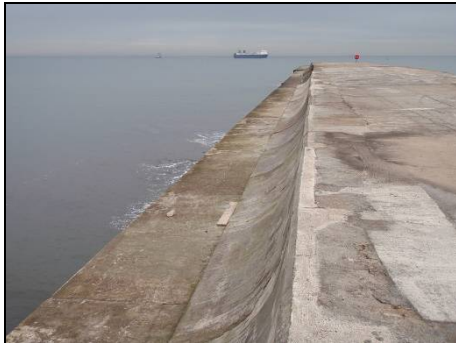
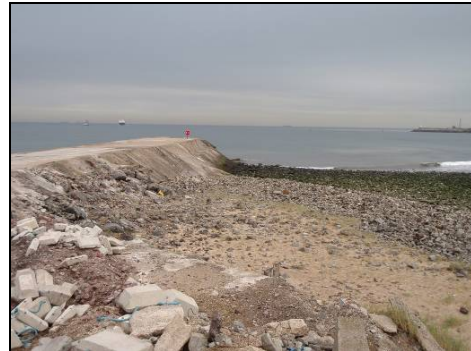
The breakwater is a masonry and concrete structure with evidence of a variety of previous repairs including bagwork, mass concrete and pre-cast concrete blocks. There

was evidence of undercutting, missing pre-cast concrete sea wall units, void formation and failure of previous repairs. There appeared to be significant settlement close to the seaward extent of the structure although this could not be confirmed by closer inspection.

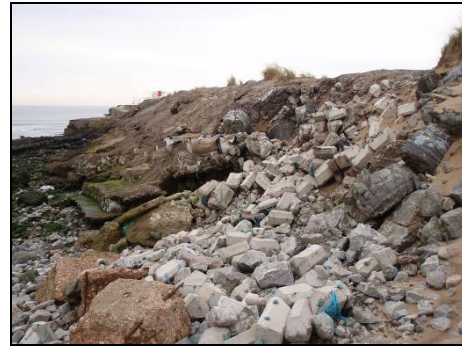
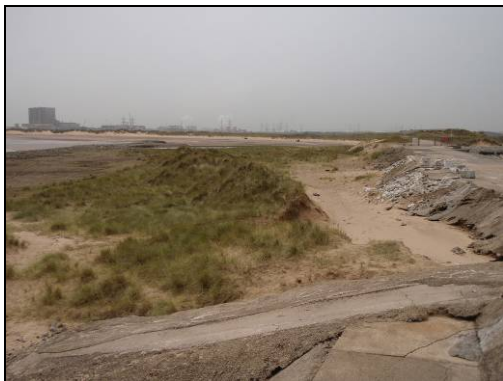
The landward end of the breakwater on the northern side was in very poor condition.

Large voids have opened up beneath the upper concrete layer which was largely damaged or missing.

This section of the structure requires urgent attention to prevent further deterioration.
