**Cell 1 Regional Coastal Monitoring Programme
Coastal Walkover Inspections 2010**

The present report is **Coastal Walkover Inspections 2010** and provides a summary of the main findings from the walkover inspections of Hartlepool Borough Council’s frontage that are undertaken once every 2 years.

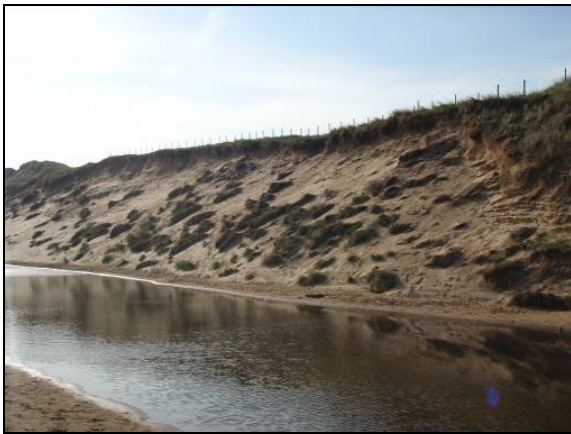
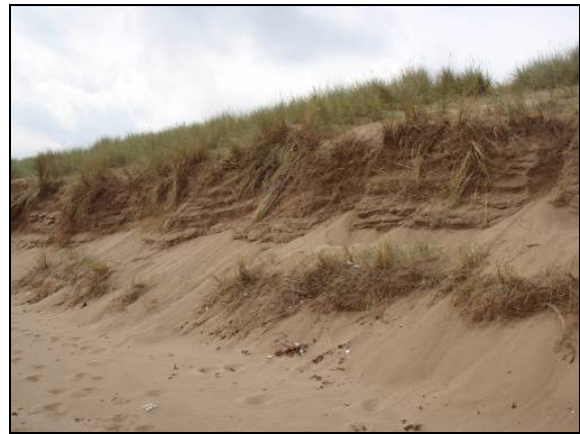
The dunes to the south of Crimdon Dene fronting Hartlepool Golf Course were high and steep with sparse vegetation coverage (below left). Minor slumping had occurred locally and cliffing had occurred at the toe caused by flows in Crimdon Beck. No flow was evident in the beck on the day of inspection although standing water was present along the embankment toe. The sand dunes appeared to maintain a consistent height along the frontage with vegetation coverage generally increasing to the south (below right). A wide sandy beach was present along North Sands.

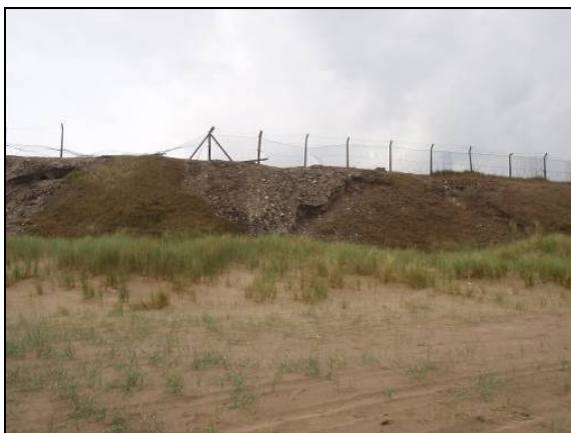
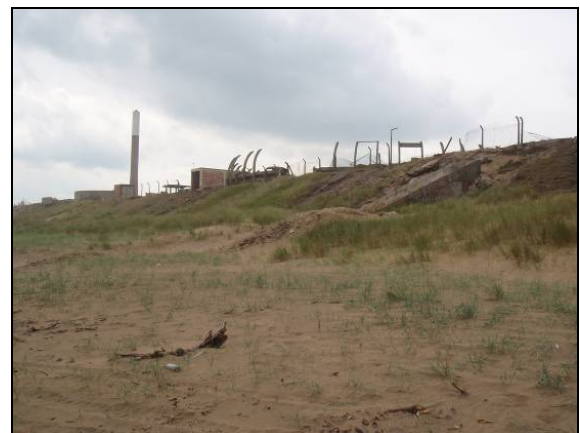
The slag embankment was actively slumping throughout with several areas bare of vegetation (below left). Accretion of sand has led to the formation of small dunes in front of the slag embankment. The dunes had a fairly consistent vegetation coverage and appeared stable. Remains of dilapidated structures from the works were protruding from the embankment and local lowering of the crest and steepening of the embankment slope was evident due to scour from wind blown sand (below right).

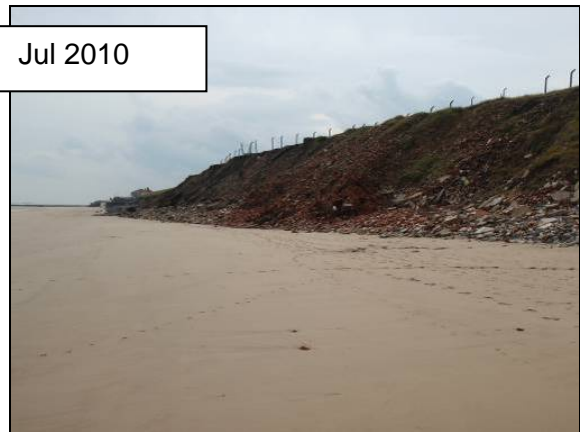
South of the cemetery, the embankment steepens in front of another former industrial structure (right). The embankment is broken up by a short length comprising of brick filled wire mesh gabions. The majority of the visible steel was heavily corroded and many of the gabions had failed completely with bricks spreading along the toe of the dunes (below left).

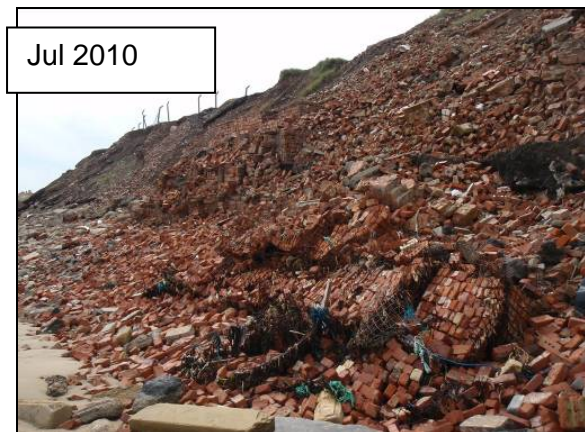
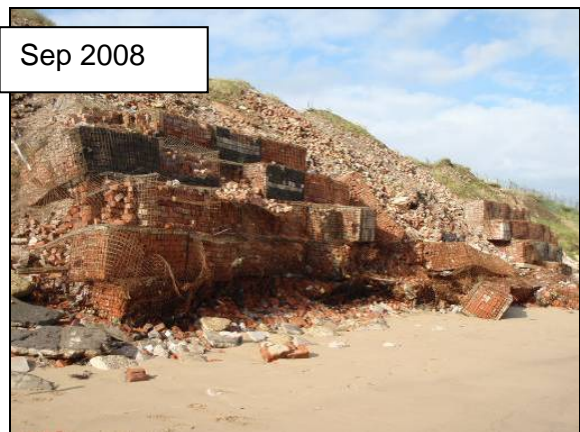
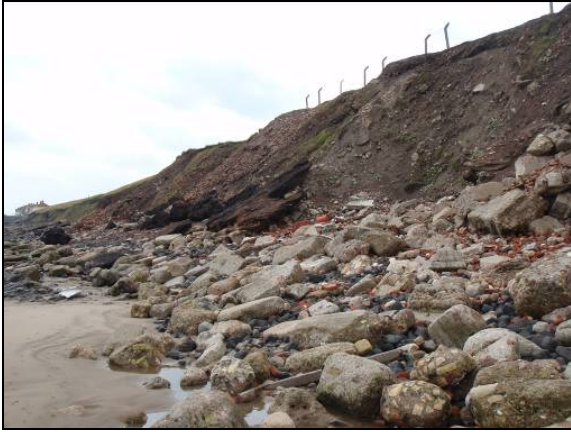
The profile of the embankment appeared fairly consistent suggesting a degree of stability although the thinning of material at the toe is likely to lead to stability issues and potential failure. There has been a significant redistribution of material since the 2008 inspection following work carried out to remove failing gabion baskets on health and safety grounds. The asset now consists of a slope/revetment rather than the vertical structure observed in 2008 (below, left and right).

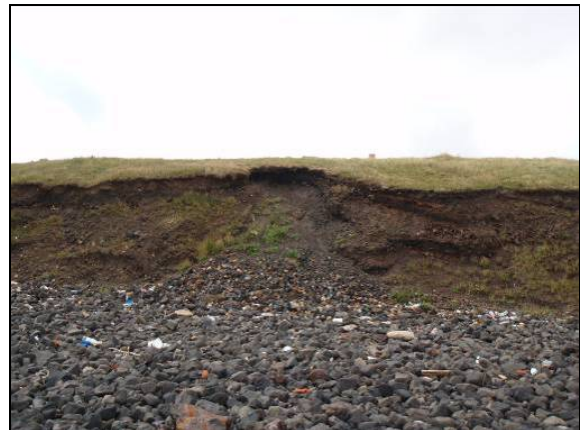
The slag and rubble embankment to the north of Marine Drive appeared to be effectively protecting the steeper vegetated embankment to the rear (below left). Historic slope failures were visible throughout the seaward face of the embankment with a more recent slip observed towards the north (below right). Further south, the rubble mixes with a cobble-sized stone revetment which appeared more uniform in size and distribution and the backing slopes appeared more stable. The majority of the frontage had a coverage of vegetation (with the exception of the steepest sections). Large pieces of broken slag were present on the surface and within the rubble revetment.

The rock revetment to the southern extent of the slag embankment appeared in good condition with no evidence of outflanking of the seawall fronting Marine Drive.

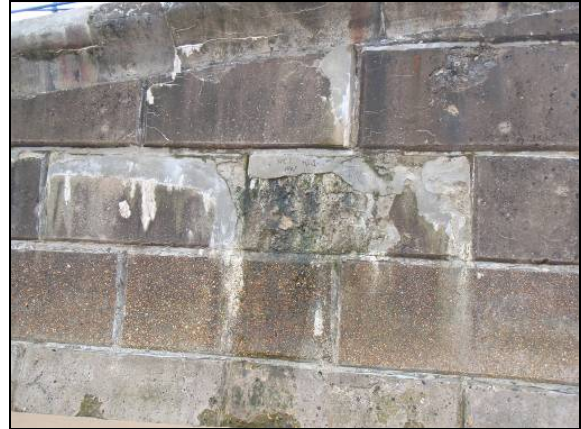
The seawall fronting Marine Drive was cracking and spalling locally with the crest particularly affected (below left). Previous patch repairs had been carried out and generally appeared to be performing well. No significant voids were observed in the masonry wall and defects were noted as minor loss of mortar and surface deterioration as abrasion to the concrete facing was evident throughout (below right).

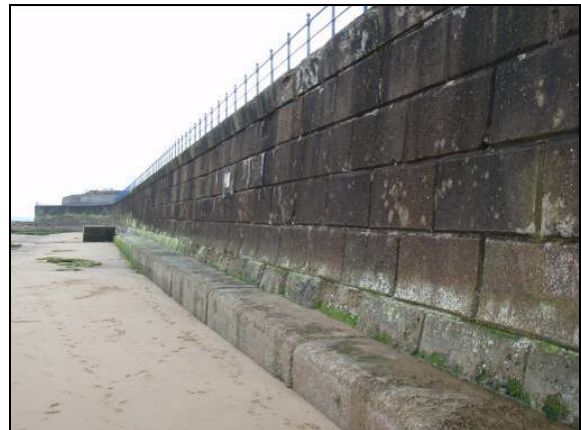
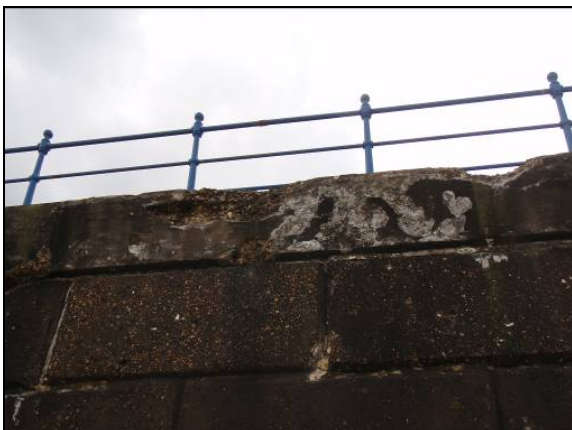
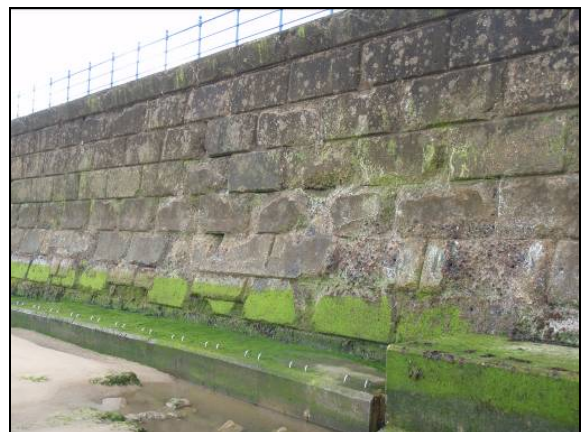
Further south, the seawall fronting Sea View Terrace is constructed from larger concrete blocks (right). Spalling of the concrete coping units was extensive (below) and abrasion of the blockwork surface appeared to worsen to the south (below right).

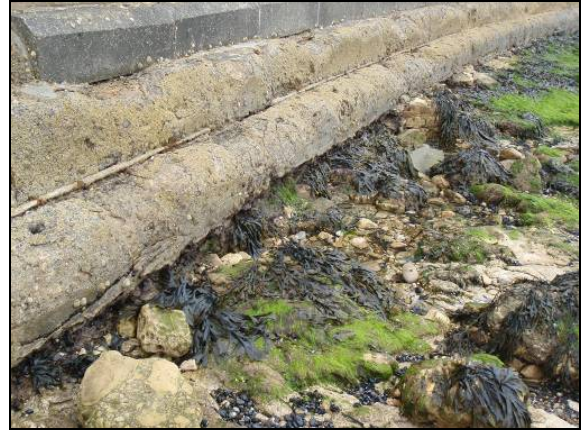
A concrete toe is present along the majority of the length of seawall. The concrete appeared to have been added in several stages, consisting of a variety of older stepped concrete profiles to more recent massive concrete blocks and was in good condition throughout. The most recently placed sections were in very good condition, with lifting eyes visible (below left). Where new concrete units were not present at the toe, the older (original?) toe was beginning to be undercut locally (below right).

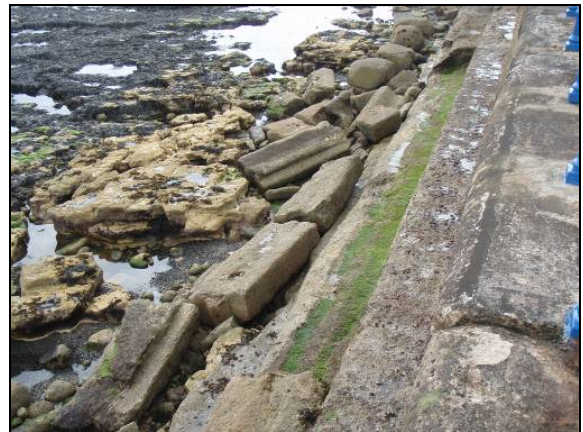
South of the Town Moor, several older concrete units had fallen from the base of the wall onto the foreshore (right). This failure is possibly attributable to scour effects due to the proximity of the rock outcrop on the foreshore. The displaced sections are large and will continue to offer a degree of protection to the base of the wall although in a large event, may be tossed against the wall causing impact damage.

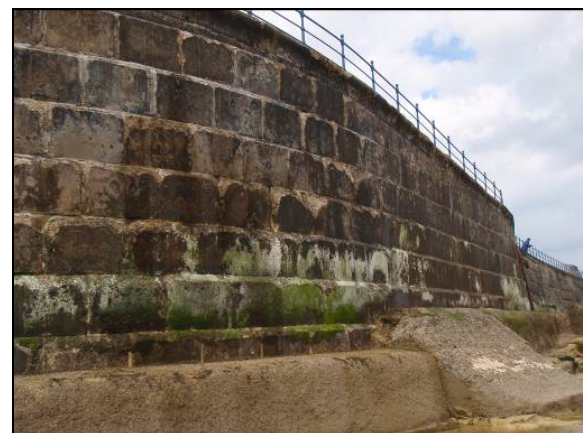
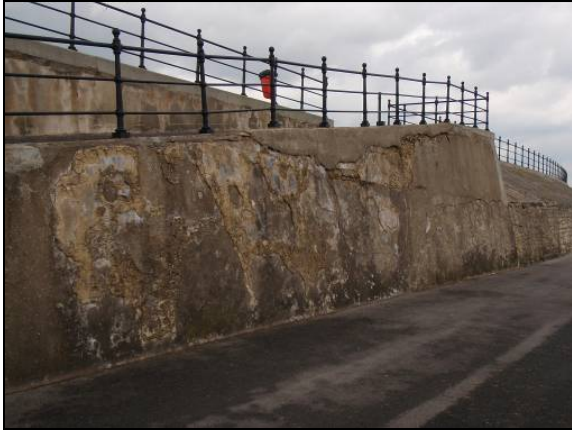
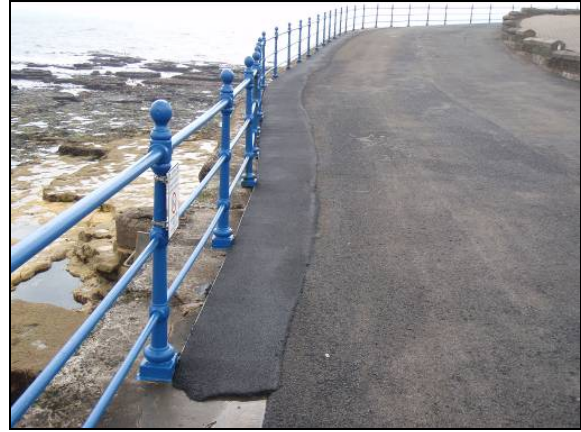
The masonry seawall at the eastern extent of the headland defences was in fair condition with surface abrasion and some mortar loss (right). The wall and revetment backing the promenade is generally in fair condition although the concrete render is cracked and missing locally (overleaf left). The promenade guardrail had been painted since the 2008 inspection. Repairs to the bitumen surfacing of the footway were also observed (overleaf right).

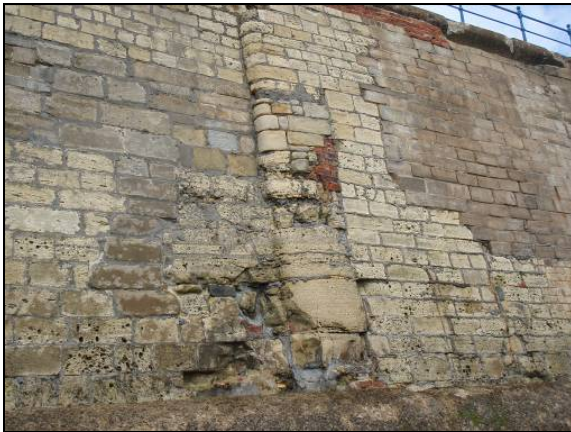
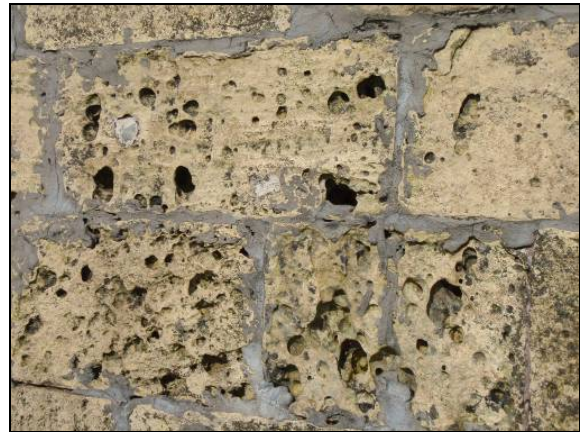
South of the easternmost point of the defences a multitude of repairs were evident in the masonry seawall including infill of voids with masonry, concrete and brickwork and repointing work (below left). Voids were present locally where masonry was missing or previous infill repairs had failed. The surface of a significant proportion of the masonry forming the lower courses was pitted (below right). Missing or deeply recessed mortar and open joints were also evident, with loss of masonry from the protruding buttresses. The wall was bulging throughout and generally in a poor condition. The concrete toe protection was generally in fair condition with minor damage locally and some abrasion/spalling of the seaward edge.

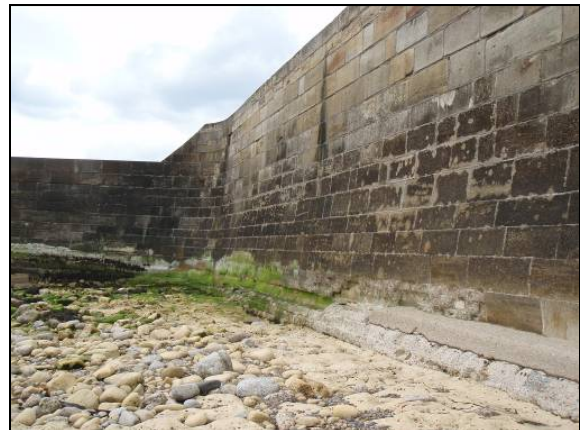
The masonry seawall fronting the access ramp was generally in fair condition. Erosion of masonry in the lowest visible courses and a lowering of the beach level was evident (below left) although no undercutting or void formation was observed. Several smaller masonry units had been lost and the abraded surface of the concrete was providing a key for vegetation growth on the wall at the tie in with the Heugh Breakwater (below right).

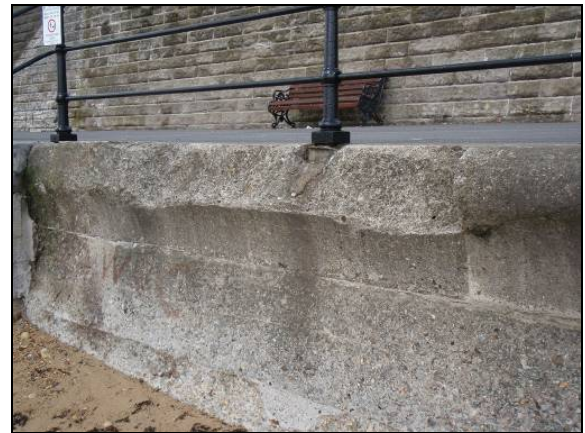
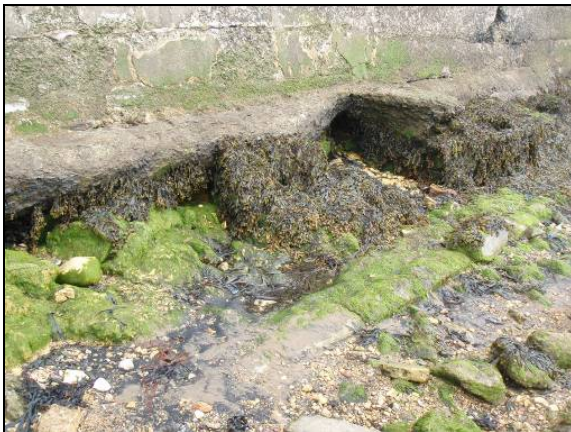
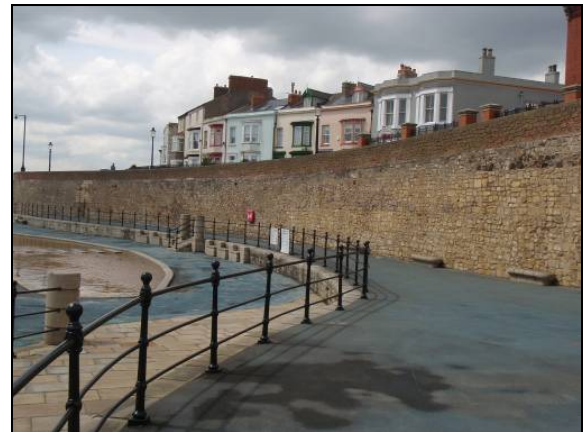
Bock Sands is located in the lee of the Heugh Breakwater. Spalling was evident to the curved coping of the concrete seawall (right) and undercutting and voids were beginning to form locally at the north of the asset (below left). Beach levels increased to south and the wall generally appears to be in good condition with minor spalling of the top edge of the concrete wall. The retaining wall fronting South Crescent/Albion Terrace/York Place appeared to be in fair condition (below right).

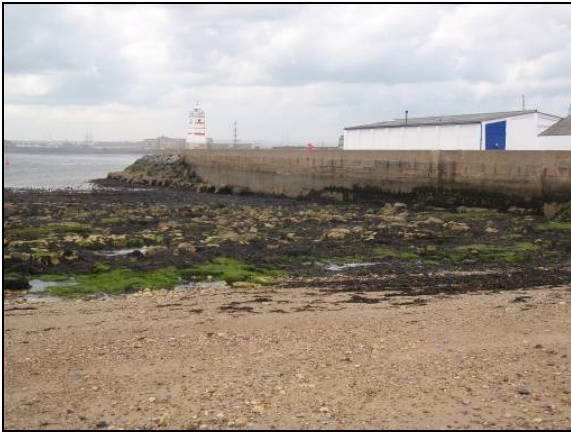
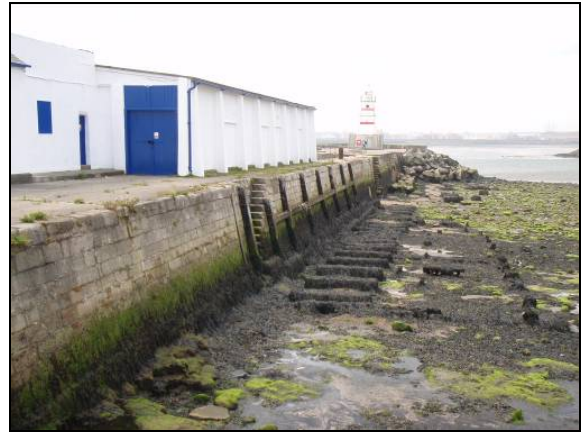
Old Pier is a concrete structure with accropod armour protection at the southern extent which provides shelter to Fish Sands (below left). The structure appeared in fair condition with minor settlement of blockwork observed on the inward face (below right). Armour units appeared in good condition with appropriate voids and good interlock between the concrete accropod units.

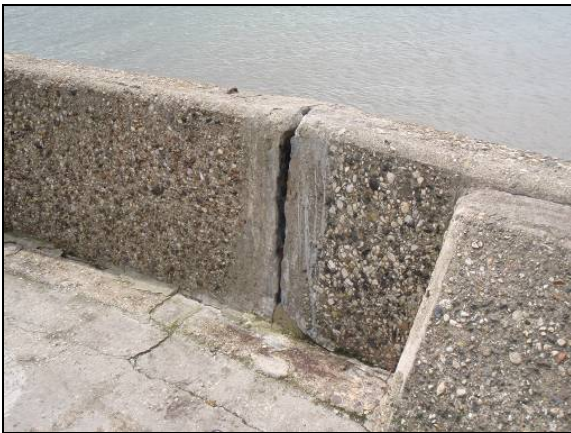
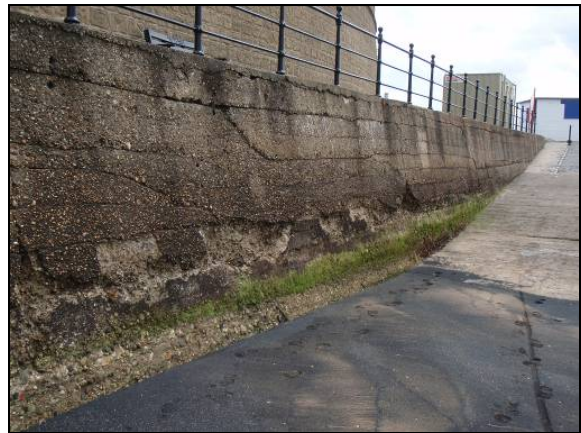
Construction joints within the concrete parapet wall were beginning to widen suggesting minor displacement (below left). No global movement or distress was noted to the end of the structure therefore the foundations were assumed to be performing satisfactorily with movement isolated in the parapet wall.

The concrete wall to the rear of the access ramp at the root of Old Pier was extensively spalled and beginning to crack (below right).

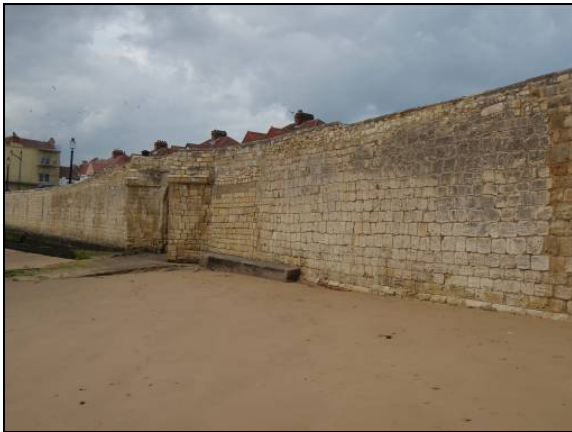
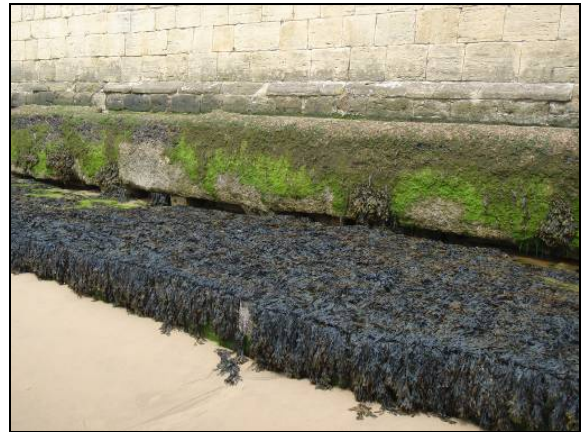
In the lee of Old Pier at the south-eastern end of Town Wall, the beach level at Fish Sands was healthy and the masonry wall appeared in fair condition (below left). Local repairs and repointing were evident and these appeared to be performing well. To the west of the access gate, lower beach levels exposed the timber piles forming the foundation of the wall and undercutting below the concrete apron was evident throughout (below right). The beach level prevented the inspection of the timber piles and extensive seaweed coverage prevented detailed inspection of the concrete apron. It was unclear to what extent undercutting of the concrete had led to void formation at the base of the wall although the existing gap and any voids should be infilled to prevent further deterioration which may affect the stability of the Scheduled Ancient Monument.

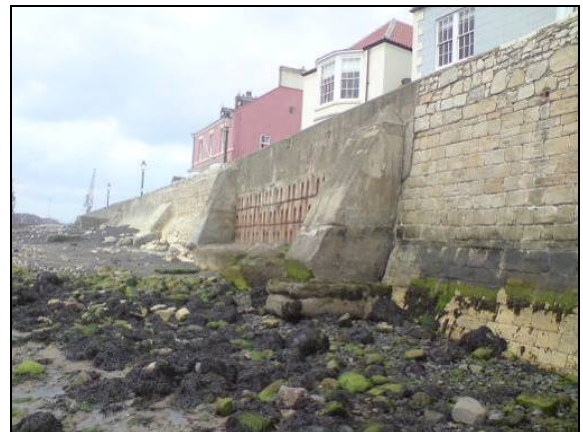
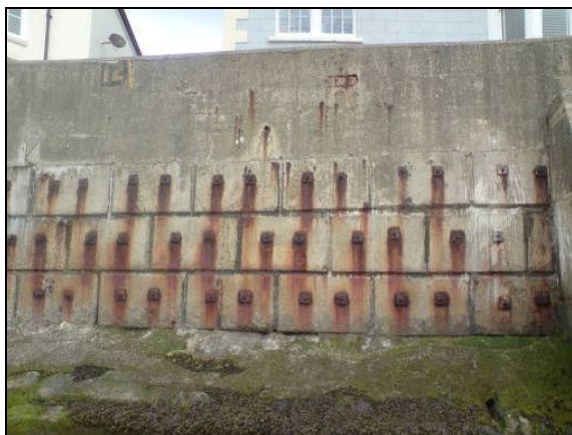
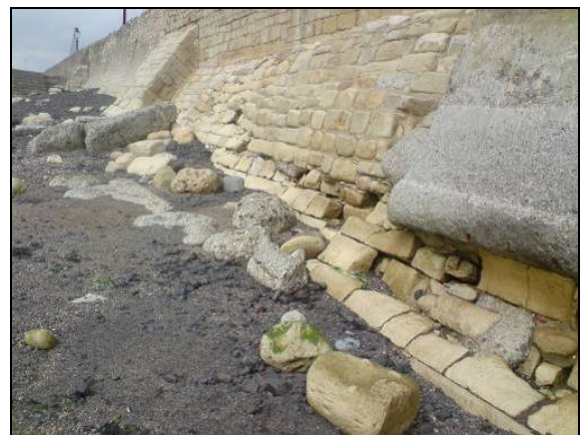
The bolts within the section of concrete blockwork wall were extensively corroded and the surrounding concrete stained with rust (right & below left). The lower concrete blocks were beginning to spall. These defects had a predominantly aesthetic impact as the structure showed no evidence of global movement. Of greater concern was the undercutting of the concrete buttresses flanking the blockwork and the subsequent loss of masonry (below right). These voids should be infilled to prevent further undercutting of the toe.

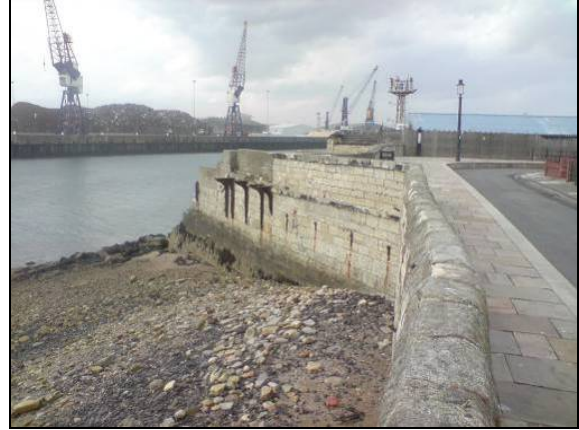
Beach levels increased leeward of the four dilapidated groyne structures and the apron and toe of the wall were buried up to the end of the length of seawall accessible to the public (below, left & right). The visible portion of the wall generally appeared to be in fair condition although local bulges were evident which should continue to be monitored. The paving stones and highway retained to the rear of the seawall appeared to be in very good condition with no evidence of movement of the structure.

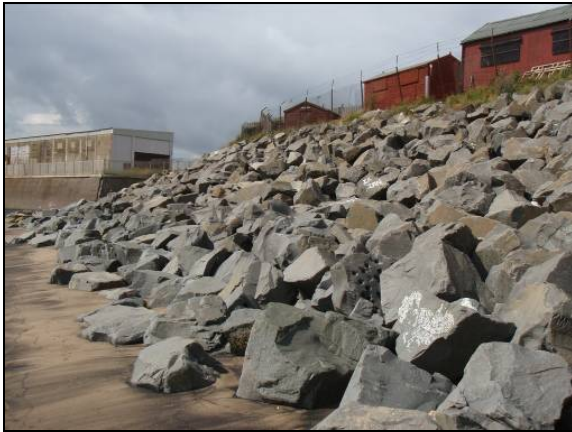
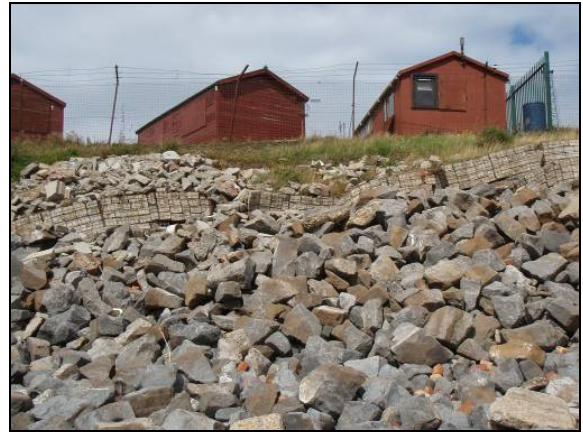
The landward end of the jetty ties into a gabion basket wall with a stepped profile. Gabion baskets generally appeared intact and were fronted by sand dunes in the north and rock armour in the south (below left). Rock armour units increased in size towards the south and appear to be performing well. The gabion baskets had settled locally (below right) which may have affected the stability of the fenceposts immediately landward, but did not appear to be affecting the structures behind. The baskets were still intact although should be monitored as the wall could unravel rapidly should baskets fail. Additional rubble appeared to be added on top of some sections of gabion basket.

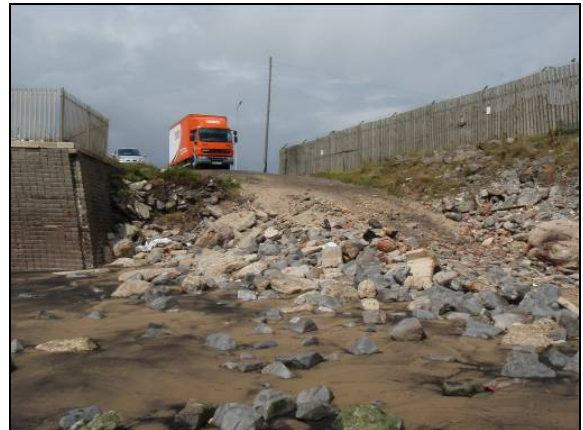
South of the rock armour, rubble was present at the access point off Perry Road (right). The slope to the southern side of the access appeared to be steep and less stable than that to the north. The purpose and frequency of use of the access ramp were unknown however it would be prudent to regrade/stabilise steep slopes to avoid failure under future use.

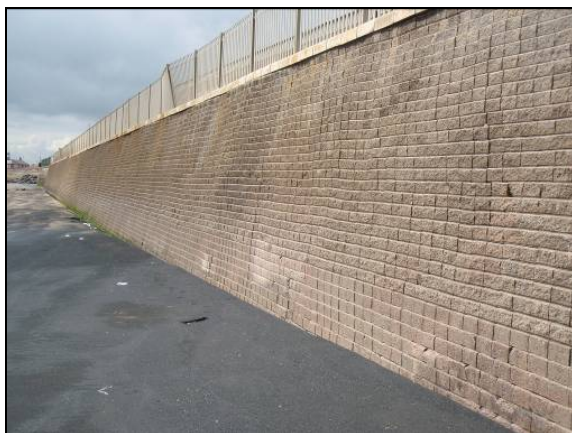
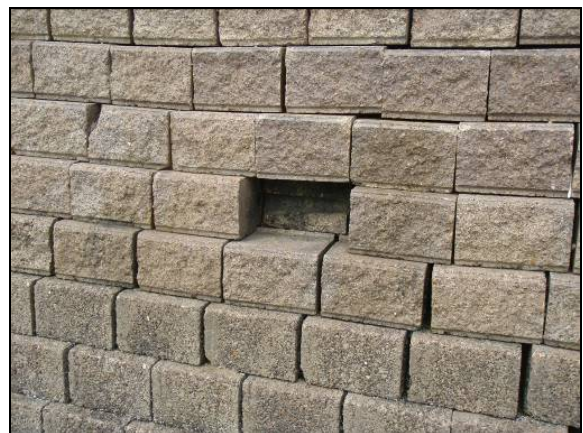
The wall fronting the industrial property was in fair condition. Local widening of construction joints was evident in addition to minor bulging (below left) and missing blocks (below right).

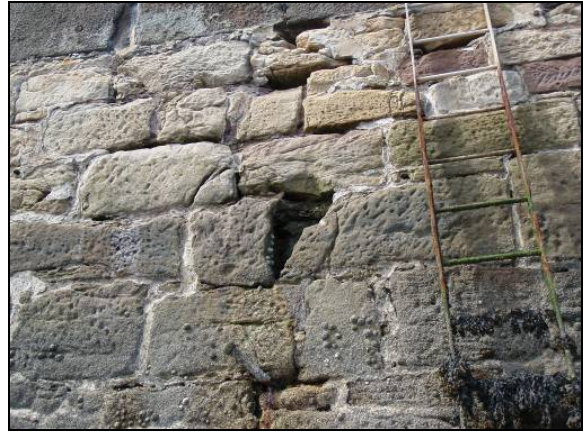
The seawall fronting the Navigation Point development was generally in fair condition although voids and missing mortar were observed locally in the masonry elements (below, left & right). Extensive seaweed coverage of the lower wall prevented inspection although there was no evidence of undercutting at the toe of the wall and no global movement or distress to the structure which suggests that the foundations were performing satisfactorily.

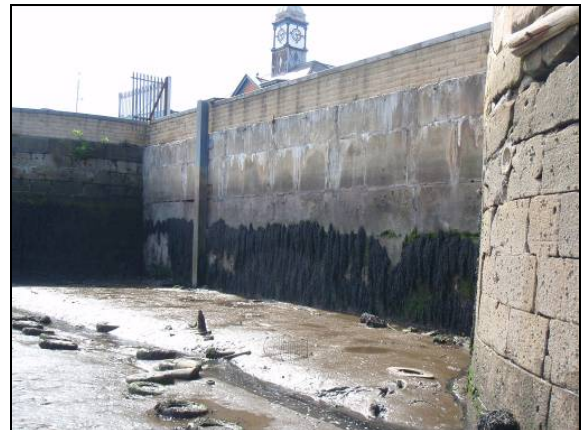
The concrete elements of the wall were in good condition with minor spalling evident to the upper edge (below, left & right). The masonry parapet wall was in very good condition throughout. The concrete structures forming the lock entrance were in good condition although water level prevented the inspection of the lower section of the walls (below left).

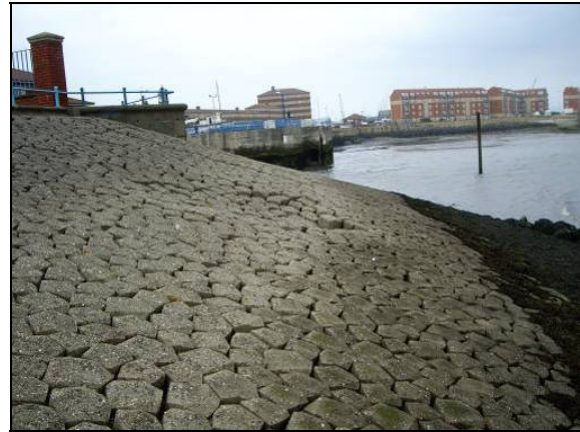
A concrete block revetment is present fronting Slake Terrace (right). A local depression recorded in the 2008 inspection was observed at the northern end of the revetment with a diameter of approximately 2m. This is indicative of a local loss of fill material below the concrete blocks and should continue to be monitored as further loss could reduce the integrity of the asset.

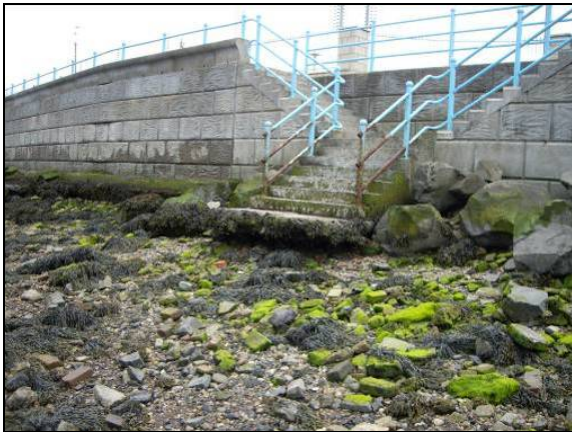
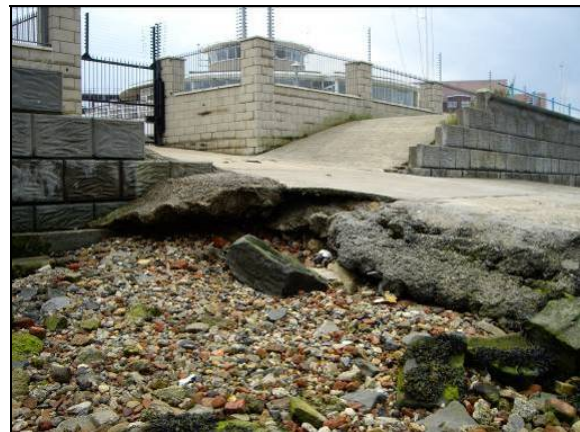
Undercutting of access steps and the slipway to the north of the Tees and Hartlepool Yacht Club was observed (below, left & right). Previous insitu concrete repairs were also beginning to fail. The concrete blockwork wall appeared in good condition with no evidence of undercutting at the toe.

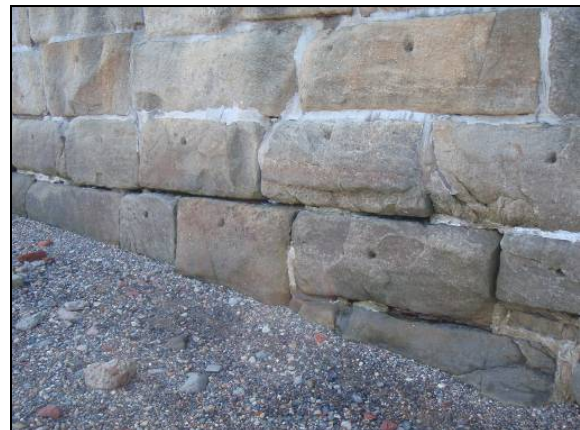
The concrete head of Middle Pier appeared to be in fair condition (below left). The masonry body of the structure ties into a masonry seawall which was in good condition. In areas where beach material was lower, mortar loss had occurred between the lower courses of masonry. Previous repointing works were evident in the upper courses but this did not appear to extend into the lower courses (below right).

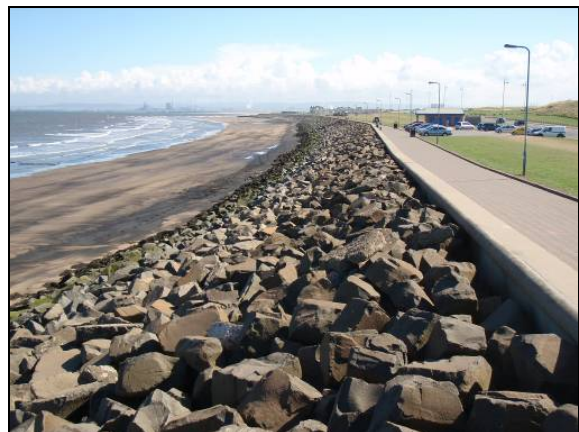
To the south of South Pier the accropode armour ties into a dolerite rock armour revetment fronting a recurved concrete splash wall (right). The defences along Carr House Sands remain in very good condition as reported in the 2008 inspection. The revetment appeared to have a consistent profile and a good degree of interlocking between armour units was present throughout.

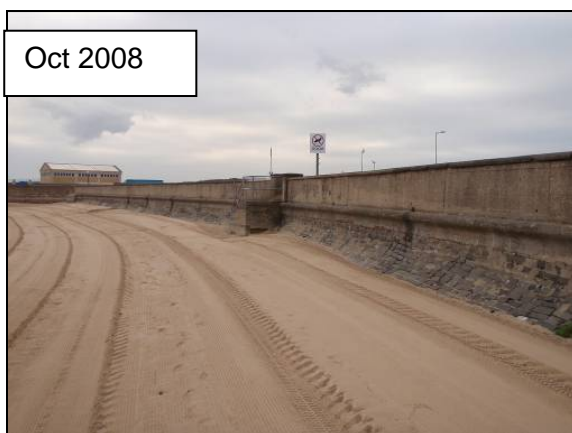
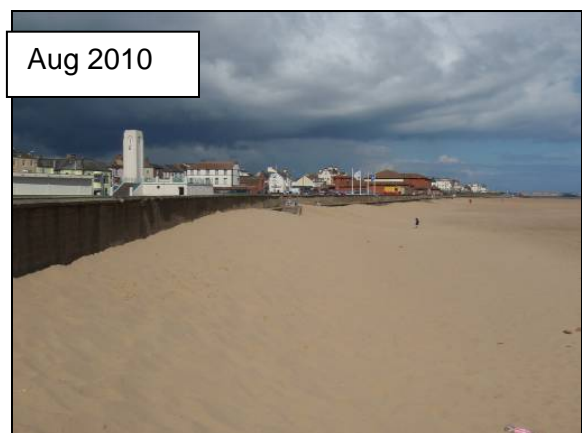
The beach levels along the Seaton Carew frontage were higher than during the 2008 inspections, especially towards the south of the frontage (below, left & right). This led to sand obscuring some of the defects previously identified in the lower sections of structures.

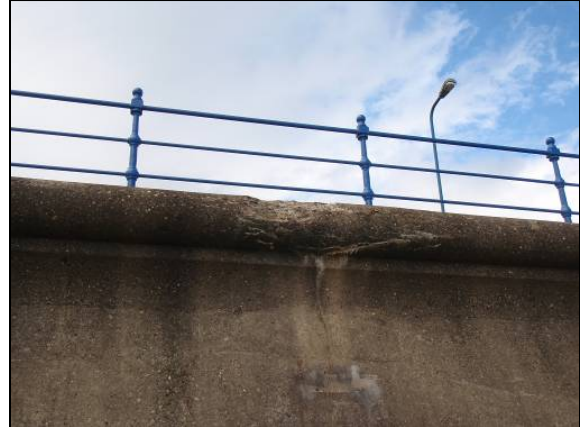
The structures along the Seaton Carew frontage consist of various concrete and masonry structures with toe rock armour units locally (below, left). There was no global movement or distress noted to any of the defence assets and therefore it was assumed that the foundations were performing satisfactorily and that no significant deterioration had taken place below the beach level. The structures were generally in fair condition with predominantly aesthetic defects which were previously recorded in the 2008 inspections (below right).

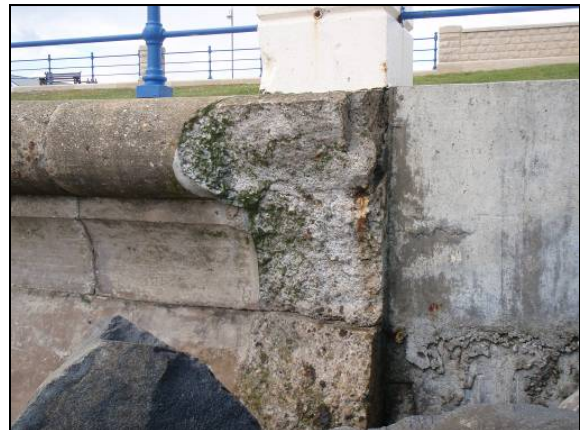
Defects included abrasion of concrete exposing aggregate and reinforcement locally (below left) and spalling of concrete (particularly copings and surrounding impact damage) (below right). Some mortar loss from the grouted masonry revetment was visible in areas with lower beach level such as access points although this did not appear to have worsened since the 2008 inspections.

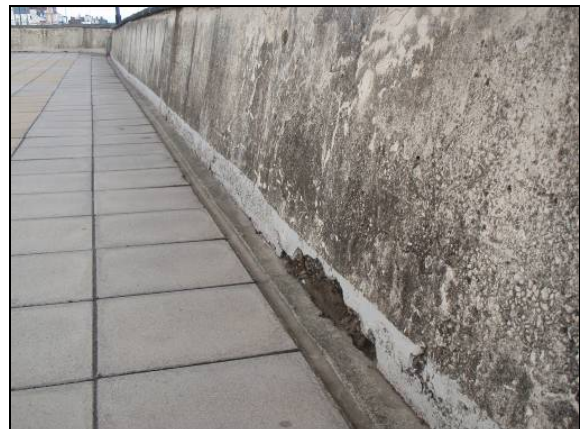
Abrasion and minor spalling was evident along the base of the wall on the promenade side (below, left & right). This erosion was most likely caused by wind blow sand and water draining from the promenade and previous patch repairs were evident although these were also eroded locally.

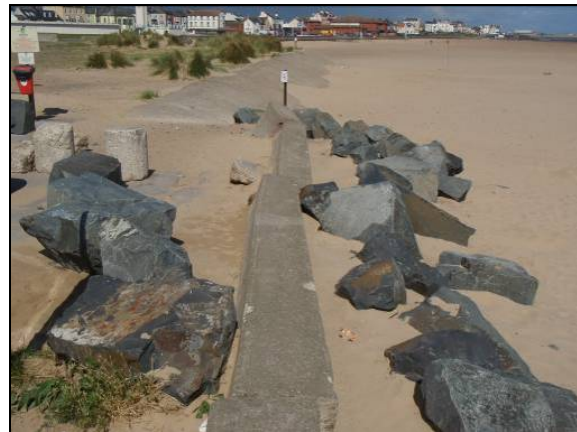
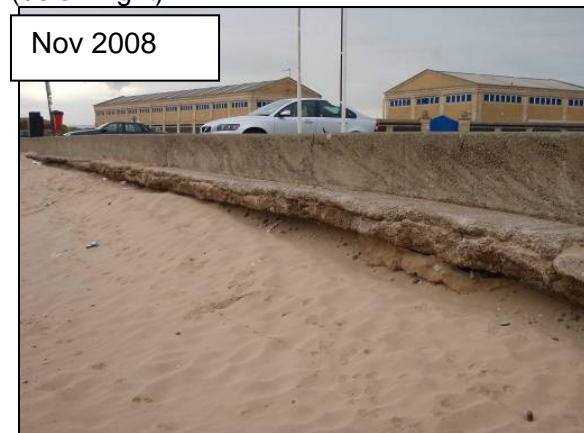
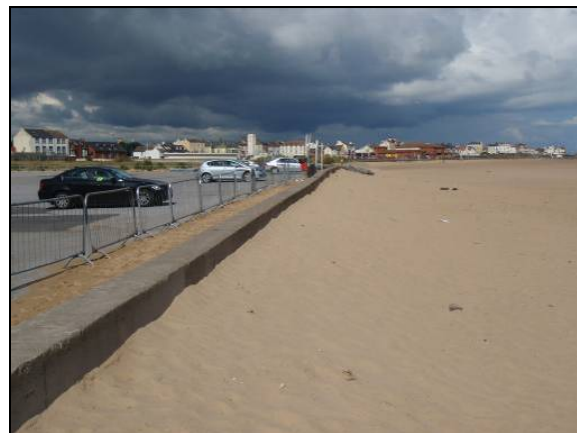
The low concrete wall fronting the public car park was generally in fair condition with displaced sections of wall at the northern extent as reported in 2008 (right). Rock armour units are present although predominantly as a barrier to prevent vehicular access to the beach.

During the 2008 inspections undercutting of the concrete apron was identified (below left High beach levels during the 2010 inspections (below right) meant that this undercutting was buried. Additionally, wind blown sand had accumulated on the landward side of the wall (below right).

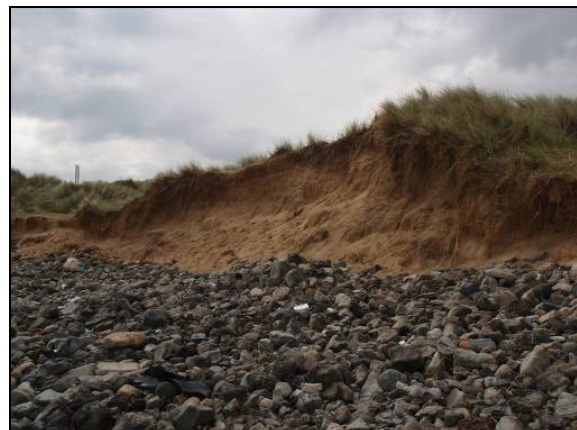
South of the sewage pumping station, the frontage is undefended and comprises of a relatively stable dune system forming the Seaton Dunes Nature Reserve (below left). The dunes were well established and had a good coverage of vegetation. Local erosion was evident due to trampling from members of the public walking through the dunes, with a lowering of the crest of the most seaward dune in several locations. Local cliffing was observed towards the south in close proximity to the North Gare breakwater (below right). The level of the dune crests generally increases to the south and a healthy beach is maintained along Seaton Sands by the North Gare breakwater.

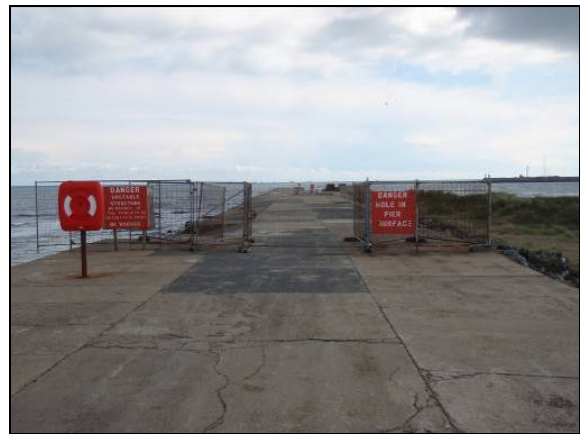
The southern extent of the Hartlepool frontage is the North Gare Breakwater. As reported in 2008, the structure remained in poor condition. Fencing was present at the landward end of the structure (right) and signs warned members of the public not to enter although on the day of inspection several members of the public were present on the structure angling and watching ships entering the River Tees.

There is also the need for action at North Gare Breakwater which provides important shelter to the mouth of the River Tees and acts to retain Carr House Sands. The structure was recorded as poor condition in 2008 and has continued to deteriorate.

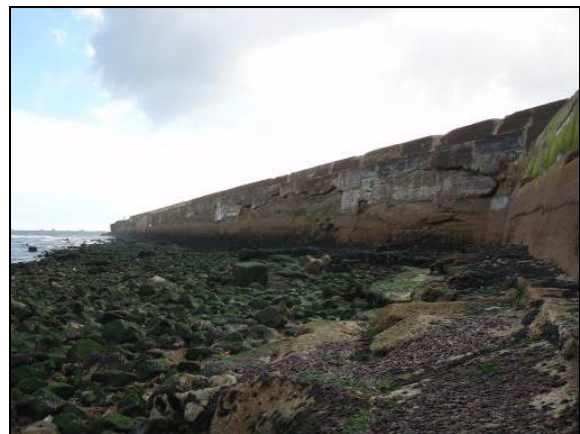
The breakwater is constructed from a combination of concrete and masonry elements, with extensive areas of previous repair including pre-cast concrete blocks, concrete bagwork of various sizes and insitu concrete pours (right).

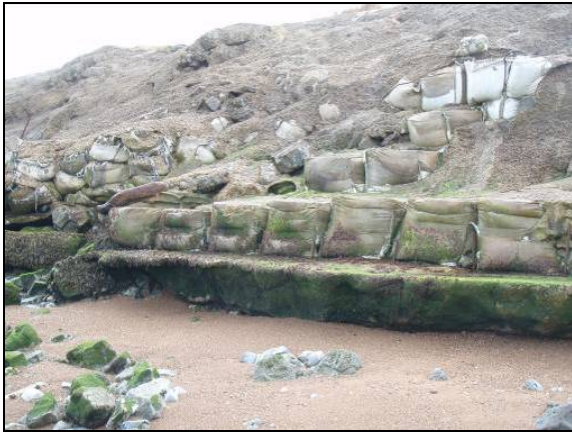
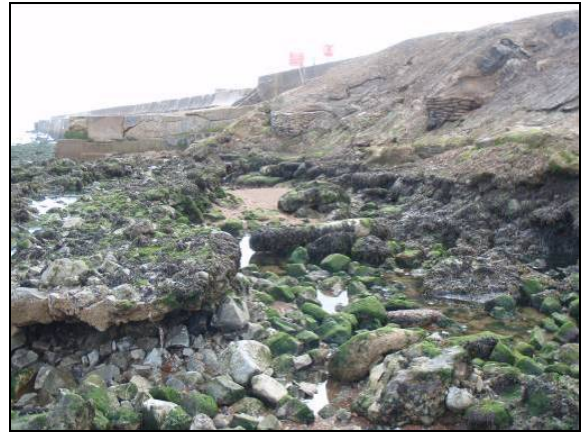
Bagwork to the northern face was holding together reasonably well although starting to be undercut and outflanked (below left). The mass concrete apron was broken up into several large pieces which were largely independent from the structure (below right). The concrete remaining on the structure was beginning to be undercut and extensive voids were present.

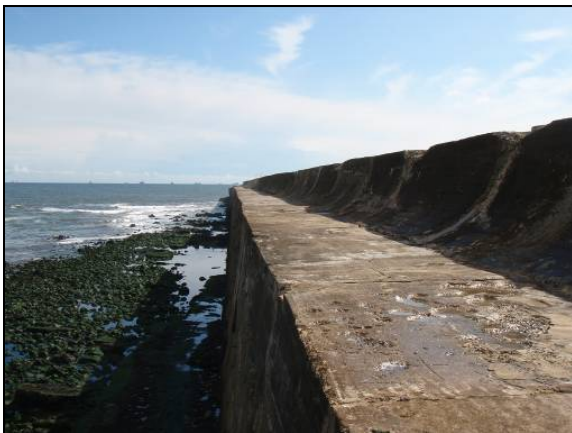
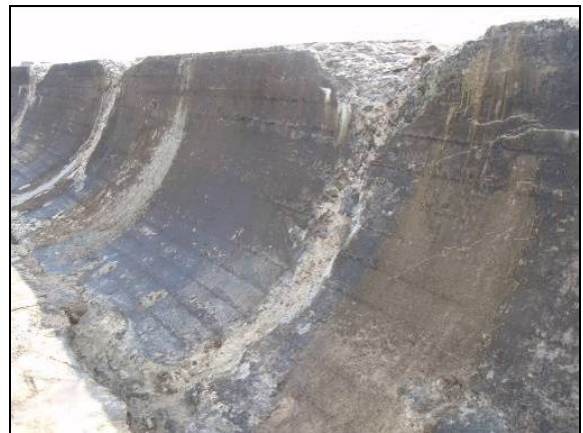
Extensive spalling of concrete was evident throughout particularly to the lower deck surface and the precast recurve units (below left & right).

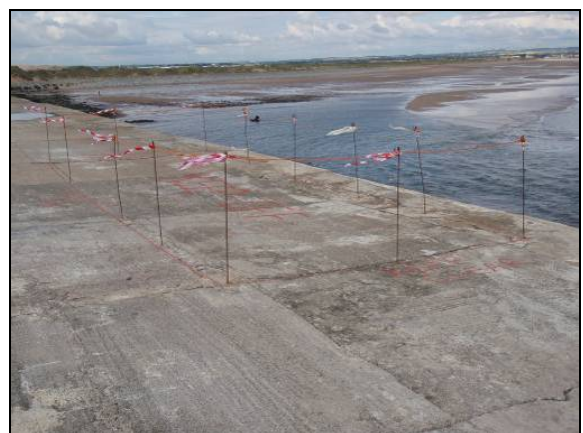
An area of the upper deck on the northern side of the structure had been taped off with steel bars and plastic tape with "KEEP OFF" painted onto the concrete (right). The reason for this was unclear although the slabs in this location were extensively cracked and potentially settling towards the seaward edge.

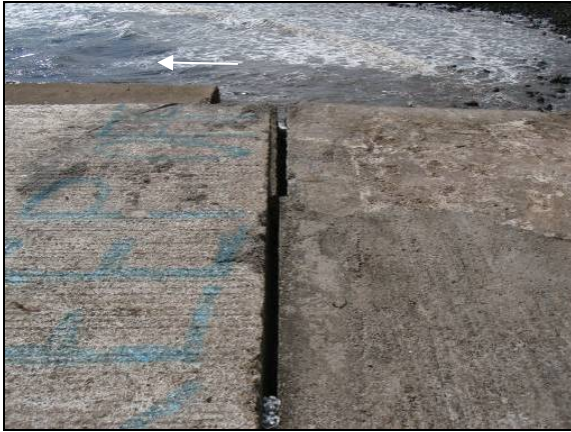
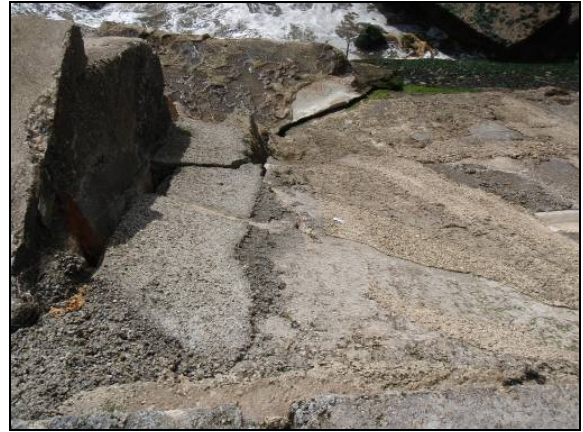
Displaced material and large cracks observed at the seaward end of the structure suggested that the head of the pier was becoming dislocated, possibly due to scour around the foundations (below, left & right). "KEEP OFF" was painted across the deck at the seaward extent of the structure. Large concrete armour units including accropodes around the nose of the pier were visible from the deck.

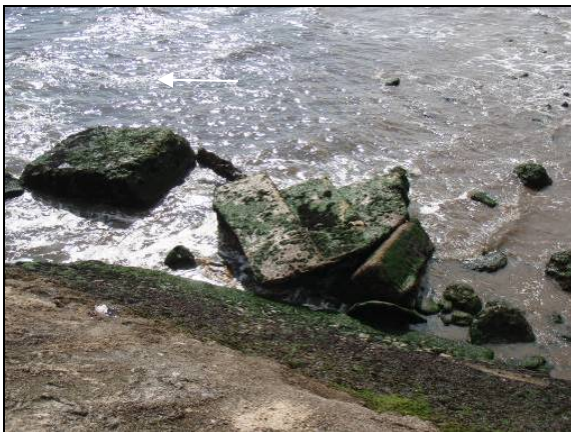
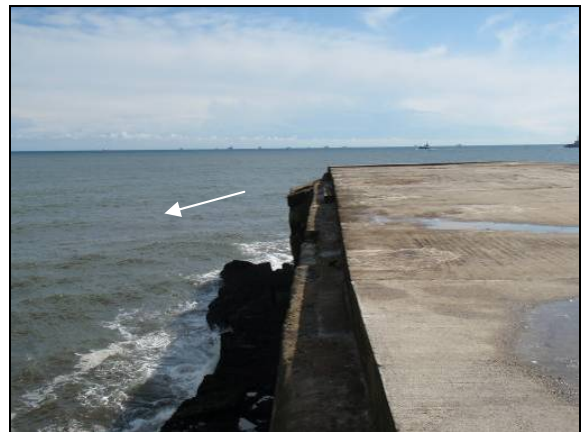
Several large pieces of concrete which appeared to have fallen from the structure were present on the foreshore to the south of the structure (below left). The nose of the breakwater appeared to step out on its northern face (below right).

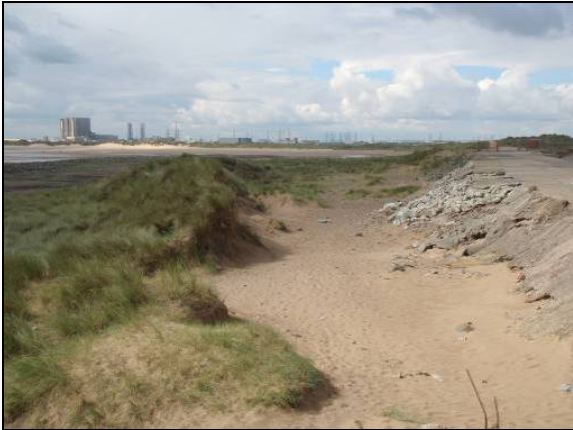
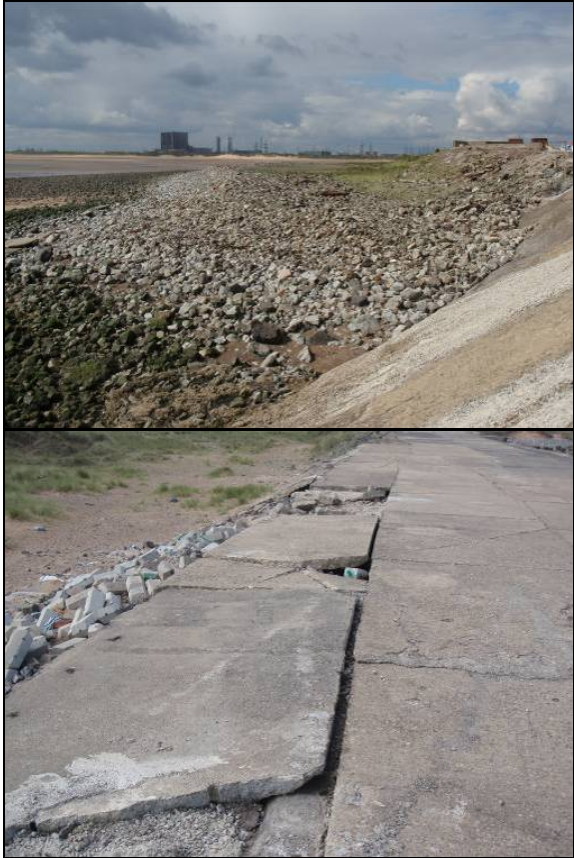
The southern side of the structure is fronted by an extensive rubble embankment and well vegetated sand dunes (right & below left). The structure was generally in better condition along its southerly, more sheltered side although significant damage was still evident locally, with loss of concrete render, evidence of settlement/displacement of previous concrete infill repairs and displaced/damaged slabs (below right).
