**Cell 1 Regional Coastal Monitoring Programme
Walkover Inspection Surveys 2016**

Hartlepool Borough Council

Walkover Inspection Surveys 2016

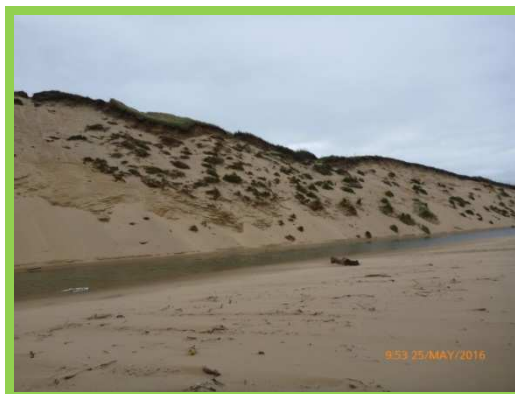
Local erosion adjacent to Crimdon Dene (/C0301C01)

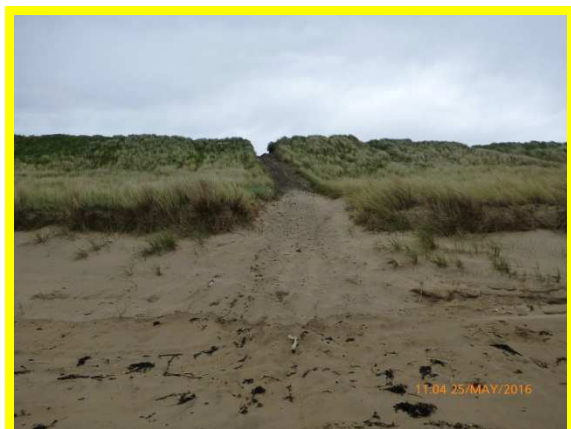
There was evidence of local lowering of the dune crest and lack of vegetation caused by trampling at informal access points, such as that fronting Spion Kop cemetery. The dunes at the landward end of the historic pier were lower than adjacent dunes, with erosion here likely exacerbated through access and scour around the timber elements. Embryo dunes were present with initial establishment of vegetation. The backing slope formed from made-ground along the former Steetley industrial site remained largely clear of vegetation.

Informal access at Spion Kop cemetery (/C0302C01)

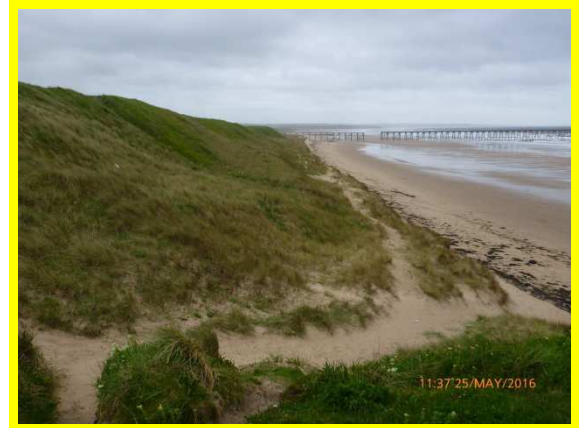
View on dunes looking north (/C0302C02)

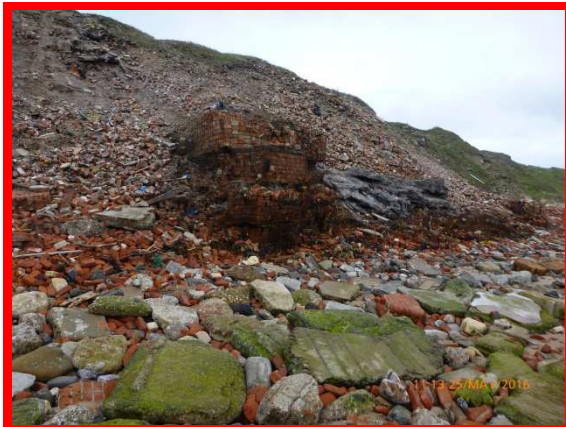
To the south of Spion Kop cemetery, the demolition/site clearance works at the former industrial site appeared to be complete. At the north of this site, several gabion baskets from the previously demolished retaining structure remained, however these were failing and could present a health and safety risk due to the unsupported mass of bricks/unstable structure. The remaining structure should be demolished as a matter of urgency. The bricks spilling from the previous structure had been spread along the foreshore, particularly visible within the cobbles/shingle of the upper beach to the north. The coastal slope to the rear appeared to be largely comprised of made ground/bricks/rubble with evidence of ongoing erosion/instability to the south of the former gabion structure.

Potentially unstable remains of former gabion structure (/C0302C02)

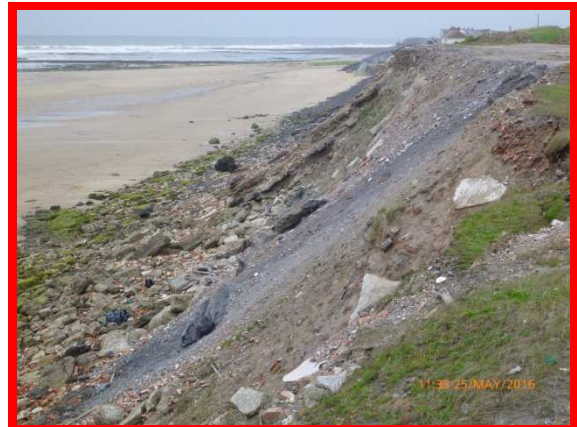
Erosion of made ground slope to south of former gabion structure (/C0302C02)

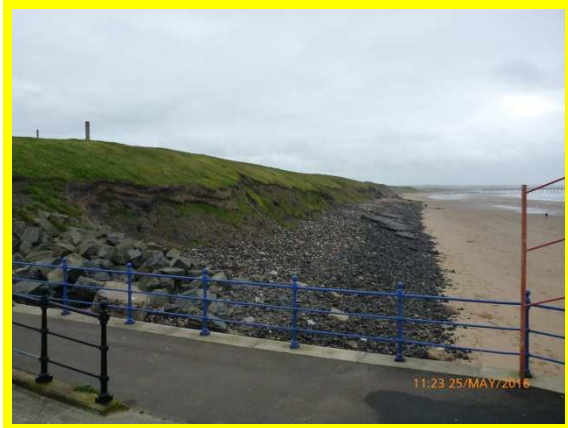
The embankment to the north of Marine Drive appears to comprise made ground /slag /rubble. Local undercutting and overhanging was observed, with this being more prevalent towards the southern extent of the asset. However, the slopes were generally vegetated. Large pieces of slag material previously poured to form a protective apron had continued to break up although the material is likely to remain *in situ*. Rock armour revetment (also incorporating several concrete tank blocks) at the interface with Marine Drive sea wall appeared in fair condition.

View looking north from Marine Drive (/C0302C03)

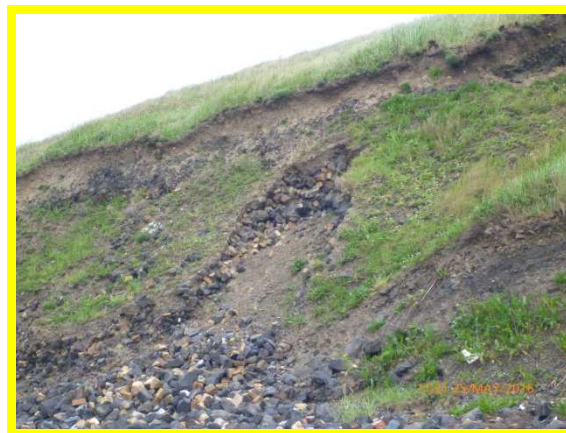
Local slope failure (/C0302C03)

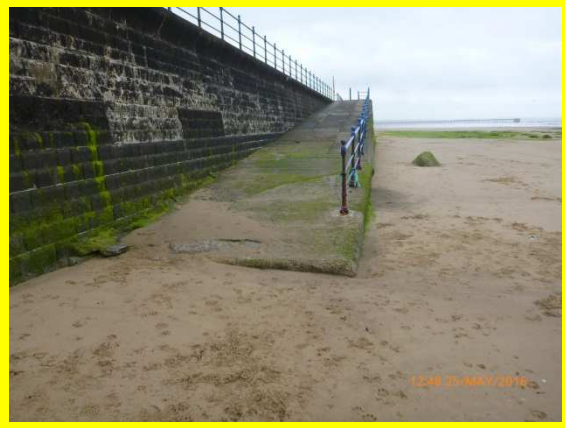
The beach level fronting the seawall was generally higher than observed during the 2014 inspections and the undercutting and toe defects previously identified were not visible. The ramp at Arabella Street was observed to be undermined in 2014, however this was not visible during the current inspection. Where rock outcrops were exposed, no voiding/undercutting was evident. On this basis, the condition grading remains as fair.

Foot of access ramp (Arabella Street) previously undercut (/C0303C01)

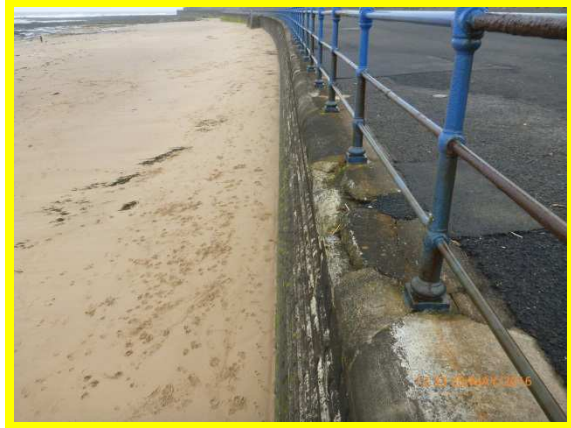
Evidence of local repairs to the masonry and concrete coping are generally holding up well. Local spalling, minor cracking and displacement of the concrete coping and minor mortar loss from the masonry were evident and require attention.

Local damage to wall crest (/C0303C01)

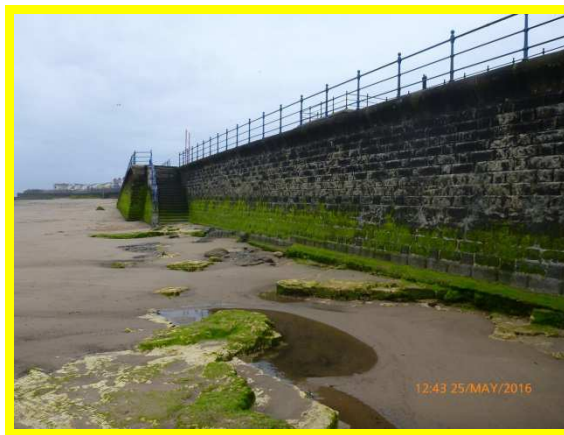
View looking south towards central access steps (/C0303C01)

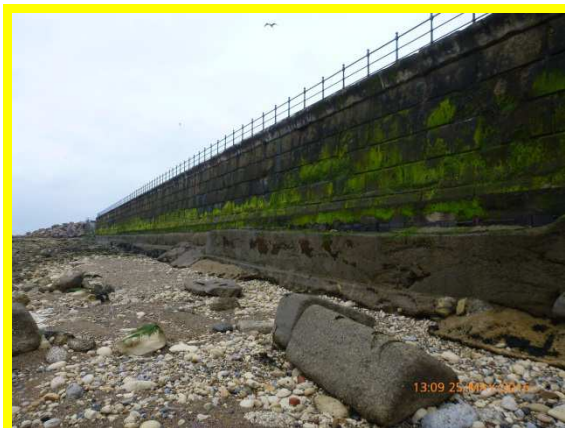
More recent construction comprising pre-cast concrete blocks at the toe of the seawall was in good condition. Toe sections which had not previously benefitted from concrete protection were damaged locally, with displaced sections of concrete visible on the foreshore. Longitudinal cracking was observed in the access ramp at Broad Field Road and should be monitored.

Damage to toe protection (/C0303C02)

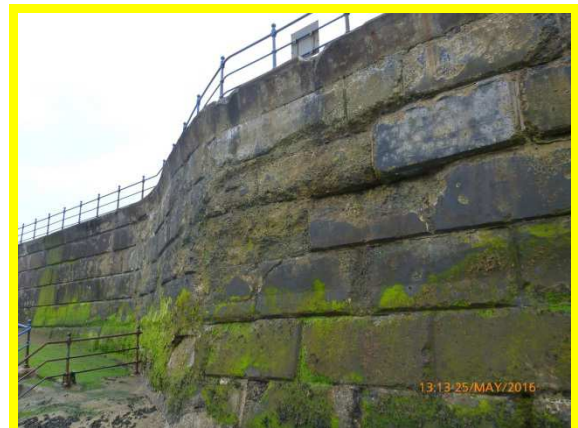
From the access ramp at Sea View Terrace, the wall construction changes to larger concrete blocks. Spalling of the concrete is evident throughout but is generally more significant toward the southern, more exposed length of seawall. Beach levels were higher than during the 2014 inspections, obscuring some of the defects identified at that time.

Spalling of concrete face (/C0303C02)

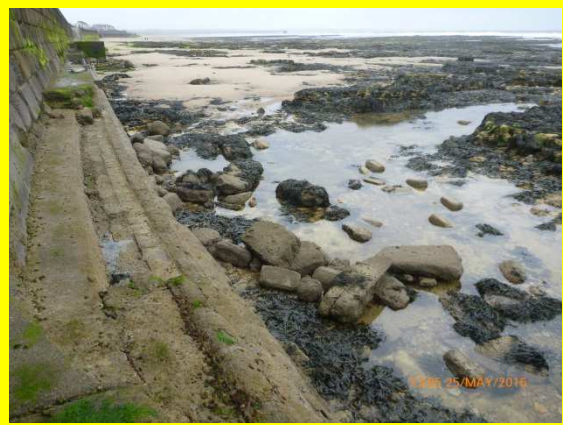
Abrasion of concrete toe protection. Displaced concrete on foreshore (/C0303C02)

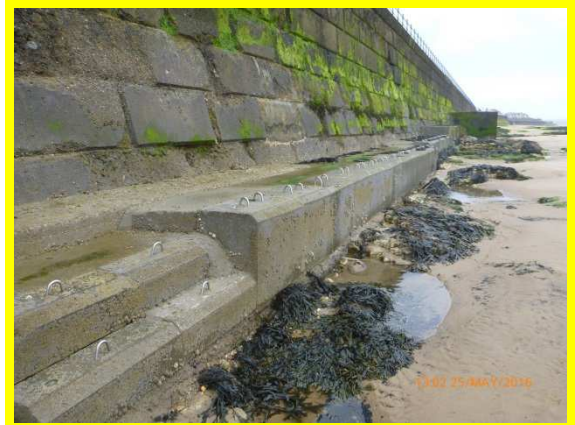
More recent concrete toe protection (/C0303C02)

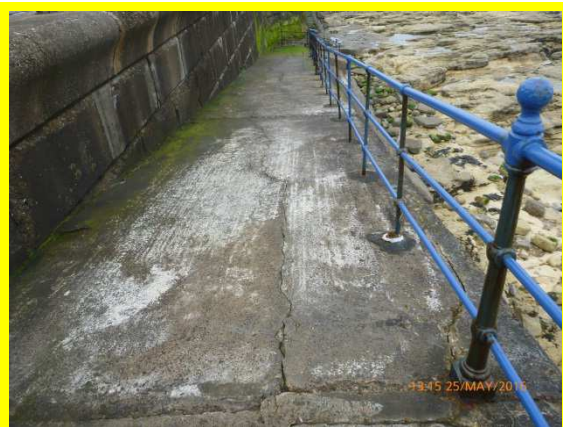
Longitudinal crack in Broad Field Road access ramp (/C0303C02)

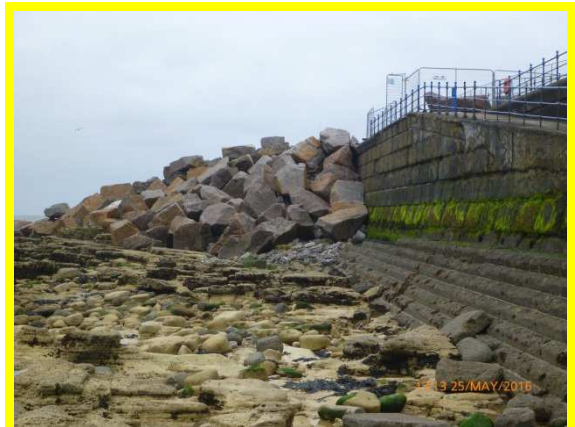
Rock armour forming temporary construction access south of Broad Field Road access ramp (/C0303C02)

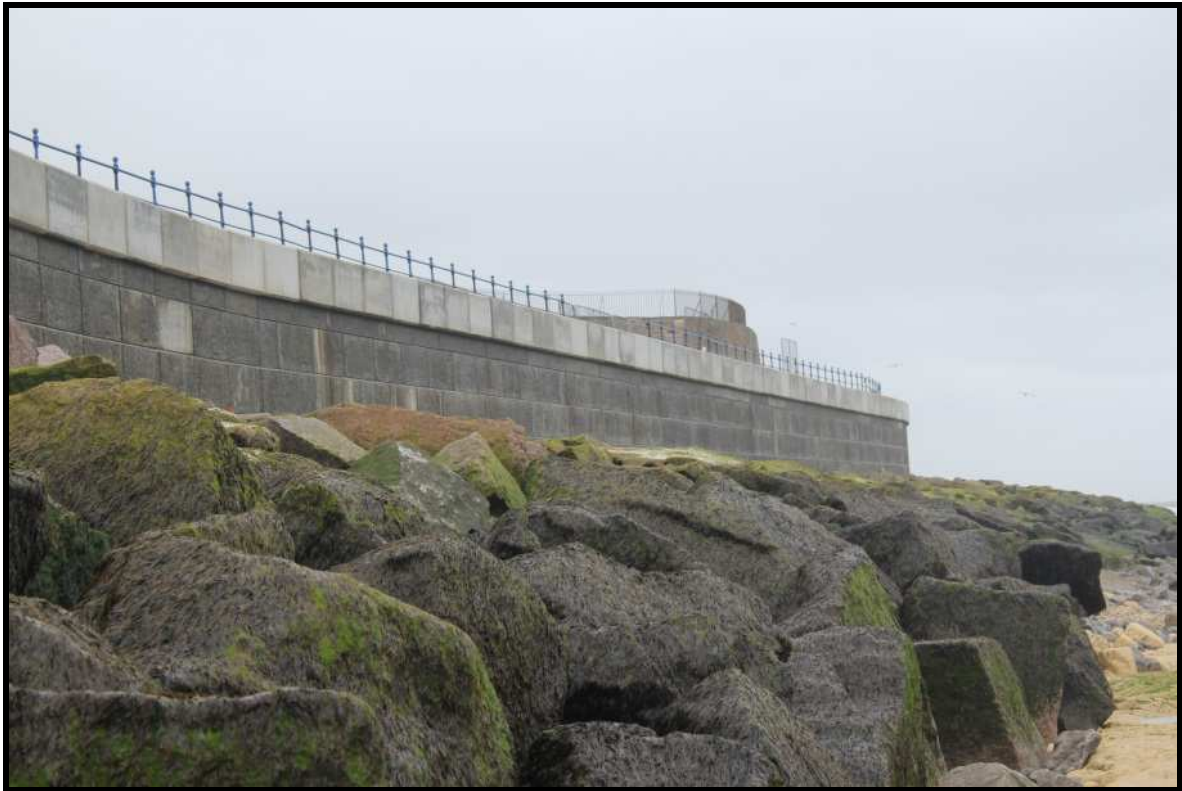
Recent/ongoing construction works viewed looking north from apex of Headland (/C0303C02)

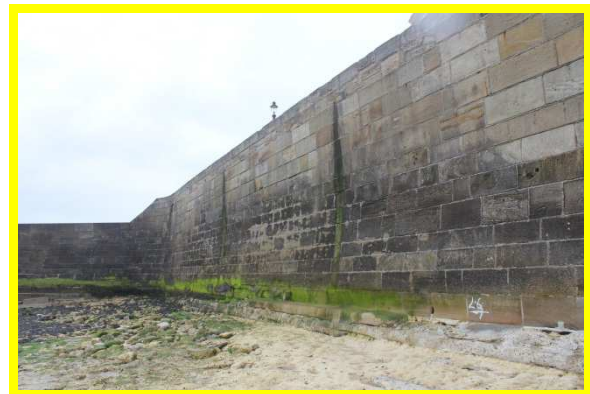
View on masonry wall looking south (/C0303C02)

Approximately half of this asset length has undergone construction work since the 2014 inspection. This length of defence (most notably the former buttresses) that was previously identified as containing significant defects has now been addressed by the new seawall and as a result the overall condition of the asset was deemed to be fair. The existing masonry seawall (not fronted by new concrete works) has undergone numerous local repairs and was generally in fair condition. Small voids were evident at the toe of the wall to the south of the access ramp and locally in the upper wall (birds were observed flying in and out of these voids, possibly nesting). The lower courses of blockwork wall showed evidence of abrasion throughout in addition to minor loss of mortar/open joints locally.

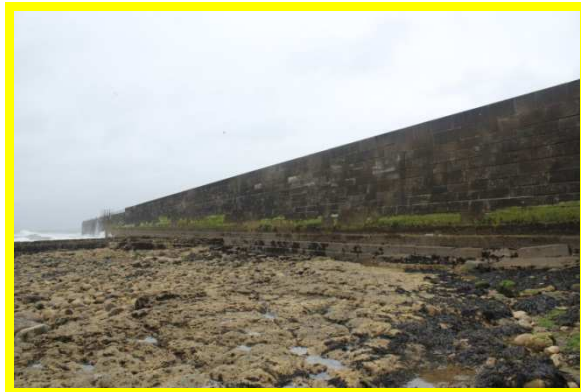
The privately owned Heugh Breakwater is not accessible to the public beyond halfway along its length, enforced with fencing and signage present. It is understood the seaward end of this structure has been in failing condition for many years. The landward section of the structure generally appeared to be in fair condition when inspected from the foreshore, with mortar loss/open joints and minor abrasion locally. Numerous previous repairs were visible on the deck of the structure.

Heugh Breakwater - North aspect (/C0401C01)

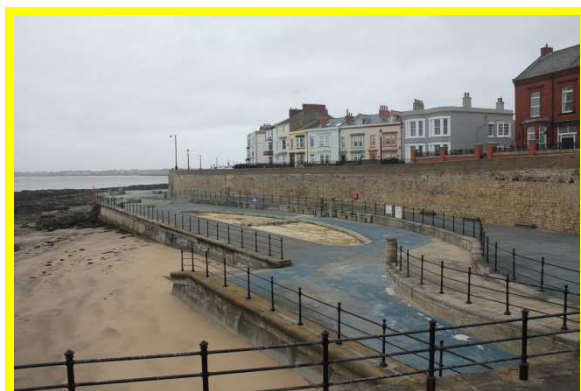
View looking south from Heugh Breakwater (/C0401C04)

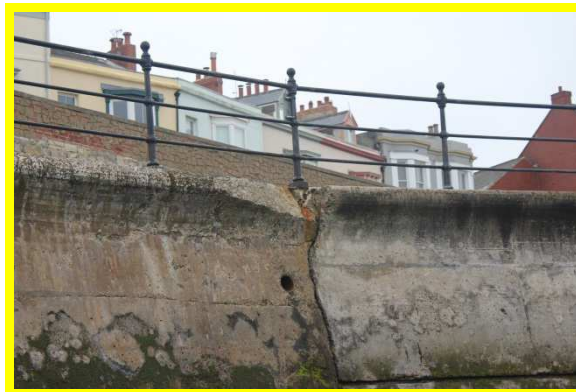
Damage to recurve concrete cope (/C0401C05)

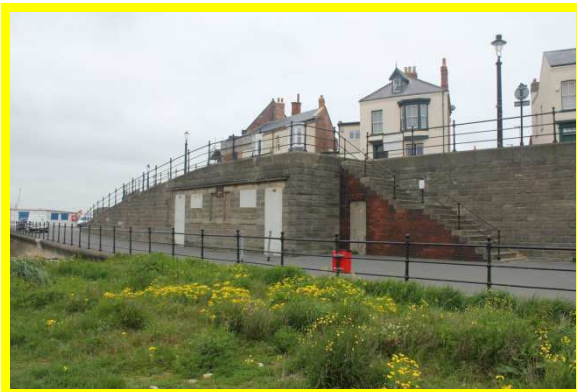
Former public conveniences. High beach with vegetation in foreground (/C0401C05)

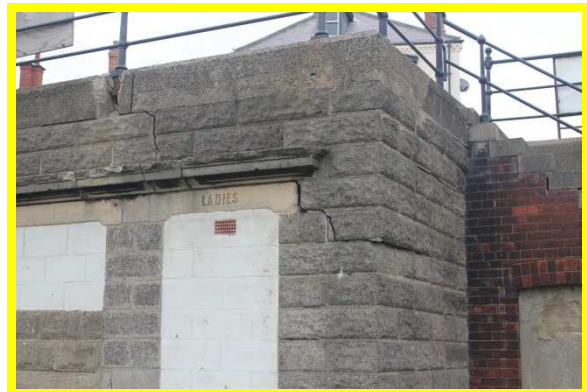
Cracks were observed in the masonry wall and access steps above the historic public conveniences. Undercutting of the wall was observed close to the interface with Old Pier. A large crack extended the full height of the wall, potentially suggesting a global movement of the structure; however no distress was evident in the promenade immediately above this section of wall. This should be monitored with consideration given to infilling/repairing the existing undercutting/voids.

Cracking in former public convenience building (/C0401C05)

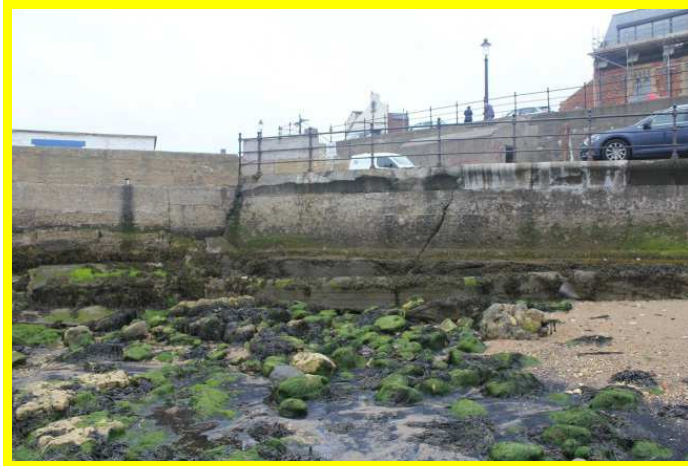
Undercutting and significant crack suggesting settlement. Old Pier to left of image (/C0401C05)

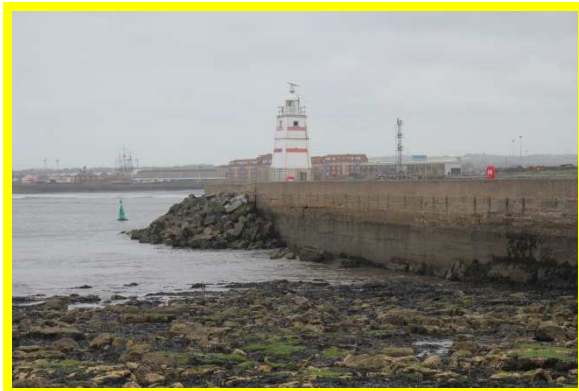
The masonry and concrete structure generally appeared to be in fair condition. The accropode armour units at the head of the structure appeared to maintain a good profile with appropriate voids and interlock. As recorded in previous inspections, cracking was present through the concrete parapet wall and in the deck adjacent to the wall in several locations. This cracking may indicate settlement of the structure rather than local damage to the parapet.

Outer face of North Pier (/C0401C34)

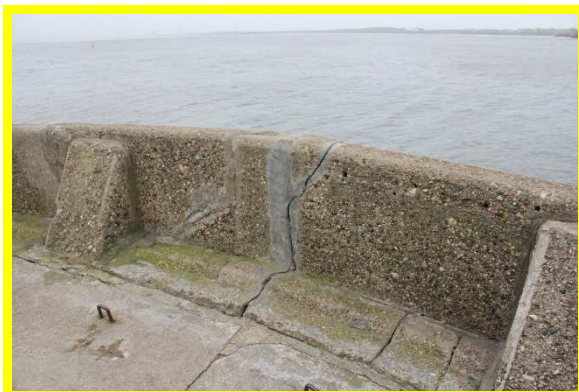
Cracking in concrete parapet wall and deck (/C0401C34)

Cracks were present in the deck, running parallel to the parapet wall, including around the roundhead. The parapet wall appeared to be leaning seaward along much of the length, most notably at the roundhead. Previous repairs to cracks in the parapet wall have subsequently reopened, suggesting continued movement. These defects were noted in the 2014 survey and do not appear to have worsened significantly. The cracks should be filled and consideration given to a more detailed survey/monitoring of the structure. The inner face of the structure seemed to show settlement in the masonry blockwork but this does not appear to have worsened since previous inspections. At the time of the inspections, Seymour Civil Engineering had established a site compound on the breakwater for the ongoing construction works along the Town Wall, to the west.

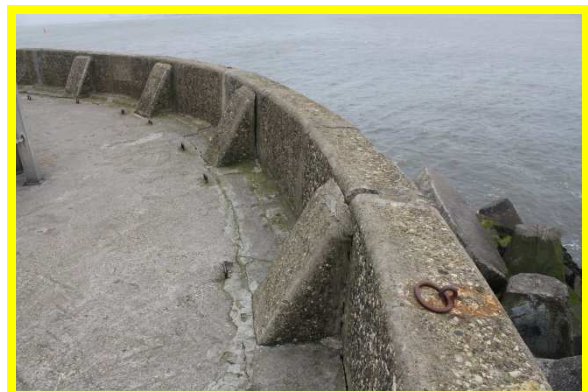
Cracking in concrete parapet wall and deck. Gaps between 'buttresses' and wall (/C0401C34)

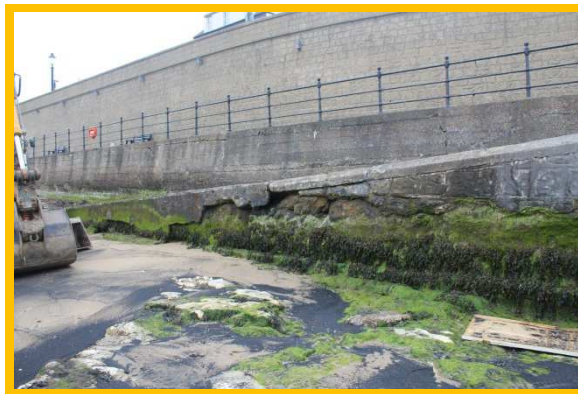
The beach level at Fish Sands appeared healthy and similar to that observed in 2014. Significant abrasion (largely obscured by marine vegetation growth) and voiding beneath the concrete deck was observed in the access ramp adjacent to Old Pier.

Voids beneath concrete deck of slipway (C0401C35)

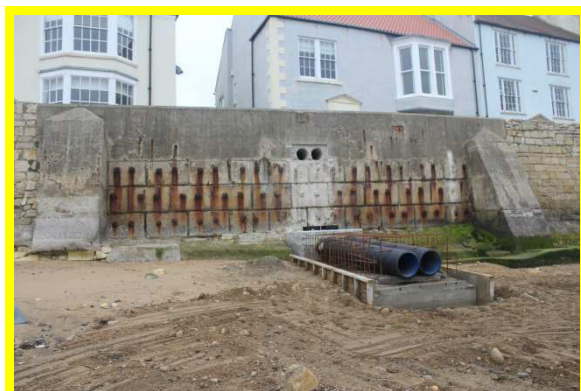
Construction works were ongoing to create a new outfall (twin HDPE pipes awaiting reinforced concrete surround) and build a new masonry retaining wall and footway/promenade to the rear of the seawall.

Concrete section of wall, ongoing construction of outfall. Significant corrosion/rust staining previously observed (C0401C35)

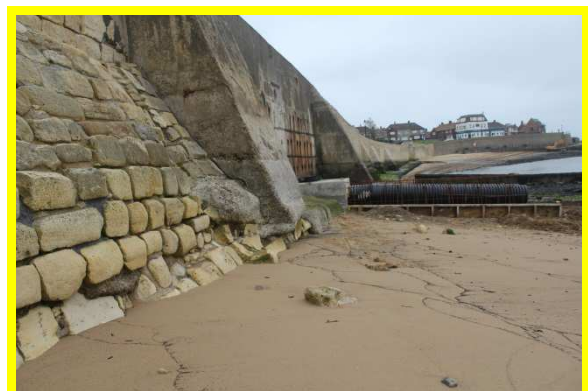
The masonry wall was generally in fair condition with some loss of mortar and open joints in the lower courses which would benefit from repointing. The concrete apron at the toe of the wall was in good condition.

Open jointing in lower masonry courses. Local undermining of concrete buttress (C0401C35)

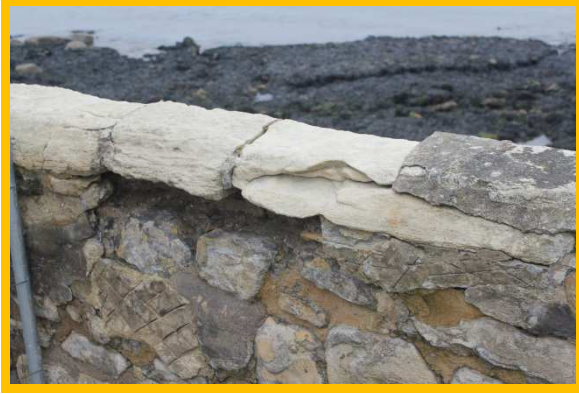
The crest wall is in poor condition locally on the landward side, with evidence of previous repairs which appear not to have been appropriate given the nature of the existing masonry. Loss of mortar and open jointing is evident throughout, with missing masonry locally.

Missing masonry at crest (/C0401C35)

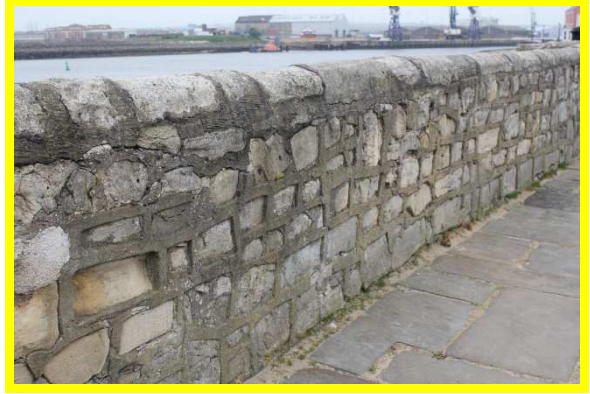
Previous repairs. Mortar used in repointing appears to be stronger than masonry and now stands proud of the stone (/C0401C35)

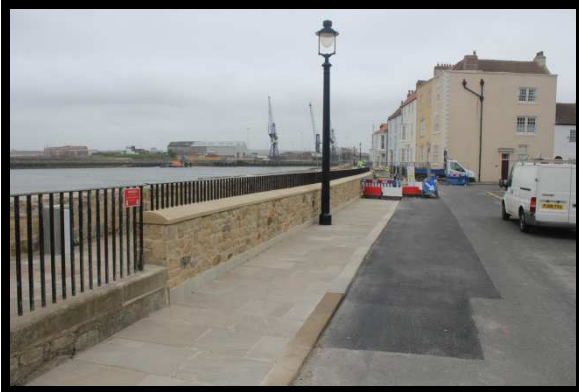
Recently completed masonry wall and walkway to rear of seawall along Northgate. Works continue in background. (/C0401C35)

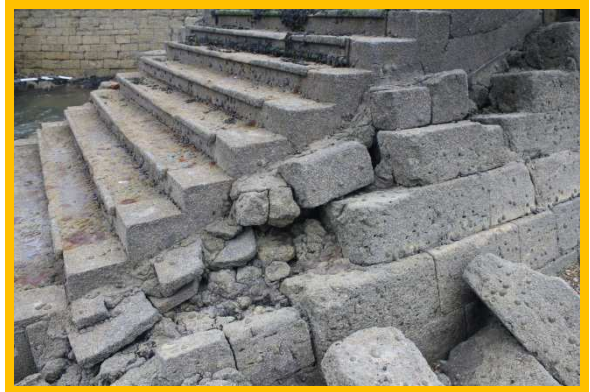
The steps at the former passenger ferry landing marking the southern extent of the asset are generally in poor condition with loose and displaced masonry and heavily corroded steel ties. Public access to this structure is prevented by a masonry wall and signage.

Damage to steps at former passenger ferry landing (/C0401C35)

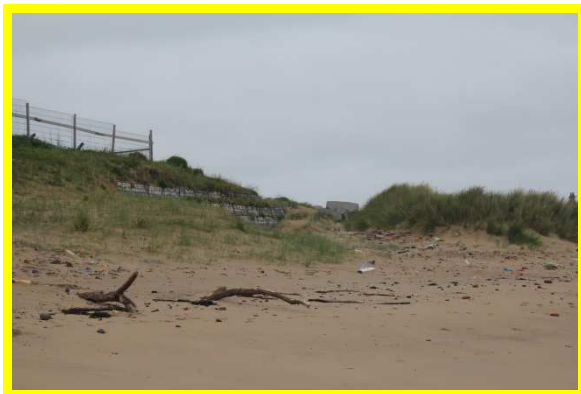
High beach levels and embryo dunes (/C0401C17)

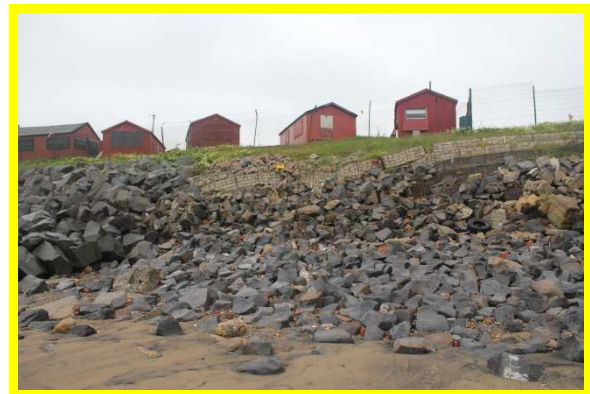
The stacked gabion wall to the south of Middleton Jetty appeared in very similar condition to that observed in the 2012 and 2014 inspections. Local settlement of the wall was evident although the gabion baskets remained intact. Consideration should be given to extending the existing larger rock armour revetment from the south to provide additional protection to the settled section.

Settlement in stacked gabion wall (/C0401C17)

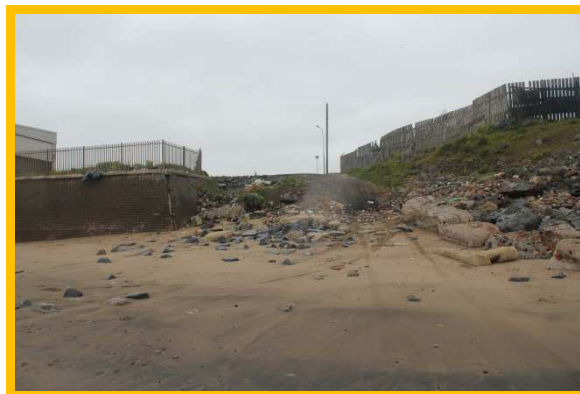
The short length of undefended frontage comprises an informal beach access ramp. The condition remains unchanged from the 2014 survey in that the southern side of the ramp is steeper and less stable than that to the north.

Informal access ramp (/C0401C18)

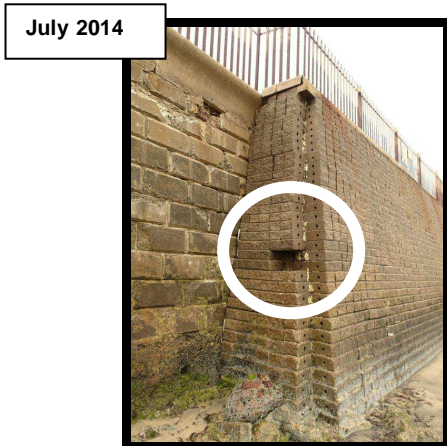
As observed in previous surveys, the profile of the concrete blockwork wall was not consistent, with bulges of various sizes visible along the full length. Numerous concrete coping units were missing. Opening joints were evident, suggesting global movement of the structure. Further blocks were missing, evidence that the defects had worsened and minor scour / local lowering of beach levels was observed.

Missing blocks at interface between two walls (/C0401C19)

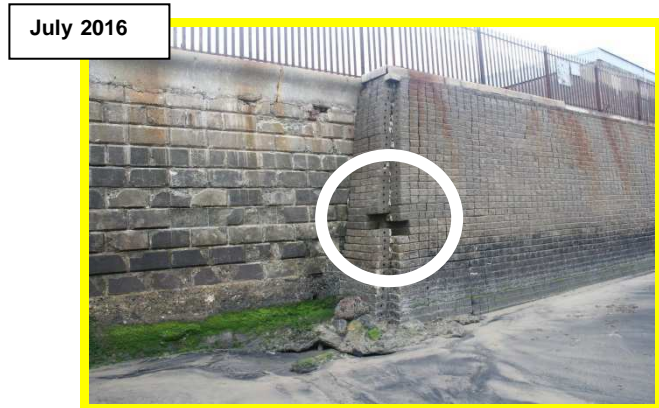
Missing blocks at interface between two walls. Local scour at toe (/C0401C19)

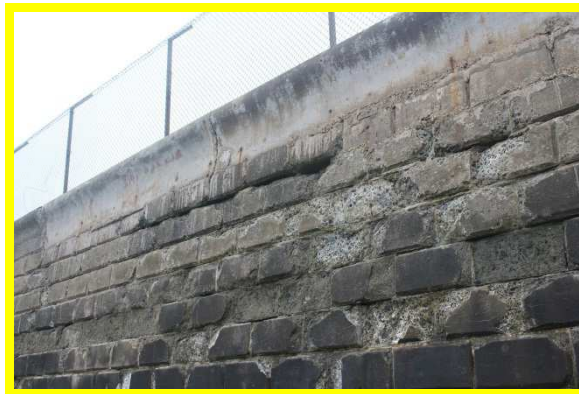
The large blockwork wall was significantly spalled with abrasion to the lower courses especially at the seaward bend cracking to the concrete coping. Several cracks extended through the parapet wall and through the full height of the seawall. These should be monitored.

Spalling/abrasion of concrete blocks (/C0401C19)

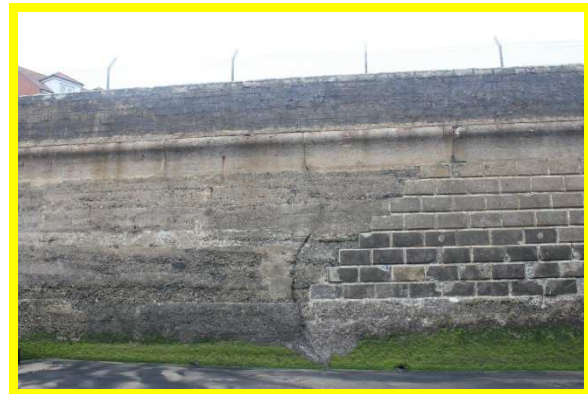
Vertical crack through parapet and seawall (/C0401C19)

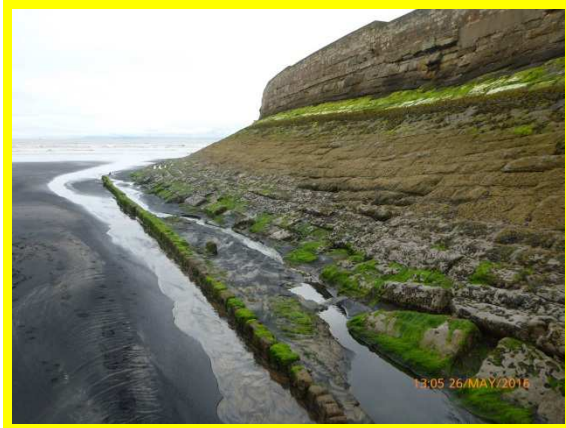
The landward end of the structure was viewed from the foreshore. As identified in previous surveys, the masonry structure appeared in fair condition, however the low beach levels exposed timber piles and a masonry apron with open jointing and local voiding which should be addressed urgently to prevent further deterioration.

North face of North Pier (/C0401C22)

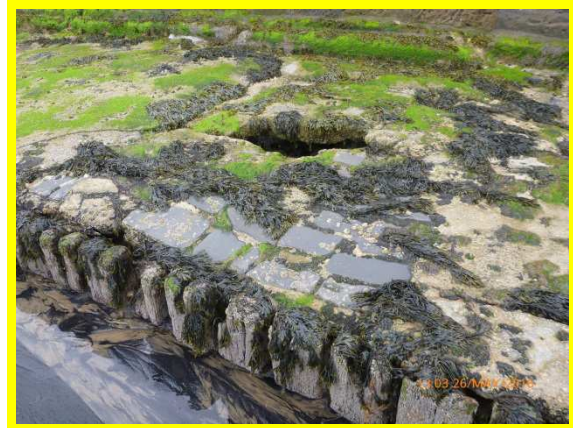
Void in apron of North Pier (/C0401C22)

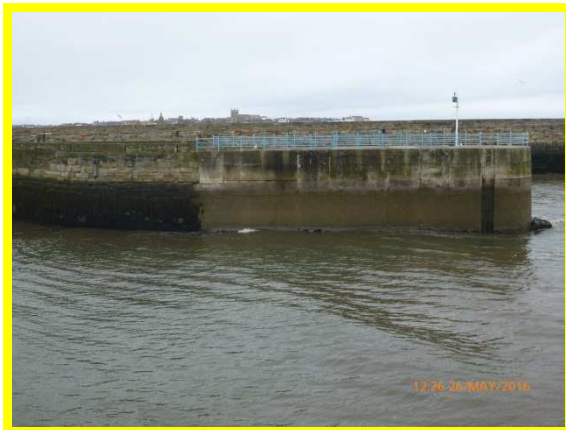
The seaward ends of the inner and outer arms of the North Pier were inspected from a distance (Middle Pier and South Pier). The structure appeared in fair to poor condition overall with defects including missing mortar, open joints, missing masonry, significant areas of damaged masonry and concrete. It was difficult to identify any significant deterioration since the 2014 survey, however it is a reasonable assumption that any defects will further worsen over time. The concrete head of the inner arm appeared to be in fair condition.

Head of inner arm of North Pier (/C0401C21)

Consideration should be given to undertaking a more detailed survey of the structure, including a boat/dive survey to inspect the permanently submerged seaward ends.

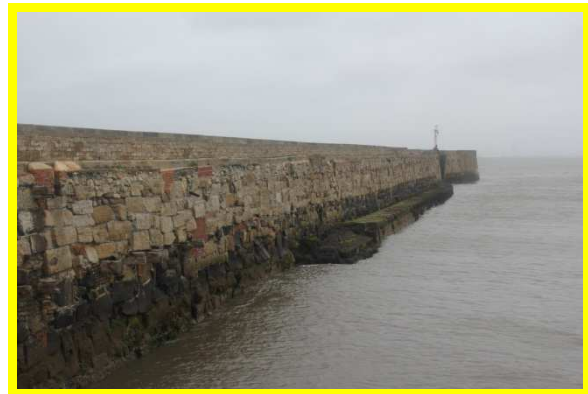
South face of North Pier (/C0401C22)

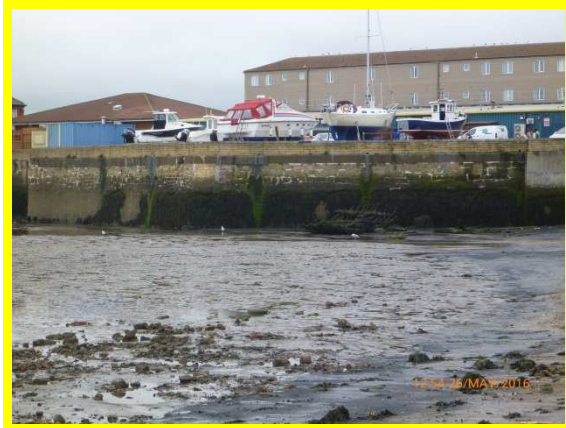
The concrete structures forming the lock entrance were in good condition with marine growth obscuring the lower sections. The masonry elements to both north and south sides were in fair condition, with evidence of various local repairs which appeared to be performing well and the more recent parapet wall constructed as part of Navigation Point development was in good condition throughout. The toe apron to the south of the entrance was completely obscured by marine growth, although the consistent profile suggested fair condition. The concrete wall to the rear of the apron was in good condition.

Masonry seawall to north of harbour entrance (/C0401C24)

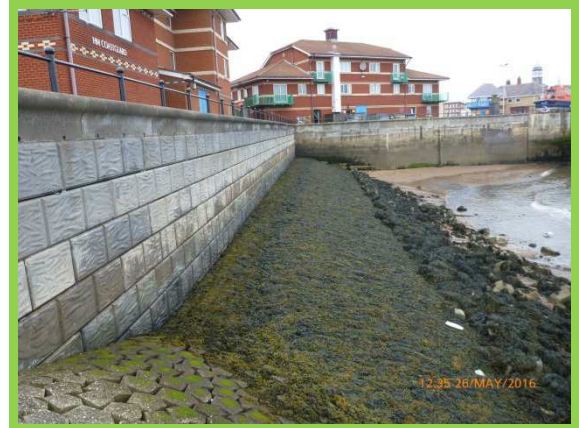
Concrete blockwork revetment obscured by vegetation (/C0401C25)

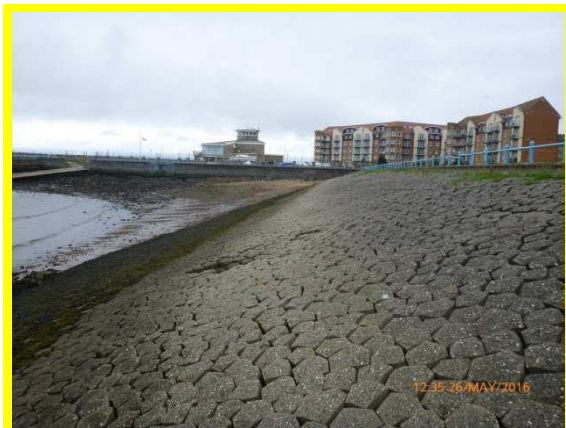
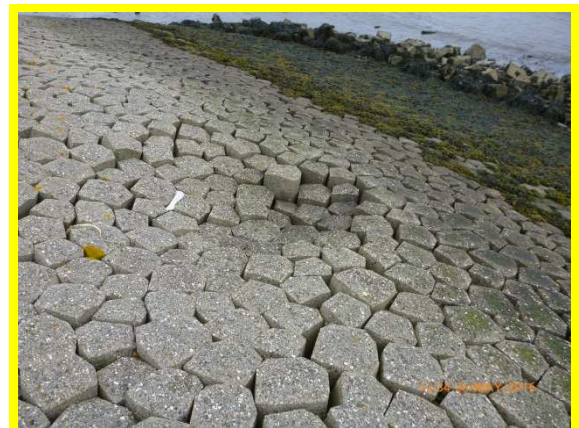
The concrete blockwork revetment to the south is generally in fair condition and the settlement of the concrete blocks noted on inspections since 2008 did not appear to have worsened significantly. Minor movement is suspected (slightly larger area of affected blocks and slightly greater displacement of central blocks). The settlement is indicative of a local loss of fill material below the concrete blocks and should continue to be monitored as further loss could reduce the integrity of the asset.

Local settlement of concrete blocks (/C0401C26)

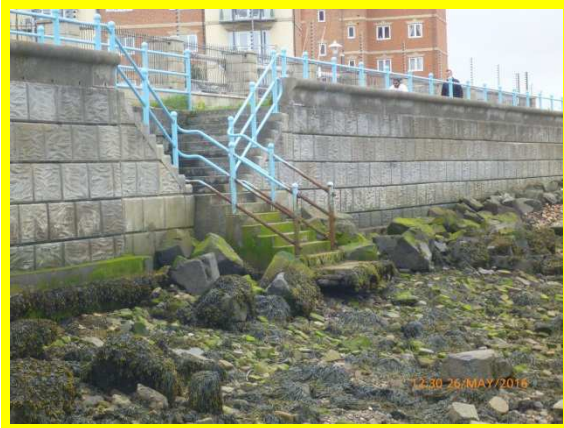
Undercutting of steps, slipway and seawall fronting Tees and Hartlepool Yacht Club was evident (although often obscured by marine growth) and appeared to be similar in extent to that observed in the 2014 inspections. It is recommended that voids are repaired locally with additional rock armour placed to avoid further scour damage. A gap was present between the concrete ramp and the precast concrete blocks forming the seawall. Voiding was evident beneath the ramp and the precast blocks were not supported on the landward side. This should be monitored to ensure the asset does not 'unravel' from this weak point.

Undercutting of access steps (/C0401C27)

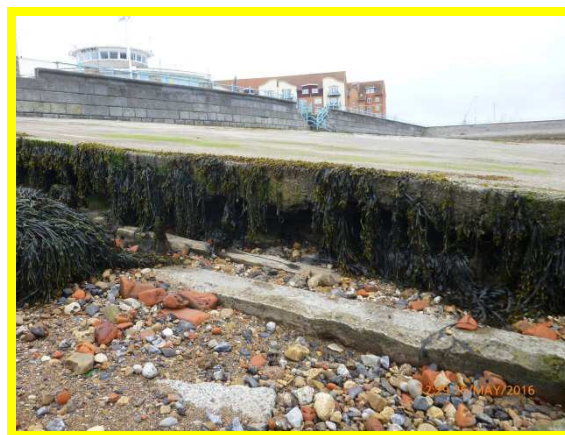
Undercutting of slipway (/C0401C27)

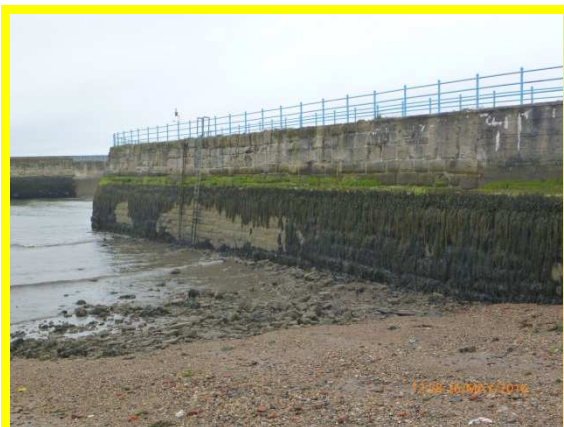
Although significantly obscured by marine vegetation, the masonry structure of Middle Pier appeared in fair condition with minor mortar loss locally. Significant vegetation growth was evident in the construction joints on the deck which should be removed and joints repointed. The rock armour placed to the toe of the inside face and around the head of the structure appeared to maintain a consistent profile with good coverage and interlock between units.

Inner face of Middle Pier (/C0401C28)

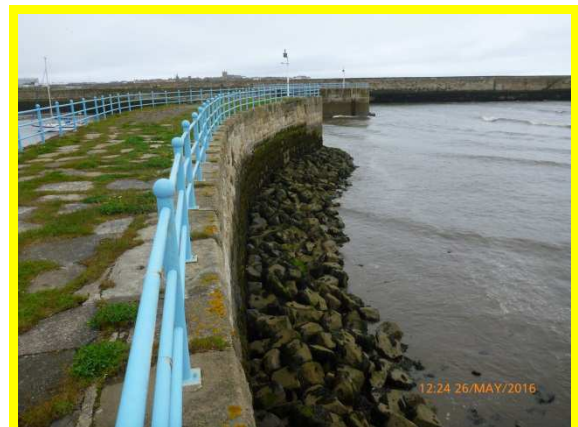
Outer face of Middle Pier – note vegetation growth on deck (/C0401C28)

Terrestrial vegetation growth along the top of the revetment to the inner face of the structure (reported in the 2014 inspection) should be removed to prevent roots causing damage to revetment or concrete.

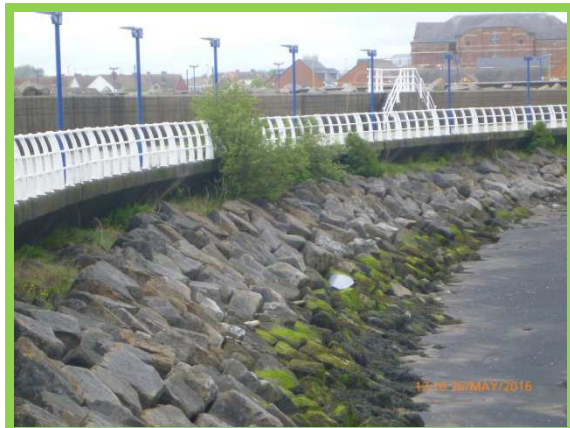
South Pier was in good condition. The rock armour placed to the inner face maintained a consistent profile and good interlock. Vegetation growth was observed at the crest of the rock armour, including several more mature shrubs which should be removed to prevent the root network damaging the concrete structure or rock revetment.

Inner face of South Pier – mature vegetation to be removed (/C0401C32)

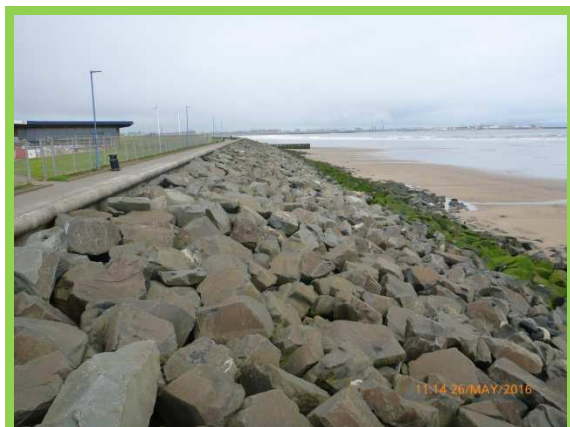
To the south of South Pier, the accropode revetment ties into a rock armour revetment with a concrete crest wall which runs for approximately 2.3km to Little Scar at the north of Seaton Carew. The defences along this section remain in good overall condition with minor local defects that will require attention. The flexible sealant used in construction joints of the concrete seawall was beginning to harden and pull away from the concrete faces and was also damaged or absent in places. Observations suggest that the sealant has previously been replaced locally, however the issue remains. Minor local spalling and cracking of the concrete access steps was evident, however these were generally in good to fair condition.

Rock armour revetment and concrete seawall (/C0401C33)

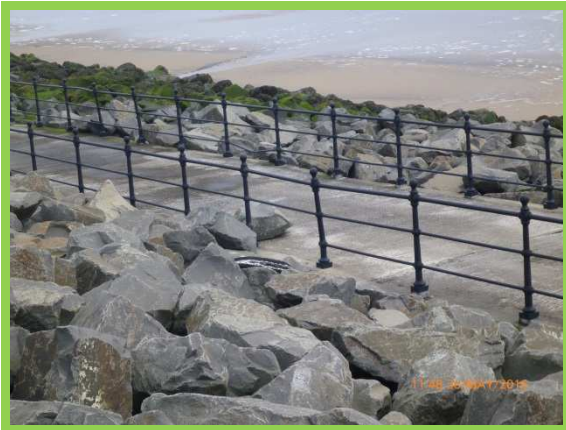
There was evidence of some potential local displacement of rock armour adjacent to the existing outfall structure in proximity to Newburn Bridge, where rock armour was visible slightly seaward of the general (visible) toe line. This was reported in 2014 inspection and should be monitored.

Displaced rock armour and damaged guardrail at northern access ramp (/C0401C33)

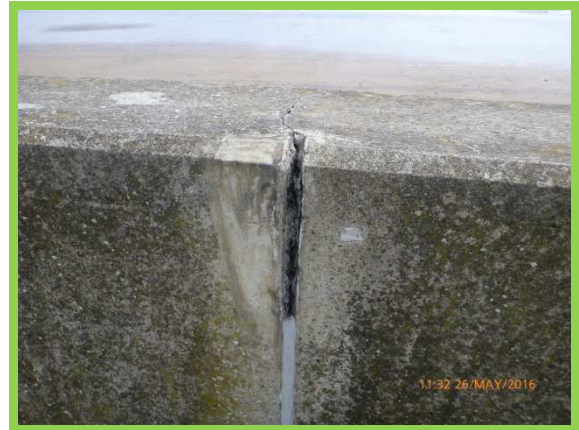
Loss of flexible joint sealant (/C0401C33)

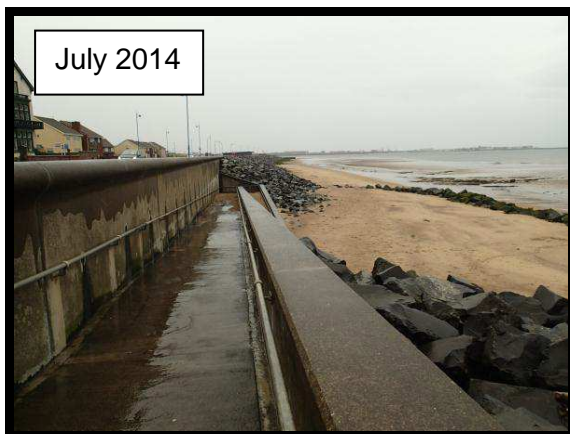
In the region of the Little Scar access ramp, beach levels were slightly lower than observed in the 2014 inspection – note the greater exposure of rock armour berm, however they remained higher than those observed in 2012 and 2010 (prior to reconfiguration of the berm). Cracks were observed in the concrete seawall at the access ramp and appeared to be associated with the fixings for the handrail. Local repairs should be undertaken and monitored to ensure this is not a more significant issue.

Exposed rock armour berm at Little Scar access ramp (/C0401C33)

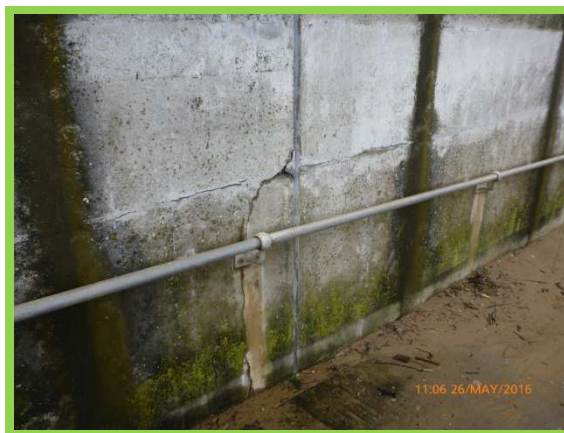
Cracks in concrete seawall at Little Scar access ramp (/C0401C33)

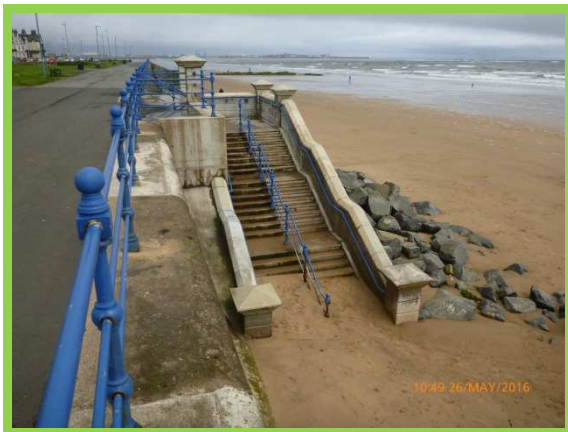
Northern access steps (/C0501C05)

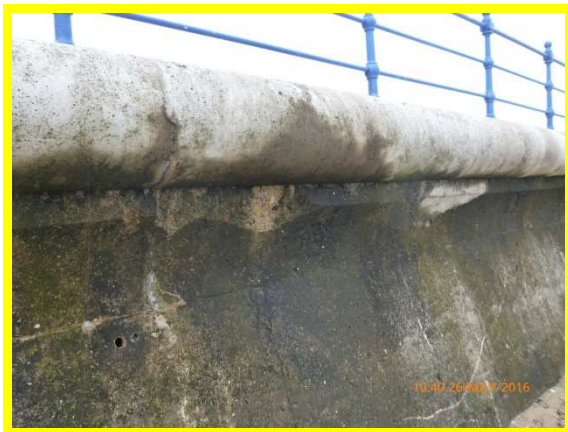
Minor defects were observed locally, several of which have previously undergone repairs, and these will require attention.

Local spalling of concrete (/C0501C05)

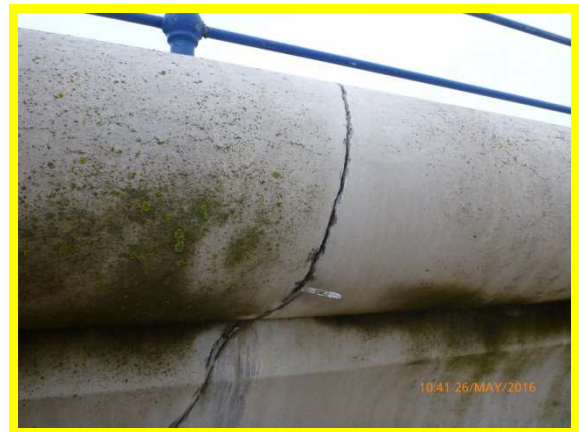
Crack in concrete cope. Note previous repair/fill now failing (/C0501C05)

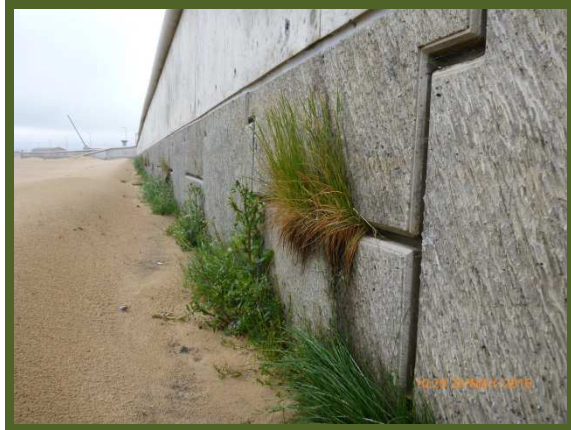
Vegetation growing in joints – should be removed (/C0501C04)

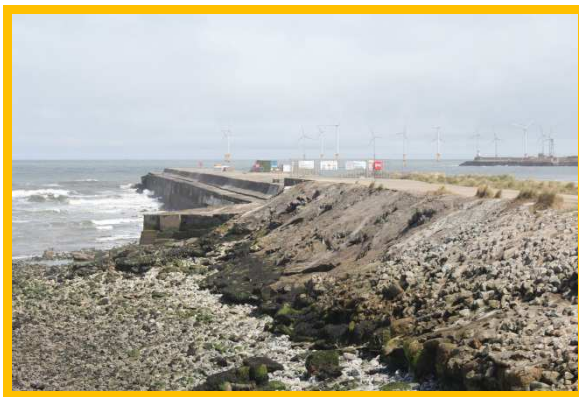
The concrete and masonry structure incorporates a multitude of ad-hoc repairs. As reported in 2008, 2010, 2012 and 2014 the structure remains in poor condition. Defects include cracking, spalling, undercutting, void formation, loss of masonry, loss of concrete render, evidenced of settlement/displacement of previous concrete infill repairs and displaced/damaged slabs.

*North face of North Gare Breakwater
(/C0503C01)*
