Cell 1 Regional Coastal Monitoring Programme Walkover Inspection Surveys 2020

Hartlepool Borough Council

Walkover Inspection Surveys 2020

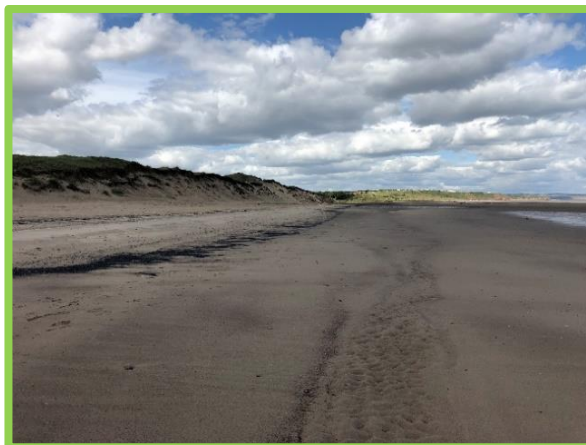
*View on steep dunes looking north
(/C0301C01)*

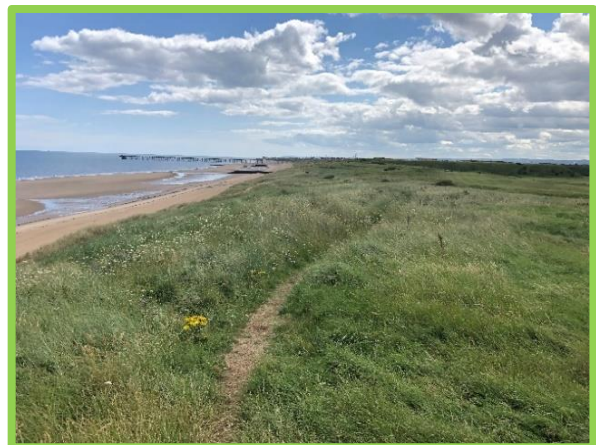
*Healthy well vegetated dunes fronting
Hartlepool golf course (/C0301C01)*

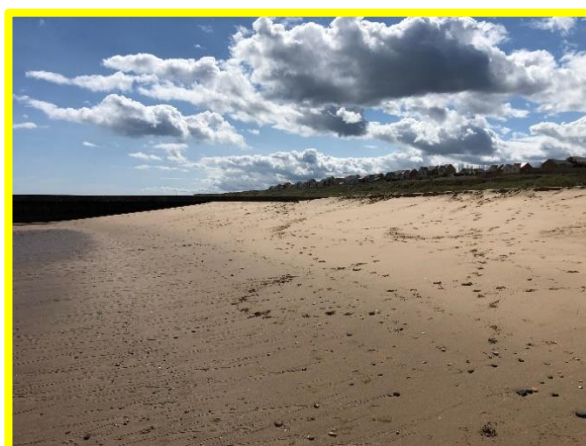
The two piled outfall structures to the north of Streetley Pier are in fair to poor condition. The sheet piles are heavily corroded, and the concrete capping beam is cracked and abraded. It was also noted that that the structures were retaining large amounts of sediment on their northern sides, especially noticeably on the southern outfall.

*Piled outfall structure retaining sediment on its
north side. (/C0302C01)*

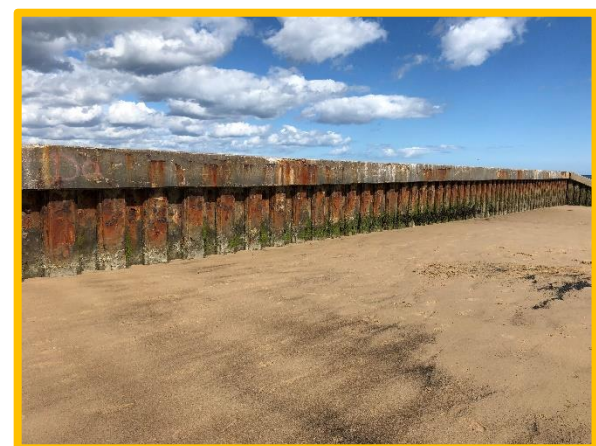
*Heavily corroded piled outfall structure
(/C0302C01)*

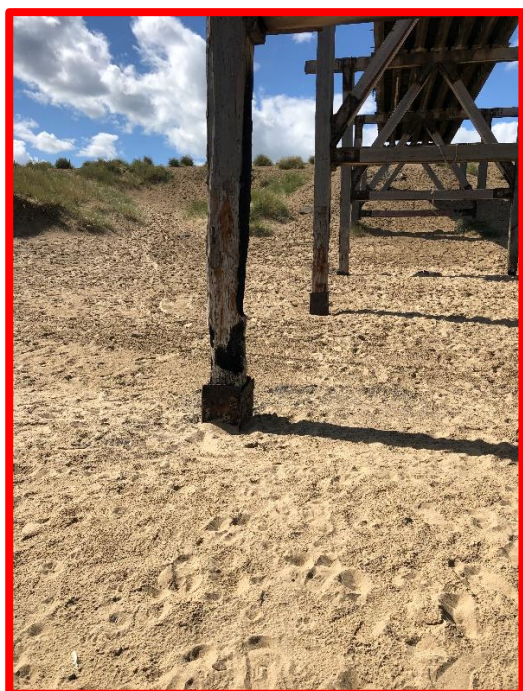
As reported in 2018, several timber columns supporting the historic pier structure have significant loss of section, likely due to fire damage. Children were observed on the deck of the structure during the 2020 inspection, and it is recommended that any informal access routes onto the pier should be reviewed urgently.

Loss of section to timber support columns of historic pier structure, likely due to fire damage (/C0302C01)

- **North Sands** – Although not noted to have worsened since 2018, significant loss of section to timber support columns of Steetley Pier remain. Detailed assessment of the structure should be undertaken, and if not already in place, a management plan for decommission/demolition of the structure should be produced. Children were noted to be sat on the deck of the landward section of the Pier during the 2020 inspection. Given the structural damage, it is recommended that any informal access routes onto the deck should be prevented immediately.

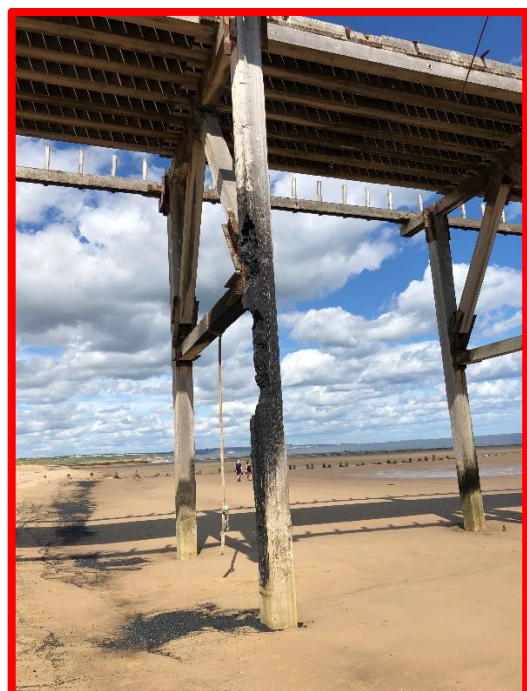
Loss of section to pier support columns, likely due to fire damage (/C0302C01)

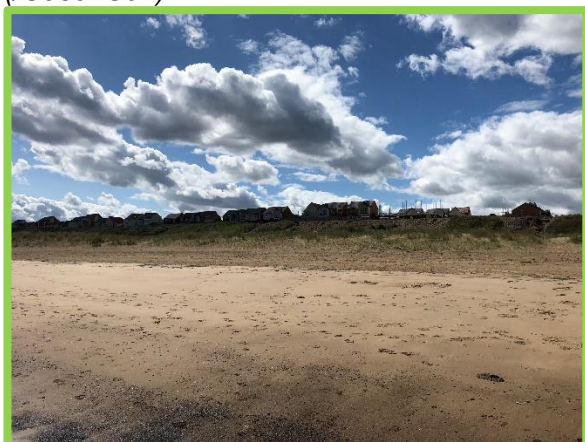
Embryo dune formation fronting housing development (/C0302C01)

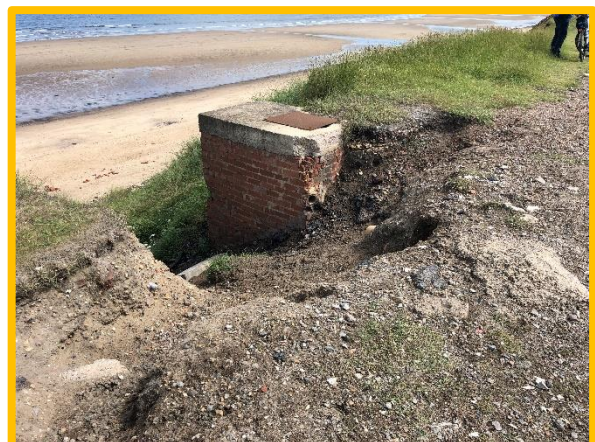
Manhole chamber at risk due to ongoing erosion (/C0302C01)

A brick manhole chamber on the southern boundary of the cemetery is a focal point for erosion and is at risk of collapsing onto the foreshore. It is recommended that the chamber is decommissioned.

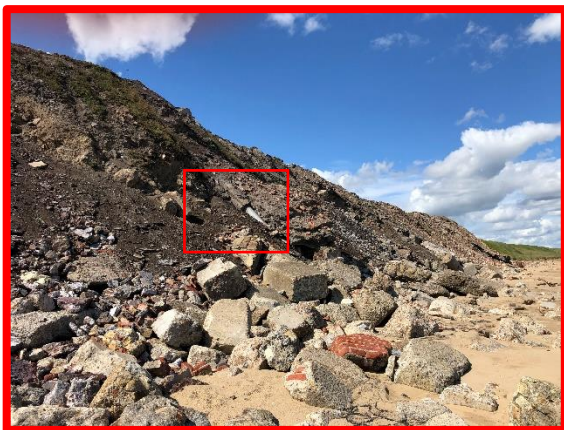
The coastal slope to the rear appeared to be largely comprised of made ground/bricks/rubble with evidence of ongoing erosion/instability. An outlet pipe has been exposed through ongoing erosion. In light of the property development in the vicinity, it is recommended a formal coastal defence is considered in this area.

Exposed pipework in made ground slope (C0302C02)

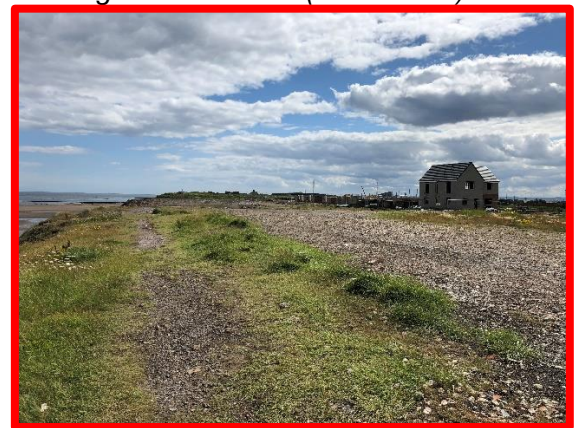
The section of made slope that is now undefended due to the failure of the brick gabion (reported in previous surveys) now fronts an ongoing residential development on the former industrial site to the south of Spion Kop cemetery. The proximity of the residential development and the ongoing erosion activity observed along this section means it is recommended that a formal coastal defence should be considered.

Property development on former industrial site, fronted by collapsed gabion structure (C0302C02)

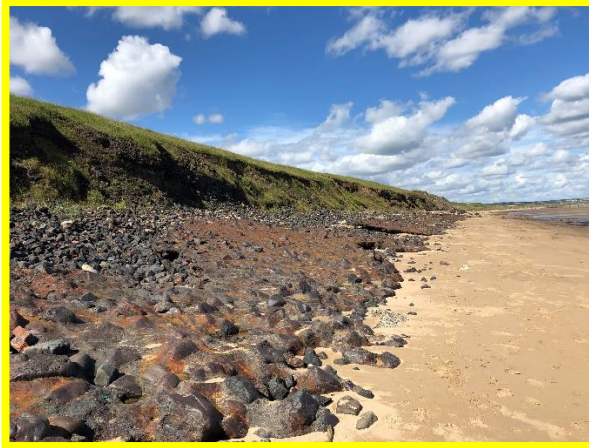
View looking north from Marine Drive (/C0302C03)

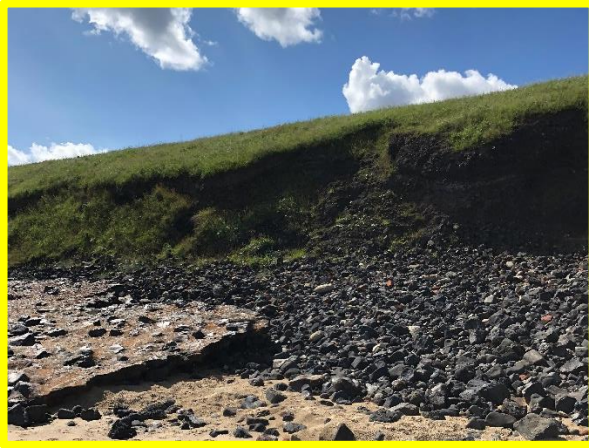
The embankment to the north of Marine Drive appears to comprise made ground /slag /rubble. Local undercutting and overhanging was observed, with this being more prevalent towards the southern extent of the asset. Small local slope failure was again observed in 2020, with a larger historic failure now fully vegetated.

Recent local slope failure (/C0302C03)

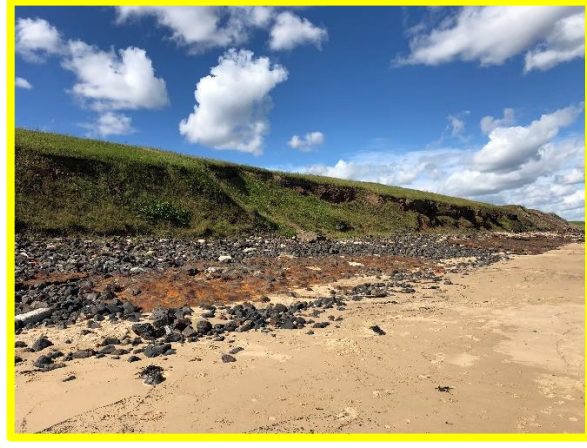
Historic large slope failure (/C0302C03)

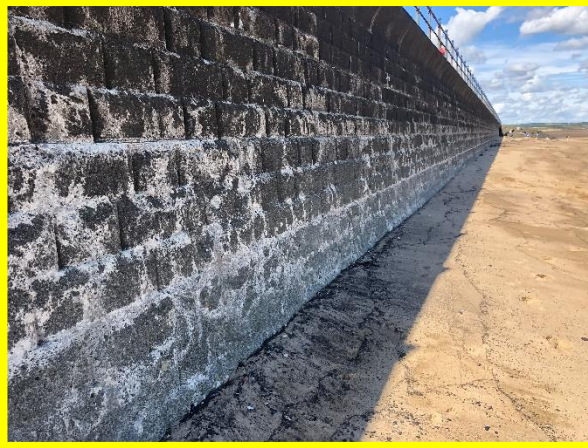
The approximately 200m of seawall north of Thorpe Street that was not included in the recent works, remains in fair condition. The lower courses were noted to be abraded and local damage to the cope stones and handrail at Thorpe Street access ramp remains. The concrete repair works undertaken at the northern end of Marine Drive in 2012 remain in good condition. A short (approximately 30m) length of rock armour remains towards the northern end of the wall.

Abrasion to lower levels of seawall (/C0303C01)

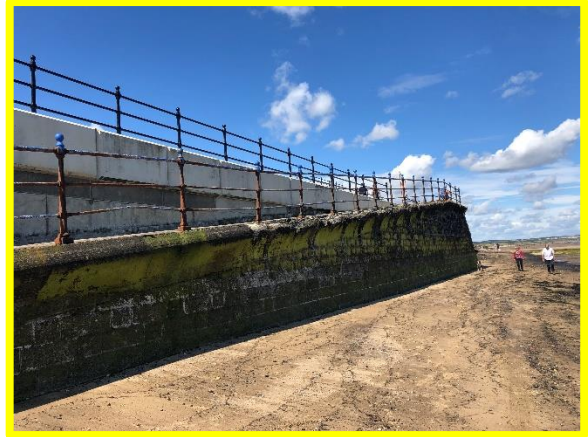
Local damage to coping/handrails at Thorpe Street access ramp (/C0303C01)

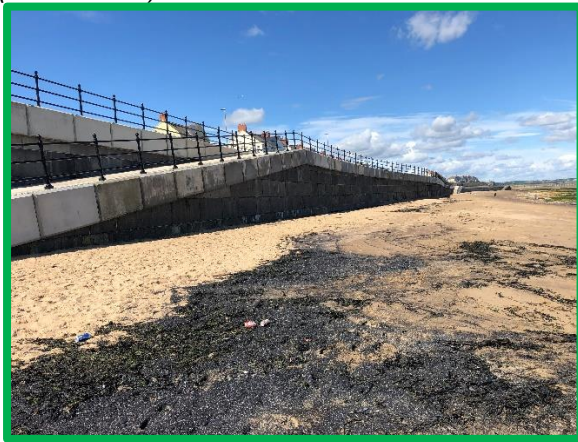
As built condition access ramp at Arabella Street, previously undercut (/C0303C01)

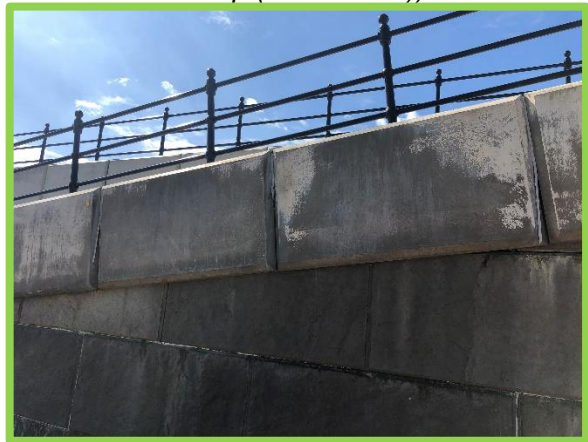
Sealant being washed out of newly installed cope stones (/C0303C01)

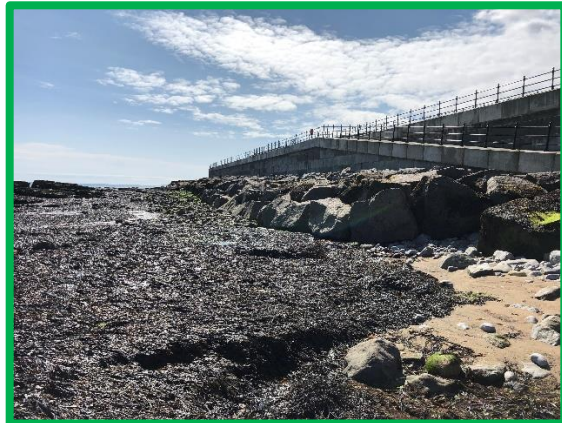
As built condition sea wall – inaccessible foreshore to the south. (/C0303C02)

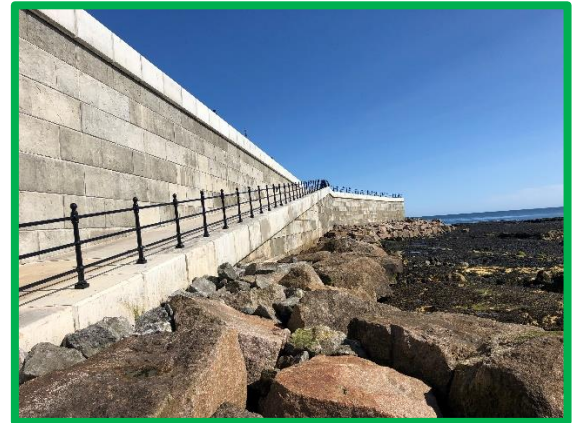
As built condition seawall (/C0303C04)

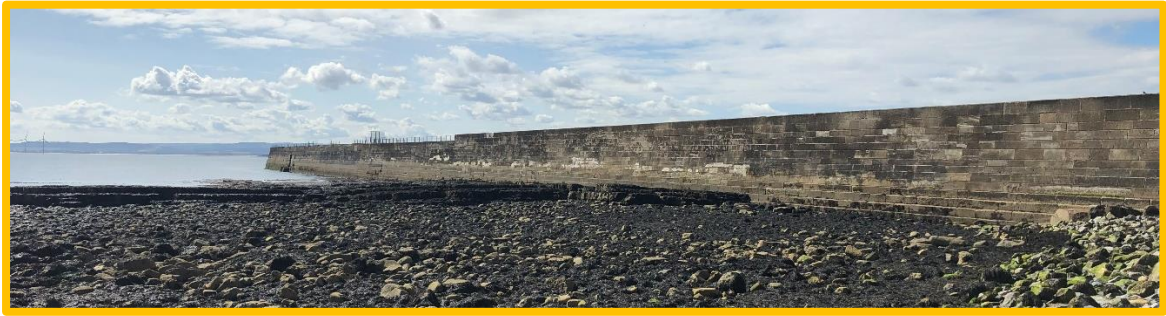
Heugh Breakwater – landward end north aspect (/C0401C01)

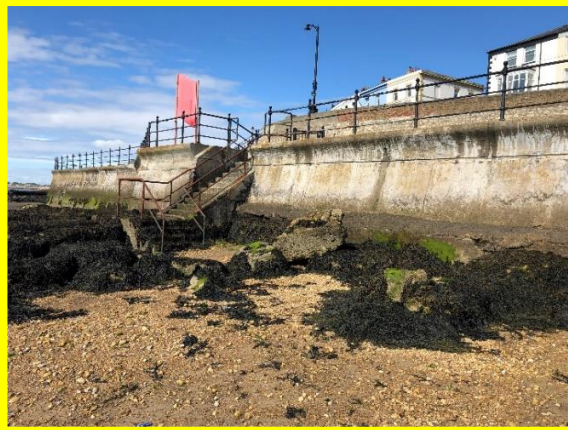
Low beach levels at access steps (/C0401C04)

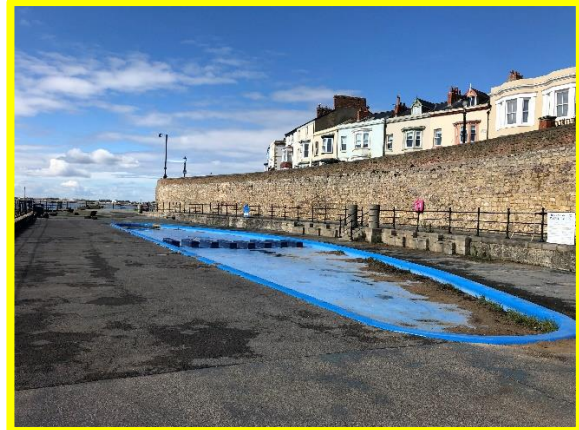
The rear masonry wall was generally in fair condition throughout, with voids/loss of mortar observed locally, and several areas where historic repairs have taken place.

Rear masonry wall in fair condition (/C0401C04)

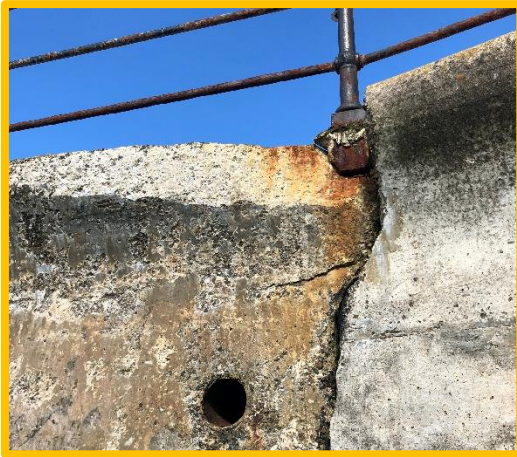
Damaged cope around handrailing fixing (/C0401C04)

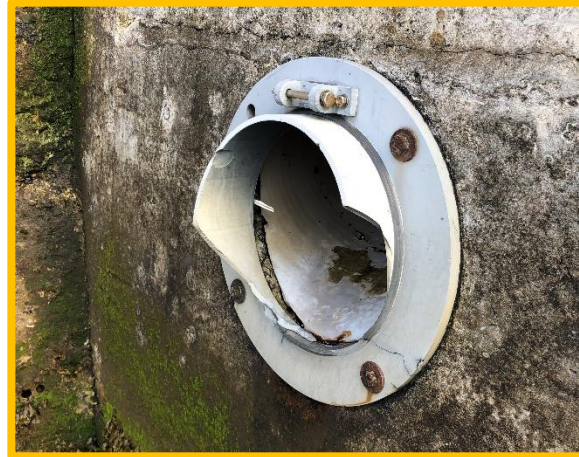
Numerous outfalls are present at the interface between the two assets along Block Sands (/C0401C04 or /C0401C05). It was noted of the five outfalls, three have no protection, one has a WaStop non-return valve which appeared in working condition and the final outfall has a failed flap valve. It is recommended that the protection to these outfalls is reviewed and the flap valve replaced if necessary.

Broken Flap Valve (/C0401C04)

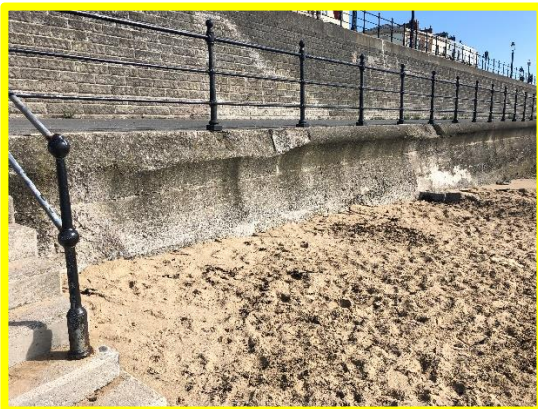
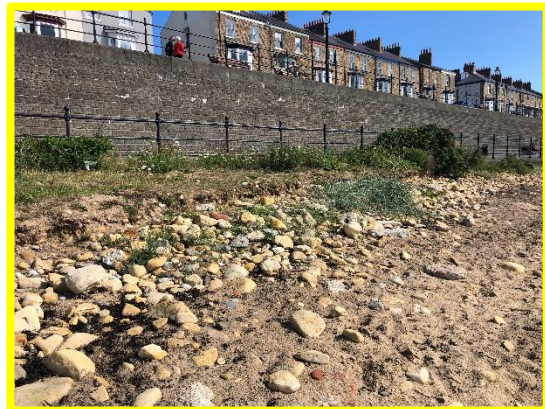
Damaged recurve cope (/C0401C05)

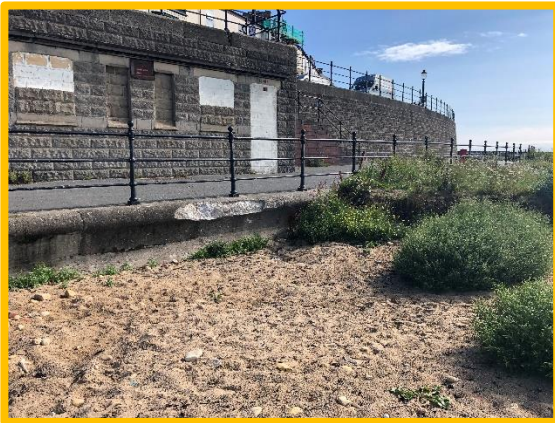
Damaged cope and cracking to former public conveniences (/C0401C05)

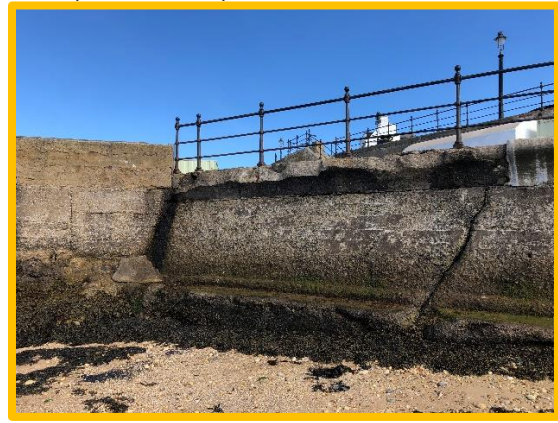
At the interface with the Old Pier the wall had sustained damage to the concrete recurve. A large crack extended the full height of the wall, potentially suggesting a global movement of the structure; however no distress was evident in the promenade immediately above this section of wall. Undercutting was identified at the interface with Old Pier in 2016, however, like 2018, this could not be observed during the present inspections due to high beach levels. This location should be monitored with consideration given to infilling/repairing the existing undercutting/voids.

Spalling damage to recurve wall, significant crack suggesting settlement. Old Pier to left of image (/C0401C05)

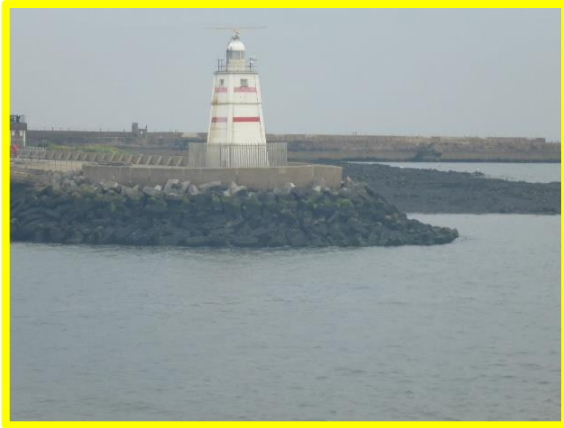
Accropode armour units around pier head taken from Middleton Jetty (/C0401C34)

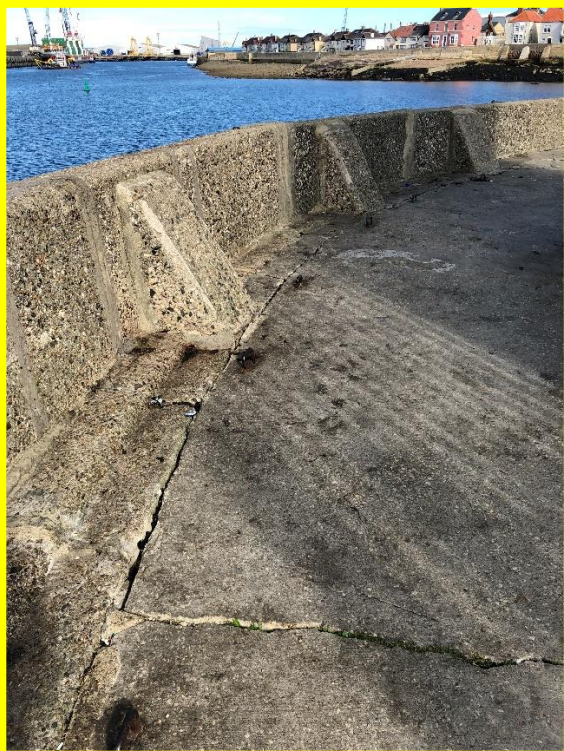
- **Fish Sands / Old Pier** - cracking between the deck and crest wall of Old Pier appears to be of a broadly similar nature to previous inspections but remains a notable defect.

Cracking in parapet wall and deck (/C0401C34)

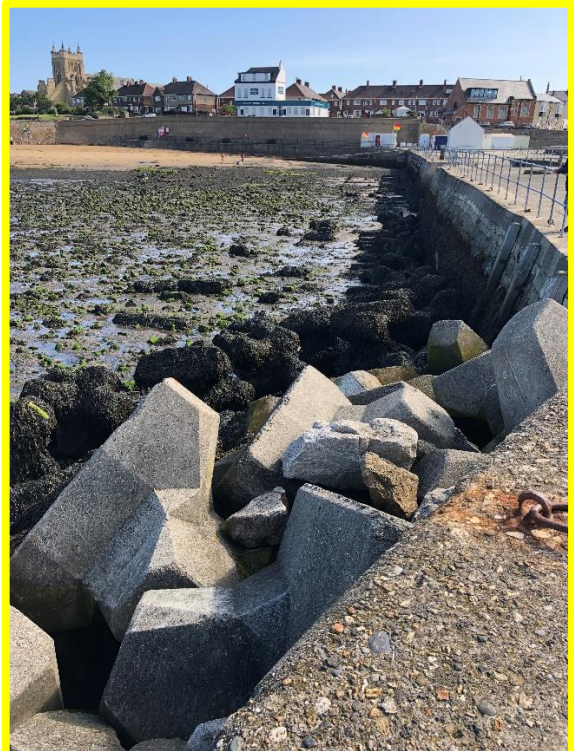
Inner face of North Pier – uneven profile suggesting potential settlement of masonry blocks (/C0401C06)

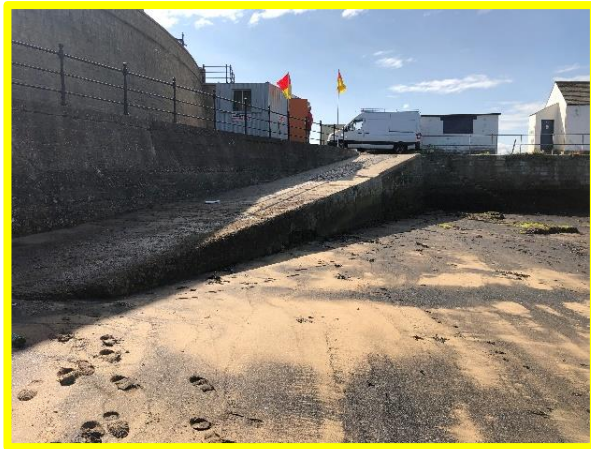
concrete repair to slipway hidden by shadow, voids/undercutting remains (/C0401C35)

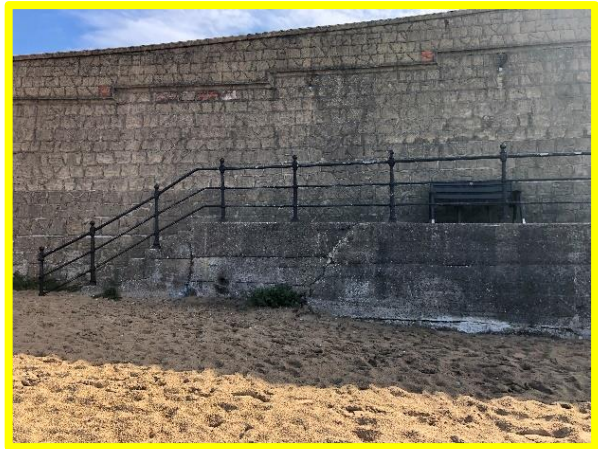
Cracking to access steps (/C0401C35)

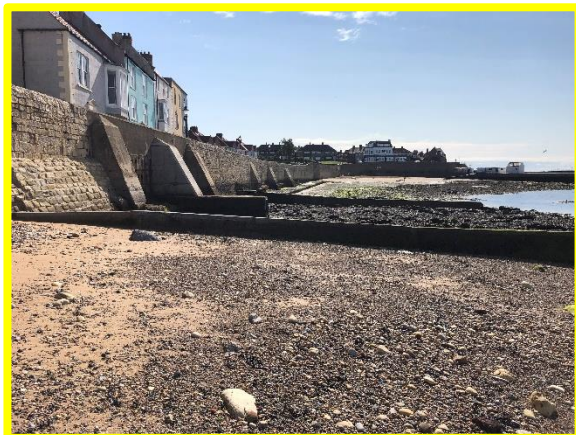
Recently constructed outfall and abutment. (/C0401C35)

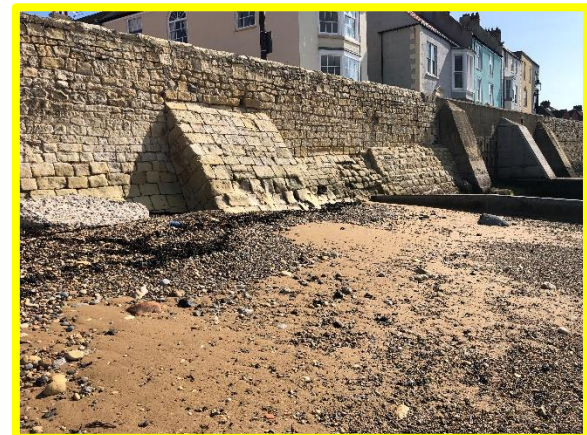
Open jointing in lower masonry courses and heavily abraded masonry blocks (/C0401C35)

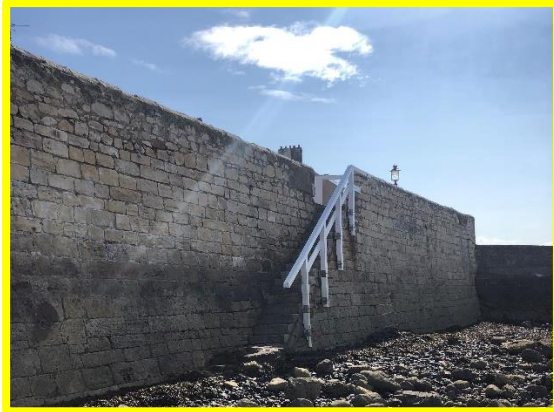
Repaired handrailing and beach access steps (/C0401C35)

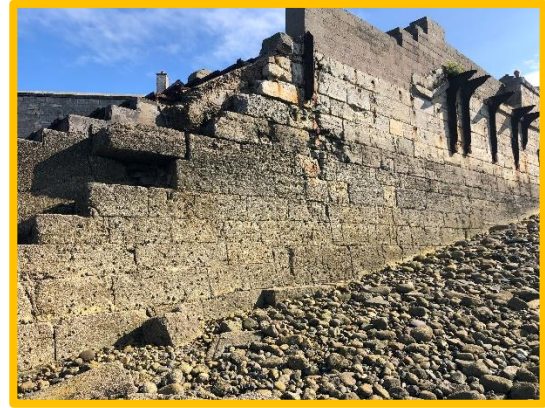
As reported in 2018, the steps at the former passenger ferry landing marking the southern extent of the asset are generally in poor condition with loose and displaced masonry and heavily corroded steel ties. However they do not appear to have deteriorated further since 2018. Public access to this structure is prevented by a masonry wall and signage.

Damage to steps at former passenger ferry landing (/C0401C35)

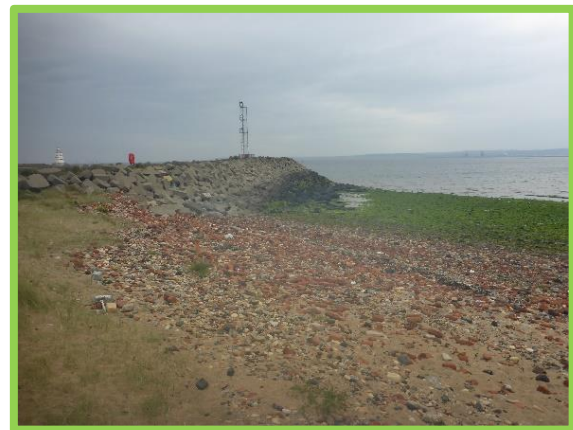
Middleton Jetty south aspect. Buildup of construction rubble in the foreground (/C0401C16)

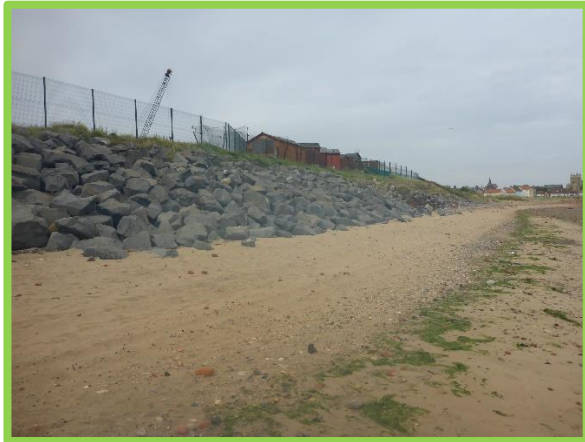
Rock armour revetment and Gabion wall looking towards Middleton Jetty (/C0401C17)

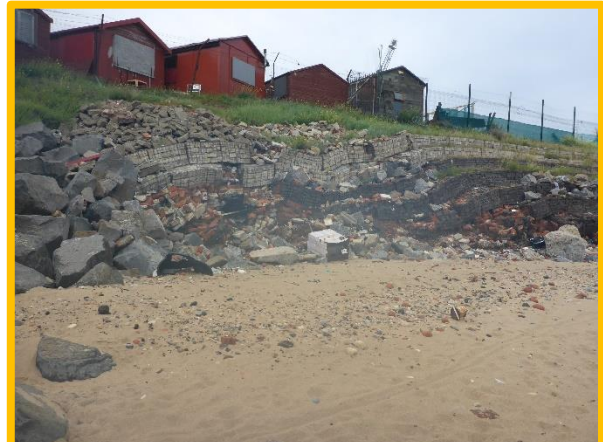
- **Middleton Beach** – A section of stacked gabion wall has failed further since the 2018 inspections. Several gabions have burst, dispersing bricks along the foreshore to the east. It was noted that more sheds have been constructed directly behind the failed section. It is recommended that consideration is given to extending the rock revetment to the west to provide better protection.

Stacked gabion wall in poor condition especially to the south. (/C0401C17)

recommended that the existing larger rock armor revetment to the south, that remains in good condition, is extended to provide protection to this section.

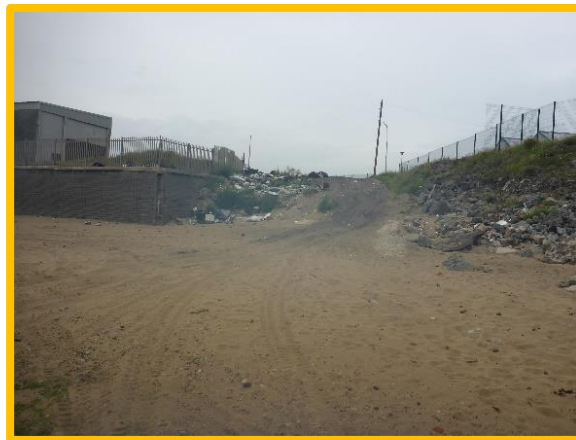
The short length of undefended frontage comprises an informal beach access ramp. The condition remains similar to the 2018 survey in that the southern side of the ramp is steeper and less stable than that to the north. Higher beach levels in 2020 appear to have made the ramp more accessible. Evidence of substantial fly-tipping was observed in this location in the 2020 inspection, and numerous track marks extending across the upper beach to just past the wrack line would suggest the problem is extensive.

Informal access ramp (/C0401C18)

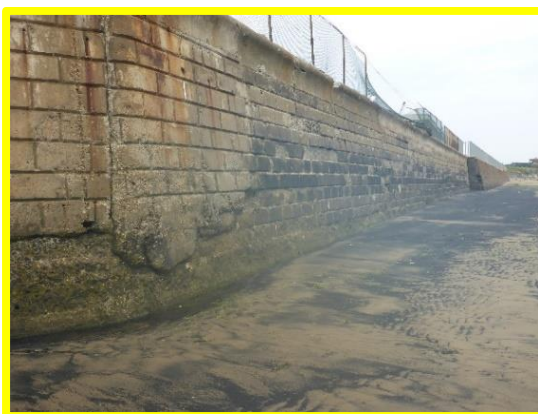
The large blockwork wall was significantly spalled with abrasion to the lower courses especially at the seaward bend cracking to the concrete coping. Several cracks extended through the parapet wall and through the full height of the seawall. These should be monitored. The Middleton Beach access structure is in fair condition with areas of concrete is showing signs of abrasion. The short section concrete toe beam to the splash wall appears to have been poured recently and is in good condition. The blockwork parapet wall is insubstantial and is not believed to offer an additional protection.

Spalling/abrasion of concrete blocks (/C0401C19)

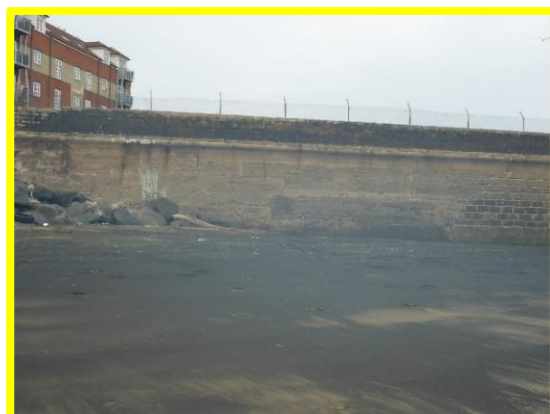
Vertical crack through parapet and seawall /C0401C20

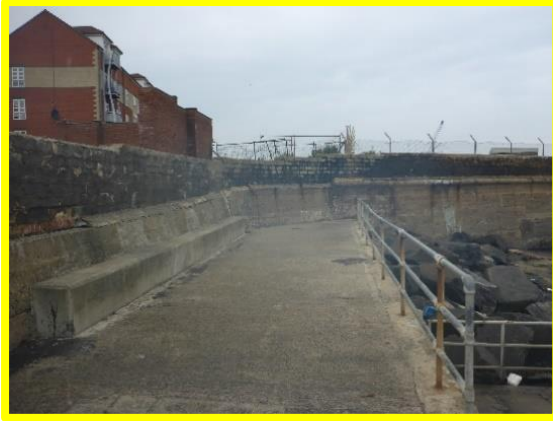
Access structure to Middleton beach in fair condition (C0401C20)

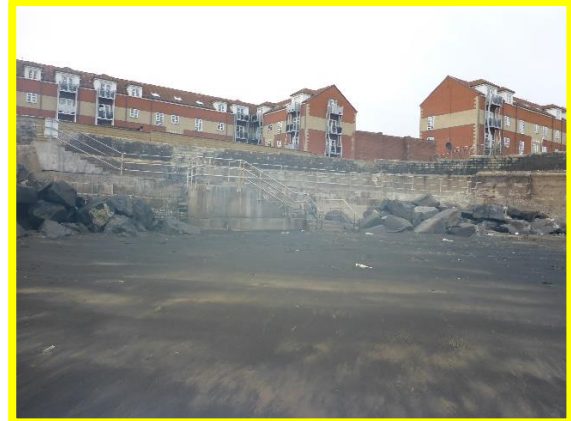
Access structure to Middleton beach in fair condition (C0401C20)

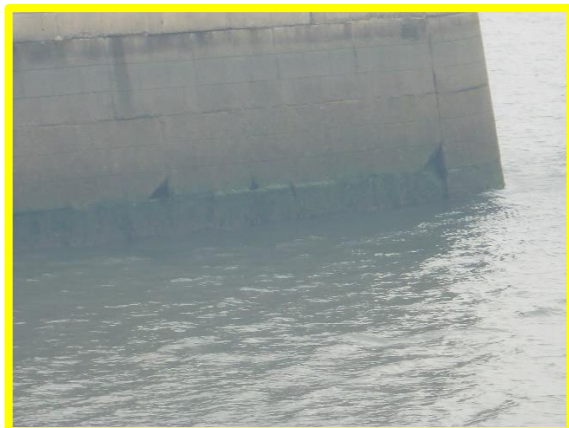
The landward end of the structure was viewed from the foreshore. As identified in previous surveys, the masonry structure appeared in fair condition. Locally lower beach levels exposed timber piles and a masonry apron with open jointing and local voiding which should be addressed urgently to prevent further deterioration. Voiding now extends greater 0.5m into the structure.

Voids in pier head of North Pier (C0401C22)

Consideration should be given to undertaking a more detailed survey of the structure, including a boat/dive survey to inspect the permanently submerged seaward ends. It is recommended that repair works are carried out urgently to prevent further deterioration of the structure.

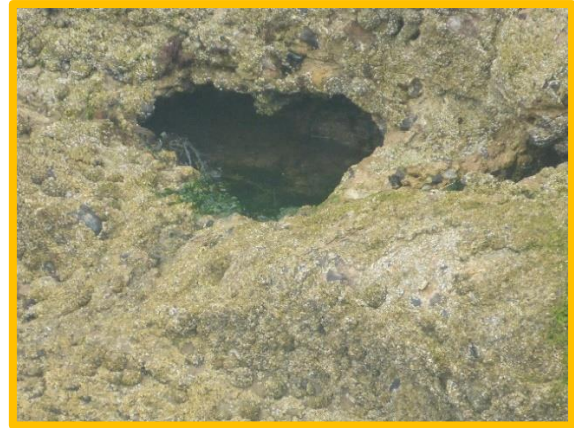
Voids observed in toe of north face of North Pier (C0401C22)

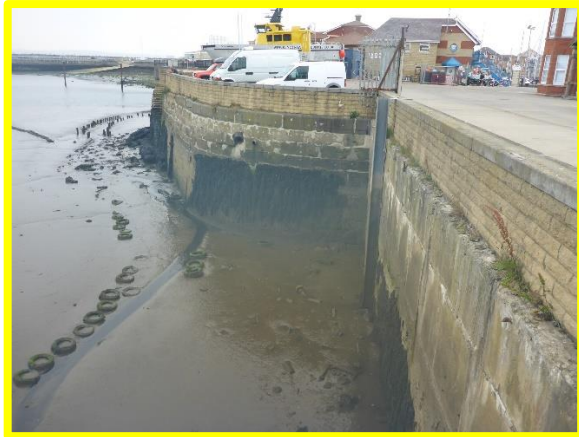
Local repairs to masonry seawall to north of harbour entrance (C0401C24)

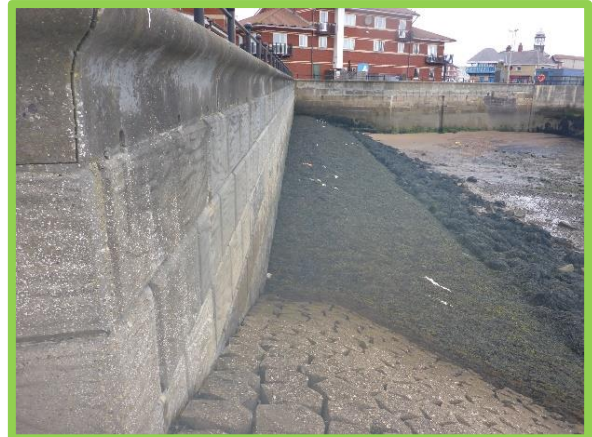
Concrete blockwork revetment obscured by vegetation (C0401C25)

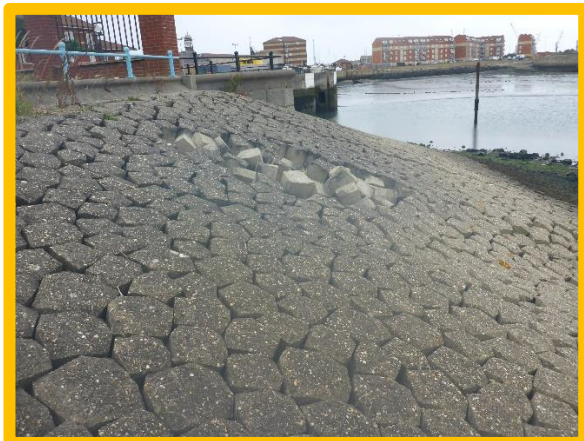
Local settlement of concrete blocks not worsened since 2018 (C0401C26)

It is strongly recommended that a repair solution is found immediately, as further loss of either fill material or concrete blocks could lead to extensive damage to the corner of the revetment, and properties at its rear.

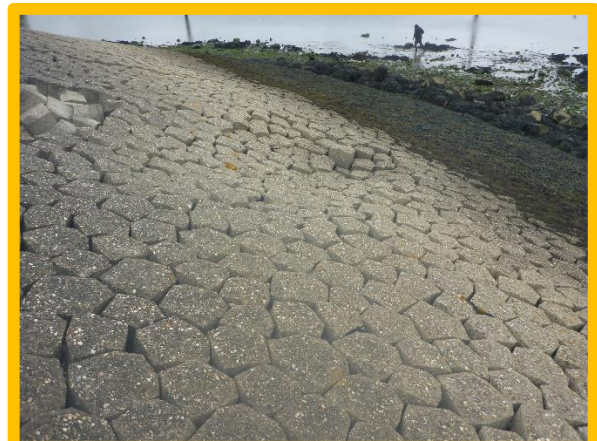
Local settlement of concrete blocks not worsened since 2018 (C0401C26)

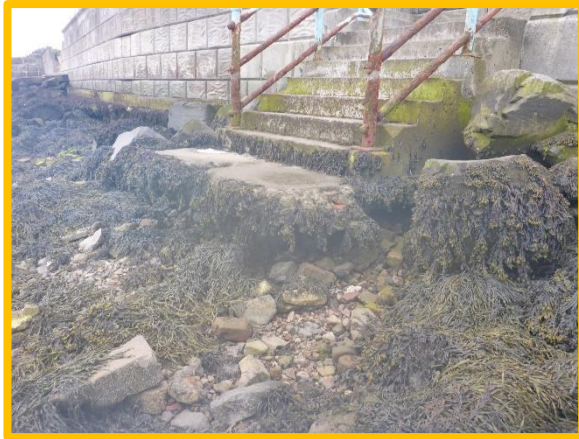
The undercutting of the steps, slipway and seawall fronting the Tees and Hartlepool Yacht Club, was observed to be generally similar to that noted in the 2018 inspections. Further marine growth concealed the full extent of the undercutting, particularly at the access steps. The seaward end of the access steps handrails was found to be heavily corroded, however they remained stable. As was recommended in previous inspection, voids should be repaired locally with additional rock armour placed to avoid further scour damage, particularly to the west of the asset where undercutting to the toe beam is exposed.

Undercutting of access steps (/C0401C27)

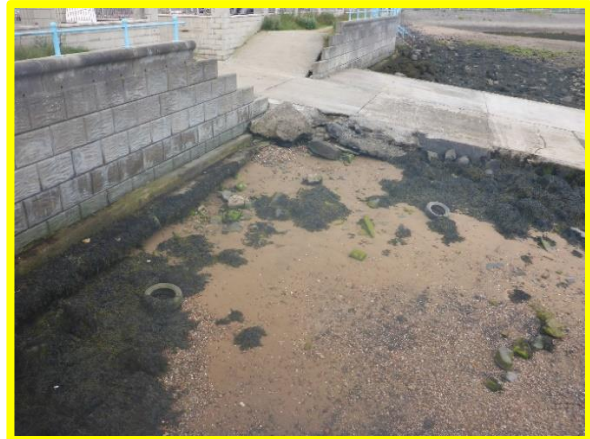
Low beach levels exposing undercutting of concrete toe to the west. (/C0401C27)

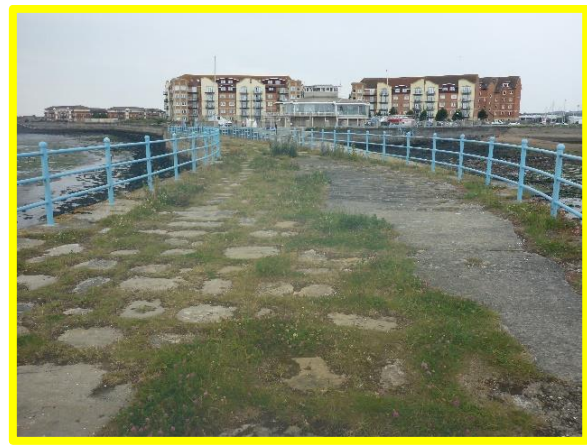
Extensive vegetation growth through joints in Middle Pier deck (/C0401C28)

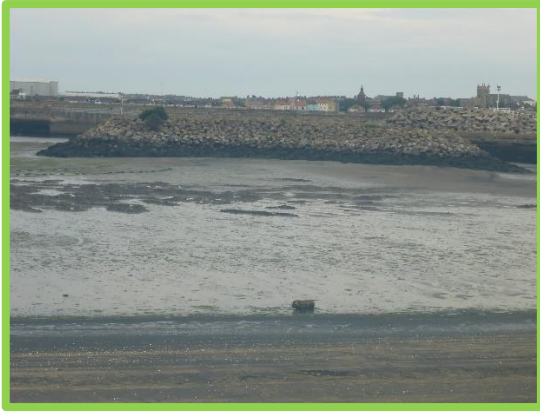
Rock revetment breakwater in good condition bar mature vegetation growth (/C0401C30)

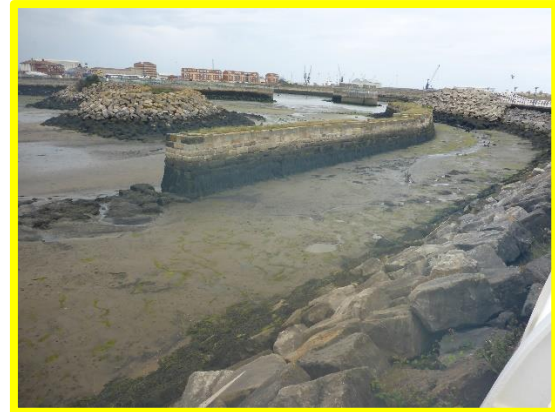
Old quay wall structure in fair condition (/C0401C31)

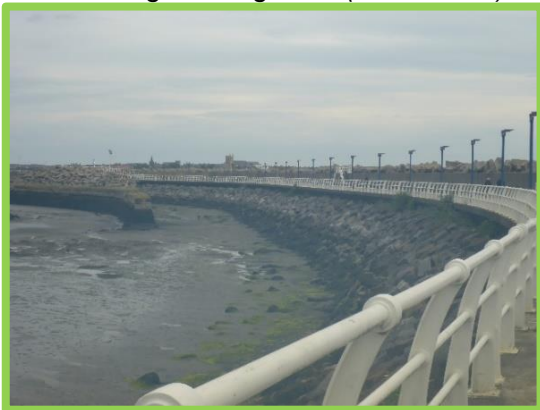
Inner face of South Pier. Vegetation can be seen on crest. (/C0401C32)

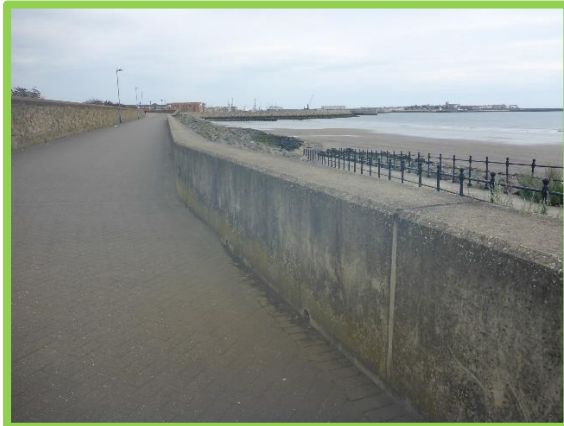
Concrete sea wall and repaired slipway handrail (/C0401C33)

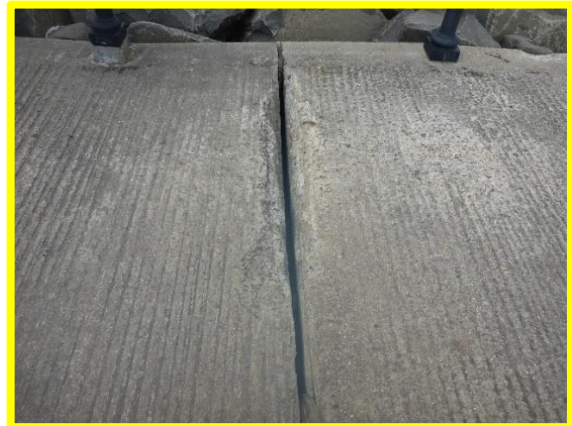
Other noticeable defects included hardened and missing flexible sealant in construction joints of the concrete seawall, minor local spalling and cracking of the concrete access steps and corroded handrails on access steps. Despite this, the seawall and various access steps remain generally in fair to good condition. A number of historic repairs, particularly to the missing or damaged flexible sealant were noted as being effective. Surface water drainage holes on the landward side of the seawall were generally found to be clear and working effectively, however some buildup of litter and sand was observed, these should be cleaned to prevent attenuation of flood water (pluvial, fluvial or coastal) on the landward side of the wall.

Loss of flexible joint sealant in northern access ramp (/C0401C33)

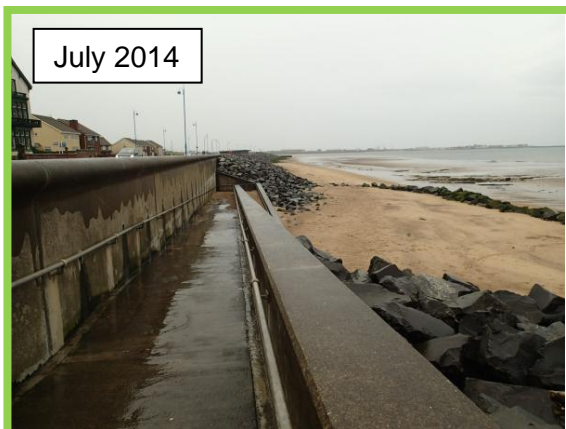
In the 2020 inspection there was little change observed in the region of the Little Scar access ramp. Beach levels in the area were broadly comparable to the previous inspection with the sediment reaching halfway up the lower ramp. This is higher than those observed in 2012 and 2010 (prior to reconfiguration of the berm). Cracks were observed in the concrete seawall at the access ramp remained. They appear to be associated with the fixings for the handrail, and do not appear to have worsened. Local repairs should be undertaken and monitored to ensure this does not become a more significant issue. The handrail on the lower ramp is corroded.

Exposed rock armour berm at Little Scar access ramp (/C0401C33)

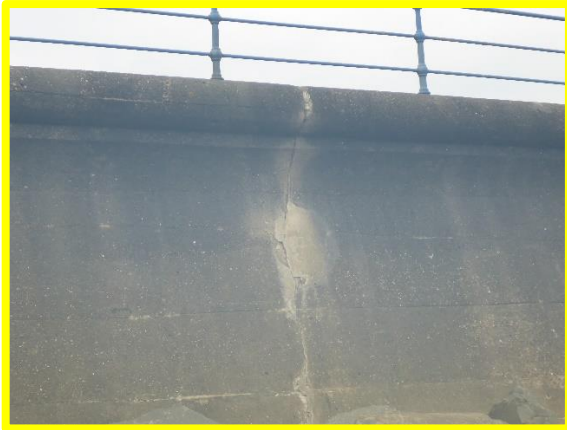
Minor defects were observed along the asset, these will require attention, and consisted of localized cracking and spalling of the cope and face of the wall and missing or damaged joint sealant. There was evidence of historic repairs, including grouting / filling of spalled sections and cracks. Some of these repairs appeared to be in poor condition and should be revisited.

Local cracking and spalling of concrete (/C0501C05)

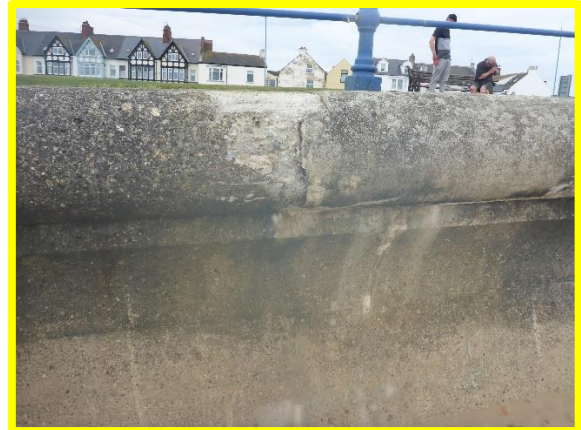
Defect in concrete cope. (/C0501C05)

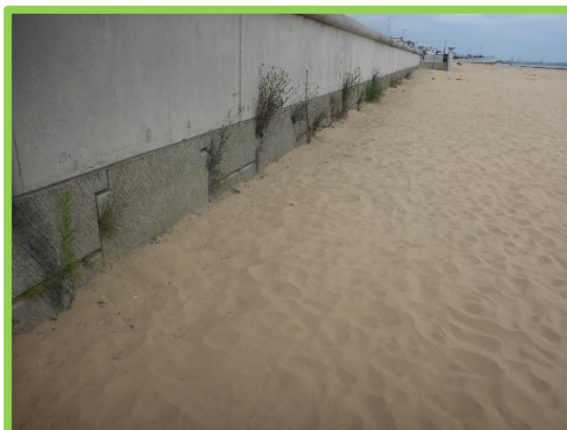
Vegetation growing in joints – should be removed (/C0501C04)

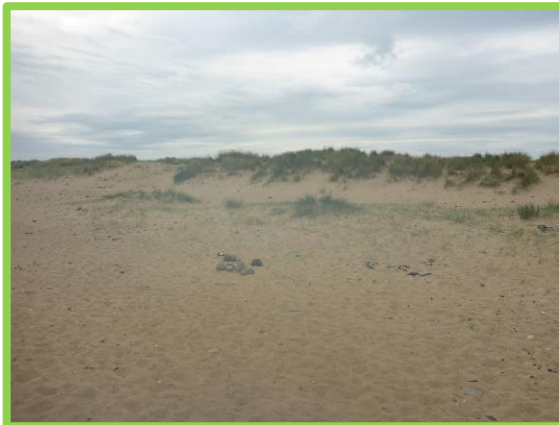
Embryo dunes forming along the frontage (/C0502C01)

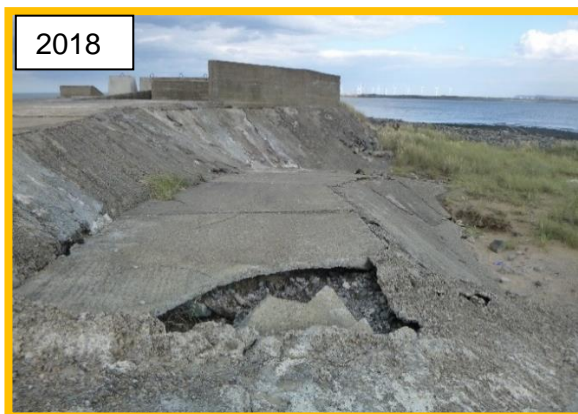
- **North Gare** – Ongoing maintenance works to the structure restricted the inspection to the foreshore only. It is believed that the works involved filling voids, the construction of a 300mm thick skin across a 20m section of the structure and the installation of a new section of concrete deck. The structure remains in poor condition with numerous defects noted including several voids around the structure.

*Voiding along south face of North Gare Breakwater
(/C0503C01)*
