NECAG Coast Protection Assets and Coastal Slope Condition Analysis

To this end, Scarborough Borough Council, acting as the 'lead authority' for NECAG, commissioned a team from Royal Haskoning and Halcrow to undertake the '*NECAG Coastal Protection Assets and Coastal Slope Condition Analysis*' between August 2008 and January 2009. Fieldwork was undertaken in the summer to autumn of 2008.

This section presents the approach taken by the slope and asset inspectors respectively for the East Riding of Yorkshire Council coastal frontage.

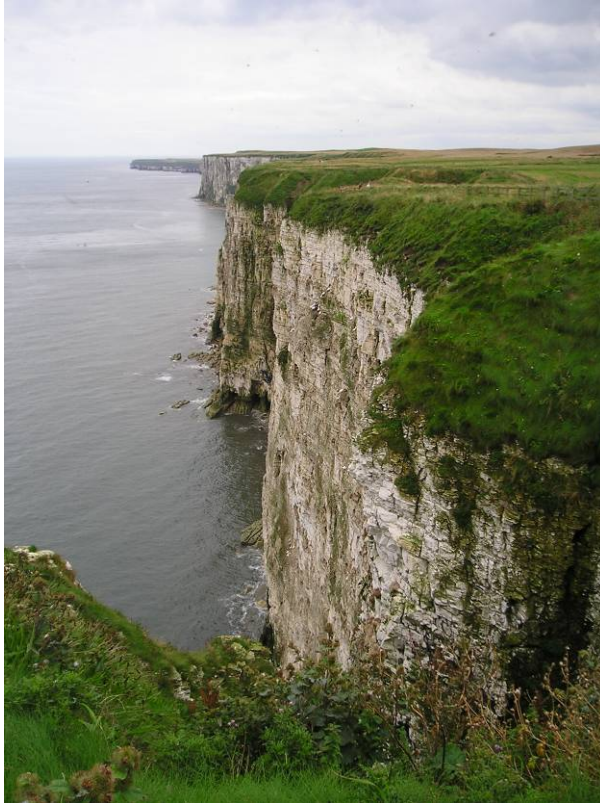
E110/3 looking eastwards from Bartlett Nab, Bempton Cliffs (Locally Active)

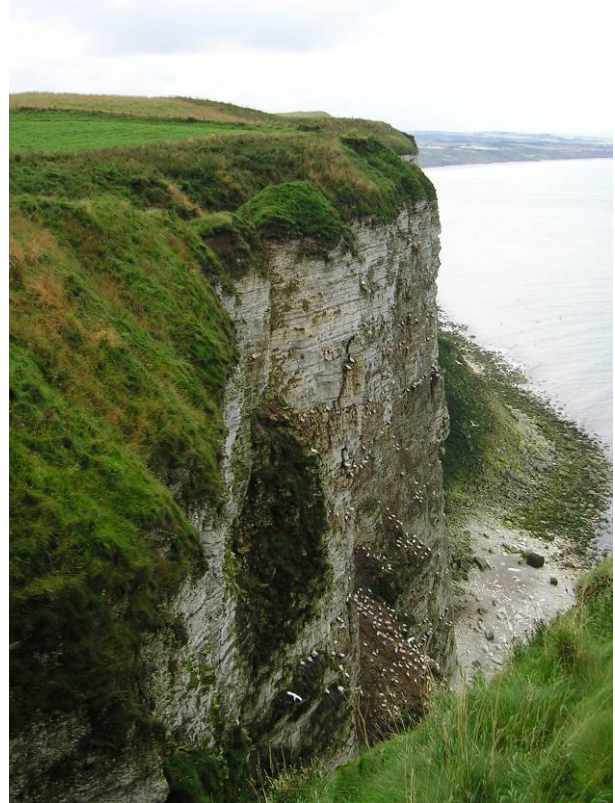
In places, preferential erosion and weathering along rock joints has resulted in the formation of gully features which cut inland from the cliff (E109/4 the east end of Buckton Cliffs, E110/4 at Crab Rocks and E111/13 near Cradle Head). These features are currently stable, but they are likely to be a focus of erosion and potential instability in the future.

E109/4 early beginnings of block detachment in the high chalk cliffs at the west end of Bempton Cliffs (Locally Active)

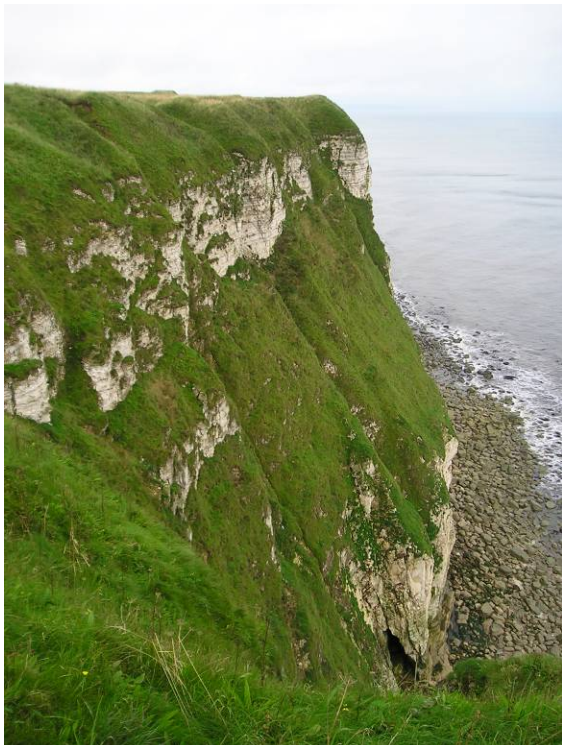
Some areas of cliff are much more heavily vegetated with very little evidence of instability. These include CBU E110/13 near Gull Nook (just east of Danes' Dyke) which supports much vegetation mid-slope and is classified as Inactive. Another example is CBU E111/7 at Holmes Gut which stretches inland and is characterised by densely vegetated gentle slopes.

E110/13 looking northwest near Gull Nook (Inactive)

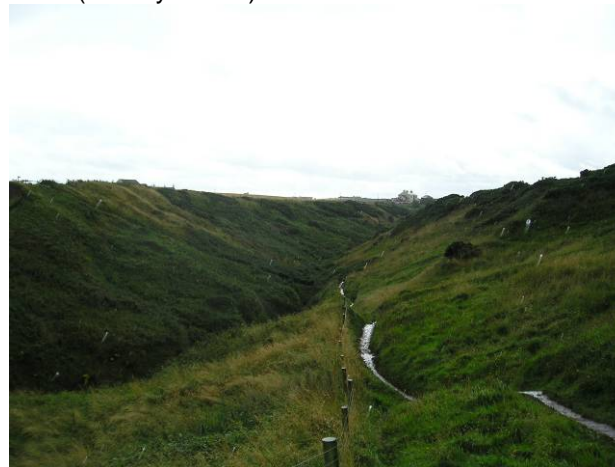
E111/7 densely vegetated slopes at Holmes Gut (Inactive)

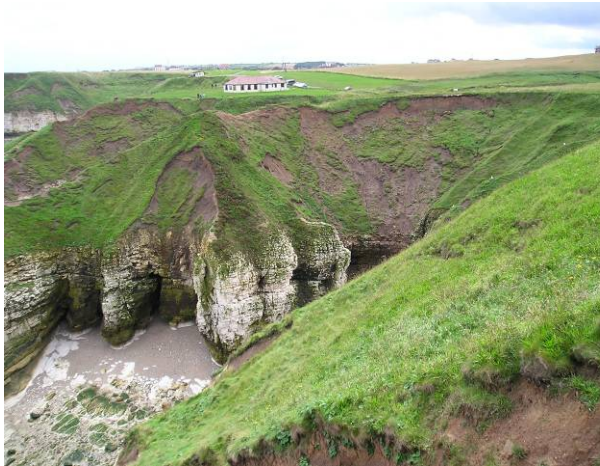
Cliffs classified as being Partly Active are generally associated with the thicker exposures of till in the south, and include the cliffs around Thornwick Nab (E111/2, E111/3, E111/4, E111/5a), where the till is undergoing failure through small mudslides. Marine action is causing undercutting of the cliff toe and the formation of caves and small gullies within Thornwick Bay. Partly Active cliffs were also recognised at E111/8a, E111/10 and E111/14 where there is localised erosion and instability in the till near Stottle Bank Nook. This has impacted on the adjacent golf course. Evidence of a retreating fence position and diversion of the footpath indicates that the problem is ongoing at this location.

E111/3 looking southeast towards Thornwick Bay (Partly Active)

Most of the cliff units along this stretch of coastline are classified as Locally Active and are undergoing minor erosion in line with the natural evolution of the coast. Continued monitoring of these, and the few less active units is recommended. The cliff units around Thornwick Nab and Stottle Bank Nook are demonstrating higher levels of activity, with the loss of land and disruption to the cliff top footpath already occurring at the latter. Consequently it is recommended that more frequent monitoring of these sites is undertaken.

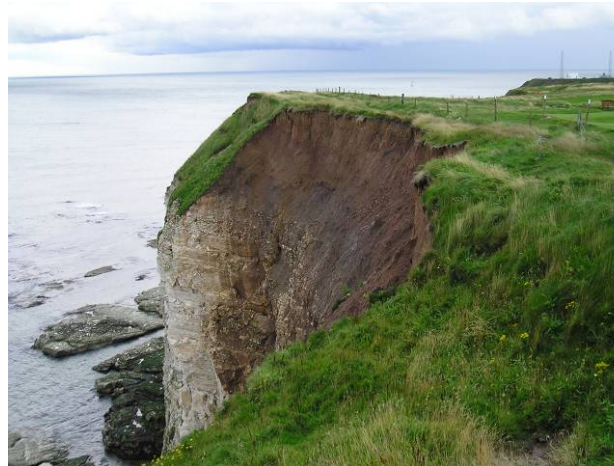
The majority of CBUs within this region are classified as Locally Active and pose little risk to the listed assets. The exceptions are the Partly Active areas around Thornwick Nab and Stottle Bank Nook. At both locations diversion of the cliff top footpath has been necessary due to cliff top retreat with the latter involving loss of land at the golf course. Continued monitoring of all units is recommended with more frequent inspection of the more active units at Thornwick Nab and especially Stottle Bank Nook required.

E111/14 erosion of the till cap near Stottle Bank Nook (Partly Active)

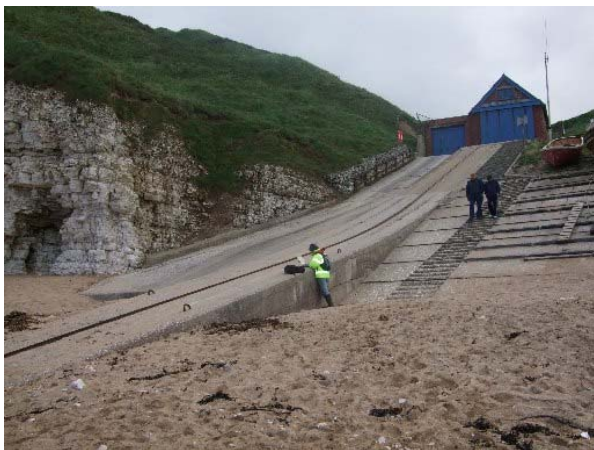
The only coastal defence assets within this region are located at North Landing and include the area around the Lifeboat station, a concrete revetment, slipway and associated gabions. The revetment shows some minor cracking and corrosion and the gabions have undergone minor deformation and loss of rock packing in places. However, none of these defects are considered serious. It is recommended that continued monitoring of these assets is undertaken but no specific repair works are required.

Lifeboat Station, slipway and revetment at North Landing (Asset Ref No. 1231D901D3201C02)

There are no specific repair works required to individual coastal assets, however, it is recommended that continued monitoring of coastal assets within the East Riding of Yorkshire area is undertaken.

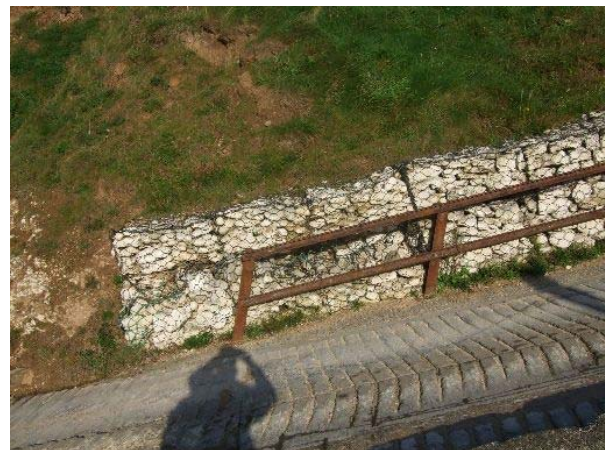
The Lifeboat Station slipway is protected on the east side with a series of gabions, retaining the earth bank behind. There is some evidence of slipping at the lower end of the gabions. Several of the baskets show deformation and have been repaired in a make-shift fashion. Loss of rock packing seems to have occurred in places and there is evidence of earth from the bank behind slipping onto the gabions. There is also a 450mm diameter clay service pipe exiting from the base of the slipway.

Gabions along edge of Lifeboat slipway (Asset Ref No. 1231D901D3201C03)

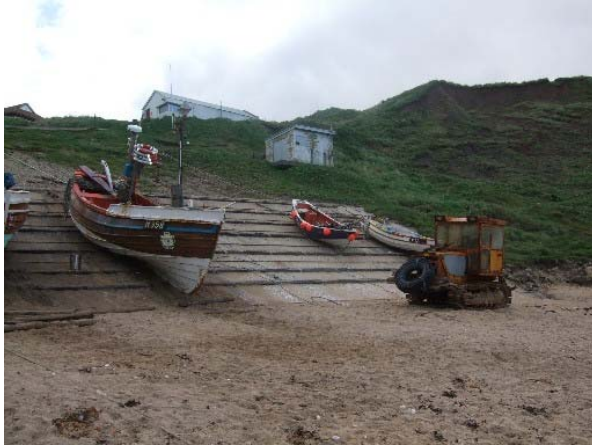
The concrete revetment, constructed with horizontal steel bars set approximately 1.5m apart, is present to the west of the Lifeboat Station. This structure features a set of steps on its eastern side giving pedestrian access to the beach and is used for mooring boats. There are only slight defects to the revetment, such as minor cracking and corrosion.

Concrete revetment (Asset Ref No. 1221D901D1803C02)
