**Cell 1 Regional Coastal Monitoring Programme
Coastal Walkover Inspections 2010**

The present report is **Coastal Walkover Inspections 2010** and provides a summary of the main findings from the walkover inspections that are undertaken once every 2 years along the part of East Riding of Yorkshire Council’s frontage that is located within Cell 1 (Dulcey Dock to Flamborough Head).

This report documents the condition of the coastal cliffs and assets along the part of East Riding of Yorkshire Council's frontage that is located within Cell 1, from just west of Dulcey Dock in the north to Flamborough Head in the south.

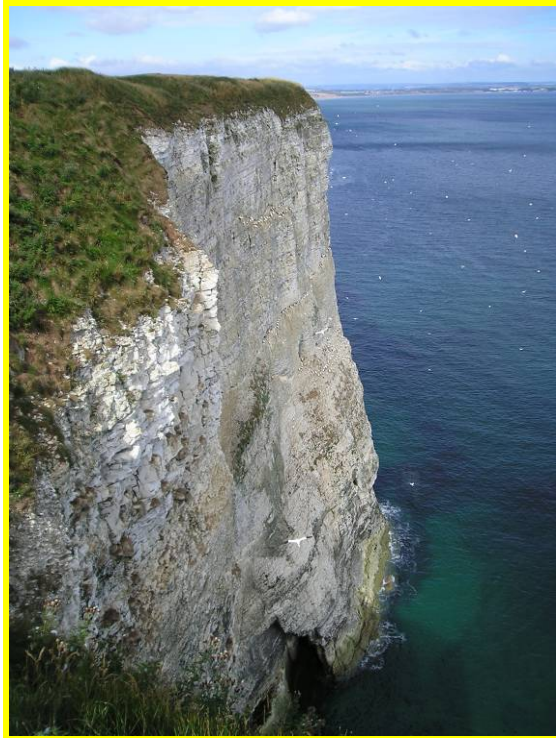
E110/2 thin till layer above fractured high chalk cliff, looking westwards (Locally Active)

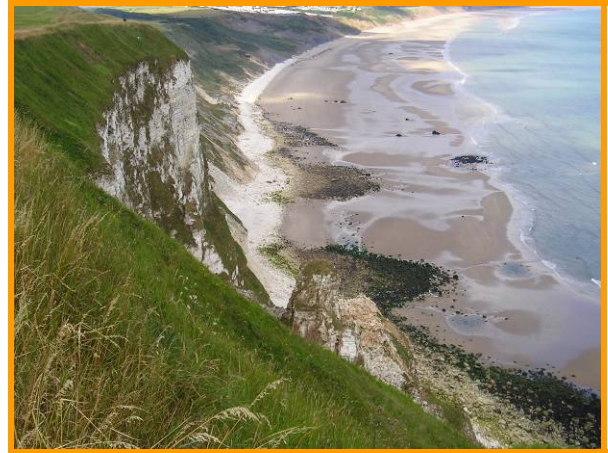
E108/2 recent rockfall and collapse of chalk pillar (Partly Active) (Note: this unit was previously classified as Locally Active in 2008)

Previous cliff condition assessment data were available from the 2008 inspection. Comparison of 2008 and 2010 survey results indicate only one unit has experienced a change in activity status within the study area. This is unit E108/2 near Dulcey Dock, where the collapse of a chalk pillar and recent rockfall has led to an increase in activity status to Partly Active. The level of activity within all other units remains much the same as it was in 2008.

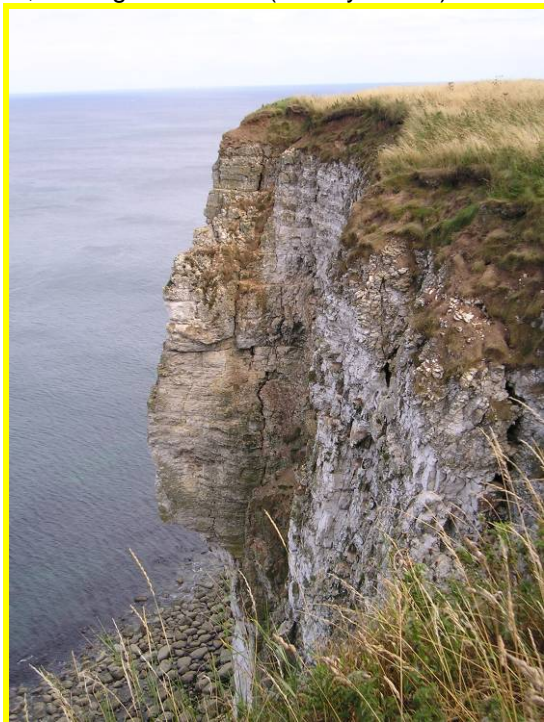
E110/8 large vertical fractures in chalk (Locally Active)

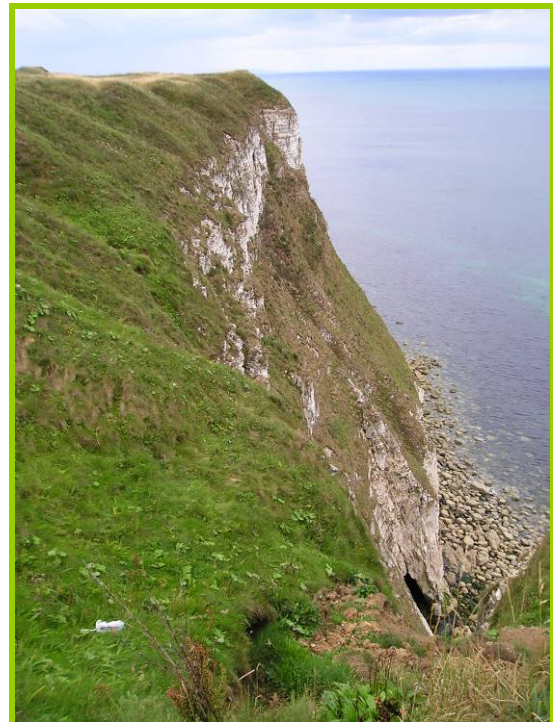
E110/13 well vegetated cliff face (Inactive)

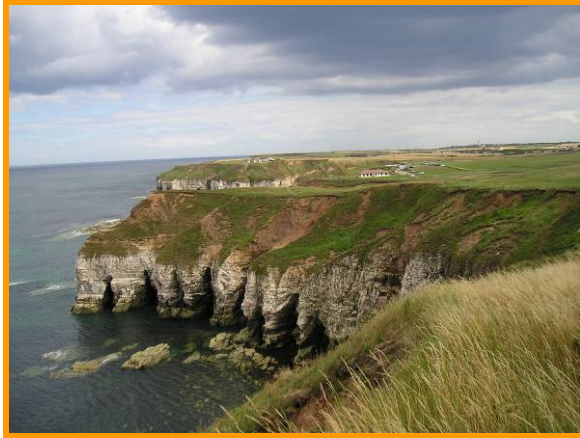
E111/2 Thornwick Nab (Partly Active)

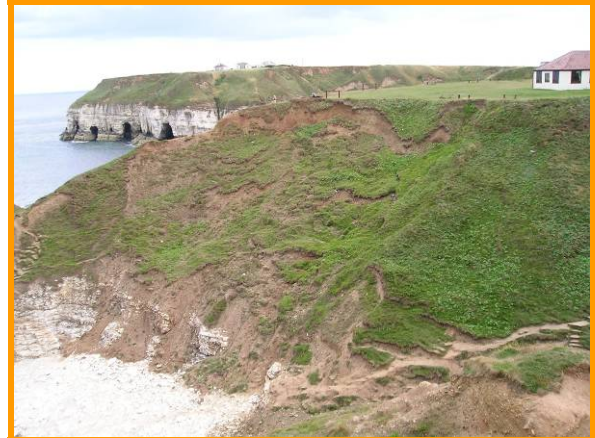
E111/4 landsliding in the till in Thornwick Bay (Partly Active)

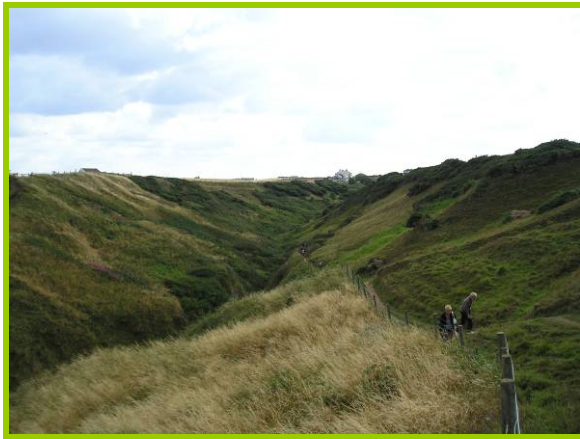
E111/7 well vegetated slopes of Holmes Gut (Inactive)

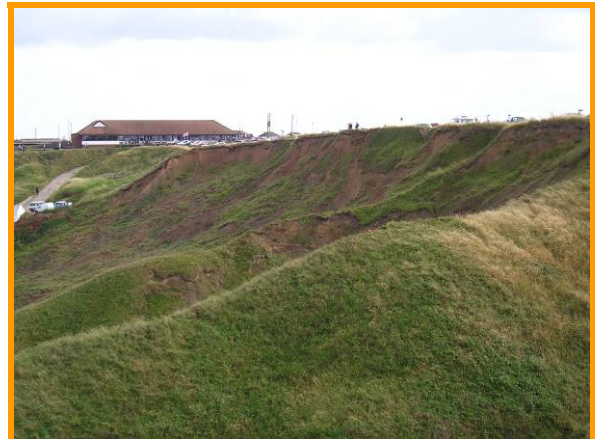
E111/8a cliffs behind North Landing (Partly Active)

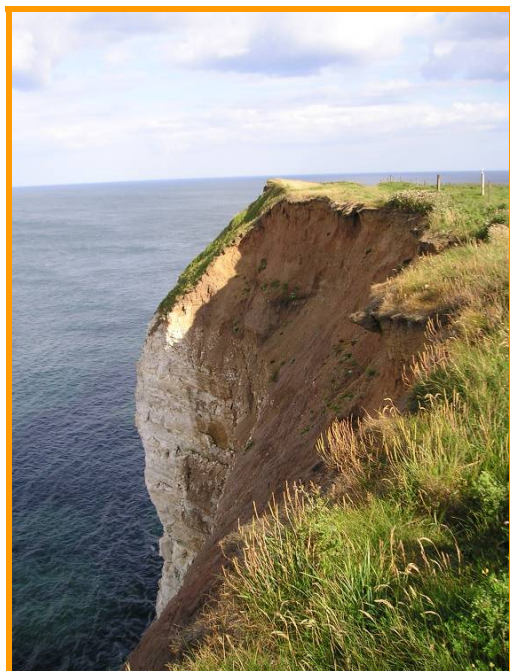
E111/14 till failure at Stottle Bank Nook (Partly Active)

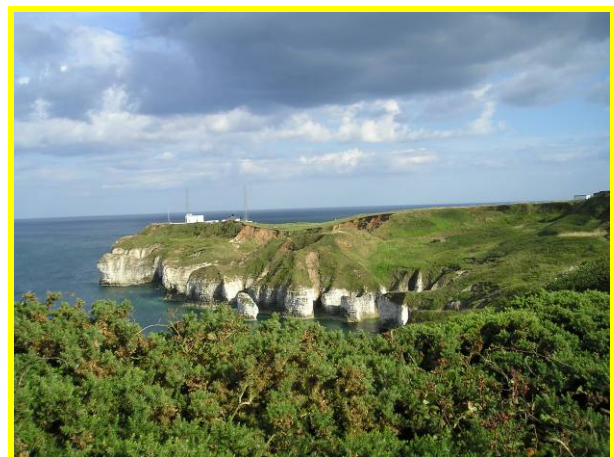
E111/15b Flamborough Head (Locally Active)

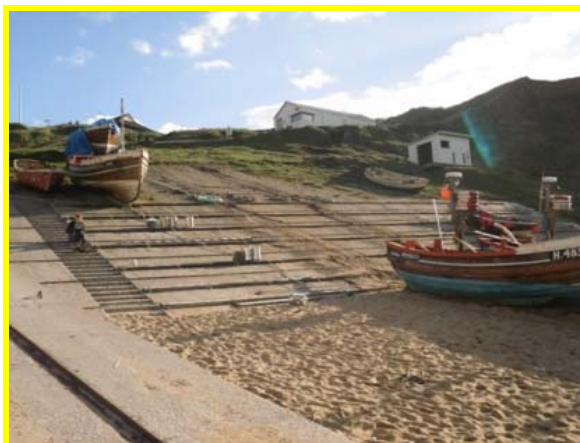
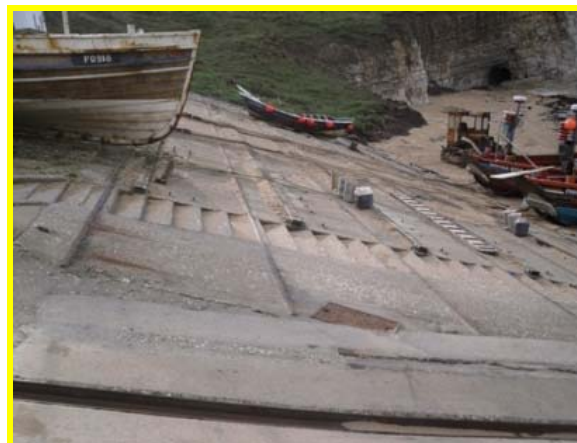
Slipway and revetment at North Landing
(Asset Ref No. 1231D901D3201C02)

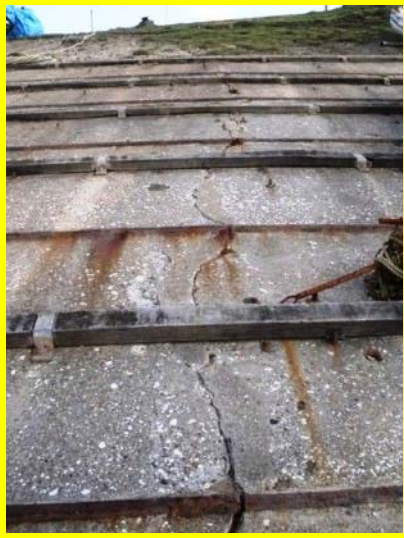
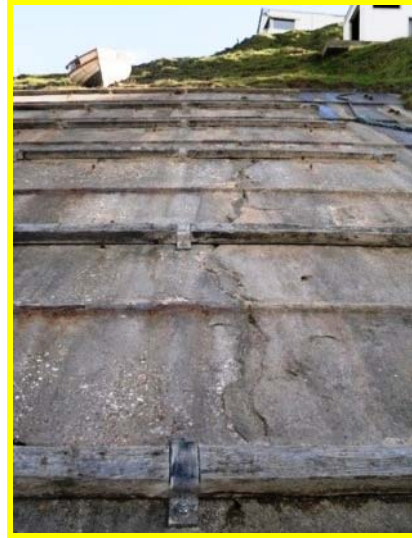
The concrete revetment, constructed with horizontal steel bars set approximately 1.5m apart, is located to the west of the Lifeboat Station. This structure features a set of steps on its eastern side, giving pedestrian access to the beach and is used for mooring boats. There are two full height cracks in the apron, which have been repaired in the past and no longer appear active. There is corrosion to the steel elements, and some erosion of an old repair near the manhole in the slipway. Immediately west of structure, there is evidence of recent large slip onto the beach.

Concrete revetment – showing crack
(Asset Ref No. 1221D901D1803C02)

There are no specific repair works required to individual coastal assets. However, it is recommended that continued monitoring of coastal assets within the East Riding of Yorkshire area is undertaken.

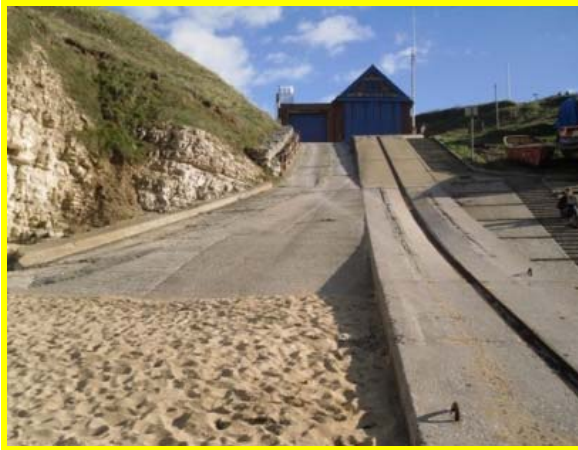
Overview of slipway
(Asset Ref No. 1221D901D1803C02)

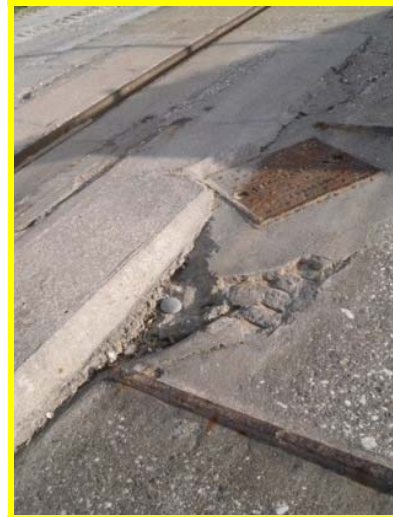
Failing repair around manhole
(Asset Ref No. 1221D901D1803C02)

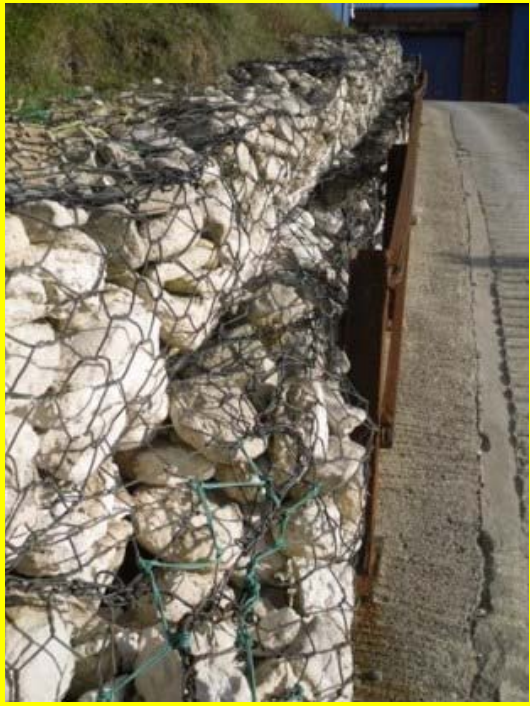
The Lifeboat Station slipway is protected on the east side with a series of gabions, retaining the earth bank behind. There is some evidence of slipping at the lower end of the gabions. Several of the baskets show deformation and have been repaired in a make-shift fashion. Loss of rock packing seems to have occurred in places and there is evidence of earth from the bank behind slipping onto the gabions. The 450mm diameter clay service pipe exiting from the base of the slipway observed in 2008 was not visible, probably be due to beach level change.

Overview of gabions and patched repair
(Asset Ref No. 1231D901D3201C03)

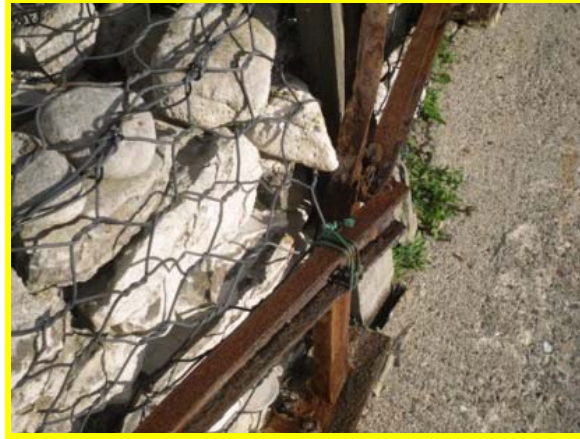
Patched repair of gabion
(Asset Ref No. 1231D901D3201C03)
