Cell 1 Regional Coastal Monitoring Programme Walkover Inspection Surveys 2018

**Scarborough
Borough Council**

October 2018

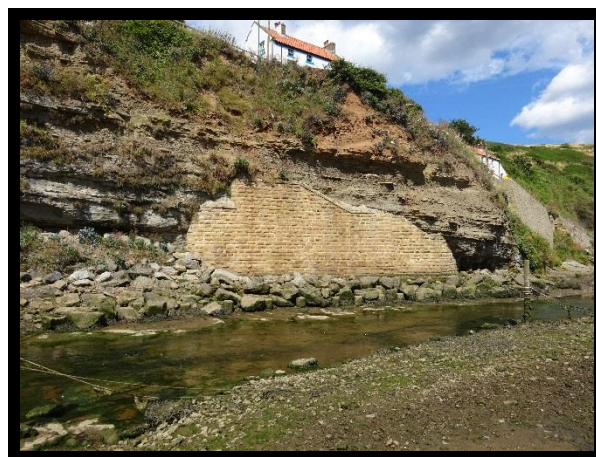
North bank: Works completed in 2013 to repair collapsed cliff (no asset ref)

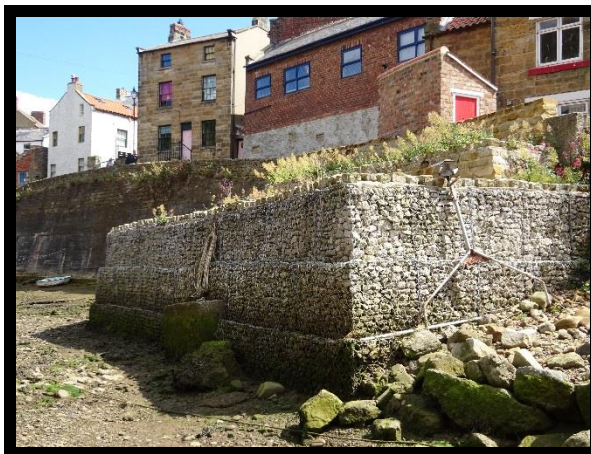
South bank: Stone-filled gabion baskets constructed in 2013 to repair collapsed wall (no asset ref)

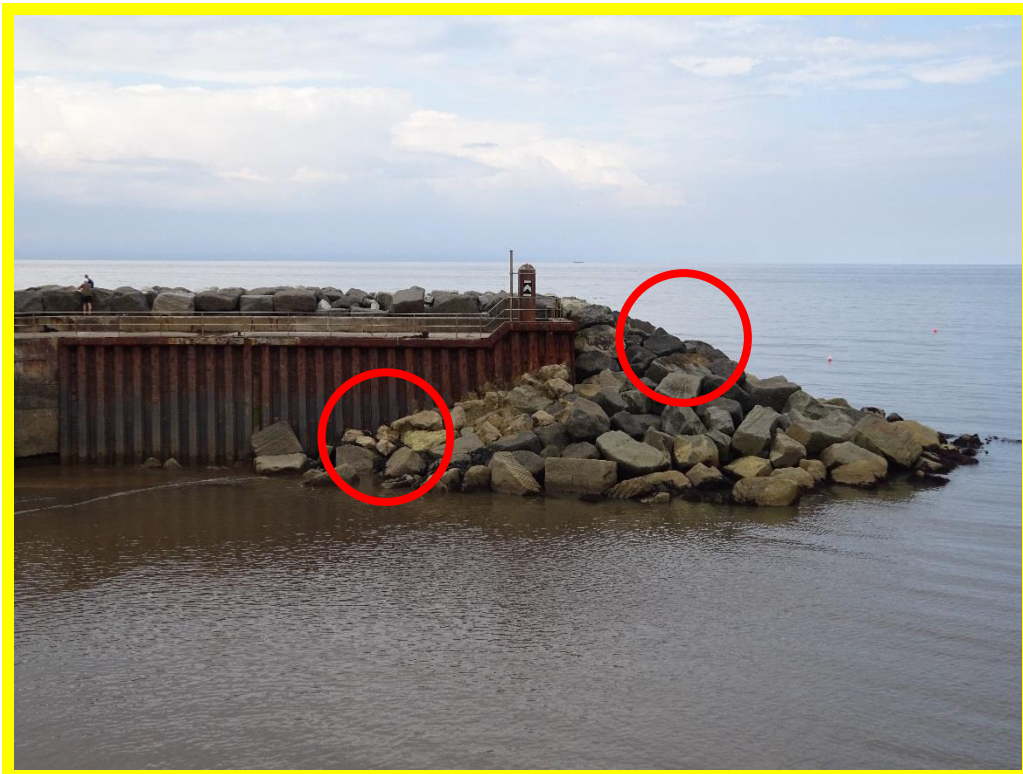
The North Breakwater (0402C01) is in fair condition overall, but certain elements are poor. The rock armour added in 2002 to the seaward face and extending around the seaward end of the breakwater mostly remains in Good condition, tightly packed and maintaining a consistent profile, however two crest blocks are missing (approx. 30m from landward end and approx. 10m from seaward end). There appears to have been some historic movement of rock armour at the eastern extent of the structure where a gap/low spot in the armour at crest level appears to coincide with high block(s) at

Rock armour at eastern extent of North Breakwater – possible historic movement of rocks (/0402C01)

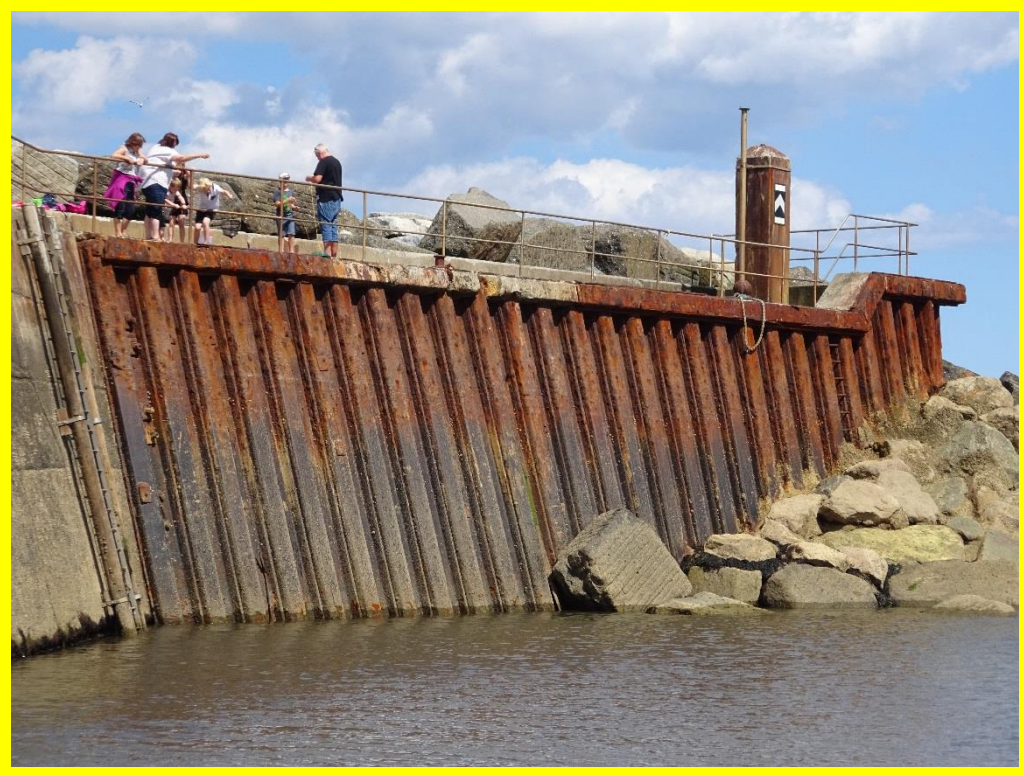
The sheet piling on the inner face of the east end of the breakwater is heavily corroded with significant loss of section in the uppermost 2m. Undercutting to the inner-facing side of the North Breakwater wall was previously reported in 2016 inspection and this was still evident, however even at low tide the toe of the structure remained submerged to prevent detailed inspection. Similar undercutting was also evident towards the landward end of the structure.

Corroded steel sheet piling on inner-face of North Breakwater (/0402C01)

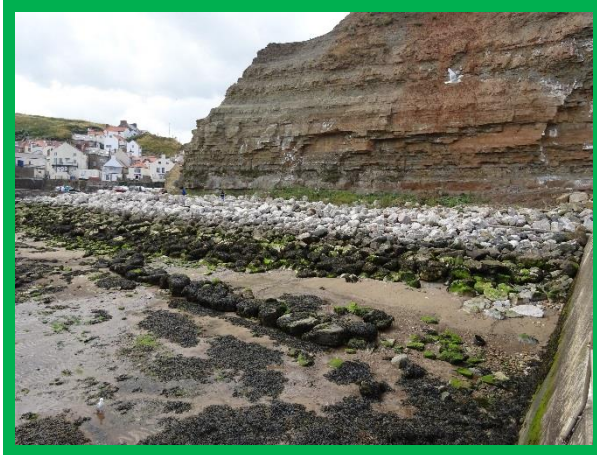
The rock armour revetment running south from the North Breakwater to the end of Cowbar Lane (/0402C02) was constructed after the 2002 upgrade to the main breakwaters and is generally in good condition. The crest level at the northern extent appears to be slightly lower, exposing the concrete walkway to the rear. It is not clear if rock armour has been displaced or if the revetment has undergone a larger scale movement/settlement. The short section of seawall which is exposed at the southern end of the rock armour, adjacent to the slipway, is in fair condition, with evidence of local abrasion of the vertical faces and the crest and cracking and open joints between concrete blocks.

Rock revetment (/0402C02)

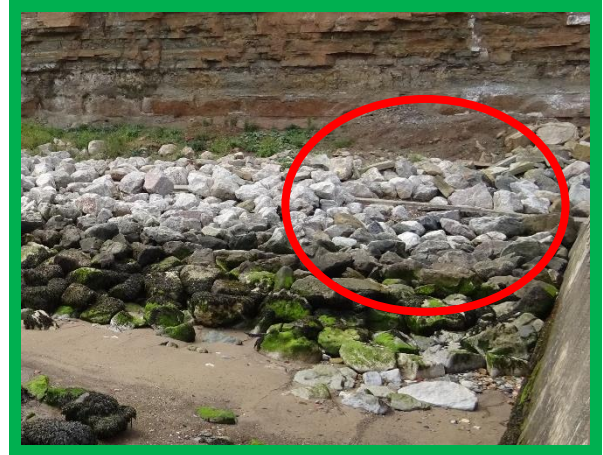
Lower crest level at northern extent of rock revetment (/0402C02)

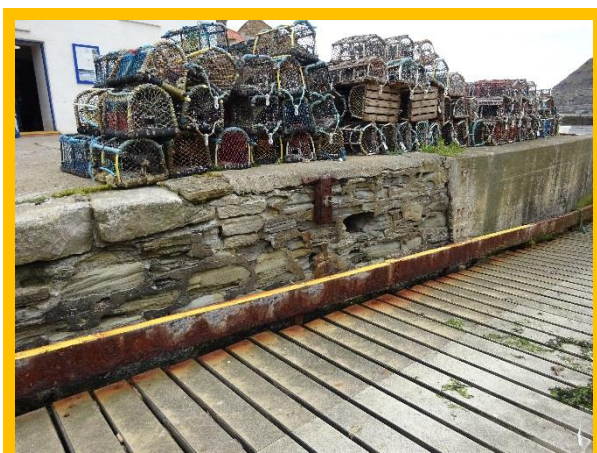
The defences that extend into the northern side of Staithes Beck are split into two asset lengths (/0402C03 and /0402C06), with the intersection at the west side of the RNLI slipway. The eastern section (/0402C03), which is in fair overall condition includes the slipway with gabion baskets beneath and a vertical concrete wall to the rear, tapering into a stone blockwork wall at the landward end of the slipway. The gabions are in a fair condition despite some settlement, but the stone wall is in poor condition along its length, with open joints between blocks and one large void caused by a missing block. Masonry has continued to erode since the 2016 survey, leaving the mortar standing proud. The concrete wall to the rear of the slipway appears in fair condition along its landward section, but in poor condition further seaward with long longitudinal cracks and cold joints.

Poor condition masonry wall to rear of slipway (/0402C03)

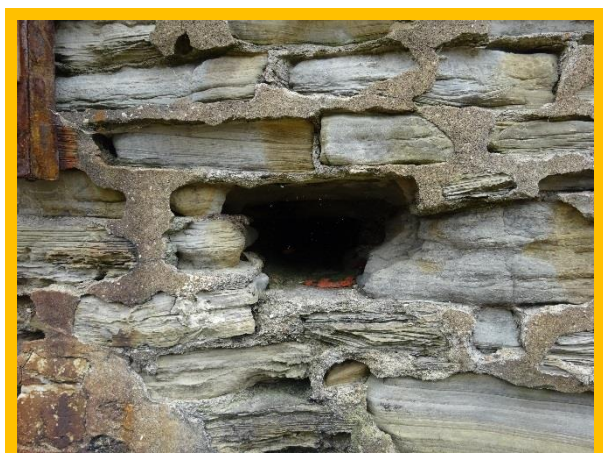
Missing blockwork in masonry wall to rear of slipway (/0402C03)

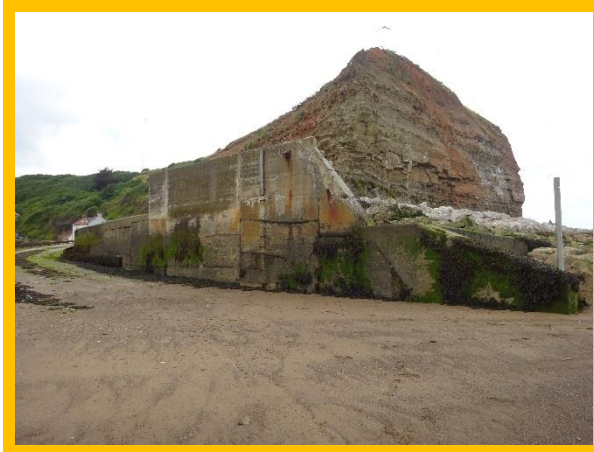
Cracks and cold joints in concrete seawall to rear of slipway (/0402C03)

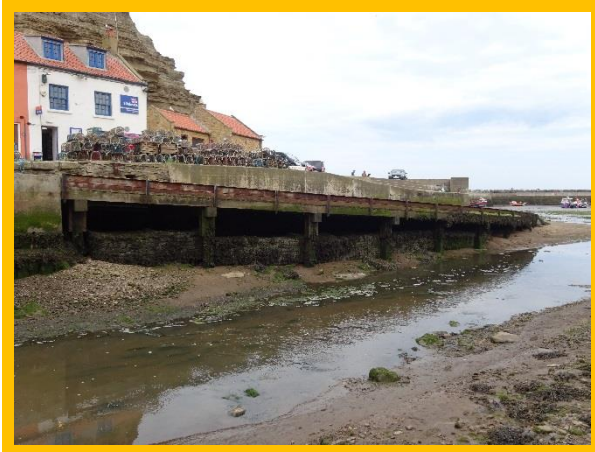
Timber slipway. Minor settlement of blocks within gabions beneath (/0402C03)

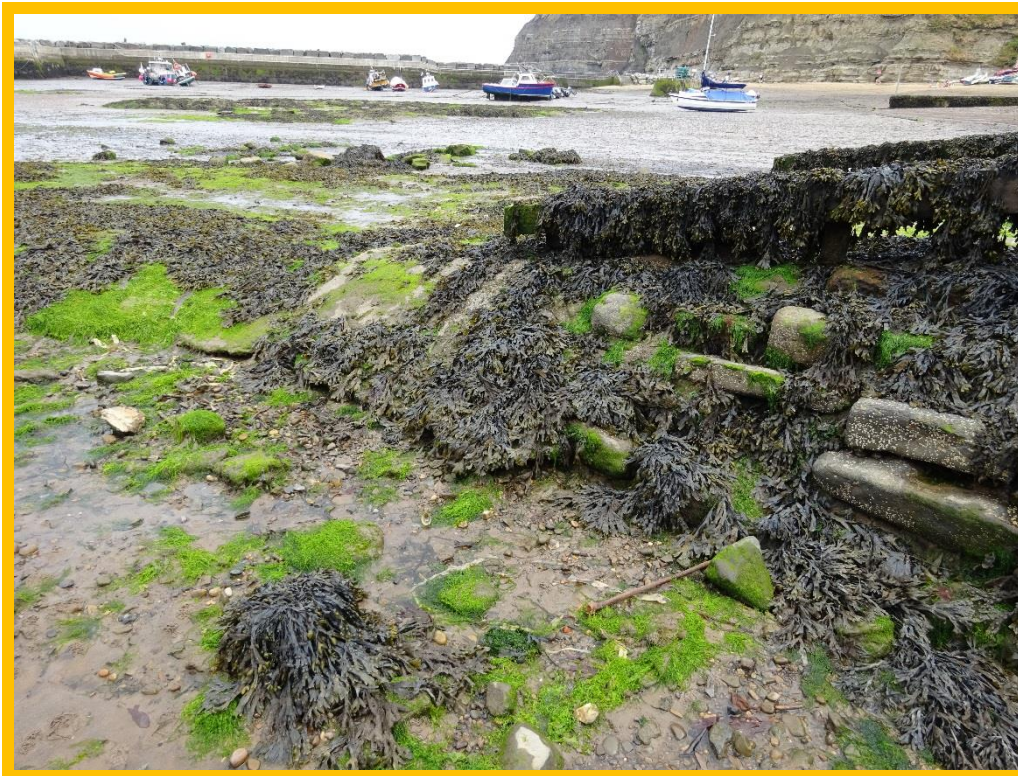
The masonry blockwork side walls to the slipway are in poor condition, with missing blocks, open joints and undermining at the toe. Some of the open joints are in an area of previous repair and need re-filling.

Open joints, loose masonry, missing blocks and undermining to North face of slipway (/0402C22)

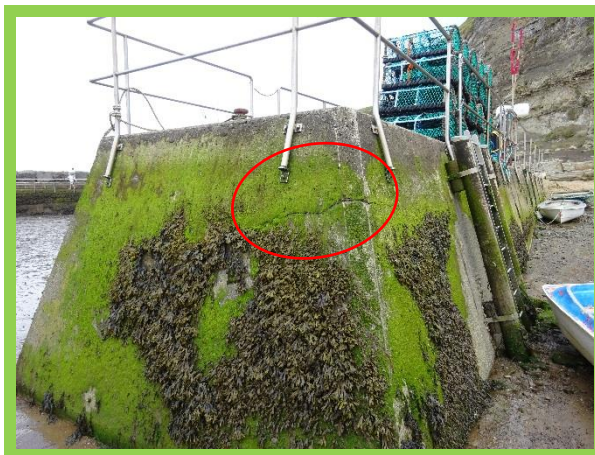
Inner harbour concrete breakwater (/0403C04)

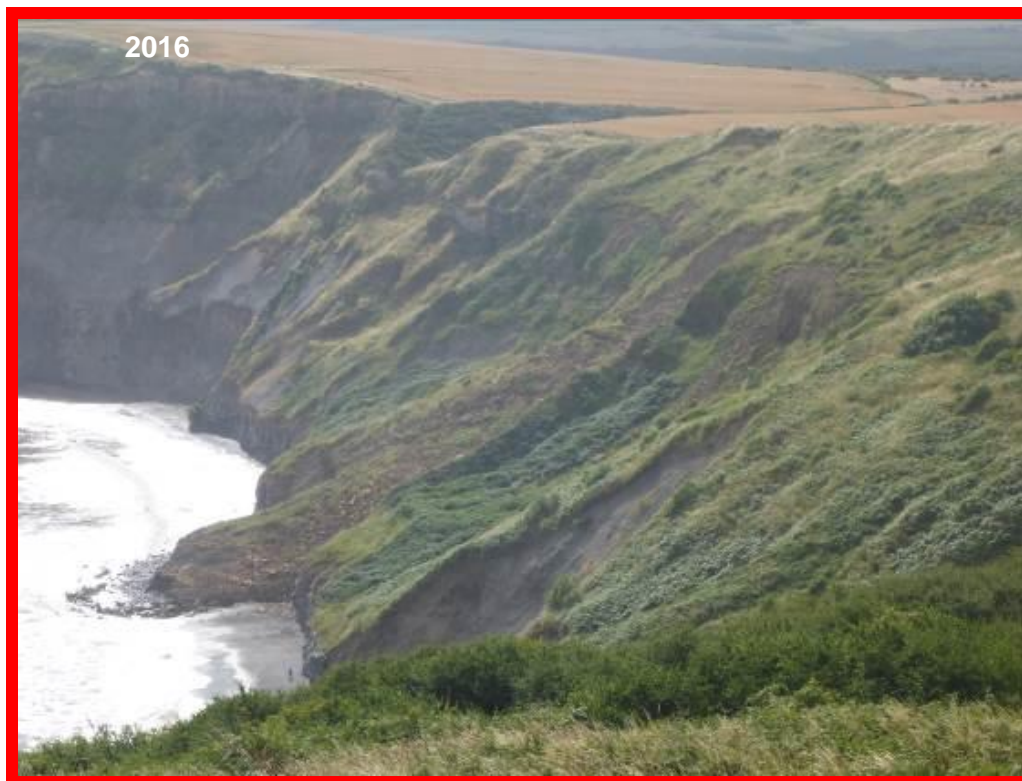
Downgraded to Partly Active in 2018, as there is a lack of evidence of significant continued activity following the large landslide which occurred in 2016 other than a reduction in the size of debris fan and a reprofiling of the toe section of the failure.

MU6/5 – View of the landslide looking across Port Mulgrave from west to east (Totally Active in August 2016)

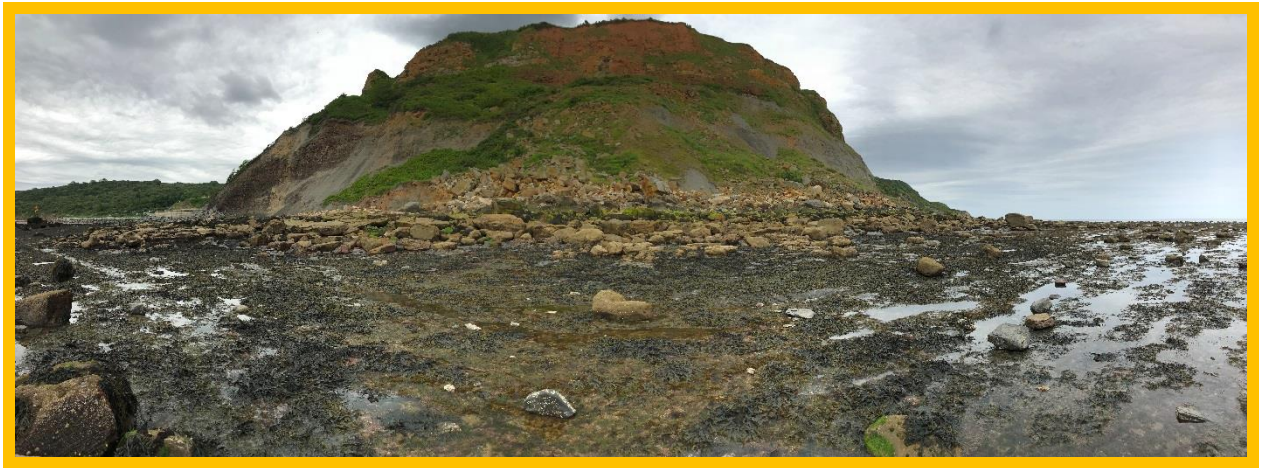
MU6/8 Partly Active in July 2018.

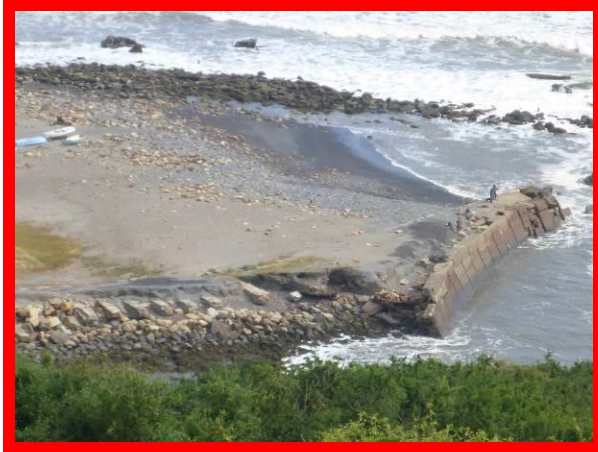
The jetty of the former port and ironstone mine at Port Mulgrave has been derelict for many years and is considered to be redundant. Virtually all coastal defences have been lost to the sea. What is left of the southern breakwater is undergoing large scale cracking, deformation, undercutting and outflanking and failure of more recently added gabions. It is estimated that more than half of its original length has now been eroded. The rate of deterioration appears to have slowed as the remains of the structure appeared very similar to observed in 2016. (0502C01).

Dilapidated asset in 2016 (0502C01)

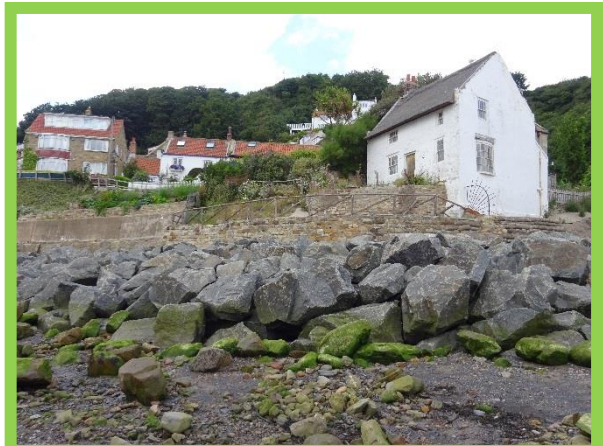
Cracks filled and masonry repointing in front of Thatched Cottage (/0601C06)

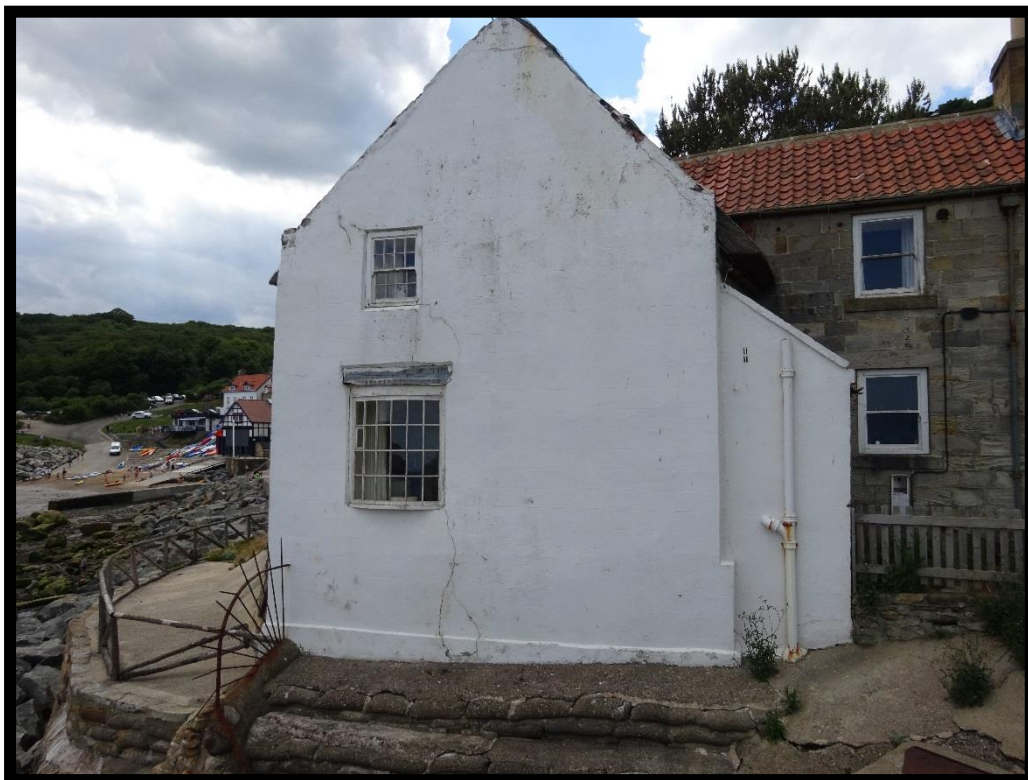
Cracks in gable end of Thatched Cottage

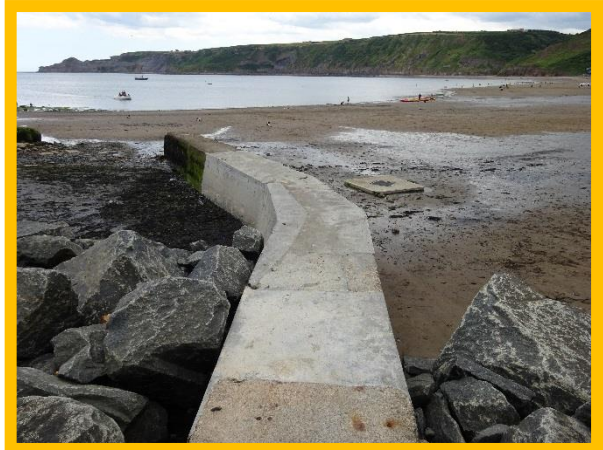
In situ poured mass concrete reinstatement of breakwater. Repair to left (/0601C02)

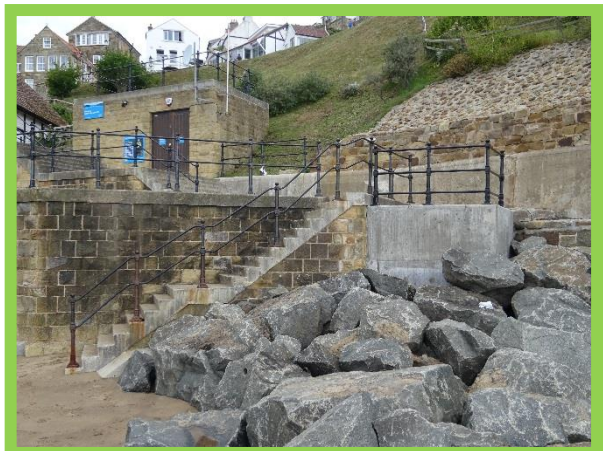
Pumping station and raised manhole chamber (/0601C07)

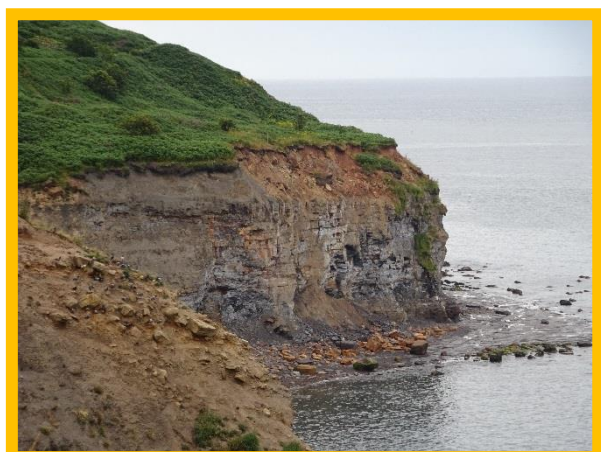
Evidence of recent headscarp failure. **MU8/13**, Partly Active in July 2018.

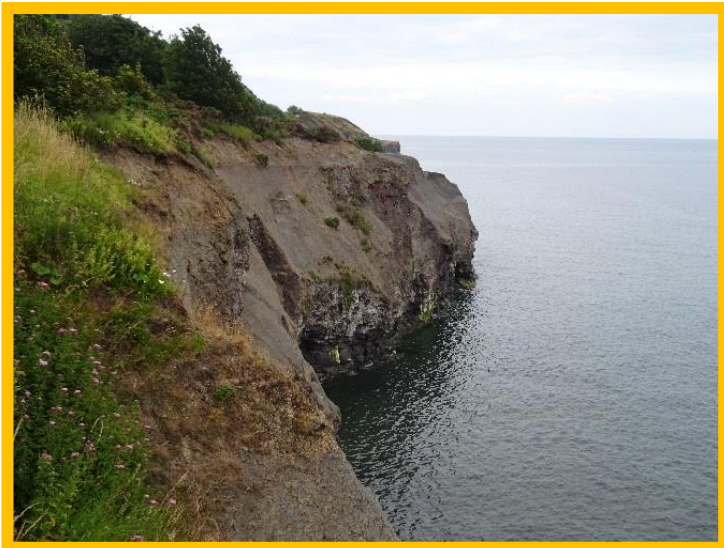
MU8/15 Partly Active in July 2018

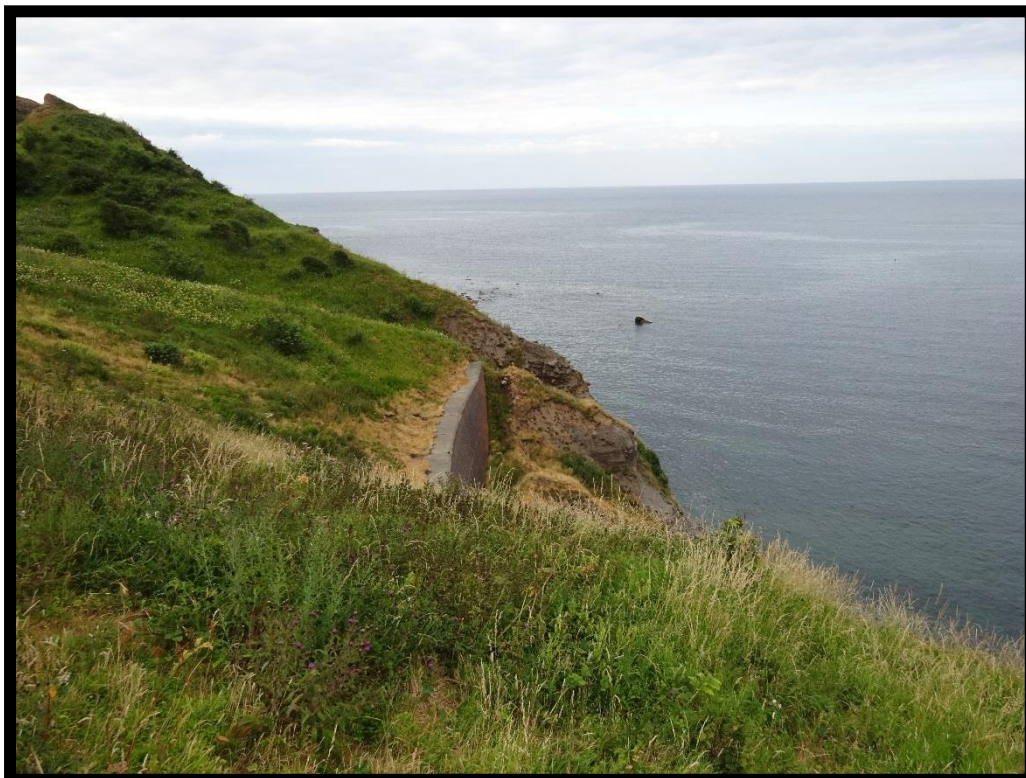
Redundant masonry retaining wall in MU8/14

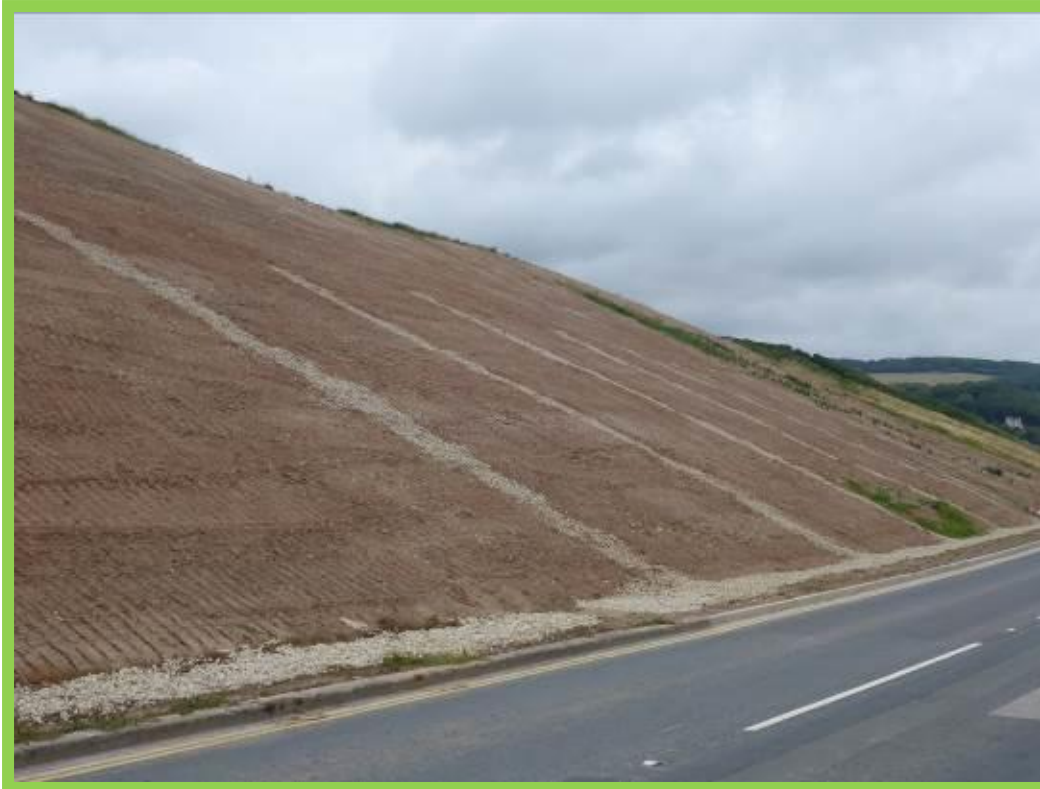
This Sub-management unit consists of unit MU9/3 only. This unit is located above the concrete sea defences immediately to the east of Sandsend. The previously failing sea defences had been replaced by a new stepped concrete apron with upper Dycel units by the time of the 2016 inspections, and the backing slopes had been stabilised. The slopes had historically been subject to slippage which, at times, caused the temporary closure of the A174 Sandsend Road. The intent of the slope stabilisation works is to improve the condition of the slopes to an inactive state through means of re-grading, drainage and seeding. Overall the stabilization scheme is working well, but one local area of slippage was observed above the installed drains. It is known that this will be remediated in the near future by battering the slope to a shallower angle.

MU9/3 Coastal slopes to rear of new sea defences generally in an inactive state following capital works involving re-grading, drainage and seeding as part of the Sandsend Road Coast Protection & Slope Stabilisation Scheme

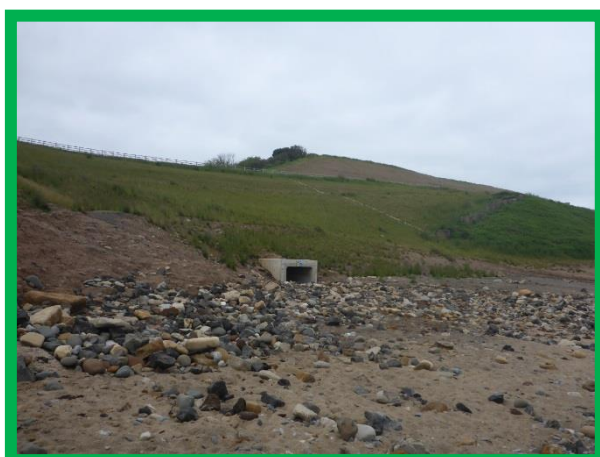
MU9/4 Infilling of Raithwaite Gill at the eastern end of the coastal slopes (Inactive) in 2016

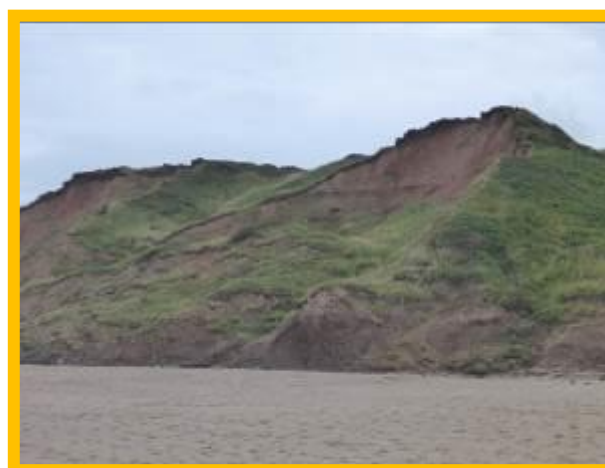
MU10/2 comprises the till cliffs behind Upgang Beach that are prone to episodic mudslides and block failures. Vegetation cover is limited along the cliff face and the unit is classified as Partly Active in 2016, unchanged since the 2005 survey.

MU10/2 Slumping cliffs along Upgang beach (Partly Active) in 2016

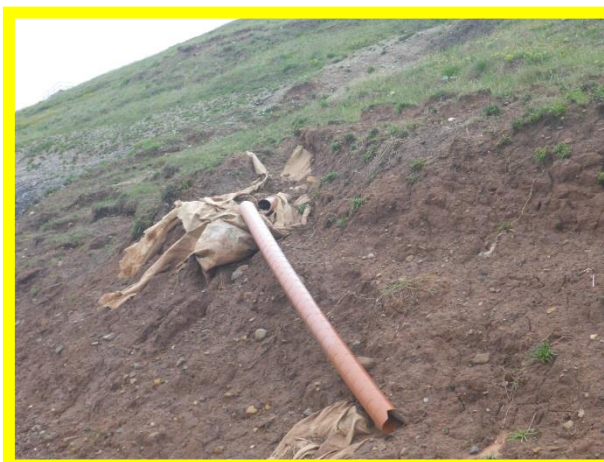
These units are comprised of re-graded slopes protected by a sea wall and promenade. The slopes are well-vegetated, and whilst they are generally stable there is evidence of localised instability in the lower slope in places within both units. There is evidence of some previous stabilisation works and in one location within MU11/1 these have become exposed and the stone-filled plastic baskets have split, requiring repair or replacement. Both these units are classified Locally Active in 2016.

MU11/1 Evidence of slumping and broken pipe in the lower coastal slopes (Locally Active)

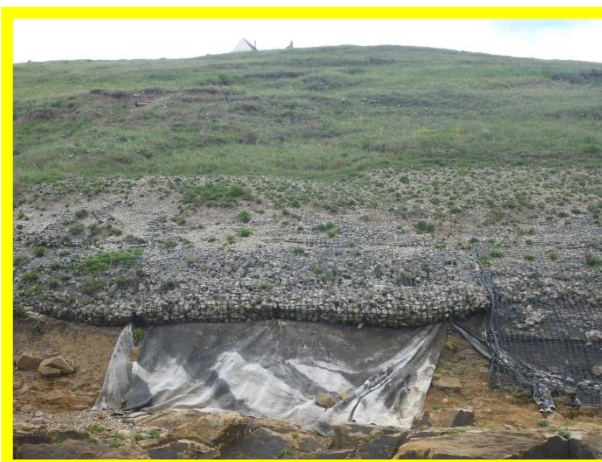
MU11/1 Exposed previous repairs (Locally Active)

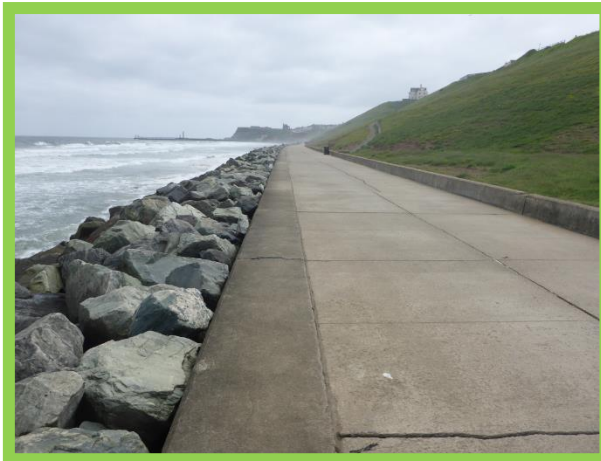
This Management Unit encompasses various sea walls and rock revetment to the west of Whitby Harbour. The most westerly defence is a rock armour revetment fronting the seawall and promenade (D0801C01). As in previous inspections, the rock armour is in good condition with only minor movement visible. The asset is in overall good condition although the promenade is rated as fair despite areas of repairs, due to previous longitudinal cracking. There is also damage to the wall to the rear of the promenade.

Rock revetment, promenade and coastal slopes of Whitby West Cliff (D0801C01)

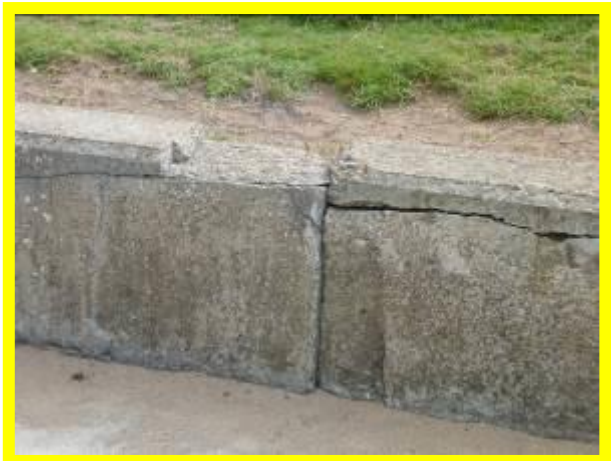
Damage to low wall at rear of promenade (D0801C01)

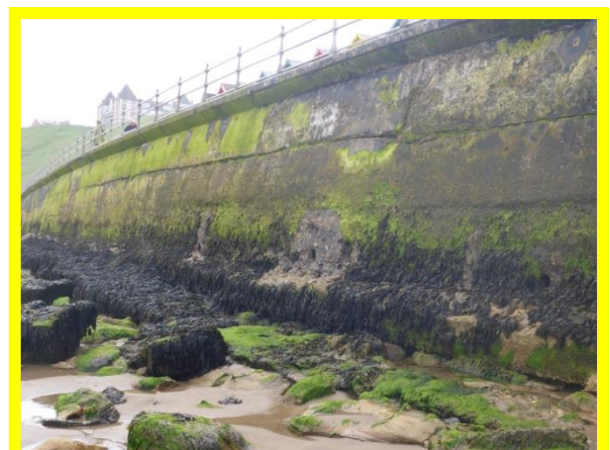
Seawall to east of rock armour revetment (D0802C01)

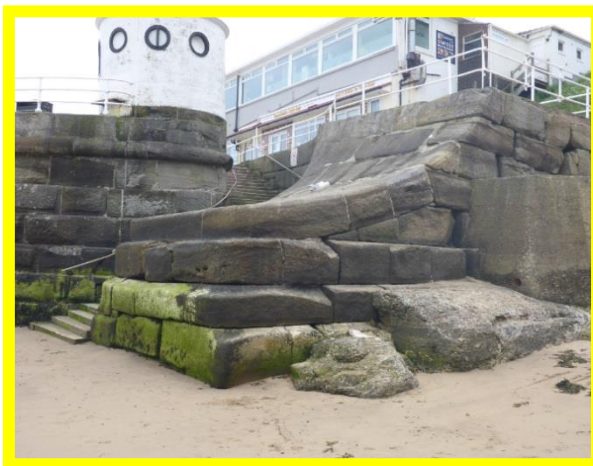
Open joints in wing wall to access steps
(\D0802C12)

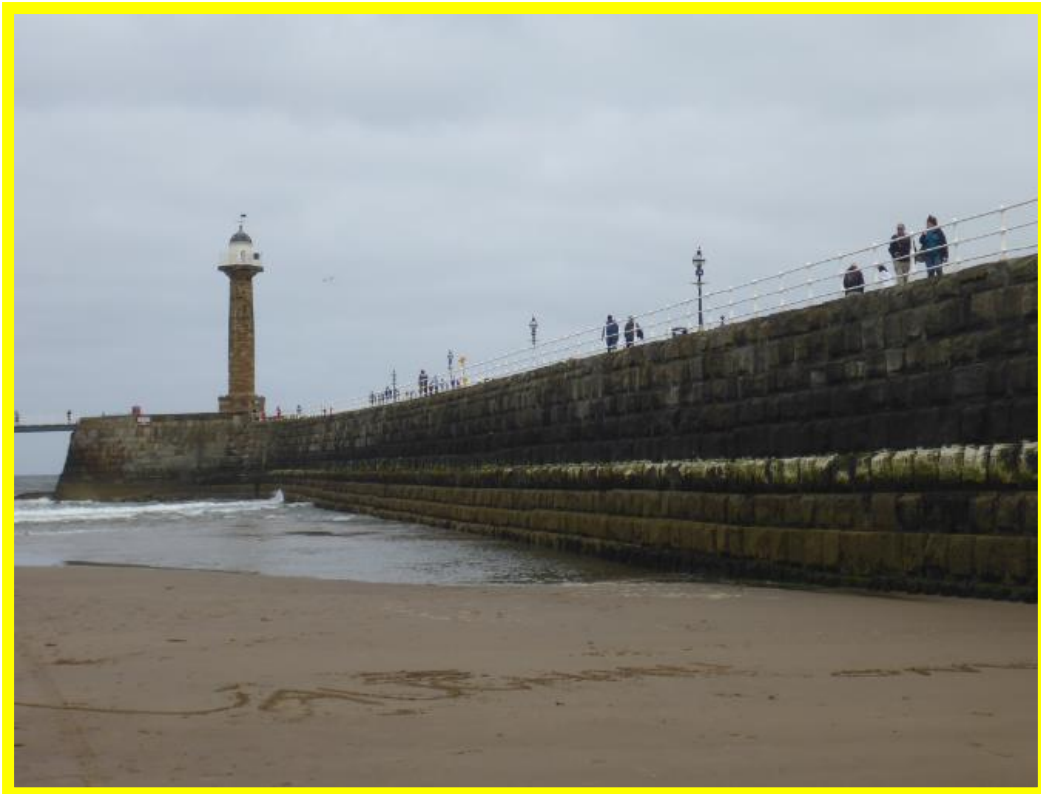
The piers have each been classified as generally fair, but the West Pier is locally poor in condition and the East Pier locally very poor in condition.

West Pier, generally in fair condition but locally poor (\803C02)

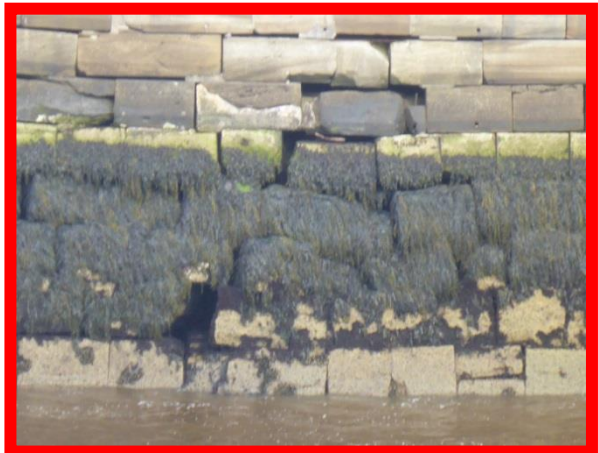
East Pier, generally in fair condition but locally very poor (\803C03)

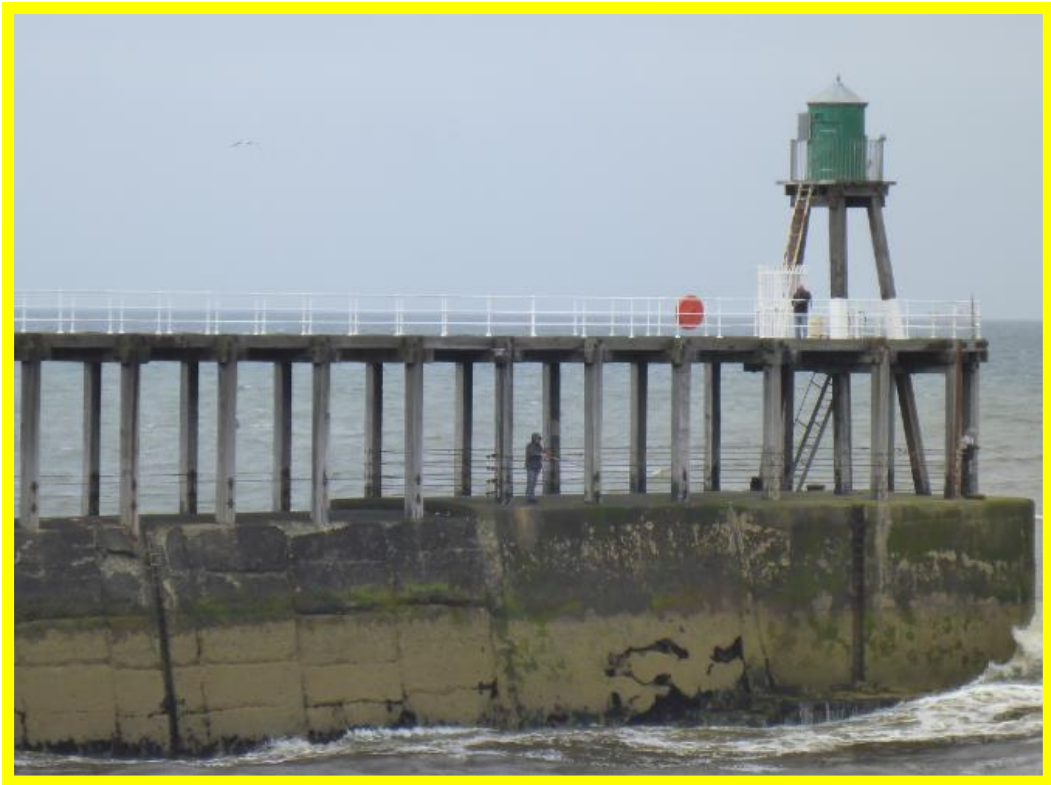
West Pier extension, generally in fair condition (\803C01)

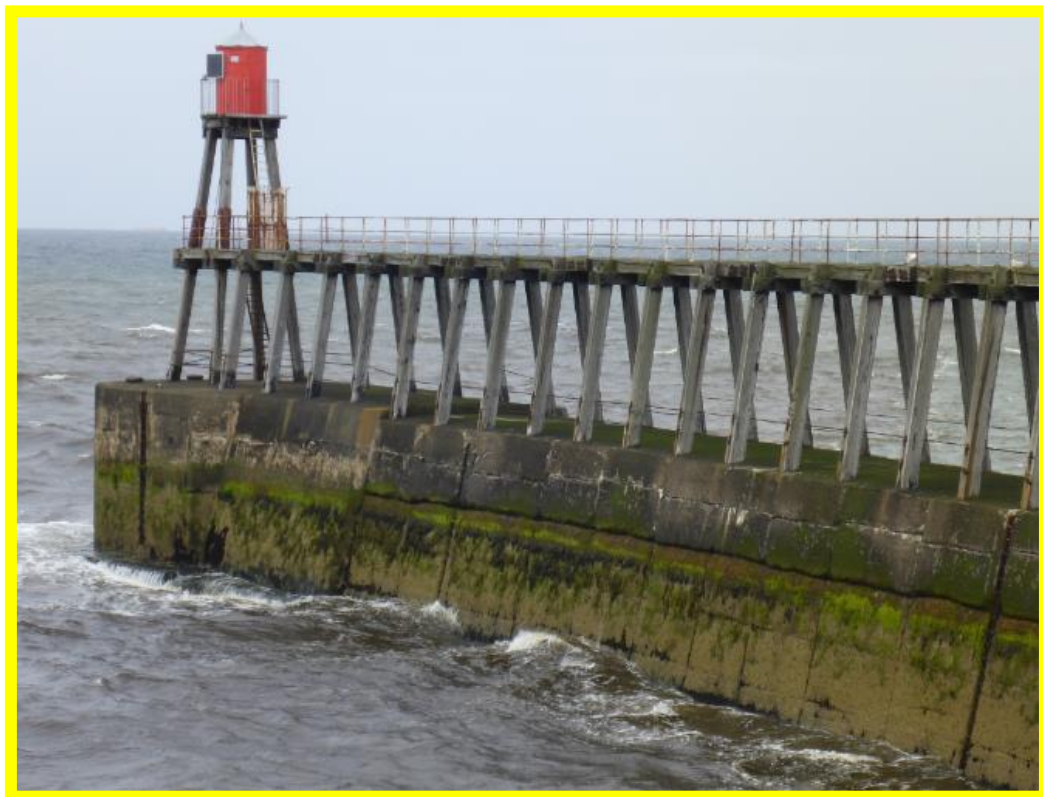
East Pier extension, generally in fair condition (\803C04)

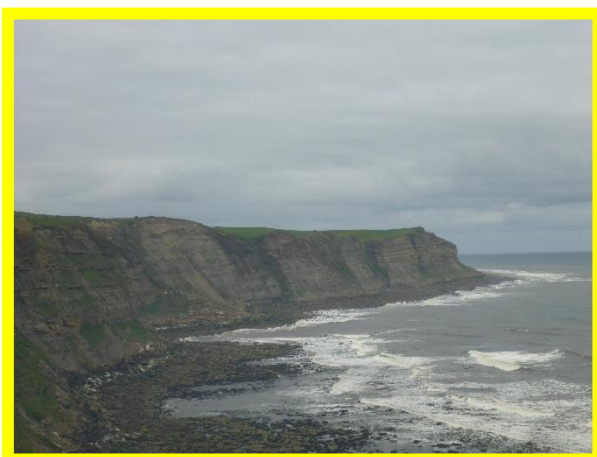
The only unit within this Management Unit is **MU14/1**. The cliffs within this unit remain classified as Locally Active in 2018 because whilst the slopes are partly vegetated, there remain small areas of erosion evident. An incipient tension crack was noted in the crest of the cliffs at the foot of timber steps south of Whitby Lighthouse. Installation of timber fencing on seaward side of path should be considered.

MU 14/1 Vegetation growing locally on face of cliff (Locally Active)

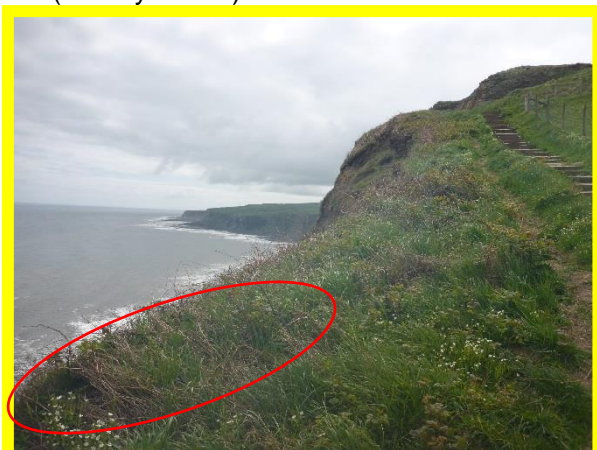
MU14/1 Tension crack located in grassland at foot of steps (crack not visible in photo)

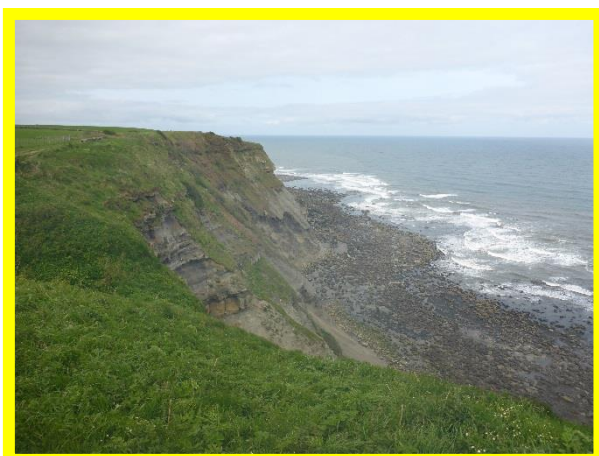
MU15/1 Vegetated slopes at cliff top (Locally Active)

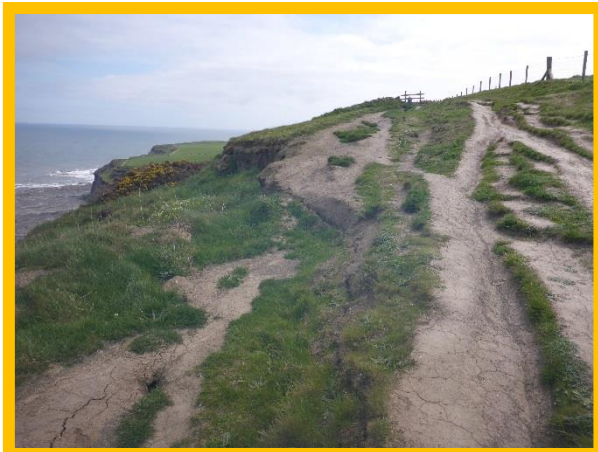
Tension cracks remain at MU15/2 (Partly Active)

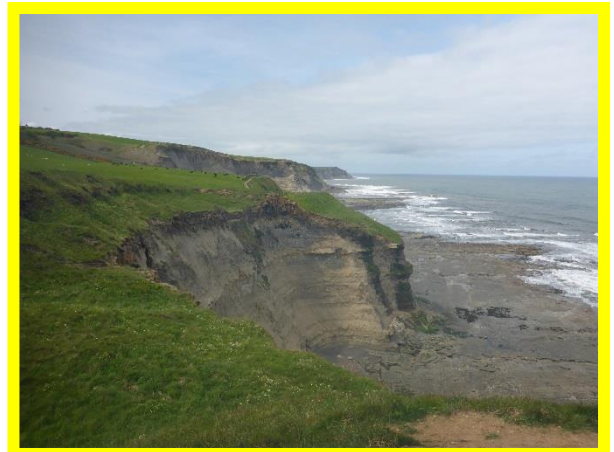
MU15/3 Local erosion at northern part of unit, vegetated upper slope (Locally Active)

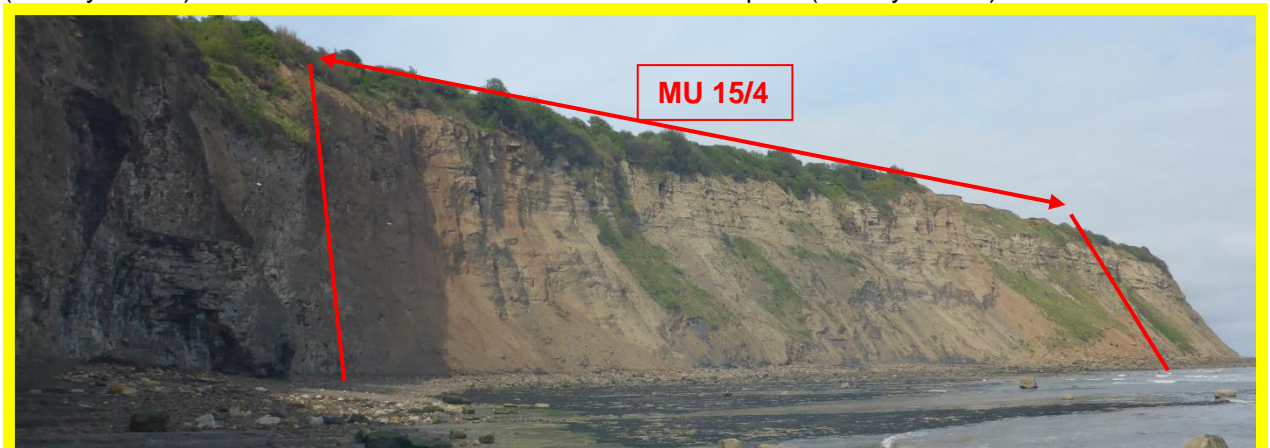
MU15/4 Locally vegetated slopes at cliff top (Locally Active)

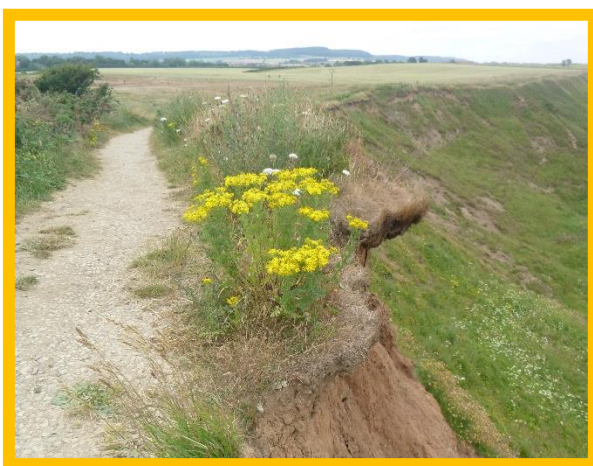
During the 2018 survey it was noted that the headscarp was actively undercutting the footpath and there was a significant risk to users of the path along several sections. This was due to the instability of the ground, evidenced by many minor landslips across the cliffs upper reach.

MU19/9 Retreat of headscarp (Partly Active)

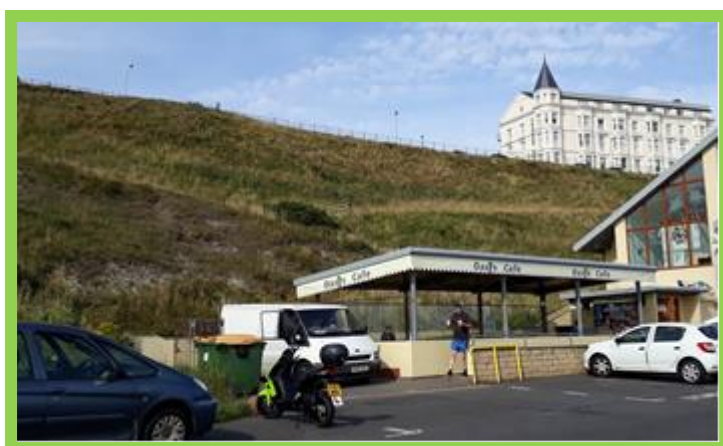
Unit MU20/4a is located to the rear of North Sands. The relict slopes are well vegetated with only minor and localised evidence of erosion, it remains classified as Inactive, unchanged since previous surveys.

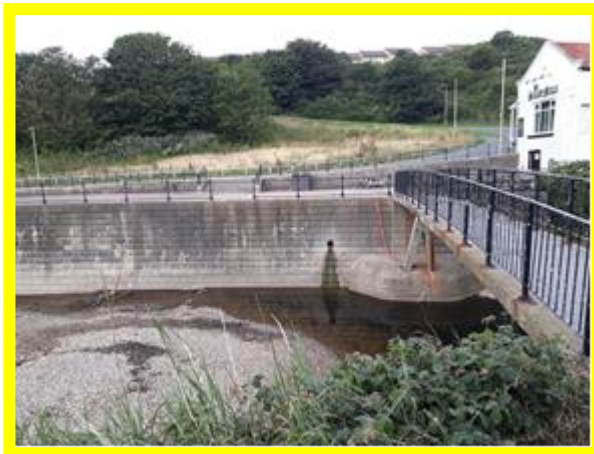
Fair condition seawall at Scalby Beck (/1201C01)

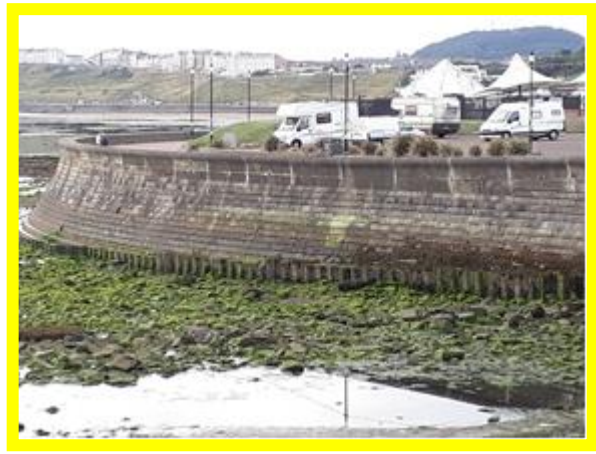
Fair condition seawall at Sea Life Centre (/1201C02)

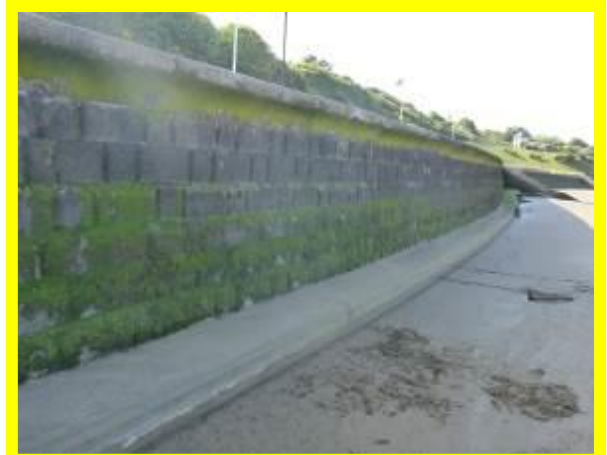
Fair condition seawall with recent repairs to toe apron (/1201C24)

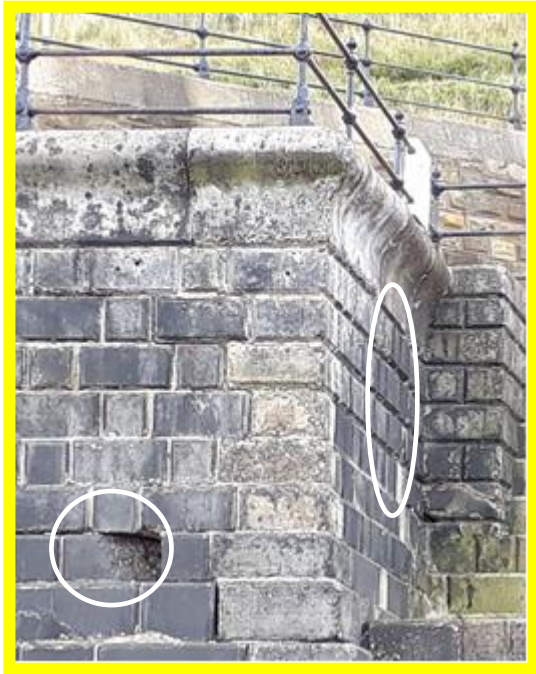
Southern end of wall with partially missing block and cracks on return (/1202C23)

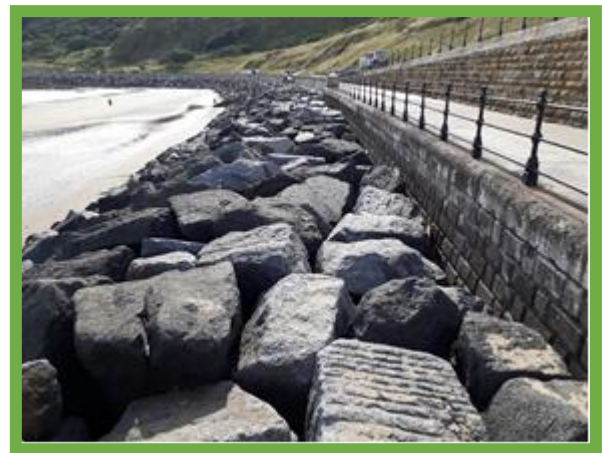
Rock revetment fronting seawall (/1202C01)

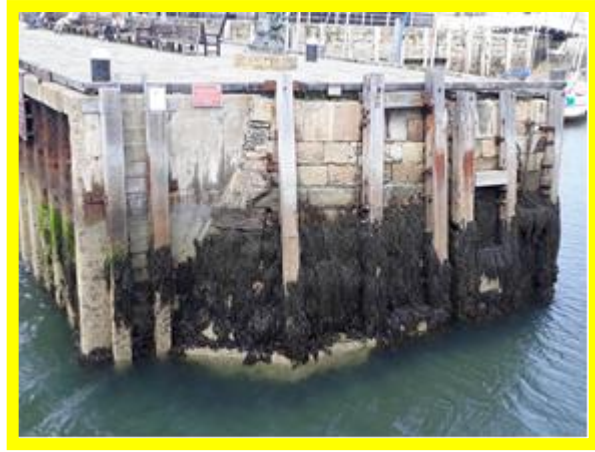
Cracks in inner wall at entrance breakwater (/1301C03)

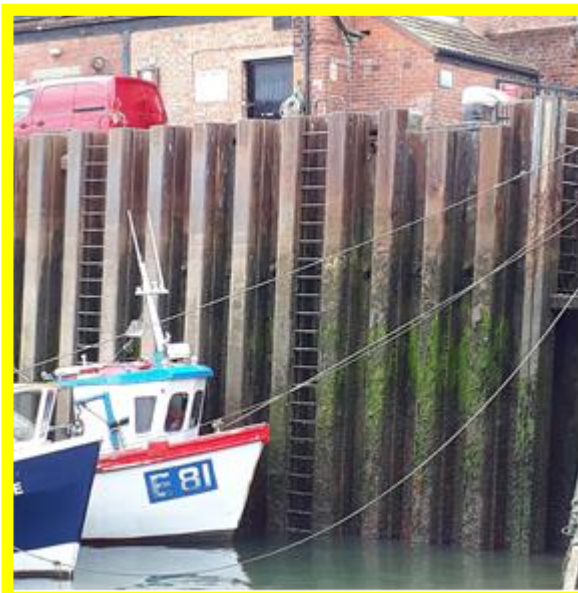
Corroded steel sheet piling on inner face of West Pier (/1301C13)

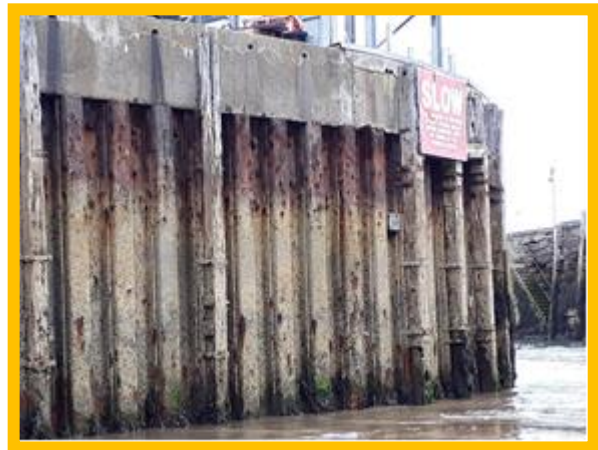
Corroded steel and cracked capping beam on seaward end of West Pier (/1301C1718)
