Cell 1 Regional Coastal Monitoring Programme Walkover Inspection Surveys 2018

**Scarborough
Borough Council**

October 2018

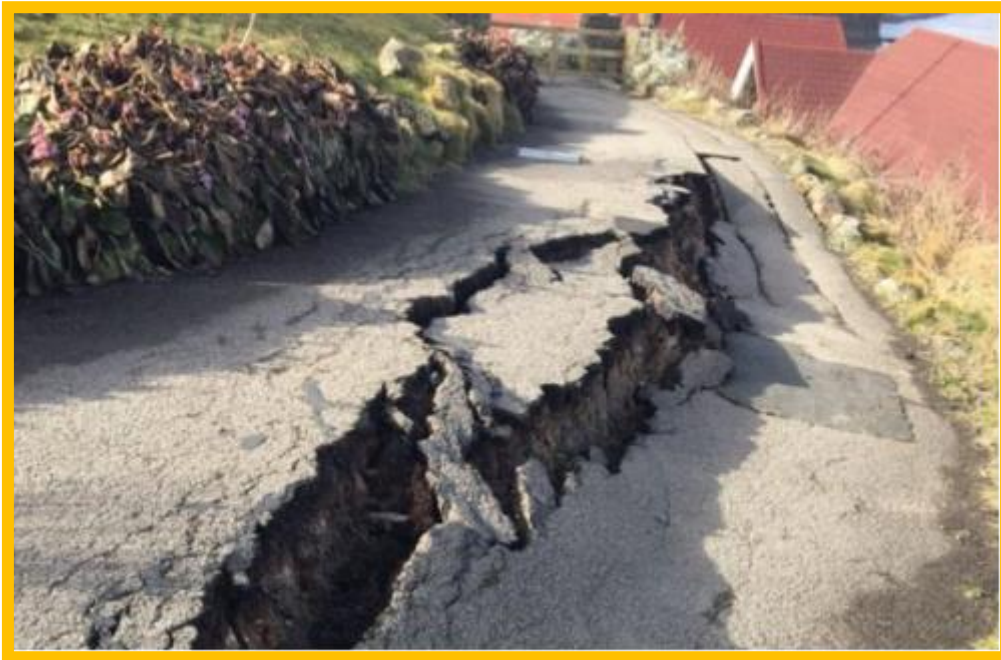
MU22/4 Large cracks in footpath above retaining wall failure

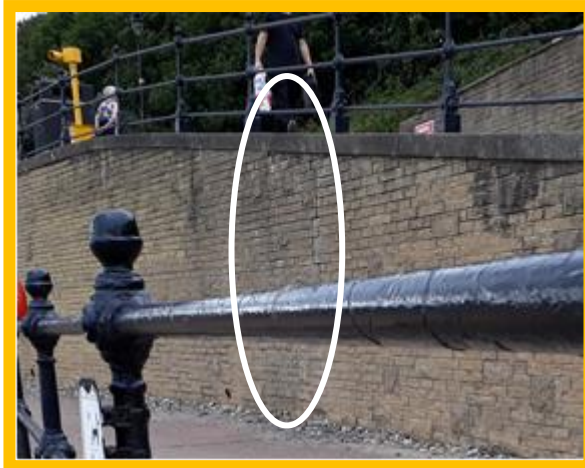
Vertical crack in wall above access ramp (/1301C10)

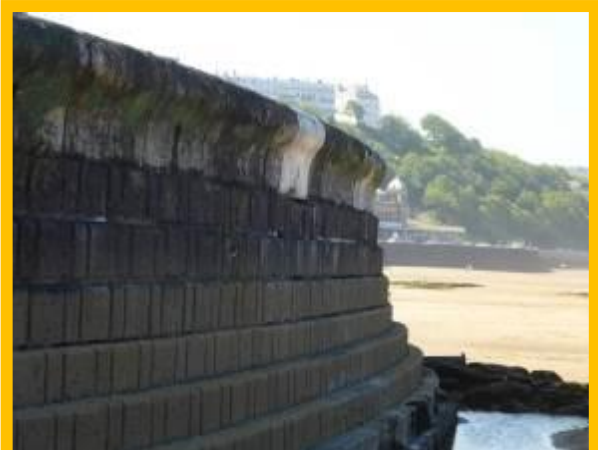
Previous repairs to wave return coping (/1303C02)

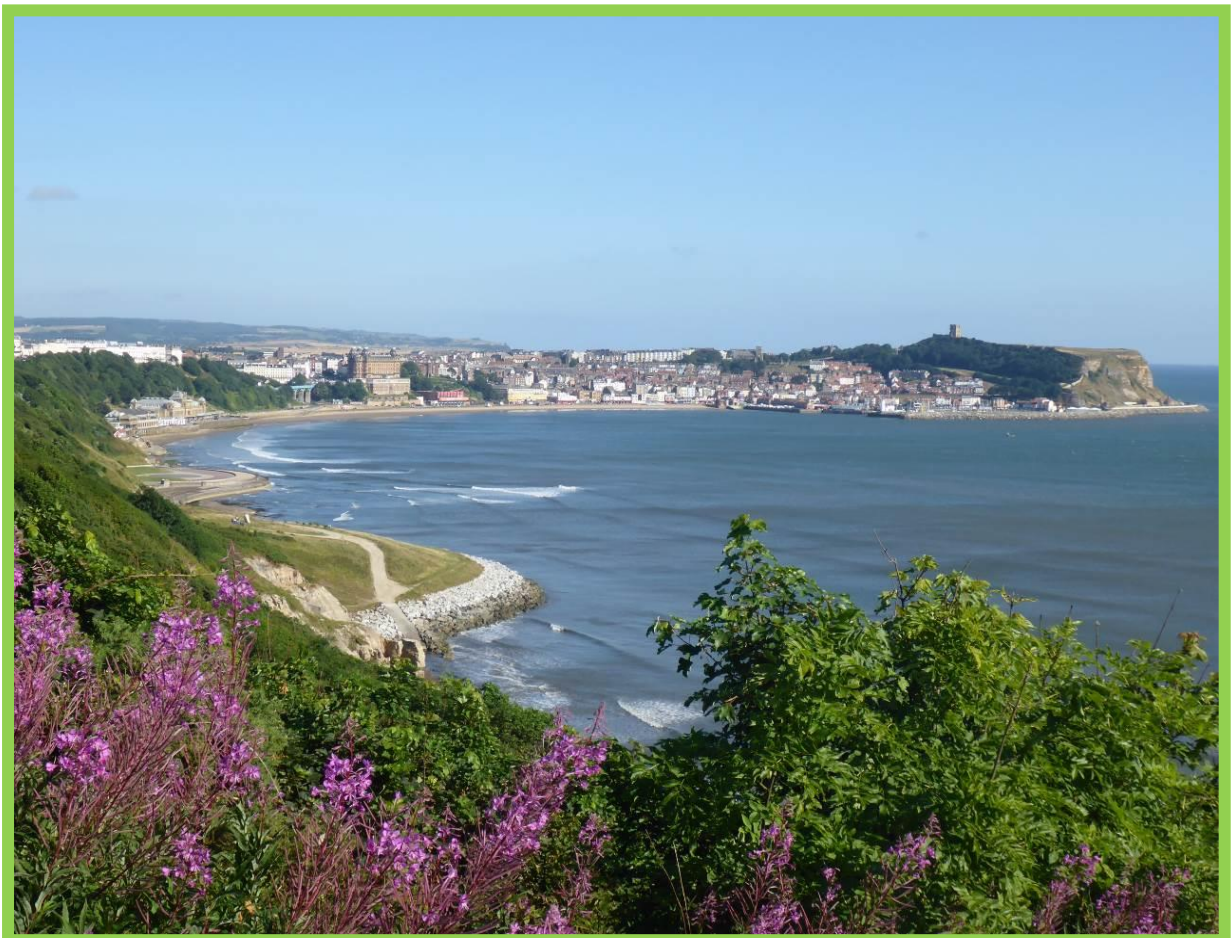
Rock revetment around debris lobe of Holbeck Hall landslide (/1304C01)

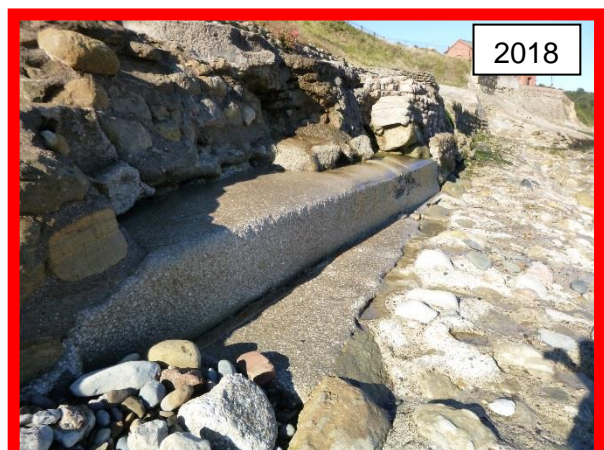
Mass concrete repair to damaged section of wall. (/1402C04)

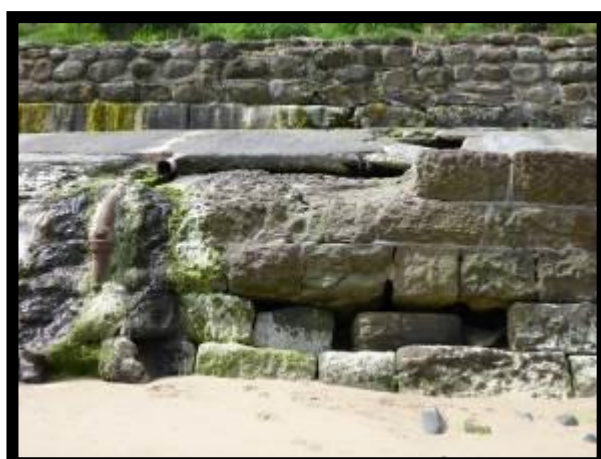
Missing blockwork in May 2015 (/1402C04)

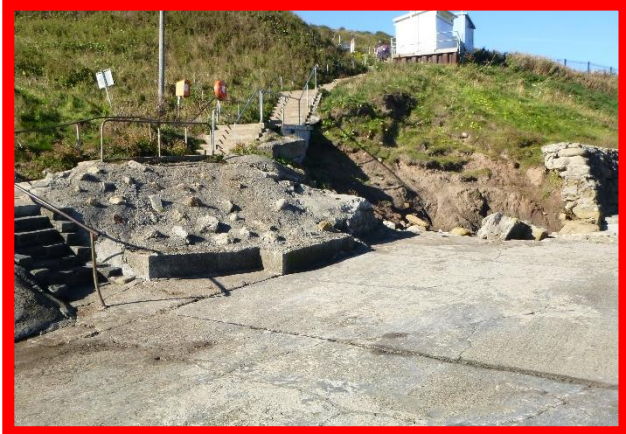
Undermining of footpath beneath 'Lucy's Shack' (/1402C04)

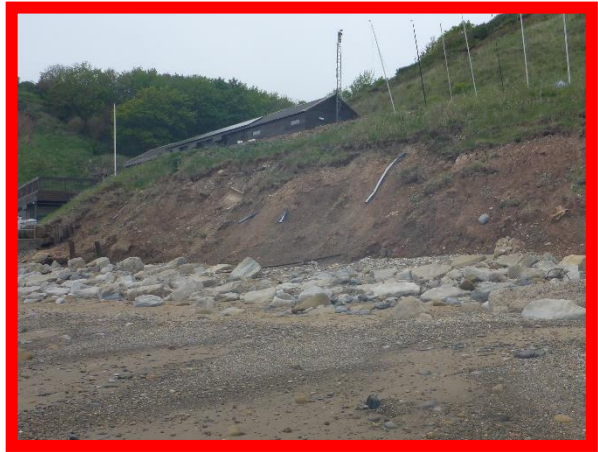
Remnants of former defences north of club building (/1601C02)

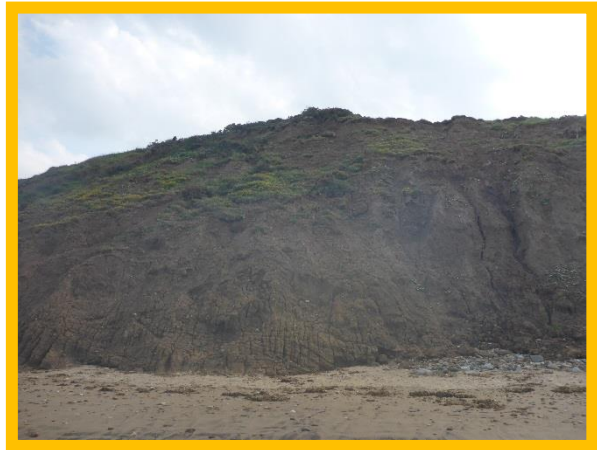
Till cliffs at Reighton Sands. MU29/BQ Partly Active in June 2018

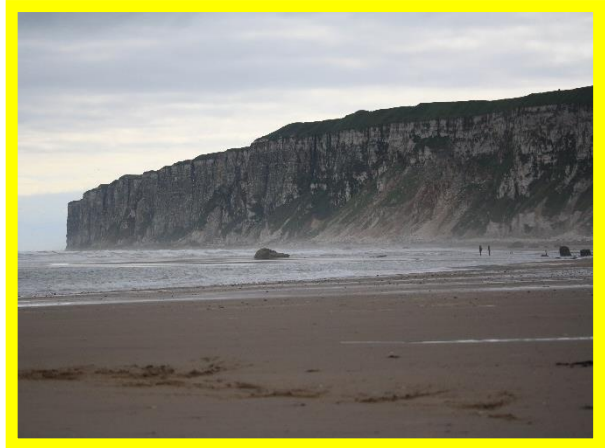
View southwards from CJ towards Bempton Cliffs
MU29/CJ Locally Active in June 2018
