Scarborough Borough Council
Strategic Coastal Monitoring Programme
2001 – 2006

Condition Analysis of Coast Protection Assets,
Cliffs and Beaches from Staithes to Speeton

November 2006

Halcrow Group Limited

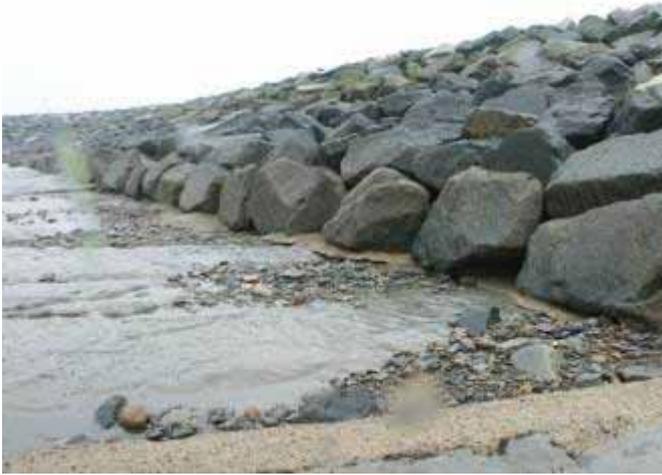
Photograph 3.1 Staithes Northern Breakwater.
View at root of seaward revetment

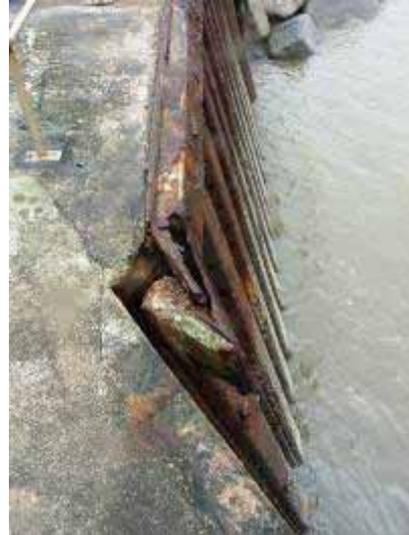
Photograph 3.4 Staithes Northern Breakwater. Corroded steel sheet piles

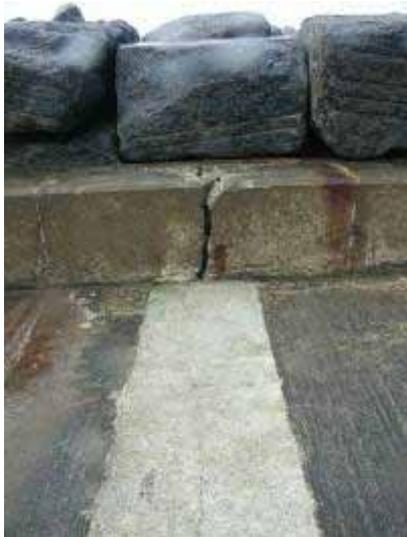
Photograph 3.5 Staithes Northern Breakwater. Abraded and damaged concrete coping

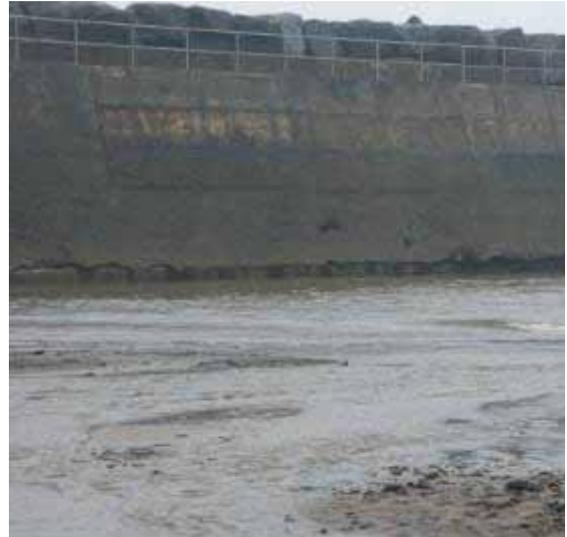
Photograph 3.6 Staithes Northern Breakwater. Abraded vertical surfaces and toe scour

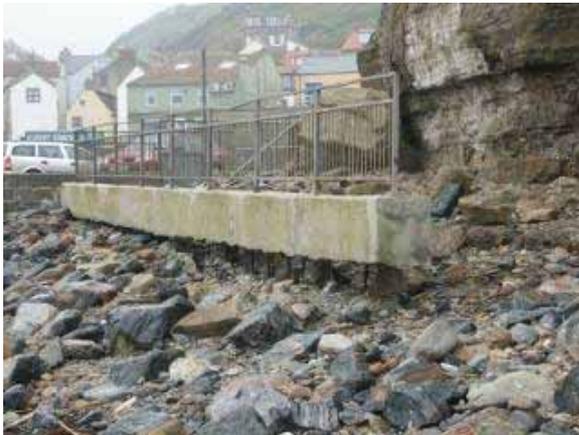
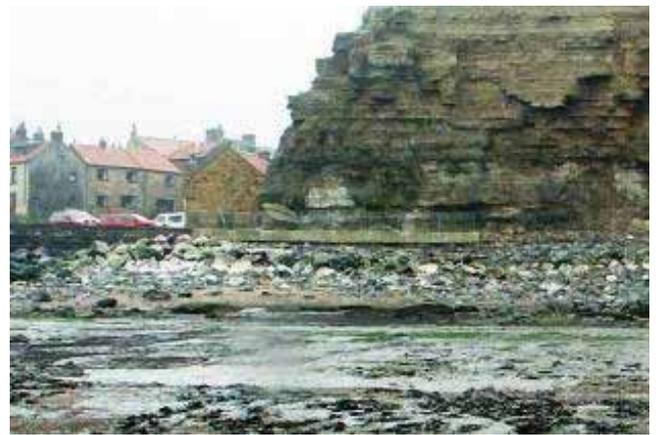
Moving eastwards, there are the remnants of a concrete promenade or apron. The coping and hand rails remain and are severely undermined. The function of these assets is not known for sure, but they are possibly there to keep people away from the cliff. However, their condition is such that they could potentially present a Health and Safety Hazard. These will continue to deteriorate and should be removed.

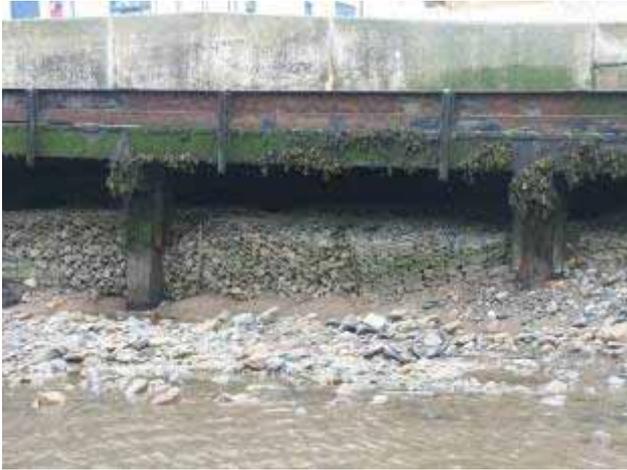
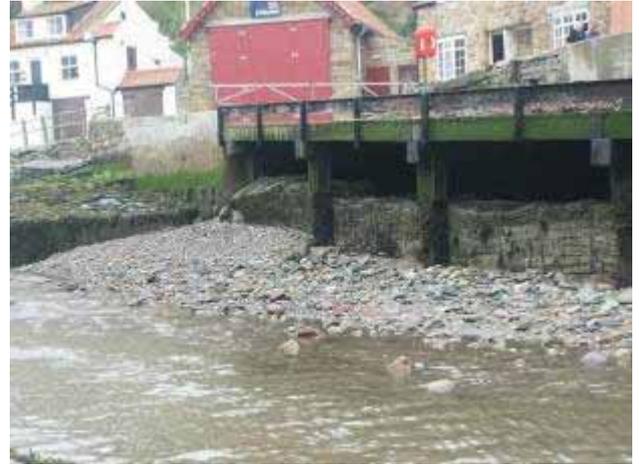
function appears to prevent further undermining of the slipway from scour. The concrete of the slipway is abraded.

Photograph 3.10 Staithes RNLI Slipway.
Gabion Baskets beneath slipway

Photograph 3.11 Staithes RNLI Slipway.
Gabion Baskets beneath slipway

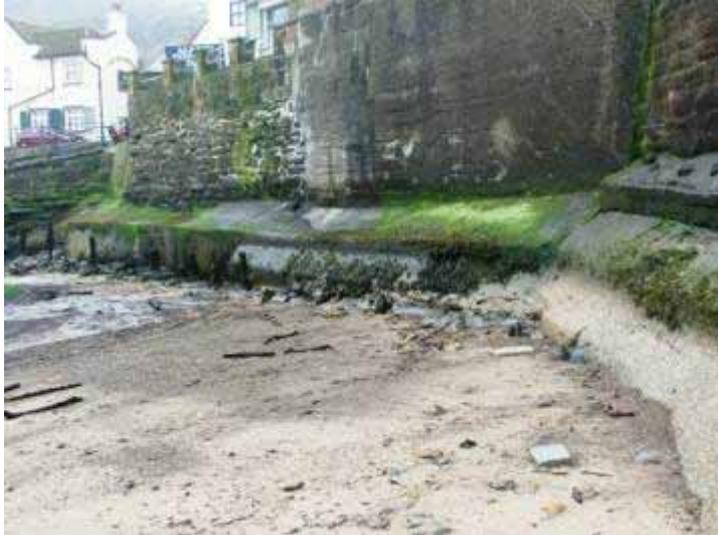
Frontage 02-04-01 is showing signs of ageing and wear, and is assessed as being in poor condition. There are voids in the masonry wall, and mesh is exposed in various concrete elements. The wall is leaning seaward and there are recently repaired bulges. These require monitoring. The coping is also assessed as being in poor conditions with surface cracks and voids evident.

Photograph 3.12 Staithes 02-04-01.
Poor condition wall, missing blocks etc

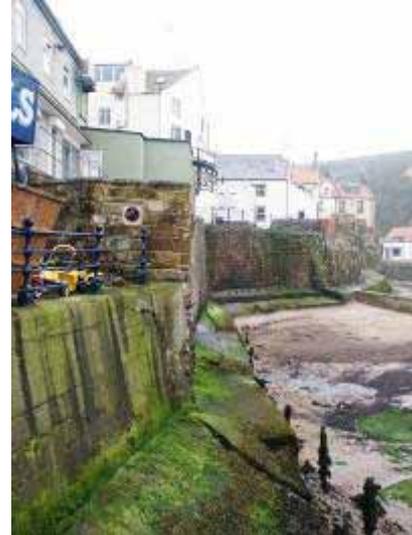
Photograph 3.13 Staithes 02-04-01.
Leaning wall with toe scour.

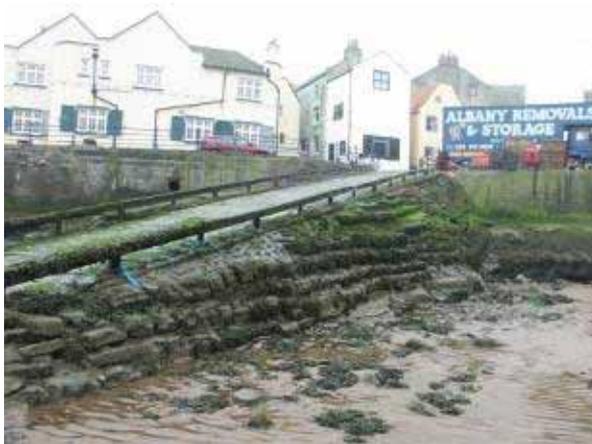
Photograph 3.14 Staithes 03-04-01.
Cod & Lobster Slipway

The central section of Staithes includes a slipway. Generally the condition is assessed as poor, with the surface of the slipway being abraded. There are damaged flap valves within the seawall itself. The wall and the coping are cracked and have been repaired. The repairs appear to be failing.

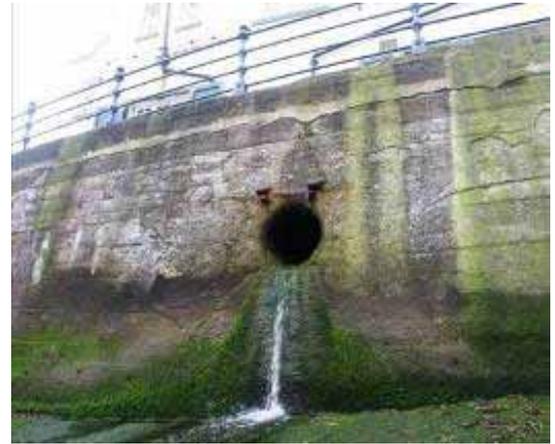
Photograph 3.15 03-04-01 Staithes.
Damaged flap valves and cracked seawall.

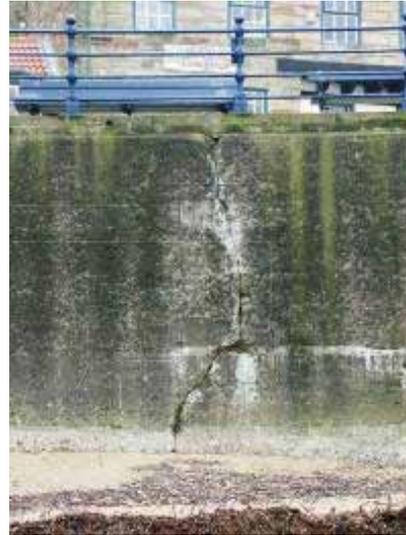
The remainder of the Staithes harbour walls located to the south appear to be in fair to good condition, with only minor signs of defects, such as cracking.

Photograph 3.17 Staithes 04-04-01
Cracked harbour walls.

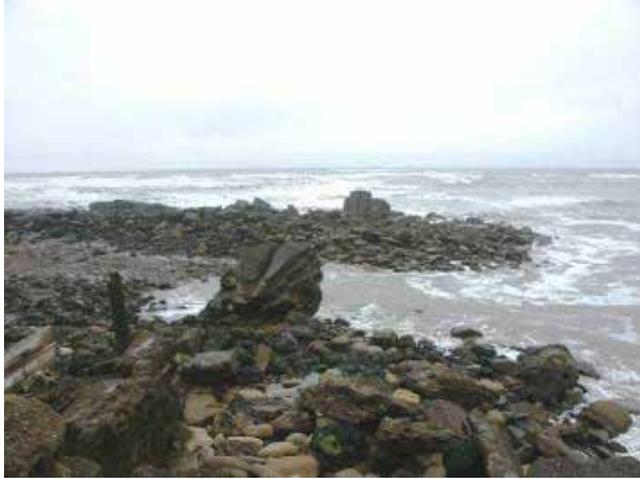
The coastal slope is locally active in this area and several small surface failures were noted during the site visit. Several small, well maintained fishing boats were landed on top of the filled basin and a few sheds housing fishing equipment, indicating some small-scale fishing activity is still taking place. Some sections of the south breakwater are still standing, but they are potentially unstable. The surface of the south breakwater has collapsed in places. The seaward facing wall of the breakwater articulates and is presently leaning against the remains of the adjacent structure. The end of the south breakwater has collapsed entirely.

Photograph 3.29 Port Mulgrave.
End of south breakwater and view onto remains of north
breakwater

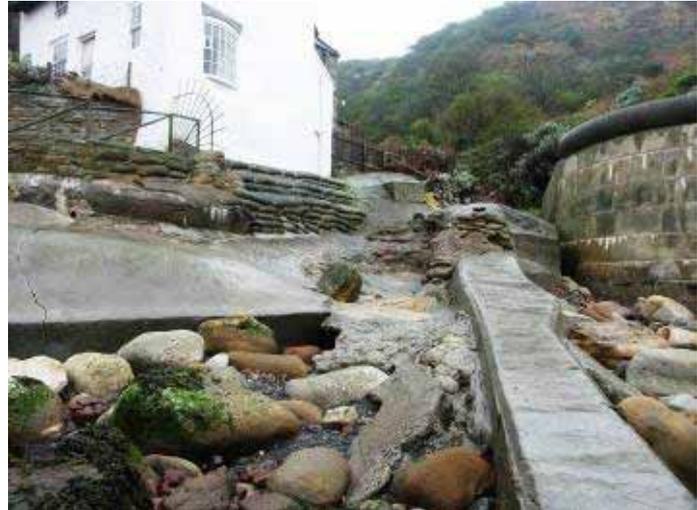
Photograph 3.32 Runswick Bay 07-07A-02
Patch repairs with ad-hoc extension of wall and access to beach

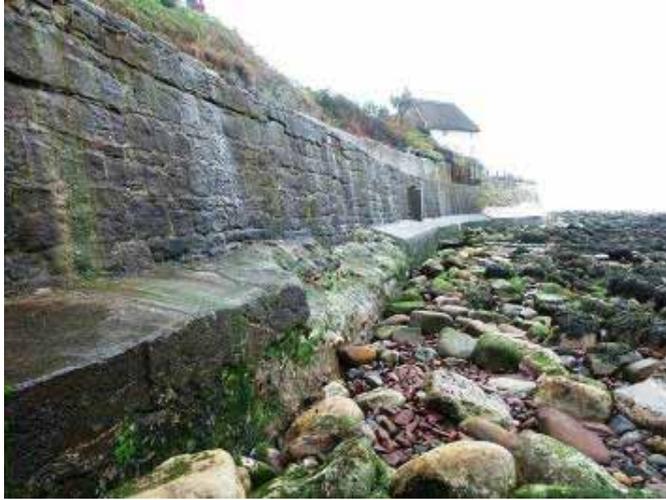
The apron of the asset no 08-07A-01 has been heavily abraded in places and has also suffered some undermining. This should be repaired now to sustain the life of the structure. The steps to the beach, asset no 08-07A-02, no longer provide safe access, due to them being steep with rounded edges, and the surfaces being covered in algae.

Photograph 3.33 Runswick Bay 08-07A-01.
Damaged apron in front of seawall

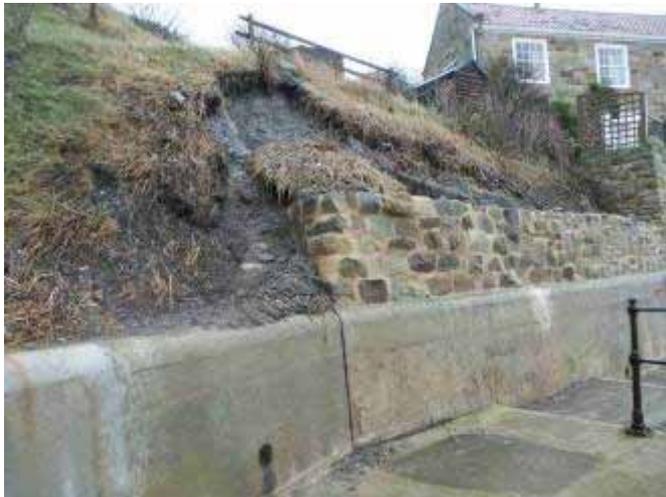
The remaining assets along this unit are in a fair to good condition. The recently built defences are in a good condition. It should be noted, however, that the slope behind these is locally active and should be monitored annually.

Photograph 3.35 Runswick Bay 08-07A-03.
Small slip onto the upper wall at promenade level.

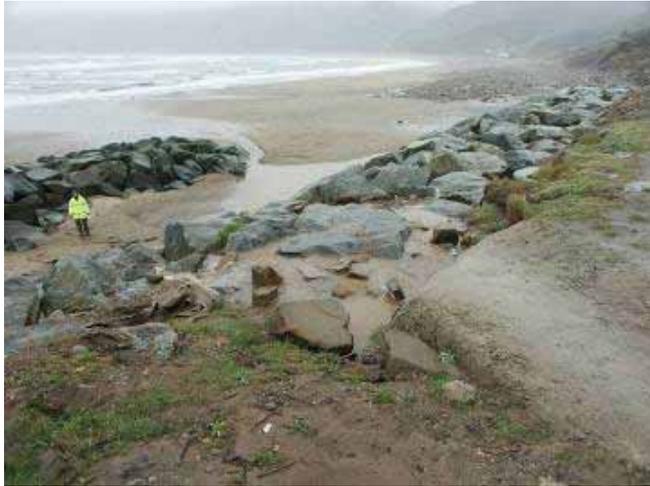
coming from this drain occasionally causes a build-up at the end of the slipway, forming a large stream, reducing the public's ability to access the beach.

Photograph 3.37 Runswick Bay 10-07B-01
Water running through rock armour onto beach

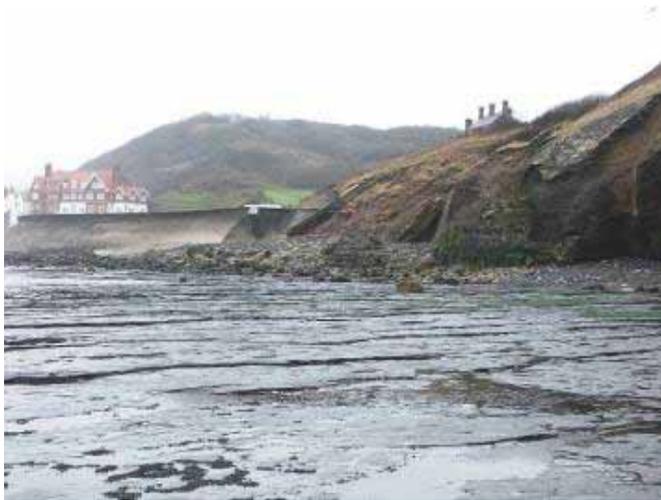
Photograph 3.39 Gouldsborough 12-08B-01.
Concrete base and masonry wall foundations.

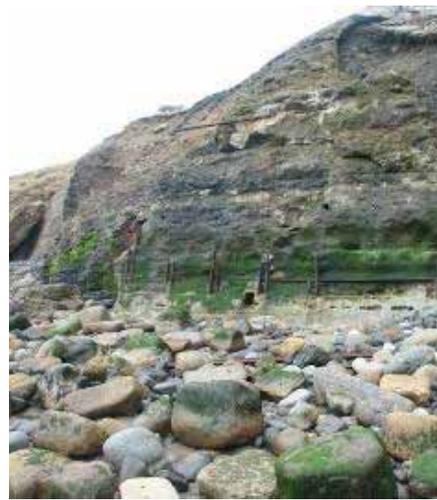
Photograph 3.40 Gouldsborough 12-08B-01.
Steel and concrete remnants of a wall

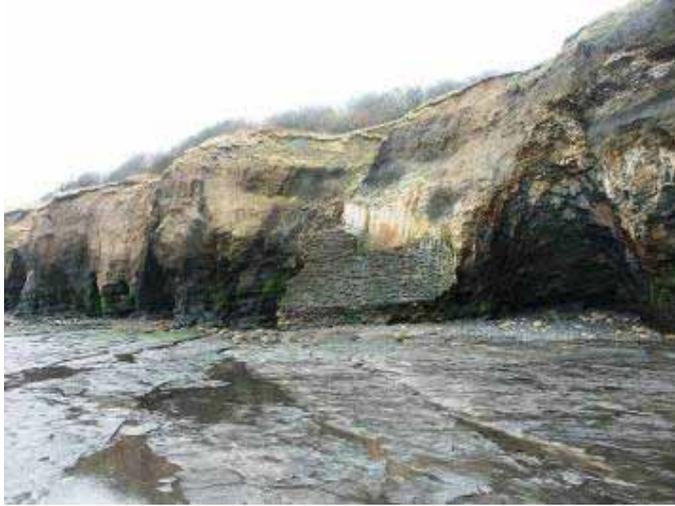
The third and fourth sections are still clearly identifiable as a masonry wall, however they have been significantly hollowed out and are undermined. The adjacent cliffs have also been subject to wave attack and several large caves and fissures have formed.

Photograph 3.41 Gouldsbrough 12-08B-01
Third remaining section of seawall

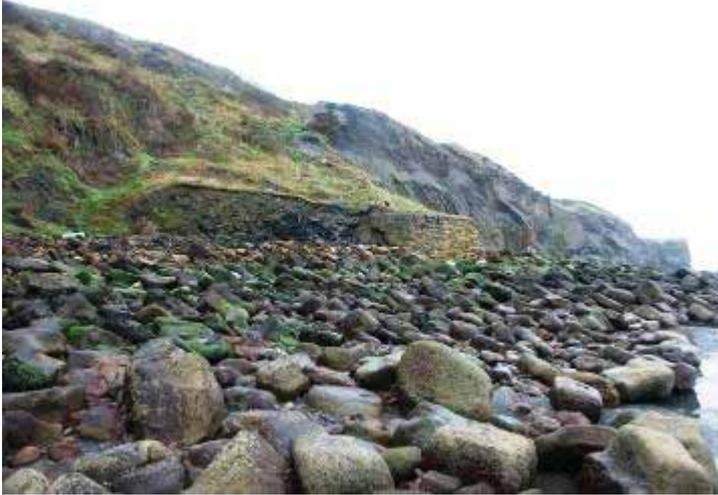
Defence ID	Residual Life		Condition		Foreshore		Repair required	Priority	Full Access
	Current	Last Insp.	Current	Last Insp.	Type	Condition			
12-08B-01	0yrs		4		Rock	Good	Yes	High	No

Photograph 3.43 Gouldsbrough 12-08B-01.
Failed seawall with rock armour

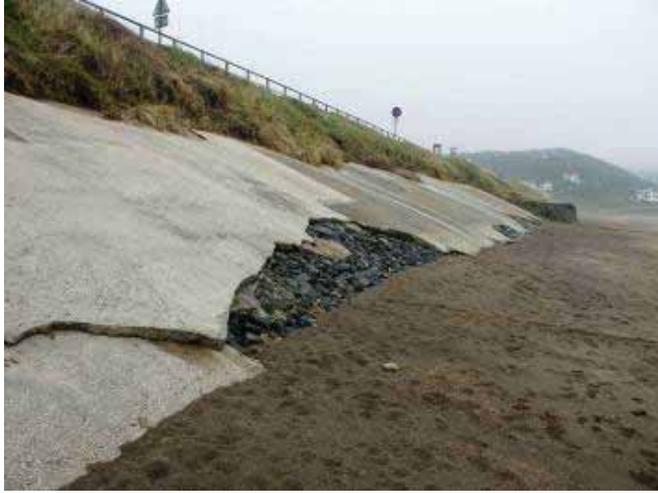
Photograph 3.45 Sandsend 17-09C-01.
Surface removed showing base material, small landslips

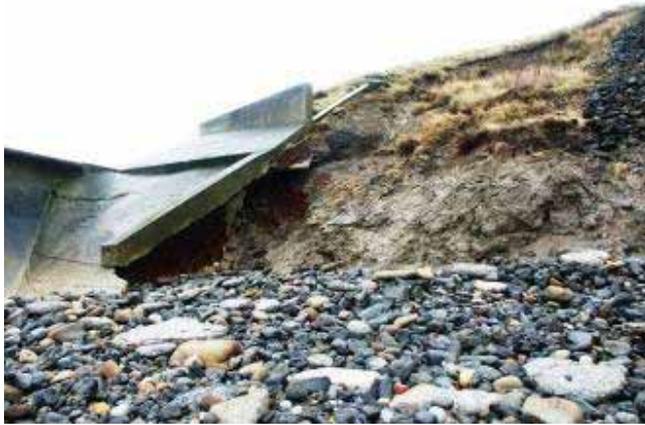
Photograph 3.49 Sandsend 13-09A-01
Undermining and **erosion** of defences

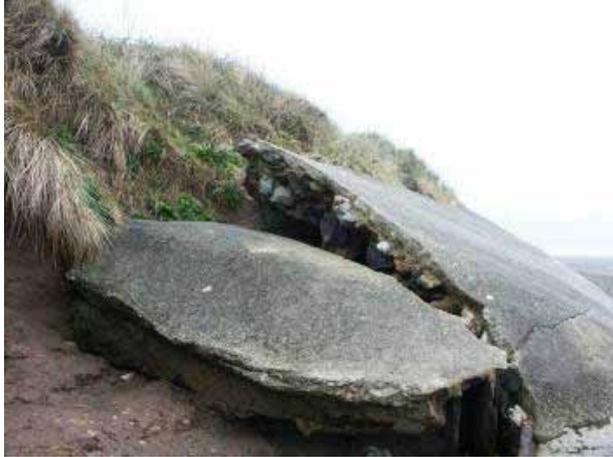
This coastal unit stretches between Whitby and Sandsend and includes Uppang Beach. Only two defences are in this unit, but both assets are in a very poor condition. The concrete apron in front of the dunes has suffered severe abrasion at the toe, with the base material being exposed and partially removed in sections. The timber and steel defences are rotten and pitted.

Photograph 3.51 Sandsend Wyke 17-10-01
Undermined and partially failed Defence

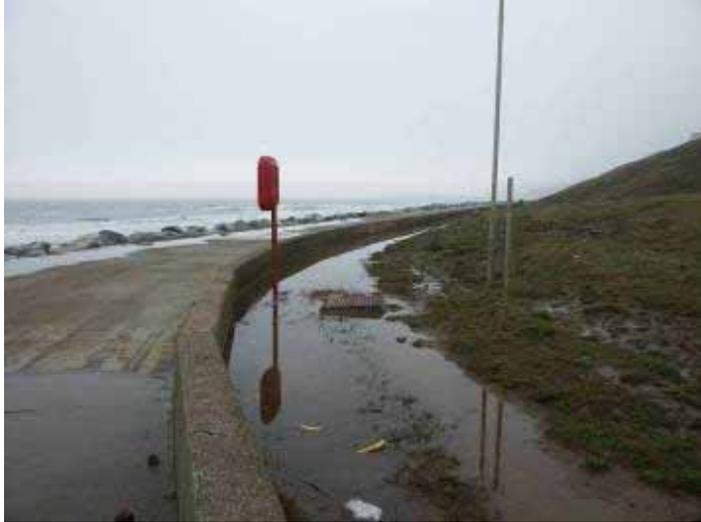
The drainage of the seawalls on the western end of the coastal unit (defence unit no 18-11A-01 to 19-11A-01) is not working properly. Water is standing behind the defences after moderate rain, with no water seeping through the drainage pipes. This may have an impact on the landward coastal slope which is locally active.

Photograph 3.53 Whitby West Cliff 18-11A-02.
Water standing behind the defence after a mild rain

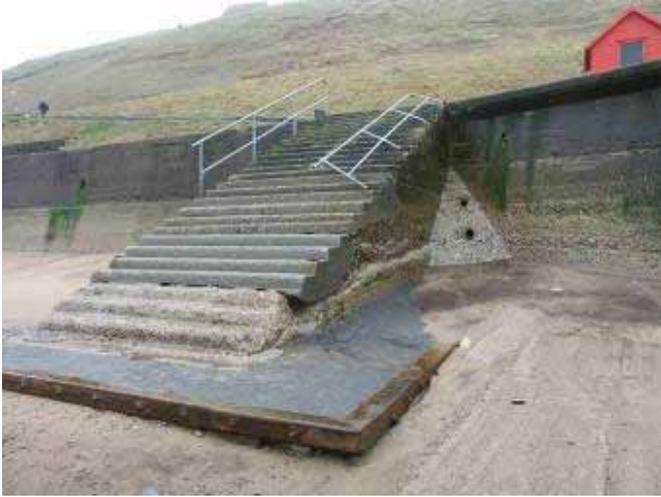
There is minor damage and some scour present at the remaining seawalls along this frontage at the western extent of the coastal unit. The minor damage encompasses mainly defects to the hand rails and coping blocks. The hand railing has become loose in places and has not been painted and is corroding. The coping blocks are cracked and damaged in places, but are overall in a good to fair condition.

Photograph 3.55 Whitby West Cliff 20-11A-01.
Loose hand railing and scour

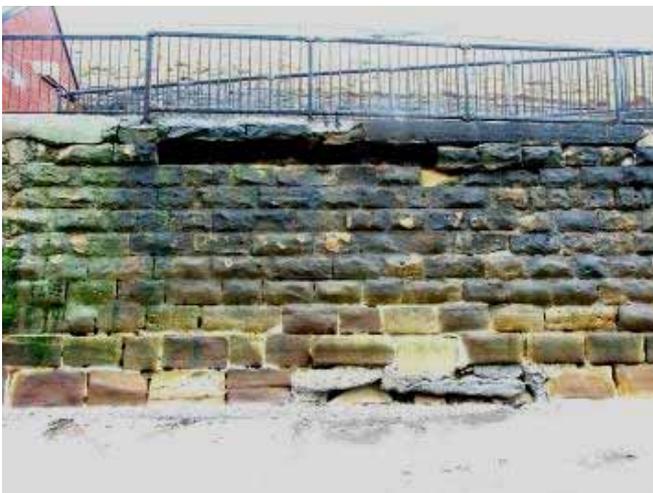
The coastal defence asset no 20-11A-02 has failed and should be repaired urgently to ensure the overall integrity of the structure. Several masonry blocks are missing below the promenade: the access to this part of the promenade has been informally blocked off.

Photograph 3.57 Whitby West Cliff 20-11A-02.
Masonry blocks are missing just below the promenade

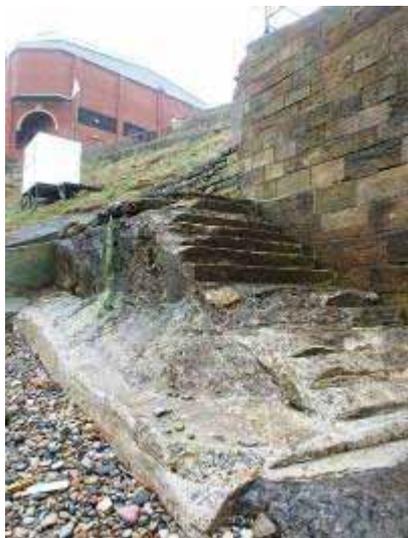
Photograph 3.59 Whitby West Pier 22-11A-02
Abraded steps

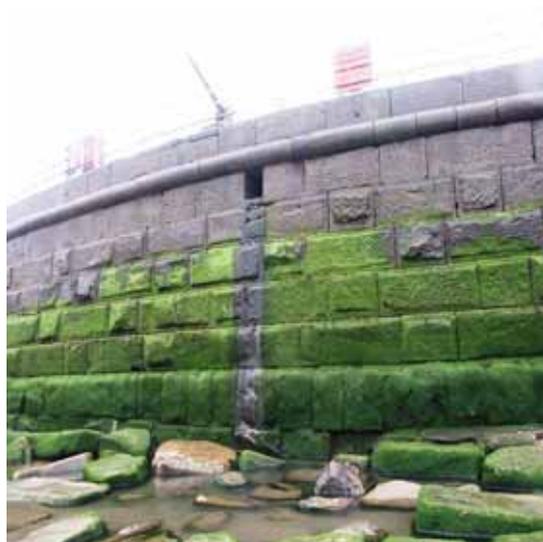
Unit 26-11B-01 has lost a masonry block just below the promenade and settlement has occurred. There is minor settlement and abrasion of the road surface.

Photograph 3.60 Whitby West Pier 26-11B-01.
Masonry blocks missing and surface settlement has occurred.

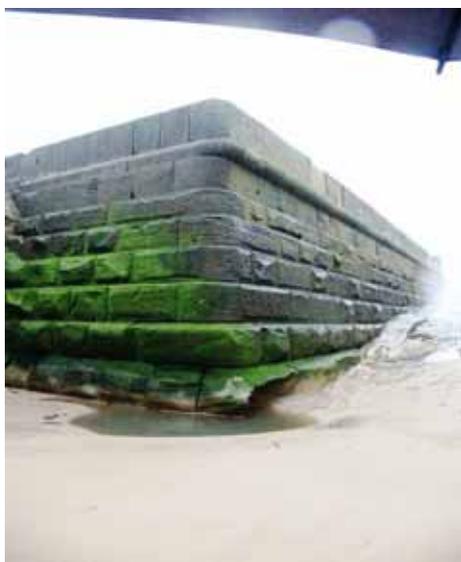
Photograph 3.61 Whitby West Pier 26-11B-02.
Scour at the base of harbour wall

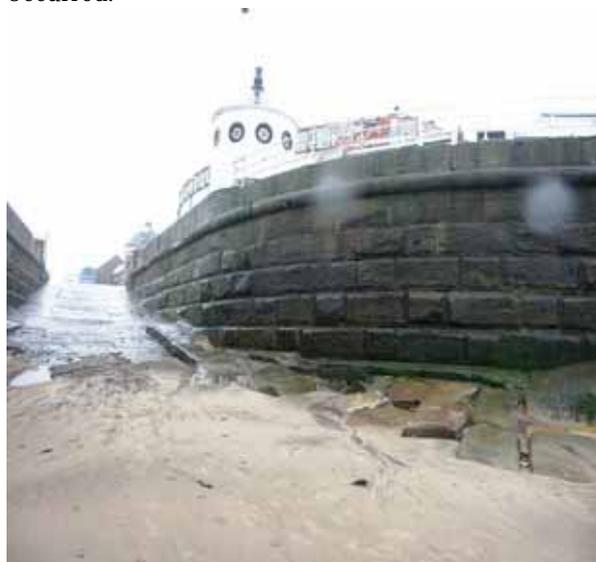
Photograph 3.62 Whitby West Pier 26-11B-02.
Uneven surface at access to walkway

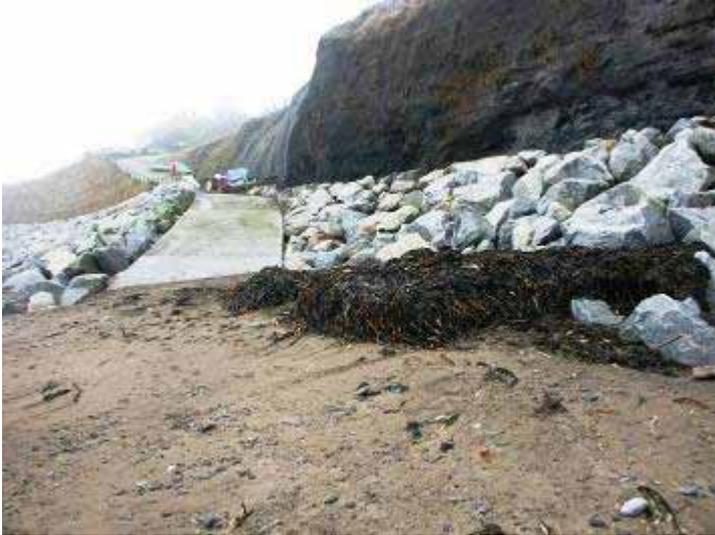
Photograph 3.64 Robin Hood's Bay (RHB) 32-16A-02.
Slipway with rocks partially covering access

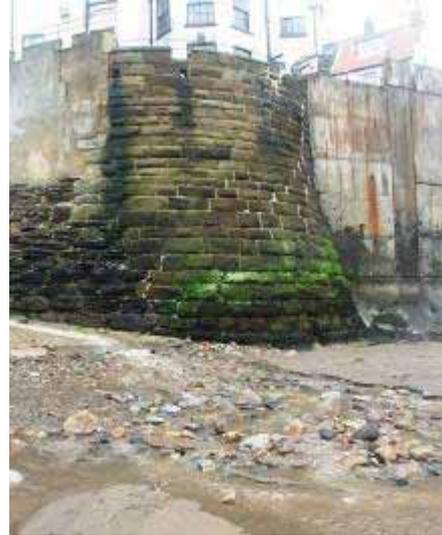
Photograph 3.65 RHB 34-16A-01.
Diagonal full height cracks

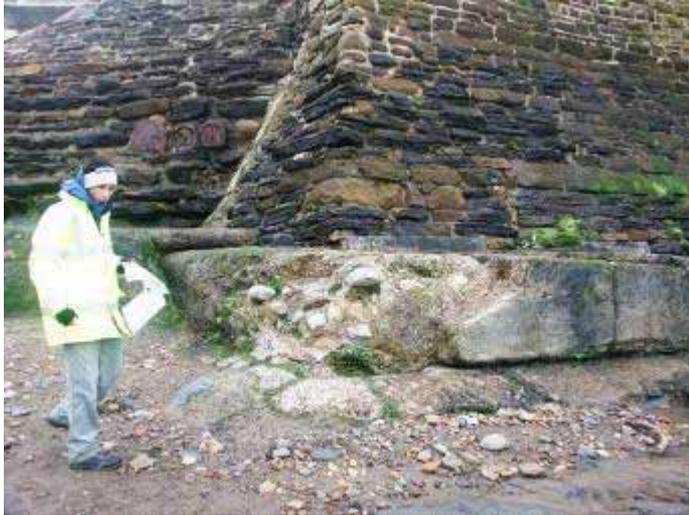
The concrete apron of asset 36-16A-01, on the other side of the slipway, is heavily abraded and should be repaired to sustain the life of the structure. It should be noted that the sea wall serves also as a foundation for a residential property.

Photograph 3.66 RHB 36-16A-01.
Heavily abraded concrete apron

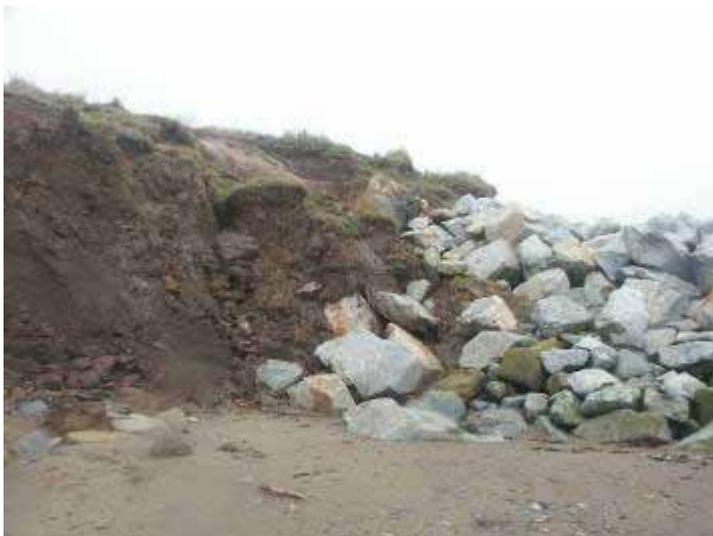
Photograph 3.67 RHB 37-16C-03.
Landslip partially covering defence asset

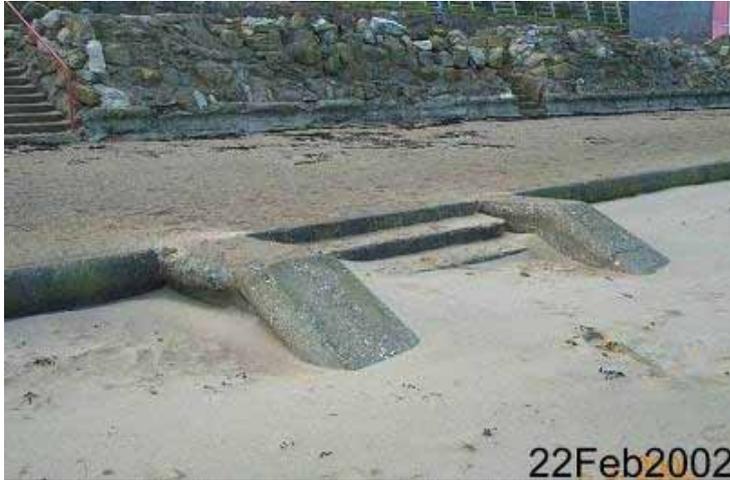
Photograph 3.68 – Scarborough North Bay (SNB) 42-20A-09. High beach levels with sand covering most of the staircase, 22 February 2002. Note elevation of sand relative to red staircase handrails in this image.

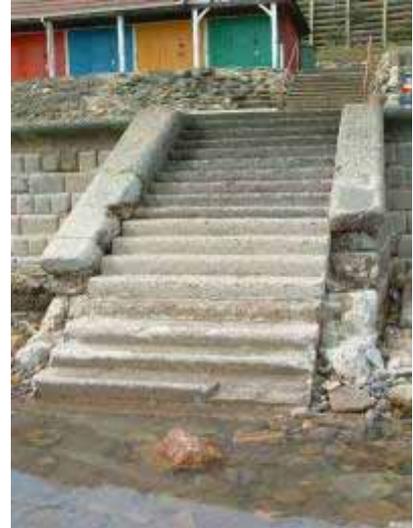
Photograph 3.69 SNB 42-20A-09. Damaged staircase with low beach levels and scouring 12 April 2005

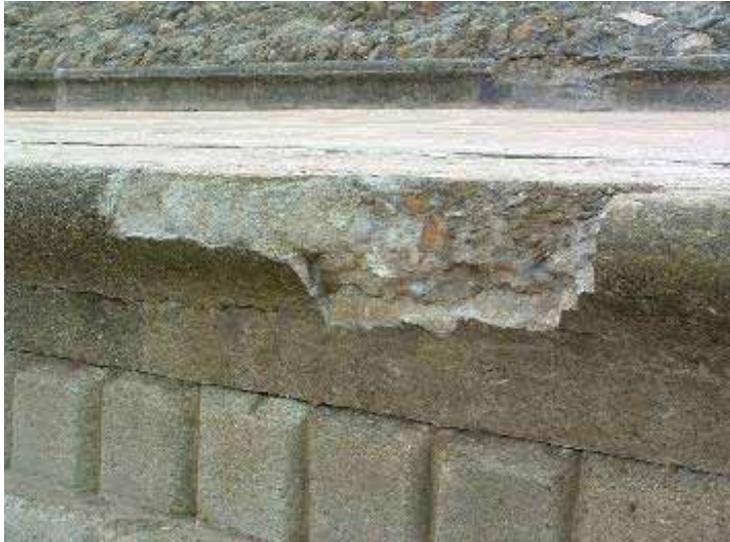
Photograph 3.70 SNB 42-20A-09. Damaged wave return wall

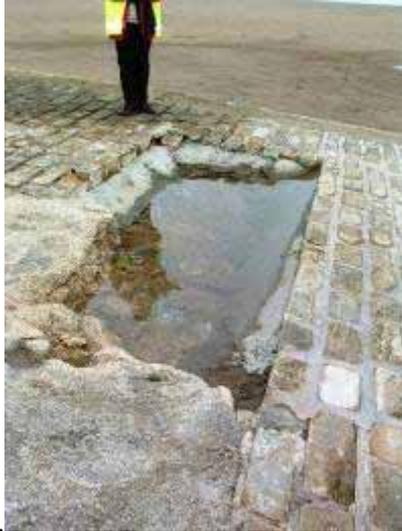
Photograph 3.74 SNB defences south of asset 44-20B-05 show some sign of wear and have suffered some damage. They require some remedial repairs

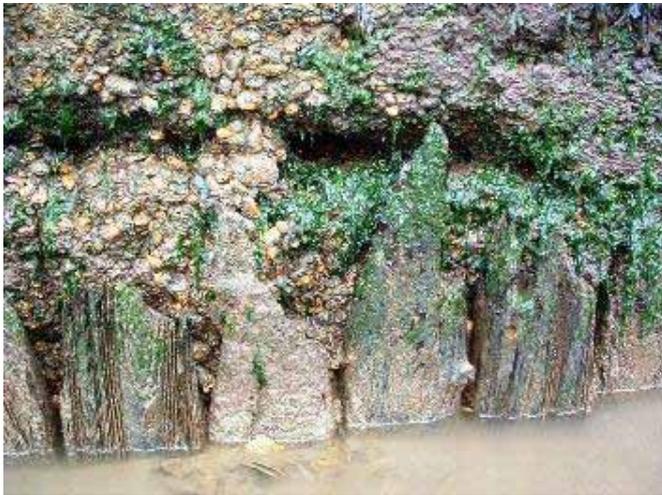
Photograph 3.76 Scarborough West Pier (SWP)
Timber toe piles and localised undermining

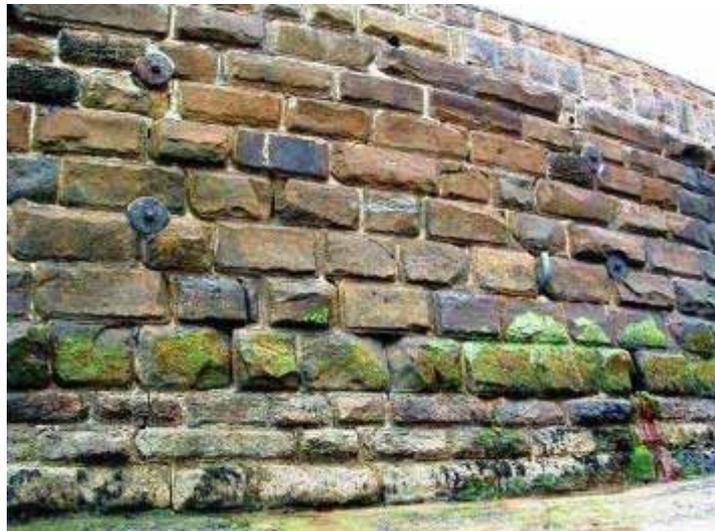
Photograph 3.81 SSB 53-22B-05.
Historical cracks and anchors

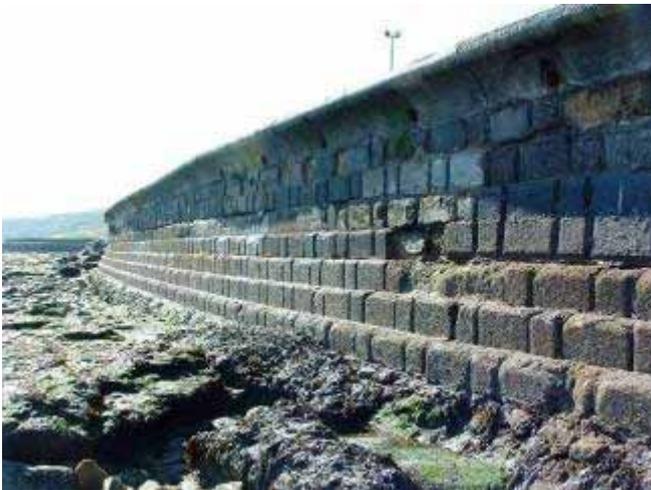
Photograph 3.82 SSB 55-22B-01.
Abraded masonry blocks

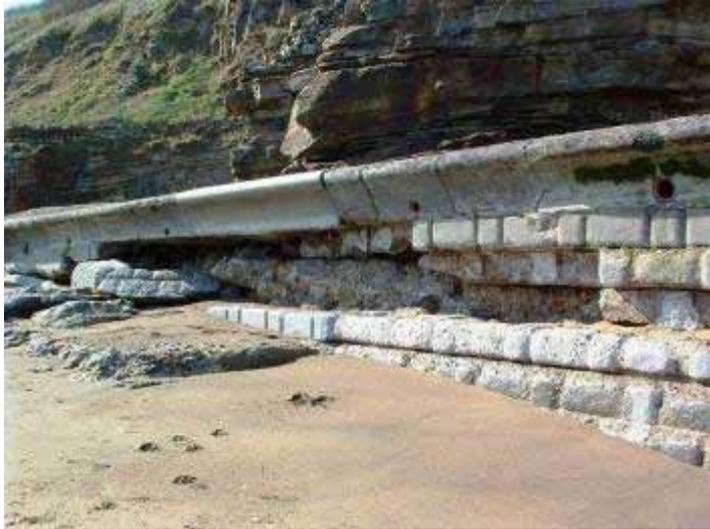
Photograph 3.84 SSB56-22B-02.
Damaged and failed defences.

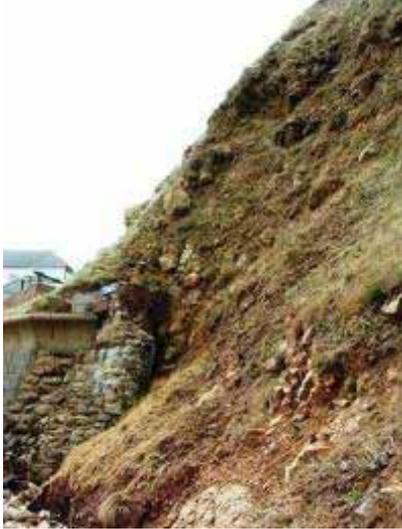
Photograph 3.85 Cayton Bay 58-24B-01. Steep coastal slope outflanking defence.

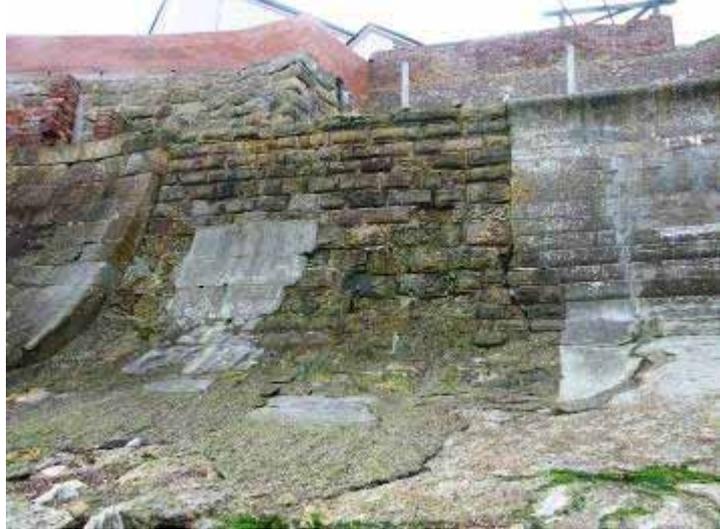
Photograph 3.86 Cayton Bay 59-24B-01. Patch repairs and interface between different wall elements

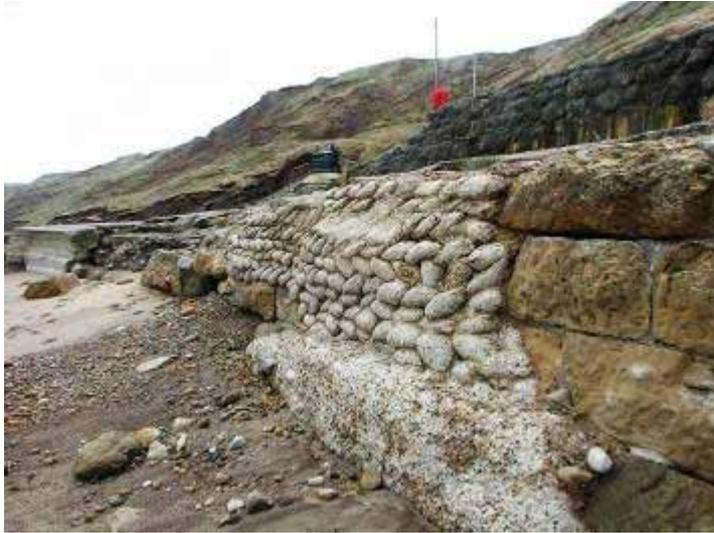
Photograph 3.87 Cayton Bay 60-24B-01.
Concrete bag-work and failed defence section.

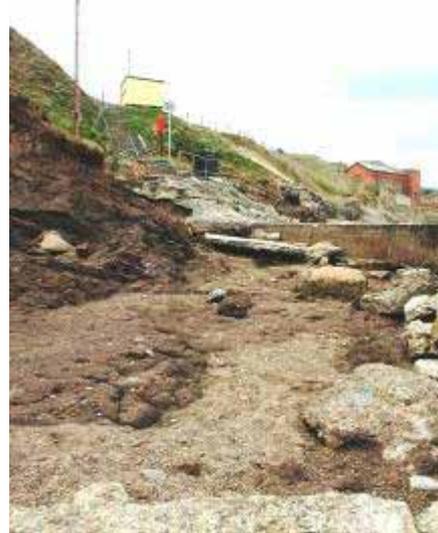
Photograph 3.88 Cayton Bay
60-24B-01. Landslip and **erosion** below
steps

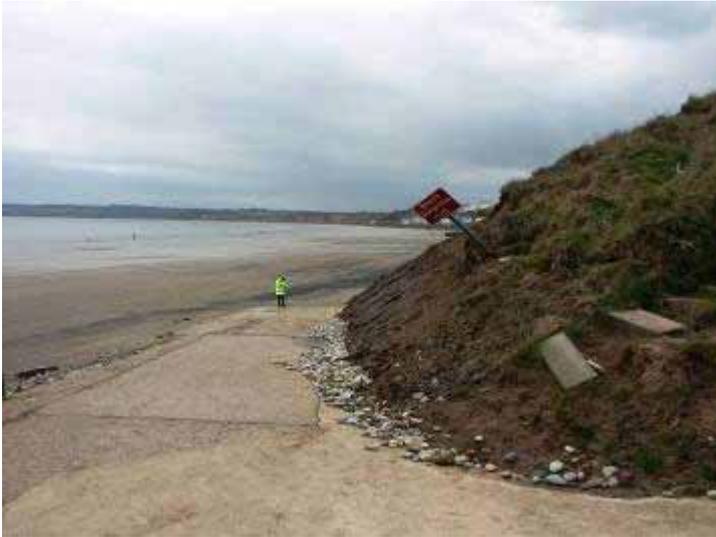
Photograph 3.89 Filey Bay 64-28A-01.
Landslide run-out lobe partially blocking the slipway

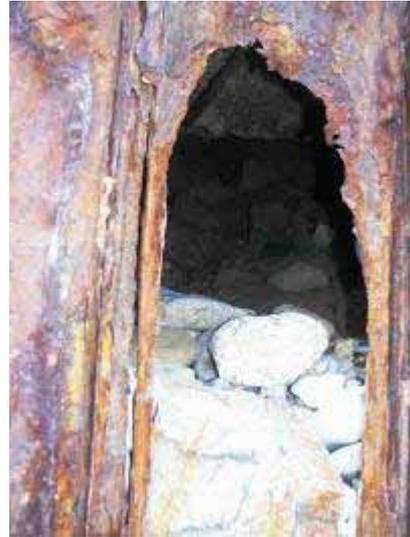
Photograph 3.90 Filey Bay 64-28A-02
Corroded sheet pile and scouring

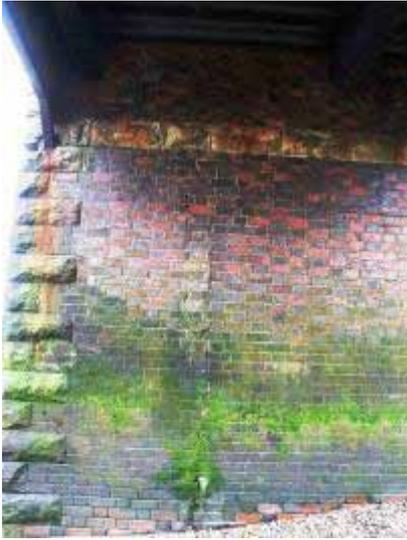
Photograph 3.91 Filey Bay 67-28B-04.
Full height vertical crack

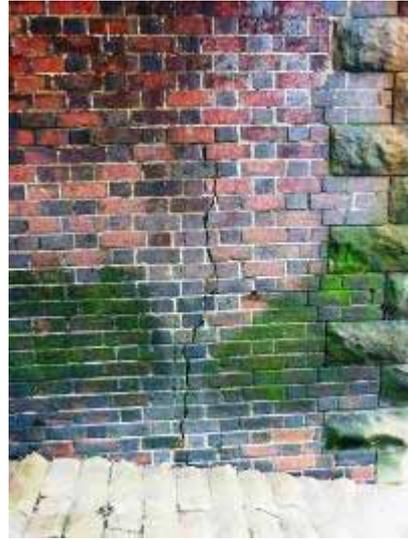
Photograph 3.92 Filey Bay 67-28B-04.
Vertical crack approx. 2m high

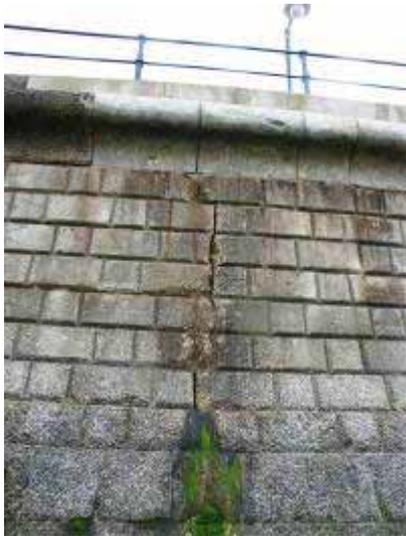
Photograph 3.93 Filey Bay 67-28B-05
Vertical full height crack

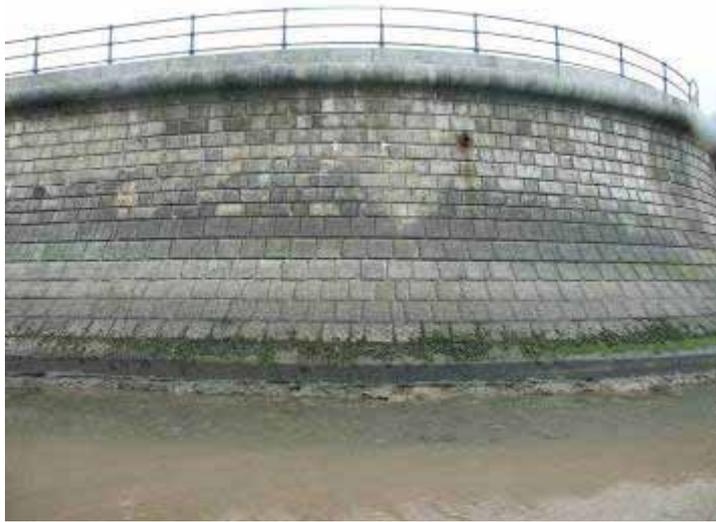
Photograph 3.94 Filey Bay 67-28B-07. Scouring at toe

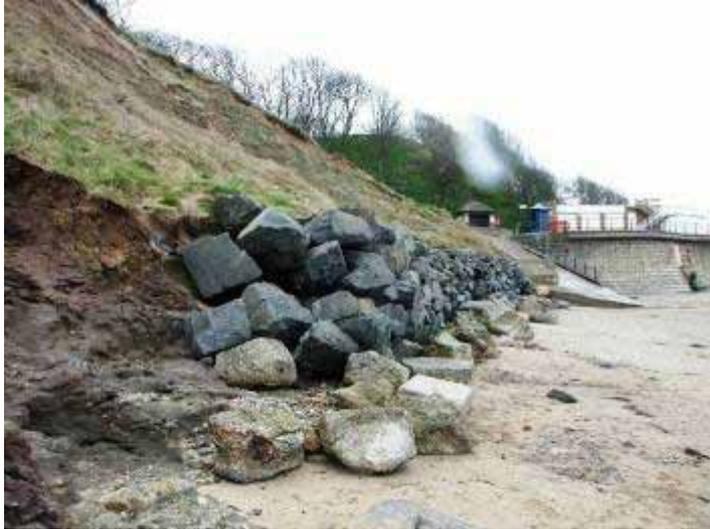
Photograph 3.95 Filey Bay 67-28B-13.
On-going coastal **erosion** and
outflanking of defences
