NECAG Coast Protection Assets and Coastal Slope Condition Analysis

**Scarborough Borough Council
Final Report**

April 2009

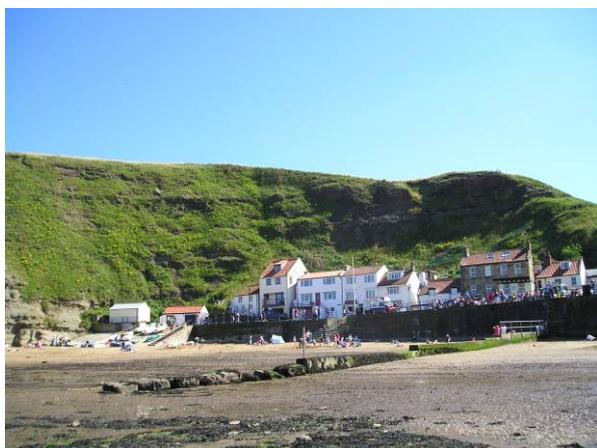
This Management Unit comprises high cliffs behind and adjacent to the village of Staithes and cliffs are generally classified as Partly Active (Mu4/1b, Mu4/3). Within Mu4/2 the cliffs are generally well vegetated and feature small, localised patches of erosion (Locally Active). Other cliffs in MU4 are free of vegetation (with the exception of the upper part of Mu4/3) and show signs of active erosion. Mu4/1a, which has toe protection, is particularly active, with evidence of recent rock fall of large blocks (Map 1).

Mu4/2 well vegetated high cliffs behind Staithes (Locally Active)

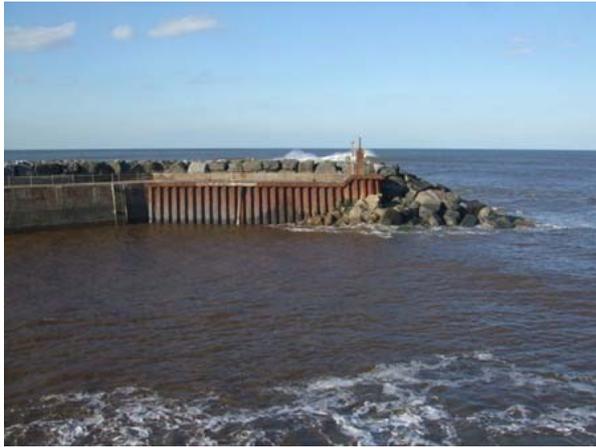
Corrosion of sheet piling on the landward side of the breakwater
(Asset Ref No.1221D901D0403C03)

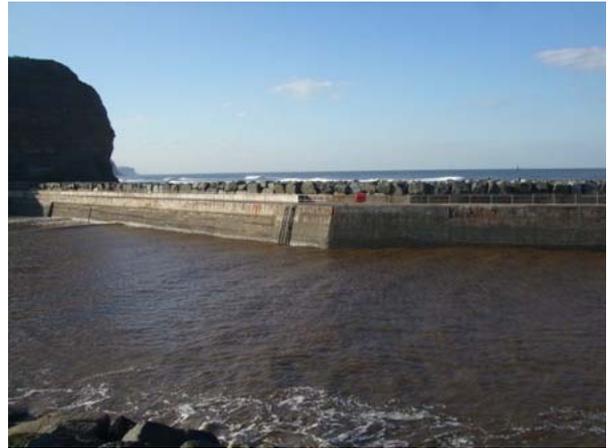
Rock armour lines the seaward side of the breakwater
(Asset Ref No.1221D901D0403C03)

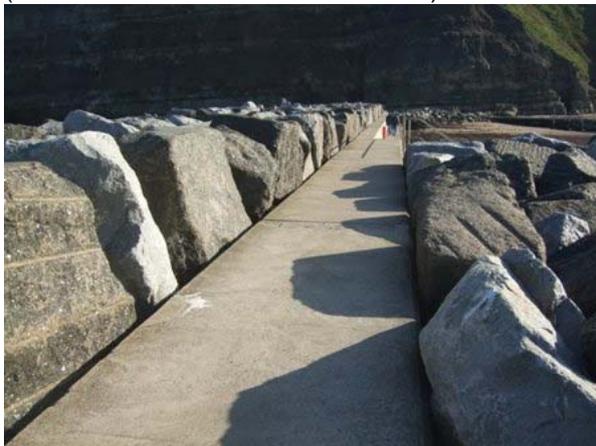
A number of the assets within the village of Staithes have recently been renewed or repaired. The most significant of these are the breakwater arms where 5-8 tonne rock armour has been placed on the seaward side and fixed using a concrete resin. This acts to provide a greater defended height and to dissipate waves from the breakwater surface. New stainless steel handrails have been added and a new concrete topping, cast over the original breakwater adds further height to the defence. The sheet piling coping piece (horizontal) on the landward side of the breakwater has failed due to corrosion at fixing points. It is recommended that this is replaced to prevent seawater intruding behind the piles. The eastern breakwater has a spur at the tip; the void of which is filled with rock armour (Asset Ref No.1221D901D0403C03).

Eastern breakwater with 5-8 tonne rock armour
(Asset Ref No.1221D901D0403C03)

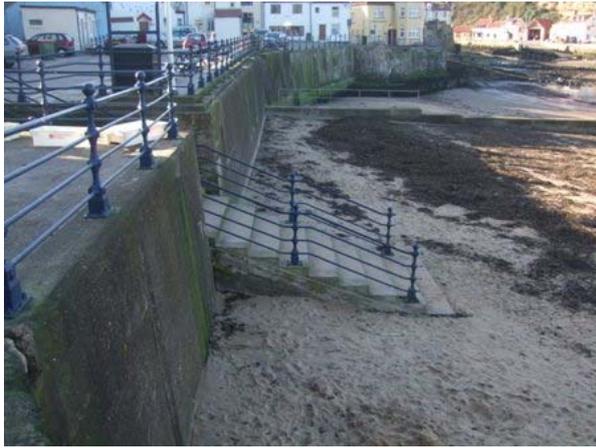
The harbour wall extends around much of the Staithe sea frontage. The rear wall of the harbour is in good condition. Minor cracking and surface erosion is present although currently it appears sustainable. A concrete groyne preventing sediment movement within the harbour is also in good condition (Asset Ref No. 1221D901D0403C01).

Rear harbour wall and concrete groynes in good condition (Asset Ref No. 1221D901D0403C01)

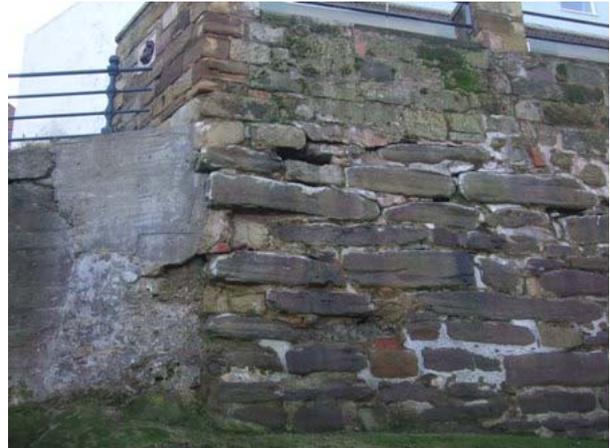
Older sections of the harbour wall consist of masonry blockwork and are often exterior walls of private properties displaying visible loss of mortar and blocks. Although there is evidence of repair work, maintenance needs to be implemented at regular intervals (Asset Ref No. 1221D901D0402C05). Should these repairs continue to fail, replacement of this asset should be considered.

Older sections of harbour wall in need of regular maintenance (Asset Ref No. 1221D901D0402C05)

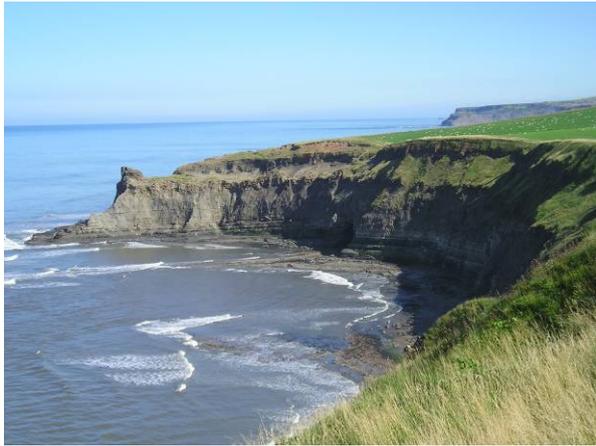
Jet Wyke forms the embayment between Penny Steel and Old Nab and is classified as Partly Active (Mu5/1). The lower slopes of the cliff are very steep, unvegetated and subject to gradual marine erosion. The upper cliff is composed of softer material and supports some vegetation cover. At the eastern extent of the unit is Old Nab, a Partly Active headland composed of highly weathered shales.

MU5 overview of Jet Wyke looking east (Partly Active)

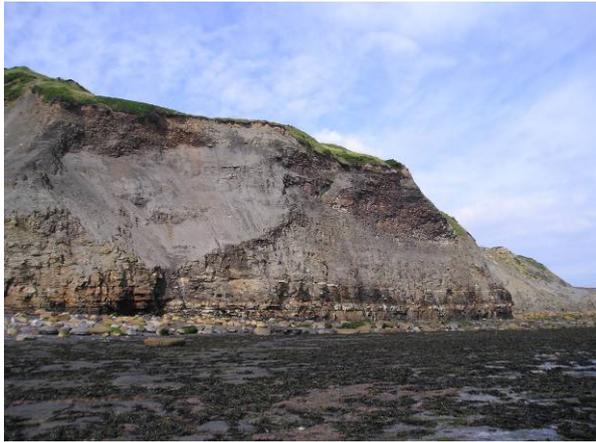
The undefended cliffs to the north of Port Mulgrave show signs of recent activity and are classified as Partly Active (Mu6/2). There is evidence of recent failures and erosion of the cliffs. Further south, the CBUs are Locally Active, with large areas covered by dense vegetation and some areas of activity (Mu6/3, Mu6/4, Mu6/5).

Mu6/2 cliffs north of Port Mulgrave (Partly Active)

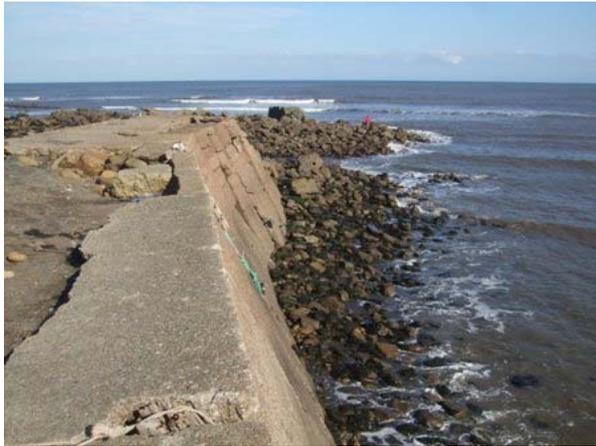
Sub-Management Unit 6B features relict assets at Port Mulgrave. This is a former port and ironstone mine which has been derelict for 70 years. Virtually all coastal defences have been lost to the sea. What is left of the breakwater is undergoing large scale cracking, deformation, undercutting and outflanking. It is estimated that half of its original length has now been eroded (Asset Ref No. 1221D901D0502C01). As a result, the launching and retrieval of boats would be difficult here. If regular access by sea was required, a regeneration project to remove the breakwater ruins and build a new access point would be of benefit.

Looking along the breakwater with evidence of surface erosion (due to deformation) (Asset Ref No. 1221D901D0502C01)

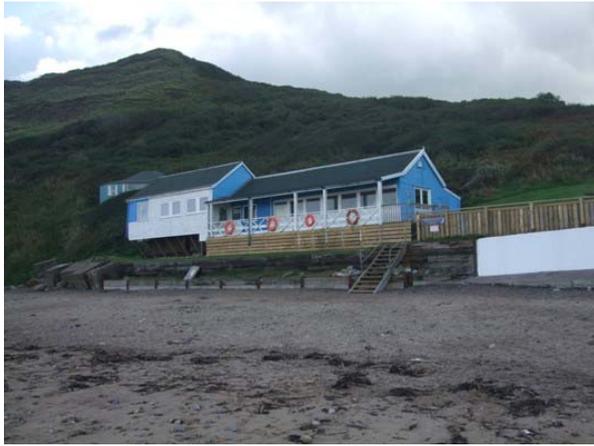
Runswick Bay has recently undergone the installation of new coastal defences inline with the building of a new pumping station (adjacent to the lifeboat station). Rock armour defences are tightly packed with extremely sound coverage. They are in very good condition with no evidence of deformation or settling. Near Runswick Sailing Club there is a new concrete slipway and revetment. These are also both in a very good condition displaying few defects (Asset Ref No. 1221D901D0602C01). The Sailing Club itself, located just south of the village, has been constructed on timber struts and features a mix of coastal defences (Asset Ref No. 1221D901D0602C03).

Runswick Sailing Club built on timber struts
(Asset Ref No. 1221D901D0602C03)

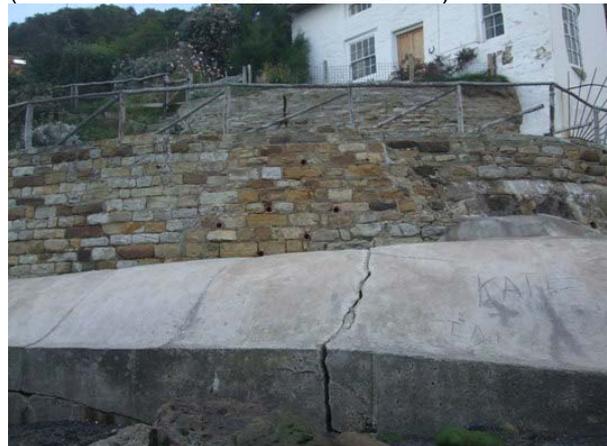
Beneath some properties, two significant cracks can be seen propagating from the toe right up through the tiered sea walls behind. Cracking in the toe, which has been recently rendered indicates that the deformation is active. Installation of a tell tale would give precise levels of ground movement. Further studies are required (Asset Ref No. 1221D901D0601C06).

Two significant cracks propagating up through the tiered sea walls indicates active deformation
(Asset Ref No. 1221D901D0601C06)

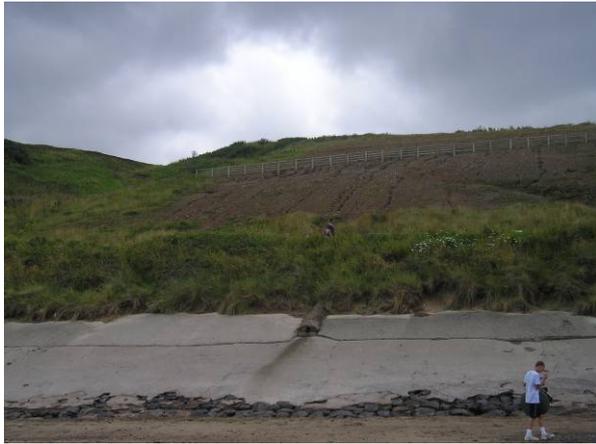
Above the concrete sea defences the slopes of this unit are Partly Active (Mu9/3). There has been some effort to stabilise the slopes; however the presence of tension cracks and rilling and gullying in exposed materials provides evidence of ongoing instability.

Mu9/3 looking up from Sandsend Beach (Partly Active)

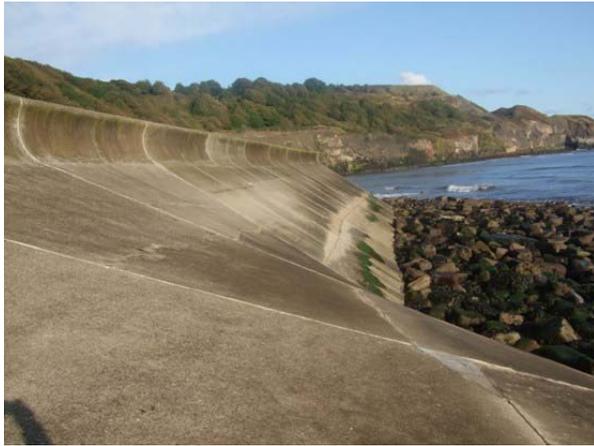
Coastal defences at Sandsend are in fair to poor condition. A concrete revetment, the most northerly defence, is in fair condition with minimal damage to the surface. There is some minor cracking, surface erosion and joint washout occurring which is typical of concrete defences such as this. The toe of the revetment is exposed in places resulting in undercutting. This could be ameliorated by increasing the basal rock armour protection (Asset Ref No.1221D901D0701C02).

Concrete revetment located in the north of Sandsend (Asset Ref No.1221D901D0701C02)

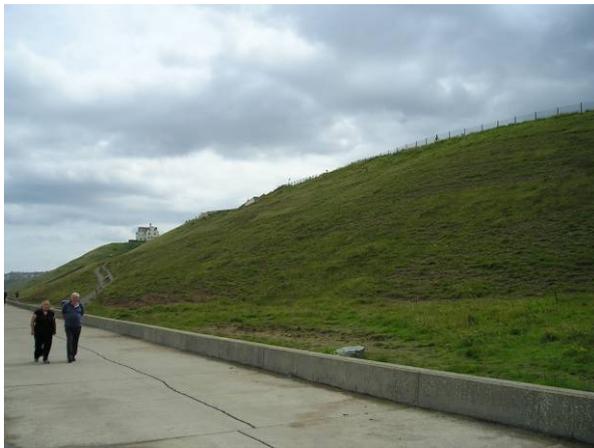
This Sub-Management Unit mostly consists of regraded slopes which are largely protected by the sea wall and promenade. As a result there is very little evidence of activity and slopes are classified as Inactive (Mu11/1). In some areas, slope wash and footpath erosion has caused localised disintegration of the underlying slope stabilisation fabrics.

Mu11/1 looking east (Inactive)

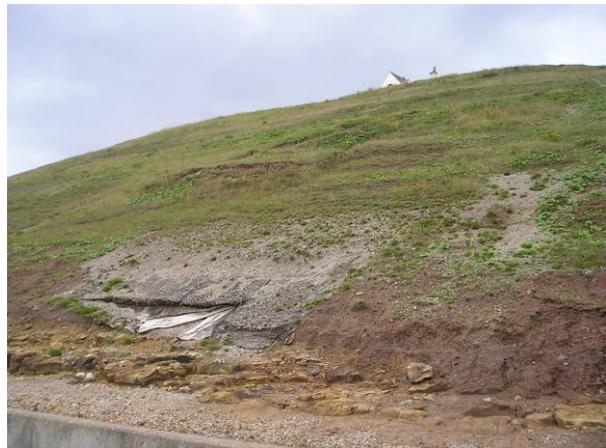
Mu11/1 degradation of slope and underlying slope stabilisation fabrics by slope wash (Inactive)

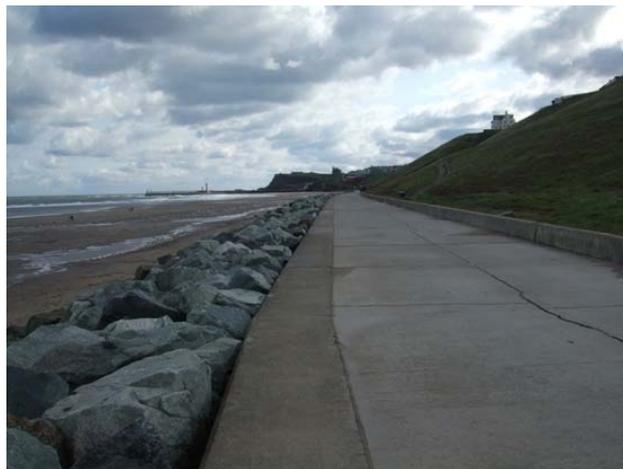
Rock armour defences along the promenade to the west of Whitby are in very good condition. The promenade and low concrete retaining wall are in good condition although lateral cracking in the promenade is evident in places along with loss of expandable sealant between concrete sections (Asset Ref No. 1221D901D0801C01).

Rock armour along the promenade, west of Whitby (Asset Ref No. 1221D901D0801C01)

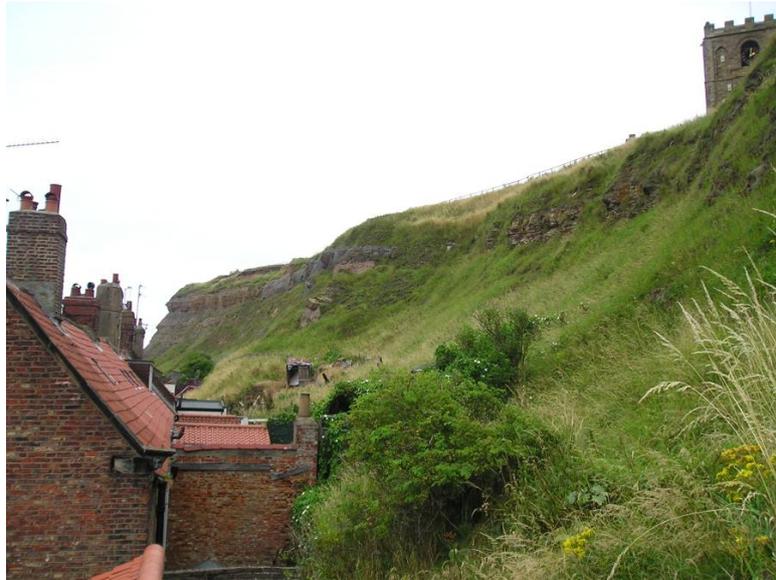
This Management Unit is below Whitby Abbey and is classified as Locally Active (Mu12/1). The slopes are generally well vegetated, with some exposure of rock just below the headscarp which is supported by wire netting.

Mu12/1 below Whitby Abbey, showing degraded cliffs and localised wire netting (Locally Active)

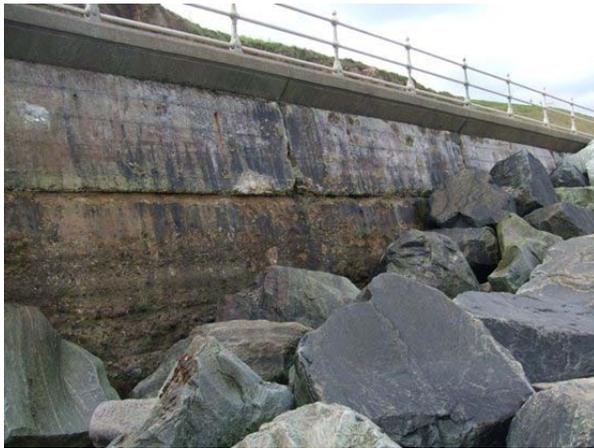
Cracking, loss of mortar and expansion sealant and surface erosion are common to virtually all concrete and blockwork structures, including the west and east harbour arms (where visible) and the adjacent sea wall. Although defects are localised, it is recommended that repointing is undertaken to prevent areas of weakness being exploited further. Sections of sea wall not protected by rock armour revetment are particularly susceptible to increased levels of surface erosion and exploitation of joints between concrete sections (Asset Ref No. 1221D901D0802C03 and 1221D901D0802C07).

Erosion and exploitation of joints in sea wall (Asset Ref No. 1221D901D0802C03)

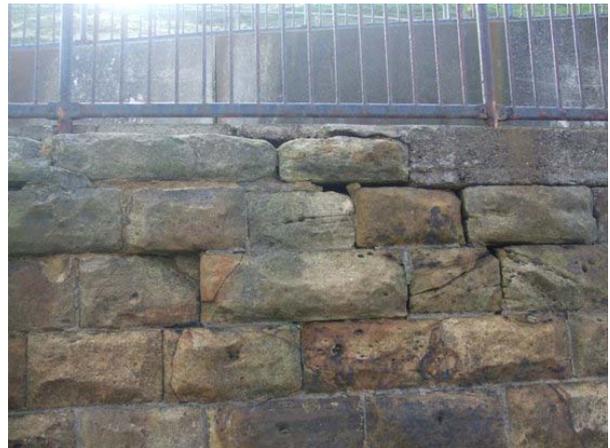
Mortar loss, surface erosion and cracking in blockwork wall (Asset Ref No. 1221D901D0802C07)

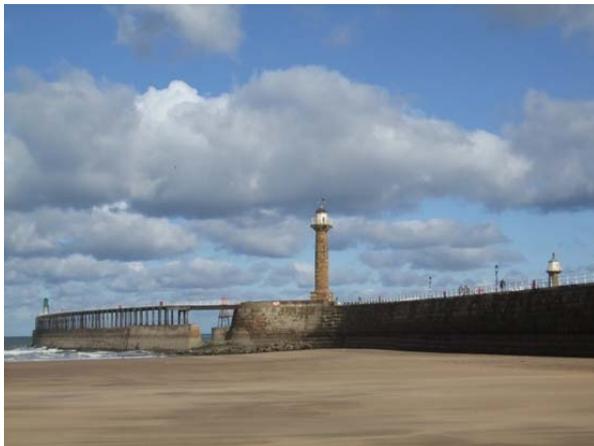
Harbour walls are still partly submerged during low tide preventing a detailed inspection on foot (Asset Ref No. 1221D901D0803C01)

The west and east harbour arms (Asset Ref No. 1221D901D0803C01/04) were not inspected thoroughly due to limited access even at low tide. It is recommended that inspection via boat is the only option here. The left bank harbour wall (Asset Ref No. 1221D901D0803C01) would also need to be inspected via a boat. Both cases would need to involve the harbour master due to commercial boat activity in the near vicinity. The eastern harbour arm (Asset Ref No. 1221D901D0803C04) shows mortar loss, loose blocks and possible vertical movement in one location. It is recommended that the fixity of the loose blocks is investigated urgently, and that subsequently the hole is filled. It is possible that this block could disappear and that there may be a significant quantity of wash-out material behind it, leading to the consequent weakening and collapse of the structure. In the longer term, the monitoring of movement of this structure is recommended, along with establishing the reason for movement if there is any.

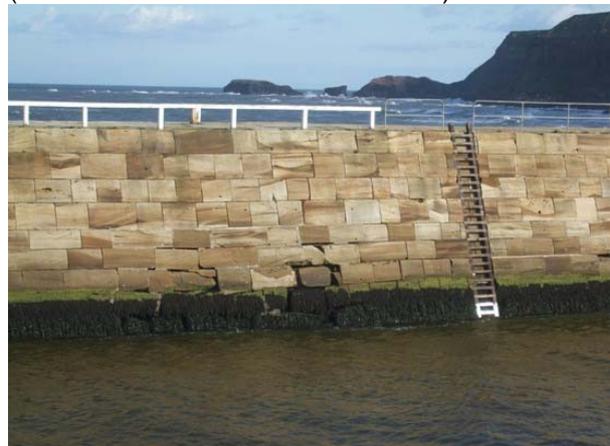
Of particular concern is the potential for significant 'blow-out' of the eastern harbour arm at Whitby and the lower blockwork of the Cayton pumping station. In both cases mortar loss has led to the loosening and washout of blocks. Investigation of the problem and urgent repair is required.

Eastern harbour arm showing mortar loss and deformation of blockwork (inspection below the water line is necessary before replacement of blocks) (Asset Ref No. 1221D901D0803C04)

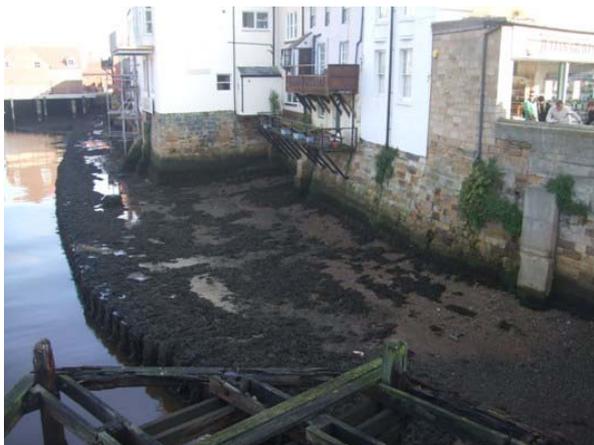
Large concrete aprons are offering protection to the toe and rear walls on private property and are acting as the right bank harbour wall. Although the walls are in a sound condition, it is recommended that constant monitoring is required to maintain a good condition. Vegetation build up is common although currently does not seem to be posing a problem (Asset Ref No. 1222101600101R02).

Concrete apron protecting toe and rear walls of private property (Asset Ref No. 1222101600101R02)

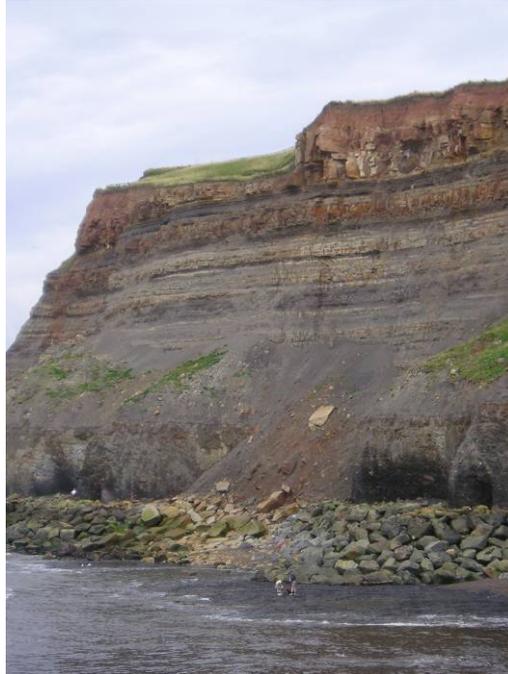
The high cliffs of this Sub-Management Unit are Partly Active (Mu12/2). There is evidence of a large recent rock fall from the upper part of the cliff. Almost the entire cliff face is exposed with very little vegetation cover.

Mu12/2 looking east from Whitby's East Pier showing recent failure from the cliff top (Partly Active)

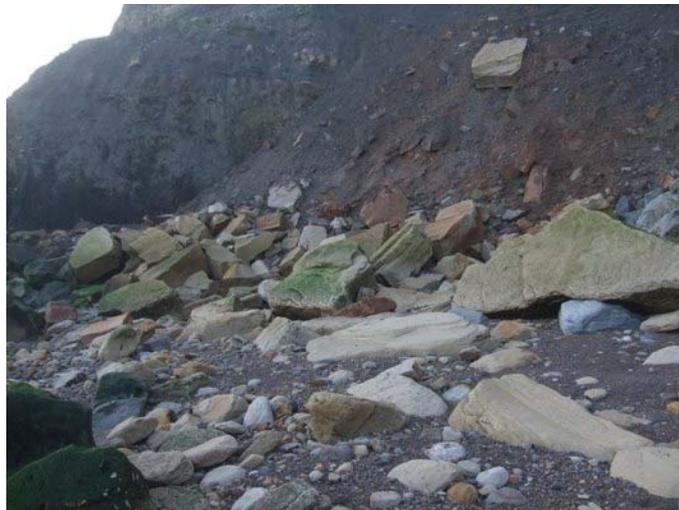
There is a section of rock armour protecting the eastern side of the harbour and toe of natural cliff directly to the east of Whitby. The rock armour varies in size from 1-4 tonnes to 5-8 tonnes. Recent rockfall in this area, identified by the Coastal Slope Condition Assessment, highlights the need for either replenishment with larger rock armour or a larger scale repair (Asset Ref No.1221D901D0803C05).

Close up of the base of recent rockfall over rock armour defences
(Asset Ref No.1221D901D0803C05)

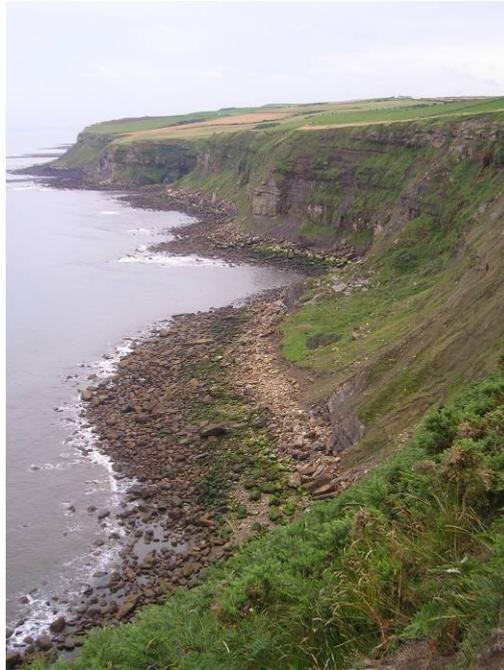
The cliffs within this Management Unit have been classified as Locally Active (Mu14/1). The slopes are generally well vegetated, with small local patches of erosion evident. Parts of the lower cliff are mantled by vegetated debris and the cliff toe is characterised by extensive boulder lobes.

Mu14/1 looking southeast, showing vegetated debris aprons and boulder lobes (Locally Active)

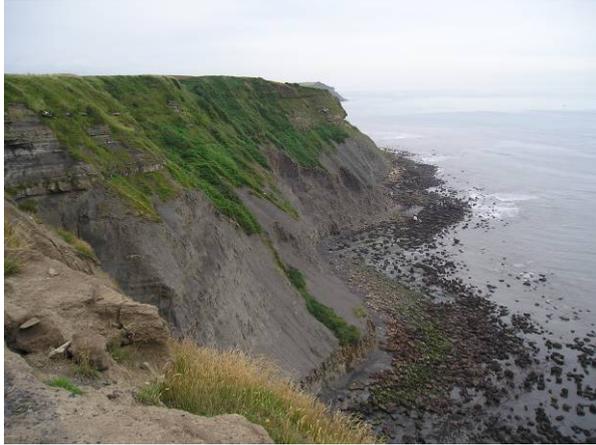
The northern part of this Management Unit is Locally Active (Mu15/1). The upper slopes are well vegetated with intermittent areas of activity. The lower slopes are largely devoid of vegetation cover, with abundant evidence for activity. The mid part of this Management Unit is Totally Active (Far Jetticks- Mu15/2). The cliff face is steep and exposed with materials slumping and sliding down the entire length. Further south, the CBUs are classified as Partly Active (Mu15/3, Mu15/4). The upper slopes support some continuous vegetation cover. The lower slopes are steep and exposed with erosion of materials through sliding and rock fall.

Mu15/1 looking northwest (Locally Active)

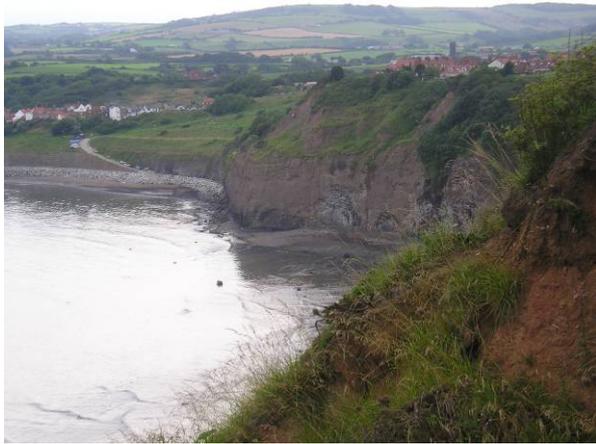
The northerly part of this Sub-Management Unit is Partly Active (Mu16/1). The upper slopes are composed of soft material and support some vegetation cover with evidence of slumping and sliding in places. The lower slopes are near vertical with no vegetation cover and are stained by the material eroded from the upper slopes. Sliding and marine undercutting is also occurring. Further south, the CBUs are protected by sea defences and show no evidence of recent activity (Dormant- Mu16/2, Mu16/3).

Mu16/1 looking towards Robin Hood's Bay
(Partly Active)

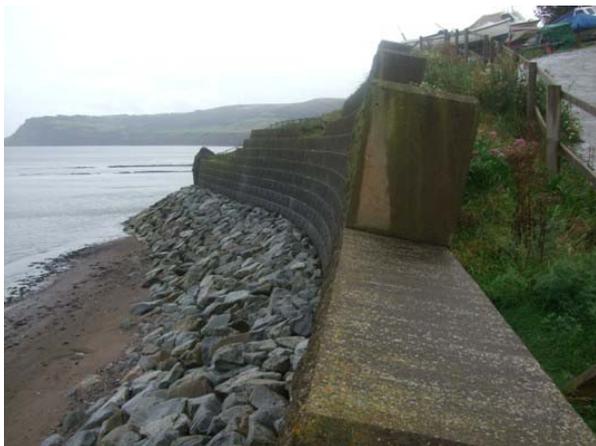
Sea wall at the northern end of Mu16A (Asset Ref No. 1221D901D1003C01)

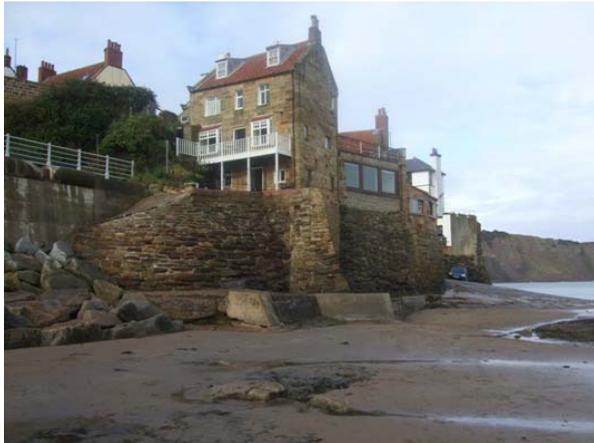
Looking northwards at the short section of defence in the south of Robin Hood's Bay village (Asset Ref No. 1221D901D1003C04)

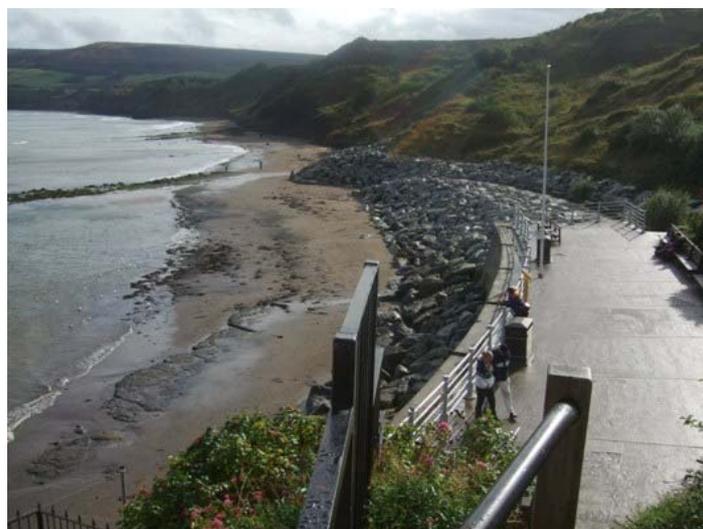
The rock armour described for Mu16B extends southwards into this Sub-Management Unit. There is also a section of newly installed rock armour which is in very good condition, is tightly packed and performing well (Asset Ref No. 1221D901D1003C07). Vegetation is present on the defences in localised spots, however it is anticipated that this will die away in the winter months. As described in the Coastal Slope Condition Assessment, there is noticeably greater erosion of the natural cliffs where the rock revetment finishes to the south.

Looking southwards across the promenade and newly installed rock armour (Asset Ref No. 1221D901D1003C07)

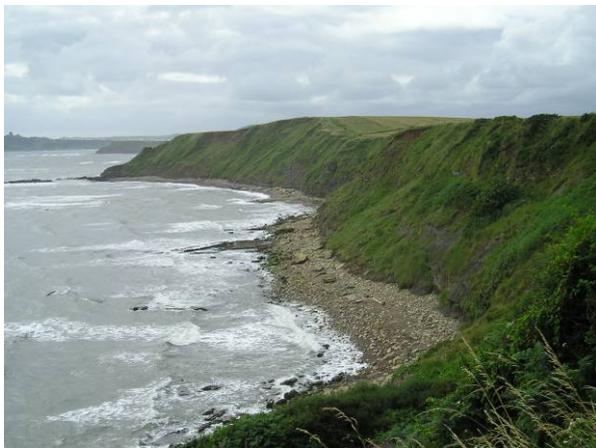
The northern part of this Sub-Management Unit is Locally Active (Mu19/6, Mu19/7, Mu19/8). The cliffs are generally well vegetated, with boulder deposits at the base of the cliff, and with minor activity evident at the toe and locally at the head. At the southern part of this MU, the toe is subject to marine action and is slumped in places. The headscarp is steep and exposed over much of the section. Mid-slope there are tension cracks, slumping, sliding and gliding blocks (Partly Active- Mu19/9, 19/10). The Scalby Ness CBU, which extends up Scalby Beck is well vegetated with occasional activity from base to top of the cliff, and is classified as Locally Active (Mu19/11).

Mu19/8 looking south (Locally Active)

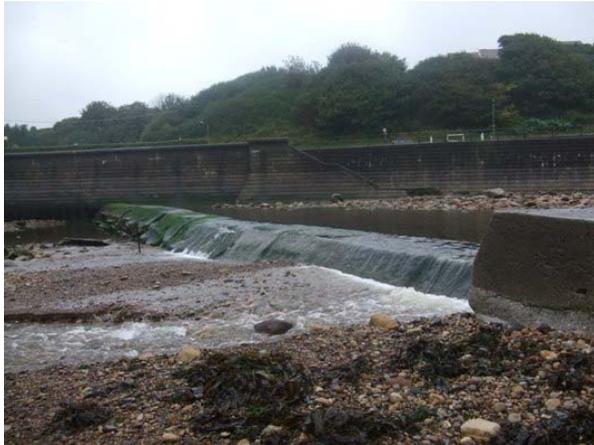
Service pipe running across the mouth of Scalby Beck (Asset Ref No. 1221D901D1201C09)

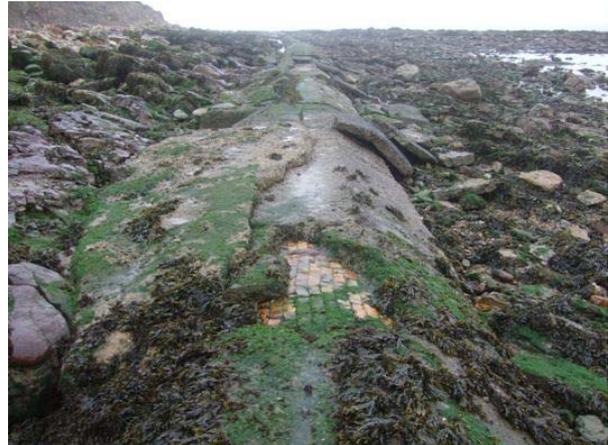
Close up of pipe at low tide showing damage to concrete surround and exposure of inner brickwork pipe (Asset Ref No. 1221D901D1201C09)

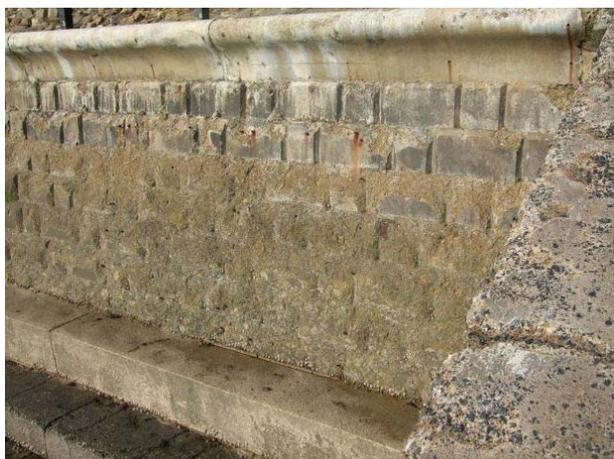
Exposed rebar and missing joints along sea wall (Asset Ref No. 1221D901D1201C03)

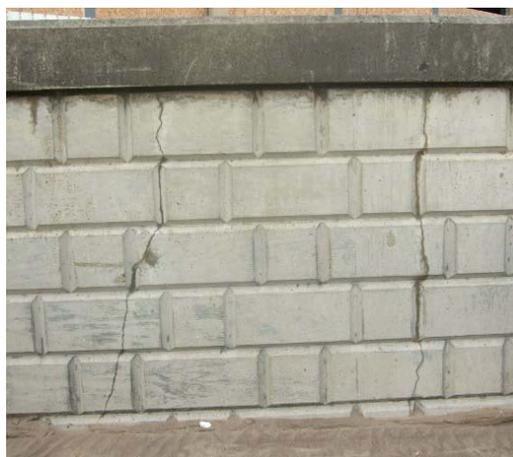
There are a number of large full height cracks in sea walls throughout the Scarborough Borough Council frontage, particularly in Scarborough's North and South Bays and in Filey. Investigation of the problem and subsequent remedial works are required.

Large vertical cracks running the full height of the sea wall (Asset Ref No. 1221D901D1201C06)

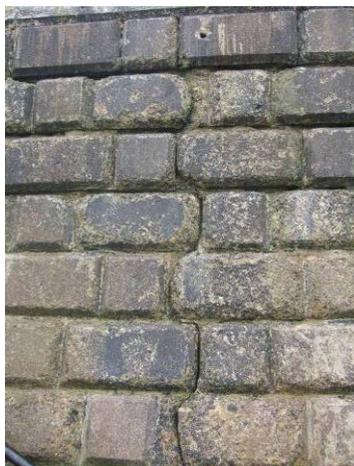
Joint cracking and loss of material from the sea wall (Asset Ref No. 1221D901D1201C07)

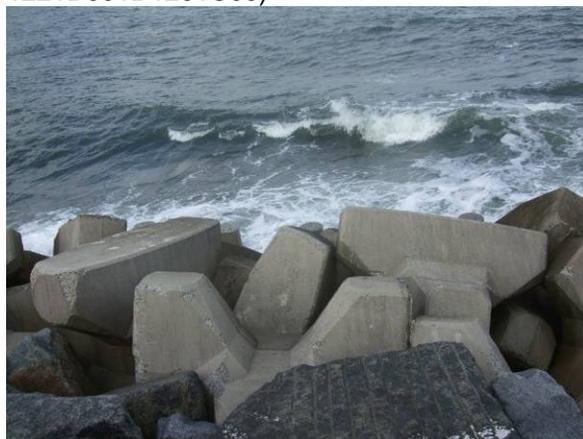
Rock armour and tetrapods around the southern end of North Bay (Asset Ref No's. 1221D901D1202C01 and 1221D901D1202C02 respectively)

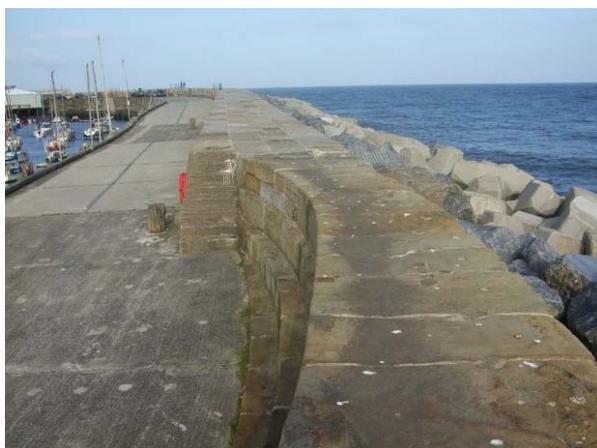
The new harbour wall with rock armour, tetrapods and raised section (Asset Ref No. 1221D901D1301C01)

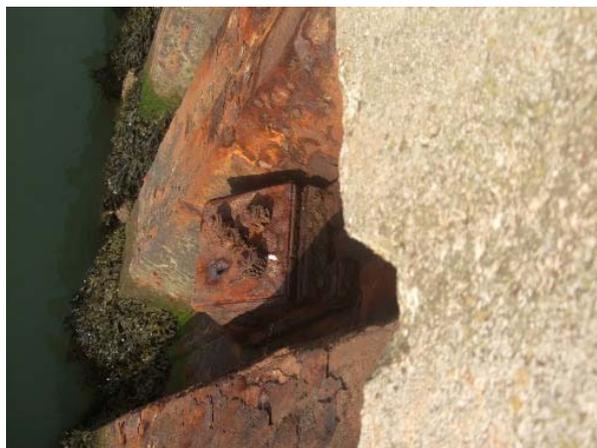
Significant corrosion of steel piling (Asset Ref No. 1221D901D1301C17)

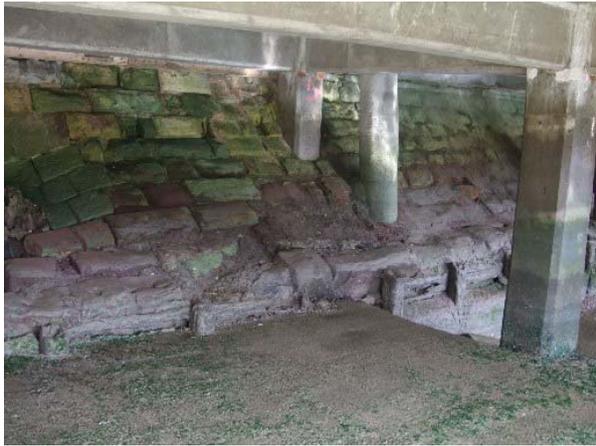
The original quay wall beneath the newer concrete jetty (Asset Ref No. 1221D901D1301C06)

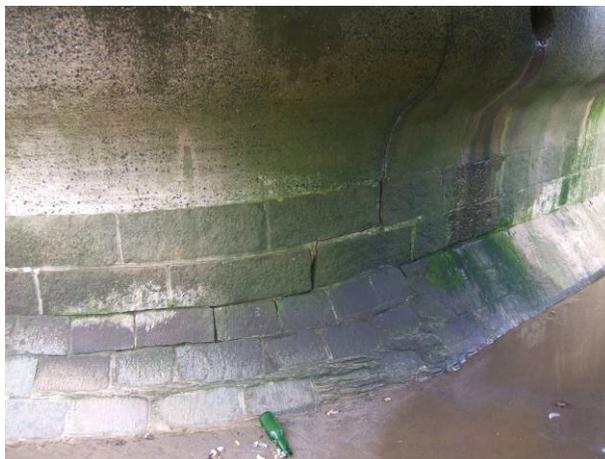
Cracking in the sea wall and footing of the Lifeboat Station (Asset Ref No. 1221D901D1301C08)

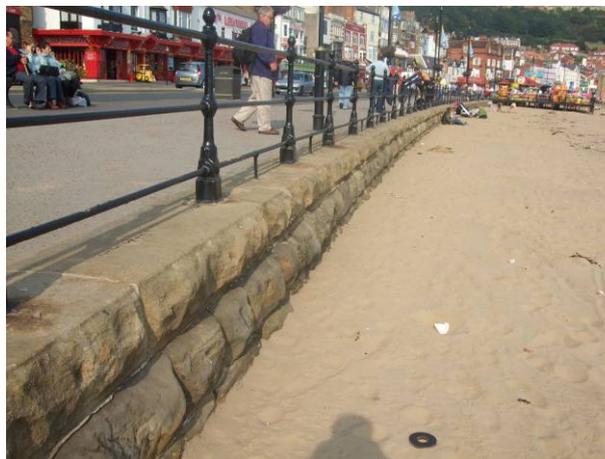
Sea wall running in front of Foreshore Road, South Bay (Asset Ref No. 1221D901D1301C15)

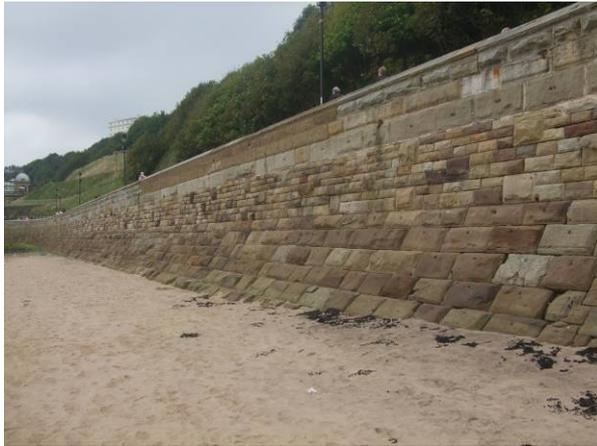
Recurved sea wall (Asset Ref No. 1221D901D1301C10)

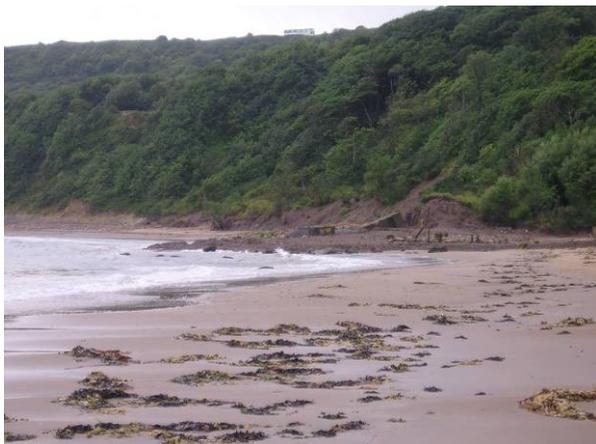
Mu24/A2 toe uplift on the beach at Cayton Bay (Totally Active)

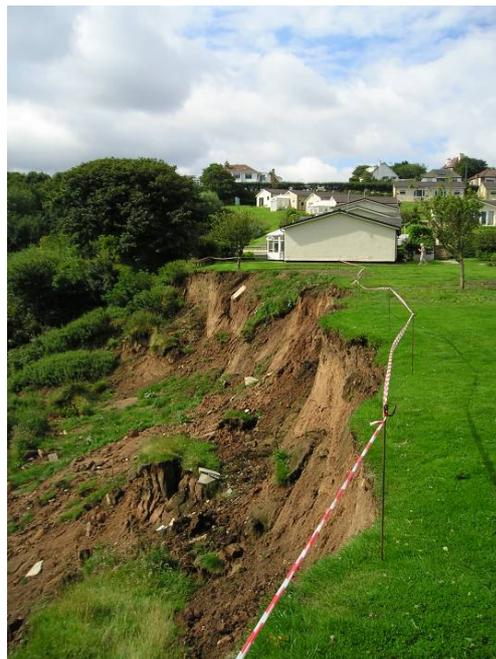
Mu24/A headscarp failure at Knipe Point

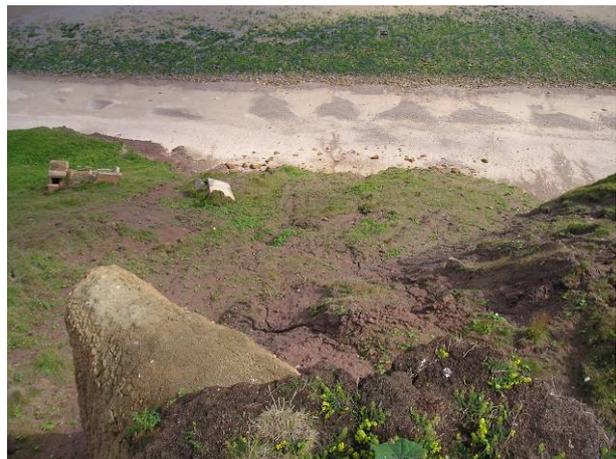
Mu24/N looking down at failing slopes (Totally Active)

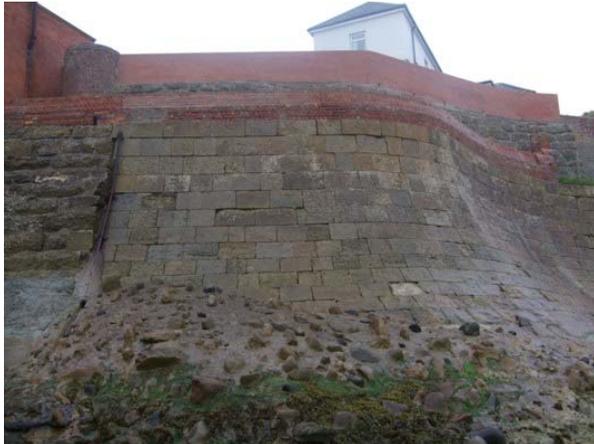
High sea defences below the pumping station, including the upper tier of red brick walls (Asset Ref No. 1221D901D1402C05)

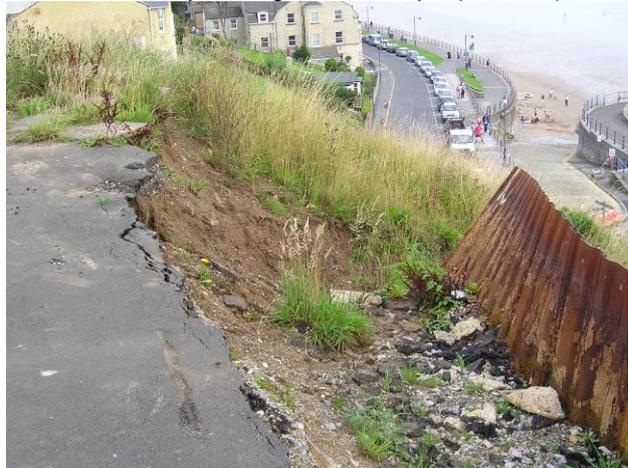
Mu28/Z recent landsliding and footpath damage (Locally Active)

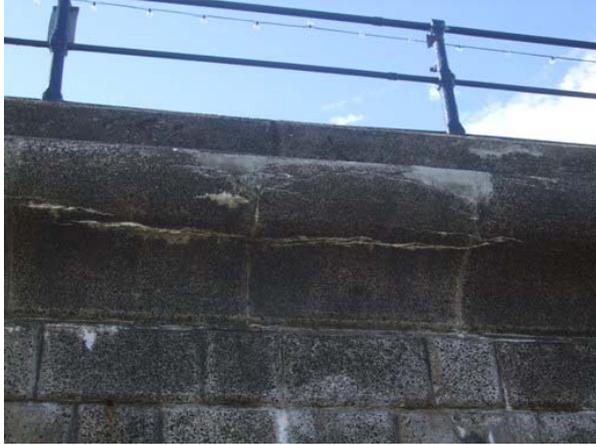
Sea wall with minor, localised defects

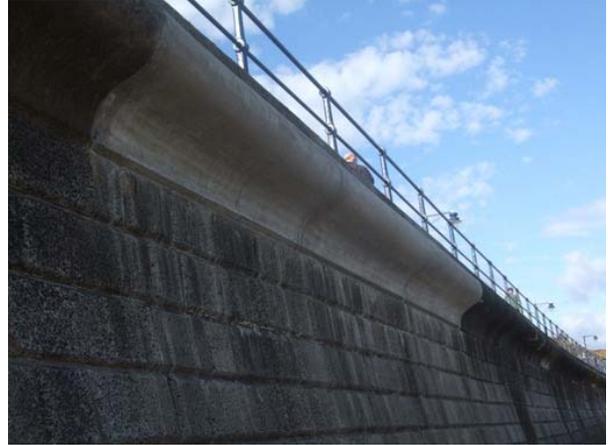
Repair work to the coping stone of the Filey sea wall

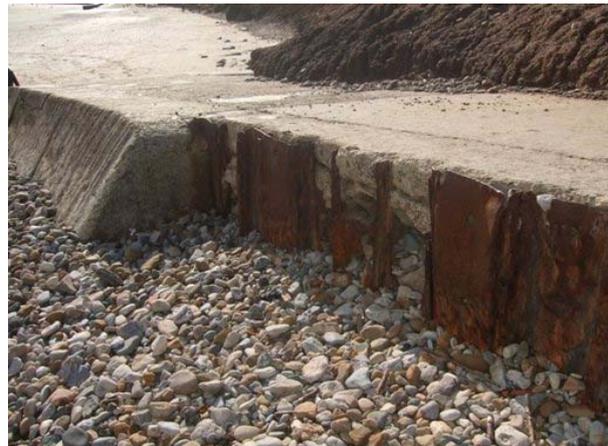
Corroded concrete and sheet pile defence at the southern end of the Sailing Club

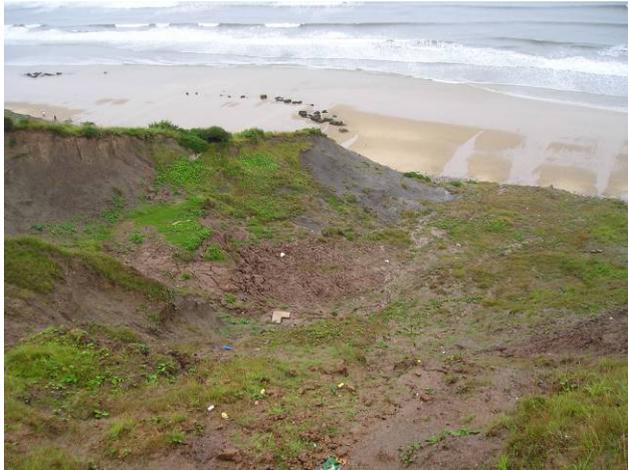
Mu30/CB looking down from cliff top (Totally Active)
