Coast Protection Assets and Coastal Slope Condition Analysis

**Scarborough Borough Council
Final Report**

March 2010

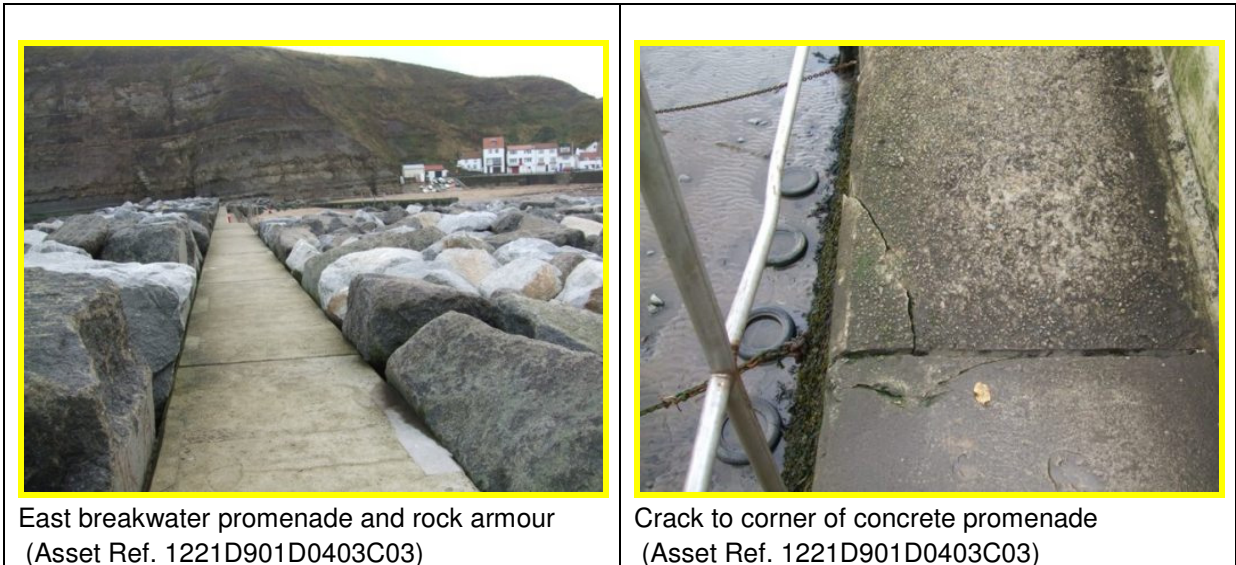
The eastern breakwater has a spur at the tip; the void of which is filled with rock armour (Asset Ref No.1221D901D0403C03). The breakwater is in good condition with the only visible defect a crack to the edge of the walkway.

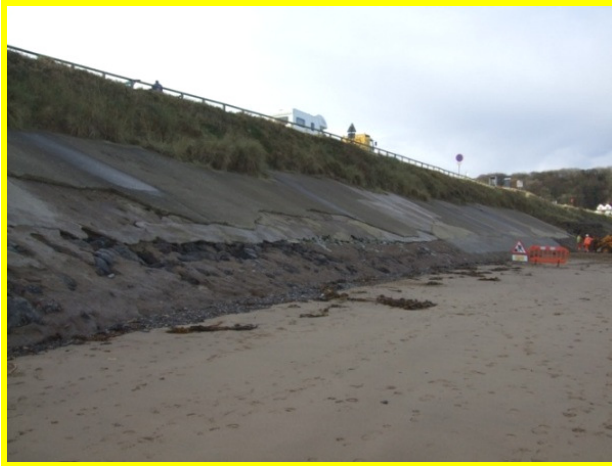
Exposed rock armour at base of concrete revetment
(Asset Ref. 1221D901D0702C02)

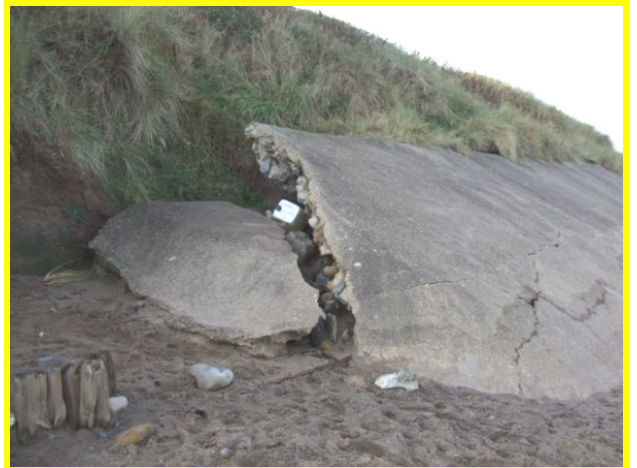
Large crack and collapse at East end of the concrete revetment
(Asset Ref. 1221D901D0702C02)

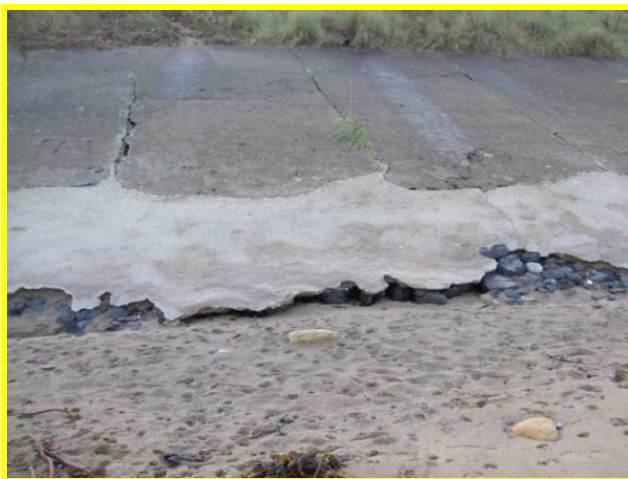
Undercutting of concrete revetment
(Asset Ref. 1221D901D0702C02)

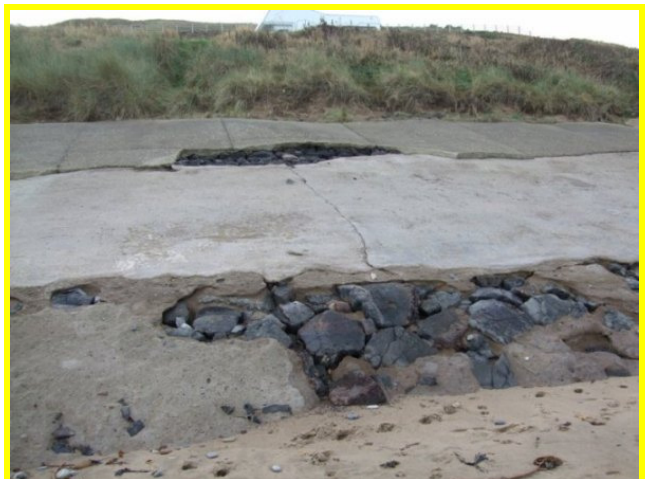
Cracks and exposed rock armour
(Asset Ref. 1221D901D0702C02)

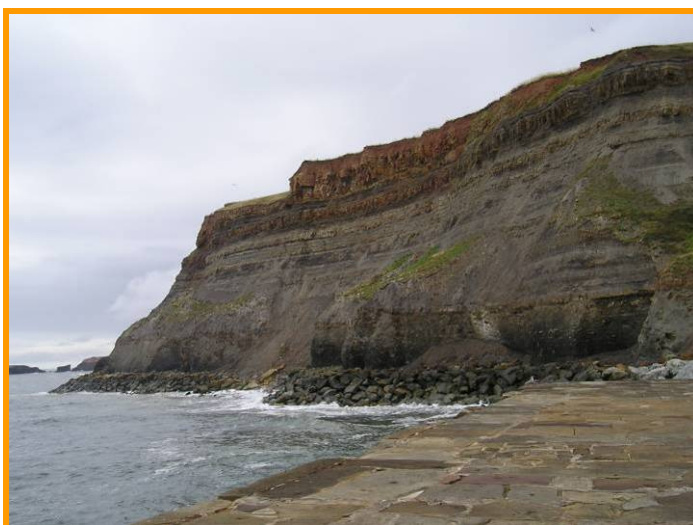
MU12/2 Looking east from Whitby's East Pier showing recent failure from the cliff top (Partly Active)

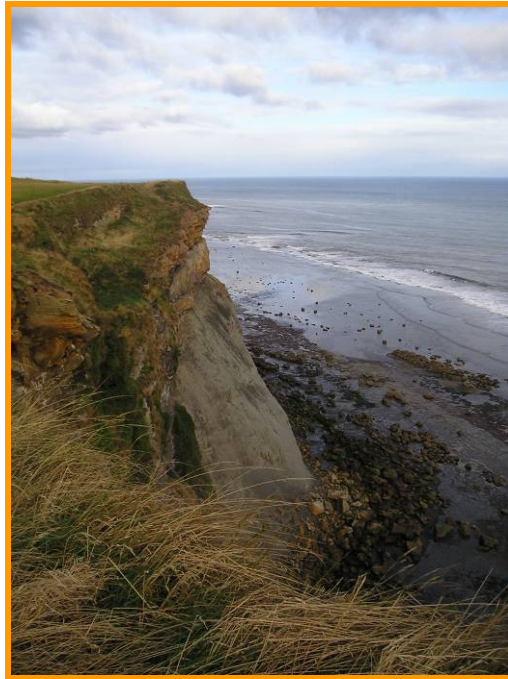
MU13/6 Steep exposed lower slope (Partly Active)

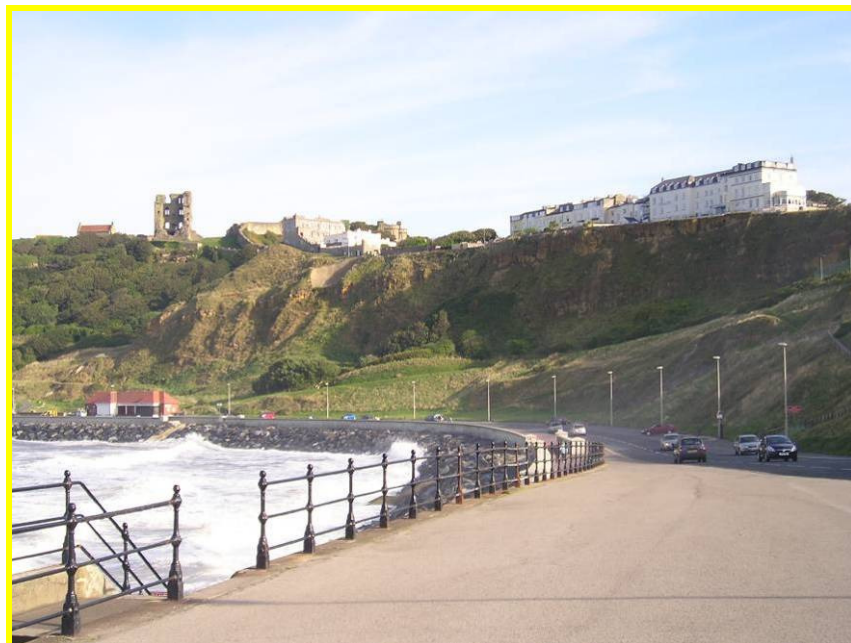
MU20/4b Exposed rock headscarp (Locally Active)

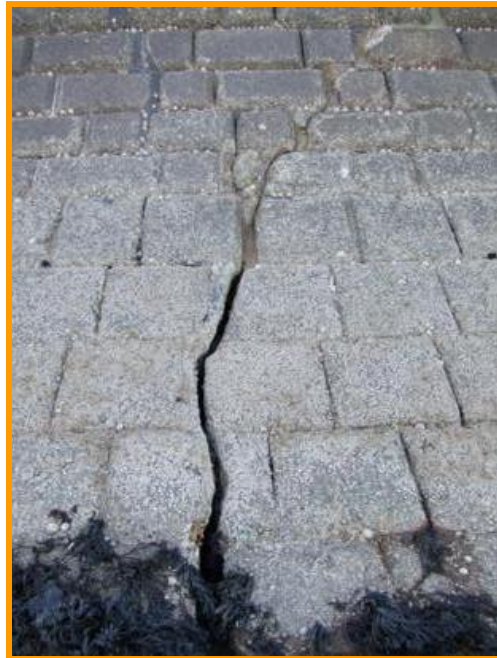
Second large crack and deep void in slipway
sea wall
(Asset Ref. 1221D901D1201C21)

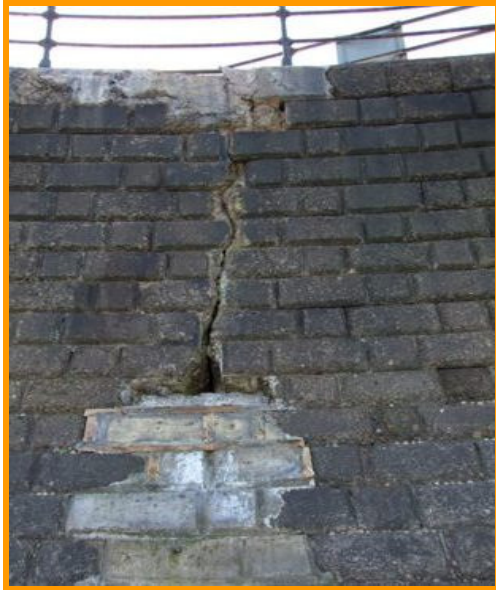
Large vertical cracks running the full height of the sea wall with repair work
(Asset Ref. 1221D901D1201C21)

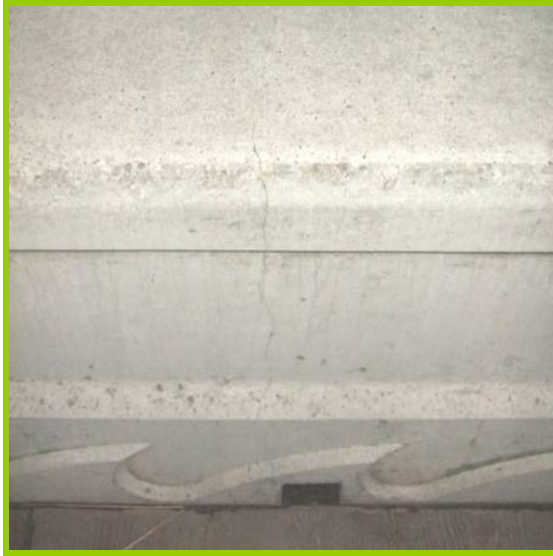
Example of crack through centre of raised wall
(Asset Ref. 1221D901D1202C03)

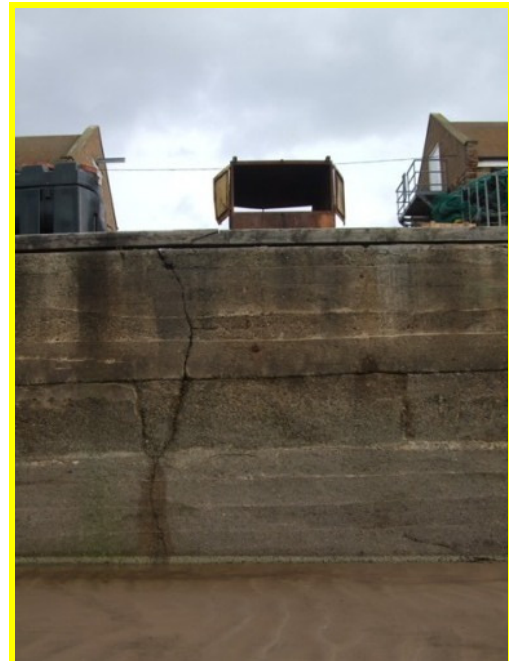
Large vertical crack extending through the wall
(Asset Ref. 1221D901D1301C19)

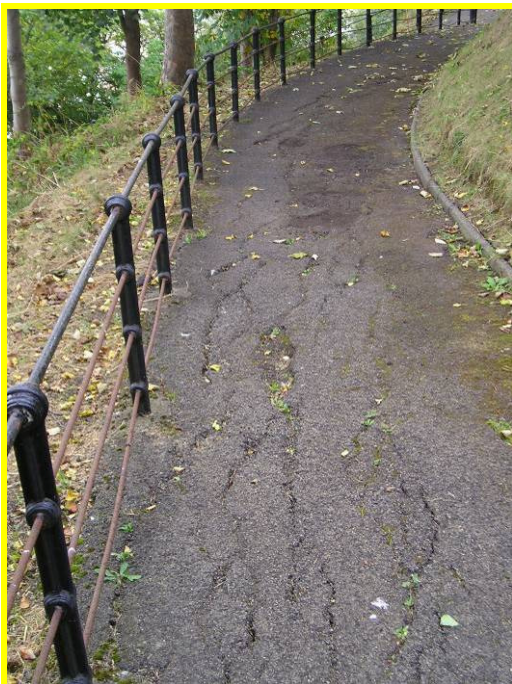
MU22/2 Extensive cracking to footpaths (Locally Active)

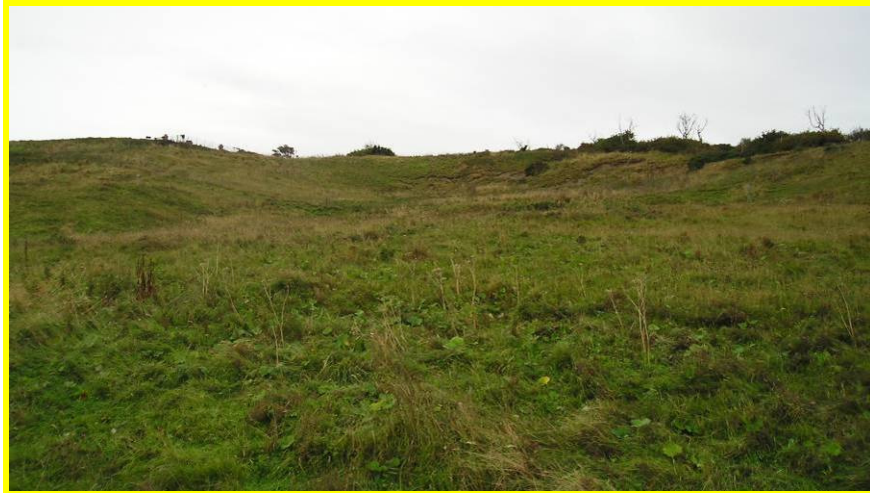
MU22/8 Localised activity at the headscarp of the Holbeck Hall landslide run-out (Locally Active)

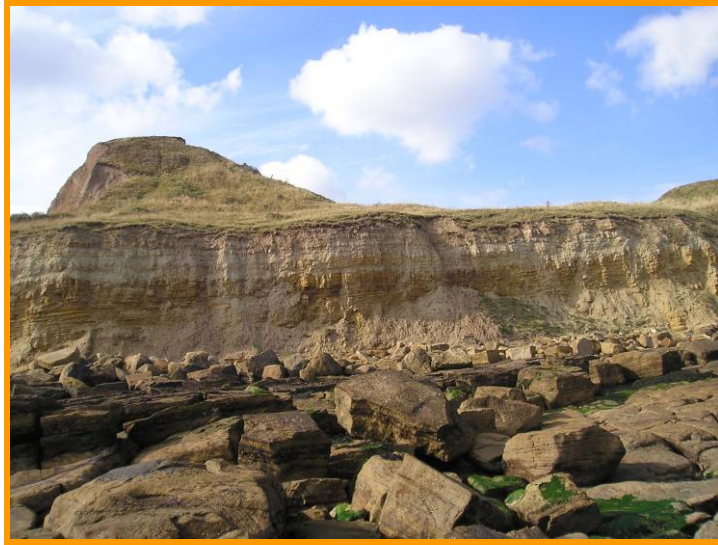
MU24/A8 Intense erosion to the east facing side of Knipe Point, and evidence of rockfall events
(Partly Active)

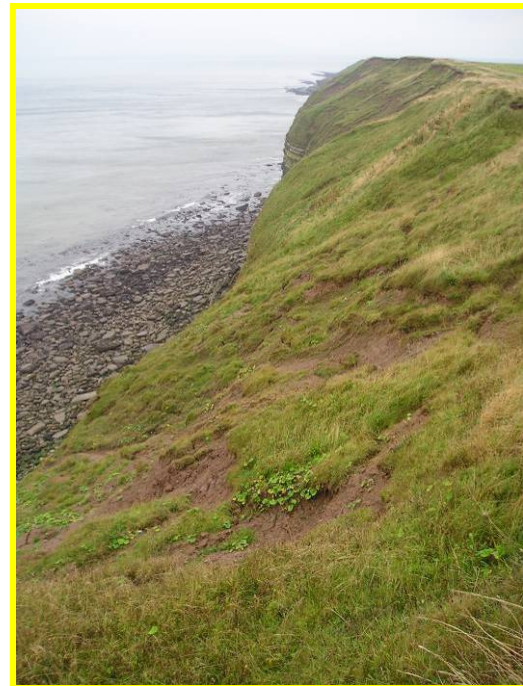
MU26/AX Localised erosion of upper soft till layer (Locally Active)

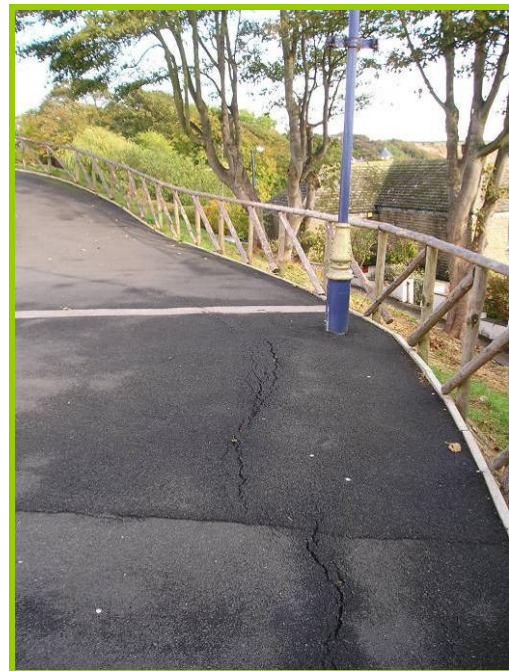
MU28/Y Cracking of footpath (Inactive)

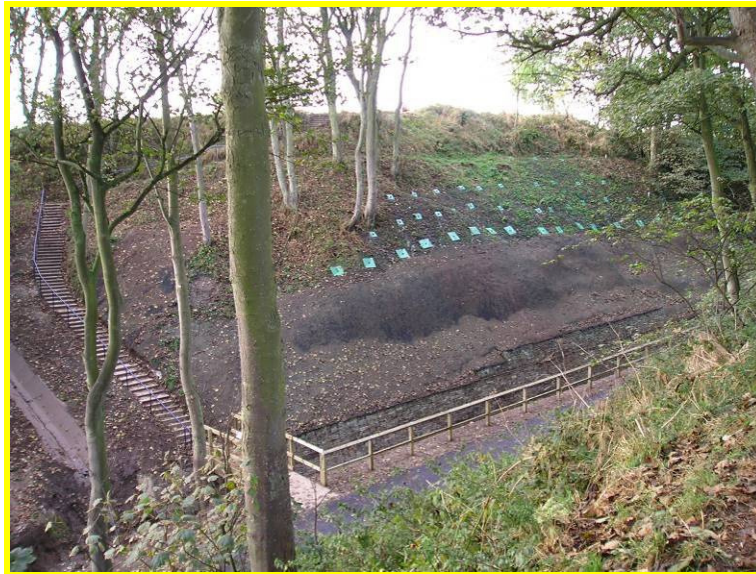
MU28/Z New slope stabilisation works to the ravine (Locally Active)
