**Walk-over Visual Inspections of Assets
including Coastal Slopes**

**Scarborough Borough Council
Final Report**

November 2014

Coast Protection Assets and Coastal Slope Condition Analysis

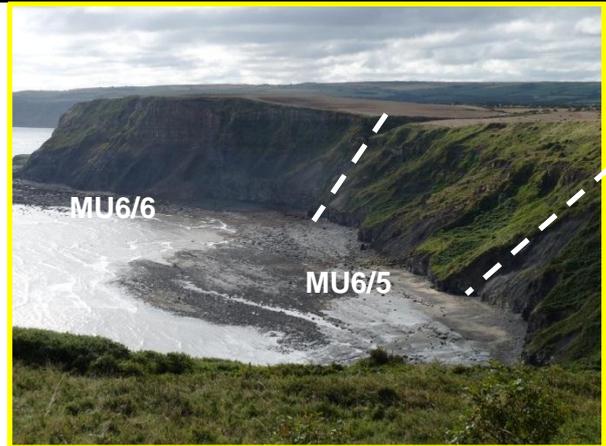
MU6/5 – The unit is substantially vegetated but active marine erosion and localised failures in the cliff are evident (Locally Active). MU6/6 is discussed below. August 2014.

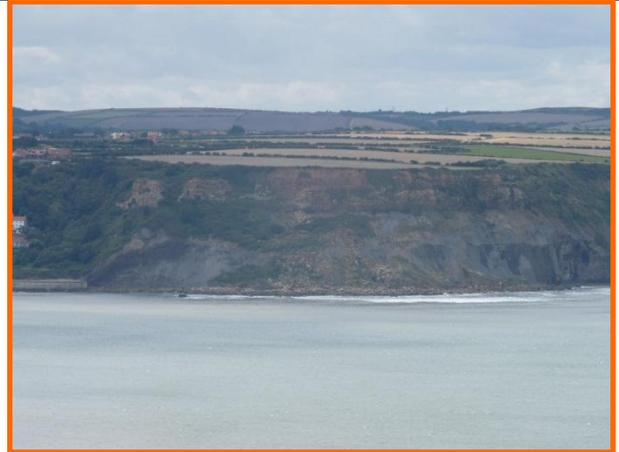
MU6/8 – Much of the cliff continues to be unvegetated and is subject to rockfalls from the upper cliff and marine erosion at the toe (Partly Active). August 2014.

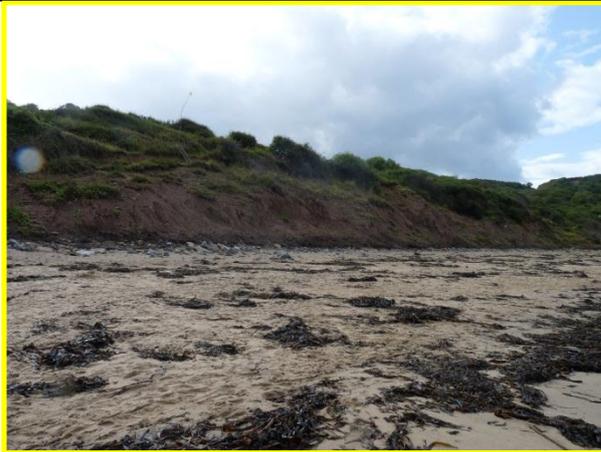
MU7/3 – Toe erosion at the base of the cliff (Locally Active). August 2014.

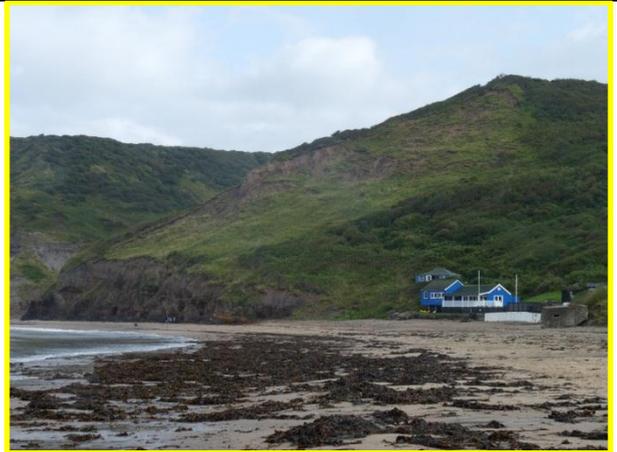
MU7/4 – Erosion at toe and instability in upper slope but still substantively vegetated. Locally Active. August 2014.

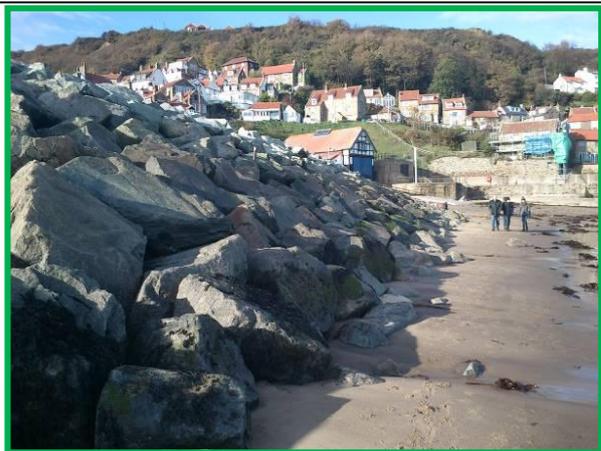
The rock armour defences (Asset ref: 1221D901D0602C01) remain generally in very good condition, with the rocks tightly packed with good coverage. However, there has been some movement resulting in loose blocks at both sides of the southern slipway and so the overall rating has been amended to good. The associated slipway towards the south from the end of the road and boat park is also in good condition. Beach levels appeared relatively high at the time of the inspection, so the toe was not visible. There is ongoing erosion of the undefended cliff at the southern end of the defence and some of the locally sourced smaller rock used at the tie in appears to have been reconfigured since the previous inspections, see lower photos below.

Runswick Bay village rock armour defences Photo from 2012 (Asset Ref. 1221D901D0602C01)

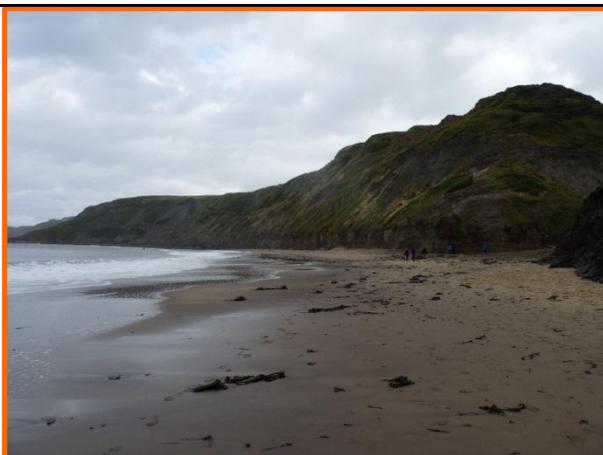
MU8/1 The cliffs behind Runswick Sands (Partly Active). August 2014.

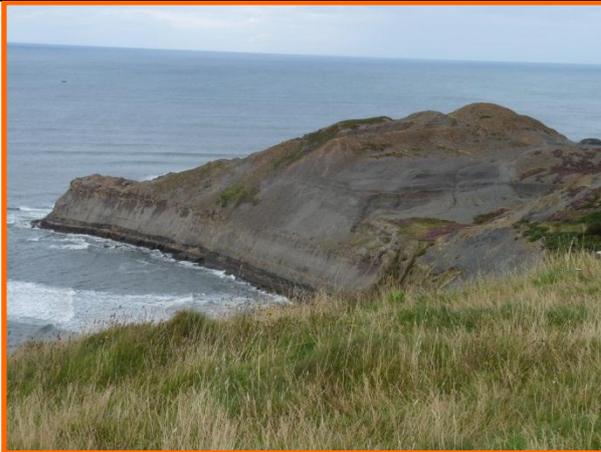
MU8/5 The ongoing erosion of the Kettle Ness headland (Partly Active). August 2014.

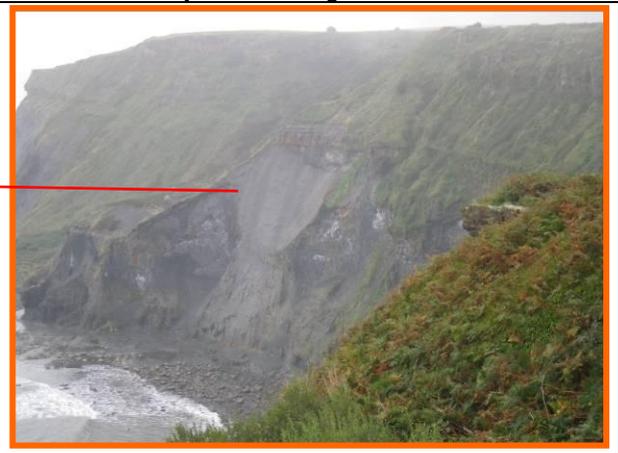
MU8/9 (2012) - The scar of this failure is still visible in the 2014 survey photograph, indicating the cliff has not yet stabilised sufficiently to support vegetation at this point. August 2014.

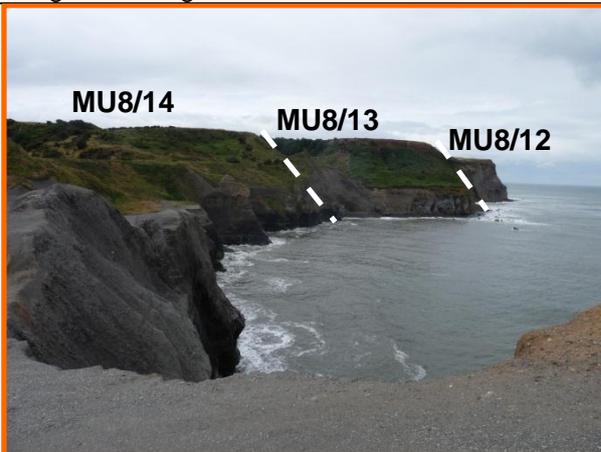
MU8/12, MU8/13 and MU8/14. The cliff is showing signs of regular erosion in the lower one- to two-thirds of the face, particularly in MU8/14 (Partly Active). August 2014.

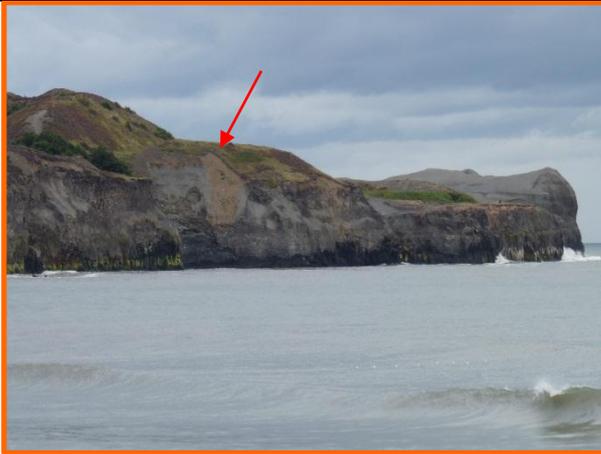
MU8/14 Active sea cliff – note recent failure just left of centre, indicated by arrow (Partly Active). August 2014.

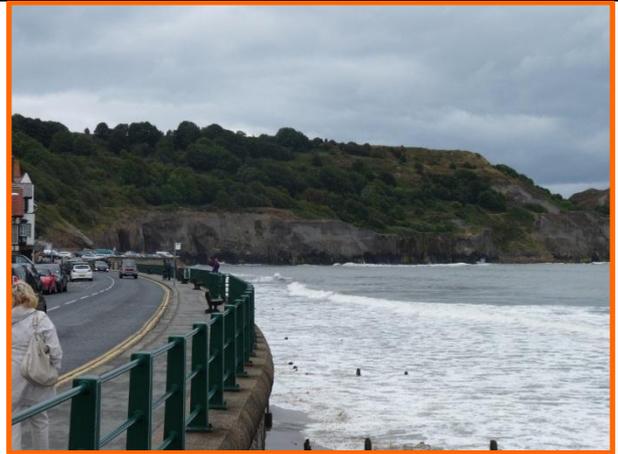
MU8/15 - Active sea cliff and indicators of ongoing failure within unit – see below. (Partly Active). August 2014.

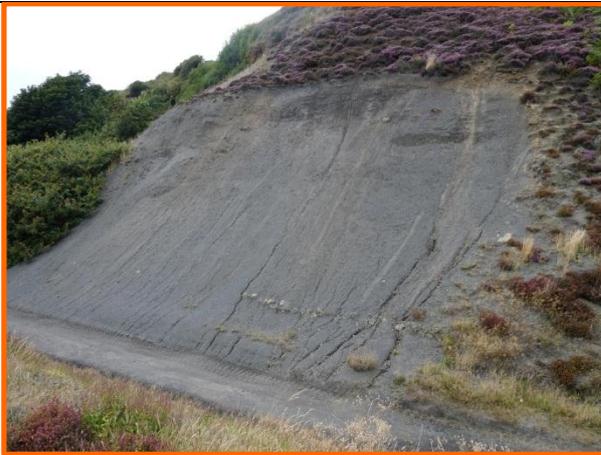
MU8/15 – Exposed shale slope in former railway cutting (now Cleveland Way) ongoing rilling and small scale slope erosion. August 2014.

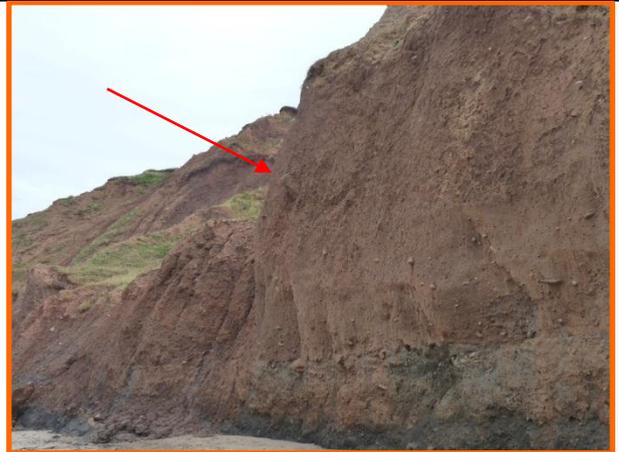
MU10/2 – Example of large cobble/small boulder sized particle posing a rockfall hazard for anyone in immediate proximity to the cliff. August 2014.

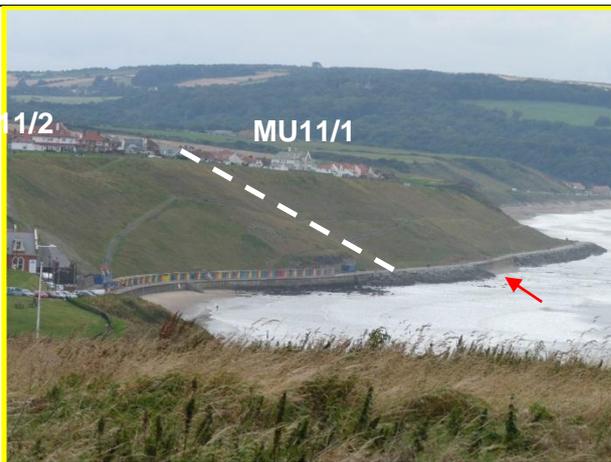
MU11/1 Locally Active. Arrow indicates gap in rock armour and location of lower slope failures. August 2014.

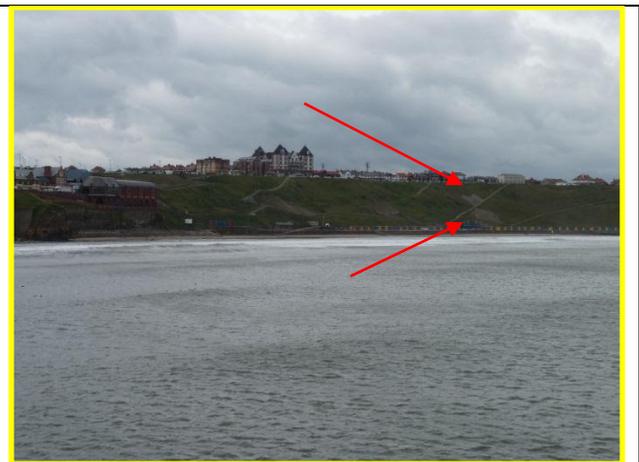
MU11/1 - Locally Active. August 2014.

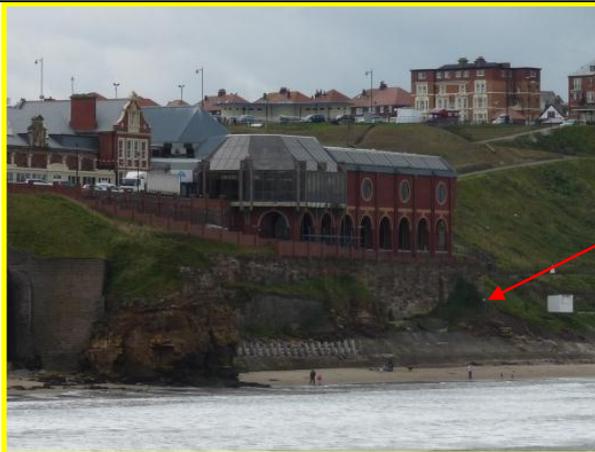
MU11/3 Defended slopes with some evidence of recent activity in the rock slopes and till slope above the defences (Locally Active). August 2014.

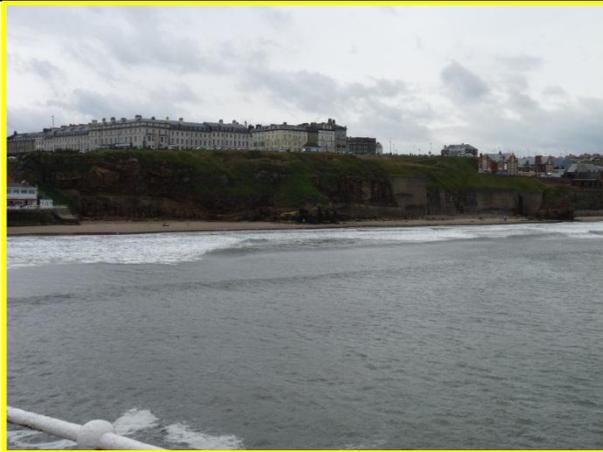
MU11/4 Localised erosion above Whitby Sands (Locally Active). August 2014.

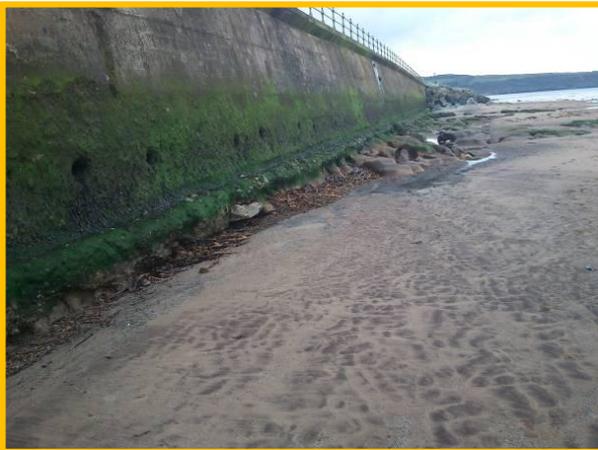
The sections of seawall along the frontage west of the North Beach Café with no protective rock armour, Asset Ref. 1221D901D0802C01, and 1221D901D0802C03 have in many places lost the concrete surface over whole lower half of wall due to abrasion. The toe is exposed and there was undercutting observed in 2012, see below left and right. Although the beach was higher in 2014 and the toe was not visible, there was significant abrasion damage to the lower part of the wall. There is also local damage to the wall capping beam and promenade slabs in a number of locations from wave overtopping damage where there is no rock revetment. The large concrete wall structure (Asset Ref. 1221D901D0802C03) is similar to the wall to the north west, but has no rock armour. The toe is exposed and eroded along its length, leading to significant undercutting, although the beach was higher at the time of inspection that during the previous, 2009 inspection. This defence is currently in a poor condition. Repairs to toe are required to prevent future instability of wall and it is recommended that consideration is given to extending the rock armour to this section. Adjacent sections of wall show similar defects although toe is often less visible.

Undermining of toe in section with no rock armour
Photo from 2012.
(Asset Ref. 1221D901D0802C01)

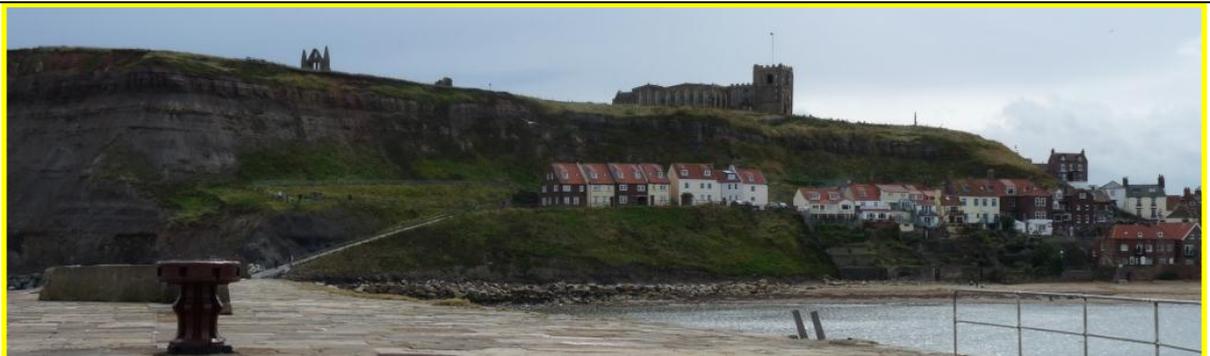
MU12/1 Below Whitby Abbey the slopes are vegetated, but with localised signs of erosion (Locally Active). Cliffs behind Henrietta St (row of white cottages extending along cliff face below St Mary's church) are subject to periodic failure. Toe erosion is evident in the more seaward (towards left of photo) part of the cliff. August 2014.

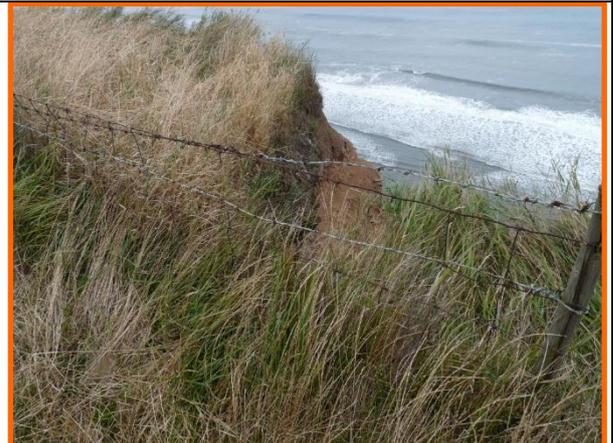
MU13/6 - Cliff top failure starting to undermine fence – grid reference 492483 510474. August 2014.

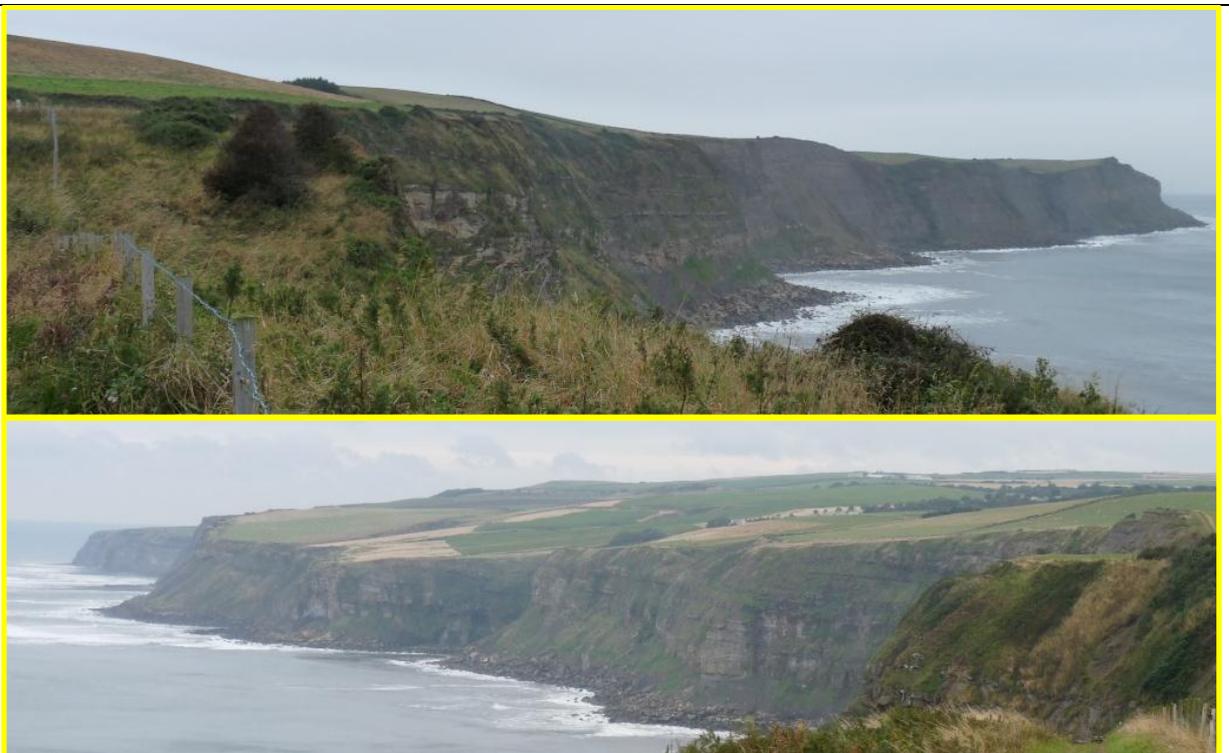
MU14/1 stable cliffs with largely-vegetated debris aprons and boulder lobes. Upper photo looking north from south end of unit, lower photo looking south from north end of unit (Locally Active). August 2014.

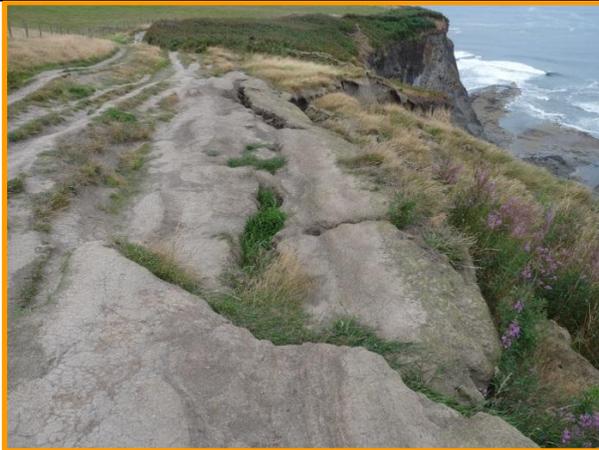
MU15/2 – Large tension cracks delineating failing section of headscarp (Partly Active). August 2014.

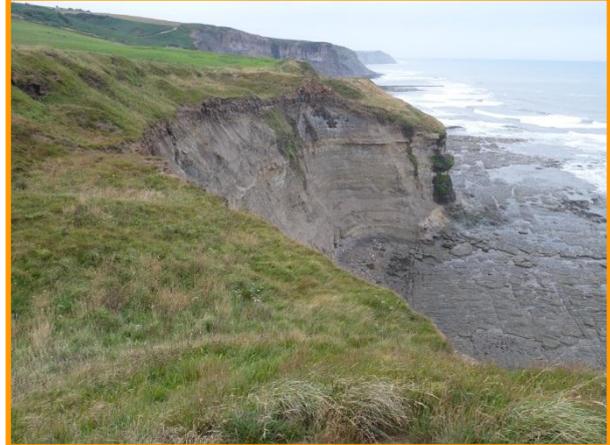
MU15/3 Upper photo - southern side, photo taken from Ravenscar golf course and northern side. Lower photo – northern part of unit (Partly Active). August 2014.

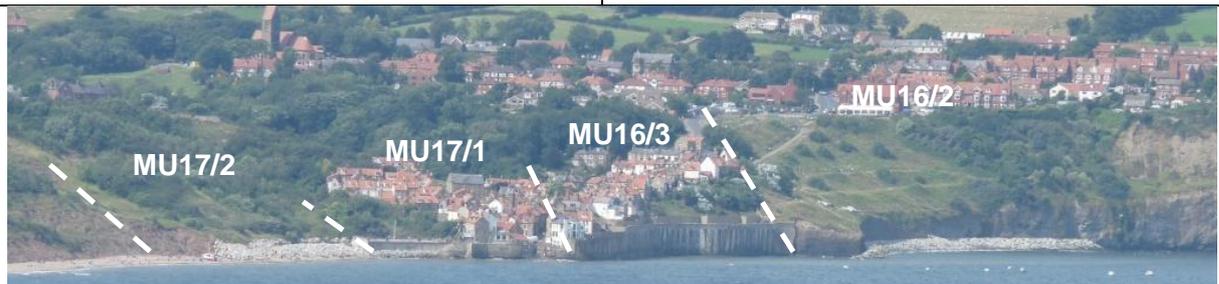
MU16/2 (Locally Active), **MU16/3** (Dormant), **MU17/1** (Dormant) and **MU17/2** (Partly Active). August 2014.

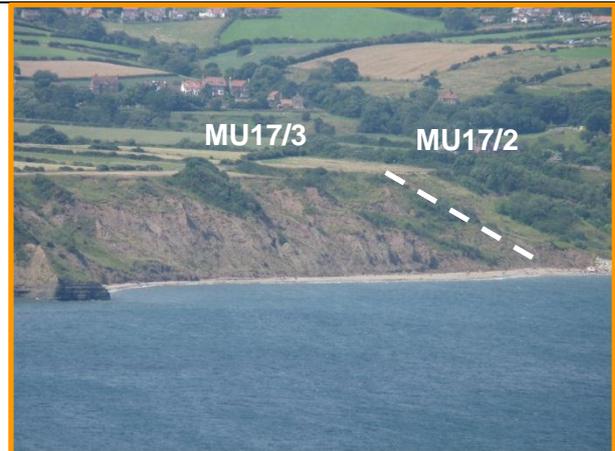
MU17/3 Poorly-vegetated slope with widespread evidence of ongoing slope failure. (Partly Active). August 2014.

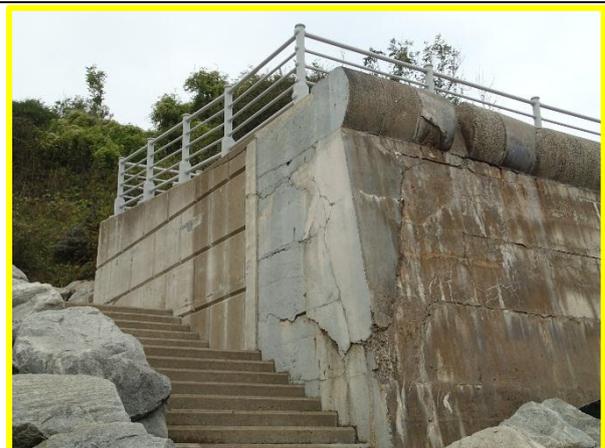
Failing previous repairs at south end of Quarter Deck (Asset Ref. 1221D901D1003C10)

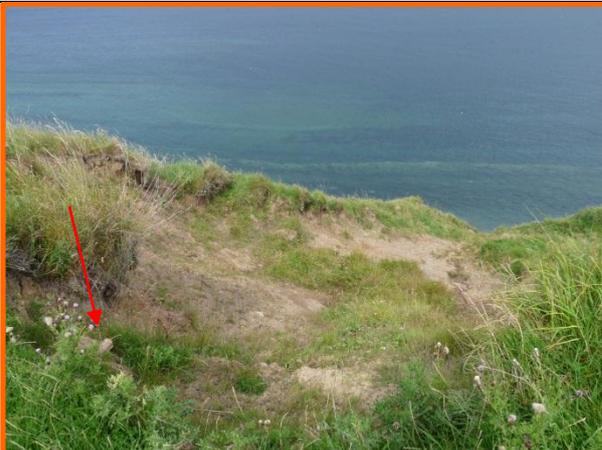
MU17/6 - Example of cliff top mudslide causing cliff top recession. Possible underlying cause is discharge from land drain identified by arrow. August 2014.

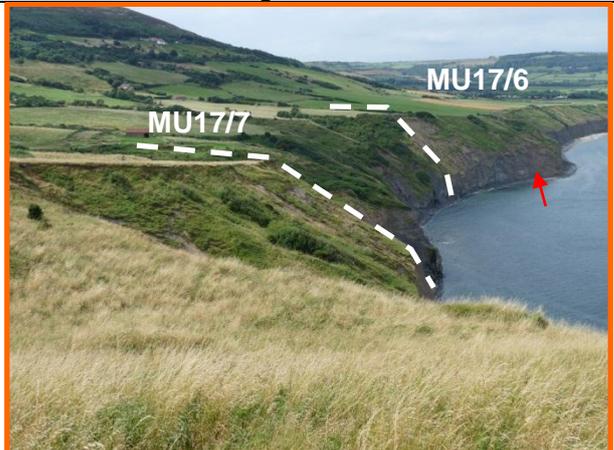
MU17/7 - Partly Active. Also note recent failure of lower cliff in 17/6, indicated by the arrow. August 2014.

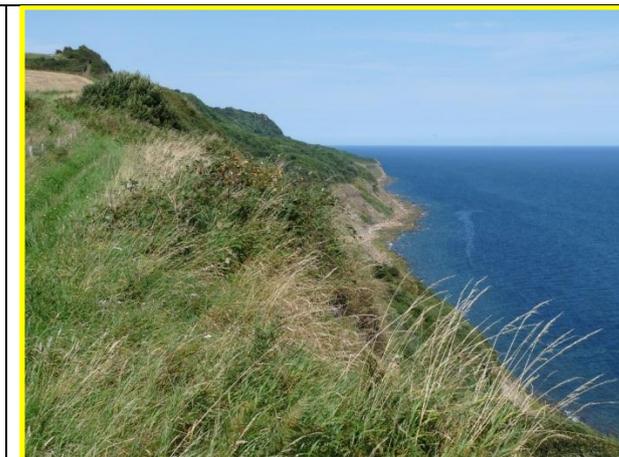
MU18/4 Vegetated overall but with very localised erosion of the headscarp (Locally Active). August 2014.

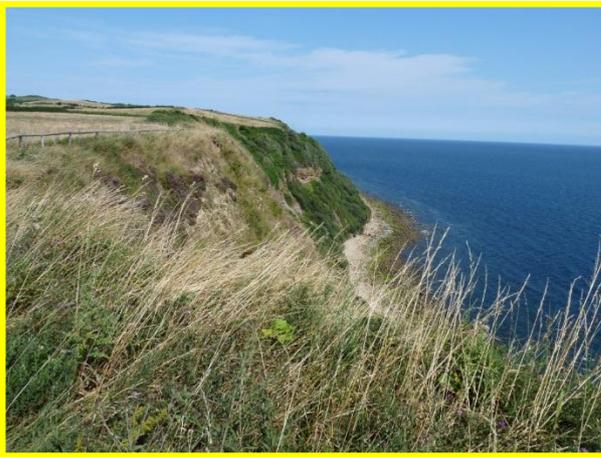
MU19/1 the well vegetated cliff face (Locally Active). August 2014.

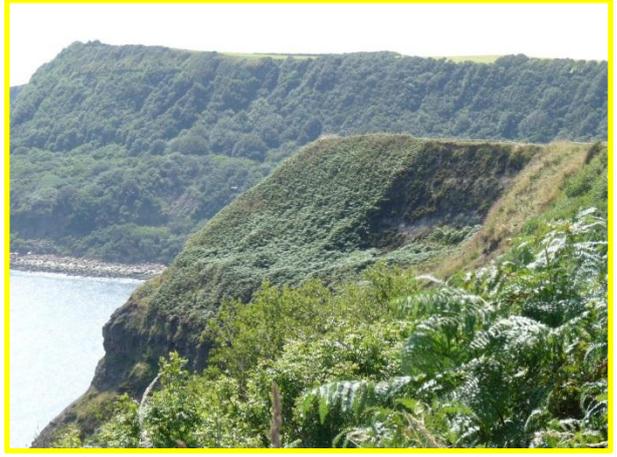
This Sub-Management Unit consists of **unit MU19/1** only. Failures are localised although a large failure in the upper cliff ca. 5-10yrs old was noted during this inspection. This unit is classified as Locally Active, and has not changed since the 2012 survey.

MU19/1 – Large ca. 5-10yr old failure of upper cliff (Locally Active). August 2014.

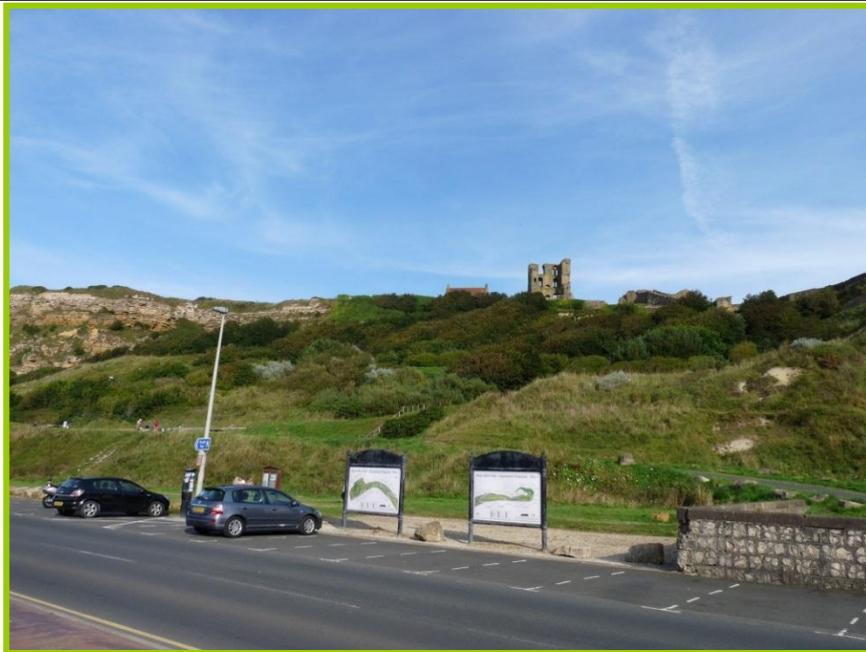
MU21/1 Well jointed hard rock has a thick cover of vegetation (Inactive). August 2014.

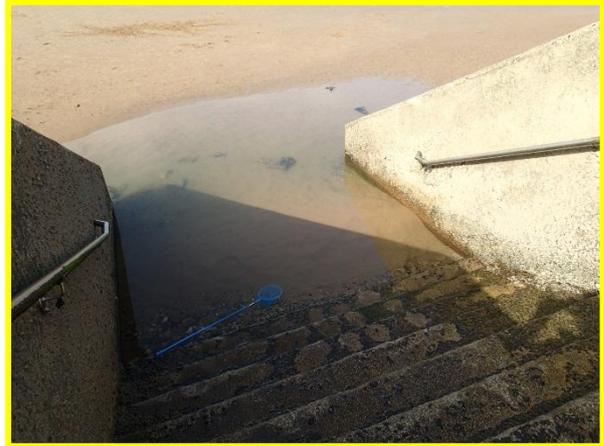
Standing water in scour hole at toe of steps
(Asset Ref. 1221D901D1202C03)

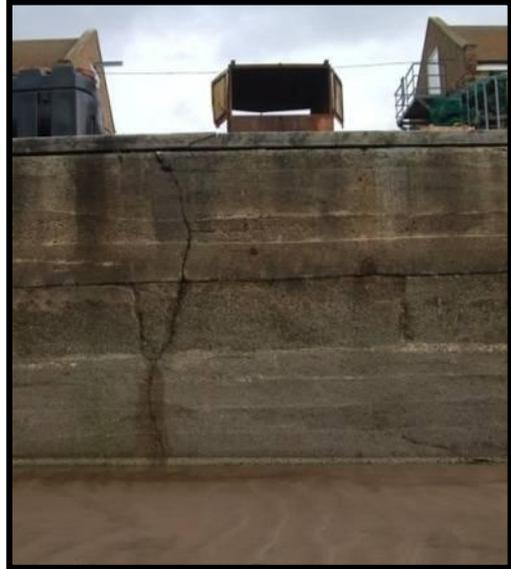
Large vertical crack extending through the wall **photo from 2009** (Asset Ref. 1221D901D1301C19)

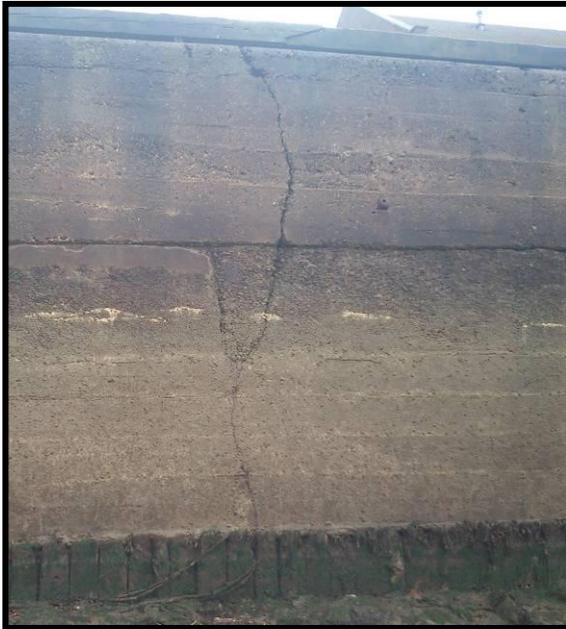
No change to vertical crack extending through the wall **photo from 16/10/12**, with low beach exposing timber toe piles. (Asset Ref. 1221D901D1301C19)

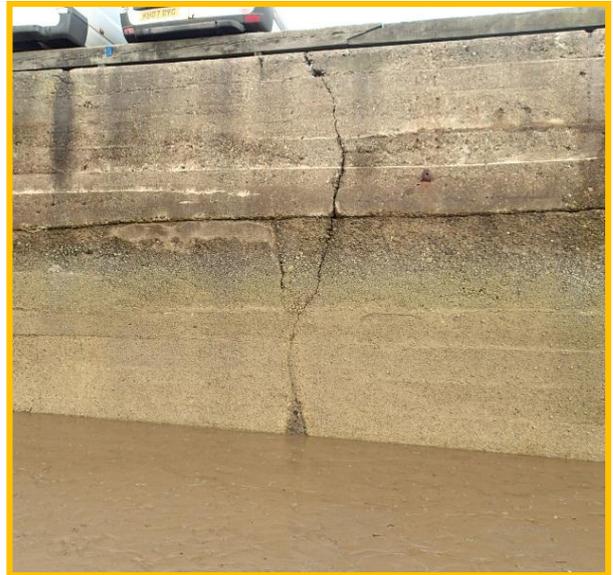
No change to large vertical crack extending through the wall, but beach levels higher than in 2012 or 2009. **Photo 10/09/2014** (Asset Ref. 1221D901D1301C19)

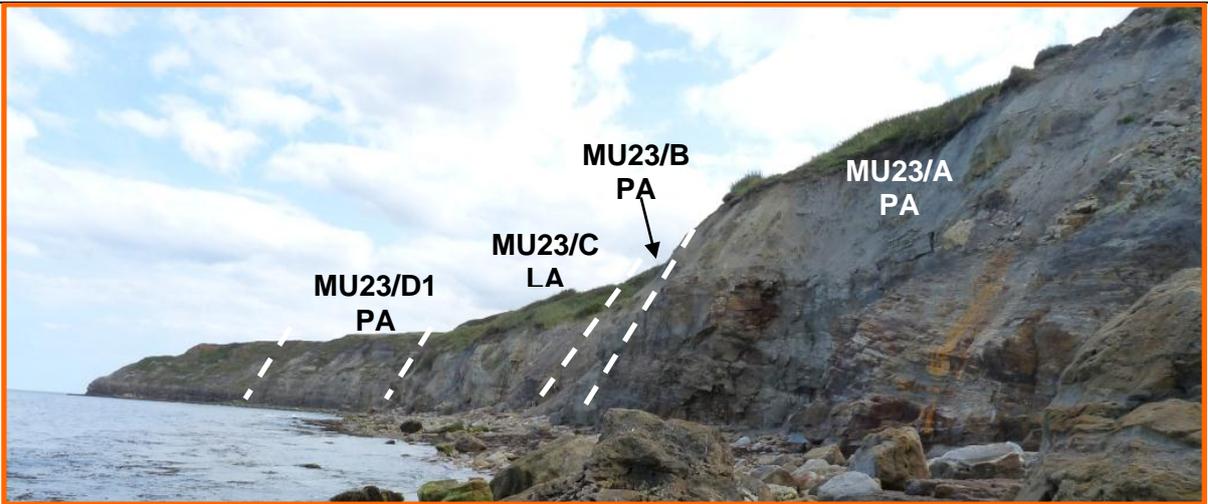
MU23/A, MU23/B, MU23/C and MU23/D1 All Partly Active except MU23/C, which is Locally Active.

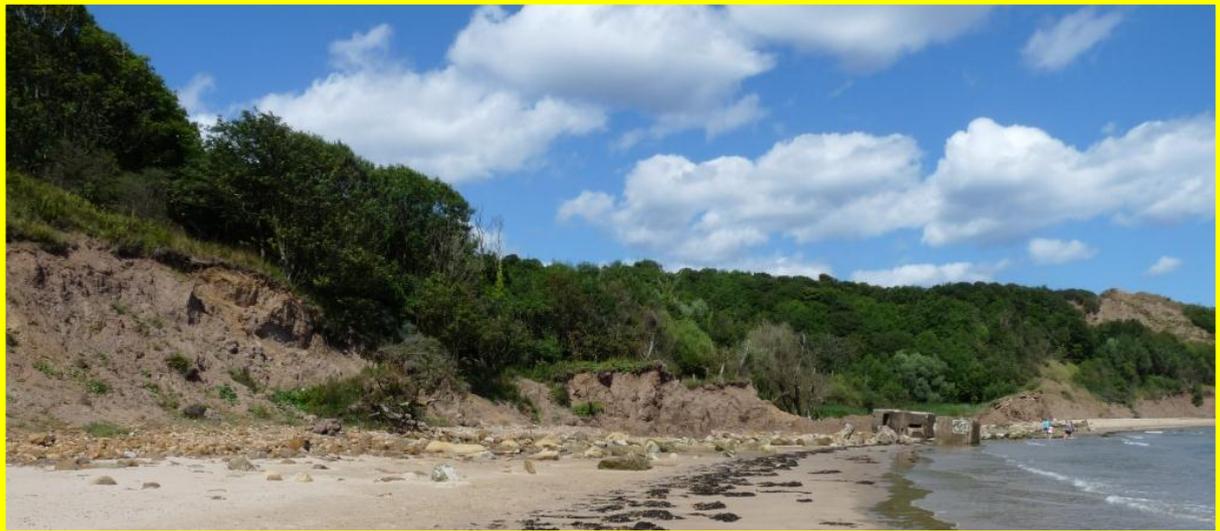
MU24/A The toe of Cayton Cliff is actively eroded but there is only localised activity in the rest of the unit (Locally Active). August 2014.

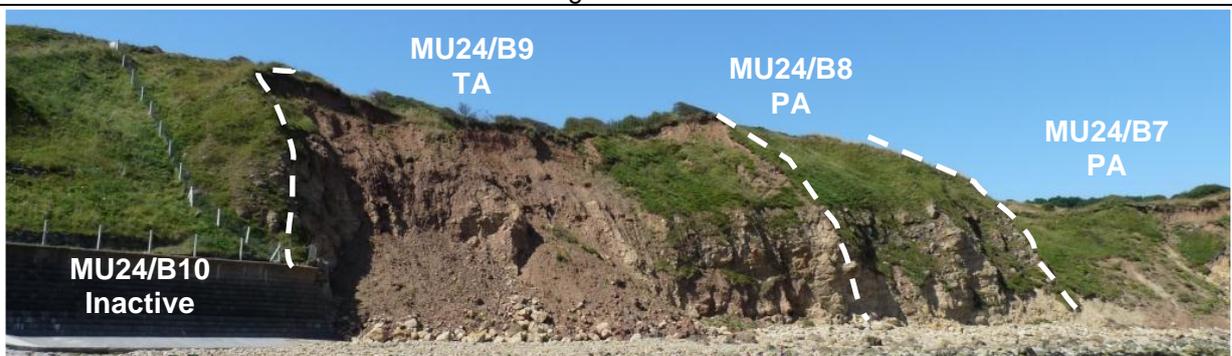
MU24/B7 to MU27/B7 - Note substantial recent cliff failure at end of sea defence likely due to outflanking of this defence by marine erosion. August 2014.

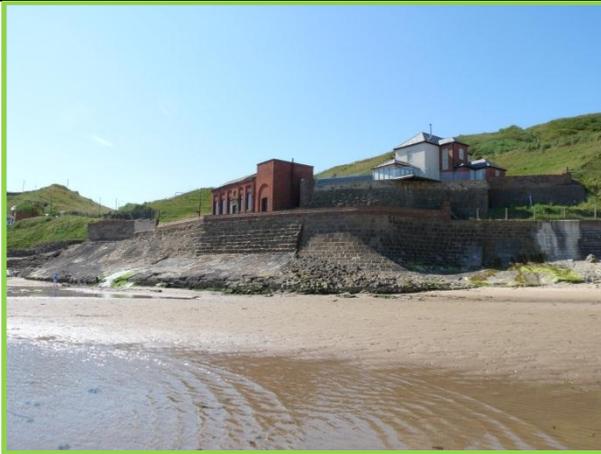
MU24/B – Cliff behind pumping station showing no indications of significant activity (Inactive).
August 2014.

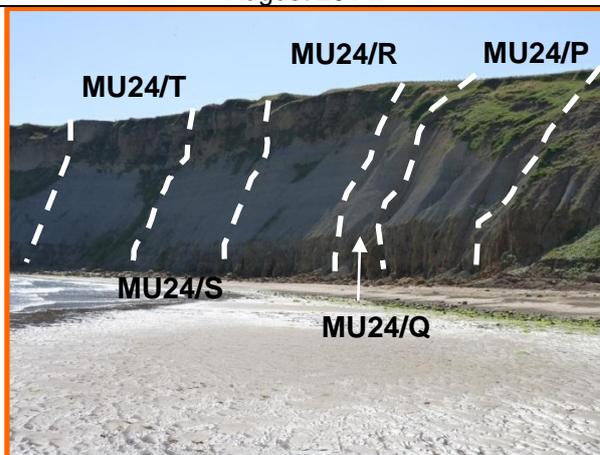
MU24/P to MU27/T – All Partly active – note absence of vegetation on lower cliff

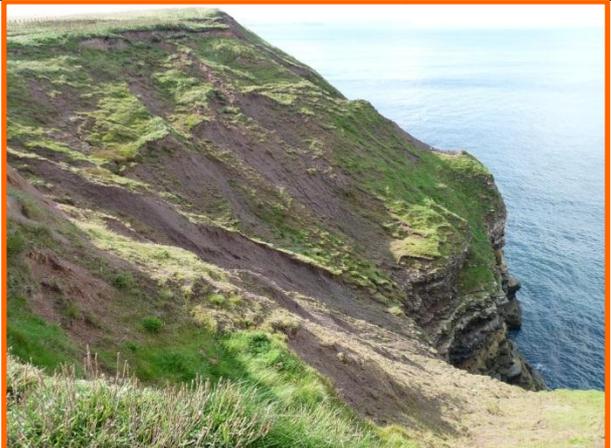
MU27/BB – Similar levels of activity in 2014
(Partly Active)

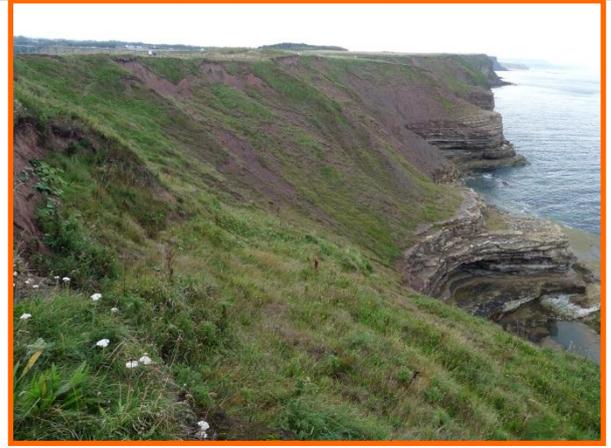
MU27/BE The vegetated slopes increased signs of failure relative to 2012 (Partly Active). August 2014.

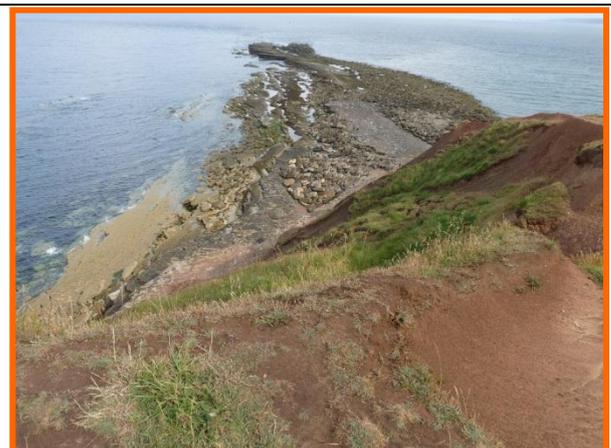
MU27/B Ongoing erosion (Partly Active). August 2014.

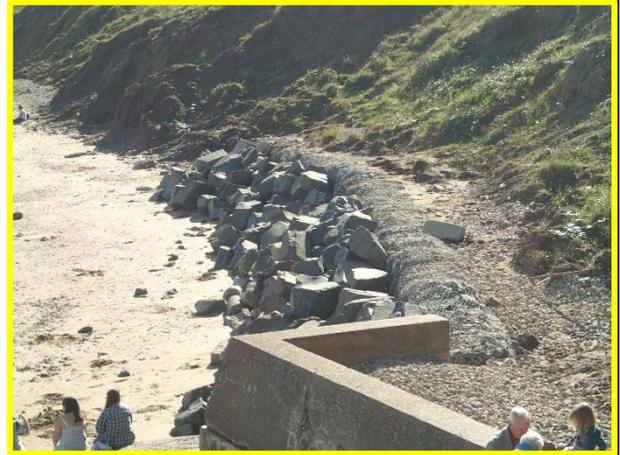
General view of rock armour at interface with natural cliff showing repaired or replaced gabions and re-profiled rock armour, which is again showing signs of displacement.
Photo 26/09/2014
(Asset Ref. 1221D901D1602C02)

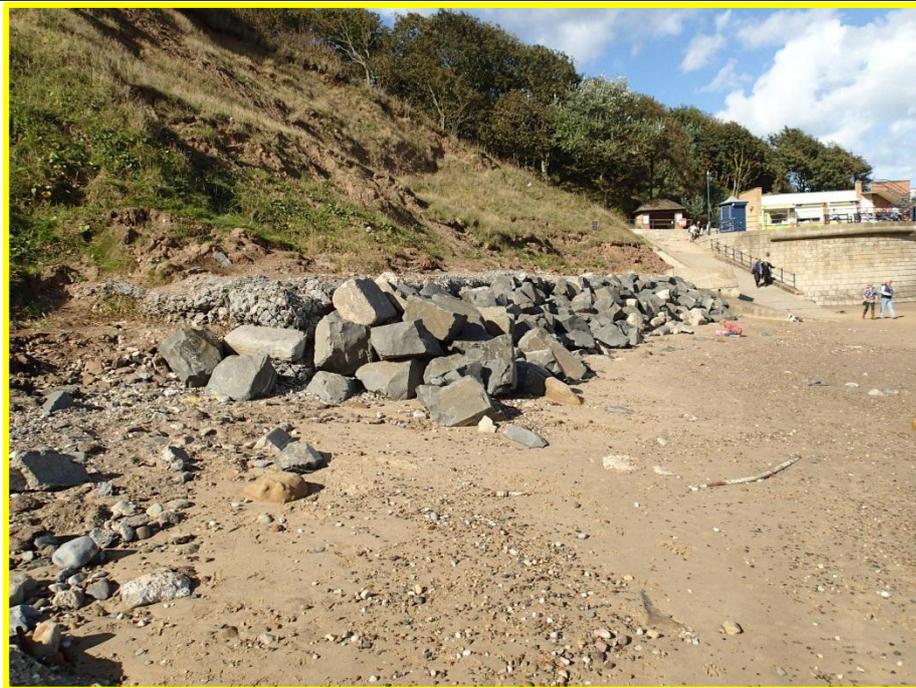
Gabion and rock defence with slumping cliff behind. (Asset Ref. 1221D901D1602C02)

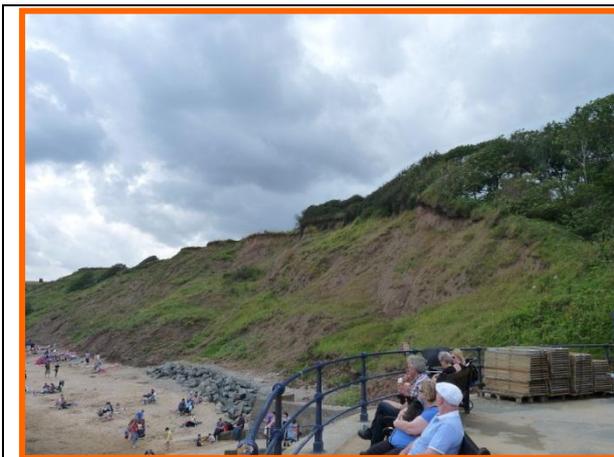
MU29/AA Very common intense erosion and headscarp recession (Partly Active). August 2014.

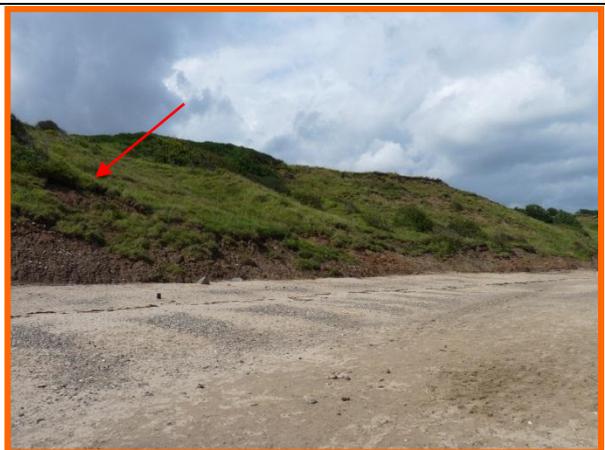
MU29/AD Note propagation of failure to the midslope following winter toe erosion in left of photo (Locally Active). August 2014.

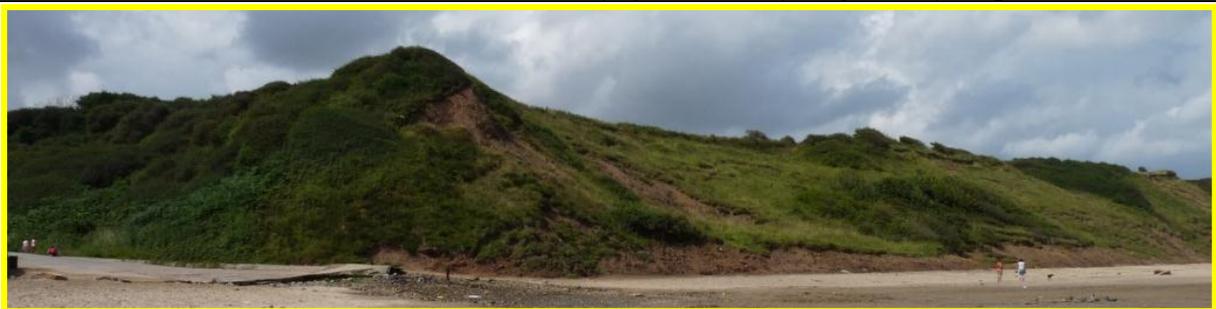
MU29/AI Locally steep and bare, but primarily vegetated (Locally Active). August 2014.

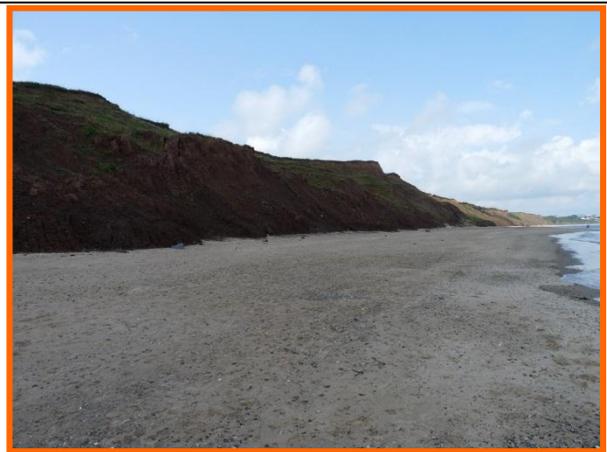
MU29/BO - BQ (Foreground) Intense erosion of the unit toes (Partly Active). August 2014.

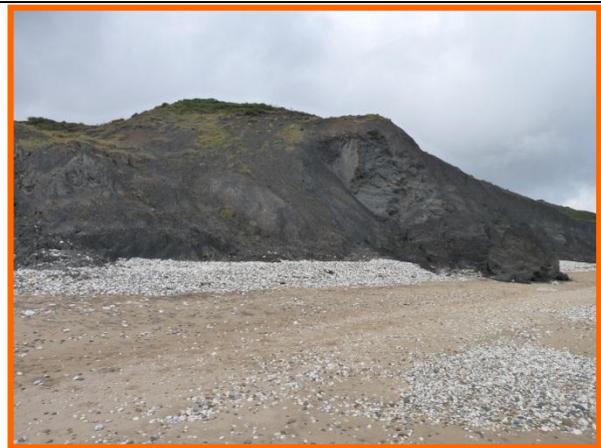
MU29/CD Large, recent block failure of the Kimmeridge Clay cliff (Partly Active). August 2014.

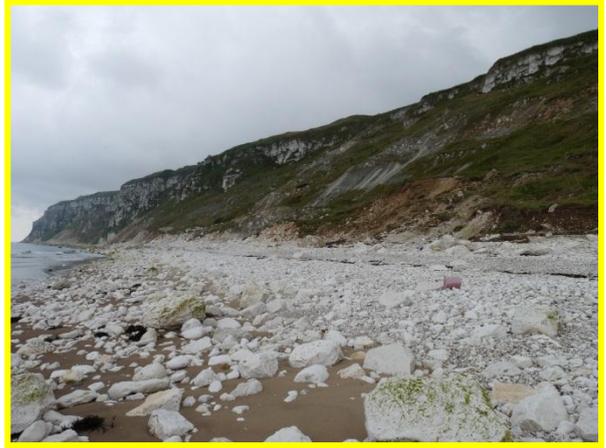
MU29/CH,I and J Actively eroding cliff toe (Locally Active). August 2014.
