Walk-over Visual Inspections of Assets – Final Report

Prepared for
Scarborough Borough Council

July 2015

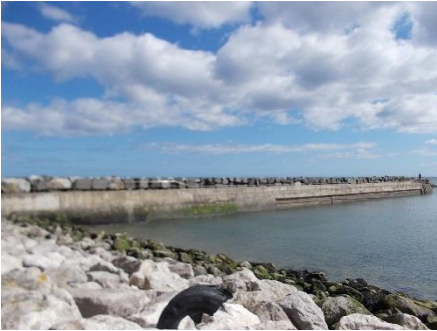
Asset Location:	NZ78271901, NZ78441906. North breakwater.	
	Asset Length:	370.8	
	Condition Assessment		
	Condition	Priority	Risk
	C	2	
	Brief Description		
	<p>Rock mostly tightly packed, but two of the stacked & pinned crest blocks missing, others have moved. Heavily corroded sheet piling, possible voids behind piling at head. Cracking to promenade and crest wall.</p> <p>Extensive rust stains on all vertical concrete faces with large cracks and spalling in places. Evident repairs to the promenade but concrete abraded in other places where not repaired. Capping of sheet pile retaining wall has failed and is now hanging on the wall (i.e. only attached at one end)</p>		
	Recommendations		
Repack rock armour at crest; replace sheet piles; grout voids in structure.

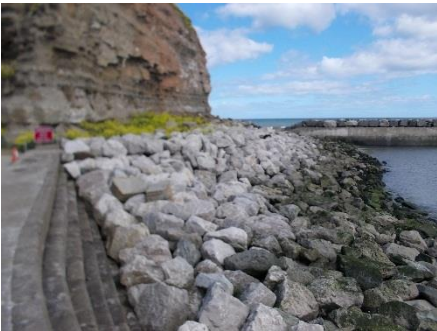
Asset Location:	NZ78301893, NZ78271901. South of Northern breakwater.	
	Asset Length:	91.4	
	Condition Assessment		
	Condition	Priority	Risk
	B	3	
	Brief Description		
	<p>Rock armour in generally good condition, but some units displaced near crest at North end by gap in Breakwater. Path has areas of damage from movement of rock armour. South end promenade eroded and exposed aggregate, cracking spalling blockwork.</p> <p>Concrete blockwork damaged / chipped presumably by rock armour installation and movement.</p>		
	Recommendations		
Re-pack cracked wall, re-profile rock crest at N end. Repair path.

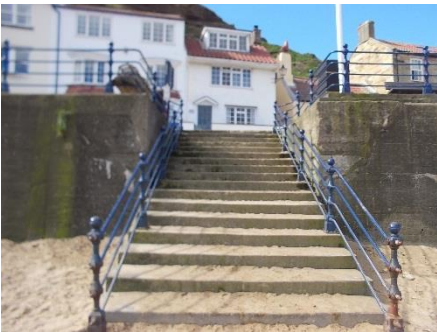
Asset Location:		
	Asset Length:	~5	
	Condition Assessment		
	Condition	Priority	Risk
	B	3	
	Brief Description		
	Steps in fair condition.		
	Recommendations		
Continue to monitor

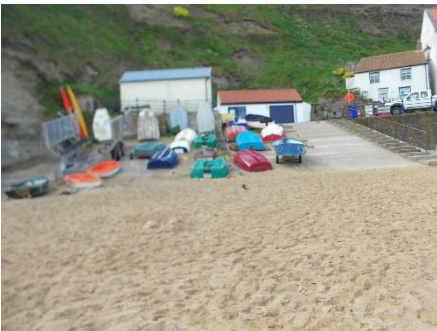
Asset Location:	NZ78421881, NZ78441881 Next to cliff.	
	Asset Length:	26.8	
	Condition Assessment		
	Condition	Priority	Risk
	B	4	>5
	Brief Description		
	Good condition no sign of defects visible, but partly covered with boats parked up along all over slipway, wall at top of slipway not inspected closely, but appears in fair condition.		
	Recommendations		
Continue to monitor

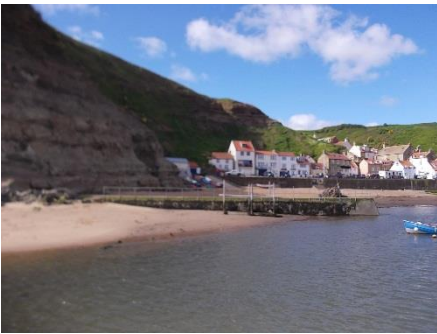
Asset Location:	NZ78431886, NZ78461884 Behind South breakwater.	
	Asset Length:	39	
	Condition Assessment		
	Condition	Priority	Risk
	B	3	
	Brief Description		
	Good condition concrete breakwater, some cracking in top surface. Vegetation growth to walls. Beach has built up on West side. Largely covered in sea weed but looks in fair condition. Vertical crack at mid-section observed		
	Recommendations		
Continue to monitor

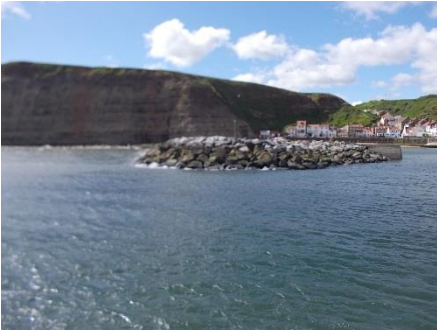
Asset Location:	NZ78491884, South Breakwater.	
	Asset Length:	327.5	
	Condition Assessment		
	Condition	Priority	Risk
	B	3	
	Brief Description		
	Concrete crest units cracked in the middle of the length, repairs evident to chips and cracks. Rock armour mostly tightly packed but small limestone blocks scattered on top. Opening of construction joints to the old part of the wall (inner face). Steps are in fair condition although the side edges are chipped in places. Vertical crack (inner face) observed and continuous across the promenade.		
	Recommendations		
Repair cracks, replace joints

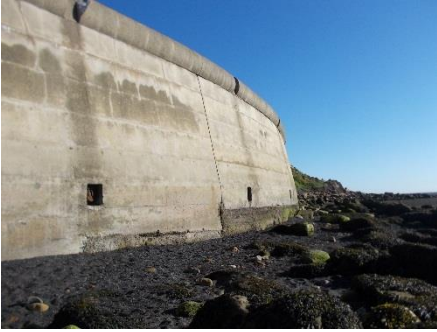
Asset Location:	NZ81081614, NZ81111619. Next to Upgarth Hill	
	Asset Length:	72.4	
	Condition Assessment		
	Condition	Priority	Risk
	B	3	
	Brief Description		
	Erosion and abrasion & undercutting to the wall toe in the mudstone. Cracks, erosion and spalling to capping beam. Wash out of the joints under the capping beam. Missing joints and filler joints in places on wall and prom. Prom slabs have dropped /moved		
	Recommendations		
	Repair joints, cracks and undercutting as well as the voids to wall

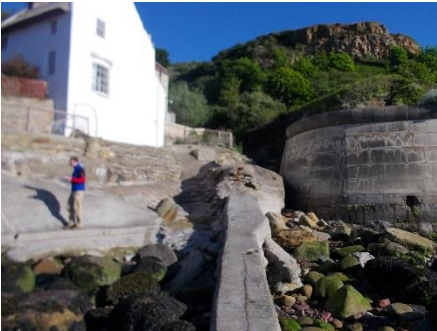
Asset Location:		
	Asset Length:	2	
	Condition Assessment		
	Condition	Priority	Risk
	B	4	>5
	Brief Description		
	Function unknown - might be sewer outfall with protective concrete encasing.		
	Recommendations		
	Continue to monitor

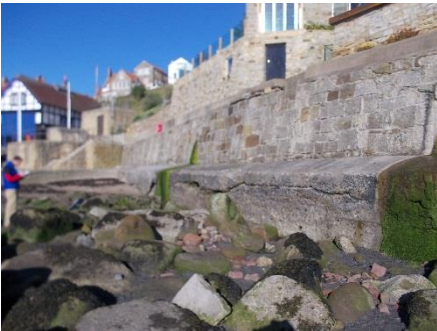
Asset Location:		
	Asset Length:	~35	
	Condition Assessment		
	Condition	Priority	Risk
	C	2	
	Brief Description		
	Evident scattered concrete repairs to the stepped berm but deep horizontal cracks still remain with significant voids in places. Cracking to the repaired concrete section observed.		
	Recommendations		
	Repair cracks, voids and undercutting. Consider extending the rock scour protection

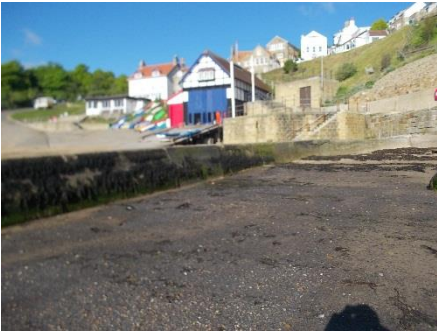
Asset Location:	NZ81011606, NZ81031605.	
	Asset Length:	26.1	
	Condition Assessment		
	Condition	Priority	Risk
	C	2	
	Brief Description		
	Breakwater / groyne. Large deep horizontal cracks through breakwater have worsened since 2012. Crest slab may have moved. Multiple patches and cracks. Smaller vertical cracks to breakwater at sea end. Poor condition overall		
Recommendations			
Patch repair where required.

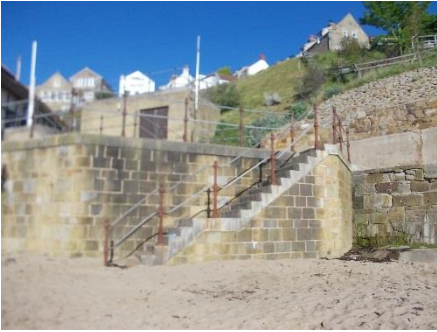
Asset Location:		
	Asset Length:	7	
	Condition Assessment		
	Condition	Priority	Risk
	B	4	>5
	Brief Description		
	Corrosion to handrail standards, especially on steps. Minor surface damage to steps.		
Recommendations			
Treat handrails or replace. Continue to monitor

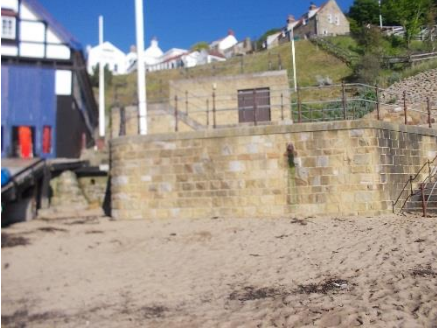
Asset Location:	Runswick Bay. Pumping station.	
	Asset Length:	33.3	
	Condition Assessment		
	Condition	Priority	Risk
	B	4	>5
	Brief Description		
	Pumping station and associated sea wall and berm. Wall and berm in good condition. Some cracks around mortar starting to show. Corrosion to handrail		
Recommendations			
Continue to monitor

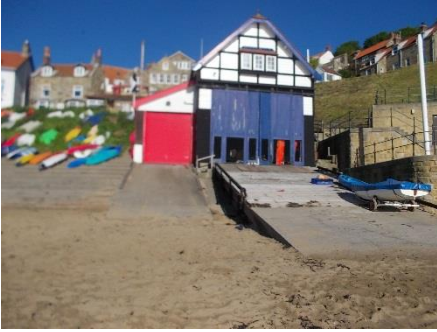
Asset Location:	NZ81011601. Lifeboat slipway.	
	Asset Length:	43.8	
	Condition Assessment		
	Condition	Priority	Risk
	B	3	
	Brief Description		
	Rotting timber supports to disused timber slipway - some planks recently replaced in deck. Cracks to side walls of smaller slipway. Southern slipway / ramp in good condition. Concrete revetment including timber grippers in good condition with joints recently repaired.		
	Recommendations		
	Repair cracks to slipway, replace rotten/missing timbers

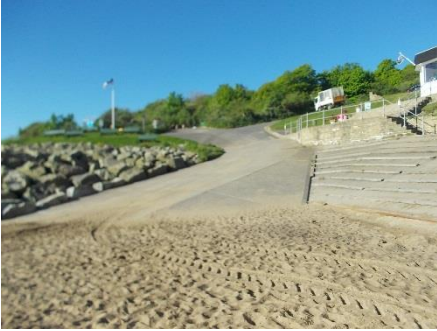
Asset Location:		
	Asset Length:	~30	
	Condition Assessment		
	Condition	Priority	Risk
	B	4	>5
	Brief Description		
	Southern slipway / ramp in good condition.		
Recommendations			
Continue to monitor

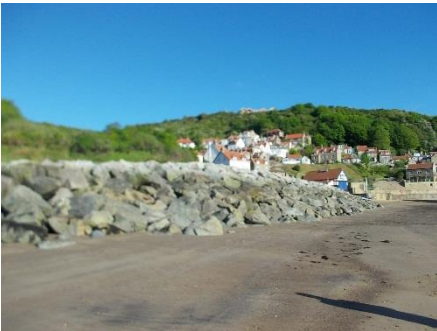
Asset Location:	NZ81051591, NZ81011601	
	Asset Length:	290	
	Condition Assessment		
	Condition	Priority	Risk
	B	4	>5
	Brief Description		
	Rock armour mostly in very good condition and tightly packed		
	Recommendations		
Continue to monitor

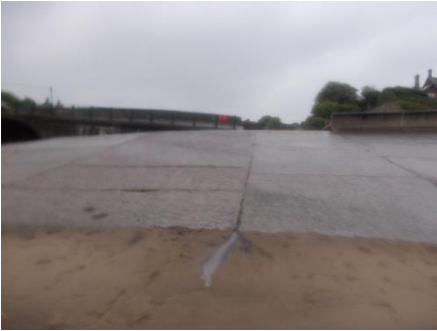
Asset Location:		
	Asset Length:	~15	
	Condition Assessment		
	Condition	Priority	Risk
	B	3	
	Brief Description		
	Missing filler in joints to slipway. Revetment in good condition		
	Recommendations		
Continue to monitor

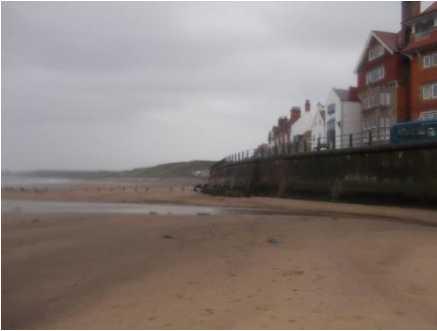
Asset Location:	NZ86061286, NZ86241268	
	Asset Length:	259.1	
	Condition Assessment		
	Condition	Priority	Risk
	C	2	
	Brief Description		
	Groynes derelict. Beach higher than 2012, apron part buried, assume still very poor. Timber planks & stakes next to apron missing and rotten. Missing joints filler under capping beam. Missing sealant in most joints in wall, with abrasion around joints.		
	Recommendations		
Re-seal joints between poured sections of sea wall, and replace apron

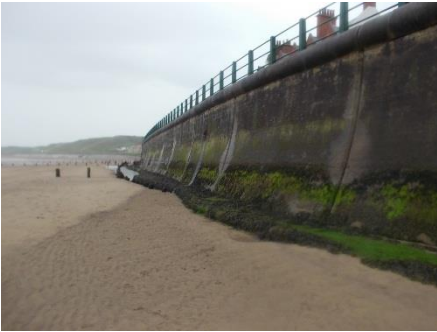
Asset Location:	Same as 14-09B-01	
	Asset Length:	Incl. in 14-09B-01	
	Condition Assessment		
	Condition	Priority	Risk
	C	2	
	Brief Description		
	Groynes derelict. Beach higher than 2012, apron part buried, assume still very poor. Timber planks & stakes next to apron missing and rotten. Missing joints filler under capping beam. Missing sealant in most joints in wall, with abrasion around joints.		
	Recommendations		
Re-seal joints between poured sections of sea wall, and replace apron

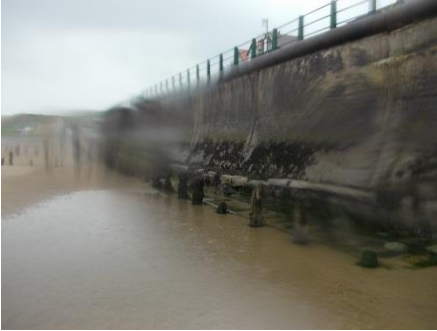
Asset Location:	Same as 14-09B-01	
	Asset Length:	Incl. in 14-09B-01	
	Condition Assessment		
	Condition	Priority	Risk
	C	2	
	Brief Description		
	Groynes derelict. Apron still very poor. Timber planks & stakes next to apron missing and rotten. Missing joints filler under capping beam. Missing sealant in most joints in wall, with abrasion around joints.		
	Recommendations		
Re-seal joint between poured sections of sea wall, and replace apron

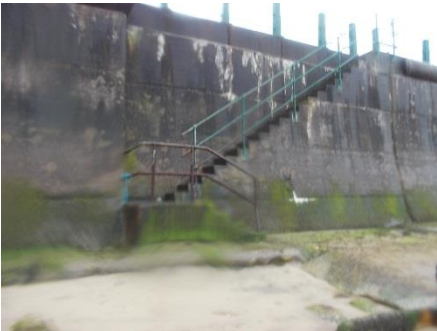
Asset Location:		
	Asset Length:	~4	
	Condition Assessment		
	Condition	Priority	Risk
	B	3	
	Brief Description		
	Fair condition with localised damage to concrete facing. Handrail corroded		
	Recommendations		
Replace handrail

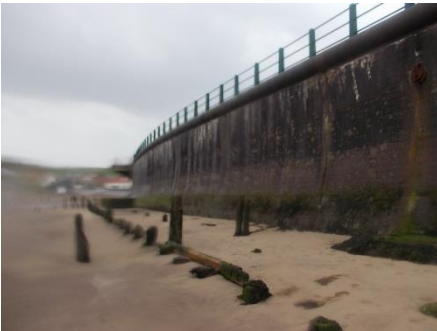
Asset Location:	Same as 14-09B-01	
	Asset Length:	Incl. in 14-09B-01	
	Condition Assessment		
	Condition	Priority	Risk
	C	2	
	Brief Description		
	Groynes derelict. Beach higher than 2012, apron part buried, assume still v poor. Timber planks & stakes next to apron missing and rotten. Missing joints filler under capping beam. Missing sealant in most very joints in wall, with abrasion around joints.		
	Recommendations		
Re-seal joints between poured sections of sea wall, and replace apron

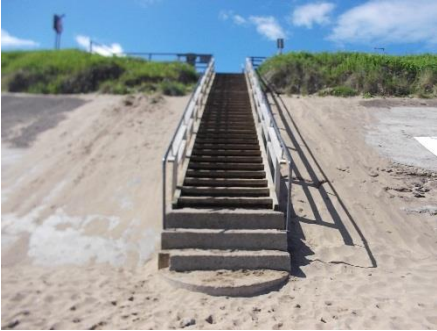
Asset Location:		
	Asset Length:	774.5 total (15-09b-06 to 17-10-02)	
	Condition Assessment		
	Condition	Priority	Risk
	B	3	
	Brief Description		
	Timber steps + 3 concrete steps on the bottom part Timber steps renewed recently		
	Recommendations		
Continue to monitor

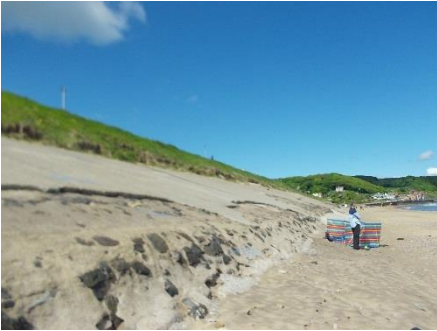
Asset Location:		
	Asset Length:	774.5 total (15-09b-06 to 17-10-02)	
	Condition Assessment		
	Condition	Priority	Risk
	C	2	
	Brief Description		
	Cracks throughout revetment and missing sections of concrete overlay exposing rubble and stone under layer and voids. Evidence of multiple repairs (presumably following surge in December 2013). Undercutting to bottom of revetment. Improvement scheme planned.		
	Recommendations		
Keep patching up until scheme in place

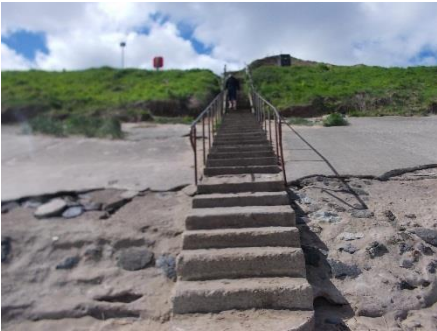
Asset Location:		
	Asset Length:	774.5 total (15-09b-06 to 17-10-02)	
	Condition Assessment		
	Condition	Priority	Risk
	C	2	
	Brief Description		
	Mixed construction (bottom concrete + top timber) 8th tread (from beach) broken / missing. Concrete surfacing weathered		
	Recommendations		
Continue to monitor

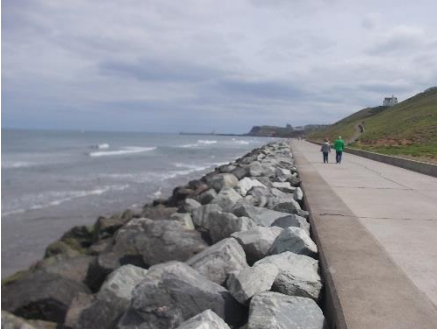
Asset Location:	NZ88161194, NZ88541185	
	Asset Length:	439.3	
	Condition Assessment		
	Condition	Priority	Risk
	B	3	
	Brief Description		
	Rock armour gen good, well packed but movement in several local areas. Some smaller armour loosely packed on crest. Prom as in 2012, some slabs have settled. Localised damages to prom capping and rear 'splash' wall observed. Large crack on prom at mid-section left opened.		
	Recommendations		
Continue to monitor surface cracking in promenade

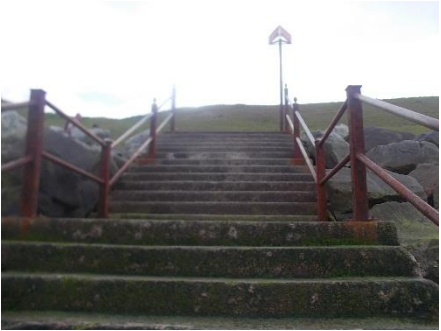
Asset Location:		
	Asset Length:	~5	
	Condition Assessment		
	Condition	Priority	Risk
	C	3	
	Brief Description		
	Steps. Heavily corroded handrail Crack on bottom tread. Steps covered by vegetation (i.e. slippery)		
	Recommendations		
Treat or replace handrails. Continue to monitor

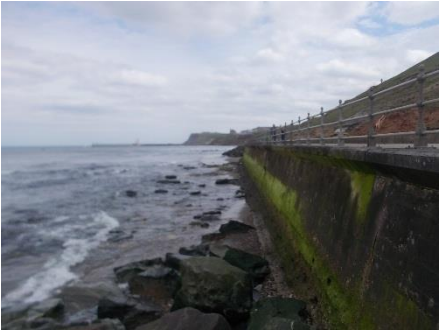
Asset Location:	Part of 18-11A-02	
	Asset Length:		
	Condition Assessment		
	Condition	Priority	Risk
	B	3	
	Brief Description		
	Rock revetment – remainder of 18-11A-02 Loosely / scattered rock armour at the end		
	Recommendations		
Reinforce rock revetment

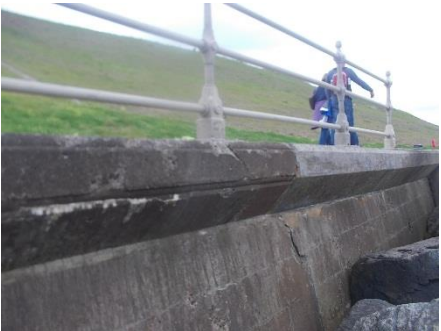
Asset Location:	NZ88541185, NZ88671180	
	Asset Length:	136.6	
	Condition Assessment		
	Condition	Priority	Risk
	C	3	
	Brief Description		
	Concrete wall has extensive minor cracking. Heavy abrasion over whole lower part of wall. Toe not visible, but beach low. Local damage to capping. Promenade no major defects. Handrails have been repaired.		
	Recommendations		
Consider extending rock revetment

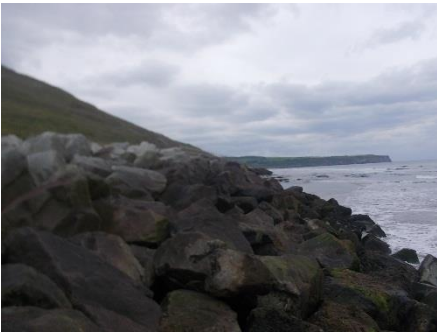
Asset Location:	NZ88671180, NZ88861170	
	Asset Length:	216.1 (inc 70-11a-01 to 70-11a-04)	
	Condition Assessment		
	Condition	Priority	Risk
	B	3	
	Brief Description		
	Rock armour in good condition, closely packed, and good coverage. Some smaller rocks on crest lost interlock. Promenade surface showing some signs of cracking and sealant loss between concrete sections.		
	Recommendations		
Replace joints. Continue to monitor

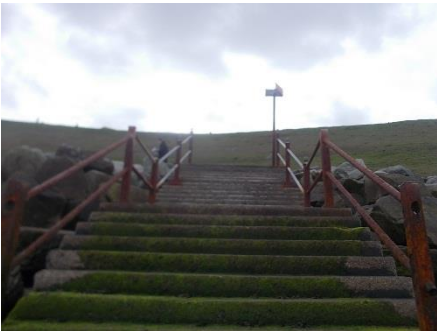
Asset Location:	Western promenade, Whitby	
	Asset Length:	216.1 (inc 70-11a-01 to 70-11a-04)	
	Condition Assessment		
	Condition	Priority	Risk
	B	3	
	Brief Description		
	Steps. Corroded handrail with vegetation cover on the bottom half. Concrete weathered		
	Recommendations		
Treat or replace handrails. Continue to monitor

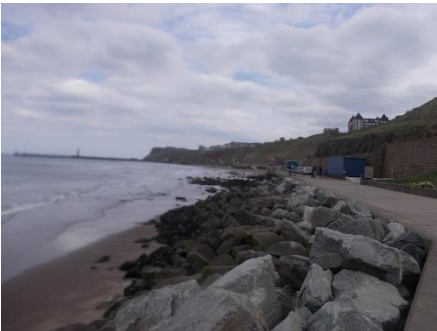
Asset Location:	Western promenade, Whitby	
	Asset Length:	216.1 (inc 70-11a-01 to 70-11a-04)	
	Condition Assessment		
	Condition	Priority	Risk
	B	3	
	Brief Description		
	Rock armour in good condition, closely packed, and good coverage. Some smaller rocks on crest lost interlock. Promenade surface showing some signs of cracking and sealant loss between concrete sections.		
	Recommendations		
Replace joints. Continue to monitor

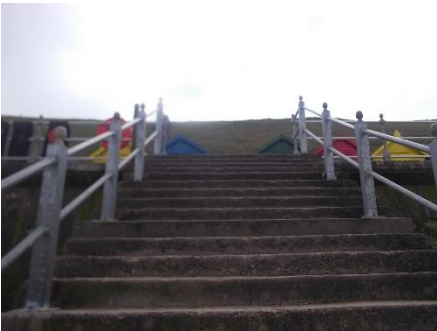
Asset Location:	Western promenade, Whitby	
	Asset Length:	~ 4	
	Condition Assessment		
	Condition	Priority	Risk
	B	3	
	Brief Description		
	Tread repaired half way up the steps. Sheet pile toe is exposed with steel capping. The steel rise 'facing' on the bottom step has moved seaward. Handrail in generally good condition.		
	Recommendations		
Continue to monitor

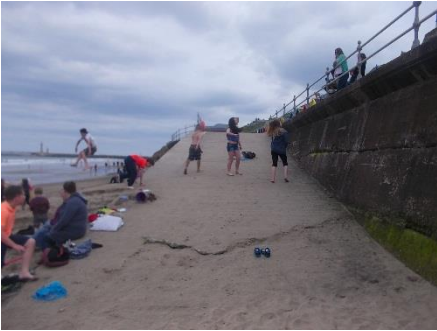
Asset Location:	Western promenade, Whitby	
	Asset Length:	~12	
	Condition Assessment		
	Condition	Priority	Risk
	C	2	
	Brief Description		
	Slipway. Loss of section of render on wing wall. Lower concrete revetment broken / missing. Toe below beach level.		
	Recommendations		
Continue to monitor

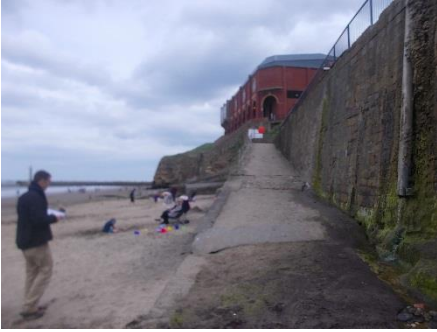
Asset Location:		
	Asset Length:	30	
	Condition Assessment		
	Condition	Priority	Risk
	C	3	
	Brief Description		
	Slipway. Mixed construction. Settlement of toe remediated with concrete transition slope. Open joints between blocks revetment		
	Recommendations		
Repair joints. Continue to monitor

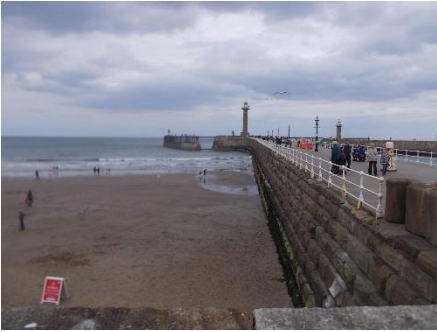
Asset Location:	NZ89861145, NZ89931173 West pier.	
	Asset Length:	639.7	
	Condition Assessment		
	Condition	Priority	Risk
	B	3	
	Brief Description		
	Inspection from crest side in generally fair condition. Some local movement and cracking of blocks. Prom has cracking between slabs. Handrails showing rust stains but intact. Where visible inner toe OK.		
	Recommendations		
Investigate and repair displaced/missing blocks

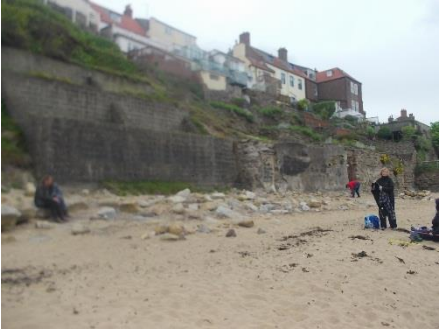
Asset Location:	South of Collier Hope and Mussel Beds	
	Asset Length:	154.9	
	Condition Assessment		
	Condition	Priority	Risk
	C	3	
	Brief Description		
	Riparian walls in various conditions, some quite poor. Protected by sand and cobble beach. Spalling to the render and exposure of the aggregate. Slipway and steps weathered with missing joints.		
	Recommendations		
Continue to monitor, repoint where needed. Replace missing blocks

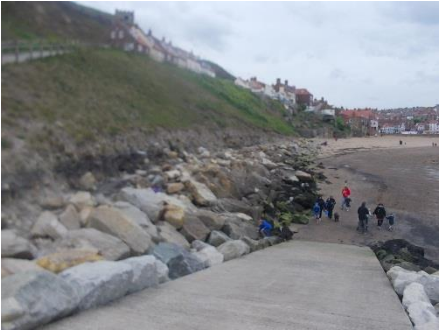
Asset Location:	NZ90171146, NZ90421143. East side of pier.	
	Asset Length:	420.7	
	Condition Assessment		
	Condition	Priority	Risk
	C	1	
	Brief Description		
	Rock armour inside harbour very poor - evidence of wave damage to slope above revetment & failed / displaced /missing rock - cliff eroding above rock. Geogrid slope revetment undermined and obsolete. Outside harbour - section of rock armour washed out to sea leaving toe of cliff exposed to wave action.		
	Recommendations		
Add rock armour outside and inside harbour

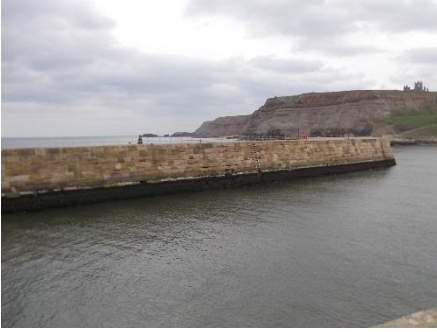
Asset Location:	NZ90161146, NZ90001174. East Pier.	
	Asset Length:	637	
	Condition Assessment		
	Condition	Priority	Risk
	B	3	
	Brief Description		
	Signs of many repairs to deck, but some open joints seen. Erosion to capping beams. Voids & settled blockwork at NE bend, inside face. Large cracks at several locations. Loose blocks at S end by rock armour. Toe piles corroded. Settled blocks on E face. Timber edge protection at Eastern end rotten.		
	Recommendations Continue to monitor and patch up pending capital repair scheme

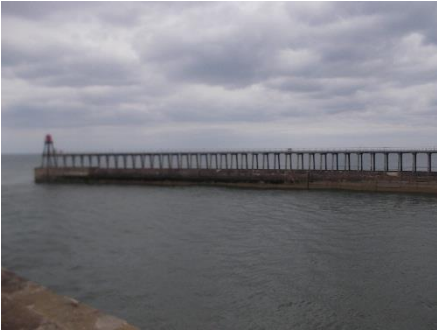
Asset Location:	NZ90041172, NZ89971186. East breakwater.	
	Asset Length:	330.9	
	Condition Assessment		
	Condition	Priority	Risk
	C	3	
	Brief Description		
	Limited visibility due to tide level and no access. Eroded joints and gaps in wall. Timber structure in poor condition. Corroded toe piles. Repair completed in 2012, more needed.		
	Recommendations Repair further sections of toe pile. Detailed inspection required

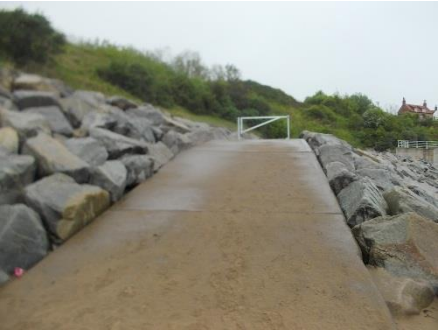
Asset Location:	NZ95320468, NZ95310481	
	Asset Length:	~20	
	Condition Assessment		
	Condition	Priority	Risk
	B	4	>5
	Brief Description		
	Slipway in good condition.		
	Recommendations		
	Continue to monitor

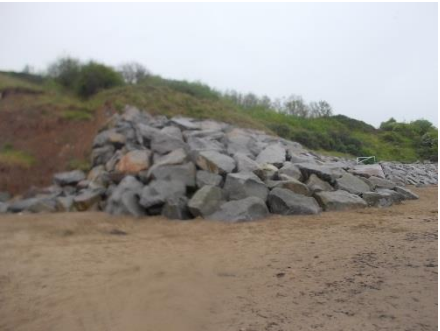
Asset Location:	NZ95320468, NZ95310481	
	Asset Length:	54.3	
	Condition Assessment		
	Condition	Priority	Risk
	B	3	
	Brief Description		
	Rock armour mostly well packed, but cliffs slumping from rear over top of revetment has damaged and displaced rock, particular just South of slipway / ramp.		
	Recommendations		
	Re-profile armour near end of slipway

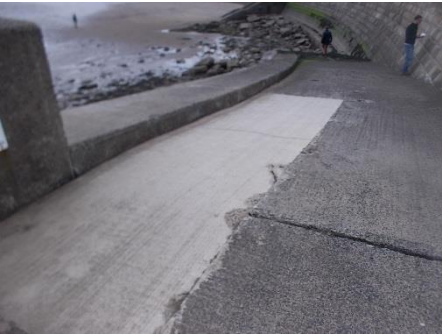
Asset Location:	TA03549057, TA03569082. Wall and promenade next to Sea Life Centre.	
	Asset Length:	~15	
	Condition Assessment		
	Condition	Priority	Risk
	B	3	
	Brief Description		
	Slipway at S not usable due to toe erosion. Evident revetment repairs seaward on the top half.		
	Recommendations		
Continue to monitor

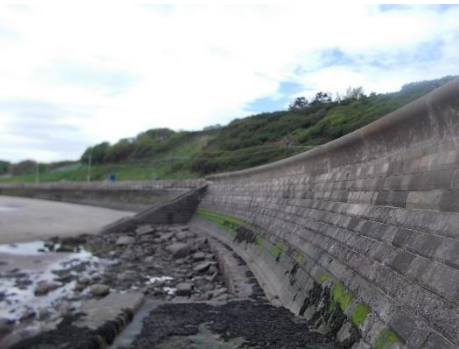
Asset Location:	Between slipway and steps	
	Asset Length:	Part of overall wall length (327.2)	
	Condition Assessment		
	Condition	Priority	Risk
	B	3	
	Brief Description		
	Blockwork in fair condition.		
	Recommendations		
Continue to monitor

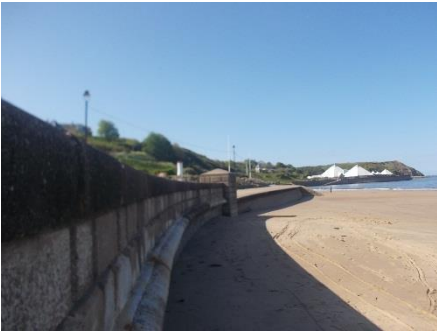
Asset Location:	TA0357690349 North of slipway and beach huts.	
	Asset Length:	73.8	
	Condition Assessment		
	Condition	Priority	Risk
	C	3	
	Brief Description		
	Face loss with exposed aggregates. Cracking to parts of promenade. Revetment to rear of prom appears in good condition, recently repaired.		
	Recommendations		
Repair face of wall and cracks in promenade

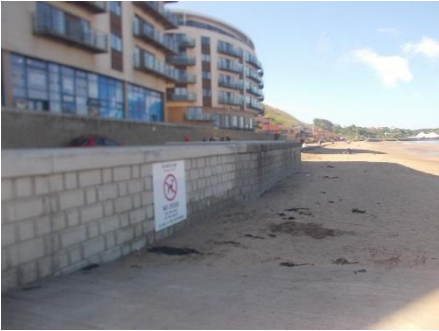
Asset Location:	TA03818971, TA03758981	
	Asset Length:	34.2	
	Condition Assessment		
	Condition	Priority	Risk
	B	3	
	Brief Description		
	Wall has been repaired. South section rebuilt / overlaid. Cracking still evident at N end (I.e. 3 vertical cracks after the section which was re-built)		
	Recommendations		
Monitor and repair cracks

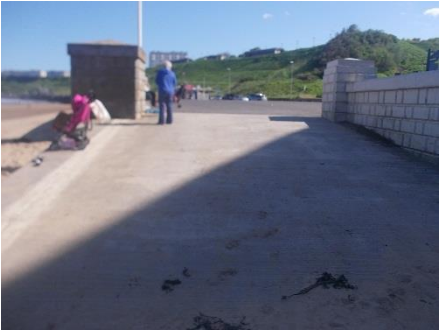
Asset Location:		
	Asset Length:		
	Condition Assessment		
	Condition	Priority	Risk
	A	4	5
	Brief Description		
	Slipway in good condition – As new		
	Recommendations		
No issues

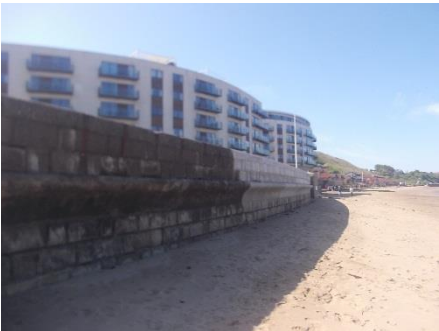
Asset Location:	TA03818971, TA03758981. In front of new development.	
	Asset Length:	93.2	
	Condition Assessment		
	Condition	Priority	Risk
	B	3	
	Brief Description		
	Upper wall has been rebuilt at North end. South pier has been rebuilt next to slipway. Facing of some blocks missing. Fair overall condition		
	Recommendations		
Repair missing joints and chipped parts of capping and splash beams

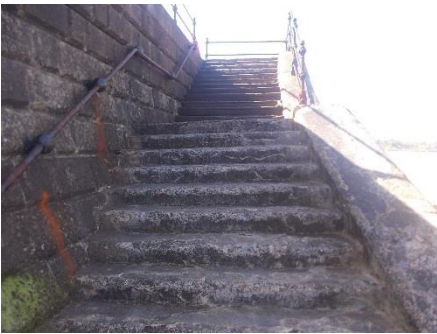
Asset Location:		
	Asset Length:	~7	
	Condition Assessment		
	Condition	Priority	Risk
	C	3	
	Brief Description		
	Erosion / undercutting of steps at South end. Steps abraded. Missing blocks near toe in centre.		
	Recommendations		
Replace missing block. Recast step treads

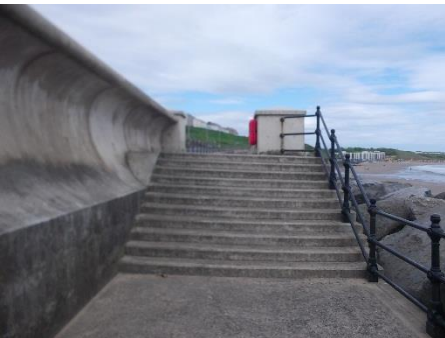
Asset Location:		
	Asset Length:	~5	
	Condition Assessment		
	Condition	Priority	Risk
	B	4	>5
	Brief Description		
	Steps: Good condition throughout		
	Recommendations		
Continue to monitor
