Asset Inspection Document

Walk-over Visual Inspections of Assets

Scarborough Borough Council

September 2016

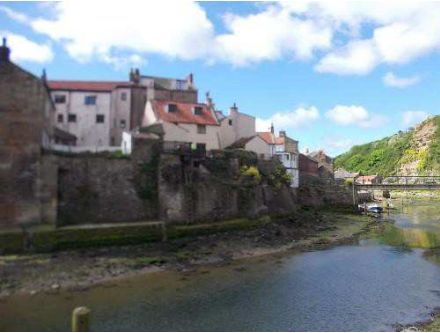
Asset Location:	NZ78261889, NZ78301886. South bank from bridge.	
	Asset Length:	117.1	
	Condition Assessment		
	Condition	Priority	Risk
	C	3	
	Brief Description		
	Repair work to parts of wall evident. Vegetation regrowing in parts of the wall. Minor cracks evident thought wall.		
	Recommendations		
Monitor, repair cracks, fill voids and undercutting to toe.

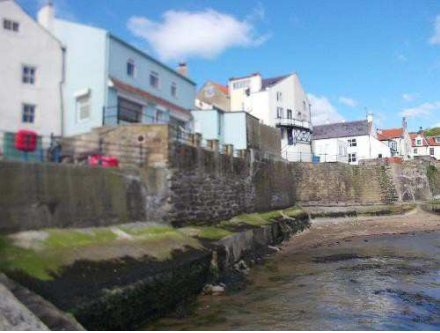
Asset Location:	Between slipway and groyne on South wall.	
	Asset Length:	47.7	
	Condition Assessment		
	Condition	Priority	Risk
	C	3	
	Brief Description		
	Repairs evident to cracks and missing blocks replaced. Groyne in good condition. Missing joints to slipway wall. Further cracks/missing blocks.		
	Recommendations		
Repairs to walls joints, cracks and toe.

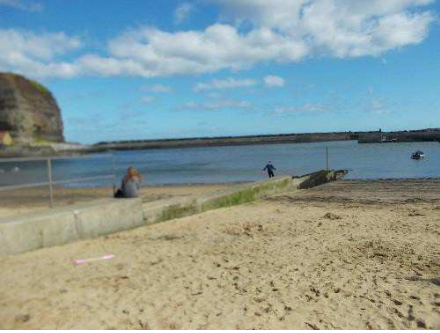
Asset Location:	NZ78361882, NZ78381885. In-between South slipways.	
	Asset Length:	32	
	Condition Assessment		
	Condition	Priority	Risk
	B	3	
	Brief Description		
	Groyne in good condition.		
	Recommendations		
	Continue to monitor.

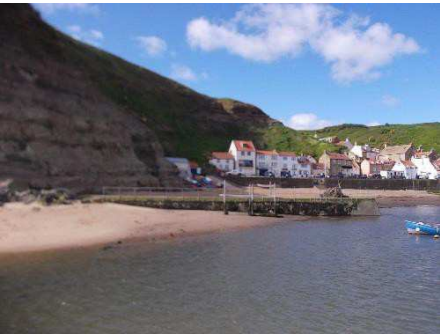
Asset Location:	NZ78431886, NZ78461884 Behind South breakwater.	
	Asset Length:	39	
	Condition Assessment		
	Condition	Priority	Risk
	B	3	
	Brief Description		
	Good condition concrete breakwater, some cracking in top surface. Algae growth to walls.		
	Recommendations		
Continue to monitor.

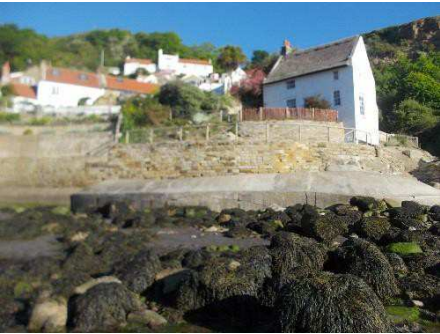
Asset Location:	North side of Runswick Bay	
	Asset Length:	25.3	
	Condition Assessment		
	Condition	Priority	Risk
	C	2	
	Brief Description		
	Cracks to top of bagwork. Some horizontal cracks at base of toe. Repair work evident to large cracks. Cracks to wall, as well as repair work evident to previous cracks. Some missing masonry blocks.		
	Recommendations		
Continue to monitor and repair cracks, replace blocks

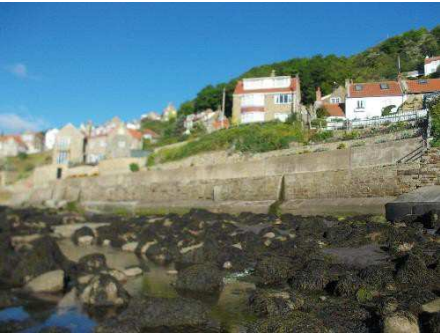
Asset Location:	NZ81001604, NZ81081614. North of breakwater.	
	Asset Length:	91.3	
	Condition Assessment		
	Condition	Priority	Risk
	C	2	
	Brief Description		
	Washout of the joints to masonry block wall. Repairs to coping masonry and crest evident. Cracks to toe berm. Some cracks to promenade. Repairs to steps and toe being undercut. Beach low West of outfall exposing mudstone platform.		
	Recommendations		
Repair cracks, voids and undercutting. Consider extending the rock scour protection.

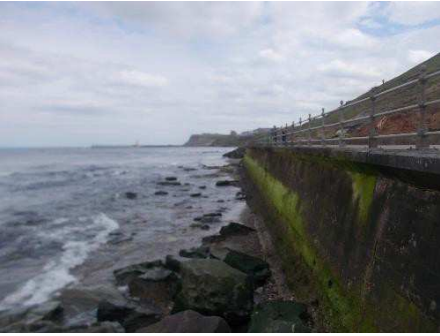
Asset Location:	Part of 18-11A-02	
	Asset Length:		
	Condition Assessment		
	Condition	Priority	Risk
	B	3	
	Brief Description		
	Rock revetment – remainder of 18-11A-02 Loosely / scattered rock armour at the end		
	Recommendations		
Reinforce rock revetment

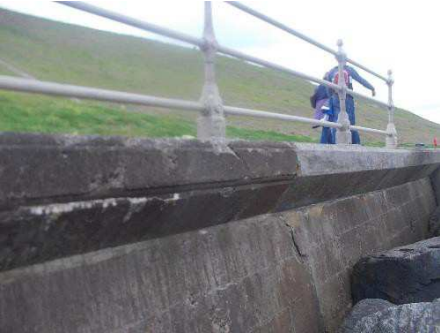
Asset Location:	NZ88541185, NZ88671180	
	Asset Length:	136.6	
	Condition Assessment		
	Condition	Priority	Risk
	C	3	
	Brief Description		
	Concrete wall has extensive minor cracking. Heavy abrasion over whole lower part of wall. Toe not visible, but beach low. Local damage to capping. Promenade no major defects. Handrails have been repaired.		
	Recommendations		
Consider extending rock revetment

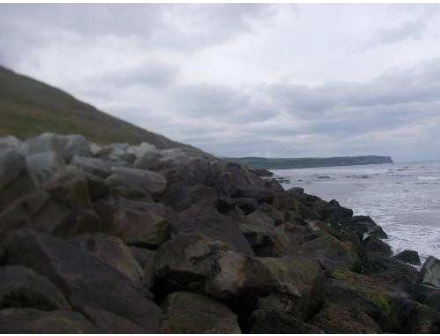
Asset Location:	NZ88671180, NZ88861170	
	Asset Length:	216.1 (inc 70-11a-01 to 70-11a-04)	
	Condition Assessment		
	Condition	Priority	Risk
	B	3	
	Brief Description		
	Rock armour in good condition, closely packed, and good coverage. Some smaller rocks on crest lost interlock. Promenade surface showing some signs of cracking and sealant loss between concrete sections.		
	Recommendations		
Replace joints. Continue to monitor

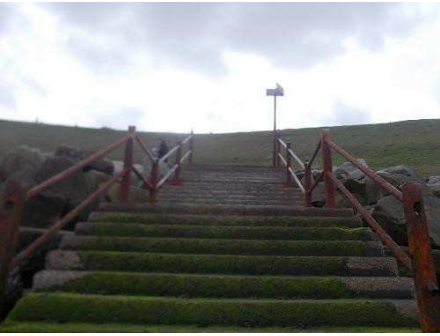
Asset Location:	Western promenade, Whitby	
	Asset Length:	216.1 (inc 70-11a-01 to 70-11a-04)	
	Condition Assessment		
	Condition	Priority	Risk
	B	3	
	Brief Description		
	Steps. Heavy abrasion on lower sections of steps.		
	Recommendations		
Continue to monitor

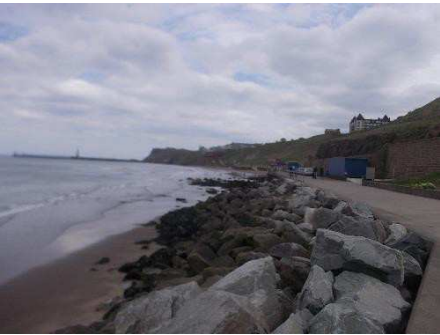
Asset Location:	Western promenade, Whitby	
	Asset Length:	216.1 (inc 70-11a-01 to 70-11a-04)	
	Condition Assessment		
	Condition	Priority	Risk
	B	3	
	Brief Description		
	Rock armour in good condition, closely packed, and good coverage. Some smaller rocks on crest lost interlock. Promenade surface showing some signs of cracking and sealant loss between concrete sections.		
	Recommendations		
Replace joints. Continue to monitor

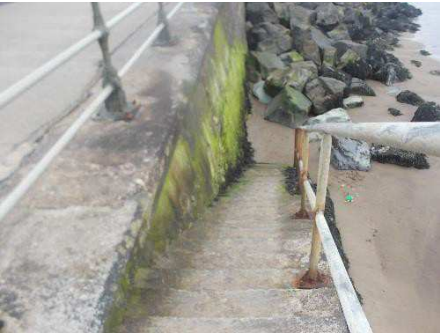
Asset Location:	Western promenade, Whitby	
	Asset Length:	216.1 (inc 70-11a-01 to 70-11a-04)	
	Condition Assessment		
	Condition	Priority	Risk
	C	3	
	Brief Description		
	Steps. Tread condition fair. Damaged capping and side wall corner - heavily abraded with missing blocks. Handrail corroded and loose fixing at the bottom. Heavy abrasion on lower sections of steps.		
	Recommendations		
Treat or replace handrails. Repair capping and replace blocks

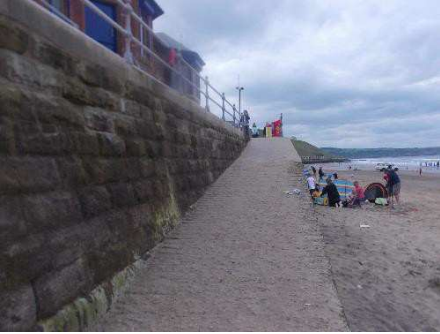
Asset Location:		
	Asset Length:	~30	
	Condition Assessment		
	Condition	Priority	Risk
	C	3	
	Brief Description		
	Slipway. Concrete deck replaced on the top half of the structure - bottom half abraded		
	Recommendations		
Continue to monitor

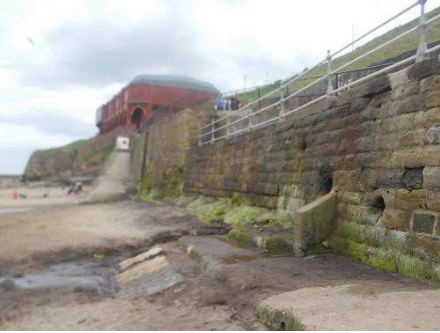
Asset Location:	NZ89361152, NZ89401152	
	Asset Length:	37.5	
	Condition Assessment		
	Condition	Priority	Risk
	C	3	
	Brief Description		
	Blockwork wall with many open joints. Abrasion and loss of blocks and mortar in lower section and under ramp. Water seeping through wall and leaking pipe as in 2012. Beach lower exposing toe structure which is abraded. Cracks in coping of upper wall behind sea wall.		
	Recommendations		
Repair or encase toe. Repair cracking in masonry wall. Repair pipe

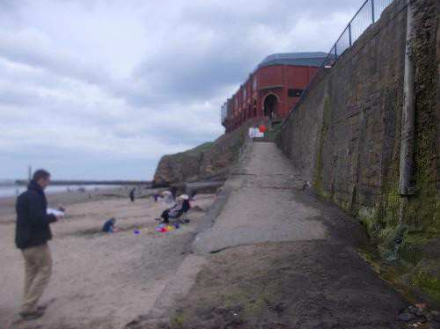
Asset Location:		
	Asset Length:	30	
	Condition Assessment		
	Condition	Priority	Risk
	C	3	
	Brief Description		
	Slipway. Mixed construction. Settlement of toe remediated with concrete transition slope. Open joints between blocks revetment and occasional cracks and voids.		
	Recommendations		
Repair joints, cracks and voids. Continue to monitor

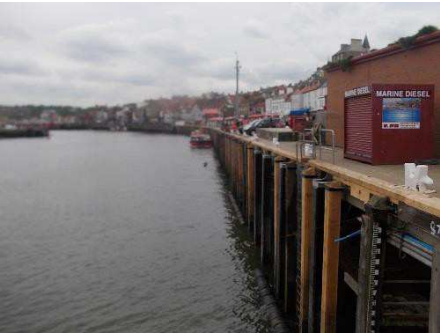
Asset Location:	West bank, Whitby Harbour	
	Asset Length:	215.4	
	Condition Assessment		
	Condition	Priority	Risk
	B	4	5
	Brief Description		
	Timber edge beam and fenders recently replaced. Deck support piles corroding. Original wall viewed from ends, looks fair. Some voids to blockwork. Deck support piles corroding.		
	Recommendations		
Detailed inspection of supporting piles to deck required

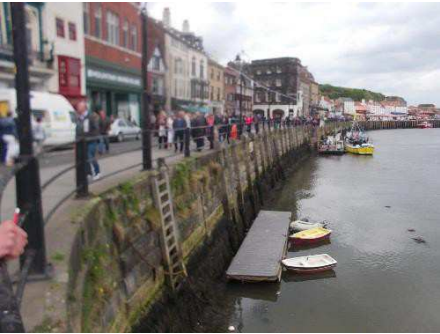
Asset Location:	West bank, Whitby Harbour	
	Asset Length:	157.4	
	Condition Assessment		
	Condition	Priority	Risk
	C	3	4
	Brief Description		
	Timber fenders along length, vegetation to upper part of wall. Promenade in good condition. Lower wall obscured by seaweed. Steps cracked and open joints at mid-length. Concrete steps repaired but cracking and abrasion still evident. No handrail. Corrosion to floating pontoon supports at steps.		
	Recommendations		
Repair and repoint joints at steps

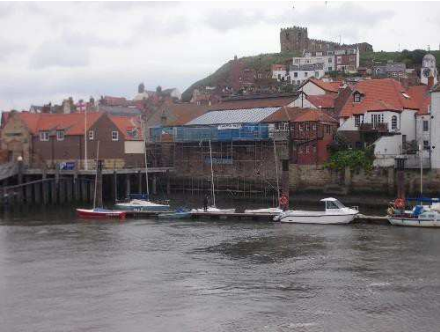
Asset Location:	East bank, D/S of Whitby Bridge	
	Asset Length:	135.2	
	Condition Assessment		
	Condition	Priority	Risk
	B	3	
	Brief Description		
	Looks fair - some joint washout to riparian walls. Area of damage to blocks 20m d/s of bridge. Limited access, visual inspection from RNLI and bridge. Concrete apron near to the bridge appears in fair condition including the sheet pile toe.		
	Recommendations		
	Continue to monitor – repair washed out joints to wall

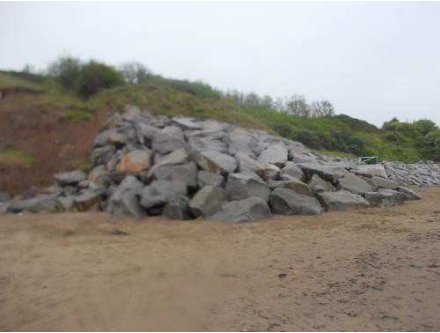
Asset Location:	NZ95320468, NZ95310481	
	Asset Length:	54.3	
	Condition Assessment		
	Condition	Priority	Risk
	B	3	
	Brief Description		
	Rock armour mostly well packed, but cliffs slumping from rear over top of revetment has damaged and displaced rock, particular just South of slipway / ramp.		
	Recommendations		
	Re-profile armour near end of slipway.

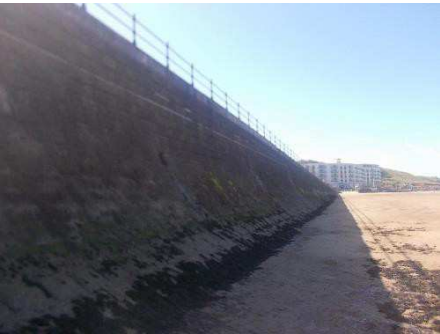
Asset Location:	TA03818971, TA04078946 East of Alexandra Gardens.	
	Asset Length:	158.9	
	Condition Assessment		
	Condition	Priority	Risk
	B	3	
	Brief Description		
	Previous repair work to cracks holding. Prom relaid in concrete in 2012 in good cond. Abrasion at steps S end.		
	Recommendations		
Cracks need repointing throughout sea wall. Repair damage to coping and toe.

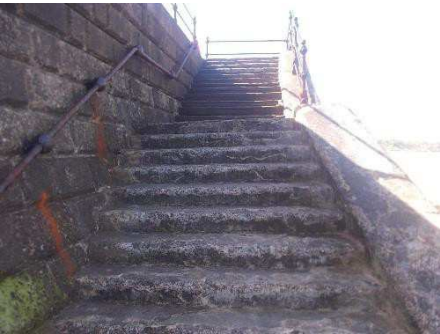
Asset Location:		
	Asset Length:	~7	
	Condition Assessment		
	Condition	Priority	Risk
	C	3	
	Brief Description		
	2015: Erosion / undercutting of steps at South end. Steps abraded. Missing blocks near toe in centre. 2016: Not inspected in detail.		
	Recommendations		
Replace missing block. Recast step treads

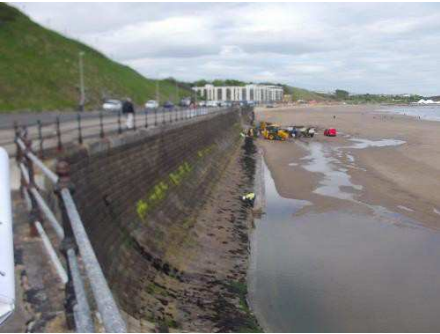
Asset Location:	TA03818971, TA04078946 East of Alexandra Gardens.	
	Asset Length:	211.1	
	Condition Assessment		
	Condition	Priority	Risk
	C	3	
	Brief Description		
	Erosion to capping at edge of prom. Cracks and holes between capping and prom. Prom surface replaced in 2012 at N and S ends, but centre still to do.		
	Recommendations		
Complete repairs. Fill/seal joints in prom at rear of coping.

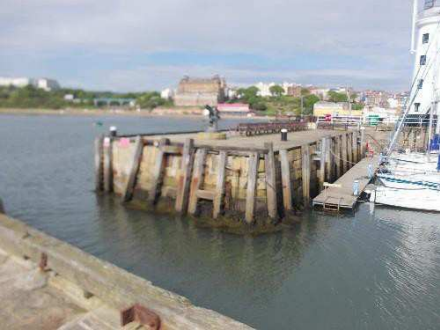
Asset Location:	TA04958853, TA04938860. Lighthouse island.	
	Asset Length:	83.5	
	Condition Assessment		
	Condition	Priority	Risk
	C	3	
	Brief Description		
	Inner wall at entrance breakwater. Numerous cracks to blocks and missing mortar in joints. Vegetation and fenders obscuring most of walls. Only inspected from distance.		
	Recommendations		
Continue to monitor and repoint cracks and joints.

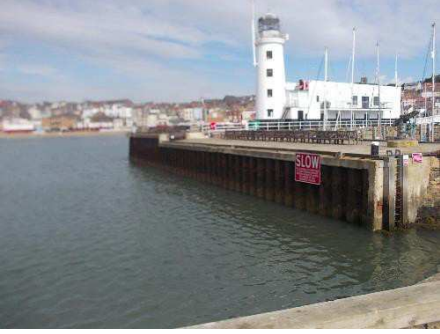
Asset Location:	TA04958853, TA04938860. Wall at south side of Lighthouse island	
	Asset Length:	97	
	Condition Assessment		
	Condition	Priority	Risk
	B	3	
	Brief Description		
	Outer face. Sheet piles heavily corroded, although obscured by vegetation growing on the bottom of the piling.		
	Recommendations		
Repair cracks.

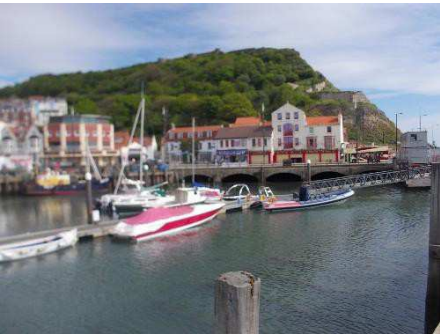
Asset Location:	TA05048878, TA05088877. South of roundabout opposite arcade.	
	Asset Length:	43.2	
	Condition Assessment		
	Condition	Priority	Risk
	B	3	
	Brief Description		
	Cracking and missing joints to top of capping, arches look structurally sound. Promenade in good condition.		
	Recommendations		
Repair cracks and damage to coping.
