Cell 1 Regional Coastal Monitoring Programme Walkover Inspection Surveys 2022

**Scarborough
Borough Council**

November 2022

Walkover Inspection Surveys 2022

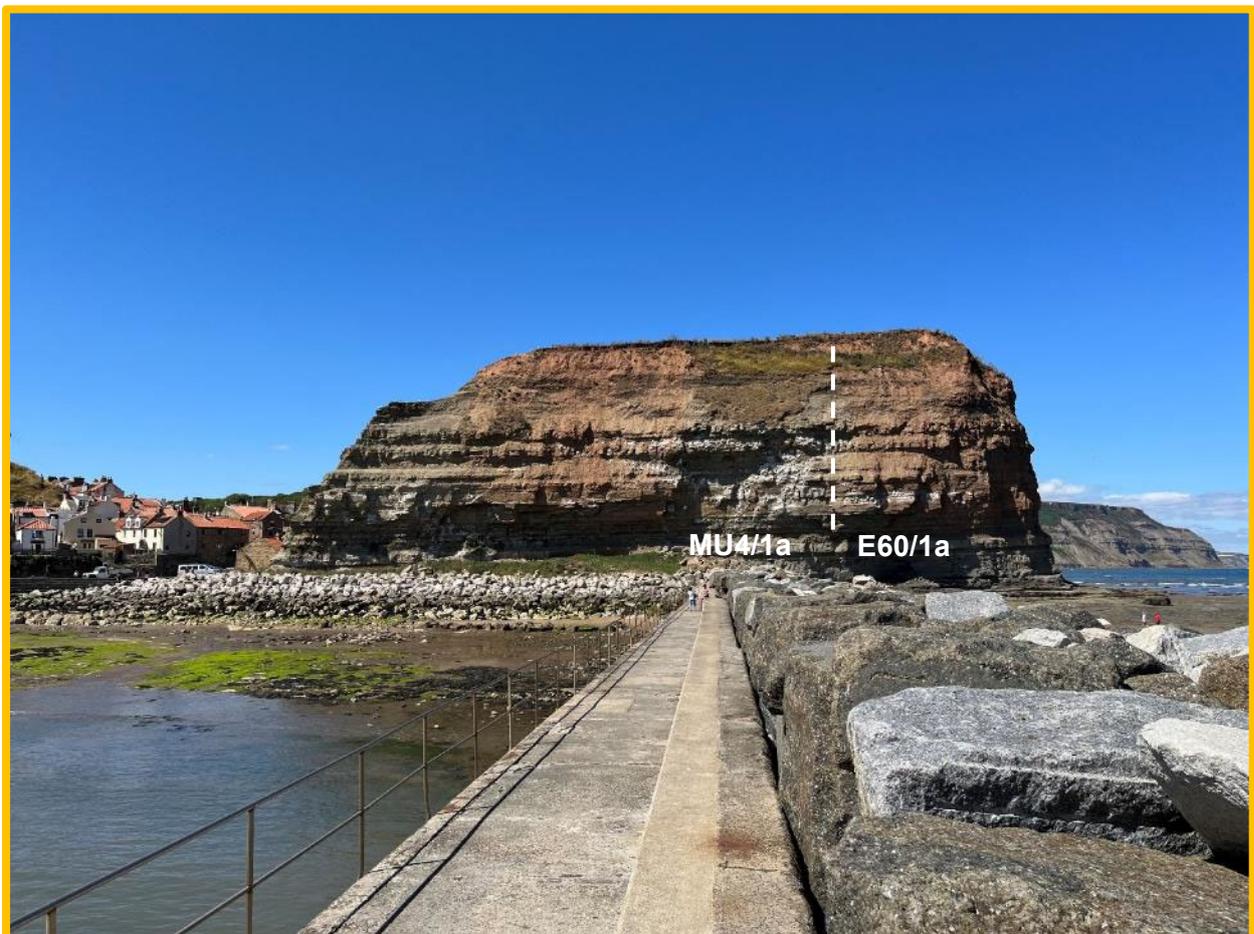
East-facing Cowbar Nab. E60/1a (right) and MU4/1a (left). Partly Active in July 2022

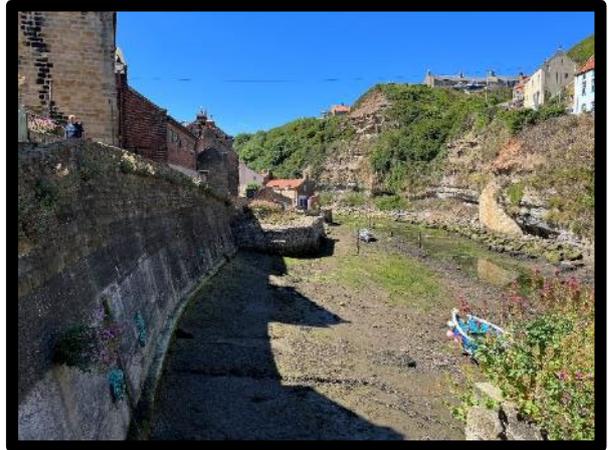
South bank: Stone-filled gabion baskets constructed in 2013 to repair collapsed wall (no asset ref)

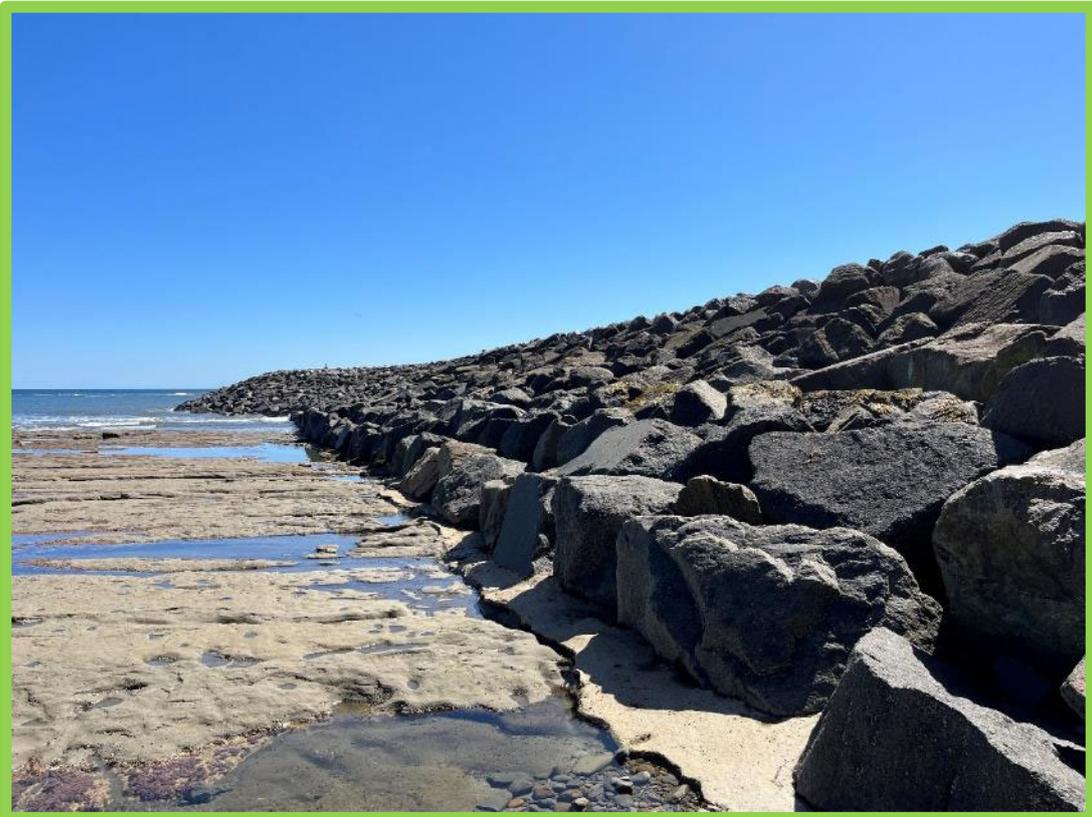
Rock armour revetment on seaward face of North Breakwater (/0402C01)

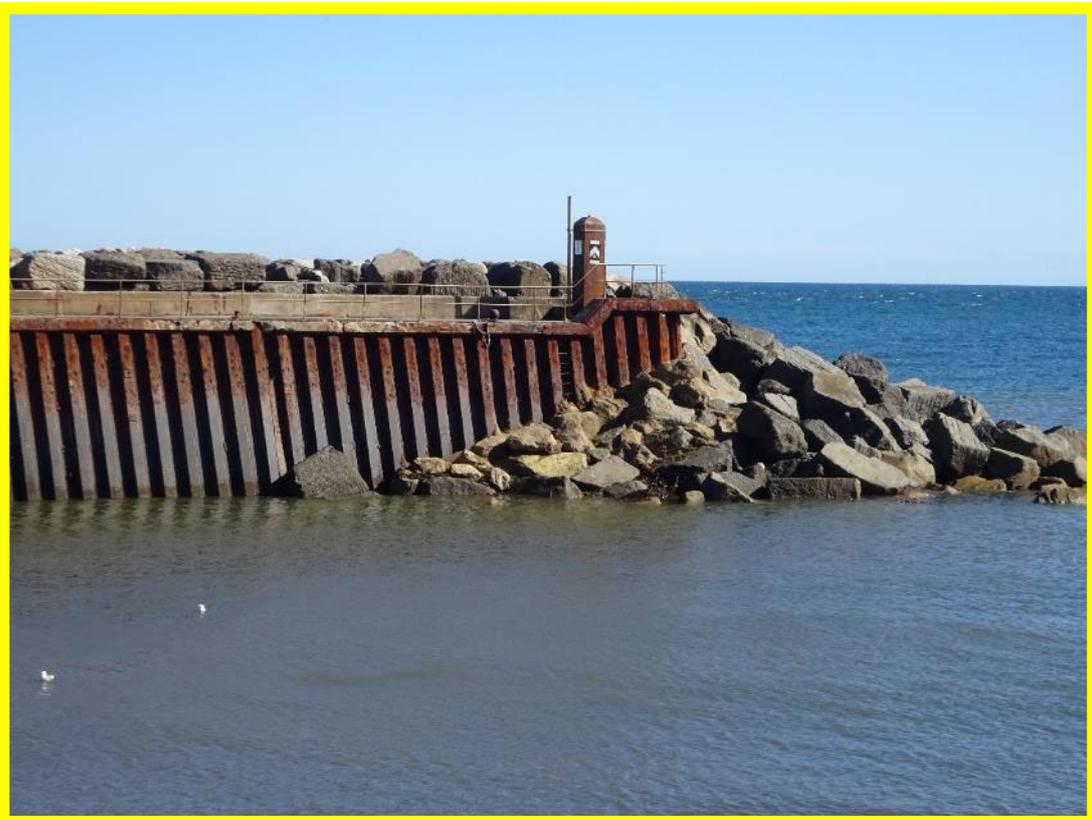
- The North Breakwater has been undercut on the inner-facing side, perhaps caused or exacerbated by propeller thrust. The sheet piles around the seaward end of the structure are significantly corroded although it is assumed that these are permanent formwork for previous *in situ* concrete pours rather than structural elements.

Corroded steel sheet piling on inner face of North Breakwater. Rock armour profile appears similar to 2020 inspection (/0402C01)

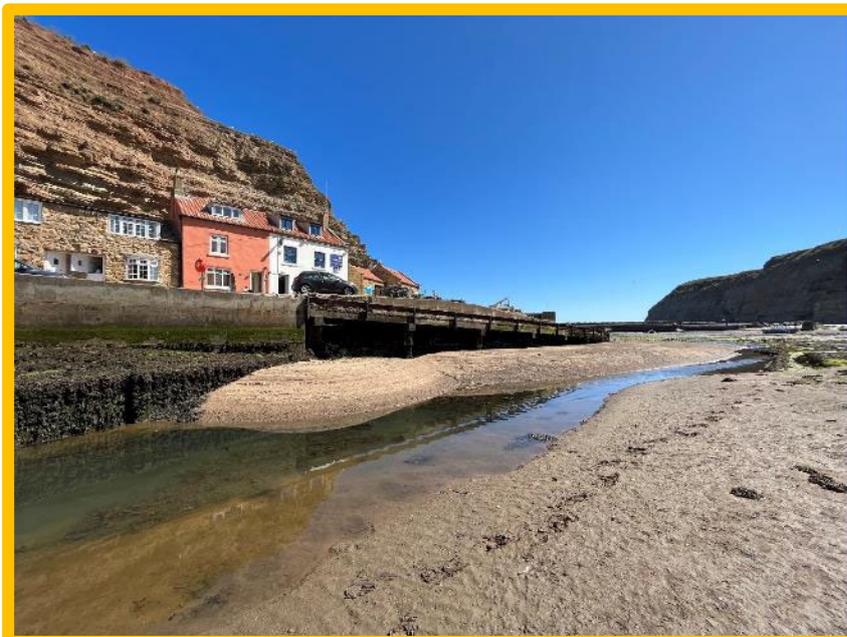
*High beach levels beneath slipway.
Timber training wall structure to left of image (/0402C03)*

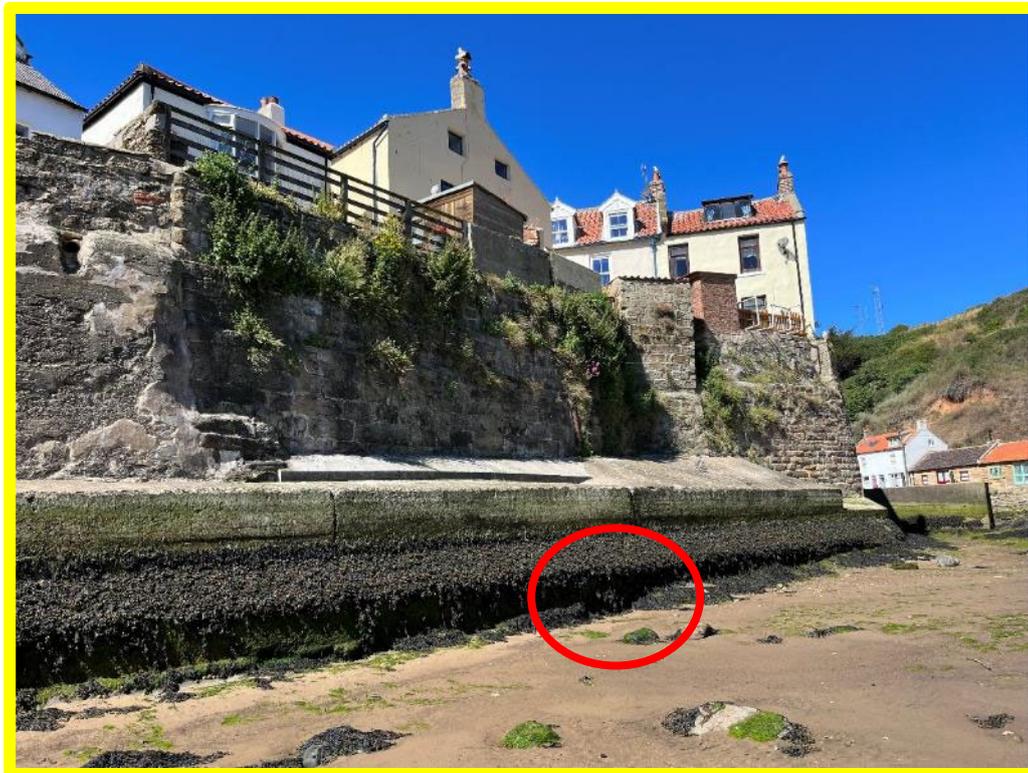
Undercutting of concrete wall – partially visible in (/0402C22)

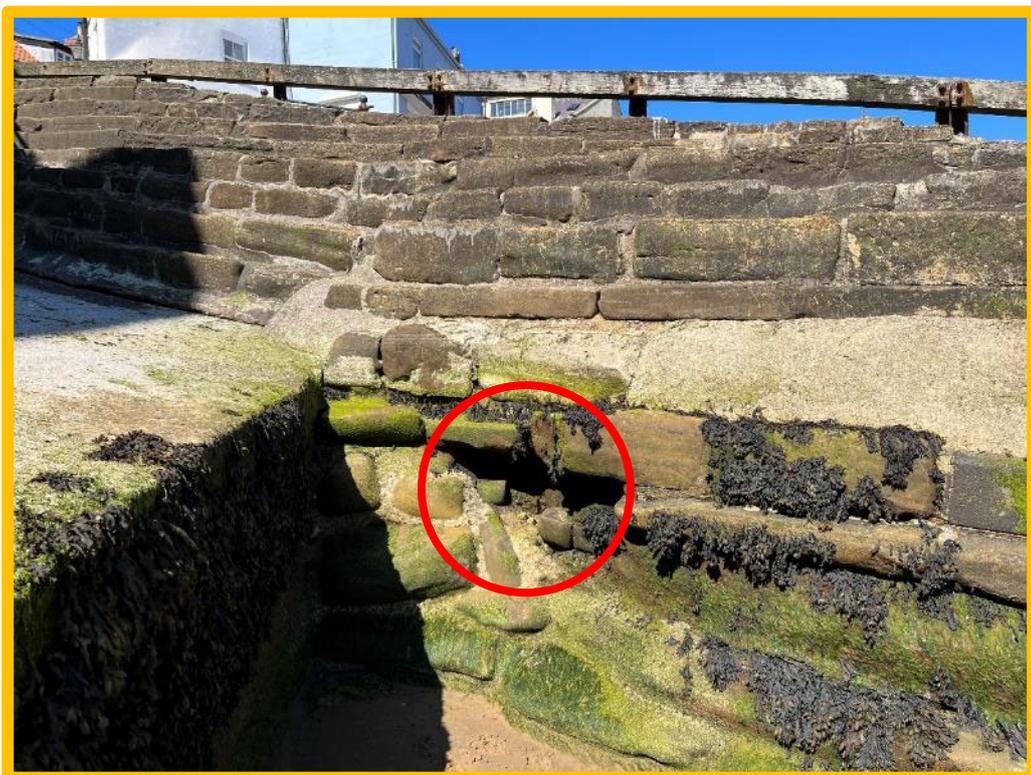
Void at interface between sea wall and south face of slipway (I0403C05)

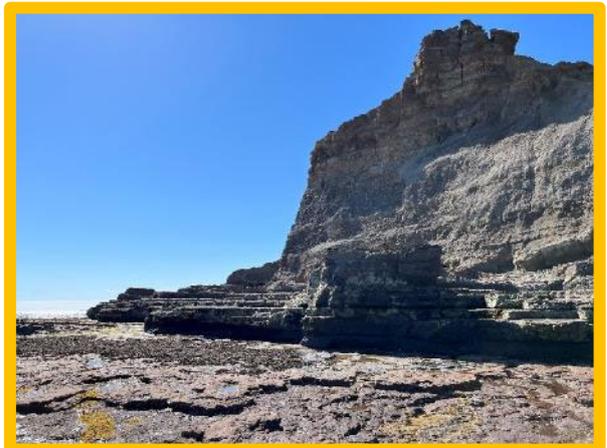
***Extensively weathered headland at Old Nab
MU5/1 Partly Active in July 2022.***

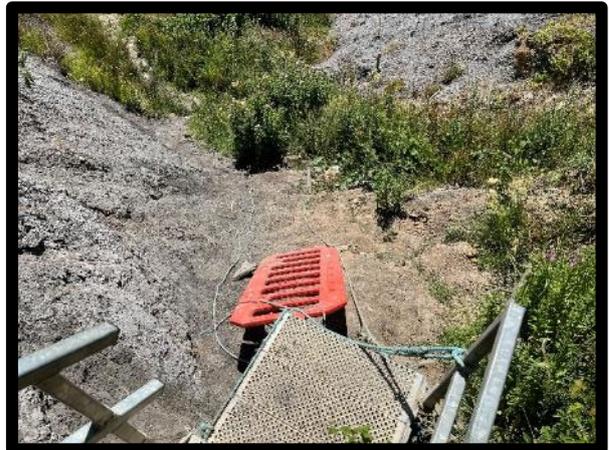
Temporary barrier at foot of steps MU6/4 July 2022.

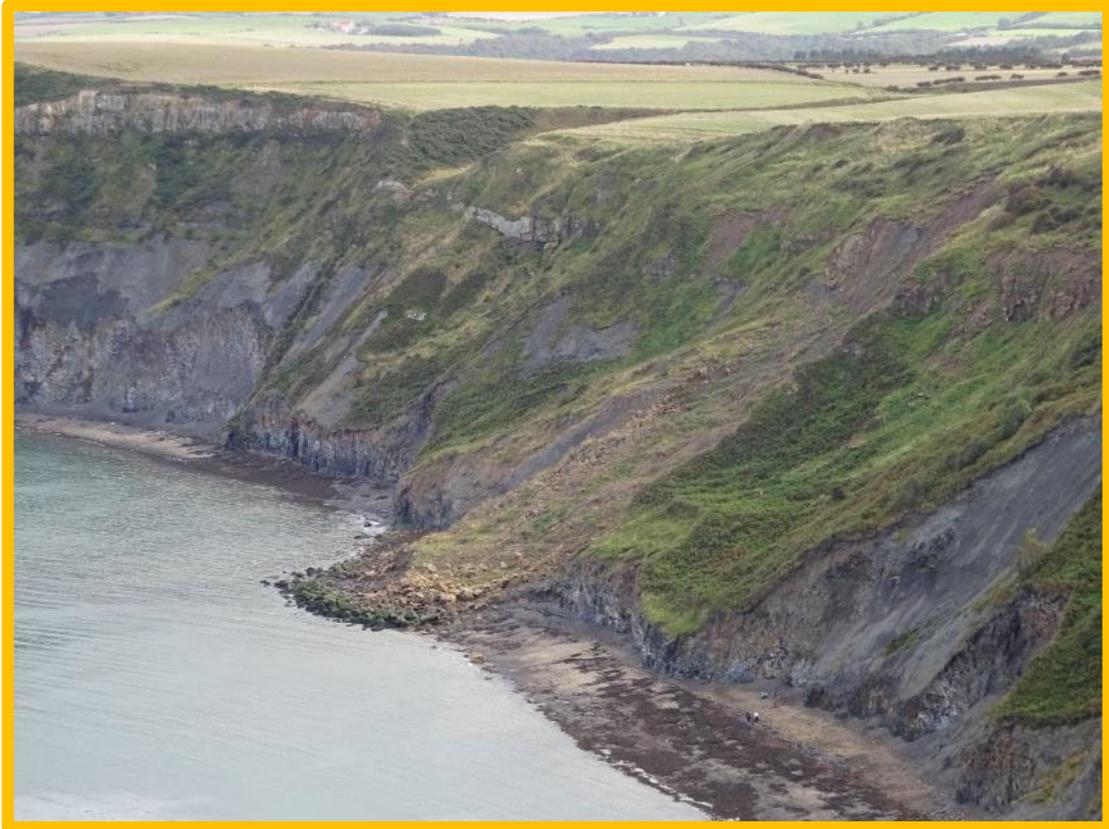
MU6/5 – View of the landslide looking across Port Mulgrave from west to east (Partly Active in September 2020).

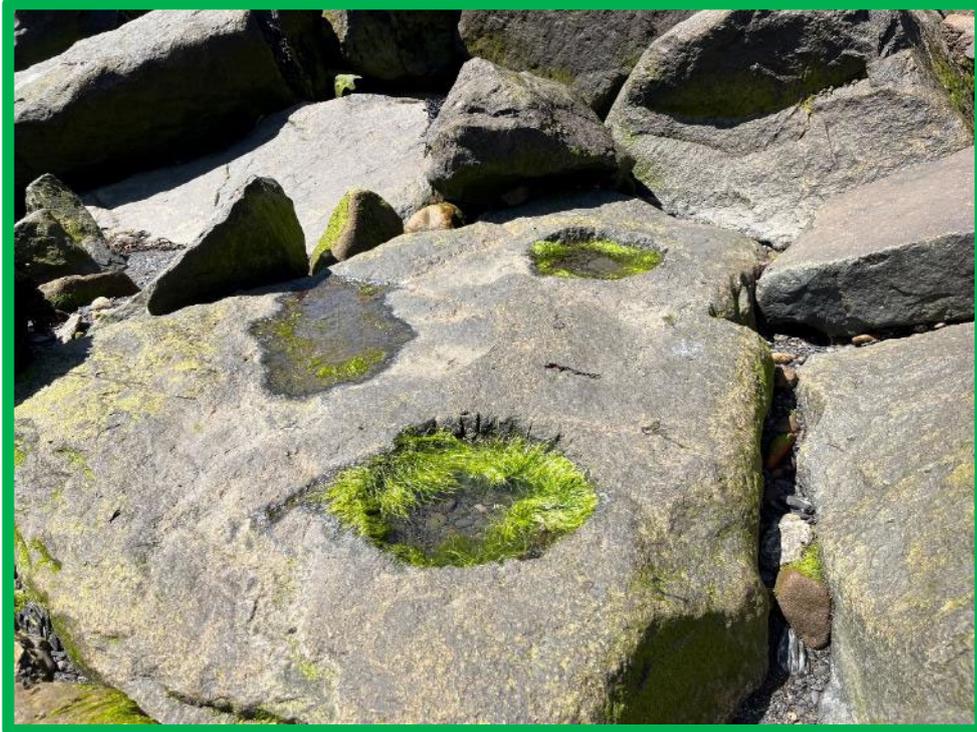
Artificial rock pools – ecological enhancement at the toe of the new rock armour fillet.

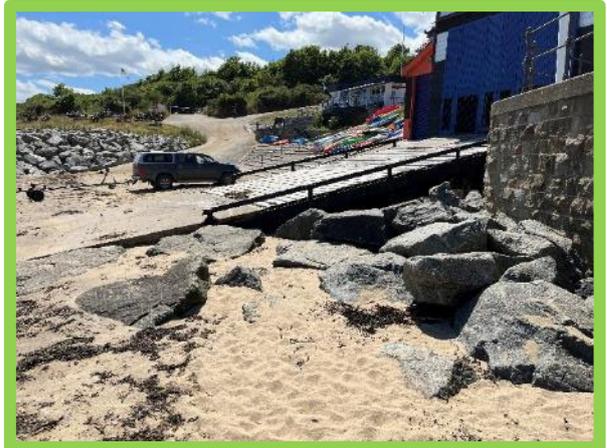
Pumping station and raised manhole chamber (/0601C07)

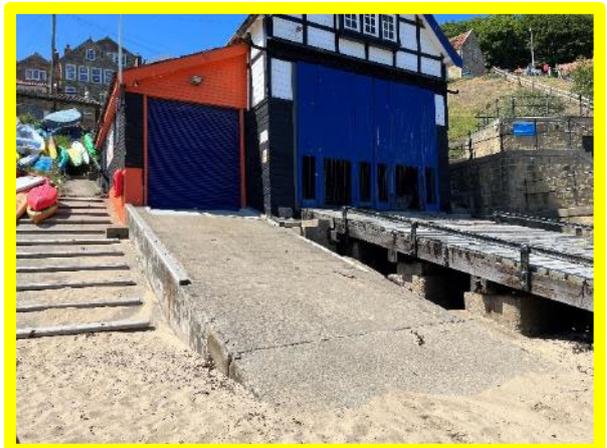
Open joints / cracks in Runswick Rescue slipway (/1003C04)

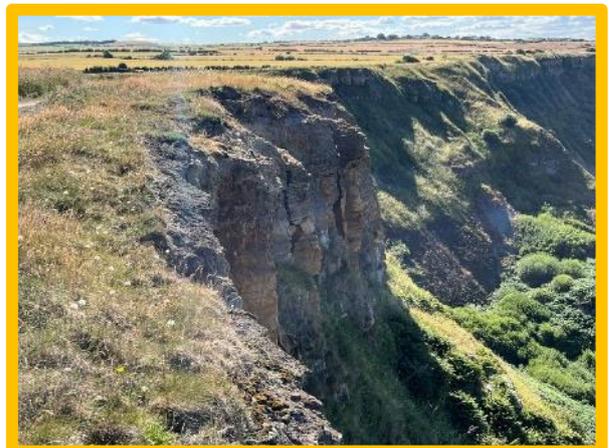
Cracking in headscarp material. **MU8/10** Partly Active in July 2022.

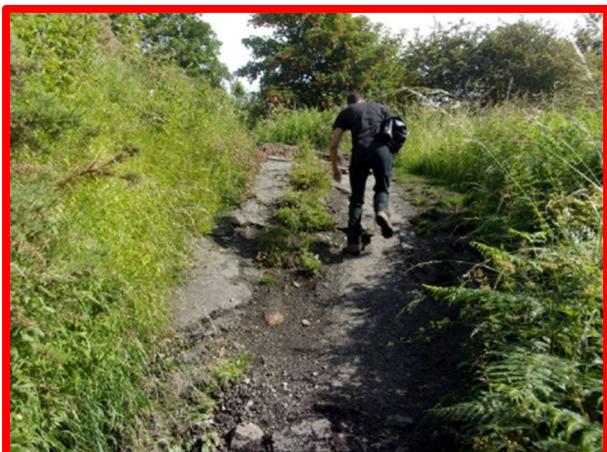
MU8/15 Totally Active in July 2022 following January 2021 landslip (northern end of slip)

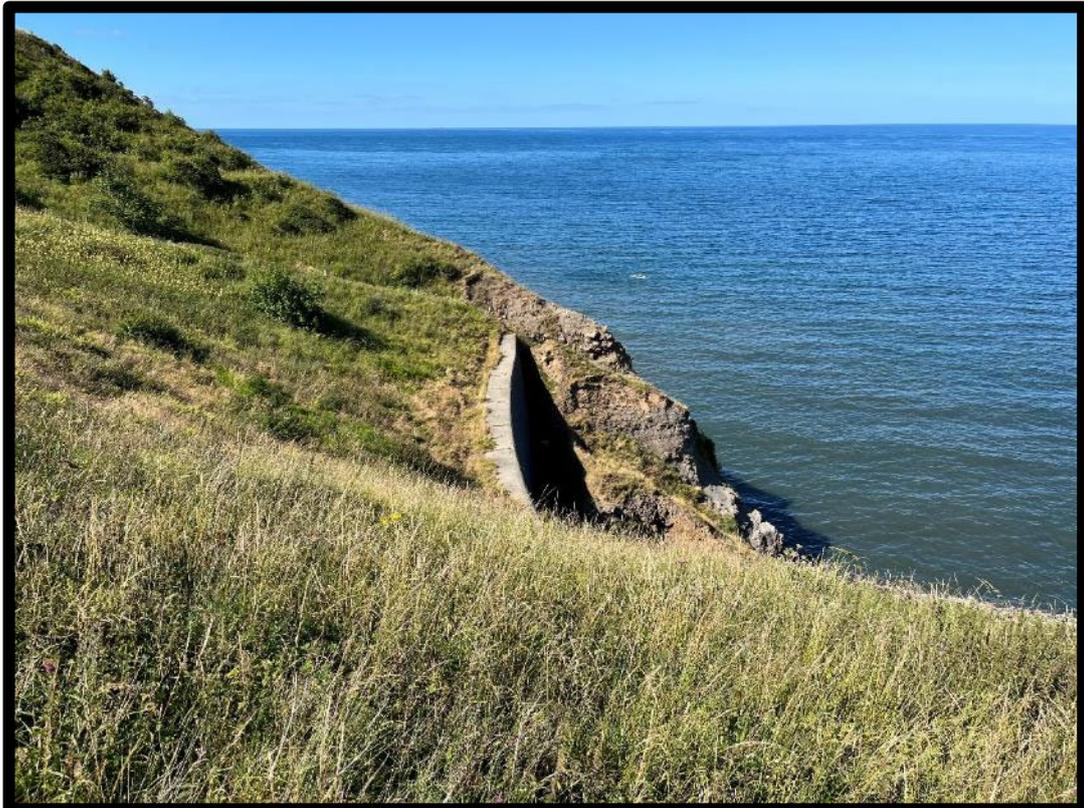
*Redundant masonry retaining wall in **MU8/14***

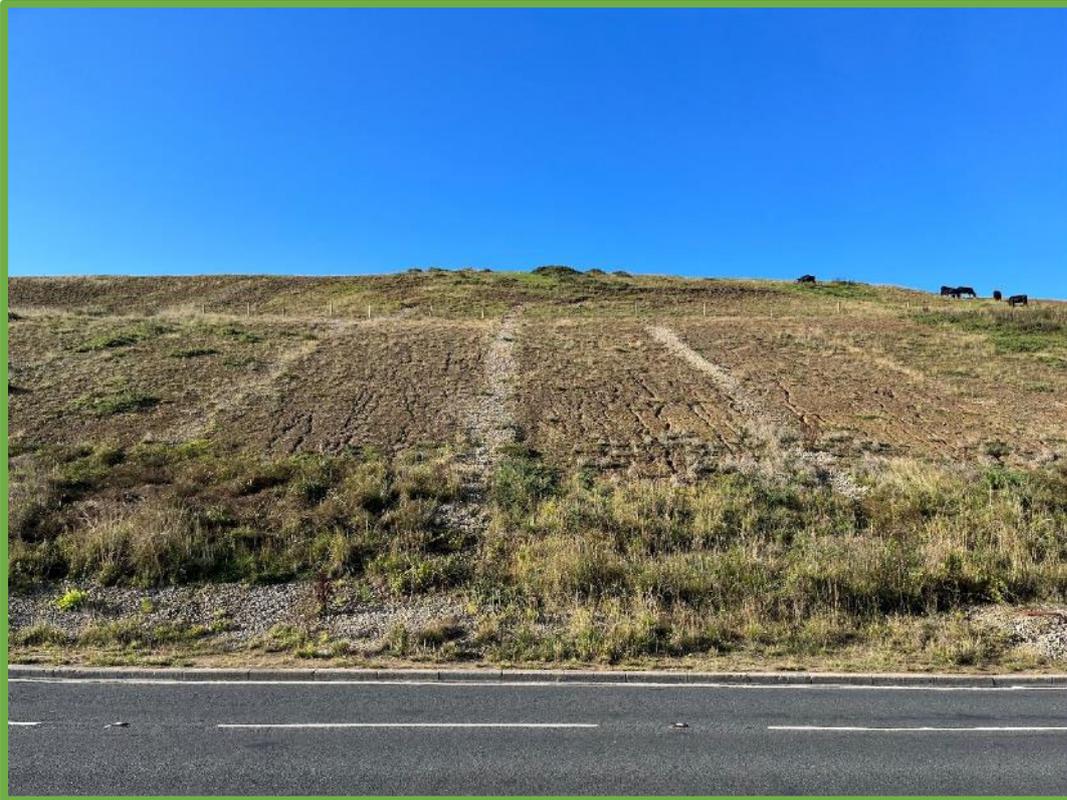
MU9/3 Coastal slopes to rear of new sea defences generally in an inactive state following capital works involving re-grading, drainage and seeding as part of the Sandsend Road Coast Protection & Slope Stabilisation Scheme

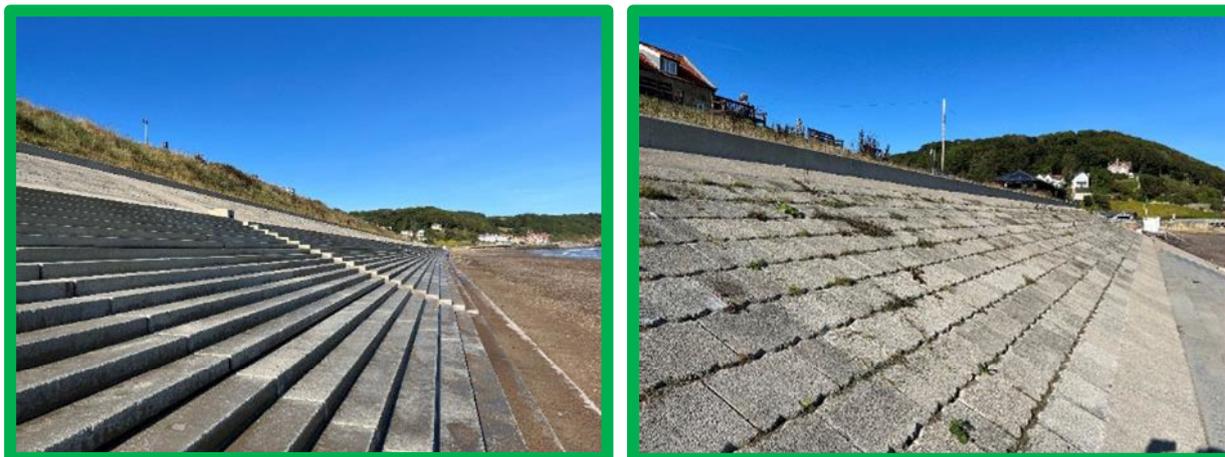
Coastal defences at Sandsend Road showing stepped pre-cast apron and upper Dycel units (D0702C02)

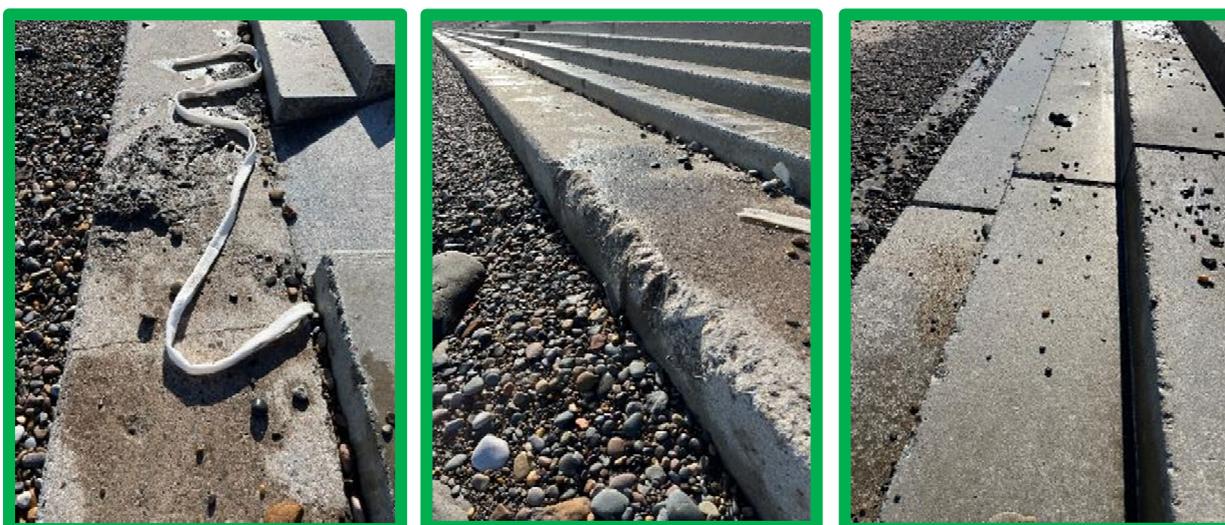
Loss of foam strips, abrasion to the toe beam, and at the leading edge of some stepped units

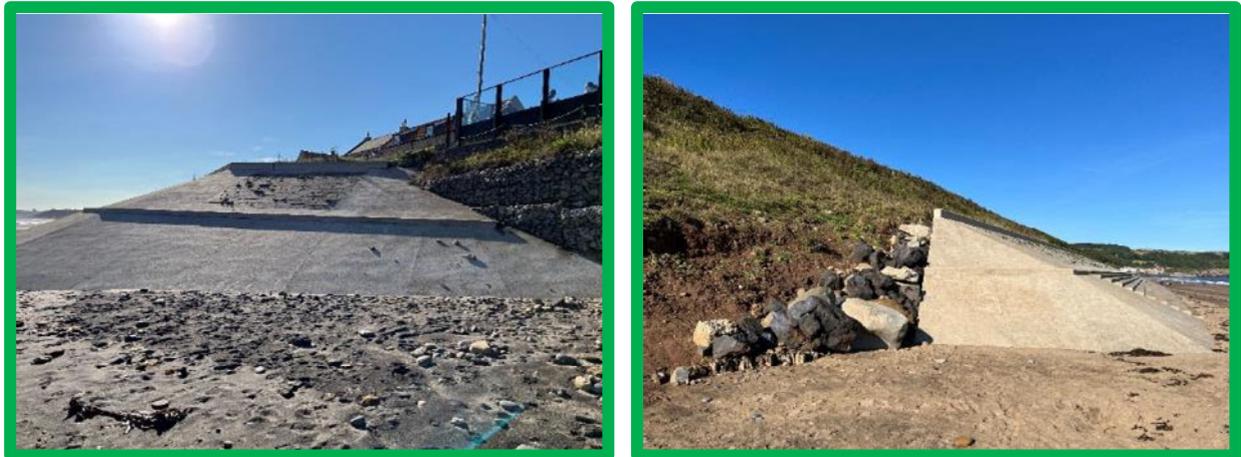
Sloping revetment structures at each end of the structure

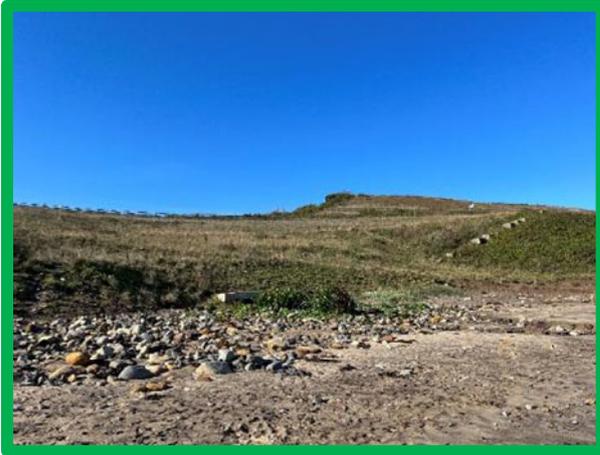
MU9/4 Infilling of Raithwaite Gill at the eastern end of the coastal slopes (Inactive)

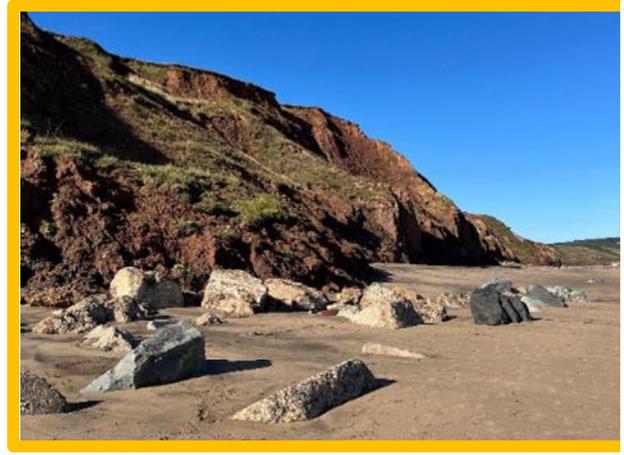
MU10/2 Slumping cliffs along Uppang beach (Partly Active) i

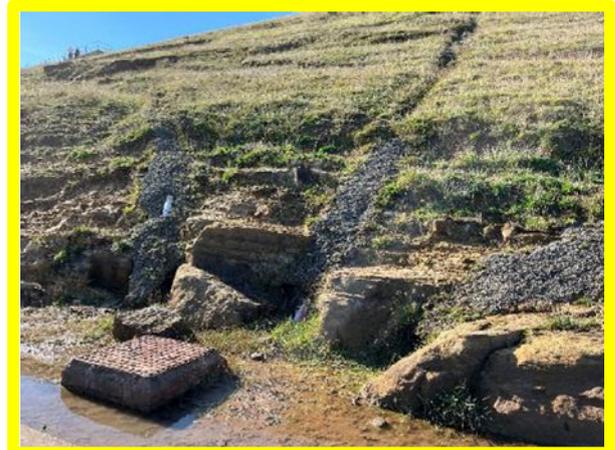
MU11/1 Cliff drainage (Locally Active)

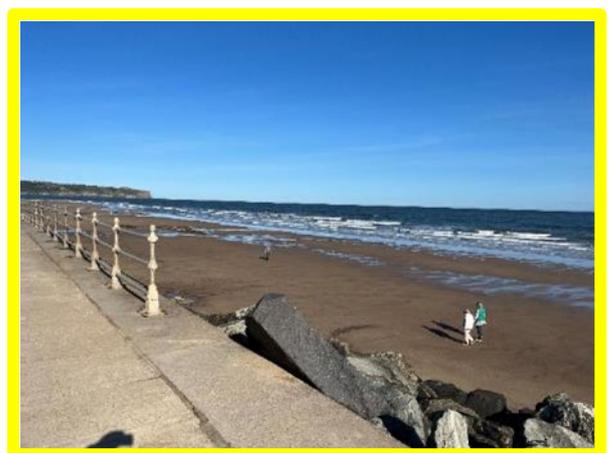
Promenade railings above section of wall without rock armour (D0802C03)

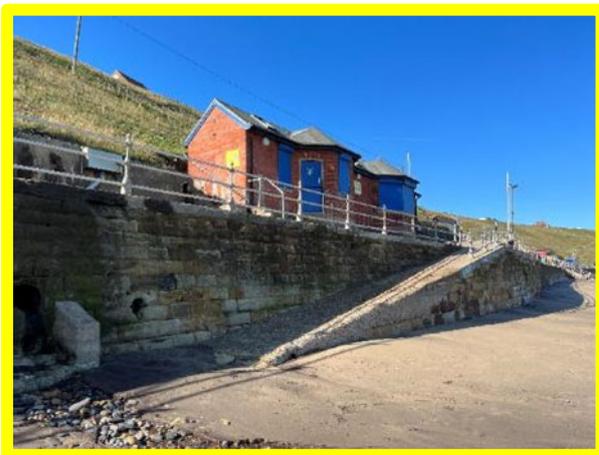
Masonry seawall and slipway in front of RNLI station (D0802C13)

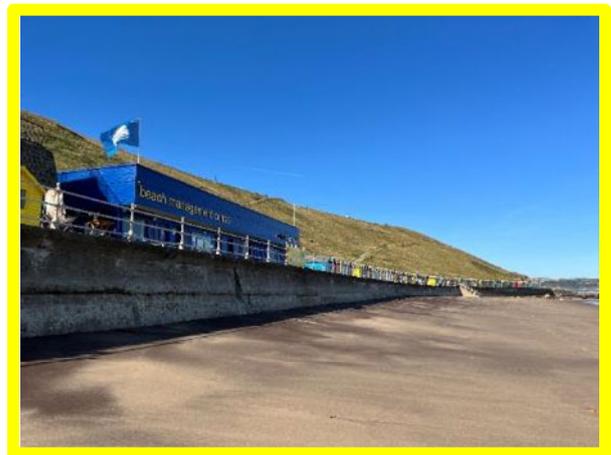
Seawall in front of the Beach Management Centre on the promenade (D0802C13)

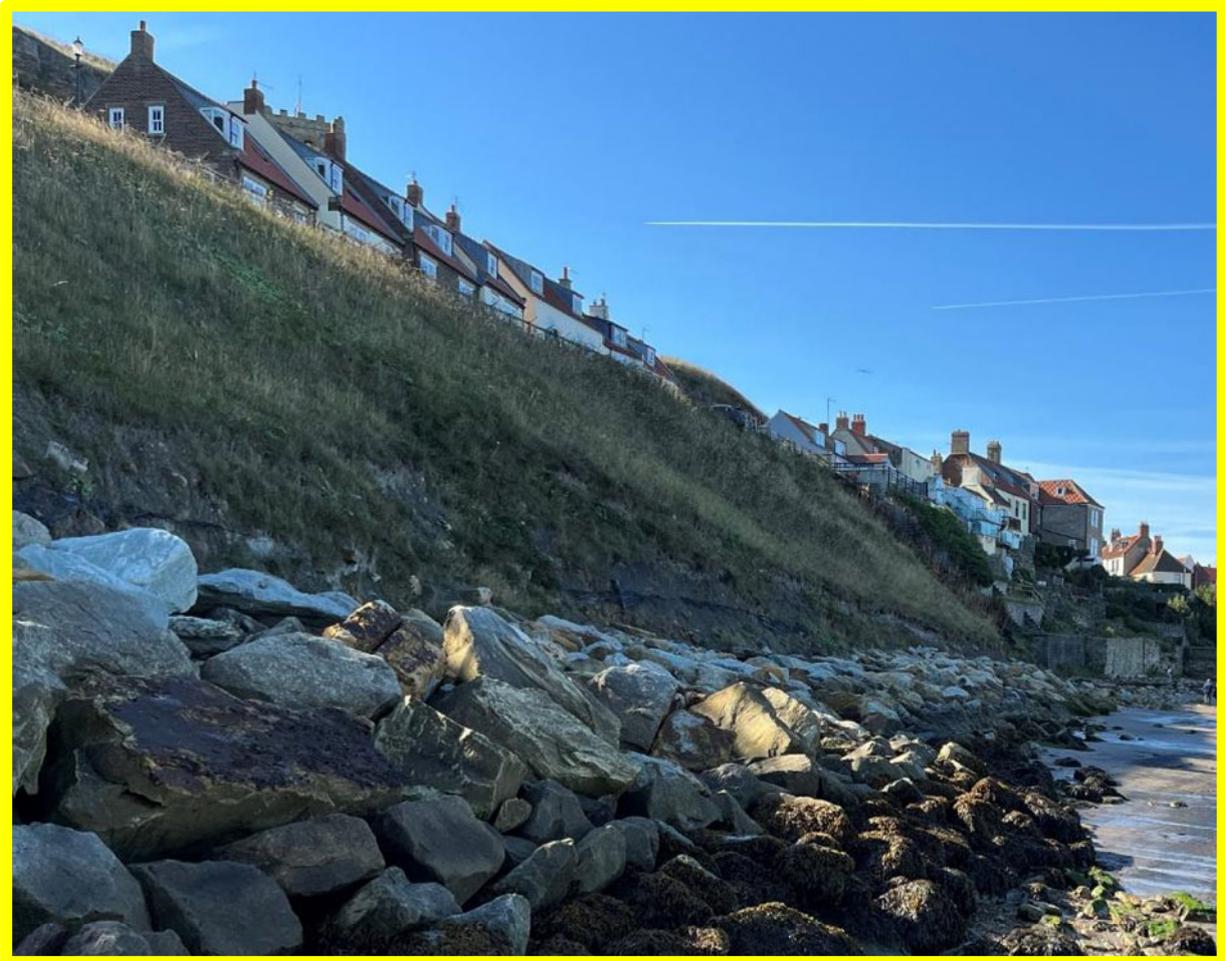
MU12/1 Slumps in lower cliff (Locally Active)

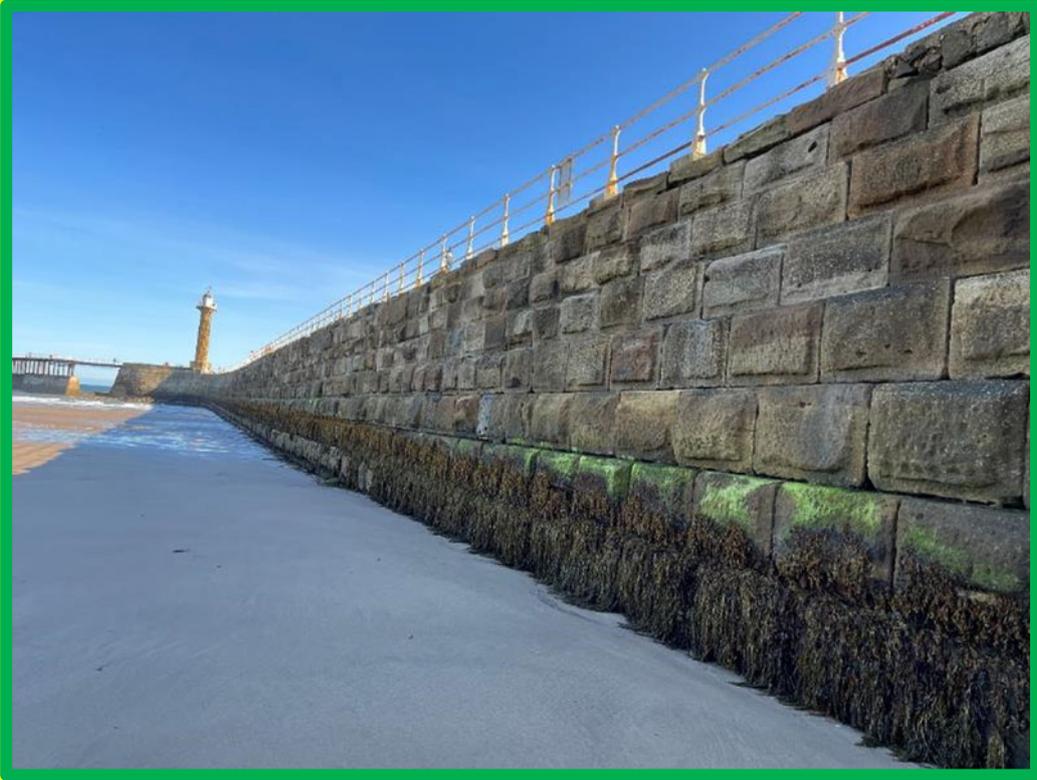
West Pier, very good condition following capital works (1803C02)

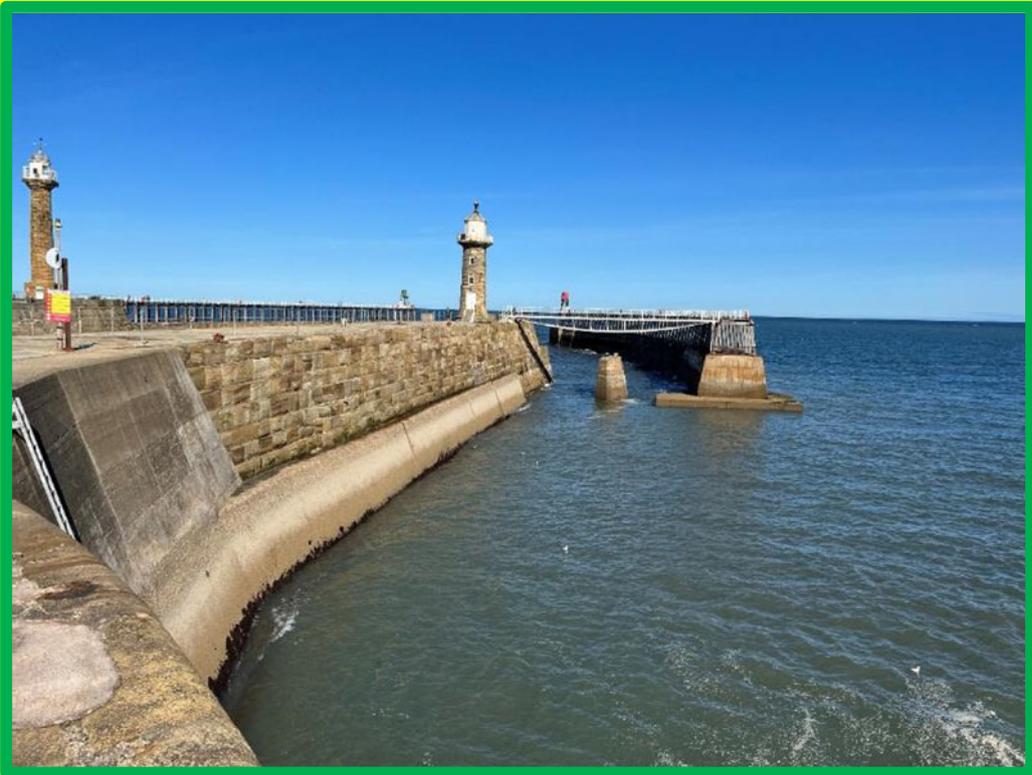
East Pier, very good condition following capital works (1803C02)

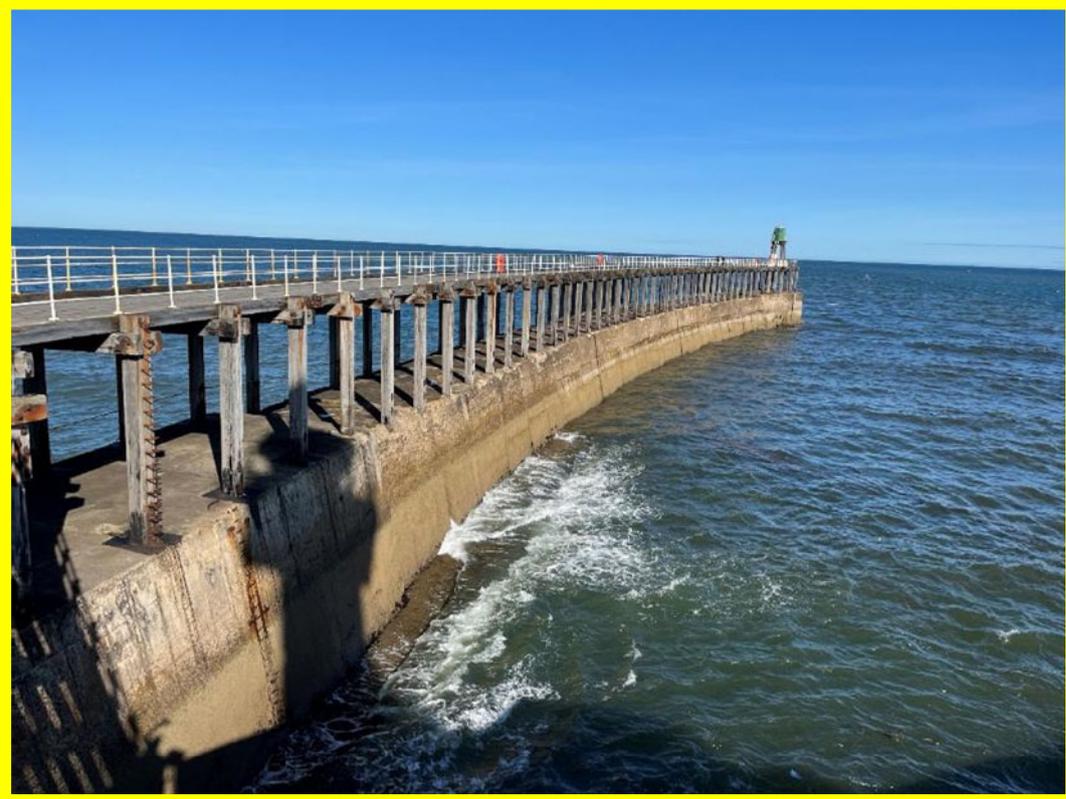
West Pier extension, generally in fair condition (1803C01)

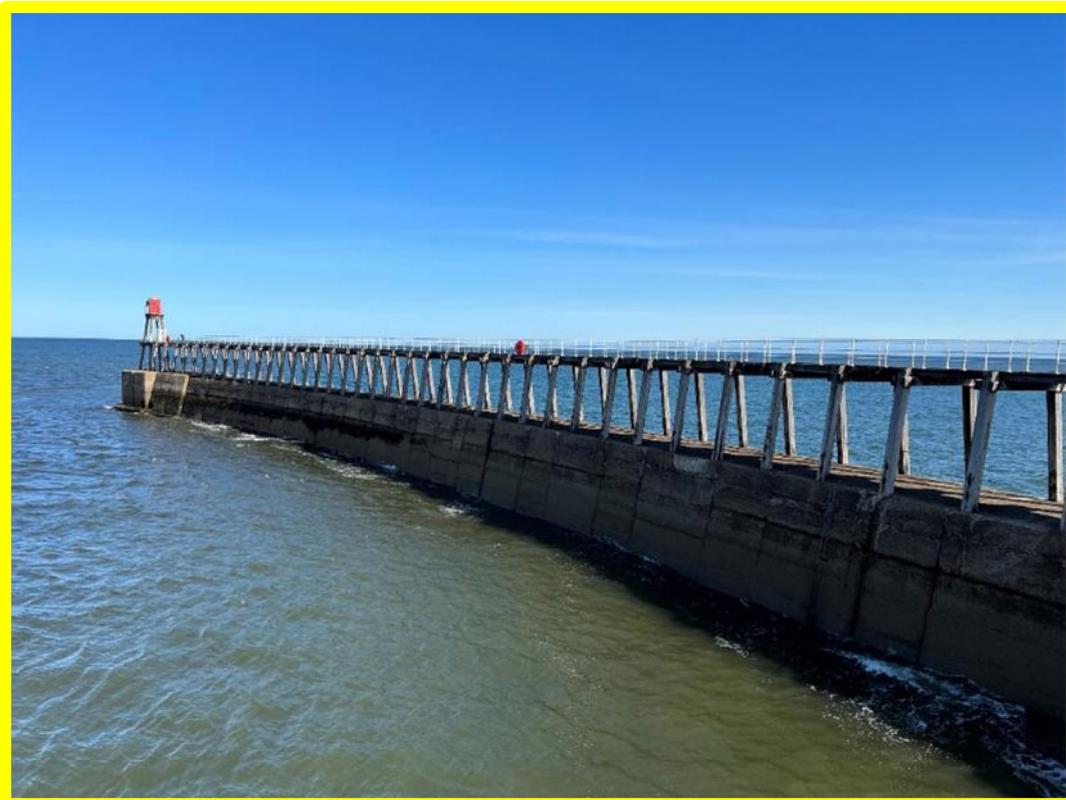
East Pier extension, generally in fair condition (1803C04)

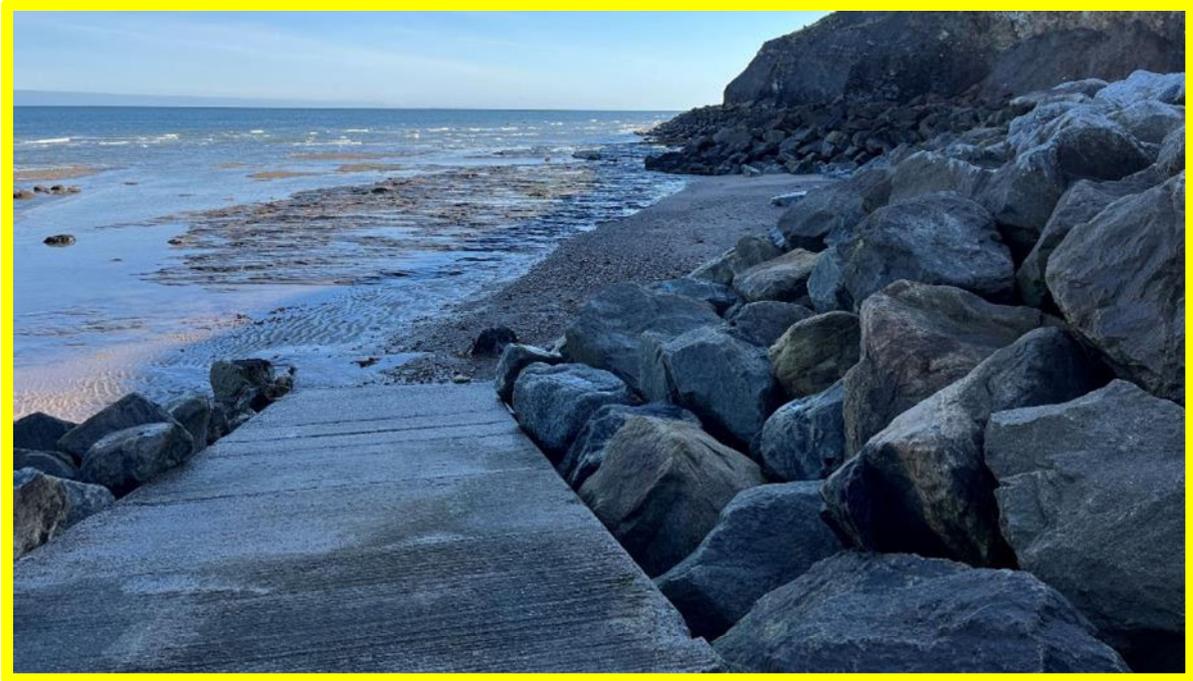
There is a section of rock armour giving protection to the toe of Abbey Cliff directly to the east of Whitby Harbour's East Pier. The rock armour varies in size from 1-4 tonnes to 5-8 tonnes. It remains in fair overall condition in 2022.

Rock armour protection to toe of Abbey Cliff (1803C06)

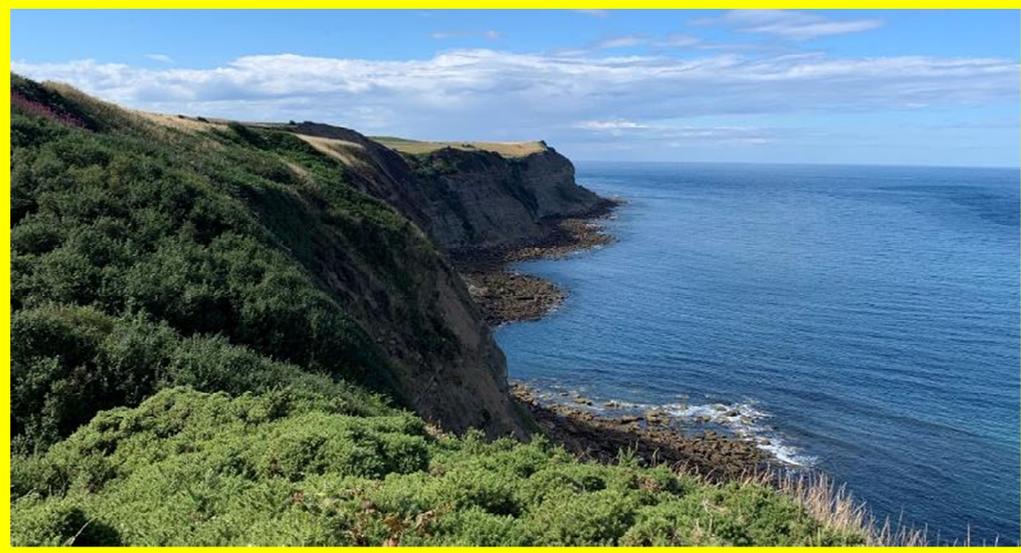
MU 14/1 Looking North - Vegetation growing locally on face of cliff (Locally Active)

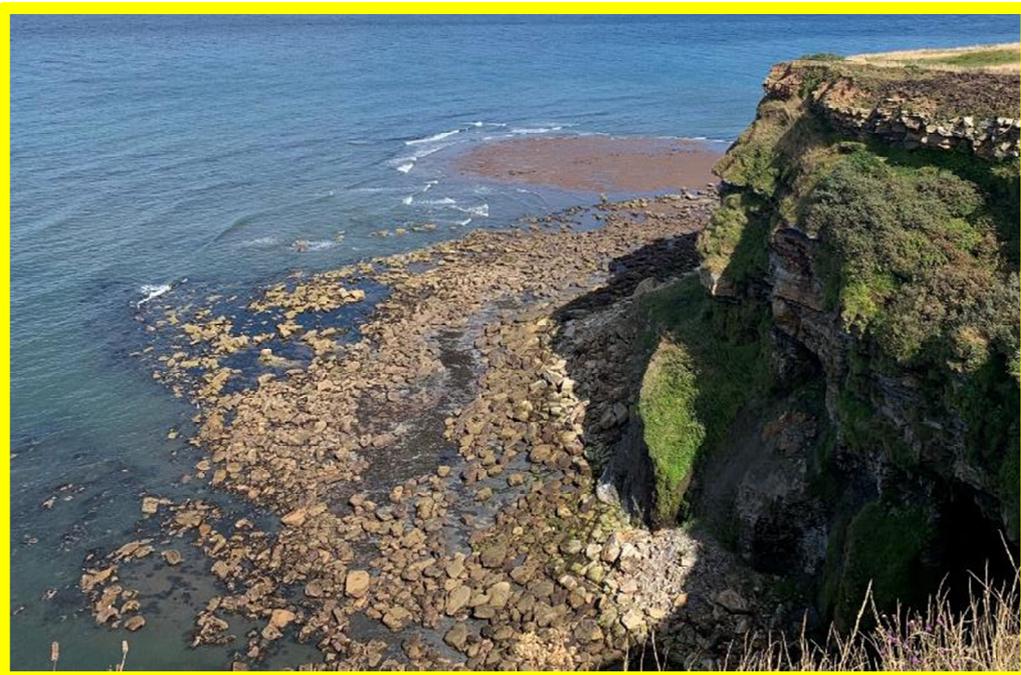
MU 14/1 Stable cliffs, upper slopes and debris aprons generally vegetated (Locally Active)

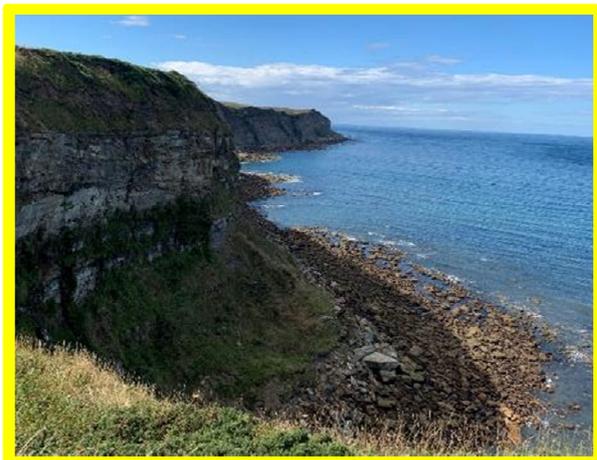
MU15/1 Vegetated slopes at cliff top (Locally Active)

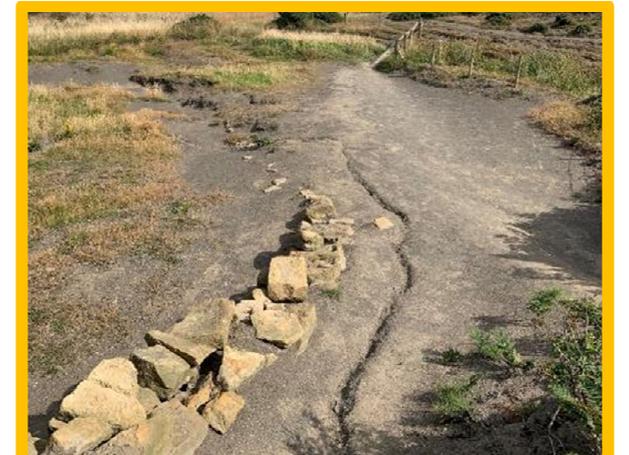
MU15/2 Tension cracks on access path to the south of Far Jetticks

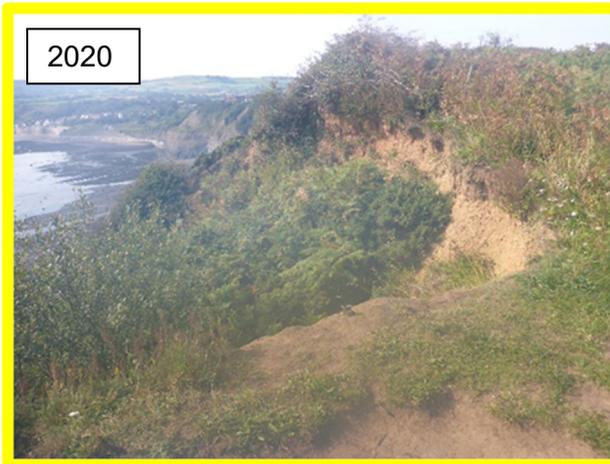
MU15/4 Local slumping of headscarp adjacent coastal path (Locally Active)

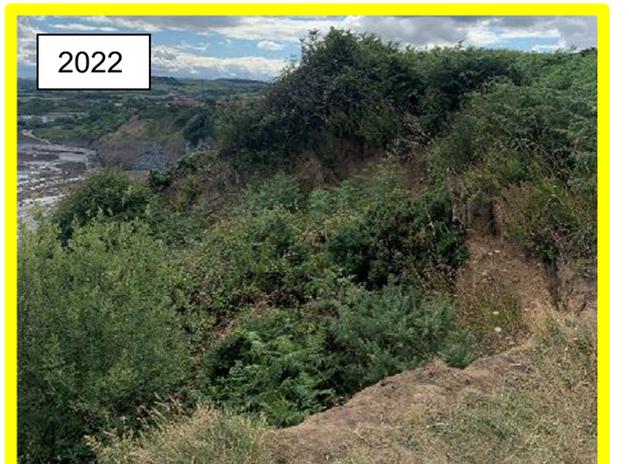
MU15/4 Local slumping of headscarp adjacent coastal path (Locally Active)

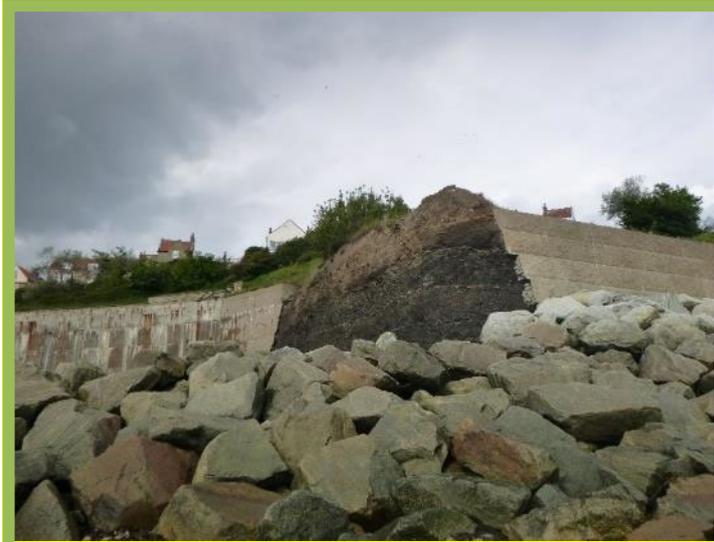
The rock armour extends south of the end of the wall, remaining in good condition, to protrude beyond the toe of the short length (~25m) of adjacent undefended shale cliffs. The cliffs (/1003C03) are generally eroding at slow rates, except for in one location at the cliff top near the interface with the southern large sea wall where a local slippage has occurred in the overlying till. The minor outflanking noted in 2016 at this location has worsened slightly as predicted.

Rock revetment protruding beyond undefended cliffs (/1003C01)
