Cell 1 Regional Coastal Monitoring Programme Walkover Inspection Surveys 2022

**Scarborough
Borough Council**

November 2022

Walkover Inspection Surveys 2022

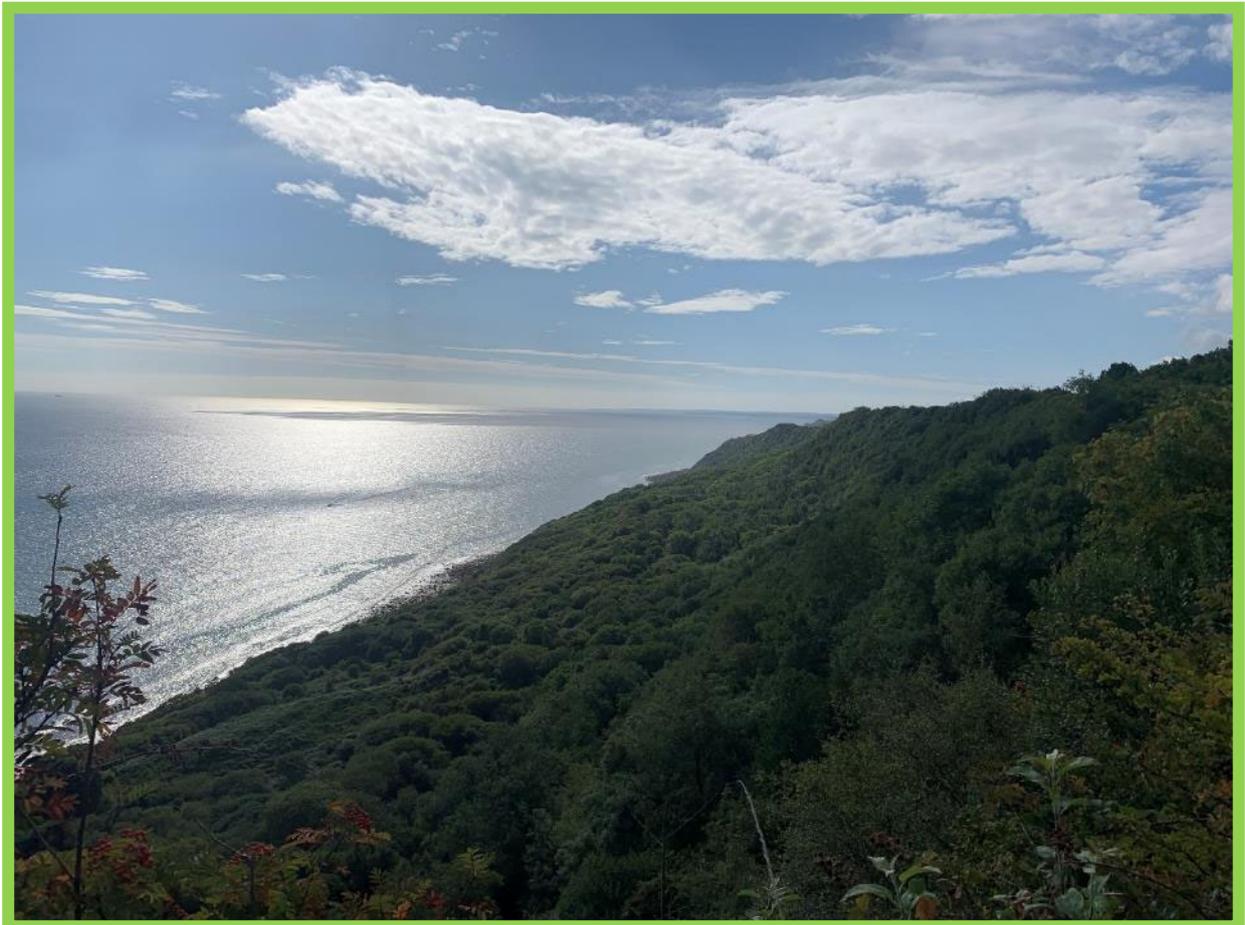
MU18/2 Distinct two-tiered cliffs
(Inactive)

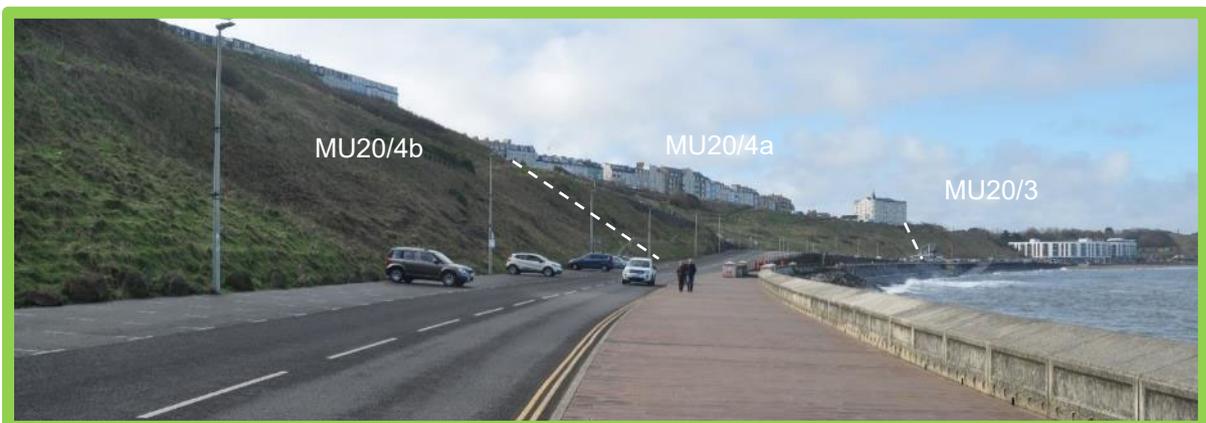
Looking across to North Sands Unit **MU20/4b** **MU20/4a** & **MU20/3**

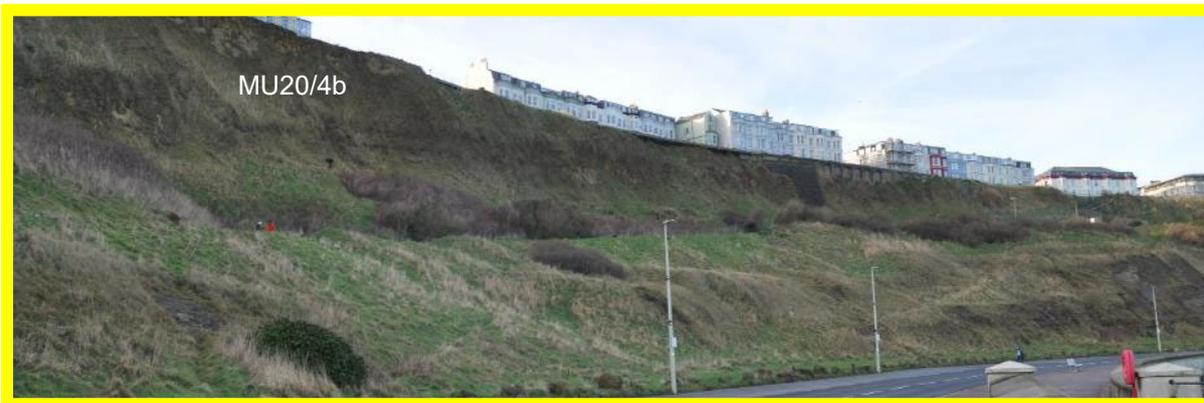
MU20/4b Locally Active

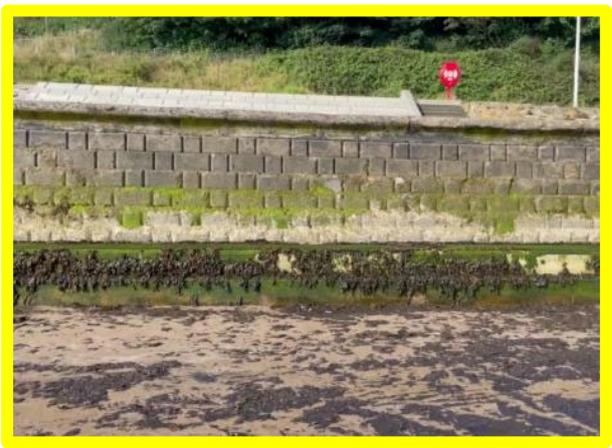
Fair condition seawall with recent repairs to toe apron (/1201C24)

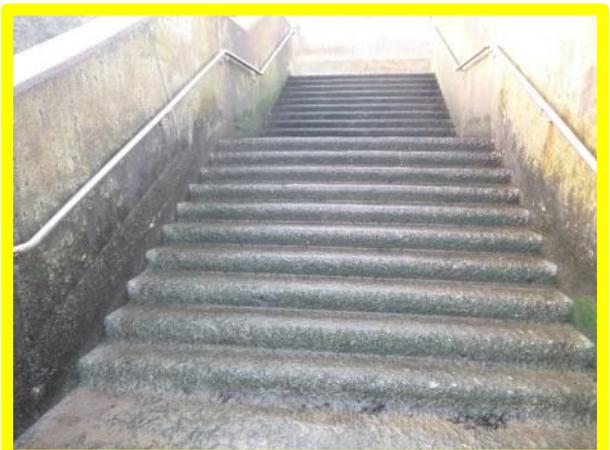
Heavily abraded steps with rounded edges (/1202C01)

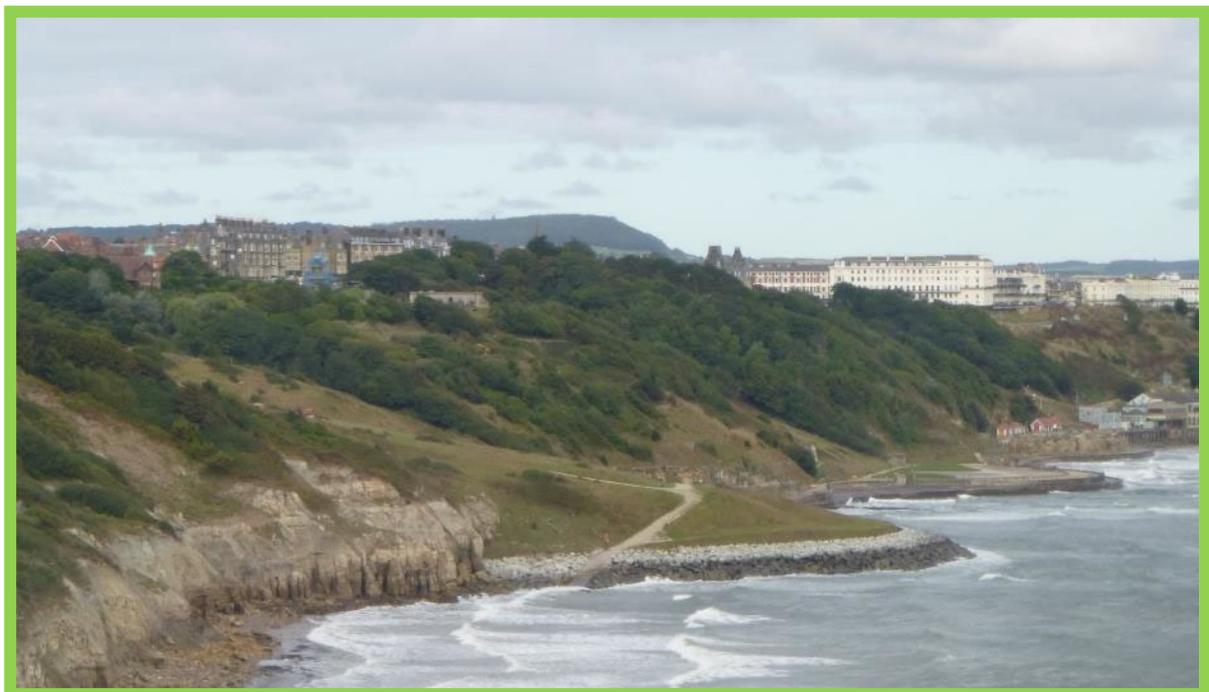
Rock revetment around debris lobe of Holbeck Hall landslide (/1304C01)

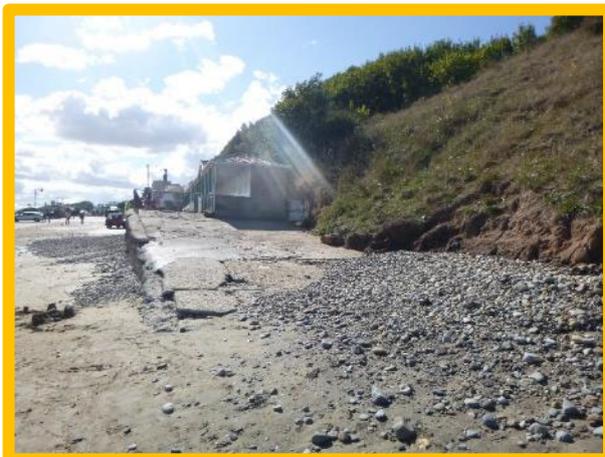
Voids in deck of rear ramp/wall at Coble Landing (/1602C01)

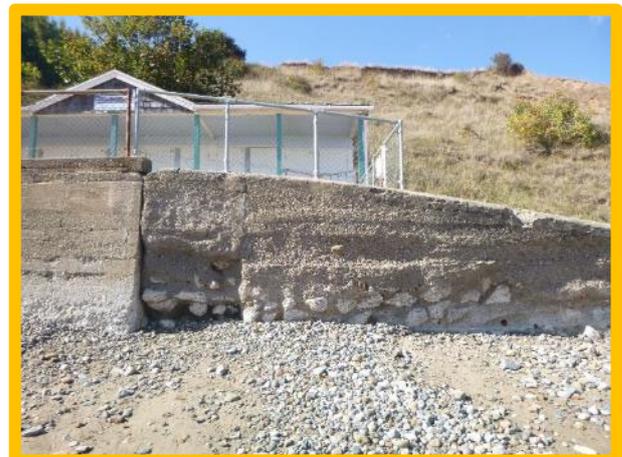
Heavy Abrasion damage to the rear wall (/1602C01)

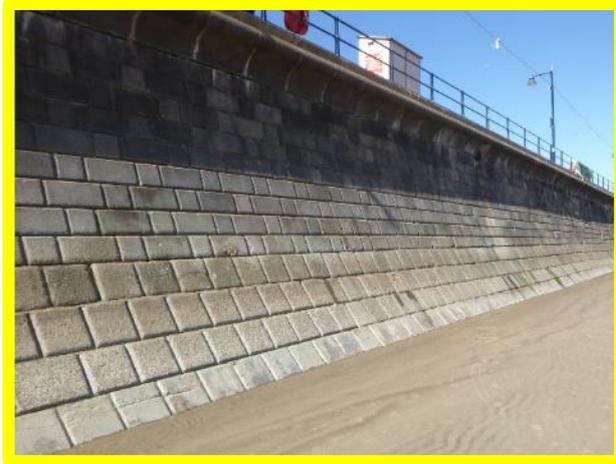
Sea wall near Ravine Road in fair condition (/1602C06)

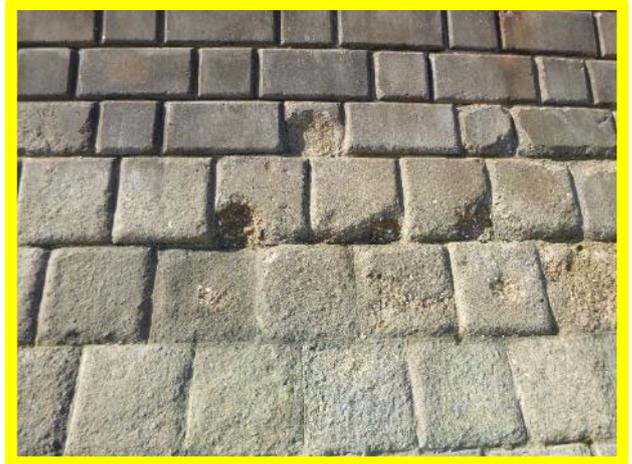
Occasional open joints with missing mortar and evidence of ongoing abrasion (/1602C06)

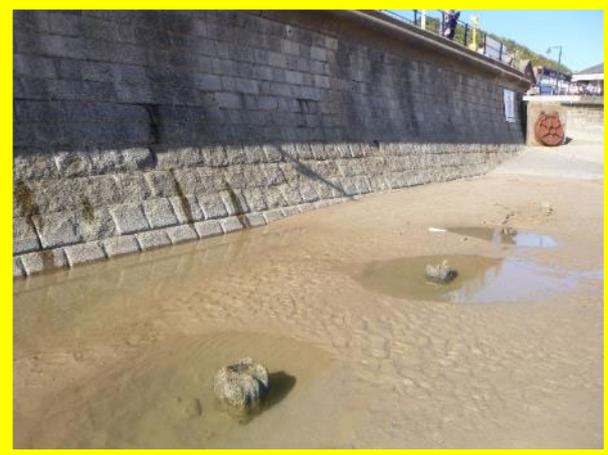
Historic timber piles exposed by low beach levels (/1602C08)

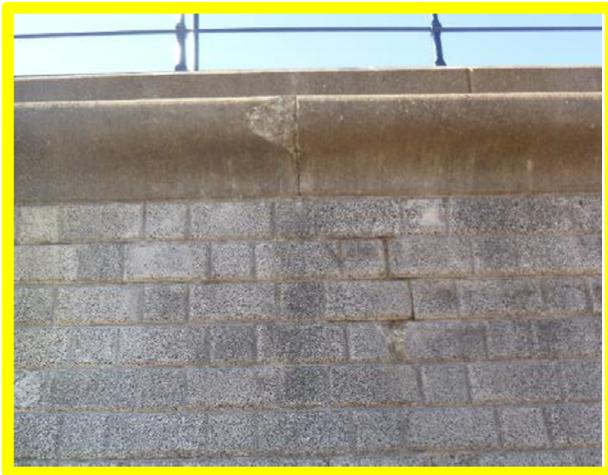
Abrasion damage and open joints in sea wall south of Cargate Hill (/1602C03)

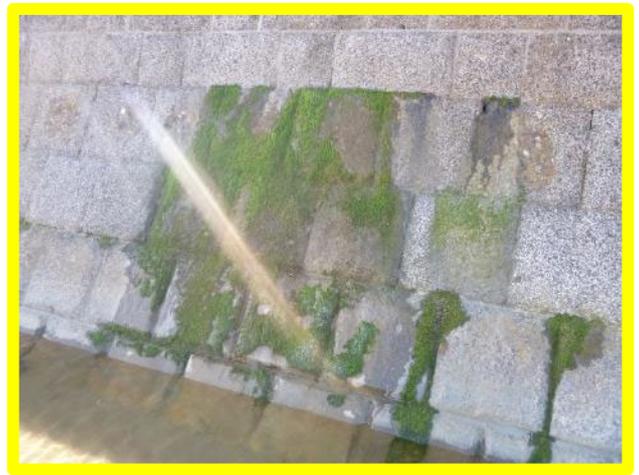
Abrasion damage and several leaking joints (/1602C03)

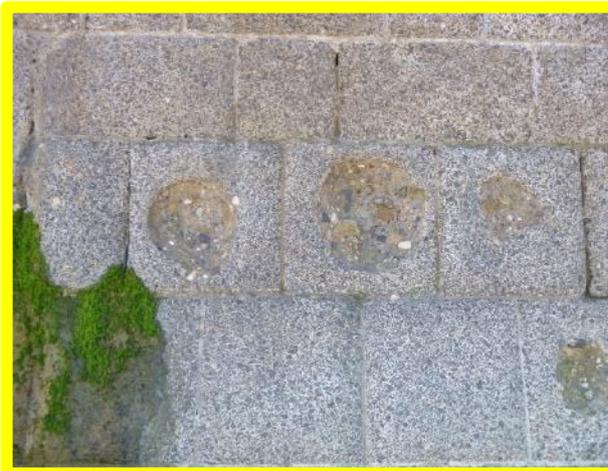
Example of 'pockmark' abrasion pattern which is common along the Filey Seawall (/1602C03)

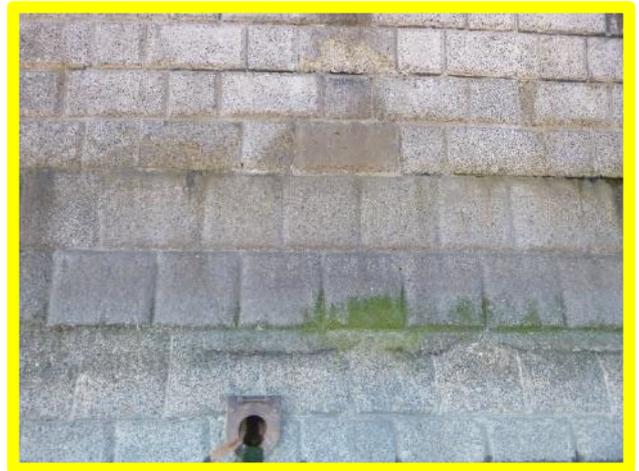
Example of replaced section of block work. Concrete repair undertaken with patterned shuttering to achieve blockwork effect (/1602C03)

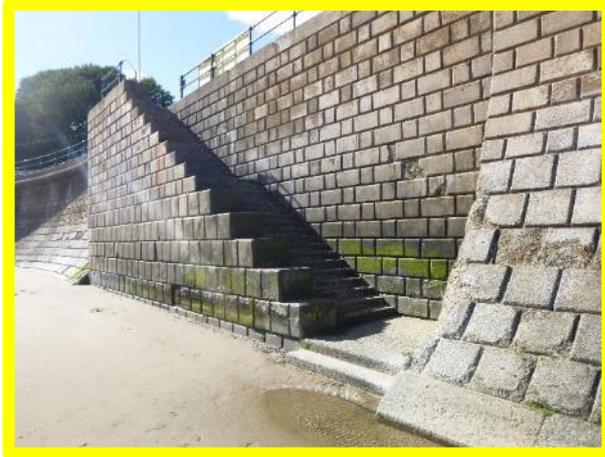
Access steps in fair condition, note abraded block facing (/1602C04)

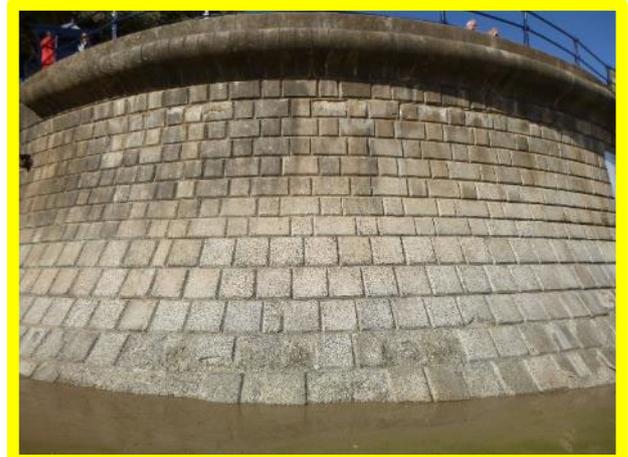
Historic horizontal cracking and abraded blocks (/1602C05)

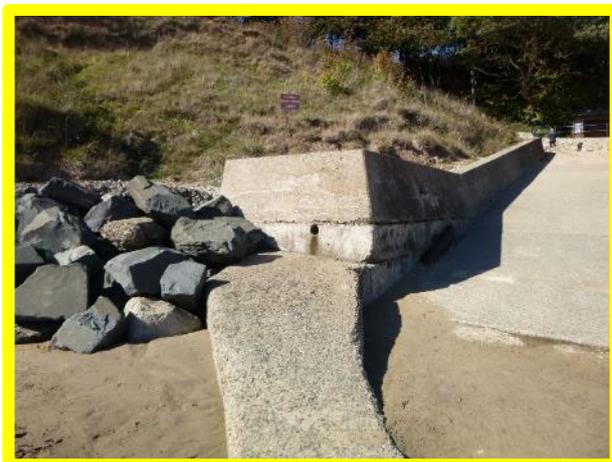
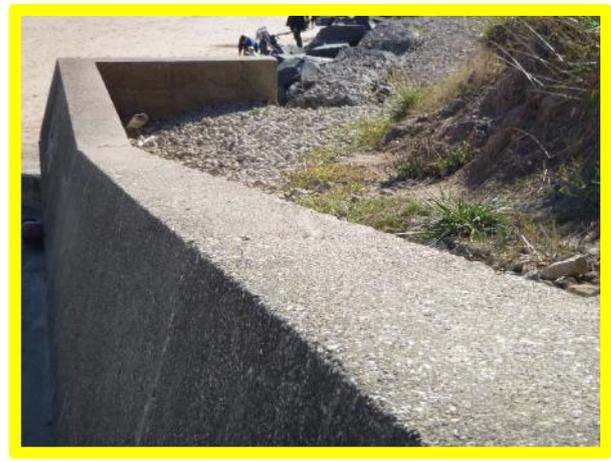
Slipway / access ramp at southern end of Filey Sea Wall (/1602C02)

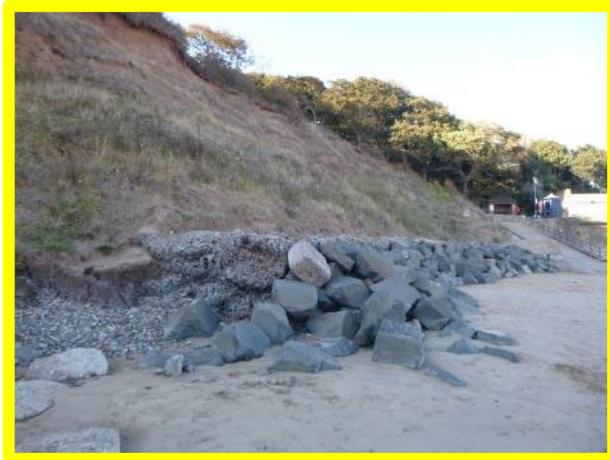
Crest depression in rock revetment at southern end of Filey Sea Wall (/1602C02)

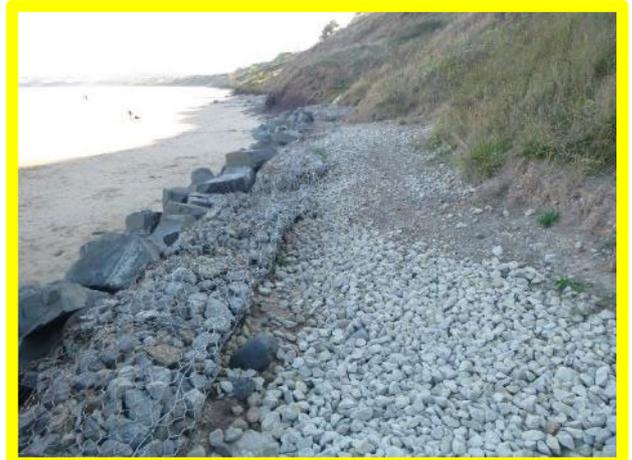
Crest depression in rock revetment at southern end of Filey Sea Wall (/1602C02)

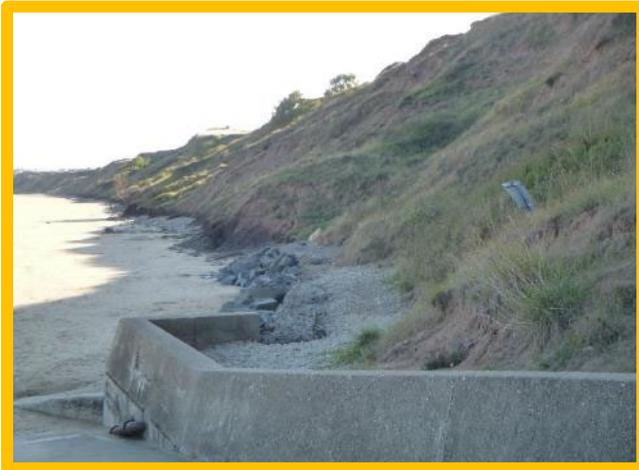
Till cliffs adjacent to Filey town **MU29/AA** Partly Active in 2022

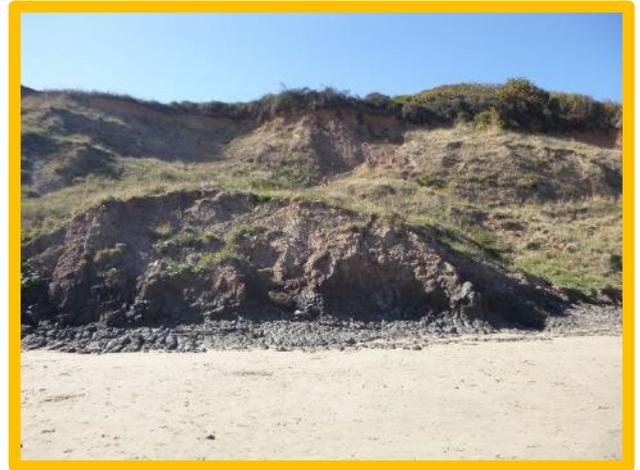
Till cliffs along Muston Sands **MU29/AB** Partly Active in 2022 with evidence of historic deep seated failures and more recent shallow failures.

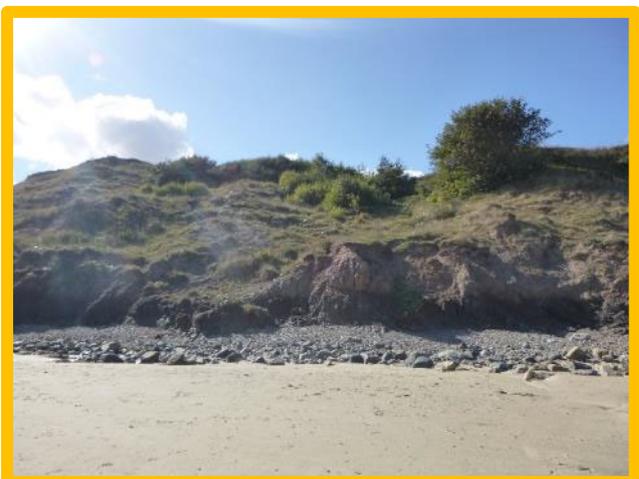
Till cliffs along Muston Sands **MU29/AC** Partly Active in 2022

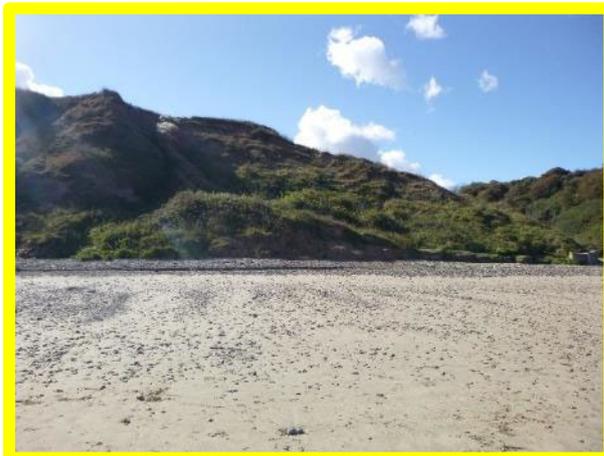
Till cliffs along Hunmanby Sands, **MU29/AJ** Locally Active in 2022

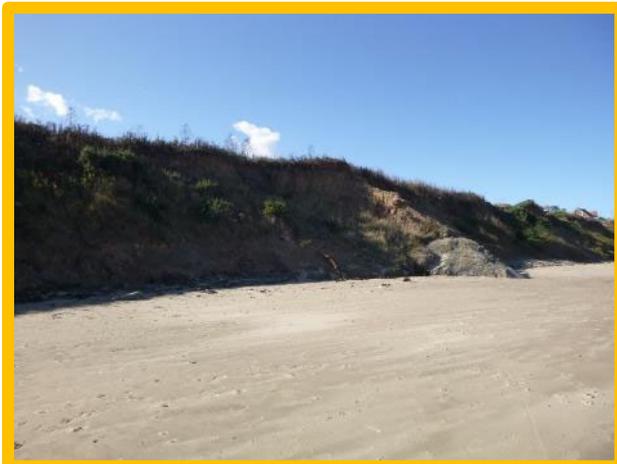
Replaced gabion baskets and outflanked rising main **MU29/AS** Partly Active in 2022.

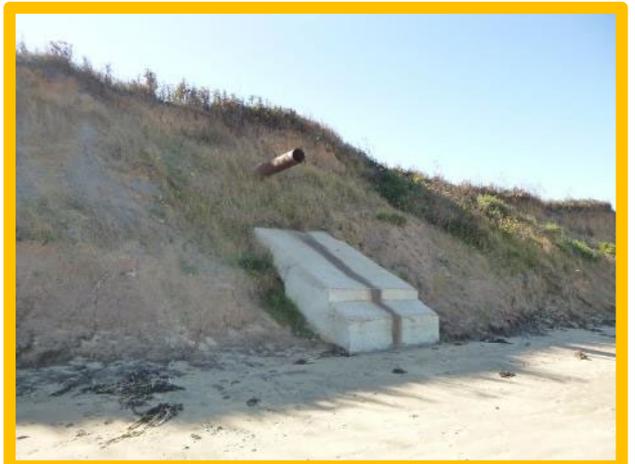
Exposed drain **MU29/AS** Partly Active in 2022.

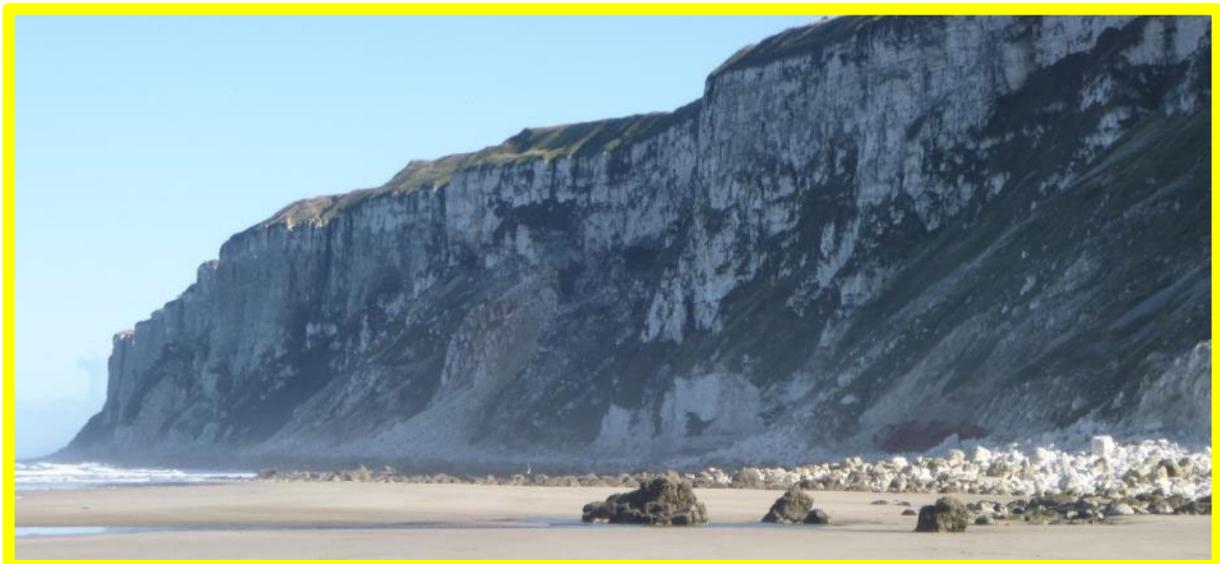
View southwards looking towards **MU29/CI** and **MU29/CJ** Locally Active 2022
