**HaskoningDHV UK Ltd.
Water**

Subject: Cell 1 Coastal Asset Condition Summary_2022

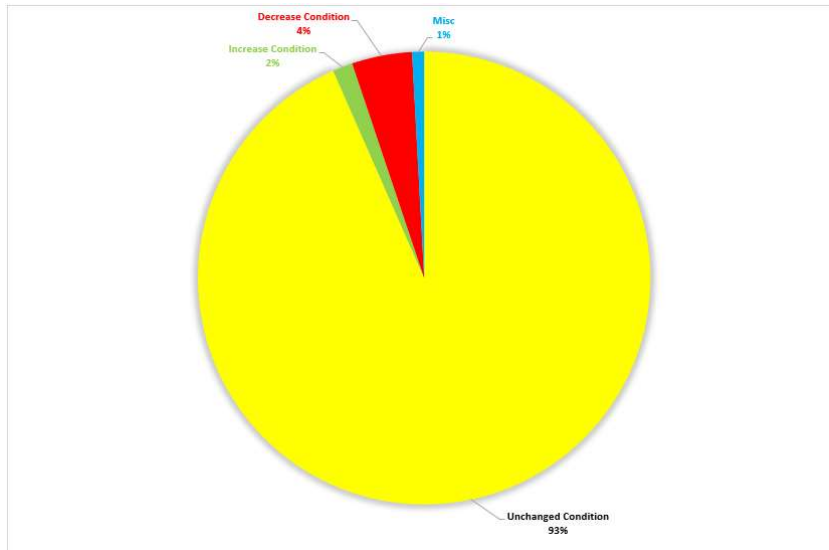
Figure 1 - Summary asset data for Northumberland County Council

Since the previous 2020 survey, there has been a minor overall drop in condition of the assets within the Northumberland County Council frontage. This is evidenced by Figure 1 below that shows whilst the vast majority of assets (93%) have held the same condition grading, a higher percentage of assets (4%) have decreased in condition compared to those that have increased (2%). This is contrary to the pattern observed in recent years that has shown a general overall improvement in the condition due primarily to recent capital schemes. The number of assets in 'very poor' or 'poor' condition fell between 2014 (58), 2016 (58), 2018 (55) and 2020 (51), but increased in 2022 to 54.

Some of the areas of deterioration include Green's Haven (concrete apron), Alnmouth church Hill (masonry wall), Newbiggin Point (upper coastal slope), Cresswell (cliff), Hawks Cliff (cliff), North Blyth (gabions) and Blyth South Beach (groynes and Meggies Burn). Whilst it is understood capital schemes are planned to address some areas of concern (Beadnell wall and Creswell), it is recommended that the frontage would benefit from additional maintenance budget or further capital schemes to improve the considerable number of assets still in poor to very poor condition.

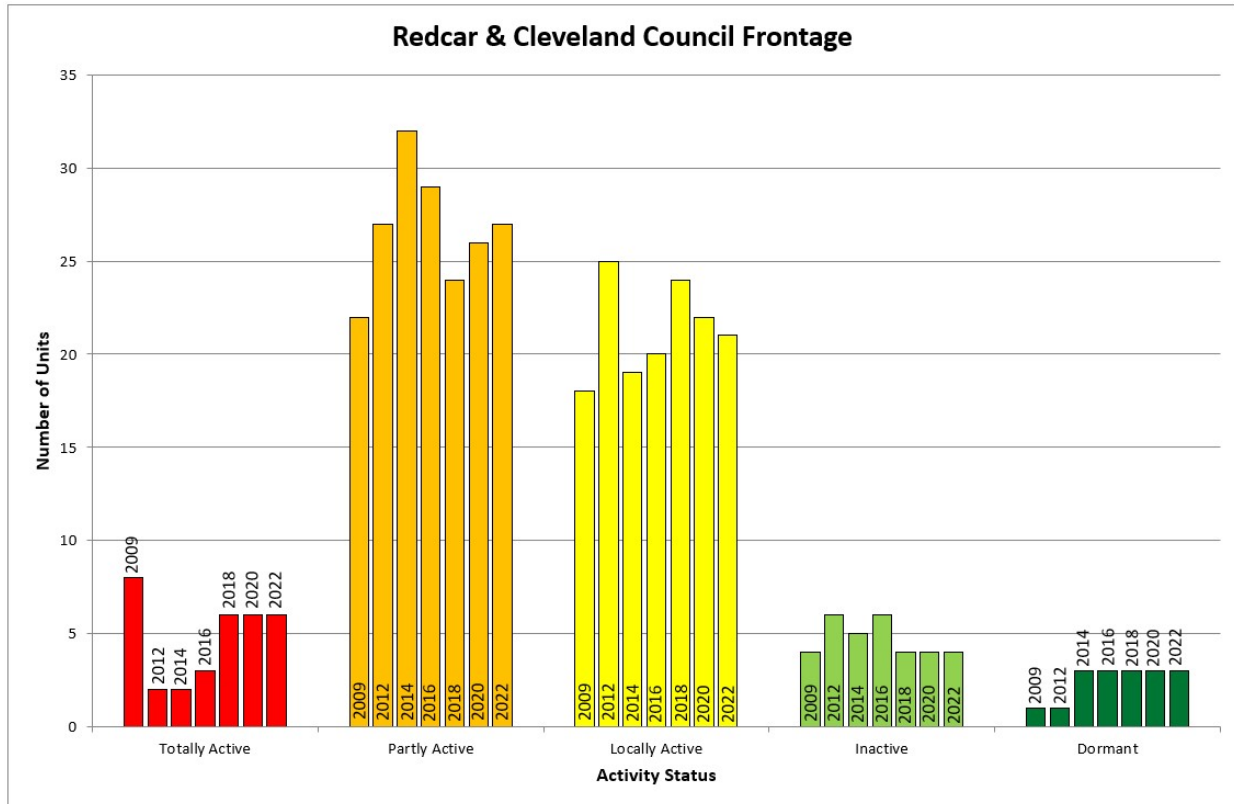
Figure 2 - Frequency of cliff activity along the Redcar & Cleveland frontage 2010 to 2022

Figure 2 shows that 95% (58/61) of the cliff units in the Redcar & Cleveland Council frontage have retained the same condition since 2020, reinforcing the consistency in the pattern of change across the frontage. The three units that have changed condition have altered between Locally and Partly Active, indicating that a slight increase (or decrease) in the magnitude of change has occurred opposed to a complete change in behaviour.

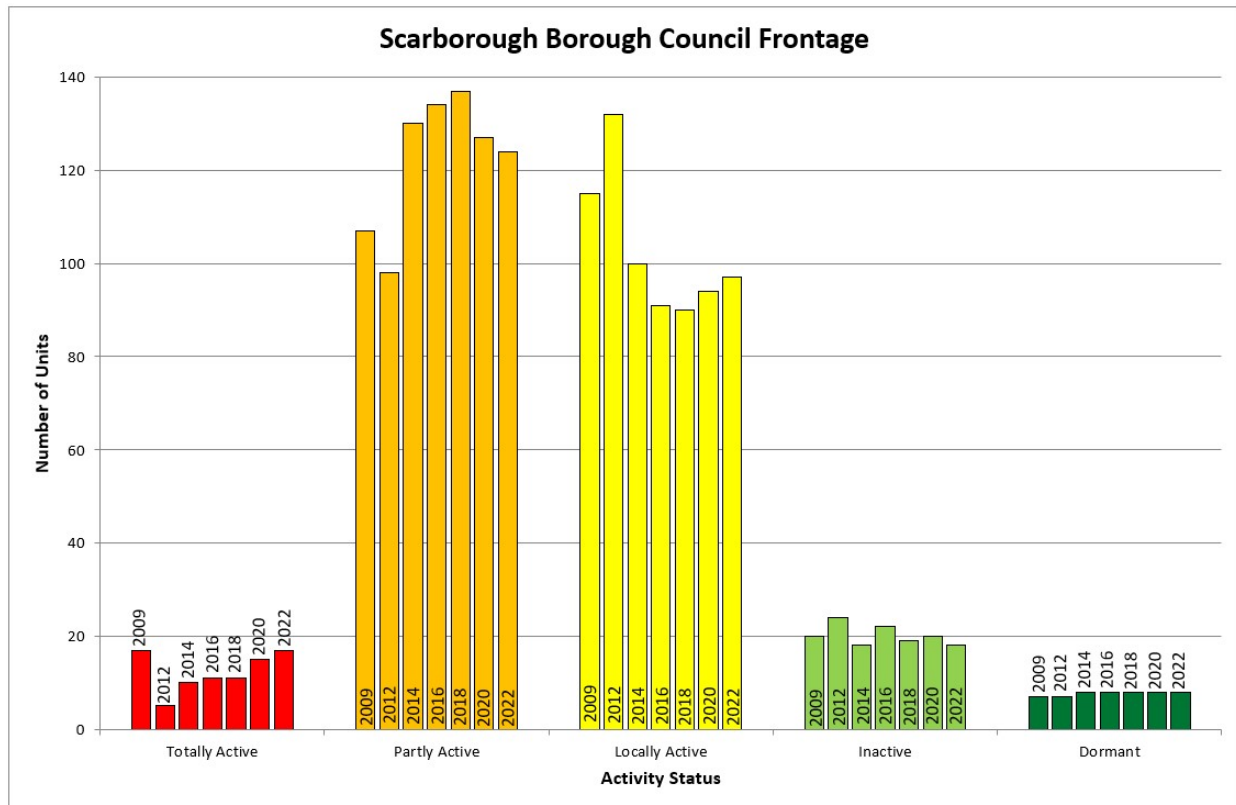
Figure 3 - Frequency of cliff activity along the Scarborough BC frontage 2009 – 2022

Figure 3 shows that ~97% (259 of 265) of the cliff behaviour units surveyed during the 2022 walkover retained the same activity status as they had in 2020. This indicates little significant change in the behaviour of the frontage. Of those units that have changed, all units have become more active since the previous inspection with none of the units becoming less active over the same period. One possible explanation for this is the significant storms (including Storm Arwen) during winter 2021/2022.
