Ongoing Analysis and Interpretation of Coastal Monitoring Data

Second Review of Restricted Suite Monitoring

Geotechnical Interpretative Report

Document Ref. No. 721229/002/GIR/004/Final

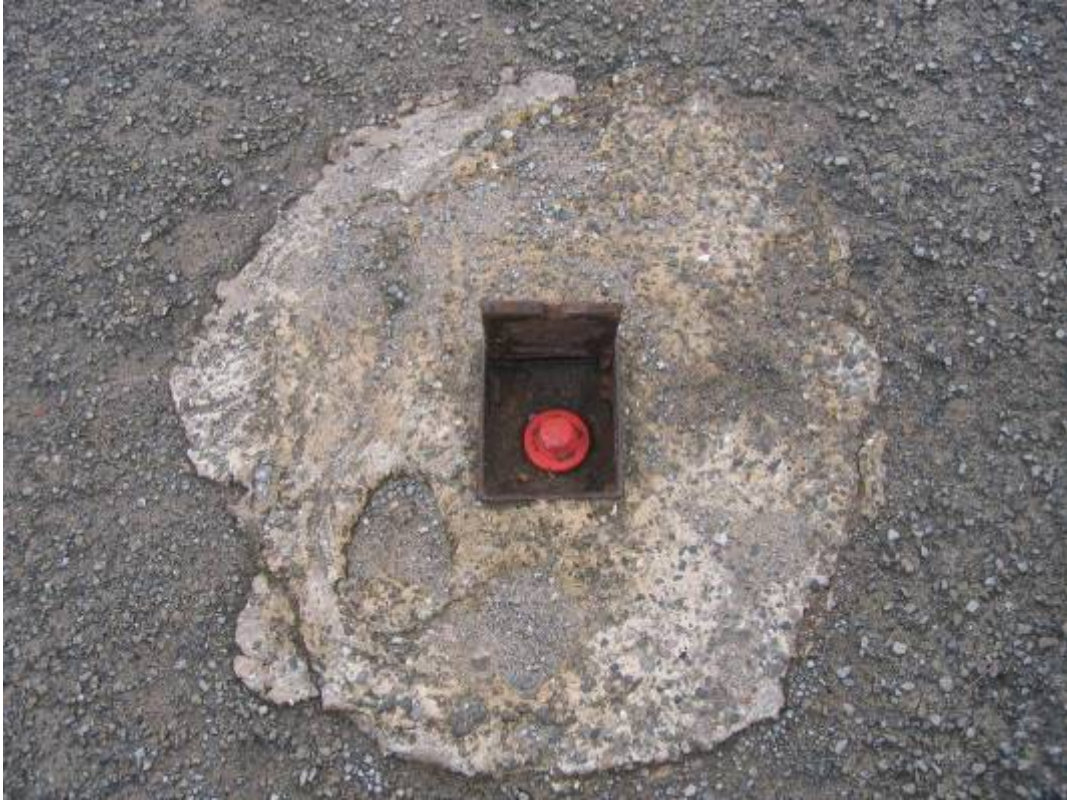
Plate 1. Whitby West Cliff BH2

The ongoing monitoring regime was initialised in July 2009 and follows that detailed in Section 2.5.1, above. Following on from the findings of the *Condition Survey Report*, monitoring consists of a single inclinometer (B001 / BH2) located within a path near the base of the coastal slope of West Cliff and the monitoring of surveying points. Groundwater was measured using a dip meter.

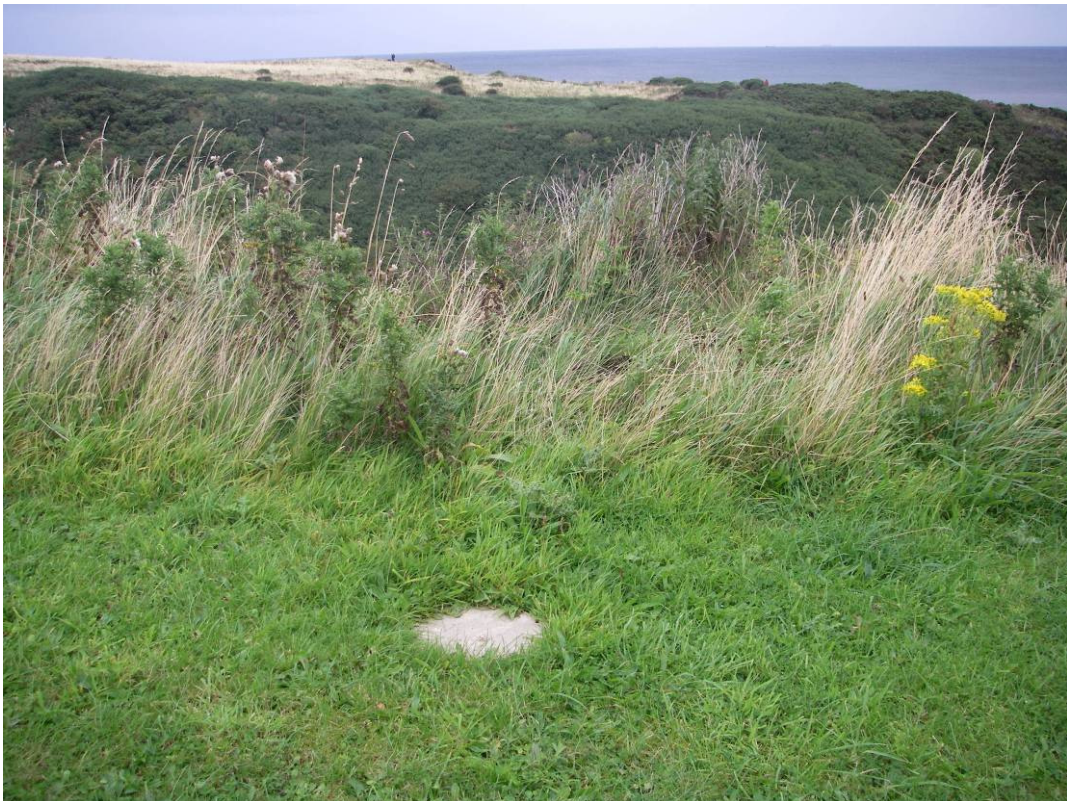
Plate 4 Scalby Ness MP3

The survey pins were measured in July and August, a comparison of measurements taken from these stations (MP1, MP2, MP3 and MP4) showed zero cliff recession rates had occurred during this period. During the proceeding months period, a cliff recession rate of 10mm was noted at MP3 though zero at other points.

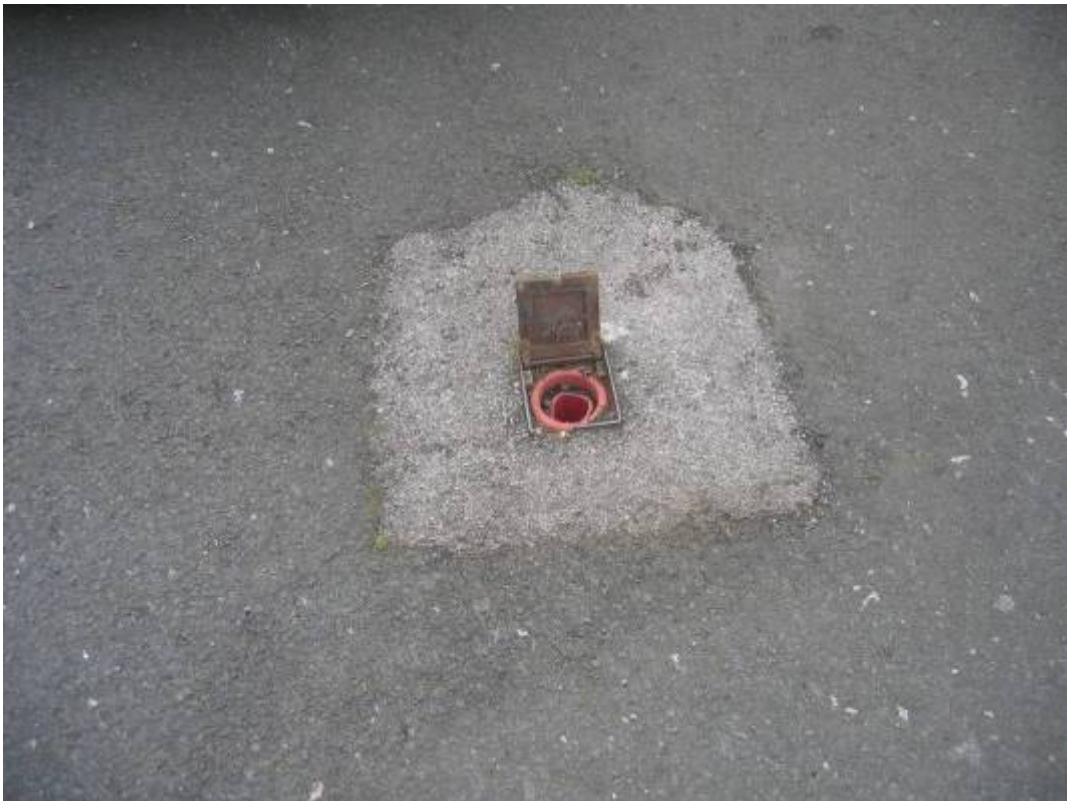
Plate 6 Scarborough North Bay L11

At present, there does not seem to be an obvious reason for the wide fluctuation of groundwater levels within L11. The borehole location, geology and surrounding topography do not readily explain the pattern of groundwater levels observed to-date. Groundwater levels within L1(b) would appear to be affected by tidal influences.
