Ongoing Analysis and Interpretation of Coastal Monitoring Data

Review of First Additional Suite Monitoring

Geotechnical Interpretative Report

February 2010

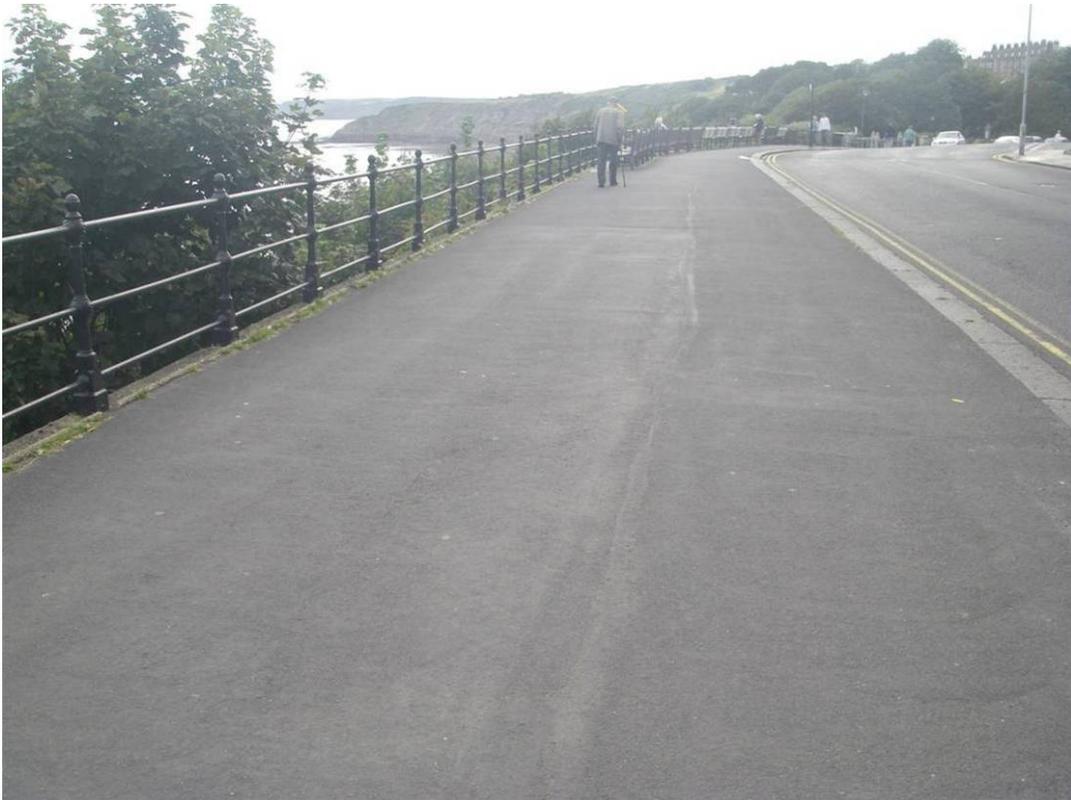
Plate 75 Scarborough South Cliff. Promenade showing signs of subsidence.

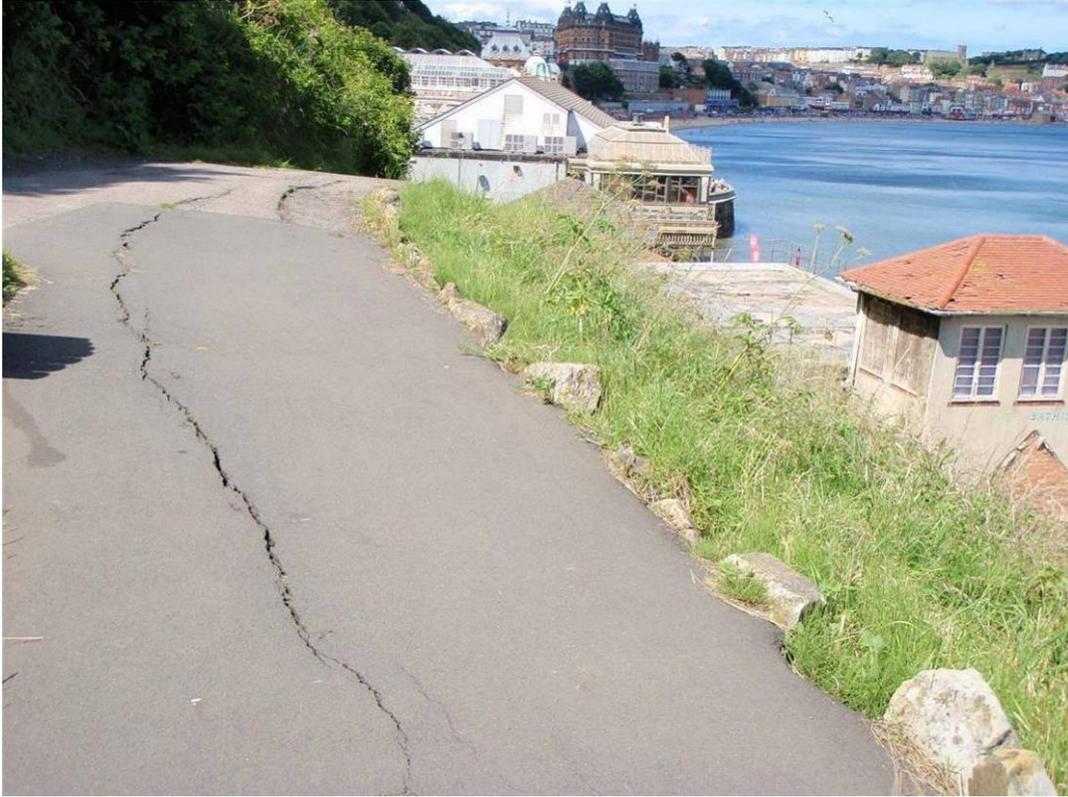
Plate 76 Scarborough South Cliff. Promenade showing signs of subsidence.

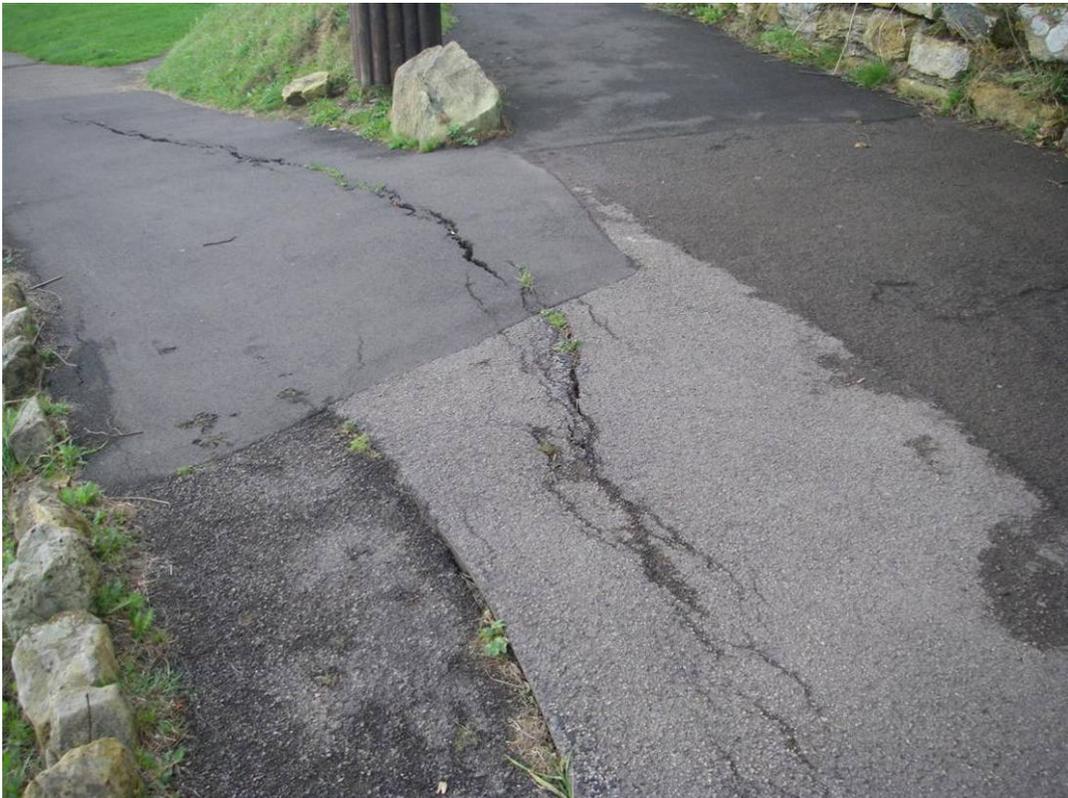
Plate 77 Scarborough South Cliff. Pavement cracking above the Clock Café (July 2008).

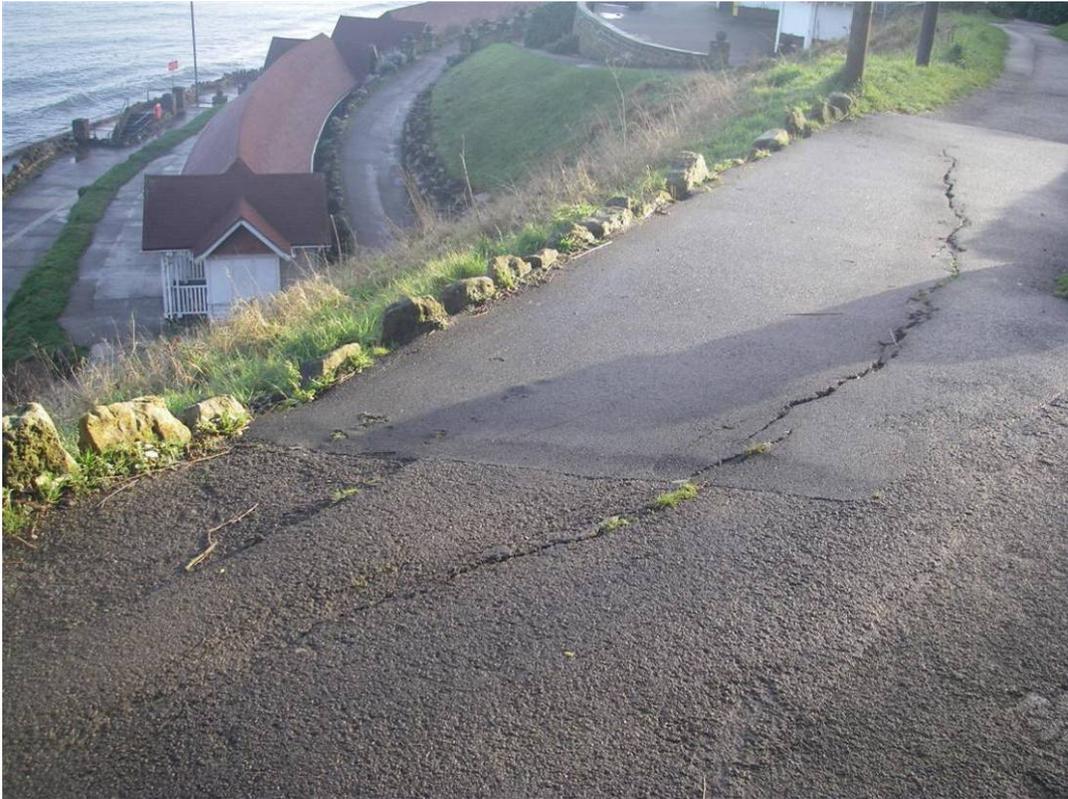
Plate 78 Scarborough South Cliff. Pavement cracking above the Clock Café (Sept 2008)

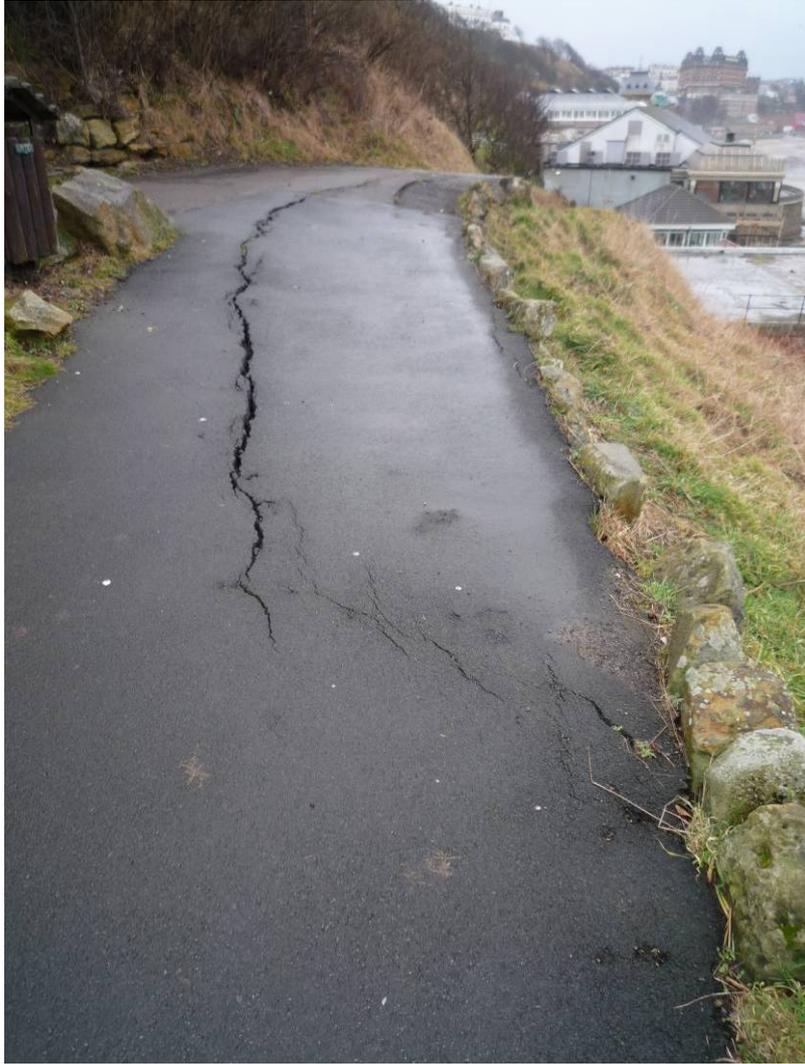
Plate 79 Scarborough South Cliff. Pavement cracking above the Clock Café (Dec 2008)

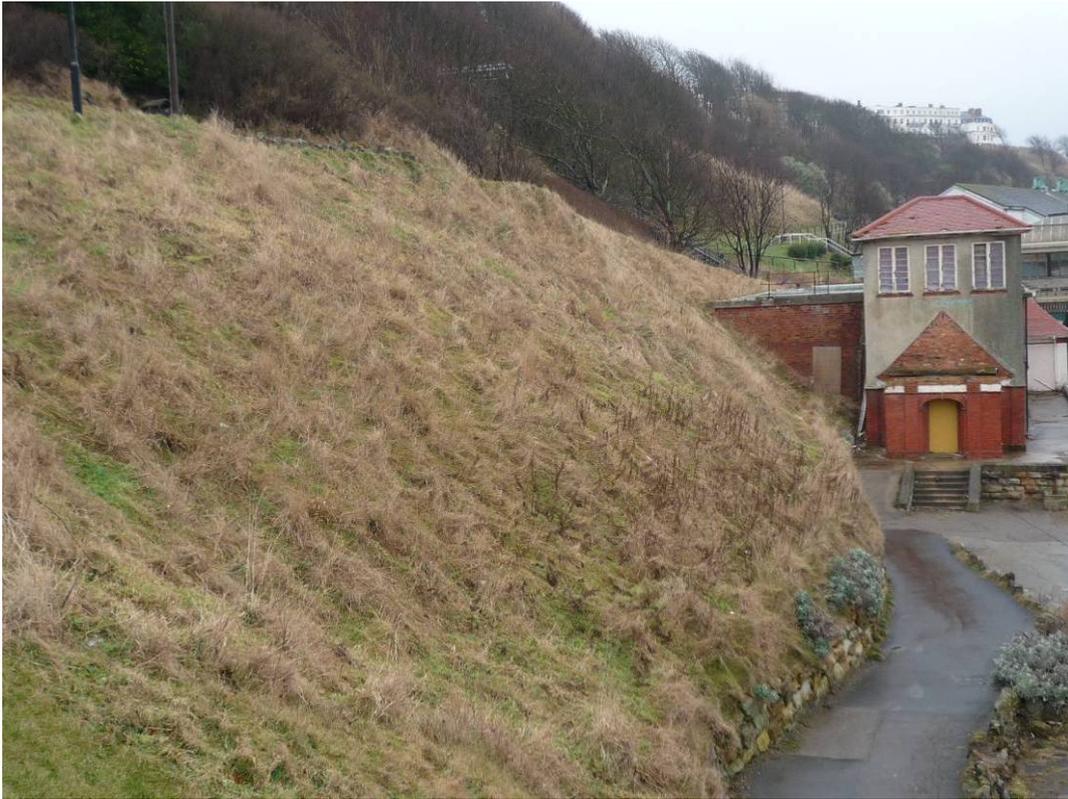
Plate 80 Scarborough South Cliff. Pavement cracking above the Clock Café (Jan. 2010).

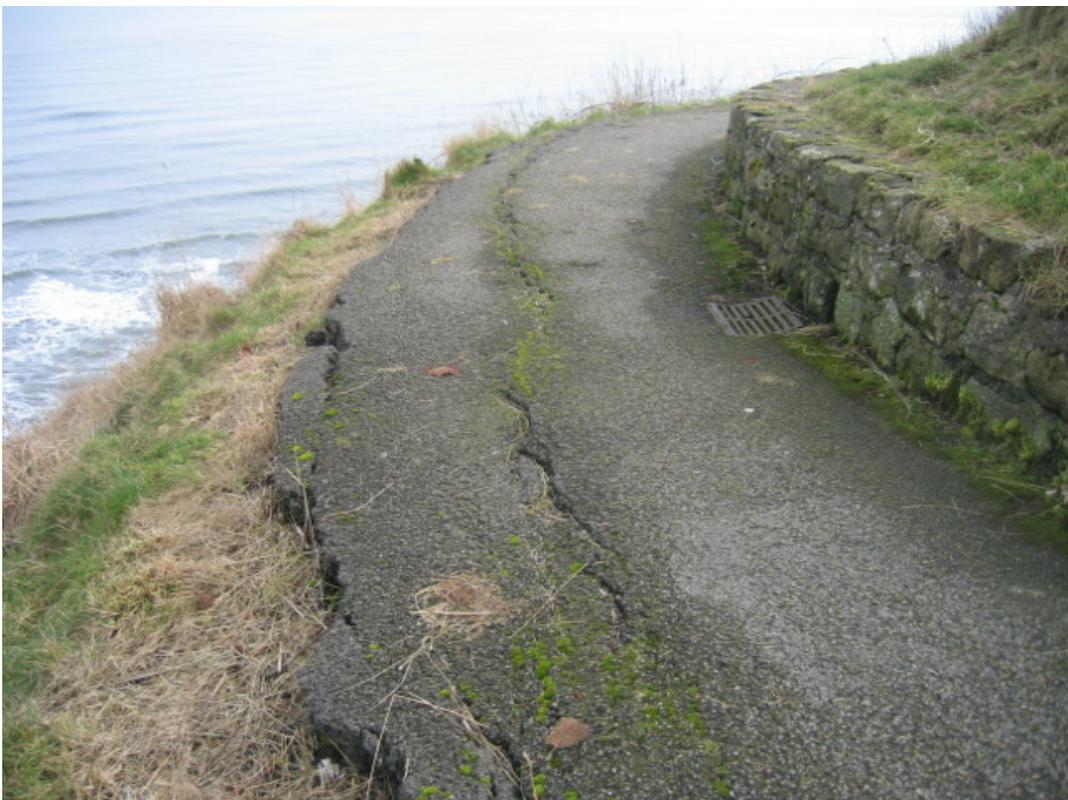
Plate 81 Scarborough South Cliff Slope bulging adjacent the Clock Café (Jan 2010).

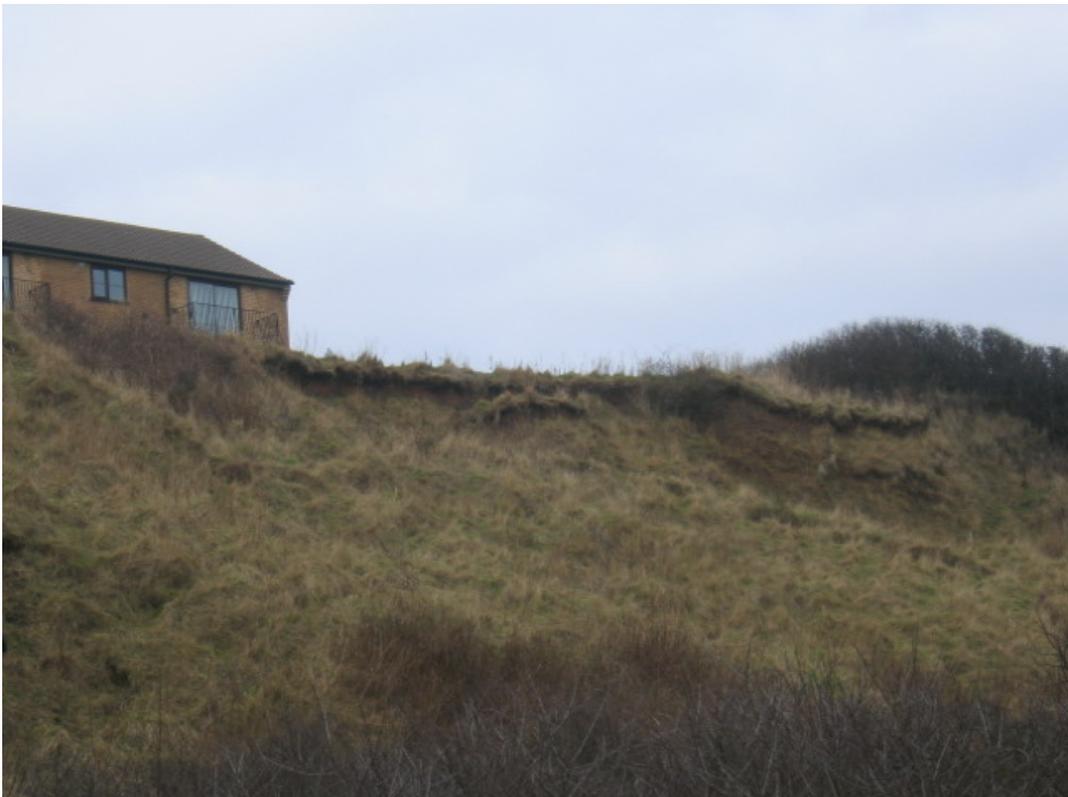
Plate 7 Site view of Behaviour Unit II showing over steepened back-scarp below Upper Plateau (November 2008).

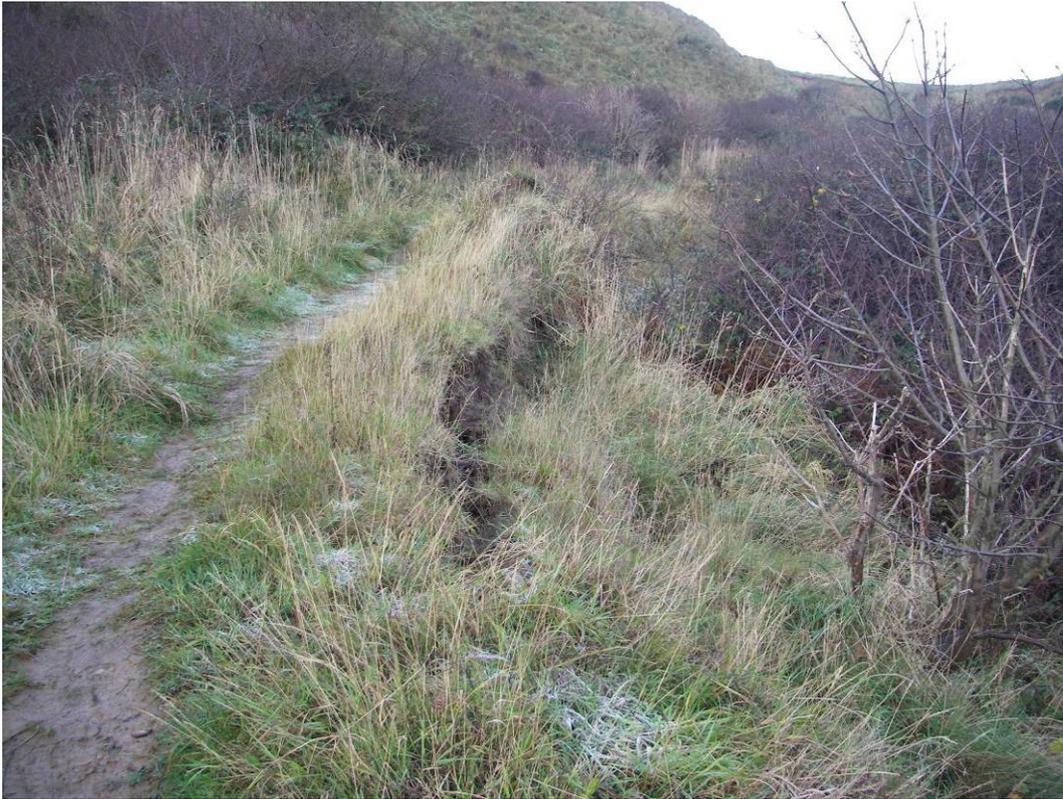
Plate 8 Site view of Behaviour Unit II showing increased degradation and collapse of over-steepened back-scarp below Upper Plateau (January 2010).

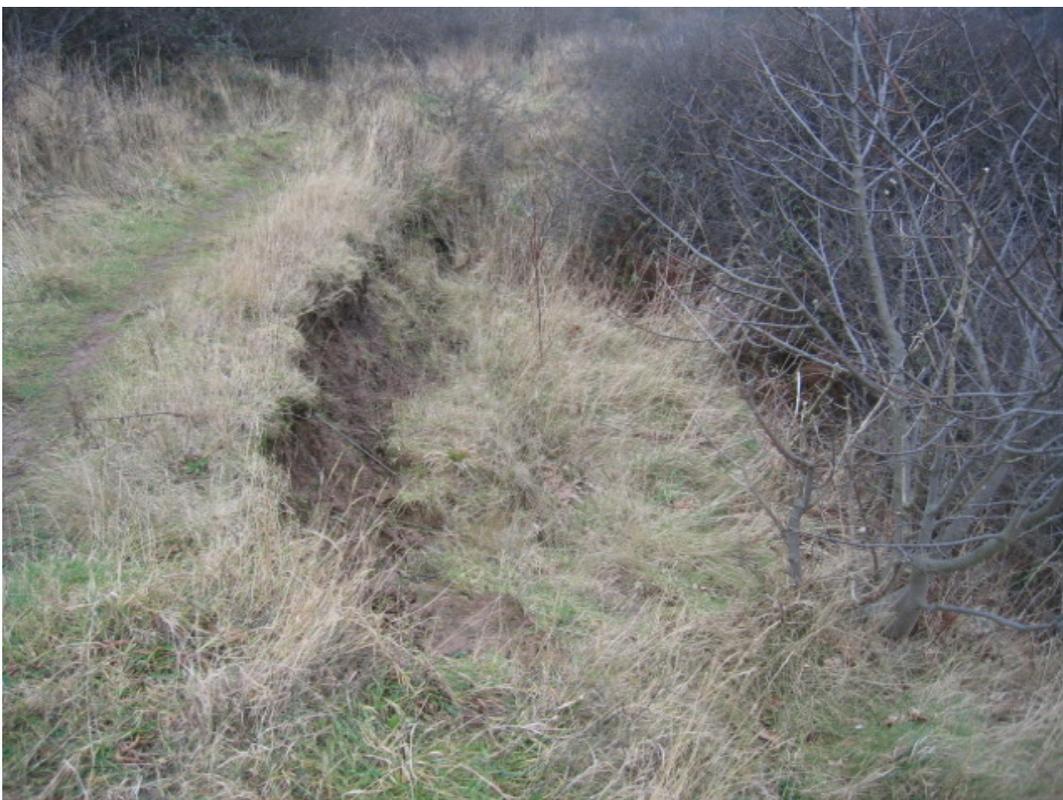
Plate 9 Site view of mid-slope back rotated block and surface tension cracking (November 2008).

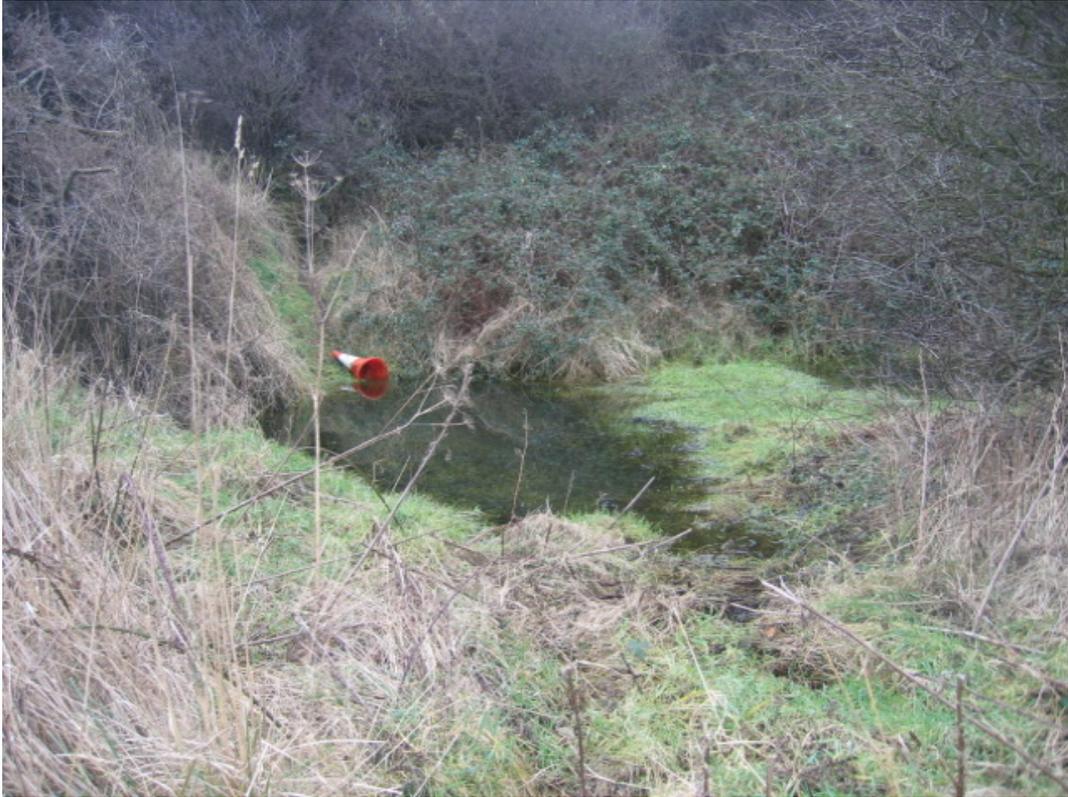
Plate 10 Site view of mid-slope back rotated block and surface tension crack development (January 2010).

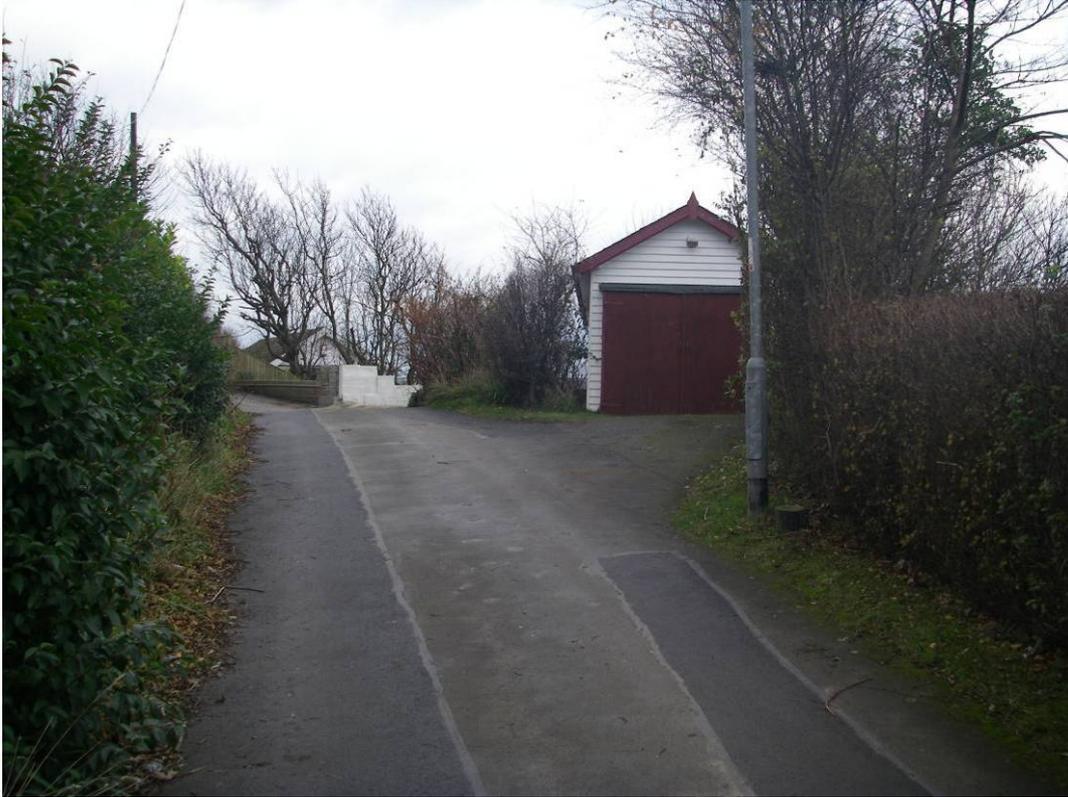
Flat Cliffs	BB02 shows 3mm movement from 12.5 to 10.5 metres and 2-3mm movement at 19.80 metres. Continued development of cracks in road surfaces	BB02 shows 3mm movement from 12.5 to 10.5 metres and 2-3mm movement at 19.80 metres. Continued development of cracks in road surfaces

Plate 29 Site view of tension cracks and bulge in access road into Flat Cliffs.

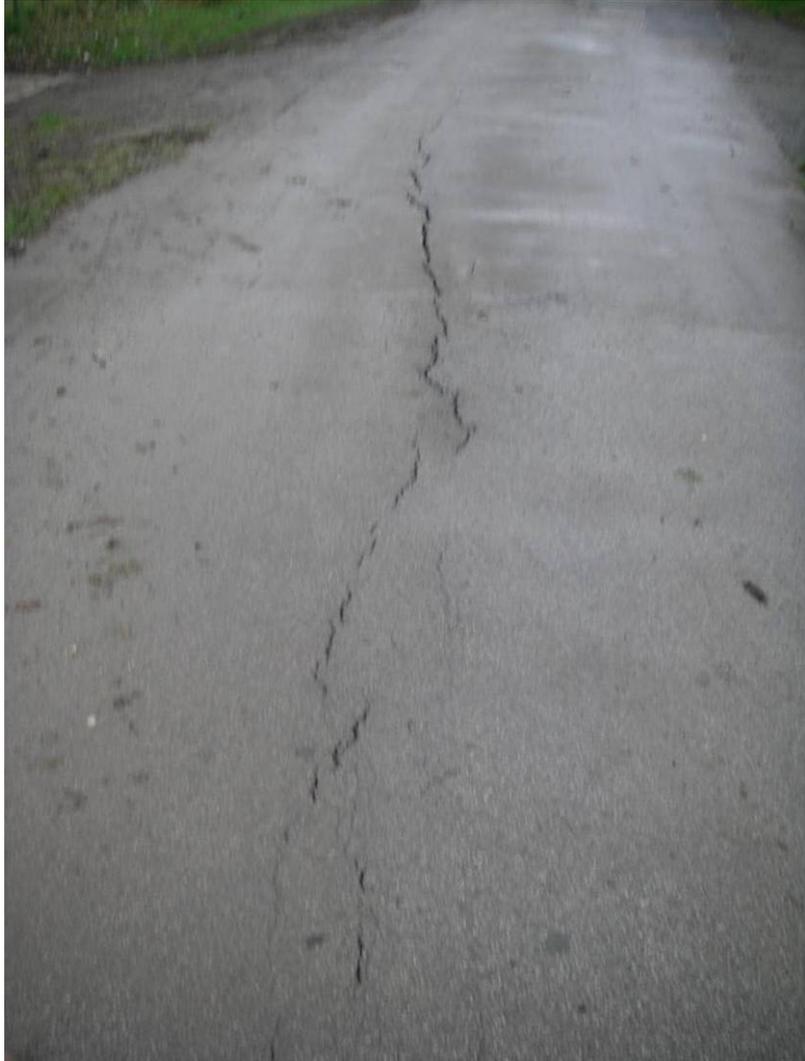
Plate 31 Site view looking down slope from 'level' mid-slope bench.

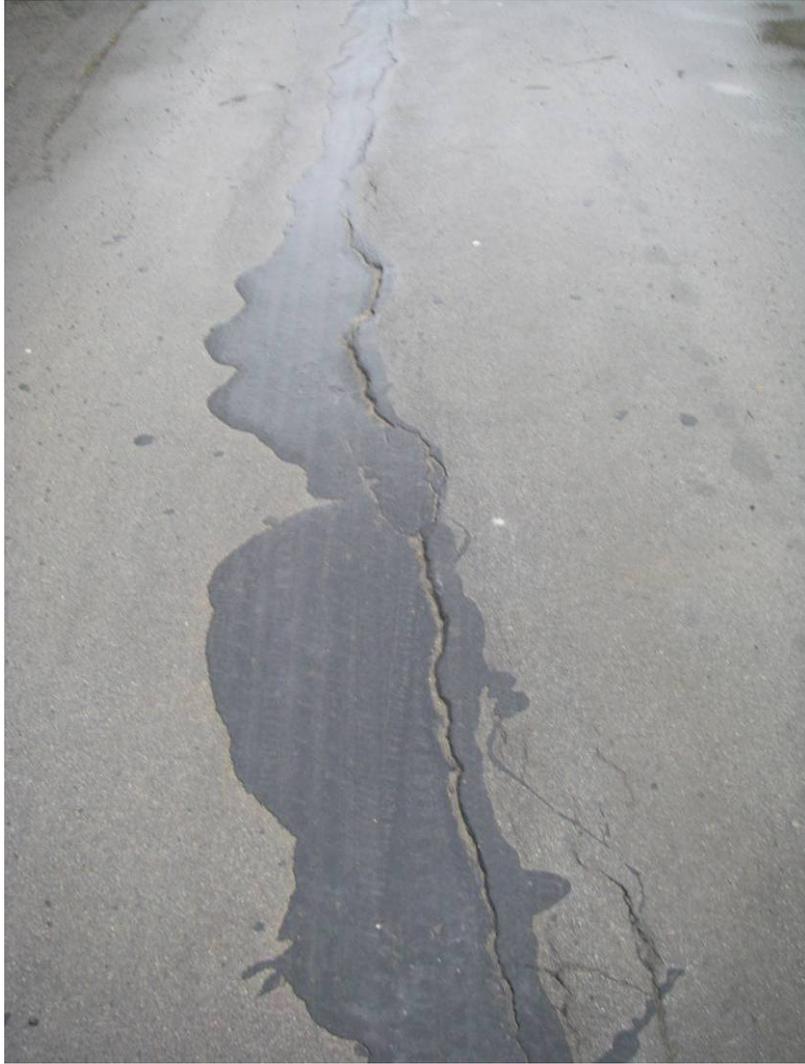
Plate 32 Site view of tension cracks in lower section of access road

(Dated 27th Nov 2008)
