Ongoing Analysis and Interpretation of Coastal Monitoring Data

Review of Second Additional Suite Monitoring

Geotechnical Interpretative Report

Document Ref. No. 721229/021/GIR/002/Final

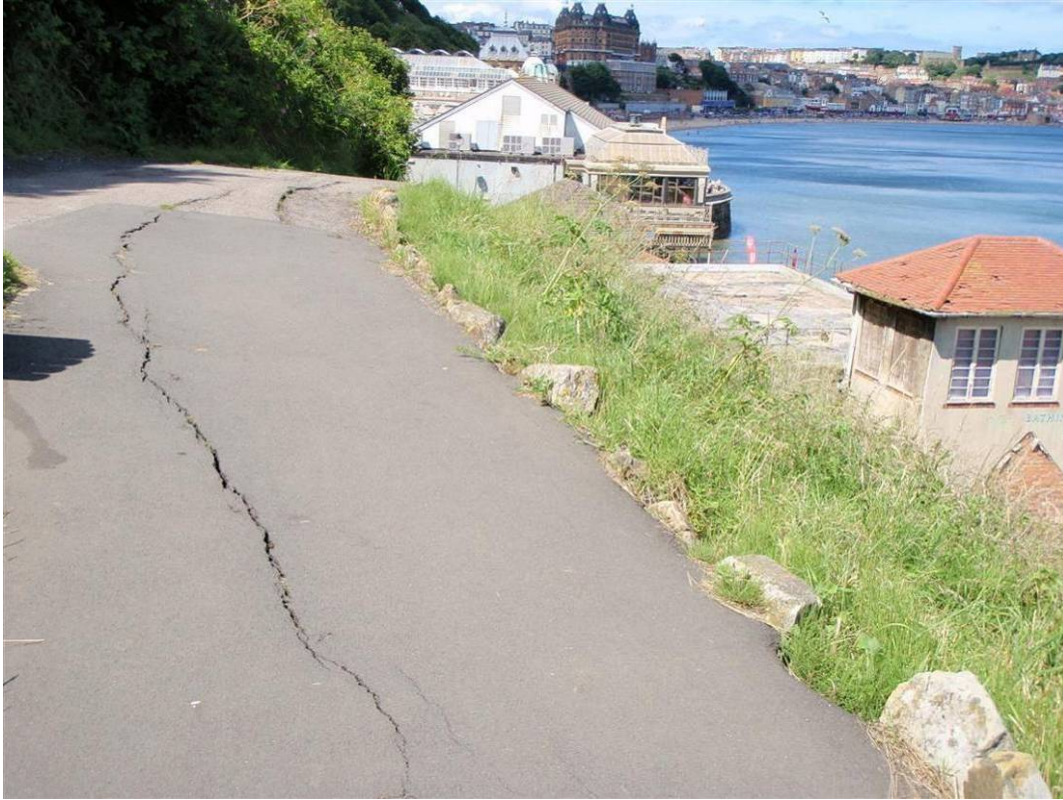
Plate 78 Scarborough South Cliff. Promenade showing signs of subsidence.

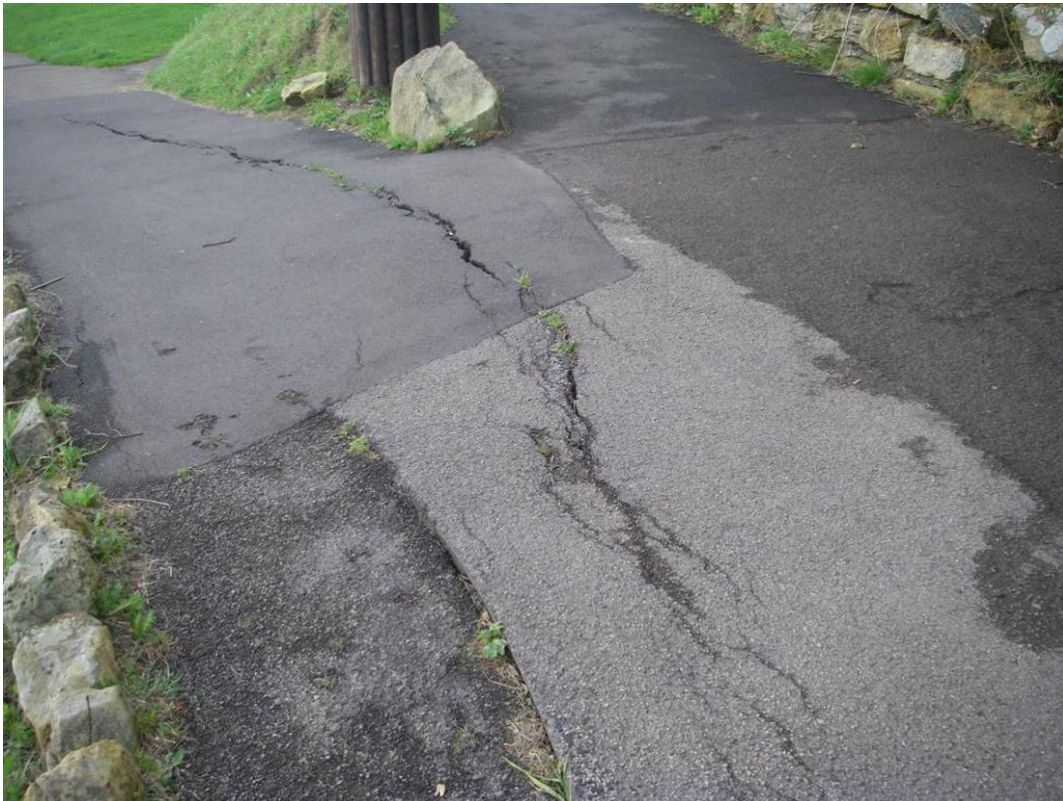
Plate 79 Scarborough South Cliff. Pavement cracks above the Clock Café (July 2008).

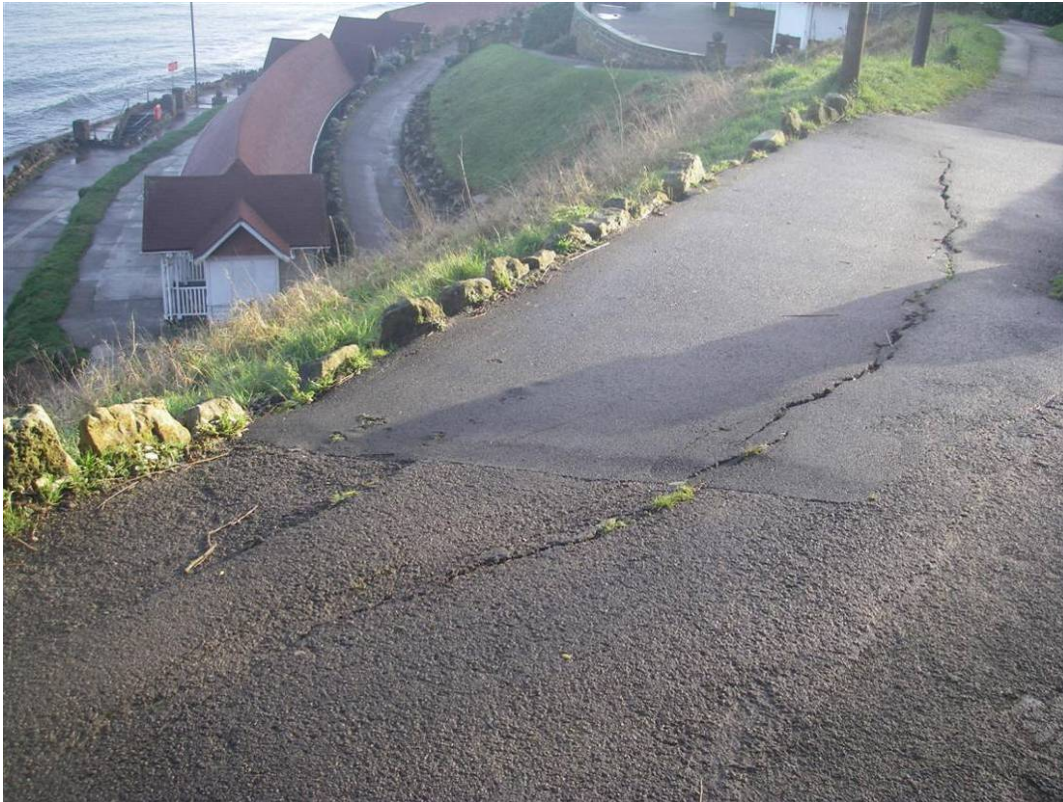
Plate 80 Scarborough South Cliff. Pavement cracks above the Clock Café (Sept 2008)

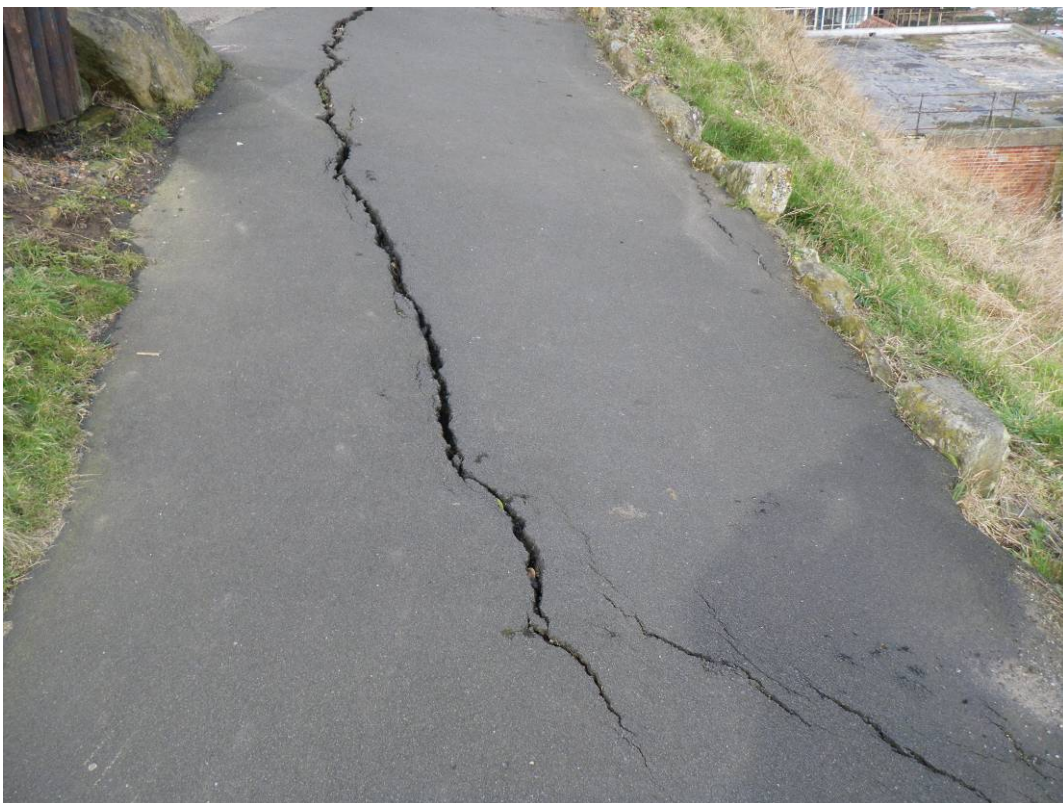
Plate 81 Scarborough South Cliff. Pavement cracks above the Clock Café (Dec 2008)

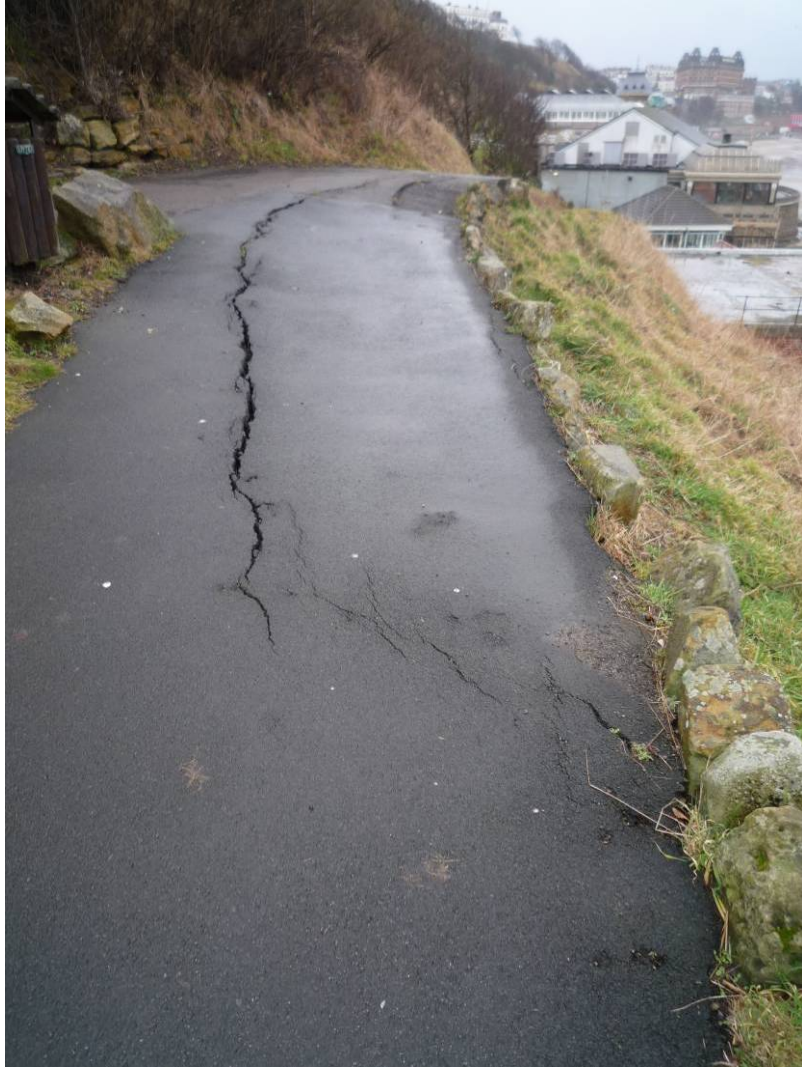
Plate 82 Scarborough South Cliff. Pavement cracks above the Clock Café (March. 2010)

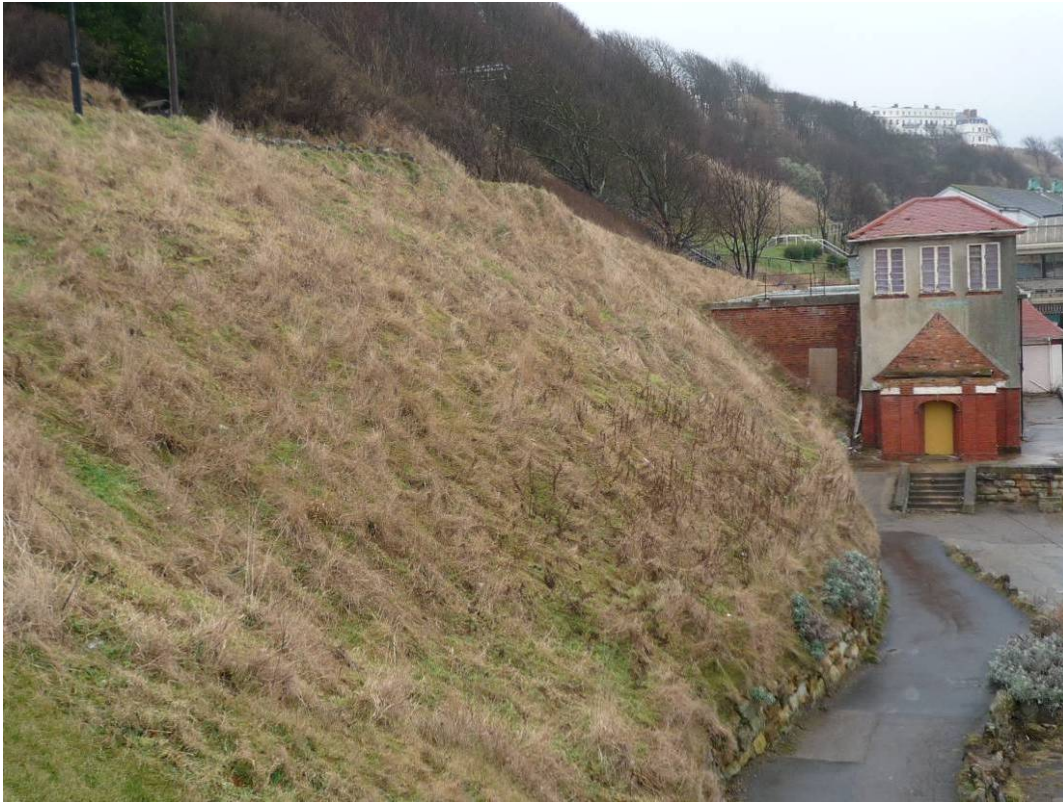
Plate 83 Scarborough South Cliff. Pavement cracks above the Clock Café (Jan. 2010).

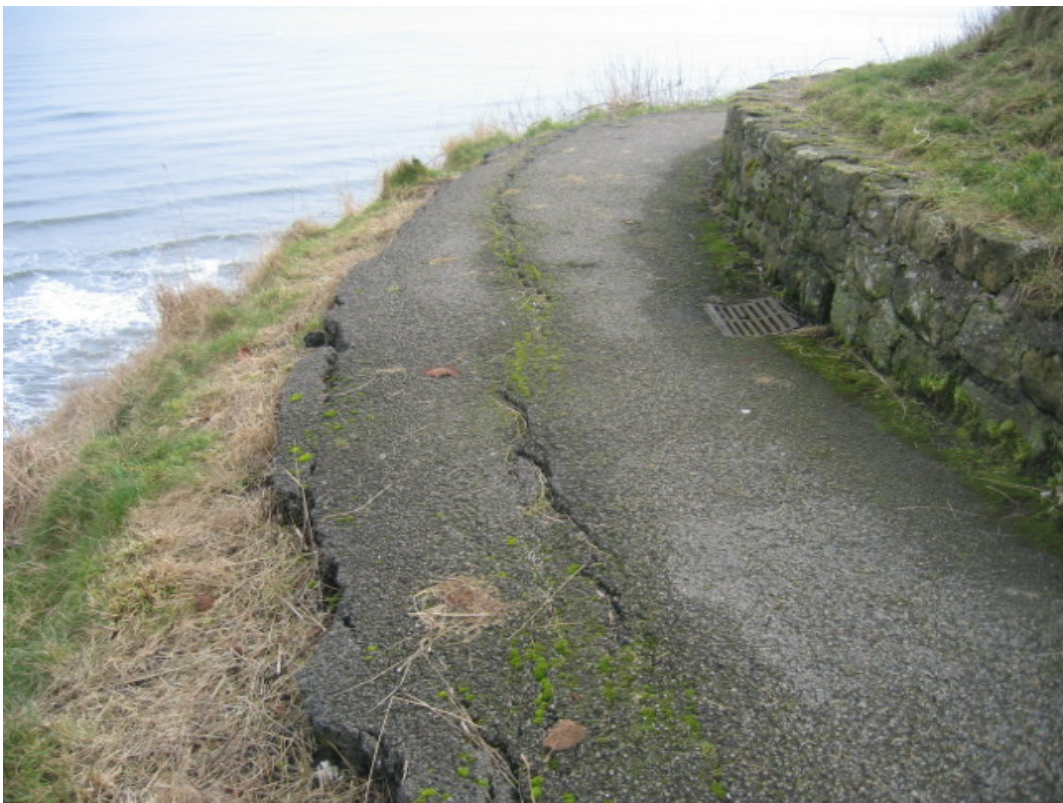
Plate 84 Scarborough South Cliff Slope bulging adjacent the Clock Café (Jan 2010).

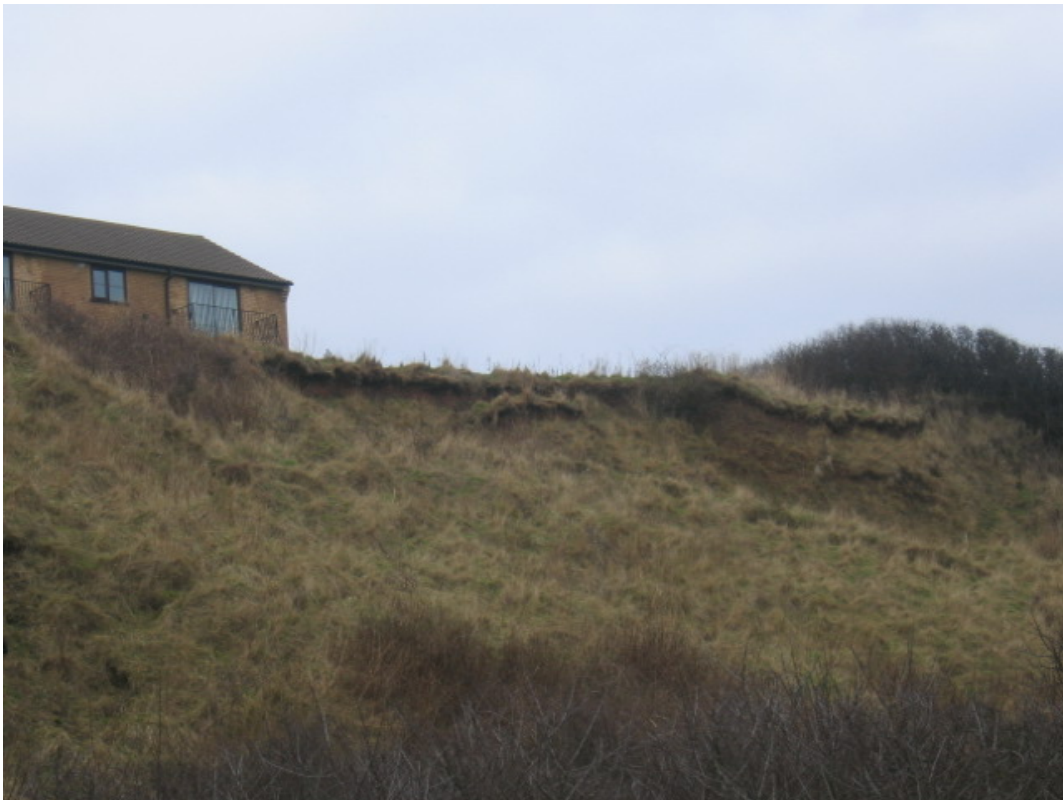
Plate 7 Site view of Behaviour Unit II showing over steepened back-scarp below Upper Plateau (November 2008).

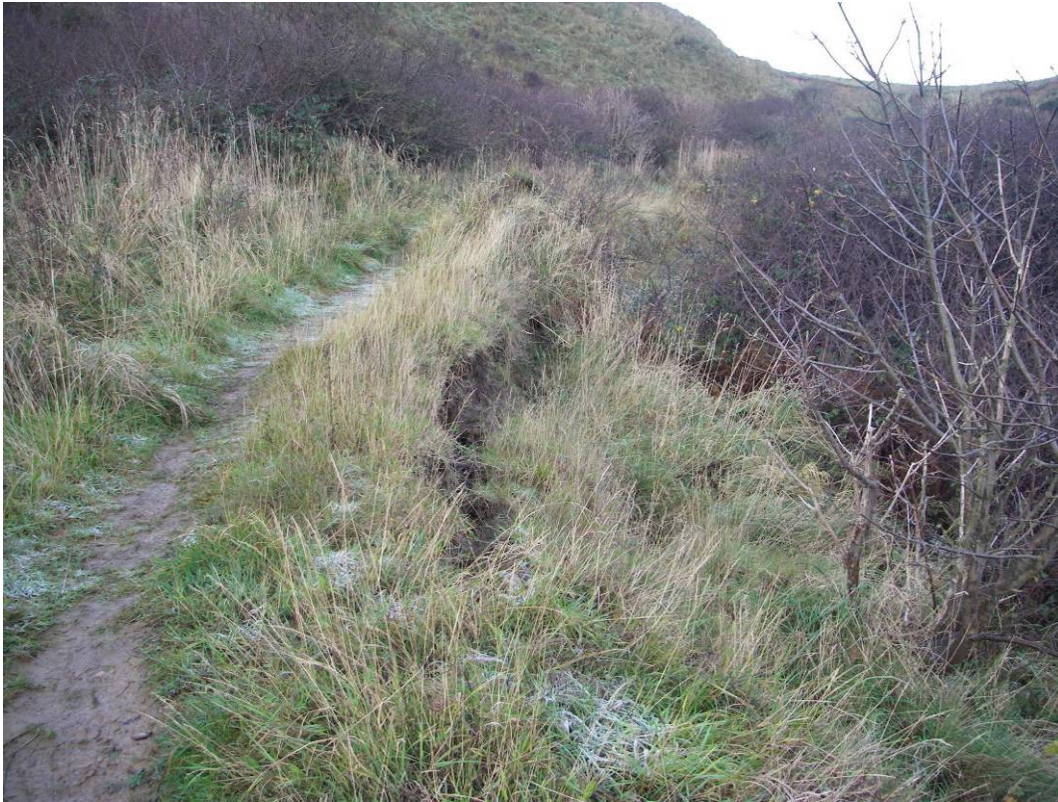
Plate 8 Site view of Behaviour Unit II showing increased degradation and collapse of over-steepened back-scarp below Upper Plateau (January 2010).

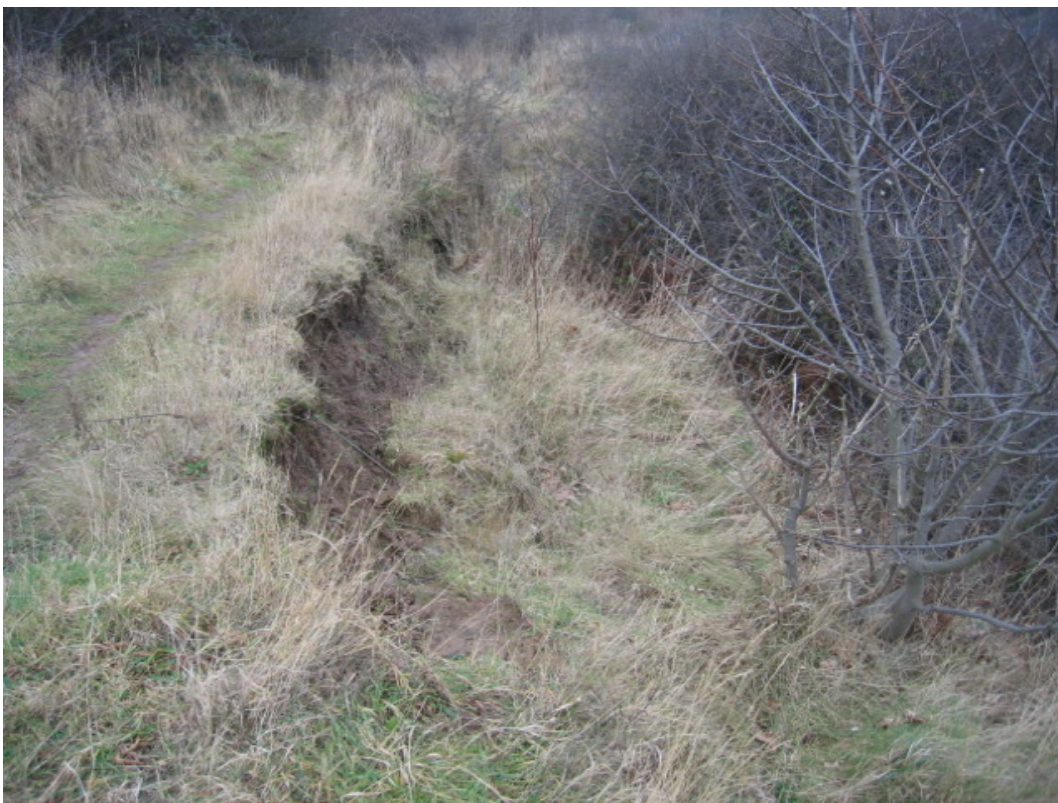
Plate 9 Site view of mid-slope back rotated block and surface tension cracking (November 2008).

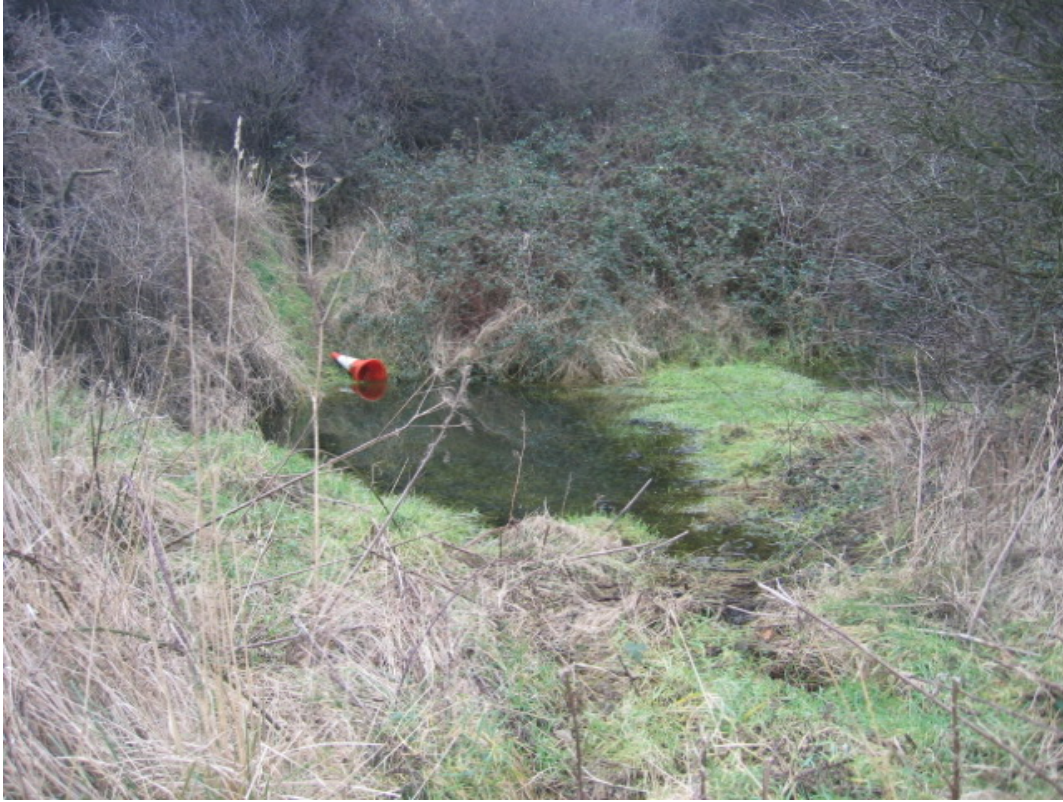
Plate 10 Site view of mid-slope back rotated block and surface tension crack development (January 2010).

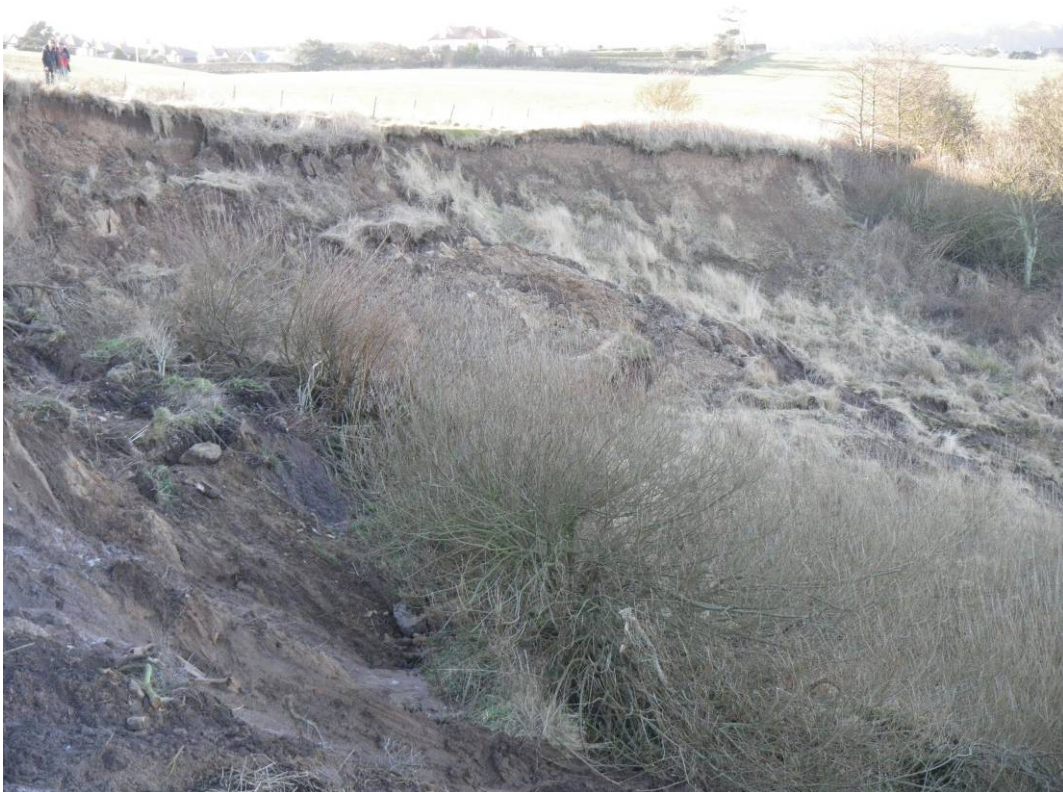
Plate 23 Slope failures on Cornelian Bay side of Knipe Point looking northwest

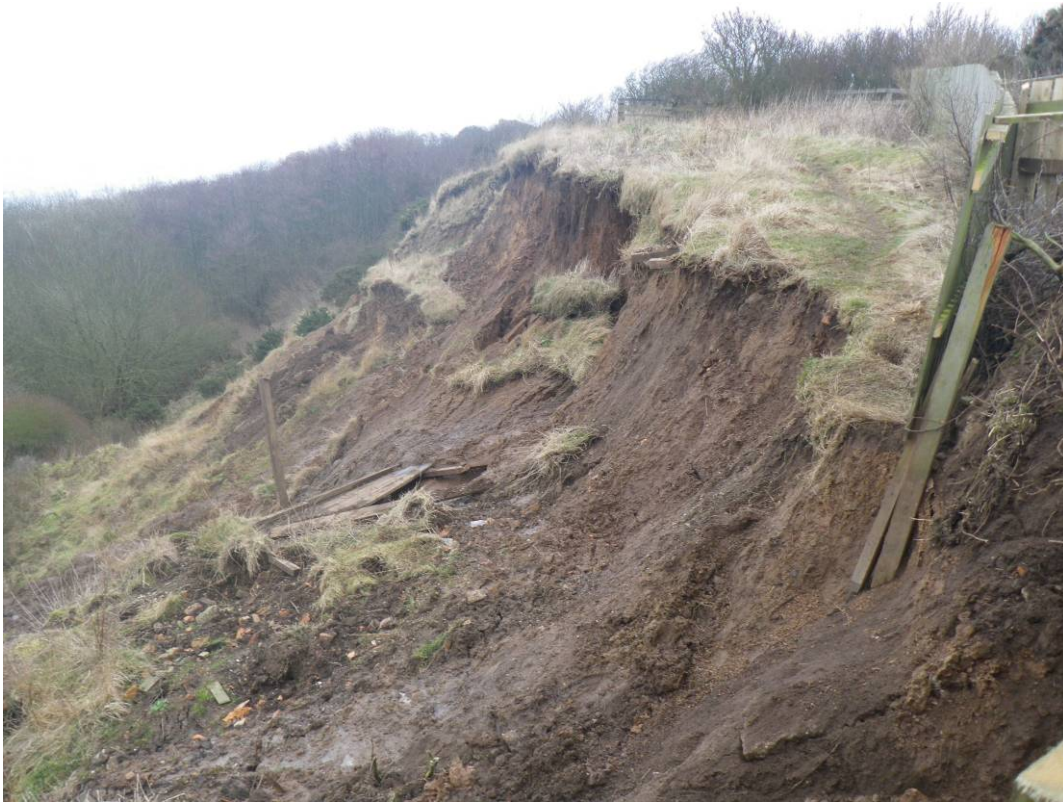
Plate 24 Slope failures on Cornelian Bay side of Knipe Point looking east (16th March 2010)

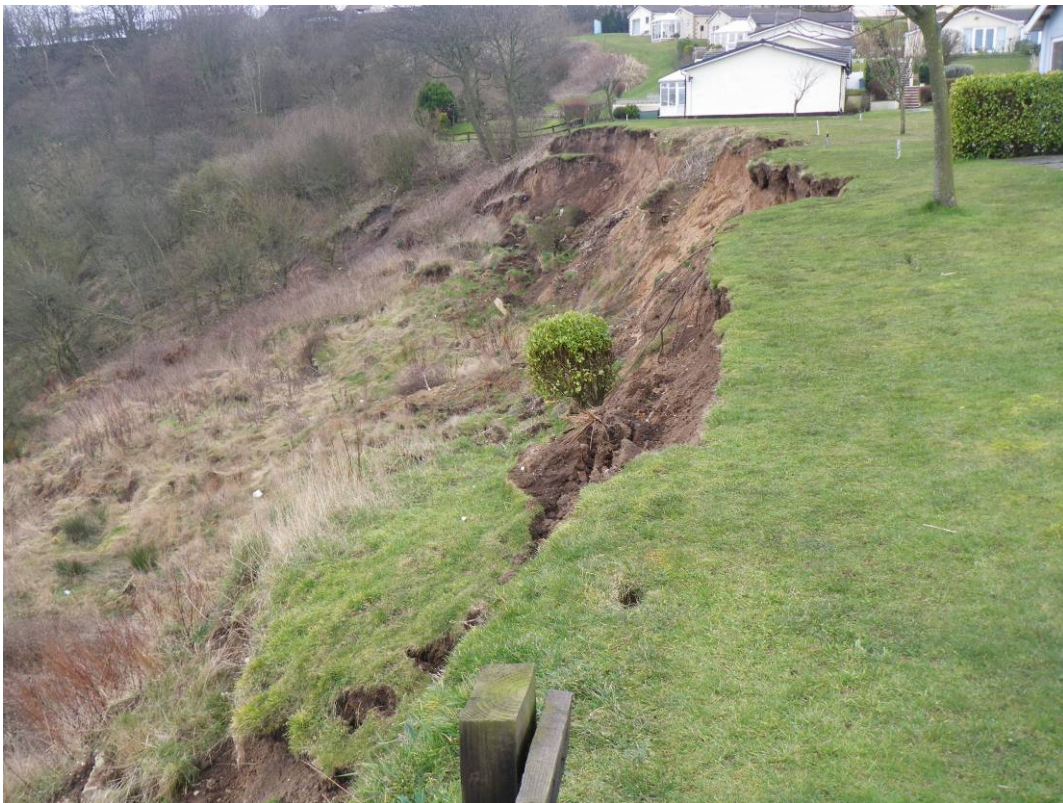
Plate 25 Cliff recession at Knipe Point Headland (8th March 2010)

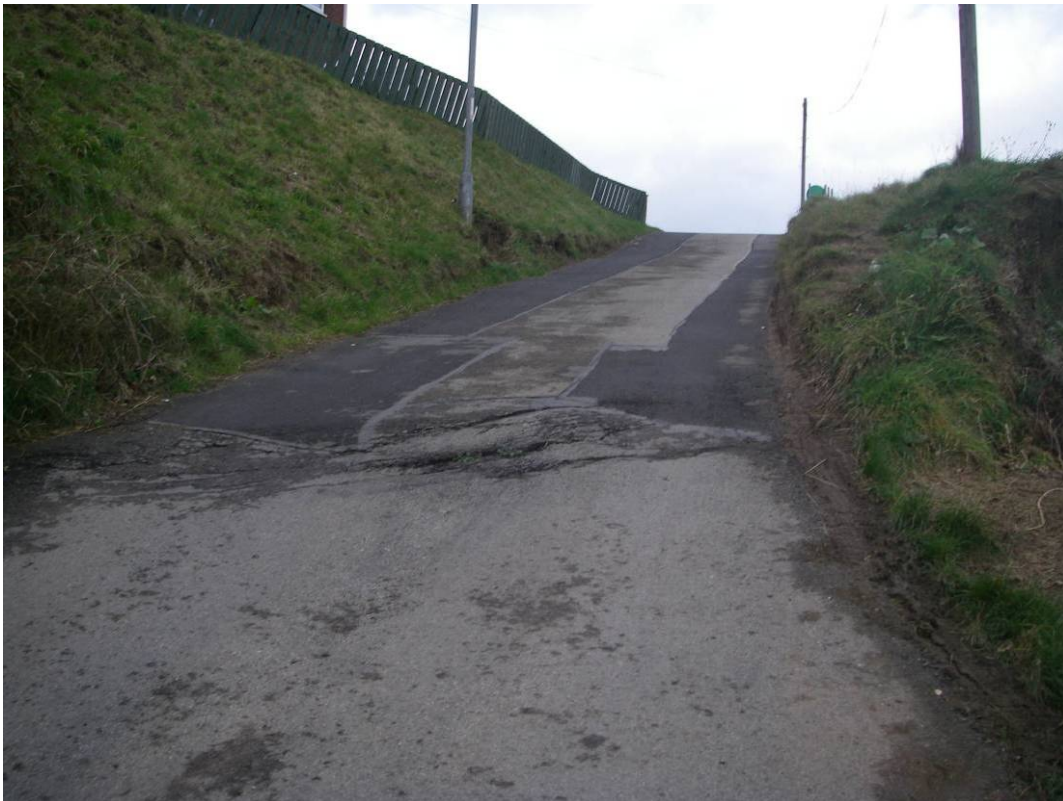
Monitoring data from the inclinometer at Filey Flat Cliffs has shown that ground movements within the slopes have so far been limited to 3mm at depths of 19.80 metres and from 12.50 to 10.50 metres. Ground movements are also discernible nearby at surface level where cracking of the road pavement is evidently developing. Cracks in the access road were identified during a site visit in November 2008; these were subsequently repaired and sealed with tar poured into the cracks. More recent photographs (taken March 2010) of the cracked pavement show the continued expansion of these cracks.

Plate 39 Site view of developing tension cracks and bulge in access road of Flat Cliffs.

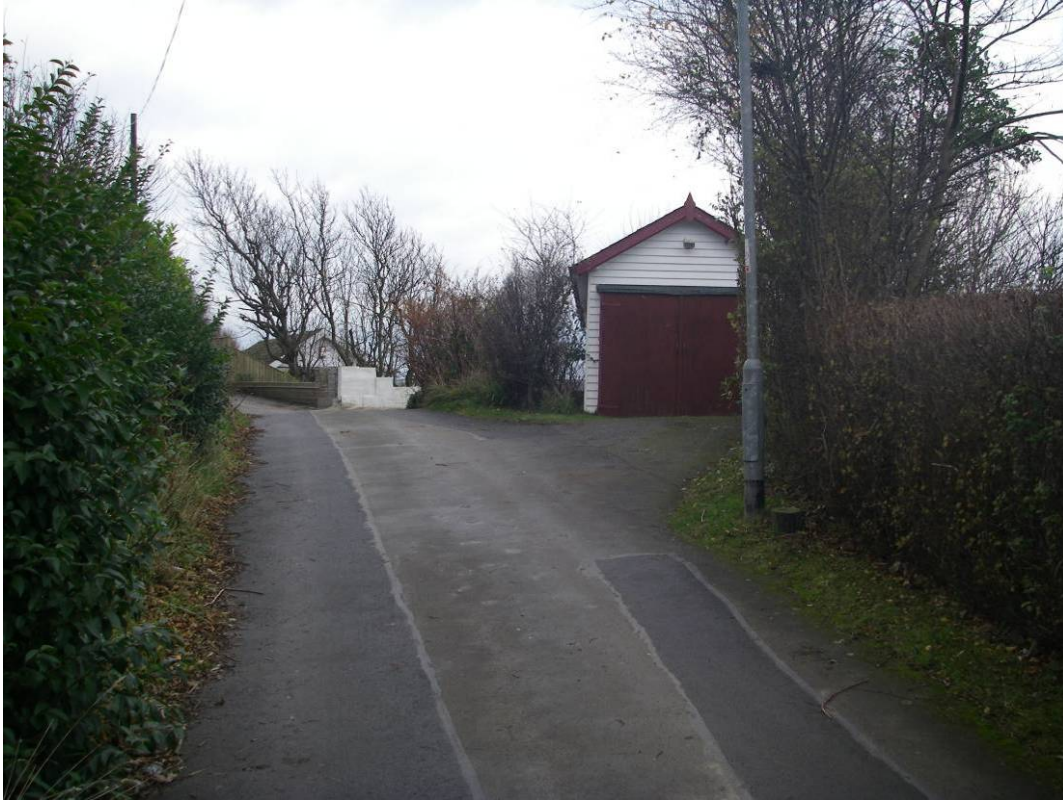
Plate 40 Site view of leaning timber garage at No. 5 Flat Cliffs; seaward of coastal slopes.

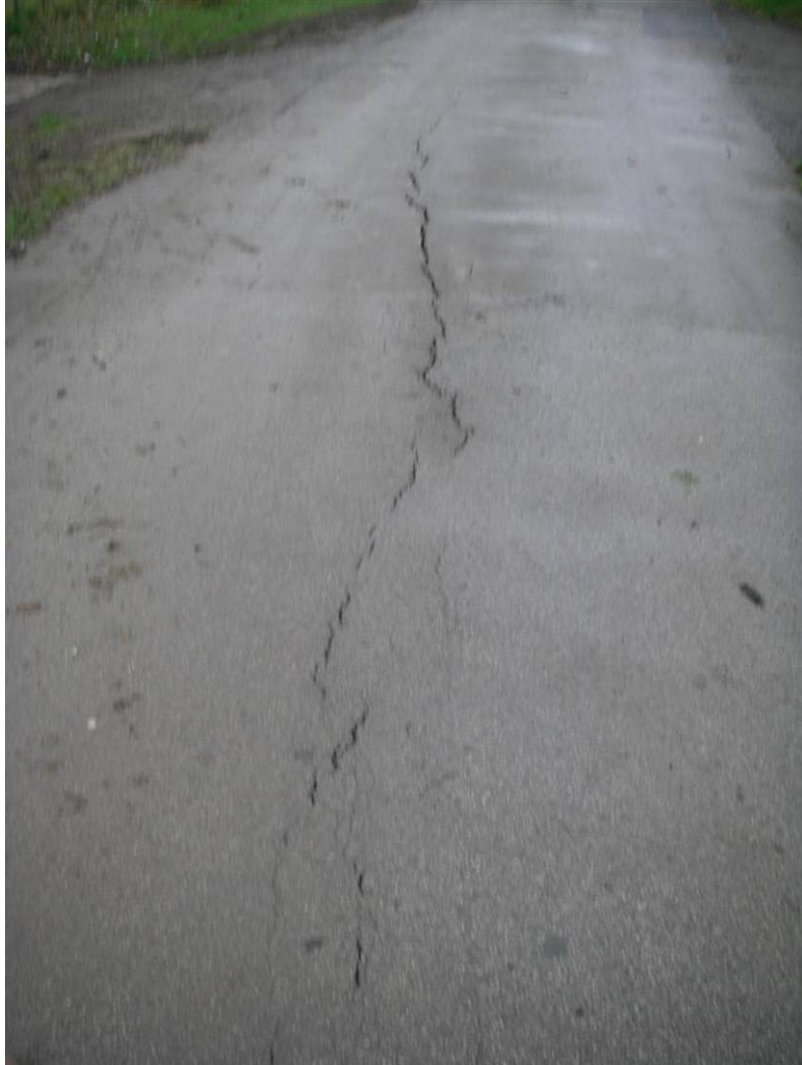
Plate 42 Site view of tension cracks in lower section of access road

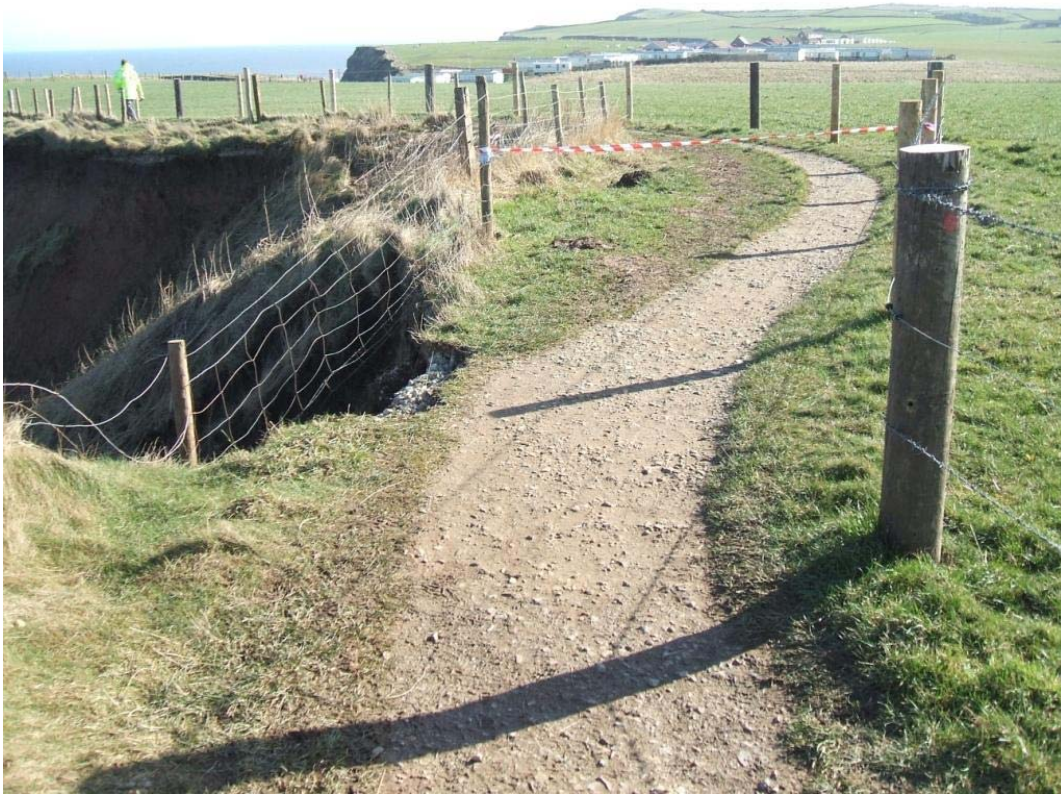
Plate 1 Cliff erosion at Saltwick
