Ongoing Analysis and Interpretation of Coastal Monitoring Data

Fourth Review of Full Suite Monitoring

Geotechnical Interpretative Report

Document Ref. No. 721229/002/GIR/011/Final

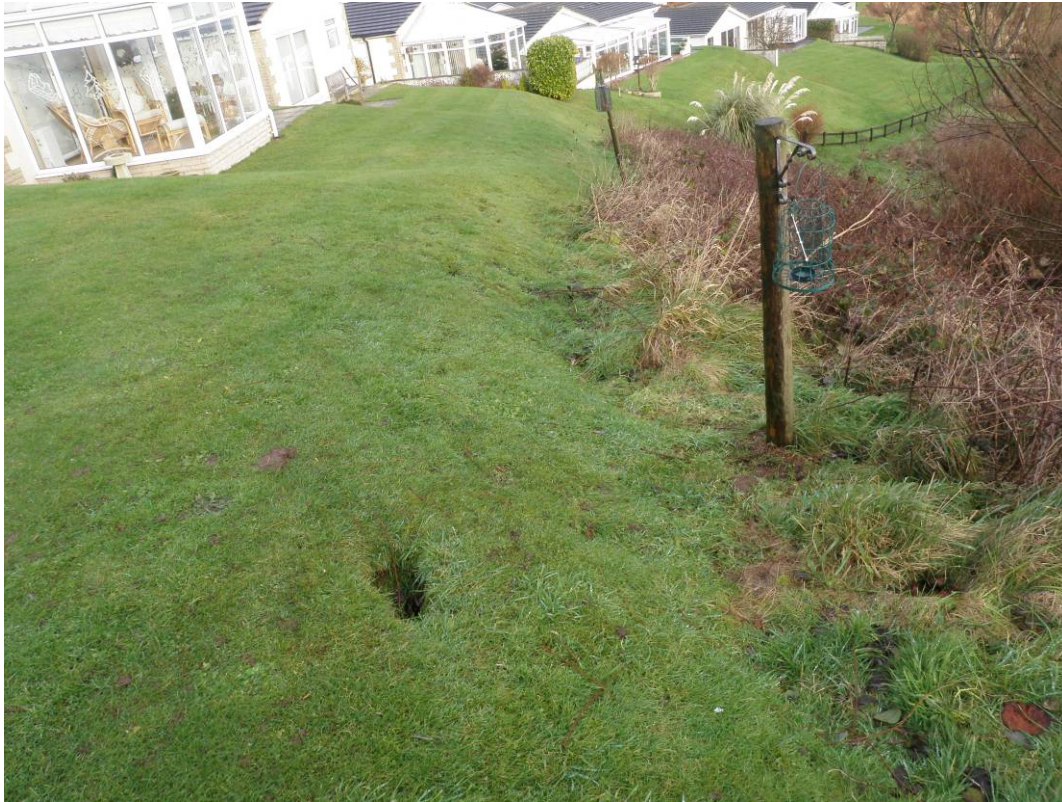
Plate 17 Cliff recession at Knipe Point Headland looking east (13th December 2010)
Note tension crack development in foreground
