# Ongoing Analysis and Interpretation of Coastal Monitoring Data

Fifth Review of Full Suite Monitoring

## Geotechnical Interpretative Report

Document Ref. No. 721229/002/GIR/012/Final

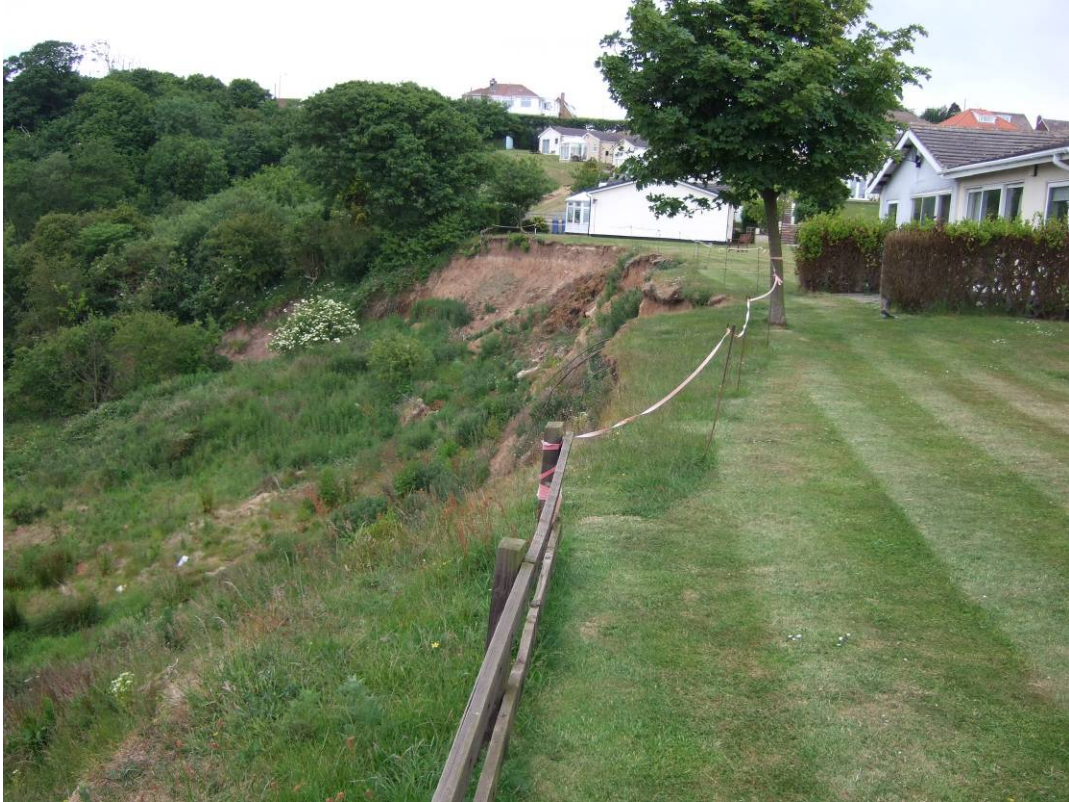
Plate 7 Cliff recession at Knipe Point Headscarp (17<sup>th</sup> June 2011)

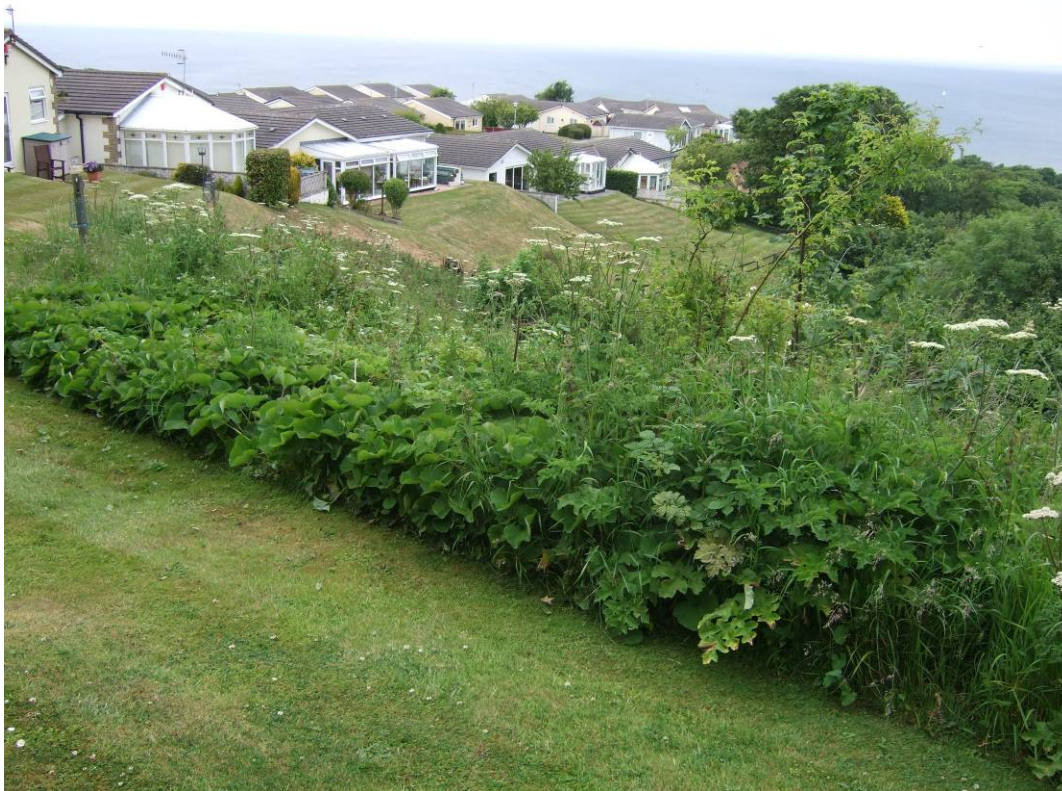
Plate 20 Cliff recession at Knipe Point Headland looking east (17<sup>th</sup> June 2011)
