Interpretation Report 14: December 2019 to July 2020

Prepared for
Scarborough
Borough Council

October 2020

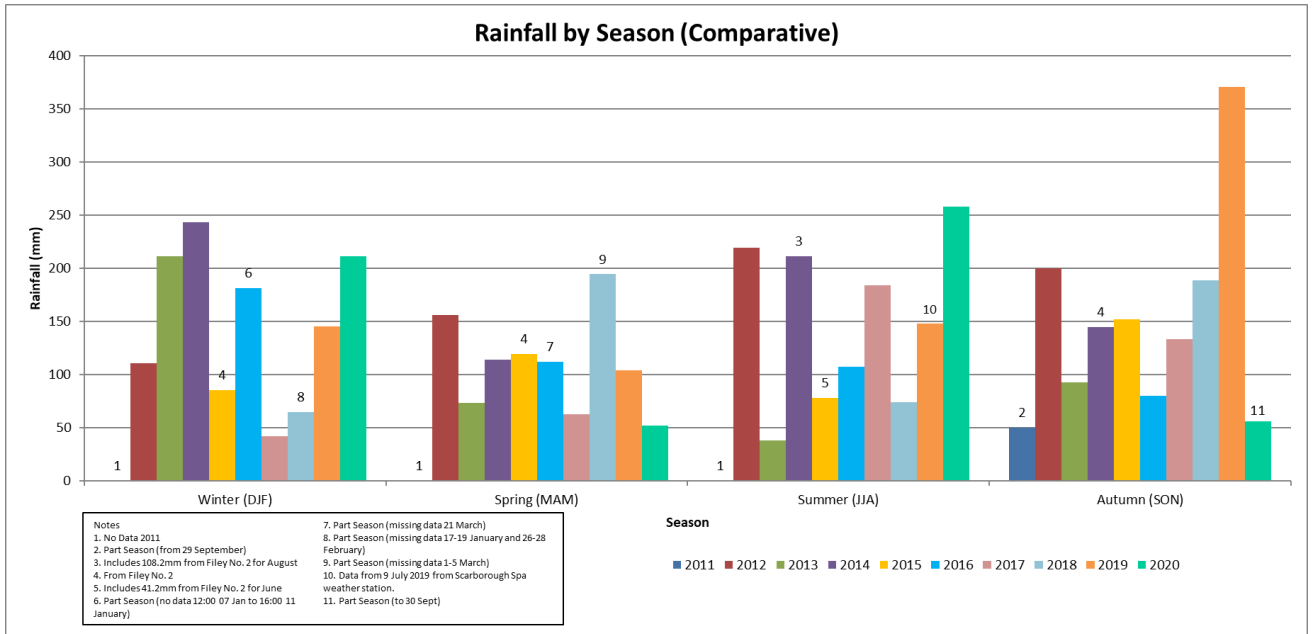
Figure 2.3 Seasonal rainfall comparison (2011-2020)

Seasonal totals are shown in Figure 2.3, which shows that the wettest season tends to be autumn, and that the spring is the driest. The wettest season on record was autumn of 2019 (i.e. September, October and November) that received a total of 371mm rainfall, which is exceptional when compared to previous years. The next wettest season is the summer of 2020 (June, July and August), with 258mm of rainfall. The winter of 2016/17 and summer 2013 were the driest on record.

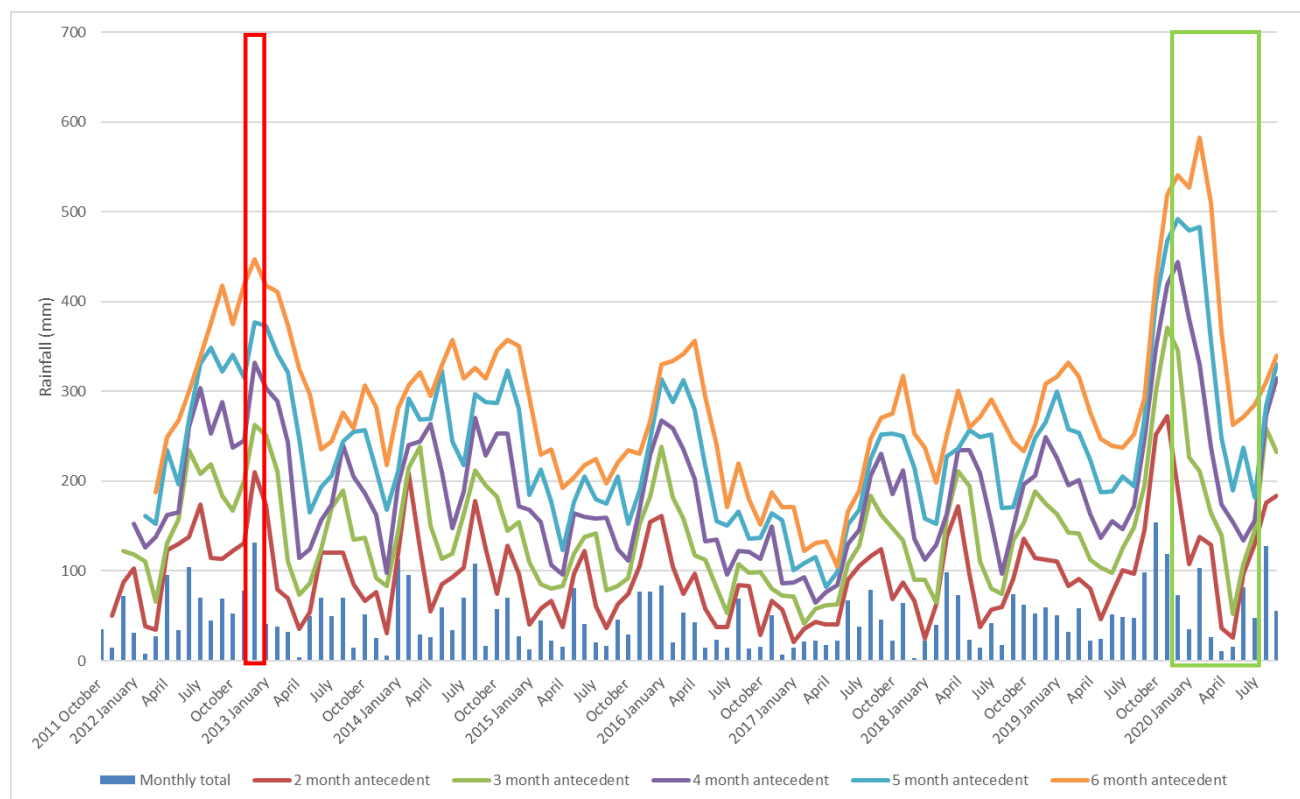
Figure 2.6. Monthly rainfall and two to six-month antecedent totals (2011 to 2020). Ground movements were recorded at Scalby Mills during December 2012 (red box). Current monitoring period shown by green box.

Antecedent conditions at the beginning of the current monitoring period show peaks significantly higher than those seen in 2012, meaning ground movements could be expected. Levels declined over the monitoring period in response to the dry spring. If the summer and autumn of 2020 are wet, the likelihood of ground movement in the next monitoring period will also be high.

Winter 2019/2020 was exceptionally wet; however, spring was comparatively dry. As a result, antecedent rainfall conditions fell during the monitoring period, but remain close to conditions recorded in December 2012 when ground movement occurred at Scalby Ness. There remains an elevated risk of ground movement. The risk will increase if the summer and autumn of 2020 are wet.

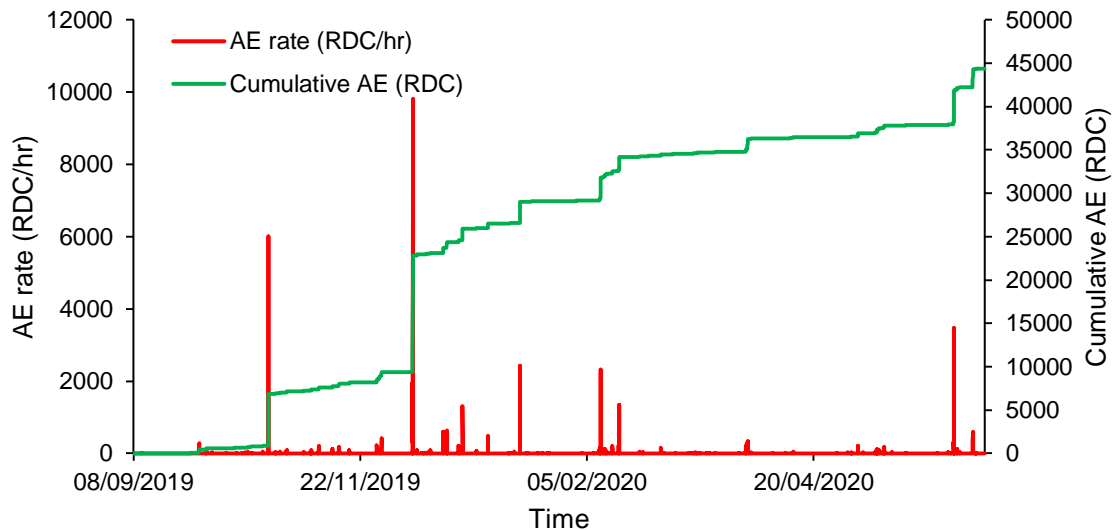
Figure 11.2 Cumulative AE (RDC) and AE rate (RDC/hr) time series at Flat Cliffs, Filey for the September 2019 to July 2020.

- No evidence for ground movements is shown by inclinometers.

- Groundwater data show levels have fallen significantly in borehole B1.
- No data collected at piezometer in borehole C4a, A3 and D1, requires readings to be retaken.
- AE measurements between September 2019 and July 2020 do not show significant slope movements. The periods of elevated AE activity, which are shown by periods of increased gradient of the cumulative RDC record, could be indicative of deformations but of a very slow rate and small magnitude. However, it is more likely that this increased AE activity was caused by extraneous noise (e.g. interference with the surface cover).
