Interpretation Report 19: June 2022 to November 2022

Document no: B2431200-19
Revision no: 0

Scarborough Borough Council

Local Coastal Slope Geotechnical Monitoring Analysis
27 January 2023

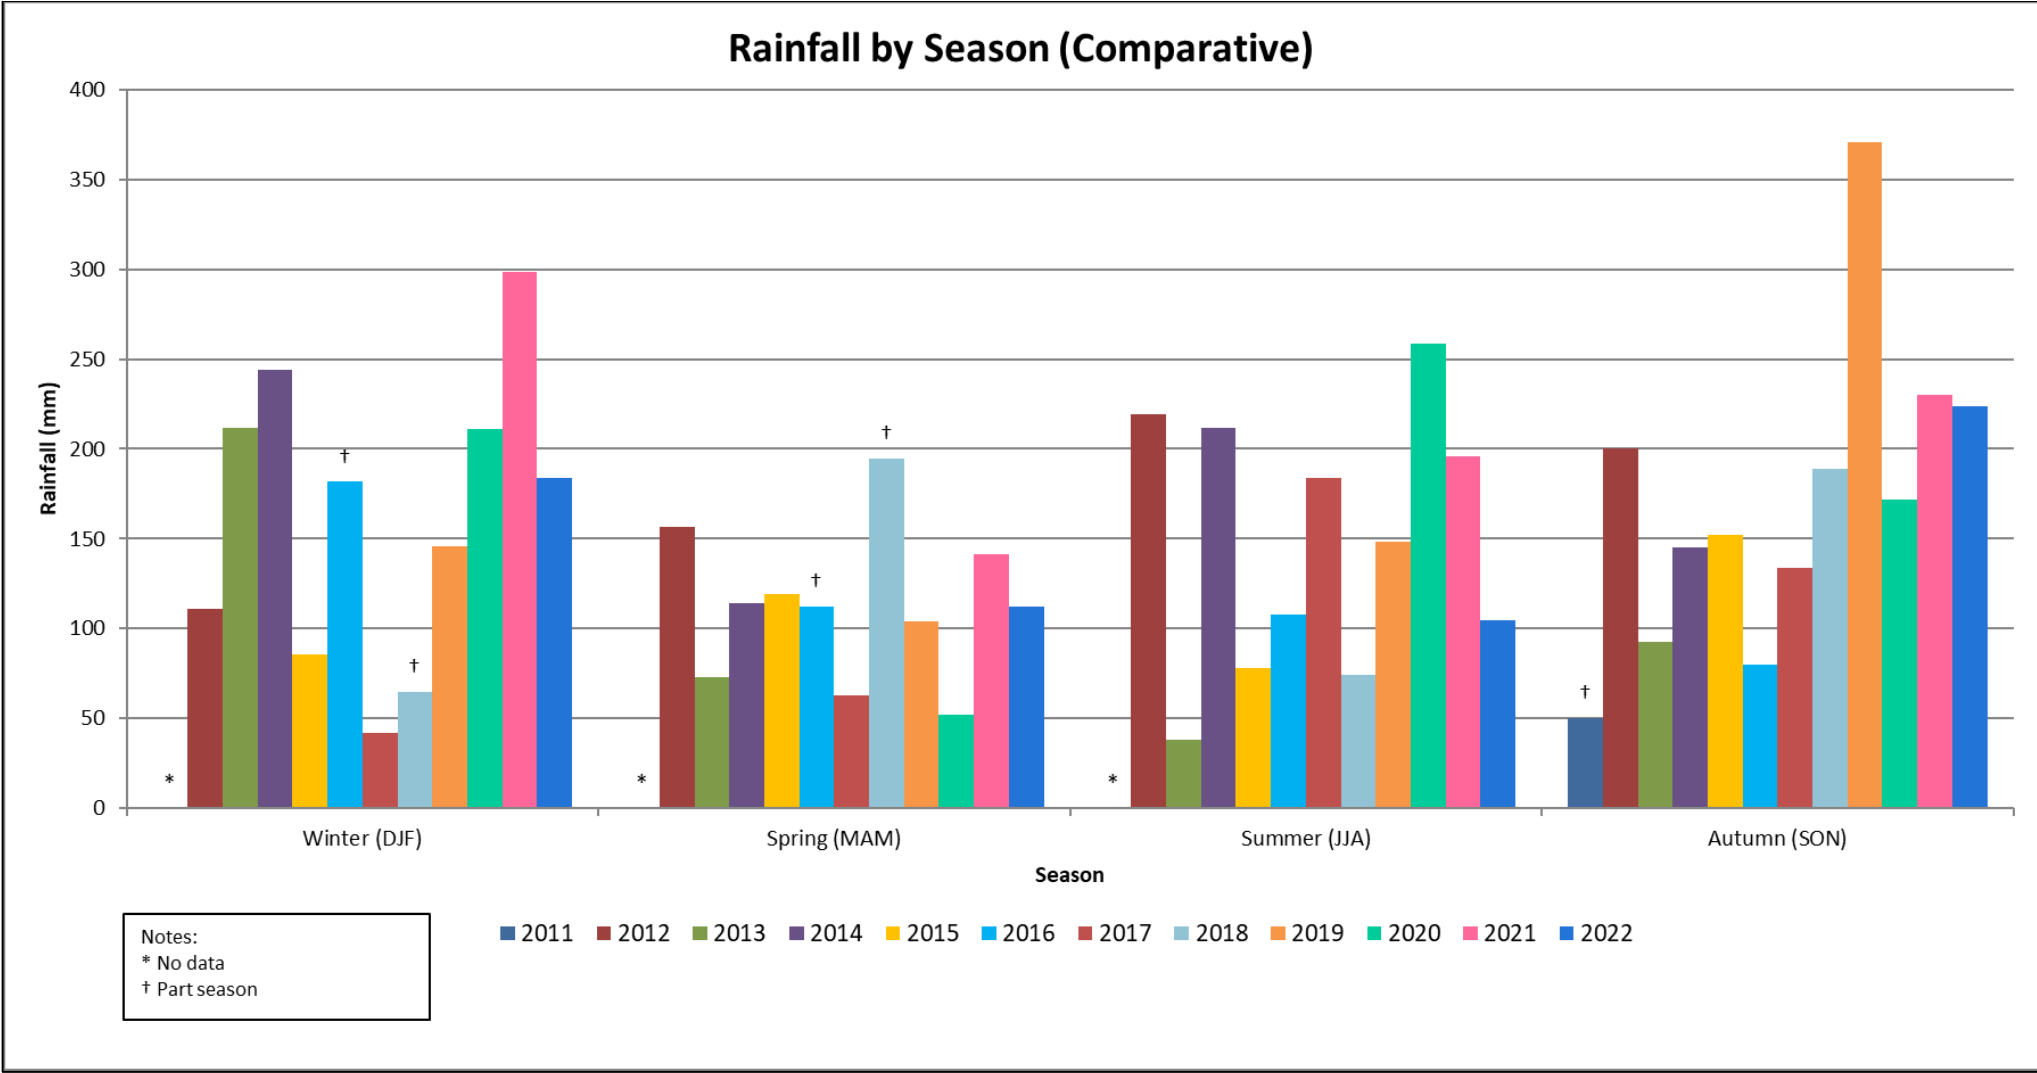
Figure 3: Seasonal rainfall comparison (2011 to 2022).

Seasonal totals are shown in Figure 3, highlighting that the wettest season tends to be autumn, though this is closely followed by winter. The spring season tends to be the driest, though data from this season is partially missing. The wettest season on record was the autumn of 2019 (i.e., September, October and November) that received a total of 371mm of rainfall, which is exceptional when compared to previous years. The next

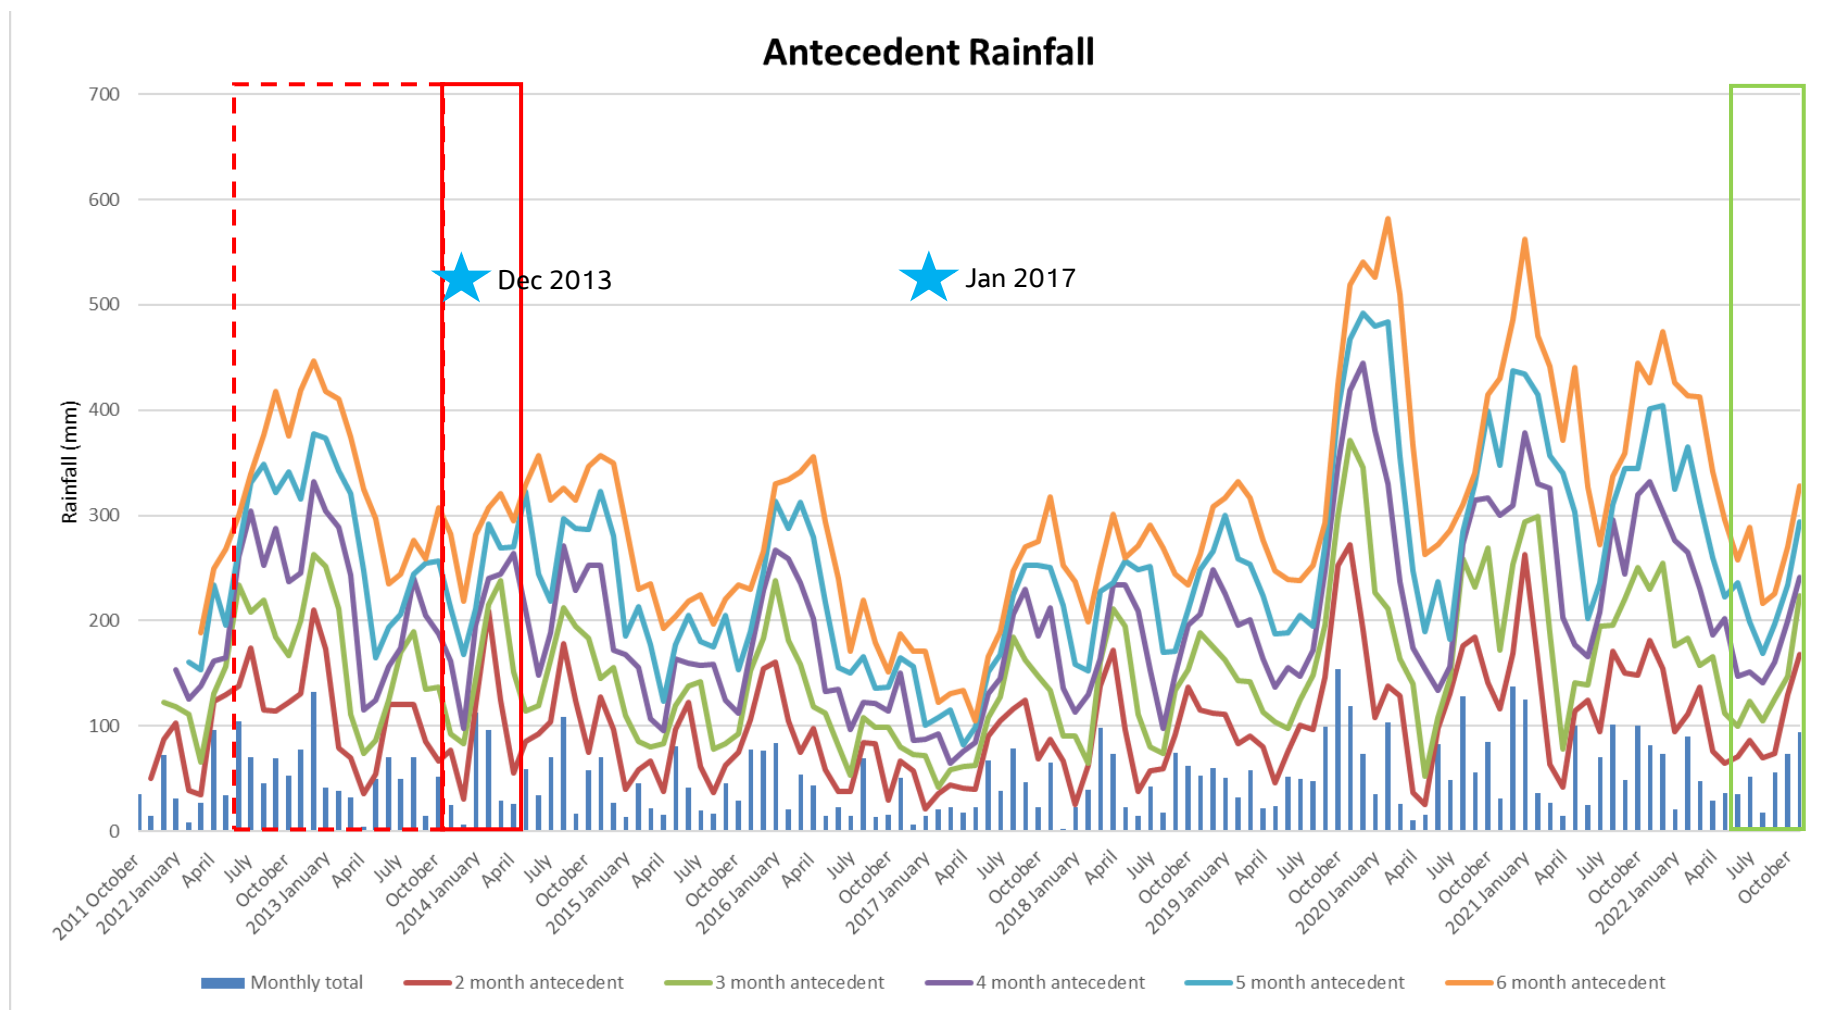
Figure 6: Monthly rainfall, two to six-month antecedent totals (2011 to 2022) and notable storm surges.

Antecedent conditions prior to the current monitoring period covering the winter of 2021/22 highlight peaks that are higher than those seen in 2012 but lower than the peak of 2019/20, meaning ground movements could be expected. However, no notable ground movement has been recorded across the network of borehole inclinometers. The spring period during this present monitoring period saw reduced groundwater levels, however, groundwater levels have increased in response to the relatively wet autumn but remain lower than recorded in the previous two autumns (2019/20 and 2020/21).

Ground movements were recorded at Scalby Mills during June-Dec 2010 and Feb-June 2011 at times of high groundwater levels. Slight movement was recorded during June 2012-Nov 2013 (red dashed box) with significant movements between November 2013 and May 2014 (solid red box). Current monitoring period shown by green box. Storm surges shown by blue stars.

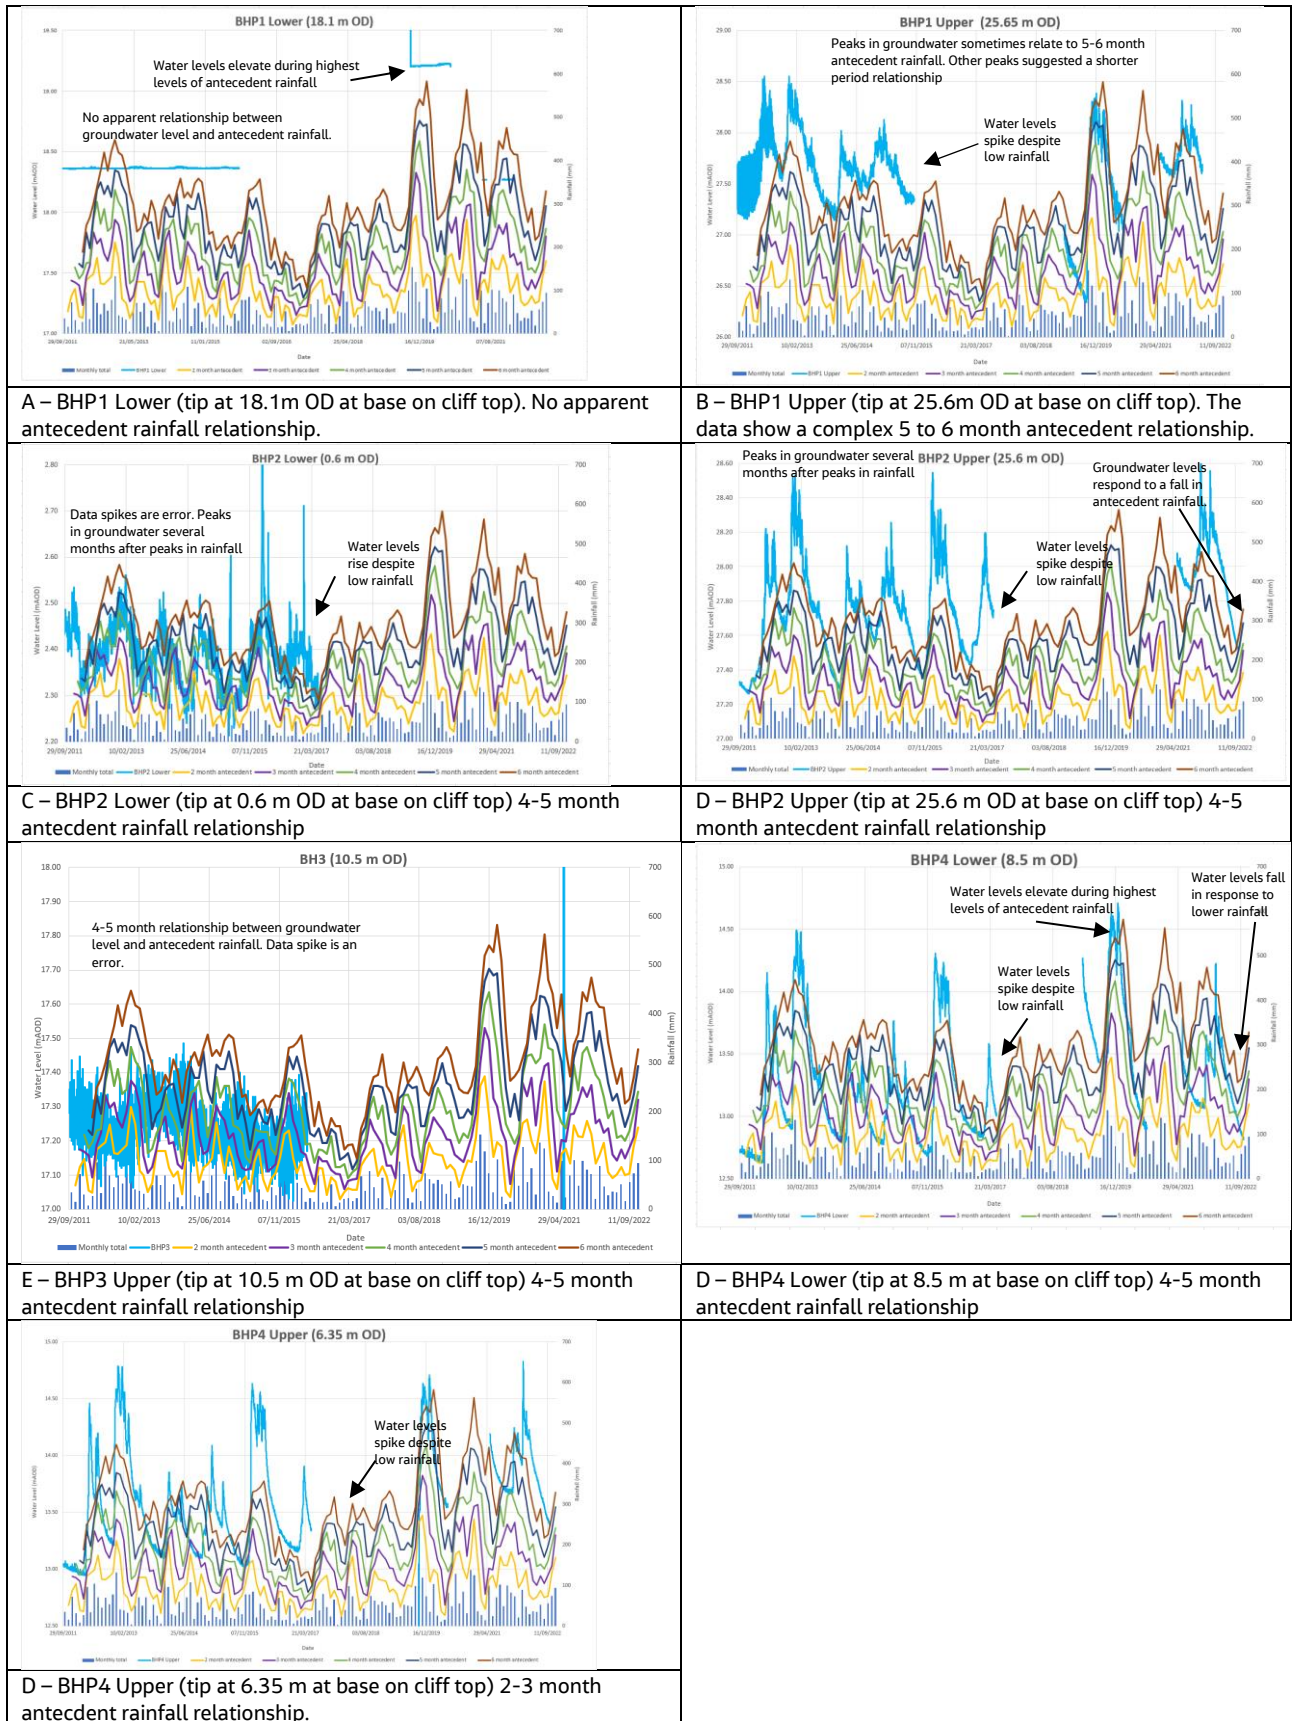
Figure 7: Relationship between groundwater levels and antecedent rainfall.

Figure 7 presents the groundwater levels at Scalby Ness recorded by each piezometer with a data logger and antecedent rainfall. The relationship with different antecedent rainfall periods has been assessed visually. BHP1 Upper (a) has a 6-month antecedent rainfall relationship, but the data from the deep piezometer at this location, BHP1 Lower (b), does not have any apparent antecedent rainfall relationship. BHP2 Lower (b), BHP2 Upper (a) and BH3 have 4–5 month antecedent rainfall relationships. The deeper piezometer at BHP4 Lower (b) has a 4-5 month relationship, while the shallower tip at this location, BHP4 Upper (a), has a 2-3 month relationship. These data confirm that deeper piezometers take longer to respond to rainfall than shallower piezometers and suggests a 4 to 5 month antecedent rainfall relationship at depth, and a 2-3 month relationship for shallower piezometers. These long response times reflect the impermeable nature of the glacial sediments.

Multiple piezometers record a spike in groundwater levels in March 2017, during a period of low antecedent rainfall. This is likely due to a very intense local rainfall event at Scalby Ness that was not recorded at the meteorological station at Scarborough Spa.

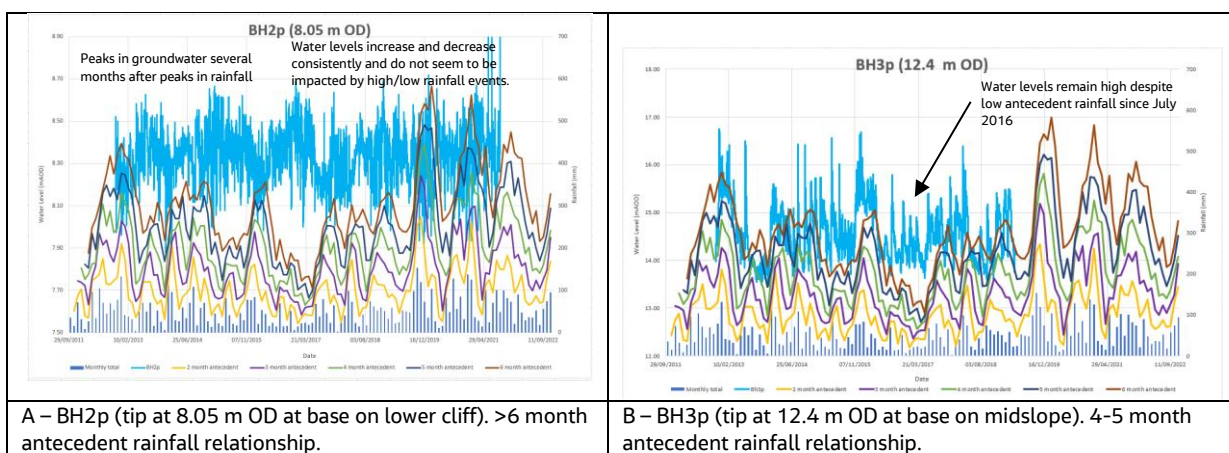
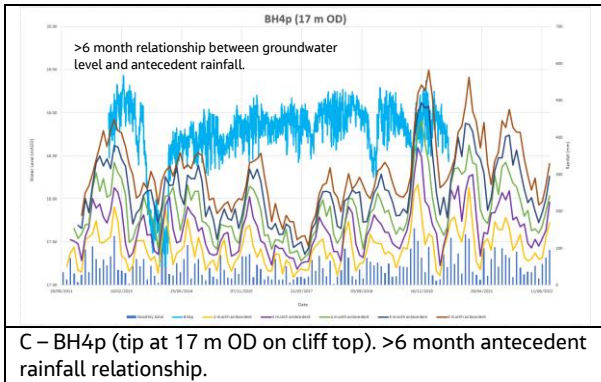
Figure 8: Relationship between groundwater levels and antecedent rainfall at Oasis Café.

Figure 8 presents the groundwater levels at Oasis Café recorded by each piezometer (with data logger) and antecedent rainfall. The relationships to different antecedent rainfall periods have been assessed visually.

BH3p, located mid-way down the cliff, has a 4-5 month antecedent rainfall relationships. In contrast BH2p and BH4p, at the base and top of the cliff respectively, appear to have an antecedent rainfall relationship greater than 6 months. These complex spatial relationships probably reflect variation in the glacial sediments that are typically low permeability clays, but locally high permeability sands.

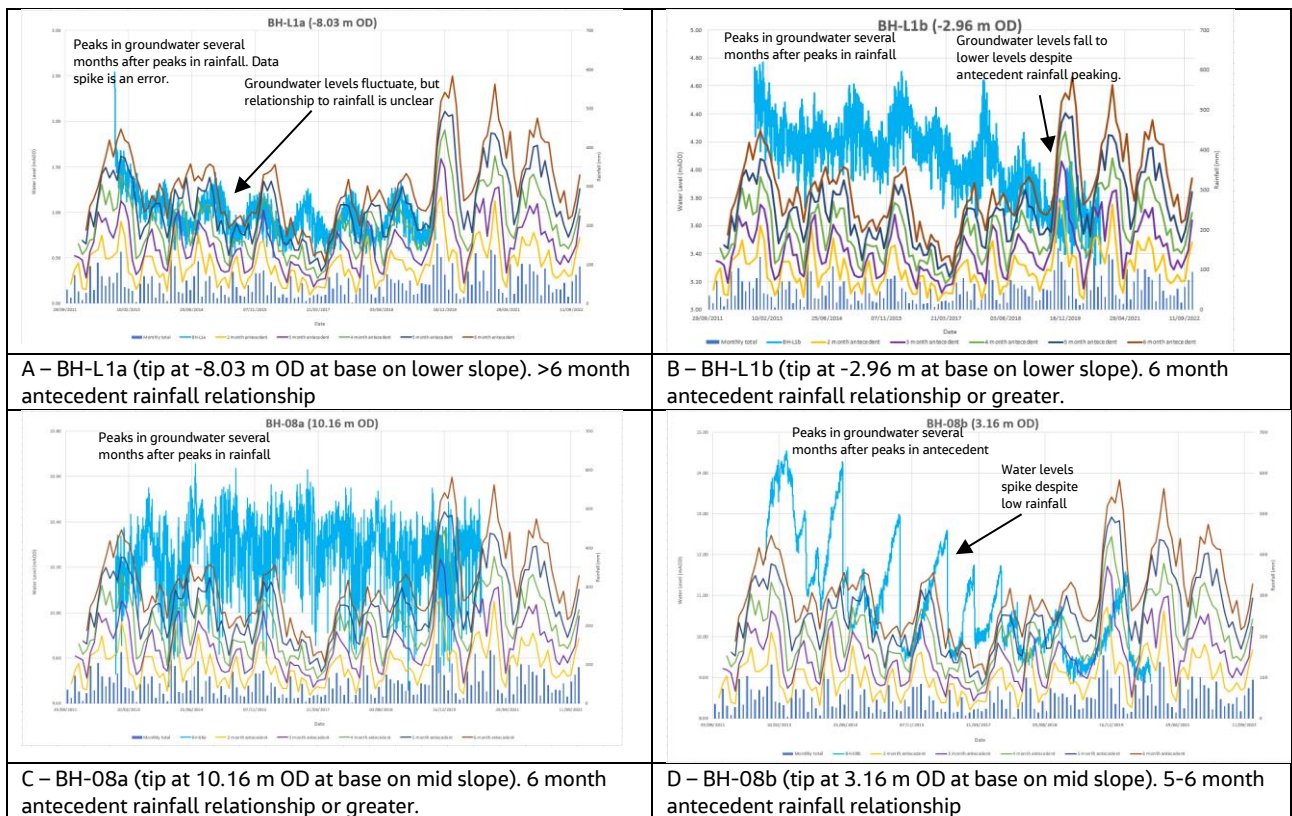
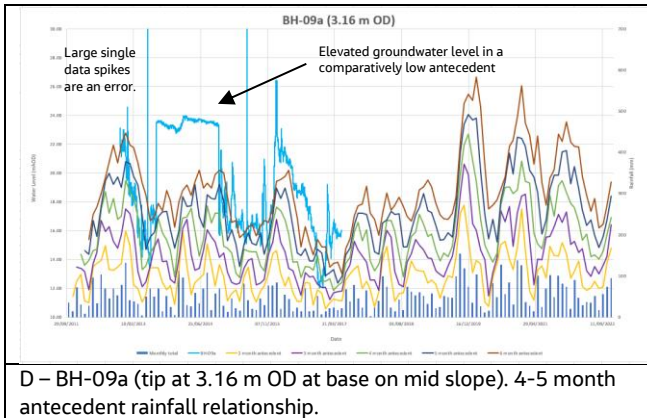
Figure 9: Relationship between groundwater levels and antecedent rainfall at the Holmes

The piezometers at The Holms show a lagged response to above average rainfall conditions, with only BH8a showing a rapid response. Groundwater levels in BH8a responded rapidly to higher-than-average rainfall in May 2015, March and November 2016. Levels fell during winter 2016/2017 following months of dry conditions then stabilised following a wet summer in 2017. Levels increased again over the drier than average winter 2017/18 and have stabilised at average levels following this. Other boreholes show a continuation of past fluctuating or steady levels of groundwater, suggesting they respond to several months' antecedent rainfall. Over the whole record, BH8b shows a different pattern of gradual highs followed by sharp falls, however, movements are not shown in the inclinometer upslope at BH10A. There is no clear response in any of the boreholes to the extreme rainfall events experienced on 23 August 2017, 20 September 2018 or during autumn. During this monitoring period, the response to the wetter than average conditions in summer are not clear at the functioning piezometers. The steady and falling groundwater levels recorded may be representative of 3-month antecedent rainfall conditions.

Figure 9 presents the groundwater levels at the Holms recorded by each piezometer (with a data logger) with enough continuous data. The charts highlight the best relationship to antecedent rainfall, which has been assessed visually by plotting various antecedent rainfall totals against the piezometer records. BH-L1a, BH-L1b and BH-08a all have an observed antecedent rainfall relationship of greater than 6-months, whereas BH-08b and BH-09a have 5-6 month and 4-5 month antecedent rainfall relationships respectively. A groundwater level spike at BH-08b in late 2016 does not coincide with antecedent rainfall levels, which probably reflects a very localised rainfall event at The Holms.

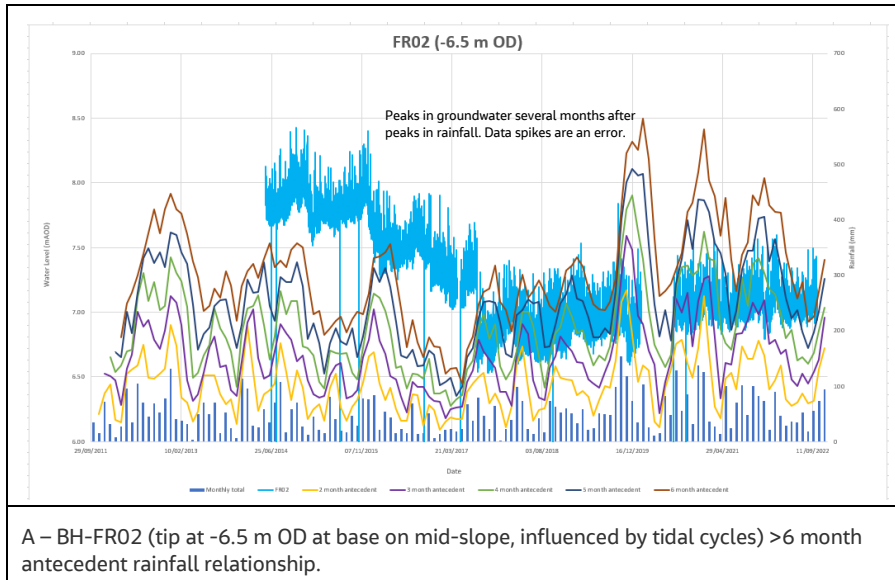
Figure 10: Relationship between groundwater levels and antecedent rainfall at St Nicholas Cliff.

At St Nicholas cliff (Figure 10) BH-FR02 shows an antecedent rainfall relationship that appears greater than 6 months. At Spa Chalet (Figure 11), antecedent rainfall relationships are unclear, with responses often appearing following 6 months antecedent rainfall and greater. The picture is similar at the Spa (Figure 12), where BH-01a Spa and BH-01 Prom also show responses of greater than 6 months. In contrast BH-H5, which is at the base of the slope behind the Spa building, suggests an antecedent rainfall relationship of 4 months. All other automated piezometers at the Spa do not have an apparent antecedent rainfall relationship. At South Cliff Gardens (Figure 13), the antecedent rainfall relationship is greater than 6 months at BH-D2a, BH-E2a and BH-E2b. Relationships at other automated piezometers at the South Cliff Gardens remain complex.

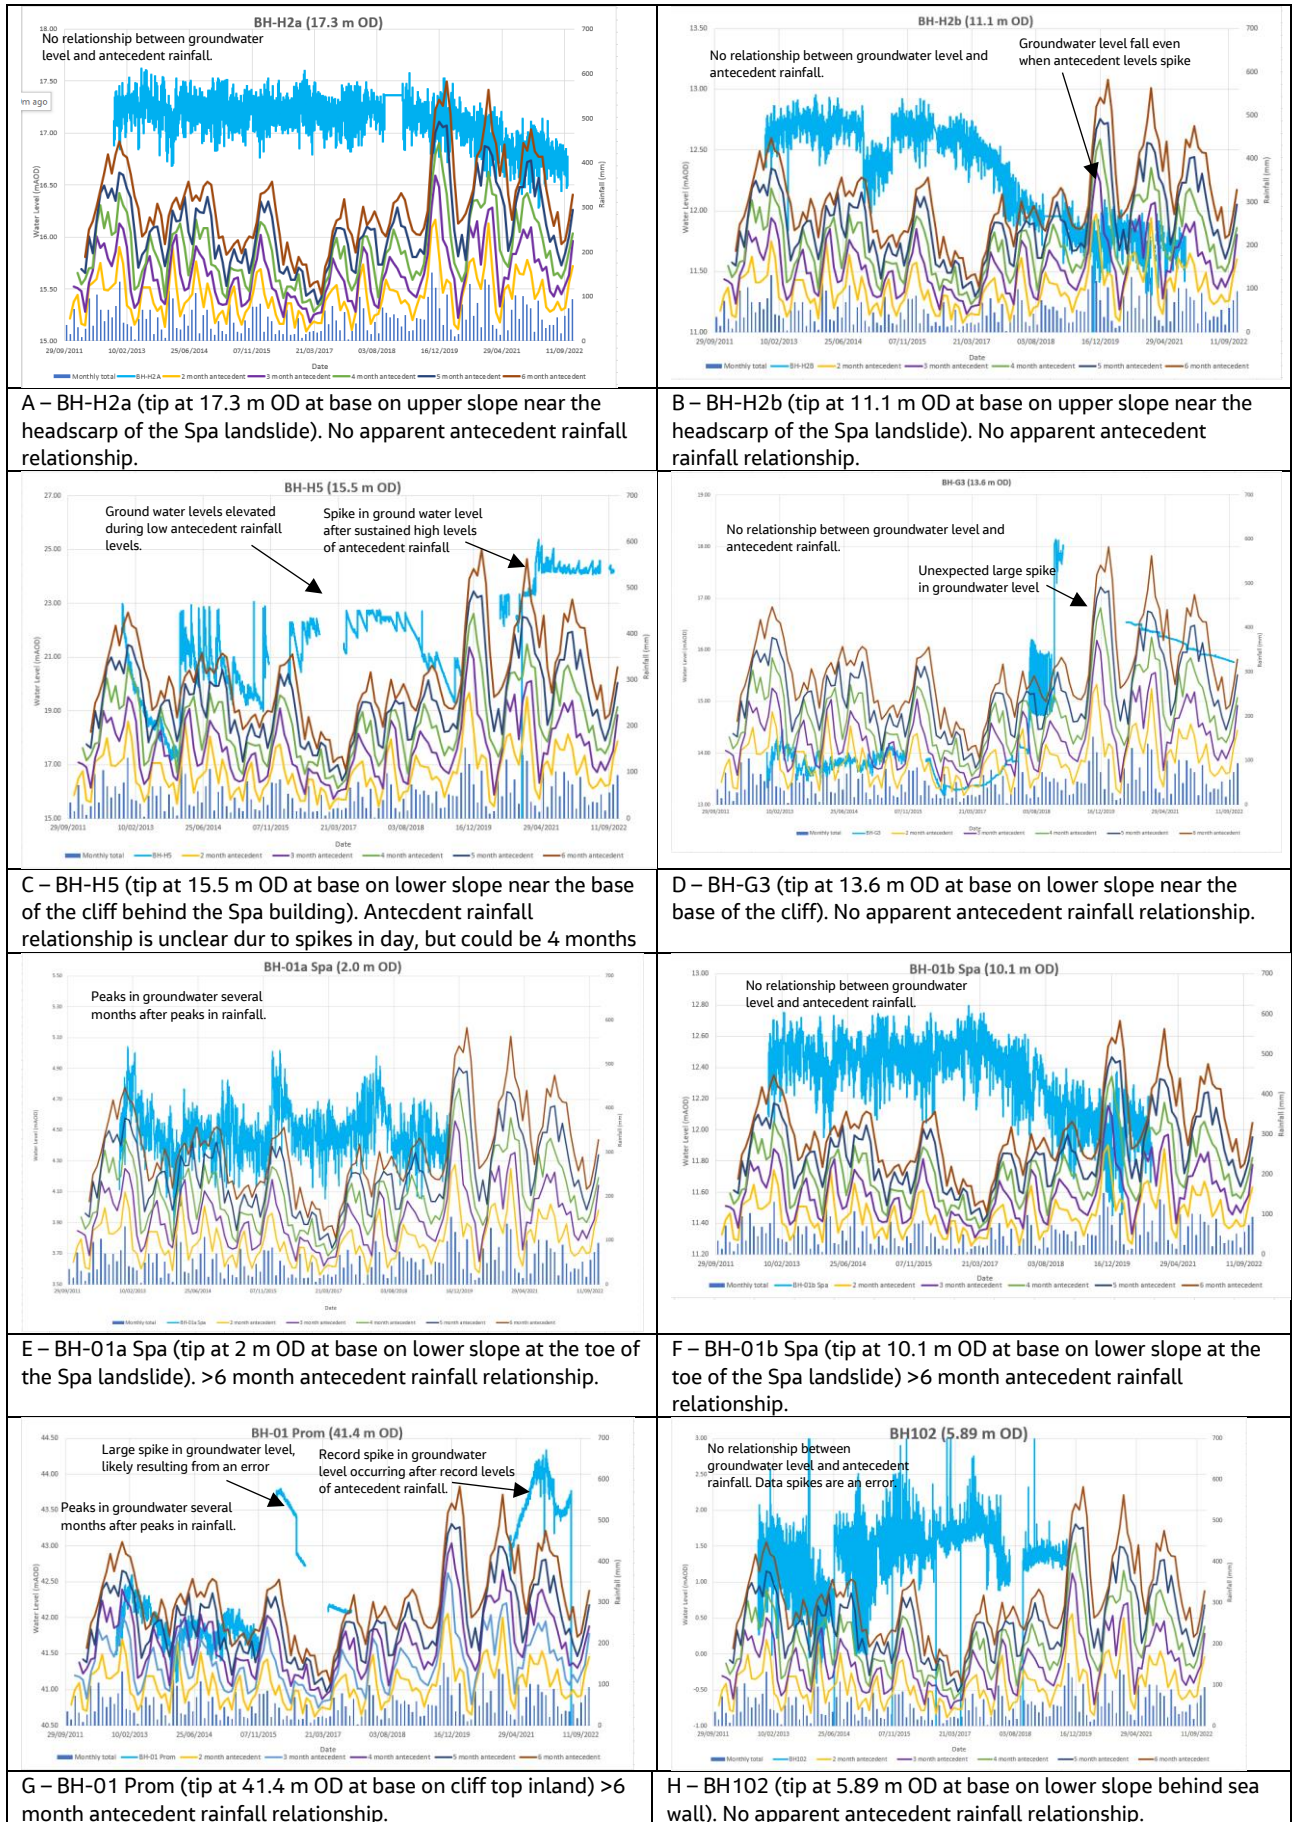
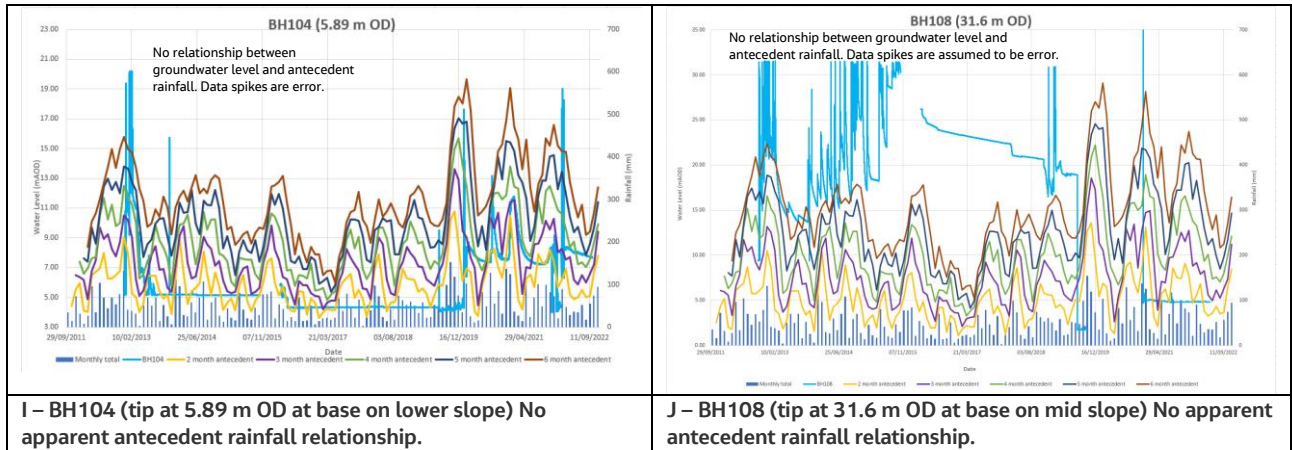
Figure 12: Relationship between groundwater levels and antecedent rainfall at Spa.

Figure 10, Figure 11, Figure 12 and Figure 13 present the groundwater levels recorded by each piezometer (with a data logger) together with different antecedent rainfall periods to highlight relationships.

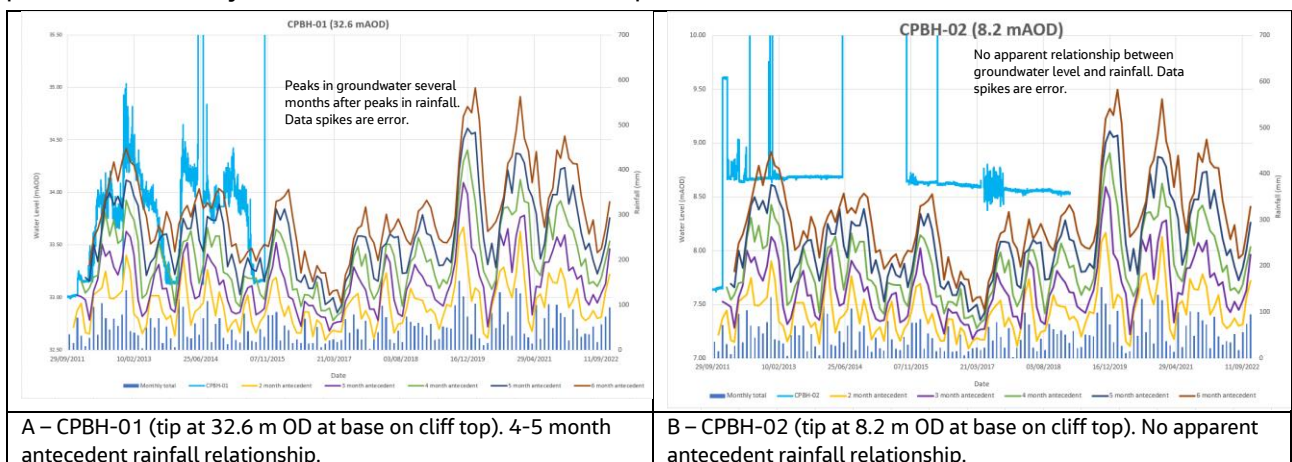
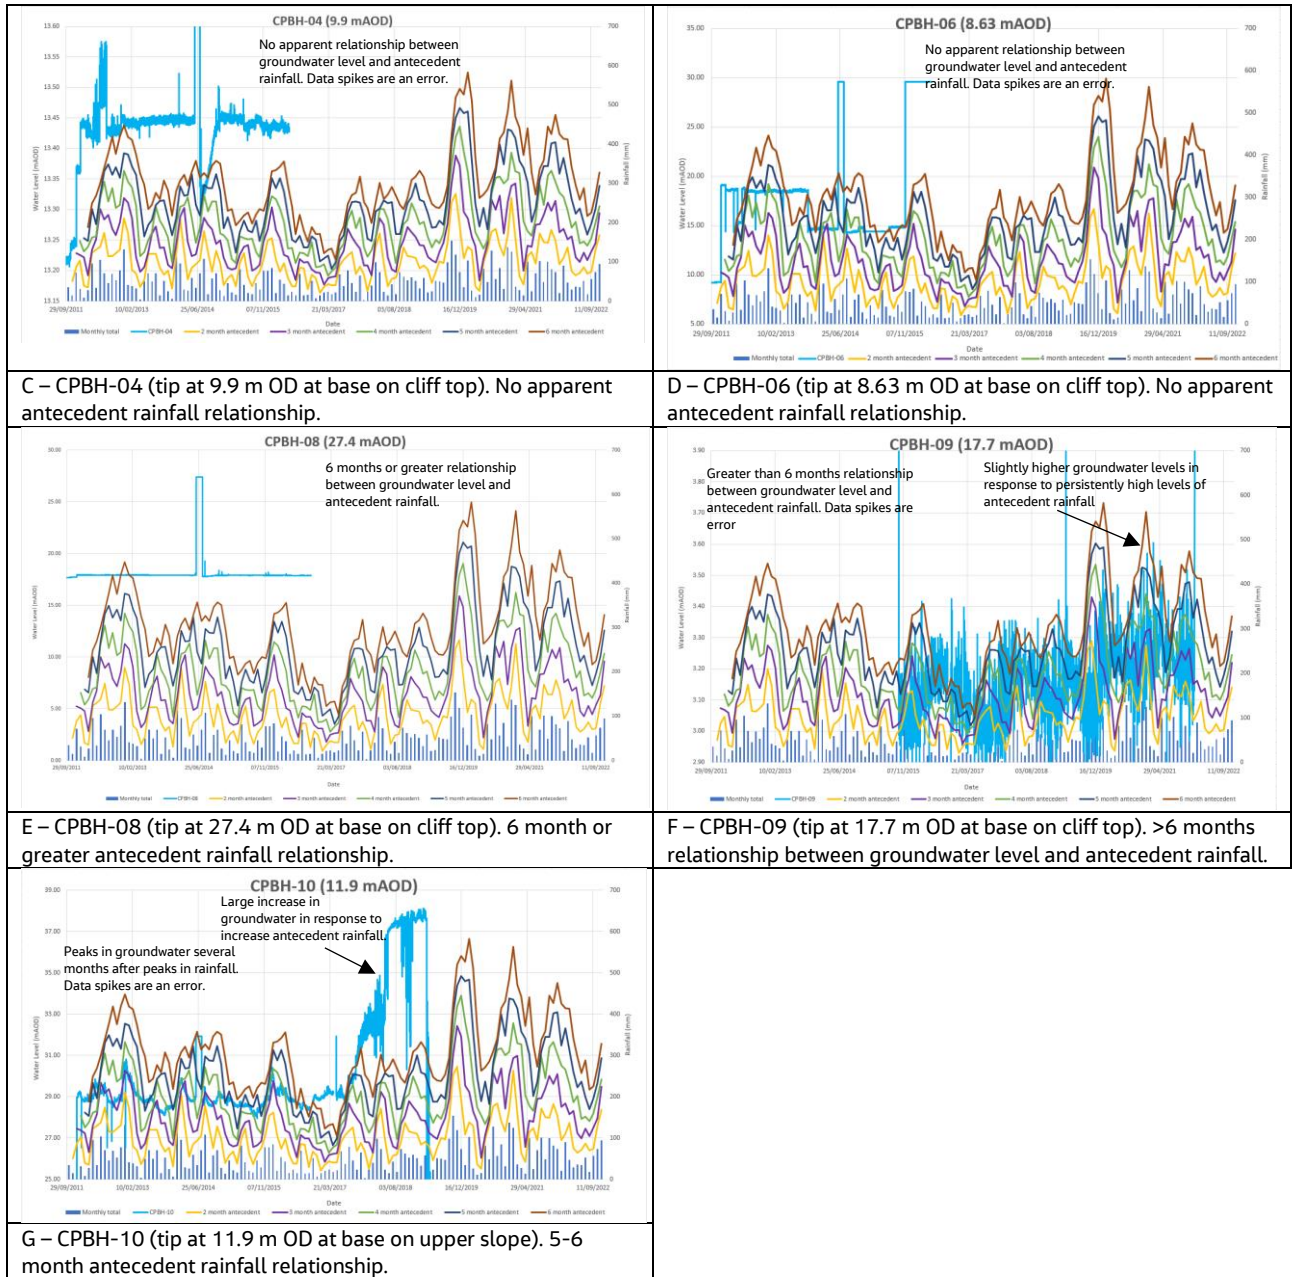
Figure 14: Relationship between groundwater levels and antecedent rainfall at Filey Town.

Figure 14 presents the groundwater levels at Filey town recorded by each piezometer (with a data logger) to highlight the relationships to antecedent rainfall. CPBH-01, CPBH-09 and CPBH-10 have antecedent rainfall relationships of 4-5 months, greater than 6 months and 5-6 months, respectively. Other automated piezometers at Filey Town have an unclear relationship with rainfall.

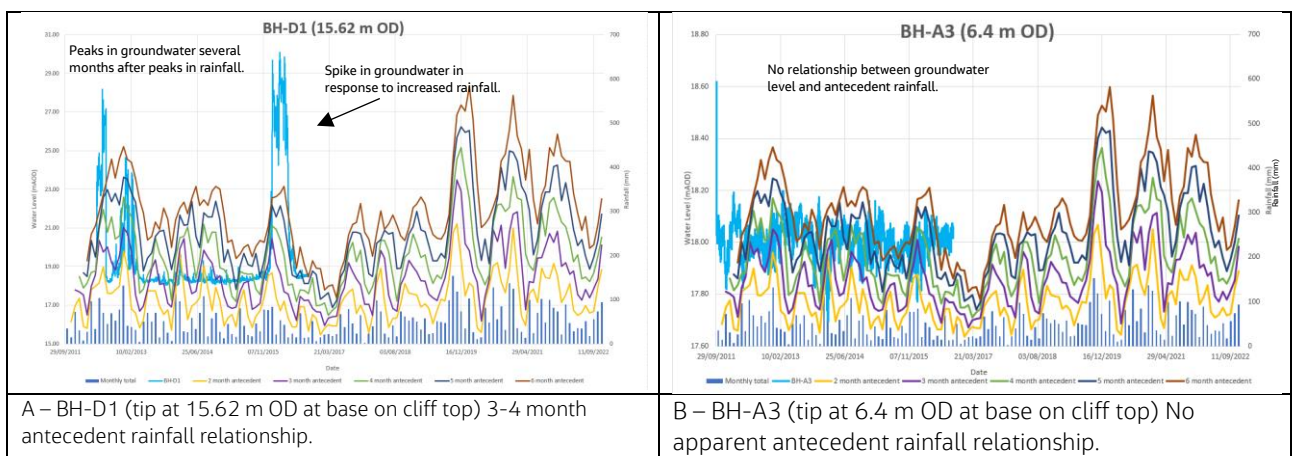
Figure 15: Relationship between groundwater levels and antecedent rainfall at Filey Flat Cliffs.

Figure 15 presents the groundwater levels at Filey Flat Cliffs recorded by each piezometer (with a data logger) to highlight the relationships to antecedent rainfall. BH-D1 has an antecedent rainfall relationship of 3-4 months. BH-A3 has an unclear antecedent rainfall relationship.
