Interpretation Report 6: December 2015 to May 2016

Prepared for
Scarborough
Borough Council

August 2016

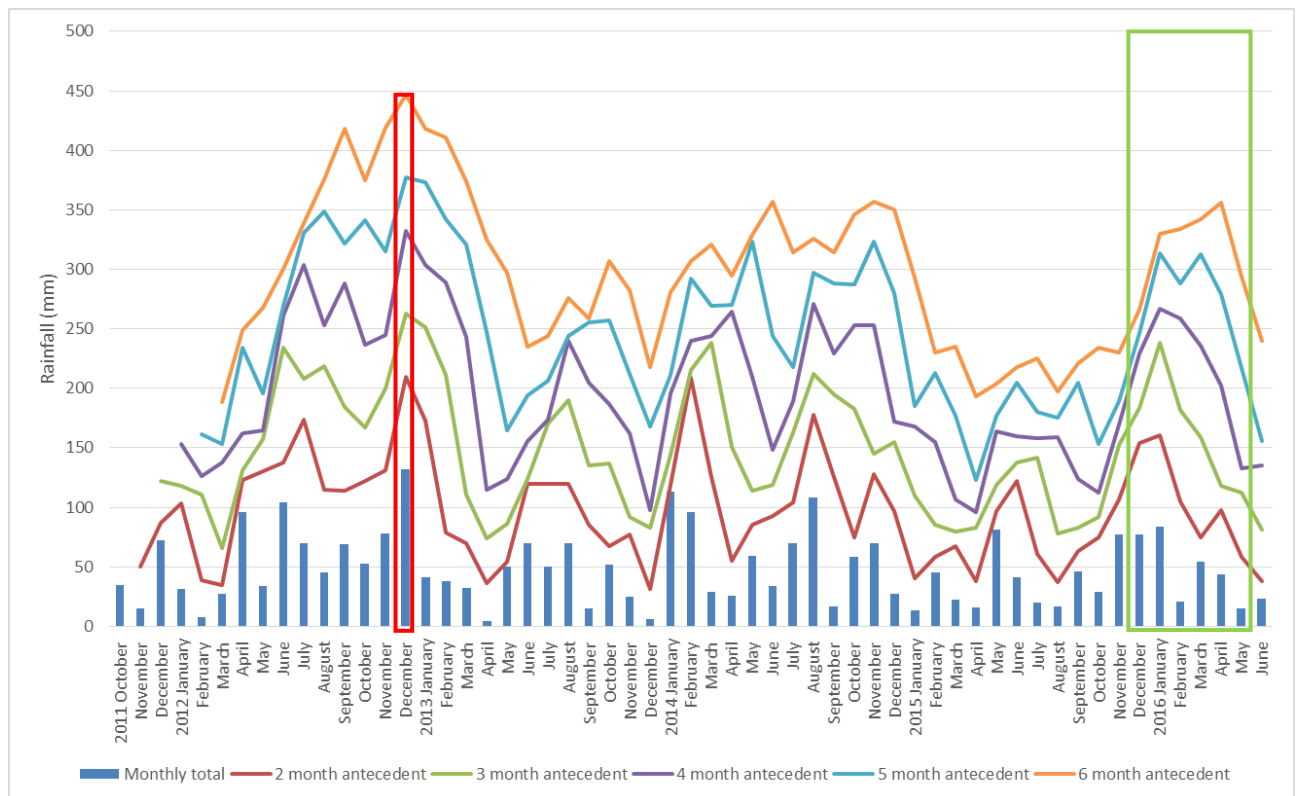
Antecedent rainfall over the current December-May monitoring period show peaks that are lower than December 2012 and with a similar pattern to the previous December to May period.

Figure 2.6. Monthly rainfall and two to six month antecedent totals (2011 to 2016). Ground movements were recorded at Scalby Mills during December 2012 (red box). Current monitoring period shown by green box.

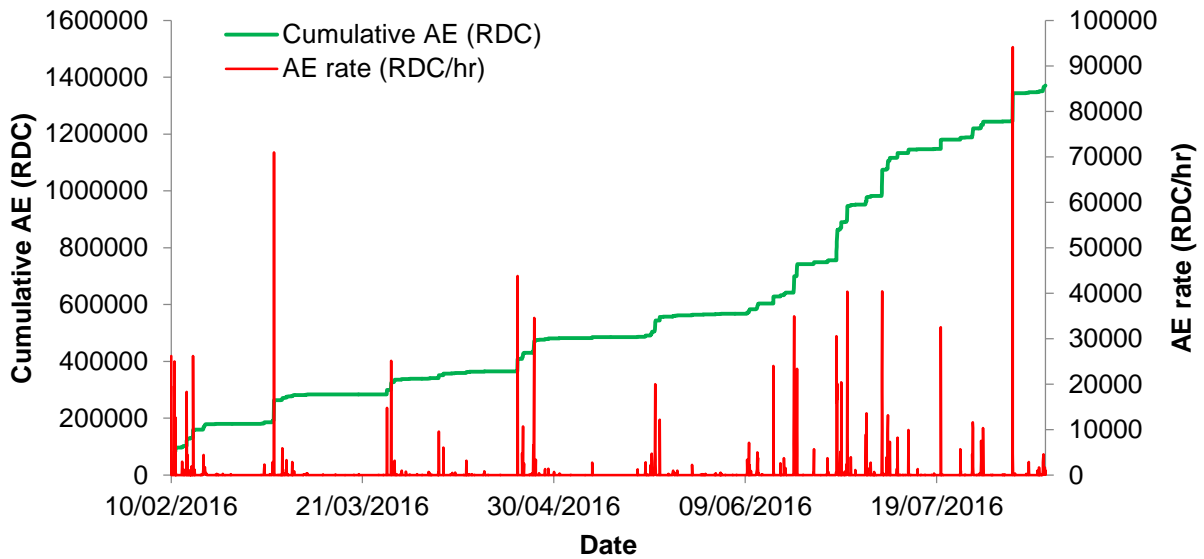
- Acoustic emissions (AE) detected are negligible and do not suggest slope movement. Fluctuations in the data represent the specific hydrogeological conditions at this site (i.e. time dependent seepage conditions following rainfall events). This is supported by the inclinometer measurements at BH105, which show negligible movement. (Figure 9.2 and 9.3)

Figure 9.2. Cumulative AE (RDC) and AE rate (RDC/hr) time series at Scarborough Spa for the period February 2016 to August 2016.

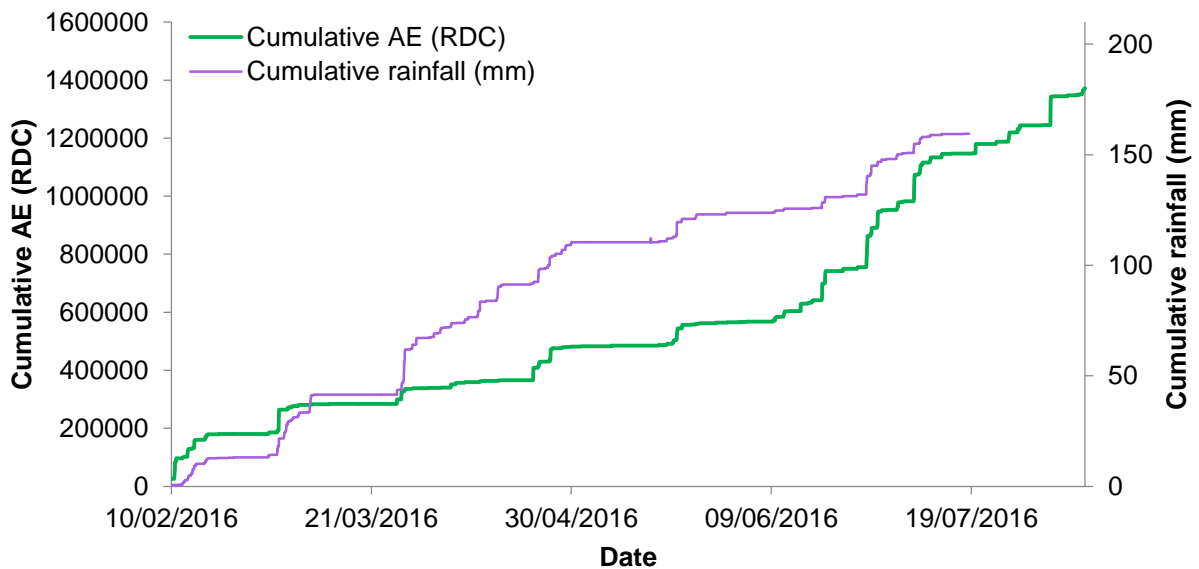
Figure 9.3. Cumulative AE (RDC) and cumulative rainfall time series at Scarborough Spa for the period February 2016 to August 2016.

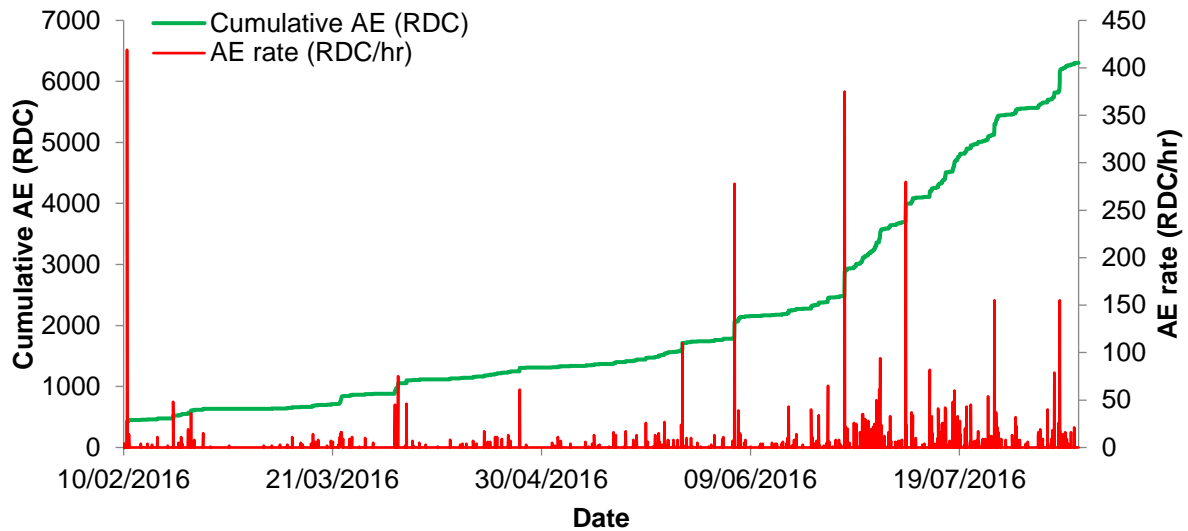
- No evidence for ground movements is shown by inclinometers.
- AE measurements between February 2016 and August 2016 do not show significant slope movements. The period of elevated AE activity after June 2016 could be indicative of minor deformations of a very slow rate and magnitude. It is likely that this is a function of the deterioration of the cover lid generating spurious AE.
- Groundwater data show no significant change except for Borehole D1 near the top of the slope adjacent to the main access road. Here, water levels rise sharply during late December and January and remain high.

Figure 11.2 Cumulative AE (RDC) and AE rate (RDC/hr) time series at Flat Cliffs, Filey for the period February 2016 to August 2016.

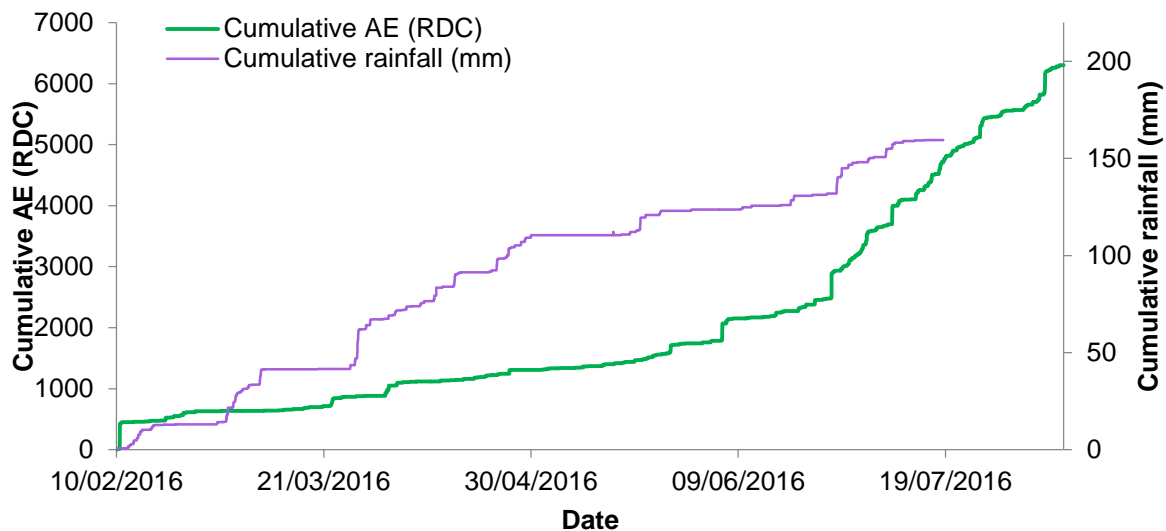
Figure 11.3 Cumulative AE (RDC) and cumulative rainfall time series at Flat Cliffs, Filey for the period February 2016 to August 2016.
