Robin Hood's Bay Coastal Defence Condition Survey

May 2014
Scarborough Borough Council

A condition assessment of the coastal defences along the Robin Hood's Bay sea wall, which forms part of the '2007, River Tyne to Flanborough Head Shoreline Management Plan (SMP2)' was carried out by representatives of Mott MacDonald on behalf of Scarborough Borough Council on 10th April 2014.

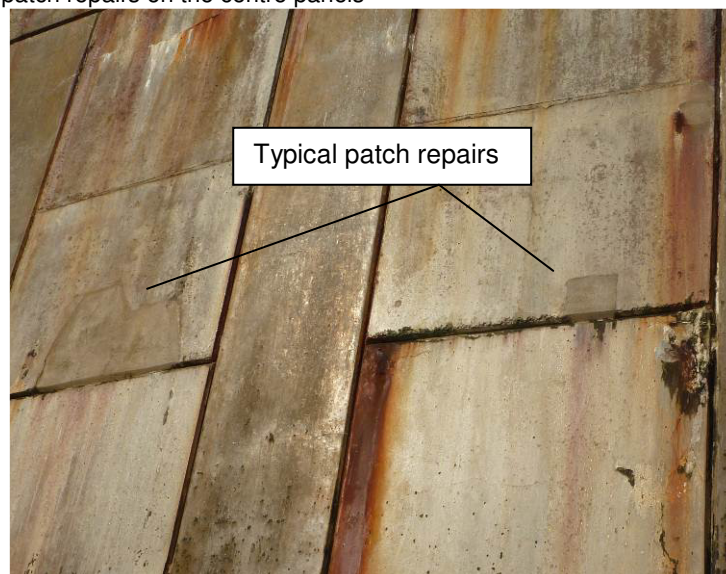
Figure 2.2: Detail of two patch repairs on the centre panels

There are several surface repairs on the face of the structure as presented in Figure 2.2. From discussion with SBC at the site visit it was confirmed that no major repair work has been undertaken since the 2007 CRL report. Any repairs have been as a result on removing loose material for safety reasons.

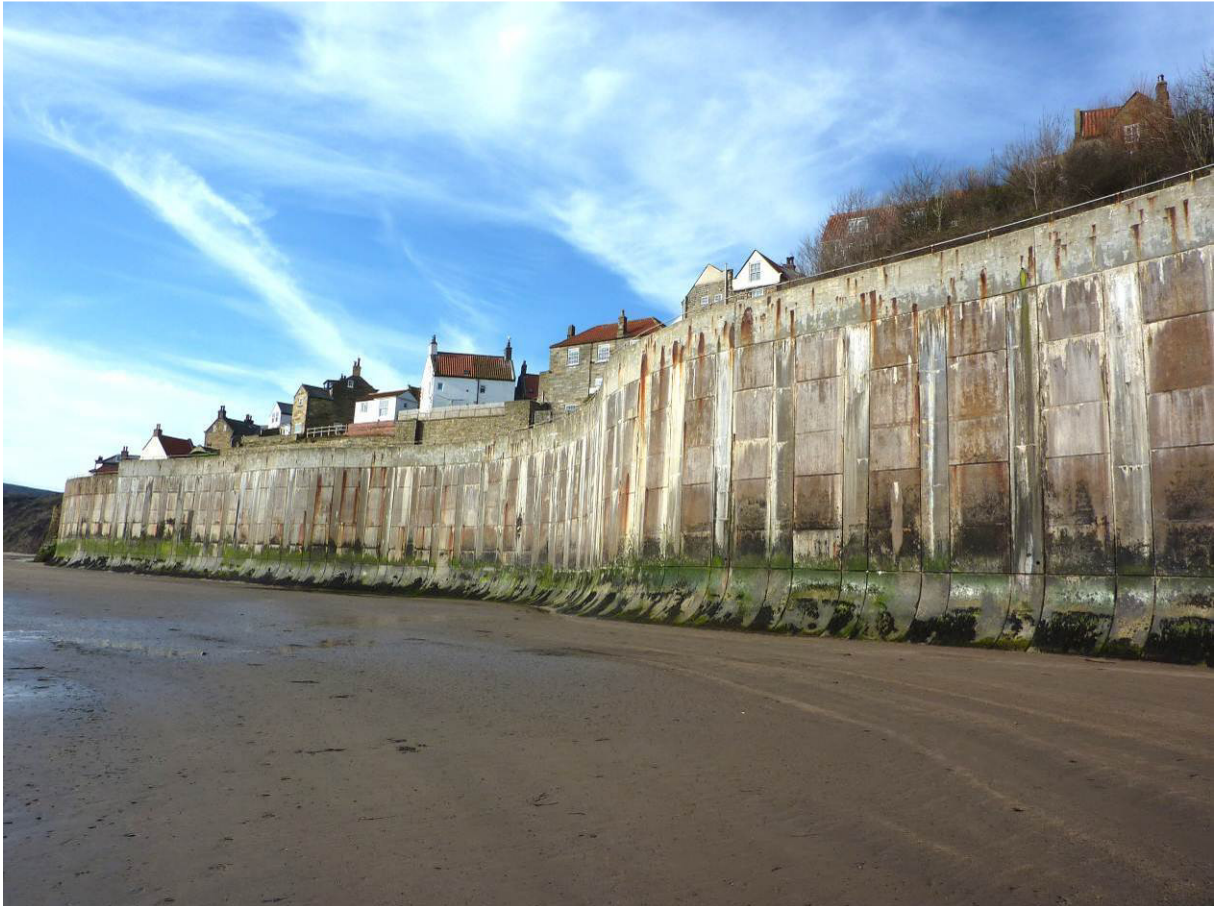
Figure 2.3: View looking south along concrete sea wall

There is extensive rust staining on the surface of the sea wall (see Figure 2.3) it is not known what the source of this is. It has been suggested in CRL (2007) that iron ore is present in the aggregate which is a likely cause of staining in some areas. This is likely to relate to the dark circular rust spots.

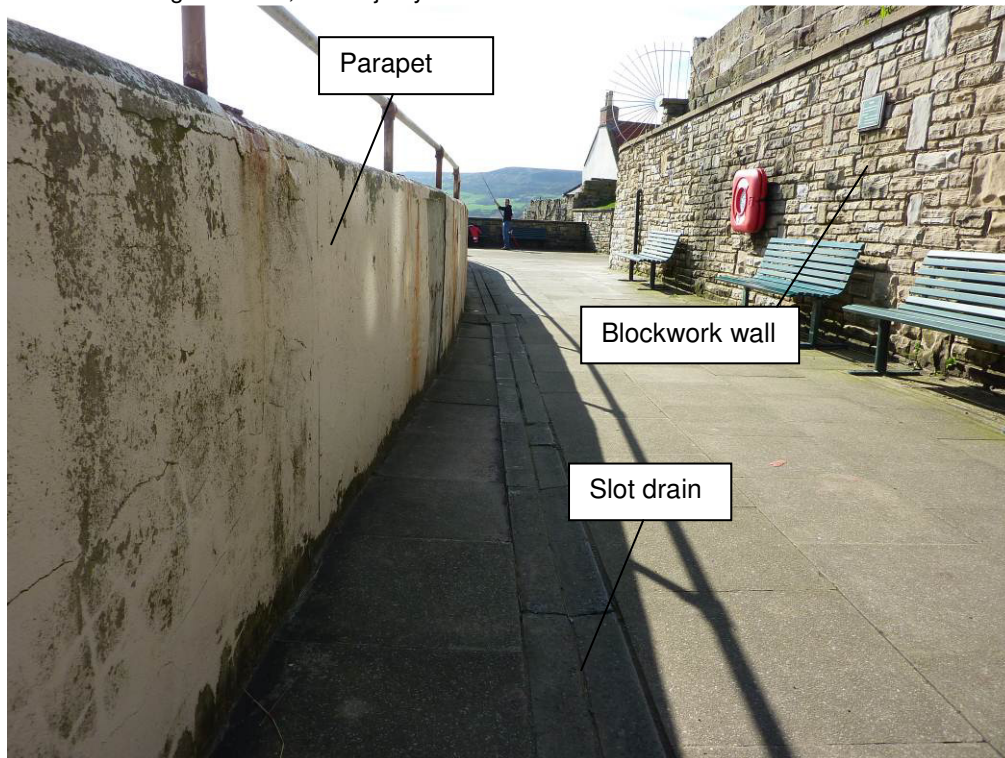
There is a paved promenade behind the parapet wall. This is backed by a blockwork wall above which are several properties. It was confirmed by SBC on site that this PAR will not consider the blockwork wall. The promenade is drained by a slot drain which runs along the majority of the seaward edge of the promenade and several gullies which are located either in the centre or the rear of the promenade. A large proportion of the slot drain is blocked (see Figure 2.4).

Figure 2.4: View south along slot drain, the majority of which is blocked.

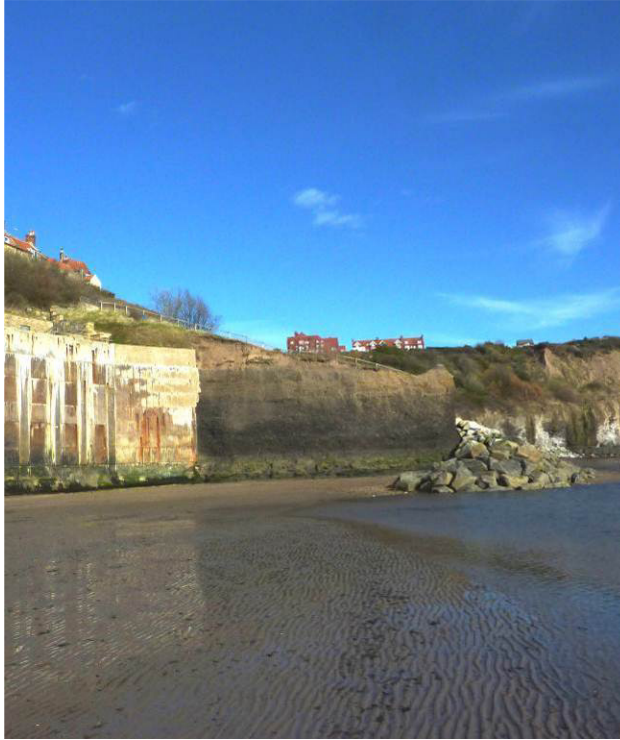
Figure 2.6: View of northern end of wall showing cliff face and rock armour

At the northern end the sea wall joins a natural shale cliff. The cliff face is protected by rock armour on the corner which may provide some shelter to the section which joins the wall (see Figure 2.6). From the site meeting with Robin Siddle and Martin Lloyd (SBC) on 10/04/2014 it was discussed that the cliff face continues to erode at low tide when not exposed to wave action. Erosion appears to be accelerated close to the sea wall. A recent patch has been made to the wall it is assumed that this was to try and reduce outflanking at this corner (see Figure 2.7). During the site visit SBC stated that at this end of the wall outflanking and refilling with mass concrete is a regular process.

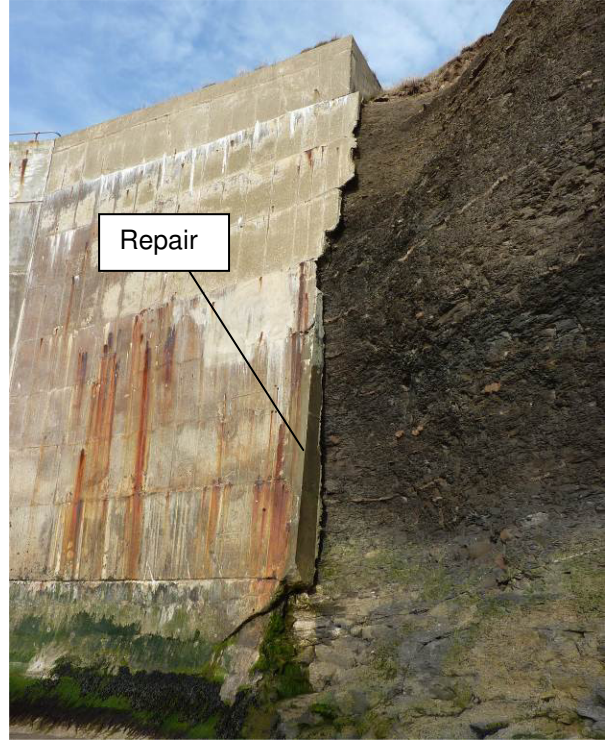
Figure 2.7: View of northern end of wall showing recent repair

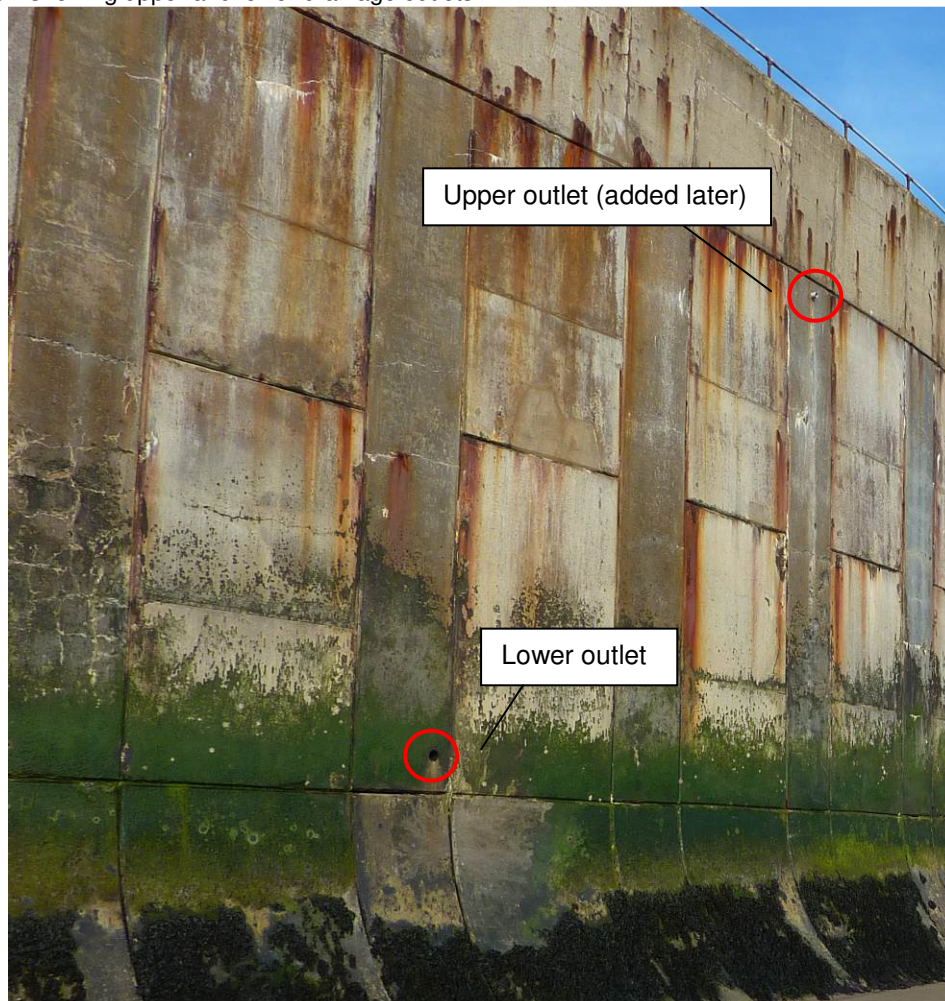
Figure 3.5: View showing upper and lower drainage outlets

Several years after the wall's construction it was realised that the drainage system was not working effectively as there was ponding on the promenade so a high level drainage system was installed. This involved modifying the original high level chambers and connecting to pipes through the seawall at a higher level than before (see Figure 3.5). From discussion with SBC the promenade no longer floods which indicates that the upper drainage system now functions. This suggests that the predominant drainage issue is now the rubble drain or lower drainage system.

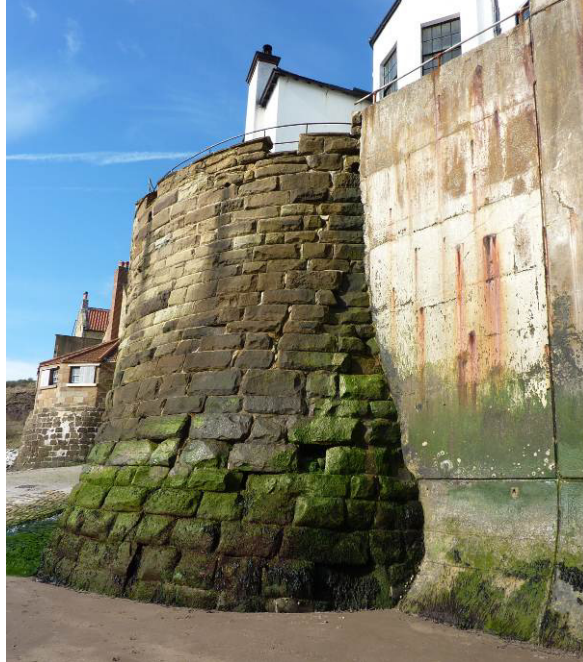
A blockwork wall extends from the slipway round to the concrete sea wall. The majority of the joint material is missing in the intertidal section of the wall and several blocks have been displaced. Voids were observed where joint material has been lost. There is also localised cracking of blocks. The condition of the wall improves above the marine zone.

View south showing the interface between the concrete sea wall and the masonry sea wall, several blocks have been displaced.

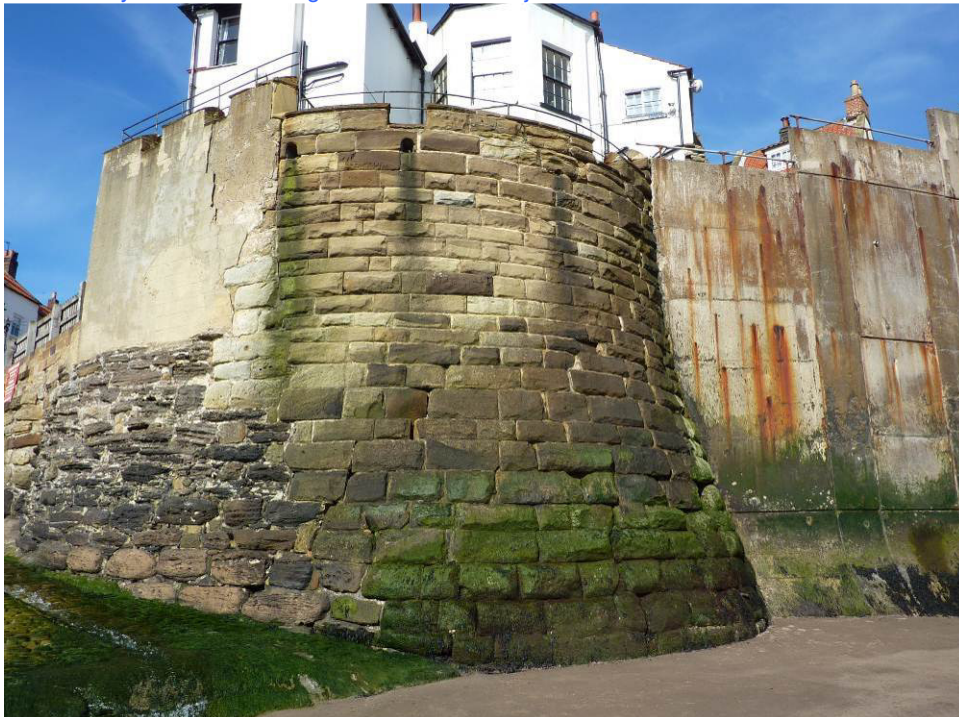
View north of the masonry sea wall showing substantial loss of joint material in the intertidal section.

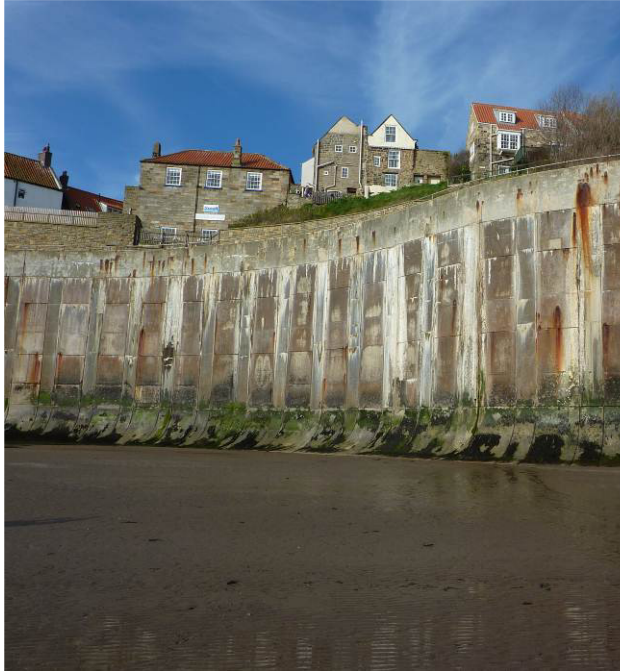
Localised spalling is visible across the whole of the surface. There is extensive rust staining which is also present across the whole surface but is worse in some areas. Although widespread rust staining is generally concentrated in localised spots. The source of this staining is uncertain. There are multiple horizontal cracks these are present in the majority of columns. These cracks are in a similar vertical position across the wall. There is a general loss of cover over the wall surface and some localised areas where the outer surface has been removed. It was not possible to see from the ground but there are a couple of areas where surface rebar is potentially exposed. There are some signs of patch repair to the surface of the structure.

There is white staining present across the whole of the structure which worsens at the northern end. The majority begins either at a horizontal crack or at the interface between the main face and the parapet wall. This could be an indication of leakage through the structure.

View of northern end of concrete sea wall showing rust staining and white staining

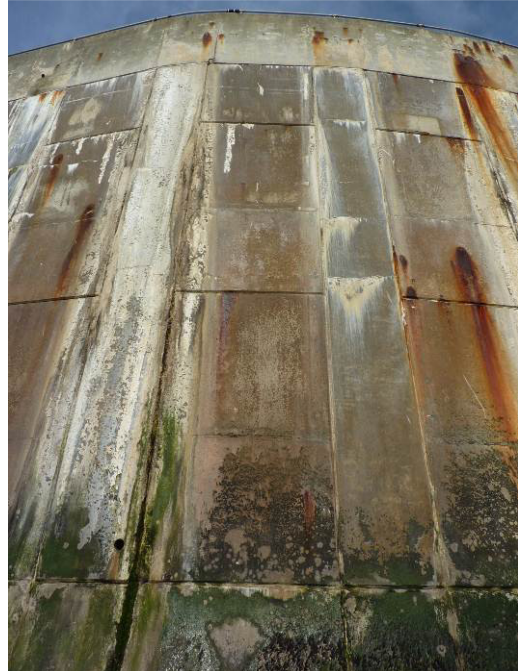
There is extensive loss of vertical joint material, in some locations exposing the underlying mass concrete. There are no viable signs of movement or slumping or heave of the ground. The toe is well covered along the majority of the section however there is one spot where water was pooling indicating that the beach may be lower in that section.

View of concrete sea wall showing extensive white staining around horizontal cracks and loss of vertical joint material

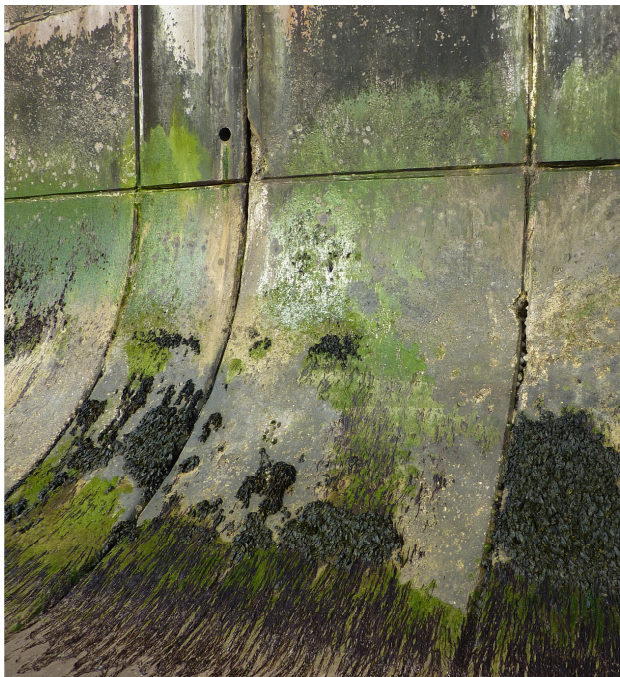
Detail of toe of concrete sea wall showing extensive loss of joint material and loss of concrete surface

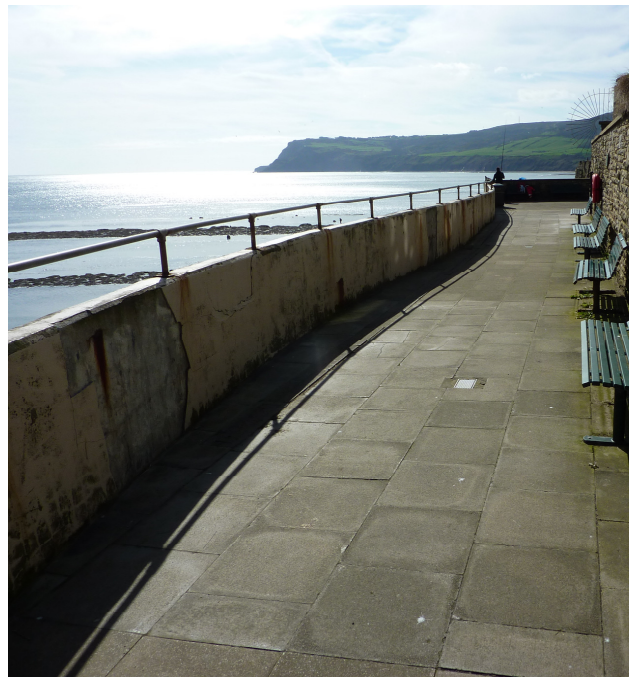
The seaward face shows extensive rust staining and horizontal cracking. The landward face is heavily cracked and the surface has been removed in multiple locations exposing the underlying concrete wall. The landward face is also rust stained although the majority of this is as a result of the handrail. There are no signs of movement of the wall

View south along rear of parapet wall showing cracks, rust staining and loss of surface.

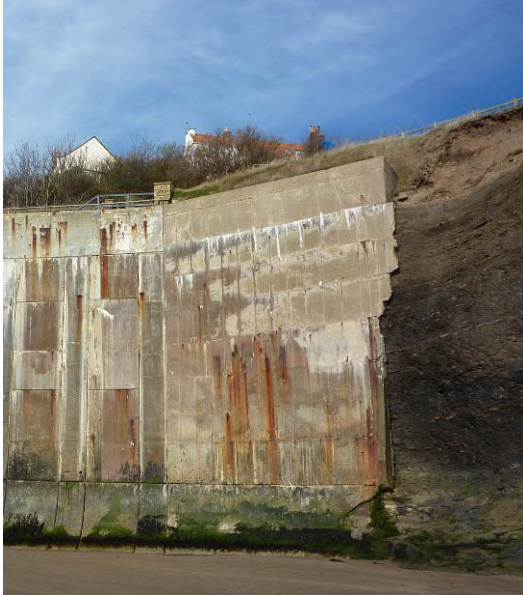
There is spalling in multiple areas across the surface of the wall. There are also several short surface cracks and extensive rust and white staining. There is extensive damage to the last toe block if this deteriorates further it could pose a structural risk to the wall. The toe is buried and there is no sign of movement or heave.

View of intersection between cliff and sea wall showing rust and white staining

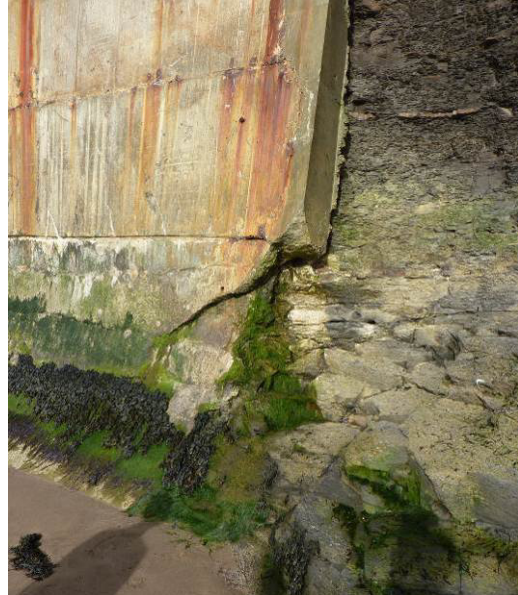
Detailed view of damaged toe block. The recent edge repair can also be seen above this block

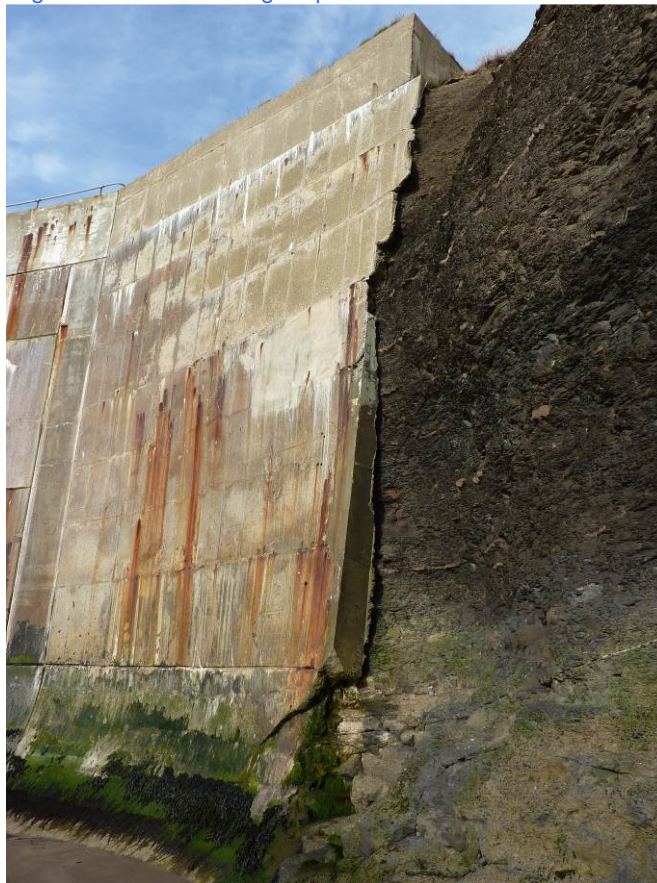
The northern most 10m of sea wall in mass concrete which ties directly into the shale cliff. The edge of the sea wall is exposed and heavily cracked there is a large repair to the lower half of the wall. The erosion of the cliff face next to the wall edge has led to outflanking and loss off back fill. If this continues it could present a risk to the structural integrity of the wall.

View South of the interface between the cliff and the sea walls showing erosion of the cliff leading to outflanking of the sea wall and damage to the edge of the wall. The edge repair is visible on the lower half of the wall.
