**CONDITION ASSESSMENT
OF
ROBIN HOOD'S BAY SEA WALL
FOR
SCARBOROUGH BOROUGH
COUNCIL**

www.concrete-repairs.co.uk email: sbladon@concrete-repairs.co.uk		
CONTRACT DETAILS				
Contract No.:	SUR07605			
Site:	Sea Wall, Robin Hood's Bay			
Client:	Scarborough Borough Council Technical Services Town Hall St. Nicolas Street Scarborough North Yorkshire YO11 2HG For the attention of: Mr. Martin Lloyd			
FOR CONCRETE REPAIRS LIMITED				
Authors:	Simon Bladon BSc., MSc. Survey Division Manager	Approved:	Simon Bladon BSc., MSc. Survey Division Manager	
	Grzegorz Nowakowski Survey Division Area Manager (UK North)	Signed:

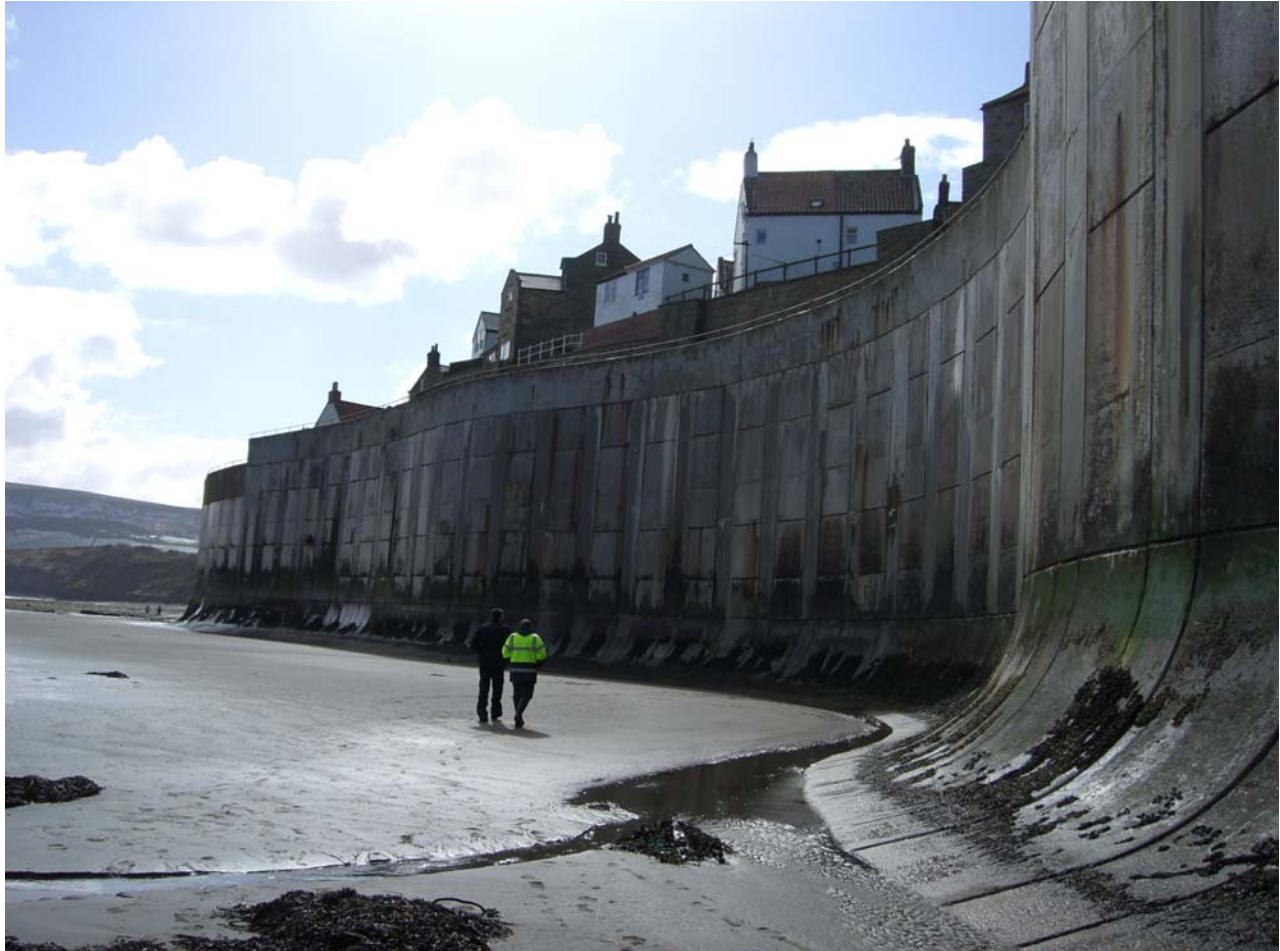
Plate T1: General view of the wall from the northern end.

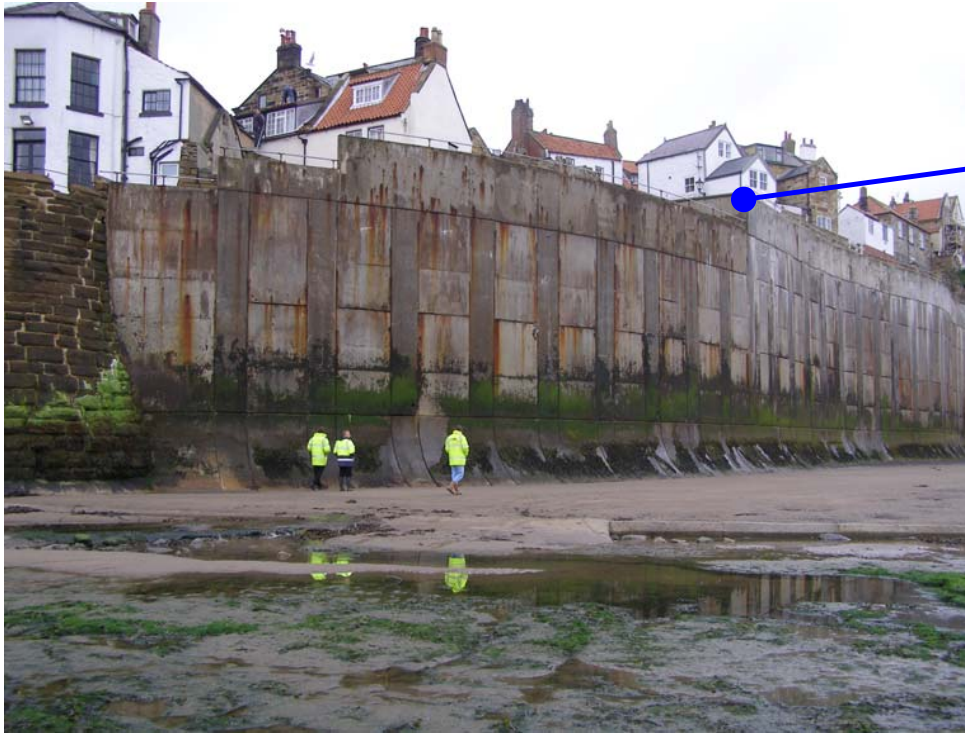
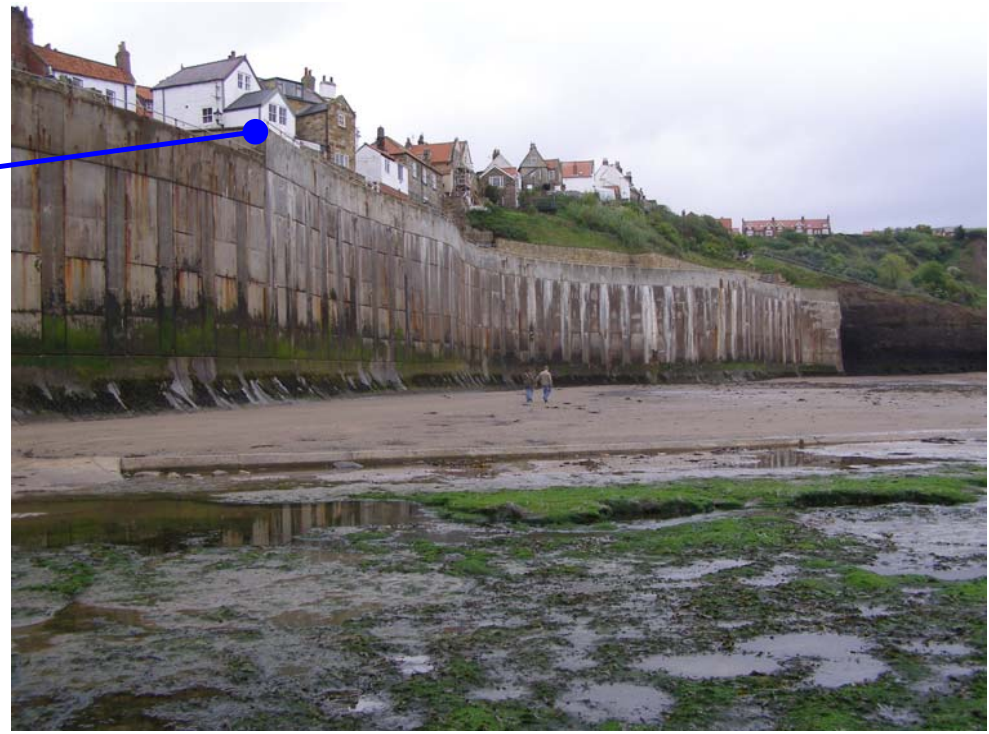
Plates T2: General views of the sea wall from the southern end

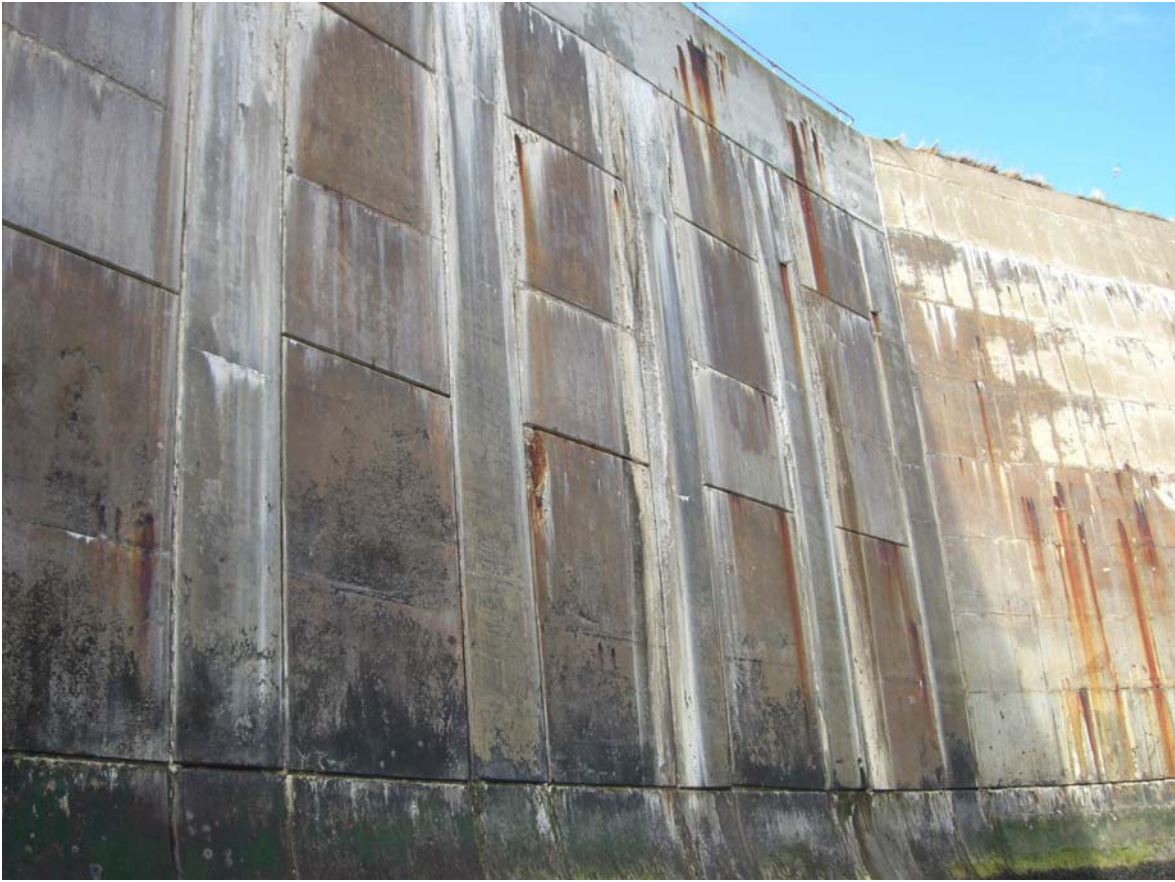
Plate T3: Close-up of the wall showing pre-cast columns, separated by discrete panels. Rust staining was widespread.

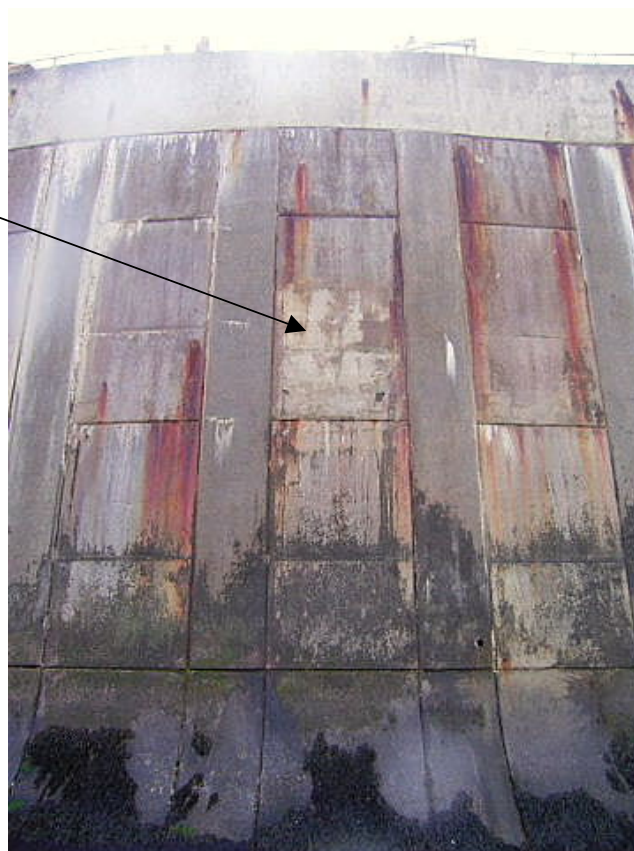
Plate T5: General view of Panels 29, 30 and 31 showing various types of 'defect' i.e. cracking, previous patch-repair, rust stains and white deposits.

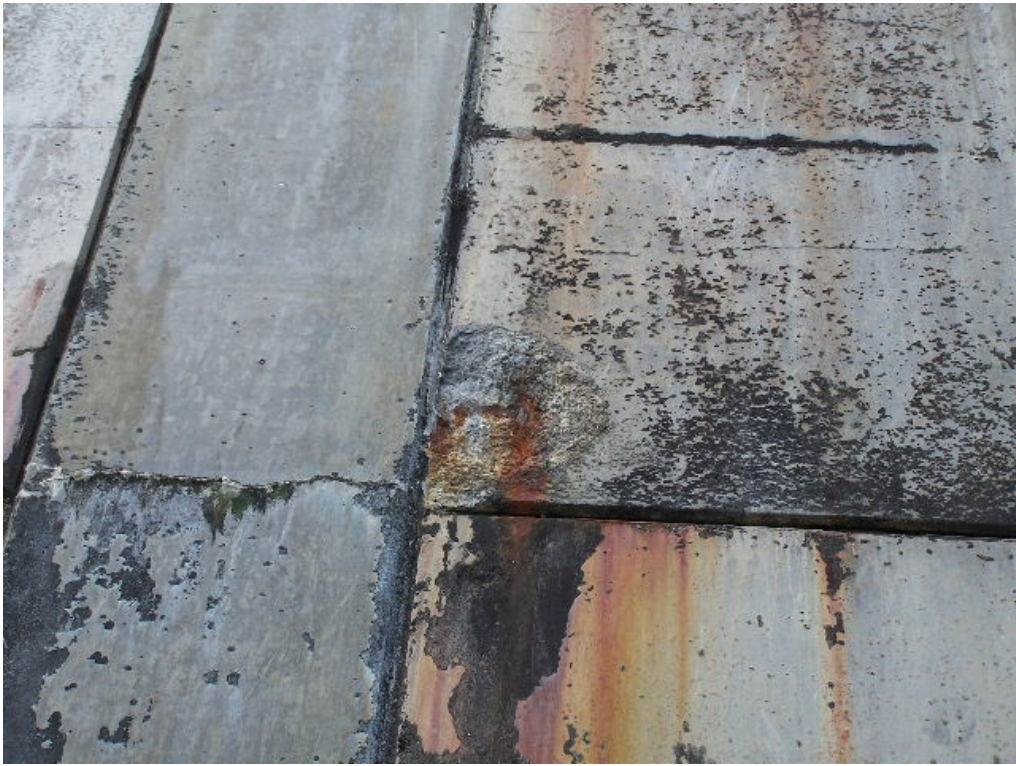
Plate T6: Close-up of a typical rust stain, with associated surface spalling at the corner of a panel.

The rust stains were found to have derived from two sources, namely corroded reinforcement and degraded pyritous aggregate particles. As a very general rule, cracking and rust staining, mainly present along unit edges, represented the former, with isolated rust 'spots' generally representing the latter.

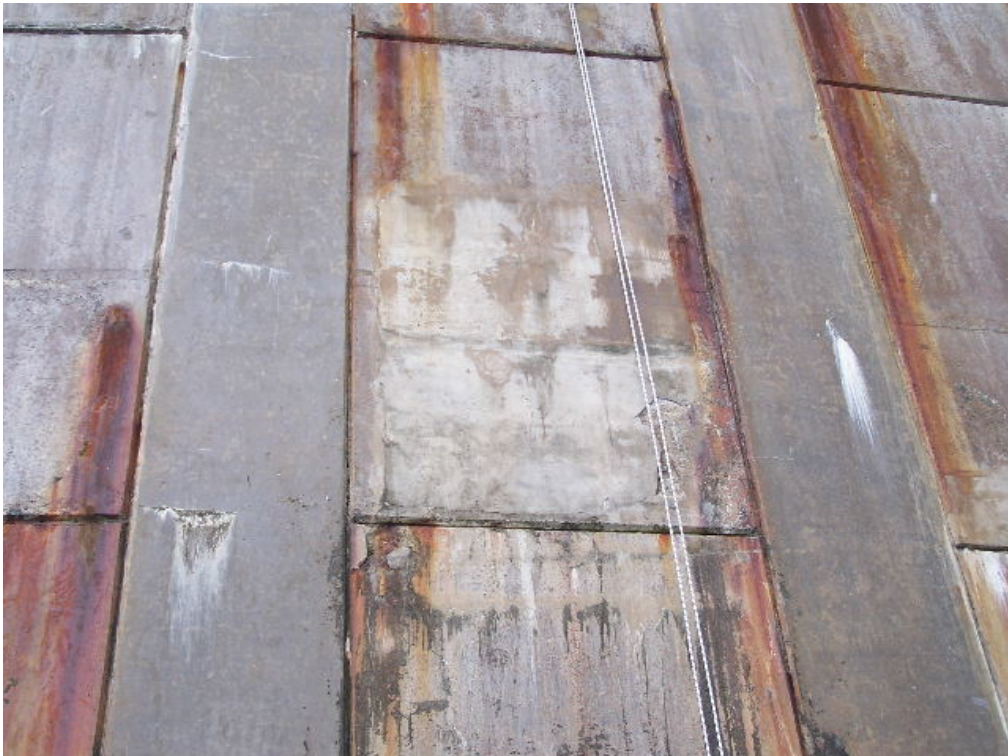
Plate T7: Close-up of previous patch-repair. Many were found to be hollow and delaminated.

In many cases, the previous repairs identified were variably hollow and delaminated. A repair was partially broken out, revealing that corrosion of the encapsulated reinforcement, presumably the original reason for repair, was continuing. Furthermore, steel mesh reinforcement, placed in the repair was also starting to corrode. In our opinion, on the basis of the repair investigated, the materials used were not fit-for-purpose, probably not proprietary repair products and almost certainly not placed to a reasonable, industry, standard.

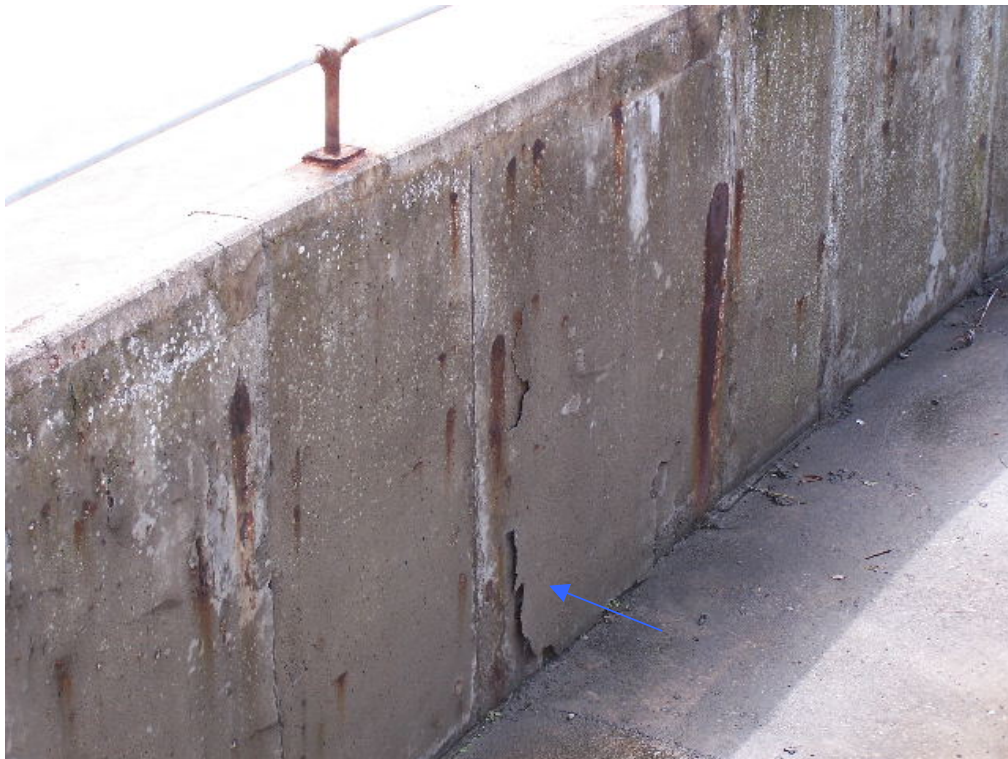
Plate T8: General rust staining and spalling (arrowed) on the inside of the parapet wall.

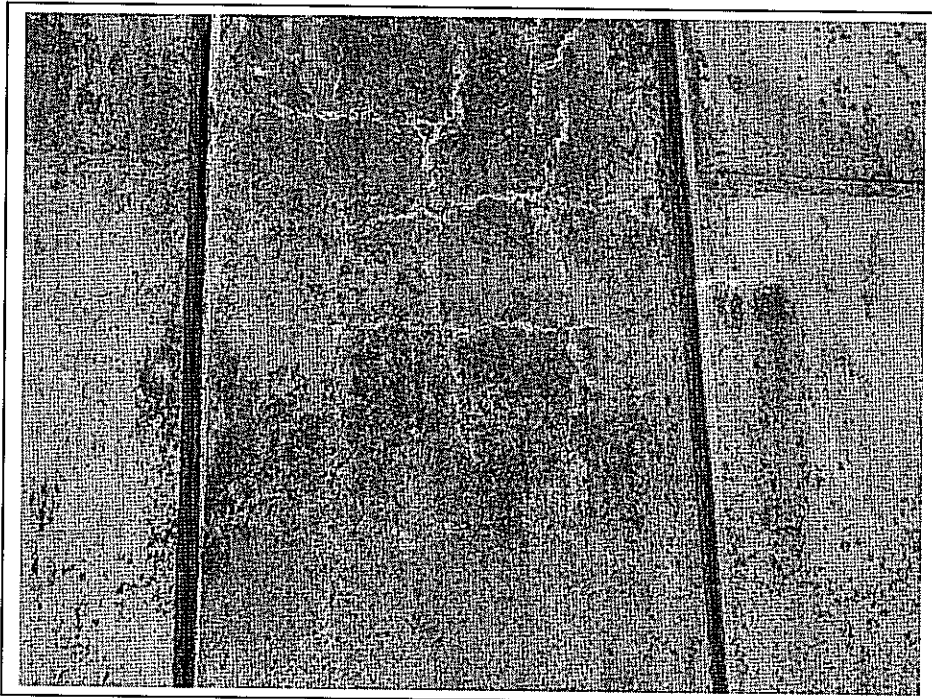
The picture below shows where the reinforcement in the column is corroding and reflective cracking is starting to push the concrete away.

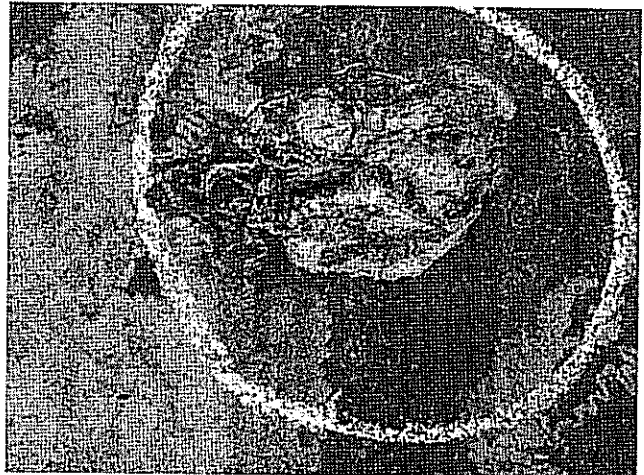
The first was pieces of tie wire, used to construct the steel cage before the concrete was poured were very close to the surface.

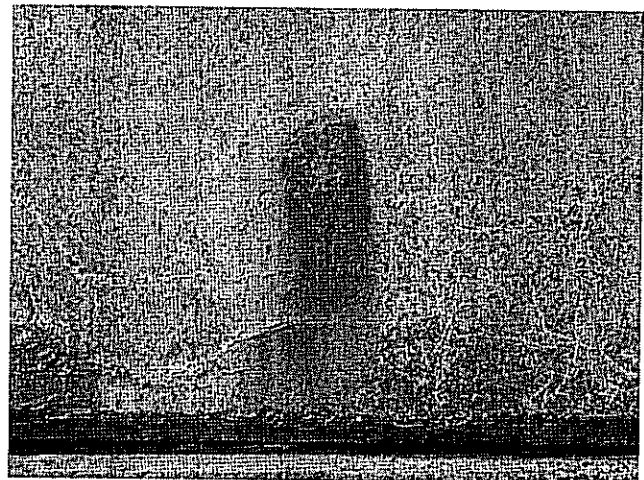
Secondly samples removed from other stained areas appeared to have pieces of iron in the matrix of the concrete. On returning samples to the laboratory and inspecting them under a microscope, it was discovered that iron ore was contained in the sandstone gravel. This has oxidised, expanded and caused the eruption of the surface.

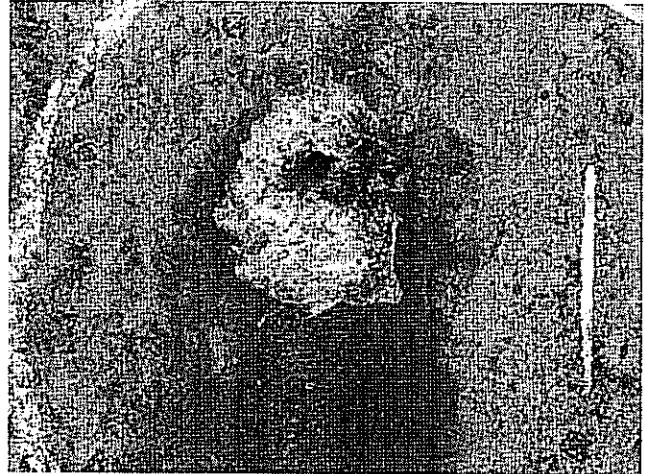
The removal of the surface reveals iron ore type material under the surface.

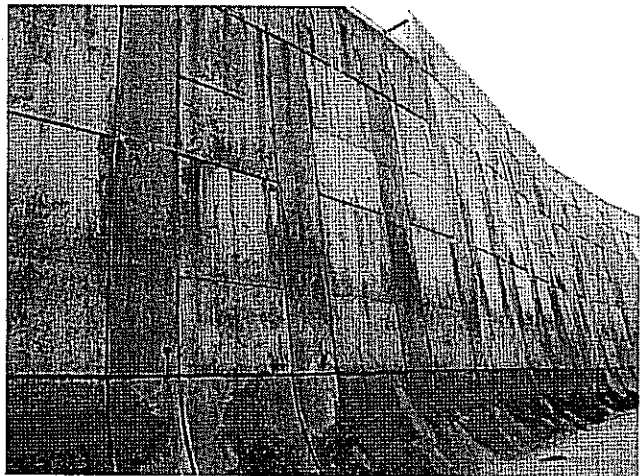
Other staining appears to be caused by the joints between pours not being completely water proof. This is evident from the amount of staining running down from the tops of panels and joints.

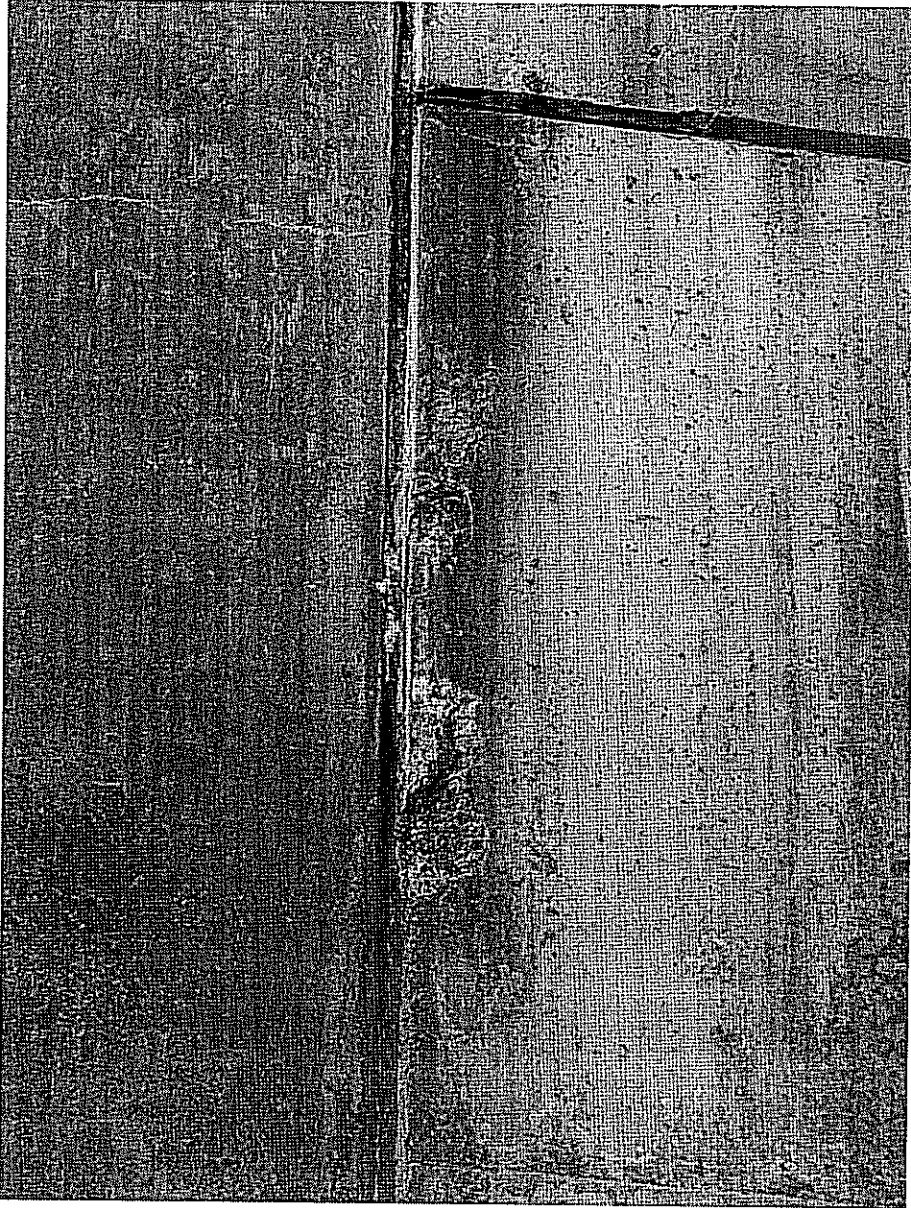
Areas of spalling, cracking and rust staining from joints

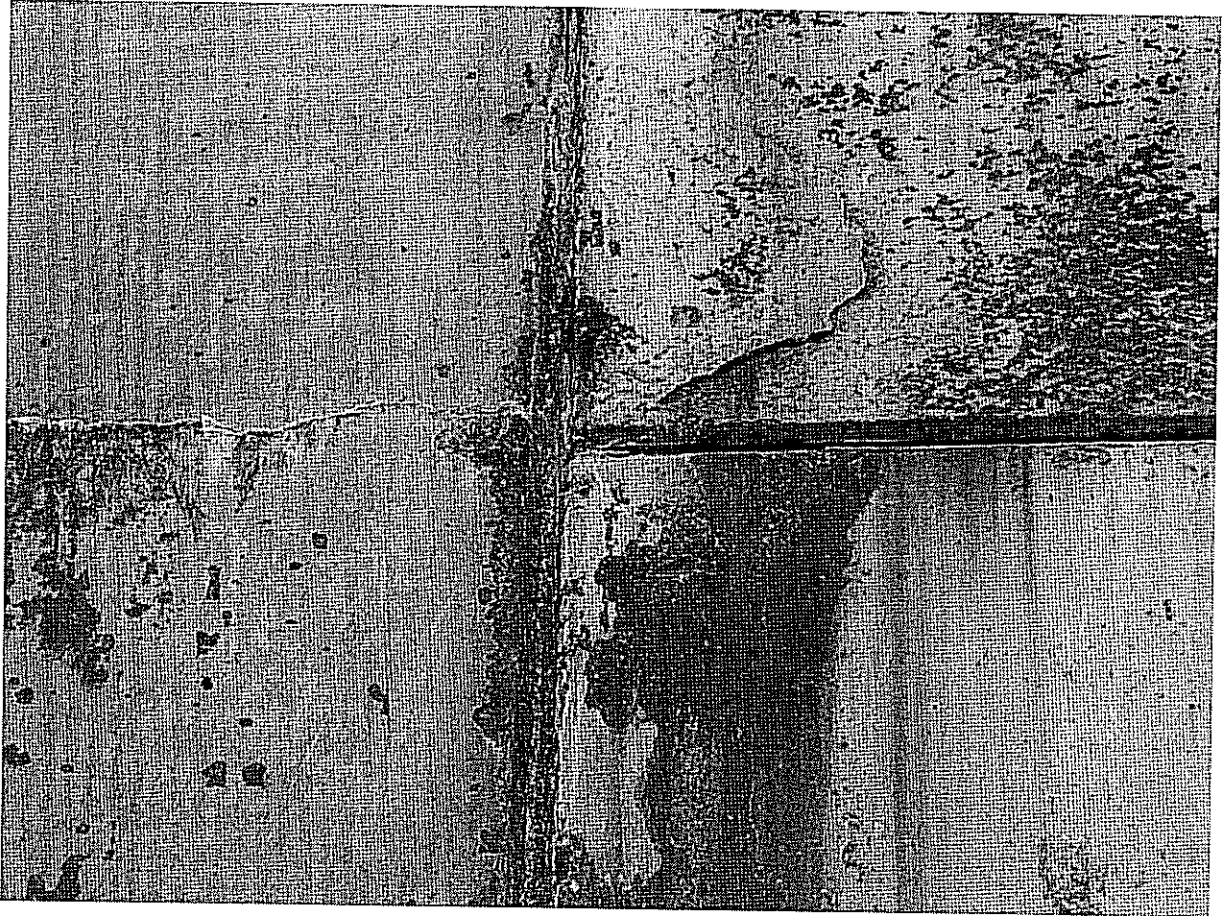
Spalling of the surface and rust staining

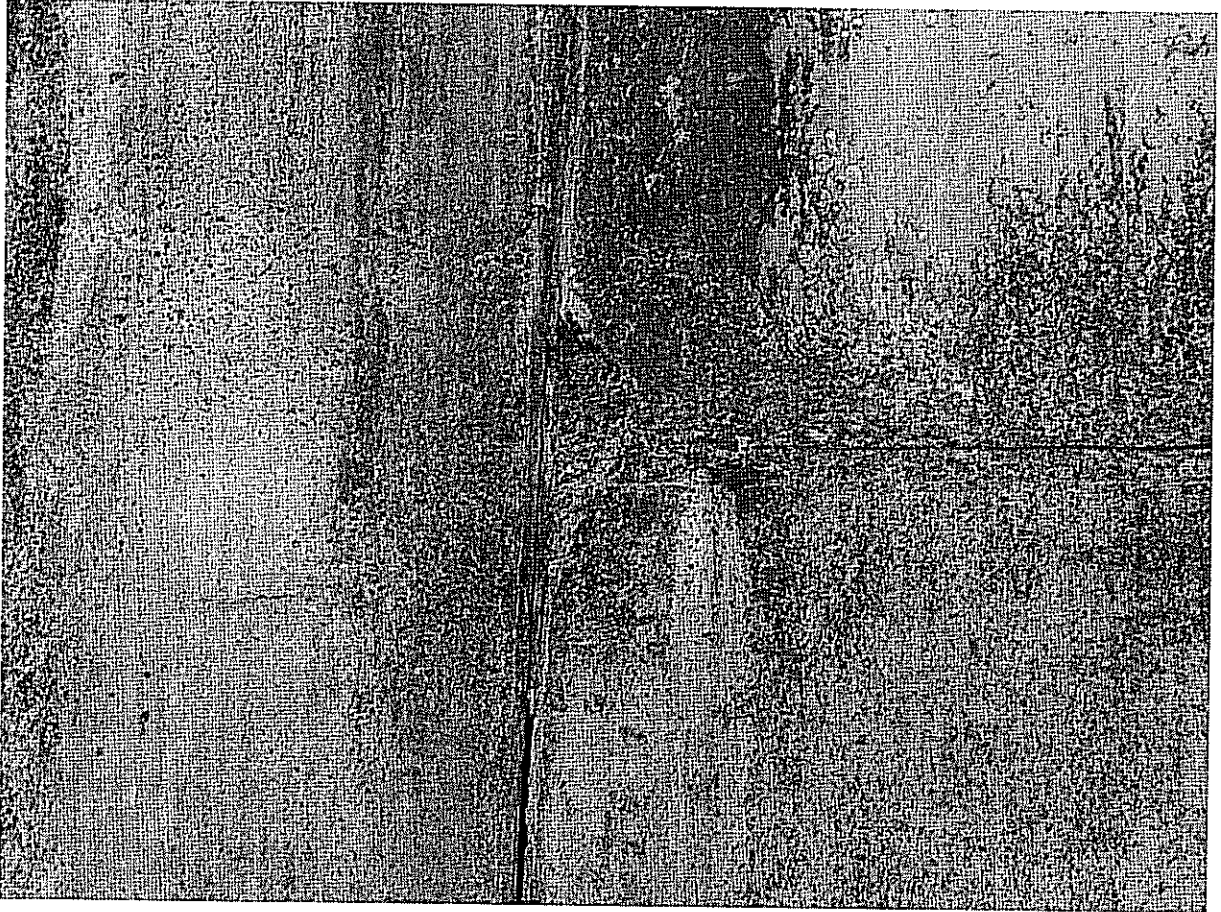
Minor Spalling and iron stone staining

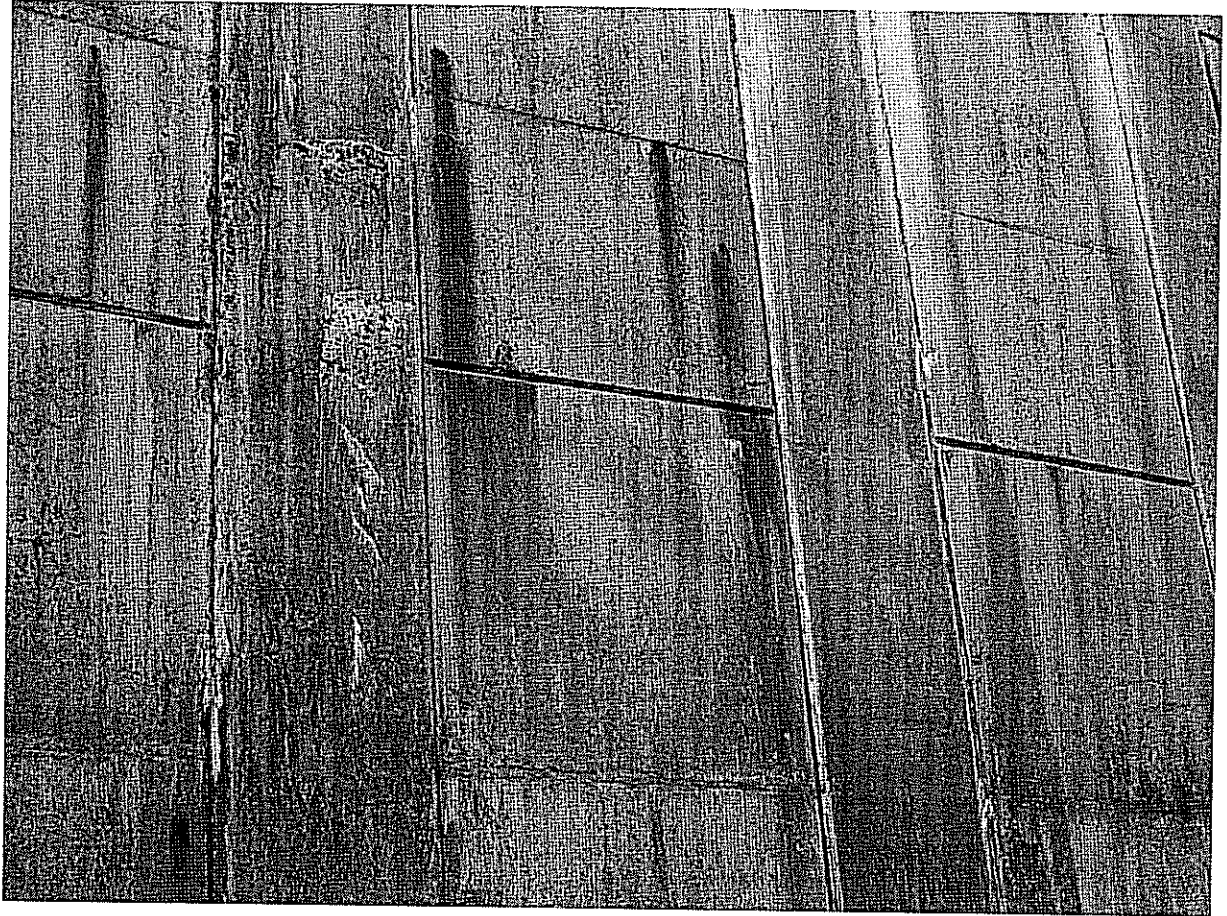
This staining is generally all from iron inclusions or tie wire close to the surface of the concrete

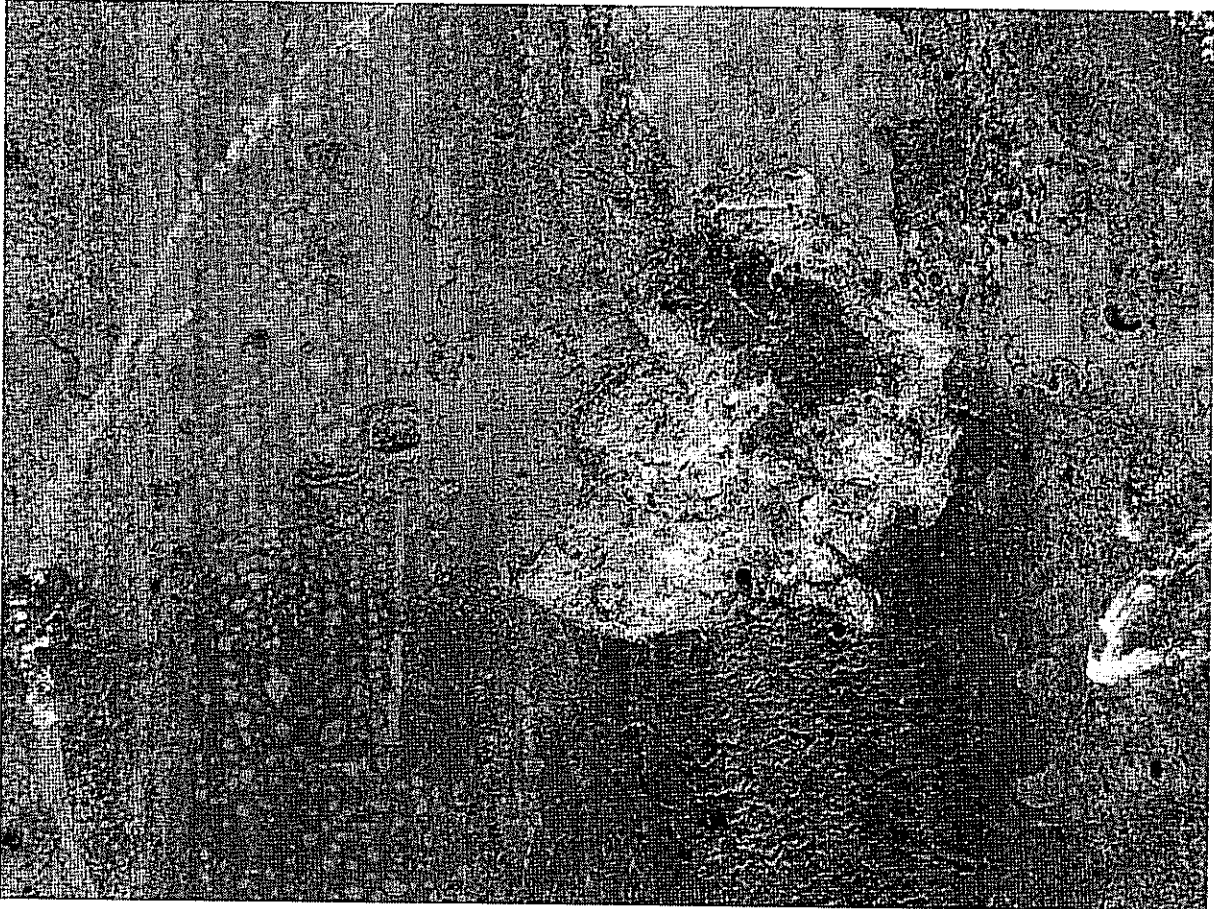
Another example of iron inclusions within the aggregate

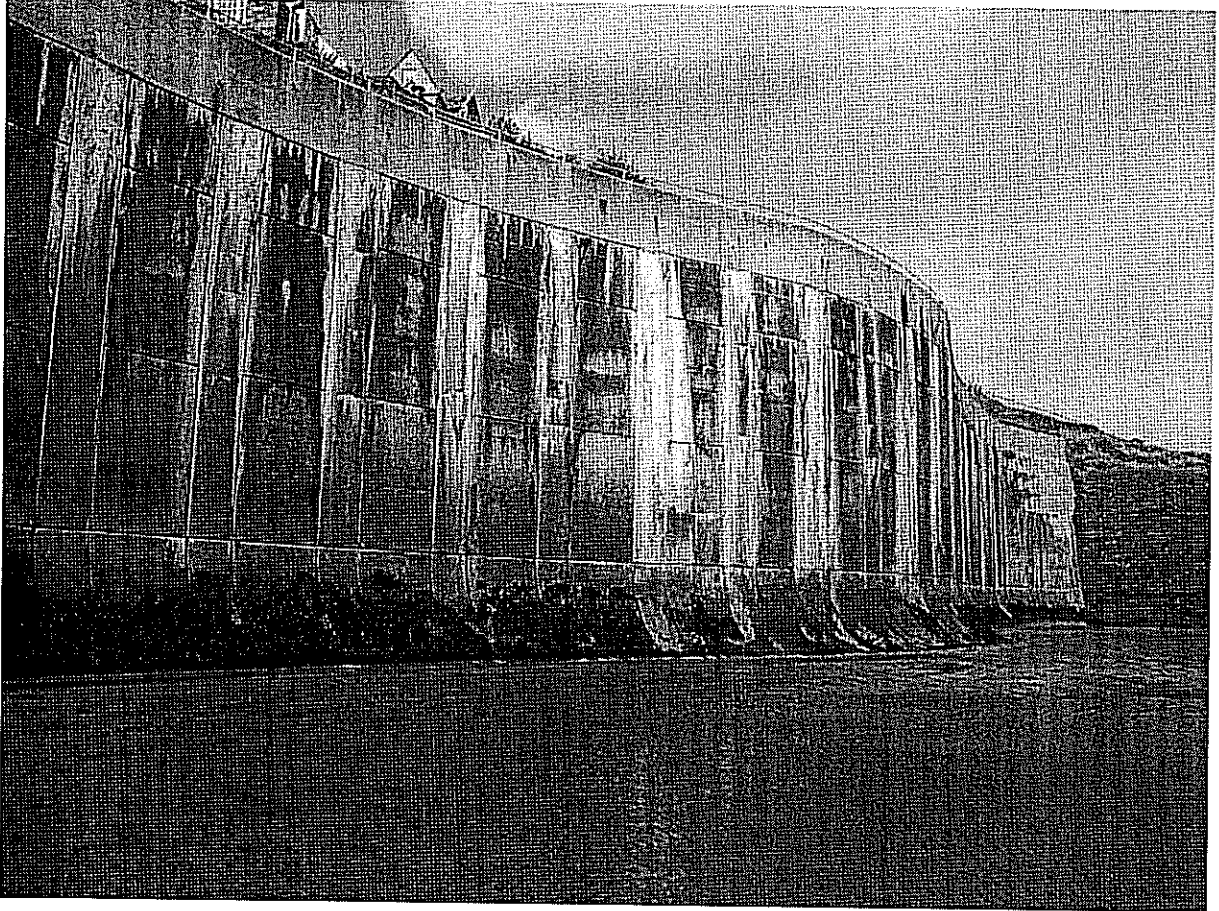
Calcium staining from the parapet wall. Leaking joint between the parapet and panel.

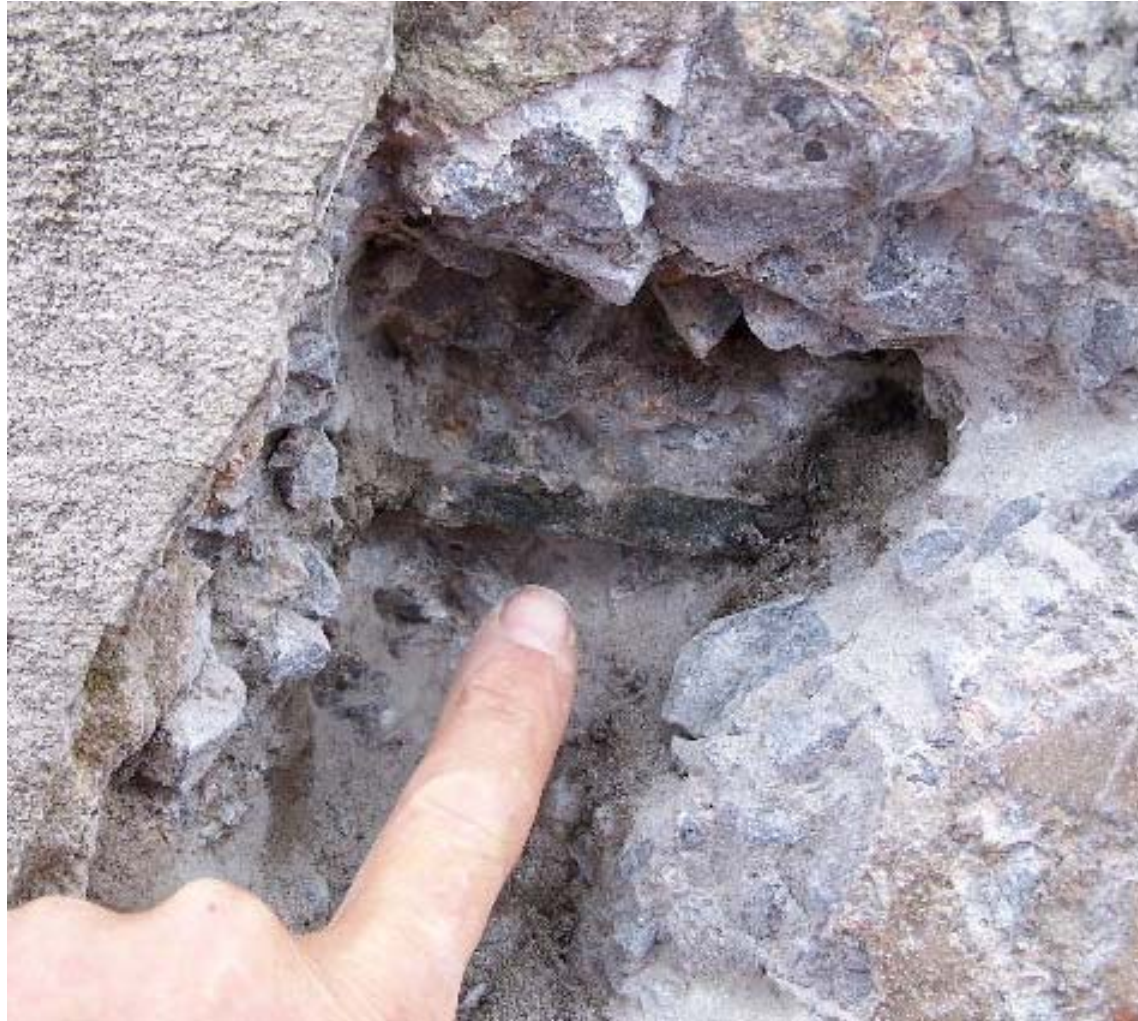
Very Badly Corroded 10mm Horizontal Bar

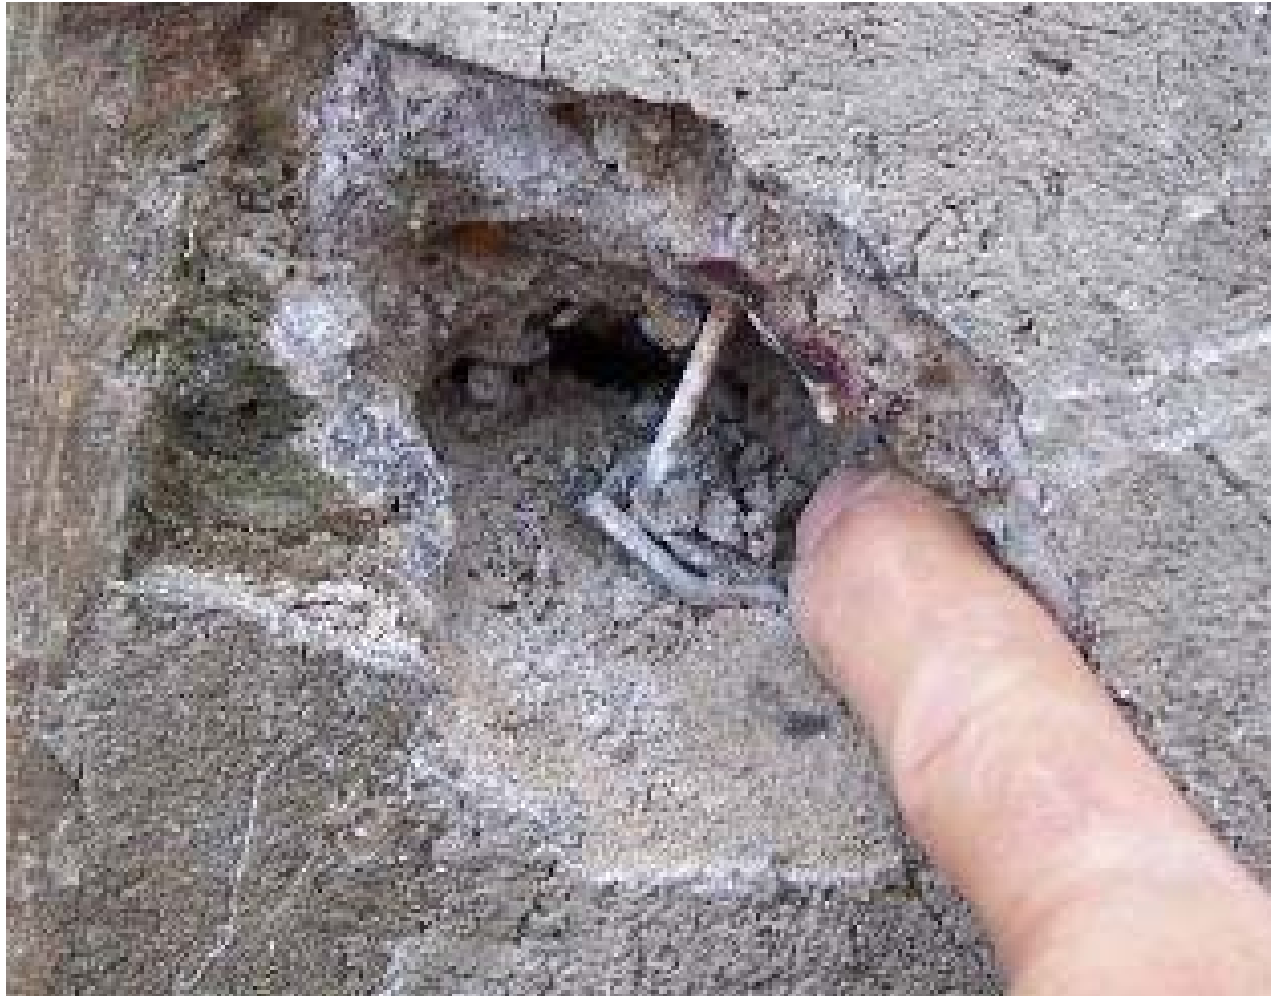
Surface Corrosion on the 2mm Mesh in the Previous Repair Patch

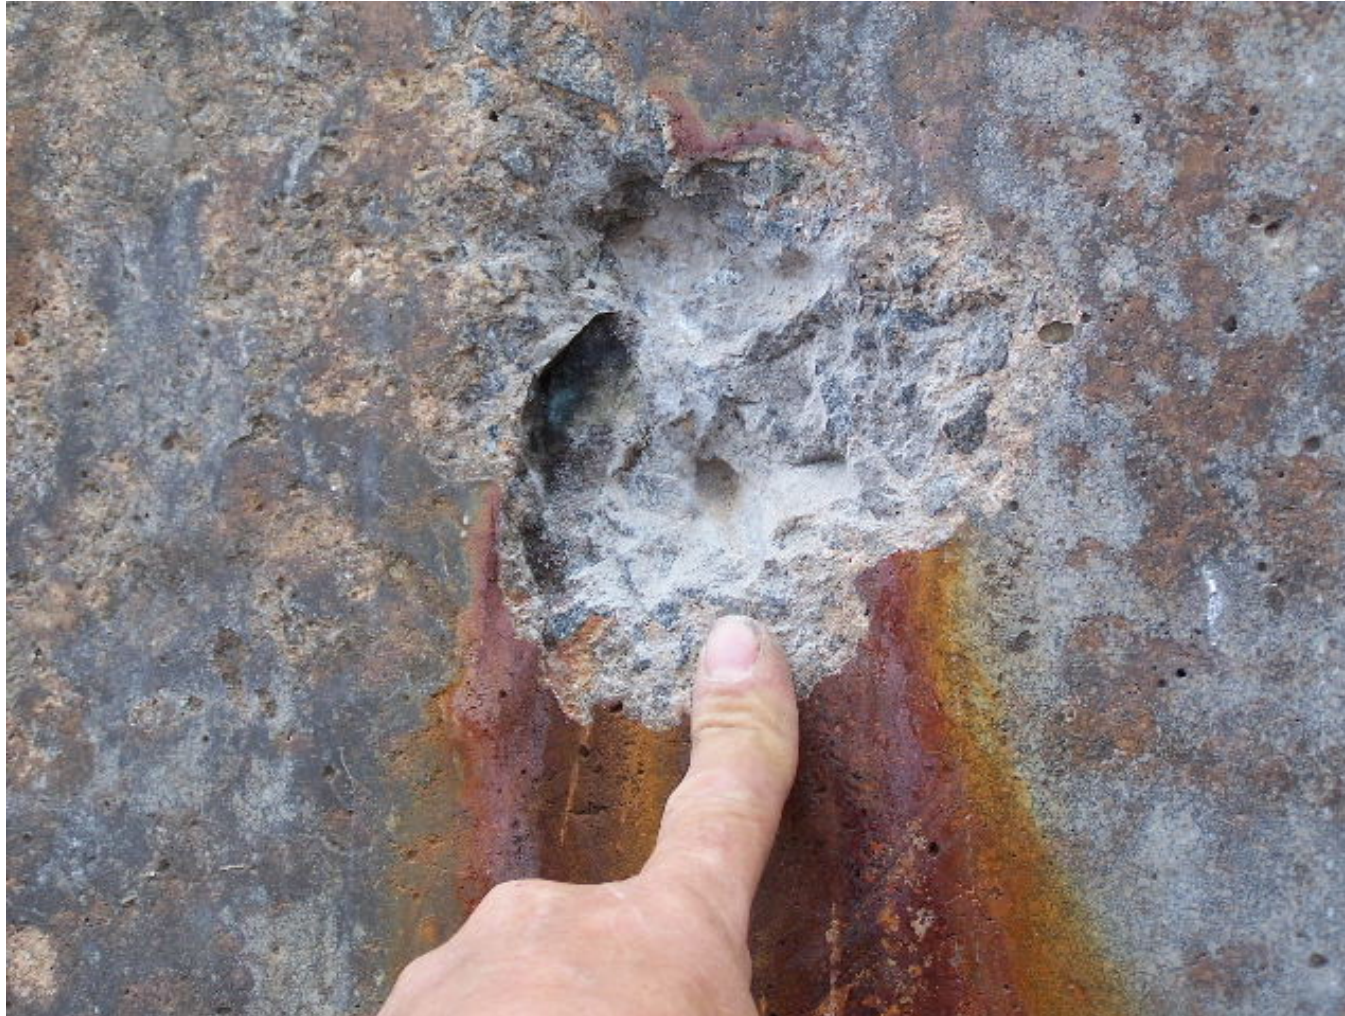
Break-out at Rust Stain to Reveal Degraded Pyritous Aggregates Particle .

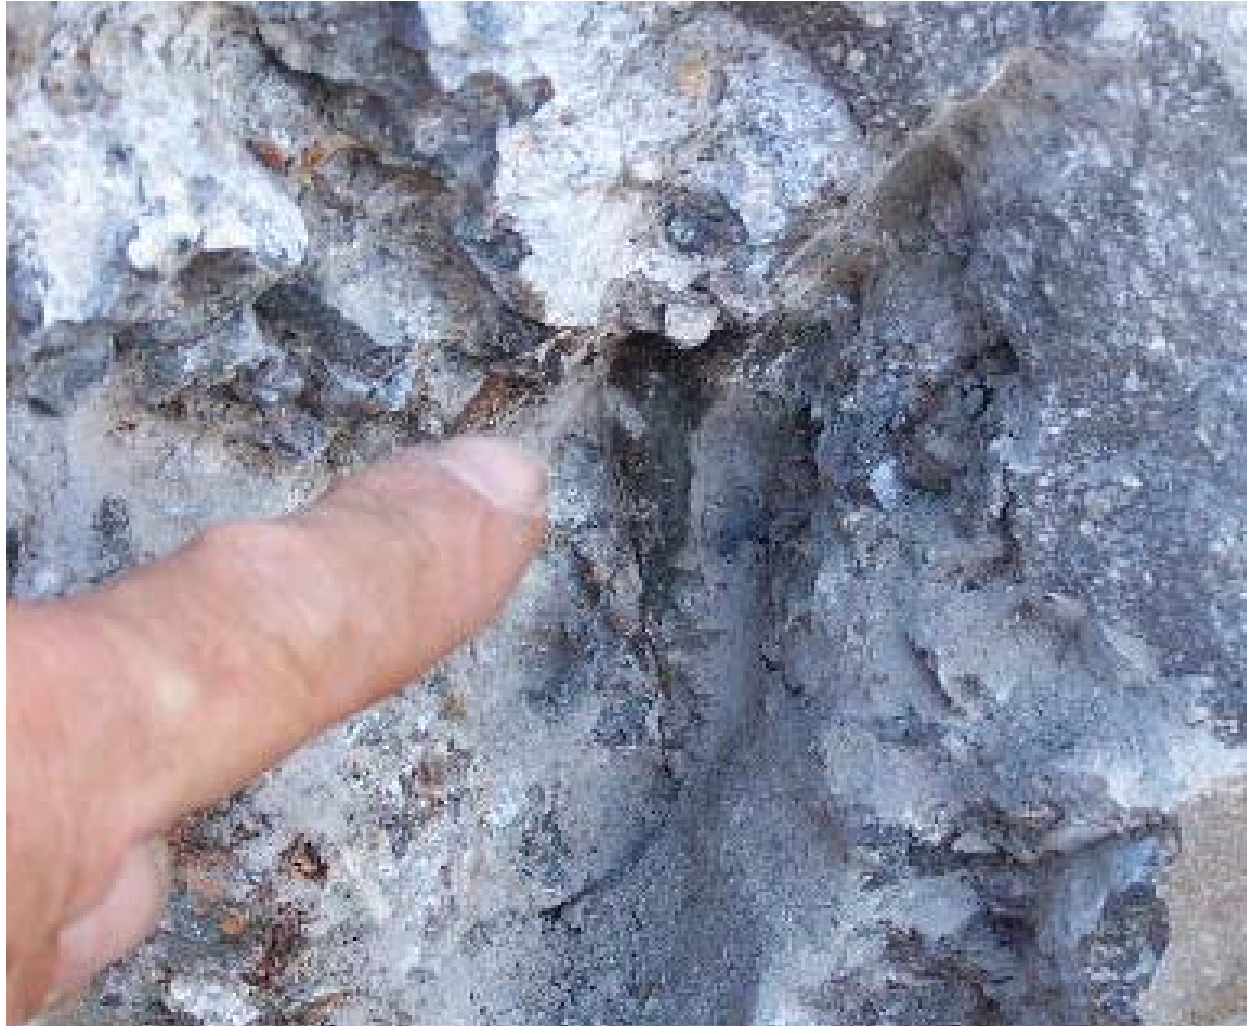
Very Badly Corroded Vertical Bar.
