Note / Memo

HaskoningDHV UK Ltd.
Water

Subject: Cell 1 Coastal Asset Condition Summary

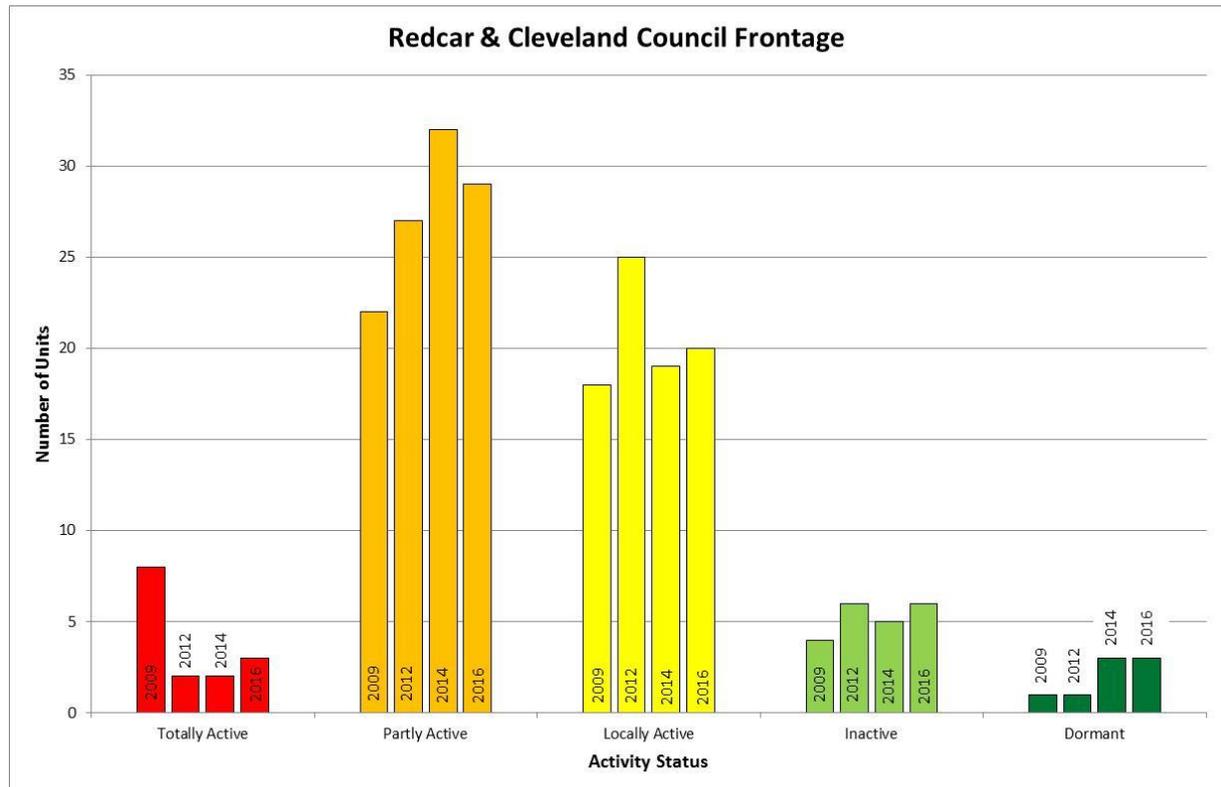
Figure 1 - Frequency of cliff activity along the Redcar & Cleveland frontage 2010 to 2016

Figures 1 and 2, taken from the 2016 walkover inspection reports, summarise the condition of the cliffs.
