Asset Inspection Document

Walk-over Visual Inspections of Assets

Scarborough Borough Council

NOVEMBER 2022

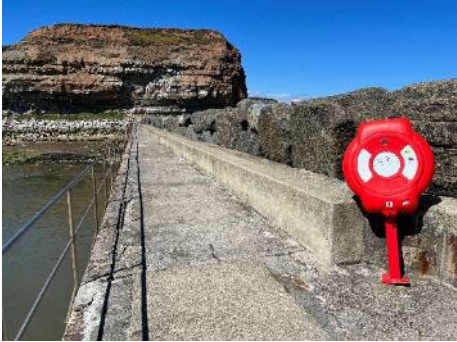
SBC Reference:	N/A		
NFCDD reference:	1221D901D0402C01

Asset Location:	NZ78271901, NZ78441906. North breakwater.	
	Asset Length:	370.8	
	Condition Assessment		
	Condition	Priority	Risk
	C	2	
	Brief Description		
	<p>Rock armour tightly packed to consistent profile. No evidence of significant displacement/movement. Possible local displacement of rock armour from crest at head of structure on inside east face. Two of stacked/pinned crest blocks missing adjacent to walkway (possible remains on foreshore). Heavily corroded steel sheet piling, particularly in uppermost 2m (believed to be permanent formwork rather than structural). Cracking to deck and crest wall. Crack to full width of deck and crest wall approx. 20m from seaward extent. Previous repair (grout/concrete infill) evident. Brittle sealant or loss of sealant within expansion joints in deck.</p> <p>Cracking, abrasion and rust staining to crest wall, particularly coping on inside face from "elbow" seaward (wall narrower). Cracking and abrasion to deck – most significant at "elbow". Rust staining of crest wall. Stainless steel guardrail in fair condition although gap beneath bottom rail is large in areas with abrasion of crest. Fixing for life ring stand damaged. Possible evidence of undercutting of outer concrete face exposed by low beach levels close to landward end. Access ramp and concrete "baffles" at landward end in good condition .</p> <p>2No approx. 0.5t armour rocks sitting on concrete access ramp .</p>

Recommendations		
	<p>Grout voids in structure. Monitor rock armour at head (inside toe) and potential undercutting of inside concrete face (likely requiring boat survey). Repair crest/deck locally. Replace flexible sealant. Adjust guard railing to reduce risk of pedestrians falling. Secure life-ring mount.</p>

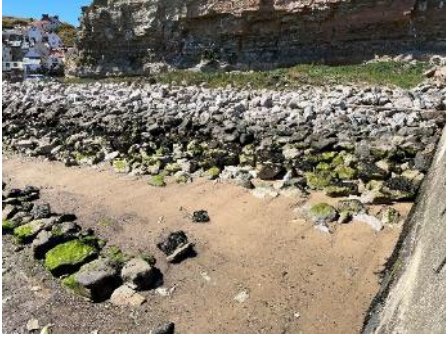
SBC Reference:	N/A		
NFCDD reference:	1221D901D0402C02

Asset Location:	NZ78301893, NZ78271901. South of Northern breakwater.	
	Asset Length:	91.4	
	Condition Assessment		
	Condition	Priority	Risk
	B	3	
	Brief Description		
	<p>Rock armour generally in good condition, with consistent profile and no evidence of significant displacement. Crest at northern extent appeared slightly lower (exposing concrete walkway behind). Rock armour on foreshore in front of toe – possibly displaced from crest. Unchanged from 2020 survey suggesting stable.</p> <p>Concrete seawall at southern end in fair condition with exposed aggregate/abrasion and open joints, esp. close to crest. Minor cracking evident. Abrasion on wall crest and promenade.</p>		
	Recommendations		
	<p>Continue to monitor. Reprofile rock at northern extent. Minor repairs to seawall (pointing/fill cracks).</p>

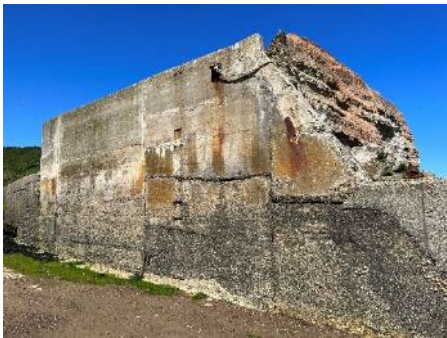
Asset Location:	NZ78251893, NZ78301893. RNLI slipway.	
	Asset Length:	55.3	
	Condition Assessment		
	Condition	Priority	Risk
	C	2	
	Brief Description		
	Abrasion / opening of horizontal construction joints in concrete wall. Slipway surface in good condition, but timber piles cracked and weathered. Gabion baskets generally in good condition although limited visibility due to high beach levels and vegetation cover. Previous survey suggested potential settlement – not evident here. Long standing void in masonry river wall – now approx. 1m deep – beneath area subject to vehicle loading. Significant abrasion of masonry leaving mortar from previous repointing standing proud.		
	Recommendations		
	Monitoring and repair cracks to wall. Infill void.

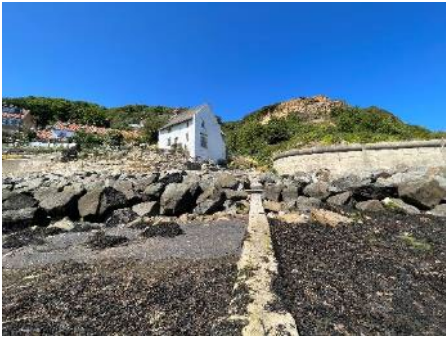
Asset Location:	Runswick Beck	
	Asset Length:	2	
	Condition Assessment		
	Condition	Priority	Risk
	B	4	>5
	Brief Description		
	Former Yorkshire Water (YW) gravity combined sewer connection into longshore outfall, redundant / filled with concrete during YW realignment works in 2017. High beach levels substantially cover concrete YW manhole between rock armour fillets remains live - combined gravity sewer runs south to pumping station (beneath rock armour). Bag work and ad hoc concrete wall/repairs running up into Runswick Beck are generally in fair to poor condition but are protected to some extent by the rock armour. Provides informal access/egress to beach. Local damage to concrete manhole cover slab.		
	Recommendations		
	Continue to monitor. Remove vegetation and infill cracks.

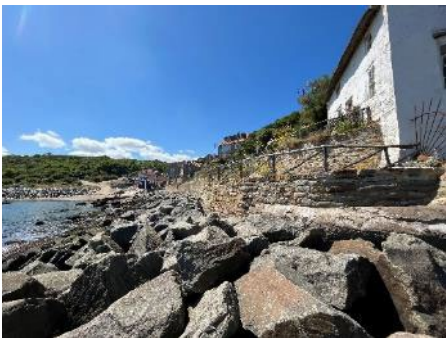
Asset Location:	North side of Runswick Bay	
	Asset Length:	25.3	
	Condition Assessment		
	Condition	Priority	Risk
	B	4	>5
	Brief Description		
	Rock armour fillet constructed as part of Coastal Protection Scheme (July 2018). Local repointing and repairing of cracks to masonry sea wall and concrete apron in advance of rock placement. Rock armour maintains good interlock and consistent profile throughout.		
	Recommendations		
	Continue to monitor.

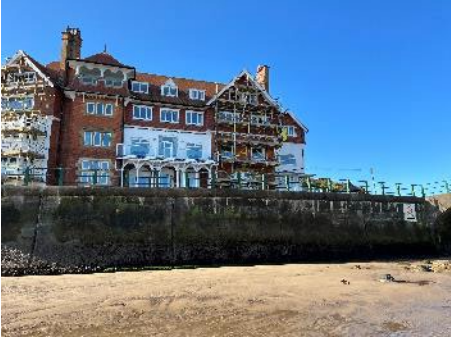
Asset Location:	NZ86061286, NZ86241268	
	Asset Length:	259.1	
	Condition Assessment		
	Condition	Priority	Risk
	C	2	
	Brief Description		
	Groynes derelict. Apron substantially exposed. Very poor with adjacent timber planks and stakes missing and rotten. Concrete-filled barrel toe structure exposed, with significant displacement of some elements Missing joint filler under capping beam. Some sections of missing sealant in most joints in wall, with minor abrasion around joints.		
	Recommendations		
	Re-seal joints where missing between poured sections of sea wall, and replace/encase apron. Whilst not yet 'urgent' the structure would benefit from works within a few years.

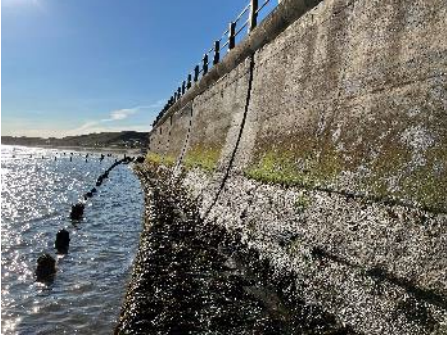
Asset Location:	Same as 14-09B-01	
	Asset Length:	Incl. in 14-09B-01	
	Condition Assessment		
	Condition	Priority	Risk
	C	2	
	Brief Description		
	Groynes derelict. Apron substantially exposed. Very poor with adjacent timber planks and stakes missing and rotten. Concrete-filled barrel toe structure exposed, with significant displacement of some elements Missing joint filler under capping beam. Some sections of missing sealant in most joints in wall, with minor abrasion around joints.		
	Recommendations		
	Re-seal joints where missing between poured sections of sea wall, and replace/encase apron. Whilst not yet 'urgent' the structure would benefit from works within a few years.

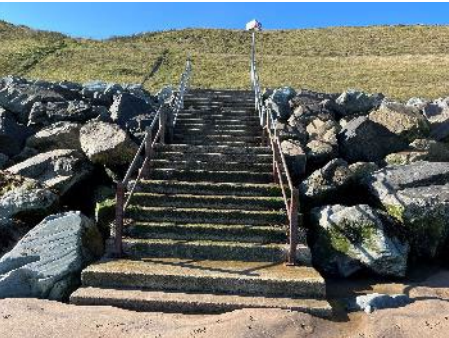
Asset Location:		
	Asset Length:	~5	
	Condition Assessment		
	Condition	Priority	Risk
	C	3	
	Brief Description		
	Steps with algae on lower courses. Heavy abrasion on generally exposed lower sections of steps, with less deterioration on the steps exposed by low 2022 beach levels.		
	Recommendations		
	Continue to monitor.

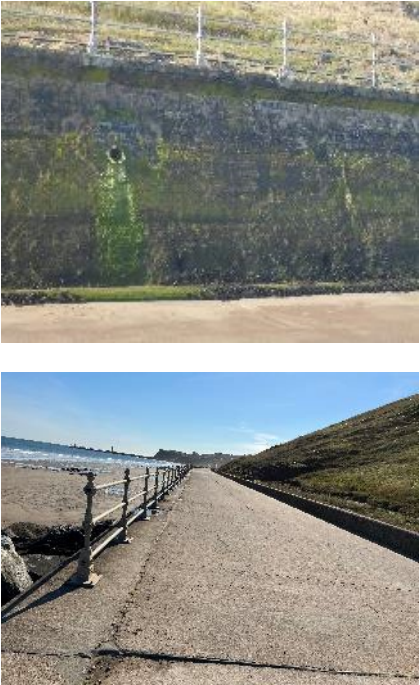
Asset Location:	NZ88541185, NZ88671180	
	Asset Length:	136.6	
	Condition Assessment		
	Condition	Priority	Risk
	C	3	
	Brief Description		
	Concrete wall has extensive minor cracking. Heavy abrasion over whole lower part of wall. Toe is heavily abraded. Local damage to capping has been repaired in the past. Promenade has no major defects. Handrails have been replaced in relatively recent years.		
	Note – Cliffs behind this section in poor condition with past slippages evident.		
	Recommendations		
	Consider placing rock armourstone at toe of wall to create one continuous revetment, rather than leaving this small gap in front of the older section of the defence.

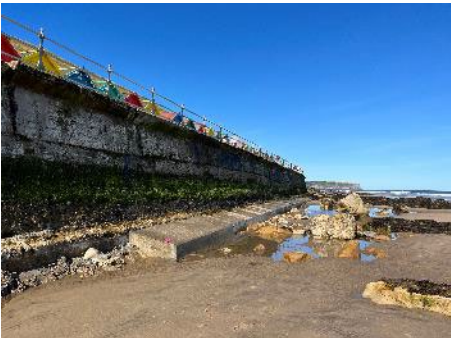
Asset Location:	NZ88861170, NZ89231154	
	Asset Length:	166.8	
	Condition Assessment		
	Condition	Priority	Risk
	C	2	
	Brief Description		
	<p>Lower half of wall abraded/eroded. Toe apron exposed along whole length due to low sand level but heavily covered by seaweed. Previous records of apron missing locally and in poor condition. Promenade fair, signs of wave overtopping causing damage. Handrails anchor bolts corroding. The concrete toe has been repaired at the eastern end.</p>		
	Recommendations		
Consider extending rock armour along this section.

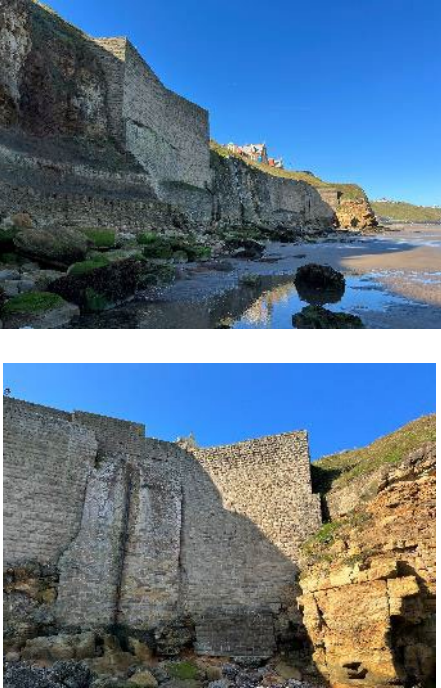
Asset Location:	NZ89541152, NZ89651151	
	Asset Length:	115.8	
	Condition Assessment		
	Condition	Priority	Risk
	B	3	
	Brief Description		
	High sections of blockwork sea wall facing in between in-situ rock outcrops. Sections of masonry appear sound condition, some mortar loss, but not worse than noted previously. In several locations tie-in of edges into cliff is getting outflanked / abraded. Low beach levels exposing the rock at the toe of the cliff, with evidence of relatively recent rockfalls		
	Recommendations		
	Repair edges of panels where tie- in to cliff

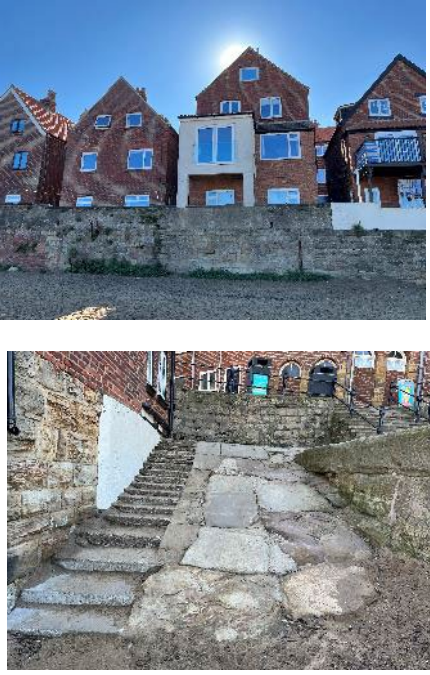
Asset Location:	South of Collier Hope and Mussel Beds	
	Asset Length:	154.9	
	Condition Assessment		
	Condition	Priority	Risk
	C	3	
	Brief Description		
	Riparian walls of (variably) brickwork, sandstone, and boulder construction in various conditions, some quite poor. Protected by sand and cobble beach. Spalling to the render and exposure of the aggregate. Slipway and steps weathered with missing joints.		
	Recommendations		
	Continue to monitor, repoint where needed. Replace missing blocks.

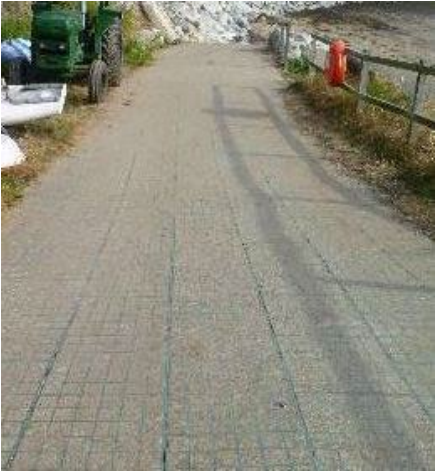
Asset Location:	Robin Hood's Bay.	
	Asset Length:	~70	
	Condition Assessment		
	Condition	Priority	Risk
	B	3	
	Brief Description		
	Slipway. Mixed construction in fair condition. Landslip on slope above slipway.		
	Recommendations		
Consider extending rock netting on slope above slipway. Continue to monitor.

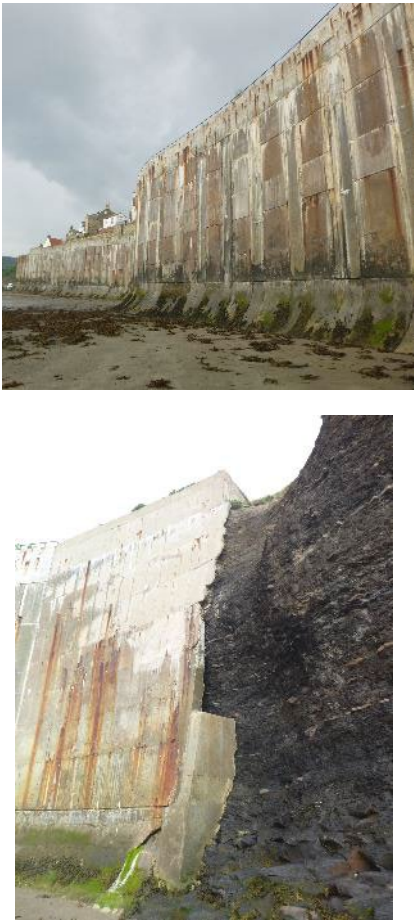
Asset Location:	NZ95330488, NZ95310502	
	Asset Length:	150.5	
	Condition Assessment		
	Condition	Priority	Risk
	C	2	
	Brief Description		
	Toe not visible high beach levels. Concrete wall poor - displaying surface cracking, loss of surface, rust staining and mineral encrustation. Defects appear significantly worse at northern transition. Wall crest showing more cracking and repair work. Recent concrete spalling evident. Signs of recent repairs and repainting on crest wall. Prom fair.		
	Recommendations		
	Continue to monitor. Undertake capital repairs.

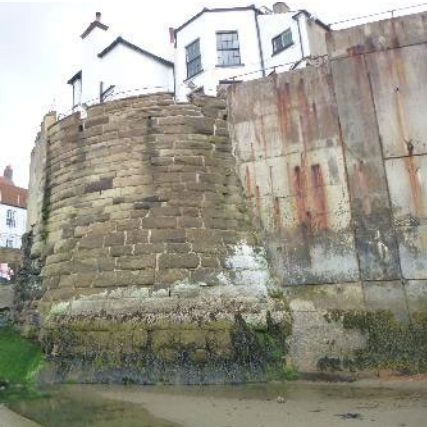
Asset Location:	NZ95320486, NZ95330488	
	Asset Length:	29.3	
	Condition Assessment		
	Condition	Priority	Risk
	C	2	
	Brief Description		
	Repairs to open joints and voids noted and appear to be working effectively. Some areas of surface erosion and joint washout still exist. Voids and open joints in masonry near tie in to concrete wall have been grouted. Toe visible due to low beach levels - appears in poor condition, with some cracking and a potential void forming at its base.		
	Recommendations		
	Continue to monitor remaining voids and joints. Monitor repairs. Perform detailed inspection of wall toe.

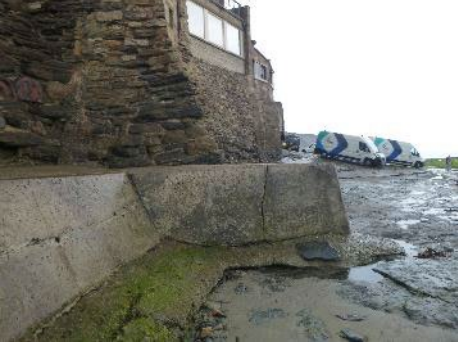
Asset Location:	NZ95310481, NZ95310485	
	Asset Length:	51.9	
	Condition Assessment		
	Condition	Priority	Risk
	B	2	
	Brief Description		
	Patchwork of repairs/repointing throughout. Void / undercutting to south end of concrete toe. Large crack through concrete toe and blinding layer at dogleg – not worse than previous inspection.		
	Recommendations		
Continue to monitor and repoint/repair. Repair crack at dogleg to prevent further damage to structure.

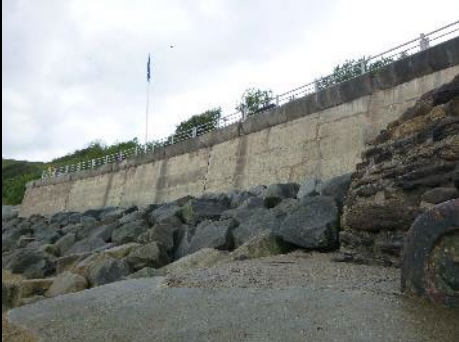
Asset Location:	NZ95320468, NZ95310481	
	Asset Length:	29.2	
	Condition Assessment		
	Condition	Priority	Risk
	B	3	
	Brief Description		
	Cracks and spalling to capping beam. Damage to previous repairs to South end of wall. Rock armour at toe in good condition, good interlock and profile.		
	Recommendations		
Continue to monitor. Repair spalling and joints where necessary.

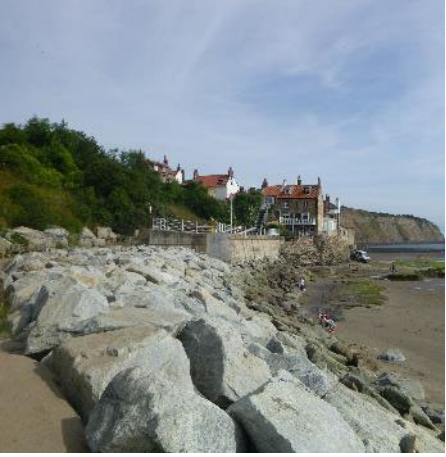
<p>Rock armour is generally tightly packed and good cover. Some smaller rocks show signs of movement. Promenade in good condition. Overall good.</p>
	<p>Recommendations</p>
	<p>Monitor armour for need to re-profile in future.</p>

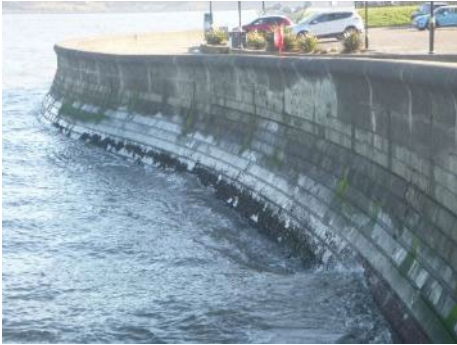
Asset Location:	TA03549057, TA03569082. Wall and promenade next to Sea Life Centre. Extends to Southern steps (40-20a-01)	
	Asset Length:	327.2	
	Condition Assessment		
	Condition	Priority	Risk
	B	3	
	Brief Description		
	Cracks to splash wall but looks sound. Prom good condition. Wall in fair condition. Stepped toe showing signs of abrasion. 1No. outlet failed but performance not affected. Crest wall cracked in several locations.		
	Recommendations		
Continue to monitor, refill joints and repair cracks.

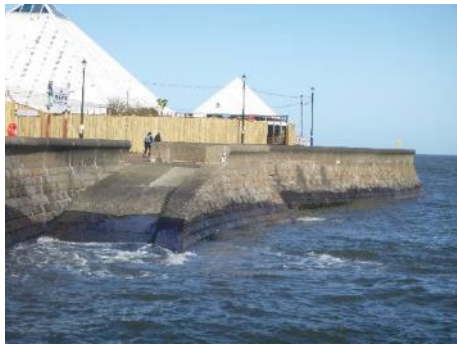
Asset Location:	TA03549057, TA03569082. Wall and promenade next to Sea Life Centre.	
	Asset Length:	~15	
	Condition Assessment		
	Condition	Priority	Risk
	C	3	
	Brief Description		
	Slipway not usable due to toe erosion. Deck slabs are in poor condition with joints heavy abraded. Repaired deck slab section shows further signs of deterioration.		
	Recommendations		
Repair deck slab

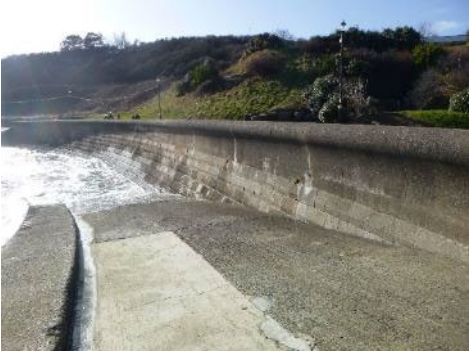
Asset Location:	Between slipway and steps	
	Asset Length:	Part of overall wall length (327.2)	
	Condition Assessment		
	Condition	Priority	Risk
	B	3	
	Brief Description		
	Blockwork in fair condition. Surface corrosion on sheet piles, with concrete toe beam heavily abraded in places. Prom good condition.		
	Recommendations		
Continue to monitor

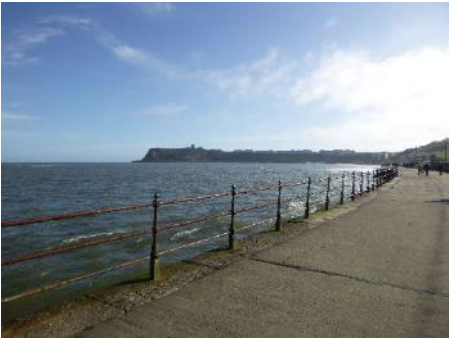
Asset Location:	TA03589031, South of Sea Life Centre.	
	Asset Length:	120.6	
	Condition Assessment		
	Condition	Priority	Risk
	C	2	
	Brief Description		
	Abrasion of external blockwork throughout sea wall, particularly to the north of the asset where reinforcement is exposed. .Stepped concrete toe is heavily abraded. Corroded handrails. As reported in 2018 and 2020, there is frequent cracking and spalling to prom slabs and some missing sealant between slabs. The rear splash wall and revetment is in poor condition. Historic repairs are now failing and there are frequent missing stones in the revetment.		
	Recommendations		
	Undertake repairs to northern extents of seawall face where reinforcement is exposed. Repair stone revetment and splash wall.

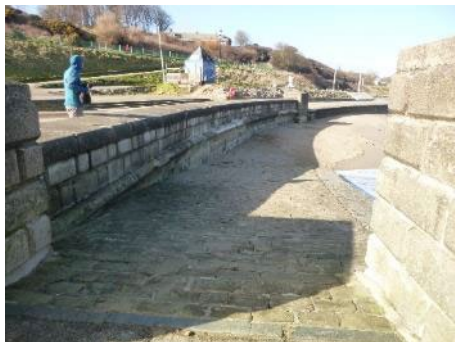
Asset Location:		
	Asset Length:	~6	
	Condition Assessment		
	Condition	Priority	Risk
	B	3	
	Brief Description		
	S–There is spalling and cracking of the coping stones and facing blockwork on the back wall of the slipway ramp. The slipway surface is generally fair however there is evidence of mortar washout from around the blocks. Beach sediment concealed the toe of the slipway.		
	Recommendations		
Replace mortar in joints on slipway ramp. Repair cracking and spalling to the slipway backwall and coping.

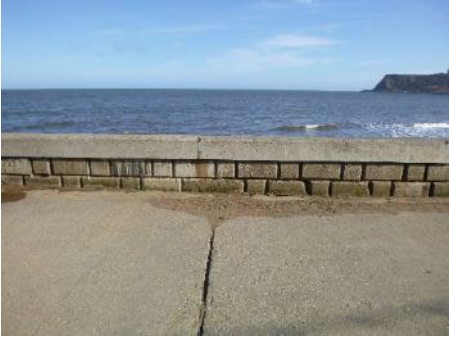
Asset Location:	TA03599020, TA03589031 At North end of beach huts.	
	Asset Length:	99.1	
	Condition Assessment		
	Condition	Priority	Risk
	B	3	
	Brief Description		
	<p>No significant change observed in 2022. As previously reported the repairs to the wall face appear to be holding. There is isolated spalling to the coping stone adjacent to the southern slipway. Promenade in good condition. Heavily abrasion to unrepaired lower sections. The low splash wall to the rear of the promenade is in poor condition with several areas of missing block and cracking throughout the coping stone. Outlet in good condition.</p>		
	Recommendations		
	Continue to monitor repair cracks and coping. Repair wall at back of promenade.

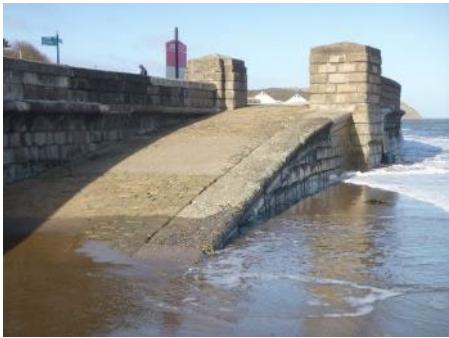
Asset Location:	TA03599020, TA03589031	
	Asset Length:	~4	
	Condition Assessment		
	Condition	Priority	Risk
	B	3	
	Brief Description		
	<p>Slipway - No significant change observed in 2022. As reported previously joints to block paving missing. The coping stone to the backwall and coping stone to the seaward edge of the ramp show signs of cracking and spalling.</p>		
	Recommendations		
	Replace joints. Continue to monitor.

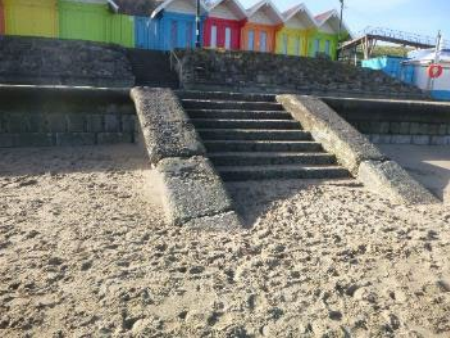
Asset Location:		
	Asset Length:		
	Condition Assessment		
	Condition	Priority	Risk
	B	3	
	Brief Description		
	Beach levels similar to 2020 with lower steps concealed. Step abutments remain heavily abraded and cracked. Steps chipped and rounded but fair condition overall.		
	Recommendations		
Repair step abutments. Continue to monitor

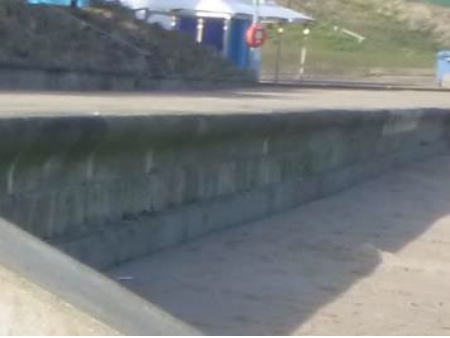
Asset Location:		TA03758981, TA03599020
	Asset Length:		58.7
	Condition Assessment		
	Condition	Priority	Risk
	B	4	5
	Brief Description		
	Unchanged. Beach levels conceal much of the wall face and toe. Repairs to the coping remain in good condition, elsewhere the coping is in fair condition. As previously reported there is abrasion of the blocks in the wall face. Promenade remains in good condition. Rear revetment in fair condition with some signs of deterioration of the grout.		
	Recommendations		
Continue to monitor.

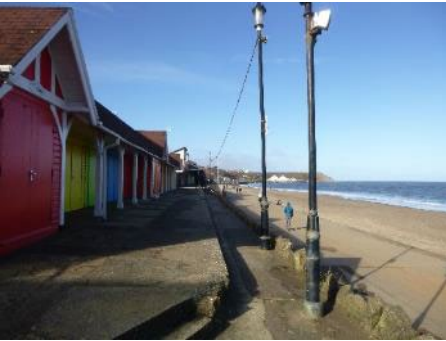
Asset Location:	TA03758981, TA03599020	
	Asset Length:	55.6	
	Condition Assessment		
	Condition	Priority	Risk
	B	4	5
	Brief Description		
	Beach levels high during the inspections, coming to near the crest level of the wall. Recently replaced sections of coping stone are in good condition, elsewhere the coping is in fair condition. The promenade remains in good condition. Beach material is frequently washed onto the promenade, locally this increases abrasion of the deck surface.		
	Recommendations		
Monitor and repair coping.

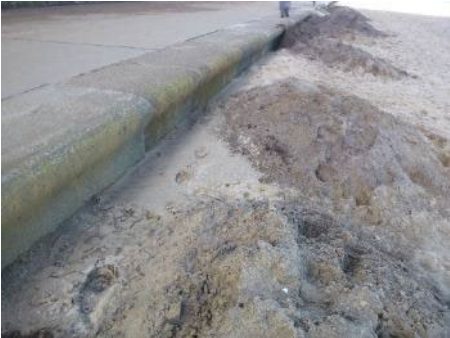
Asset Location:	In front on new apartments.	
	Asset Length:	22.8	
	Condition Assessment		
	Condition	Priority	Risk
	B	4	5
	Brief Description		
	<p>High beach levels mean that only the wall coping stone was visible. Condition remains unchanged in 2022. There is some minor evidence of abrasion and cracks on the coping stone and across the promenade deckslab. Generally however, the condition remains in good condition.</p>		
	Recommendations		
Repair defects to coping/prom edge and rear revetment.

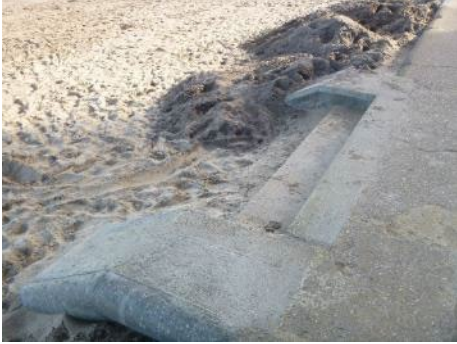
Asset Location:		
	Asset Length:	~3	
	Condition Assessment		
	Condition	Priority	Risk
	B	4	5
	Brief Description		
	<p>Unchanged since 2020. The steps are in fair overall condition. Penultimate step replaced in 2015 in good condition. The upper section of step abutments has historic repairs in fair condition. Evidence of abrasion throughout the steps and abutments. Unable to inspect lower steps or lower section of abutments due to beach levels.</p>		
	Recommendations		
	Continue to monitor.

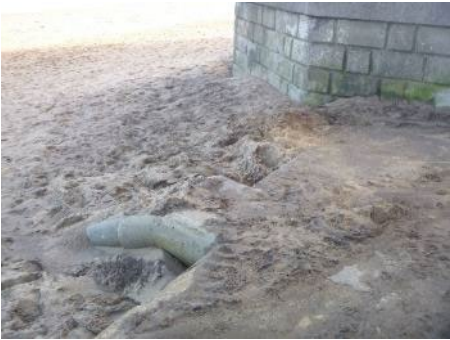
Asset Location:		
	Asset Length:	~3	
	Condition Assessment		
	Condition	Priority	Risk
	B	4	5
	Brief Description		
	Beach levels are locally very high adjacent the steps. Only a small portion of the northern abutment was visible, this appeared in fair condition. Previous inspections have reported that the overall condition of the steps is fair.		
	Recommendations		
	Continue to monitor.

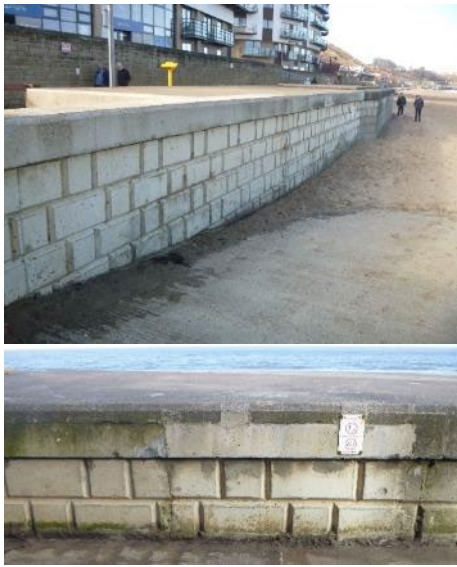
Asset Location:	TA03818971, TA03758981	
	Asset Length:	34.2	
	Condition Assessment		
	Condition	Priority	Risk
	B	3	
	Brief Description		
	<p>Wall has been repaired since 2012 and is in fair condition. The southern section has been more recently encased and this is generally in good condition. There is one full height crack evident in the middle section, although this does not appear to have worsened since 2018.</p>		
Recommendations			
Monitor and repair cracks.

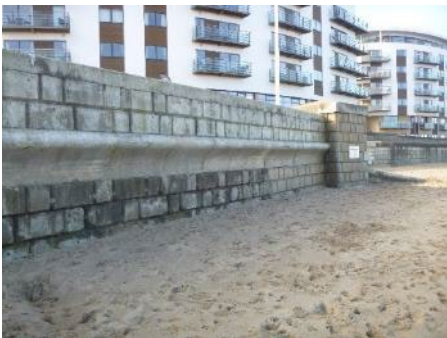
Asset Location:	TA03818971, TA03758981. In front of new development.	
	Asset Length:	93.2	
	Condition Assessment		
	Condition	Priority	Risk
	B	3	
	Brief Description		
	Unchanged since 2020. High beach levels concealed the toe of the wall. The upper section of wall has been rebuilt at North end. Some missing joints and chipping of capping beam and splash beam.		
	Recommendations		
Repair missing joints and chipped parts of capping and splash beams.

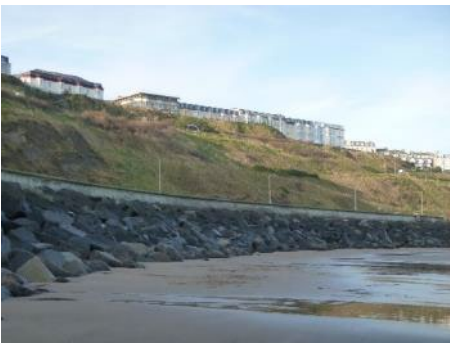
Asset Location:		
	Asset Length:	429.2	
	Condition Assessment		
	Condition	Priority	Risk
	B	4	>5
	Brief Description		
	Constructed circa 2003. The Holms. Prom & Splash wall in good condition. Armour well packed and good cover. The original wall is no longer visible.		
	Recommendations		
Continue to monitor.

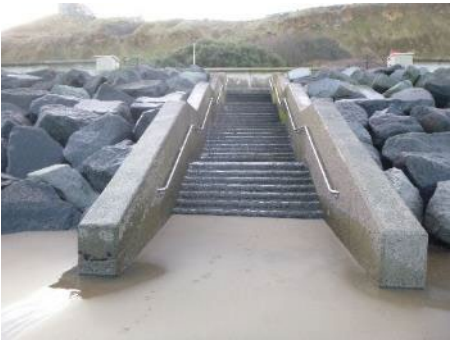
Asset Location:	Part of 46-20B-04	
	Asset Length:	~4	
	Condition Assessment		
	Condition	Priority	Risk
	A	4	
	Brief Description		
	Upper flight of steps remains in good condition throughout. Steps combine with SBC Ref: 46-20B-05 with single flight to beach level. Steps to lower part of flight to each level rounded.		
	Recommendations		
Continue to monitor.

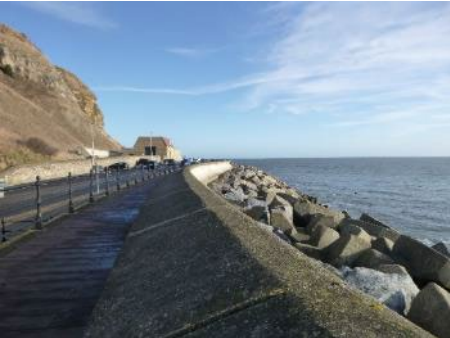
Asset Location:	TA05178883, TA04988952. East of Scarborough Castle.	
	Asset Length:	886.7	
	Condition Assessment		
	Condition	Priority	Risk
	B	4	>5
	Brief Description		
	Pre-cast concrete accropodes are slightly abraded and chipped throughout, with some localised areas of movement, including most significantly at the apex of the defence. No change to the condition and no significant cause for concern at present.		
	Recommendations		
Continue to monitor, in particular where there has been obvious movement of the units.

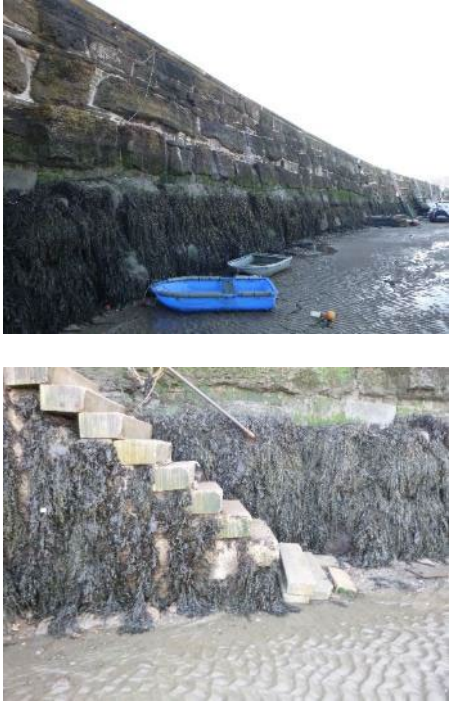
Asset Location:	Scarborough Harbour. North breakwater inner wall.	
	Asset Length:	362.1	
	Condition Assessment		
	Condition	Priority	Risk
	C	2	
	Brief Description		
	<p>The wall was inspected in detail at low water during the 2022 inspection. There is extensive vegetation cover along the lower half of the wall, covering voids and open joints. Wall was repaired in 2004/5, however many of these repairs are now failing. There is evidence of voids and missing blockwork along the toe of the breakwater. The lower steps have failed and don't enable safe access of the harbour bed. There are some cracks in the promenade. Evidence of lateral voids at seaward end of breakwater. Visible along the low water mark during inspection from the beach to the south.</p>		
	Recommendations		
<p>Major works required to repair toe of wall and missing. Continue to monitor. Repair toe voids. Inspection of seaward end of structure required from boat.</p>

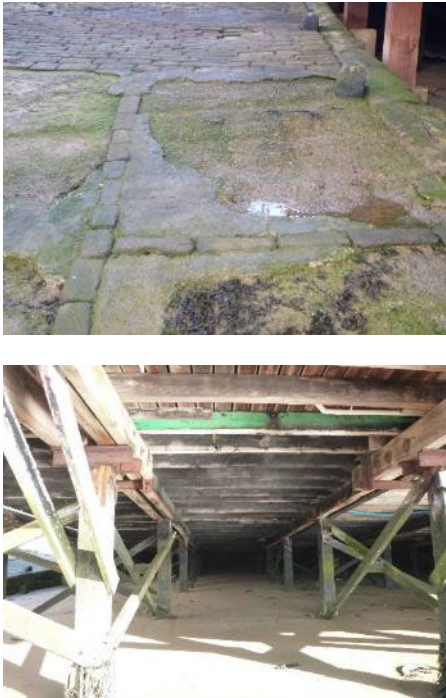
Asset Location:	TA05108874, TA05148874. Next to and under fairground.	
	Asset Length:	77.9	
	Condition Assessment		
	Condition	Priority	Risk
	C	3	
	Brief Description		
	<p>Slipway in poor condition, with missing cobbles on the upper reach and extensive abrasion across lower reach. Wall unable to be inspected in great detail due presence of overhanging timber balcony. Wall appeared generally to be in fair condition with some missing mortar. The timber structure appeared in fair condition, with no obvious areas of concern. However, as this is not a coastal defence asset it was not inspected in detail.</p>		
	Recommendations		
Report missing joints to spillway wall and repair slipway surfacing.

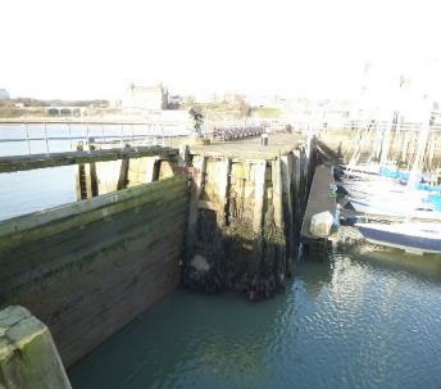
Asset Location:	TA04958853, TA04938860. Lighthouse island.	
	Asset Length:	83.5	
	Condition Assessment		
	Condition	Priority	Risk
	C	3	
	Brief Description		
	<p>Inner wall at entrance breakwater. Numerous cracks to blocks and missing mortar in joints. Vegetation and fenders obscuring most of walls. Stop logs were in place between the Lighthouse Island and the harbour breakwater during the inspection. It was also noted that the floating marina pontoons are in poor condition, and in one location the runners (which allow the pontoons to rise and fall with the tide) are no longer attached to the risers. This may lead to uneven loading on the structure and risks damaging the condition of the wall.</p>		
	Recommendations		
Continue to monitor and repoint cracks and joints.

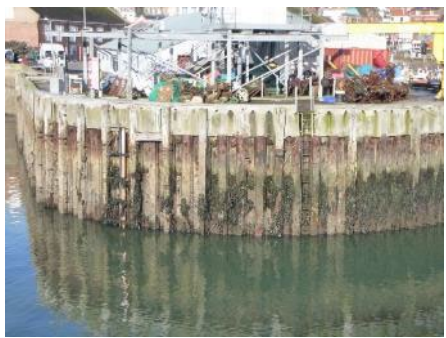
Asset Location:	West Pier, Scarborough South Bay.	
	Asset Length:	115.6	
	Condition Assessment		
	Condition	Priority	Risk
	C	1	
	Brief Description		
	<p>Section remains in poor condition, priority upgraded to 1 (Urgent) due to weight limit currently being in place on pier deck. Heavily corroded piles throughout, some voiding visible around low water mark. Recent dive surveys have recorded large voids around seaward end of structure. Cracking evident in coping beam.</p>		
	Recommendations		
Continue to monitor. Inspect piles, repair cracks.

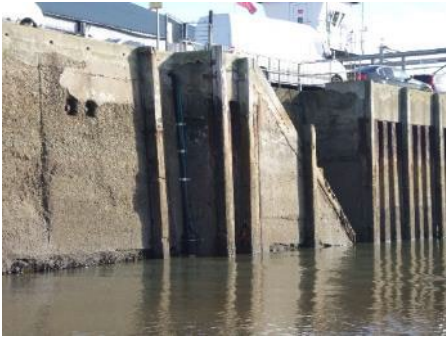
Asset Location:	West Pier, Scarborough South Bay.	
	Asset Length:	~5	
	Condition Assessment		
	Condition	Priority	Risk
	C	2	
	Brief Description		
	Steps in poor condition, cracking and missing render around steps. Treads not inspected. Back wall heavily abraded with exposed aggregates and missing capping block in places. Heavily corroded handrail. Large lateral void above toe of side wall on seaward side.		
	Recommendations		
Treat or replace handrail. Replace missing capping block and concrete skim the back wall. Repair cracks in seaward wall.

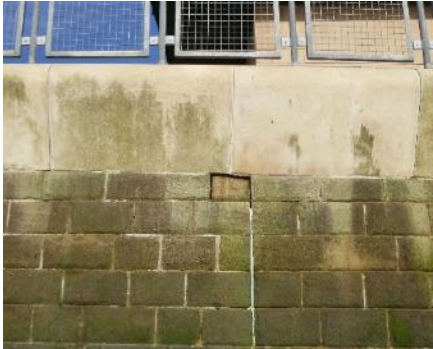
Asset Location:	TA04708872, TA04738870	
	Asset Length:	69.2	
	Condition Assessment		
	Condition	Priority	Risk
	B	4	
	Brief Description		
	Wall replaced as part of RNLI development. Wall remains in good condition. Vegetation growth around full perimeter of wall may obscure defects. Vegetation coverage most dense beneath the slipway. One displaced block was noted to the south of the slipway, appeared unchanged since 2020. Staining around flap valve beneath RNLI slipway.		
	Recommendations		
Repair damaged blockwork. Clean vegetation, particularly beneath slipway.

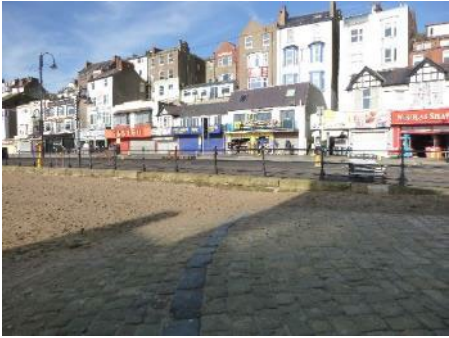
Asset Location:	Next to Life boat house.	
	Asset Length:	28.5	
	Condition Assessment		
	Condition	Priority	Risk
	B	3	
	Brief Description		
	Slipway appears in fair condition. Some cracked blocks and mortar required. Beach levels are locally high at the slipway in 2022 and this obscured a view of much of the slipway.		
	Recommendations		
	Repoint and replace blocks as required

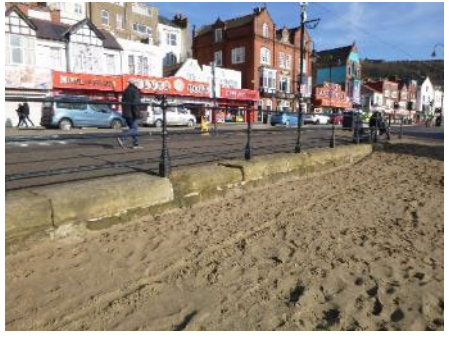
Asset Location:	TA04538856, TA04698873	
	Asset Length:	40.3	
	Condition Assessment		
	Condition	Priority	Risk
	B	3	
	Brief Description		
	High beach levels in 2022 mean only the coping and upper course of blockwork was visible.. Some missing mortar between joints in the coping and localised corrosion to handrails, notably at base.		
	Recommendations		
	Repair joints between blocks. Treat handrails and re-affix when bases become loose.

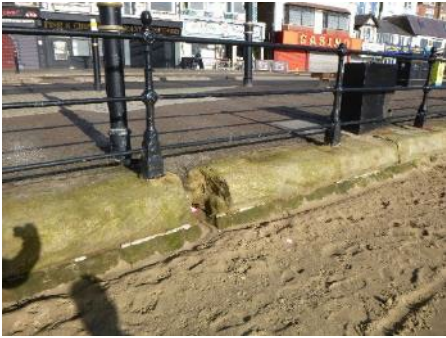
Asset Location:	TA04538856, TA04698873	
	Asset Length:	57.8	
	Condition Assessment		
	Condition	Priority	Risk
	B	3	
	Brief Description		
	<p>High beach levels in 2022 mean only the coping and upper course of blockwork was visible. Missing mortar between joints in the coping and localised corrosion to handrails, notably at base.</p>		
	Recommendations		
Repoint when necessary.
