Cell 1 Regional Coastal Monitoring Programme Walkover Inspection Surveys 2020

Scarborough Borough Council

November 2020

Walkover Inspection Surveys 2020

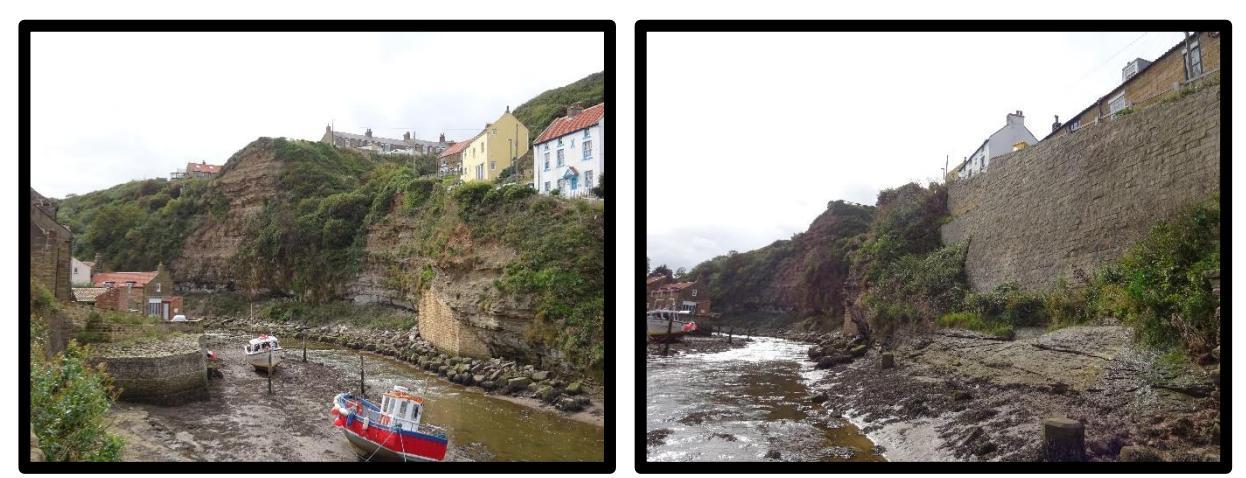
North bank: Works completed in 2013 to repair collapsed cliff (no asset ref)

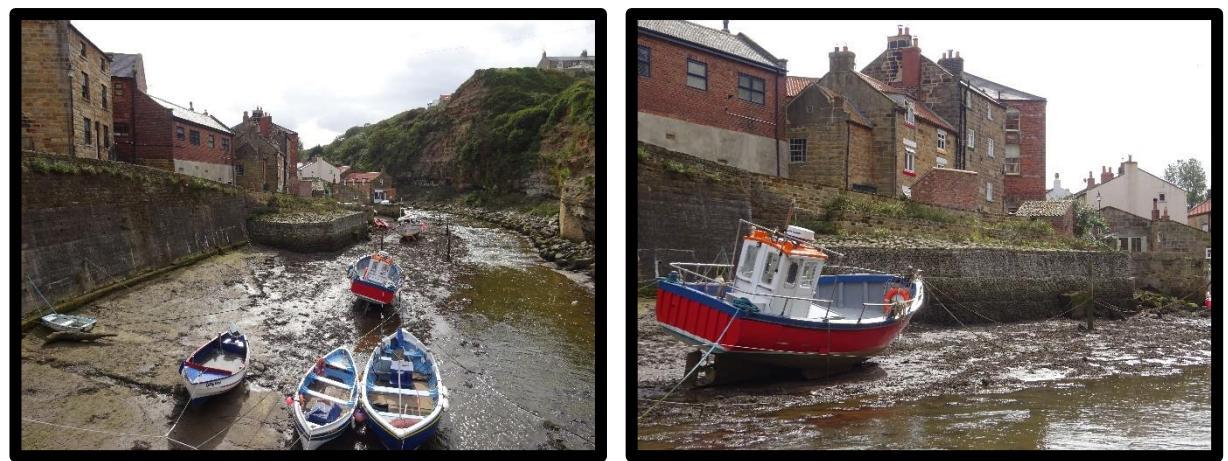
South bank: Stone-filled gabion baskets constructed in 2013 to repair collapsed wall (no asset ref)

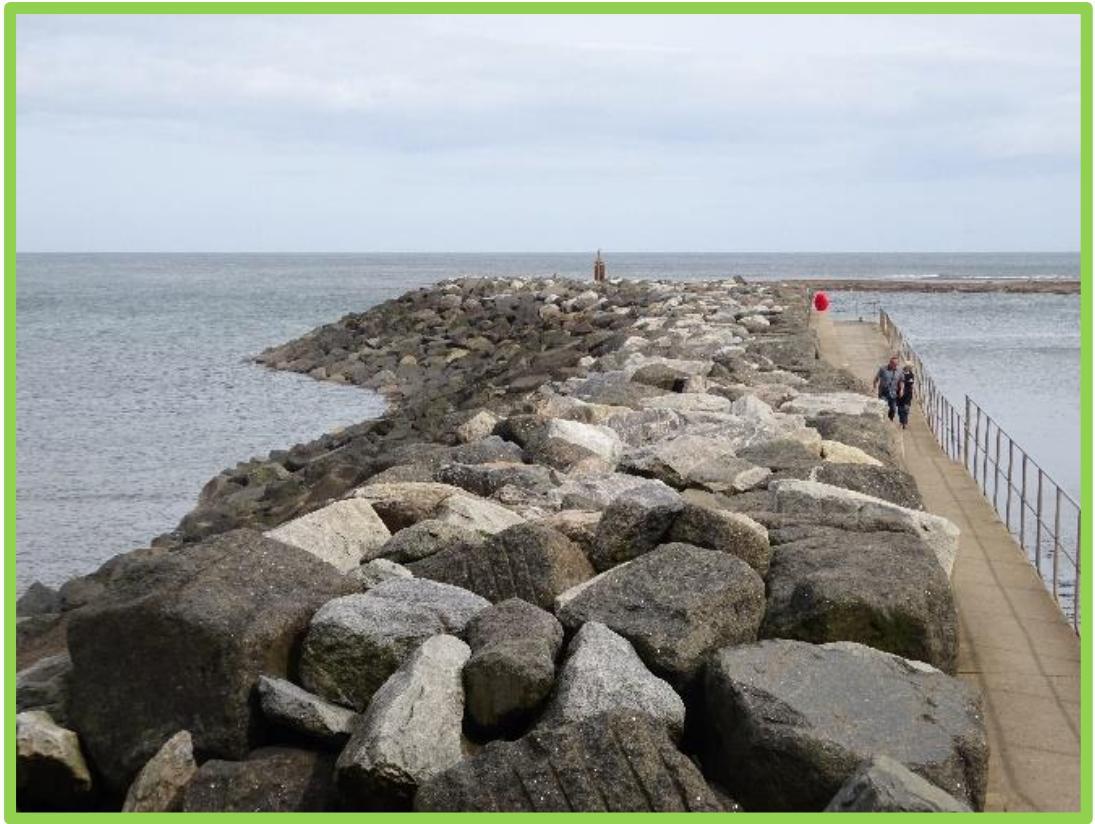
Rock armour revetment on seaward face of North Breakwater (/0402C01)

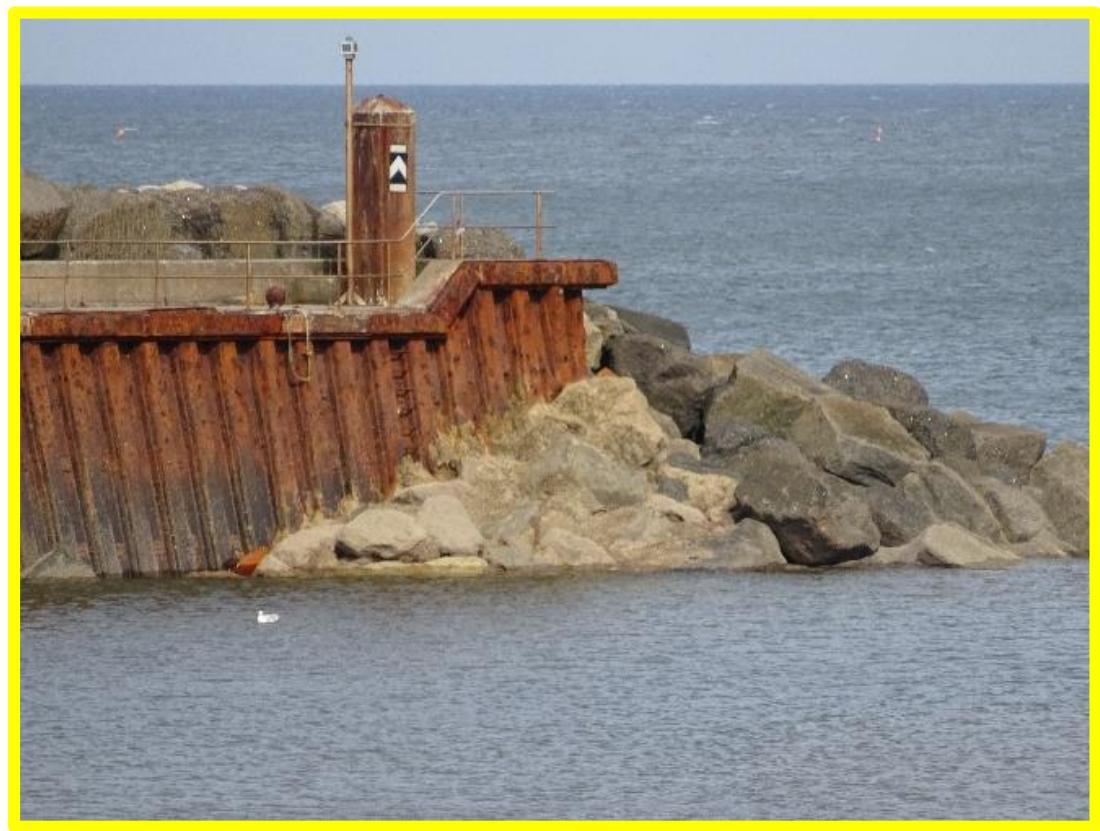
Corroded steel sheet piling on inner face of North Breakwater. Rock armour profile appears similar to 2018 inspection (/0402C01)

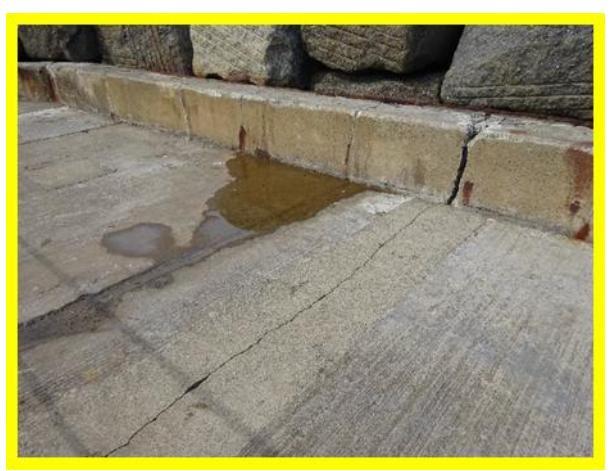
Crack in deck and crest wall (/0402C01). No significant change from 2018.

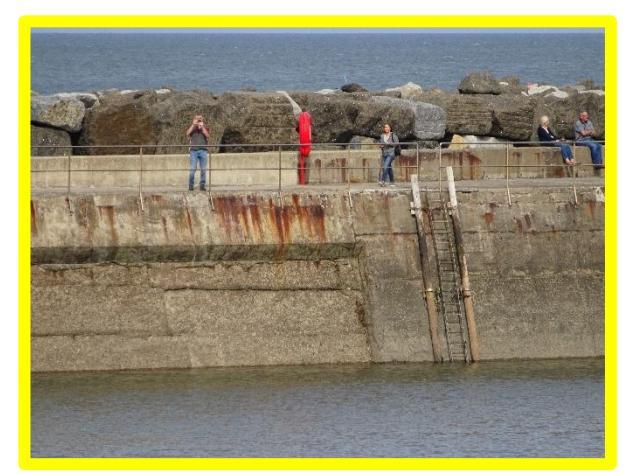
Rust staining of inside face and crest wall (/0402C01)

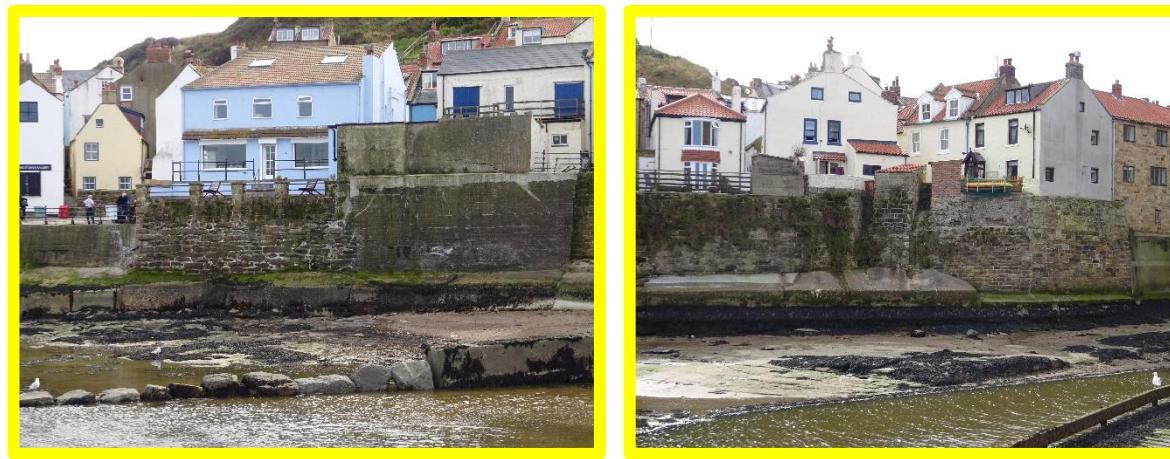
The walls continue as a series of masonry blockwork walls, often exterior walls of private properties (/0402C22), which continue to display visible loss of mortar causing open joints and missing blocks and vegetation growth locally. It is recognised that some previous repairs have been undertaken, but deterioration continues. Although undercutting of the toe has previously been reported in several locations, exposing timber piling, this was not observed during the 2020 inspections.

Cracking and open joints locally (/0402C22)

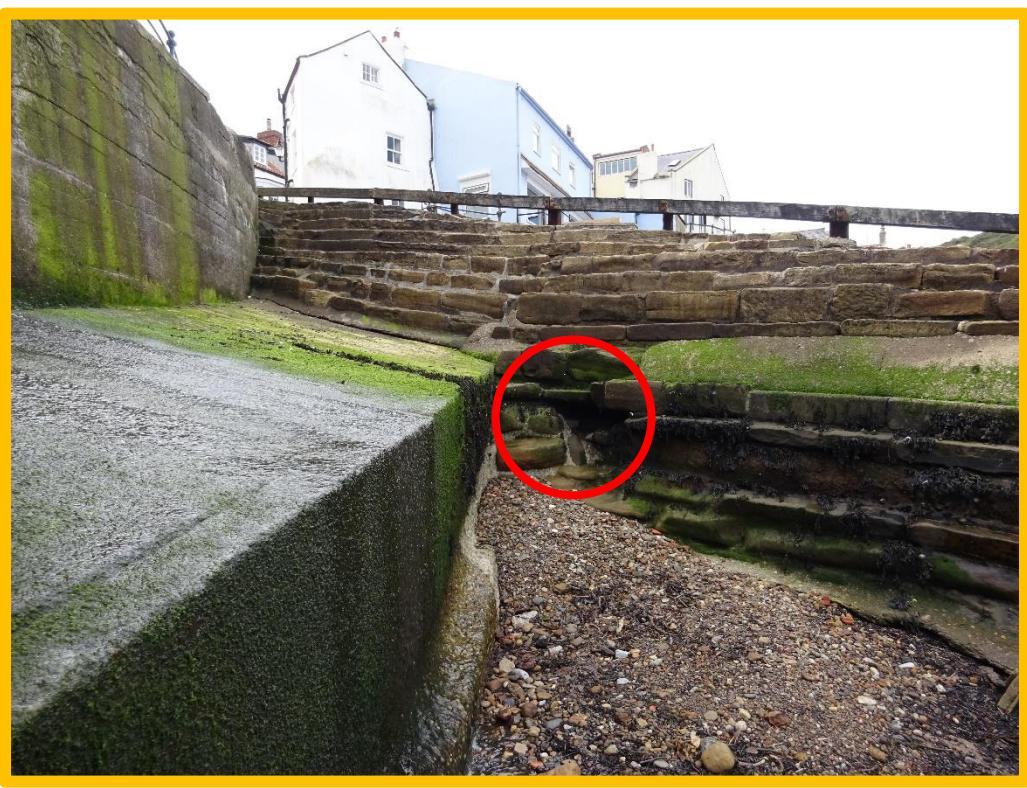
Void at interface between sea wall and south face of slipway (/0403C05)

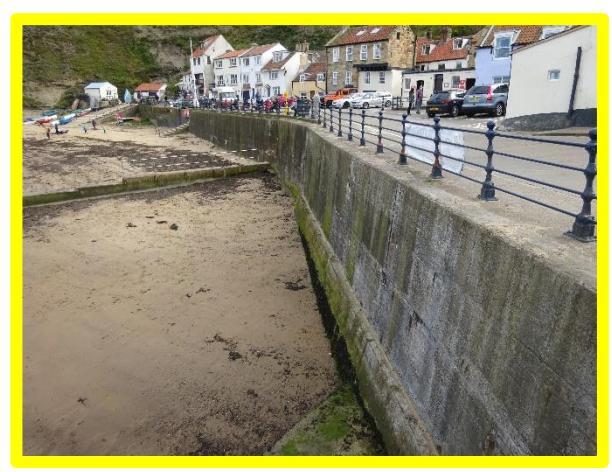
Whilst repairs and improvements have previously been undertaken to the sea wall west of the Cod & Lobster (/0403C05), the wall remains heavily abraded and cracked in places, although in fair overall condition. There is notable cracking and loss of render at the interface between adjacent seawall sections. The concrete groyne (/0403C07) limiting sediment movement within the harbour is in fair condition.

Concrete sea wall in Fair condition (/0403C05)

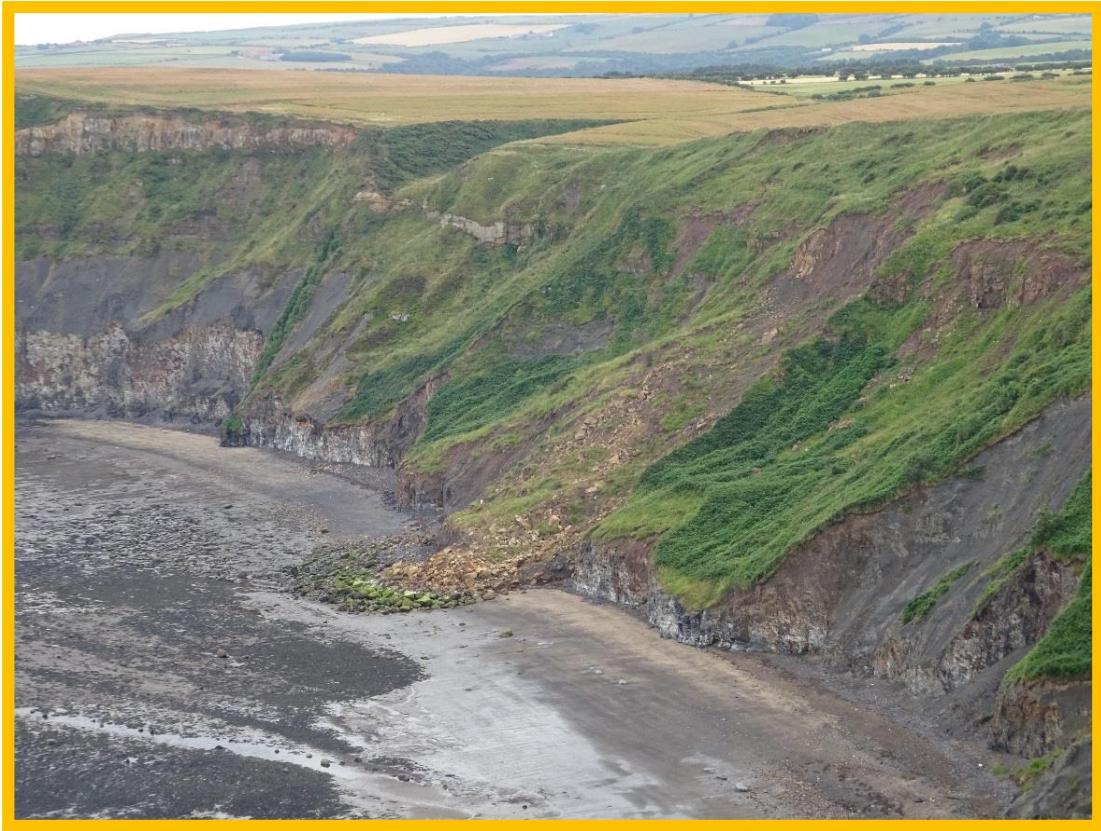
There is a lack of evidence of significant continued activity other than minor changes in the size of debris fan and a reprofiling of the toe section of the failure and this unit remains as Partly Active in September 2020.

MU6/5 – View of the landslip looking across Port Mulgrave from west to east (Partly Active in July 2018).

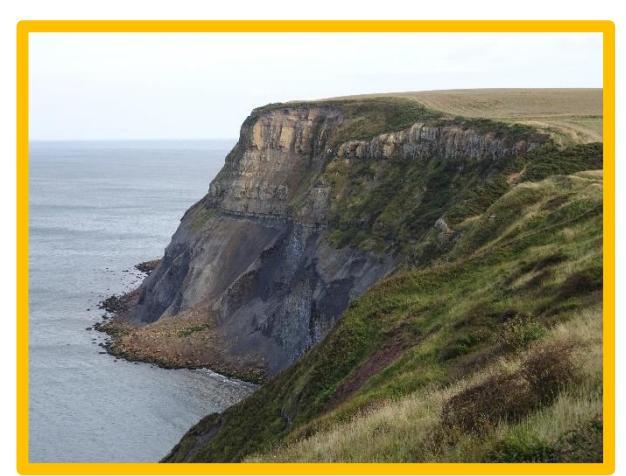
MU6/6 - Localised rock fall (Partly Active)

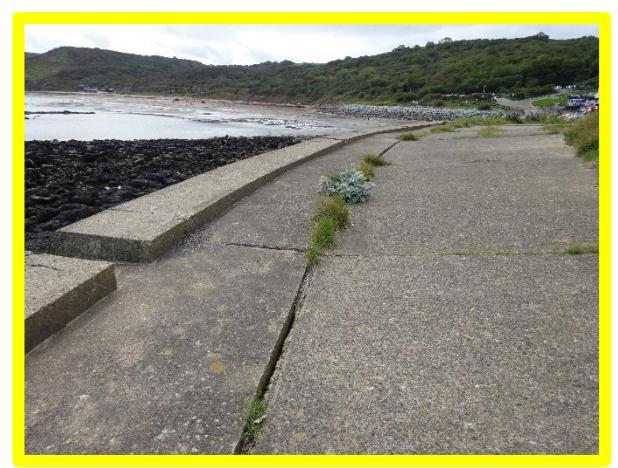
Open expansion joint with vegetation growth (/0601C01)

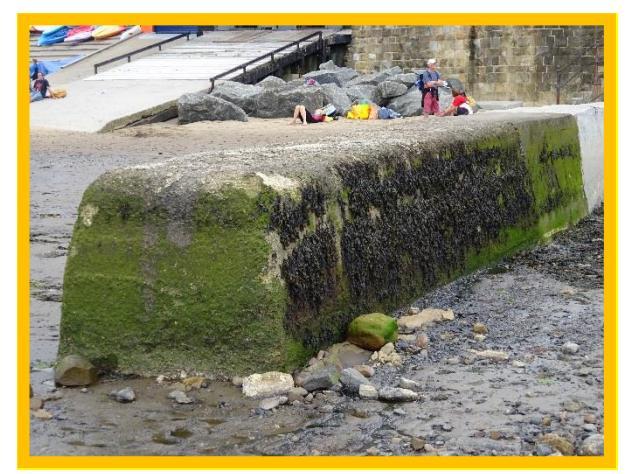
July 2018 - Significant abrasion of concrete. Opening of joint between wall and crest concrete – largely obscured by vegetation (/0601C02)

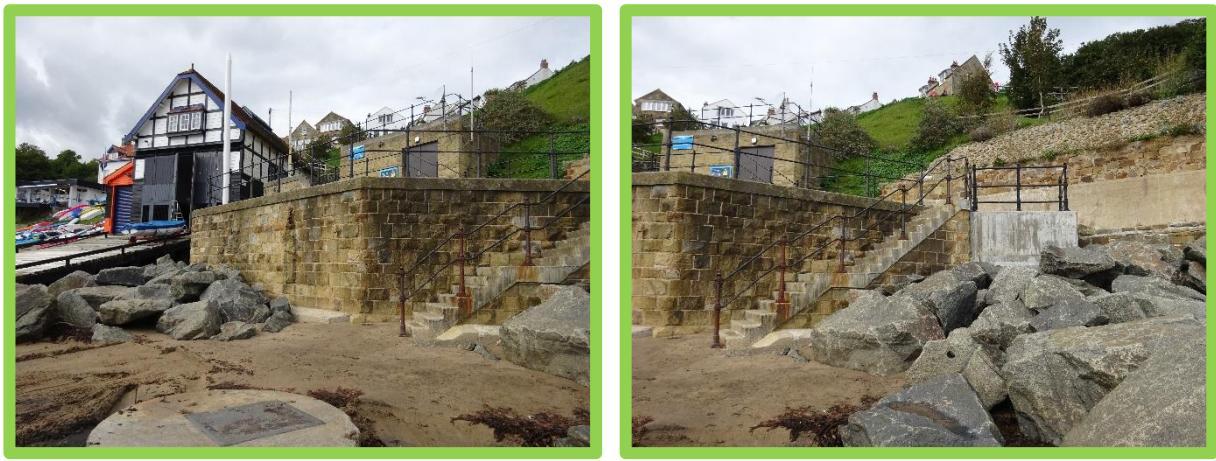
Break in rock armour fillet at pumping station (/0601C07)

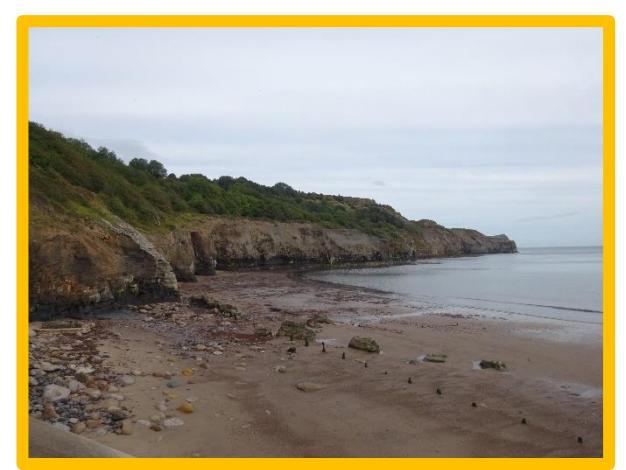
MU8/15 Partly Active in September 2020.

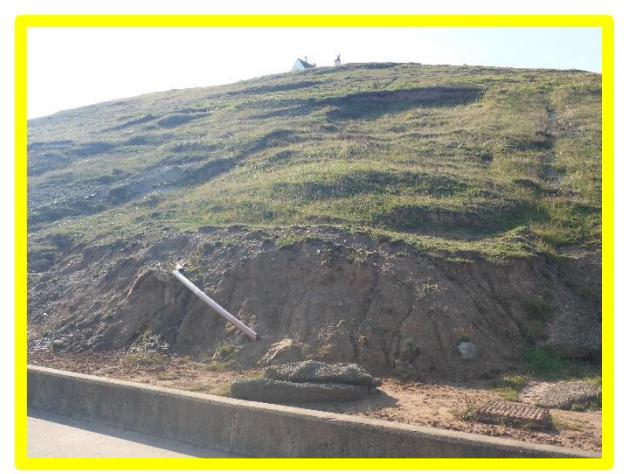
MU11/1 Evidence of slumping and broken pipe in the lower coastal slopes (Locally Active)

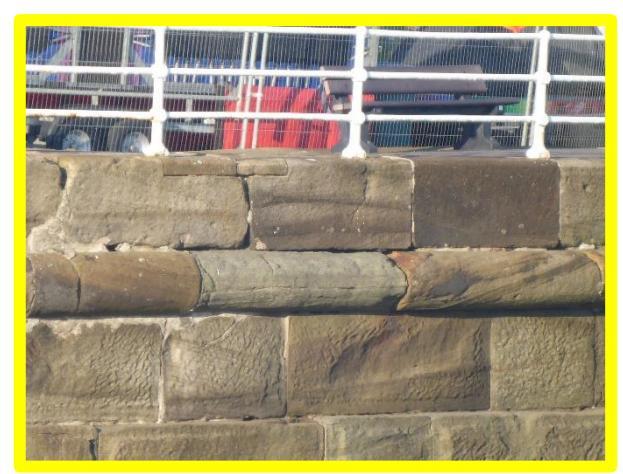
Open joints in wing wall to access steps (\D0802C12)

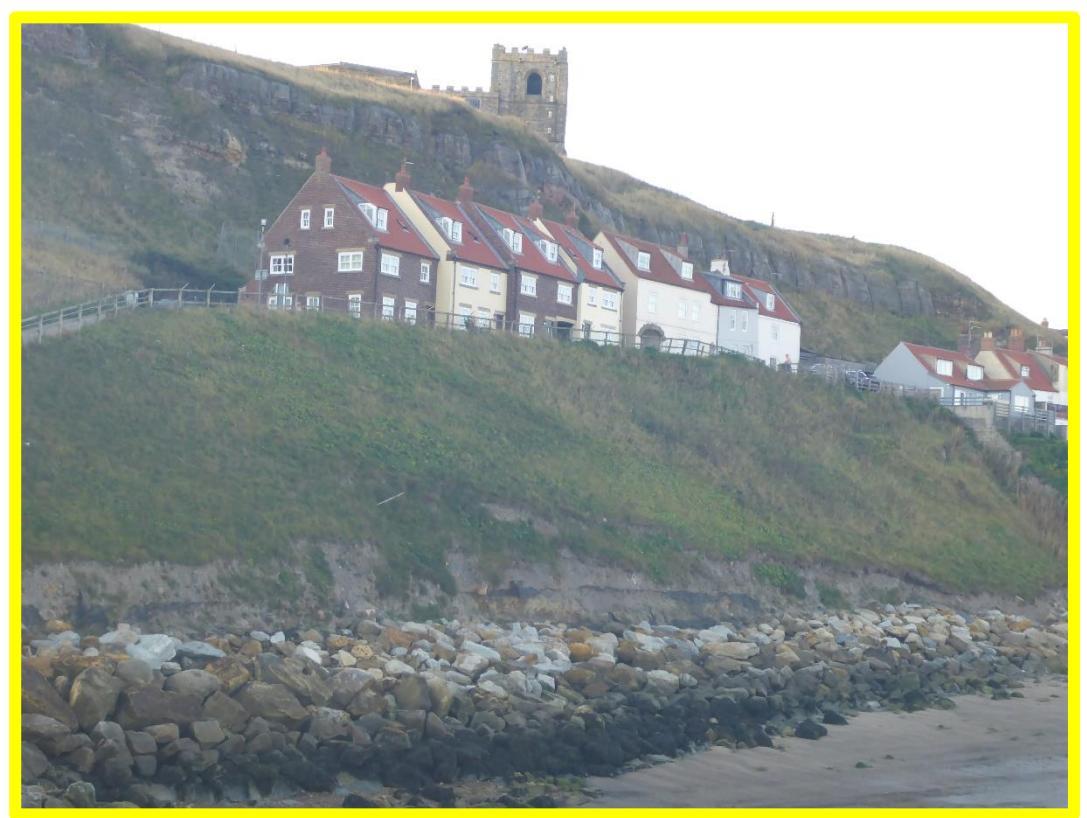
MU12/1 Slumps in lower cliff (Locally Active)

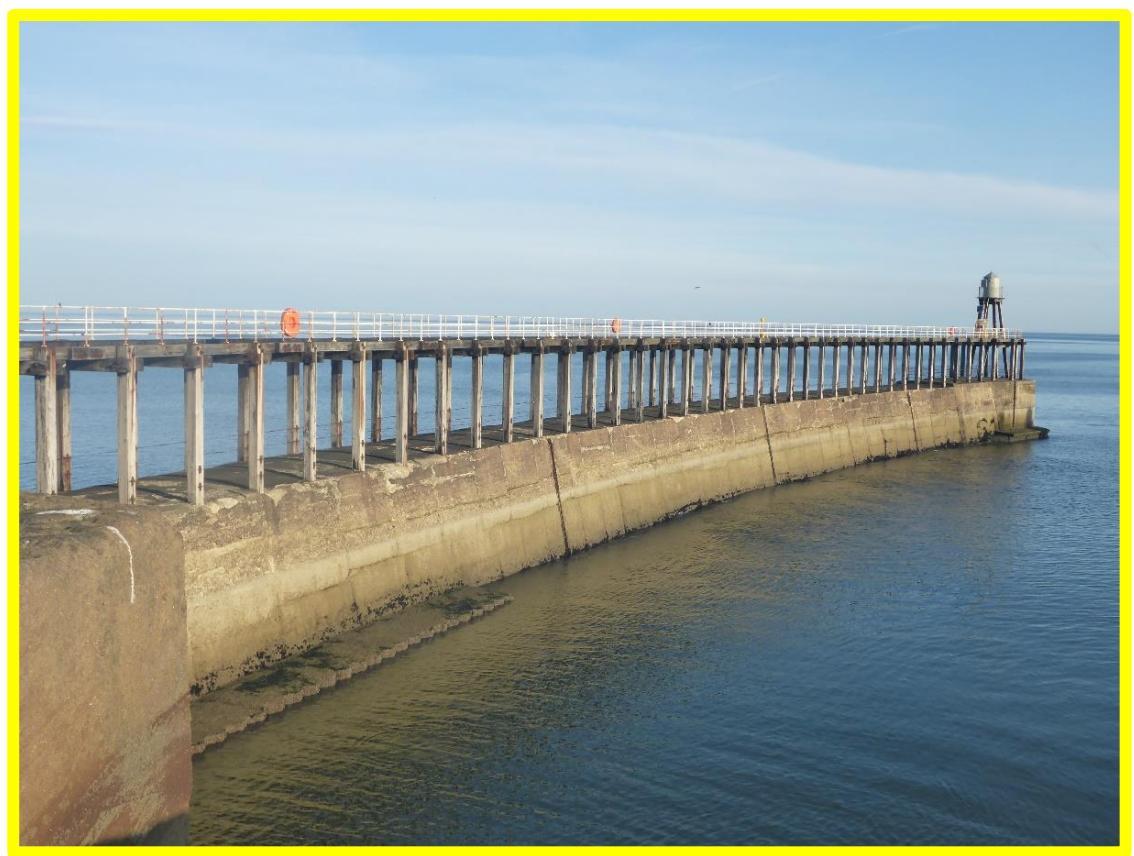
West Pier extension, generally in fair condition (\803C01)

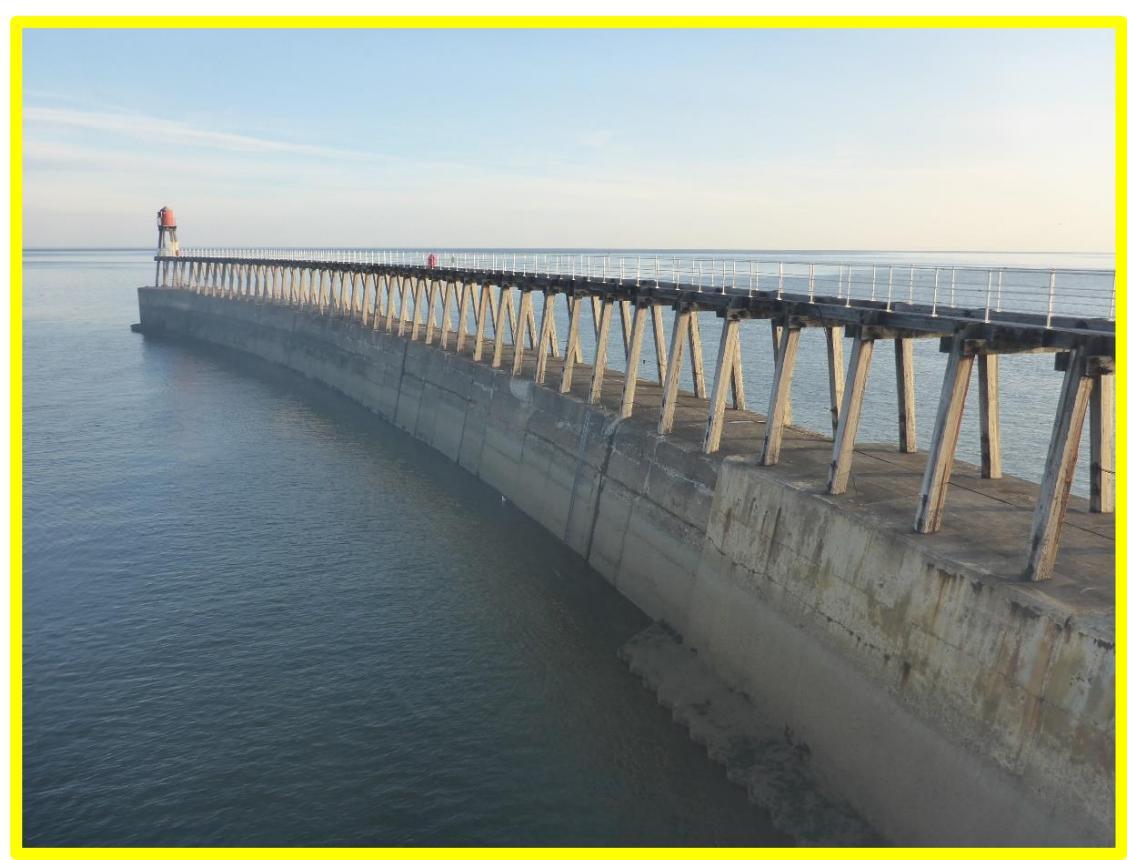
East Pier extension, generally in fair condition (\803C04)

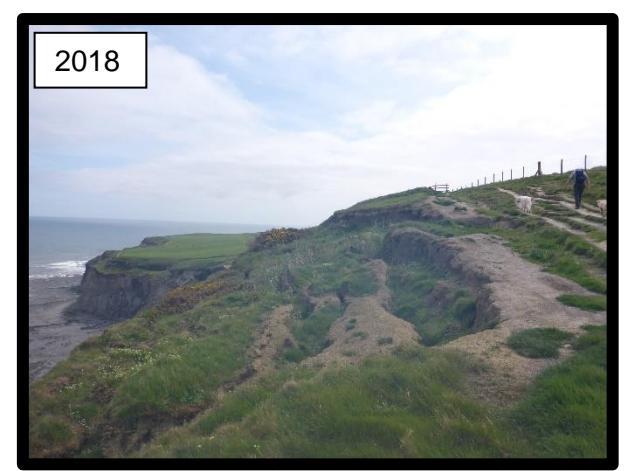
Tension cracks at **MU15/2** (Partly Active)

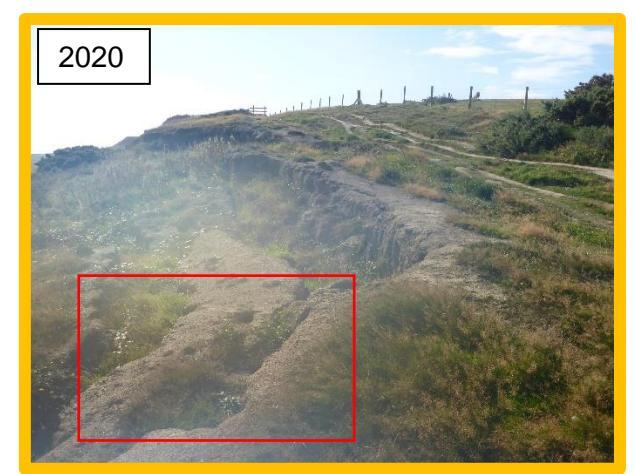
Tension cracks at MU15/2 (Partly Active)

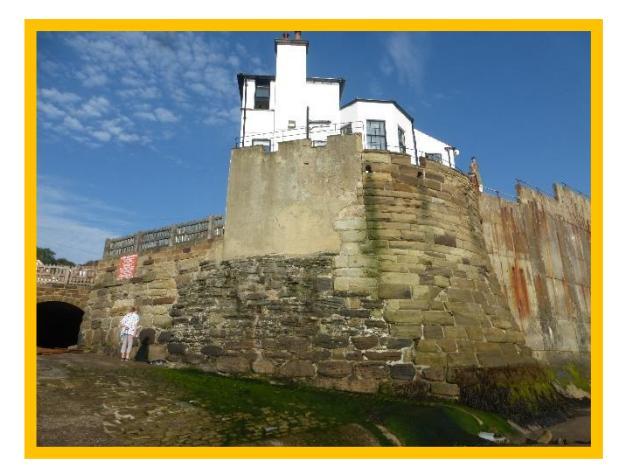
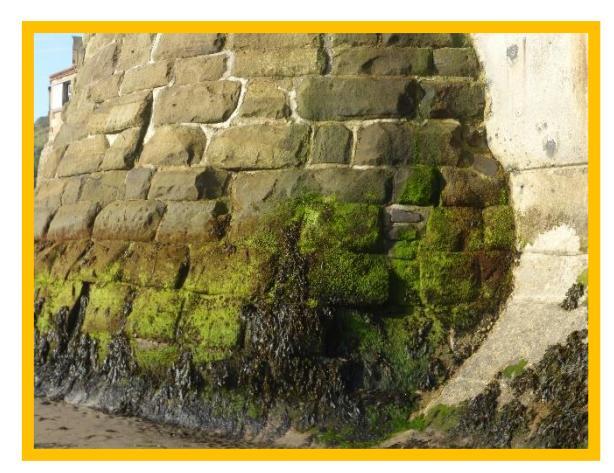
Immediately south of the large concrete sea wall, a private blockwork wall fronts the Bay Hotel (/1003C04). This wall extends south to the central slipway and is in overall poor condition. Ongoing maintenance activities are undertaken *ad hoc* on the asset. These include grouting of open joints and sealing the open interface with the precast concrete seawall to the north. Generally, the repairs appear to work effectively, however there remains a number of open joints visible in the wall face. Additionally, the low beach levels exposed voids in the concrete toe at beach level.

Blockwork wall in poor condition fronting the Bay Hotel (/1003C04)

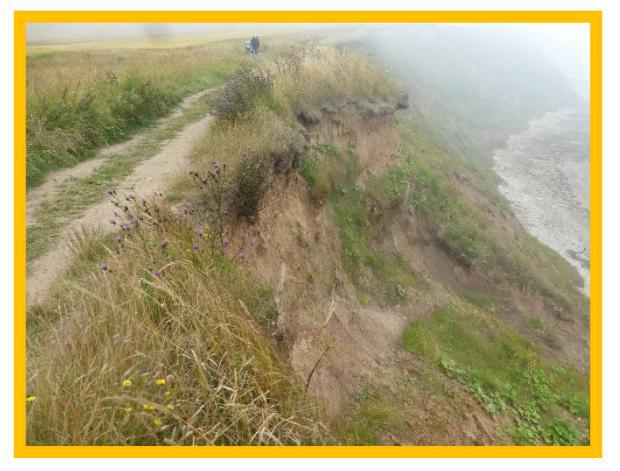
MU19/9 Landsliding and retreat of headscarp (Partly Active)

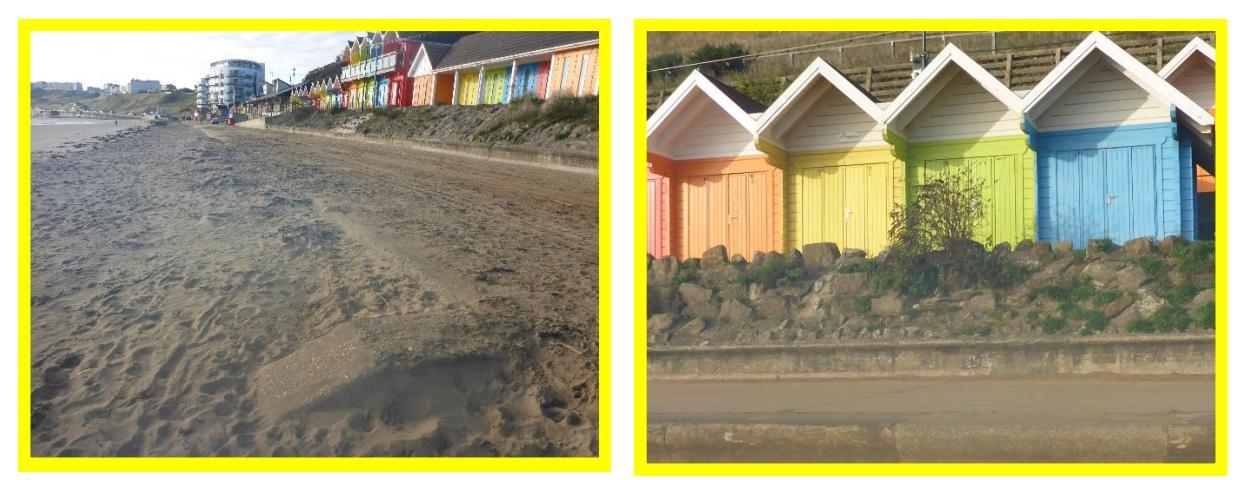
High beach levels almost overtopping Mature Vegetation growth (/1201C05) (/1201C05)

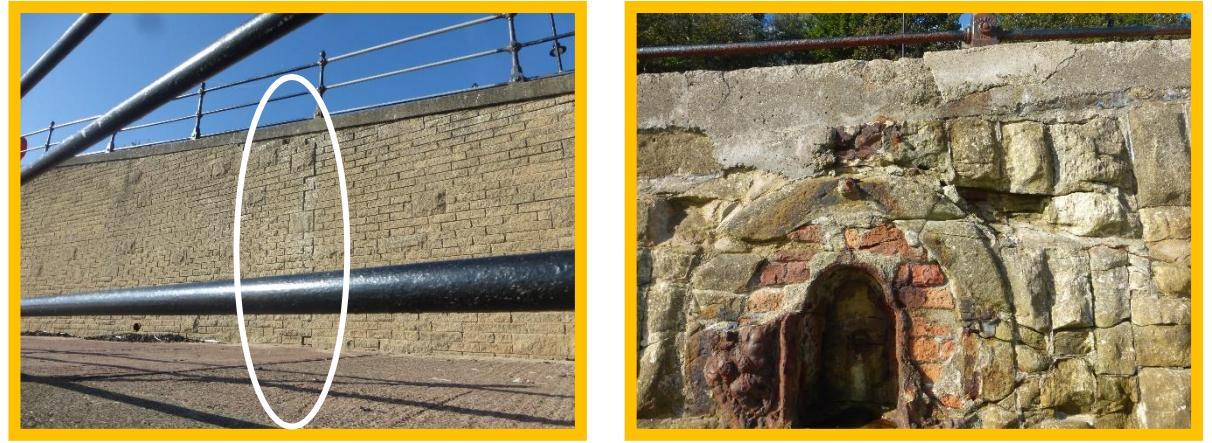
Vertical crack in wall above access ramp Missing blocks around Spa feature (/1301C10) (/1301C10)

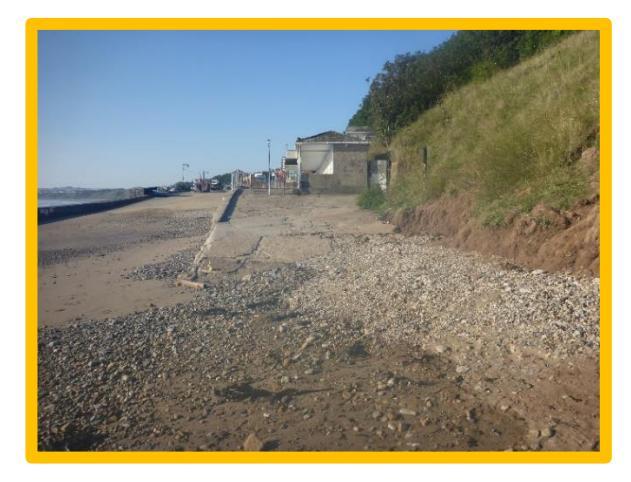
Voids in deck of rear ramp/wall at Coble Landing (/1602C01)

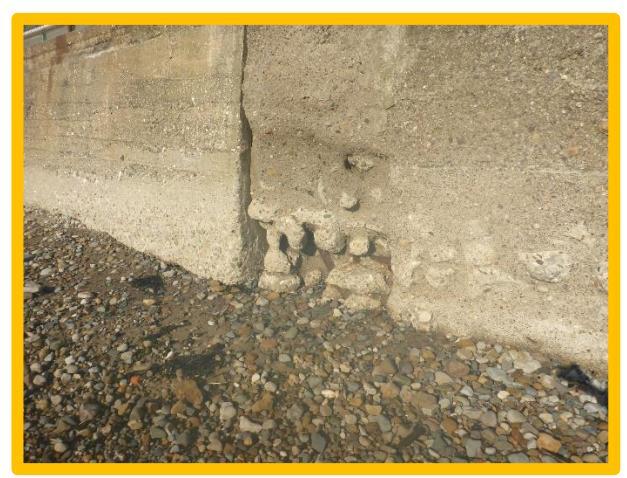
Heavy Abrasion damage to the rear wall (/1602C01)

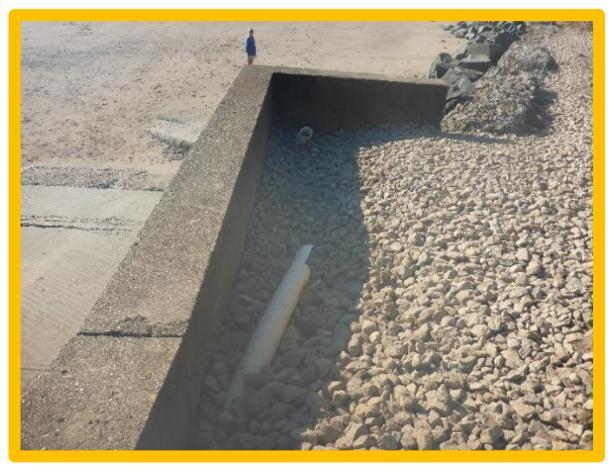
Broken drainage outlet and washout of material behind slipway (/1602C02)

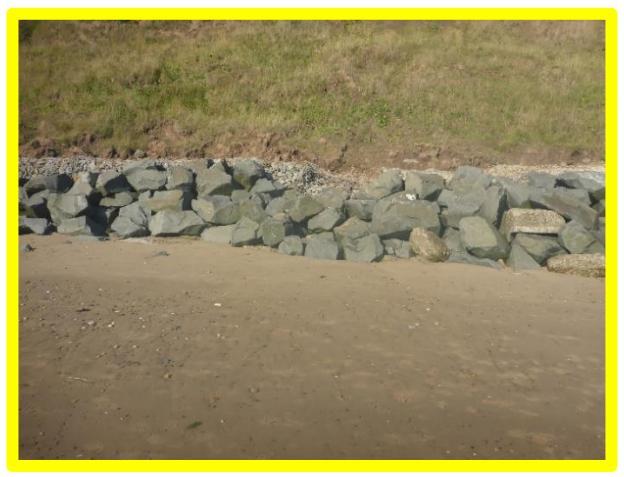
Crest depression in rock revetment at southern end of Filey Sea Wall (/1602C02)

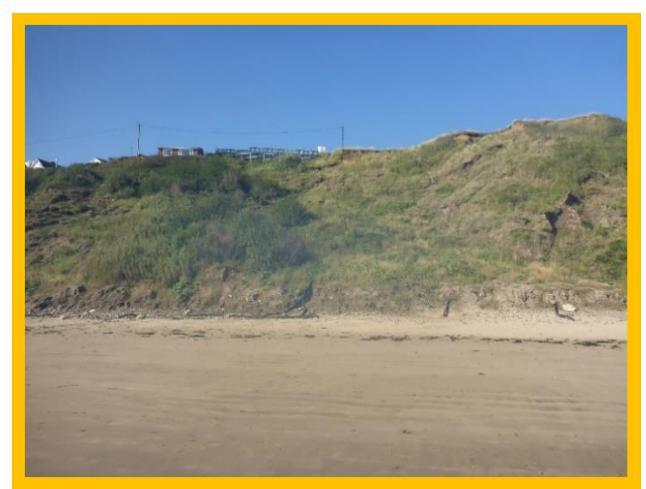
Eroded toe of till cliffs exposing damaged drains at Flat Cliffs. **MU29/AQ** Partly Active 2020

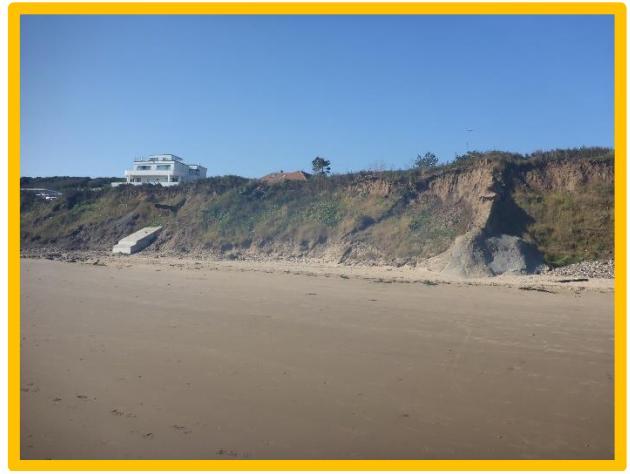
Replaced gabion baskets and outflanked rising main **MU29/AS** Partly Active in 2020.
