# Hundale Point to Scalby Ness Strategy Review – Stage II Report

August 2006

**Halcrow Group Limited**

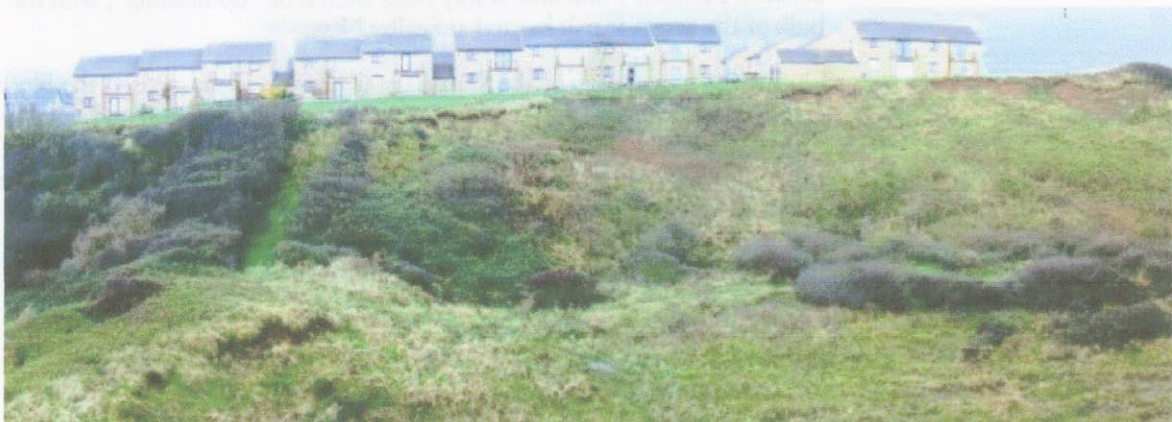
*Photograph 1. Panoramic view of properties near the cliff edge above north-east facing slope in management unit 19E/VI*

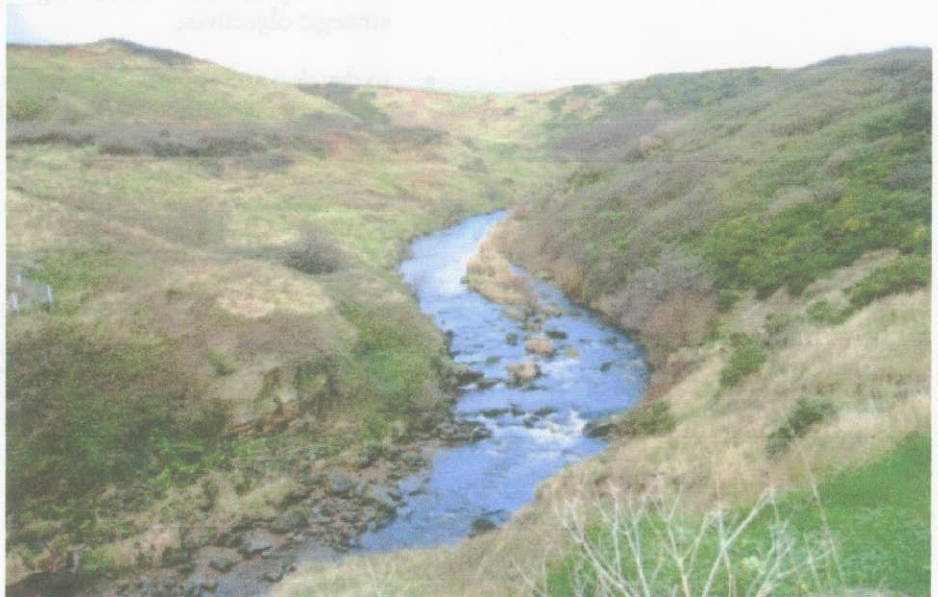
*Photograph 2. View of Scalby Beck below north-east facing slope*

Observations on site indicate that the river outfall of Scalby Beck is affected by marine influences, with wave rush and backing up of the river during periods of high sea states. The outfall characteristics of the river are significantly restricted by tidal influence and storm surge, particularly during spring tides and strong south easterly winds. The interaction of flood river water and tidal action during storm conditions adversely affects the toes of slopes adjacent to the beck.

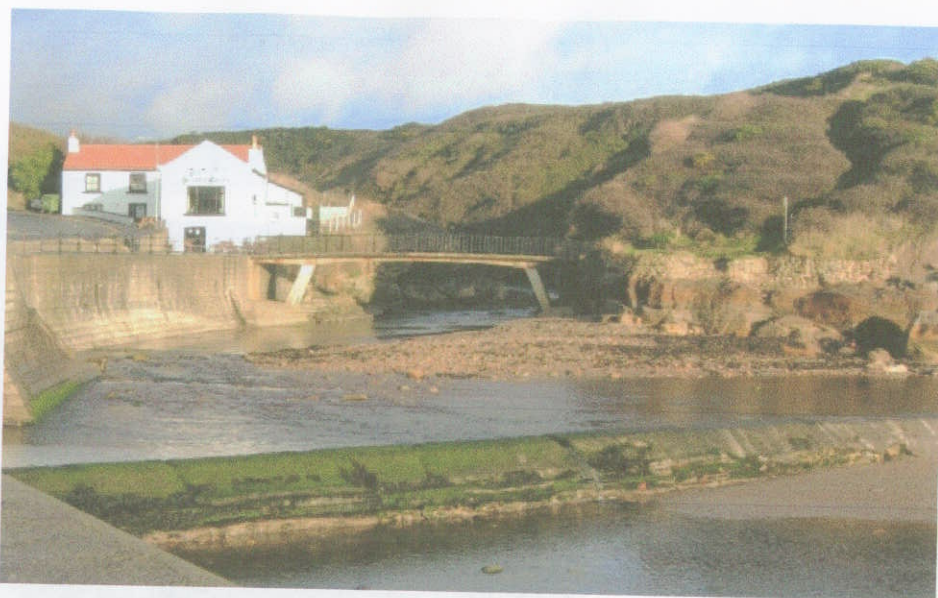
Photograph 3. View up Scalby Beck from the sea defences adjacent to the Sealife Centre

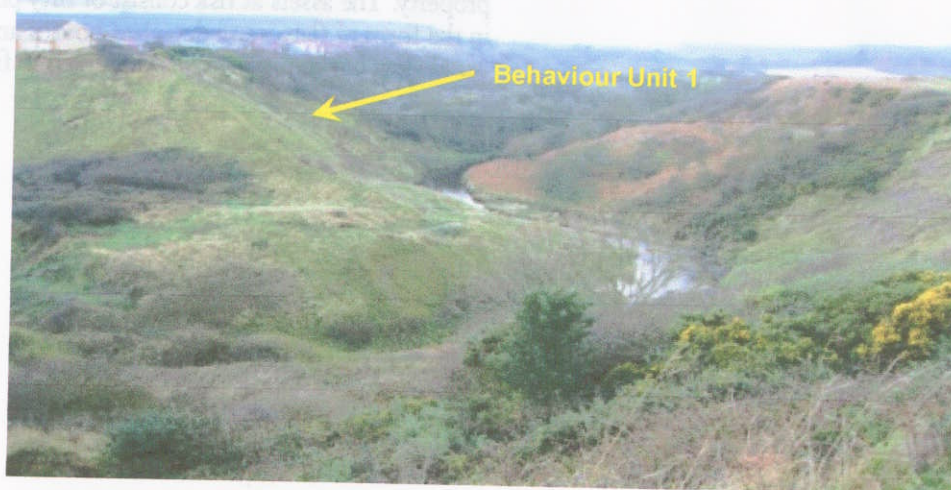
The north-west facing slope consists of recent shallow instability developed in the over steepened glacial till.

Photograph 4. View of north-west facing slope (to the centre left of the picture)

This behaviour unit is characterised by a non-circular failure involving the translational motion on a non-planar surface in glacial till deposits. There is evidence of blocky, episodic loss at the crest. This unit is likely to be subject to periodic movement, evidenced by fresh headscarp and cracking in the centre of the slope. Active toe erosion is occurring, reducing support for the material above.

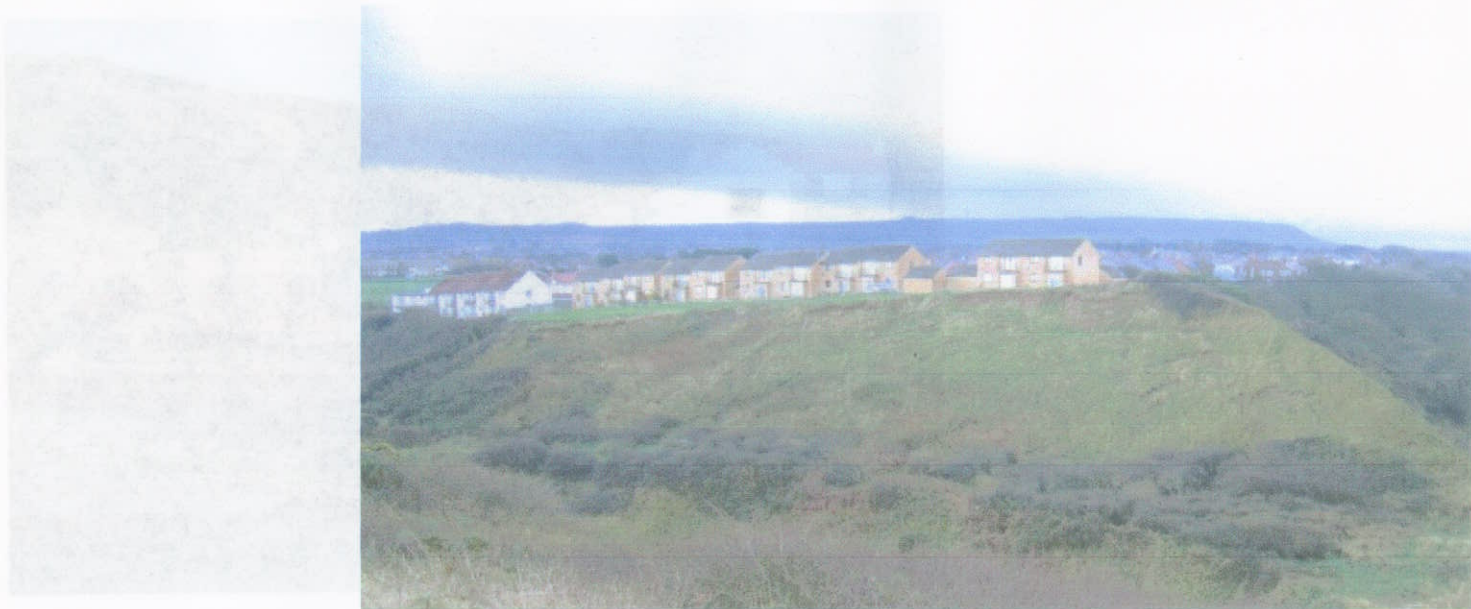
The north-east facing slope consists of a larger, deep embayment in glacial till with a back scar, approximately 100m in width, and a distinct reverse slope bench feature located midway up the slope. The southern part of the slope comprises an arcuate headscarp, with vegetated glacial till slopes beneath.

Photograph 5. View of north-east facing slope

This behaviour unit is characterised by an oversteep headscarp above oversteep glacial till slopes, which show evidence of cracking and localised shallow surface movement. There is evidence of blocky episodic loss at the crest. A large back-tilted block is present across the unit, the location and morphology of which suggests a large ancient deep-seated landslide. Part of the lower slope is inactive, but the part that is currently active shows saturated ground and tension cracks. Active toe erosion is taking place.

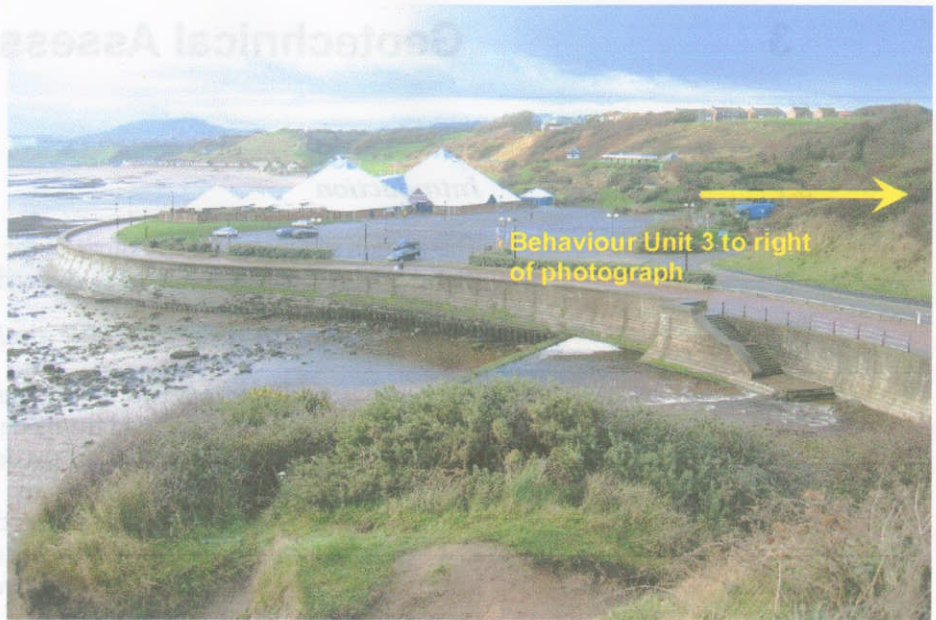
The slope in this unit was re-graded during the road construction and is currently well vegetated and showing no signs of instability. The toe is protected by rock outcrops at Scalby Beck and by toe protection put in place around the Sea Life Centre car park. This unit is considered stable.

*Photograph 6. Behaviour unit 3 looking south towards the Sea Life Centre*

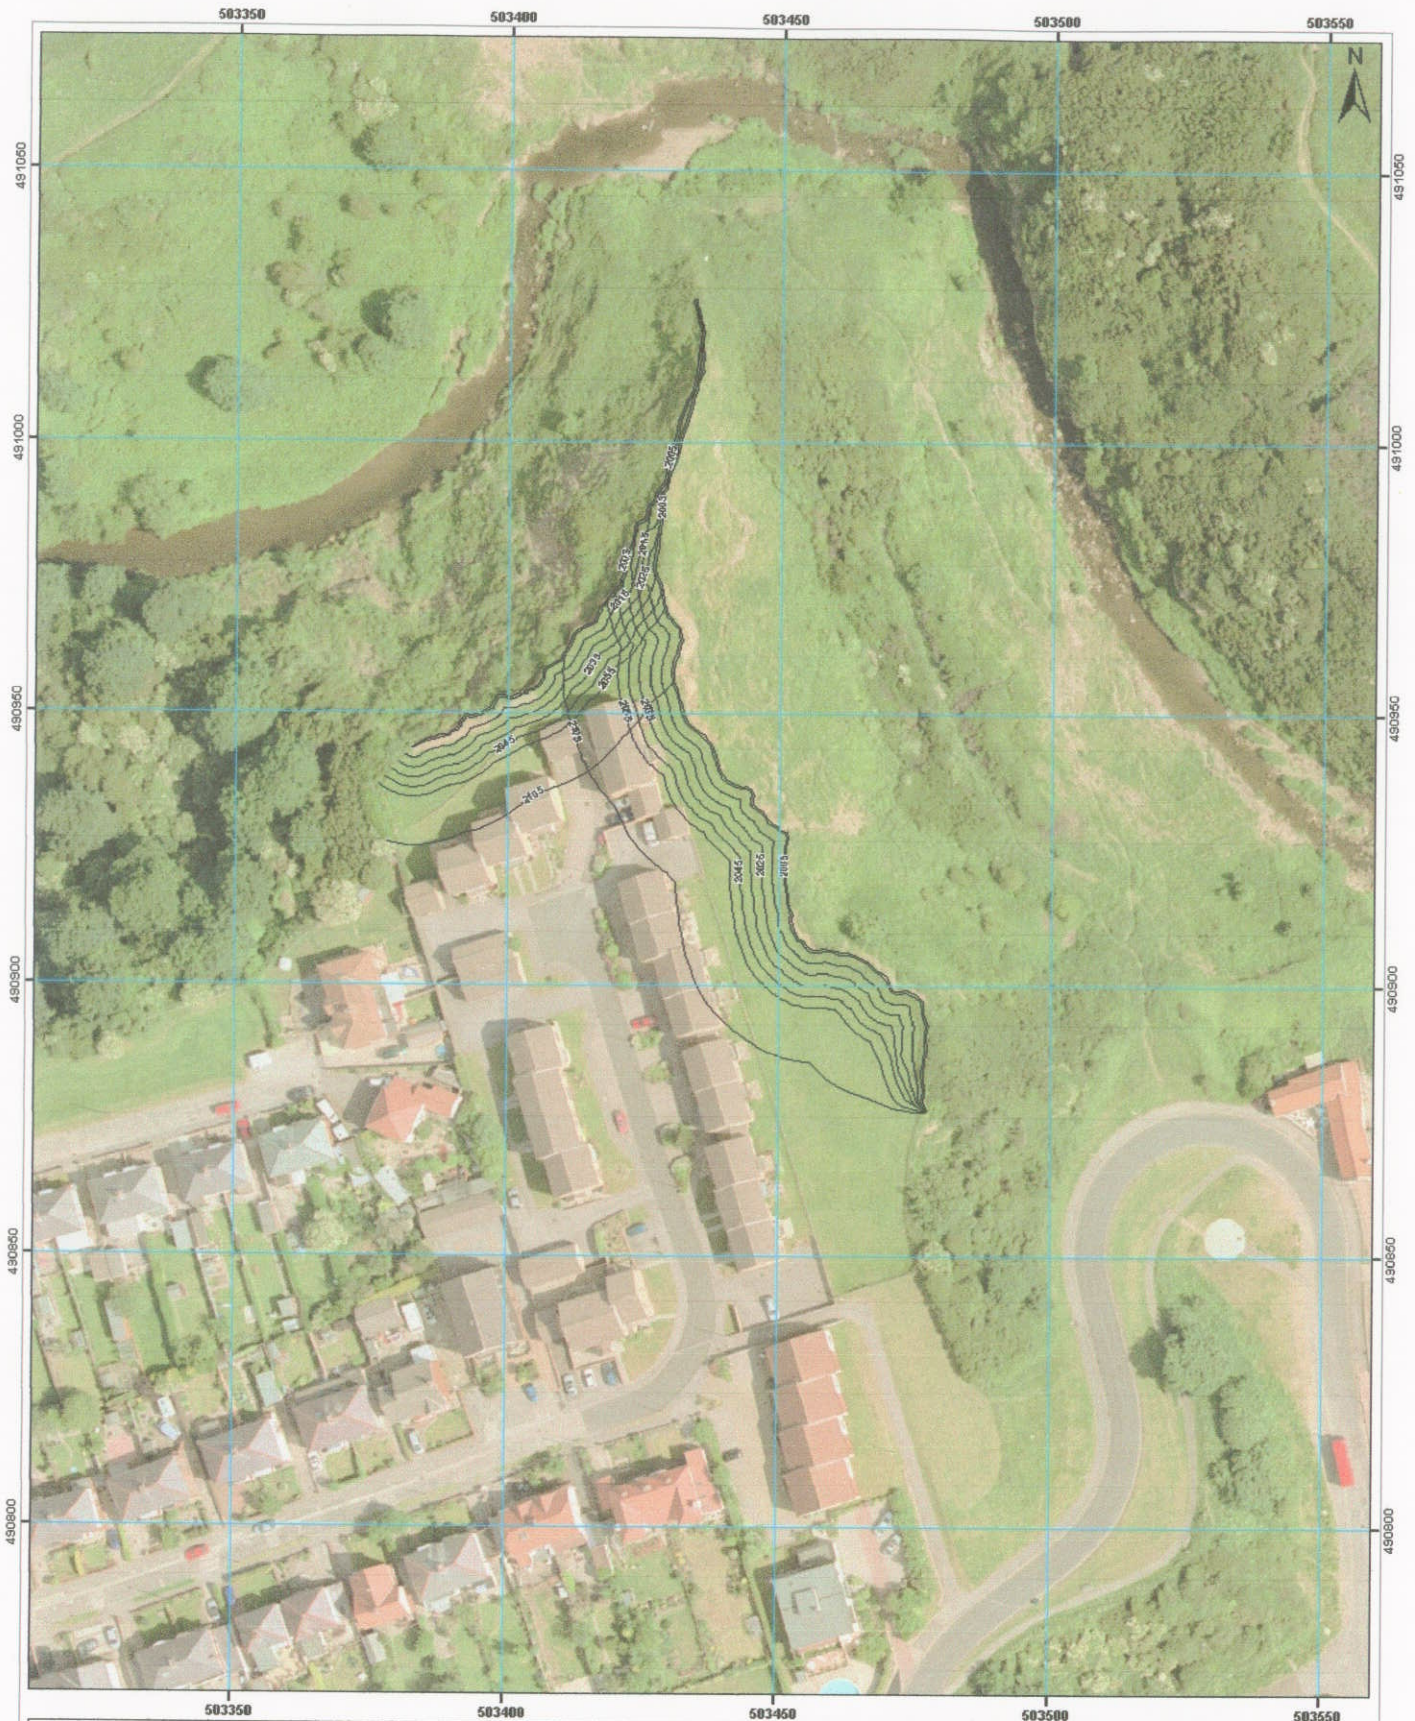
*Figure 16 – Cliff Recession Rates*

Recession of the headscarp is taking place through the localised failure of blocks, typically 0.75 to 1.0m wide, falling from the headscarps onto the slopes below. The rate of retreat has been estimated based on aerial photography and observations on site. Full details are presented in section 6 of the Stage 1 report (Ref. 1, Halcrow 2005) in Appendix A.
