Historic Trend Analysis and Geomorphological Review -Crimdon Beck, Hartlepool

Client: North East Coastal Observatory (on behalf of Hartlepool Borough Council)

Reference: PC1950-IB-RP-230911

Status: Draft/P01

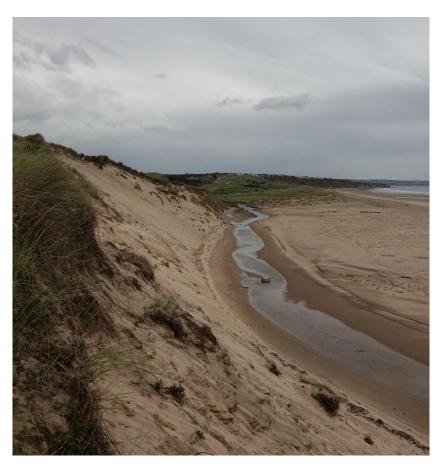
Crimdon Beck is a small stream that discharges onto North Sands beach, Hartlepool (**Figure 1.1**). Over recent years, the beck has migrated in position from a more direct route to the sea to a deflection south along the toe of the dunes and it is believed that its current alignment is potentially affecting the dune system that borders the Hartlepool Golf Course (**Figure 1.1**).

Figure 1.1 A view towards the north of the beck running along the toe of the dune cliff. Image taken during a walkover inspection in September 2023

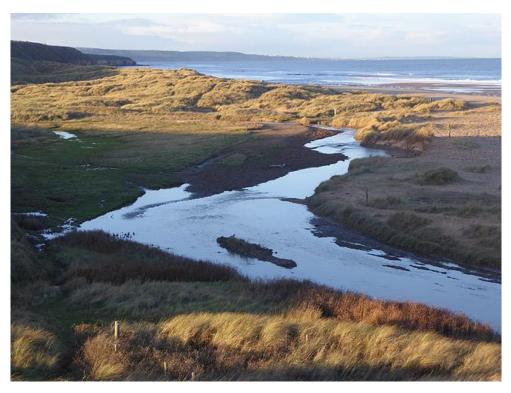
Figure 2.6 Crimdon Beck deflecting south by barrier of well vegetated dunes, image taken on 19th November 2015 by Oliver Dixon (Geograph.co.uk, 2015a). The photo is copyrighted but also licensed for further reuse.

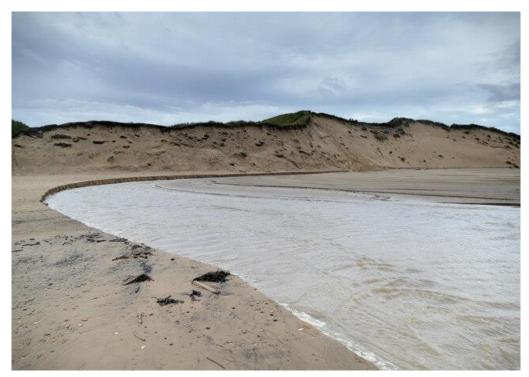
Figure 2.11 Crimdon Beck eroding into Hart Warren dunes, image taken by Andy Waddington 1st November 2021 (Geograph.org.uk, 2021). The photo is copyrighted but also licensed for further reuse.

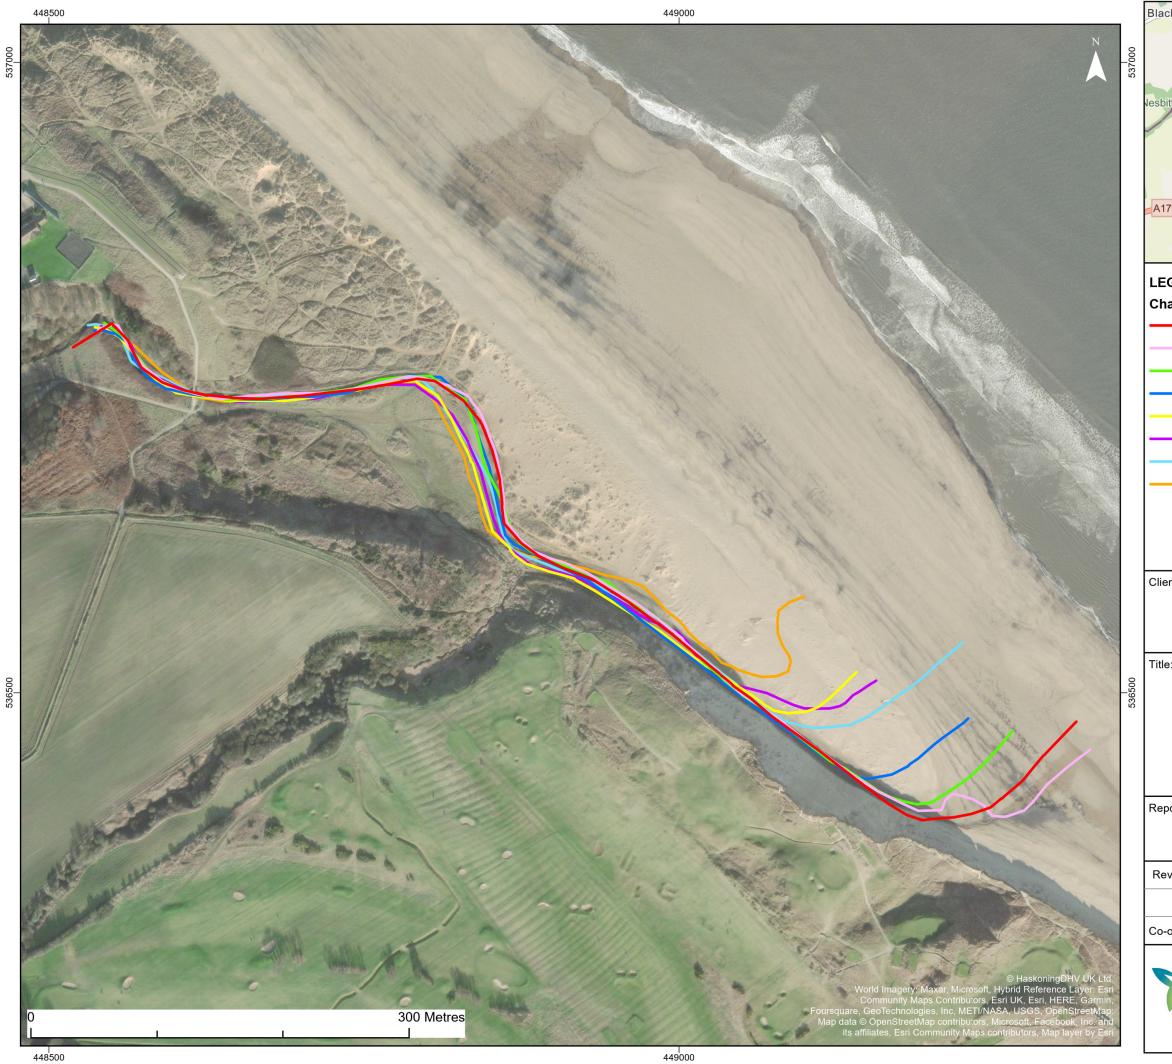
The beck channel was mapped on Google Earth for the years 2000, 2005, 2006, 2007, 2017, 2020, 2022 and 2023 to show the progressive southerly route (**Figure 2.14**). The figure shows a total movement of approximately 200m south between 2000 and 2023.

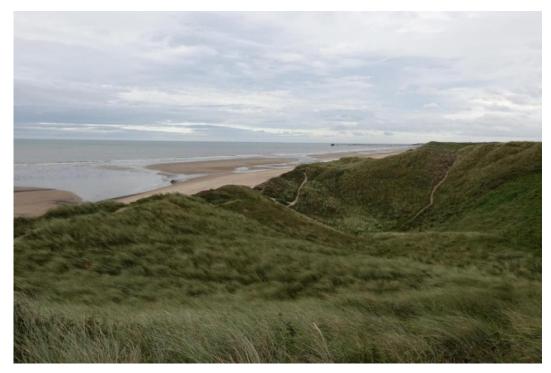
Figure 3.2 Well vegetated dunes north of the beck, showing informal access routes

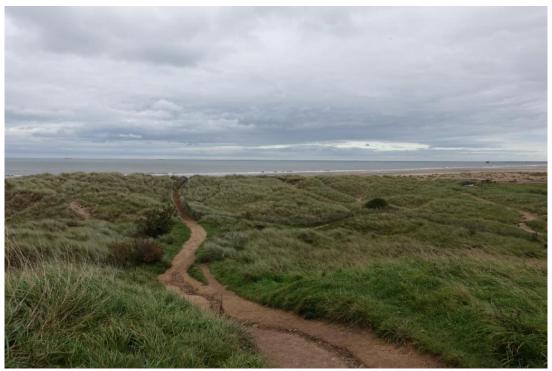
Figure 3.3 Informal access routes through dunes north of beck

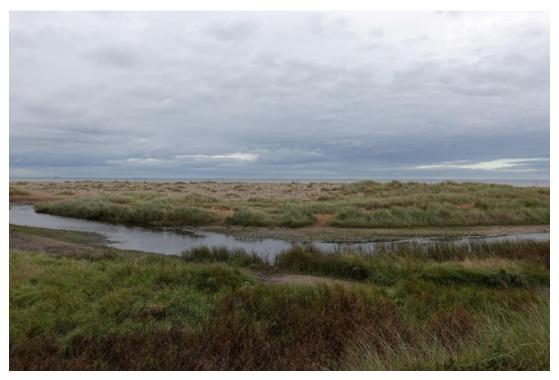
Figure 3.5 Deflection of the beck south (right of photo) showing vegetated low dunes on upper beach

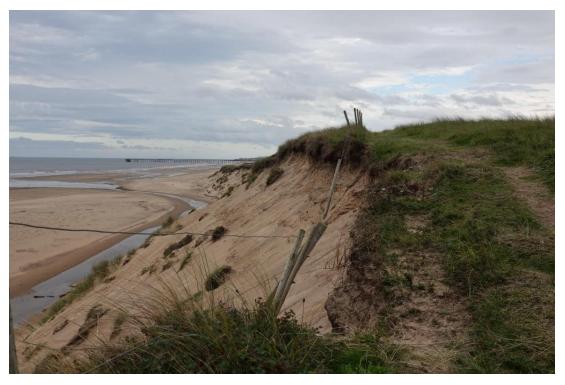
The inspection continued along the top of the dunes adjacent to the golf course, where the sand fence once at the crest of the dunes was visible on the face of the dunes (**Figure 3.7**). The crest of the dunes has eroded close to the fence bordering the golf course (**Figure 3.8**). The beck cuts along the toe of the dunes before discharging to the sea (**Figure 3.9**).

Figure 3.7 Sand fence on crest of dune now on dune face adjacent to golf course

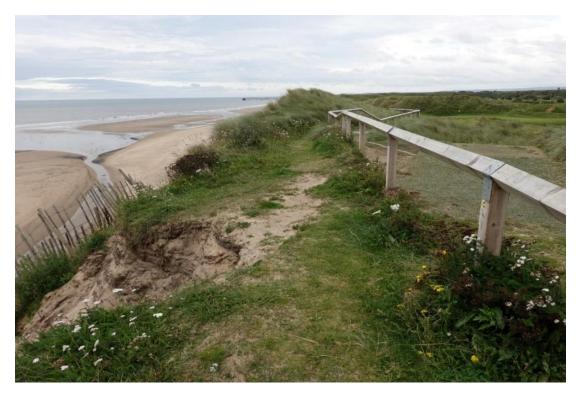
Figure 3.8 Top of dune crest showing erosion within 1.5m of golf course perimeter

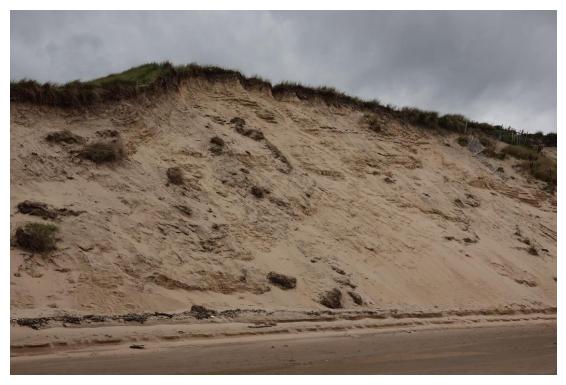
The inspection continued onto North Sands beach and over the beck, where cliffing of the dunes was visible (Figure 3.10 and Figure 3.11).

Figure 3.10 Cliffing of steep sand dune adjacent to the golf course

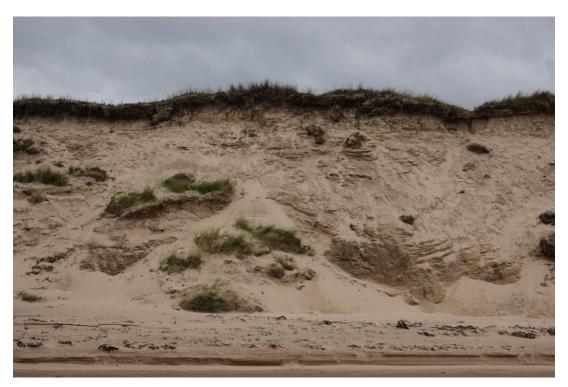
Figure 3.11 Cliffing of steep sand dune adjacent to the golf course
