**Cell 1 Regional Coastal Monitoring Programme
Analytical Report 3: 'Full Measures' Survey 2010**

^(*) The present report is **Analytical Report 3** and provides an analysis of the 2010 Full Measures survey for Northumberland County Council's frontage.

**Figure 2 - Map 1
 Northumberland County
 Council Frontage**
 Analytical Report 3
 'Full Measures' Survey 2010

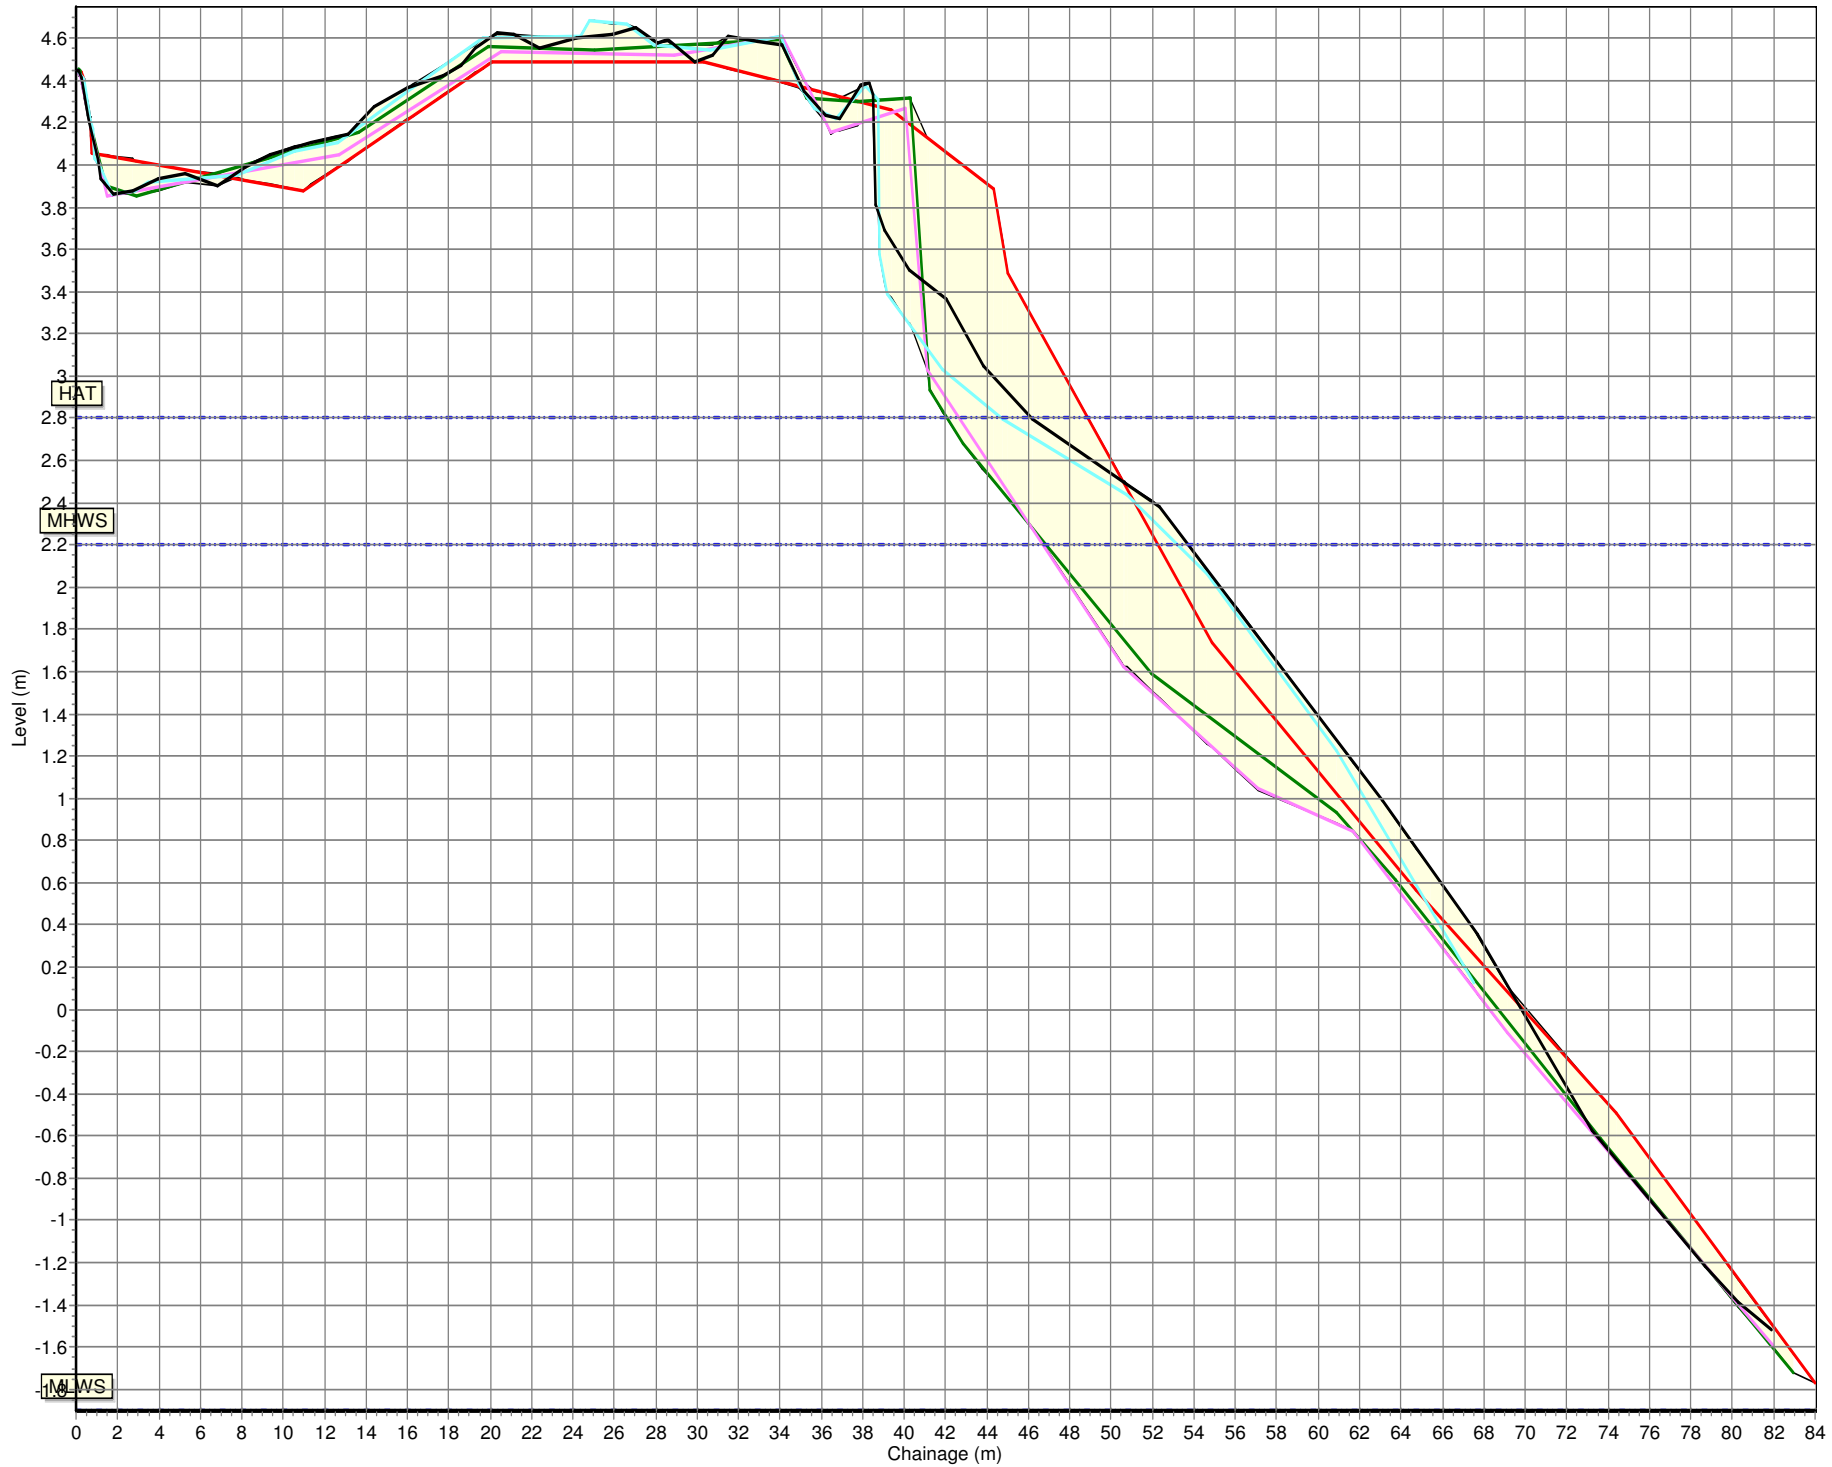
Beach Profiles: 1aBTBC02

- Profiles Envelope
- 01/04/2002
- 12/03/2009
- 21/09/2009
- 31/03/2010
- 23/09/2010
